North Fork Guadalupe River, from the Upstream Boundary
of the Kerr Wildlife Management Area to the Farm-to-Market 1340
Bridge Crossing at Mo-Ranch

River Studies Report No. 20

Inland Fisheries Division
Texas Parks and Wildlife Department
Austin, Texas

September 2012

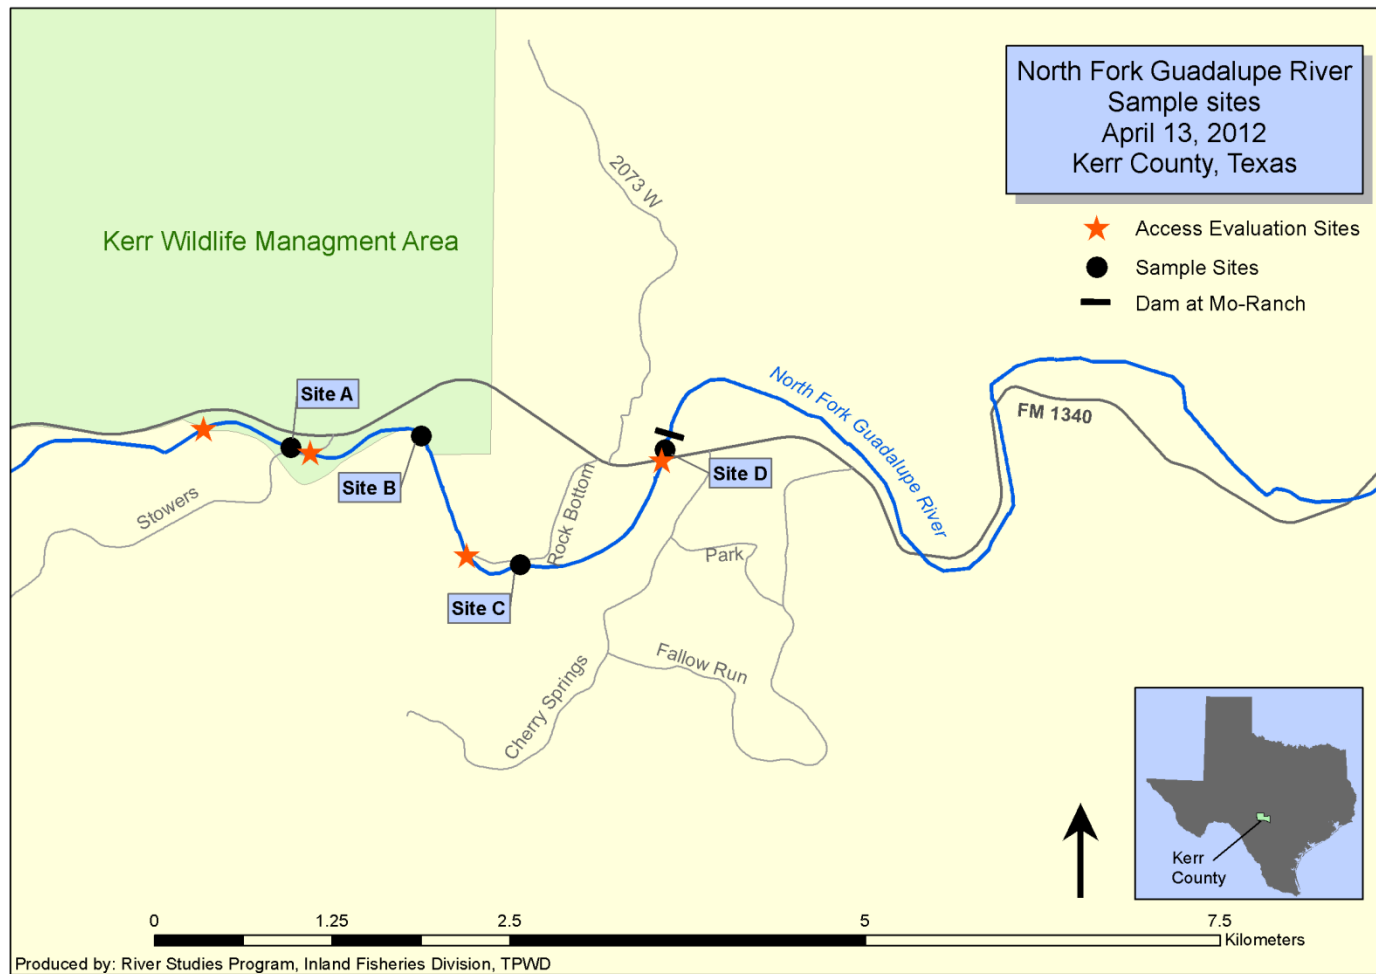
Figure 1. Map of aquatic survey sample and access evaluation sites on the North Fork Guadalupe River, Kerr County, Texas, April 2012.

Fish Assemblage: Fish were collected from four sites (Figure 1) within the study reach using a combination of boat electrofishing (Site D), backpack electrofishing (Sites A and C), and seining (Sites A, B, and C) techniques following TCEQ protocol (TCEQ 2007). For large fish, total lengths were recorded and a voucher photograph was taken before release. All other fish captured were preserved in 10% formalin and taken to the laboratory for enumeration and species identification. Once all fish were identified, a regional index of biotic integrity was calculated (Linam *et al.* 2002).

Mussel Assemblage: Mussels were surveyed using timed snorkel surveys in multiple mesohabitat types (Strayer and Smith 2003) from Site A downstream to Site C (Figure 1). Search time totaled 100 minutes.

Macroinvertebrate Assemblage: Aquatic macroinvertebrates were collected from four locations at Site A (Figure 1). Macroinvertebrates were collected using a D-frame kick net following

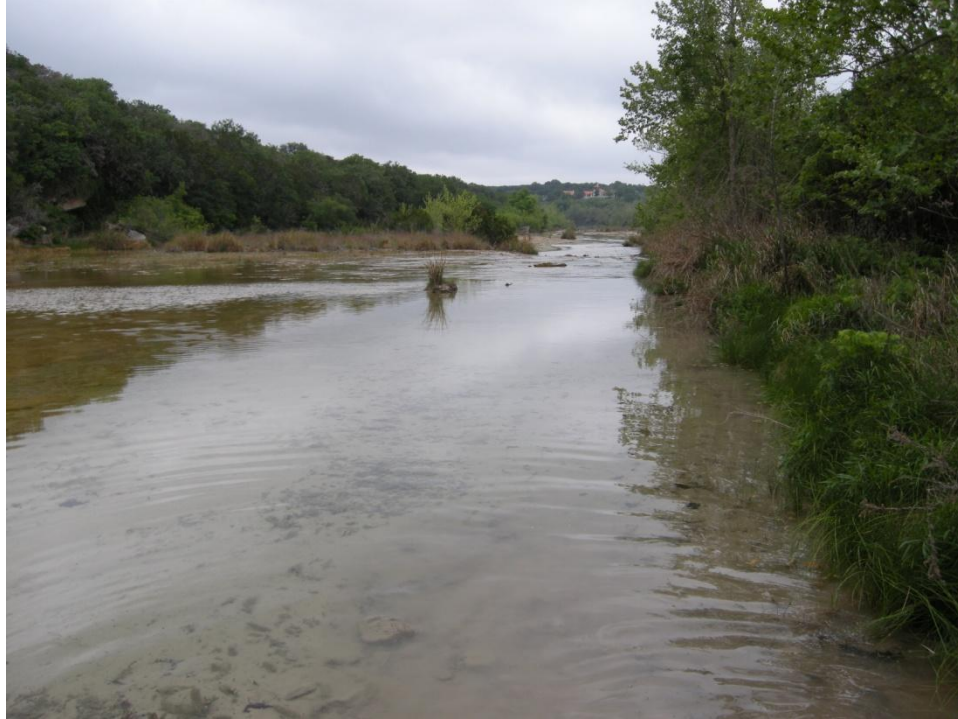
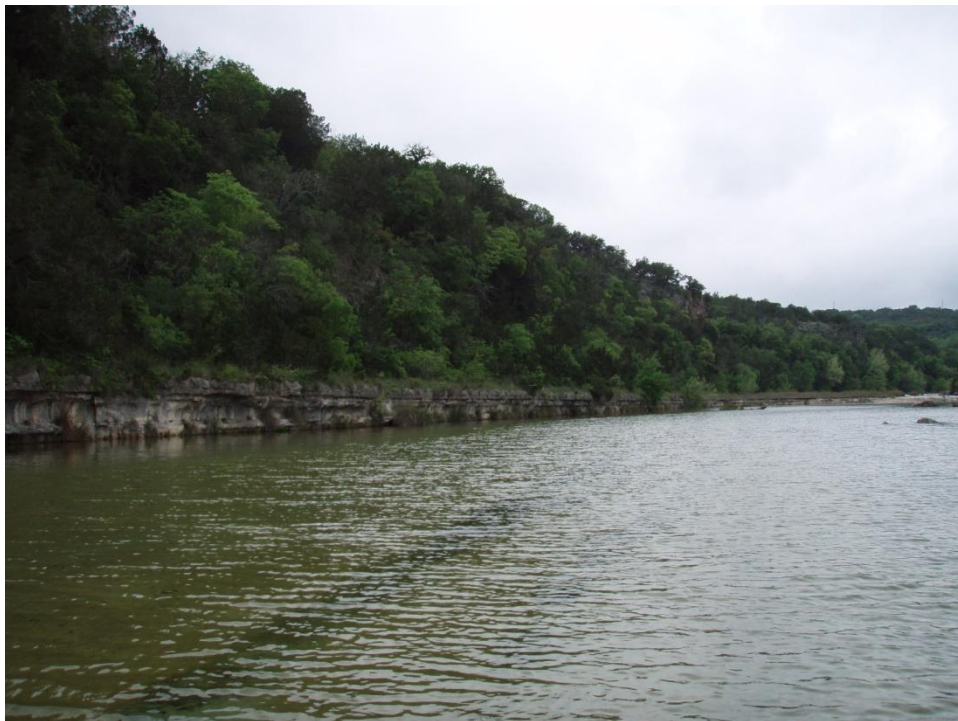
Figure 2. Photographs of typical habitat on the North Fork Guadalupe River at Sites A, B, and C (upper photograph) and site D (lower photograph), April 2012. Sites A, B, and C were dominated by shallow pool habitat with braided bedrock veins. A deeper pool was located at Site D.

Instream Physical Habitat: Much of the reach (Sites A, B, and C) was dominated by shallow habitats with braided stream channels cut through limestone bedrock (Figure 2). Many of the braids were filled with senescing organic matter. Severe drought in 2011 and lack of recent scouring flows in this section of the river may have caused build-up of organic matter. The channel morphological classification (Rosgen 1996) appeared to be a C1. This channel type is slightly entrenched, has moderate to high width to depth ratio, moderate to high sinuosity, a channel slope of 2% or less and is dominated by bedrock. Aquatic vegetation was present intermittently throughout the reach, but was not identified. Site D was impacted by a low water dam located just downstream of the FM 1340 bridge crossing and was deeper than the upstream sites with a mean depth of 1.04 m (Figure 2). Mean maximum depth calculated from the six physical habitat transects between the upstream boundary of the WMA and Site B was 0.43 m. Mean stream width for the transects was 26.2 m and appeared representative of downstream widths. TCEQ habitat scores for the reach ranged from moderate to high in all habitat categories assessed with the exception of substrate stability. The primary reason for the low substrate stability score was the bedrock stream bed, which is not conducive to stability of other substrate types, but is common in streams throughout this ecoregion. This section of the

river demonstrated many positive habitat qualities including extensive riparian vegetation, highly stable banks, large pools, common riffle habitats, and common instream cover (Table 2). The overall habitat quality index score was 24 which falls into the high quality habitat availability category. While the TCEQ methodology ranked the reach as having high quality aquatic habitat there were few deeper areas for adult sportfish such as Guadalupe or largemouth bass. Perkin *et al.* (2010) indicated depth most suitable for Guadalupe bass was 1 m. Throughout most of the reach this depth was not attained.

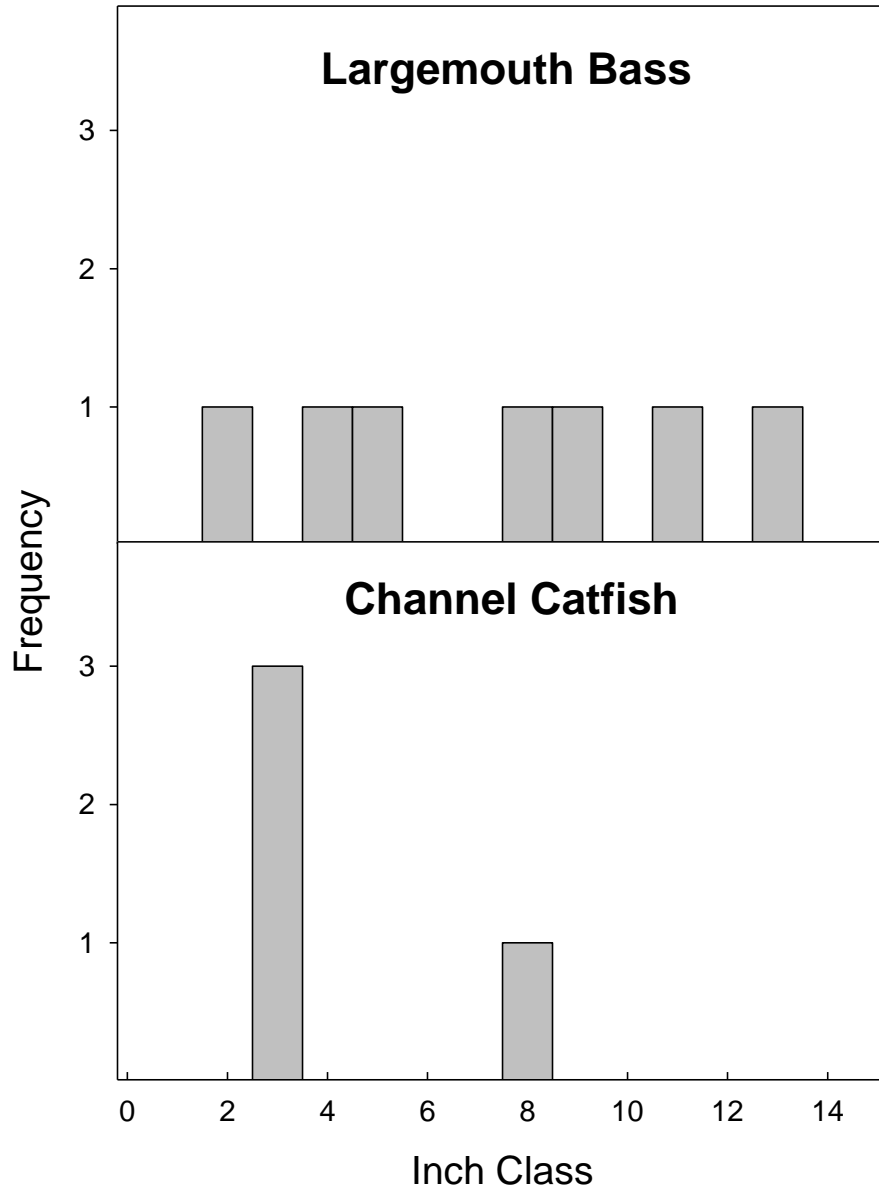
Figure 3. Number of largemouth bass and channel catfish caught by inch class using all gear types at Sites A-D on the North Fork Guadalupe River, April 2012.

Largemouth bass and channel catfish were the only sportfish collected (Figure 3). While present, these individuals made up less than 1% of the total catch. Largemouth bass up to 13 inches in length (Figure 3) were collected and provide a sportfishing opportunity; however, channel catfish collected were small, only measuring up to 8 inches in length. Larger channel catfish were observed, but not captured. Surprisingly no Guadalupe bass were collected despite past stockings in this area. This species has been documented as abundant in the mainstem Guadalupe River (Terre and Magnelia 1996). The aforementioned lack of suitable depth habitat in most of the reach may have been responsible for our inability to collect this species. In addition, high water clarity likely limited electrofishing effectiveness for adult sportfish. Length frequency data for sportfish species may have been supplemented through a hook-and-line angling survey. Six species of sunfish were collected throughout the reach, including redbreast sunfish, warmouth (*Lepomis gulosus*), and bluegill (*Lepomis machrochirus*), which provide additional angling opportunity. No threatened, endangered, or species of concern were collected.

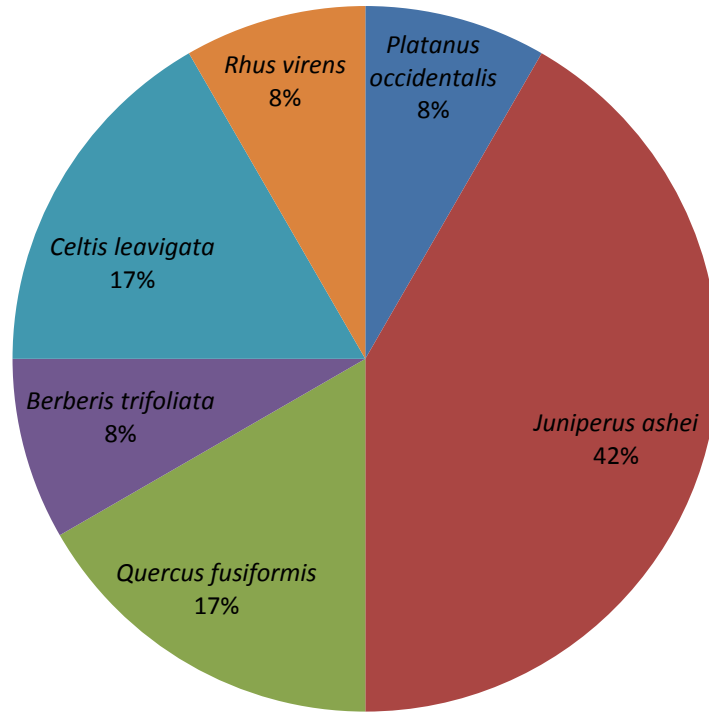
Tree & Shrub Species Composition

Figure 4. Tree and shrub species composition for a representative 50 m x 10 m riparian transect in the Kerr Wildlife Management Area, April 2012.

Riparian Area: The riparian species documented within the transect (Figures 4 and 5, Table 8) were consistent with the riparian types identified in the Texas Ecological Systems Classification Project database, which records the following riparian vegetative community types on the Kerr WMA: Edwards Plateau: Riparian Ashe Juniper Forest; Edwards Plateau: Riparian Ashe Juniper Shrubland; Edwards Plateau: Riparian Deciduous Shrubland; Edwards Plateau: Riparian Hardwood Forest; Edwards Plateau: Floodplain Hardwood/Ashe Juniper Forest; and Edwards Plateau: Floodplain Live Oak Forest. The transect data, coupled with visual observation of other important riparian species not represented in the transect such as switchgrass (*Panicum virgatum*), eastern gammagrass (*Tripsacum dactyloides*), white-top sedge (*Rhynchospora colorata*), buttonbush (*Cephalanthus occidentalis*), baccharis (*Baccharis neglecta*), watercress (*Rorippa nasturtium-aquaticum*), and frogfruit (*Phyla nodiflora*), showed the riparian area to be very diverse, with recruitment of riparian species actively occurring. In addition to the diverse riparian vegetation, the substrate was confined by bedrock, making it vertically stable. Large woody debris was present to help reduce current velocities during flood events and trap sediment for additional riparian plant recruitment.

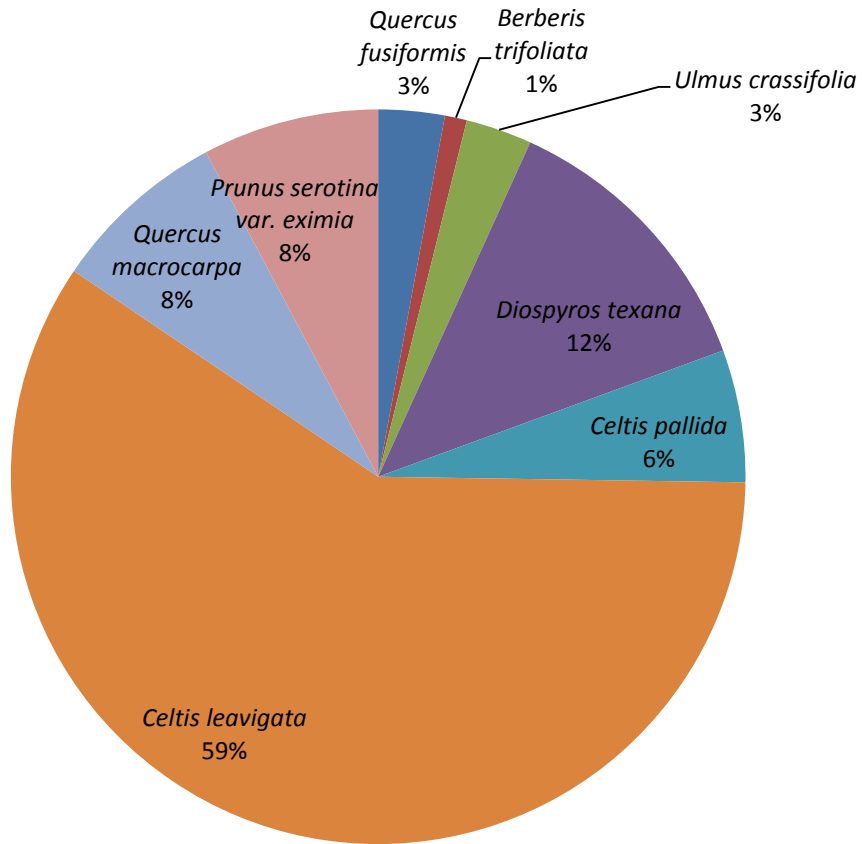
Seedling Species Composition

Figure 5. Seedling tree species composition for a representative 50 m x 10 m riparian transect in the Kerr Wildlife Management Area, April 2012.
