Project: Setting Monumentation Points for Locations of Wildrice

Project 84: Setting Monumentation Points for Location of Wildrice

Established Monument Points for Location of Texas Wild-rice (*Zizania texana*) in the Upper San Marcos River, Hays County, Texas

Appendix I: Detailed field drawings of monument locations

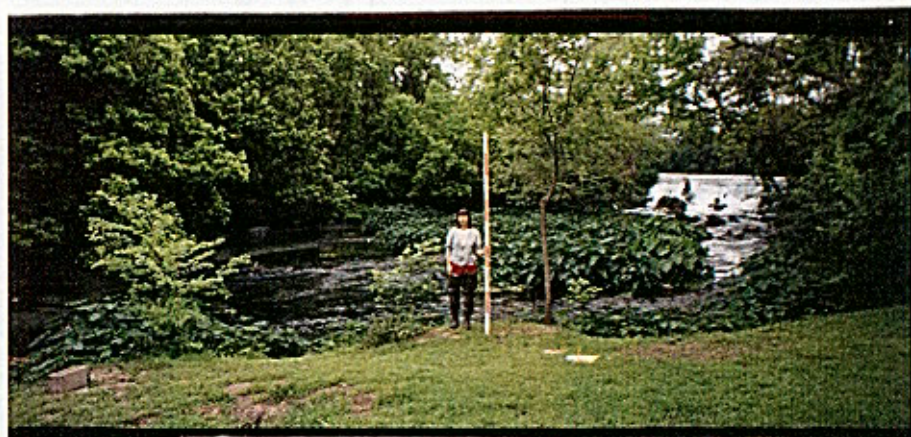
Monument 2 at Clear Springs Apartments
spillway from Spring Lake in background

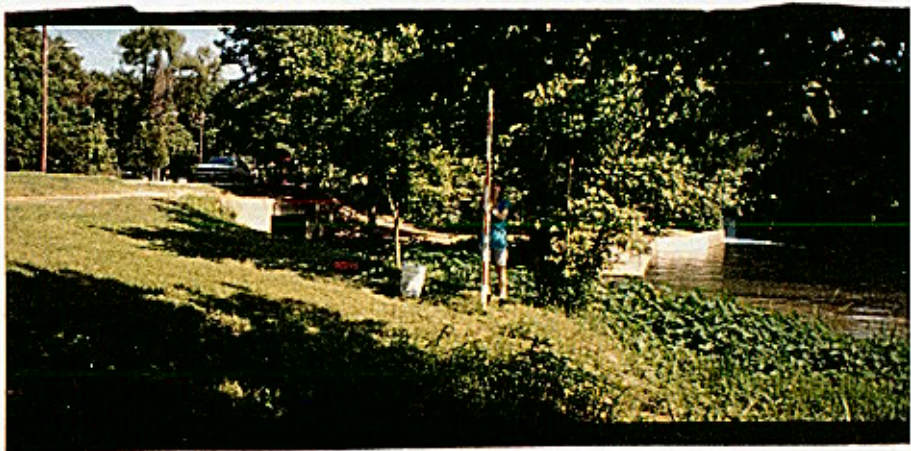
Monument #25
Sessoms at San Marcos R. looking u/s

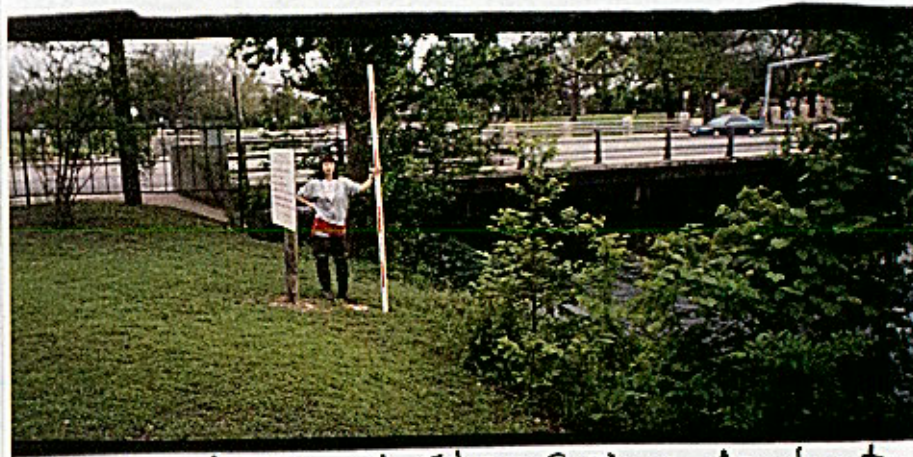
Monument #3 at Clear Springs Apartments
(looking downstream) Aquaplena Springs Bridge background

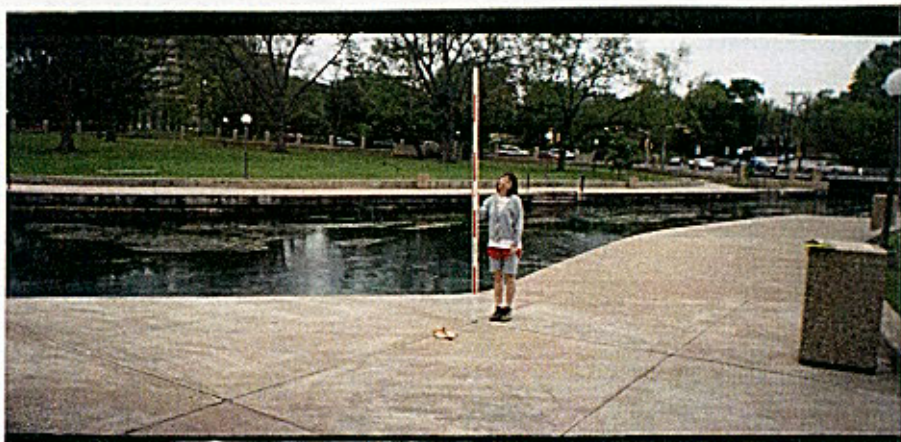
Monument 6 Sewell Park (looking upstream)
Aquarena Springs Bridge in background

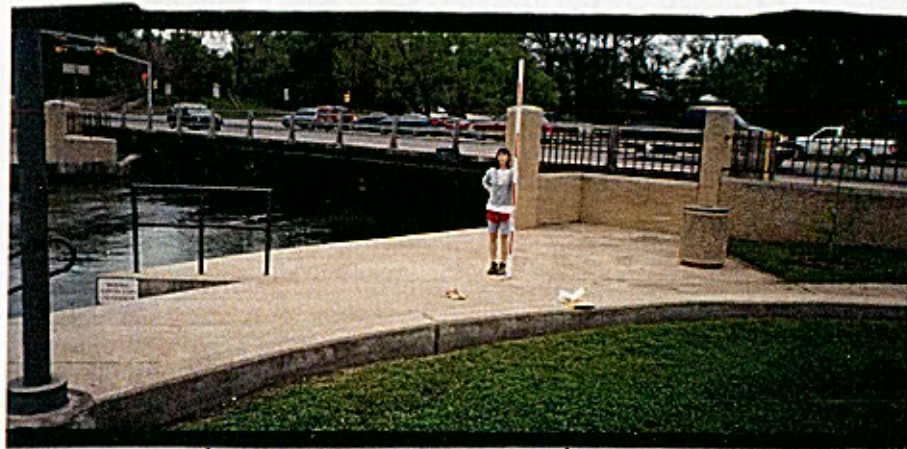
Monument 4 in Sewell Park (looking upstream)
Aquarena Springs Bridge in background

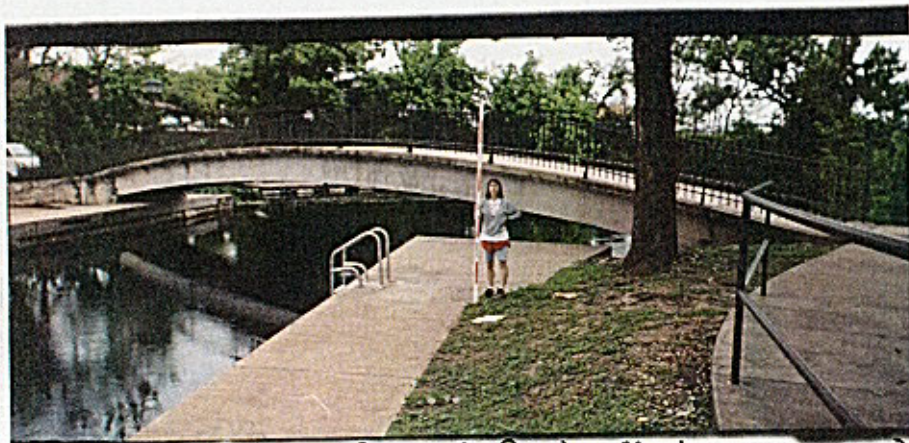
Monument 9 Sewell Park (looking downstr.)
2nd footbridge in background

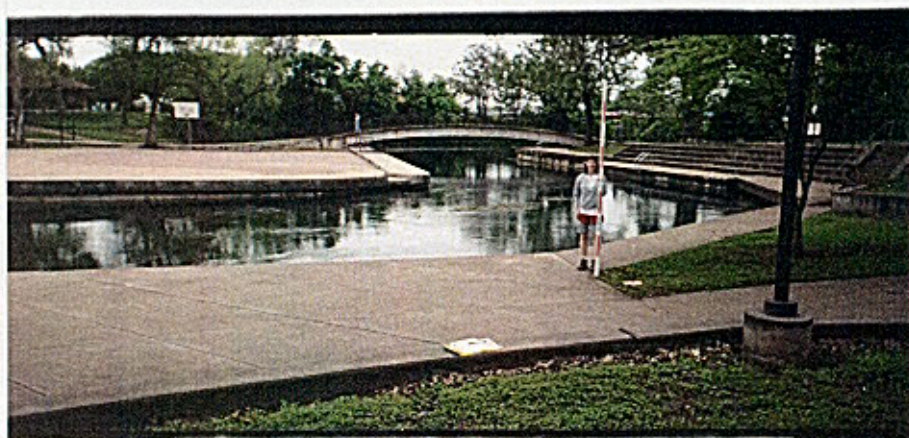
Monument 8 Sewell Park (looking downstream)
2nd footbridge in background (river right)

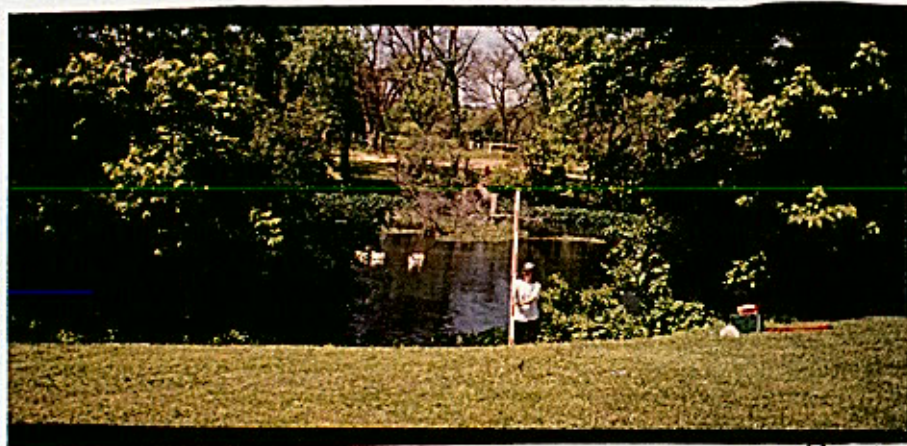
Monument 11 City Park; Sewell Park
across river ← flow

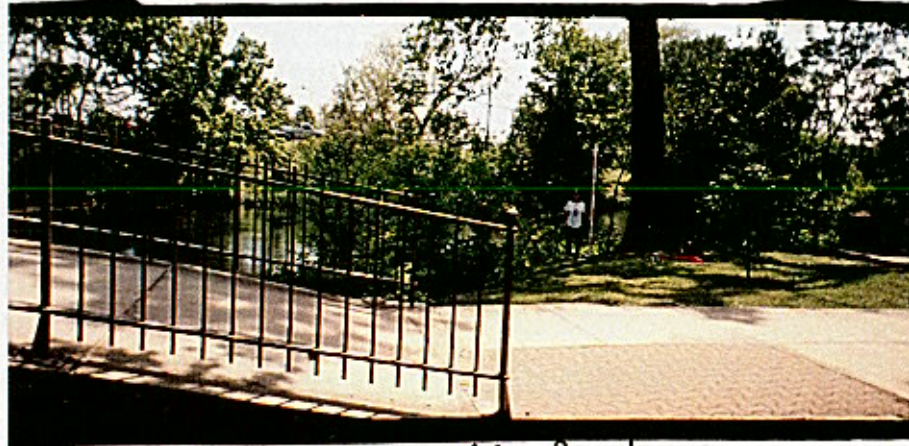
Monument 10 Sewell Park
2nd footbridge in foreground

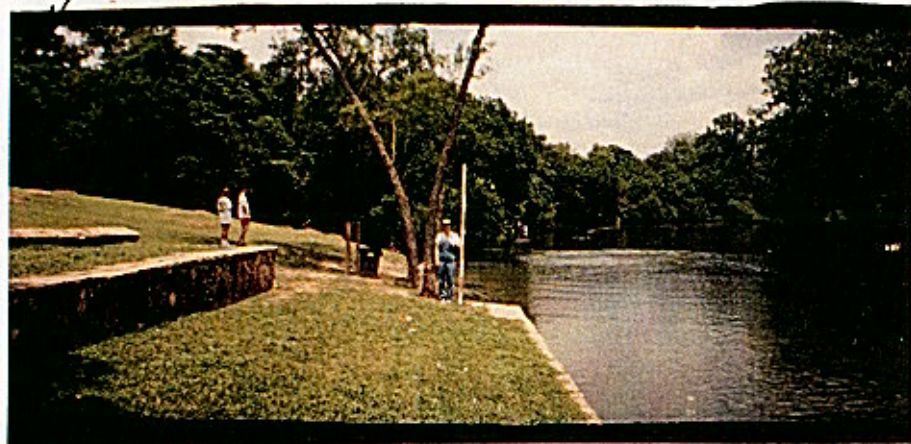
Monument 14 looking upstream

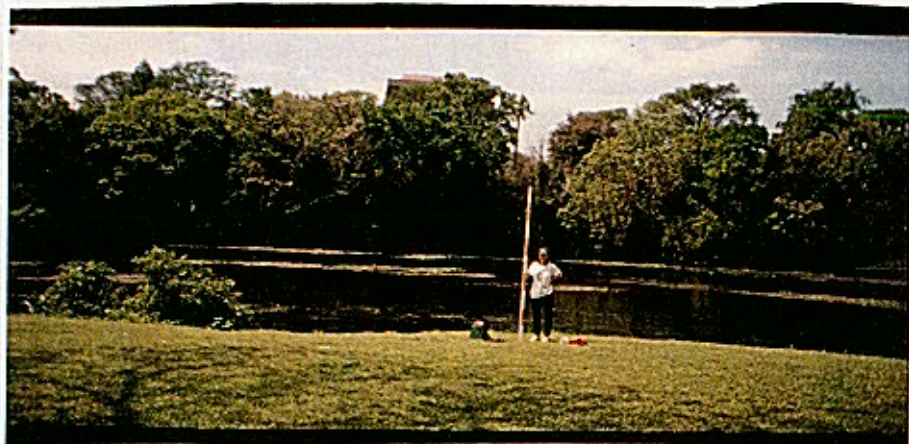
Monument 12 City Park (SWTSU campus
in background across river) ← flow

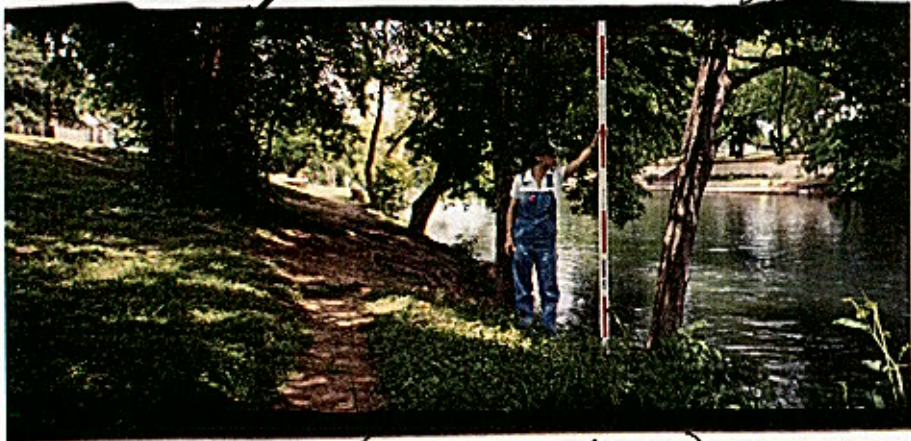
Monument 15 (looking upstream)

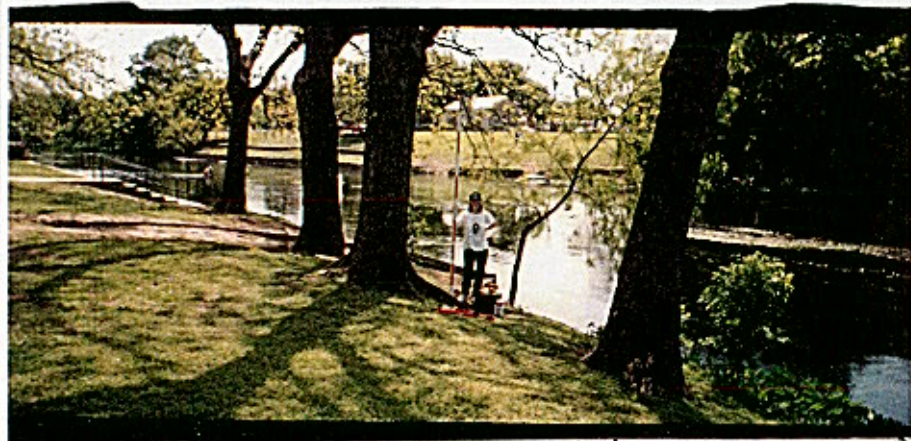
Monument 13 City Park (looking downstream)

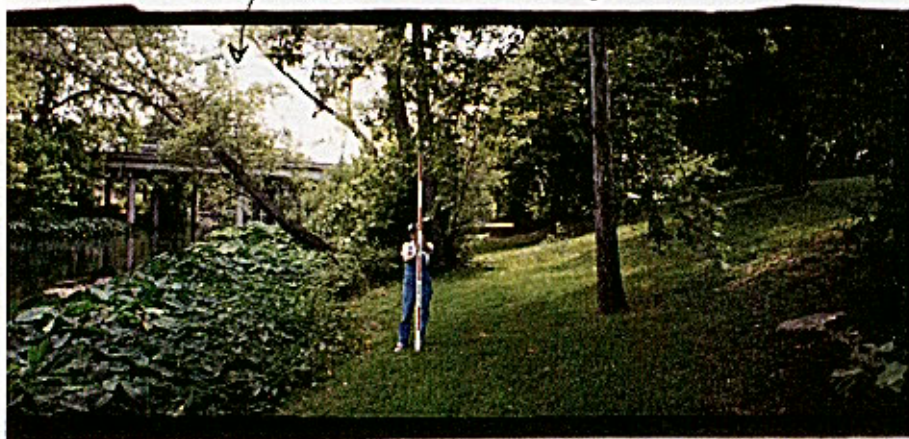
Monument 17 looking downstream

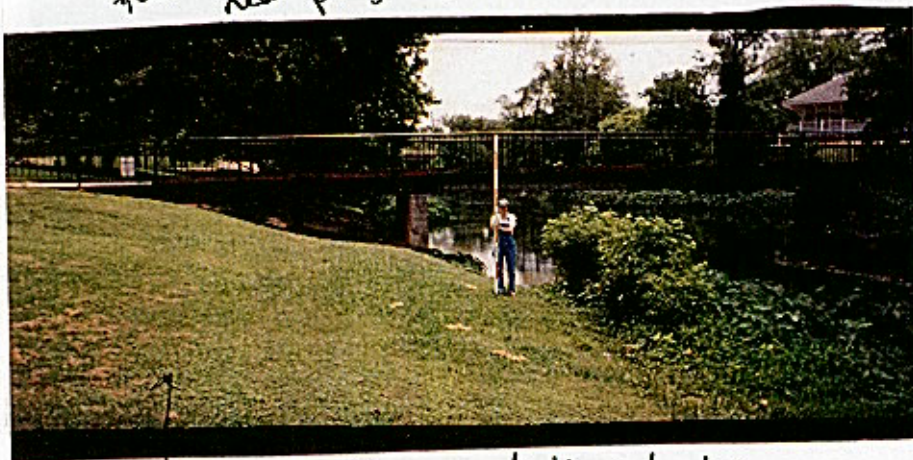
City park Monument 16 looking downstream

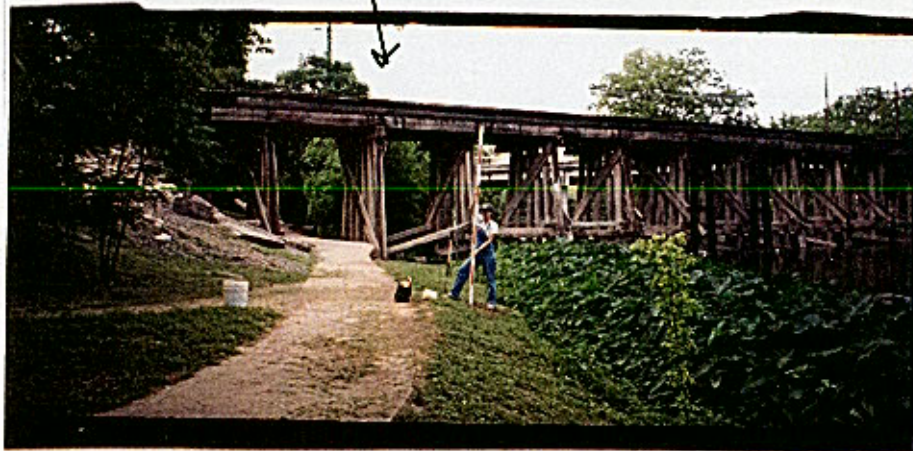
Monument 18 looking upstream

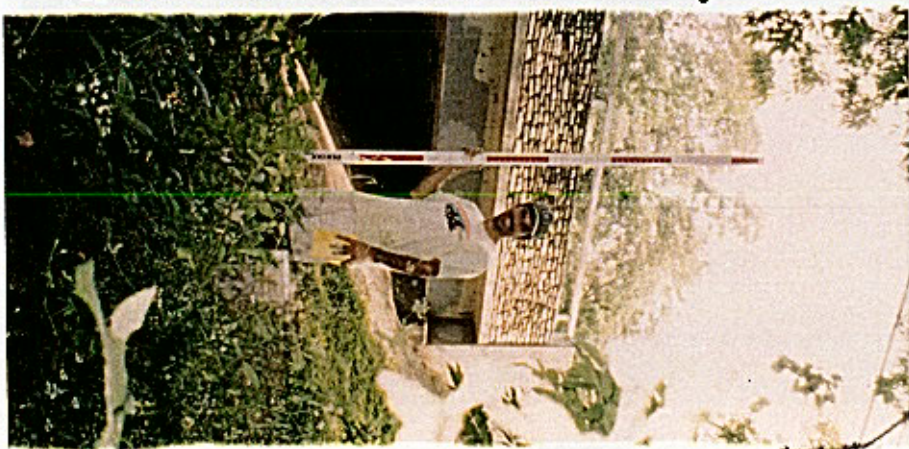
Monument 27 on river right

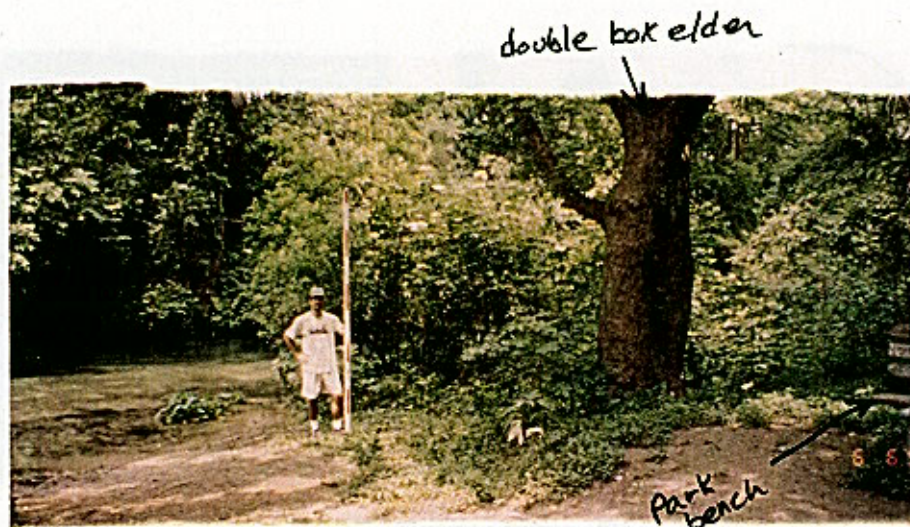
Monument 29 Glover's Island

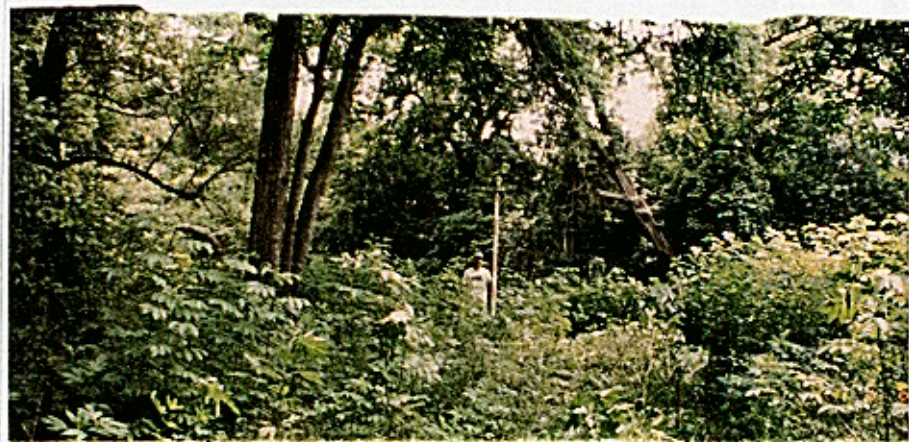
Monument 31 Glover's Island
from gravel trail

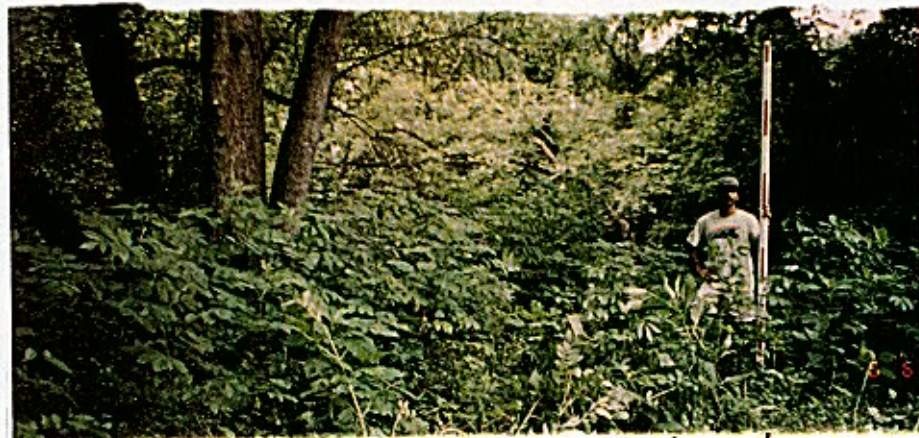
Monument 31 Glover's Island
(looking downstream)

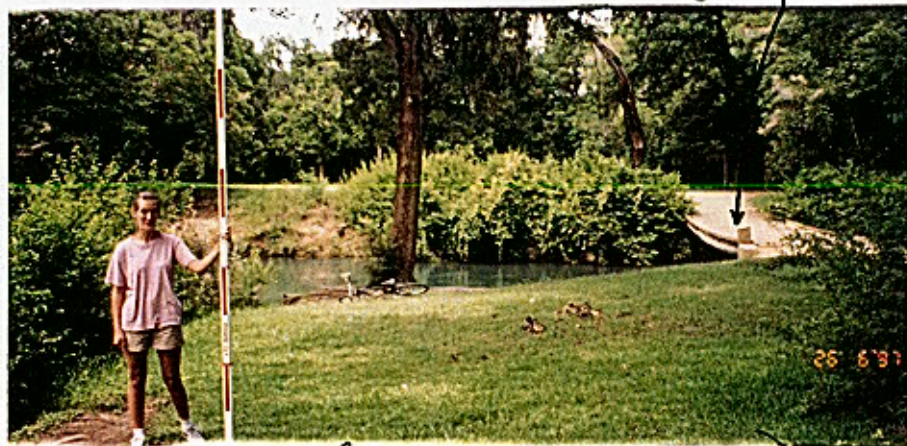
Monument 32 (looking downstream)

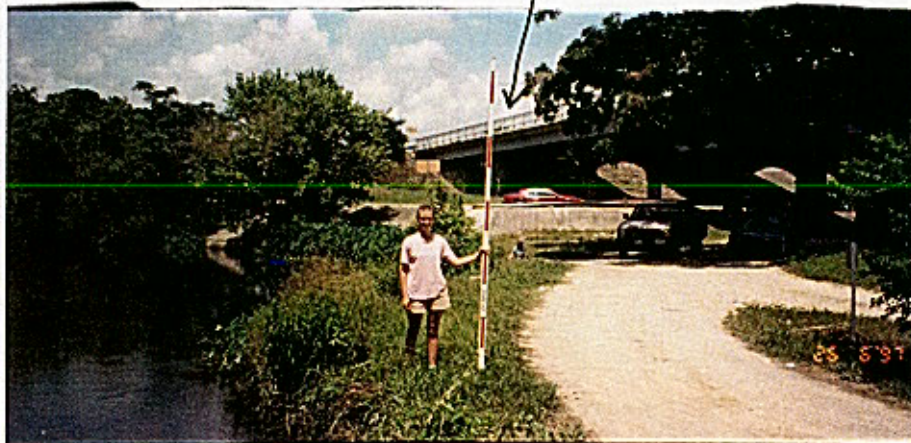
monument 33 (looking upstream)

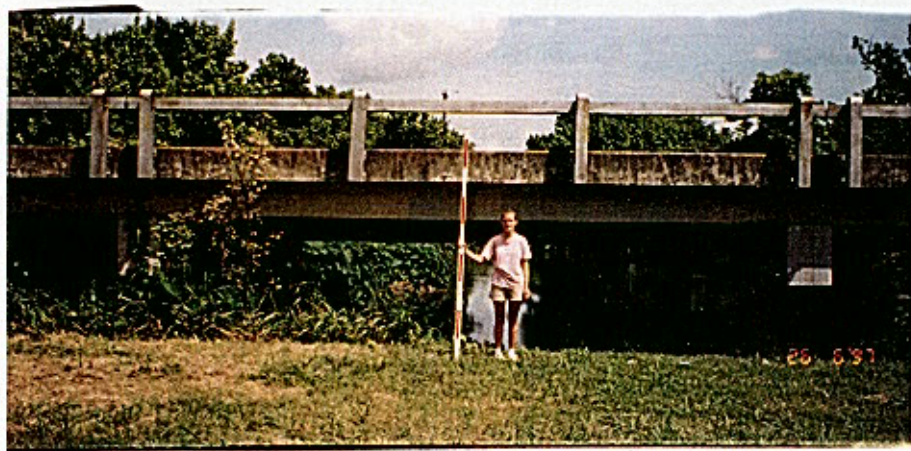
monument 35 at northbound feeder lane
of IH 35

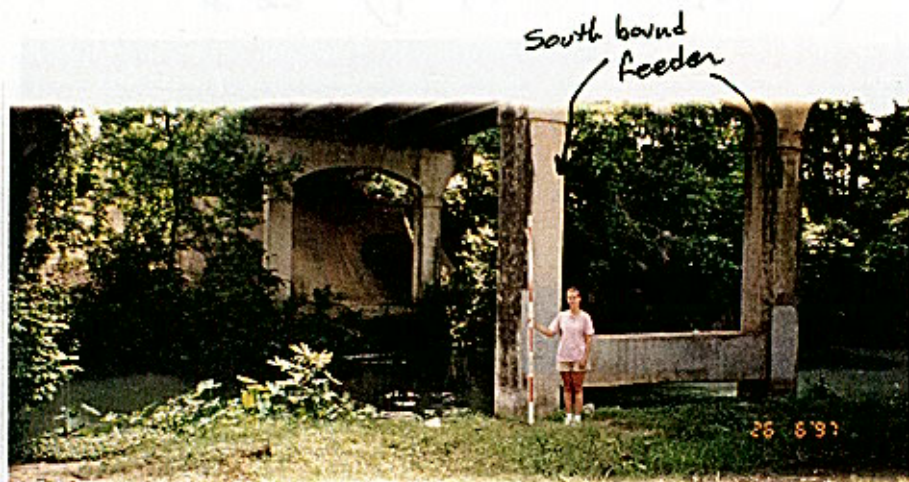
mon # 34 at IH 35

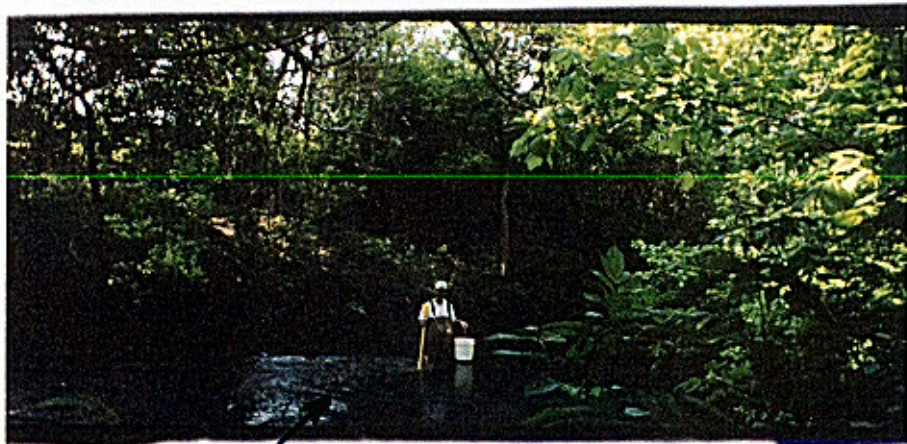
location of Texas Wild-rice in relation
to monument #61 on opposite bank

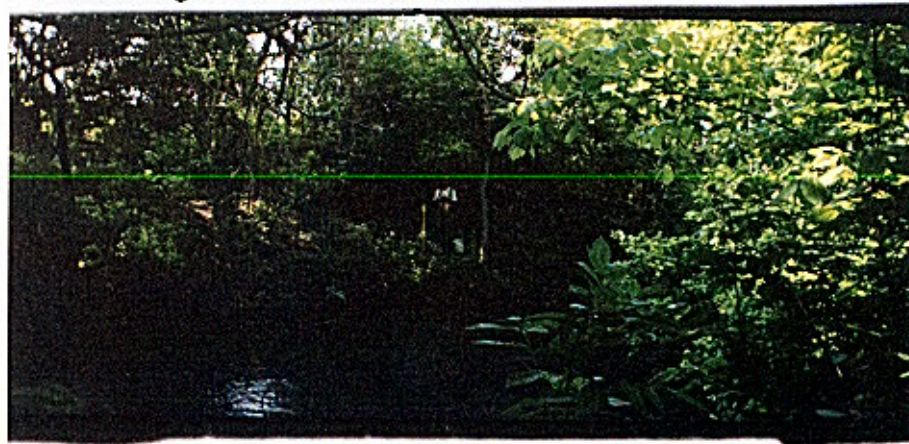
Monument #61 (across river)
facing upstream
