Access Audit Site Report

Big Spring State Park
100 State Park Rd 8
Big Spring, TX 79720
Accessibility Evaluation
Inspection Date: 12/13/2021
Inspectors: Tanya Scheibe

Prepared By
WT Group

**AMERICANS WITH DISABILITIES ACT COMPLIANCE INITIATIVE
PROGRAM AND POLICY REPORT
JULY 28, 2023**

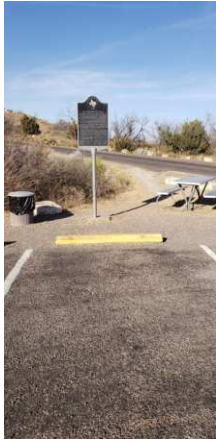
Finding Number	Area Description	Lat/Long	Finding	As Built	Recommendation	Citation	Photos	Figure
1	Exterior: Exterior Accessible Route	[32.2292644, -101.4818228]	There is no accessible route to the picnic table, trash cans, signage, trailhead, water fountain, or sitting area at the park entry. At least one accessible route shall connect accessible buildings, accessible facilities, accessible elements, and accessible spaces that are on the same site.	Park Entrance - No accessible route to picnic table, trash cans, signs, trailhead, water fountain or sitting area	Create an accessible route with crushed stone or other outdoor material from parking or walkway to park site elements at park entry.	2015 ABAAS Section: F206.2.2 2012 TAS Section: 206.2.2 2010 ADAS Section: 206.2.2

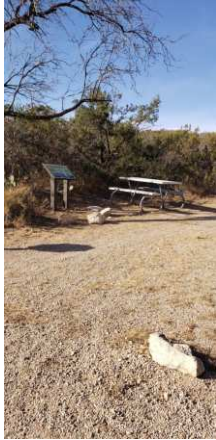
2	Exterior: Exterior Accessible Route	[32.2293279, -101.4819153]	There is no accessible route to the picnic table, trash cans, signs, and trail head at the scenic mountain trail. At least one accessible route shall connect accessible buildings, accessible facilities, accessible elements, and accessible spaces that are on the same site.	Scenic Mountain Trail - No accessible route to picnic table, trash cans, signs, and trailhead	Create an outdoor recreation accessible route (ORAR) with crushed stone or other outdoor material from parking or walkway to park elements at Scenic Mountain Trailhead as a smart practice.	2015 ABAAS Section: F206.2.2 2012 TAS Section: 206.2.2 2010 ADAS Section: 206.2.2

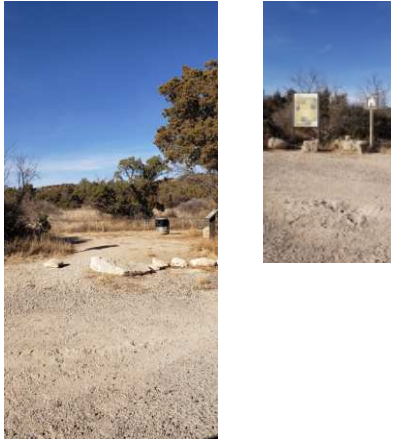
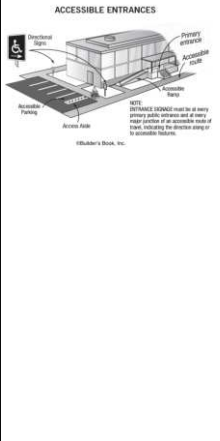
Finding Number	Area Description	Lat/Long	Finding	As Built	Recommendation	Citation	Photos	Figure
3	Exterior: Exterior Accessible Route	[32.2291623, -101.4869498]	There is no accessible route to the picnic table, trash cans, signs, and trailhead at the Nature Trail parking area. At least one accessible route shall connect accessible buildings, accessible facilities, accessible elements, and accessible spaces that are on the same site.	Nature Trail Parking - No accessible route to picnic table, trash cans, signs, and trailhead	Create an outdoor recreation accessible route (ORAR) with crushed stone or other outdoor material from parking or walkway to park elements at the Nature Trail parking area as a smart practice.	2015 ABAAS Section: F206.2.2 2012 TAS Section: 206.2.2 2010 ADAS Section: 206.2.2

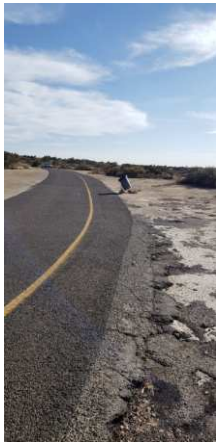
4	Exterior: Exterior Accessible Route	[32.229995, -101.4955316]	There is no accessible route to the trash can or outlook at the overlook area along road. At least one accessible route shall connect accessible buildings, accessible facilities, accessible elements, and accessible spaces that are on the same site.	Overlook - No accessible route to trash can or overlook	Create an accessible route with crushed stone or other outdoor material from parking or walkway to outlook and trash can at overlook pull off area.	2015 ABAAS Section: F206.2.2 2012 TAS Section: 206.2.2 2010 ADAS Section: 206.2.2

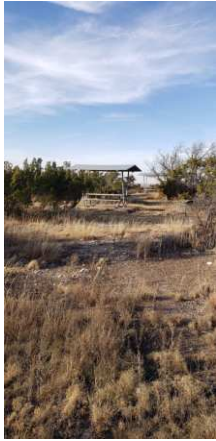
Finding Number	Area Description	Lat/Long	Finding	As Built	Recommendation	Citation	Photos	Figure
5	Exterior: Exterior Accessible Route	[32.2319811, -101.4912736]	There is no accessible route to the picnic tables. At least one accessible route shall connect accessible buildings, accessible facilities, accessible elements, and accessible spaces that are on the same site.	Headquarters Picnic Area - No accessible route to picnic tables	Create an accessible route with crushed stone or other outdoor material from parking or walkway to picnic tables.	2015 ABAAS Section: F206.2.2 2012 TAS Section: 206.2.2 2010 ADAS Section: 206.2.2

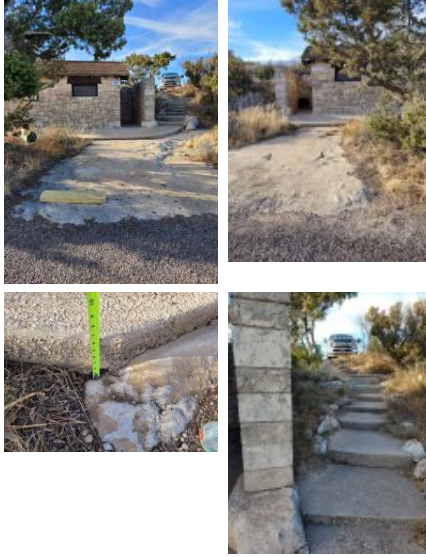
6	Exterior: Exterior Accessible Route	[32.2318282, -101.4906996]	There is no accessible route to the restroom building. At least one accessible route shall connect accessible buildings, accessible facilities, accessible elements, and accessible spaces that are on the same site.	no AR to restroom building 2 due to surface, large change in level (CIL), and stairs	Create an accessible route with crushed stone or other outdoor material from parking or walkway to restroom building from lower roadway	2015 ABAAS Section: F206.2.2 2012 TAS Section: 206.2.2 2010 ADAS Section: 206.2.2

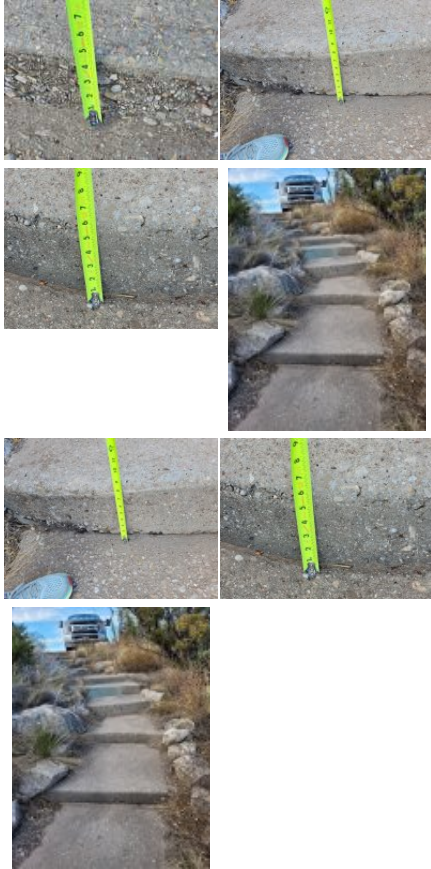
Finding Number	Area Description	Lat/Long	Finding	As Built	Recommendation	Citation	Photos	Figure
7	Exterior: Exterior Accessible Route	[32.2318688, -101.4906644]	The stair risers are not uniform in height. Stair riser heights shall be 7 inches maximum and 4 inches minimum. On any given flight of stairs, all steps shall have uniform riser height and uniform tread widths.	from bottom - 4",8",6". All different sizes due to the stone build	Correct riser heights on stairs to consistent height between 4" to 7", leave as is if technically infeasible	2015 ABAAS Section: 504.2 2012 TAS Section: 504.2 2010 ADAS Section: 504.2

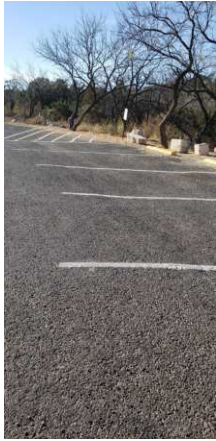
Finding Number	Area Description	Lat/Long	Finding	As Built	Recommendation	Citation	Photos	Figure
12	Exterior: Parking	[32.2292576, -101.4818268]	There are no accessible parking stalls. Each lot where parking is provided for the public as clients, guests or employees, shall provide accessible parking and shall be located on the shortest accessible route of travel from adjacent parking to an accessible entrance. There are a total of 15 parking stalls in the parking lot that could be reasonably associated with this facility. There should be a minimum of 1 accessible stalls with a minimum of 1 being designed as van accessible.	Park Entrance Parking - no accessible Stalls. 0 of 15 accessible	Create one or more 8' accessible parking stalls, with one 5' adjacent access aisle, with proper signage and striping based on the total number of stalls	2015 ABAAS Section: F208.2 2012 TAS Section: 208.2 2010 ADAS Section: 208.2

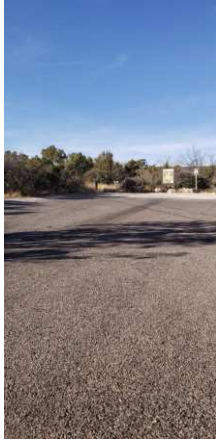
13	Exterior: Parking	[32.2289694, -101.4869498]	There are no accessible parking stalls. Each lot where parking is provided for the public as clients, guests or employees, shall provide accessible parking and shall be located on the shortest accessible route of travel from adjacent parking to an accessible entrance. There are a total of 14 parking stalls in the parking lot that could be reasonably associated with this facility. There should be a minimum of 1 accessible stalls with a minimum of 1 being designed as van accessible.	Nature Trail Trailhead - no accessible Stalls. 0 of 14 assumed accessible	Create one or more 8' accessible parking stalls, with one 5' adjacent access aisle, with proper signage and striping based on the total number of stalls	2015 ABAAS Section: F208.2 2012 TAS Section: 208.2 2010 ADAS Section: 208.2

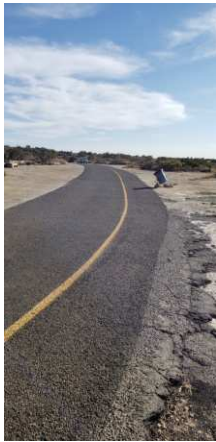
Finding Number	Area Description	Lat/Long	Finding	As Built	Recommendation	Citation	Photos	Figure
14	Exterior: Parking	[32.2301583, -101.4956174]	There are no accessible parking stalls. Each lot where parking is provided for the public as clients, guests or employees, shall provide accessible parking and shall be located on the shortest accessible route of travel from adjacent parking to an accessible entrance. There are an estimated total of 30 parking stalls in the parking lot that could be reasonably associated with this facility. There should be a minimum of 2 accessible stalls with a minimum of 1 being designed as van accessible.	Overlook pulloff - no accessible Stalls. 0 of approx 30 accessible	Create one or more 8' accessible parking stalls, with one 5' adjacent access aisle, with proper signage and striping based on the total number of stalls	2015 ABAAS Section: F208.2 2012 TAS Section: 208.2 2010 ADAS Section: 208.2

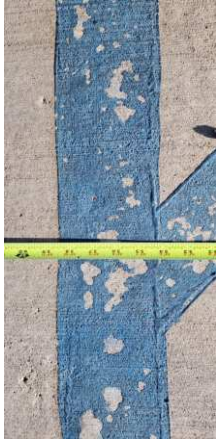
15	Exterior: Parking	[32.2321935, -101.4906795]	The access aisle is not a minimum 5 feet wide. A car accessible parking stall's access aisle must be a minimum of 5 feet wide measured from centerline to centerline. Where the access aisle is not adjacent to another parking space or access aisle, measurements shall be permitted to include the full width of the line defining the access aisle.	HQ parking - access aisle is 56", the accessible stall is over 12' wide	Repaint access aisles to be 5' each	2015 ABAAS Section: 502.3.1 2012 TAS Section: 502.3.1 2010 ADAS Section: 502.3.1

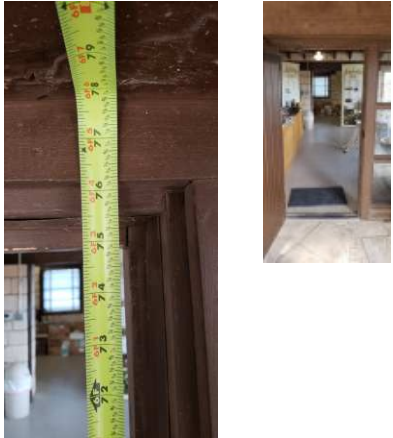
Finding Number	Area Description	Lat/Long	Finding	As Built	Recommendation	Citation	Photos	Figure
18	Headquarters : Public Spaces - Headquarters	[32.2322865 , -101.49078]	Vertical clearance shall be 80 inches (2030 mm) high minimum. Guardrails or other barriers shall be provided where the vertical clearance is less than 80 inches (2030 mm) high. The leading edge of such guardrail or barrier shall be located 27 inches (685 mm) maximum above the finish floor or ground. EXCEPTION: Door closers and door stops shall be permitted to be 78 inches (1980 mm) minimum above the finish floor or ground.	entry- 76" overhead clearance	Replace doors with doors having 80" overhead clearance	2015 ABAAS Section: 307.4, 307.4 EXCEPTION 2012 TAS Section: 307.4, 307.4 Exception 2010 ADAS Section: 307.4, 307.4 Exception

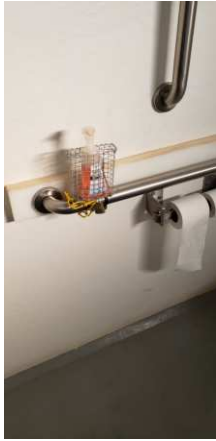
Finding Number	Area Description	Lat/Long	Finding	As Built	Recommendation	Citation	Photos	Figure
21	Restrooms: Restrooms 1 Playground	[32.2332576 , -101.4899 351]	The grab bar height and/or spacing fails. Grab bars must be mounted between 33" and 36" to the top of the gripping surface. There must be 1.5" of clearance between the grab bar and the wall. There must be a minimum of 1.5" of clearance below and minimum 12" above the grab bar to any dispenser or other obstruction.	Men's - sanitizer locked to bar	Relocate sanitizer to provide min 12" above and 1.5" below grab bar	2015 ABAAS Section: 609.3, 609.4 2012 TAS Section: 609.4, 609.3 2010 ADAS Section: 609.3, 609.4

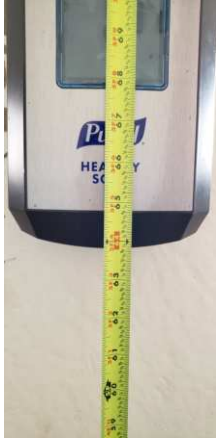
22	Restrooms: Restrooms 1 Playground	[32.2332656 , -101.4899 258]	Where a high forward reach is over an obstruction, the clear floor space shall extend beneath the element for a distance not less than the required reach depth over the obstruction. The high forward reach shall be 48 inches (1220 mm) maximum where the reach depth is 20 inches (510 mm) maximum. Where the reach depth exceeds 20 inches (510 mm), the high forward reach shall be 44 inches (1120 mm) maximum and the reach depth shall be 25 inches (635 mm) maximum.	women's - sanitizer 64" aff	Lower operating mechanisms in Playground Women's Restroom to max 48" aff to highest operable part; leave as is if employee only operated	2015 ABAAS Section: 308.2.1, 308.3.2 2012 TAS Section: 308.2.1, 308.3.2 2010 ADAS Section: 308.2.1, 308.3.2

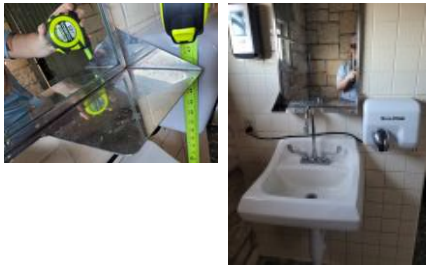
25	Restrooms: Restrooms 2	[32.2318169 , -101.4906 996]	The mirror is mounted too high. Mirrors must have the bottom edge of the reflecting surface a maximum of 40 inches above the floor if above a sink or counter. Mirrors not located above lavatories or countertops shall be installed with the bottom edge of the reflecting surface 35 inches maximum above the finish floor or ground.	mens - mirror 47" aff	Lower mirror so reflective surface is max 40" aff	2015 ABAAS Section: 603.3 2012 TAS Section: 603.3 2010 ADAS Section: 603.3

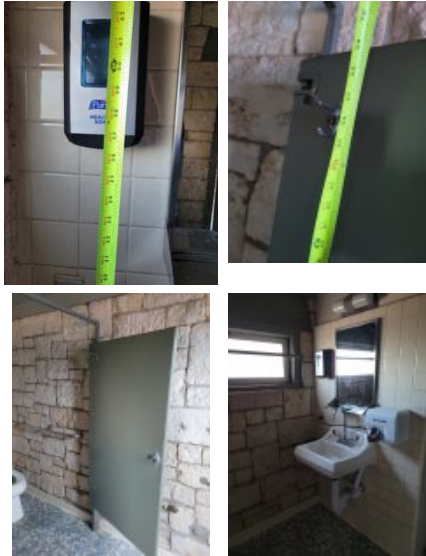
Finding Number	Area Description	Lat/Long	Finding	As Built	Recommendation	Citation	Photos	Figure
26	Restrooms: Restrooms 2	[32.2318282 , -101.4906 835]	Where a high forward reach is over an obstruction, the clear floor space shall extend beneath the element for a distance not less than the required reach depth over the obstruction. The high forward reach shall be 48 inches (1220 mm) maximum where the reach depth is 20 inches (510 mm) maximum. Where the reach depth exceeds 20 inches (510 mm), the high forward reach shall be 44 inches (1120 mm) maximum and the reach depth shall be 25 inches (635 mm) maximum. Where a clear floor or ground space allows a parallel approach to an element and the high side reach is over an obstruction, the height of the obstruction shall be 34 inches (865 mm) maximum and the depth of the obstruction shall be 24 inches (610 mm) maximum. The high side reach shall be 48 inches (1220 mm) maximum for a reach depth of 10 inches (255 mm) maximum. Where the reach depth exceeds 10 inches (255 mm), the high side reach shall be 46 inches (1170 mm) maximum for a reach depth of 24 inches (610 mm) maximum.	men's - soap at 56" aff, hook in stall - 66" aff	Lower operating mechanisms to max 48" above the finished floor (AFF) to highest operable part. Lower soap dispenser to max 44" above the finished floor (AFF) for a forward reach over counter.	2015 ABAAS Section: 308.2.1, 308.3.2 2012 TAS Section: 308.2.1, 308.3.2 2010 ADAS Section: 308.2.1, 308.3.2

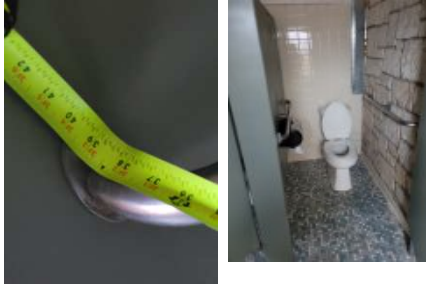
Finding Number	Area Description	Lat/Long	Finding	As Built	Recommendation	Citation	Photos	Figure
28	Restrooms: Restrooms 2	[32.2318214 , -101.4907 049]	The ambulatory stall is not between 35" to 37" wide and 60" deep.	men's - 39" by 60"	Correct ambulatory stall to be 35" to 37" wide and minimum 60" deep	2015 ABAAS Section: 604.8.2.1 2012 TAS Section: 604.8.2.1 2010 ADAS Section: 604.8.2.1

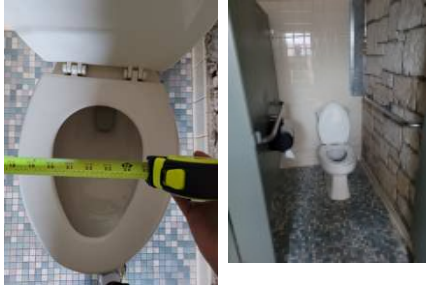
29	Restrooms: Restrooms 2	[32.2318226 , -101.4906 982]	The toilet is not located within the range to the side wall or partition. The centerline of the toilet shall be 17 inches minimum and 19 inches maximum side wall or partition in the ambulatory accessible toilet compartment.	men's - 22.5" from toilet paper side	Remount toilet to 17" to 19" from the side wall to center line in ambulatory stalls	2015 ABAAS Section: 604.9.1 2012 TAS Section: 604.9.1 2010 ADAS Section: 604.9.1

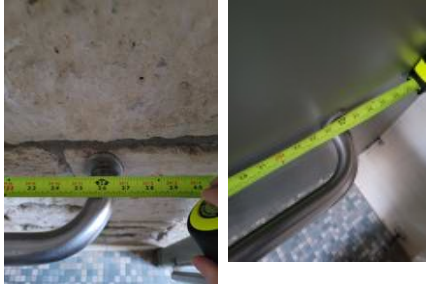
Finding Number	Area Description	Lat/Long	Finding	As Built	Recommendation	Citation	Photos	Figure
31	Restrooms: Restrooms 2	[32.2318158 , -101.4906 982]	Grab bars shall comply with 609. A side-wall grab bar complying with 604.5.1 shall be provided on both sides of the compartment. The space between the wall and the grab bar shall be 1½ inches (38 mm). The space between the grab bar and projecting objects below and at the ends shall be 1½ inches (38 mm) minimum. The space between the grab bar and projecting objects above shall be 12 inches (305 mm) minimum. Grab bars shall be installed in a horizontal position, 33 inches (840 mm) minimum and 36 inches (915 mm) maximum above the finish floor measured to the top of the gripping surface, except that at water closets for children's use complying with 604.9, grab bars shall be installed in a horizontal position 18 inches (455 mm) minimum and 27 inches (685 mm) max	men's - both grab bars 36" long	Replace or add side grab bars with a 42" long grab bar, mounted max 12" from the rear wall at the close end and min 54" on the far end and 33" to 36" aff	2015 ABAAS Section: 604.8.2.3, 609.3, 609.4 2012 TAS Section: 609.4, 609.3, 604.8.2.3 2010 ADAS Section: 609.3, 609.4, 604.8.2.3

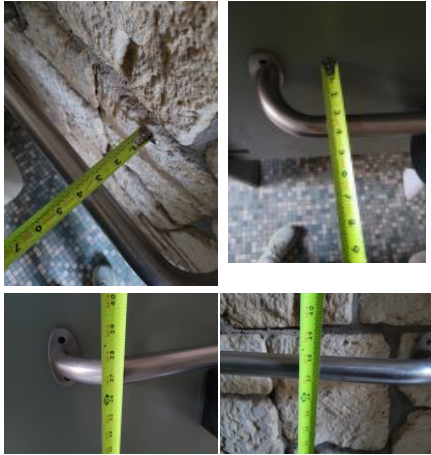
32	Restrooms: Restrooms 2	[32.2318237 , -101.4906 969]	The grab bar height and/or spacing fails. Grab bars must be mounted between 33" and 36" to the top of the gripping surface. There must be 1.5" of clearance between the grab bar and the wall. There must be a minimum of 1.5" of clearance below and minimum 12" above the grab bar to any dispenser or other obstruction.	men's - 3" clearance between wall and grab bar, both 38" aff	Remount grab bars in accessible stall to 33" to 36" aff Replace grab bars in accessible stall with bars that provide 1.5" clearance between the grab bar and the wall	2015 ABAAS Section: 609.3, 609.4 2012 TAS Section: 609.4, 609.3 2010 ADAS Section: 609.3, 609.4

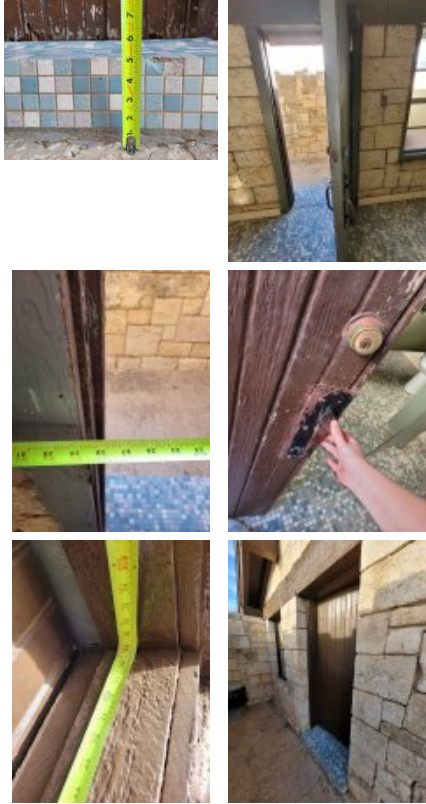
Finding Number	Area Description	Lat/Long	Finding	As Built	Recommendation	Citation	Photos	Figure
33	Restrooms: Restrooms 2	[32.2318192 , -101.4906 969]	Door openings shall provide a clear width of 32 inches (815 mm) minimum. Clear openings of doorways with swinging doors shall be measured between the face of the door and the stop, with the door open 90 degrees. Openings more than 24 inches (610 mm) deep shall provide a clear opening of 36 inches (915 mm) minimum. There shall be no projections into the required clear opening width lower than 34 inches (865 mm) above the finish floor or ground. Projections into the clear opening width between 34 inches (865 mm) and 80 inches (2030 mm) above the finish floor or ground shall not exceed 4 inches (100 mm). The threshold has a vertical change greater than 1/4 inch high. The threshold at a doorway shall be no higher than 1/2 inch. Changes in level between 1/4 inch and 1/2 inch must be beveled at 1:2 or less. 1/4 inch is the maximum vertical rise. Exterior doors are recommended to be maintained at 8.5 lbf as a smart practice. Force is to be measured at the operating hardware or 30 inches from the hinges, whichever is greater. Hand-activated door opening hardware, handles, pulls, latches, locks, and other operating devices on accessible doors shall have a shape that is easy to grasp with one hand and does not require tight grasping, tight pinching or twisting of the wrist to operate. Hardware shall be 34 inches minimum and 48 inches maximum above the finish floor or ground.	women's restroom door - 28# push, doesn't open 90 degrees, 5" CIL, 28" width, hardware requires pinch, 75" overhead	For all doors along the public circulation route, replace doors with doors having 80" overhead clearance and 32" clear width For all doors along the public circulation route, repair, bevel, or ramp CILs at door entries to max .25" For all doors along the public circulation route, inspect, adjust, and maintain 8.5 lbf to open exterior doors as a smart practice For all doors along the public circulation route, replace hardware with lever hardware or hardware operable without a tight pinch or grasp	2010 ADAS Section: 404.2.3, 404.2.7, 404.2.4, 404.2.11, 404.2.11 Exception

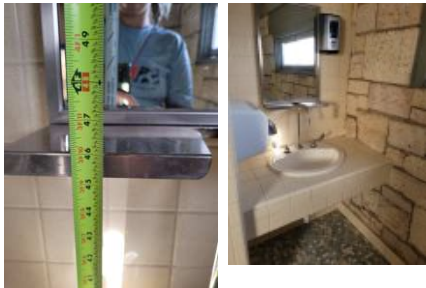
34	Restrooms: Restrooms 2	[32.2318282 , -101.4906 996]	The mirror is mounted too high. Mirrors must have the bottom edge of the reflecting surface a maximum of 40 inches above the floor if above a sink or counter. Mirrors not located above lavatories or countertops shall be installed with the bottom edge of the reflecting surface 35 inches maximum above the finish floor or ground.	women's - mirror 47" aff	Lower mirror so reflective surface is max 40" aff	2015 ABAAS Section: 603.3 2012 TAS Section: 603.3 2010 ADAS Section: 603.3

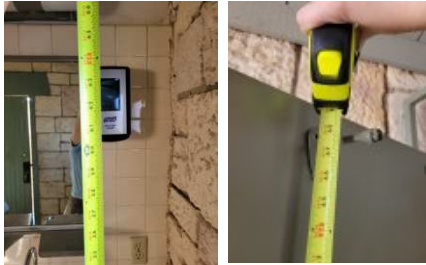
Finding Number	Area Description	Lat/Long	Finding	As Built	Recommendation	Citation	Photos	Figure
35	Restrooms: Restrooms 2	[32.2318169 , -101.4907 023]	Where a high forward reach is over an obstruction, the clear floor space shall extend beneath the element for a distance not less than the required reach depth over the obstruction. The high forward reach shall be 48 inches (1220 mm) maximum where the reach depth is 20 inches (510 mm) maximum. Where the reach depth exceeds 20 inches (510 mm), the high forward reach shall be 44 inches (1120 mm) maximum and the reach depth shall be 25 inches (635 mm) maximum. Where a clear floor or ground space allows a parallel approach to an element and the high side reach is over an obstruction, the height of the obstruction shall be 34 inches (865 mm) maximum and the depth of the obstruction shall be 24 inches (610 mm) maximum. The high side reach shall be 48 inches (1220 mm) maximum for a reach depth of 10 inches (255 mm) maximum. Where the reach depth exceeds 10 inches (255 mm), the high side reach shall be 46 inches (1170 mm) maximum for a reach depth of 24 inches (610 mm) maximum.	women's - soap 60" aff, hook in stall 67" aff	Lower operating mechanisms to max 48" above the finished floor (AFF) to highest operable part. Lower soap dispenser to max 44" above the finished floor (AFF) for a forward reach over counter.	2015 ABAAS Section: 308.2.1, 308.3.2 2012 TAS Section: 308.2.1, 308.3.2 2010 ADAS Section: 308.2.1, 308.3.2

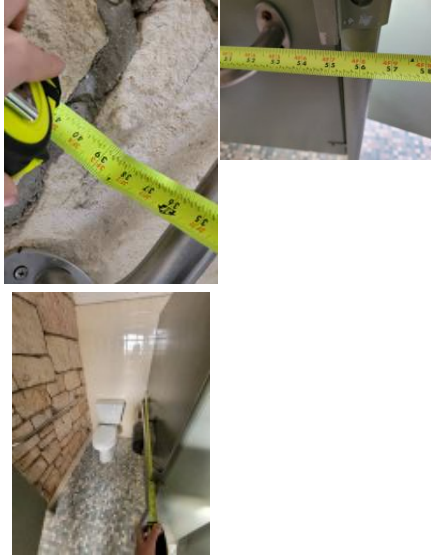
Finding Number	Area Description	Lat/Long	Finding	As Built	Recommendation	Citation	Photos	Figure
37	Restrooms: Restrooms 2	[32.2318226 , -101.4906 969]	The ambulatory stall is not between 35" to 37" wide and 60" deep.	women's - 39" by 55.5"	Correct ambulatory stall to be 35" to 37" wide and minimum 60" deep	2015 ABAAS Section: 604.8.2.1 2012 TAS Section: 604.8.2.1 2010 ADAS Section: 604.8.2.1

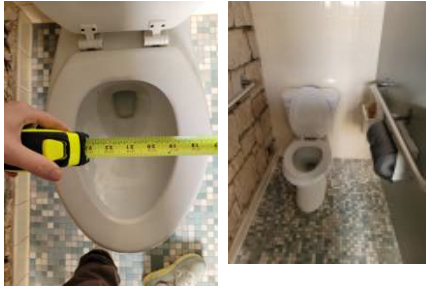
38	Restrooms: Restrooms 2	[32.2318192 , -101.4907 157]	The toilet is not located within the range to the side wall or partition. The centerline of the toilet shall be 17 inches minimum and 19 inches maximum side wall or partition in the ambulatory accessible toilet compartment.	women's - 21" from toilet paper side	Remount toilet to 17" to 19" from the side wall to center line in ambulatory stalls	2015 ABAAS Section: 604.9.1 2012 TAS Section: 604.9.1 2010 ADAS Section: 604.9.1

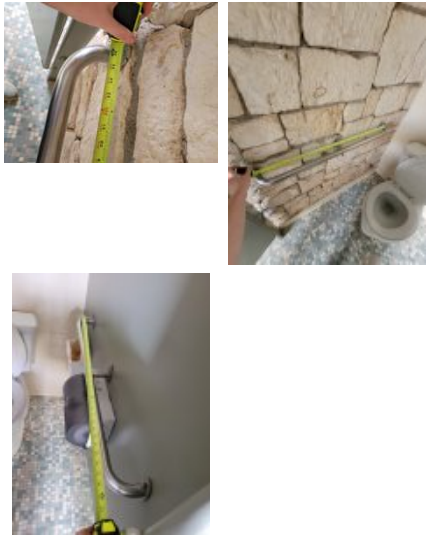
40	Restrooms: Restrooms 2	[32.2318169 , -101.4907 049]	Grab bars shall comply with 609. A side-wall grab bar complying with 604.5.1 shall be provided on both sides of the compartment. The space between the wall and the grab bar shall be 1½ inches (38 mm). The space between the grab bar and projecting objects below and at the ends shall be 1½ inches (38 mm) minimum. The space between the grab bar and projecting objects above shall be 12 inches (305 mm) minimum. Grab bars shall be installed in a horizontal position, 33 inches (840 mm) minimum and 36 inches (915 mm) maximum above the finish floor measured to the top of the gripping surface, except that at water closets for children's use complying with 604.9, grab bars shall be installed in a horizontal position 18 inches (455 mm) minimum and 27 inches (685 mm) max	women's - both grab bars are 36" long	Replace or add side grab bars with a 42" long grab bar, mounted max 12" from the rear wall at the close end and min 54" on the far end and 33" to 36" aff	2015 ABAAS Section: 604.8.2.3, 609.3, 609.4 2012 TAS Section: 609.4, 609.3, 604.8.2.3 2010 ADAS Section: 609.3, 609.4, 604.8.2.3

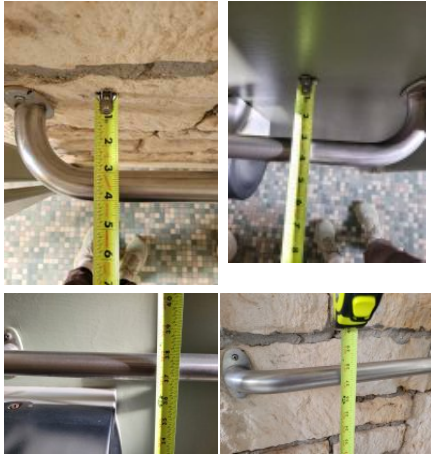
Finding Number	Area Description	Lat/Long	Finding	As Built	Recommendation	Citation	Photos	Figure
41	Restrooms: Restrooms 2	[32.2318124 , -101.4907 023]	The grab bar height and/or spacing fails. Grab bars must be mounted between 33" and 36" to the top of the gripping surface. There must be 1.5" of clearance between the grab bar and the wall. There must be a minimum of 1.5" of clearance below and minimum 12" above the grab bar to any dispenser or other obstruction.	women's - 3" clearance between wall and grab bar, both 38" aff	Remount grab bars in accessible stall to 33" to 36" aff Replace grab bars in accessible stall with bars that provide 1.5" clearance between the grab bar and the wall	2015 ABAAS Section: 609.3, 609.4 2012 TAS Section: 609.4, 609.3 2010 ADAS Section: 609.3, 609.4

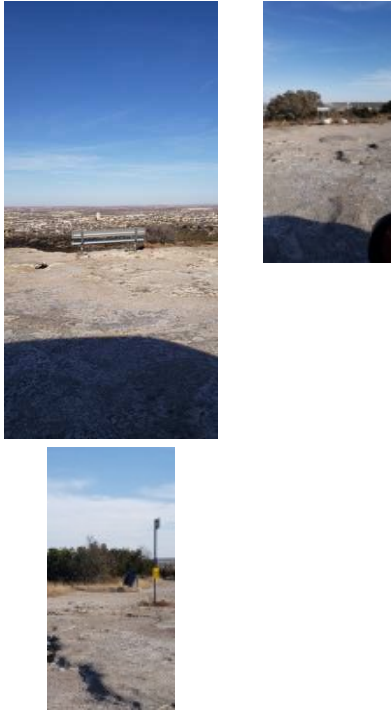
Finding Number	Area Description	Lat/Long	Finding	As Built	Recommendation	Citation	Photos	Figure
42	Park Site: Park Elements	[32.2335628, -101.4889253]	There is no accessible route to the trash can, bench, or sign at overlook pull off. At least one accessible route shall connect accessible buildings, accessible facilities, accessible elements, and accessible spaces that are on the same site.	Overlook - No accessible route to trash can, bench, or sign	Create an accessible route with crushed stone or other outdoor material from parking or walkway to overlook pull off area.	2015 ABAAS Section: F206.2.2 2012 TAS Section: 206.2.2 2010 ADAS Section: 206.2.2

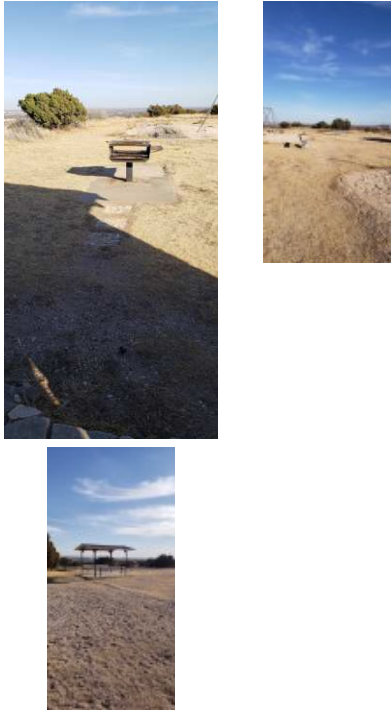
Finding Number	Area Description	Lat/Long	Finding	As Built	Recommendation	Citation	Photos	Figure
43	Park Site: Park Elements	[32.2332701, -101.4899231]	At least one outdoor recreation access route shall connect accessible elements, spaces, and facilities provided within picnic units with mobility features	group pavilion- no accessible route to grill or benches	Extend an AR to features and elements in the shelter or picnic area as a smart practice.	2015 ABAAS Section: F245.4.1

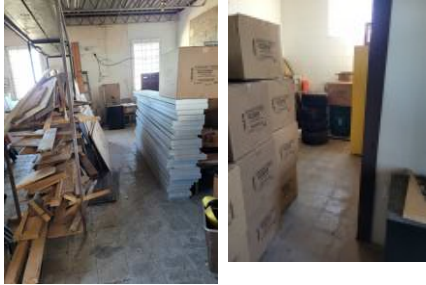
Finding Number	Area Description	Lat/Long	Finding	As Built	Recommendation	Citation	Photos	Figure
47	Park Site: Maintenance	[32.2305622, -101.4918113]	Employee Work Areas. Common use circulation paths within employee work areas shall comply with 402. EXCEPTIONS: 1. Common use circulation paths located within employee work areas that are less than 1000 square feet (93 m2) and defined by permanently installed partitions, counters, casework, or furnishings shall not be required to comply with 402. 2. Common use circulation paths located within employee work areas that are an integral component of work area equipment shall not be required to comply with 402. 3. Common use circulation paths located within exterior employee work areas that are fully exposed to the weather shall not be required to comply with 402.	storage throughout reduces width	Make corrections for compliant circulation path.	2015 ABAAS Section: F206.2.8, F206.2.8.1, F206.2.8.2 2012 TAS Section: 206.2.8, 206.2.8 Exception 1, 206.2.8 Exception 2, 206.2.8 Exception 3, 206.2.8 Advisory 1, 206.2.8 Advisory 2 2010 ADAS Section: 206.2.8, 206.2.8 Exception 1, 206.2.8 Exception 2, 206.2.8 Exception 3

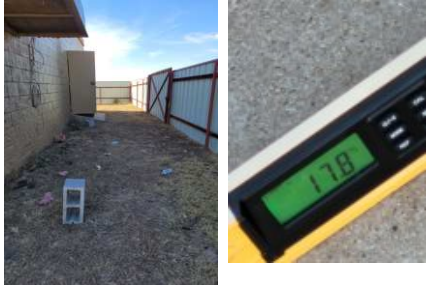
48	Park Site: Maintenance	[32.2305781, -101.4917939]	Spaces and elements within employee work areas shall only be required to comply with 206.2.8, 207.1, and 215.3 and shall be designed and constructed so that individuals with disabilities can approach, enter, and exit the employee work area. Employee work areas, or portions of employee work areas, other than raised courtroom stations, that are less than 300 square feet (28 m2) and elevated 7 inches (180 mm) or more above the finish floor or ground where the elevation is essential to the function of the space shall not be required to comply with these requirements or to be on an accessible route.	no AR to entry, 17.8% slope up, knob in office, knob and 2 steps up to blue door in garage. no AR to shed	Correct slope in door clearance to max 2.08%. Repair, bevel, or ramp CILs at door entries to max .25". Replace hardware with lever hardware or hardware operable without a tight pinch or grasp. Create an accessible route to building entries	2015 ABAAS Section: F203.9 2012 TAS Section: 203.9 2010 ADAS Section: 203.9

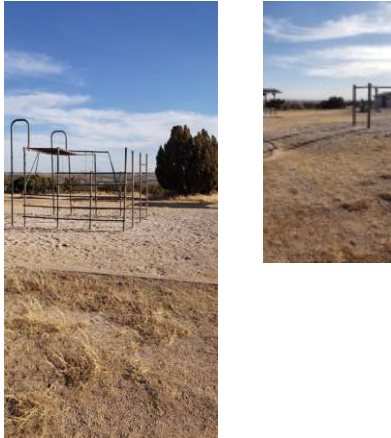
Finding Number	Area Description	Lat/Long	Finding	As Built	Recommendation	Citation	Photos	Figure
50	Play Area: Playground	[32.2331169, -101.4897823]	There is no accessible route to the play area. Accessible routes serving play areas shall comply with Chapter 4 and 1008.2 and shall be permitted to use the exceptions in 1008.2.1 through 1008.2.3. Where accessible routes serve ground level play components, the vertical clearance shall be 80 inches high (2030 mm) minimum.	no route to any of the play area sections	Create an AR to the play area within the site	2015 ABAAS Section: F206.2.2 2012 TAS Section: 1008.2 2010 ADAS Section: 206.2.2

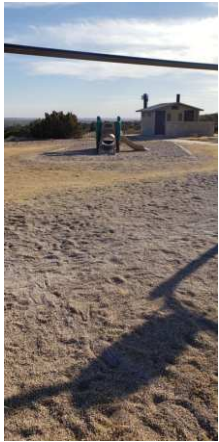
51	Play Area: Playground	[32.2330443, -101.4898252]	Play area shall have signage listing designated ages of intended users	Lacks posted age group of intended users	Acquire and install intended user signage and mount at designated entry as a smart practice	2015 ABAAS Section: F240.1 2012 TAS Section: 240.1 2010 ADAS Section: 240.1

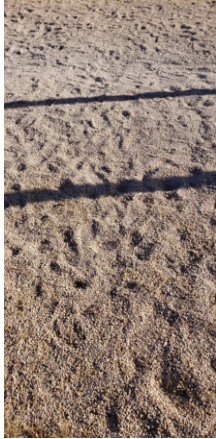
Finding Number	Area Description	Lat/Long	Finding	As Built	Recommendation	Citation	Photos	Figure
52	Play Area: Playground	[32.2330897, -101.4898198]	Compliance with ASTM F 1951 for accessibility for ground surfaces on accessible routes, clear floor or ground spaces, and turning spaces has not been determined. Ground surfaces shall comply with ASTM F 1951. Ground surfaces shall be inspected and maintained regularly and frequently to ensure continued compliance with ASTM F 1951.	gravel surface	Replace existing surface with an accessible surface such as EWF, PIP or tiles, with compliant slopes and CILs	2012 TAS Section: 1008.2.6.1 2010 ADAS Section: 1008.2.6.1

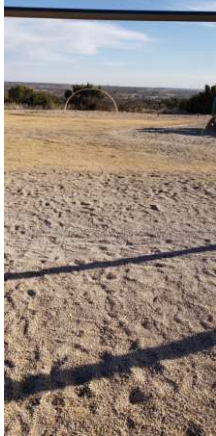
53	Play Area: Playground	[32.2331033, -101.4897662]	The route within the play area does not connect to all play components	grass and gravel between structures	Extend accessible play surface to provide AR to all GLPCs and EPCs	2012 TAS Section: 206.2.17, 206.2.17.1 2010 ADAS Section: 206.2.17, 206.2.17.1

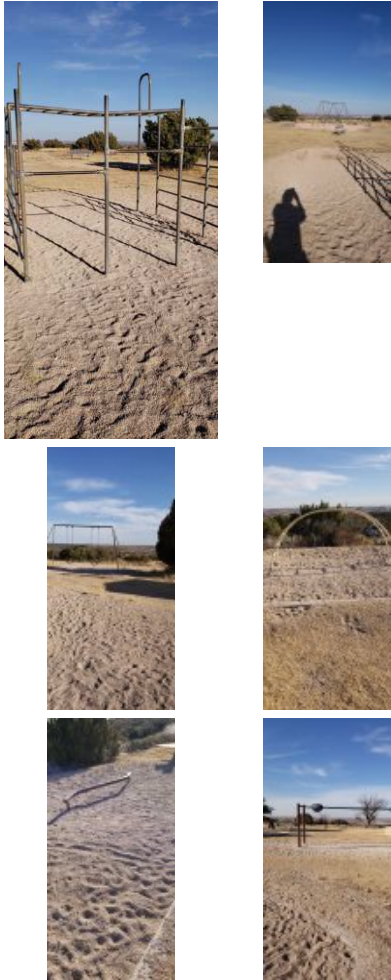
Finding Number	Area Description	Lat/Long	Finding	As Built	Recommendation	Citation	Photos	Figure
55	Play Area: Playground	[32.233126, -101.4897769]	A minimum of one of each type of ground level play components is not on an accessible route. Where ground level play components are provided, at least one of each type shall be on an accessible route and shall comply.	3 climbers, 2 swingers, 1 slider lack AR due to surface	Provide an AR to all ground level play components for one of each type accessible; surface replacement cost included in earlier finding	2012 TAS Section: 240.2.1.1 2010 ADAS Section: 240.2.1.1

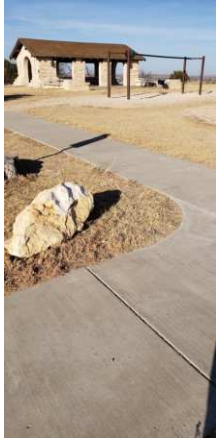
Finding Number	Area Description	Lat/Long	Finding	As Built	Recommendation	Citation	Photos	Figure
56	Play Area: Playground	[32.22916, -101.4818]	Element meets all standards and requirements	AR from parking lot to playground group picnic area is compliant	None	2010 ADAS Section: N/A
