# Access Audit Site Report

**Copper Breaks State Park  
777 State Hwy Park Rd 62  
Quanah, TX 79252**

**Accessibility Evaluation  
Inspection Date: 05/18/2022  
Inspectors: Tanya Scheibe**

Prepared By  
**WT Group**

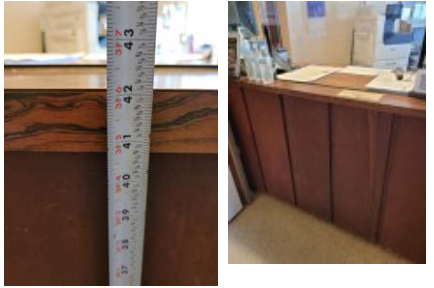
12	Headquarters Area: HQ - Public Spaces	[34.1121906 , -99.743233 5]	The transaction counter is too high. A portion of the counter surface that is 36 inches long minimum and 36 inches high maximum above the finish floor shall be provided. Knee and toe space must be provided for a forward approach. A 30 inch by 48 inch clear floor space on an accessible route must be provided for either a forward or parallel approach.	Service counter 42" AFF	Lower 36" wide segment of service counter to max 36" AFF.	2015 ABAAS Section: 904.4.2, 904.4.1  2012 TAS Section: 904.4.1, 904.4.2  2010 ADAS Section: 904.4.2, 904.4.1

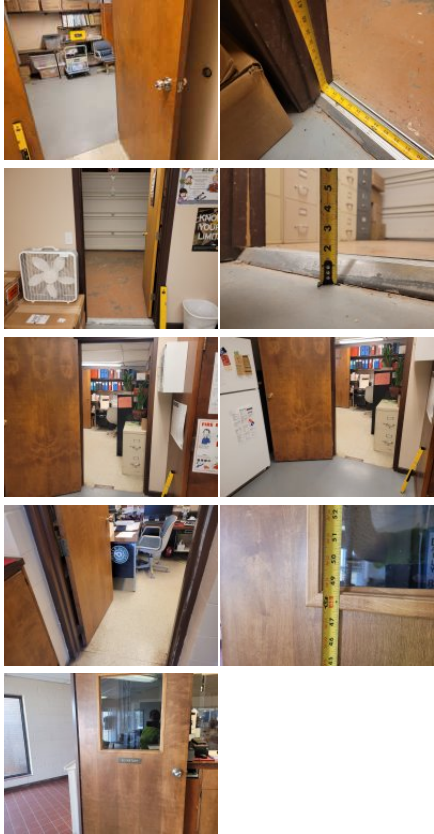
Finding Number	Area Description	Lat/Long	Finding	As Built	Recommendation	Citation	Photos	Figure
13	Headquarters Area: HQ - Employee Areas	[34.1121972 , -99.743245 6]	Spaces and elements within employee work areas shall only be required to comply with 206.2.8, 207.1, and 215.3 and shall be designed and constructed so that individuals with disabilities can approach, enter, and exit the employee work area. Employee work areas, or portions of employee work areas, other than raised courtroom stations, that are less than 300 square feet (28 m2) and elevated 7 inches (180 mm) or more above the finish floor or ground where the elevation is essential to the function of the space shall not be required to comply with these requirements or to be on an accessible route.	Entry double- knob; room with overhead door- 30" wide, knob, 1.5" threshold; work room to office- cabinets both sides, knob; office to reception- 29", knob; office secretary- 49" window, knob	For employee spaces, relocate storage, furniture, and other obstacles at doorways to provide approach, enter and exit at the employee space. Replace doors with doors having 80" overhead clearance and 32" clear width. Repair, provide beveled threshold. Replace hardware with lever hardware or hardware operable without a tight pinch or grasp. Replace doors with ones having sidelight viewing windows max 43" AFF.	2015 ABAAS Section: F203.9 2012 TAS Section: 203.9 2010 ADAS Section: 203.9

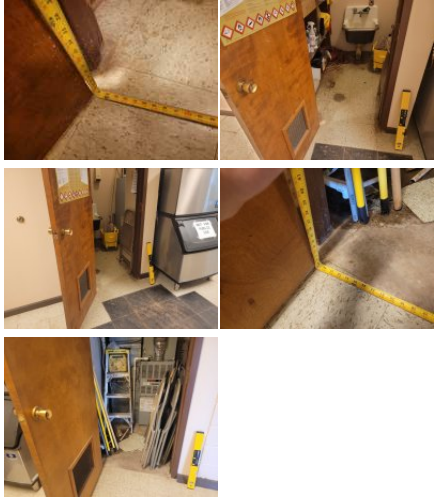
Finding Number	Area Description	Lat/Long	Finding	As Built	Recommendation	Citation	Photos	Figure
14	Headquarters Area: HQ - Employee Areas	[34.112215, -99.743225 5]	Spaces and elements within employee work areas shall only be required to comply with 206.2.8, 207.1, and 215.3 and shall be designed and constructed so that individuals with disabilities can approach, enter, and exit the employee work area. Employee work areas, or portions of employee work areas, other than raised courtroom stations, that are less than 300 square feet (28 m2) and elevated 7 inches (180 mm) or more above the finish floor or ground where the elevation is essential to the function of the space shall not be required to comply with these requirements or to be on an accessible route.	Janitor- 29.5" wide, knob, storage push side; furnace- 29.5" wide, knob, storage push side	For employee spaces, relocate storage, furniture, and other obstacles at doorways to provide approach, enter and exit at the employee space. Replace doors with doors having 80" overhead clearance and 32" clear width. Replace hardware with lever hardware or hardware operable without a tight pinch or grasp.	2015 ABAAS Section: F203.9 2012 TAS Section: 203.9 2010 ADAS Section: 203.9

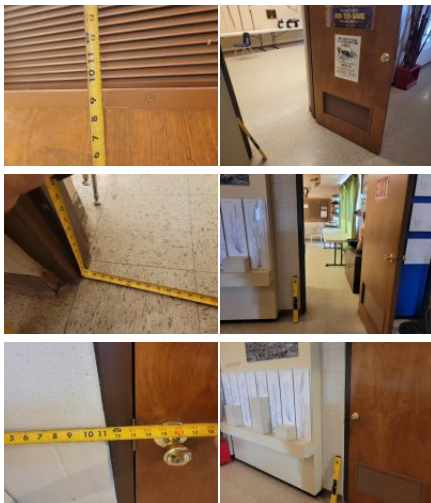
18	Headquarters Area: HQ - Interpretive Center	[34.1122, -99.74324]	Minimum maneuvering clearances at doors and gates shall comply with 404.2.4. Maneuvering clearances shall extend the full width of the doorway and the required latch side or hinge side clearance. Door openings shall provide a clear width of 32 inches (815 mm) minimum. Clear openings of doorways with swinging doors shall be measured between the face of the door and the stop, with the door open 90 degrees. Openings more than 24 inches (610 mm) deep shall provide a clear opening of 36 inches (915 mm) minimum. There shall be no projections into the required clear opening width lower than 34 inches (865 mm) above the finish floor or ground. Projections into the clear opening width between 34 inches (865 mm) and 80 inches (2030 mm) above the finish floor or ground shall not exceed 4 inches (100 mm). Hand-activated door opening hardware, handles, pulls, latches, locks, and other operating devices on accessible doors shall have a shape that is easy to grasp with one hand and does not require tight grasping, tight pinching or twisting of the wrist to operate. Hardware shall be 34 inches minimum and 48 inches maximum above the finish floor or ground. The bottom 10 inches on the push side must be smooth and free of obstructions (hold open devices).	Classroom: first door - knob, vent starts at 9.5" AFF; rear door - knob hardware, 29" wide with display 13" pull side	For all doors along the public circulation route, provide required maneuvering clearance on push and pull side of doors. For all doors along the public circulation route, replace doors with doors having 80" overhead clearance and 32" clear width. For all doors along the public circulation route, replace hardware with lever hardware or hardware operable without a tight pinch or grasp. For all doors along the public circulation route, provide kick plate on push side of door from floor to 10" AFF.	2010 ADAS Section: 404.2.3, 404.2.7, 404.2.4, 404.2.11, 404.2.11 Exception

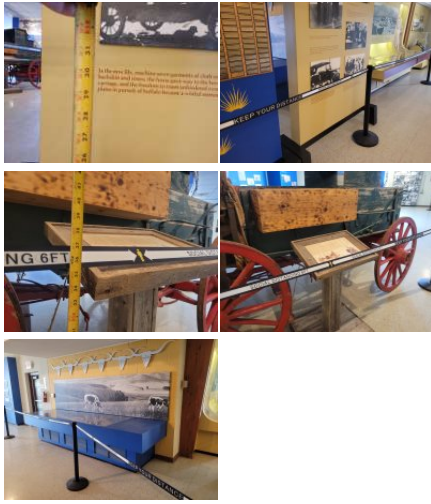
21	Headquarters Area: HQ - Interpretive Center	[34.1122034 , -99.74328]	The sign providing directional and information is noncompliant. Signs that identify, direct to or give information about accessible elements and features of a building or site, shall have a non-glare finish, contrast with their background, be selected from fonts where the width of the uppercase letter "O" is 55 percent minimum and 110 percent maximum of the height of the uppercase letter "I". Characters shall be uppercase or lowercase or a combination of both, conventional in form and shall not be italic, oblique, script, highly decorative, or of other unusual forms and be sized according to the viewing distance. Visual characters shall be 40 inches (1015 mm) minimum above the finish floor or ground.	Interpretive signage in museum text sometimes below 40", post mounted signs have small text	Create template for signs that addresses height of sign, size of characters, location of Braille, and other requirements Implement a sign revision program throughout the building, discriminating between directional signs and signs for permanent spaces Remount signage to be a min of 40" aff or agl (above ground level)	2015 ABAAS Section: F216.3 2012 TAS Section: 216.3 2010 ADAS Section: 216.3, 703.5.6 Exception

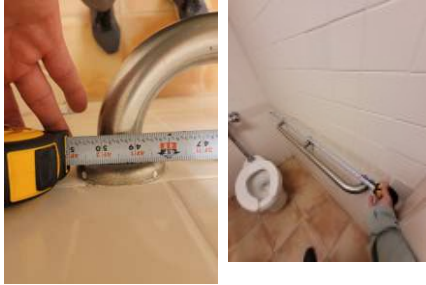
Finding Number	Area Description	Lat/Long	Finding	As Built	Recommendation	Citation	Photos	Figure
30	Headquarters Area: HQ - Men's Restroom	[34.112195, -99.743238 9]	The side grab bars are not in the correct location. Grab bars on the side wall must be installed so that the end closest to the rear wall is maximum 12" from the rear wall. The end furthest from the rear wall must be mounted minimum 54" from the rear wall.	side bar extends 49.5" from rear wall	Replace side grab bar with a 42" long bar mounted to max 12" from the rear wall at the close end and min 54" on the far end, and 33" to 36" AFF.	2015 ABAAS Section: 604.5.1 2012 TAS Section: 604.5.1 2010 ADAS Section: 604.5.1

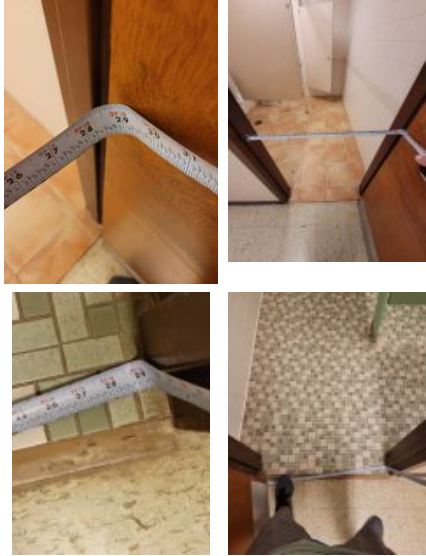
Finding Number	Area Description	Lat/Long	Finding	As Built	Recommendation	Citation	Photos	Figure
33	Headquarters Area: HQ - Men's Restroom	[34.11229, -99.74319]	The door opening does not provide at least 32 inches between the face of the door and the opposite stop. Door openings shall provide a clear width of 32 inches minimum. Clear openings of doorways with swinging doors shall be measured between the face of the door and the stop, with the door open 90 degrees. There shall be no projections into the required clear opening width lower than 34 inches above the finish floor or ground. Projections into the clear opening width between 34 inches and 80 inches above the finish floor or ground shall not exceed 4 inches.	Men's and women's restroom doors 29" width	Replace door with one having 32" clear width.	2015 ABAAS Section: 404.2.3  2012 TAS Section: 404.2.3  2010 ADAS Section: 404.2.3

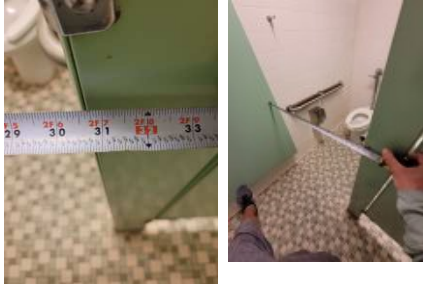
38	Headquarters Area: HQ - Women's Restroom	[34.1122483 , -99.7432335]	The stall door fails to comply with all of the door requirements. The stall door must be a minimum of 32" wide.	ambulatory stall 30.5" width	Widen stall doors to 32" when opened to 90 degrees.	2015 ABAAS Section: 404.2.3, 404.2.7, 604.8.2.2 2012 TAS Section: 404.2.3, 404.2.7, 604.8.2.2 2010 ADAS Section: 404.2.3, 404.2.7, 604.8.2.2

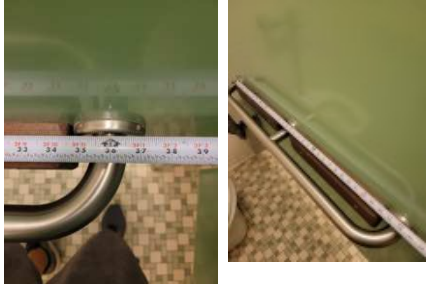
Finding Number	Area Description	Lat/Long	Finding	As Built	Recommendation	Citation	Photos	Figure
39	Headquarters Area: HQ - Women's Restroom	[34.1122017, -99.7432228]	Grab bars shall comply with 609. A side-wall grab bar complying with 604.5.1 shall be provided on both sides of the compartment. The space between the wall and the grab bar shall be 1½ inches (38 mm). The space between the grab bar and projecting objects below and at the ends shall be 1½ inches (38 mm) minimum. The space between the grab bar and projecting objects above shall be 12 inches (305 mm) minimum. Grab bars shall be installed in a horizontal position, 33 inches (840 mm) minimum and 36 inches (915 mm) maximum above the finish floor measured to the top of the gripping surface, except that at water closets for children's use complying with 604.9, grab bars shall be installed in a horizontal position 18 inches (455 mm) minimum and 27 inches (685 mm) max	Grab bars 36" long	Replace side grab bars with a 42" long grab bar, mounted max 12" from the rear wall at the close end and min 54" on the far end and 33" to 36" AFF.	2015 ABAAS Section: 604.8.2.3, 609.3, 609.4  2012 TAS Section: 609.4, 609.3, 604.8.2.3  2010 ADAS Section: 609.3, 609.4, 604.8.2.3

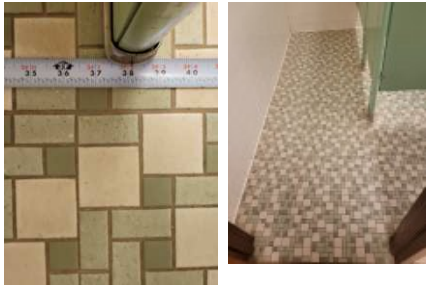
40	Headquarters Area: HQ - Women's Restroom	[34.112285, -99.7432161]	The grab bar height and/or spacing fails. Grab bars must be mounted between 33" and 36" to the top of the gripping surface. There must be 1.5" of clearance between the grab bar and the wall. There must be a minimum of 1.5" of clearance below and minimum 12" above the grab bar to any dispenser or other obstruction.	3.25" gap to wall	Replace grab bar with one that provides 1.5" of clearance between the grab bar and the wall. Cost included in previous finding.	2015 ABAAS Section: 609.3, 609.4  2012 TAS Section: 609.4, 609.3  2010 ADAS Section: 609.3, 609.4		
41	Headquarters Area: HQ - Women's Restroom	[34.1121773, -99.7431906]	There is insufficient turning space within this room or space. The space required for a wheelchair to make a 180-degree turn is a clear space of 60 inches in diameter or a T-shaped space.	37.5" width, the space it too small with current layout	Remodel restroom to provide minimum 60" diameter or T-shaped turning space.	2015 ABAAS Section: 304.3.1, 304.3.2  2012 TAS Section: 304.3.1, 304.3.2  2010 ADAS Section: 304.3.1, 304.3.2

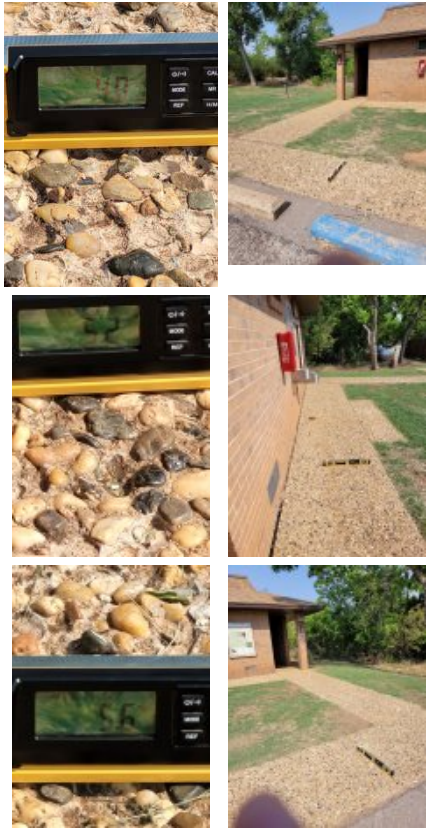
60	Kiowa Camping Area: Kiowa - Men's Restroom	[34.1129733, -99.7491728], [34.1129978, -99.7491111]	The accessible route of travel contains cross slopes greater than 2%. Cross slopes shall not exceed one unit vertical in 48 units horizontal (2-percent slope).	On route to men's restroom - 4.9%; drinking fountain - 5.2%; on route to women's - 5.6%	Correct or repair cross slope along AR to max 2.08%.	2015 ABAAS Section: 403.3 2012 TAS Section: 403.3 2010 ADAS Section: 403.3

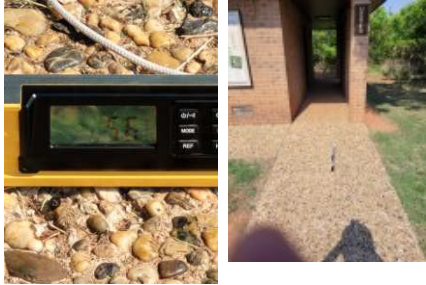
Finding Number	Area Description	Lat/Long	Finding	As Built	Recommendation	Citation	Photos	Figure
61	Kiowa Camping Area: Kiowa - Men's Restroom	[34.1129556 , -99.7491138]	The running slope of walking surfaces shall not be steeper than 1:20.	5.6% on route to women's restroom	Correct running slope along the AR to max 5%.	2015 ABAAS Section: 403.3  2012 TAS Section: 403.3  2010 ADAS Section: 403.3

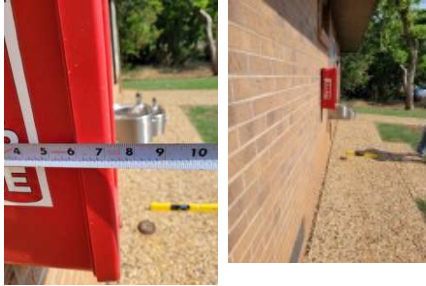
62	Kiowa Camping Area: Kiowa - Men's Restroom	[34.1130011 , -99.7490883]	An item or items project more than 4 inches into the circulation path. Wall-mounted objects that have leading edges between 27 inches and 80 inches from the floor must not project more than 4 inches into the circulation path. Protruding objects that extend to the floor or within 27 inches of the floor are cane detectable and are therefore not hazardous. Where it is necessary or desirable to have objects protrude from the wall, a manner of cane detection must be provided.	Fire extinguisher protrudes 7.25" on route to drinking fountain	Relocate protruding objects or place cane detectable warning or bollard at foot of item.	2015 ABAAS Section: 307.2  2012 TAS Section: 307.2  2010 ADAS Section: 307.2

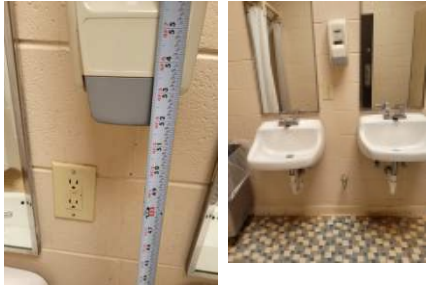
Finding Number	Area Description	Lat/Long	Finding	As Built	Recommendation	Citation	Photos	Figure
66	Kiowa Camping Area: Kiowa - Men's Restroom	[34.11303, -99.74907]	Where a high forward reach is over an obstruction, the clear floor space shall extend beneath the element for a distance not less than the required reach depth over the obstruction. The high forward reach shall be 48 inches (1220 mm) maximum where the reach depth is 20 inches (510 mm) maximum. Where the reach depth exceeds 20 inches (510 mm), the high forward reach shall be 44 inches (1120 mm) maximum and the reach depth shall be 25 inches (635 mm) maximum. Where a clear floor or ground space allows a parallel approach to an element and the high side reach is over an obstruction, the height of the obstruction shall be 34 inches (865 mm) maximum and the depth of the obstruction shall be 24 inches (610 mm) maximum. The high side reach shall be 48 inches (1220 mm) maximum for a reach depth of 10 inches (255 mm) maximum. Where the reach depth exceeds 10 inches (255 mm), the high side reach shall be 46 inches (1170 mm) maximum for a reach depth of 24 inches (610 mm) maximum.	Soap dispenser 52" AFF, between 2 sinks	Lower to max 44" above the finished floor (AFF) for a forward reach over sink.	2015 ABAAS Section: 308.2.1, 308.3.2  2012 TAS Section: 308.2.1, 308.3.2  2010 ADAS Section: 308.2.1, 308.3.2

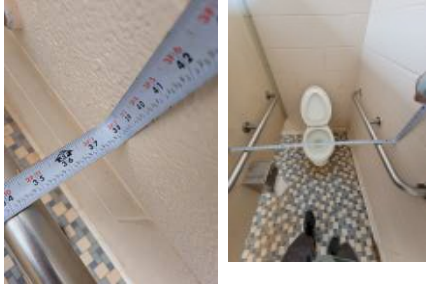
Finding Number	Area Description	Lat/Long	Finding	As Built	Recommendation	Citation	Photos	Figure
68	Kiowa Camping Area: Kiowa - Men's Restroom	[34.11303, -99.74907]	The ambulatory stall is not between 35" to 37" wide and 60" deep.	ambulatory stall 38" width	Correct ambulatory stall to be 35" to 37" wide and minimum 60" deep.	2015 ABAAS Section: 604.8.2.1  2012 TAS Section: 604.8.2.1  2010 ADAS Section: 604.8.2.1

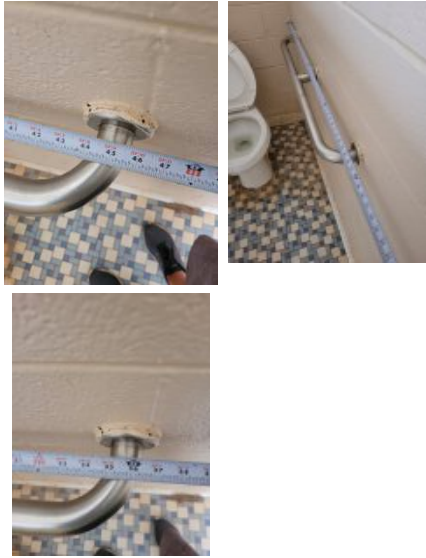
Finding Number	Area Description	Lat/Long	Finding	As Built	Recommendation	Citation	Photos	Figure
70	Kiowa Camping Area: Kiowa - Men's Restroom	[34.11303, -99.74907]	The side grab bars are not in the correct location. Grab bars on the side wall must be installed so that the end closest to the rear wall is maximum 12" from the rear wall. The end furthest from the rear wall must be mounted minimum 54" from the rear wall.	extend 45" from rear wall; 36" grab bars	Replace side grab bar with a 42" long bar mounted to max 12" from the rear wall at the close end and min 54" on the far end, and 33" to 36" AFF.	2015 ABAAS Section: 604.5.1 2012 TAS Section: 604.5.1 2010 ADAS Section: 604.5.1

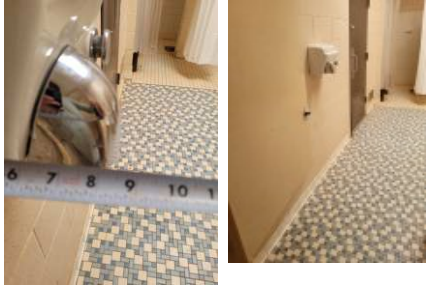
72	Kiowa Camping Area: Kiowa - Men's Restroom	[34.11303, -99.74907]	An item or items project more than 4 inches into the circulation path. Wall-mounted objects that have leading edges between 27 inches and 80 inches from the floor must not project more than 4 inches into the circulation path. Protruding objects that extend to the floor or within 27 inches of the floor are cane detectable and are therefore not hazardous. Where it is necessary or desirable to have objects protrude from the wall, a manner of cane detection must be provided.	Hand dryer projects 8.5"	Relocate protruding objects or place cane detectable warning or bollard at foot of item.	2015 ABAAS Section: 307.2 2012 TAS Section: 307.2 2010 ADAS Section: 307.2

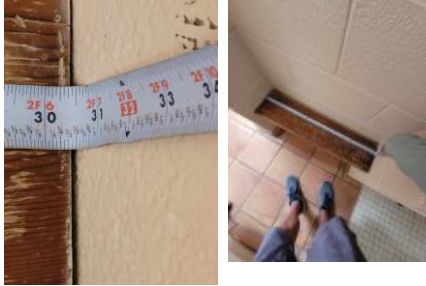
74	Kiowa Camping Area: Kiowa - Women's Restroom	[34.1122039, -99.7432335]	The bench is not deep enough or long enough or is missing. Benches shall be provided having seats that are 42 inches long minimum and 20 inches deep minimum and 24 inches deep maximum. The bench shall provide for back support or shall be affixed to a wall. Back support shall be 42 inches (1065 mm) long minimum and shall extend from a point 2 inches (51 mm) maximum above the seat surface to a point 18 inches (455 mm) minimum above the seat surface. Back support shall be 2½ inches (64 mm) maximum from the rear edge of the seat measured horizontally. The top of the bench seat surface shall be 17 inches (430 mm) minimum and 19 inches (485 mm) maximum above the finish floor or ground. Clear floor or ground space complying with 305 shall be provided and shall be positioned at the end of the bench seat and parallel to the short axis of the bench	bench 30.5" width	Replace bench in dressing area with one having a seat depth of 20" to 24" deep, 42" long, affixed to the wall or having a back and mounted 17" to 19" AFF and provide required clear floor space on the short axis of the bench.	2012 TAS Section: 903.4, 903.2, 903.3, 903.5  2010 ADAS Section: 903.4, 903.2, 903.3, 903.5

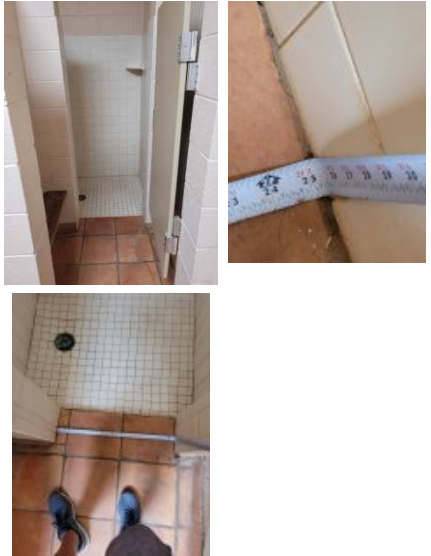
Finding Number	Area Description	Lat/Long	Finding	As Built	Recommendation	Citation	Photos	Figure
75	Kiowa Camping Area: Kiowa - Women's Restroom	[34.1122394 , -99.743271 1]	There are no accessible bathing or shower facilities. Where facilities for bathing are provided for the public, clients or employees, including showers or bathtubs, at least one shower or bathtub and support facilities such as lockers, and not less than 1 percent of all facilities, shall be accessible.	shower not compliant- 25" entry	Create an accessible shower in locker/bathing room.	2015 ABAAS Section: F213.3.6  2012 TAS Section: 213.3.6  2010 ADAS Section: 213.3.6

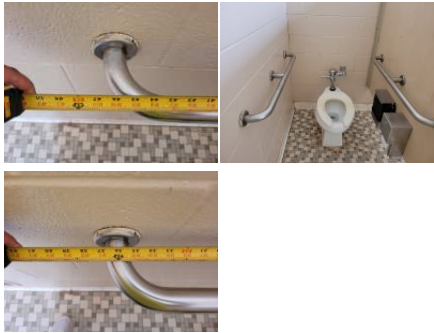
81	Kiowa Camping Area: Kiowa - Women's Restroom	[34.11303, -99.74907]	The side grab bars are not in the correct location. Grab bars on the side wall must be installed so that the end closest to the rear wall is maximum 12" from the rear wall. The end furthest from the rear wall must be mounted minimum 54" from the rear wall.	Extend 46" from rear wall; grab bar 36"	Replace side grab bar with a 42" long bar mounted to max 12" from the rear wall at the close end and min 54" on the far end, and 33" to 36" AFF.	2015 ABAAS Section: 604.5.1  2012 TAS Section: 604.5.1  2010 ADAS Section: 604.5.1

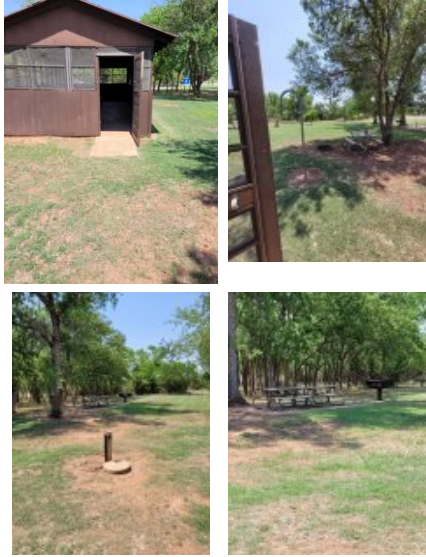
89	Day Use - Group Picnic Area & Pavilion: Shelters/Picnic Areas	[34.1128834 , -99.7498089]	An item or items project more than 4 inches into the circulation path. Wall-mounted objects that have leading edges between 27 inches and 80 inches from the floor must not project more than 4 inches into the circulation path. Protruding objects that extend to the floor or within 27 inches of the floor are cane detectable and are therefore not hazardous. Where it is necessary or desirable to have objects protrude from the wall, a manner of cane detection must be provided.	Fire extinguisher protrudes 5"	Relocate protruding objects or place cane detectable warning or bollard at foot of item.	2015 ABAAS Section: 307.2  2012 TAS Section: 307.2  2010 ADAS Section: 307.2

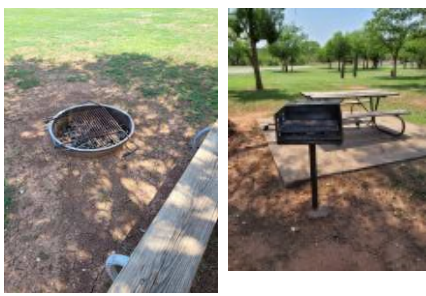
93	Day Use - Group Picnic Area & Pavilion: Shelters/Picnic Areas	[34.1128857, -99.7495126]	48 inches (1220 mm) by 48 inches (1220 mm) on all usable sides of the fire ring, grill, fireplace, and woodstove Center the space on each usable side of the grill, fireplace, and woodstove	Lacks clear ground space at grill and fire pit	Provide required 48" clear ground space centered along usable side of fire ring, grill, fireplace, or woodstove as a smart practice.	2015 ABAAS Section: 1011.2

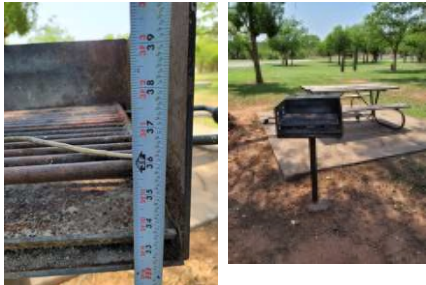
95	Day Use - Group Picnic Area & Pavilion: Shelters/Picnic Areas	[34.1126447 , -99.749957 8]	Where provided, cooking surfaces shall be 15 inches (380 mm) minimum and 34 inches (865 mm) maximum above the ground.	Cooking surface 36" above ground surface	Raise or lower cooking surface to be 15" min to 34" max above the ground	2015 ABAAS Section: 1011.5.2

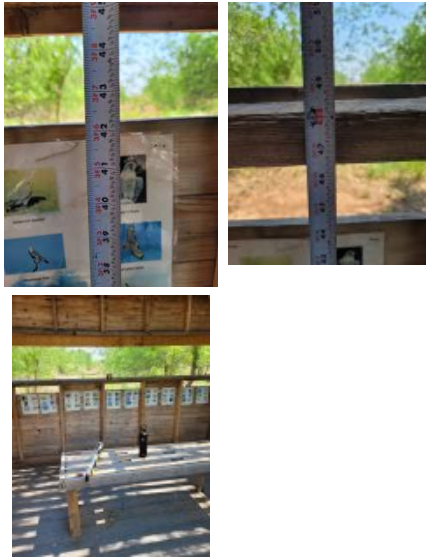
101	Day Use - Group Picnic Area & Pavilion: Day Use - Bird Blind	[34.1120981, -99.749729]	There is no accessible route to the bird blind. At least one accessible route shall connect accessible buildings, accessible facilities, accessible elements, and accessible spaces that are on the same site.	Day use bird blind - lacks AR, 1.75" change in level at ramp	Create an accessible route with crushed stone or other outdoor material from parking or walkway to bird blind. Repair, bevel, or ramp CIL to be max .25".	2015 ABAAS Section: F206.2.2 2012 TAS Section: 206.2.2 2010 ADAS Section: 206.2.2

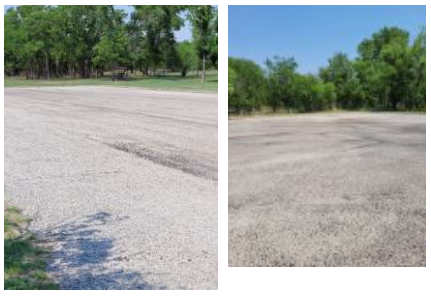
Finding Number	Area Description	Lat/Long	Finding	As Built	Recommendation	Citation	Photos	Figure																																																																																																																																																																																																										
102	Day Use - Group Picnic Area & Pavilion: Day Use - Parking	[34.1122066 , -99.750079 1]	There are no or not enough accessible parking stalls. Each lot where parking is provided for the public as clients, guests or employees, shall provide accessible parking and shall be located on the shortest accessible route of travel from adjacent parking to an accessible entrance. There are a total of 25 parking stalls in the parking lot that could be reasonably associated with this facility. There should be a minimum of 1 accessible stalls with a minimum of 1 being designed as van accessible.	day use - lacks accessible parking, area not striped, approx 25 spaces	Create one or more 8' accessible parking stalls, with one 5' adjacent access aisle, with proper signage and striping based on the total number of stalls.	2015 ABAAS Section: F208.2  2012 TAS Section: 208.2  2010 ADAS Section: 208.2

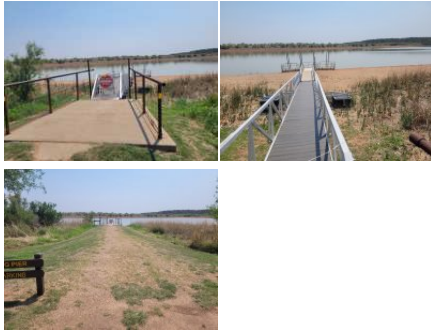
120	Cottonwood Group Campground: Cottonwood - Fishing	[34.1068341, -99.7475733]	At least one accessible route shall connect accessible buildings, accessible facilities, accessible elements, and accessible spaces that are on the same site. For areas of sport activity, an accessible route is required to connect to the boundary of each area of sport activity. The size of an area of sport activity includes only the space needed to play. Where multiple sports fields or courts are provided, an accessible route is required to each field or area of sport activity.	Unable to audit pier; lacks AR to pier	Provide an accessible route (AR) to fishing pier.	2010 ADAS Section: 206.2.2, 206.2

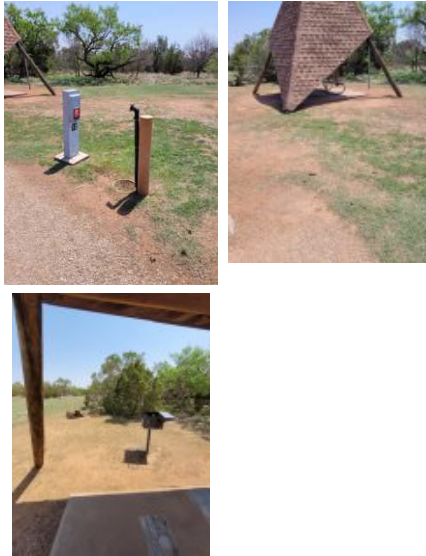
126	Comanche Camping Area: Comanche - Campsites 1-25	[34.10802, -99.754009 3]	Picnic tables shall provide at least one wheelchair space for each 24 linear feet (7320 mm) of usable table surface perimeter. Wheelchair spaces shall be 30 inches (760 mm) minimum by 48 inches (1220 mm) minimum. Wheelchair spaces shall be positioned for a forward approach to the table and provide knee and toe clearance complying with 306 under the table	Site 10 - Picnic table lacks wheelchair space	Replace picnic table with one of an accessible design as a smart practice.	2015 ABAAS Section: 1011.4.2

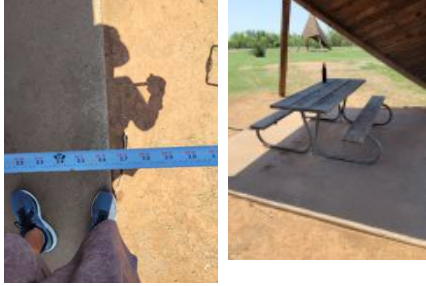
127	Comanche Camping Area: Comanche - Campsites 1-25	[34.1080211 , -99.754006 6]	36 inches (915 mm) on all usable sides of the table measured from the back edge of the benches.	Site 10 - Lacks clear ground space on all 4 sides	Provide required 36" clear ground space around all usable portions of the table as a smart practice.	2015 ABAAS Section: 1011.2.1

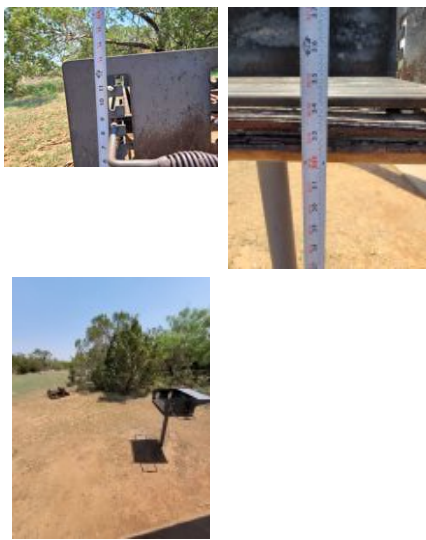
130	Comanche Camping Area: Comanche - Campsites 1-25	[34.1080899 , -99.753991 9]	Where provided, cooking surfaces shall be 15 inches (380 mm) minimum and 34 inches (865 mm) maximum above the ground.	Site 10 - Lacks proper cooking level range at fire ring and grill	Raise or lower cooking surface to be 15" min to 34" max above the ground; in the alternative, replace with a compliant surface as a smart practice.	2015 ABAAS Section: 1011.5.2

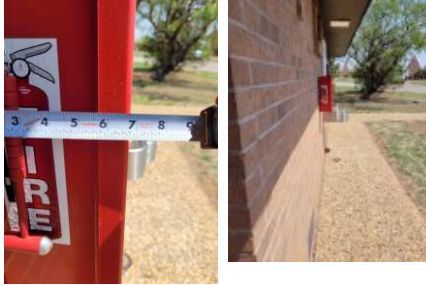
141	Comanche Camping Area: Comanche - Men's Restroom	[34.1079345 , -99.754434 4]	The bench is not deep enough or long enough or is missing. Benches shall be provided having seats that are 42 inches long minimum and 20 inches deep minimum and 24 inches deep maximum. The bench shall provide for back support or shall be affixed to a wall. Back support shall be 42 inches (1065 mm) long minimum and shall extend from a point 2 inches (51 mm) maximum above the seat surface to a point 18 inches (455 mm) minimum above the seat surface. Back support shall be 2½ inches (64 mm) maximum from the rear edge of the seat measured horizontally. The top of the bench seat surface shall be 17 inches (430 mm) minimum and 19 inches (485 mm) maximum above the finish floor or ground. Clear floor or ground space complying with 305 shall be provided and shall be positioned at the end of the bench seat and parallel to the short axis of the bench	Bench 7.25" depth	Replace bench in dressing area with one having a seat depth of 20" to 24" deep, 42" long, affixed to the wall or having a back and mounted 17" to 19" aff and provide required clear floor space on the short axis of the bench.	2012 TAS Section: 903.4, 903.2, 903.3, 903.5  2010 ADAS Section: 903.4, 903.2, 903.3, 903.5

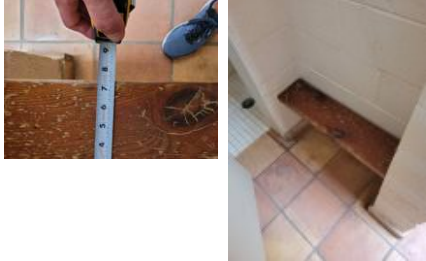
142	Comanche Camping Area: Comanche - Men's Restroom	[34.1079256 , -99.754435 8]	There are no accessible bathing or shower facilities. Where facilities for bathing are provided for the public, clients or employees, including showers or bathtubs, at least one shower or bathtub and support facilities such as lockers, and not less than 1 percent of all facilities, shall be accessible.	0 of 2 showers accessible	Create an accessible shower in locker/bathing room.	2015 ABAAS Section: F213.3.6  2012 TAS Section: 213.3.6  2010 ADAS Section: 213.3.6

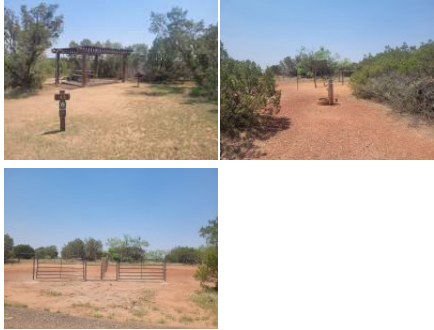
175	Big Pond Group Campground: Big Pond - Equestrian Campsites 37-50	[34.11303, -99.74907]	36 inches (915 mm) by 48 inches (1220 mm) positioned near the bench with one side of the space adjoining an outdoor recreation access route or trail, as applicable The clear ground space shall not overlap the outdoor recreation access route or trail, or another clear ground space	Lacks clear ground space at bench	Construct firm, stable, and slip resistant pads at least 36" by 48" adjacent to 20% of benches, and locate along an AR as a smart practice.	2015 ABAAS Section: 1011.2, 1011.2.1

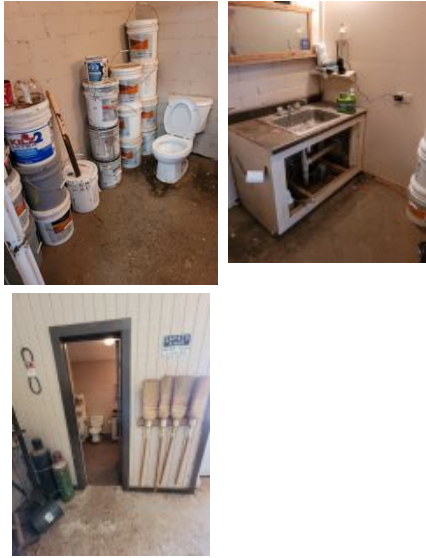
214	Employee Areas: Maintenance	[34.1102585 , -99.732697 8]	The restroom sign does not comply with one or more applicable requirements for the location, height, and properties of the sign.	Lacks signage	Acquire and mount signage, including Braille and raised lettering and mount on wall, latch side of door, 48" to baseline of lowest character and 60" to baseline of highest character.	2015 ABAAS Section: F216.2, 703.1, 703.2, 703.5, 703.6 2012 TAS Section: 216.2, 703.1, 703.2, 703.5, 703.6 2010 ADAS Section: 216.2, 703.1, 703.2, 703.5, 703.6

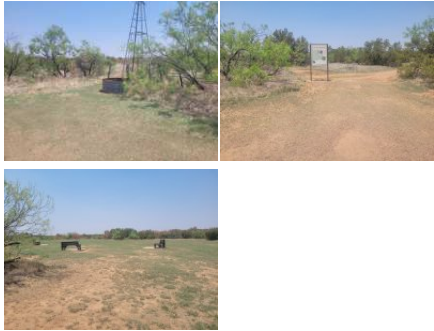
221	Trails: Trailhead	[34.1177745 , -99.758221]	Benches shall have a 36" by 48" clear ground space (CGS) positioned near the bench with one side of the space adjoining an outdoor recreation access route (ORAR) or trail, as applicable The CGS shall not overlap with the ORAR or trail or another CGS	0 of 3 benches have clear ground space at equestrian trailhead	Construct firm, stable, and slip resistant pads at least 36" by 48" adjacent to 20% of benches, and locate along an AR as a smart practice.	2015 ABAAS Section: 1011.2.1

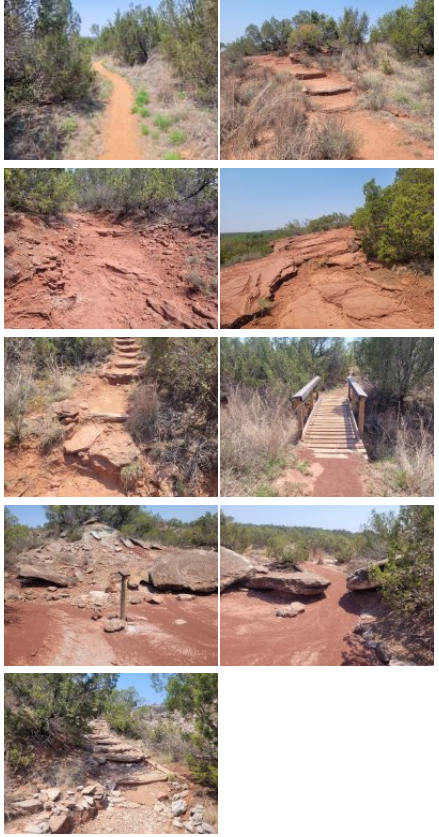
233	Trails: Trail Surface	[34.1075876 , -99.7453613]	The surface of trails, passing spaces, and resting intervals shall be firm and stable	natural surface at MTB trail	Leave as is and designate hiking trails in the park as accessible	2015 ABAAS Section: 1017.2
