Gene Howe WMA- ADA Evaluation

WMA- Gene Howe, Canadian TX, ADA Evaluation

Accessibility Evaluation

Inspection Date: 06/27/2022

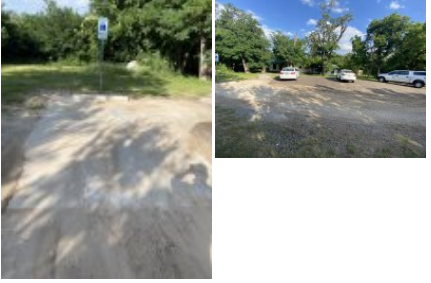
Finding Number	Area Description	Finding	As Built	Recommendation	Citation	Photos	Figure
1	Exterior of Property (Public): Bunk House/HQ Parking (1 Spot) 1 Van - Van Accessible Stall	The striping and markings for the accessible parking stall, loading/unloading access aisle are dilapidated and in need of repair and/or maintenance.	Parking stall outside of HQ building. Stall borders and ISA insignia is faded or missing,	https://www.access-board.gov/ada/#ada-502_2 https://www.access-board.gov/ada/#ada-502_3_3	2012 TAS Section: 502.3.3 2010 ADAS Section: 502.3.3 2015 ABAAS Section: 502.3.3, 503.3.3

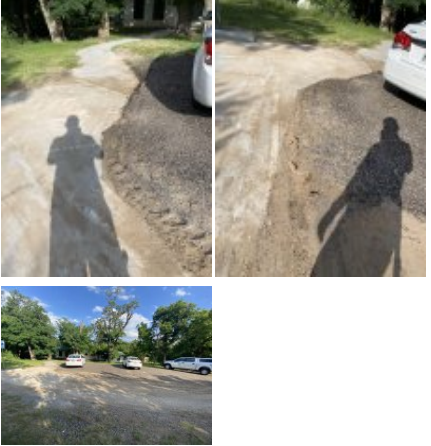
2	Exterior of Property (Public): Bunk House/HQ Parking (1 Spot) 1 Van - Access Aisle (Van)	The access aisle is in not nearly compliant. The access ai the minimum width. The access aisle is not as long as the parking space it serves. There are no markings to discourage parking. The floor or ground surface is not firm stable or slip resistant. The parking space contains changes in level and/or gaps that exceed the maximum allowable requirements.	Access aisle has multiple infractions. Access aisle slope is over 2% due to gravel pile up, area is not clearly marked. Access aisle fails to run the length of parking spot Obstructions, changes in elevation, abrupt edges, and curb ramps are prohibited from being placed in access aisle. Floor or Ground Surfaces. Access aisles are required to be nearly level in all directions to provide a surface for wheelchair transfer to and from vehicles. Access aisle width requirments depend on van stall size. van stall 11' access aisle 5' or van stall 8' access aisle 8'	https://www.access-board.gov/ada/#ada-502_3	2012 TAS Section: 502.3 2010 ADAS Section: 502.3 2015 ABAAS Section: 502.3

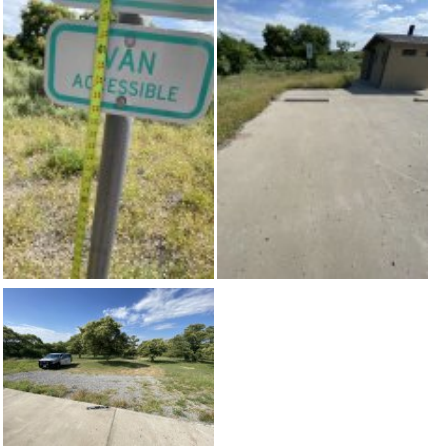
Finding Number	Area Description	Finding	As Built	Recommendation	Citation	Photos	Figure
3	Exterior of Property (Public): Camping Parking Lot (1 Space) 1 Van - Van Accessible Stall	The parking sign is mounted too low. Parking space identification signs shall include the International Symbol of Accessibility. Signs identifying van parking spaces shall contain the designation "van accessible." Signs shall be 60 inches minimum above the finish floor or ground surface measured to the bottom of the sign.	Bellow 60"	https://www.access-board.gov/ada/#ada-502_6	2012 TAS Section: 502.6 2010 ADAS Section: 502.6 2015 ABAAS Section: 502.6

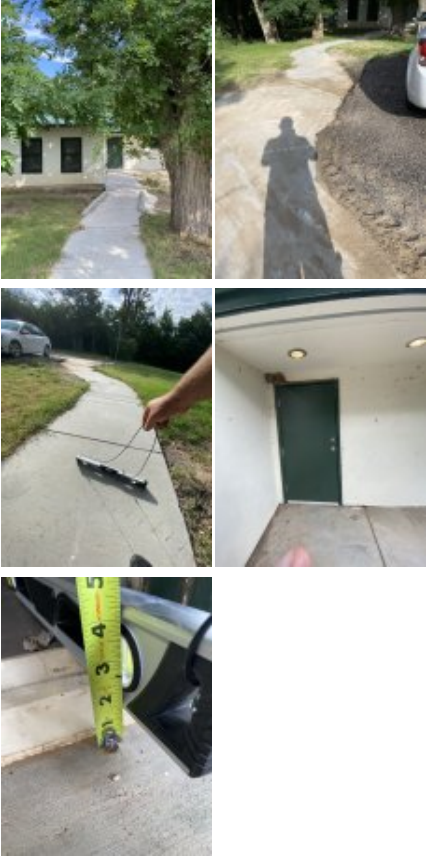
Finding Number	Area Description	Finding	As Built	Recommendation	Citation	Photos	Figure
9	Structures on Property (Public) : Bunk House/ HQ Building (Exterior)	The building entrance is not located on an accessible route. When a building, or portion of a building, is required to be accessible, an accessible route of travel shall be provided to all portions of the building, to accessible building entrances and between the building and the public way. At least one accessible route within the boundary of the site must be provided from public transportation stops, accessible parking and accessible passenger loading zones and public streets or sidewalks to the accessible building entrance they serve. The accessible route shall, to the maximum extent feasible, coincide with the route for the general public. At least one accessible route shall connect accessible buildings, facilities, elements and spaces that are on the same site. At least one accessible route shall connect accessible building or facility entrances with all accessible spaces and elements.	Due to pathway terrain type, lack of accessible pathway, and door hardware or thresholds there is no way to access this building at this time. This building is not accessible	https://www.access-board.gov/ada/#ada-206_2_1	2012 TAS Section: 206.2.1 2010 ADAS Section: 206.2.1 2015 ABAAS Section: F206.2.1

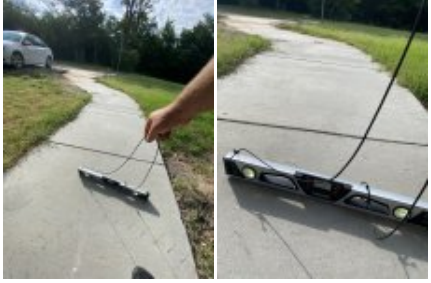
Finding Number	Area Description	Finding	As Built	Recommendation	Citation	Photos	Figure
11	Structures on Property (Public) : Bunk House/ HQ Building (Exterior) - Pathway to Bunk House/HQ	The accessible path of travel between the building entrance and the accessible parking has cross slopes greater than 2%. Surface cross slopes shall not exceed 1 unit vertical in 48 units horizontal (2-percent slope).	Greater than 2% cross slope		https://www.access-board.gov/ada/#ada-403_3	2012 TAS Section: 403.3 2010 ADAS Section: 403.3 2015 ABAAS Section: 403.3

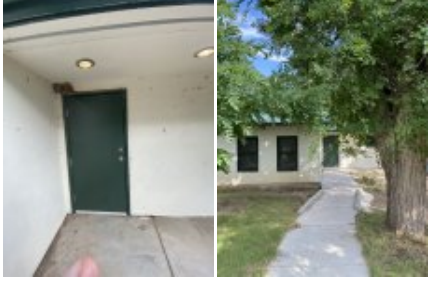
12	Structures on Property (Public) : Bunk House/ HQ Building (Interior)	There is no ISA at this entrance. In existing buildings and facilities where not all entrances are accessible, entrances to buildings and facilities that are accessible to and usable by persons with disabilities shall be identified with an International Symbol of Accessibility (ISA). Typically this is 6 inches by 6 inches in size.	Only accessible door does not have a sign or symbol. Door has compliant hardware and is considered most accessible entrance.		https://www.access-board.gov/ada/#ada-216_6	2012 TAS Section: 216.6 2010 ADAS Section: 216.6 2015 ABAAS Section: F216.6

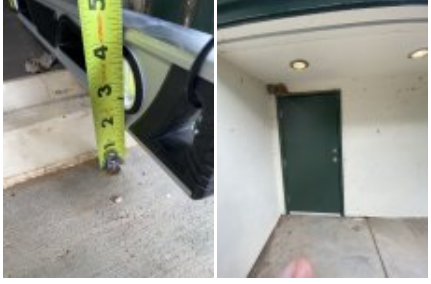
13	Structures on Property (Public) : Bunk House/ HQ Building (Interior) - Entrance/Exit Doors	The threshold is greater than 1/2 inch high. The threshold at a doorway shall be no higher than 1/2 inch. Changes in level between 1/4 inch and 1/2 inch must be beveled at 1:2 or less. 1/4 inch is the maximum vertical rise.	Threshold exceeds 1/2"		https://www.access-board.gov/ada/#ada-404_2_5	2012 TAS Section: 404.2.5 2010 ADAS Section: 404.2.5 2015 ABAAS Section: 404.2.5

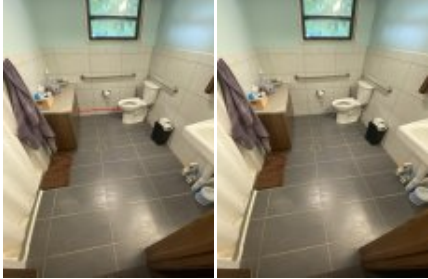
18	Structures on Property (Public) : Bunk House/ HQ Building (Interior) - Restroom/Showe r (Unisex)	There is insufficient turning space within this room or space. A Circular space or a T-shaped space must be provided. Turning space shall either be a 60" Circular Space or T-Shaped Space. Doors cannot swing into this space by more than 12 inches Circular Space. The turning space shall be a space of 60 inches diameter minimum. The space shall be permitted to include knee and toe clearance. T-Shaped Space. The turning space shall be a T-shaped space within a 60 inch square minimum with arms and base 36 inches wide minimum. Each arm of the T shall be clear of obstructions 12 inches minimum in each direction and the base shall be clear of obstructions 24 inches minimum. The space shall be permitted to include knee and toe clearance.	Cabinet on left of restroom blocks the circle and the T	https://www.access-board.gov/ada/#ada-304_3_1 https://www.access-board.gov/ada/#ada-304_3_2	2012 TAS Section: 304.3.1, 304.3.2 2010 ADAS Section: 304.3.1, 304.3.2

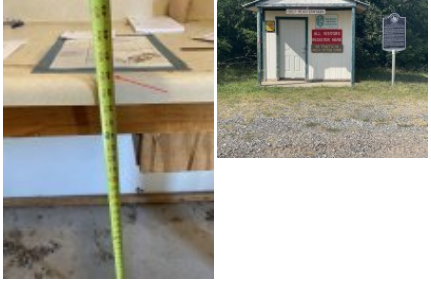
Finding Number	Area Description	Finding	As Built	Recommendation	Citation	Photos	Figure
21	Outdoor Features (Public) : Registration Shack	The work surface is not within the allowable range. The tops of work surfaces provided for public use or common use shall be 28 inches minimum and 34 inches maximum above the finish floor or ground.	Work surface height at 40"	https://www.access-board.gov/ada/#ada-902_3	2012 TAS Section: 226.1 2010 ADAS Section: 902.3 2015 ABAAS Section: 902.3
