# Gus Engeling WMA- ADA Evaluation

**WMA- Gus Engeling, Tennessee Colony TX, ADA Evalua**

**Accessibility Evaluation**

**Inspection Date: 07/07/2022**

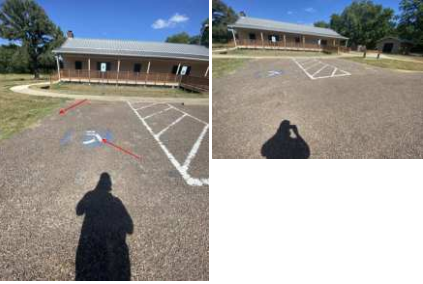
2	Exterior of Property (Public): Parking Lot Conservation Center (2 Spaces) 1 Van 1 Car - Van Accessible Stall (L) Side	The stripe is missing at the left side of the left parking stall which identifies its border. Vehicle spaces shall be marked to define the width, and shall have an adjacent access aisle.	Painted on to gravel, border missing (L) side and ISA insignia is faded.		<a href="https://www.access-board.gov/ada/#ada-502_2">https://www.access-board.gov/ada/#ada-502_2</a>  2012 TAS Section: 502.2  2010 ADAS Section: 502.2  2015 ABAAS Section: 502.2

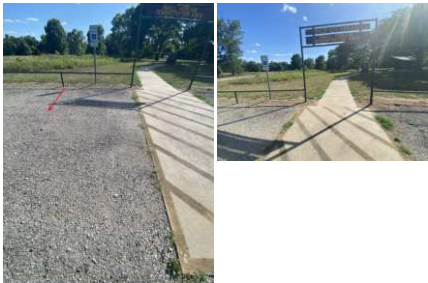
14	Exterior of Property (Public): Parking Lot Demonstration Area (1 Space) 1 Van - Van Accessible Stall	The accessible parking space is missing the required markings. Vehicle spaces shall be marked to define the width, and shall have an adjacent access aisle.	Parking stall border markings and ISA insignia are missing.	<a href="https://www.access-board.gov/ada/#ada-502_1">https://www.access-board.gov/ada/#ada-502_1</a> <a href="https://www.access-board.gov/ada/#ada-502_2">https://www.access-board.gov/ada/#ada-502_2</a>	2012 TAS Section: 502.2 2010 ADAS Section: 502.2 2015 ABAAS Section: 502.1, 502.2

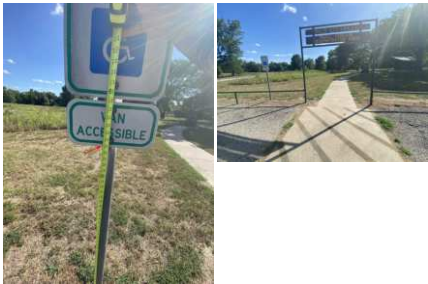
15	Exterior of Property (Public): Parking Lot Demonstration Area (1 Space) 1 Van - Van Accessible Stall	The parking sign is mounted too low. Parking space identification signs shall include the International Symbol of Accessibility. Signs identifying van parking spaces shall contain the designation "van accessible." Signs shall be 60 inches minimum above the finish floor or ground surface measured to the bottom of the sign.	sign height measured at 53"	<a href="https://www.access-board.gov/ada/#ada-502_6">https://www.access-board.gov/ada/#ada-502_6</a>	2012 TAS Section: 502.6 2010 ADAS Section: 502.6 2015 ABAAS Section: 502.6

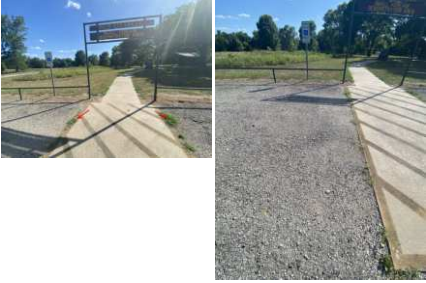
Finding Number	Area Description	Finding	As Built	Recommendation	Citation	Photos	Figure
16	Exterior of Property (Public): Parking Lot Demonstration Area (1 Space) 1 Van - Access Aisle (Van)	The access aisle contains loose gravel and/or surface materials that do not provide for a stable, firm slip resistant surface. Parking spaces and access aisles serving them shall comply with floor or ground surface requirements. The ground surface shall be stable, firm, and slip resistant. Access aisles shall be at the same level as the parking spaces they serve. Changes in level, slopes exceeding 1:48, and detectable warnings shall not be permitted.	Grass overgrowth prevents access and causes change in elevation or tripping hazard. Location of access aisle needs to be verified for compliance.	<a href="https://www.access-board.gov/ada/#ada-502_4">https://www.access-board.gov/ada/#ada-502_4</a>	2012 TAS Section: 502.4  2010 ADAS Section: 502.4  2015 ABAAS Section: 502.4

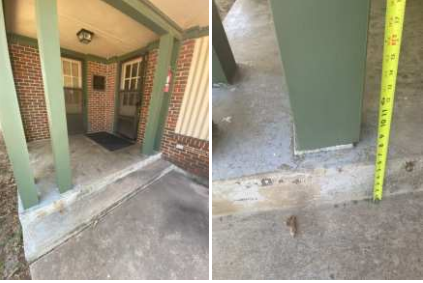
Finding Number	Area Description	Finding	As Built	Recommendation	Citation	Photos	Figure
23	Structures on Property (Public) : HQ Offices (Exterior)	The building entrance is not located on an accessible route. When a building, or portion of a building, is required to be accessible, an accessible route of travel shall be provided to all portions of the building, to accessible building entrances and between the building and the public way. At least one accessible route within the boundary of the site must be provided from public transportation stops, accessible parking and accessible passenger loading zones and public streets or sidewalks to the accessible building entrance they serve. The accessible route shall, to the maximum extent feasible, coincide with the route for the general public. At least one accessible route shall connect accessible buildings, facilities, elements and spaces that are on the same site. At least one accessible route shall connect accessible building or facility entrances with all accessible spaces and elements.	Due to pathway terrain type, lack of accessible pathway, stairs, and door hardware or thresholds there is no way to access this building at this time. This building is not accessible	<a href="https://www.access-board.gov/ada/#ada-206_2_1">https://www.access-board.gov/ada/#ada-206_2_1</a>	2012 TAS Section: 206.2.1  2010 ADAS Section: 206.2.1  2015 ABAAS Section: F206.2.1

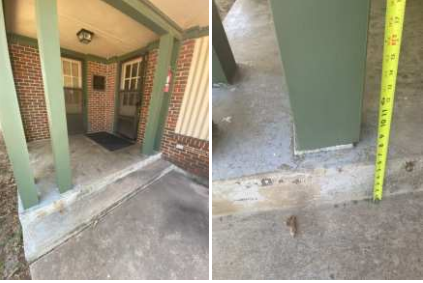
24	Structures on Property (Public) : HQ Offices (Exterior) - Pathway to HQ Office	The walkway contains changes in level greater than a 1/2 inch high that should be ramped. Changes in level greater than 1/2 inch shall be constructed as a ramp or curb ramp.	Large lip near entrance prevents access to door	<a href="https://www.access-board.gov/ada/#ada-303_4">https://www.access-board.gov/ada/#ada-303_4</a>	2012 TAS Section: 303.4  2010 ADAS Section: 303.4  2015 ABAAS Section: 303.4

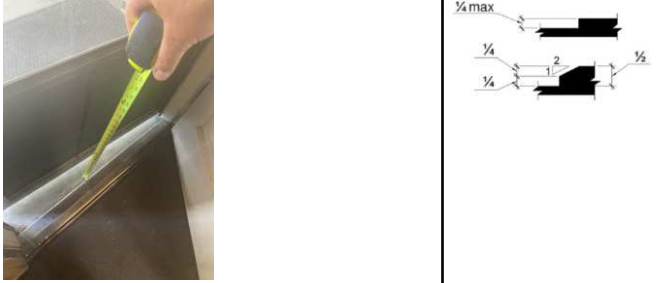
Finding Number	Area Description	Finding	As Built	Recommendation	Citation	Photos	Figure
29	Structures on Property (Public) : HQ Office (Interior) - Entrance/Exit Doors	The threshold is greater than 1/2 inch high. The threshold at a doorway shall be no higher than 1/2 inch. Changes in level between 1/4 inch and 1/2 inch must be beveled at 1:2 or less. 1/4 inch is the maximum vertical rise.	Threshold exceeds 1/2" tolerance		<a href="https://www.access-board.gov/ada/#ada-404_2_5">https://www.access-board.gov/ada/#ada-404_2_5</a>	2012 TAS Section: 404.2.5  2010 ADAS Section: 404.2.5  2015 ABAAS Section: 404.2.5

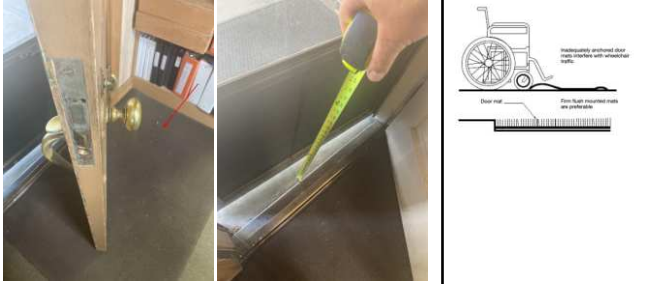
31	Structures on Property (Public) : HQ Office (Interior) - Entrance/Exit Doors	The floor mat at the door is not secured in place. If carpet or carpet tile is used on a ground or floor surface, then it shall be securely attached; have a firm cushion, pad or backing or no cushion or pad; and have a level loop, textured loop, level-cut pile or level-cut/uncut pile texture. The maximum pile height shall be 1/2 inch. Exposed edges of carpet shall be fastened to floor surfaces and have trim along the entire length of the exposed edge. Recessed doormats shall be adequately anchored to prevent interference with wheelchair traffic.	Floor mat looks worn and no longer compliant.		<a href="https://www.access-board.gov/ada/#ada-302_2">https://www.access-board.gov/ada/#ada-302_2</a>	2012 TAS Section: 302.2  2010 ADAS Section: 302.2  2015 ABAAS Section: 302.2

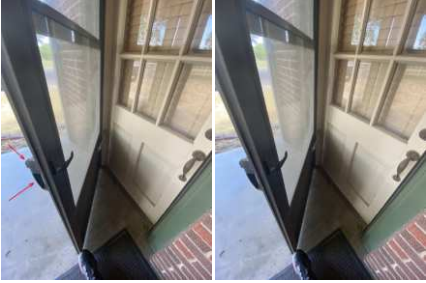
Finding Number	Area Description	Finding	As Built	Recommendation	Citation	Photos	Figure
32	Structures on Property (Public) : HQ Office (Interior) - Entrance/Exit Doors	The door operating hardware requires tight grasping, pinching or twisting of the wrist to operate. Hand-activated hardware, handles, pulls, latches, locks, and other operating devices on accessible elements shall have a shape that is easy to grasp with one hand and does not require tight grasping, pinching or twisting of the wrist to operate.	screen or storm doors are not considered "doors in series" since they are part of the same doorway opening as the entry door. They are not prohibited by the Standards but must meet all applicable requirements for doors except those pertaining to doors in series. Screen door hardware does not meet compliance	<a href="https://www.access-board.gov/ada/#ada-309_4">https://www.access-board.gov/ada/#ada-309_4</a>	2012 TAS Section: 309.4 2010 ADAS Section: 309.4 2015 ABAAS Section: 309.4

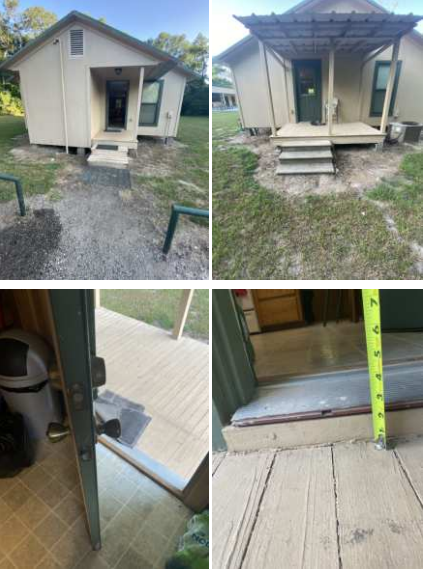
41	Structures on Property (Public) : Bunk Houses (Exterior)	The building entrance is not located on an accessible route. When a building, or portion of a building, is required to be accessible, an accessible route of travel shall be provided to all portions of the building, to accessible building entrances and between the building and the public way. At least one accessible route within the boundary of the site must be provided from public transportation stops, accessible parking and accessible passenger loading zones and public streets or sidewalks to the accessible building entrance they serve. The accessible route shall, to the maximum extent feasible, coincide with the route for the general public. At least one accessible route shall connect accessible buildings, facilities, elements and spaces that are on the same site. At least one accessible route shall connect accessible building or facility entrances with all accessible spaces and elements.	Due to pathway terrain type, lack of accessible pathway, stairs, and door hardware or thresholds there is no way to gain access to building. This building is not accessible	<a href="https://www.access-board.gov/ada/#ada-206_2_1">https://www.access-board.gov/ada/#ada-206_2_1</a>	2012 TAS Section: 206.2.1  2010 ADAS Section: 206.2.1  2015 ABAAS Section: F206.2.1

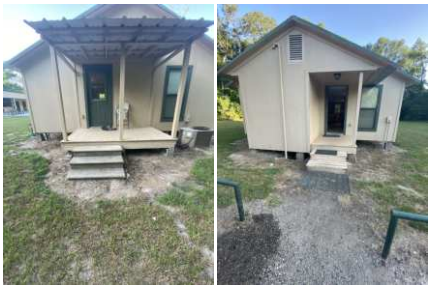
Finding Number	Area Description	Finding	As Built	Recommendation	Citation	Photos	Figure
42	Structures on Property (Public) : Bunk Houses (Exterior) - Pathway to Bunk House	The walkway contains abrupt vertical edges and/or variations over a 1/2 inch. 1/4 inch is the maximum vertical rise. Changes in level between 1/4 inch and 1/2 inch must be beveled at 1:2 or less. Changes in level greater than 1/2 inch must be by way of a ramp.	Steps on the back porch. Neither entrance is accessible.	<a href="https://www.access-board.gov/ada/#ada-303_2">https://www.access-board.gov/ada/#ada-303_2</a>	2012 TAS Section: 303.3, 303.2  2010 ADAS Section: 303.3, 303.2  2015 ABAAS Section: 303.2, 303.3

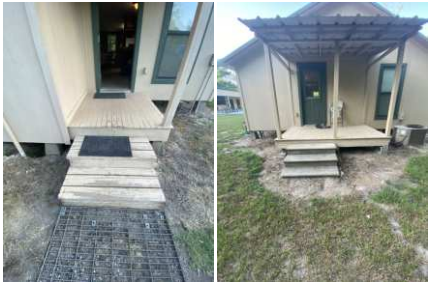
44	Structures on Property (Public) : Bunk Houses (Exterior) - Pathway to Bunk House	The walkway contains abrupt vertical edges and/or variations over a 1/2 inch. 1/4 inch is the maximum vertical rise. Changes in level between 1/4 inch and 1/2 inch must be beveled at 1:2 or less. Changes in level greater than 1/2 inch must be by way of a ramp.	Steps on front and rear entrances	<a href="https://www.access-board.gov/ada/#ada-303_2">https://www.access-board.gov/ada/#ada-303_2</a>	2012 TAS Section: 303.3, 303.2  2010 ADAS Section: 303.3, 303.2  2015 ABAAS Section: 303.2, 303.3

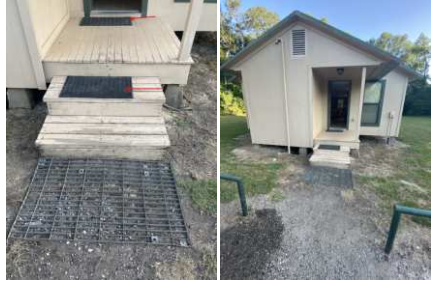
Finding Number	Area Description	Finding	As Built	Recommendation	Citation	Photos	Figure
45	Structures on Property (Public) : Bunk Houses (Exterior) - Pathway to Bunk House	The floor mat at the door is not secured in place. If carpet or carpet tile is used on a ground or floor surface, then it shall be securely attached; have a firm cushion, pad or backing or no cushion or pad; and have a level loop, textured loop, level-cut pile or level-cut/uncut pile texture. The maximum pile height shall be 1/2 inch. Exposed edges of carpet shall be fastened to floor surfaces and have trim along the entire length of the exposed edge. Recessed doormats shall be adequately anchored to prevent interference with wheelchair traffic.	Door mat is not of compliant size or durability and does not meet compliance.	<a href="https://www.access-board.gov/ada/#ada-302_2">https://www.access-board.gov/ada/#ada-302_2</a>	2012 TAS Section: 302.2 2010 ADAS Section: 302.2 2015 ABAAS Section: 302.2

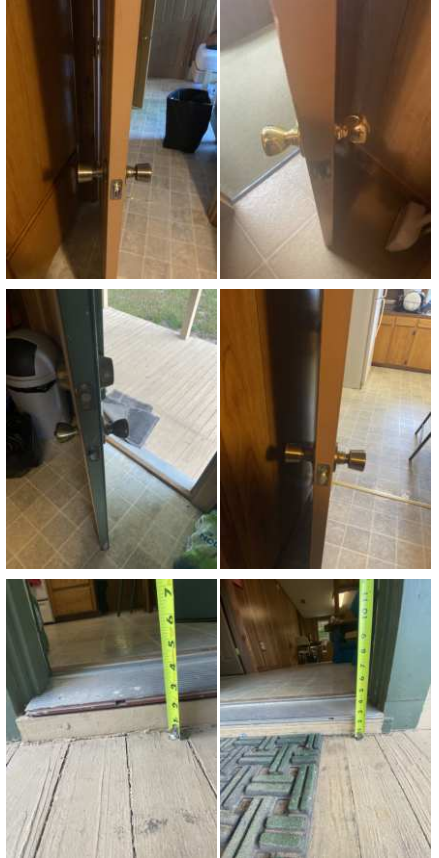
46	Structures on Property (Public) : Bunk Houses (Interior) - Entrance/Exit Doors	Minimum maneuvering clearances at doors and gates shall comply with 404.2.4. Maneuvering clearances shall extend the full width of the doorway and the required latch side or hinge side clearance. Maneuvering clearances shall have a max slope of 2.08%. Door openings shall provide a clear width of 32 inches (815 mm) minimum. Clear openings of doorways with swinging doors shall be measured between the face of the door and the stop, with the door open 90 degrees. Openings more than 24 inches (610 mm) deep shall provide a clear opening of 36 inches (915 mm) minimum. There shall be no projections into the required clear opening width lower than 34 inches (865 mm) above the finish floor or ground. Projections into the clear opening width between 34 inches (865 mm) and 80 inches (2030 mm) above the finish floor or ground shall not exceed 4 inches (100 mm). The threshold has a vertical change greater than 1/4 inch high. The threshold has a gap greater than 1/2 inch wide. The threshold at a doorway shall be no higher than 1/2 inch. Changes in level between 1/4 inch and 1/2 inch must be beveled at 1:2 or less. 1/4 inch is the maximum vertical rise. All interior doors must be maintained so that the operating pressure does not exceed 5 lbf to open. The sweep period for doors with closers shall be adjusted so that from an open position of 70 degrees, the door will take at least 3 seconds to move to a point 3 inches from the latch, measured to the leading edge of the door. Exterior doors are recommended to be maintained at 8.5	More than 60% doors/entrances are equipped with non-compliant hardware. Most doorway thresholds in exceed 1/2" tolerance. Interior hallways of Bunk houses, entrance and exit doors into bunk house.	Review door and threshold componets to make accessible <a href="https://www.access-board.gov/ada/#ada-404">https://www.access-board.gov/ada/#ada-404</a>	2010 ADAS Section: 404.2.3, 404.2.7, 404.2.4, 404.2.11, 404.2.11 Exception

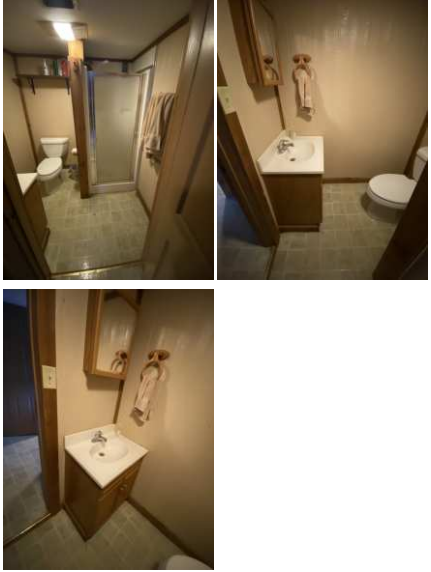
Finding Number	Area Description	Finding	As Built	Recommendation	Citation	Photos	Figure
47	Structures on Property (Public) : Bunk Houses (Interior) - Restroom (Unisex)	The restroom is not nearly compliant. The restroom does not have the required minimum clear floor space or maneuvering clearances for the toilet. The restroom does not have the required minimum clear floor space or maneuvering clearances for the lavatory. The entry door does not contain the required minimum maneuvering spaces on the pull/push sides. The entry door encroach into the required clear floor space for fixtures. Grab bars are missing and/or incorrectly installed. Accessories, such as toilet seat covers, paper towel holders, garbage cans, hand dryers, and mirrors are either too high or without clear floor space or both. The restroom contain floor level changes greater than a 1/2 inch of the floor drains and is slope (XX) - (XX), the shower is too small and missing numerous accessible elements.	This restroom requires a number of componets to gain compliance.	<a href="https://www.access-board.gov/ada/#ada-213_2">https://www.access-board.gov/ada/#ada-213_2</a> Review restrooms componets to make accessible. <a href="https://www.access-board.gov/ada/#ada-603">https://www.access-board.gov/ada/#ada-603</a>	2012 TAS Section: 213.2  2010 ADAS Section: 213.2  2015 ABAAS Section: F213.2

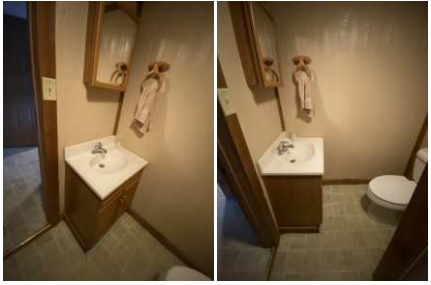
48	Structures on Property (Public) : Bunk Houses (Interior) - Restroom (Unisex)	There are not enough accessible lavatories. Where lavatories are provided, at least one shall be accessible and shall not be located in a toilet compartment.	The lavatory and accessories are not complaint.	<a href="https://www.access-board.gov/ada/#ada-213_3_4">https://www.access-board.gov/ada/#ada-213_3_4</a> Review lavatory componets to make accessible. <a href="https://www.access-board.gov/ada/#ada-606">https://www.access-board.gov/ada/#ada-606</a>	2012 TAS Section: 213.3.4  2010 ADAS Section: 213.3.4  2015 ABAAS Section: F213.3.4

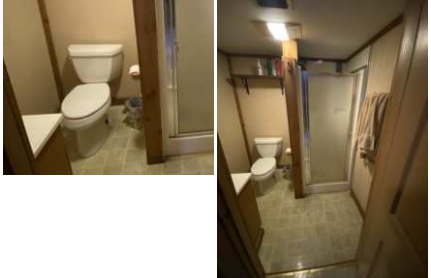
49	Structures on Property (Public) : Bunk Houses (Interior) - Restroom (Unisex)	Accessible toilets must have grab bars installed. The side grab bar must extend at least 54 inches minimum beyond the rear wall and start a maximum of 12 inches from the rear wall. The rear grab bar must be a minimum of 36 inches long and extend from the centerline of the toilet 12 inches minimum on one side and 24 inches minimum on the other side. Grab bars shall be installed in a horizontal position, 33 inches minimum and 36 inches maximum above the finish floor measured to the top of the gripping surface.	There are no grab bars installed at this time.	<a href="https://www.access-board.gov/ada/#ada-604_5">https://www.access-board.gov/ada/#ada-604_5</a> Review grab bar componets to make accessible <a href="https://www.access-board.gov/ada/#ada-609">https://www.access-board.gov/ada/#ada-609</a>	2012 TAS Section: 604.5  2010 ADAS Section: 604.5  2015 ABAAS Section: 604.5

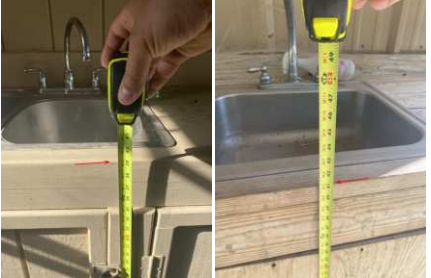
57	Structures on Property (Public) : Cleaning/Check Station	The top of the sink is above the allowable height requirement. Sinks shall be installed with the front of the higher of the rim or counter surface 34 inches maximum above the finish floor or ground.	Sinks are not accessible via front or parallel approach, due to counter height over 39" Sink does not require knee or toe space since there is no stove top in vicinity. In kitchens, kitchenettes, and breakrooms without a cooktop or conventional range, a parallel approach is permitted at kitchen sinks.	<a href="https://www.access-board.gov/aba/#aba-606_3">https://www.access-board.gov/aba/#aba-606_3</a>	2012 TAS Section: 606.3  2010 ADAS Section: 606.3  2015 ABAAS Section: 606.3

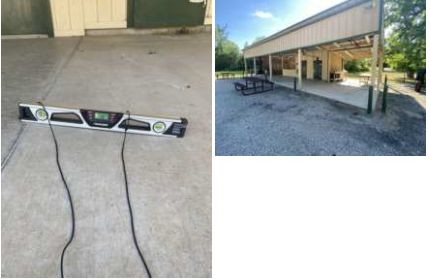
58	Structures on Property (Public) : Cleaning/Check Station	The accessible route on the site has running slopes greater than 5 percent and has not been constructed as a ramp (i.e. handrails, edge protection, etc.). When the slope in the direction of travel of any walk exceeds 1 unit vertical in 20 units horizontal (5-percent slope), it must be constructed as a ramp. Surface cross slopes must not exceed one unit vertical in 48 units horizontal (2-percent slope).	Slope in front of freezer at 7.5%	<a href="https://www.access-board.gov/ada/#ada-403_3">https://www.access-board.gov/ada/#ada-403_3</a>	2012 TAS Section: 403.3  2010 ADAS Section: 403.3  2015 ABAAS Section: 403.3

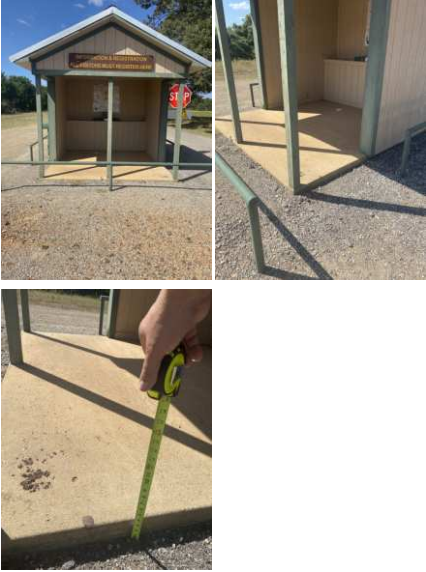
Finding Number	Area Description	Finding	As Built	Recommendation	Citation	Photos	Figure																																				
66	Outdoor Features (Public) : Informational Kiosk #1	The building entrance is not located on an accessible route. When a building, or portion of a building, is required to be accessible, an accessible route of travel shall be provided to all portions of the building, to accessible building entrances and between the building and the public way. At least one accessible route within the boundary of the site must be provided from public transportation stops, accessible parking and accessible passenger loading zones and public streets or sidewalks to the accessible building entrance they serve. The accessible route shall, to the maximum extent feasible, coincide with the route for the general public. At least one accessible route shall connect accessible buildings, facilities, elements and spaces that are on the same site. At least one accessible route shall connect accessible building or facility entrances with all accessible spaces and elements.	Due to terrain and change in elevation there is no way to gain access to this area. This building is not accessible	<a href="https://www.access-board.gov/ada/#ada-206_2_1">https://www.access-board.gov/ada/#ada-206_2_1</a>	2012 TAS Section: 206.2.1  2010 ADAS Section: 206.2.1  2015 ABAAS Section: F206.2.1

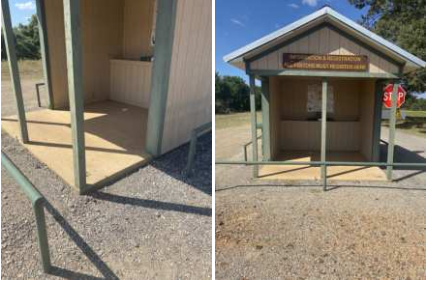
Finding Number	Area Description	Finding	As Built	Recommendation	Citation	Photos	Figure
69	Outdoor Features (Public) : Informational Kiosk #1 - Pathway to Kiosk	The accessible route contains loose gravel and/or surface materials that do not provide for a stable, firm slip resistant surface. Floor and ground surfaces shall be stable, firm, and slip resistant.	N/A	<a href="https://www.access-board.gov/ada/#ada-302_1">https://www.access-board.gov/ada/#ada-302_1</a>	2012 TAS Section: 302.1  2010 ADAS Section: 302.1  2015 ABAAS Section: 302.1

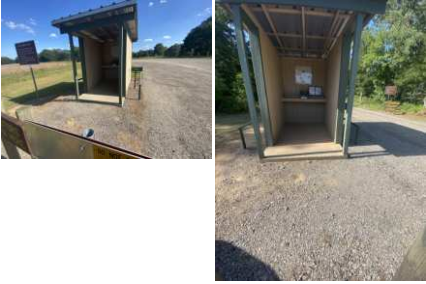
71	Outdoor Features (Public) : Informational Kiosk #2	There are no accessible parking stalls. Each lot where parking is provided for the public as clients, guests or employees, shall provide accessible parking and shall be located on the shortest accessible route of travel from adjacent parking to an accessible entrance. There are a total of (XX) parking stalls in the parking lot that could be reasonably associated with this facility. There should be a minimum of (XX) accessible stalls with a minimum of (XX) being designed as van accessible.	There are no accessible parking stalls provided to kiosk	Review parking stall and access aisle requirements <a href="https://www.access-board.gov/ada/#ada-208_2">https://www.access-board.gov/ada/#ada-208_2</a> <a href="https://www.access-board.gov/ada/#ada-502">https://www.access-board.gov/ada/#ada-502</a>	2012 TAS Section: 208.2  2010 ADAS Section: 208.2  2015 ABAAS Section: F208.2

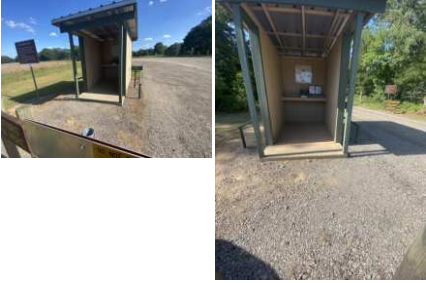
Finding Number	Area Description	Finding	As Built	Recommendation	Citation	Photos	Figure
72	Outdoor Features (Public) : Informational Kiosk #2	The building entrance is not located on an accessible route. When a building, or portion of a building, is required to be accessible, an accessible route of travel shall be provided to all portions of the building, to accessible building entrances and between the building and the public way. At least one accessible route within the boundary of the site must be provided from public transportation stops, accessible parking and accessible passenger loading zones and public streets or sidewalks to the accessible building entrance they serve. The accessible route shall, to the maximum extent feasible, coincide with the route for the general public. At least one accessible route shall connect accessible buildings, facilities, elements and spaces that are on the same site. At least one accessible route shall connect accessible building or facility entrances with all accessible spaces and elements.	Due to terrain and change in elevation pathway is not compliant This building is not accessible	<a href="https://www.access-board.gov/ada/#ada-206_2_1">https://www.access-board.gov/ada/#ada-206_2_1</a>	2012 TAS Section: 206.2.1  2010 ADAS Section: 206.2.1  2015 ABAAS Section: F206.2.1
