WMA- J.D. Murphree, Port Arthur TX, ADA Evaluation

Accessibility Evaluation

Inspection Date: 07/19/2022

Report Date: 01/18/2024

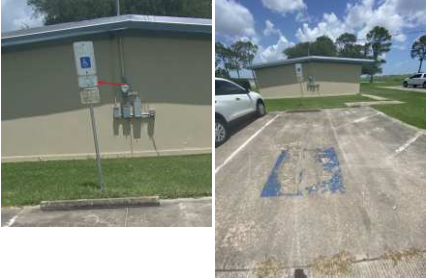
2	Exterior of Property (Public): Parking Lot Bunk Area (1 Space) 1 Van - Van Accessible Stall	The van stall is missing a sign identifying it as a van accessible stall. Parking space identification signs shall include the International Symbol of Accessibility. Signs identifying van parking spaces shall contain the designation "van accessible."	Sign is faded and no longer legible.	https://www.access-board.gov/ada/#ada-502_6	2012 TAS Section: 502.6 2010 ADAS Section: 502.6 2015 ABAAS Section: 502.6

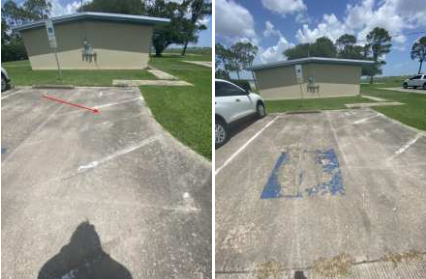
3	Exterior of Property (Public): Parking Lot Bunk Area (1 Space) 1 Van - Access Aisle (Van)	The striping and markings for the accessible parking stalls, loading/unloading access aisle are dilapidated and in need of repair and/or maintenance. Access aisles shall be marked so as to discourage parking in them. Where parking spaces are marked with lines, width measurements of parking spaces and access aisles shall be made from the centerline of the markings.	Access aisle markings are faded and not clearly marked.	https://www.access-board.gov/ada/#ada-502_3	2012 TAS Section: 502.3.3 2010 ADAS Section: 502.3.3 2015 ABAAS Section: 502.3.3, 503.3.3

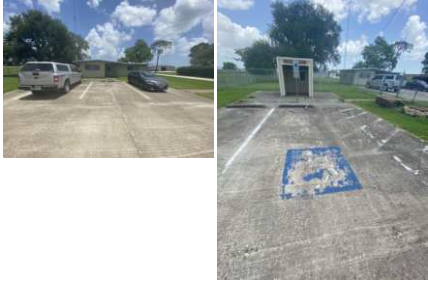
Finding Number	Area Description	Finding	As Built	Recommendation	Citation	Photos	Figure
4	Exterior of Property (Public): Parking Lot Office (1 Space) 1 Van	The accessible parking space is not located on the shortest accessible route to the building. Accessible parking spaces serving a particular building or facility entrance shall be located on the shortest accessible route of travel from the parking space to an accessible entrance.	There is no accessible parking provided in front of building. There is a accessible stall outside of the gated area.	https://www.access-board.gov/ada/#ada-208_3_1	2012 TAS Section: 208.3.1 2010 ADAS Section: 208.3.1 2015 ABAAS Section: F208.3.1

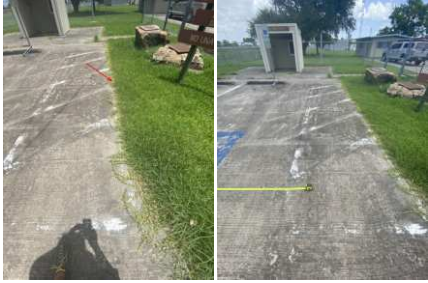
Finding Number	Area Description	Finding	As Built	Recommendation	Citation	Photos	Figure
7	Exterior of Property (Public): Parking Lot Office (1 Space) 1 Van - Access Aisle (Van)	The access aisle is not a minimum 8 feet to the centerline of the stripe. The accessible parking stall access aisle must be a minimum of 8 feet wide measured from centerline to centerline. Where parking spaces or access aisles are not adjacent to another parking space or access aisle, measurements shall be permitted to include the full width of the line defining the parking space or access aisle. Alternatively, the stall can be 11 feet wide and the access aisle may be 5 feet wide.	Access aisle width does not meet width requirements and has grass overgrowth preventing access. Access aisle width requirements depend on van stall size. van stall 11' access aisle 5' or van stall 8' access aisle 8' Obstructions, changes in elevation, abrupt edges, and curb ramps are prohibited from being placed in access aisle. Floor or Ground Surfaces. Access aisles are required to be nearly level in all directions to provide a surface for wheelchair transfer to and from vehicles.	https://www.access-board.gov/ada/#ada-502_2	2012 TAS Section: 502.2 Exception 2010 ADAS Section: 502.2 Exception 2015 ABAAS Section: 502.2, 502.2 EXCEPTION

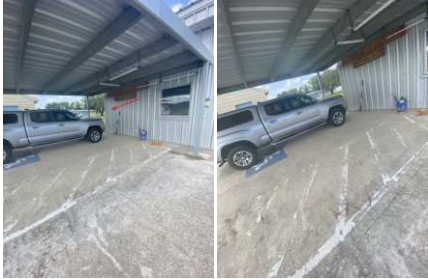
11	Exterior of Property (Public): Parking Lot Unknown Location (1 Space) Not Labeled - Accessible Stall (Unlabeled)	The required parking signage is missing. Parking space identification signs shall include the International Symbol of Accessibility (ISA). Signs identifying van parking spaces shall contain the designation "van accessible." All signs shall be 60 inches minimum above the finish floor or ground surface measured to the bottom of the sign.	None provided	https://www.access-board.gov/ada/#ada-502_6	2012 TAS Section: 502.6 2010 ADAS Section: 502.6 2015 ABAAS Section: 502.6

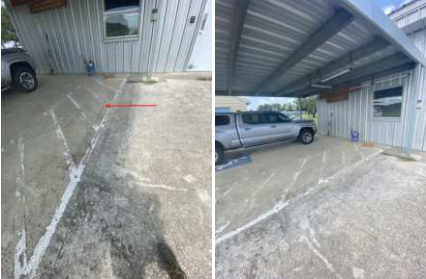
13	Exterior of Property (Public): Parking Lot Unknown Location (1 Space) Not Labeled - Access Aisle (Unlabeled Stall)	The striping and markings for the accessible parking stalls, loading/unloading access aisle are dilapidated and in need of repair and/or maintenance. Access aisles shall be marked so as to discourage parking in them. Where parking spaces are marked with lines, width measurements of parking spaces and access aisles shall be made from the centerline of the markings.	Access aisle markings are faded and dilapidated.	https://www.access-board.gov/ada/#ada-502_3_3 https://www.access-board.gov/ada/#ada-503_3_3	2012 TAS Section: 502.3.3 2010 ADAS Section: 502.3.3 2015 ABAAS Section: 502.3.3, 503.3.3

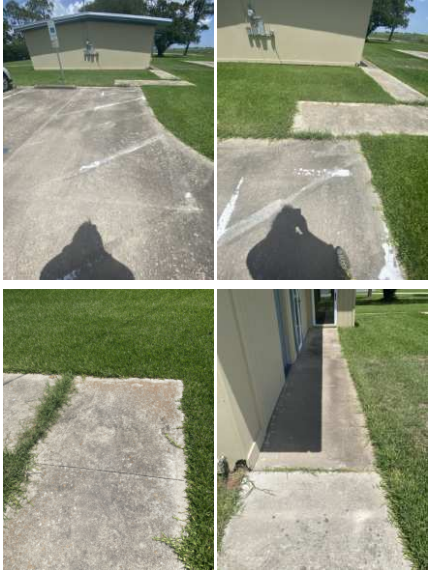
Finding Number	Area Description	Finding	As Built	Recommendation	Citation	Photos	Figure
14	Structures on Property (Public) : Bunk Areas (Exterior)	The building entrance is not located on an accessible route. When a building, or portion of a building, is required to be accessible, an accessible route of travel shall be provided to all portions of the building, to accessible building entrances and between the building and the public way. At least one accessible route within the boundary of the site must be provided from public transportation stops, accessible parking and accessible passenger loading zones and public streets or sidewalks to the accessible building entrance they serve. The accessible route shall, to the maximum extent feasible, coincide with the route for the general public. At least one accessible route shall connect accessible buildings, facilities, elements and spaces that are on the same site. At least one accessible route shall connect accessible building or facility entrances with all accessible spaces and elements.	Due to non accessible pathway, and door hardware or thresholds there is no way to access this building at this time. This building is not accessible.	https://www.access-board.gov/ada/#ada-206_2_1	2012 TAS Section: 206.2.1 2010 ADAS Section: 206.2.1 2015 ABAAS Section: F206.2.1

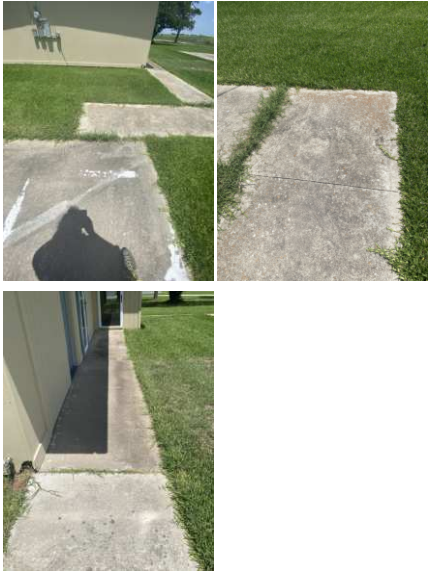
15	Structures on Property (Public) : Bunk Areas (Exterior) - Pathway to Bunk Area	The route contains openings greater than 1/2 inch. Openings in floor or ground surfaces shall not allow passage of a sphere more than 1/2 inch diameter. Elongated openings shall be placed so that the long dimension is perpendicular to the dominant direction of travel.	Pathway is not compliant due to grass overgrowth.	https://www.access-board.gov/ada/#ada-302_3	2012 TAS Section: 302.3 2010 ADAS Section: 302.3 2015 ABAAS Section: 302.3

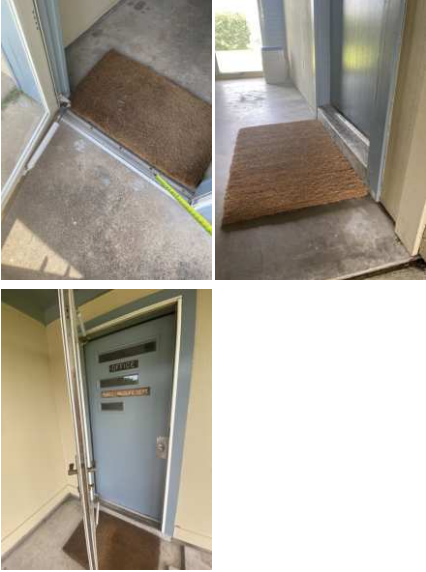
Finding Number	Area Description	Finding	As Built	Recommendation	Citation	Photos	Figure
22	Structures on Property (Public) : Bunk Areas (Interior) - Entrance Doors	The floor mat at the door is not secured in place. If carpet or carpet tile is used on a ground or floor surface, then it shall be securely attached; have a firm cushion, pad or backing or no cushion or pad; and have a level loop, textured loop, level-cut pile or level-cut/uncut pile texture. The maximum pile height shall be 1/2 inch. Exposed edges of carpet shall be fastened to floor surfaces and have trim along the entire length of the exposed edge. Recessed doormats shall be adequately anchored to prevent interference with wheelchair traffic.	This style door mat is not of compliant size or durability and does not meet compliance.	https://www.access-board.gov/ada/#ada-302_2	2012 TAS Section: 302.2 2010 ADAS Section: 302.2 2015 ABAAS Section: 302.2

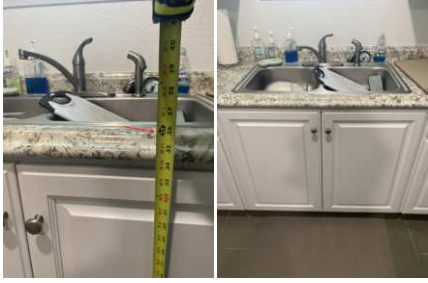
25	Structures on Property (Public) : Bunk Areas (Interior) - Kitchenette	The top of the sink is above the allowable height requirement. Sinks shall be installed with the front of the higher of the rim or counter surface 34 inches maximum above the finish floor or ground.	Sink/counter height 36"	https://www.access-board.gov/ada/#ada-606_3	2012 TAS Section: 606.3 2010 ADAS Section: 606.3 2015 ABAAS Section: 606.3

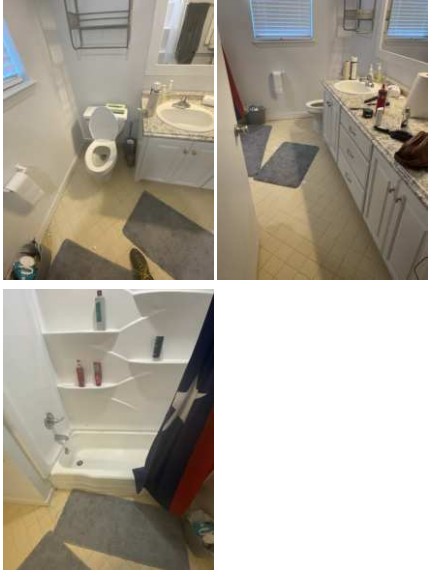
Finding Number	Area Description	Finding	As Built	Recommendation	Citation	Photos	Figure
27	Structures on Property (Public) : Bunk Areas (Interior) - Restroom #1 Bunk House (Unisex)	The restroom is not nearly compliant. The restroom does not have the required minimum clear floor space or maneuvering clearances for the toilet. The restroom does not have the required minimum clear floor space or maneuvering clearances for the lavatory. The entry door does not contain the required minimum maneuvering spaces on the pull/push sides. The entry door encroach into the required clear floor space for fixtures. Grab bars are missing and/or incorrectly installed. Accessories, such as toilet seat covers, paper towel holders, garbage cans, hand dryers, and mirrors are either too high or without clear floor space or both. The restroom contain floor level changes greater than a 1/2 inch of the floor drains and is slope (XX) - (XX), the shower is too small and missing numerous accessible elements.	This restroom requires a number of componets to gain compliance.	https://www.access-board.gov/ada/#ada-213_2 Review restrooms componets to make accessible. https://www.access-board.gov/ada/#ada-603	2012 TAS Section: 213.2 2010 ADAS Section: 213.2 2015 ABAAS Section: F213.2

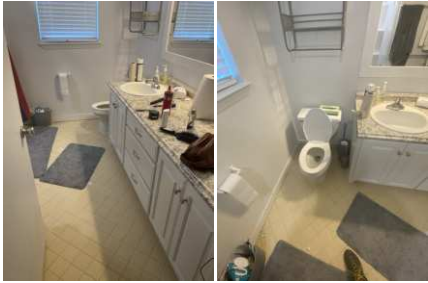
28	Structures on Property (Public) : Bunk Areas (Interior) - Restroom #1 Bunk House (Unisex)	There are not enough accessible lavatories. Where lavatories are provided, at least one shall be accessible and shall not be located in a toilet compartment.	Restrooms are required to have front approach for lavatory access, providing knee and toe space.	The lavatory and accessories are not complaint. https://www.access-board.gov/ada/#ada-213_3_4 Review lavatory componets to make accessible. https://www.access-board.gov/ada/#ada-606	2012 TAS Section: 213.3.4 2010 ADAS Section: 213.3.4 2015 ABAAS Section: F213.3.4

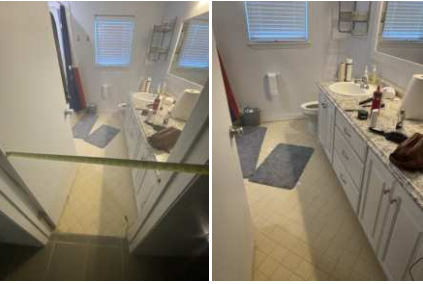
31	Structures on Property (Public) : Bunk Areas (Interior) - Restroom #1 Bunk House (Unisex)	The door opening does not provide at least 32 inches between the face of the door and the opposite stop. Door openings shall provide a clear width of 32 inches minimum. Clear openings of doorways with swinging doors shall be measured between the face of the door and the stop, with the door open 90 degrees.	Restroom doorway 29"	https://www.access-board.gov/ada/#ada-404_2_3	2012 TAS Section: 404.2.3 2010 ADAS Section: 404.2.3 2015 ABAAS Section: 404.2.3

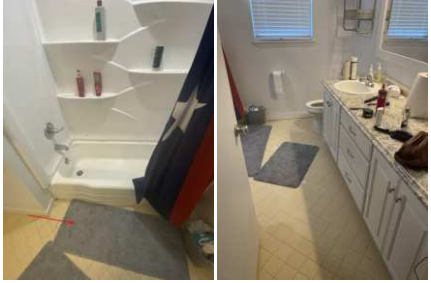
Finding Number	Area Description	Finding	As Built	Recommendation	Citation	Photos	Figure
33	Structures on Property (Public) : Bunk Areas (Interior) - Restroom #1 Bunk House (Unisex)	The carpet, rug, or mat is not secured in place. If carpet or carpet tile is used on a ground or floor surface, then it shall be securely attached; have a firm cushion, pad or backing or no cushion or pad; and have a level loop, textured loop, level-cut pile or level-cut/uncut pile texture. The maximum pile height shall be 1/2 inch. Exposed edges of carpet shall be fastened to floor surfaces and have trim along the entire length of the exposed edge. Recessed doormats shall be adequately anchored to prevent interference with wheelchair traffic.	Pictured floor mats are not of compliant size or durability and does not meet compliance.	https://www.access-board.gov/ada/#ada-302_2	2012 TAS Section: 302.2 2010 ADAS Section: 302.2 2015 ABAAS Section: 302.2

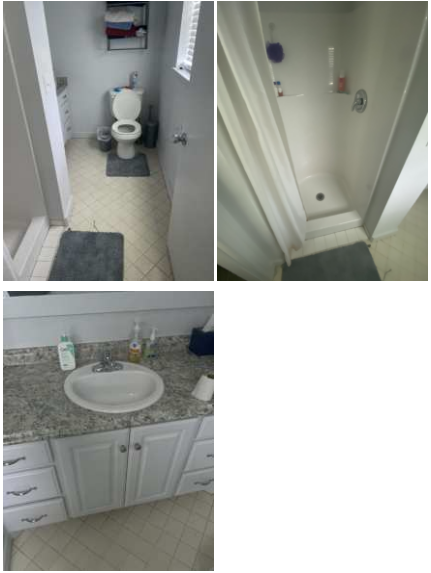
34	Structures on Property (Public) : Bunk Areas (Interior) - Restroom #2 Rear of Bunk House (Unisex)	The restroom is not nearly compliant. The restroom does not have the required minimum clear floor space or maneuvering clearances for the toilet. The restroom does not have the required minimum clear floor space or maneuvering clearances for the lavatory. The entry door does not contain the required minimum maneuvering spaces on the pull/push sides. The entry door encroaches into the required clear floor space for fixtures. Grab bars are missing and/or incorrectly installed. Accessories, such as toilet seat covers, paper towel holders, garbage cans, hand dryers, and mirrors are either too high or without clear floor space or both. The restroom contains floor level changes greater than a 1/2 inch of the floor drains and is slope (XX) - (XX), the shower is too small and missing numerous accessible elements.	This restroom requires a number of components to gain compliance.	https://www.access-board.gov/ada/#ada-213_2 Review restroom components to make accessible. https://www.access-board.gov/ada/#ada-603	2012 TAS Section: 213.2 2010 ADAS Section: 213.2 2015 ABAAS Section: F213.2

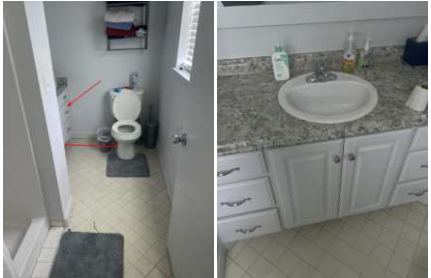
35	Structures on Property (Public) : Bunk Areas (Interior) - Restroom #2 Rear of Bunk House (Unisex)	There are not enough accessible lavatories. Where lavatories are provided, at least one shall be accessible and shall not be located in a toilet compartment.	The lavatory and accessories are not compliant. There is not enough clear floor space to access lavatory. Restrooms are required to provide front approach with knee and toe space.	https://www.access-board.gov/ada/#ada-213_3_4 Review lavatory components to make accessible. https://www.access-board.gov/ada/#ada-606	2012 TAS Section: 213.3.4 2010 ADAS Section: 213.3.4 2015 ABAAS Section: F213.3.4

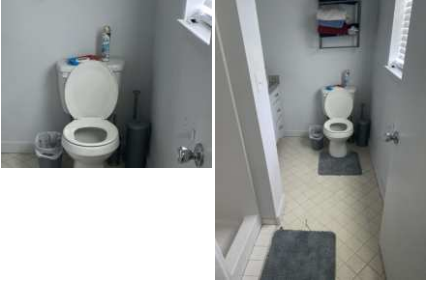
Finding Number	Area Description	Finding	As Built	Recommendation	Citation	Photos	Figure
36	Structures on Property (Public) : Bunk Areas (Interior) - Restroom #2 Rear of Bunk House (Unisex)	Accessible toilets must have grab bars installed. The side grab bar must extend at least 54 inches minimum beyond the rear wall and start a maximum of 12 inches from the rear wall. The rear grab bar must be a minimum of 36 inches long and extend from the centerline of the toilet 12 inches minimum on one side and 24 inches minimum on the other side. Grab bars shall be installed in a horizontal position, 33 inches minimum and 36 inches maximum above the finish floor measured to the top of the gripping surface.	There are no grab bars installed at this time.	https://www.access-board.gov/ada/#ada-604_5 Review grab bar componets to make accessible https://www.access-board.gov/ada/#ada-609	2012 TAS Section: 604.5 2010 ADAS Section: 604.5 2015 ABAAS Section: 604.5

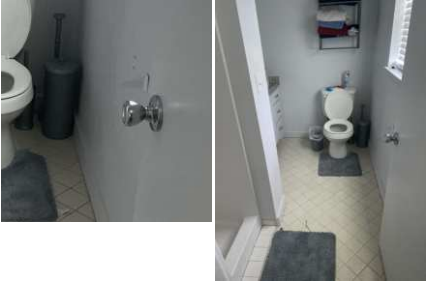
38	Structures on Property (Public) : Bunk Areas (Interior) - Restroom #2 Rear of Bunk House (Unisex)	The operating hardware requires tight grasping, pinching or twisting of the wrist to operate. Hand-activated hardware, handles, pulls, latches, locks, and other operating devices on accessible elements shall have a shape that is easy to grasp with one hand and does not require tight grasping, pinching or twisting of the wrist to operate.	Door hardware and locking mechanisms are not compliant	https://www.access-board.gov/ada/#ada-309_4	2012 TAS Section: 309.4 2010 ADAS Section: 309.4 2015 ABAAS Section: 309.4

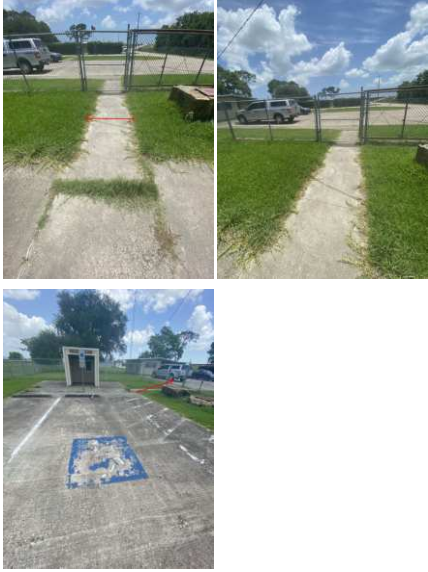
40	Structures on Property (Public) : Office (Exterior)	The building entrance is not located on an accessible route. When a building, or portion of a building, is required to be accessible, an accessible route of travel shall be provided to all portions of the building, to accessible building entrances and between the building and the public way. At least one accessible route within the boundary of the site must be provided from public transportation stops, accessible parking and accessible passenger loading zones and public streets or sidewalks to the accessible building entrance they serve. The accessible route shall, to the maximum extent feasible, coincide with the route for the general public. At least one accessible route shall connect accessible buildings, facilities, elements and spaces that are on the same site. At least one accessible route shall connect accessible building or facility entrances with all accessible spaces and elements.	Accessible stall to building pathway not compliant due to narrowing and grass overgrowth on pathway. Pathway also contains gated entrance preventing access.	https://www.access-board.gov/ada/#ada-206_2_1	2012 TAS Section: 206.2.1 2010 ADAS Section: 206.2.1 2015 ABAAS Section: F206.2.1

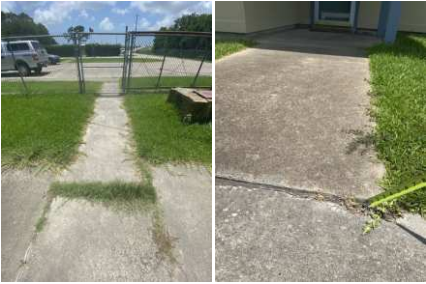
42	Structures on Property (Public) : Office (Exterior) - Pathway to Office	The concrete expansion joint is spaced greater than 1/2 inch. Openings in floor or ground surfaces shall not allow passage of a sphere more than 1/2 inch diameter. Elongated openings shall be placed so that the long dimension is perpendicular to the dominant direction of travel.	Pathway obstructed by large gaps exceeding 1/2" due or change in elevation due to overgrowth.	https://www.access-board.gov/ada/#ada-302_3	2012 TAS Section: 302.3 2010 ADAS Section: 302.3 2015 ABAAS Section: 302.3

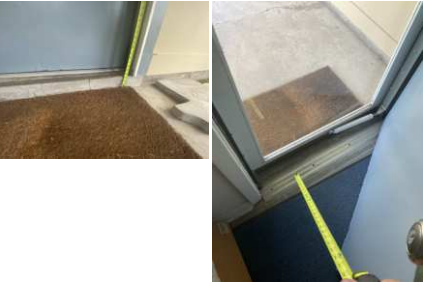
45	Structures on Property (Public) : Office (Interior) - Entrance Doors	The threshold has a vertical change greater than 1/4 inch. The threshold at a doorway shall be no higher than 1/2 inch. Changes in level between 1/4 inch and 1/2 inch must be beveled at 1:2 or less. The maximum vertical rise shall be 1/4 inch.	Threshold into building are not compliant.	https://www.access-board.gov/ada/#ada-404_2_5	2012 TAS Section: 404.2.5 2010 ADAS Section: 404.2.5 2015 ABAAS Section: 404.2.5

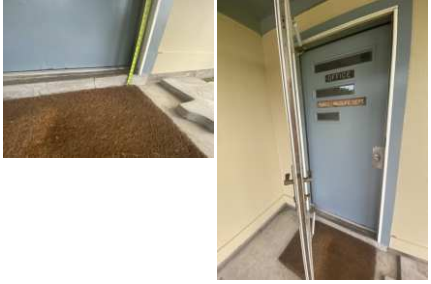
Finding Number	Area Description	Finding	As Built	Recommendation	Citation	Photos	Figure
47	Structures on Property (Public) : Office (Interior) - Entrance Doors	The floor mat at the door is not secured in place. If carpet or carpet tile is used on a ground or floor surface, then it shall be securely attached; have a firm cushion, pad or backing or no cushion or pad; and have a level loop, textured loop, level-cut pile or level-cut/uncut pile texture. The maximum pile height shall be 1/2 inch. Exposed edges of carpet shall be fastened to floor surfaces and have trim along the entire length of the exposed edge. Recessed doormats shall be adequately anchored to prevent interference with wheelchair traffic.	Door mat is not of compliant size or durability and does not meet compliance.	https://www.access-board.gov/ada/#ada-302_2	2012 TAS Section: 302.2 2010 ADAS Section: 302.2 2015 ABAAS Section: 302.2

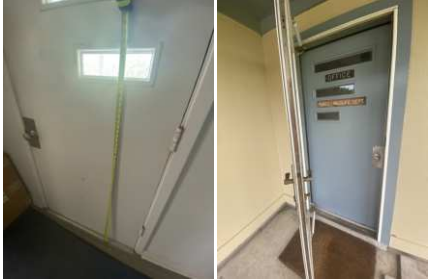
48	Structures on Property (Public) : Office (Interior) - Entrance Doors	The vision light panels (glazing/window) exceed height requirements. Doors, gates, and side lights adjacent to doors or gates, containing one or more glazing panels that permit viewing through the panels shall have the bottom of at least one glazed panel located 43 inches maximum above the finish floor.	Measures over 49"	https://www.access-board.gov/ada/#ada-404_2_11	2012 TAS Section: 404.2.11 2010 ADAS Section: 404.2.11 2015 ABAAS Section: 404.2.11

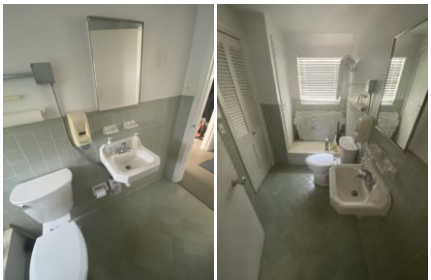
49	Structures on Property (Public) : Office (Interior) - Restroom (Unisex)	The restroom is not nearly compliant. The restroom does not have the required minimum clear floor space or maneuvering clearances for the toilet. The restroom does not have the required minimum clear floor space or maneuvering clearances for the lavatory. The entry door does not contain the required minimum maneuvering spaces on the pull/push sides. The entry door encroach into the required clear floor space for fixtures. Grab bars are missing and/or incorrectly installed. Accessories, such as toilet seat covers, paper towel holders, garbage cans, hand dryers, and mirrors are either too high or without clear floor space or both. The restroom contain floor level changes greater than a 1/2 inch of the floor drains and is slope (XX) - (XX), the shower is too small and missing numerous accessible elements.	This restroom requires a number of componets to gain compliance.	https://www.access-board.gov/ada/#ada-213_2 Review restrooms componets to make accessible. https://www.access-board.gov/ada/#ada-603	2012 TAS Section: 213.2 2010 ADAS Section: 213.2 2015 ABAAS Section: F213.2

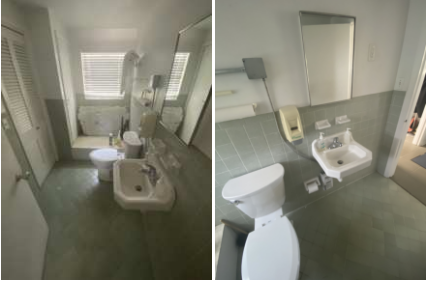
Finding Number	Area Description	Finding	As Built	Recommendation	Citation	Photos	Figure
50	Structures on Property (Public) : Office (Interior) - Restroom (Unisex)	The door to the toilet room swings into the required clear floor space required at the lavatory. In multiple accommodation toilet or bathing rooms doors shall not swing into the clear floor space required for any fixture. A clear floor space 30 inches by 48 inches shall be provided in front of a lavatory to allow a forward approach. Such clear floor space shall adjoin or overlap an accessible route and shall extend a maximum of 19 inches into knee and toe space underneath the lavatory.	Clear floor space obstructed by door swing.	https://www.access-board.gov/ada/#ada-603_2_3	2012 TAS Section: 603.2.3 2010 ADAS Section: 603.2.3 2015 ABAAS Section: 603.2.3

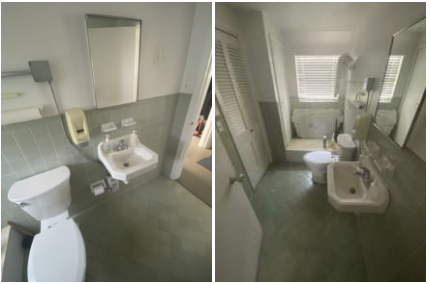
52	Structures on Property (Public) : Office (Interior) - Restroom (Unisex)	Accessible toilets must have grab bars installed. The side grab bar must extend at least 54 inches minimum beyond the rear wall and start a maximum of 12 inches from the rear wall. The rear grab bar must be a minimum of 36 inches long and extend from the centerline of the toilet 12 inches minimum on one side and 24 inches minimum on the other side. Grab bars shall be installed in a horizontal position, 33 inches minimum and 36 inches maximum above the finish floor measured to the top of the gripping surface.	There are no grab bars installed at this time.	https://www.access-board.gov/ada/#ada-604_5 https://www.access-board.gov/ada/#ada-609	2012 TAS Section: 604.5 2010 ADAS Section: 604.5 2015 ABAAS Section: 604.5

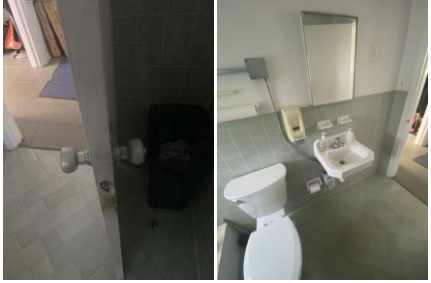
Finding Number	Area Description	Finding	As Built	Recommendation	Citation	Photos	Figure
53	Structures on Property (Public) : Office (Interior) - Restroom (Unisex)	The operating hardware requires tight grasping, pinching or twisting of the wrist to operate. Hand-activated hardware, handles, pulls, latches, locks, and other operating devices on accessible elements shall have a shape that is easy to grasp with one hand and does not require tight grasping, pinching or twisting of the wrist to operate.	Door hardware and locking mechanisms are not compliant.	https://www.access-board.gov/ada/#ada-309_4	2012 TAS Section: 309.4 2010 ADAS Section: 309.4 2015 ABAAS Section: 309.4

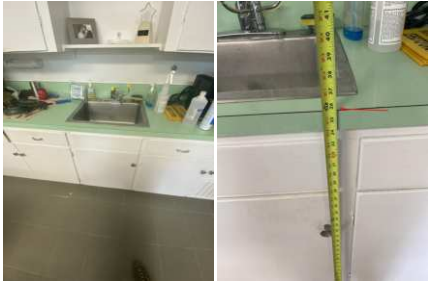
54	Structures on Property (Public) : Office (Interior) - Kitchenette	The top of the sink is above the allowable height requirement. Sinks shall be installed with the front of the higher of the rim or counter surface 34 inches maximum above the finish floor or ground.	Sinks is not accessible via frontal or parallel approach due to rim height. Sinks do not require knee and toe space since there is no stove top oven in vicinity. Sink rim and counter height 36"	https://www.access-board.gov/ada/#ada-606_3	2012 TAS Section: 606.3 2010 ADAS Section: 606.3 2015 ABAAS Section: 606.3

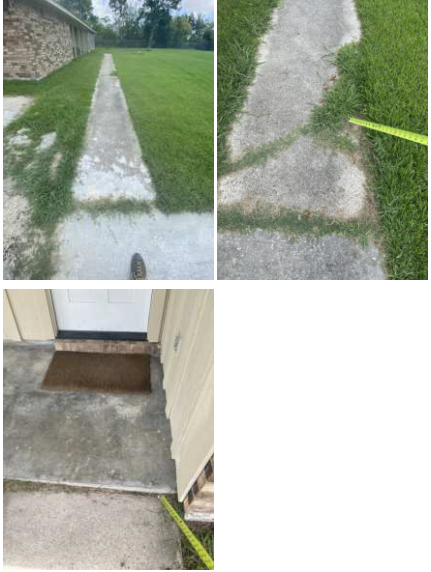
Finding Number	Area Description	Finding	As Built	Recommendation	Citation	Photos	Figure
55	Structures on Property (Public) : Biologist Building (Exterior)	The building entrance is not located on an accessible route. When a building, or portion of a building, is required to be accessible, an accessible route of travel shall be provided to all portions of the building, to accessible building entrances and between the building and the public way. At least one accessible route within the boundary of the site must be provided from public transportation stops, accessible parking and accessible passenger loading zones and public streets or sidewalks to the accessible building entrance they serve. The accessible route shall, to the maximum extent feasible, coincide with the route for the general public. At least one accessible route shall connect accessible buildings, facilities, elements and spaces that are on the same site. At least one accessible route shall connect accessible building or facility entrances with all accessible spaces and elements.	Due to pathway overgrowth, large gaps or changes in elevation, and narrowing there is no accessible route to building. This building is not accessible	https://www.access-board.gov/ada/#ada-206_2_1	2012 TAS Section: 206.2.1 2010 ADAS Section: 206.2.1 2015 ABAAS Section: F206.2.1

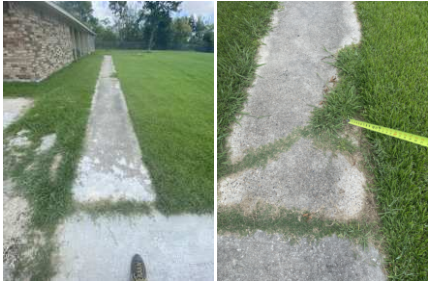
56	Structures on Property (Public) : Biologist Building (Exterior) - Pathway to Biologist Building	The route contains openings greater than 1/2 inch. Openings in floor or ground surfaces shall not allow passage of a sphere more than 1/2 inch diameter. Elongated openings shall be placed so that the long dimension is perpendicular to the dominant direction of travel.	Pathway has large gaps due to grass overgrowth.	https://www.access-board.gov/ada/#ada-302_3	2012 TAS Section: 302.3 2010 ADAS Section: 302.3 2015 ABAAS Section: 302.3

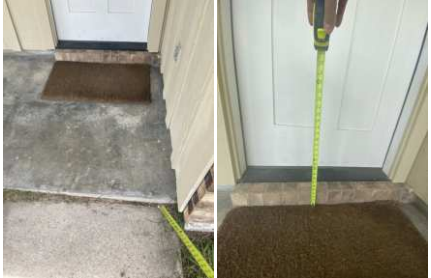
57	Structures on Property (Public) : Biologist Building (Exterior) - Pathway to Biologist Building	There is a change in level greater than 1/4 inch. 1/4 inch is the maximum vertical rise. Changes in level between 1/4 inch and 1/2 inch must be beveled at 1:2 or less. Changes in level greater than 1/2 inch must be by way of a ramp.	There are changes in elevation which exceed 1/4" or 1/2" tolerance.	https://www.access-board.gov/ada/#ada-303_2 https://www.access-board.gov/ada/#ada-303_3 https://www.access-board.gov/ada/#ada-303_4	2012 TAS Section: 303.3 2010 ADAS Section: 303.3 2015 ABAAS Section: 303.3

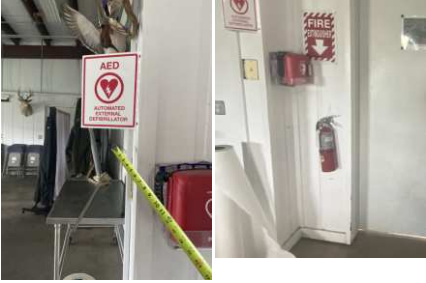
Finding Number	Area Description	Finding	As Built	Recommendation	Citation	Photos	Figure
64	Structures on Property (Public) : Check Station/Assembly Room	The element projects more than 4 inches into the circulation path. Wall-mounted objects that have leading edges between 27 inches and 80 inches from the floor must not project more than 4 inches into the circulation path. Protruding objects that extend to the floor or within 27 inches of the floor are cane detectable and are therefore not hazardous. Where it is necessary or desirable to have objects protrude from the wall, a manner of cane detection must be provided.	2 obstructions in this area ADA Accessibility Guidelines (ADAAG) specify that objects such as automated external defibrillator wall cabinets shall not protrude more than 4 inches from the wall into walks, corridors, passageways, or aisles. There are no official ADA fire extinguisher height or fire alarm ADA requirements. However, there are rules that govern the placement of all protruding objects, no matter their function, to accommodate blind and other visually impaired people.	https://www.access-board.gov/ada/#ada-307_2	2012 TAS Section: 307.2 2010 ADAS Section: 307.2 2015 ABAAS Section: 307.2
