WMA- Justin Hurst, Jones Creek TX, ADA Evaluation

Accessibility Evaluation

Inspection Date: 07/28/2022

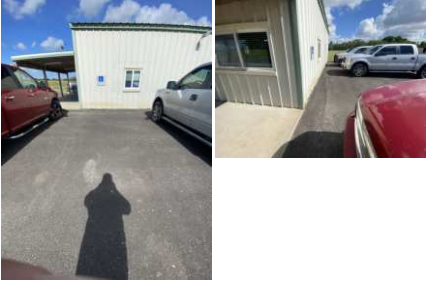
Finding Number	Area Description	Finding	As Built	Recommendation	Citation	Photos	Figure
1	Exterior of Property (Public): Parking Lot HQ (1 Space) 1 Labeled	There are no accessible parking stalls. Each lot where parking is provided for the public as clients, guests or employees, shall provide accessible parking and shall be located on the shortest accessible route of travel from adjacent parking to an accessible entrance. There are a total of (XX) parking stalls in the parking lot that could be reasonably associated with this facility. There should be a minimum of (XX) accessible stalls with a minimum of (XX) being designed as van accessible.	There is space dedicated to accessible parking but requires a number of elements to be compliant. There is no compliant ADA parking at this time.	Review parking stall and access aisle requirements https://www.access-board.gov/ada/#ada-208_2 https://www.access-board.gov/ada/#ada-502	2012 TAS Section: 208.2 2010 ADAS Section: 208.2 2015 ABAAS Section: F208.2

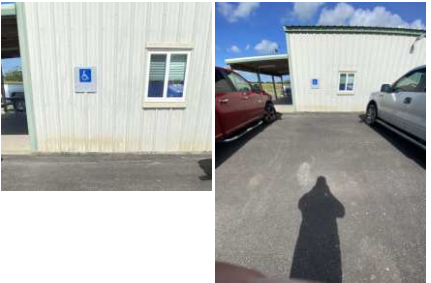
3	Exterior of Property (Public): Parking Lot HQ (1 Space) 1 Labeled - Accessible Stall (Labeled)	The van stall is missing a sign identifying it as a van accessible stall. Parking space identification signs shall include the International Symbol of Accessibility. Signs identifying van parking spaces shall contain the designation "van accessible."	Sign is incorrect style/model, mounted below 60", and is missing van designation.	https://www.access-board.gov/ada/#ada-502_6	2012 TAS Section: 502.6 2010 ADAS Section: 502.6 2015 ABAAS Section: 502.6

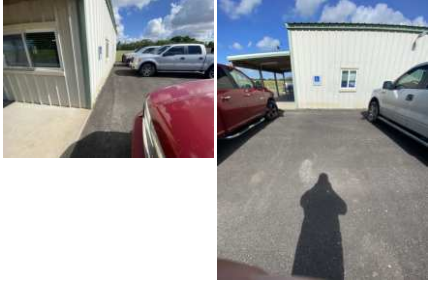
Finding Number	Area Description	Finding	As Built	Recommendation	Citation	Photos	Figure
4	Exterior of Property (Public): Parking Lot HQ (1 Space) 1 Labeled - Access Aisle (Labeled Stall)	The access aisle is in not nearly compliant. The access ai the minimum width. The access aisle is not as long as the parking space it serves. There are no markings to discourage parking. The floor or ground surface is not firm stable or slip resistant. The parking space contains changes in level and/or gaps that exceed the maximum allowable requirements.	Access aisle not provided, markings missing and does not connect to accessible pathway. Access aisle width requirments depend on van stall size. van stall 11' access aisle 5' or van stall 8' access aisle 8'	https://www.access-board.gov/ada/#ada-502_3	2012 TAS Section: 502.3 2010 ADAS Section: 502.3 2015 ABAAS Section: 502.3

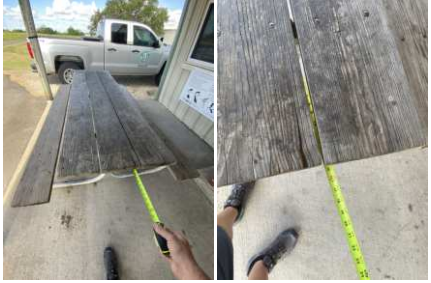
Finding Number	Area Description	Finding	As Built	Recommendation	Citation	Photos	Figure
5	Structures on Property (Public) : HQ Building (Exterior)	All of the picnic units do not provide mobility features. Where picnic facilities contain two or fewer picnic units, each picnic unit shall provide mobility features.	Picnic table is not of compliant style or model. Table does not provide required knee space.	Provide ADA accessible picnic table. Knee space for wheelchair seating must be at least 30 inches wide, 19 inches deep, and 27 inches high, as measured from the ground or floor to the bottom of the tabletop. Toe clearance of at least 9 inches above the ground or floor must extend at least an additional 5 inches beyond the knee clearance.	2015 ABAAS Section: F245.2.1

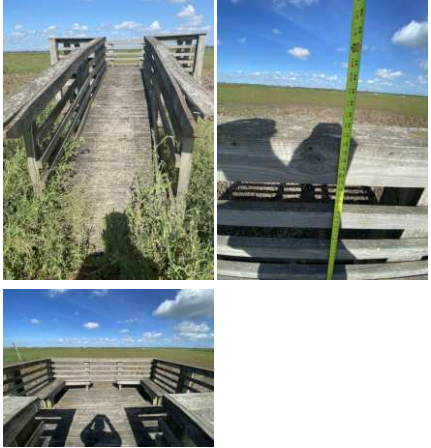
Finding Number	Area Description	Finding	As Built	Recommendation	Citation	Photos	Figure
21	Outdoor Features (Public) : Wildlife viewing Blinds/Towers - Ramp/Deck	The ramp contains surface materials that do not provide for a stable, firm slip resistant surface. Floor and ground surfaces shall be stable, firm, and slip resistant.	Ramp surface is deteriorating and need of repair. Ramp railing is too high. Ramp has multiple infractions	Review ramp componets to make accessible. https://www.access-board.gov/aba/#aba-405	2012 TAS Section: 302.1, 405.4 2010 ADAS Section: 302.1, 405.4 2015 ABAAS Section: 302.1, 405.4

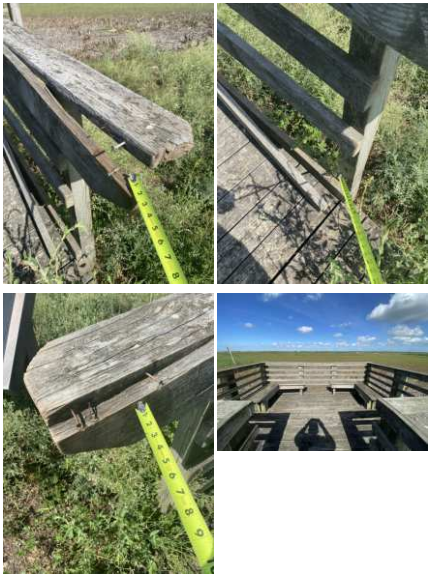
22	Outdoor Features (Public) : Wildlife viewing Blinds/Towers - Ramp/Deck	The ramp does not have compliant handrails. Handrails are required on both sides of all surfaces that are sloped greater than 5 percent (1:20). Handrails must be between 34 inches and 38 inches above the ramp surface, and must extend horizontally 12 inches beyond the top and bottom of the ramp. The diameter of the handrails must be 1 1/4 inches minimum and 2 inches maximum in cross-sectional nominal dimension for circular handrails. Handrail gripping surfaces with a non-circular cross section shall have a perimeter dimension of 4 inches minimum and 6 1/4 inches maximum, and a cross-section dimension of 2 1/4 inches maximum. The space between handrails and walls must be 1-1/2 inches minimum.	Handrails type, style, and instillation are not compliant.	Review handrail componets to make accessible https://www.access-board.gov/aba/#aba-505_1	2012 TAS Section: 505.1 2010 ADAS Section: 505.1 2015 ABAAS Section: 505.1
