# Keechi Creek WMA- ADA Evaluation

**WMA- Keechi Creek, Oakwood TX, ADA Evaluation**

**Accessibility Evaluation**

**Inspection Date: 07/18/2022**

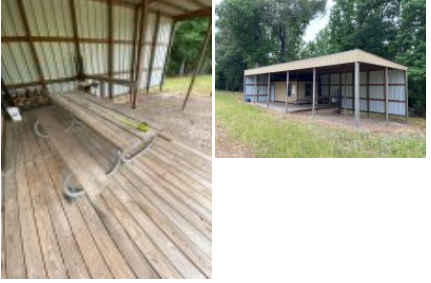
Finding Number	Area Description	Finding	As Built	Recommendation	Citation	Photos	Figure
4	Structures on Property (Public) : Cleaning/Check Station	All of the picnic units do not provide mobility features. Where picnic facilities contain two or fewer picnic units, each picnic unit shall provide mobility features.	Exterior pathway leading to tables non-compliant. There are no accessible picnic tables provided Picnic tables at cleaning station are considered work tables and have a higher priority.	Provide compliant picnic table option. Knee space for wheelchair seating must be at least 30 inches wide, 19 inches deep, and 27 inches high, as measured from the ground or floor to the bottom of the tabletop. Toe clearance of at least 9 inches above the ground or floor must extend at least an additional 5 inches beyond the knee clearance.	2015 ABAAS Section: F245.2.1

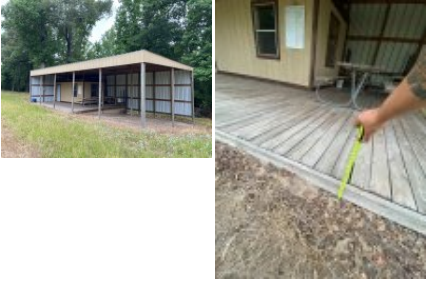
5	Structures on Property (Public) : Cleaning/Check Station - Pathway to Cleaning/Check Station	There is no accessible route to the element. At least one accessible route shall connect accessible buildings, accessible facilities, accessible elements, and accessible spaces that are on the same site.	This element is not accessible.	<a href="https://www.access-board.gov/ada/#ada-206_2_2">https://www.access-board.gov/ada/#ada-206_2_2</a>	2012 TAS Section: 206.2.2  2010 ADAS Section: 206.2.2  2015 ABAAS Section: F206.2.2

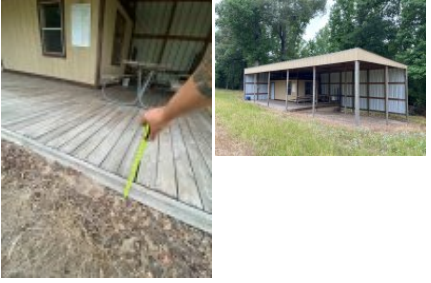
6	Structures on Property (Public) : Cleaning/Check Station - Pathway to Cleaning/Check Station	The path of contains multiple issues and is not accessible. The path of travel exceeds the maximum allowable cross and running slope requirements. It also contains changes in level and/or gaps that exceed the allowable maximum requirements. The path of travel does not meet the minimum width requirements for clearances, turning spaces, and/or passing spaces. The floor or ground surface is not firm, stable, and slip resistant.	Due to terrain and change in elevation pathway is not compliant. Pathway has multiple infractions	Review accessible pathway componets to make accessible <a href="https://www.access-board.gov/ada/#ada-402">https://www.access-board.gov/ada/#ada-402</a> <a href="https://www.access-board.gov/ada/#ada-403_1">https://www.access-board.gov/ada/#ada-403_1</a>	2010 ADAS Section: 403.1  2015 ABAAS Section: 403.1
