Kerr WMA- ADA Evaluation

Report Date: 01/17/2024

WMA- Kerr, Hunt TX, ADA Evaluation

Accessibility Evaluation

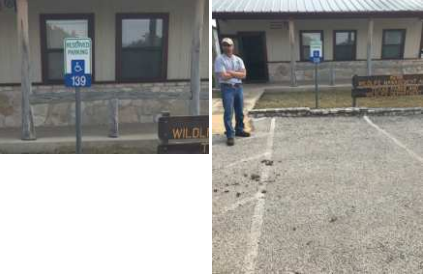
Finding Number	Area Description	Finding	As Built	Recommendation	Citation	Photos	Figure
1	Exterior of Property (Public): Office Parking Lot (1 Space) 1 Labeled - Accessible Stall (Labeled)	The parking sign/s are missing. Parking space identification signs shall include the International Symbol of Accessibility (ISA). Signs identifying van parking spaces shall contain the designation "van accessible." All signs shall be 60 inches minimum above the finish floor or ground surface measured to the bottom of the sign.	Van designation sign missing sign looks to be to lower than 60" min height.	https://www.access-board.gov/ada/#ada-502_6	2012 TAS Section: 502.6 2010 ADAS Section: 502.6 2015 ABAAS Section: 502.6

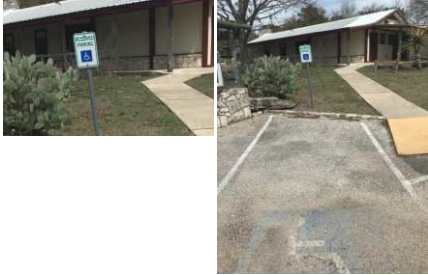
Finding Number	Area Description	Finding	As Built	Recommendation	Citation	Photos	Figure
3	Exterior of Property (Public): Restroom Parking Lot (1 Space) 1 Labeled - Accessible Stall (Labeled)	The van stall is missing a sign identifying it as a van accessible stall. Parking space identification signs shall include the International Symbol of Accessibility. Signs identifying van parking spaces shall contain the designation "van accessible."	Van designation sign missing		https://www.access-board.gov/ada/#ada-502_6	2012 TAS Section: 502.6 2010 ADAS Section: 502.6 2015 ABAAS Section: 502.6

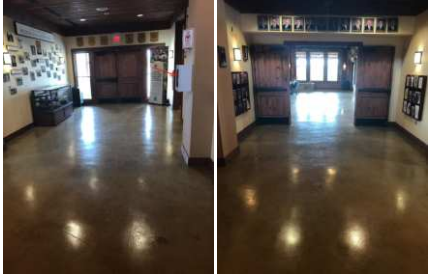
Finding Number	Area Description	Finding	As Built	Recommendation	Citation	Photos	Figure
6	Structures on Property (Public) : Conference Building (Interior)	The element projects more than 4 inches into the circulation path. Wall-mounted objects that have leading edges between 27 inches and 80 inches from the floor must not project more than 4 inches into the circulation path. Protruding objects that extend to the floor or within 27 inches of the floor are cane detectable and are therefore not hazardous. Where it is necessary or desirable to have objects protrude from the wall, a manner of cane detection must be provided.	ADA Accessibility Guidelines (ADAAG) specify that objects such as automated external defibrillator wall cabinets shall not protrude more than 4 inches from the wall into walks, corridors, passageways, or aisles.	https://www.access-board.gov/ada/#ada-307_2	2012 TAS Section: 307.2 2010 ADAS Section: 307.2 2015 ABAAS Section: 307.2
