M.O. Neasloney WMA- ADA Evaluation

WMA- M.O. Neasloney, Gonzales TX, ADA Evaluation

Accessibility Evaluation

Inspection Date: 12/08/2021

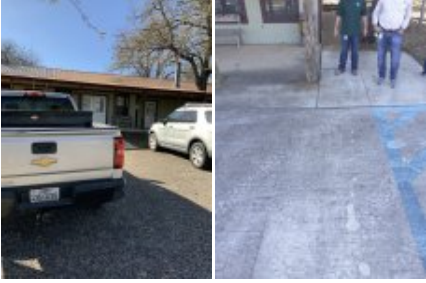
Finding Number	Area Description	Finding	As Built	Recommendation	Citation	Photos	Figure
1	Exterior of Property (Public): HQ Parking Lot (1 Space) Unlabeled	The parking lot has been found to be in substantial compliance with accessibility codes, standards, and regulations.	Parking lot marked as compliant. Need photo verification.	N/A	2012 TAS Section: Advisory 2010 ADAS Section: Advisory 2015 ABAAS Section: Advisory

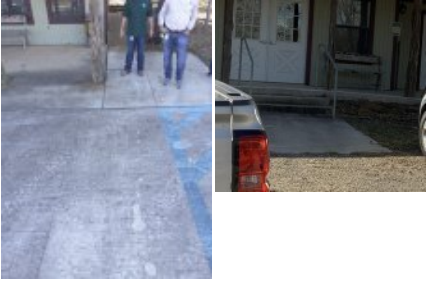
2	Exterior of Property (Public): HQ Parking Lot (1 Space) Unlabeled - Van Accessible Stall	The van stall is missing a sign identifying it as a van accessible stall. Parking space identification signs shall include the International Symbol of Accessibility. Signs identifying van parking spaces shall contain the designation "van accessible."	Need photo verification	https://www.access-board.gov/aba/#aba-502_6	2012 TAS Section: 502.6 2010 ADAS Section: 502.6 2015 ABAAS Section: 502.6

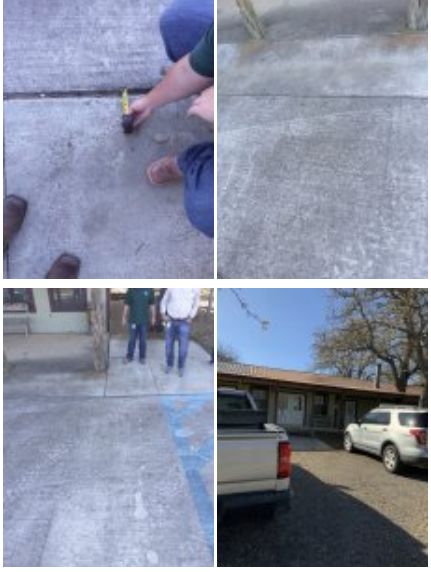
Finding Number	Area Description	Finding	As Built	Recommendation	Citation	Photos	Figure
4	Structures on Property (Public) : HQ Building (Exterior) - Pathway to HQ Building	The concrete expansion joint is spaced greater than 1/2 inch. Openings in floor or ground surfaces shall not allow passage of a sphere more than 1/2 inch diameter. Elongated openings shall be placed so that the long dimension is perpendicular to the dominant direction of travel.	Pathway has a few locations where gaps exceed 1/2" tolerance. See additional photos for location.	https://www.access-board.gov/aba/#aba-302_3	2012 TAS Section: 302.3 2010 ADAS Section: 302.3 2015 ABAAS Section: 302.3

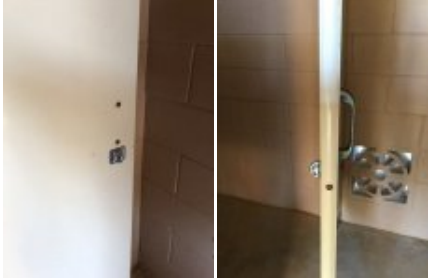
5	Structures on Property (Public) : Public Restrooms - Restroom (Men's)	The water closet compartment is missing a loop handle on the one side of the door. Water closet compartments must be equipped with a door that has a loop or U-shaped handle on both sides of the door near the latch. The latch must be flip-over style, sliding or other hardware not requiring the user to grasp or twist.	N/A	https://www.access-board.gov/aba/#aba-604_8_1_2	2012 TAS Section: 604.8.1.2 2010 ADAS Section: 604.8.1.2 2015 ABAAS Section: 604.8.1.2

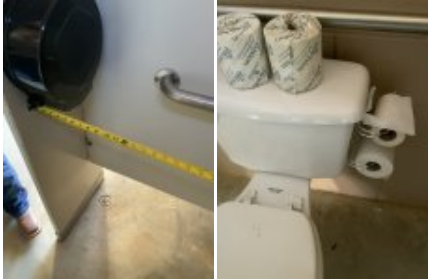
7	Structures on Property (Public) : Public Restrooms - Restroom (Men's)	The toilet paper is not installed within the compliant range in front of the toilet. Toilet paper dispensers shall be 7 inches minimum and 9 inches maximum in front of the water closet measured to the centerline of the dispenser. The outlet of the dispenser shall be 15 inches minimum and 48 inches maximum above the finish floor and shall not be located behind grab bars. Dispensers shall not be of a type that controls delivery or that does not allow continuous paper flow. There shall be a clearance of 1 1/2 inches minimum below the grab bar.	TP dispenser out of range	https://www.access-board.gov/aba/#aba-604_7	2012 TAS Section: 604.7 2010 ADAS Section: 604.7 2015 ABAAS Section: 604.7

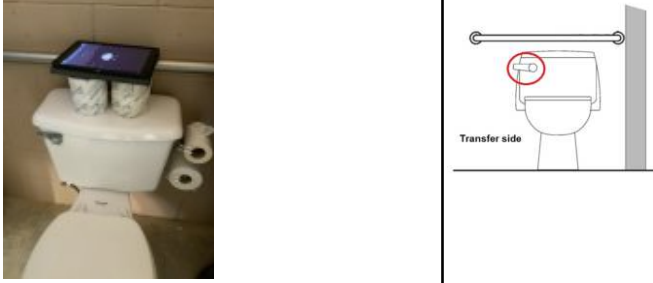
Finding Number	Area Description	Finding	As Built	Recommendation	Citation	Photos	Figure
9	Structures on Property (Public) : Public Restrooms - Restroom (Men's)	The flush handle is located on the wrong side of the toilet. Controls shall be operable with one hand and shall not require tight grasping, pinching or twisting. Controls for the flush valves shall be mounted on the wide side of toilet areas, no more than 48 inches above the floor.	N/A		https://www.access-board.gov/aba/#aba-604_6	2012 TAS Section: 604.6 2010 ADAS Section: 604.6 2015 ABAAS Section: 604.6

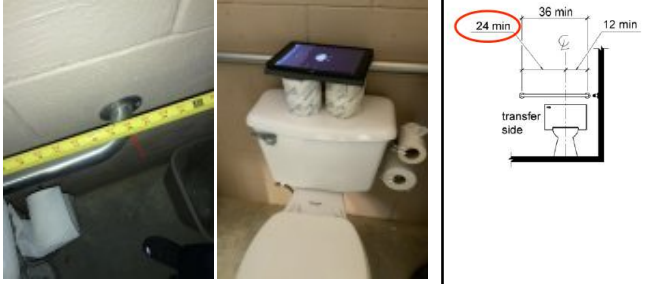
10	Structures on Property (Public) : Public Restrooms - Restroom (Men's)	The rear grab bar does not extend adequately past the toilet on the wide side. The rear grab bar must be a minimum of 36 inches long and extend from the centerline of the toilet 12 inches minimum on wall side and 24 inches minimum on the wide side. Grab bars shall be installed in a horizontal position, 33 inches minimum and 36 inches maximum above the finish floor measured to the top of the gripping surface and the space between the grab bar and the top of the tank shall be 1-1/2 inches minimum.	Measures at 20"		https://www.access-board.gov/aba/#aba-604_5_2	2012 TAS Section: 604.5.2 2010 ADAS Section: 604.5.2 2015 ABAAS Section: 604.5.2

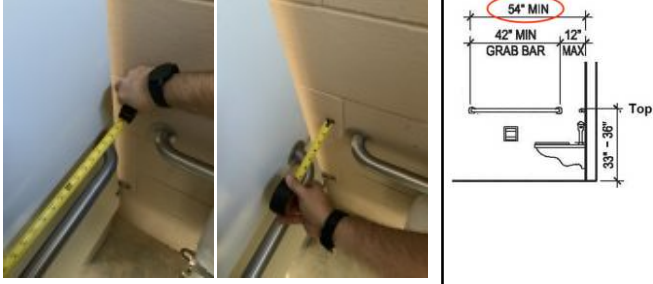
11	Structures on Property (Public) : Public Restrooms - Restroom (Men's)	The side grab bar does not extend far enough from the rear wall. The side grab bar must extend at least 54 inches minimum beyond the rear wall and start a maximum of 12 inches from the rear wall. A 42 inch grab bar installed the maximum distance from the rear wall (12 inches) will leave the leading end 54 inches from the rear wall. Grab bars shall be installed in a horizontal position, 33 inches minimum and 36 inches maximum above the finish floor measured to the top of the gripping surface.	Side grab bar mounted to close to rear wall.		https://www.access-board.gov/aba/#aba-604_5_1	2012 TAS Section: 604.5.1 2010 ADAS Section: 604.5.1 2015 ABAAS Section: 604.5.1

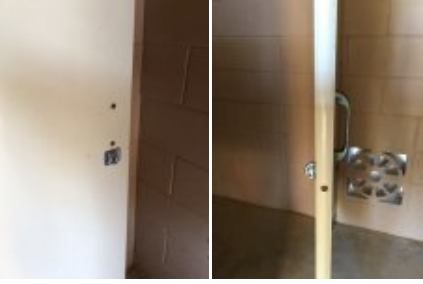
13	Structures on Property (Public) : Public Restrooms - Restroom (Women's)	The water closet compartment is missing a loop handle on the one side of the door. Water closet compartments must be equipped with a door that has a loop or U-shaped handle on both sides of the door near the latch. The latch must be flip-over style, sliding or other hardware not requiring the user to grasp or twist.	N/A	https://www.access-board.gov/aba/#aba-604_8_1_2	2012 TAS Section: 604.8.1.2 2010 ADAS Section: 604.8.1.2 2015 ABAAS Section: 604.8.1.2

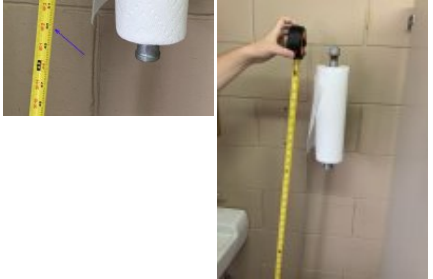
16	Structures on Property (Public) : Public Restrooms - Restroom (Women's)	The paper towel dispenser's operation mechanism is too high off the floor. Dispensers must have all operable parts a maximum of 48 inches above the floor.	exceeds 48" reach tolerance.	https://www.access-board.gov/aba/#aba-308_2_1 https://www.access-board.gov/aba/#aba-308_2_2	2012 TAS Section: 308.2.1 2010 ADAS Section: 308.2.1 2015 ABAAS Section: 308.2.1

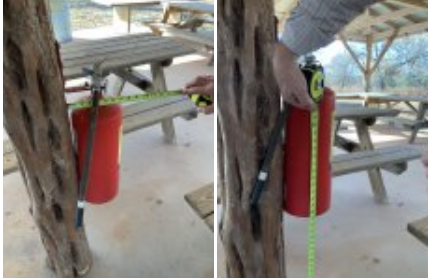
Finding Number	Area Description	Finding	As Built	Recommendation	Citation	Photos	Figure
17	Outdoor Features (Public) : Pavilion	The (XX) projects more than 4 inches into the circulation path. Wall-mounted objects that have leading edges between 27 inches and 80 inches from the floor must not project more than 4 inches into the circulation path. Protruding objects that extend to the floor or within 27 inches of the floor are cane detectable and are therefore not hazardous. Where it is necessary or desirable to have objects protrude from the wall, a manner of cane detection must be provided.	There are no official ADA fire extinguisher height or fire alarm ADA requirements. However, there are rules that govern the placement of all protruding objects, no matter their function, to accommodate blind and other visually impaired people. This applies to all fire extinguishers in area.	https://www.access-board.gov/ada/#ada-307_2	2012 TAS Section: 307.2 2010 ADAS Section: 307.2 2015 ABAAS Section: 307.2

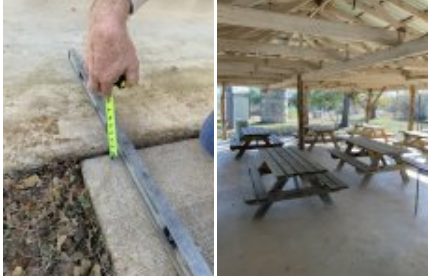
18	Outdoor Features (Public) : Pavilion - Path of Travel to Pavilion	The walkway contains abrupt vertical edges and/or variations over 1/4 inch. 1/4 inch is the maximum vertical rise. Changes in level between 1/4 inch and 1/2 inch must be beveled at 1:2 or less. Changes in level greater than 1/2 inch must be by way of a ramp.	N/A	https://www.access-board.gov/aba/#aba-303_2 https://www.access-board.gov/aba/#aba-303_3	2012 TAS Section: 303.3, 303.2 2010 ADAS Section: 303.3, 303.2 2015 ABAAS Section: 303.2, 303.3
