# Muse WMA- ADA Evaluation

**WMA- Muse, May TX , ADA Evaluation**

**Accessibility Evaluation**

**Inspection Date: 06/15/2022**

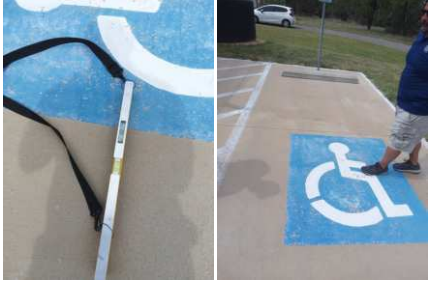
Finding Number	Area Description	Finding	As Built	Recommendation	Citation	Photos	Figure
1	Exterior of Property (Public): Office Parking Lot (1 Space) 1 Van - Van Accessible Stall	The cross slope (narrow dimension) of the parking stall exceeds 2%. The running and cross slope in an accessible parking stall and the access aisle must not exceed 2%.	Cross slope 3%	<a href="https://www.access-board.gov/ada/#ada-502_4">https://www.access-board.gov/ada/#ada-502_4</a>	2012 TAS Section: 502.4 2010 ADAS Section: 502.4 2015 ABAAS Section: 502.4

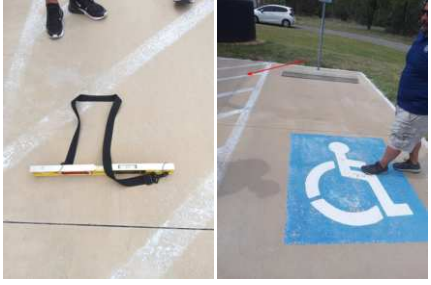
2	Exterior of Property (Public): Office Parking Lot (1 Space) 1 Van - Access Aisle (Van)	The cross slope (short dimension) of the access aisle exceeds 2%. The cross slope in an accessible parking stall and the access aisle must not exceed 2%.	Cross slope is 2.8%	<a href="https://www.access-board.gov/ada/#ada-502_4">https://www.access-board.gov/ada/#ada-502_4</a>	2012 TAS Section: 502.4 2010 ADAS Section: 502.4 2015 ABAAS Section: 502.4

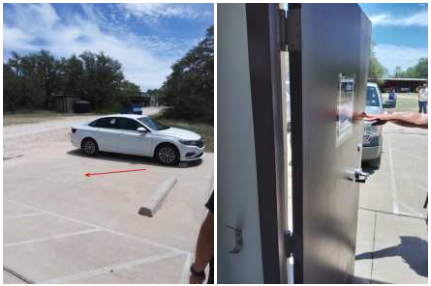
3	Exterior of Property (Public): Outdoor Restroom Parking Lot (1 Space) 1 Van - Van Accessible Stall	The striping and markings for the accessible parking stall, loading/unloading access aisle are dilapidated and in need of repair and/or maintenance.	Parking space borders and ISA insignia are faded/dilapidated	<a href="https://www.access-board.gov/ada/#ada-502_3_3">https://www.access-board.gov/ada/#ada-502_3_3</a>	2012 TAS Section: 502.3.3 2010 ADAS Section: 502.3.3 2015 ABAAS Section: 502.3.3, 503.3.3

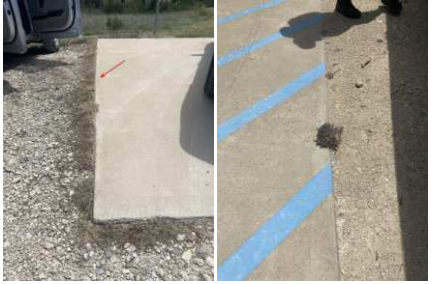
6	Exterior of Property (Public): Multipurpose Building Parking Lot (1 Space) 1 Van - Van Accessible Stall	The stripe is missing at the left side of the left parking stall which identifies its border. Vehicle spaces shall be marked to define the width, and shall have an adjacent access aisle.	Parking stall needs to have defined border markings. missing (L) side of stall.  Overgrowth needs to be removed to make compliant.	<a href="https://www.access-board.gov/ada/#ada-502_2">https://www.access-board.gov/ada/#ada-502_2</a>	2012 TAS Section: 502.2  2010 ADAS Section: 502.2  2015 ABAAS Section: 502.2

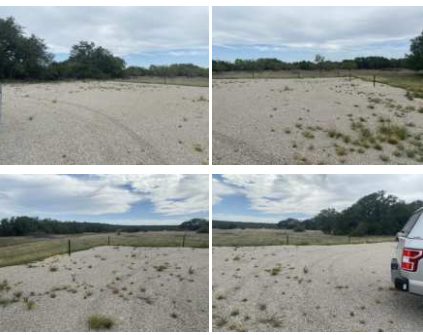
Finding Number	Area Description	Finding	As Built	Recommendation	Citation	Photos	Figure
10	Exterior of Property (Public): Dove Hunting Parking Lot (0 Spaces)	There are no accessible parking stalls. Each lot where parking is provided for the public as clients, guests or employees, shall provide accessible parking and shall be located on the shortest accessible route of travel from adjacent parking to an accessible entrance. There are a total of (XX) parking stalls in the parking lot that could be reasonably associated with this facility. There should be a minimum of (XX) accessible stalls with a minimum of (XX) being designed as van accessible.	Parking lot is not compliant due to surfacing material and striping requirements.	Review parking stall and access aisle requirements <a href="https://www.access-board.gov/ada/#ada-208_2">https://www.access-board.gov/ada/#ada-208_2</a> <a href="https://www.access-board.gov/ada/#ada-502">https://www.access-board.gov/ada/#ada-502</a>	2012 TAS Section: 208.2  2010 ADAS Section: 208.2  2015 ABAAS Section: F208.2

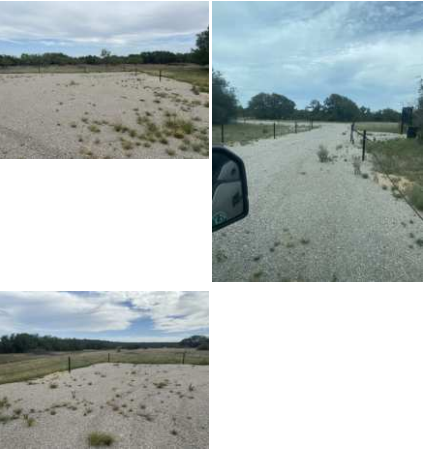
11	Exterior of Property (Public): Dove Hunting Parking Lot (0 Spaces) - Van Spot Requirements	The parking space is in not nearly compliant. The parking space the minimum width. The floor or ground surface is not firm stable or slip resistant. The parking space contains changes in level and/or gaps that exceed the maximum allowable requirements. The parking space does not have the proper identifications signs or the signs are not installed at the correct height. The parking space is missing an adjacent access aisle.	The parking stall is missing border markings and has non compliant surfacing material. Gravel is not compliant surfacing for parking stall or access aisles.	<a href="https://www.access-board.gov/aba/#aba-502_1">https://www.access-board.gov/aba/#aba-502_1</a> <a href="https://www.access-board.gov/aba/#aba-502_2">https://www.access-board.gov/aba/#aba-502_2</a>	2012 TAS Section: 502.1, 502.1 Exception  2010 ADAS Section: 502.1, 502.1 Exception  2015 ABAAS Section: 502.1, 502.1 Exception

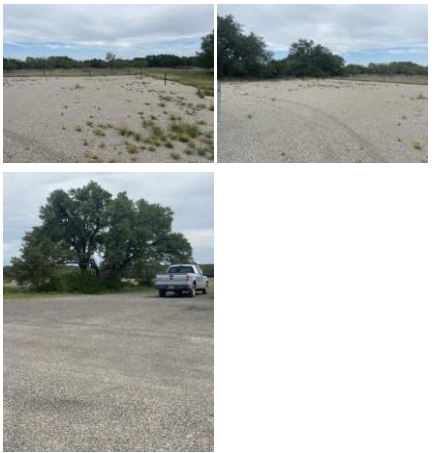
Finding Number	Area Description	Finding	As Built	Recommendation	Citation	Photos	Figure
12	Exterior of Property (Public): Dove Hunting Parking Lot (0 Spaces) - Access Aisle Requirments (Van)	The access aisle is in not nearly compliant. The access ai the minimum width. The access aisle is not as long as the parking space it serves. There are no markings to discourage parking. The floor or ground surface is not firm stable or slip resistant. The parking space contains changes in level and/or gaps that exceed the maximum allowable requirements.	There is no access aisle provided. Gravel surfacing material is not compliant for access aisle and missing boundary markings. Access aisle width requirments depend on van stall size. van stall 11' access aisle 5' or van stall 8' access aisle 8'	<a href="https://www.access-board.gov/ada/#ada-502_3">https://www.access-board.gov/ada/#ada-502_3</a>	2012 TAS Section: 502.3 2010 ADAS Section: 502.3 2015 ABAAS Section: 502.3

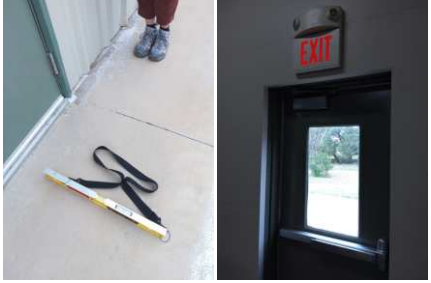
Finding Number	Area Description	Finding	As Built	Recommendation	Citation	Photos	Figure
13	Structures on Property (Public) : Office (Interior) - Entrance/Exit Doors	The maneuvering clearance at the entrance door exceeds 2% slope. Exterior doors with a front approach must have a landing on the pull side that is a minimum of 60 inches in depth perpendicular to the door in a close position by a minimum width dimension of 18 inches plus the door width. The additional 18 inches must extend past the door on the latch side. The entire maneuvering clearance must be free of obstructions and must be flat (2% max. slope is considered flat in any direction).	Closest door to accessible stall. slope is 3.0%	<a href="https://www.access-board.gov/ada/#ada-404_2_4_4">https://www.access-board.gov/ada/#ada-404_2_4_4</a>	2012 TAS Section: 404.2.4.4 2010 ADAS Section: 404.2.4.4 2015 ABAAS Section: 404.2.4.4

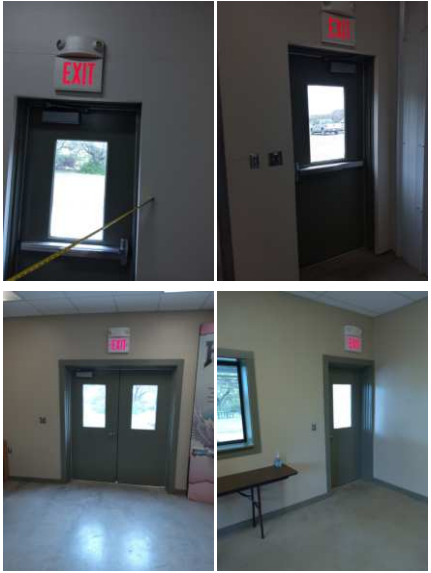
14	Structures on Property (Public) : Office (Interior) - Entrance/Exit Doors	The tactile EXIT sign is missing at the door. Wall signs identifying exits shall have characters raised 1/32 inch minimum and shall be uppercase characters a minimum of 5/8 inch and a maximum of 2 inches high. Braille shall be placed directly below the tactile characters; flush left or centered. Signs shall be located a minimum of 48 inches above the floor, measured from the baseline of the lowest tactile characters and 60 inches maximum above the finish floor or ground surface, measured from the baseline of the highest tactile characters. Where a tactile sign is provided at a door, the sign shall be located on the latch side. Where a tactile sign is provided at double doors the sign shall be located to the right of the right-hand door. Where there is no wall space at the latch side of a single door or at the right side of double doors, signs shall be located on the nearest adjacent wall.	This applies to all doors which feature exit overhead exit sign. Where visual EXIT is provided, accompanying tactile EXIT sign must also be provided for same doorway. Doorway exit signs and emergency exits with emergency exit signs that are overhead or visual only, or pictograms only, must have an accompanying ADA Braille sign. Exit passages, including doors, stairs and routes, must be identified with tactile ADA signage. Signs must include braille and raised characters. Pictograms are optional.	<a href="https://www.access-board.gov/ada/#ada-216_4_1">https://www.access-board.gov/ada/#ada-216_4_1</a>	2012 TAS Section: 216.4.1 2010 ADAS Section: 216.4.1 2015 ABAAS Section: F216.4.1

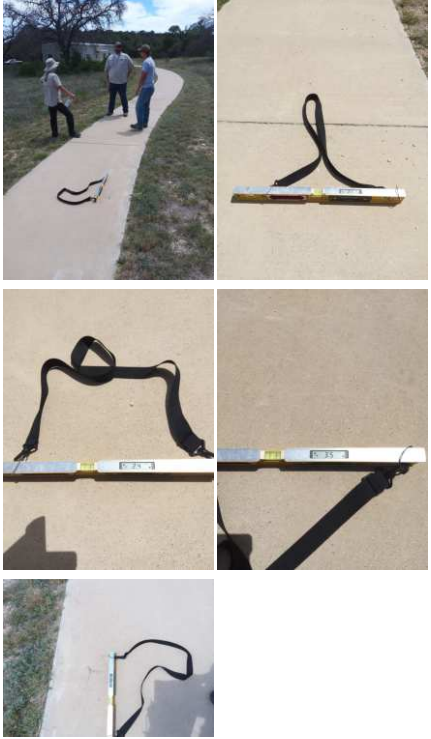
Finding Number	Area Description	Finding	As Built	Recommendation	Citation	Photos	Figure
22	Structures on Property (Public) : Multipurpose Building (Exterior) - Pathway to Multipurpose Building	The accessible route has running slopes greater than 5% and has not been constructed as a ramp (i.e. handrails, edge protection, etc.). Cross slopes are greater than 2% across the width of the walk. When the slope in the direction of travel of any walk exceeds 1 unit vertical in 20 units horizontal (5-percent slope), it must be constructed as a ramp. Surface cross slopes must not exceed 1 unit vertical in 48 units horizontal (2-percent slope).	There are several locations where exterior pathway exceed tolerance of cross or running slopes. See additional photos for location of slope noncompliance in accessible pathway or sidewalk. Improve pathway and correct sloping to improve access when feasible.	<a href="https://www.access-board.gov/ada/#ada-403_3">https://www.access-board.gov/ada/#ada-403_3</a>	2012 TAS Section: 403.3 2010 ADAS Section: 403.3 2015 ABAAS Section: 403.3

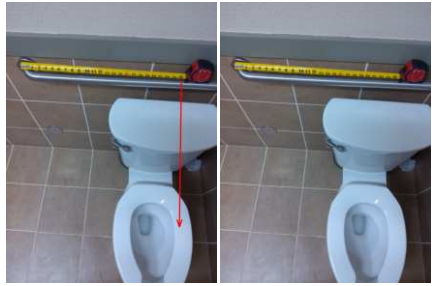
Finding Number	Area Description	Finding	As Built	Recommendation	Citation	Photos	Figure
31	Structures on Property (Public) : Multipurpose Building (Interior) - Restroom/Showe r (Unisex) #1	The rear grab bar does not extend adequately past the toilet on the wide side. The rear grab bar must be a minimum of 36 inches long and extend from the centerline of the toilet 12 inches minimum on wall side and 24 inches minimum on the wide side. Grab bars shall be installed in a horizontal position, 33 inches minimum and 36 inches maximum above the finish floor measured to the top of the gripping surface and the space between the grab bar and the top of the tank shall be 1-1/2 inches minimum.	Midline looks less than 24"		<a href="https://www.access-board.gov/ada/#ada-604_5_2">https://www.access-board.gov/ada/#ada-604_5_2</a>  2012 TAS Section: 604.5.2  2010 ADAS Section: 604.5.2  2015 ABAAS Section: 604.5.2

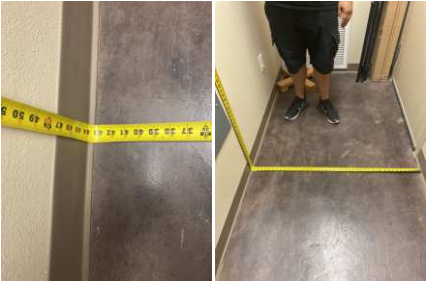
35	Structures on Property (Public) : Multipurpose Building (Interior) - Restroom/Showe r (Unisex) #2	The maneuvering clearance perpendicular to the door on the pull side is less than 48 inches. Maneuvering clearance for doors on the pull side with a latch approach must be flat (2% max. slope in any direction) for a minimum distance of 48 inches in the direction of travel. The width of the maneuvering clearance must be as wide as the door plus an additional 24 inches on the latch side. This latch side clearance must also be flat (2% max. slope in any direction) and clear of obstructions.	Not enough width provided to access restroom door.	<a href="https://www.access-board.gov/ada/#ada-404_2_4_1">https://www.access-board.gov/ada/#ada-404_2_4_1</a>	2012 TAS Section: 404.2.4.1  2010 ADAS Section: 404.2.4.1  2015 ABAAS Section: 404.2.4.1

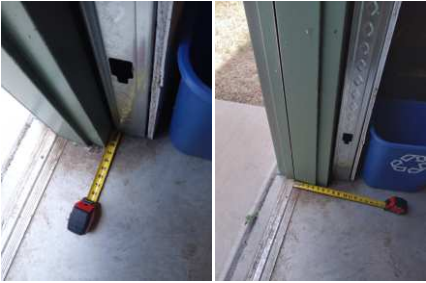
<p>1/4 max</p> <p>1/4</p> <p>1/4</p> <p>1/4</p>
42	Structures on Property (Public) : Workshop (Interior) - Entrance/Exit Doors	The door is equipped with both a closer and a latch and is recessed on the latch side greater than 8 inches deep. There is no latch side clearance within the alcove. Maneuvering clearance for doors on the push side equipped with both a closer and latch must be 48 inches minimum in depth. The width of the maneuvering clearance must be as wide as the door plus an additional 12 inches in the same plane as the door on the latch side. The additional maneuvering clearance does not have to be in the same plane as the door if the door is recessed 8 inches or less, The maneuvering clearance must be flat (2% max. slope in any direction) and clear of obstructions.	No latch side clearance of 12"	<a href="https://www.access-board.gov/ada/#ada-404_2_4_3">https://www.access-board.gov/ada/#ada-404_2_4_3</a>	2012 TAS Section: 404.2.4.3 2010 ADAS Section: 404.2.4.3 2015 ABAAS Section: 404.2.4.3

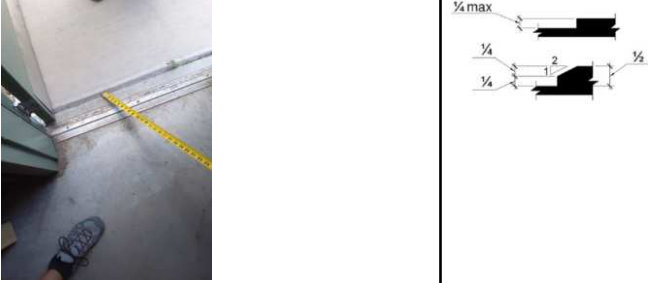
Finding Number	Area Description	Finding	As Built	Recommendation	Citation	Photos	Figure
43	Structures on Property (Public) : Workshop (Interior) - Entrance/Exit Doors	The threshold has a vertical change greater than 1/4 inch. The threshold at a doorway shall be no higher than 1/2 inch. Changes in level between 1/4 inch and 1/2 inch must be beveled at 1:2 or less. The maximum vertical rise shall be 1/4 inch.	exceeds 1/4"		<a href="https://www.access-board.gov/ada/#ada-404_2_5">https://www.access-board.gov/ada/#ada-404_2_5</a>	2012 TAS Section: 404.2.5  2010 ADAS Section: 404.2.5  2015 ABAAS Section: 404.2.5

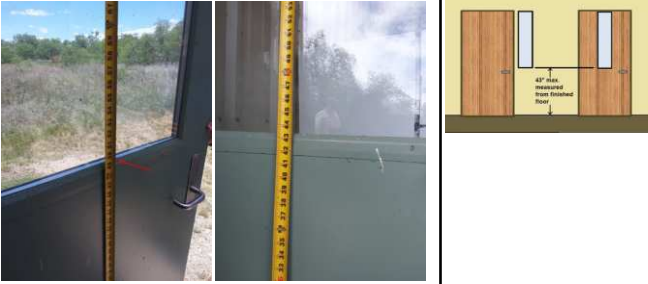
44	Structures on Property (Public) : Workshop (Interior) - Entrance/Exit Doors	The vision light panels (glazing/window) exceed height requirements. Doors, gates, and side lights adjacent to doors or gates, containing one or more glazing panels that permit viewing through the panels shall have the bottom of at least one glazed panel located 43 inches maximum above the finish floor.	Greater than 43" allowance. Applies to both doors used in this area.		<a href="https://www.access-board.gov/ada/#ada-404_2_11">https://www.access-board.gov/ada/#ada-404_2_11</a>	2012 TAS Section: 404.2.11  2010 ADAS Section: 404.2.11  2015 ABAAS Section: 404.2.11

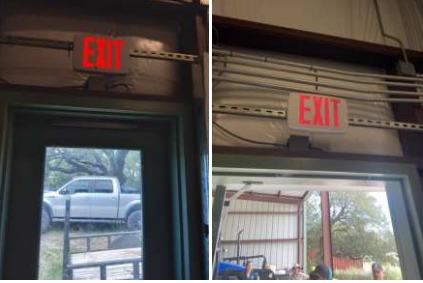
Finding Number	Area Description	Finding	As Built	Recommendation	Citation	Photos	Figure
45	Structures on Property (Public) : Workshop (Interior) - Entrance/Exit Doors	The tactile EXIT sign is missing at the door. Wall signs identifying exits shall have characters raised 1/32 inch minimum and shall be uppercase characters a minimum of 5/8 inch and a maximum of 2 inches high. Braille shall be placed directly below the tactile characters; flush left or centered. Signs shall be located a minimum of 48 inches above the floor, measured from the baseline of the lowest tactile characters and 60 inches maximum above the finish floor or ground surface, measured from the baseline of the highest tactile characters. Where a tactile sign is provided at a door, the sign shall be located on the latch side. Where a tactile sign is provided at double doors the sign shall be located to the right of the right-hand door. Where there is no wall space at the latch side of a single door or at the right side of double doors, signs shall be located on the nearest adjacent wall.	Applies to all doors featuring over head exit. Where visual EXIT is provided, accompanying tactile EXIT sign must also be provided for same doorway. Doorway exit signs and emergency exits with emergency exit signs that are overhead or visual only, or pictograms only, must have an accompanying ADA Braille sign. Exit passages, including doors, stairs and routes, must be identified with tactile ADA signage. Signs must include braille and raised characters. Pictograms are optional.	<a href="https://www.access-board.gov/ada/#ada-216_4_1">https://www.access-board.gov/ada/#ada-216_4_1</a>	2012 TAS Section: 216.4.1  2010 ADAS Section: 216.4.1  2015 ABAAS Section: F216.4.1
