Access Audit Site Report

Stephen F. Austin State Park

Accessibility Evaluation

Inspection Date: 08/18/2022

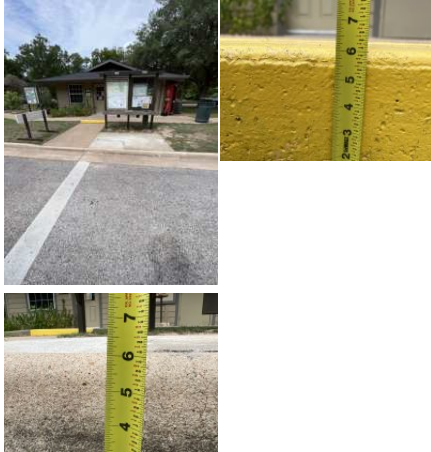
11	Headquarters Area: HQ - Public Spaces	[29.8120098 , -96.107997 8]	Changes in level greater than ½ inch (13 mm) high shall be ramped, and shall comply with 405 or 406.	Lacks route to pay station, maps due to 2 - 6" changes in level	Create a curb ramp to be max running slope 8.33%, max cross slope 2.08%, having a top landing as wide as the ramp and 36" deep and side flares with a max slope 10% along the AR where curbs are present.	2015 ABAAS Section: 303.4 2012 TAS Section: 303.4 2010 ADAS Section: 303.4

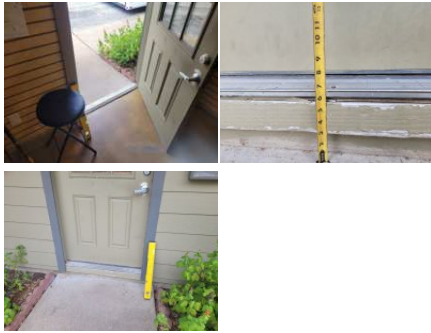
14	Headquarters Area: HQ - Employee Spaces	[29.81197, -96.10805]	Spaces and elements within employee work areas shall only be required to comply with 206.2.8, 207.1, and 215.3 and shall be designed and constructed so that individuals with disabilities can approach, enter, and exit the employee work area. Employee work areas, or portions of employee work areas, other than raised courtroom stations, that are less than 300 square feet (28 m2) and elevated 7 inches (180 mm) or more above the finish floor or ground where the elevation is essential to the function of the space shall not be required to comply with these requirements or to be on an accessible route.	Reception - 6" CIL, stool pull side	For employee spaces, relocate storage, furniture, and other obstacles at doorways to provide approach, enter and exit at the employee space. Provide required maneuvering clearance on push and pull side of doors. Repair, bevel, or ramp CILs at door entries to max .25".	2015 ABAAS Section: F203.9 2012 TAS Section: 203.9 2010 ADAS Section: 203.9

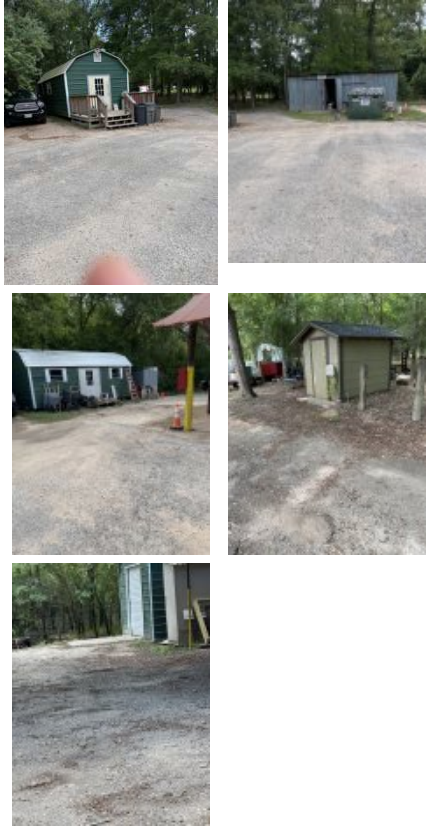
29	Employee Areas: Maintenance	[29.8123639 , -96.1085749], [29.8122591 , -96.1089639]	The building entrance is not located on an accessible route. When a building, or portion of a building, is required to be accessible, an accessible route of travel shall be provided to all portions of the building, to accessible building entrances and between the building and the public way. All walks, halls, corridors, aisles, skywalks, tunnels, and other spaces that are part of an accessible route must comply. An accessible route of travel must not pass through kitchens, storage rooms, restrooms, closets or other spaces used for similar purposes. At least one accessible route within the boundary of the site must be provided from public transportation stops, accessible parking and accessible passenger loading zones and public streets or sidewalks to the accessible building entrance they serve. The accessible route shall, to the maximum extent feasible, coincide with the route for the general public. At least one accessible route shall connect accessible buildings, facilities, elements and spaces that are on the same site. At least one accessible route shall connect accessible building or facility entrances with all accessible spaces and elements.	Lacks route to small buildings at maintenance - gravel, stairs other changes in level	Create AR with crushed and compacted stone or similar outdoor material from parking or sidewalk to building entrance	2015 ABAAS Section: F206.2.1 2012 TAS Section: 206.2.1 2010 ADAS Section: 206.2.1

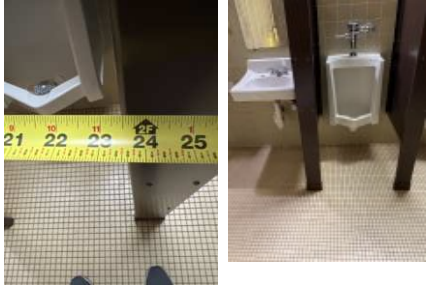
41	Day Use Area: Day Use - Men's Restroom	[29.8138162 , -96.112443 8]	The urinal is located in an area that does not provide the required clear floor space for a front approach. The surrounding elements of a urinal must provide a minimum of 30 by 48 inches of clear floor space for a front approach.	23.5" width, also impacts CFS at sink	Relocate privacy wall at urinal to provide 30" CFS.	2015 ABAAS Section: 605.2 2012 TAS Section: 605.2 2010 ADAS Section: 605.2

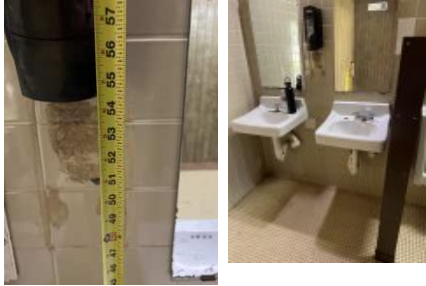
43	Day Use Area: Day Use - Men's Restroom	[29.8138139 , -96.1124464]	Where a high forward reach is over an obstruction, the clear floor space shall extend beneath the element for a distance not less than the required reach depth over the obstruction. The high forward reach shall be 48 inches (1220 mm) maximum where the reach depth is 20 inches (510 mm) maximum. Where the reach depth exceeds 20 inches (510 mm), the high forward reach shall be 44 inches (1120 mm) maximum and the reach depth shall be 25 inches (635 mm) maximum. Where a clear floor or ground space allows a parallel approach to an element and the high side reach is over an obstruction, the height of the obstruction shall be 34 inches (865 mm) maximum and the depth of the obstruction shall be 24 inches (610 mm) maximum. The high side reach shall be 48 inches (1220 mm) maximum for a reach depth of 10 inches (255 mm) maximum. Where the reach depth exceeds 10 inches (255 mm), the high side reach shall be 46 inches (1170 mm) maximum for a reach depth of 24 inches (610 mm) maximum.	Soap 54.5"	Lower soap dispenser to max 44" above the finished floor (AFF) for a forward reach over counter.	2015 ABAAS Section: 308.2.1, 308.3.2 2012 TAS Section: 308.2.1, 308.3.2 2010 ADAS Section: 308.2.1, 308.3.2

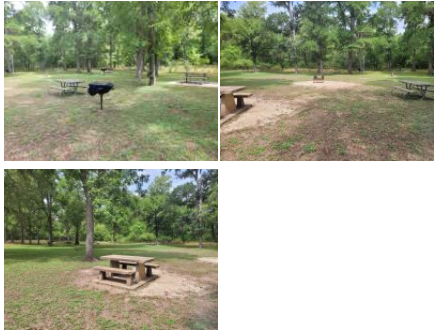
64	Day Use Area/Walk-In Campsites: Walk-In Campsites - Group Camping	[29.8136517 , -96.1143469]	Camping facilities shall provide camping units with mobility features complying with F244.2 in accordance with Table F244.2. Where a camping facility provides different types of camping units, Table F244.2 shall apply to each type of camping unit provided. Total Number of Camping Units Provided in Camping Facility Minimum Number of Camping Units with Mobility Features Required 1 1 2 to 25 2 26 to 50 3 51 to 75 4 76 to 100 5 101 to 150 7 151 to 200 8 201 and over 8, plus 2 percent of the number over 200	Group campsite lacks accessible features, 9 tables, 4 grills, 1 fire pit, 2 hooks, 1 water spout	Create the required number of accessible camp sites per table F244.2 as a smart practice.	2015 ABAAS Section: F244.2

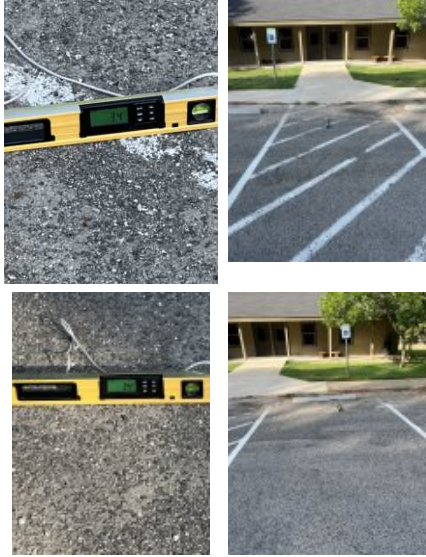
Finding Number	Area Description	Lat/Long	Finding	As Built	Recommendation	Citation	Photos	Figure
68	Bullinger Creek Group Lodge: Bullinger Creek - Parking	[29.8152749 , -96.1107725]	The cross slopes (narrow dimension) and/or running slopes (long dimension) of the access aisle exceeds 2%. The running slope and the cross slope in an accessible parking stall and the access aisle must not exceed 2%.	3.4% in aisle, 3.4% in right stall	Repair or correct slope of parking space and access aisle to max 2.08% in any direction.	2015 ABAAS Section: 502.4 2012 TAS Section: 502.4 2010 ADAS Section: 502.4

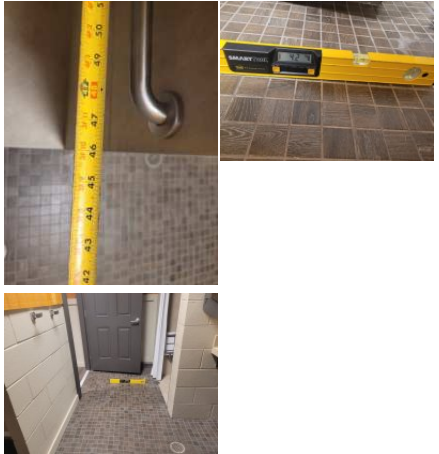
Finding Number	Area Description	Lat/Long	Finding	As Built	Recommendation	Citation	Photos	Figure
70	Bullinger Creek Group Lodge: Bullinger Creek - Lodge	[29.814897, -96.1104754]	Minimum maneuvering clearances at doors and gates shall comply with 404.2.4. Maneuvering clearances shall extend the full width of the doorway and the required latch side or hinge side clearance. Maneuvering clearances shall have a max slope of 2.08%.	accessible room toilet room door - shower back 46" pull side, 4.2% in clearance due to drain	For all doors along the public circulation route, provide required maneuvering clearance on push and pull side of doors. For all doors along the public circulation route, correct slope in door clearance to max 2.08%.	2010 ADAS Section: 404.2.3, 404.2.7, 404.2.4, 404.2.11, 404.2.11 Exception

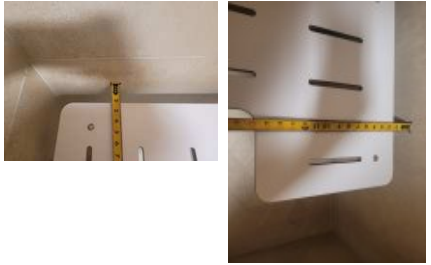
Finding Number	Area Description	Lat/Long	Finding	As Built	Recommendation	Citation	Photos	Figure
81	Bullinger Creek Group Lodge: Bullinger Creek - Lodge	[29.81488, -96.11048]	The shower seat does not have a compliant space between it and the wall. The folding seat must be mounted 17-19 inches above the floor, and have a maximum space of 1-1/2 inches between the edge of the seat and the side wall and 2-1/2 inches maximum to the seat wall.	accessible room restroom- seat dimensions from back wall fail	Remount shower seat to the correct location and height in the shower.	2015 ABAAS Section: 610.3.2 2012 TAS Section: 610.3.2 2010 ADAS Section: 610.3.2

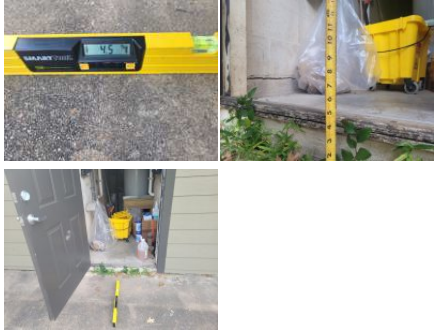
86	Bullinger Creek Group Lodge: Bullinger Creek - Lodge	[29.8148684 , -96.110498 5]	Spaces and elements within employee work areas shall only be required to comply with 206.2.8, 207.1, and 215.3 and shall be designed and constructed so that individuals with disabilities can approach, enter, and exit the employee work area. Employee work areas, or portions of employee work areas, other than raised courtroom stations, that are less than 300 square feet (28 m2) and elevated 7 inches (180 mm) or more above the finish floor or ground where the elevation is essential to the function of the space shall not be required to comply with these requirements or to be on an accessible route.	Janitor - storage push side, 4.5% slope, 5" CIL	For employee spaces, relocate storage, furniture, and other obstacles at doorways to provide approach, enter and exit at the employee space. Provide required maneuvering clearance on push and pull side of doors. Correct slope in door clearance to max 2.08%. Repair, bevel, or ramp CILs at door entries to max .25".	2015 ABAAS Section: F203.9 2012 TAS Section: 203.9 2010 ADAS Section: 203.9

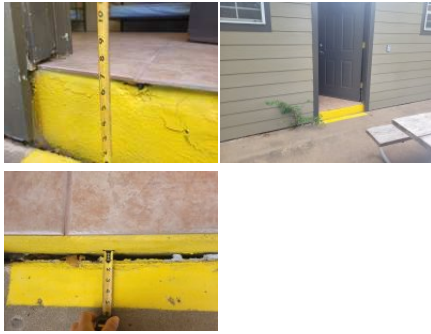
88	Bullinger Creek Group Lodge: Bullinger Creek - Lodge	[29.8149826 , -96.110502 4]	The threshold has a vertical change greater than 1/4 inch high. The threshold has a gap greater than 1/2 inch wide.	Bedroom off kitchen w/ steps exterior door - 7" step, 1" gap	For all doors along the public circulation route, repair, bevel, or ramp CILs at door entries to max .25". For all doors along the public circulation route, fill gaps at door entries to max .5".	2010 ADAS Section: 404.2.3, 404.2.7, 404.2.4, 404.2.11, 404.2.11 Exception

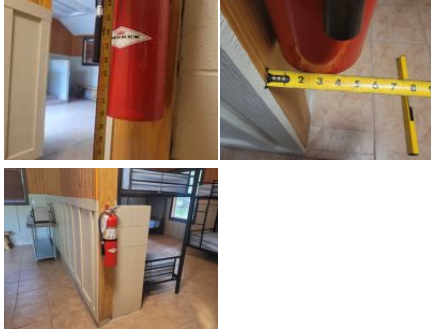
91	Bullinger Creek Group Lodge: Bullinger Creek - Lodge	[29.8149924 , -96.1105105]	An item or items project more than 4 inches into the circulation path. Wall-mounted objects that have leading edges between 27 inches and 80 inches from the floor must not project more than 4 inches into the circulation path. Protruding objects that extend to the floor or within 27 inches of the floor are cane detectable and are therefore not hazardous. Where it is necessary or desirable to have objects protrude from the wall, a manner of cane detection must be provided.	lodge kitchen- fire extinguisher protrudes 5"	Relocate protruding objects or place cane detectable warning or bollard at foot of item.	2015 ABAAS Section: 307.2 2012 TAS Section: 307.2 2010 ADAS Section: 307.2

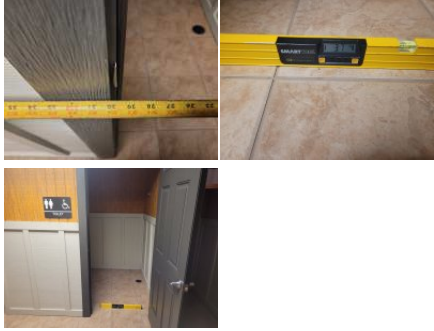
95	Bullinger Creek Group Lodge: Bullinger Creek - Lodge	[29.8148953 , -96.1104939]	Minimum maneuvering clearances at doors and gates shall comply with 404.2.4. Maneuvering clearances shall extend the full width of the doorway and the required latch side or hinge side clearance. Maneuvering clearances shall have a max slope of 2.08%. Door openings shall provide a clear width of 32 inches (815 mm) minimum. Clear openings of doorways with swinging doors shall be measured between the face of the door and the stop, with the door open 90 degrees. Openings more than 24 inches (610 mm) deep shall provide a clear opening of 36 inches (915 mm) minimum. There shall be no projections into the required clear opening width lower than 34 inches (865 mm) above the finish floor or ground. Projections into the clear opening width between 34 inches (865 mm) and 80 inches (2030 mm) above the finish floor or ground shall not exceed 4 inches (100 mm).	Toilet room off kitchen area - 29.5" wide, 3.7% slope	For all doors along the public circulation route, correct slope in door clearance to max 2.08%. For all doors along the public circulation route, replace doors with doors having 80" overhead clearance and 32" clear width.	2010 ADAS Section: 404.2.3, 404.2.7, 404.2.4, 404.2.11, 404.2.11 Exception

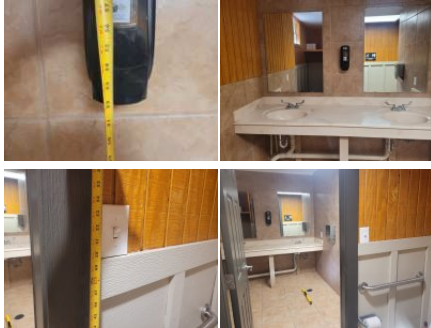
100	Bullinger Creek Group Lodge: Bullinger Creek - Lodge	[29.8149075 , -96.110469 9]	Where a high forward reach is over an obstruction, the clear floor space shall extend beneath the element for a distance not less than the required reach depth over the obstruction. The high forward reach shall be 48 inches (1220 mm) maximum where the reach depth is 20 inches (510 mm) maximum. Where the reach depth exceeds 20 inches (510 mm), the high forward reach shall be 44 inches (1120 mm) maximum and the reach depth shall be 25 inches (635 mm) maximum. Where a clear floor or ground space allows a parallel approach to an element and the high side reach is over an obstruction, the height of the obstruction shall be 34 inches (865 mm) maximum and the depth of the obstruction shall be 24 inches (610 mm) maximum. The high side reach shall be 48 inches (1220 mm) maximum for a reach depth of 10 inches (255 mm) maximum. Where the reach depth exceeds 10 inches (255 mm), the high side reach shall be 46 inches (1170 mm) maximum for a reach depth of 24 inches (610 mm) maximum.	restroom off kitchen-soap dispenser 52" AFF and over sink, light switch in toilet room 52" AFF	Lower operating mechanisms to max 48" above the finished floor (AFF) to highest operable part. Lower to max 44" above the finished floor (AFF) for a forward reach over counter.	2015 ABAAS Section: 308.2.1, 308.3.2 2012 TAS Section: 308.2.1, 308.3.2 2010 ADAS Section: 308.2.1, 308.3.2

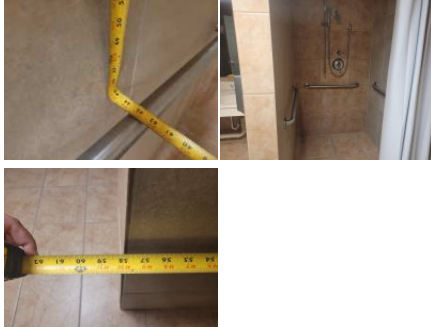
107	Bullinger Creek Group Lodge: Bullinger Creek - Lodge	[29.8149085 , -96.110476 7]	There are no accessible bathing or shower facilities. Where facilities for bathing are provided for the public, clients or employees, including showers or bathtubs, at least one shower or bathtub and support facilities such as lockers, and not less than 1 percent of all facilities, shall be accessible.	restroom off kitchen- 45" wide, 58" deep shower with grab bars on 3 sides and handheld shower head, does not comply with any type	Create an accessible shower in locker/bathing room.	2015 ABAAS Section: F213.3.6 2012 TAS Section: 213.3.6 2010 ADAS Section: 213.3.6

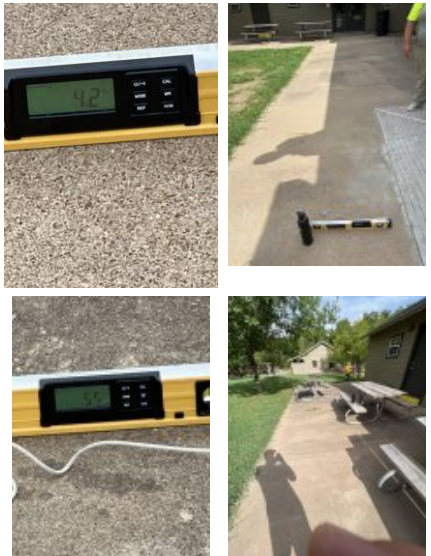
113	Bullinger Creek Group Lodge: Bullinger Creek - Lodge	[29.8149681 , -96.1105821], [29.8148704 , -96.1105754]	The accessible route of travel contains cross slopes greater than 2%. Cross slopes shall not exceed one unit vertical in 48 units horizontal (2-percent slope).	4.2%, 5.5% on route to double doors; 3.5% near picnic tables	Correct or repair cross slope along AR to max 2.08%.	2015 ABAAS Section: 403.3 2012 TAS Section: 403.3 2010 ADAS Section: 403.3

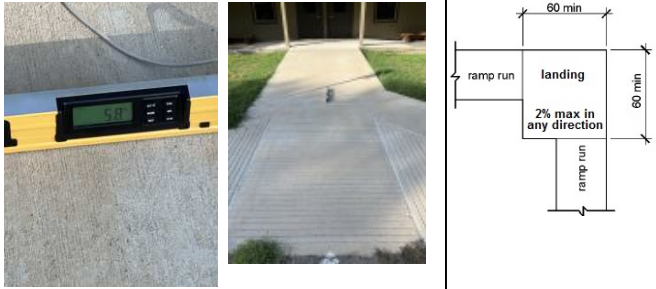
117	Bullinger Creek Group Lodge: Bullinger Creek - Dining/Rec Hall	[29.8152211 , -96.1107866]	The landing of the ramp has a slope greater than 2%. Landings at a change in direction shall have a dimension not less than 60 inches by 60 inches and have a slope of 2% maximum in any direction.	5.8% on landing	Correct ramp landing slope to max 2.08%.	2015 ABAAS Section: 405.7.1, 405.7.1 EXCEPTION 2012 TAS Section: 405.7.1, 405.7.1 Exception 2010 ADAS Section: 405.7.1, 405.7.1 Exception

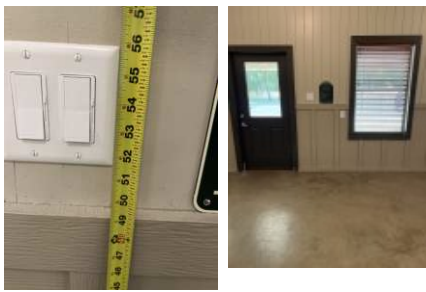
121	Bullinger Creek Group Lodge: Bullinger Creek - Dining/Rec Hall	[29.8151265 , -96.1108205]	The operable part is positioned too high for either a side or front approach. Where a clear floor or ground space allows a parallel approach to an element and the side reach is unobstructed, the high side reach shall be 48 inches maximum and the low side reach shall be 15 inches minimum above the finish floor or ground. Where a forward reach is unobstructed, the high forward reach shall be 48 inches maximum and the low forward reach shall be 15 inches minimum above the finish floor or ground.	Light switch 55" AFF	Remount operable parts to be in reach range of 15" min to 48" max.	2015 ABAAS Section: 308.1 2012 TAS Section: 308.1 2010 ADAS Section: 308.1

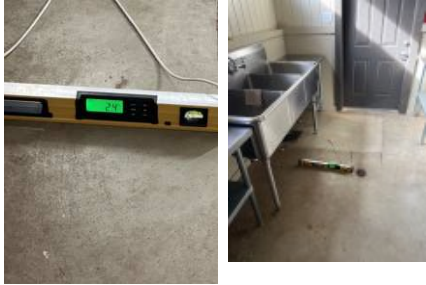
Finding Number	Area Description	Lat/Long	Finding	As Built	Recommendation	Citation	Photos	Figure
126	Bullinger Creek Group Lodge: Bullinger Creek - Dining/Rec Hall	[29.815146, -96.110817 2]	The accessible path of travel contains cross slopes greater than 2%. Surface cross slopes shall not exceed one unit vertical in 48 units horizontal (2-percent slope). When the slope in the direction of travel of any walk exceeds 1 unit vertical in 20 units horizontal (5-percent slope), it must be constructed as ramp.	kitchen- 2.4% near drain	Correct or repair cross slope of AR to max 2.08%.	2015 ABAAS Section: F206.2.4, 403.3 2012 TAS Section: 206.2.4, 403.3 2010 ADAS Section: 206.2.4, 403.3

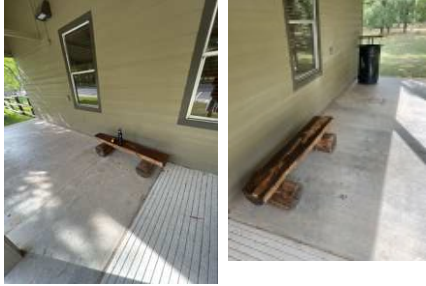
129	Bullinger Creek Group Lodge: Bullinger Creek - Dining/Rec Hall	[29.815172, -96.110768 3]	Element meets all standards and requirements	2 benches and garbage at entry to dining/rec hall comply	None	2010 ADAS Section: N/A

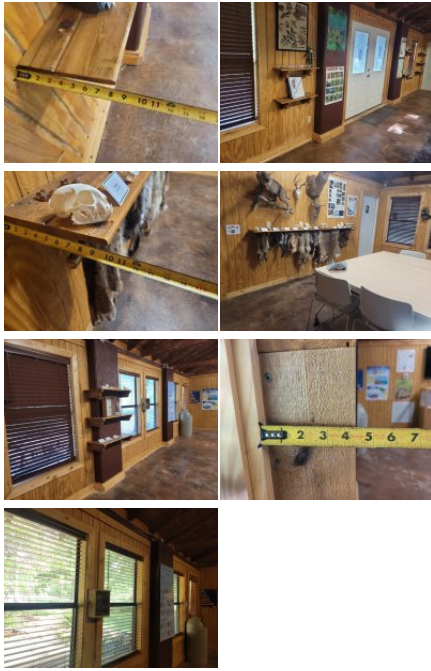
138	Bullinger Creek Group Lodge: Bullinger Creek - Interpretive Center	[29.8145049 , -96.1094128]	An item or items project more than 4 inches into the circulation path. Wall-mounted objects that have leading edges between 27 inches and 80 inches from the floor must not project more than 4 inches into the circulation path. Protruding objects that extend to the floor or within 27 inches of the floor are cane detectable and are therefore not hazardous. Where it is necessary or desirable to have objects protrude from the wall, a manner of cane detection must be provided.	main room- shelves protrude, 6 locations; nest box protrudes 4.25"	Relocate protruding objects or place cane detectable warning or bollard at foot of item.	2015 ABAAS Section: 307.2 2012 TAS Section: 307.2 2010 ADAS Section: 307.2

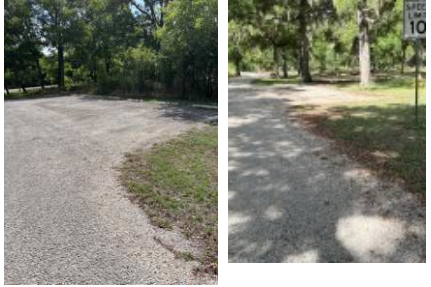
143	Bullinger Creek Group Lodge: Bullinger Creek - Interpretive Center	[29.8143356, -96.1091053]	There are no or not enough accessible parking stalls. Each lot where parking is provided for the public as clients, guests or employees, shall provide accessible parking and shall be located on the shortest accessible route of travel from adjacent parking to an accessible entrance. There are a total of 12 parking stalls in the parking lot that could be reasonably associated with this facility. There should be a minimum of 1 accessible stalls with a minimum of 1 being designed as van accessible.	Two small lots total of 12-13 spaces, 0 accessible	Create one or more 8' accessible parking stalls, with one 5' adjacent access aisle, with proper signage and striping based on the total number of stalls.	2015 ABAAS Section: F208.2 2012 TAS Section: 208.2 2010 ADAS Section: 208.2

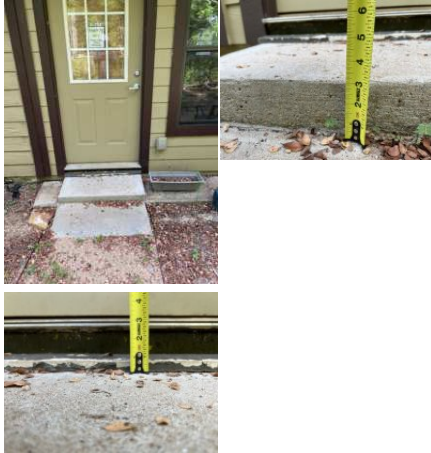
Finding Number	Area Description	Lat/Long	Finding	As Built	Recommendation	Citation	Photos	Figure
147	Bullinger Creek Group Lodge: Bullinger Creek - Interpretive Center	[29.8145072 , -96.1094051]	Minimum maneuvering clearances at doors and gates shall comply with 404.2.4. Maneuvering clearances shall extend the full width of the doorway and the required latch side or hinge side clearance. The threshold has a vertical change greater than 1/4 inch high.	Employee door - lacks clearance on push, two 3" CILs	For all doors along the public circulation route, provide required maneuvering clearance on push and pull side of doors. For all doors along the public circulation route, repair, bevel, or ramp CILs at door entries to max .25".	2010 ADAS Section: 404.2.3, 404.2.7, 404.2.4, 404.2.11, 404.2.11 Exception

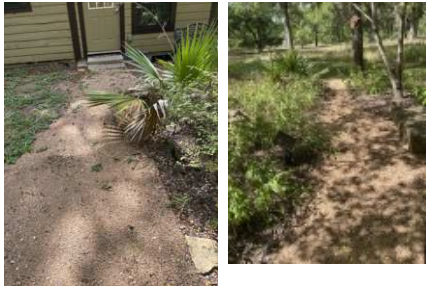
148	Bullinger Creek Group Lodge: Bullinger Creek - Interpretive Center	[29.8145573 , -96.1094587]	The route of travel at this location does not provide the required minimum width. The minimum clear width for sidewalks and walks is 36 inches.	Path width reduced by plants	Maintain landscaping to provide min 36" clear width.	2015 ABAAS Section: 403.5.1 2012 TAS Section: 403.5.1 2010 ADAS Section: 403.5.1

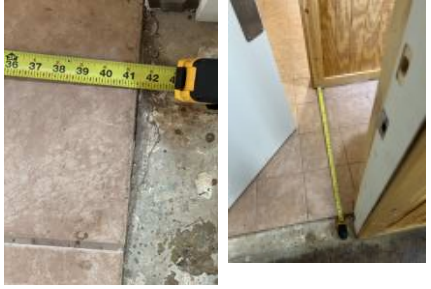
149	Bullinger Creek Group Lodge: Bullinger Creek - Interpretive Center	[29.8145224 , -96.1094064]	Minimum maneuvering clearances at doors and gates shall comply with 404.2.4. Maneuvering clearances shall extend the full width of the doorway and the required latch side or hinge side clearance.	Men's door - clearance reduced to 41.5" on pull	Provide required maneuvering clearance around pull side of door.	2015 ABAAS Section: 404.2.4.1 , 404.2.4.4 2012 TAS Section: 404.2.4.4, 404.2.4.1 2010 ADAS Section: 404.2.4.4, 404.2.4.1

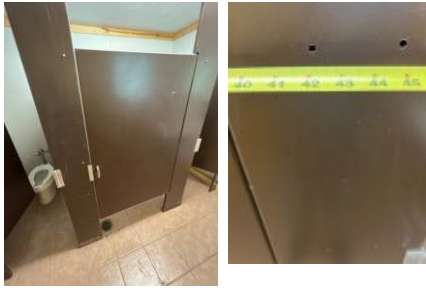
162	Bullinger Creek Group Lodge: Bullinger Creek - Interpretive Center	[29.8145176 , -96.109395]	There are not enough accessible toilet compartments. The room contains toilet compartments. A minimum of 1 must be wheelchair accessible .	women's- stall locked cannot audit, appears to have same issues as men's	Create a wheelchair accessible stall with grab bars and fixtures mounted in correct locations and at correct heights.	2015 ABAAS Section: F213.3.1 2012 TAS Section: 213.3.1 2010 ADAS Section: 213.3.1

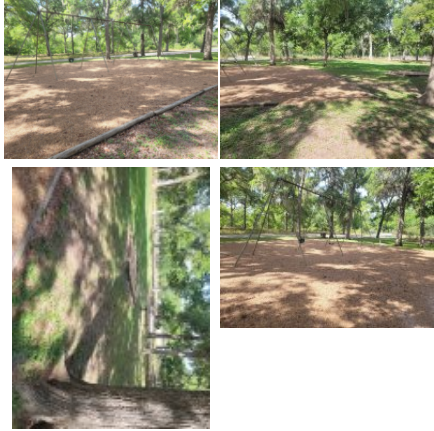
168	Bullinger Creek Group Lodge: Bullinger Creek - Playground	[29.8142727 , -96.109917 4]	The route within the play area does not connect to all play components	no AR to playground (3 swings) and sand area, pebble surface	Replace playground surface with one that meets ASTM F1951 and extend an accessible route to playground entry.	2012 TAS Section: 206.2.17, 206.2.17.1 2010 ADAS Section: 206.2.17, 206.2.17.1

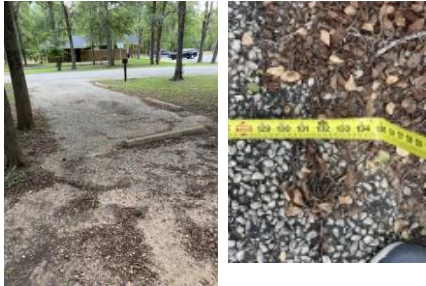
Finding Number	Area Description	Lat/Long	Finding	As Built	Recommendation	Citation	Photos	Figure
203	Campsites with Water (along Ironwood Trail): Campsites Water - Sample Campsite	[29.8188154 , -96.1092756]	Camping facilities shall provide camping units with mobility features complying with F244.2 in accordance with Table F244.2. Where a camping facility provides different types of camping units, Table F244.2 shall apply to each type of camping unit provided. Total Number of Camping Units Provided in Camping Facility Minimum Number of Camping Units with Mobility Features Required 1 1 2 to 25 2 26 to 50 3 51 to 75 4 76 to 100 5 101 to 150 7 151 to 200 8 201 and over 8, plus 2 percent of the number over 200	0 of 39 campsites accessible	Create the required number of accessible camp sites per table F244.2 as a smart practice.	2015 ABAAS Section: F244.2		
204	Campsites with Water (along Ironwood Trail): Campsites Water - Sample Campsite	[29.8187805 , -96.1092542]	Parking spaces and pull-up spaces for recreational vehicles shall be 20 feet (6100 mm) wide minimum. EXCEPTION: Where two adjacent parking spaces are provided for recreational vehicles, one parking space shall be permitted to be 16 feet (4880 mm) wide minimum.	Site 80 - Single car space, 11'	Correct RV parking space to be 20' wide minimum; or 16' for two adjacent spaces as a smart practice.	2015 ABAAS Section: 1012.2, 1012.2 EXCEPTION

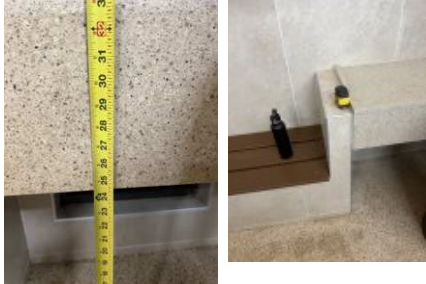
213	Campsites with Water (along Ironwood Trail): Campsites Water - Men's Restroom	[29.8184734 , -96.1091502]	Compliant knee and toe clearance is not provided at the accessible table. When seating for persons in wheelchairs is provided at fixed tables or counters, knee spaces at least 27 inches high, 30 inches wide and 19 inches deep shall be provided.	Changing station doesn't provide clearance	Replace 5% of the tables with ones providing required knee and toe clearances.	2015 ABAAS Section: 306.3.3 2012 TAS Section: 306.3.3 2010 ADAS Section: 306.3.3

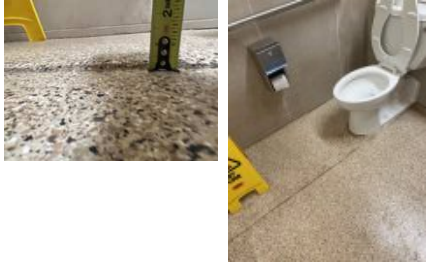
218	Campsites with Water (along Ironwood Trail): Campsites Water - Men's Restroom	[29.818468, -96.109159 7]	There is a change in level greater than 1/4 inch. 1/4 inch is the maximum vertical rise. Changes in level between 1/4 inch and 1/2 inch must be beveled at 1:2 or less. Changes in level greater than 1/2 inch must be by way of a ramp.	.5" CIL at toilet	Repair, bevel or ramp CIL along accessible route (AR) to max .25".	2015 ABAAS Section: 303.3 2012 TAS Section: 303.3 2010 ADAS Section: 303.3

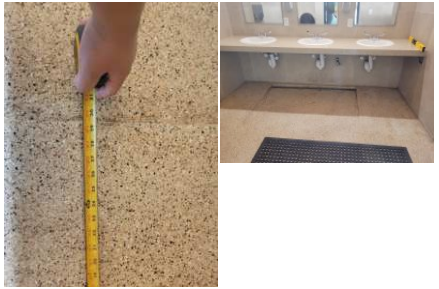
220	Campsites with Water (along Ironwood Trail): Campsites Water - Women's Restroom	[29.8184808 , -96.109133 3]	Knee clearance at 27 inches off the floor is not 8 inches minimum deep. The knee clearance, measured from the bottom of the apron or the outside bottom edge of the lavatory, must be 27 inches at a point located 8 inches back from the front edge and continuing to 11 inches minimum in depth at 9 inches above the floor. The top of the lavatory rim may be no higher than 34 inches.	Right side 29.5" wide before dip, slope in center	Correct floor surface to provide CFS at sink	2015 ABAAS Section: 306.3.1, 306.3.2, 306.3.3, 306.3.4 , 306.3.5 2012 TAS Section: 306.3.2, 306.3.3, 306.3.4, 306.3.5, 306.3.1 2010 ADAS Section: 306.3.3, 306.3.2, 306.3.4, 306.3.5, 306.3.1

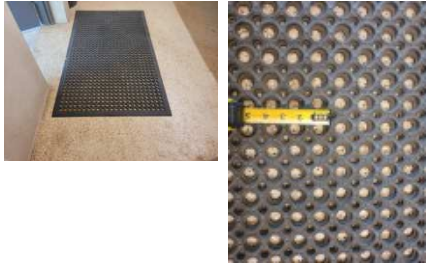
Finding Number	Area Description	Lat/Long	Finding	As Built	Recommendation	Citation	Photos	Figure
229	Campsites with Water (along Ironwood Trail): Campsites Water - Women's Restroom	[29.8184738 , -96.10914]	Openings in floor or ground surfaces shall not allow passage of a sphere more than 1/2 inch (13 mm) diameter except as allowed in 407.4.3, 409.4.3, 410.4, 810.5.3 and 810.10. Elongated openings shall be placed so that the long dimension is perpendicular to the dominant direction of travel.	1" gaps in mat	Replace mat with one that has gaps max .5"	2015 ABAAS Section: 302.3 2012 TAS Section: 302.3 2010 ADAS Section: 302.3

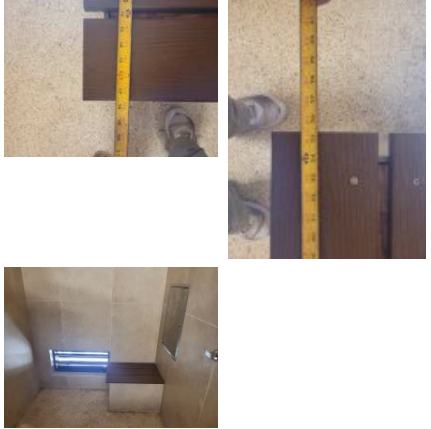
231	Campsites with Water (along Ironwood Trail): Campsites Water - Women's Restroom	[29.8184657 , -96.109144 9]	The bench is not deep enough or long enough or is missing. Benches shall be provided having seats that are 42 inches long minimum and 20 inches deep minimum and 24 inches deep maximum. The bench shall provide for back support or shall be affixed to a wall. Back support shall be 42 inches (1065 mm) long minimum and shall extend from a point 2 inches (51 mm) maximum above the seat surface to a point 18 inches (455 mm) minimum above the seat surface. Back support shall be 2 1/2 inches (64 mm) maximum from the rear edge of the seat measured horizontally. The top of the bench seat surface shall be 17 inches (430 mm) minimum and 19 inches (485 mm) maximum above the finish floor or ground. Clear floor or ground space complying with 305 shall be provided and shall be positioned at the end of the bench seat and parallel to the short axis of the bench	Bench - 17.5" deep, 25.5" wide	Replace bench in dressing area with one having a seat depth of 20" to 24" deep, 42" long, affixed to the wall or having a back and mounted 17" to 19" AFF and provide required clear floor space on the short axis of the bench.	2012 TAS Section: 903.4, 903.2, 903.3, 903.5 2010 ADAS Section: 903.4, 903.2, 903.3, 903.5

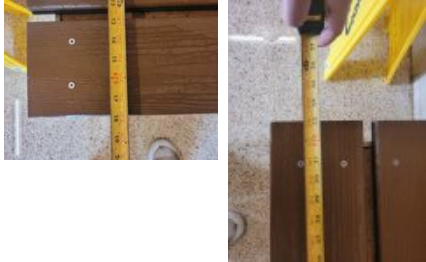
Finding Number	Area Description	Lat/Long	Finding	As Built	Recommendation	Citation	Photos	Figure
238	Campsites with Water (along Ironwood Trail): Campsites Water-Family Restroom Women's Side	[29.8184586 , -96.1091775]	The bench is not deep enough or long enough or is missing. Benches shall be provided having seats that are 42 inches long minimum and 20 inches deep minimum and 24 inches deep maximum. The bench shall provide for back support or shall be affixed to a wall. Back support shall be 42 inches (1065 mm) long minimum and shall extend from a point 2 inches (51 mm) maximum above the seat surface to a point 18 inches (455 mm) minimum above the seat surface. Back support shall be 2½ inches (64 mm) maximum from the rear edge of the seat measured horizontally. The top of the bench seat surface shall be 17 inches (430 mm) minimum and 19 inches (485 mm) maximum above the finish floor or ground. Clear floor or ground space complying with 305 shall be provided and shall be positioned at the end of the bench seat and parallel to the short axis of the bench	Bench 18" deep, 33" wide	Replace bench in dressing area with one having a seat depth of 20" to 24" deep, 42" long, affixed to the wall or having a back and mounted 17" to 19" AFF and provide required clear floor space on the short axis of the bench.	2012 TAS Section: 903.4, 903.2, 903.3, 903.5 2010 ADAS Section: 903.4, 903.2, 903.3, 903.5

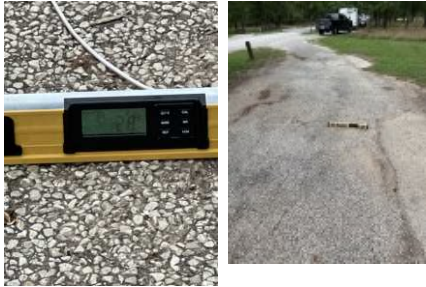
250	Full Hook-Up Campsites (RV loops): RV - Sample Campsite	[29.8206066 , -96.110758 3]	The surface of parking spaces and pull-up spaces shall be firm and stable. The slope of the surface of parking spaces and pull-up spaces shall not be steeper than 1:48 in any direction. EXCEPTION: Where the surface is other than asphalt, concrete, or boards, slopes not steeper than 1:20 shall be permitted when necessary for drainage.	Site 30 - 2.8% in parking area	Correct surface of parking spaces to be firm and stable with slopes max of 2.08% or 5% for surfaces other than concrete, asphalt or boards as a smart practice.	2015 ABAAS Section: 1012.4, 1012.5, 1012.5 EXCEPTION

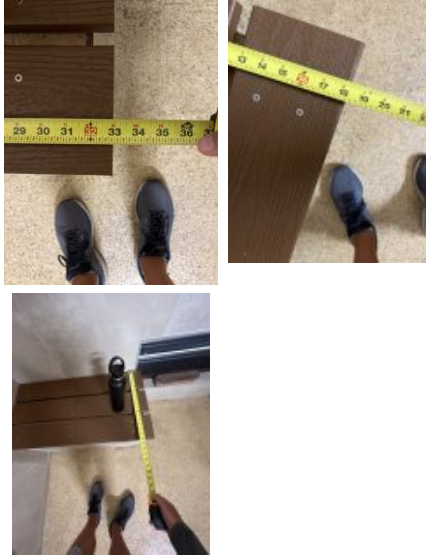
256	Full Hook-Up Campsites (RV loops): RV - Men's Restroom	[29.8210627 , -96.1110587]	The bench is not deep enough or long enough or is missing. Benches shall be provided having seats that are 42 inches long minimum and 20 inches deep minimum and 24 inches deep maximum. The bench shall provide for back support or shall be affixed to a wall. Back support shall be 42 inches (1065 mm) long minimum and shall extend from a point 2 inches (51 mm) maximum above the seat surface to a point 18 inches (455 mm) minimum above the seat surface. Back support shall be 2½ inches (64 mm) maximum from the rear edge of the seat measured horizontally. The top of the bench seat surface shall be 17 inches (430 mm) minimum and 19 inches (485 mm) maximum above the finish floor or ground. Clear floor or ground space complying with 305 shall be provided and shall be positioned at the end of the bench seat and parallel to the short axis of the bench	Bench 33" long, 18" deep	Replace bench in dressing area with one having a seat depth of 20" to 24" deep, 42" long, affixed to the wall or having a back and mounted 17" to 19" AFF and provide required clear floor space on the short axis of the bench.	2012 TAS Section: 903.4, 903.2, 903.3, 903.5 2010 ADAS Section: 903.4, 903.2, 903.3, 903.5

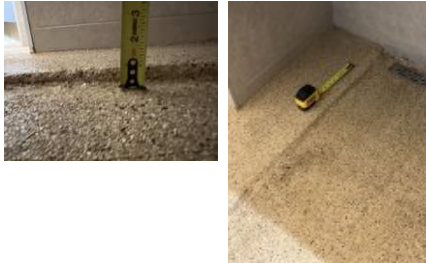
Finding Number	Area Description	Lat/Long	Finding	As Built	Recommendation	Citation	Photos	Figure
260	Full Hook-Up Campsites (RV loops): RV - Men's Restroom	[29.8210456 , -96.1110136]	There is a change in level greater than 1/4 inch. 1/4 inch is the maximum vertical rise. Changes in level between 1/4 inch and 1/2 inch must be beveled at 1:2 or less. Changes in level greater than 1/2 inch must be by way of a ramp.	1-1.5" CIL to drain	Repair, bevel or ramp CIL along accessible route (AR) to max .25".	2015 ABAAS Section: 303.3 2012 TAS Section: 303.3 2010 ADAS Section: 303.3

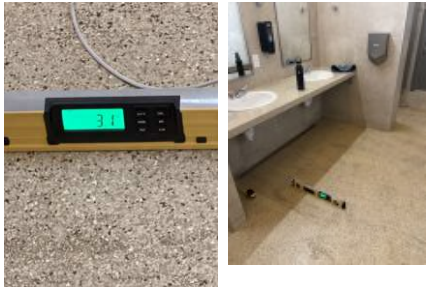
261	Full Hook-Up Campsites (RV loops): RV - Men's Restroom	[29.8210631 , -96.1110377]	The accessible route contains running slopes greater than 5 percent and cross slopes greater than 2 percent across the width of the walk and has not been constructed as a ramp (i.e. handrails, wheel guides, etc.). When the slope in the direction of travel of any walk exceeds 1 unit vertical in 20 units horizontal (5-percent slope), it must be constructed as ramp. Surface cross slopes must not exceed one unit vertical in 48 units. Horizontal (2-percent slope).	3.1% at sink	Correct or repair slope to max 2.08% in restroom.	2015 ABAAS Section: 403.3 2012 TAS Section: 403.3 2010 ADAS Section: 403.3

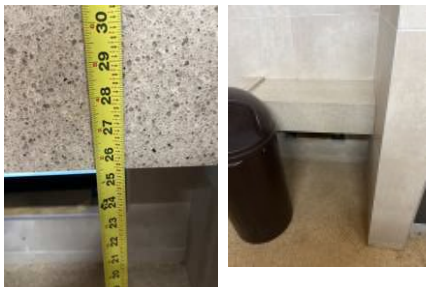
262	Full Hook-Up Campsites (RV loops): RV - Men's Restroom	[29.8210488 , -96.1110292]	The baby changing table is not provided with a forward approach. Baby changing tables must be provided with a forward approach. Knee and toe clearance shall be provided.	Changing station in men's lacks knee clearance, 25.5" AFF	Provide knee and toe clearance at changing table	2015 ABAAS Section: 902.2 2012 TAS Section: 902.2 2010 ADAS Section: 902.2

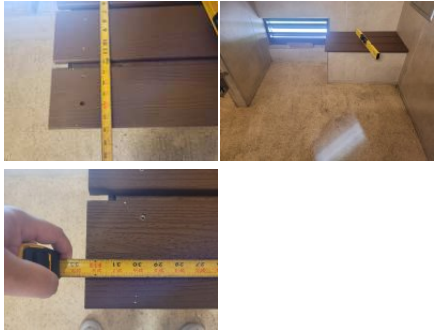
Finding Number	Area Description	Lat/Long	Finding	As Built	Recommendation	Citation	Photos	Figure
274	Full Hook-Up Campsites (RV loops): RV - Women's Restroom	[29.8210451 , -96.1110305]	The bench is not deep enough or long enough or is missing. Benches shall be provided having seats that are 42 inches long minimum and 20 inches deep minimum and 24 inches deep maximum. The bench shall provide for back support or shall be affixed to a wall. Back support shall be 42 inches (1065 mm) long minimum and shall extend from a point 2 inches (51 mm) maximum above the seat surface to a point 18 inches (455 mm) minimum above the seat surface. Back support shall be 2½ inches (64 mm) maximum from the rear edge of the seat measured horizontally. The top of the bench seat surface shall be 17 inches (430 mm) minimum and 19 inches (485 mm) maximum above the finish floor or ground. Clear floor or ground space complying with 305 shall be provided and shall be positioned at the end of the bench seat and parallel to the short axis of the bench	Bench 18" deep, 32" long	Replace bench in dressing area with one having a seat depth of 20" to 24" deep, 42" long, affixed to the wall or having a back and mounted 17" to 19" AFF and provide required clear floor space on the short axis of the bench.	2012 TAS Section: 903.4, 903.2, 903.3, 903.5 2010 ADAS Section: 903.4, 903.2, 903.3, 903.5

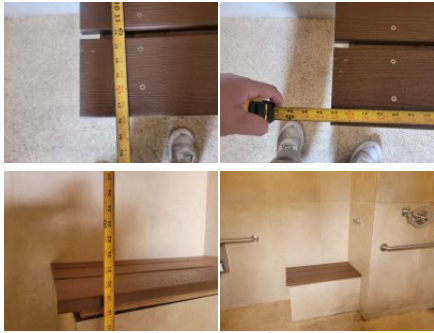
282	Full Hook-Up Campsites (RV loops): RV - Family Restrooms	[29.8210296 , -96.1110341]	The bench is not deep enough or long enough or is missing. Benches shall be provided having seats that are 42 inches long minimum and 20 inches deep minimum and 24 inches deep maximum. The bench shall provide for back support or shall be affixed to a wall. Back support shall be 42 inches (1065 mm) long minimum and shall extend from a point 2 inches (51 mm) maximum above the seat surface to a point 18 inches (455 mm) minimum above the seat surface. Back support shall be 2½ inches (64 mm) maximum from the rear edge of the seat measured horizontally. The top of the bench seat surface shall be 17 inches (430 mm) minimum and 19 inches (485 mm) maximum above the finish floor or ground. Clear floor or ground space complying with 305 shall be provided and shall be positioned at the end of the bench seat and parallel to the short axis of the bench	women's side family restroom- bench 18" deep, 33" long, 19.25" high	Replace bench in dressing area with one having a seat depth of 20" to 24" deep, 42" long, affixed to the wall or having a back and mounted 17" to 19" AFF and provide required clear floor space on the short axis of the bench.	2012 TAS Section: 903.4, 903.2, 903.3, 903.5 2010 ADAS Section: 903.4, 903.2, 903.3, 903.5

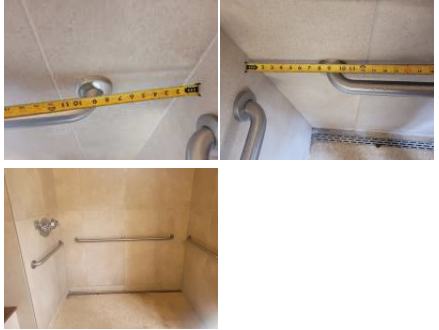
Finding Number	Area Description	Lat/Long	Finding	As Built	Recommendation	Citation	Photos	Figure
283	Full Hook-Up Campsites (RV loops): RV - Family Restrooms	[29.8210249 , -96.1110261]	Standard Roll-In Type Shower Compartments. Where a seat is provided in standard roll-in type shower compartments, grab bars shall be provided on the back wall and the side wall opposite the seat. Grab bars shall not be provided above the seat. Where a seat is not provided in standard roll-in type shower compartments, grab bars shall be provided on three walls. Grab bars shall be installed 6 inches (150 mm) maximum from adjacent walls. Alternate Roll-In Type Shower Compartments. In alternate roll-in type shower compartments, grab bars shall be provided on the back wall and the side wall farthest from the compartment entry. Grab bars shall not be provided above the seat. Grab bars shall be installed 6 inches (150 mm) maximum from adjacent walls. Grab bars shall be installed in a horizontal position, 33 inches (840 mm) minimum and 36 inches (915 mm) maximum above the finish floor measured to the top of the gripping surface, except that at water closets for children's use complying with 604.9, grab bars shall be installed in a horizontal position 18 inches (455 mm) minimum and 27 inches (685 mm) maximum above the finish floor measured to the top of the gripping surface.	women's side family restroom- rear wall bar 9" from each side wall	Remount grab bars to the correct location in the shower, mounted 33" to 36" AFF and max 6" from adjacent walls.	2015 ABAAS Section: 608.3.2, 608.3.3, 609.4 2012 TAS Section: 609.4, 608.3.2, 608.3.3 2010 ADAS Section: 609.4, 608.3.2, 608.3.3

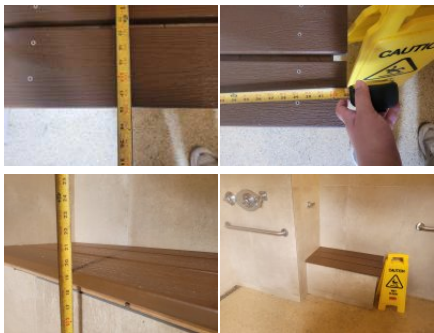
288	Full Hook-Up Campsites (RV loops): RV - Family Restrooms	[29.82104, -96.11102]	The bench is not deep enough or long enough or is missing. Benches shall be provided having seats that are 42 inches long minimum and 20 inches deep minimum and 24 inches deep maximum. The bench shall provide for back support or shall be affixed to a wall. Back support shall be 42 inches (1065 mm) long minimum and shall extend from a point 2 inches (51 mm) maximum above the seat surface to a point 18 inches (455 mm) minimum above the seat surface. Back support shall be 2½ inches (64 mm) maximum from the rear edge of the seat measured horizontally. The top of the bench seat surface shall be 17 inches (430 mm) minimum and 19 inches (485 mm) maximum above the finish floor or ground. Clear floor or ground space complying with 305 shall be provided and shall be positioned at the end of the bench seat and parallel to the short axis of the bench	men's side family restroom- bench 18" deep, 33" wide, 19.5" high	Replace bench in dressing area with one having a seat depth of 20" to 24" deep, 42" long, affixed to the wall or having a back and mounted 17" to 19" AFF and provide required clear floor space on the short axis of the bench.	2012 TAS Section: 903.4, 903.2, 903.3, 903.5 2010 ADAS Section: 903.4, 903.2, 903.3, 903.5

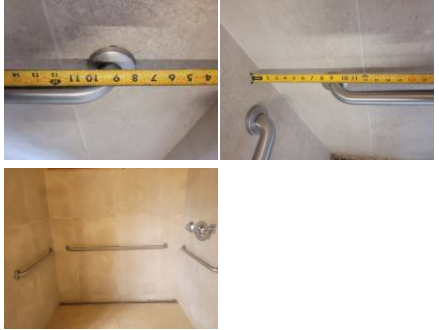
Finding Number	Area Description	Lat/Long	Finding	As Built	Recommendation	Citation	Photos	Figure
289	Full Hook-Up Campsites (RV loops): RV - Family Restrooms	[29.82104, -96.11102]	Standard Roll-In Type Shower Compartments. Where a seat is provided in standard roll-in type shower compartments, grab bars shall be provided on the back wall and the side wall opposite the seat. Grab bars shall not be provided above the seat. Where a seat is not provided in standard roll-in type shower compartments, grab bars shall be provided on three walls. Grab bars shall be installed 6 inches (150 mm) maximum from adjacent walls. Alternate Roll-In Type Shower Compartments. In alternate roll-in type shower compartments, grab bars shall be provided on the back wall and the side wall farthest from the compartment entry. Grab bars shall not be provided above the seat. Grab bars shall be installed 6 inches (150 mm) maximum from adjacent walls. Grab bars shall be installed in a horizontal position, 33 inches (840 mm) minimum and 36 inches (915 mm) maximum above the finish floor measured to the top of the gripping surface, except that at water closets for children's use complying with 604.9, grab bars shall be installed in a horizontal position 18 inches (455 mm) minimum and 27 inches (685 mm) maximum above the finish floor measured to the top of the gripping surface.	men's side family restroom- rear bar 9" from both sides	Remount grab bars to the correct location in the shower, mounted 33" to 36" AFF and max 6" from adjacent walls.	2015 ABAAS Section: 608.3.2, 608.3.3, 609.4 2012 TAS Section: 609.4, 608.3.2, 608.3.3 2010 ADAS Section: 609.4, 608.3.2, 608.3.3

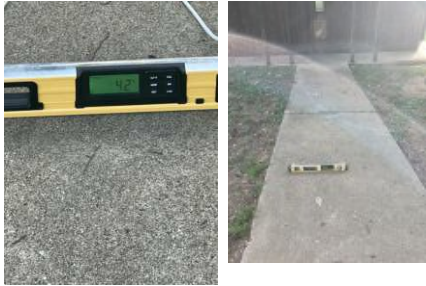
Finding Number	Area Description	Lat/Long	Finding	As Built	Recommendation	Citation	Photos	Figure
297	Group Dining Hall: Group Dining - Exterior Accessible Route	[29.8218896 , -96.1128201]	The accessible route of travel contains cross slopes greater than 2%. Cross slopes shall not exceed one unit vertical in 48 units horizontal (2-percent slope).	To restrooms - 4.2%	Correct or repair cross slope along AR to max 2.08%.	2015 ABAAS Section: 403.3 2012 TAS Section: 403.3 2010 ADAS Section: 403.3

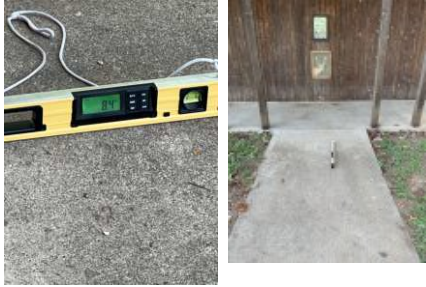
298	Group Dining Hall: Group Dining - Exterior Accessible Route	[29.8219016 , -96.1127807]	The running slope of walking surfaces shall not be steeper than 1:20.	To restrooms - 8.4%	Correct running slope along the AR to max 5%.	2015 ABAAS Section: 403.3 2012 TAS Section: 403.3 2010 ADAS Section: 403.3

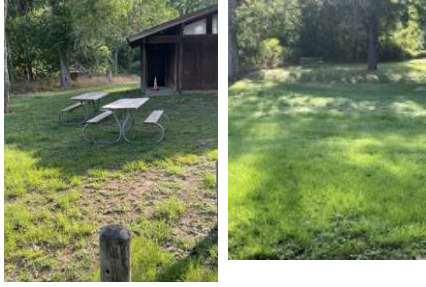
299	Group Dining Hall: Group Dining - Exterior Accessible Route	[29.8219388 , -96.1128973]	Picnic tables shall provide at least one wheelchair space for each 24 linear feet (7320 mm) of usable table surface perimeter. Wheelchair spaces shall be 30 inches (760 mm) minimum by 48 inches (1220 mm) minimum. Wheelchair spaces shall be positioned for a forward approach to the table and provide knee and toe clearance complying with 306 under the table	Lacks route to 3 picnic tables, none accessible	Replace picnic table with one of an accessible design as a smart practice.	2015 ABAAS Section: 1011.4.2

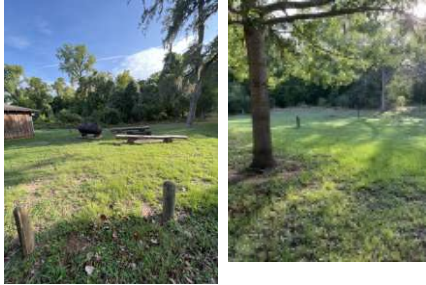
Finding Number	Area Description	Lat/Long	Finding	As Built	Recommendation	Citation	Photos	Figure
300	Group Dining Hall: Group Dining - Exterior Accessible Route	[29.8219458 , -96.1129456]	At least one accessible route shall connect accessible buildings, accessible facilities, accessible elements, and accessible spaces that are on the same site. For areas of sport activity, an accessible route is required to connect to the boundary of each area of sport activity. The size of an area of sport activity includes only the space needed to play. Where multiple sports fields or courts are provided, an accessible route is required to each field or area of sport activity.	Lacks route to grill, fire pit, benches, 2 water spout, 2 hooks	Provide an accessible route (AR) to each element within the site.	2010 ADAS Section: 206.2.2, 206.2

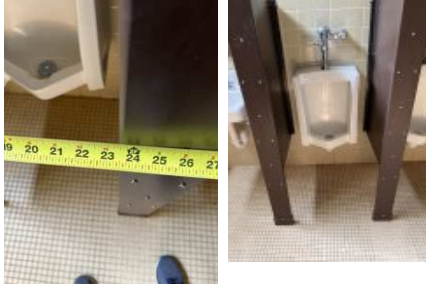
Finding Number	Area Description	Lat/Long	Finding	As Built	Recommendation	Citation	Photos	Figure
313	Group Dining Hall: Group Dining - Men's Restroom	[29.8219289 , -96.112741 2]	The urinal is located in an area that does not provide the required clear floor space for a front approach. The surrounding elements of a urinal must provide a minimum of 30 by 48 inches of clear floor space for a front approach.	23.5" with at urinal	Relocate privacy wall at urinal to provide 30" CFS.	2015 ABAAS Section: 605.2 2012 TAS Section: 605.2 2010 ADAS Section: 605.2

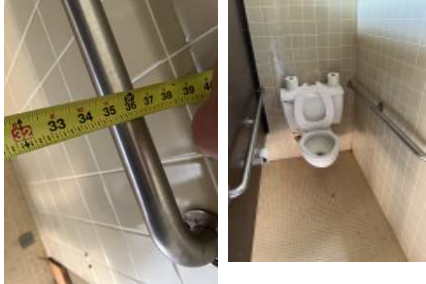
316	Group Dining Hall: Group Dining - Men's Restroom	[29.8219336 , -96.112738 5]	The ambulatory stall is not between 35" to 37" wide and 60" deep.	ambulatory stall 38.5" width	Correct ambulatory stall to be 35" to 37" wide and minimum 60" deep.	2015 ABAAS Section: 604.8.2.1 2012 TAS Section: 604.8.2.1 2010 ADAS Section: 604.8.2.1

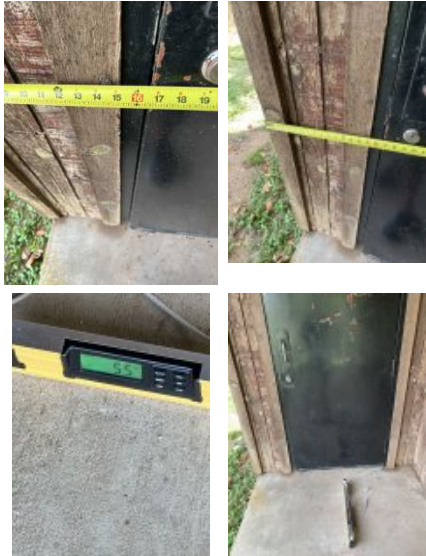
Finding Number	Area Description	Lat/Long	Finding	As Built	Recommendation	Citation	Photos	Figure
320	Group Dining Hall: Group Dining - Men's Restroom	[29.8219354 , -96.112735 1]	Minimum maneuvering clearances at doors and gates shall comply with 404.2.4. Maneuvering clearances shall extend the full width of the doorway and the required latch side or hinge side clearance. Maneuvering clearances shall have a max slope of 2.08%. Exterior doors are recommended to be maintained at 8.5 lbf as a smart practice. Force is to be measured at the operating hardware or 30 inches from the hinges, whichever is greater.	Men's - 16" clearance and 5.5% slope on pull, 15 lbf	For all doors along the public circulation route, provide required maneuvering clearance on push and pull side of doors. For all doors along the public circulation route, correct slope in door clearance to max 2.08%. For all doors along the public circulation route, inspect, adjust, and maintain 8.5 lbf to open exterior doors as a smart practice.	2010 ADAS Section: 404.2.3, 404.2.7, 404.2.4, 404.2.11, 404.2.11 Exception

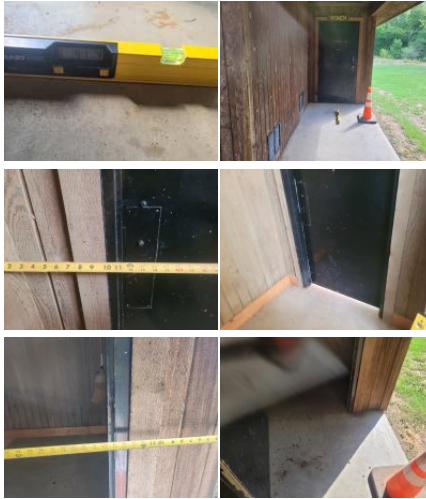
321	Group Dining Hall: Group Dining - Women's Restroom	[29.821897, -96.112750 6]	Minimum maneuvering clearances at doors and gates shall comply with 404.2.4. Maneuvering clearances shall extend the full width of the doorway and the required latch side or hinge side clearance. Maneuvering clearances shall have a max slope of 2.08%. The sweep period for doors with closers shall be adjusted so that from an open position of 70 degrees, the door will take at least 3 seconds to move to a point 3 inches from the latch, measured to the leading edge of the door. Exterior doors are recommended to be maintained at 8.5 lbf as a smart practice. Force is to be measured at the operating hardware or 30 inches from the hinges, whichever is greater.	Women's - 4.1% slope, 15 lbf, closes fast, wall 11.5" push side, 15" clearance pull side	For all doors along the public circulation route, provide required maneuvering clearance on push and pull side of doors. For all doors along the public circulation route, correct slope in door clearance to max 2.08%. For all doors along the public circulation route, inspect, adjust, and maintain closing speed on door closers. For all doors along the public circulation route, inspect, adjust, and maintain 8.5 lbf to open exterior doors as a smart practice.	2010 ADAS Section: 404.2.3, 404.2.7, 404.2.4, 404.2.11, 404.2.11 Exception

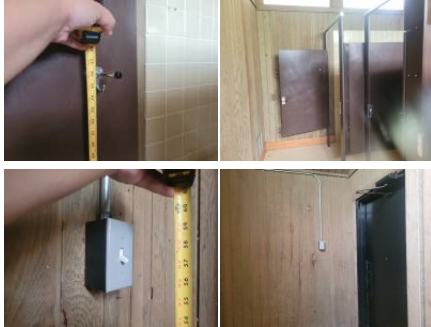
324	Group Dining Hall: Group Dining - Women's Restroom	[29.821913, -96.1127477]	The operable part is positioned too high for either a side or front approach. Where a clear floor or ground space allows a parallel approach to an element and the side reach is unobstructed, the high side reach shall be 48 inches maximum and the low side reach shall be 15 inches minimum above the finish floor or ground. Where a forward reach is unobstructed, the high forward reach shall be 48 inches maximum and the low forward reach shall be 15 inches minimum above the finish floor or ground.	Hook 55", light switch 57"	Remount operable parts to be in reach range of 15" min to 48" max	2015 ABAAS Section: 308.1 2012 TAS Section: 308.1 2010 ADAS Section: 308.1
