# Access Audit Site Report

**Abilene State Park**

**Accessibility Evaluation**

**Inspection Date: 12/14/2021**

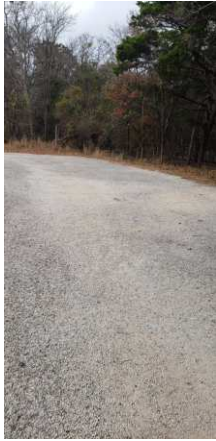
Finding Number	Area Description	Lat/Long	Finding	As Built	Recommendation	Citation	Photos	Figure
3	Exterior: Parking	[32.2378336 , -99.881790 9]	There are no accessible parking stalls. Each lot where parking is provided for the public as clients, guests or employees, shall provide accessible parking and shall be located on the shortest accessible route of travel from adjacent parking to an accessible entrance. There are a total of 8 parking stalls in the parking lot that could be reasonably associated with this facility. There should be a minimum of 1 accessible stalls with a minimum of 1 being designed as van accessible.	Elm Creek Nature Trail parking lacks required number of accessible stalls - approximately 8 standard, 0 accessible	Create one or more 8' accessible parking stalls, with one 5' adjacent access aisle, with proper signage and striping based on the total number of stalls.	2015 ABAAS Section: F208.2  2012 TAS Section: 208.2  2010 ADAS Section: 208.2

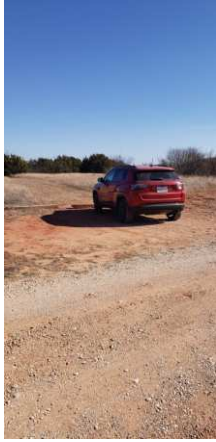
4	Exterior: Parking	[32.2323, -99.8951]	There are no accessible parking stalls. Each lot where parking is provided for the public as clients, guests or employees, shall provide accessible parking and shall be located on the shortest accessible route of travel from adjacent parking to an accessible entrance. There are a total of 3 parking stalls in the parking lot that could be reasonably associated with this facility. There should be a minimum of 1 accessible stalls with a minimum of 1 being designed as van accessible.	Boat Ramp restroom parking - approximately 3 standard, 0 accessible	Create one or more 8' accessible parking stalls, with one 5' adjacent access aisle, with proper signage and striping based on the total number of stalls.	2015 ABAAS Section: F208.2  2012 TAS Section: 208.2  2010 ADAS Section: 208.2

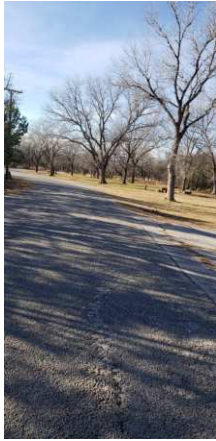
Finding Number	Area Description	Lat/Long	Finding	As Built	Recommendation	Citation	Photos	Figure
5	Exterior: Parking	[32.2367786 , -99.877456 4]	There are no accessible parking stalls. Each lot where parking is provided for the public as clients, guests or employees, shall provide accessible parking and shall be located on the shortest accessible route of travel from adjacent parking to an accessible entrance. There are a total of 35 parking stalls in the parking lot that could be reasonably associated with this facility. There should be a minimum of 2 accessible stalls with a minimum of 1 being designed as van accessible.	Picnic Area parking - approximately 35 standard, 0 accessible	Create one or more 8' accessible parking stalls, with one 5' adjacent access aisle, with proper signage and striping based on the total number of stalls	2015 ABAAS Section: F208.2  2012 TAS Section: 208.2  2010 ADAS Section: 208.2

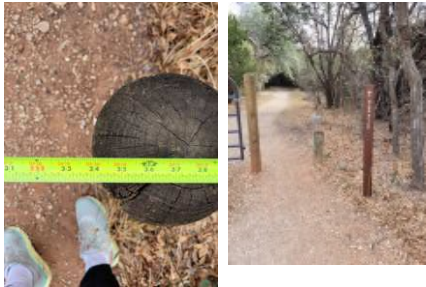
6	Exterior: Exterior Accessible Route	[32.2341798 , -99.879861 1]	The route of travel at this location does not provide the required minimum width. The minimum clear width for sidewalks and walks is 36 inches.	34" width at bird blind entry	Remove or relocate wooden bollard to widen EAR to min 36" clear width.	2015 ABAAS Section: 403.5.1  2012 TAS Section: 403.5.1  2010 ADAS Section: 403.5.1

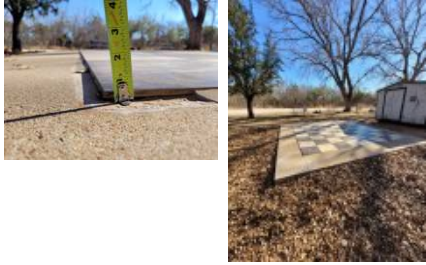
Finding Number	Area Description	Lat/Long	Finding	As Built	Recommendation	Citation	Photos	Figure
10	Exterior: Exterior Accessible Route	[32.2375863 , -99.8832514]	The walkway contains abrupt vertical edges and/or variations over a 1/4 inch. 1/4 inch is the maximum vertical rise. Changes in level between 1/4 inch and 1/2 inch must be beveled at 1:2 or less. Changes in level greater than 1/2 inch must be by way of a ramp.	.5" CIL around chess board	Repair, bevel or ramp change in level at perimeter of chess board and provide a route.	2012 TAS Section: 303.2, 303.3  2010 ADAS Section: 303.2, 303.3

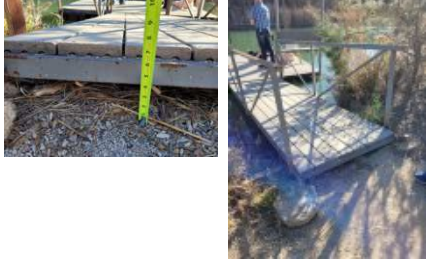
11	Exterior: Exterior Accessible Route	[32.2348865 , -99.8855943]	The walkway contains abrupt vertical edges and/or variations over a 1/4 inch. 1/4 inch is the maximum vertical rise. Changes in level between 1/4 inch and 1/2 inch must be beveled at 1:2 or less. Changes in level greater than 1/2 inch must be by way of a ramp.	7" CIL at fishing pier off Buffalo Wallow Trail	Ramp entry to pier.	2012 TAS Section: 303.2, 303.3  2010 ADAS Section: 303.2, 303.3

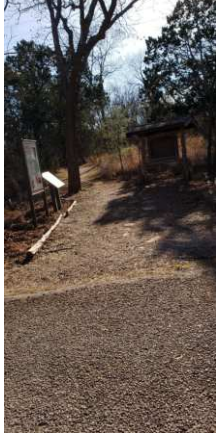
12	Exterior: Exterior Accessible Route	[32.2377984 , -99.8821145]	An accessible access route is not provided between elements, spaces and the facilities provided within the accessible camping unit. At least one outdoor recreation access route shall connect accessible elements, spaces and facilities provided within camping units with mobility features.	Elm Creek Trail lacks AR to trailhead sign	Create AR with crushed and compacted stone or similar outdoor material to trailhead signs.	2015 ABAAS Section: F244.5.1

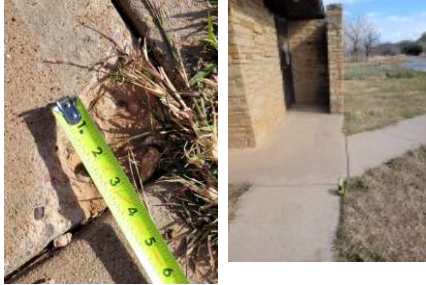
Finding Number	Area Description	Lat/Long	Finding	As Built	Recommendation	Citation	Photos	Figure
13	Exterior: Exterior Accessible Route	[32.2367253, -99.8777301]	There is a gap spaced greater than a 1/2 inch. Openings in floor or ground surfaces shall not allow passage of a sphere more than 1/2 inch diameter. Elongated openings shall be placed so that the long dimension is perpendicular to the dominant direction of travel.	4" gap at Star restroom, women's side	Correct or fill gaps to be max .5".	2015 ABAAS Section: 302.3 2012 TAS Section: 302.3 2010 ADAS Section: 302.3

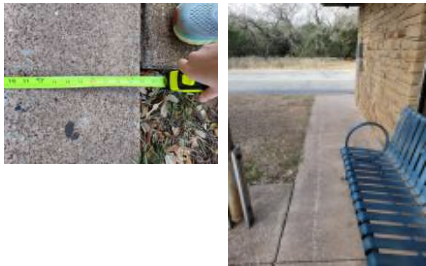
16	Headquarters : Parking and Exterior Accessible Route	[32.2406241 , -99.879089 9]	The route of travel at this location does not provide the required minimum width. The minimum clear width for sidewalks and walks is 36 inches.	Sidewalk at HQ reduces to 20" width at bench	Relocate bench at HQ to widen EAR to min 36" clear width.	2015 ABAAS Section: 403.5.1  2012 TAS Section: 403.5.1  2010 ADAS Section: 403.5.1

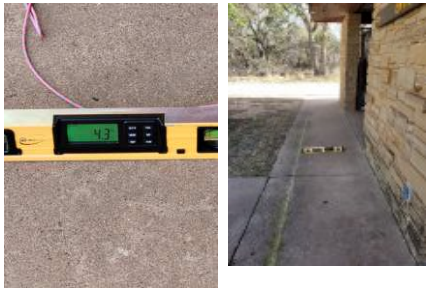
20	Headquarters : Parking and Exterior Accessible Route	[32.2405787 , -99.879157]	The accessible route contains cross slopes greater than 2%. Cross slopes shall not exceed one unit vertical in 48 units horizontal (2-percent slope).	4.3% cross slope around HQ	Correct or repair cross slope along AR to max 2.08%.	2015 ABAAS Section: 403.3  2012 TAS Section: 403.3  2010 ADAS Section: 403.3

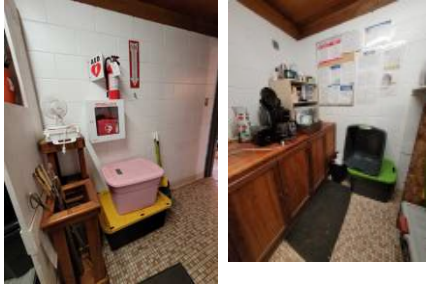
Finding Number	Area Description	Lat/Long	Finding	As Built	Recommendation	Citation	Photos	Figure
24	Headquarters : Employee Spaces	[32.240606, -99.879103 3]	The operable part is not accessible because there is not adequate clear floor space for either a forward or side approach. The clear floor or ground space shall be 30 inches minimum by 48 inches minimum.	Break Room - AED and microwave lacks CFS due to storage	Remove, or relocate storage in CFS at fixtures and operable parts along the AR.	2015 ABAAS Section: 305.3  2012 TAS Section: 305.3  2010 ADAS Section: 305.3

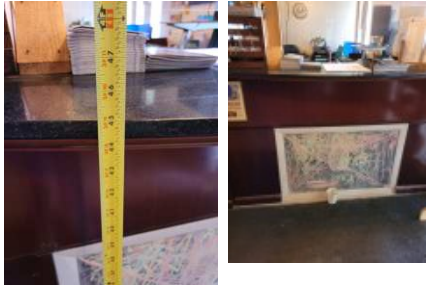
Finding Number	Area Description	Lat/Long	Finding	As Built	Recommendation	Citation	Photos	Figure
26	Headquarters : Public Spaces	[32.240615, -99.879049 7]	The transaction counter is too high. A portion of the counter surface that is 36 inches long minimum and 36 inches high maximum above the finish floor shall be provided. Knee and toe space must be provided for a forward approach. A 30 inch by 48 inch clear floor space on an accessible route must be provided for either a forward or parallel approach.	Service counter is 45" AFF	Lower 36" wide segment of service counter to max 36" AFF.	2015 ABAAS Section: 904.4.2, 904.4.1  2012 TAS Section: 904.4.1, 904.4.2  2010 ADAS Section: 904.4.2, 904.4.1

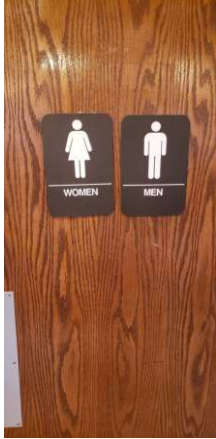
31	Headquarters : Headquarters Restroom	[32.240615, -99.879092 6]	The tactile restroom wall sign is missing the International Symbol of Accessibility (ISA). Accessible toilet rooms or bathing rooms shall be identified by the International Symbol of Accessibility (ISA). Wall signs identifying permanent rooms and spaces of a building shall have be horizontal format and the characters raised 1/32 inch minimum and shall be sans serif uppercase characters a minimum of 5/8 inch and a maximum of 2 inches high. Contracted Grade 2 Braille shall be in a horizontal format and shall be placed a minimum of 3/8 inch and a maximum of 1/2 inch directly below the tactile characters; flush left or centered. Signs with raised characters or Braille shall be located 48 inches minimum above the finish floor or ground surface, measured from the baseline of the lowest tactile character and 60 inches maximum above the finish floor or ground surface, measured from the baseline of the highest tactile character.	Signage lacks ISA	Acquire and mount signage, including Braille and access symbol mounted on wall, latch side of door, 48" to baseline of lowest character and 60" to baseline of highest character.	2015 ABAAS Section: F216.8  2012 TAS Section: 216.8  2010 ADAS Section: 216.8

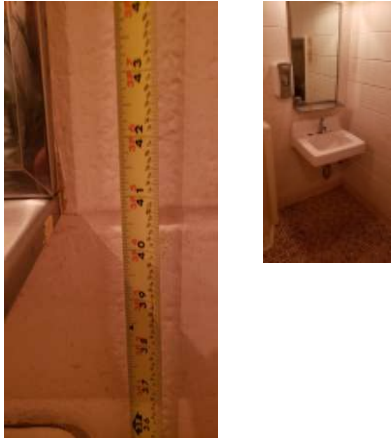
Finding Number	Area Description	Lat/Long	Finding	As Built	Recommendation	Citation	Photos	Figure
32	Headquarters : Headquarters Restroom	[32.2406377 , -99.879081 9]	The mirror is mounted too high. Mirrors must have the bottom edge of the reflecting surface a maximum of 40 inches above the floor if above a sink or counter. Mirrors not located above lavatories or countertops shall be installed with the bottom edge of the reflecting surface 35 inches maximum above the finish floor or ground.	Bottom edge at 41.5" AFF	Lower mirror so reflective surface is max 40" AFF.	2015 ABAAS Section: 603.3  2012 TAS Section: 603.3  2010 ADAS Section: 603.3

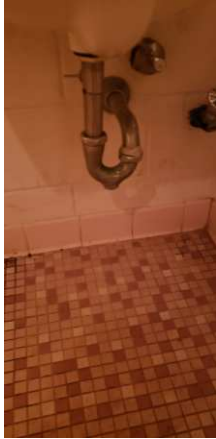
Finding Number	Area Description	Lat/Long	Finding	As Built	Recommendation	Citation	Photos	Figure
34	Headquarters : Headquarters Restroom	[32.2406513 , -99.879060 4]	The water and drain pipes under the lavatory are not adequately insulated. Water supply and drain pipes under lavatories and sinks shall be insulated or otherwise configured to protect against contact. There shall be no sharp or abrasive surfaces under lavatories and sinks.	Sink lacks insulated pipes	Insulate exposed pipes under one sink.	2015 ABAAS Section: 606.5  2012 TAS Section: 606.5  2010 ADAS Section: 606.5

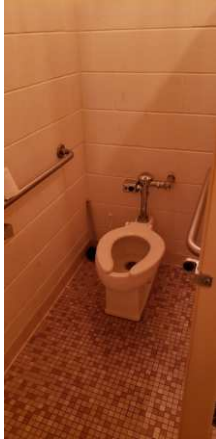
35	Headquarters : Headquarters Restroom	[32.2407058 , -99.879092 6]	There are not enough accessible toilet compartments. The room contains toilet compartments. A minimum of 1 must be wheelchair accessible .	Ambulatory stall only	Create a wheelchair accessible stall with grab bars and fixtures mounted in correct locations and at correct heights.	2015 ABAAS Section: F213.3.1  2012 TAS Section: 213.3.1  2010 ADAS Section: 213.3.1

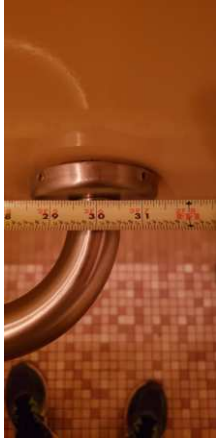
Finding Number	Area Description	Lat/Long	Finding	As Built	Recommendation	Citation	Photos	Figure
38	Headquarters : Headquarters Restroom	[32.2406445 , -99.879092 6]	Grab bars shall comply with 609. A side-wall grab bar complying with 604.5.1 shall be provided on both sides of the compartment. The space between the wall and the grab bar shall be 1½ inches (38 mm). The space between the grab bar and projecting objects below and at the ends shall be 1½ inches (38 mm) minimum. The space between the grab bar and projecting objects above shall be 12 inches (305 mm) minimum. Grab bars shall be installed in a horizontal position, 33 inches (840 mm) minimum and 36 inches (915 mm) maximum above the finish floor measured to the top of the gripping surface, except that at water closets for children's use complying with 604.9, grab bars shall be installed in a horizontal position 18 inches (455 mm) minimum and 27 inches (685 mm) max	Grab bars are 30" long	Replace side grab bars with a 42" long grab bar, mounted max 12" from the rear wall at the close end and min 54" on the far end and 33" to 36" AFF.	2015 ABAAS Section: 604.8.2.3, 609.3, 609.4  2012 TAS Section: 609.4, 609.3, 604.8.2.3  2010 ADAS Section: 609.3, 609.4, 604.8.2.3

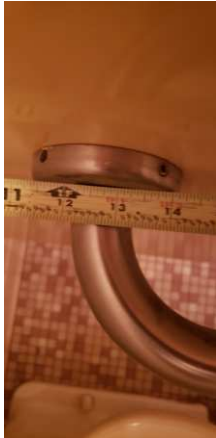
39	Headquarters : Headquarters Restroom	[32.2406309 , -99.879081 9]	The side grab bars are not in the correct location. Grab bars on the side wall must be installed so that the end closest to the rear wall is maximum 12" from the rear wall. The end furthest from the rear wall must be mounted minimum 54" from the rear wall.	Grab bars start 12.5" from rear wall and extend to 42.5" from rear wall	Replace side grab bar with a 42" long grab bar, mounted max 12" from the rear wall at the close end and min 54" on the far end, and 33" to 36" AFF. See previous finding for cost.	2015 ABAAS Section: 604.5.1  2012 TAS Section: 604.5.1  2010 ADAS Section: 604.5.1

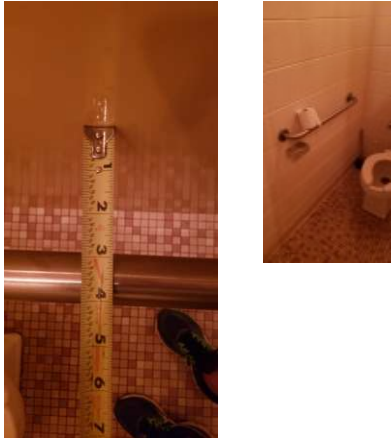
Finding Number	Area Description	Lat/Long	Finding	As Built	Recommendation	Citation	Photos	Figure
40	Headquarters : Headquarters Restroom	[32.2406275 , -99.879102]	The grab bar height and/or spacing fails. Grab bars must be mounted between 33" and 36" to the top of the gripping surface. There must be 1.5" of clearance between the grab bar and the wall. There must be a minimum of 1.5" of clearance below and minimum 12" above the grab bar to any dispenser or other obstruction.	Grab bars mounted 3" from wall, with toilet paper stored on bar	Replace grab bars per previous finding and assure gap between bar and wall in max 1.5" and obstructions min 12" above or 1.5" below grab bar.	2015 ABAAS Section: 609.3, 609.4  2012 TAS Section: 609.4, 609.3  2010 ADAS Section: 609.3, 609.4

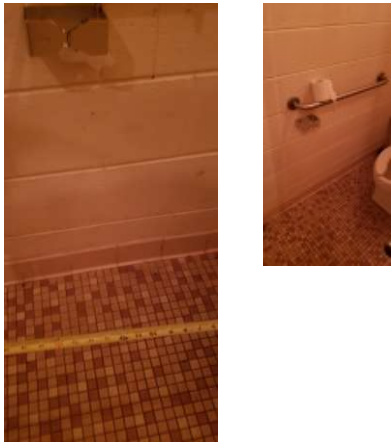
41	Headquarters : Headquarters Restroom	[32.2406513 , -99.879060 4]	The toilet paper is not installed within the compliant range in front of the toilet. Toilet paper dispensers shall be 7 inches minimum and 9 inches maximum in front of the water closet measured to the centerline of the dispenser. The outlet of the dispenser shall be 15 inches minimum and 48 inches maximum above the finish floor and shall not be located behind grab bars. Dispensers shall not be of a type that controls delivery or that does not allow continuous paper flow. There shall be a clearance of 1 1/2 inches minimum below the grab bar.	TP 14" from front of toilet	Remount toilet paper dispenser max 7" to 9" from front of toilet, 15" to 48" AFF and min 12" above or 1.5" below grab bar.	2015 ABAAS Section: 604.7  2012 TAS Section: 604.7  2010 ADAS Section: 604.7

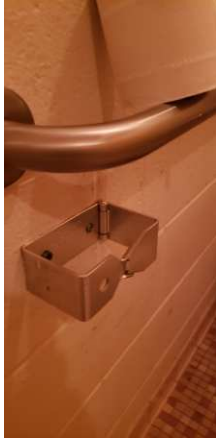
Finding Number	Area Description	Lat/Long	Finding	As Built	Recommendation	Citation	Photos	Figure
42	Headquarters : Headquarters Restroom	[32.2406343 , -99.879072 5]	The toilet paper dispenser does not allow a continuous flow. Toilet paper dispensers shall be 7 inches minimum and 9 inches maximum in front of the water closet measured to the centerline of the dispenser. The outlet of the dispenser shall be 15 inches minimum and 48 inches maximum above the finish floor and shall not be located behind grab bars. Dispensers shall not be of a type that controls delivery or that does not allow continuous paper flow. There shall be a clearance of 1 1/2 inches minimum below the grab bar.	Unable to test, but this style typically does not turn with type of paper used	Replace toilet paper dispenser with one that provides continuous flow of paper.	2015 ABAAS Section: 604.7  2012 TAS Section: 604.7  2010 ADAS Section: 604.7

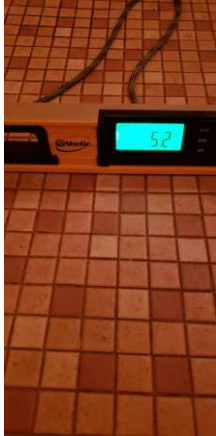
43	Headquarters : Headquarters Restroom	[32.2406264 , -99.879080 5]	The accessible route contains running slopes greater than 5 percent and cross slopes greater than 2 percent across the width of the walk and has not been constructed as a ramp (i.e. handrails, wheel guides, etc.). When the slope in the direction of travel of any walk exceeds 1 unit vertical in 20 units horizontal (5-percent slope), it must be constructed as ramp. Surface cross slopes must not exceed one unit vertical in 48 units. Horizontal (2-percent slope).	5.2% cross slope	Correct or repair slope to max 2.08% in restroom.	2015 ABAAS Section: 403.3  2012 TAS Section: 403.3  2010 ADAS Section: 403.3

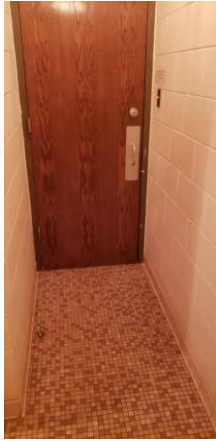
Finding Number	Area Description	Lat/Long	Finding	As Built	Recommendation	Citation	Photos	Figure
44	Headquarters : Headquarters Restroom	[32.240615, -99.879092 6]	Minimum maneuvering clearances at doors and gates shall comply with 404.2.4. Maneuvering clearances shall extend the full width of the doorway and the required latch side or hinge side clearance. All interior doors must be maintained so that the operating pressure does not exceed 5 lb. force to open. The sweep period for doors with closers shall be adjusted so that from an open position of 70 degrees, the door will take at least 3 seconds to move to a point 3 inches from the latch, measured to the leading edge of the door.	Door - wall in pull side clearance, more than 5# push, fast close	For all doors along the public circulation route, provide required maneuvering clearance on push and pull side of doors. For all doors along the public circulation route, inspect, adjust, and maintain 5 lbf to open interior doors. For all doors along the public circulation route, inspect, adjust, and maintain closing speed on door closers.	2010 ADAS Section: 404.2.3, 404.2.7, 404.2.4, 404.2.11, 404.2.11 Exception

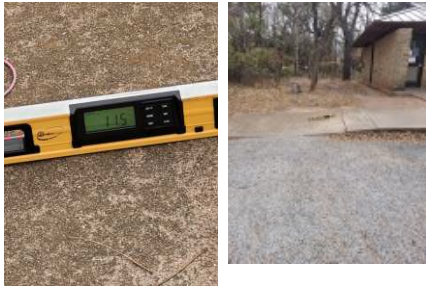
47	Pecan Grove: Parking and Exterior Accessible Route	[32.2331588, -99.884879 5]	The running slope of walking surfaces shall not be steeper than 1:20.	11.5% slope at entry to Pecan Grove restroom building	Correct running slope along the AR to max 5%.	2015 ABAAS Section: 403.3 2012 TAS Section: 403.3 2010 ADAS Section: 403.3

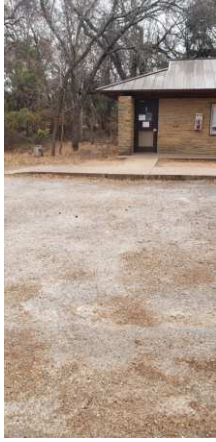
Finding Number	Area Description	Lat/Long	Finding	As Built	Recommendation	Citation	Photos	Figure
48	Pecan Grove: Parking and Exterior Accessible Route	[32.2331872, -99.8848942]	There are no accessible parking stalls. Each lot where parking is provided for the public as clients, guests or employees, shall provide accessible parking and shall be located on the shortest accessible route of travel from adjacent parking to an accessible entrance. There are a total of 5 parking stalls in the parking lot that could be reasonably associated with this facility. There should be a minimum of 1 accessible stalls with a minimum of 1 being designed as van accessible.	Pecan Grove restroom parking - approximately 5 stalls, 0 accessible	Create one or more 8' accessible parking stalls, with one 5' adjacent access aisle, with proper signage and striping based on the total number of stalls.	2015 ABAAS Section: F208.2  2012 TAS Section: 208.2  2010 ADAS Section: 208.2

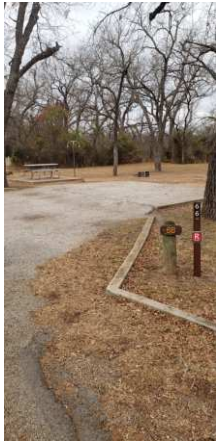
49	Pecan Grove: Camping	[32.23307, -99.88515]	Camping facilities shall provide camping units with mobility features complying with F244.2 in accordance with Table F244.2. Where a camping facility provides different types of camping units, Table F244.2 shall apply to each type of camping unit provided. Total Number of Camping Units Provided in Camping Facility Minimum Number of Camping Units with Mobility Features Required 1 1 2 to 25 2 26 to 50 3 51 to 75 4 76 to 100 5 101 to 150 7 151 to 200 8 201 and over 8, plus 2 percent of the number over 200	Pecan Grove Campsite Area (40 total electric sites) lacks accessible campsites - Campsite 66 is representative and has no accessible features - lacks AR to picnic table, firepit, and cooking surface	Create the required number of accessible camp sites per table F244.2 as a smart practice.	2015 ABAAS Section: F244.2

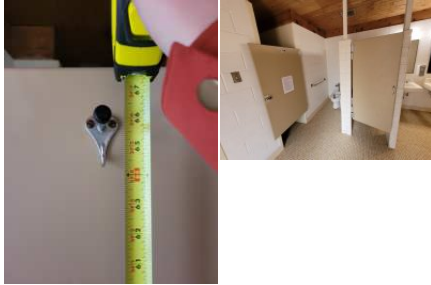
Finding Number	Area Description	Lat/Long	Finding	As Built	Recommendation	Citation	Photos	Figure
53	Pecan Grove: Pecan Grove - Women's Restroom	[32.2331418 , -99.884875 5]	The operable part is positioned too high for either a side or front approach. Where a clear floor or ground space allows a parallel approach to an element and the side reach is unobstructed, the high side reach shall be 48 inches maximum and the low side reach shall be 15 inches minimum above the finish floor or ground. Where a forward reach is unobstructed, the high forward reach shall be 48 inches maximum and the low forward reach shall be 15 inches minimum above the finish floor or ground.	Women's - Hook in stall at 61" AFF	Remount operable parts to be in reach range of 15" min to 48" max.	2015 ABAAS Section: 308.1  2012 TAS Section: 308.1  2010 ADAS Section: 308.1

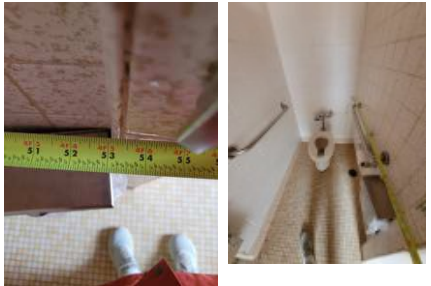
55	Pecan Grove: Pecan Grove - Women's Restroom	[32.2331282 , -99.884859 4]	The ambulatory stall is not between 35" to 37" wide and 60" deep.	Women's - 37" by 53"	Correct ambulatory stall to be 35" to 37" wide and minimum 60" deep. In the alternative, use existing ambulatory stall to create required wheelchair accessible stall.	2015 ABAAS Section: 604.8.2.1  2012 TAS Section: 604.8.2.1  2010 ADAS Section: 604.8.2.1

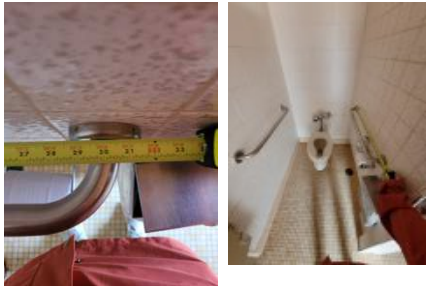
57	Pecan Grove: Pecan Grove - Women's Restroom	[32.2331327 , -99.884891 6]	Grab bars shall comply with 609. A side-wall grab bar complying with 604.5.1 shall be provided on both sides of the compartment. The space between the wall and the grab bar shall be 1½ inches (38 mm). The space between the grab bar and projecting objects below and at the ends shall be 1½ inches (38 mm) minimum. The space between the grab bar and projecting objects above shall be 12 inches (305 mm) minimum. Grab bars shall be installed in a horizontal position, 33 inches (840 mm) minimum and 36 inches (915 mm) maximum above the finish floor measured to the top of the gripping surface, except that at water closets for children's use complying with 604.9, grab bars shall be installed in a horizontal position 18 inches (455 mm) minimum and 27 inches (685 mm) max.	Women's - Both bars are 30" long	Replace side grab bars with a 42" long grab bar, mounted max 12" from the rear wall at the close end and min 54" on the far end and 33" to 36" AFF.	2015 ABAAS Section: 604.8.2.3, 609.3, 609.4  2012 TAS Section: 609.4, 609.3, 604.8.2.3  2010 ADAS Section: 609.3, 609.4, 604.8.2.3

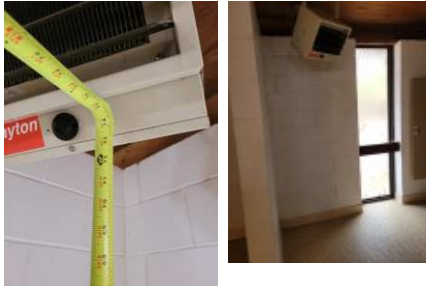
61	Pecan Grove: Pecan Grove - Women's Restroom	[32.235819, -99.880498 1]	The heater extends down too close to the route of travel. Any obstruction that overhangs a route of travel must be a minimum of 80 inches above the walking surface as measured from the bottom of the obstruction.	Women's - Heater at 73" AFF	Raise heater to min 80", or pad object to prevent hazard in overhead clearance along AR.	2015 ABAAS Section: 307.4  2012 TAS Section: 307.4  2010 ADAS Section: 307.4

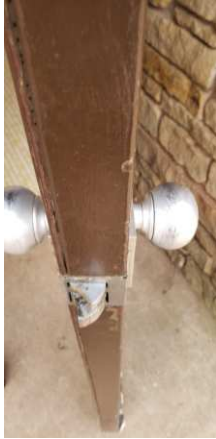
Finding Number	Area Description	Lat/Long	Finding	As Built	Recommendation	Citation	Photos	Figure
65	Pecan Grove: Pecan Grove - Men's Restroom	[32.2331191 , -99.884854]	The sweep period for doors with closers shall be adjusted so that from an open position of 70 degrees, the door will take at least 3 seconds to move to a point 3 inches from the latch, measured to the leading edge of the door. Exterior doors are recommended to be maintained at 8.5 lbf as a smart practice. Force is to be measured at the operating hardware or 30 inches from the hinges, whichever is greater. Hand-activated door opening hardware, handles, pulls, latches, locks, and other operating devices on accessible doors shall have a shape that is easy to grasp with one hand and does not require tight grasping, tight pinching or twisting of the wrist to operate. Hardware shall be 34 inches minimum and 48 inches maximum above the finish floor or ground.	Restroom door - knobs on both sides, 20# push, fast close	For all doors along the public circulation route, inspect, adjust, and maintain closing speed on door closers. For all doors along the public circulation route, inspect, adjust, and maintain 8.5 lbf to open exterior doors as a smart practice. For all doors along the public circulation route, replace hardware with lever hardware or hardware operable without a tight pinch or grasp.	2010 ADAS Section: 404.2.3, 404.2.7, 404.2.4, 404.2.11, 404.2.11 Exception

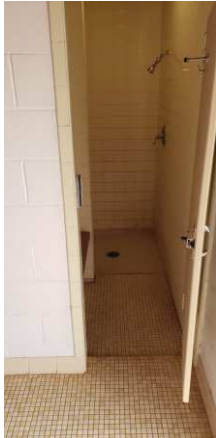
66	Pecan Grove: Pecan Grove - Men's Restroom	[32.2331214 , -99.884846]	There are no accessible bathing or shower facilities. Where facilities for bathing are provided for the public, clients or employees, including showers or bathtubs, at least one shower or bathtub and support facilities such as lockers, and not less than 1 percent of all facilities, shall be accessible.	Lacks accessible shower facilities	Create an accessible shower in locker/bathing room.	2015 ABAAS Section: F213.3.6  2012 TAS Section: 213.3.6  2010 ADAS Section: 213.3.6

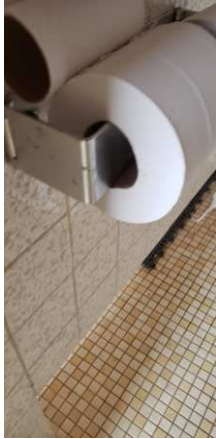
Finding Number	Area Description	Lat/Long	Finding	As Built	Recommendation	Citation	Photos	Figure
69	Pecan Grove: Pecan Grove - Men's Restroom	[32.2331191 , -99.884859 4]	The toilet paper dispenser does not allow a continuous flow. Toilet paper dispensers shall be 7 inches minimum and 9 inches maximum in front of the water closet measured to the centerline of the dispenser. The outlet of the dispenser shall be 15 inches minimum and 48 inches maximum above the finish floor and shall not be located behind grab bars. Dispensers shall not be of a type that controls delivery or that does not allow continuous paper flow. There shall be a clearance of 1 1/2 inches minimum below the grab bar.	TP dispenser does not allow continuous flow	Replace toilet paper dispenser with one that provides continuous flow of paper.	2015 ABAAS Section: 604.7  2012 TAS Section: 604.7  2010 ADAS Section: 604.7

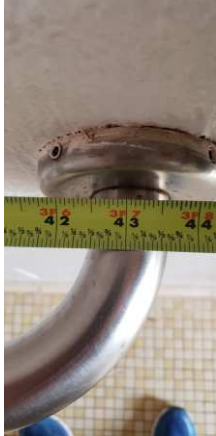
70	Pecan Grove: Pecan Grove - Men's Restroom	[32.2331599 , -99.884870 1]	The side grab bars are not in the correct location. Grab bars on the side wall must be installed so that the end closest to the rear wall is maximum 12" from the rear wall. The end furthest from the rear wall must be mounted minimum 54" from the rear wall.	Bars end 43" from rear wall	Remount side grab bar to max 12" from the rear wall at the close end and min 54" on the far end, and 33" to 36" AFF. See previous finding for cost.	2015 ABAAS Section: 604.5.1  2012 TAS Section: 604.5.1  2010 ADAS Section: 604.5.1

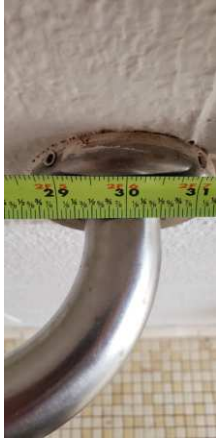
Finding Number	Area Description	Lat/Long	Finding	As Built	Recommendation	Citation	Photos	Figure
71	Pecan Grove: Pecan Grove - Men's Restroom	[32.2331032 , -99.884819 1]	Grab bars shall comply with 609. A side-wall grab bar complying with 604.5.1 shall be provided on both sides of the compartment. The space between the wall and the grab bar shall be 1½ inches (38 mm). The space between the grab bar and projecting objects below and at the ends shall be 1½ inches (38 mm) minimum. The space between the grab bar and projecting objects above shall be 12 inches (305 mm) minimum. Grab bars shall be installed in a horizontal position, 33 inches (840 mm) minimum and 36 inches (915 mm) maximum above the finish floor measured to the top of the gripping surface, except that at water closets for children's use complying with 604.9, grab bars shall be installed in a horizontal position 18 inches (455 mm) minimum and 27 inches (685 mm) max	Grab bars 30" long	Replace or add side grab bars with a 42" long grab bar, mounted max 12" from the rear wall at the close end and min 54" on the far end and 33" to 36" AFF.	2015 ABAAS Section: 604.8.2.3, 609.3, 609.4  2012 TAS Section: 609.4, 609.3, 604.8.2.3  2010 ADAS Section: 609.3, 609.4, 604.8.2.3

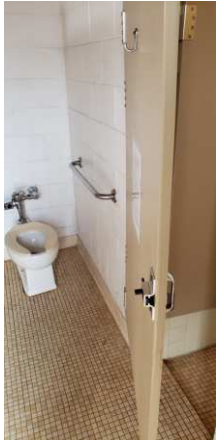
72	Pecan Grove: Pecan Grove - Men's Restroom	[32.2331191 , -99.884832 5]	The stall door fails to comply with all of the door requirements. The stall door must be a minimum of 32" wide and have compliant hardware on both sides. The stall door must be self-closing.	Lacks self-closing door	Adjust stall door to be self-closing.	2015 ABAAS Section: 404.2.3, 404.2.7, 604.8.2.2  2012 TAS Section: 404.2.3, 404.2.7, 604.8.2.2  2010 ADAS Section: 404.2.3, 404.2.7, 604.8.2.2

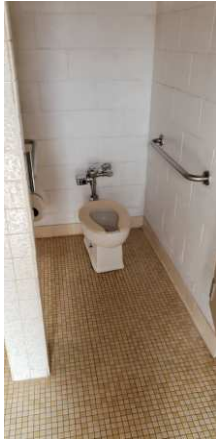
Finding Number	Area Description	Lat/Long	Finding	As Built	Recommendation	Citation	Photos	Figure
75	Pecan Grove: Pecan Grove - Men's Restroom	[32.2331077 , -99.884862]	There are not enough accessible toilet compartments. The room contains several toilet compartments. A minimum of 1 must be wheelchair accessible .	Ambulatory stall only	Create a wheelchair accessible stall with grab bars and fixtures mounted in correct locations and at correct heights.	2015 ABAAS Section: F213.3.1  2012 TAS Section: 213.3.1  2010 ADAS Section: 213.3.1

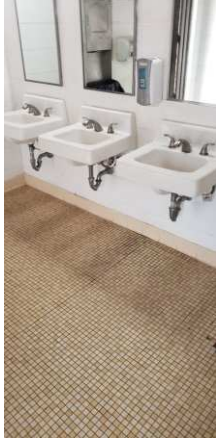
76	Pecan Grove: Pecan Grove - Men's Restroom	[32.2331781 , -99.884886 2]	The water and drain pipes under the lavatory are not adequately insulated. Water supply and drain pipes under lavatories and sinks shall be insulated or otherwise configured to protect against contact. There shall be no sharp or abrasive surfaces under lavatories and sinks.	Sinks lack insulated pipes	Insulate exposed pipes under one sink.	2015 ABAAS Section: 606.5  2012 TAS Section: 606.5  2010 ADAS Section: 606.5

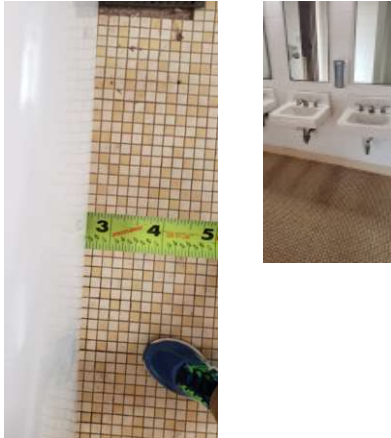
Finding Number	Area Description	Lat/Long	Finding	As Built	Recommendation	Citation	Photos	Figure
77	Pecan Grove: Pecan Grove - Men's Restroom	[32.233118, -99.884829 9]	Knee clearance at 27 inches off the floor is not 8 inches minimum deep. The knee clearance, measured from the bottom of the apron or the outside bottom edge of the lavatory, must be 27 inches at a point located 8 inches back from the front edge and continuing to 11 inches minimum in depth at 9 inches above the floor. The top of the lavatory rim may be no higher than 34 inches.	Sink lacks knee clearance - 2.5" deep at 27"	Replace sink with one providing 27" knee clearance that is a min 8" deep.	2015 ABAAS Section: 306.3.1, 306.3.2, 306.3.3, 306.3.4 , 306.3.5  2012 TAS Section: 306.3.2, 306.3.3, 306.3.4, 306.3.5, 306.3.1  2010 ADAS Section: 306.3.3, 306.3.2, 306.3.4, 306.3.5, 306.3.1

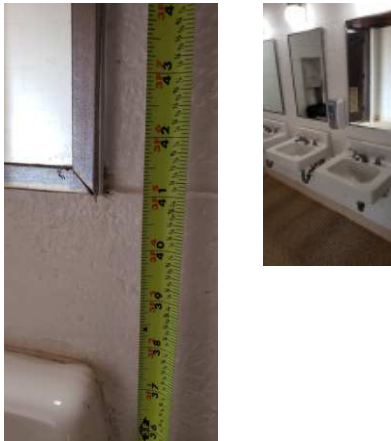
78	Pecan Grove: Pecan Grove - Men's Restroom	[32.2331418 , -99.884870 1]	The mirror is mounted too high. Mirrors must have the bottom edge of the reflecting surface a maximum of 40 inches above the floor if above a sink or counter. Mirrors not located above lavatories or countertops shall be installed with the bottom edge of the reflecting surface 35 inches maximum above the finish floor or ground.	Men's - Bottom edge at 41.5" AFF	Lower mirror so reflective surface is max 40" AFF.	2015 ABAAS Section: 603.3  2012 TAS Section: 603.3  2010 ADAS Section: 603.3

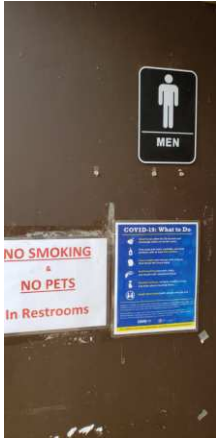
Finding Number	Area Description	Lat/Long	Finding	As Built	Recommendation	Citation	Photos	Figure
79	Pecan Grove: Pecan Grove - Men's Restroom	[32.23311, -99.884896 9]	The tactile restroom wall sign is missing the International Symbol of Accessibility (ISA). Accessible toilet rooms or bathing rooms shall be identified by the International Symbol of Accessibility (ISA). Wall signs identifying permanent rooms and spaces of a building shall have be horizontal format and the characters raised 1/32 inch minimum and shall be sans serif uppercase characters a minimum of 5/8 inch and a maximum of 2 inches high. Contracted Grade 2 Braille shall be in a horizontal format and shall be placed a minimum of 3/8 inch and a maximum of 1/2 inch directly below the tactile characters; flush left or centered. Signs with raised characters or Braille shall be located 48 inches minimum above the finish floor or ground surface, measured from the baseline of the lowest tactile character and 60 inches maximum above the finish floor or ground surface, measured from the baseline of the highest tactile character.	signage lacks ISA	Acquire and mount signage, including access symbol.	2015 ABAAS Section: F216.8  2012 TAS Section: 216.8  2010 ADAS Section: 216.8

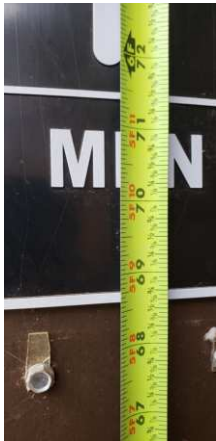
80	Pecan Grove: Pecan Grove - Men's Restroom	[32.2331372 , -99.884896 9]	The restroom sign does not comply with one or more applicable requirements for the location, height, and properties of the sign.	Men's - mounted 70" AFF	Remount signage on wall, latch side of the door, 48" to baseline of lowest character and 60" to baseline of highest character.	2015 ABAAS Section: F216.2, 703.1, 703.2, 703.5, 703.6  2012 TAS Section: 216.2, 703.1, 703.2, 703.5, 703.6  2010 ADAS Section: 216.2, 703.1, 703.2, 703.5, 703.6

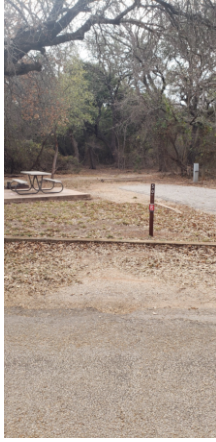
Finding Number	Area Description	Lat/Long	Finding	As Built	Recommendation	Citation	Photos	Figure
81	Brushy Trail: Camping	[32.2339722, -99.881453]	Camping facilities shall provide camping units with mobility features complying with F244.2 in accordance with Table F244.2. Where a camping facility provides different types of camping units, Table F244.2 shall apply to each type of camping unit provided. Total Number of Camping Units Provided in Camping Facility Minimum Number of Camping Units with Mobility Features Required 1 1 2 to 25 2 26 to 50 3 51 to 75 4 76 to 100 5 101 to 150 7 151 to 200 8 201 and over 8, plus 2 percent of the number over 200	Brushy Trail Campsite Area (19 total RV sites) lacks accessible campsites - Campsite 50 is representative and has no accessible features - lacks AR to accessible picnic table, firepit, and cooking surface	Create the required number of accessible camp sites per table F244.2 as a smart practice.	2015 ABAAS Section: F244.2

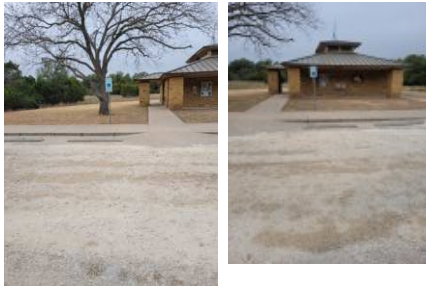
84	Oak Grove: Parking and Exterior Accessible Route	[32.235777, -99.8803439]	The accessible parking stall is not wide enough. Each parking space must be at least 8' feet wide and shall be marked to define the width. The measurements of parking spaces and access aisles shall be made from the centerline of the markings. Where the parking space is not adjacent to another parking space or access aisle, the measurement shall be permitted to include the full width of the line defining the parking space.	Shelter Restroom - lacks compliant parking surface, lacks striping - unable to test width	Create one or more 8' accessible parking stalls, with one 8' adjacent access aisle, with proper signage and striping on a firm and stable surface.	2015 ABAAS Section: 502.2 2012 TAS Section: 502.2 2010 ADAS Section: 502.2

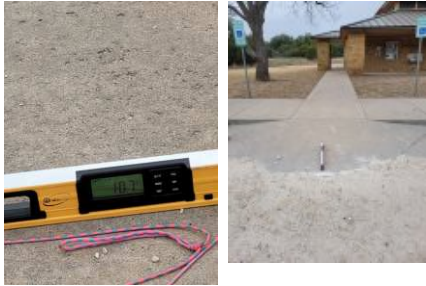
Finding Number	Area Description	Lat/Long	Finding	As Built	Recommendation	Citation	Photos	Figure
86	Oak Grove: Parking and Exterior Accessible Route	[32.2358099 , -99.880382 8]	The curb ramp slope exceeds the maximum running slope (Parallel to the direction of travel) allowable of 8.33%. Curb ramps should have the least possible slope but in no case more than 8.3% (1:12).	10.7% running slope on curb ramp at shelter restroom	Correct curb ramp running slope to max 8.33%.	2015 ABAAS Section: 406.1  2012 TAS Section: 406.1  2010 ADAS Section: 406.1

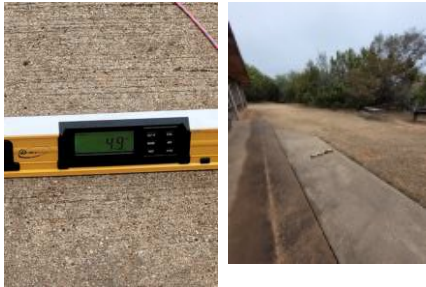
88	Oak Grove: Parking and Exterior Accessible Route	[32.2367809 , -99.881411 4]	The accessible route of travel on the accessible route contains cross slopes greater than 2%. Cross slopes shall not exceed one unit vertical in 48 units horizontal (2-percent slope).	4.9% slope on backside of group hall by yurts	Correct or repair cross slope along AR to max 2.08%.	2015 ABAAS Section: 403.3  2012 TAS Section: 403.3  2010 ADAS Section: 403.3

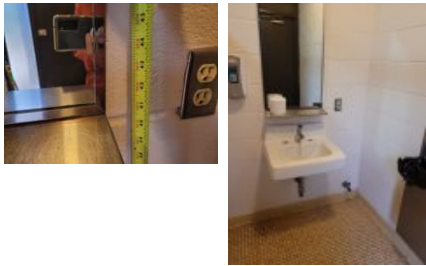
94	Oak Grove: Group Hall by Yurts - Women's Restroom	[32.2366947, -99.88141]	The mirror is mounted too high. Mirrors must have the bottom edge of the reflecting surface a maximum of 40 inches above the floor if above a sink or counter. Mirrors not located above lavatories or countertops shall be installed with the bottom edge of the reflecting surface 35 inches maximum above the finish floor or ground.	Bottom edge at 41" AFF	Lower mirror so reflective surface is max 40" AFF.	2015 ABAAS Section: 603.3 2012 TAS Section: 603.3 2010 ADAS Section: 603.3

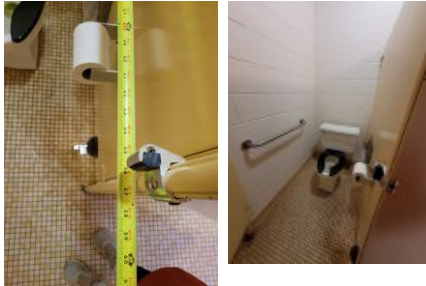
97	Oak Grove: Group Hall by Yurts - Women's Restroom	[32.2367083 , -99.881426 1]	The ambulatory stall is not between 35" to 37" wide and 60" deep.	Ambulatory stall is 37" by 56"	Correct ambulatory stall to be 35" to 37" wide and minimum 60" deep. In the alternative, use existing ambulatory stall to create required wheelchair accessible stall.	2015 ABAAS Section: 604.8.2.1 2012 TAS Section: 604.8.2.1 2010 ADAS Section: 604.8.2.1

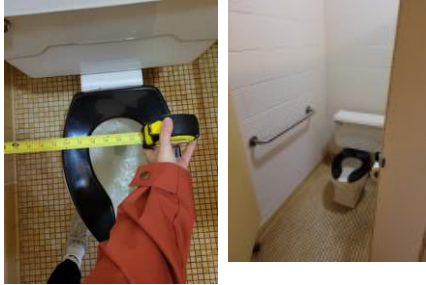
Finding Number	Area Description	Lat/Long	Finding	As Built	Recommendation	Citation	Photos	Figure
98	Oak Grove: Group Hall by Yurts - Women's Restroom	[32.2367083 , -99.881442 2]	The toilet is not located within the range to the side wall or partition. The centerline of the toilet shall be 17 inches minimum and 19 inches maximum side wall or partition in the ambulatory accessible toilet compartment.	20" centerline from grab bar wall	Remount toilet to 17" to 19" from the side wall to center line in ambulatory stalls, or 16" to 18" in new wheelchair stall.	2015 ABAAS Section: 604.9.1 2012 TAS Section: 604.9.1 2010 ADAS Section: 604.9.1

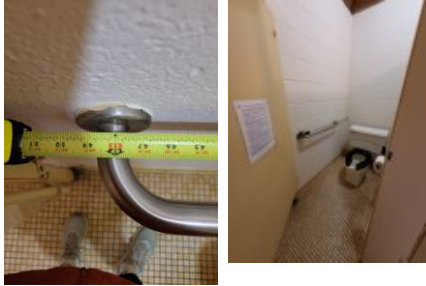
101	Oak Grove: Group Hall by Yurts - Women's Restroom	[32.2367446 , -99.877735 4]	The side grab bars are not in the correct location. Grab bars on the side wall must be installed so that the end closest to the rear wall is maximum 12" from the rear wall. The end furthest from the rear wall must be mounted minimum 54" from the rear wall.	Grab bar ends 48" from rear wall	Remount side grab bar to max 12" from the rear wall at the close end and min 54" on the far end, and 33" to 36" AFF. See previous finding.	2015 ABAAS Section: 604.5.1  2012 TAS Section: 604.5.1  2010 ADAS Section: 604.5.1

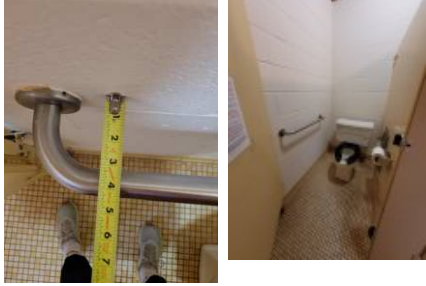
102	Oak Grove: Group Hall by Yurts - Women's Restroom	[32.2366403 , -99.881367 1]	The grab bar height and/or spacing fails. Grab bars must be mounted between 33" and 36" to the top of the gripping surface. There must be 1.5" of clearance between the grab bar and the wall. There must be a minimum of 1.5" of clearance below and minimum 12" above the grab bar to any dispenser or other obstruction.	3.25" clearance from grab bar to wall	Replace grab bars per previous finding and assure gap between bar and wall in max 1.5".	2015 ABAAS Section: 609.3, 609.4  2012 TAS Section: 609.4, 609.3  2010 ADAS Section: 609.3, 609.4

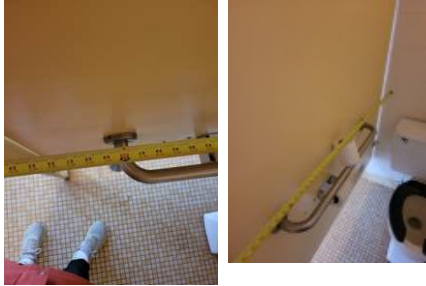
113	Oak Grove: Group Hall By Yurts - Men's Restroom	[32.236731, -99.881415 4]	The side grab bars are not in the correct location. Grab bars on the side wall must be installed so that the end closest to the rear wall is maximum 12" from the rear wall. The end furthest from the rear wall must be mounted minimum 54" from the rear wall.	Grab bar ends 48" from rear wall	Remount side grab bar to max 12" from the rear wall at the close end and min 54" on the far end, and 33" to 36" AFF. See previous finding for cost.	2015 ABAAS Section: 604.5.1  2012 TAS Section: 604.5.1  2010 ADAS Section: 604.5.1

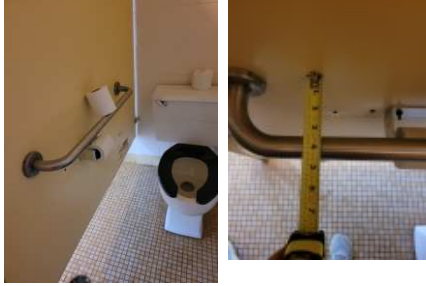
114	Oak Grove: Group Hall By Yurts - Men's Restroom	[32.2367492 , -99.881453]	The grab bar height and/or spacing fails. Grab bars must be mounted between 33" and 36" to the top of the gripping surface. There must be 1.5" of clearance between the grab bar and the wall. There must be a minimum of 1.5" of clearance below and minimum 12" above the grab bar to any dispenser or other obstruction.	3.5" clearance between bar and wall, TP stored on bar	Replace grab bars per previous finding and assure gap between bar and wall in max 1.5". Relocate toilet paper to min 12" above or 1.5" below grab bar.	2015 ABAAS Section: 609.3, 609.4  2012 TAS Section: 609.4, 609.3  2010 ADAS Section: 609.3, 609.4

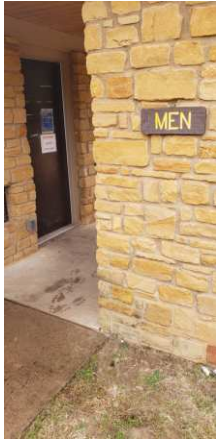
Finding Number	Area Description	Lat/Long	Finding	As Built	Recommendation	Citation	Photos	Figure
115	Oak Grove: Group Hall By Yurts - Men's Restroom	[32.2358212 , -99.8805115]	The restroom sign does not comply with one or more applicable requirements for the location, height, and properties of the sign.	Men's - lacks compliant signage	Replace sign with one of contrasting colors that includes Braille, raised characters, and the symbol of accessibility and mount on the wall, latch side of the door, 48" to the baseline of the lowest character and 60" to the baseline of the highest character.	2015 ABAAS Section: F216.2, 703.1, 703.2, 703.5, 703.6  2012 TAS Section: 216.2, 703.1, 703.2, 703.5, 703.6  2010 ADAS Section: 216.2, 703.1, 703.2, 703.5, 703.6

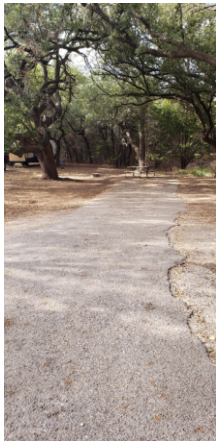
116	Oak Grove: Camping	[32.2359649 , -99.8825913]	Camping facilities shall provide camping units with mobility features complying with F244.2 in accordance with Table F244.2. Where a camping facility provides different types of camping units, Table F244.2 shall apply to each type of camping unit provided. Total Number of Camping Units Provided in Camping Facility Minimum Number of Camping Units with Mobility Features Required 1 1 2 to 25 2 26 to 50 3 51 to 75 4 76 to 100 5 101 to 150 7 151 to 200 8 201 and over 8, plus 2 percent of the number over 200	Oak Grove Campsite Area (19 total RV sites) lacks accessible campsites - Campsite 50 is representative and has no accessible features - lacks AR to accessible picnic table, firepit, and cooking surface	Create the required number of accessible camp sites per table F244.2 as a smart practice.	2015 ABAAS Section: F244.2

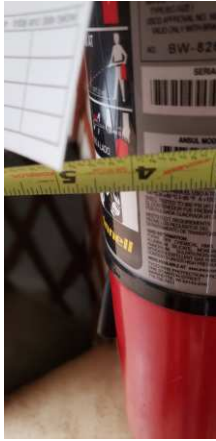
Finding Number	Area Description	Lat/Long	Finding	As Built	Recommendation	Citation	Photos	Figure
121	Oak Grove: Accessible Yurt	[32.2360027 , -99.881699 7]	The fire extinguisher projects more than 4 inches into the circulation path. Wall-mounted objects that have leading edges between 27 inches and 80 inches from the floor must not project more than 4 inches into the circulation path. Protruding objects that extend to the floor or within 27 inches of the floor are cane detectable and are therefore not hazardous. Where it is necessary or desirable to have objects protrude from the wall, a manner of cane detection must be provided.	Fire extinguisher protrudes 4.5"	Relocate protruding objects or place cane detectable warning or bollard at foot of item.	2015 ABAAS Section: 307.2 2012 TAS Section: 307.2 2010 ADAS Section: 307.2

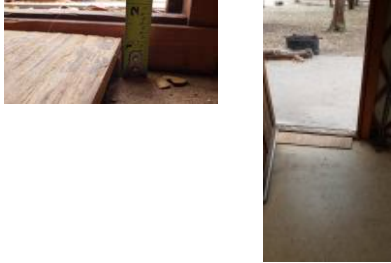
122	Oak Grove: Accessible Yurt	[32.2360118 , -99.881702 4]	The threshold is greater than 1/2 inch high. The threshold at a doorway shall be no higher than 1/2 inch. Changes in level between 1/4 inch and 1/2 inch must be beveled at 1:2 or less. 1/4 inch is the maximum vertical rise.	Entry - 1.5 " threshold	For all doors along the public circulation route, replace thresholds at exterior doors with ADA thresholds.	2015 ABAAS Section: 404.2.5 2012 TAS Section: 404.2.5 2010 ADAS Section: 404.2.5

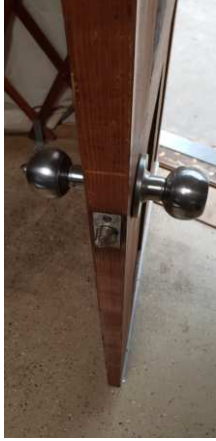
123	Oak Grove: Accessible Yurt	[32.2360095 , -99.881691 7]	The door operating hardware is not accessible. Hand-activated door opening hardware, handles, pulls, latches, locks, and other operating devices on accessible doors shall have a shape that is easy to grasp with one hand and does not require tight grasping, tight pinching or twisting of the wrist to operate. Hardware shall be 34 inches minimum and 48 inches maximum above the finish floor or ground.	Knob hardware	Replace hardware with lever hardware or hardware operable without a tight pinch or grasp.	2015 ABAAS Section: 404.2.7 2012 TAS Section: 404.2.7 2010 ADAS Section: 404.2.7

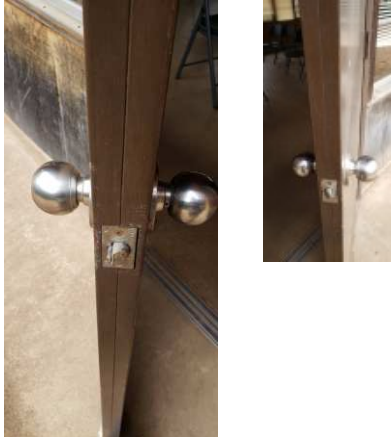
Finding Number	Area Description	Lat/Long	Finding	As Built	Recommendation	Citation	Photos	Figure
124	Oak Grove: Shelters Group Rec Hall	[32.2367219 -99.8813886]	The sweep period for doors with closers shall be adjusted so that from an open position of 70 degrees, the door will take at least 3 seconds to move to a point 3 inches from the latch, measured to the leading edge of the door. Exterior doors are recommended to be maintained at 8.5 lbf as a smart practice. Force is to be measured at the operating hardware or 30 inches from the hinges, whichever is greater. Hand-activated door opening hardware, handles, pulls, latches, locks, and other operating devices on accessible doors shall have a shape that is easy to grasp with one hand and does not require tight grasping, tight pinching or twisting of the wrist to operate. Hardware shall be 34 inches minimum and 48 inches maximum above the finish floor or ground.	2 exit doors - both had knobs, 12# push, and fast close	For all doors along the public circulation route, inspect, adjust, and maintain closing speed on door closers. For all doors along the public circulation route, inspect, adjust, and maintain 8.5 lbf to open exterior doors as a smart practice. For all doors along the public circulation route, replace hardware with lever hardware or hardware operable without a tight pinch or grasp.	2010 ADAS Section: 404.2.3, 404.2.7, 404.2.4, 404.2.11, 404.2.11 Exception

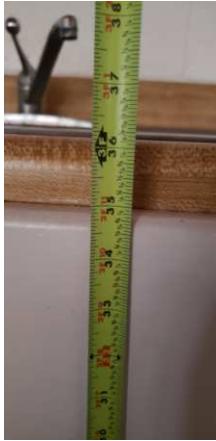
125	Oak Grove: Shelters Group Rec Hall	[32.2367741 -99.8814449]	The top rim of the sink is too high. All lavatories/sinks that are designated to be accessible shall be a minimum 17 inches in horizontal depth and mounted with the rim or counter edge no higher than 34 inches above the finished floor.	Sink rim at 36.25" AFF	Lower sinks to max 34" AFF to front of rim. See next finding for cost.	2015 ABAAS Section: 606.3  2012 TAS Section: 606.3  2010 ADAS Section: 606.3

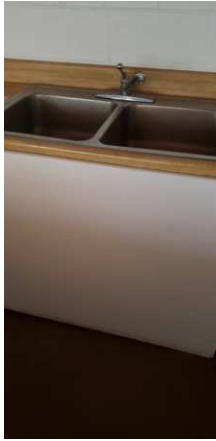
Finding Number	Area Description	Lat/Long	Finding	As Built	Recommendation	Citation	Photos	Figure
126	Oak Grove: Shelters Group Rec Hall	[32.2367129 , -99.881418 1]	Knee and toe space has not been provided at the sink. Kitchen sinks must be provided with a clear floor space positioned for a forward approach including knee and toe clearance.	Sink lacks knee clearance	Remove base cabinet and lower sink height to max 34" AFF.	2015 ABAAS Section: 606.2, 804.4  2012 TAS Section: 606.2, 804.4  2010 ADAS Section: 606.2, 804.4

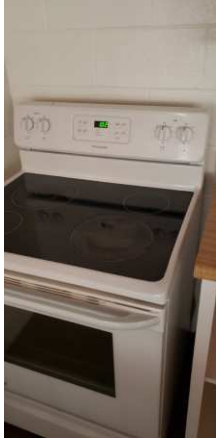
127	Oak Grove: Shelters Group Rec Hall	[32.2366947 , -99.88141]	The controls are located such that operation require reaching across burners. Where knee and toe space is provided, the underside of the range or cooktop shall be insulated or otherwise configured to prevent burns, abrasions, or electrical shock. The location of controls shall not require reaching across burners	Controls require reach across burners	Replace oven with one having controls on the front panel.	2015 ABAAS Section: 804.6.4  2012 TAS Section: 804.6.4  2010 ADAS Section: 804.6.4

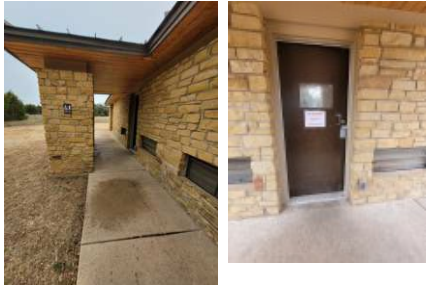
Finding Number	Area Description	Lat/Long	Finding	As Built	Recommendation	Citation	Photos	Figure
130	Oak Grove: Shelter - Women's Restroom	[32.235828, -99.8804927]	The restroom sign does not comply with one or more applicable requirements for the location, height, and properties of the sign.	Women's - lacks compliant signage location	Remount signage on wall, latch side of the door, 48" to baseline of lowest character and 60" to baseline of highest character.	2015 ABAAS Section: F216.2, 703.1, 703.2, 703.5, 703.6  2012 TAS Section: 216.2, 703.1, 703.2, 703.5, 703.6  2010 ADAS Section: 216.2, 703.1, 703.2, 703.5, 703.6

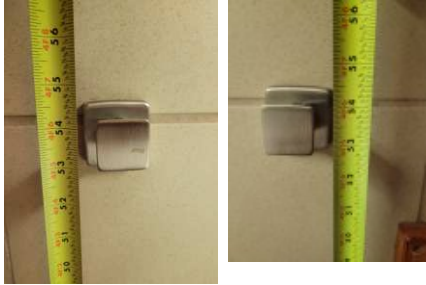
Finding Number	Area Description	Lat/Long	Finding	As Built	Recommendation	Citation	Photos	Figure
132	Oak Grove: Shelter - Women's Restroom	[32.2358054 , -99.880508 8]	The operable part is positioned too high for either a side or front approach. Where a clear floor or ground space allows a parallel approach to an element and the side reach is unobstructed, the high side reach shall be 48 inches maximum and the low side reach shall be 15 inches minimum above the finish floor or ground. Where a forward reach is unobstructed, the high forward reach shall be 48 inches maximum and the low forward reach shall be 15 inches minimum above the finish floor or ground.	Women's - 2 of 2 hooks by sink at 54" AFF	Remount operable parts to be in reach range of 15" min to 48" max.	2015 ABAAS Section: 308.1 2012 TAS Section: 308.1 2010 ADAS Section: 308.1

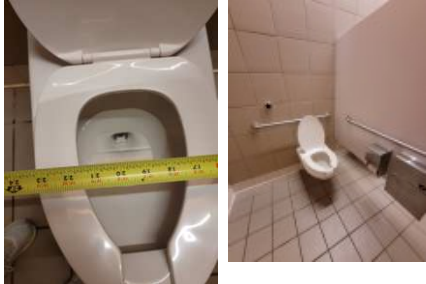
134	Oak Grove: Shelter - Women's Restroom	[32.2357827 , -99.880519 6]	The toilet is not located within the range allowed from the side wall or partition. The centerline of the toilet must be 16 to 18 inches from the side wall.	Women's - 19.5" to toilet centerline	Remount toilets to 16" to 18" from the side wall to centerline.	2015 ABAAS Section: 604.2 2012 TAS Section: 604.2 2010 ADAS Section: 604.2

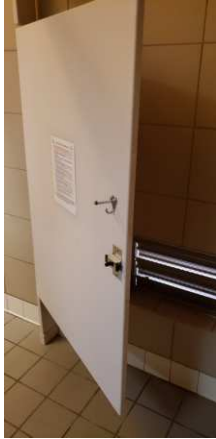
Finding Number	Area Description	Lat/Long	Finding	As Built	Recommendation	Citation	Photos	Figure
139	Oak Grove: Shelter - Men's Restroom	[32.2358417 , -99.880508 8]	The stall door fails to comply with all of the door requirements. The stall door must be a minimum of 32" wide and have compliant hardware on both sides. The stall door must be self-closing.	Men's - Stall lacks self-closing door	Adjust stall door to be self-closing.	2015 ABAAS Section: 404.2.3, 404.2.7, 604.8.2.2  2012 TAS Section: 404.2.3, 404.2.7, 604.8.2.2  2010 ADAS Section: 404.2.3, 404.2.7, 604.8.2.2

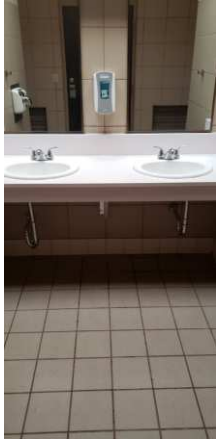
140	Oak Grove: Shelter - Men's Restroom	[32.2358598 , -99.880551 7]	The water and drain pipes under the lavatory are not adequately insulated. Water supply and drain pipes under lavatories and sinks shall be insulated or otherwise configured to protect against contact. There shall be no sharp or abrasive surfaces under lavatories and sinks.	Men's - Sinks lack insulation	Insulate exposed pipes under one sink.	2015 ABAAS Section: 606.5  2012 TAS Section: 606.5  2010 ADAS Section: 606.5

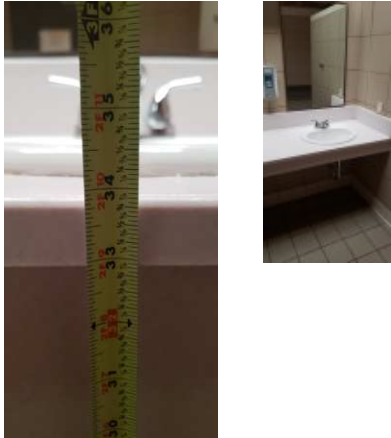
Finding Number	Area Description	Lat/Long	Finding	As Built	Recommendation	Citation	Photos	Figure
141	Oak Grove: Shelter - Men's Restroom	[32.2358235 , -99.880498 1]	The top rim of the sink is too high. All lavatories/sinks that are designated to be accessible shall be a minimum 17 inches in horizontal depth and mounted with the rim or counter edge no higher than 34 inches above the finished floor.	Men's - Sink rim at 34.5" AFF	Lower sinks to max 34" AFF to front of rim.	2015 ABAAS Section: 606.3  2012 TAS Section: 606.3  2010 ADAS Section: 606.3

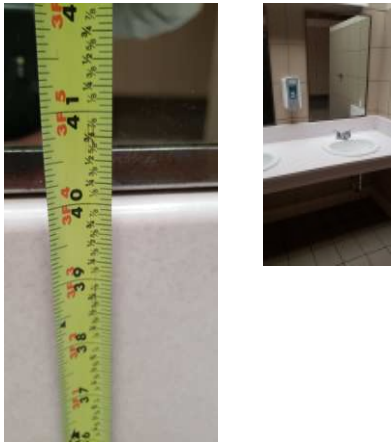
142	Oak Grove: Shelter - Men's Restroom	[32.2358144 , -99.880487 4]	The mirror is mounted too high. Mirrors must have the bottom edge of the reflecting surface a maximum of 40 inches above the floor if above a sink or counter. Mirrors not located above lavatories or countertops shall be installed with the bottom edge of the reflecting surface 35 inches maximum above the finish floor or ground.	Men's - Bottom edge at 40.5" AFF	Lower mirror so reflective surface is max 40" AFF.	2015 ABAAS Section: 603.3  2012 TAS Section: 603.3  2010 ADAS Section: 603.3
