# Access Audit Site Report

**Abilene State Park**

**Accessibility Evaluation**

**Inspection Date: 12/14/2021**

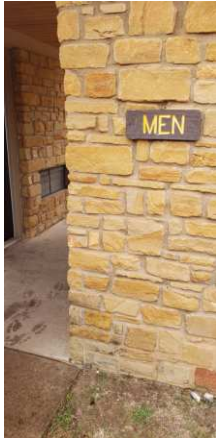
Finding Number	Area Description	Lat/Long	Finding	As Built	Recommendation	Citation	Photos	Figure
143	Oak Grove: Shelter - Men's Restroom	[32.2358235 , -99.880487 4]	The tactile restroom wall sign is missing the International Symbol of Accessibility (ISA). Accessible toilet rooms or bathing rooms shall be identified by the International Symbol of Accessibility (ISA). Wall signs identifying permanent rooms and spaces of a building shall have be horizontal format and the characters raised 1/32 inch minimum and shall be sans serif uppercase characters a minimum of 5/8 inch and a maximum of 2 inches high. Contracted Grade 2 Braille shall be in a horizontal format and shall be placed a minimum of 3/8 inch and a maximum of 1/2 inch directly below the tactile characters; flush left or centered. Signs with raised characters or Braille shall be located 48 inches minimum above the finish floor or ground surface, measured from the baseline of the lowest tactile character and 60 inches maximum above the finish floor or ground surface, measured from the baseline of the highest tactile character.	Men's - Lacks ISA	Acquire and mount signage, including access symbol. Acquire and mount signage, including Braille and access symbol mounted on wall, latch side of door, 48" to baseline of lowest character and 60" to baseline of highest character.	2015 ABAAS Section: F216.8  2012 TAS Section: 216.8  2010 ADAS Section: 216.8

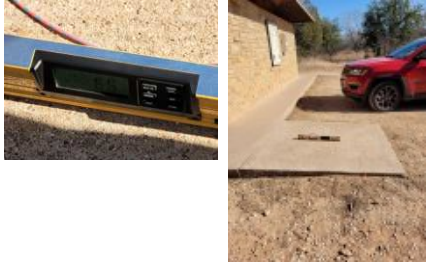
Finding Number	Area Description	Lat/Long	Finding	As Built	Recommendation	Citation	Photos	Figure
145	Cedar Grove: Parking and Exterior Accessible Route	[32.2379766 , -99.878737 2]	The running slope of walking surfaces shall not be steeper than 1:20.	6.6% slope up to men's restroom at Cedar Grove restroom building	Correct running slope along the AR to max 5%.	2015 ABAAS Section: 403.3 2012 TAS Section: 403.3 2010 ADAS Section: 403.3

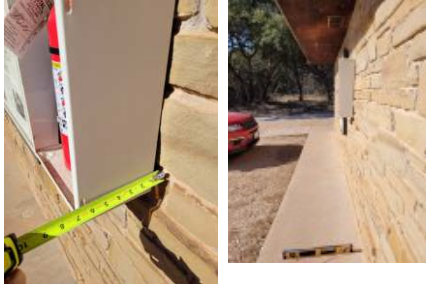
146	Cedar Grove: Parking and Exterior Accessible Route	[32.2379924 , -99.878717 1]	The fire extinguisher projects more than 4 inches into the circulation path. Wall-mounted objects that have leading edges between 27 inches and 80 inches from the floor must not project more than 4 inches into the circulation path. Protruding objects that extend to the floor or within 27 inches of the floor are cane detectable and are therefore not hazardous. Where it is necessary or desirable to have objects protrude from the wall, a manner of cane detection must be provided.	Fire extinguisher projects 7" at Cedar Grove restroom building	Relocate protruding objects or place cane detectable warning or bollard at foot of item.	2015 ABAAS Section: 307.2 2012 TAS Section: 307.2 2010 ADAS Section: 307.2

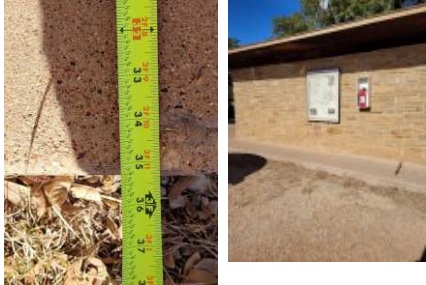
147	Cedar Grove: Parking and Exterior Accessible Route	[32.2379766 , -99.878683 6]	The route of travel at this location does not provide the required minimum width. The minimum clear width for sidewalks and walks is 36 inches.	35.25" width around Cedar Grove restroom building	Widen EAR to min 36" clear width.	2015 ABAAS Section: 403.5.1 2012 TAS Section: 403.5.1 2010 ADAS Section: 403.5.1

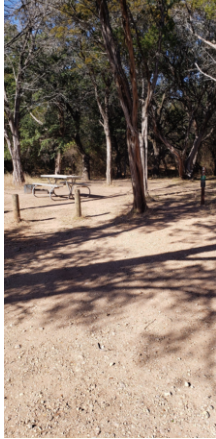
Finding Number	Area Description	Lat/Long	Finding	As Built	Recommendation	Citation	Photos	Figure
148	Cedar Grove: Camping	[32.2359946 , -99.882528]	Camping facilities shall provide camping units with mobility features complying with F244.2 in accordance with Table F244.2. Where a camping facility provides different types of camping units, Table F244.2 shall apply to each type of camping unit provided. Total Number of Camping Units Provided in Camping Facility Minimum Number of Camping Units with Mobility Features Required 1 1 2 to 25 2 26 to 50 3 51 to 75 4 76 to 100 5 101 to 150 7 151 to 200 8 201 and over 8, plus 2 percent of the number over 200	Cedar Grove Campsite Area (12 total primitive sites) lacks accessible campsites - Campsite 37 is representative and has no accessible features - lacks AR to accessible picnic table, firepit, and cooking surface	Create the required number of accessible camp sites per table F244.2 as a smart practice.	2015 ABAAS Section: F244.2

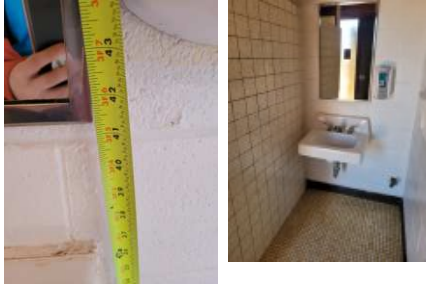
Finding Number	Area Description	Lat/Long	Finding	As Built	Recommendation	Citation	Photos	Figure
150	Cedar Grove: Cedar Grove - Women's Restroom	[32.2380015 , -99.878599 1]	The mirror is mounted too high. Mirrors must have the bottom edge of the reflecting surface a maximum of 40 inches above the floor if above a sink or counter. Mirrors not located above lavatories or countertops shall be installed with the bottom edge of the reflecting surface 35 inches maximum above the finish floor or ground.	Bottom edge at 42" AFF	Lower mirror so reflective surface is max 40" AFF.	2015 ABAAS Section: 603.3  2012 TAS Section: 603.3  2010 ADAS Section: 603.3

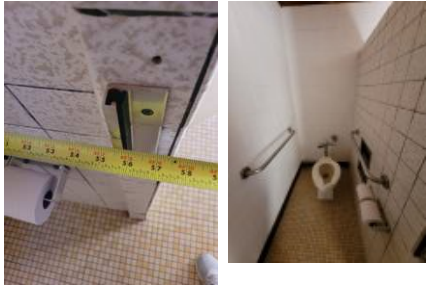
153	Cedar Grove: Cedar Grove - Women's Restroom	[32.2379471 , -99.878674 2]	The ambulatory stall is not between 35" to 37" wide and 60" deep.	Ambulatory stall 35" by 55.5"	Correct ambulatory stall to be 35" to 37" wide and minimum 60" deep. In the alternative use existing ambulatory stall to create required wheelchair stall.	2015 ABAAS Section: 604.8.2.1  2012 TAS Section: 604.8.2.1  2010 ADAS Section: 604.8.2.1

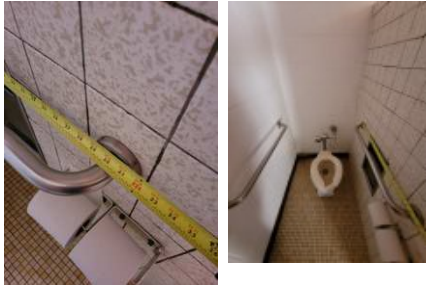
Finding Number	Area Description	Lat/Long	Finding	As Built	Recommendation	Citation	Photos	Figure
156	Cedar Grove: Cedar Grove - Women's Restroom	[32.2380015 , -99.878663 5]	Grab bars shall comply with 609. A side-wall grab bar complying with 604.5.1 shall be provided on both sides of the compartment. The space between the wall and the grab bar shall be 1½ inches (38 mm). The space between the grab bar and projecting objects below and at the ends shall be 1½ inches (38 mm) minimum. The space between the grab bar and projecting objects above shall be 12 inches (305 mm) minimum. Grab bars shall be installed in a horizontal position, 33 inches (840 mm) minimum and 36 inches (915 mm) maximum above the finish floor measured to the top of the gripping surface, except that at water closets for children's use complying with 604.9, grab bars shall be installed in a horizontal position 18 inches (455 mm) minimum and 27 inches (685 mm) max	Both bars are 30" long	Replace side grab bars with a 42" long grab bar, mounted max 12" from the rear wall at the close end and min 54" on the far end and 33" to 36" AFF.	2015 ABAAS Section: 604.8.2.3, 609.3, 609.4  2012 TAS Section: 609.4, 609.3, 604.8.2.3  2010 ADAS Section: 609.3, 609.4, 604.8.2.3

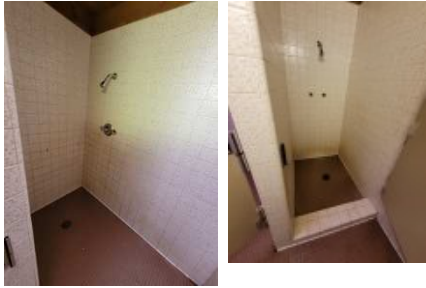
161	Cedar Grove: Cedar Grove - Women's Restroom	[32.2379879 , -99.878702 4]	There are no accessible bathing or shower facilities. Where facilities for bathing are provided for the public, clients or employees, including showers or bathtubs, at least one shower or bathtub and support facilities such as lockers, and not less than 1 percent of all facilities, shall be accessible.	Lacks accessible showers	Create an accessible shower in locker/bathing room.	2015 ABAAS Section: F213.3.6  2012 TAS Section: 213.3.6  2010 ADAS Section: 213.3.6

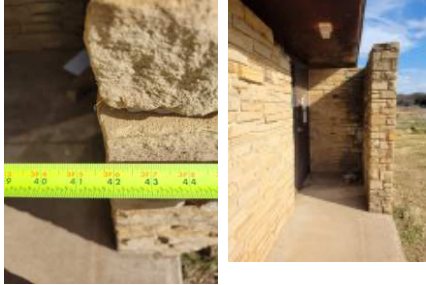
Finding Number	Area Description	Lat/Long	Finding	As Built	Recommendation	Citation	Photos	Figure
163	Cedar Grove: Cedar Grove - Women's Restroom	[32.2379663 , -99.878648 7]	Minimum maneuvering clearances at doors and gates shall comply with 404.2.4. Maneuvering clearances shall extend the full width of the doorway and the required latch side or hinge side clearance. Exterior doors are recommended to be maintained at 8.5 lbf as a smart practice. Force is to be measured at the operating hardware or 30 inches from the hinges, whichever is greater.	Restroom door - 11# push, lacks MC due to 42" wide approach	For all doors along the public circulation route, provide required maneuvering clearance on push and pull side of doors. For all doors along the public circulation route, inspect, adjust, and maintain 8.5 lbf to open exterior doors as a smart practice.	2010 ADAS Section: 404.2.3, 404.2.7, 404.2.4, 404.2.11, 404.2.11 Exception

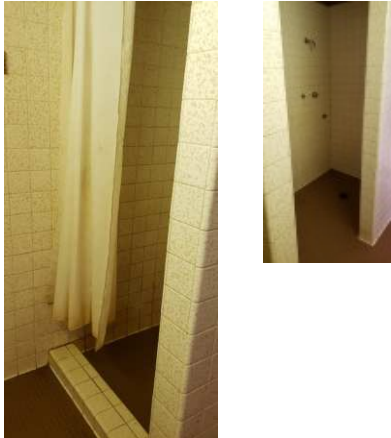
Finding Number	Area Description	Lat/Long	Finding	As Built	Recommendation	Citation	Photos	Figure
165	Cedar Grove: Cedar Grove - Men's Restroom	[32.2380197 , -99.878663 5]	There are no accessible bathing or shower facilities. Where facilities for bathing are provided for the public, clients or employees, including showers or bathtubs, at least one shower or bathtub and support facilities such as lockers, and not less than 1 percent of all facilities, shall be accessible.	Lacks accessible showers	Create an accessible shower in locker/bathing room.	2015 ABAAS Section: F213.3.6  2012 TAS Section: 213.3.6  2010 ADAS Section: 213.3.6

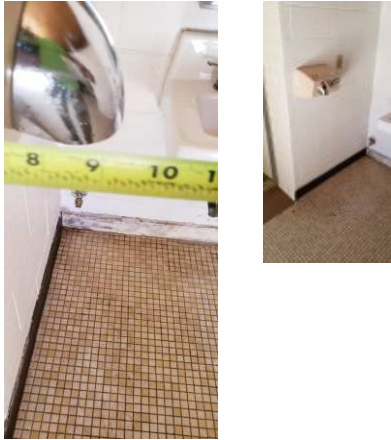
Finding Number	Area Description	Lat/Long	Finding	As Built	Recommendation	Citation	Photos	Figure
167	Cedar Grove: Cedar Grove - Men's Restroom	[32.2379471 , -99.878684 9]	The hand dryer projects more than 4 inches into the circulation path. Wall-mounted objects that have leading edges between 27 inches and 80 inches from the floor must not project more than 4 inches into the circulation path. Protruding objects that extend to the floor or within 27 inches of the floor are cane detectable and are therefore not hazardous. Where it is necessary or desirable to have objects protrude from the wall, a manner of cane detection must be provided.	Hand dryer protrudes 9"	Relocate protruding objects or place cane detectable warning or bollard at foot of item.	2015 ABAAS Section: 307.2  2012 TAS Section: 307.2  2010 ADAS Section: 307.2

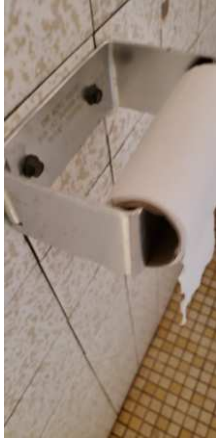
168	Cedar Grove: Cedar Grove - Men's Restroom	[32.2380197 , -99.878642]	The toilet paper dispenser does not allow a continuous flow. Toilet paper dispensers shall be 7 inches minimum and 9 inches maximum in front of the water closet measured to the centerline of the dispenser. The outlet of the dispenser shall be 15 inches minimum and 48 inches maximum above the finish floor and shall not be located behind grab bars. Dispensers shall not be of a type that controls delivery or that does not allow continuous paper flow. There shall be a clearance of 1 1/2 inches minimum below the grab bar.	TP dispenser does not allow a continuous flow	Replace toilet paper dispenser with one that provides continuous flow of paper.	2015 ABAAS Section: 604.7  2012 TAS Section: 604.7  2010 ADAS Section: 604.7

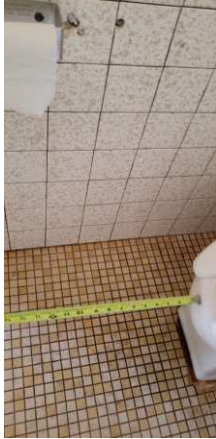
Finding Number	Area Description	Lat/Long	Finding	As Built	Recommendation	Citation	Photos	Figure
169	Cedar Grove: Cedar Grove - Men's Restroom	[32.2379652 , -99.878652 7]	The toilet paper is not installed within the compliant range in front of the toilet. Toilet paper dispensers shall be 7 inches minimum and 9 inches maximum in front of the water closet measured to the centerline of the dispenser. The outlet of the dispenser shall be 15 inches minimum and 48 inches maximum above the finish floor and shall not be located behind grab bars. Dispensers shall not be of a type that controls delivery or that does not allow continuous paper flow. There shall be a clearance of 1 1/2 inches minimum below the grab bar.	TP is 15" from front of toilet	Remount toilet paper dispenser max 7" to 9" from front of toilet, 15" to 48" AFF and min 12" above or 1.5" below grab bar.	2015 ABAAS Section: 604.7  2012 TAS Section: 604.7  2010 ADAS Section: 604.7

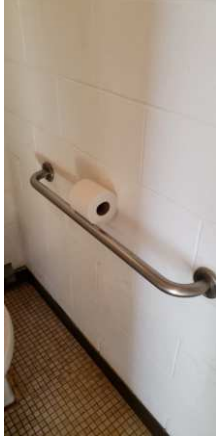
170	Cedar Grove: Cedar Grove - Men's Restroom	[32.2379289 , -99.878663 5]	The grab bar height and/or spacing fails. Grab bars must be mounted between 33" and 36" to the top of the gripping surface. There must be 1.5" of clearance between the grab bar and the wall. There must be a minimum of 1.5" of clearance below and minimum 12" above the grab bar to any dispenser or other obstruction.	TP stored on grab bar, gap too big	Replace grab bars per previous finding and assure gap between bar and wall in max 1.5". Remount toilet paper to min 12" above or 1.5" below grab bar.	2015 ABAAS Section: 609.3, 609.4  2012 TAS Section: 609.4, 609.3  2010 ADAS Section: 609.3, 609.4

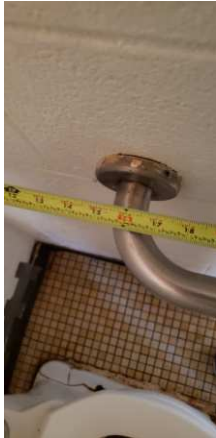
Finding Number	Area Description	Lat/Long	Finding	As Built	Recommendation	Citation	Photos	Figure
171	Cedar Grove: Cedar Grove - Men's Restroom	[32.2379834 , -99.878684 9]	The side grab bars are not in the correct location. Grab bars on the side wall must be installed so that the end closest to the rear wall is maximum 12" from the rear wall. The end furthest from the rear wall must be mounted minimum 54" from the rear wall.	Bar starts 16" and ends 46" from rear wall	Remount side grab bar to max 12" from the rear wall at the close end and min 54" on the far end, and 33" to 36" AFF. See previous finding for cost.	2015 ABAAS Section: 604.5.1  2012 TAS Section: 604.5.1  2010 ADAS Section: 604.5.1

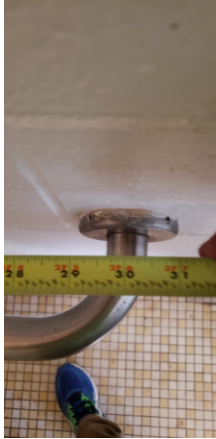
Finding Number	Area Description	Lat/Long	Finding	As Built	Recommendation	Citation	Photos	Figure
172	Cedar Grove: Cedar Grove - Men's Restroom	[32.2380197, -99.8786635]	Grab bars shall comply with 609. A side-wall grab bar complying with 604.5.1 shall be provided on both sides of the compartment. The space between the wall and the grab bar shall be 1½ inches (38 mm). The space between the grab bar and projecting objects below and at the ends shall be 1½ inches (38 mm) minimum. The space between the grab bar and projecting objects above shall be 12 inches (305 mm) minimum. Grab bars shall be installed in a horizontal position, 33 inches (840 mm) minimum and 36 inches (915 mm) maximum above the finish floor measured to the top of the gripping surface, except that at water closets for children's use complying with 604.9, grab bars shall be installed in a horizontal position 18 inches (455 mm) minimum and 27 inches (685 mm) max	Only one 30" bar on right side - no bar on left	Replace or add side grab bars with a 42" long grab bar, mounted max 12" from the rear wall at the close end and min 54" on the far end and 33" to 36" AFF.	2015 ABAAS Section: 604.8.2.3, 609.3, 609.4  2012 TAS Section: 609.4, 609.3, 604.8.2.3  2010 ADAS Section: 609.3, 609.4, 604.8.2.3

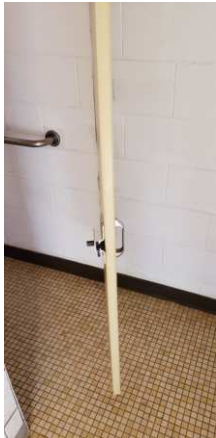
173	Cedar Grove: Cedar Grove - Men's Restroom	[32.2379471, -99.878642]	The stall door fails to comply with all of the door requirements. The stall door must be a minimum of 32" wide and have compliant hardware on both sides. The stall door must be self-closing.	Stall lacks self-closing door	Adjust stall door to be self-closing.	2015 ABAAS Section: 404.2.3, 404.2.7, 604.8.2.2  2012 TAS Section: 404.2.3, 404.2.7, 604.8.2.2  2010 ADAS Section: 404.2.3, 404.2.7, 604.8.2.2

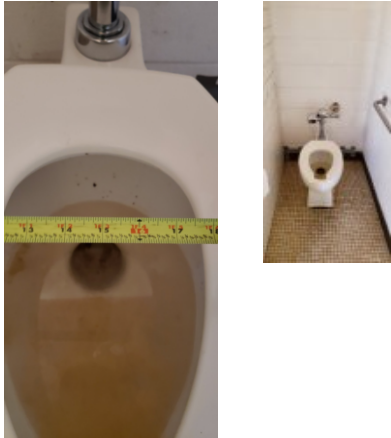
Finding Number	Area Description	Lat/Long	Finding	As Built	Recommendation	Citation	Photos	Figure
174	Cedar Grove: Cedar Grove - Men's Restroom	[32.2379652 , -99.878663 5]	The toilet is not located within the range to the side wall or partition. The centerline of the toilet shall be 17 inches minimum and 19 inches maximum side wall or partition in the ambulatory accessible toilet compartment.	15" from left	Remount toilet to 17" to 19" from the side wall to center line in ambulatory stalls, or 16" to 18" in new wheelchair stall.	2015 ABAAS Section: 604.9.1  2012 TAS Section: 604.9.1  2010 ADAS Section: 604.9.1

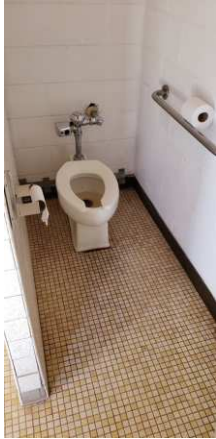
Finding Number	Area Description	Lat/Long	Finding	As Built	Recommendation	Citation	Photos	Figure
176	Cedar Grove: Cedar Grove - Men's Restroom	[32.2379652 , -99.878663 5]	There are not enough accessible toilet compartments. The room contains several toilet compartments. A minimum of 1 must be wheelchair accessible .	Ambulatory stall only	Create a wheelchair accessible stall with grab bars and fixtures mounted in correct locations and at correct heights.	2015 ABAAS Section: F213.3.1  2012 TAS Section: 213.3.1  2010 ADAS Section: 213.3.1

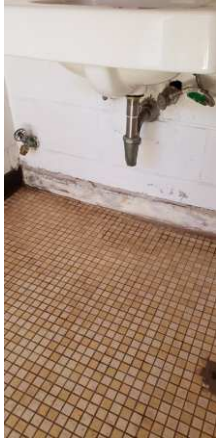
177	Cedar Grove: Cedar Grove - Men's Restroom	[32.2380197 , -99.878663 5]	The water and drain pipes under the lavatory are not adequately insulated. Water supply and drain pipes under lavatories and sinks shall be insulated or otherwise configured to protect against contact. There shall be no sharp or abrasive surfaces under lavatories and sinks.	Sink lacks insulated pipes	Insulate exposed pipes under one sink.	2015 ABAAS Section: 606.5  2012 TAS Section: 606.5  2010 ADAS Section: 606.5

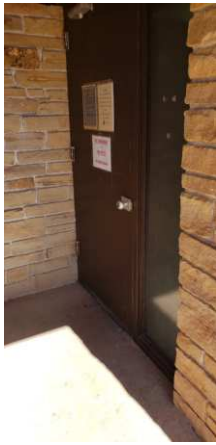
179	Cedar Grove: Cedar Grove - Men's Restroom	[32.2380197, -99.8786849]	The restroom sign does not comply with one or more applicable requirements for the location, height, and properties of the sign.	Lacks signage	Acquire and mount signage, including Braille and access symbol mounted on wall, latch side of door, 48" to baseline of lowest character and 60" to baseline of highest character.	2015 ABAAS Section: F216.2, 703.1, 703.2, 703.5, 703.6  2012 TAS Section: 216.2, 703.1, 703.2, 703.5, 703.6  2010 ADAS Section: 216.2, 703.1, 703.2, 703.5, 703.6

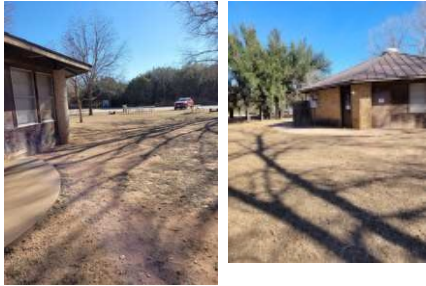
Finding Number	Area Description	Lat/Long	Finding	As Built	Recommendation	Citation	Photos	Figure
180	Wagon Circle: Parking and Exterior Accessible Route	[32.24488, -99.87611]	The building entrance is not located on an accessible route. When a building, or portion of a building, is required to be accessible, an accessible route of travel shall be provided to all portions of the building, to accessible building entrances and between the building and the public way. All walks, halls, corridors, aisles, skywalks, tunnels, and other spaces that are part of an accessible route must comply. An accessible route of travel must not pass through kitchens, storage rooms, restrooms, closets or other spaces used for similar purposes. At least one accessible route within the boundary of the site must be provided from public transportation stops, accessible parking and accessible passenger loading zones and public streets or sidewalks to the accessible building entrance they serve. The accessible route shall, to the maximum extent feasible, coincide with the route for the general public. At least one accessible route shall connect accessible buildings, facilities, elements and spaces that are on the same site. At least one accessible route shall connect accessible building or facility entrances with all accessible spaces and elements.	Lacks AR to dining hall and dining hall restrooms (men's and women's)	Create AR with crushed and compacted stone or similar outdoor material from parking or sidewalk to building entrance.	2015 ABAAS Section: F206.2.1  2012 TAS Section: 206.2.1  2010 ADAS Section: 206.2.1

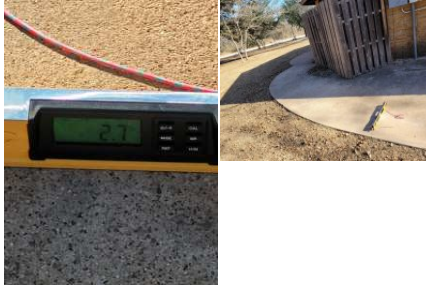
181	Wagon Circle: Parking and Exterior Accessible Route	[32.2375262, -99.883533]	The accessible route of travel on the accessible route contains cross slopes greater than 2%. Cross slopes shall not exceed one unit vertical in 48 units horizontal (2-percent slope).	2.7% slope on path from men's to women's restrooms at dining hall building	Correct or repair cross slope along AR to max 2.08%.	2015 ABAAS Section: 403.3  2012 TAS Section: 403.3  2010 ADAS Section: 403.3

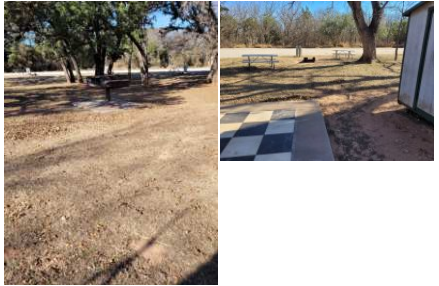
Finding Number	Area Description	Lat/Long	Finding	As Built	Recommendation	Citation	Photos	Figure
182	Wagon Circle: Parking and Exterior Accessible Route	[32.2375863 , -99.8832366]	There is no accessible route to the grill, chess board, and chess storage at dining hall. At least one accessible route shall connect accessible buildings, accessible facilities, accessible elements, and accessible spaces that are on the same site.	Lacks AR to grill, chess board, and chess storage at dining hall	Create an accessible route with crushed stone or other outdoor material from parking or walkway to the grill, chess board, and chess storage.	2015 ABAAS Section: F206.2.2  2012 TAS Section: 206.2.2  2010 ADAS Section: 206.2.2

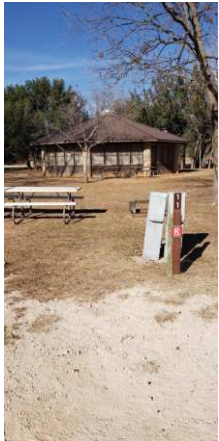
183	Wagon Circle: Camping	[32.2379548 , -99.8834936]	Camping facilities shall provide camping units with mobility features complying with F244.2 in accordance with Table F244.2. Where a camping facility provides different types of camping units, Table F244.2 shall apply to each type of camping unit provided. Total Number of Camping Units Provided in Camping Facility Minimum Number of Camping Units with Mobility Features Required 1 1 2 to 25 2 26 to 50 3 51 to 75 4 76 to 100 5 101 to 150 7 151 to 200 8 201 and over 8, plus 2 percent of the number over 200	Wagon Circle Campsite Area (40 total electric sites) lacks accessible campsites - Campsite 11 is representative and has no accessible features - lacks AR to picnic table, firepit, and cooking surface	Create the required number of accessible camp sites per table F244.2 as a smart practice.	2015 ABAAS Section: F244.2

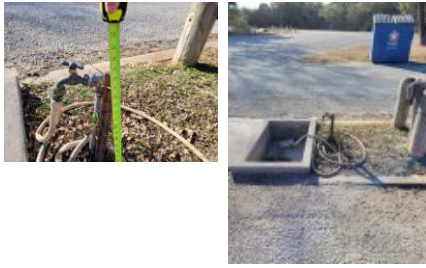
184	Wagon Circle: Camping	[32.2340448 , -99.8800113]	Water spouts at water hydrants and water utility hook-ups shall be 28 inches (710 mm) minimum and 36 inches (915 mm) maximum above the ground.	Wagon Circle dump station - water spout at 19" AGL	Remount water spouts to 28" min or 36" max above the ground as a smart practice.	2015 ABAAS Section: 1011.6

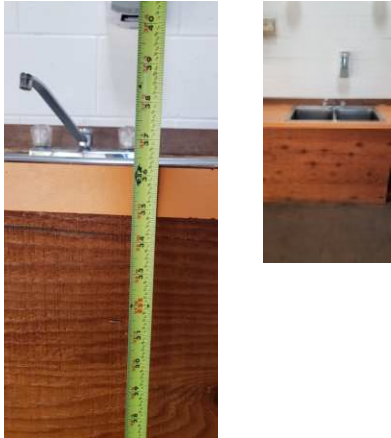
Finding Number	Area Description	Lat/Long	Finding	As Built	Recommendation	Citation	Photos	Figure
185	Wagon Circle: Dining Hall	[32.2375387, -99.8834646]	The top rim of the sink is too high. All lavatories/sinks that are designated to be accessible shall be a minimum 17 inches in horizontal depth and mounted with the rim or counter edge no higher than 34 inches above the finished floor.	Sink rim at 36.5" AFF	Lower sinks to max 34" AFF to front of rim.	2015 ABAAS Section: 606.3 2012 TAS Section: 606.3 2010 ADAS Section: 606.3

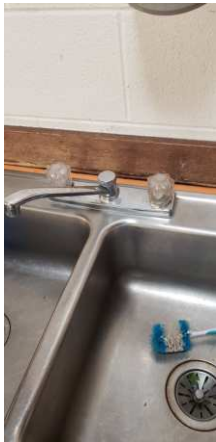
186	Wagon Circle: Dining Hall	[32.2375841, -99.8834914]	Controls for faucets shall comply with 309. Hand-operated metering faucets shall remain open for 10 seconds minimum. Operable parts shall be operable with one hand and shall not require tight grasping, pinching, or twisting of the wrist. The force required to activate operable parts shall be 5 pounds (22.2 N) maximum.	Sink has knob hardware	Replace sink/shower hardware with one operable without a tight pinch or grasp.	2015 ABAAS Section: 309.4, 606.4 2012 TAS Section: 309.4, 606.4 2010 ADAS Section: 309.4, 606.4

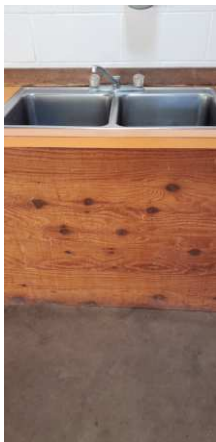
Finding Number	Area Description	Lat/Long	Finding	As Built	Recommendation	Citation	Photos	Figure
187	Wagon Circle: Dining Hall	[32.2375568 , -99.88347]	Knee and toe space has not been provided at the sink. Kitchen sinks must be provided with a clear floor space positioned for a forward approach including knee and toe clearance.	Sink lacks knee clearance	Remove base cabinet and lower sink height to max 34" AFF.	2015 ABAAS Section: 606.2, 804.4  2012 TAS Section: 606.2, 804.4  2010 ADAS Section: 606.2, 804.4

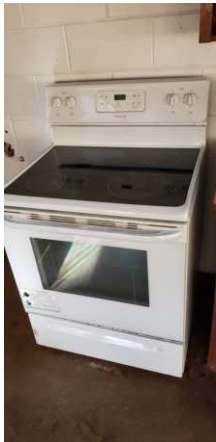
188	Wagon Circle: Dining Hall	[32.2375659 , -99.883448 5]	The controls are located such that operation require reaching across burners. Where knee and toe space is provided, the underside of the range or cooktop shall be insulated or otherwise configured to prevent burns, abrasions, or electrical shock. The location of controls shall not require reaching across burners.	Controls require reach across burners	Replace oven with one having controls on the front panel.	2015 ABAAS Section: 804.6.4  2012 TAS Section: 804.6.4  2010 ADAS Section: 804.6.4

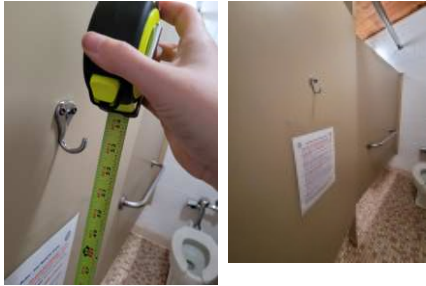
Finding Number	Area Description	Lat/Long	Finding	As Built	Recommendation	Citation	Photos	Figure
194	Wagon Circle: Dining Hall - Women's Restroom	[32.2375841, -99.88347]	The operable part is positioned too high for either a side or front approach. Where a clear floor or ground space allows a parallel approach to an element and the side reach is unobstructed, the high side reach shall be 48 inches maximum and the low side reach shall be 15 inches minimum above the finish floor or ground. Where a forward reach is unobstructed, the high forward reach shall be 48 inches maximum and the low forward reach shall be 15 inches minimum above the finish floor or ground.	Hook in stall at 53" AFF	Remount operable parts to be in reach range of 15" min to 48" max.	2015 ABAAS Section: 308.1 2012 TAS Section: 308.1 2010 ADAS Section: 308.1

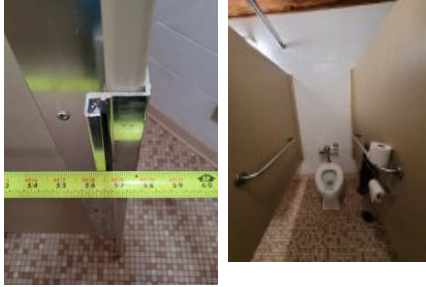
196	Wagon Circle: Dining Hall - Women's Restroom	[32.2375727, -99.8834727]	The ambulatory stall is not between 35" to 37" wide and 60" deep.	Ambulatory stall is 37" by 56"	Correct ambulatory stall to be 35" to 37" wide and minimum 60" deep. In the alternative, use existing ambulatory stall to create required wheelchair stall.	2015 ABAAS Section: 604.8.2.1 2012 TAS Section: 604.8.2.1 2010 ADAS Section: 604.8.2.1

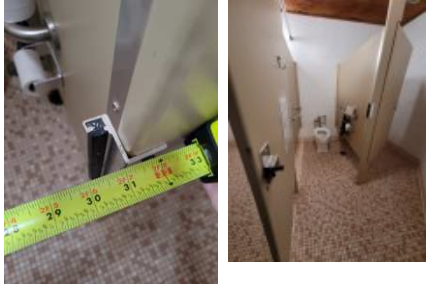
Finding Number	Area Description	Lat/Long	Finding	As Built	Recommendation	Citation	Photos	Figure
197	Wagon Circle: Dining Hall - Women's Restroom	[32.2375841, -99.8834485]	The stall door fails to comply with all of the door requirements. The stall door must be a minimum of 32" wide and have compliant hardware on both sides. The stall door must be self-closing.	Stall door is 31" wide	Widen stall doors to 32" when opened to 90 degrees.	2015 ABAAS Section: 404.2.3, 404.2.7, 604.8.2.2  2012 TAS Section: 404.2.3, 404.2.7, 604.8.2.2  2010 ADAS Section: 404.2.3, 404.2.7, 604.8.2.2

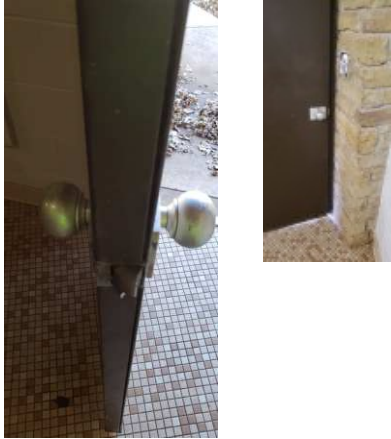
Finding Number	Area Description	Lat/Long	Finding	As Built	Recommendation	Citation	Photos	Figure
204	Wagon Circle: Dining Hall - Men's Restroom	[32.2375478 , -99.883437 8]	Minimum maneuvering clearances at doors and gates shall comply with 404.2.4. Maneuvering clearances shall extend the full width of the doorway and the required latch side or hinge side clearance. The sweep period for doors with closers shall be adjusted so that from an open position of 70 degrees, the door will take at least 3 seconds to move to a point 3 inches from the latch, measured to the leading edge of the door. Exterior doors are recommended to be maintained at 8.5 lbf as a smart practice. Force is to be measured at the operating hardware or 30 inches from the hinges, whichever is greater. Hand-activated door opening hardware, handles, pulls, latches, locks, and other operating devices on accessible doors shall have a shape that is easy to grasp with one hand and does not require tight grasping, tight pinching or twisting of the wrist to operate. Hardware shall be 34 inches minimum and 48 inches maximum above the finish floor or ground.	Restroom door - knob, wall in pull side clearance, 20lbf, fast close	For all doors along the public circulation route, provide required maneuvering clearance on push and pull side of doors. For all doors along the public circulation route, inspect, adjust, and maintain closing speed on door closers. For all doors along the public circulation route, inspect, adjust, and maintain 8.5 lbf to open exterior doors as a smart practice. For all doors along the public circulation route, replace hardware with lever hardware or hardware operable without a tight pinch or grasp.	2010 ADAS Section: 404.2.3, 404.2.7, 404.2.4, 404.2.11, 404.2.11 Exception

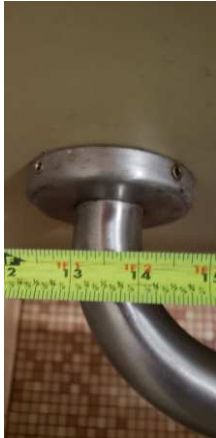
Finding Number	Area Description	Lat/Long	Finding	As Built	Recommendation	Citation	Photos	Figure
207	Wagon Circle: Dining Hall - Men's Restroom	[32.2375704 , -99.883510 2]	The side grab bars are not in the correct location. Grab bars on the side wall must be installed so that the end closest to the rear wall is maximum 12" from the rear wall. The end furthest from the rear wall must be mounted minimum 54" from the rear wall.	Grab bars start 13.5" and end 43.5" from rear wall	Remount side grab bar to max 12" from the rear wall at the close end and min 54" on the far end, and 33" to 36" AFF. See previous finding for cost.	2015 ABAAS Section: 604.5.1  2012 TAS Section: 604.5.1  2010 ADAS Section: 604.5.1

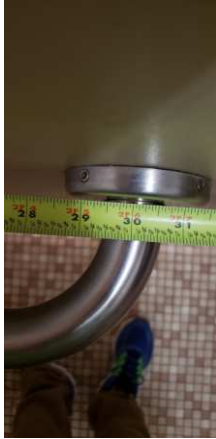
Finding Number	Area Description	Lat/Long	Finding	As Built	Recommendation	Citation	Photos	Figure
208	Wagon Circle: Dining Hall - Men's Restroom	[32.2375659 , -99.88347]	Grab bars shall comply with 609. A side-wall grab bar complying with 604.5.1 shall be provided on both sides of the compartment. The space between the wall and the grab bar shall be 1½ inches (38 mm). The space between the grab bar and projecting objects below and at the ends shall be 1½ inches (38 mm) minimum. The space between the grab bar and projecting objects above shall be 12 inches (305 mm) minimum. Grab bars shall be installed in a horizontal position, 33 inches (840 mm) minimum and 36 inches (915 mm) maximum above the finish floor measured to the top of the gripping surface, except that at water closets for children's use complying with 604.9, grab bars shall be installed in a horizontal position 18 inches (455 mm) minimum and 27 inches (685 mm) max.	Grab bars are 30" long	Replace or add side grab bars with a 42" long grab bar, mounted max 12" from the rear wall at the close end and min 54" on the far end and 33" to 36" AFF.	2015 ABAAS Section: 604.8.2.3, 609.3, 609.4  2012 TAS Section: 609.4, 609.3, 604.8.2.3  2010 ADAS Section: 609.3, 609.4, 604.8.2.3

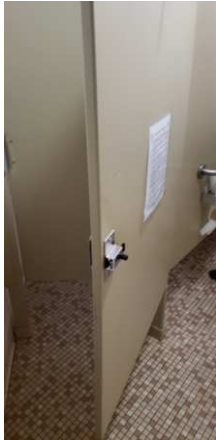
209	Wagon Circle: Dining Hall - Men's Restroom	[32.2375251 , -99.883459 3]	The stall door fails to comply with all of the door requirements. The stall door must be a minimum of 32" wide and have compliant hardware on both sides. The stall door must be self-closing.	Lacks self-closing door	Adjust stall door to be self-closing.	2015 ABAAS Section: 404.2.3, 404.2.7, 604.8.2.2  2012 TAS Section: 404.2.3, 404.2.7, 604.8.2.2  2010 ADAS Section: 404.2.3, 404.2.7, 604.8.2.2

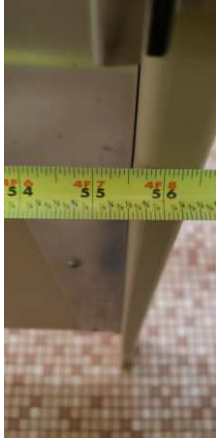
Finding Number	Area Description	Lat/Long	Finding	As Built	Recommendation	Citation	Photos	Figure
210	Wagon Circle: Dining Hall - Men's Restroom	[32.2375659 , -99.883478]	The ambulatory stall is not between 35" to 37" wide and 60" deep.	Ambulatory stall is 55.5" deep	Correct ambulatory stall to be 35" to 37" wide and minimum 60" deep. In the alternative, use existing ambulatory stall to create required wheelchair stall.	2015 ABAAS Section: 604.8.2.1  2012 TAS Section: 604.8.2.1  2010 ADAS Section: 604.8.2.1

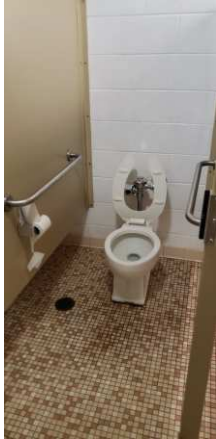
211	Wagon Circle: Dining Hall - Men's Restroom	[32.2375614 , -99.883480 7]	There are not enough accessible toilet compartments. The room contains several toilet compartments. A minimum of 1 must be wheelchair accessible .	Ambulatory stall only	Create a wheelchair accessible stall with grab bars and fixtures mounted in correct locations and at correct heights.	2015 ABAAS Section: F213.3.1  2012 TAS Section: 213.3.1  2010 ADAS Section: 213.3.1

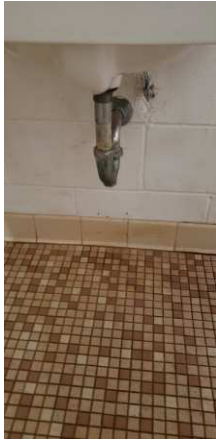
Finding Number	Area Description	Lat/Long	Finding	As Built	Recommendation	Citation	Photos	Figure
212	Wagon Circle: Dining Hall - Men's Restroom	[32.2375432 , -99.883466]	The water and drain pipes under the lavatory are not adequately insulated. Water supply and drain pipes under lavatories and sinks shall be insulated or otherwise configured to protect against contact. There shall be no sharp or abrasive surfaces under lavatories and sinks.	Sink lacks insulated pipes	Insulate exposed pipes under one sink.	2015 ABAAS Section: 606.5  2012 TAS Section: 606.5  2010 ADAS Section: 606.5

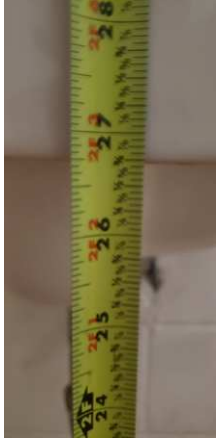
213	Wagon Circle: Dining Hall - Men's Restroom	[32.2375387 , -99.883461 9]	Knee clearance at 27 inches off the floor is not 8 inches minimum deep. The knee clearance, measured from the bottom of the apron or the outside bottom edge of the lavatory, must be 27 inches at a point located 8 inches back from the front edge and continuing to 11 inches minimum in depth at 9 inches above the floor. The top of the lavatory rim may be no higher than 34 inches.	Sink lacks knee clearance	Replace sink with one providing 27" knee clearance that is a min 8" deep.	2015 ABAAS Section: 306.3.1, 306.3.2, 306.3.3, 306.3.4 , 306.3.5  2012 TAS Section: 306.3.2, 306.3.3, 306.3.4, 306.3.5, 306.3.1  2010 ADAS Section: 306.3.3, 306.3.2, 306.3.4, 306.3.5, 306.3.1

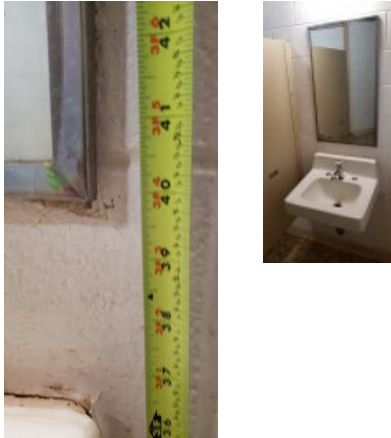
Finding Number	Area Description	Lat/Long	Finding	As Built	Recommendation	Citation	Photos	Figure
214	Wagon Circle: Dining Hall - Men's Restroom	[32.2375478 , -99.88347]	The mirror is mounted too high. Mirrors must have the bottom edge of the reflecting surface a maximum of 40 inches above the floor if above a sink or counter. Mirrors not located above lavatories or countertops shall be installed with the bottom edge of the reflecting surface 35 inches maximum above the finish floor or ground.	Bottom edge at 40.5"	Lower mirror so reflective surface is max 40" AFF.	2015 ABAAS Section: 603.3  2012 TAS Section: 603.3  2010 ADAS Section: 603.3

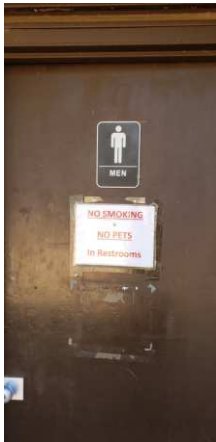
215	Wagon Circle: Dining Hall - Men's Restroom	[32.2375115 , -99.883448 5]	The tactile restroom wall sign is missing the International Symbol of Accessibility (ISA). Accessible toilet rooms or bathing rooms shall be identified by the International Symbol of Accessibility (ISA). Wall signs identifying permanent rooms and spaces of a building shall have be horizontal format and the characters raised 1/32 inch minimum and shall be sans serif uppercase characters a minimum of 5/8 inch and a maximum of 2 inches high. Contracted Grade 2 Braille shall be in a horizontal format and shall be placed a minimum of 3/8 inch and a maximum of 1/2 inch directly below the tactile characters; flush left or centered. Signs with raised characters or Braille shall be located 48 inches minimum above the finish floor or ground surface, measured from the baseline of the lowest tactile character and 60 inches maximum above the finish floor or ground surface, measured from the baseline of the highest tactile character.	Lacks ISA	Acquire and mount signage, including access symbol. Acquire and mount signage, including Braille and access symbol mounted on wall, latch side of door, 48" to baseline of lowest character and 60" to baseline of highest character.	2015 ABAAS Section: F216.8  2012 TAS Section: 216.8  2010 ADAS Section: 216.8

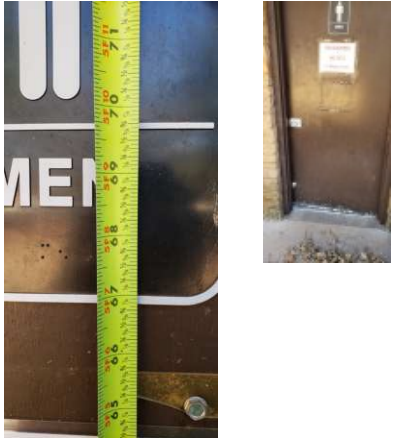
Finding Number	Area Description	Lat/Long	Finding	As Built	Recommendation	Citation	Photos	Figure
216	Wagon Circle: Dining Hall - Men's Restroom	[32.2375841 , -99.883491 4]	The restroom sign does not comply with one or more applicable requirements for the location, height, and properties of the sign.	Raised letters at 68.5" AFF	Remount signage on wall, latch side of the door, 48" to baseline of lowest character and 60" to baseline of highest character.	2015 ABAAS Section: F216.2, 703.1, 703.2, 703.5, 703.6  2012 TAS Section: 216.2, 703.1, 703.2, 703.5, 703.6  2010 ADAS Section: 216.2, 703.1, 703.2, 703.5, 703.6

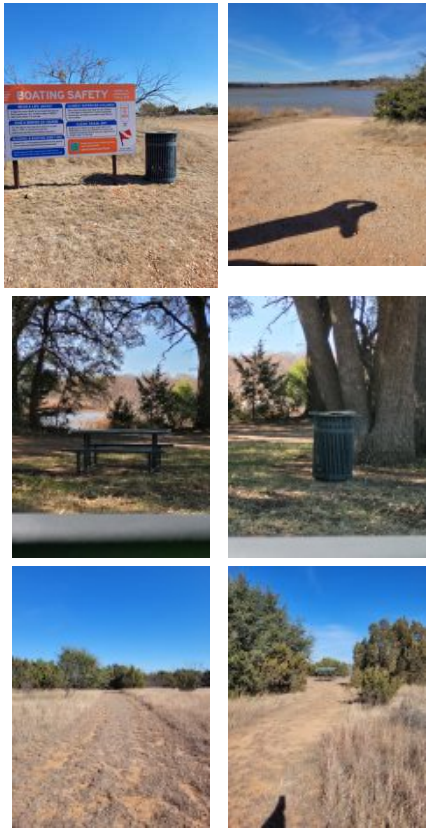
218	Park Site: Park Elements	[32.2334299 , -99.894641 4]	There is no accessible route to the boat ramp, boating safety sign, garbage cans, picnic tables, and grills. At least one accessible route shall connect accessible buildings, accessible facilities, accessible elements, and accessible spaces that are on the same site.	Lacks AR to boat ramp, boating safety sign, 2 garbage cans, 11 of 11 picnic tables, and 6 of 6 grills	Create an accessible route with crushed stone or other outdoor material from parking or walkway to the boat ramp, boating safety sign, 2 picnic tables, and 2 grills. Relocate 20% of garbage cans to be along AR.	2015 ABAAS Section: F206.2.2  2012 TAS Section: 206.2.2  2010 ADAS Section: 206.2.2

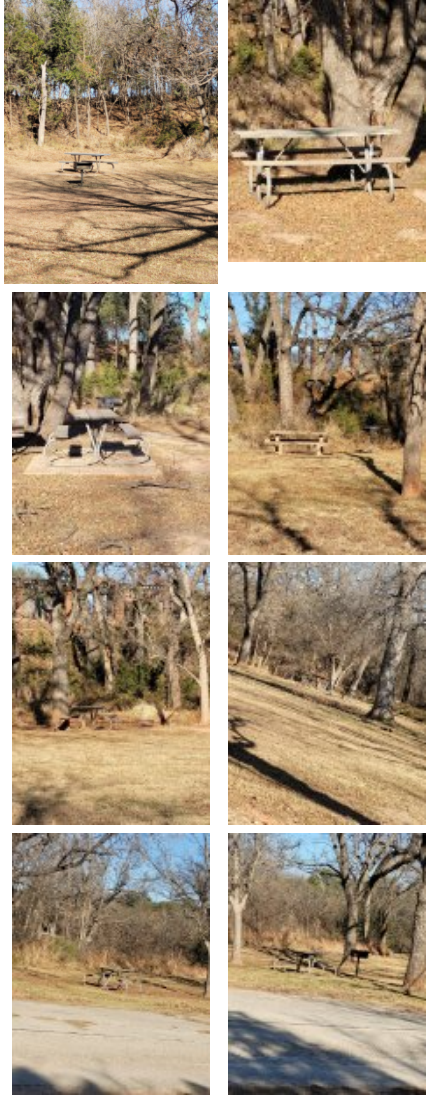
Finding Number	Area Description	Lat/Long	Finding	As Built	Recommendation	Citation	Photos	Figure
220	Park Site: Park Elements	[32.2377792 , -99.881356 4]	There is no accessible route to the picnic tables. At least one accessible route shall connect accessible buildings, accessible facilities, accessible elements, and accessible spaces that are on the same site.	Picnic area behind pool - Lacks AR to 26 of 26 picnic tables	Create an accessible route with crushed stone or other outdoor material from parking or walkway to 6 picnic tables.	2015 ABAAS Section: F206.2.2  2012 TAS Section: 206.2.2  2010 ADAS Section: 206.2.2

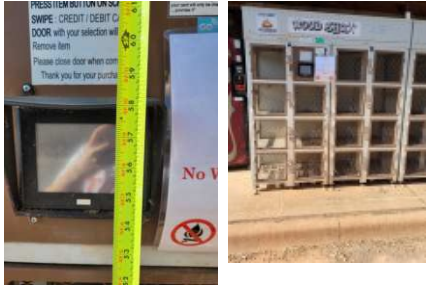
Finding Number	Area Description	Lat/Long	Finding	As Built	Recommendation	Citation	Photos	Figure
222	Park Site: Park Elements	[32.2406082 , -99.879094]	The item is too high and is out of the maximum reach range for a side approach. Where a clear floor or ground space allows a parallel approach to an element and the side reach is unobstructed, the high side reach shall be 48 inches maximum to the finished floor.	Fire wood operable part at 57" AGL	Lower operating mechanisms to max 48" AFF to highest operable part.	2015 ABAAS Section: 308.3.1  2012 TAS Section: 308.3.1  2010 ADAS Section: 308.3.1

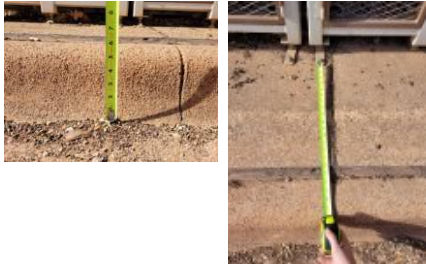
223	Park Site: Park Elements	[32.2407693 , -99.8790926]	Changes in level greater than 1/2 inch (13 mm) high shall be ramped, and shall comply with 405 or 406.	Lacks CFS for firewood lockers due to curb/CIL	Create a curb ramp to be max running slope 8.33%, max cross slope 2.08%, having a top landing as wide as the ramp and 36" deep and side flares with a max slope 10% along the AR where curbs are present.	2015 ABAAS Section: 303.4  2012 TAS Section: 303.4  2010 ADAS Section: 303.4

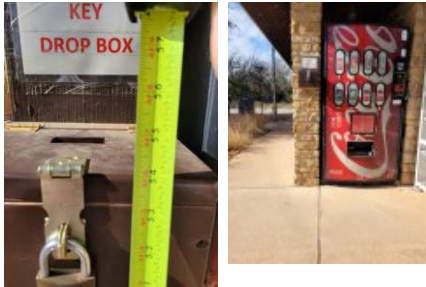
224	Park Site: Park Elements	[32.2406513 , -99.8790926]	The operable part is positioned too high for either a side or front approach. Where a clear floor or ground space allows a parallel approach to an element and the side reach is unobstructed, the high side reach shall be 48 inches maximum and the low side reach shall be 15 inches minimum above the finish floor or ground. Where a forward reach is unobstructed, the high forward reach shall be 48 inches maximum and the low forward reach shall be 15 inches minimum above the finish floor or ground.	Key drop box at 54.5" AFF	Remount operable parts to be in reach range of 15" min to 48" max.	2015 ABAAS Section: 308.1  2012 TAS Section: 308.1  2010 ADAS Section: 308.1

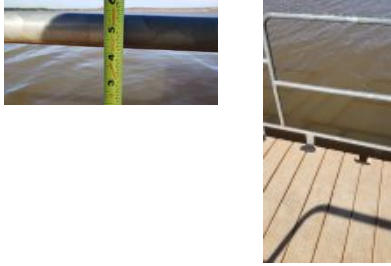
227	Park Site: Fishing/ Fishing Pier	[32.2323942, -99.890219 8]	The required edge protection is not provided. Where compliant railings, guards, or handrails are provided, edge protection shall also be provided. Curbs or barriers shall extend 2 inches minimum above the surface of the fishing pier or platform or The ground or deck surface shall extend 12 inches minimum beyond the inside face of the railing. Toe clearance shall be provided and shall be 30 inches wide minimum and 9 inches minimum above the ground or deck surface beyond the railing.	Height of existing edge protection at 4" AGL	Provide 2" high curb or 12" extended surface beyond railing for edge protection.	2015 ABAAS Section: 1005.3.1, 1005.3.2  2010 ADAS Section: 1005.3.1, 1005.3.2

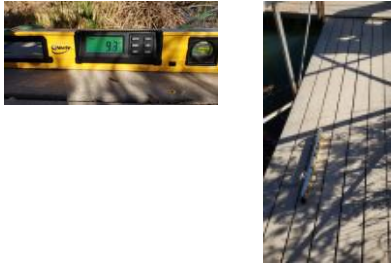
Finding Number	Area Description	Lat/Long	Finding	As Built	Recommendation	Citation	Photos	Figure
228	Park Site: Fishing/ Fishing Pier	[32.232384, -99.890221 1]	The running slope of walking surfaces shall not be steeper than 1:20.	Running slope of 9.3% on fishing pier	Correct running slope along the route to the pier to max 5%.	2015 ABAAS Section: 403.3  2012 TAS Section: 403.3  2010 ADAS Section: 403.3

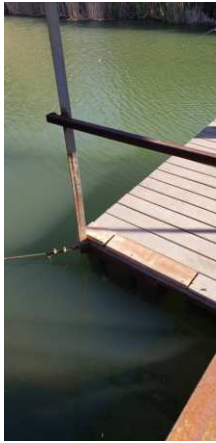
229	Park Site: Fishing/ Fishing Pier	[32.2323068, -99.890210 4]	The required edge protection is not provided. Where compliant railings, guards, or handrails are provided, edge protection shall also be provided. Curbs or barriers shall extend 2 inches minimum above the surface of the fishing pier or platform or The ground or deck surface shall extend 12 inches minimum beyond the inside face of the railing. Toe clearance shall be provided and shall be 30 inches wide minimum and 9 inches minimum above the ground or deck surface beyond the railing.	Fishing pier at Buffalo Wallow pond - Lacks edge protection	Provide 2" high curb or 12" extended surface beyond railing for edge protection.	2015 ABAAS Section: 1005.3.1, 1005.3.2  2010 ADAS Section: 1005.3.1, 1005.3.2

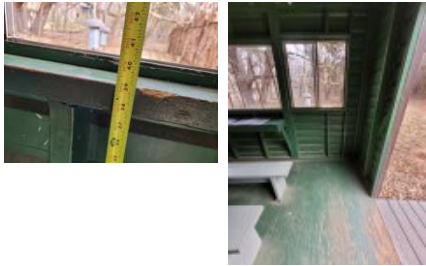
230	Park Site: Bird Blind	[32.2346551, -99.878947 8]	Each distinct viewing location shall provide a viewing space adjacent to the clear ground space required by 1015.2 through which the point of interest is viewable. The viewing space shall be 32 inches (815 mm) maximum and 51 inches (1295 mm) minimum high above the ground and shall extend the full width of the clear ground space. EXCEPTION: Guards or similar safety barriers shall be permitted to obstruct the viewing space to the extent the obstruction is necessary for the guard or safety barrier to serve its intended purpose.	Bird Blind lacks viewing location - window at 40" AFF	Lower a 32" wide portion of railing/window to max 32" for unobstructed viewing as a smart practice.	2015 ABAAS Section: 1015.3, 1015.3 EXCEPTION

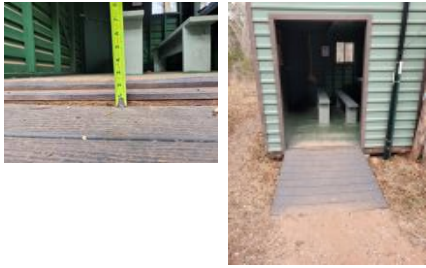
232	Park Site: Bird Blind	[32.23468, -99.8789639]	The walkway contains abrupt vertical edges and/or variations over a 1/4 inch. 1/4 inch is the maximum vertical rise. Changes in level between 1/4 inch and 1/2 inch must be beveled at 1:2 or less. Changes in level greater than 1/2 inch must be by way of a ramp.	2.5" change in level (CIL) at entry to bird blind	Repair, bevel or ramp CIL along AR.	2012 TAS Section: 303.2, 303.3  2010 ADAS Section: 303.2, 303.3

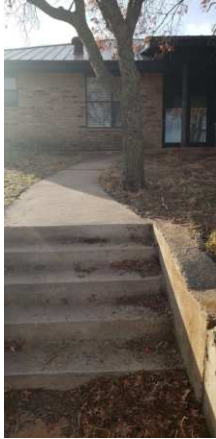
Finding Number	Area Description	Lat/Long	Finding	As Built	Recommendation	Citation	Photos	Figure
233	Park Site: Residence	[32.2313051 , -99.8908407]	The building entrance is not located on an accessible route. When a building, or portion of a building, is required to be accessible, an accessible route of travel shall be provided to all portions of the building, to accessible building entrances and between the building and the public way. All walks, halls, corridors, aisles, skywalks, tunnels, and other spaces that are part of an accessible route must comply. An accessible route of travel must not pass through kitchens, storage rooms, restrooms, closets or other spaces used for similar purposes. At least one accessible route within the boundary of the site must be provided from public transportation stops, accessible parking and accessible passenger loading zones and public streets or sidewalks to the accessible building entrance they serve. The accessible route shall, to the maximum extent feasible, coincide with the route for the general public. At least one accessible route shall connect accessible buildings, facilities, elements and spaces that are on the same site. At least one accessible route shall connect accessible building or facility entrances with all accessible spaces and elements.	Lake residence - Lacks accessible route - stairs access only to entrance	Create AR with crushed and compacted stone or similar outdoor material from parking or sidewalk to building entrance.	2015 ABAAS Section: F206.2.1  2012 TAS Section: 206.2.1  2010 ADAS Section: 206.2.1

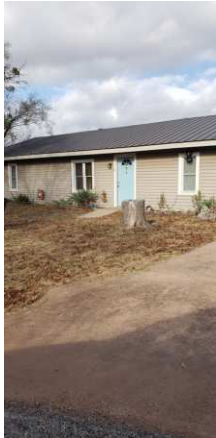
Finding Number	Area Description	Lat/Long	Finding	As Built	Recommendation	Citation	Photos	Figure
234	Park Site: Residence	[32.24055, -99.88159]	The building entrance is not located on an accessible route. When a building, or portion of a building, is required to be accessible, an accessible route of travel shall be provided to all portions of the building, to accessible building entrances and between the building and the public way. All walks, halls, corridors, aisles, skywalks, tunnels, and other spaces that are part of an accessible route must comply. An accessible route of travel must not pass through kitchens, storage rooms, restrooms, closets or other spaces used for similar purposes. At least one accessible route within the boundary of the site must be provided from public transportation stops, accessible parking and accessible passenger loading zones and public streets or sidewalks to the accessible building entrance they serve. The accessible route shall, to the maximum extent feasible, coincide with the route for the general public. At least one accessible route shall connect accessible buildings, facilities, elements and spaces that are on the same site. At least one accessible route shall connect accessible building or facility entrances with all accessible spaces and elements.	Residence closest to maintenance - lacks AR - grass only to entrance	Create AR with crushed and compacted stone or similar outdoor material from parking or sidewalk to building entrance.	2015 ABAAS Section: F206.2.1  2012 TAS Section: 206.2.1  2010 ADAS Section: 206.2.1

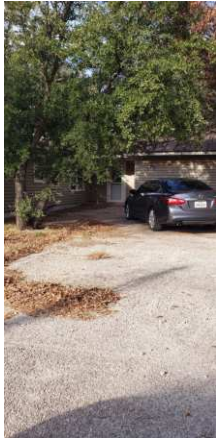
Finding Number	Area Description	Lat/Long	Finding	As Built	Recommendation	Citation	Photos	Figure
235	Park Site: Residence	[32.2397877 , -99.882459]	The building entrance is not located on an accessible route. When a building, or portion of a building, is required to be accessible, an accessible route of travel shall be provided to all portions of the building, to accessible building entrances and between the building and the public way. All walks, halls, corridors, aisles, skywalks, tunnels, and other spaces that are part of an accessible route must comply. An accessible route of travel must not pass through kitchens, storage rooms, restrooms, closets or other spaces used for similar purposes. At least one accessible route within the boundary of the site must be provided from public transportation stops, accessible parking and accessible passenger loading zones and public streets or sidewalks to the accessible building entrance they serve. The accessible route shall, to the maximum extent feasible, coincide with the route for the general public. At least one accessible route shall connect accessible buildings, facilities, elements and spaces that are on the same site. At least one accessible route shall connect accessible building or facility entrances with all accessible spaces and elements.	residence closest to pool- no accessible route, step only at entrance	Create AR with crushed and compacted stone or similar outdoor material from parking or sidewalk to building entrance. Provide a ramp for entry.	2015 ABAAS Section: F206.2.1  2012 TAS Section: 206.2.1  2010 ADAS Section: 206.2.1

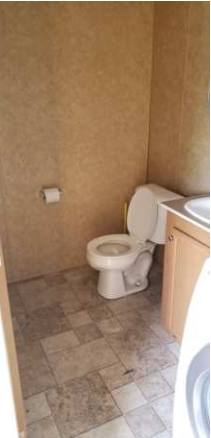
Finding Number	Area Description	Lat/Long	Finding	As Built	Recommendation	Citation	Photos	Figure
236	Park Site: Maintenance	[32.2406241, -99.8811311]	50% of the single accommodation restrooms provided in this grouping are not nearly compliant. The restrooms do not have the required minimum clear floor space or maneuvering clearances for the toilet, The restrooms do not have the required minimum clear floor space or maneuvering clearances for the lavatory, The entry doors do not contain the required minimum maneuvering spaces on the pull/push sides, The entry doors encroach into the required clear floor space for fixtures, Grab bars are missing and/or incorrectly installed, Accessories, such as toilet seat covers, paper towel holders, garbage cans, hand dryers, and mirrors are either too high or without clear floor space or both, The restrooms contain floor level changes greater than a 1/2 inch, the showers are too small and missing numerous accessible elements.	Residence office trailer - Lacks wheelchair accessible restroom	Create compliant wheelchair accessible restrooms and correct all features to be accessible if feasible to meet 50% compliant restrooms in this location.	2015 ABAAS Section: 603.1 2012 TAS Section: 603.1 2010 ADAS Section: 603.1

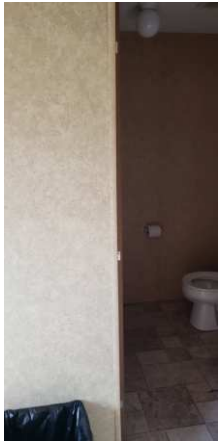
238	Park Site: Maintenance	[32.2406332 , -99.881141 8]	The restroom sign does not comply with one or more applicable requirements for the location, height, and properties of the sign.	Office across from residence - Restroom lacks any signage	Acquire and mount signage, including Braille and access symbol mounted on wall, latch side of door, 48" to baseline of lowest character and 60" to baseline of highest character.	2015 ABAAS Section: F216.2, 703.1, 703.2, 703.5, 703.6  2012 TAS Section: 216.2, 703.1, 703.2, 703.5, 703.6  2010 ADAS Section: 216.2, 703.1, 703.2, 703.5, 703.6

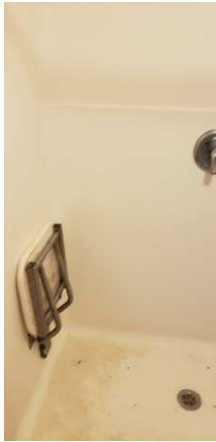
240	Park Site: Maintenance	[32.2405878 , -99.881152 6]	The required grab bars are not provided in the shower compartment. Where a seat is provided in standard roll-in type shower compartments, grab bars shall be provided on the back wall and the side wall opposite the seat. Grab bars shall not be provided above the seat. Where a seat is not provided in standard roll-in type shower compartments, grab bars shall be provided on three walls. Grab bars shall be installed 6 inches maximum from adjacent walls.	Office across residence - Lacks grab bars	Provide grab bars in the shower mounted in the correct locations for the shower type.	2015 ABAAS Section: 608.3.2  2012 TAS Section: 608.3.2  2010 ADAS Section: 608.3.2

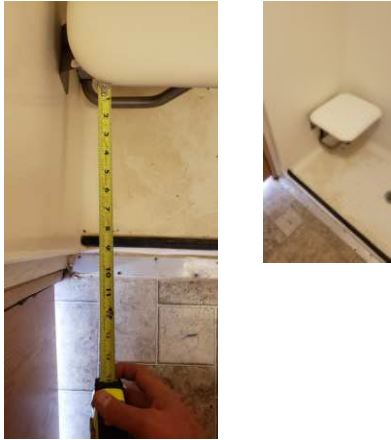
Finding Number	Area Description	Lat/Long	Finding	As Built	Recommendation	Citation	Photos	Figure
241	Park Site: Maintenance	[32.2406105, -99.8811311]	Where a seat is provided in a standard roll-in shower compartment, it shall be a folding type, shall be installed on the side wall adjacent to the controls, and shall extend from the back wall to a point within 3 inches (75 mm) of the compartment entry. Where a seat is provided in an alternate roll-in type shower compartment, it shall be a folding type, shall be installed on the front wall opposite the back wall, and shall extend from the adjacent side wall to a point within 3 inches (75 mm) of the compartment entry. In transfer-type showers, the seat shall extend from the back wall to a point within 3 inches (75 mm) of the compartment entry. The top of the seat shall be 17 inches (430 mm) minimum and 19 inches (485 mm) maximum above the bathroom finish floor. Seats shall comply with 610.3.1 or 610.3.2.	Office across residence - Shower seat 9" from entry	Remount shower seat to within 3" of compartment entry.	2015 ABAAS Section: 610.3  2012 TAS Section: 610.3  2010 ADAS Section: 610.3

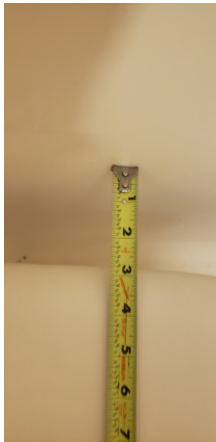
242	Park Site: Maintenance	[32.240606, -99.8811311]	The shower seat does not have a compliant space between it and the seat wall. The folding seat must be mounted 17-19 inches above the floor, and have a maximum space of 2-1/2 inches between the edge of the seat and the seat wall and 1-1/2 inches maximum to the side wall.	Office across residence - 3" from side wall	Remount shower seat to the correct location and height in the shower.	2015 ABAAS Section: 610.3.1  2012 TAS Section: 610.3.1  2010 ADAS Section: 610.3.1
