# Access Audit Site Report

**Abilene State Park**

**Accessibility Evaluation**

**Inspection Date: 12/14/2021**

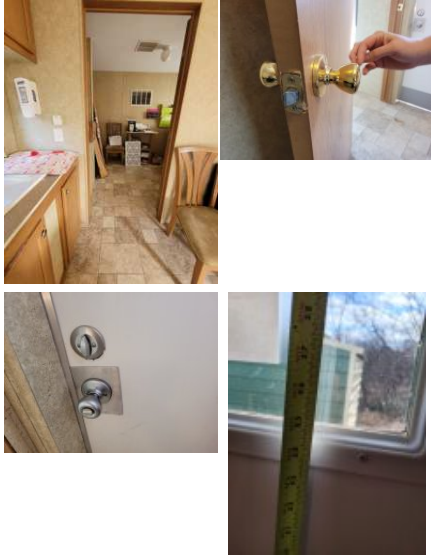
Finding Number	Area Description	Lat/Long	Finding	As Built	Recommendation	Citation	Photos	Figure
247	Park Site: Maintenance	[32.2406264 , -99.8811016]	Spaces and elements within employee work areas shall only be required to comply with 206.2.8, 207.1, and 215.3 and shall be designed and constructed so that individuals with disabilities can approach, enter, and exit the employee work area. Employee work areas, or portions of employee work areas, other than raised courtroom stations, that are less than 300 square feet (28 m2) and elevated 7 inches (180 mm) or more above the finish floor or ground where the elevation is essential to the function of the space shall not be required to comply with these requirements or to be on an accessible route.	Work space across from residence: door to office off of kitchen - lacks maneuvering clearance on push and pull sides Door on farther end - knob Entry door - knob, vision window at 55" AFF	For employee spaces, relocate storage, furniture, and other obstacles at doorways to provide approach, enter and exit at the employee space. Provide required maneuvering clearance on push and pull side of doors. Replace hardware with lever hardware or hardware operable without a tight pinch or grasp. Replace doors with ones having sidelight viewing windows max 43" AFF.	2015 ABAAS Section: F203.9 2012 TAS Section: 203.9 2010 ADAS Section: 203.9

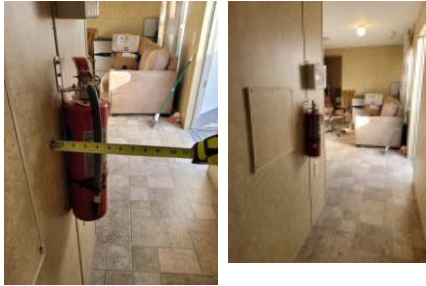
Finding Number	Area Description	Lat/Long	Finding	As Built	Recommendation	Citation	Photos	Figure
248	Park Site: Maintenance	[32.240615, -99.881104 3]	Employee Work Areas. Common use circulation paths within employee work areas shall comply with 402. EXCEPTIONS: 1. Common use circulation paths located within employee work areas that are less than 1000 square feet (93 m2) and defined by permanently installed partitions, counters, casework, or furnishings shall not be required to comply with 402. 2. Common use circulation paths located within employee work areas that are an integral component of work area equipment shall not be required to comply with 402. 3. Common use circulation paths located within exterior employee work areas that are fully exposed to the weather shall not be required to comply with 402.	Work space across from residence - Fire extinguisher protrudes 4.5" in hallway	Make corrections for compliant circulation path.	2015 ABAAS Section: F206.2.8, F206.2.8.1, F206.2.8.2  2012 TAS Section: 206.2.8, 206.2.8 Exception 1, 206.2.8 Exception 2, 206.2.8 Exception 3, 206.2.8 Advisory 1, 206.2.8 Advisory 2  2010 ADAS Section: 206.2.8, 206.2.8 Exception 1, 206.2.8 Exception 2, 206.2.8 Exception 3

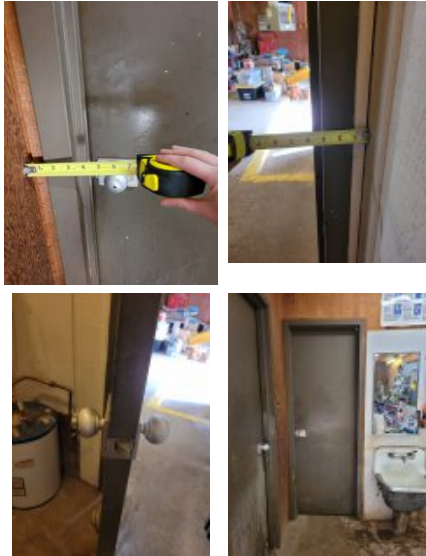
Finding Number	Area Description	Lat/Long	Finding	As Built	Recommendation	Citation	Photos	Figure
251	Park Site: Maintenance	[32.2415089, -99.8806]	Minimum maneuvering clearances at doors and gates shall comply with 404.2.4. Maneuvering clearances shall extend the full width of the doorway and the required latch side or hinge side clearance. Hand-activated door opening hardware, handles, pulls, latches, locks, and other operating devices on accessible doors shall have a shape that is easy to grasp with one hand and does not require tight grasping, tight pinching or twisting of the wrist to operate. Hardware shall be 34 inches minimum and 48 inches maximum above the finish floor or ground.	Restroom door - knob, lacks clearance on push and pull sides due to wall	For all doors along the public circulation route, provide required maneuvering clearance on push and pull side of doors. For all doors along the public circulation route, replace hardware with lever hardware or hardware operable without a tight pinch or grasp.	2010 ADAS Section: 404.2.3, 404.2.7, 404.2.4, 404.2.11, 404.2.11 Exception

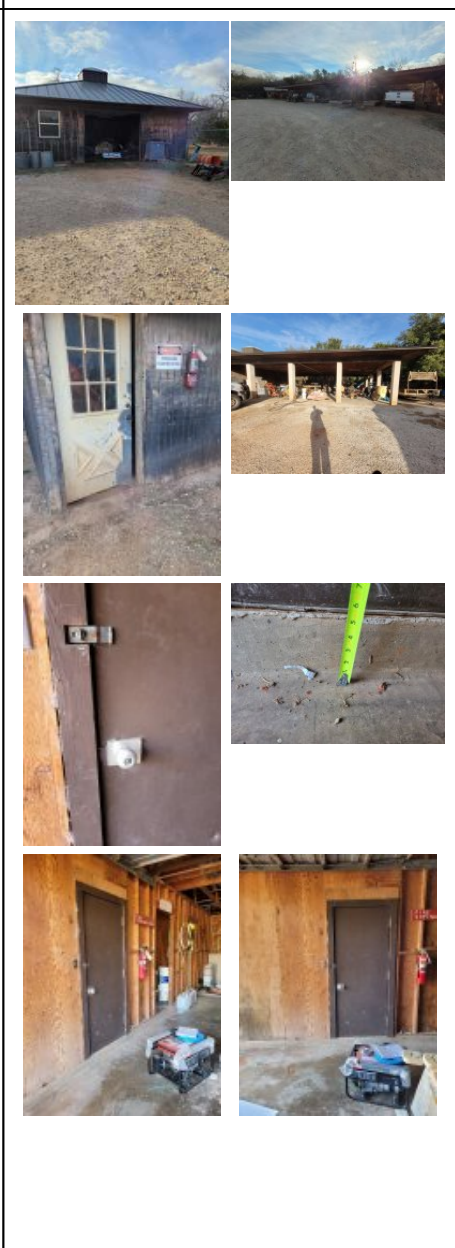
Finding Number	Area Description	Lat/Long	Finding	As Built	Recommendation	Citation	Photos	Figure
252	Park Site: Maintenance	[32.2411958 , -99.880347 9]	Spaces and elements within employee work areas shall only be required to comply with 206.2.8, 207.1, and 215.3 and shall be designed and constructed so that individuals with disabilities can approach, enter, and exit the employee work area. Employee work areas, or portions of employee work areas, other than raised courtroom stations, that are less than 300 square feet (28 m2) and elevated 7 inches (180 mm) or more above the finish floor or ground where the elevation is essential to the function of the space shall not be required to comply with these requirements or to be on an accessible route.	Lacks AR to shed and garage bays, storage shed at end has knob, backside of main building under awning lacks AR, larger shed, within - door has knob	For employee spaces, relocate storage, furniture, and other obstacles at doorways to provide approach, enter and exit at the employee space. Replace hardware with lever hardware or hardware operable without a tight pinch or grasp. Provide stable parking pad at outbuildings for use by an employee with a parking placard.	2015 ABAAS Section: F203.9 2012 TAS Section: 203.9 2010 ADAS Section: 203.9

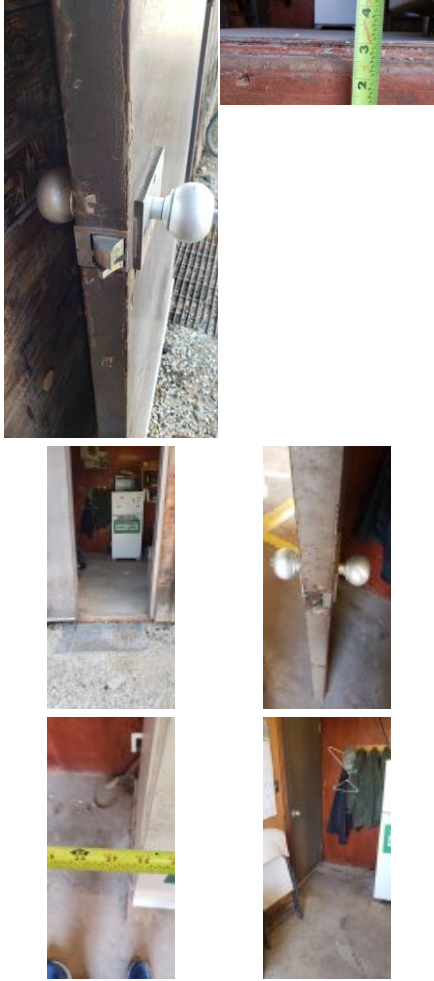
Finding Number	Area Description	Lat/Long	Finding	As Built	Recommendation	Citation	Photos	Figure
253	Park Site: Maintenance	[32.2414771 , -99.880664 4]	Spaces and elements within employee work areas shall only be required to comply with 206.2.8, 207.1, and 215.3 and shall be designed and constructed so that individuals with disabilities can approach, enter, and exit the employee work area. Employee work areas, or portions of employee work areas, other than raised courtroom stations, that are less than 300 square feet (28 m2) and elevated 7 inches (180 mm) or more above the finish floor or ground where the elevation is essential to the function of the space shall not be required to comply with these requirements or to be on an accessible route.	Entrance door - knob, 3.5" change in level (CIL), metal grate Door to Garage - knobs on both sides, fridge and chairs in pull side MC Storage closet door - items stored in push side MC	For employee spaces, relocate storage, furniture, and other obstacles at doorways to provide approach, enter and exit at the employee space. Provide required maneuvering clearance on push and pull side of doors. Remove metal grate at door to prevent trip hazard. Repair, bevel, or ramp CILs at door entries to max .25". Replace hardware with lever hardware or hardware operable without a tight pinch or grasp.	2015 ABAAS Section: F203.9 2012 TAS Section: 203.9 2010 ADAS Section: 203.9

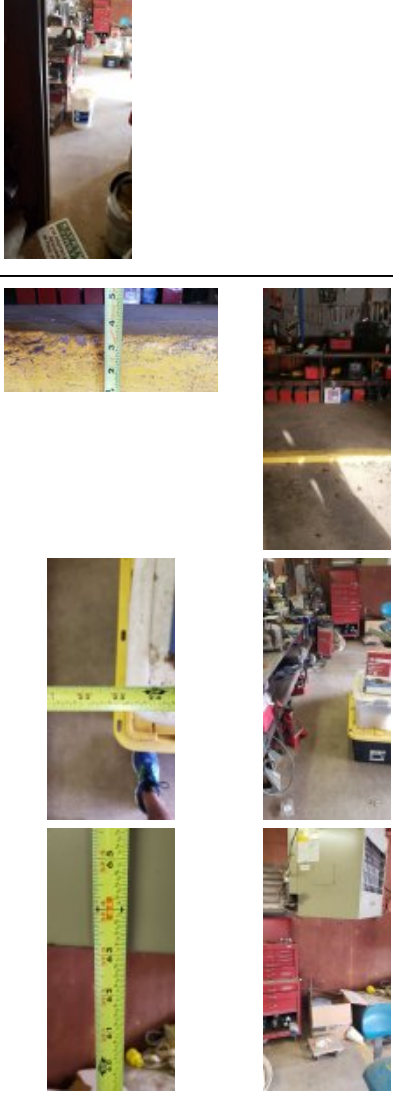
Finding Number	Area Description	Lat/Long	Finding	As Built	Recommendation	Citation	Photos	Figure
254	Park Site: Maintenance	[32.2415043, -99.8805303]	Employee Work Areas. Common use circulation paths within employee work areas shall comply with 402. EXCEPTIONS: 1. Common use circulation paths located within employee work areas that are less than 1000 square feet (93 m2) and defined by permanently installed partitions, counters, casework, or furnishings shall not be required to comply with 402. 2. Common use circulation paths located within employee work areas that are an integral component of work area equipment shall not be required to comply with 402. 3. Common use circulation paths located within exterior employee work areas that are fully exposed to the weather shall not be required to comply with 402.	Office - 3.5" curb stop, containers in circulation path, heater at 63" AFF	Make corrections for compliant circulation path. Remount operable parts of heater to be in reach range of 15" min to 48" max. Repair, bevel or ramp CIL along accessible route (AR) to max .25". Relocate storage to widen AR to compliant 36" clear width.	2015 ABAAS Section: F206.2.8, F206.2.8.1, F206.2.8.2  2012 TAS Section: 206.2.8, 206.2.8 Exception 1, 206.2.8 Exception 2, 206.2.8 Exception 3, 206.2.8 Advisory 1, 206.2.8 Advisory 2  2010 ADAS Section: 206.2.8, 206.2.8 Exception 1, 206.2.8 Exception 2, 206.2.8 Exception 3

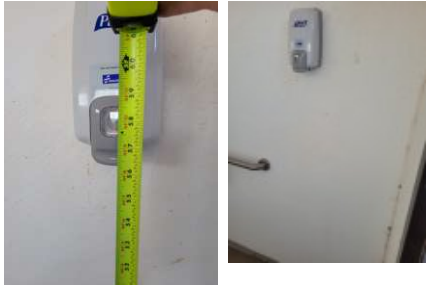
Finding Number	Area Description	Lat/Long	Finding	As Built	Recommendation	Citation	Photos	Figure
255	Restrooms: Boat Ramp Restrooms	[32.2323205 , -99.895153 7]	The operable part is positioned too high for either a side or front approach. Where a clear floor or ground space allows a parallel approach to an element and the side reach is unobstructed, the high side reach shall be 48 inches maximum and the low side reach shall be 15 inches minimum above the finish floor or ground. Where a forward reach is unobstructed, the high forward reach shall be 48 inches maximum and the low forward reach shall be 15 inches minimum above the finish floor or ground.	Hand sanitizer at 56.5" AFF	Remount operable parts to be in reach range of 15" min to 48" max.	2015 ABAAS Section: 308.1  2012 TAS Section: 308.1  2010 ADAS Section: 308.1

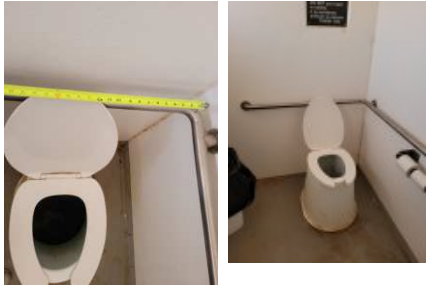
Finding Number	Area Description	Lat/Long	Finding	As Built	Recommendation	Citation	Photos	Figure
258	Restrooms: Boat Ramp Restrooms	[32.2323023 , -99.895164 4]	The rear grab bar is not 36" long or is not mounted in the correct location. The rear grab bar must be a minimum of 36" long and extend from the toilet centerline a minimum 12" towards the wall side and a minimum 24" towards the open side of the toilet. Grab bars shall be installed in a horizontal position, 33 inches minimum and 36 inches maximum above the finish floor measured to the top of the gripping surface and the space between the grab bar and the top of the tank shall be 1-1/2 inches minimum.	16" to toilet centerline	Remount rear grab bar to behind the toilet, 12" to one side of center and 24" to the other and 33" to 36" AFF.	2015 ABAAS Section: 604.5.2  2012 TAS Section: 604.5.2  2010 ADAS Section: 604.5.2

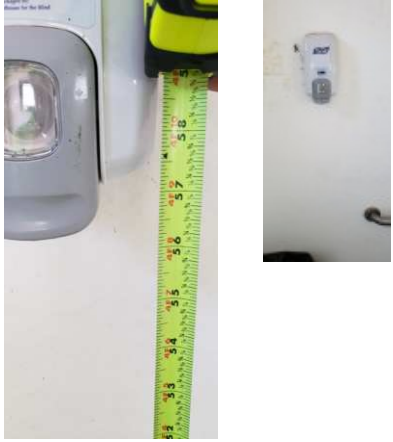
260	Restrooms: Boat Ramp Restrooms	[32.2322887 , -99.895148 3]	The operable part is positioned too high for either a side or front approach. Where a clear floor or ground space allows a parallel approach to an element and the side reach is unobstructed, the high side reach shall be 48 inches maximum and the low side reach shall be 15 inches minimum above the finish floor or ground. Where a forward reach is unobstructed, the high forward reach shall be 48 inches maximum and the low forward reach shall be 15 inches minimum above the finish floor or ground.	Hand sanitizer dispenser at 57" AFF	Remount operable parts to be in reach range of 15" min to 48" max.	2015 ABAAS Section: 308.1  2012 TAS Section: 308.1  2010 ADAS Section: 308.1

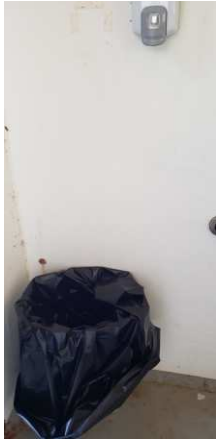
Finding Number	Area Description	Lat/Long	Finding	As Built	Recommendation	Citation	Photos	Figure
261	Restrooms: Boat Ramp Restrooms	[32.2322887 , -99.8951456]	The operable part is not accessible because there is not adequate clear floor space for either a forward or side approach. The clear floor or ground space shall be 30 inches minimum by 48 inches minimum.	Garbage can in CFS of hand sanitizer dispenser	Remove, or relocate storage in CFS at fixtures and operable parts along the AR.	2015 ABAAS Section: 305.3 2012 TAS Section: 305.3 2010 ADAS Section: 305.3

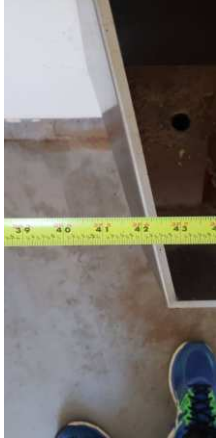
262	Restrooms: Boat Ramp Restrooms	[32.2322853 , -99.895143]	The required 56 inches by 60 inches clear floor space for the water closet has been obstructed. The clear floor space around the water closet shall be 60 inches minimum measured perpendicular from the side wall and 56 inches minimum measured perpendicular from the rear wall.	Urinal is 42" from toilet, obstructs CFS	Renovate restroom to provide 60" by 56" clearance around the toilet.	2015 ABAAS Section: 604.3. 2012 TAS Section: 604.3.1 2010 ADAS Section: 604.3.1

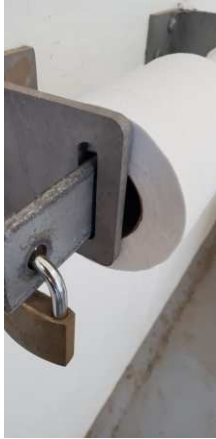
Finding Number	Area Description	Lat/Long	Finding	As Built	Recommendation	Citation	Photos	Figure
263	Restrooms: Boat Ramp Restrooms	[32.2322751 , -99.895153 7]	The toilet paper dispenser does not allow a continuous flow. Toilet paper dispensers shall be 7 inches minimum and 9 inches maximum in front of the water closet measured to the centerline of the dispenser. The outlet of the dispenser shall be 15 inches minimum and 48 inches maximum above the finish floor and shall not be located behind grab bars. Dispensers shall not be of a type that controls delivery or that does not allow continuous paper flow. There shall be a clearance of 1 1/2 inches minimum below the grab bar.	TP dispenser does not allow a continuous flow	Replace toilet paper dispenser with one that provides continuous flow of paper.	2015 ABAAS Section: 604.7 2012 TAS Section: 604.7 2010 ADAS Section: 604.7

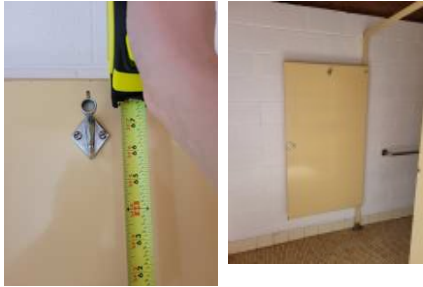
266	Restrooms: Star Restrooms (Within Picnic Area) - Women's Restroom	[32.2367287 , -99.877712 6]	The operable part is positioned too high for either a side or front approach. Where a clear floor or ground space allows a parallel approach to an element and the side reach is unobstructed, the high side reach shall be 48 inches maximum and the low side reach shall be 15 inches minimum above the finish floor or ground. Where a forward reach is unobstructed, the high forward reach shall be 48 inches maximum and the low forward reach shall be 15 inches minimum above the finish floor or ground.	Hook in stall at 66" AFF	Remount operable parts to be in reach range of 15" min to 48" max.	2015 ABAAS Section: 308.1  2012 TAS Section: 308.1  2010 ADAS Section: 308.1

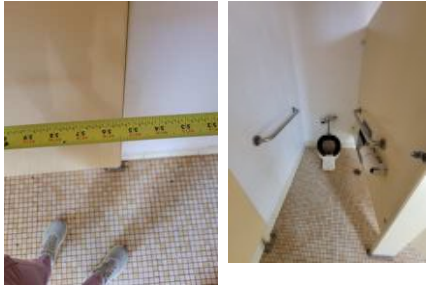
Finding Number	Area Description	Lat/Long	Finding	As Built	Recommendation	Citation	Photos	Figure
268	Restrooms: Star Restrooms (Within Picnic Area) - Women's Restroom	[32.2367129 , -99.877723 3]	The ambulatory stall is not between 35" to 37" wide and 60" deep.	Ambulatory stall is 36" by 55.5"	Correct ambulatory stall to be 35" to 37" wide and minimum 60" deep. In the alternative, use existing ambulatory stall to create required wheelchair stall.	2015 ABAAS Section: 604.8.2.1  2012 TAS Section: 604.8.2.1  2010 ADAS Section: 604.8.2.1

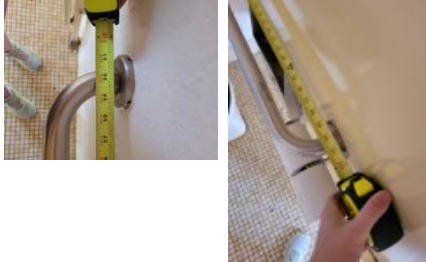
Finding Number	Area Description	Lat/Long	Finding	As Built	Recommendation	Citation	Photos	Figure
270	Restrooms: Star Restrooms (Within Picnic Area) - Women's Restroom	[32.2367265 , -99.877740 8]	Grab bars shall comply with 609. A side-wall grab bar complying with 604.5.1 shall be provided on both sides of the compartment. The space between the wall and the grab bar shall be 1½ inches (38 mm). The space between the grab bar and projecting objects below and at the ends shall be 1½ inches (38 mm) minimum. The space between the grab bar and projecting objects above shall be 12 inches (305 mm) minimum. Grab bars shall be installed in a horizontal position, 33 inches (840 mm) minimum and 36 inches (915 mm) maximum above the finish floor measured to the top of the gripping surface, except that at water closets for children's use complying with 604.9, grab bars shall be installed in a horizontal position 18 inches (455 mm) minimum and 27 inches (685 mm) max	Both grab bars are 30" long	Replace side grab bars with a 42" long grab bar, mounted max 12" from the rear wall at the close end and min 54" on the far end and 33" to 36" AFF.	2015 ABAAS Section: 604.8.2.3, 609.3, 609.4  2012 TAS Section: 609.4, 609.3, 604.8.2.3  2010 ADAS Section: 609.3, 609.4, 604.8.2.3

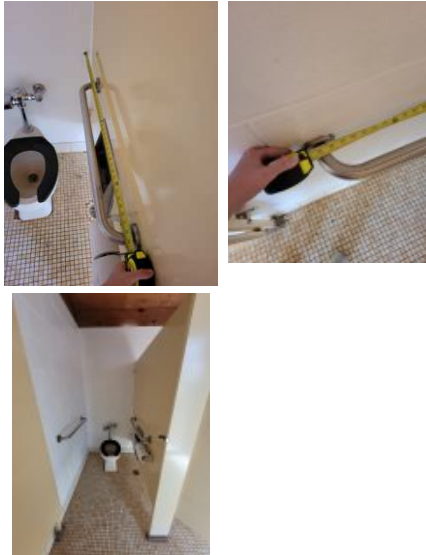
271	Restrooms: Star Restrooms (Within Picnic Area) - Women's Restroom	[32.2367174 , -99.877708 6]	The side grab bars are not in the correct location. Grab bars on the side wall must be installed so that the end closest to the rear wall is maximum 12" from the rear wall. The end furthest from the rear wall must be mounted minimum 54" from the rear wall.	Both bars end 43" from rear wall	Remount side grab bar to max 12" from the rear wall at the close end and min 54" on the far end, and 33" to 36" AFF. See previous finding for cost.	2015 ABAAS Section: 604.5.1  2012 TAS Section: 604.5.1  2010 ADAS Section: 604.5.1

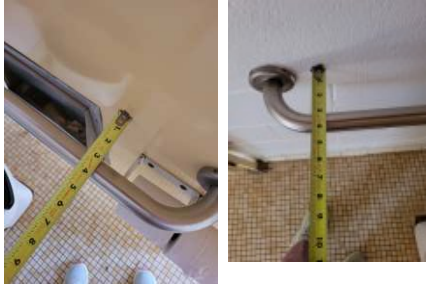
Finding Number	Area Description	Lat/Long	Finding	As Built	Recommendation	Citation	Photos	Figure
272	Restrooms: Star Restrooms (Within Picnic Area) - Women's Restroom	[32.2366856 , -99.877762 2]	The grab bar height and/or spacing fails. Grab bars must be mounted between 33" and 36" to the top of the gripping surface. There must be 1.5" of clearance between the grab bar and the wall. There must be a minimum of 1.5" of clearance below and minimum 12" above the grab bar to any dispenser or other obstruction.	3" between bars and wall	Replace grab bars per previous finding and assure gap between bar and wall in max 1.5".	2015 ABAAS Section: 609.3, 609.4  2012 TAS Section: 609.4, 609.3  2010 ADAS Section: 609.3, 609.4

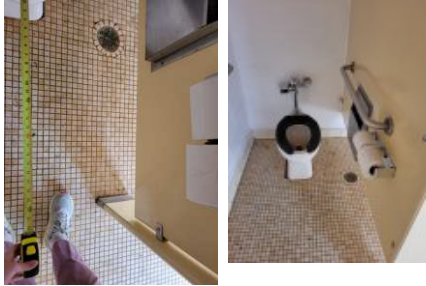
273	Restrooms: Star Restrooms (Within Picnic Area) - Women's Restroom	[32.2367446 , -99.877738 1]	The toilet paper is not installed within the compliant range in front of the toilet. Toilet paper dispensers shall be 7 inches minimum and 9 inches maximum in front of the water closet measured to the centerline of the dispenser. The outlet of the dispenser shall be 15 inches minimum and 48 inches maximum above the finish floor and shall not be located behind grab bars. Dispensers shall not be of a type that controls delivery or that does not allow continuous paper flow. There shall be a clearance of 1 1/2 inches minimum below the grab bar.	TP too far from front of toilet	Remount toilet paper dispenser max 7" to 9" from front of toilet, 15" to 48" AFF and min 12" above or 1.5" below grab bar.	2015 ABAAS Section: 604.7  2012 TAS Section: 604.7  2010 ADAS Section: 604.7

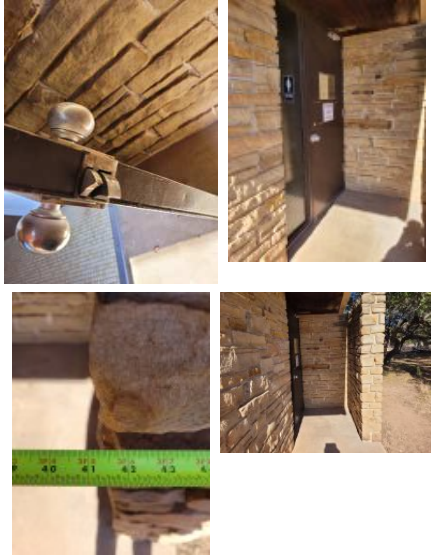
Finding Number	Area Description	Lat/Long	Finding	As Built	Recommendation	Citation	Photos	Figure
275	Restrooms: Star Restrooms (Within Picnic Area) - Women's Restroom	[32.2366924 , -99.877724 7]	Minimum maneuvering clearances at doors and gates shall comply with 404.2.4. Maneuvering clearances shall extend the full width of the doorway and the required latch side or hinge side clearance. Exterior doors are recommended to be maintained at 8.5 lbf as a smart practice. Force is to be measured at the operating hardware or 30 inches from the hinges, whichever is greater. Hand-activated door opening hardware, handles, pulls, latches, locks, and other operating devices on accessible doors shall have a shape that is easy to grasp with one hand and does not require tight grasping, tight pinching or twisting of the wrist to operate. Hardware shall be 34 inches minimum and 48 inches maximum above the finish floor or ground.	Restroom door - knob hardware, 11# push, width of clearance reduced to 41" on approach	For all doors along the public circulation route, provide required maneuvering clearance on push and pull side of doors. For all doors along the public circulation route, inspect, adjust, and maintain 8.5 lbf to open exterior doors as a smart practice. For all doors along the public circulation route, replace hardware with lever hardware or hardware operable without a tight pinch or grasp.	2010 ADAS Section: 404.2.3, 404.2.7, 404.2.4, 404.2.11, 404.2.11 Exception

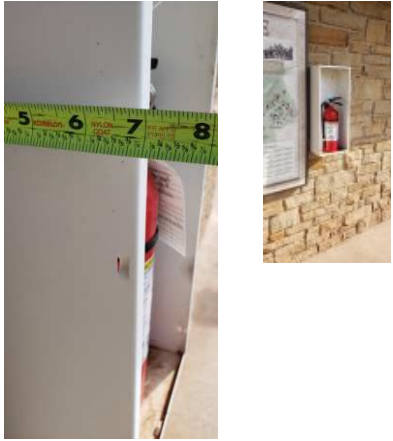
276	Restrooms: Star Restrooms (Within Picnic Area) - Men's Restroom	[32.2367129 , -99.877719 3]	An object or objects project more than 4 inches into the circulation path. Wall-mounted objects that have leading edges between 27 inches and 80 inches from the floor must not project more than 4 inches into the circulation path. Protruding objects that extend to the floor or within 27 inches of the floor are cane detectable and are therefore not hazardous. Where it is necessary or desirable to have objects protrude from the wall, a manner of cane detection must be provided.	Fire extinguisher protrudes 7"	Relocate protruding objects or place cane detectable warning or bollard at foot of item.	2015 ABAAS Section: 307.2 2012 TAS Section: 307.2 2010 ADAS Section: 307.2

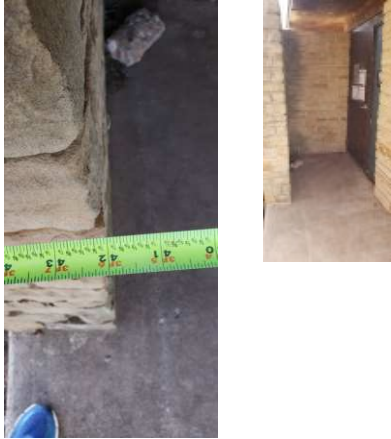
Finding Number	Area Description	Lat/Long	Finding	As Built	Recommendation	Citation	Photos	Figure
277	Restrooms: Star Restrooms (Within Picnic Area) - Men's Restroom	[32.2367287 , -99.877708 6]	Minimum maneuvering clearances at doors and gates shall comply with 404.2.4. Maneuvering clearances shall extend the full width of the doorway and the required latch side or hinge side clearance. Exterior doors are recommended to be maintained at 8.5 lbf as a smart practice. Force is to be measured at the operating hardware or 30 inches from the hinges, whichever is greater.	Restroom door - 20# push, wall in pull side clearance	For all doors along the public circulation route, provide required maneuvering clearance on push and pull side of doors. For all doors along the public circulation route, inspect, adjust, and maintain 8.5 lbf to open exterior doors as a smart practice.	2010 ADAS Section: 404.2.3, 404.2.7, 404.2.4, 404.2.11, 404.2.11 Exception

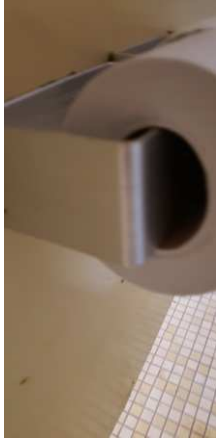
278	Restrooms: Star Restrooms (Within Picnic Area) - Men's Restroom	[32.2367356 , -99.877738 1]	The toilet paper dispenser does not allow a continuous flow. Toilet paper dispensers shall be 7 inches minimum and 9 inches maximum in front of the water closet measured to the centerline of the dispenser. The outlet of the dispenser shall be 15 inches minimum and 48 inches maximum above the finish floor and shall not be located behind grab bars. Dispensers shall not be of a type that controls delivery or that does not allow continuous paper flow. There shall be a clearance of 1 1/2 inches minimum below the grab bar.	TP dispenser does not allow a continuous flow	Replace toilet paper dispenser with one that provides continuous flow of paper.	2015 ABAAS Section: 604.7  2012 TAS Section: 604.7  2010 ADAS Section: 604.7

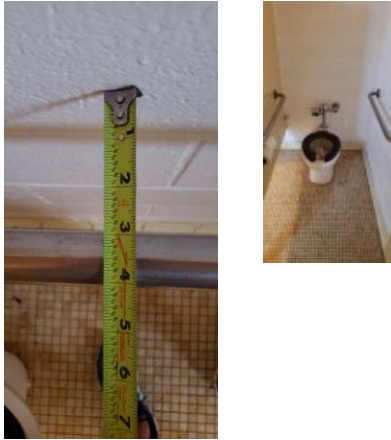
Finding Number	Area Description	Lat/Long	Finding	As Built	Recommendation	Citation	Photos	Figure
279	Restrooms: Star Restrooms (Within Picnic Area) - Men's Restroom	[32.236731, -99.877703 2]	The grab bar height and/or spacing fails. Grab bars must be mounted between 33" and 36" to the top of the gripping surface. There must be 1.5" of clearance between the grab bar and the wall. There must be a minimum of 1.5" of clearance below and minimum 12" above the grab bar to any dispenser or other obstruction.	Bars are 3" from wall	Replace grab bars per previous finding and assure gap between bar and wall in max 1.5". See previous finding for cost.	2015 ABAAS Section: 609.3, 609.4  2012 TAS Section: 609.4, 609.3  2010 ADAS Section: 609.3, 609.4

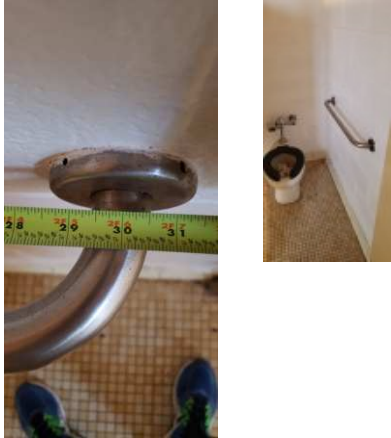
280	Restrooms: Star Restrooms (Within Picnic Area) - Men's Restroom	[32.2367401, -99.877724 7]	Grab bars shall comply with 609. A side-wall grab bar complying with 604.5.1 shall be provided on both sides of the compartment. The space between the wall and the grab bar shall be 1½ inches (38 mm). The space between the grab bar and projecting objects below and at the ends shall be 1½ inches (38 mm) minimum. The space between the grab bar and projecting objects above shall be 12 inches (305 mm) minimum. Grab bars shall be installed in a horizontal position, 33 inches (840 mm) minimum and 36 inches (915 mm) maximum above the finish floor measured to the top of the gripping surface, except that at water closets for children's use complying with 604.9, grab bars shall be installed in a horizontal position 18 inches (455 mm) minimum and 27 inches (685 mm) max	Bars are 30" long	Replace or add side grab bars with a 42" long grab bar, mounted max 12" from the rear wall at the close end and min 54" on the far end and 33" to 36" AFF.	2015 ABAAS Section: 604.8.2.3, 609.3, 609.4  2012 TAS Section: 609.4, 609.3, 604.8.2.3  2010 ADAS Section: 609.3, 609.4, 604.8.2.3

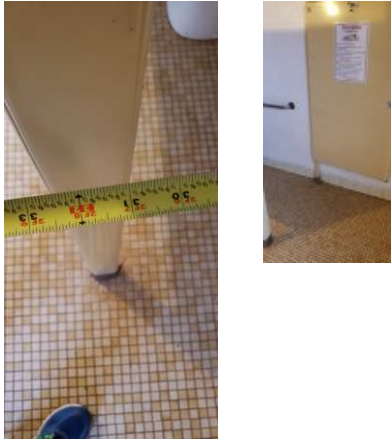
Finding Number	Area Description	Lat/Long	Finding	As Built	Recommendation	Citation	Photos	Figure
281	Restrooms: Star Restrooms (Within Picnic Area) - Men's Restroom	[32.2367174, -99.8777247]	The stall door fails to comply with all of the door requirements. The stall door must be a minimum of 32" wide and have compliant hardware on both sides. The stall door must be self-closing.	Ambulatory stall door is 31" wide and is not self-closing	Widen stall doors to 32" when opened to 90 degrees. Adjust stall door to be self-closing.	2015 ABAAS Section: 404.2.3, 404.2.7, 604.8.2.2  2012 TAS Section: 404.2.3, 404.2.7, 604.8.2.2  2010 ADAS Section: 404.2.3, 404.2.7, 604.8.2.2

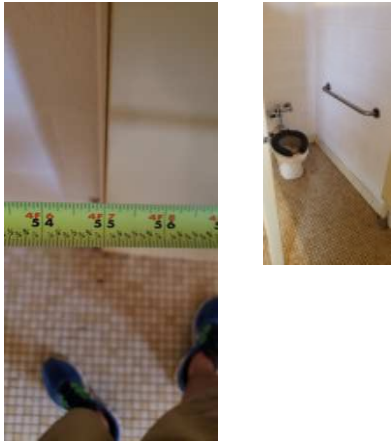
282	Restrooms: Star Restrooms (Within Picnic Area) - Men's Restroom	[32.236731, -99.8777274]	The ambulatory stall is not between 35" to 37" wide and 60" deep.	Ambulatory stall is 55" deep	Correct ambulatory stall to be 35" to 37" wide and minimum 60" deep. In the alternative, use existing ambulatory stall to create required wheelchair stall.	2015 ABAAS Section: 604.8.2.1  2012 TAS Section: 604.8.2.1  2010 ADAS Section: 604.8.2.1

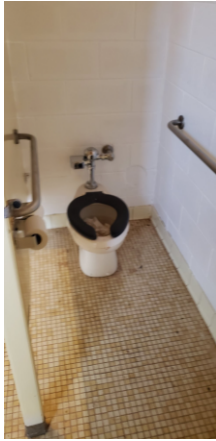
Finding Number	Area Description	Lat/Long	Finding	As Built	Recommendation	Citation	Photos	Figure
283	Restrooms: Star Restrooms (Within Picnic Area) - Men's Restroom	[32.2367163 , -99.877724 7]	There are not enough accessible toilet compartments. The room contains several toilet compartments. A minimum of 1 must be wheelchair accessible .	Ambulatory stall only	Create a wheelchair accessible stall with grab bars and fixtures mounted in correct locations and at correct heights.	2015 ABAAS Section: F213.3.1  2012 TAS Section: 213.3.1  2010 ADAS Section: 213.3.1

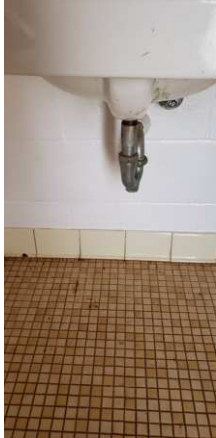
284	Restrooms: Star Restrooms (Within Picnic Area) - Men's Restroom	[32.2367129 , -99.877719 3]	The water and drain pipes under the lavatory are not adequately insulated. Water supply and drain pipes under lavatories and sinks shall be insulated or otherwise configured to protect against contact. There shall be no sharp or abrasive surfaces under lavatories and sinks.	Sink lacks insulated pipes	Insulate exposed pipes under one sink.	2015 ABAAS Section: 606.5  2012 TAS Section: 606.5  2010 ADAS Section: 606.5

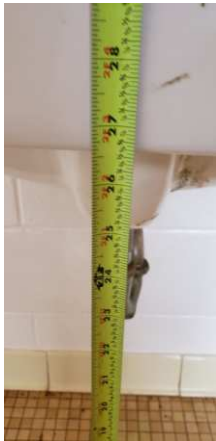
Finding Number	Area Description	Lat/Long	Finding	As Built	Recommendation	Citation	Photos	Figure
285	Restrooms: Star Restrooms (Within Picnic Area) - Men's Restroom	[32.236731, -99.877726]	The self closing faucet controls do not stay open for a minimum of 10 seconds. Faucet controls and operating mechanisms shall be operable with one hand and shall not require tight grasping, pinching or twisting of the wrist. The force required to activate controls shall be no greater than 5 lb. Lever-operated, push-type and electronically controlled mechanisms are examples of acceptable designs. Self-closing valves are allowed if the faucet remains open for at least 10 seconds.	Sink inoperable, unable to test	Adjust timing of sink faucets to remain on for min 10 seconds.	2015 ABAAS Section: 606.4  2012 TAS Section: 606.4  2010 ADAS Section: 606.4		
286	Restrooms: Star Restrooms (Within Picnic Area) - Men's Restroom	[32.2367129, -99.8777086]	Knee clearance at 27 inches off the floor is not 8 inches minimum deep. The knee clearance, measured from the bottom of the apron or the outside bottom edge of the lavatory, must be 27 inches at a point located 8 inches back from the front edge and continuing to 11 inches minimum in depth at 9 inches above the floor. The top of the lavatory rim may be no higher than 34 inches.	Sink lacks knee clearance	Replace sink with one providing 27" knee clearance that is a min 8" deep.	2015 ABAAS Section: 306.3.1, 306.3.2, 306.3.3, 306.3.4, 306.3.5  2012 TAS Section: 306.3.2, 306.3.3, 306.3.4, 306.3.5, 306.3.1  2010 ADAS Section: 306.3.3, 306.3.2, 306.3.4, 306.3.5, 306.3.1

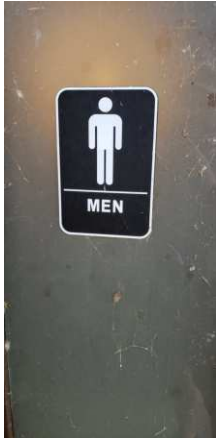
Finding Number	Area Description	Lat/Long	Finding	As Built	Recommendation	Citation	Photos	Figure
287	Restrooms: Star Restrooms (Within Picnic Area) - Men's Restroom	[32.2367356 , -99.877727 4]	The tactile restroom wall sign is missing the International Symbol of Accessibility (ISA). Accessible toilet rooms or bathing rooms shall be identified by the International Symbol of Accessibility (ISA). Wall signs identifying permanent rooms and spaces of a building shall have be horizontal format and the characters raised 1/32 inch minimum and shall be sans serif uppercase characters a minimum of 5/8 inch and a maximum of 2 inches high. Contracted Grade 2 Braille shall be in a horizontal format and shall be placed a minimum of 3/8 inch and a maximum of 1/2 inch directly below the tactile characters; flush left or centered. Signs with raised characters or Braille shall be located 48 inches minimum above the finish floor or ground surface, measured from the baseline of the lowest tactile character and 60 inches maximum above the finish floor or ground surface, measured from the baseline of the highest tactile character.	Lacks ISA	Acquire and mount signage, including access symbol. Acquire and mount signage, including Braille and access symbol mounted on wall, latch side of door, 48" to baseline of lowest character and 60" to baseline of highest character.	2015 ABAAS Section: F216.8 2012 TAS Section: 216.8 2010 ADAS Section: 216.8

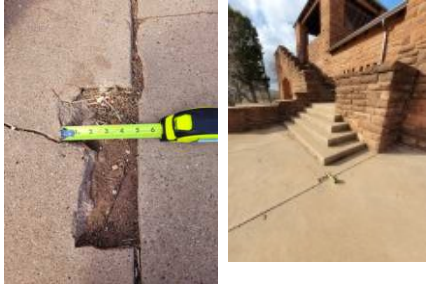
Finding Number	Area Description	Lat/Long	Finding	As Built	Recommendation	Citation	Photos	Figure
291	Swimming Pool: Parking and Exterior Accessible Route	[32.2383157 , -99.880818 6]	There is a gap spaced greater than a 1/2 inch. Openings in floor or ground surfaces shall not allow passage of a sphere more than 1/2 inch diameter. Elongated openings shall be placed so that the long dimension is perpendicular to the dominant direction of travel.	5" gap at steps to viewing platform outside of pool	Correct or fill gaps to be max .5".	2015 ABAAS Section: 302.3  2012 TAS Section: 302.3  2010 ADAS Section: 302.3

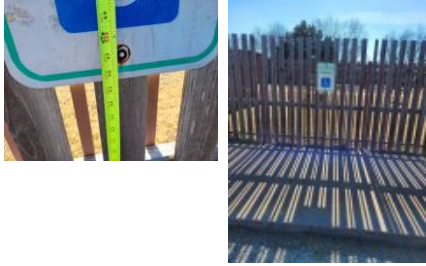
292	Swimming Pool: Parking and Exterior Accessible Route	[32.2385403 , -99.881000 2]	The parking sign is mounted too low. Parking space identification signs shall include the International Symbol of Accessibility complying with. Signs identifying van parking spaces shall contain the designation "van accessible." Signs shall be 60 inches minimum above the finish floor or ground surface measured to the bottom of the sign.	Pool Parking - parking sign at 45.5" AGL	Raise existing accessible parking signs so lowest end of bottom sign is min 60" AFF.	2015 ABAAS Section: 502.6  2012 TAS Section: 502.6  2010 ADAS Section: 502.6

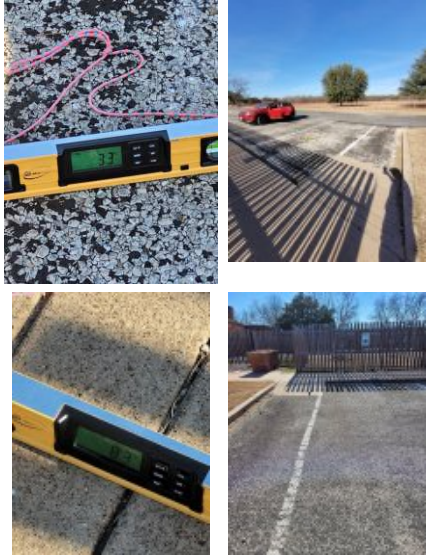
Finding Number	Area Description	Lat/Long	Finding	As Built	Recommendation	Citation	Photos	Figure
293	Swimming Pool: Parking and Exterior Accessible Route	[32.2385381, -99.8809728]	The cross slopes (narrow dimension) and/or running slopes (long dimension) of the access aisle exceeds 2%. The running slope and the cross slope in an accessible parking stall and the access aisle must not exceed 2%.	Pool Parking - slopes of 3.3% in stall and 8.3% in access aisle due to ramp	Repair or correct slope of parking space and access aisle to max 2.08% in any direction.	2015 ABAAS Section: 502.4 2012 TAS Section: 502.4 2010 ADAS Section: 502.4

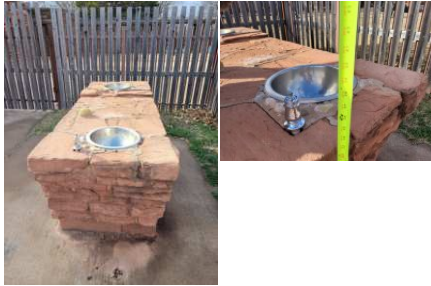
Finding Number	Area Description	Lat/Long	Finding	As Built	Recommendation	Citation	Photos	Figure
294	Swimming Pool: Pool/Deck	[32.2387434 , -99.8816675]	The drinking fountain has multiple violations. Drinking fountains must be on an accessible route that provides a 30 inch by 48 inch clear floor space centered on the low unit, allowing a forward approach. Spout outlets shall be 36 inches maximum above the finish floor or ground. Spout outlets of drinking fountains for standing persons shall be 38 inches minimum and 43 inches maximum above the finish floor or ground. The spout shall be located 15 inches minimum from the vertical support and 5 inches maximum from the front edge of the unit, including bumpers. The spout shall provide a flow of water 4 inches high minimum and shall be located 5 inches maximum from the front of the unit. The angle of the water stream shall be measured horizontally relative to the front face of the unit. Where spouts are located less than 3 inches of the front of the unit, the angle of the water stream shall be 30 degrees maximum. Where spouts are located between 3 inches and 5 inches maximum from the front of the unit, the angle of the water stream shall be 15 degrees maximum. Operable parts shall comply with applicable standards.	Double fountain outside of pool is not in use, not accessible	Replace drinking fountain with a hi-lo bowl fountain.	2015 ABAAS Section: 403.5.1 , 602.1  2012 TAS Section: 403.5.1, 602.1  2010 ADAS Section: 403.5.1, 602.1

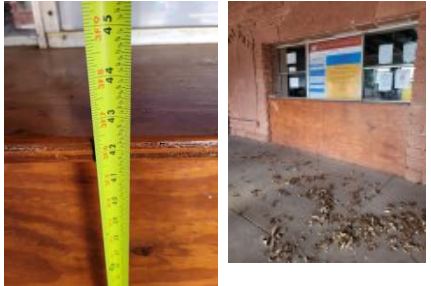
295	Swimming Pool: Pool/Deck	[32.2383475 , -99.8808749]	The transaction counter is too high. A portion of the counter surface that is 36 inches long minimum and 36 inches high maximum above the finish floor shall be provided. Knee and toe space must be provided for a forward approach. A 30 inch by 48 inch clear floor space on an accessible route must be provided for either a forward or parallel approach.	Entry counter at pool at 42" AFF	Lower 36" wide segment of service counter to max 36" AFF.	2015 ABAAS Section: 904.4.2, 904.4.1  2012 TAS Section: 904.4.1, 904.4.2  2010 ADAS Section: 904.4.2, 904.4.1

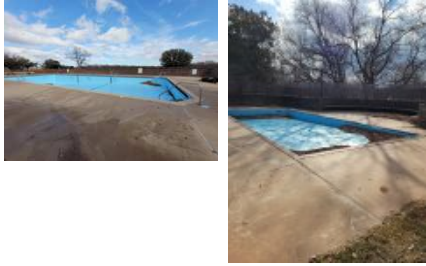
304	Swimming Pool: Pool/Deck	[32.2385687 , -99.881396 6]	The swimming pool does not contain a mechanism to assist persons with disabilities in gaining entry into the pool and in exiting from the pool. Where a swimming pool has more than 300 linear feet of swimming pool wall at least two accessible means of entry for swimming pools are required. Accessible means of entry shall be swimming pool lifts ; sloped entries; transfer walls; transfer systems; and pool stairs. Where two accessible means of entry are required one must be a pool lift or a sloped entry.	Chair lift entry only into main pool	Install a second pool lift and make it available every hour the pool is open; if pool has more than 300' of linear wall, install a second means of entry.	2015 ABAAS Section: F242.2  2012 TAS Section: 242.2  2010 ADAS Section: 242.2

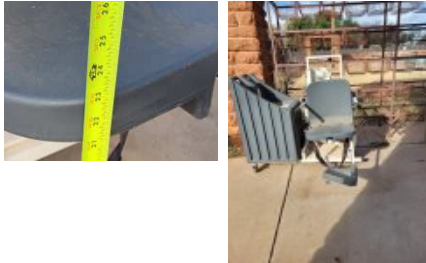
Finding Number	Area Description	Lat/Long	Finding	As Built	Recommendation	Citation	Photos	Figure
307	Swimming Pool: Pool/Deck	[32.2385097 , -99.881281 3]	The swimming pool/spa lift is noncompliant. The lift shall meet the following criteria: 1. The lift must be on an accessible route 2. The deck surface between the centerline of the seat and the pool edge shall have a slope less than 1:48. 3. The seat shall be not less than 16 inches and not more than 19 inches above the pool deck; 4. The seat shall have two armrests. The armrest on the side by which access is gained shall be either removable or fold clear of the seat; 5. The seat shall be 16 inches wide minimum. 6. The seat shall meet the standards for operable controls. 7. The lift shall be capable of unassisted operation from both the deck and water levels. 8. Footrests shall be provided and shall move with the seat. 9. The lift shall be designed to have a live-load capacity of not less than 300 pounds. 10. Pool lifts shall be located where the water level does not exceed 48 inches. 11. The lift shall lower the operator at least 18 inches below the surface of the water.	Lift seat at 23" AGL	Correct or repair pool lift with one that can be stopped between 16" and 19" AFF.	2015 ABAAS Section: 1009.2  2012 TAS Section: 1009.2  2010 ADAS Section: 1009.2

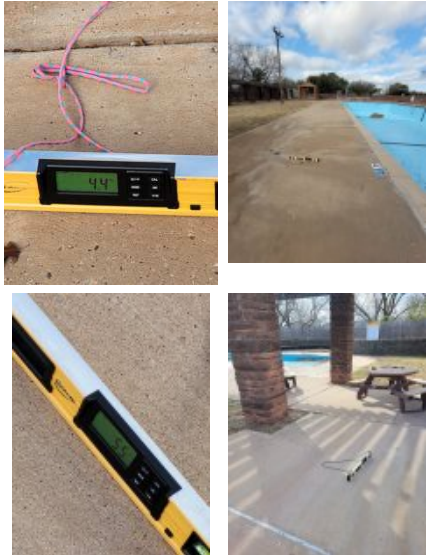
Finding Number	Area Description	Lat/Long	Finding	As Built	Recommendation	Citation	Photos	Figure
310	Swimming Pool: Pool/Deck	[32.2383792 , -99.881274 6]	An accessible route on the deck shall be maintained for access to all areas of the pool accessed by the public.	4.4% cross all the way around pool, 5.5% running to get to kid pool	Maintain an accessible route along the pool deck that is min 36" clear width and having 80" overhead clearance and turning spaces and free of gaps and CIL. Provide a guard rail or barrier at protruding objects.	2010 ADAS Section: 403.5.1, 304.3.1, 307.4, 206.2.2

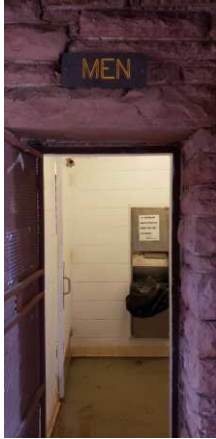
Finding Number	Area Description	Lat/Long	Finding	As Built	Recommendation	Citation	Photos	Figure
311	Swimming Pool: Men's Locker Room	[32.2383736, -99.8808589]	The tactile restroom wall sign is missing the International Symbol of Accessibility (ISA). Accessible toilet rooms or bathing rooms shall be identified by the International Symbol of Accessibility (ISA). Wall signs identifying permanent rooms and spaces of a building shall have be horizontal format and the characters raised 1/32 inch minimum and shall be sans serif uppercase characters a minimum of 5/8 inch and a maximum of 2 inches high. Contracted Grade 2 Braille shall be in a horizontal format and shall be placed a minimum of 3/8 inch and a maximum of 1/2 inch directly below the tactile characters; flush left or centered. Signs with raised characters or Braille shall be located 48 inches minimum above the finish floor or ground surface, measured from the baseline of the lowest tactile character and 60 inches maximum above the finish floor or ground surface, measured from the baseline of the highest tactile character.	Lacks compliant signage with ISA	Acquire and mount signage, including access symbol. Acquire and mount signage, including Braille and access symbol mounted on wall, latch side of door, 48" to baseline of lowest character and 60" to baseline of highest character.	2015 ABAAS Section: F216.8 2012 TAS Section: 216.8 2010 ADAS Section: 216.8

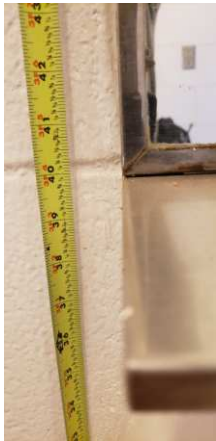
312	Swimming Pool: Men's Locker Room	[32.2383792, -99.8808481]	The mirror is mounted too high. Mirrors must have the bottom edge of the reflecting surface a maximum of 40 inches above the floor if above a sink or counter. Mirrors not located above lavatories or countertops shall be installed with the bottom edge of the reflecting surface 35 inches maximum above the finish floor or ground.	Bottom edge at 40.5" AFF	Lower mirror so reflective surface is max 40" AFF.	2015 ABAAS Section: 603.3 2012 TAS Section: 603.3 2010 ADAS Section: 603.3

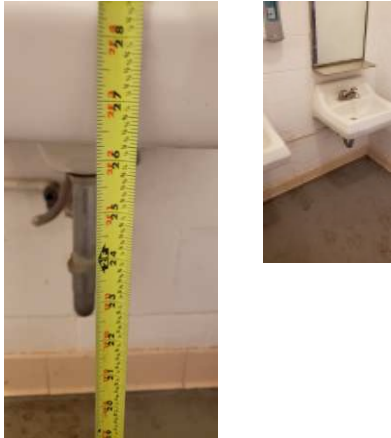
Finding Number	Area Description	Lat/Long	Finding	As Built	Recommendation	Citation	Photos	Figure
313	Swimming Pool: Men's Locker Room	[32.238369, -99.880842 8]	Knee clearance at 27 inches off the floor is not 8 inches minimum deep. The knee clearance, measured from the bottom of the apron or the outside bottom edge of the lavatory, must be 27 inches at a point located 8 inches back from the front edge and continuing to 11 inches minimum in depth at 9 inches above the floor. The top of the lavatory rim may be no higher than 34 inches.	Sink lacks knee clearance	Replace sink with one providing 27" knee clearance that is a min 8" deep.	2015 ABAAS Section: 306.3.1, 306.3.2, 306.3.3, 306.3.4, 306.3.5  2012 TAS Section: 306.3.2, 306.3.3, 306.3.4, 306.3.5, 306.3.1  2010 ADAS Section: 306.3.3, 306.3.2, 306.3.4, 306.3.5, 306.3.1

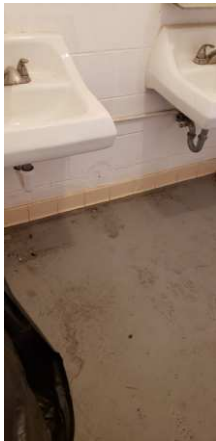
314	Swimming Pool: Men's Locker Room	[32.2383418, -99.880852 1]	The water and drain pipes under the lavatory are not adequately insulated. Water supply and drain pipes under lavatories and sinks shall be insulated or otherwise configured to protect against contact. There shall be no sharp or abrasive surfaces under lavatories and sinks.	Sinks lack insulated pipes	Insulate exposed pipes under one sink.	2015 ABAAS Section: 606.5  2012 TAS Section: 606.5  2010 ADAS Section: 606.5

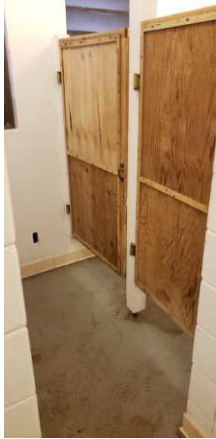
Finding Number	Area Description	Lat/Long	Finding	As Built	Recommendation	Citation	Photos	Figure
315	Swimming Pool: Men's Locker Room	[32.2383464 , -99.880895 1]	There are not enough accessible toilet compartments. The room contains several toilet compartments. A minimum of 1 must be wheelchair accessible .	Ambulatory stall only	Create a wheelchair accessible stall with grab bars and fixtures mounted in correct locations and at correct heights.	2015 ABAAS Section: F213.3.1  2012 TAS Section: 213.3.1  2010 ADAS Section: 213.3.1

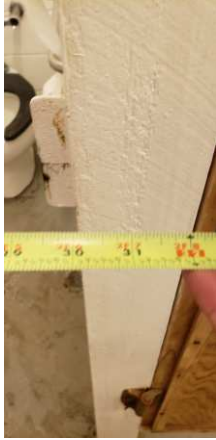
316	Swimming Pool: Men's Locker Room	[32.2383464 , -99.880865 6]	The stall door fails to comply with all of the door requirements. The stall door must be a minimum of 32" wide and have compliant hardware on both sides. The stall door must be self-closing.	Ambulatory stall door is 30" wide	Widen stall doors to 32" when opened to 90 degrees.	2015 ABAAS Section: 404.2.3, 404.2.7, 604.8.2.2  2012 TAS Section: 404.2.3, 404.2.7, 604.8.2.2  2010 ADAS Section: 404.2.3, 404.2.7, 604.8.2.2

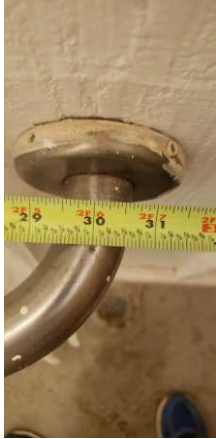
Finding Number	Area Description	Lat/Long	Finding	As Built	Recommendation	Citation	Photos	Figure
317	Swimming Pool: Men's Locker Room	[32.2383713 , -99.880844 1]	Grab bars shall comply with 609. A side-wall grab bar complying with 604.5.1 shall be provided on both sides of the compartment. The space between the wall and the grab bar shall be 1½ inches (38 mm). The space between the grab bar and projecting objects below and at the ends shall be 1½ inches (38 mm) minimum. The space between the grab bar and projecting objects above shall be 12 inches (305 mm) minimum. Grab bars shall be installed in a horizontal position, 33 inches (840 mm) minimum and 36 inches (915 mm) maximum above the finish floor measured to the top of the gripping surface, except that at water closets for children's use complying with 604.9, grab bars shall be installed in a horizontal position 18 inches (455 mm) minimum and 27 inches (685 mm) max.	30" long bars	Replace or add side grab bars with a 42" long grab bar, mounted max 12" from the rear wall at the close end and min 54" on the far end and 33" to 36" AFF.	2015 ABAAS Section: 604.8.2.3, 609.3, 609.4  2012 TAS Section: 609.4, 609.3, 604.8.2.3  2010 ADAS Section: 609.3, 609.4, 604.8.2.3

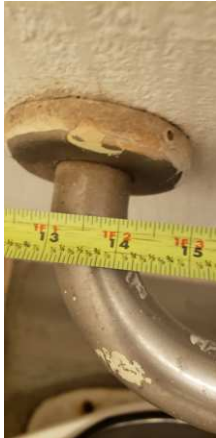
Finding Number	Area Description	Lat/Long	Finding	As Built	Recommendation	Citation	Photos	Figure
318	Swimming Pool: Men's Locker Room	[32.2383826 , -99.880846 8]	The side grab bars are not in the correct location. Grab bars on the side wall must be installed so that the end closest to the rear wall is maximum 12" from the rear wall. The end furthest from the rear wall must be mounted minimum 54" from the rear wall.	Grab bars start 13.5" from the rear wall and end 43.5" from rear wall	Remount side grab bar to max 12" from the rear wall at the close end and min 54" on the far end, and 33" to 36" AFF. Cost in previous finding.	2015 ABAAS Section: 604.5.1  2012 TAS Section: 604.5.1  2010 ADAS Section: 604.5.1

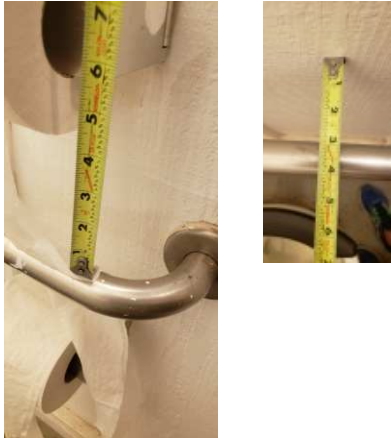
Finding Number	Area Description	Lat/Long	Finding	As Built	Recommendation	Citation	Photos	Figure
319	Swimming Pool: Men's Locker Room	[32.2383917, -99.8808414]	The grab bar height and/or spacing fails. Grab bars must be mounted between 33" and 36" to the top of the gripping surface. There must be 1.5" of clearance between the grab bar and the wall. There must be a minimum of 1.5" of clearance below and minimum 12" above the grab bar to any dispenser or other obstruction.	Toilet paper dispenser 4.5" over bar, bar mounted 3" from wall	Replace grab bars per previous finding and assure gap between bar and wall in max 1.5". Remount toilet paper dispenser max 7" to 9" from front of toilet, 15" to 48" AFF and min 12" above or 1.5" below grab bar.	2015 ABAAS Section: 609.3, 609.4  2012 TAS Section: 609.4, 609.3  2010 ADAS Section: 609.3, 609.4

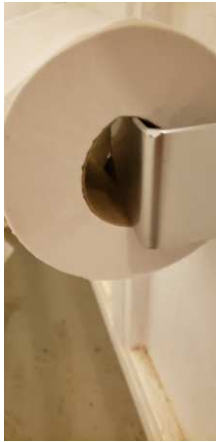
320	Swimming Pool: Men's Locker Room	[32.2383146, -99.8808897]	The toilet paper dispenser does not allow a continuous flow. Toilet paper dispensers shall be 7 inches minimum and 9 inches maximum in front of the water closet measured to the centerline of the dispenser. The outlet of the dispenser shall be 15 inches minimum and 48 inches maximum above the finish floor and shall not be located behind grab bars. Dispensers shall not be of a type that controls delivery or that does not allow continuous paper flow. There shall be a clearance of 1 1/2 inches minimum below the grab bar.	TP dispenser does not allow a continuous flow	Replace toilet paper dispenser with one that provides continuous flow of paper.	2015 ABAAS Section: 604.7  2012 TAS Section: 604.7  2010 ADAS Section: 604.7

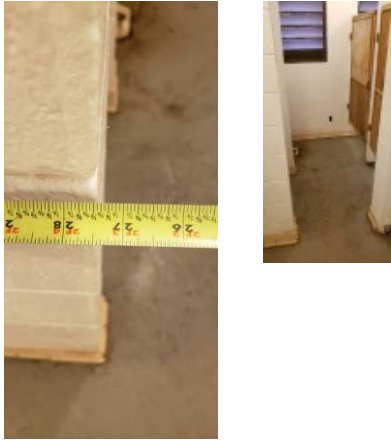
Finding Number	Area Description	Lat/Long	Finding	As Built	Recommendation	Citation	Photos	Figure
321	Swimming Pool: Men's Locker Room	[32.2383237, -99.8808602]	The route of travel at this location does not provide a minimum width of 36 inches. The clear width shall be permitted to be reduced to 32 inches minimum for a length of 24 inches maximum provided that reduced width segments are separated by segments that are 48 inches long minimum and 36 inches wide minimum.	Route reduces to 27.5" to access toilets	Widen AR to compliant 36" clear width.	2015 ABAAS Section: 403.5.1  2012 TAS Section: 403.5.1  2010 ADAS Section: 403.5.1

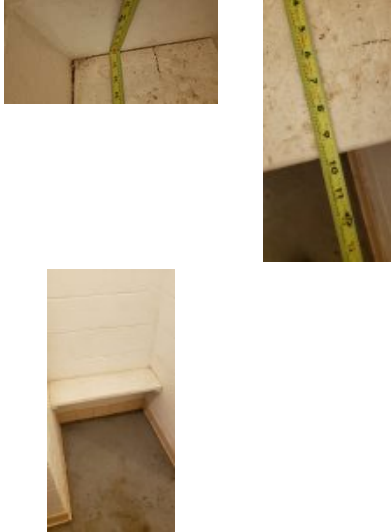
322	Swimming Pool: Men's Locker Room	[32.2383464, -99.8808642]	The bench is not deep enough or long enough or is missing. Benches shall be provided having seats that are 42 inches long minimum and 20 inches deep minimum and 24 inches deep maximum. The bench shall provide for back support or shall be affixed to a wall. Back support shall be 42 inches (1065 mm) long minimum and shall extend from a point 2 inches (51 mm) maximum above the seat surface to a point 18 inches (455 mm) minimum above the seat surface. Back support shall be 2 1/2 inches (64 mm) maximum from the rear edge of the seat measured horizontally. The top of the bench seat surface shall be 17 inches (430 mm) minimum and 19 inches (485 mm) maximum above the finish floor or ground. Clear floor or ground space complying with 305 shall be provided and shall be positioned at the end of the bench seat and parallel to the short axis of the bench	Lacks compliant bench - 32" by 9.5"	Replace bench in dressing area with one having a seat depth of 20" to 24" deep, 42" long, affixed to the wall or having a back and mounted 17" to 19" AFF and provide required clear floor space on the short axis of the bench.	2012 TAS Section: 903.4, 903.2, 903.3, 903.5  2010 ADAS Section: 903.4, 903.2, 903.3, 903.5

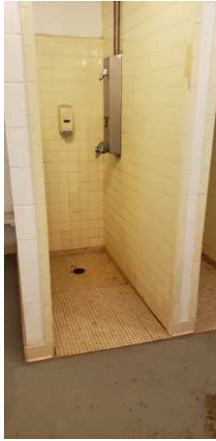
Finding Number	Area Description	Lat/Long	Finding	As Built	Recommendation	Citation	Photos	Figure
323	Swimming Pool: Men's Locker Room	[32.2383464 , -99.880857 5]	There are no accessible bathing or shower facilities. Where facilities for bathing are provided for the public, clients or employees, including showers or bathtubs, at least one shower or bathtub and support facilities such as lockers, and not less than 1 percent of all facilities, shall be accessible.	Lacks accessible shower	Create an accessible shower in locker/bathing room.	2015 ABAAS Section: F213.3.6  2012 TAS Section: 213.3.6  2010 ADAS Section: 213.3.6

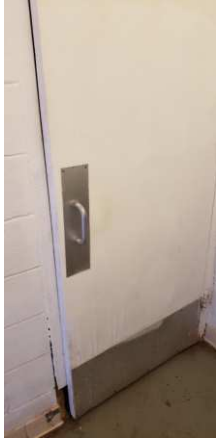
324	Swimming Pool: Men's Locker Room	[32.2383191 , -99.880857 5]	It is recommended that exterior doors be maintained so that the operating pressure does not exceed 8.5 lb. force to open. The sweep period for doors with closers shall be adjusted so that from an open position of 70 degrees, the door will take at least 3 seconds to move to a point 7 inches from the latch, measured to the leading edge of the door.	Men's locker room door - 20# push, fast close	For all doors along the public circulation route, inspect, adjust, and maintain 8.5 lbf to open exterior doors as a smart practice. For all doors along the public circulation route, inspect, adjust, and maintain closing speed on door closers.	2012 TAS Section: 404.2.9, 404.2.9 Advisory, 404.2.8.1  2010 ADAS Section: 404.2.9, 404.2.8.1

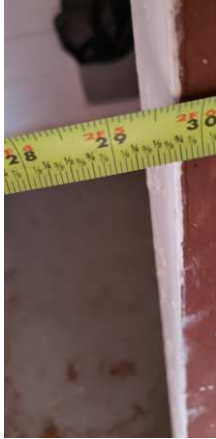
Finding Number	Area Description	Lat/Long	Finding	As Built	Recommendation	Citation	Photos	Figure
325	Swimming Pool: Men's Locker Room	[32.2383373 , -99.880857 5]	Door openings shall provide a clear width of 32 inches (815 mm) minimum. Clear openings of doorways with swinging doors shall be measured between the face of the door and the stop, with the door open 90 degrees. Openings more than 24 inches (610 mm) deep shall provide a clear opening of 36 inches (915 mm) minimum. There shall be no projections into the required clear opening width lower than 34 inches (865 mm) above the finish floor or ground. Projections into the clear opening width between 34 inches (865 mm) and 80 inches (2030 mm) above the finish floor or ground shall not exceed 4 inches (100 mm).	Men's locker room entry - 29.75" wide and 76.75" tall	For all doors along the public circulation route, replace doors with doors having 80" overhead clearance and 32" clear width.	2010 ADAS Section: 404.2.3, 404.2.7, 404.2.4, 404.2.11, 404.2.11 Exception

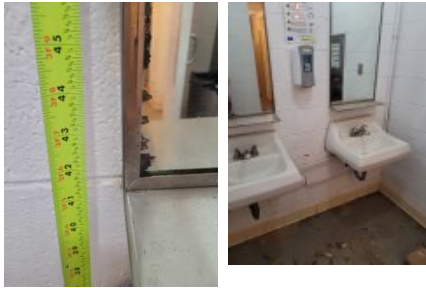
327	Swimming Pool: Women's Locker Room	[32.2383554 , -99.880862 9]	The mirror is mounted too high. Mirrors must have the bottom edge of the reflecting surface a maximum of 40 inches above the floor if above a sink or counter. Mirrors not located above lavatories or countertops shall be installed with the bottom edge of the reflecting surface 35 inches maximum above the finish floor or ground.	Bottom edge at 42" AFF	Lower mirror so reflective surface is max 40" AFF.	2015 ABAAS Section: 603.3  2012 TAS Section: 603.3  2010 ADAS Section: 603.3
