# Access Audit Site Report

**Abilene State Park**

**Accessibility Evaluation**

**Inspection Date: 12/14/2021**

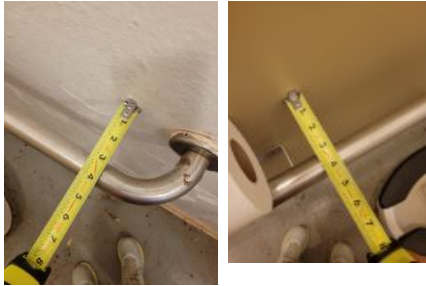
Finding Number	Area Description	Lat/Long	Finding	As Built	Recommendation	Citation	Photos	Figure
334	Swimming Pool: Women's Locker Room	[32.2382851 , -99.880876 3]	The grab bar height and/or spacing fails. Grab bars must be mounted between 33" and 36" to the top of the gripping surface. There must be 1.5" of clearance between the grab bar and the wall. There must be a minimum of 1.5" of clearance below and minimum 12" above the grab bar to any dispenser or other obstruction.	Both bars have 3" space between bar and wall	Replace grab bars per previous finding and assure gap between bar and wall in max 1.5".	2015 ABAAS Section: 609.3, 609.4  2012 TAS Section: 609.4, 609.3  2010 ADAS Section: 609.3, 609.4

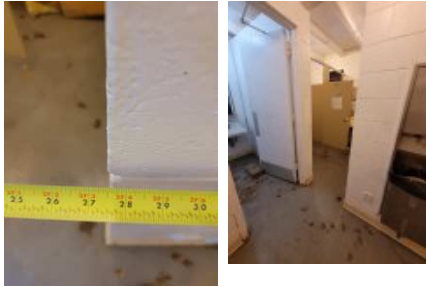
336	Swimming Pool: Women's Locker Room	[32.2382828 , -99.880895 1]	The route of travel at this location does not provide a minimum width of 36 inches. The clear width shall be permitted to be reduced to 32 inches minimum for a length of 24 inches maximum provided that reduced width segments are separated by segments that are 48 inches long minimum and 36 inches wide minimum.	27.5" width at entry to stall space	Widen AR to compliant 36" clear width.	2015 ABAAS Section: 403.5.1  2012 TAS Section: 403.5.1  2010 ADAS Section: 403.5.1

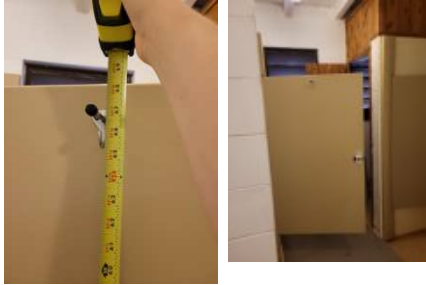
Finding Number	Area Description	Lat/Long	Finding	As Built	Recommendation	Citation	Photos	Figure
337	Swimming Pool: Women's Locker Room	[32.2383316 , -99.880869 6]	Coat hooks provided within the room shall be located within one of the reach ranges specified in 308. Shelves shall be 40 inches (1015 mm) minimum and 48 inches (1220 mm) maximum above the finish floor or ground. Where coat hooks or shelves are provided in dressing, fitting or locker rooms without individual compartments, at least one of each type shall comply with 803.5. Where coat hooks or shelves are provided in individual compartments at least one of each type complying with 803.5 shall be provided in individual compartments in dressing, fitting, or locker rooms required to comply with 222.1.	2 of 2 hooks in dressing rooms are 67" AFF	Remount at least one hook to max 48" AFF.	2015 ABAAS Section: 308.2.1, 308.1, F222.2, 803.5  2012 TAS Section: 308.2.1, 308.1, 222.2, 803.5  2010 ADAS Section: 308.2.1, 308.1, 222.2, 803.5

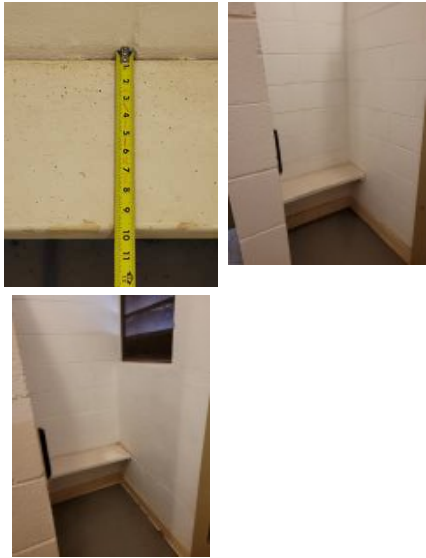
338	Swimming Pool: Women's Locker Room	[32.2383146 , -99.880868 2]	The bench is not deep enough or long enough or is missing. Benches shall be provided having seats that are 42 inches long minimum and 20 inches deep minimum and 24 inches deep maximum. The bench shall provide for back support or shall be affixed to a wall. Back support shall be 42 inches (1065 mm) long minimum and shall extend from a point 2 inches (51 mm) maximum above the seat surface to a point 18 inches (455 mm) minimum above the seat surface. Back support shall be 2½ inches (64 mm) maximum from the rear edge of the seat measured horizontally. The top of the bench seat surface shall be 17 inches (430 mm) minimum and 19 inches (485 mm) maximum above the finish floor or ground. Clear floor or ground space complying with 305 shall be provided and shall be positioned at the end of the bench seat and parallel to the short axis of the bench	Two 10" deep benches	Replace bench in dressing area with one having a seat depth of 20" to 24" deep, 42" long, affixed to the wall or having a back and mounted 17" to 19" AFF and provide required clear floor space on the short axis of the bench.	2012 TAS Section: 903.4, 903.2, 903.3, 903.5  2010 ADAS Section: 903.4, 903.2, 903.3, 903.5

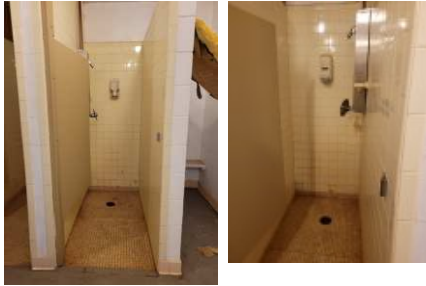
Finding Number	Area Description	Lat/Long	Finding	As Built	Recommendation	Citation	Photos	Figure
339	Swimming Pool: Women's Locker Room	[32.2382874 , -99.880868 2]	There are no accessible bathing or shower facilities. Where facilities for bathing are provided for the public, clients or employees, including showers or bathtubs, at least one shower or bathtub and support facilities such as lockers, and not less than 1 percent of all facilities, shall be accessible.	2 of 2 showers are not accessible	Create an accessible shower in locker/bathing room.	2015 ABAAS Section: F213.3.6  2012 TAS Section: 213.3.6  2010 ADAS Section: 213.3.6

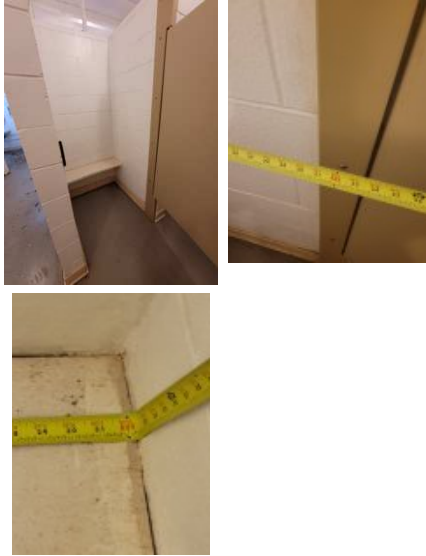
340	Swimming Pool: Women's Locker Room	[32.2383611 , -99.880846 8]	The room does not contain compliant turning space. Dressing Rooms must contain a 60 inch circular turning space or a T-shaped turning space. Doors shall not swing into the room unless a clear floor or ground space is provided beyond the arc of the door swing.	2 of 2 dressing rooms are 31" by 32" and lack turning space	Enlarge dressing stalls to 60" by 60" clear inside dimension.	2015 ABAAS Section: 803.2  2012 TAS Section: 803.2  2010 ADAS Section: 803.2

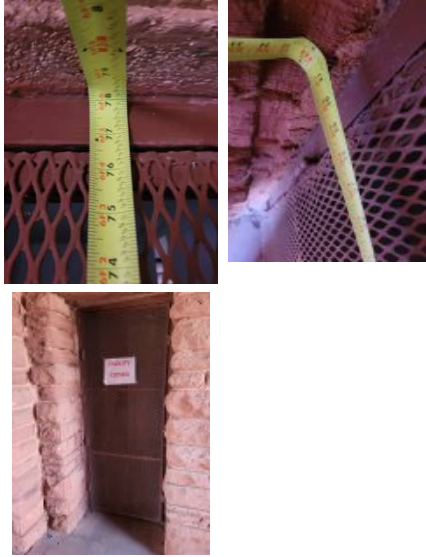
Finding Number	Area Description	Lat/Long	Finding	As Built	Recommendation	Citation	Photos	Figure
341	Swimming Pool: Women's Locker Room	[32.2383509 , -99.880868 2]	Door openings shall provide a clear width of 32 inches (815 mm) minimum. Clear openings of doorways with swinging doors shall be measured between the face of the door and the stop, with the door open 90 degrees. Openings more than 24 inches (610 mm) deep shall provide a clear opening of 36 inches (915 mm) minimum. There shall be no projections into the required clear opening width lower than 34 inches (865 mm) above the finish floor or ground. Projections into the clear opening width between 34 inches (865 mm) and 80 inches (2030 mm) above the finish floor or ground shall not exceed 4 inches (100 mm).	Women's locker room entry - 77" overhead, 29" width	For all doors along the public circulation route, replace doors with doors having 80" overhead clearance and 32" clear width.	2010 ADAS Section: 404.2.3, 404.2.7, 404.2.4, 404.2.11, 404.2.11 Exception

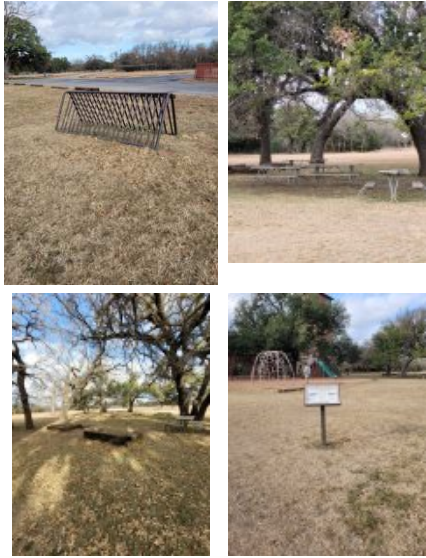
Finding Number	Area Description	Lat/Long	Finding	As Built	Recommendation	Citation	Photos	Figure
342	Play Area: Playground	[32.2387048, -99.8818607]	There is no accessible route to the bike rack, picnic tables, horseshoe pits, and sign. At least one accessible route shall connect accessible buildings, accessible facilities, accessible elements, and accessible spaces that are on the same site.	Lacks AR to bike rack, 5 of 5 picnic tables, 2 horseshoe pits, and sign	Create an accessible route with crushed stone or other outdoor material from parking or walkway to bike rack, one picnic table, horseshoe pits, and sign.	2015 ABAAS Section: F206.2.2 2012 TAS Section: 206.2.2 2010 ADAS Section: 206.2.2

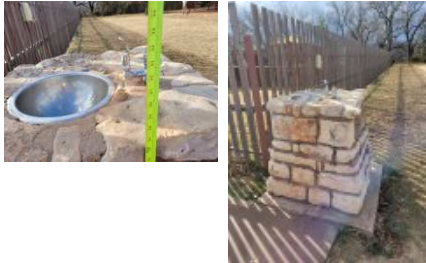
343	Play Area: Playground	[32.238774, -99.8816944]	The there is no lower drinking fountain meeting the requirements for persons using wheelchairs. Spout outlets of the lower bowl drinking fountains shall be 36 inches maximum above the finish floor or ground. Lower bowl drinking fountains shall provide knee and toe clearance centered on the unit.	Lacks low bowl - spout at 45" AFF	Add second low bowl fountain for persons using wheelchairs.	2015 ABAAS Section: 602.4 2012 TAS Section: 602.4 2010 ADAS Section: 211.2

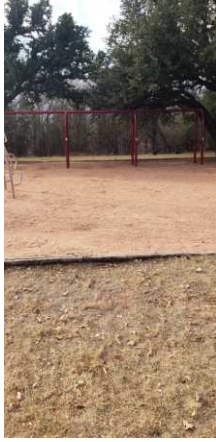
Finding Number	Area Description	Lat/Long	Finding	As Built	Recommendation	Citation	Photos	Figure
344	Play Area: Playground	[32.2386549 , -99.881967 9]	There is no accessible route to the play area. Accessible routes serving play areas shall comply with Chapter 4 and 1008.2 and shall be permitted to use the exceptions in 1008.2.1 through 1008.2.3. Where accessible routes serve ground level play components, the vertical clearance shall be 80 inches high (2030 mm) minimum.	Lacks AR to play area	Create an AR to the play area within the site.	2015 ABAAS Section: F206.2.2  2012 TAS Section: 1008.2  2010 ADAS Section: 206.2.2

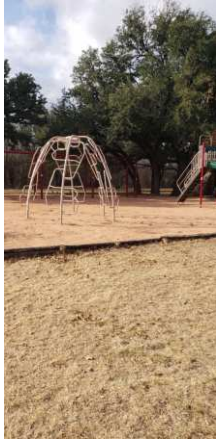
345	Play Area: Playground	[32.2387059 , -99.881868 7]	Play area shall have signage listing designated ages of intended users.	Lacks posted ages of intended users	Acquire and install intended user signage and mount at designated entry as a smart practice.	2015 ABAAS Section: F240.1  2012 TAS Section: 240.1  2010 ADAS Section: 240.1

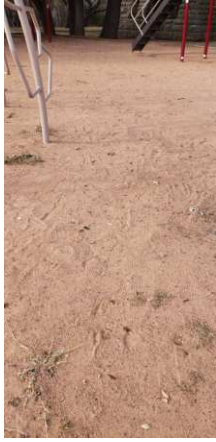
Finding Number	Area Description	Lat/Long	Finding	As Built	Recommendation	Citation	Photos	Figure
346	Play Area: Playground	[32.2386685 , -99.881849 9]	Compliance with ASTM F 1951 for accessibility for ground surfaces on accessible routes, clear floor or ground spaces, and turning spaces has not been determined. Ground surfaces shall comply with ASTM F 1951. Ground surfaces shall be inspected and maintained regularly and frequently to ensure continued compliance with ASTM F 1951.	Play area lacks compliant surface - sand surface to 6 swings, climber and slide	Replace existing surface with an accessible surface such as EWF, PIP or tiles, with compliant slopes and CILs.	2012 TAS Section: 1008.2.6.1  2010 ADAS Section: 1008.2.6.1

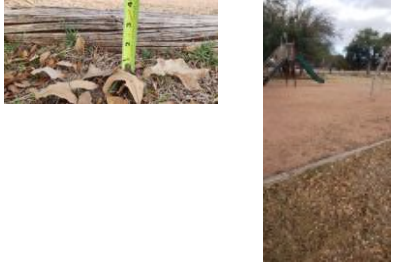
347	Play Area: Playground	[32.2387456 , -99.881710 5]	The walkway contains abrupt vertical edges and/or variations over a 1/4 inch. 1/4 inch is the maximum vertical rise. Changes in level between 1/4 inch and 1/2 inch must be beveled at 1:2 or less. Changes in level greater than 1/2 inch must be by way of a ramp.	4" border around playground	Frequently inspect and regularly maintain accessible portions of play area surface that are comprised of loose fill such as EWF so that surface is level with other surfaces.	2012 TAS Section: 303.2, 303.3  2010 ADAS Section: 303.2, 303.3

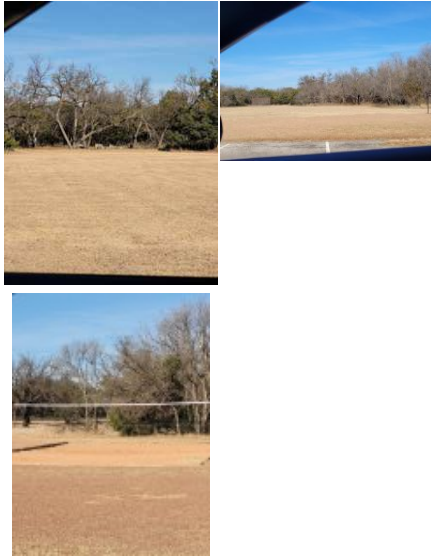
Finding Number	Area Description	Lat/Long	Finding	As Built	Recommendation	Citation	Photos	Figure
348	Play Area: Sports Fields/Courts	[32.2393083 , -99.8817105]	At least one accessible route shall connect accessible buildings, accessible facilities, accessible elements, and accessible spaces that are on the same site. For areas of sport activity, an accessible route is required to connect to the boundary of each area of sport activity. The size of an area of sport activity includes only the space needed to play. Where multiple sports fields or courts are provided, an accessible route is required to each field or area of sport activity.	Lacks AR to volleyball court, soccer field, and baseball field	Provide an accessible route to each element within the site.	2010 ADAS Section: 206.2.2, 206.2

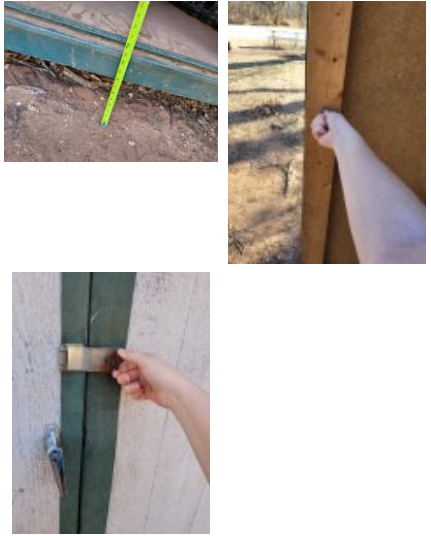
349	Play Area: Sports Fields/Courts	[32.2375444 , -99.8832675]	The threshold has a vertical change greater than 1/4 inch high. Exterior doors are recommended to be maintained at 8.5 lbf as a smart practice. Force is to be measured at the operating hardware or 30 inches from the hinges, whichever is greater. Hand-activated door opening hardware, handles, pulls, latches, locks, and other operating devices on accessible doors shall have a shape that is easy to grasp with one hand and does not require tight grasping, tight pinching or twisting of the wrist to operate. Hardware shall be 34 inches minimum and 48 inches maximum above the finish floor or ground.	Chess storage shed - 7" step, lock latch requires tight pinch, 17# push	For all doors along the public circulation ramp CILs at door entries to max .25". For all doors along the public circulation route, inspect, adjust, and maintain 8.5 lbf to open exterior doors as a smart practice. For all doors along the public circulation route, replace hardware with lever hardware or hardware operable without a tight pinch or grasp.	2010 ADAS Section: 404.2.3, 404.2.7, 404.2.4, 404.2.11, 404.2.11 Exception

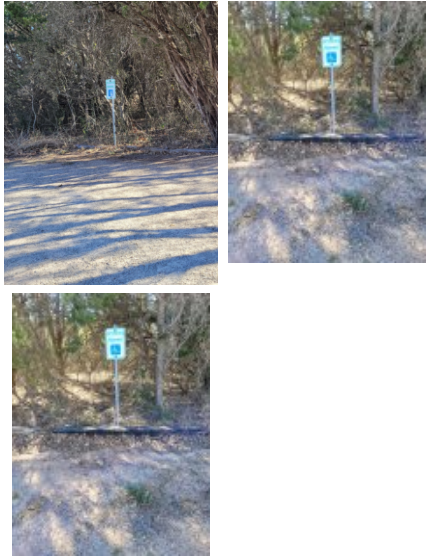
Finding Number	Area Description	Lat/Long	Finding	As Built	Recommendation	Citation	Photos	Figure
352	Trails : Trailhead Parking	[32.2371, -99.88374]	The van stall is missing a sign identifying it as a van accessible stall. Parking space identification signs shall include the International Symbol of Accessibility. Signs identifying van parking spaces shall contain the designation "van accessible."	Eagle Trailhead - lacks signage for van accessible parking space	Add one van parking sign to one accessible stall and repaint stall and access aisle to 11' and 5' or 8' and 8'.	2015 ABAAS Section: 502.6 2012 TAS Section: 502.6 2010 ADAS Section: 502.6

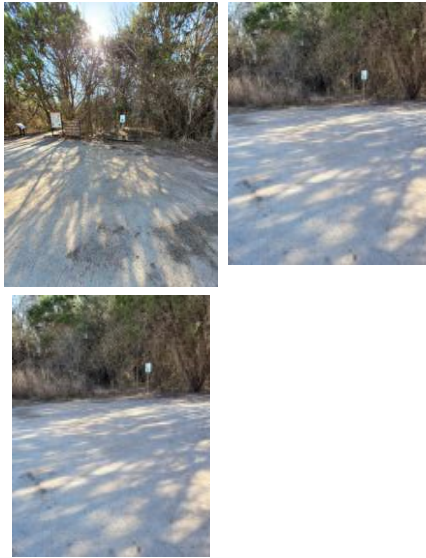
356	Trails : Trailhead Parking	[32.2371, -99.88374]	The accessible parking stall is not wide enough. Each parking space must be at least 8' feet wide and shall be marked to define the width. The measurements of parking spaces and access aisles shall be made from the centerline of the markings. Where the parking space is not adjacent to another parking space or access aisle, the measurement shall be permitted to include the full width of the line defining the parking space.	Eagle Trailhead - unable to test stall width - lacks striping	Repaint stalls to be 8' wide each.	2015 ABAAS Section: 502.2  2012 TAS Section: 502.2  2010 ADAS Section: 502.2

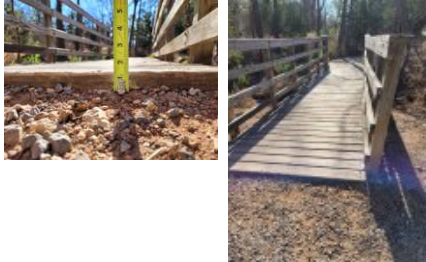
Finding Number	Area Description	Lat/Long	Finding	As Built	Recommendation	Citation	Photos	Figure
361	Trails : Trail Surface	[32.2354174 , -99.884964]	Where the surface is other than asphalt, concrete, or boards, tread obstacles shall be permitted to not exceed 2 inches (50 mm) in height measured vertically to the highest point.	Eagle Trail - 1.25" CIL at bridge	Repair, bevel or ramp tread obstacle along pathway to max 2" for surfaces other than concrete, asphalt or boards.	2015 ABAAS Section: 1017.5 EXCEPTION
