Access Audit Site Report

Bentsen-Rio Grande Valley State Park

Accessibility Evaluation

Inspection Date: 07/13/2022

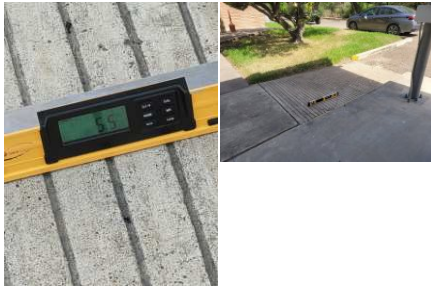
| Finding Number | Area Description | Lat/Long | Finding | As Built | Recommendation | Citation | Photos | Figure |
|---|---|---|--|---|---|--|---|---|
| 8 | Exterior: Exterior Accessible Route | [26.1836761 , -98.3806299] | Element meets all standards and requirements | curb ramps at Nature Center Pavilion comply | None | 2010 ADAS Section: N/A | | |

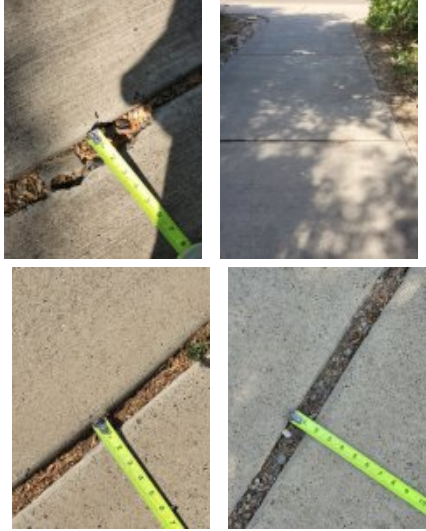
| Finding Number | Area Description | Lat/Long | Finding | As Built | Recommendation | Citation | Photos | Figure |
|---|---|---|---|---|--|--|--|---|
| 13 | Exterior: Exterior Accessible Route | [26.18568, -98.38081] | The accessible route of travel contains cross slopes greater than 2%. Cross slopes shall not exceed one unit vertical in 48 units horizontal (2-percent slope). | Administrative Office Area - 3.3%, 2.6% cross | Correct or repair cross slope along AR to max 2.08%. | 2015 ABAAS Section: 403.3 2012 TAS Section: 403.3 2010 ADAS Section: 403.3 | | |

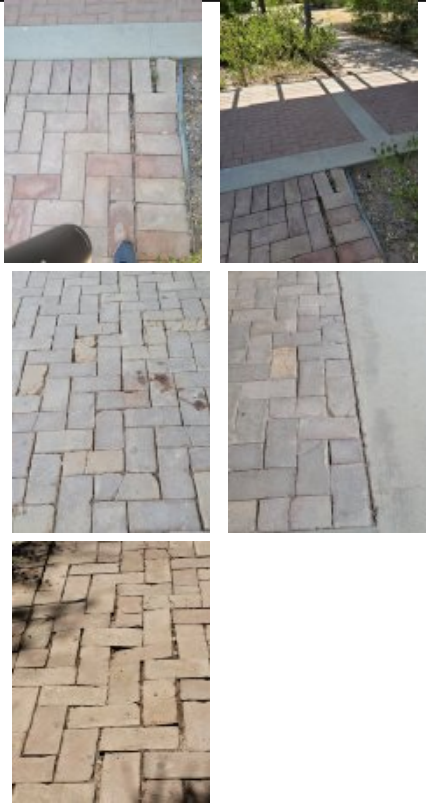
| Finding Number | Area Description | Lat/Long | Finding | As Built | Recommendation | Citation | Photos | Figure |
|---|---|---|---|--|--|--|--|---|
| 16 | Exterior: Exterior Accessible Route | [26.18546, -98.37991] | The accessible route of travel contains cross slopes greater than 2%. Cross slopes shall not exceed one unit vertical in 48 units horizontal (2-percent slope). | slopes from back of Exhibit Hall to Park Store - 3.8%, 3% | Correct or repair cross slope along AR to max 2.08%. | 2015 ABAAS Section: 403.3 2012 TAS Section: 403.3 2010 ADAS Section: 403.3 | | |

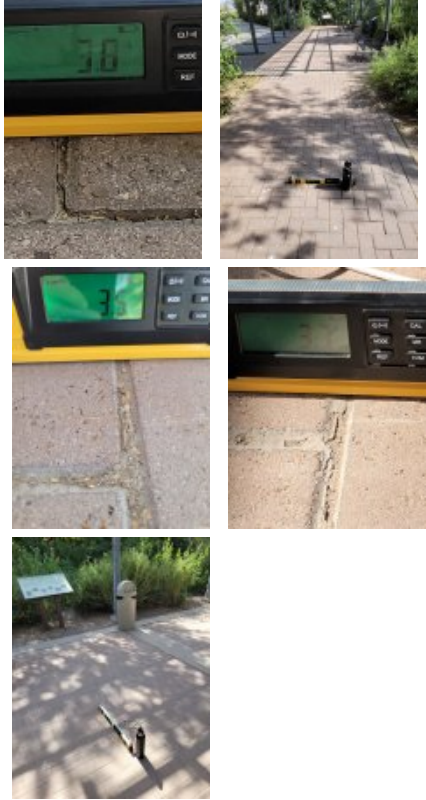
| Finding Number | Area Description | Lat/Long | Finding | As Built | Recommendation | Citation | Photos | Figure |
|---|---|---|---|---|--|--|---|---|
| 18 | Exterior: Exterior Accessible Route | [26.1859783 , -98.379760 7] | The accessible route of travel contains cross slopes greater than 2%. Cross slopes shall not exceed one unit vertical in 48 units horizontal (2-percent slope). | from park store to mailbox turn around - 4.8%, 5.2% | Correct or repair cross slope along AR to max 2.08%. | 2015 ABAAS Section: 403.3 2012 TAS Section: 403.3 2010 ADAS Section: 403.3 | | |

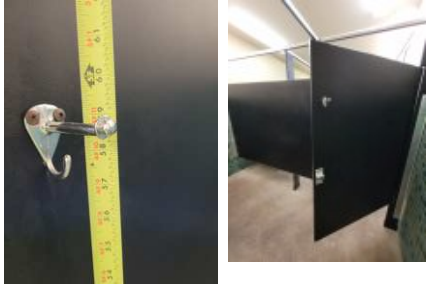
| Finding Number | Area Description | Lat/Long | Finding | As Built | Recommendation | Citation | Photos | Figure |
|---|---|---|--|--|---|--|---|---|
| 21 | Headquarters Area: HQ - Men's Restroom | [26.18571, -98.37984] | The operable part is positioned too high for either a side or front approach. Where a clear floor or ground space allows a parallel approach to an element and the side reach is unobstructed, the high side reach shall be 48 inches maximum and the low side reach shall be 15 inches minimum above the finish floor or ground. Where a forward reach is unobstructed, the high forward reach shall be 48 inches maximum and the low forward reach shall be 15 inches minimum above the finish floor or ground. | hook in stall 57.5" above finished floor (AFF) | Remount operable parts to be in reach range of 15" min to 48" max | 2015 ABAAS Section: 308.1 2012 TAS Section: 308.1 2010 ADAS Section: 308.1 | | |

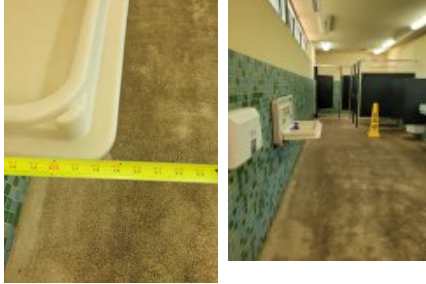
| Finding Number | Area Description | Lat/Long | Finding | As Built | Recommendation | Citation | Photos | Figure |
|---|---|---|--|--|---|--|---|---|
| 22 | Headquarters Area: HQ - Men's Restroom | [26.18571, -98.37984] | The baby changing table is not compliant. Baby changing tables are work surfaces. If fixed or built-in baby changing tables are provided, at least 5%, but not less than one, must comply with TAS 902 based TAS 226.1. Baby changing tables cannot violate the protruding object requirements in either an open or closed position since either position is a potential hazard for persons with visual impairments. Baby changing tables are not prohibited from being located in wheelchair accessible toilet compartments; however, the minimum space required for the compartment cannot be obstructed by the baby changing table in either an open or closed position. The clear floor space required for a baby changing table may overlap the water closet clearance since baby changing tables are considered convenience "fixtures" based on Advisory 604.8.1.1. The overlap is applicable only to the clear floor space and not to actual table itself. Baby changing tables must be dispersed throughout a space, however, an additional baby changing table is not required in a common use area of a toilet or bathing room when the only baby changing table is located in a toilet compartment. | projects 19" when open | Relocate baby changing table to eliminate protrusion when in the open position. | 2012 TAS Section: 226.1, 902.3, 604.3.2, 204.1, 226.1 Advisory, 226.2, 307.1, 604.8.1.1 Advisory, 902.1, 902.1 Advisory, 902.2 | | |

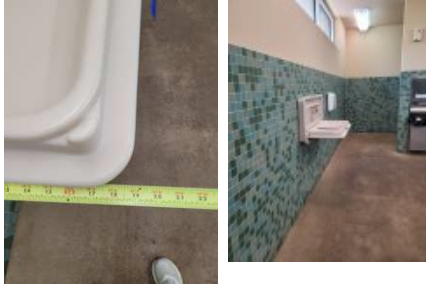
| Finding Number | Area Description | Lat/Long | Finding | As Built | Recommendation | Citation | Photos | Figure |
|---|--|---|--|---|---|--|---|---|
| 31 | Headquarters Area: HQ - Women's Restroom | [26.18571, -98.37984] | The baby changing table is not compliant. Baby changing tables are work surfaces. If fixed or built-in baby changing tables are provided, at least 5%, but not less than one, must comply with TAS 902 based TAS 226.1. Baby changing tables cannot violate the protruding object requirements in either an open or closed position since either position is a potential hazard for persons with visual impairments. Baby changing tables are not prohibited from being located in wheelchair accessible toilet compartments; however, the minimum space required for the compartment cannot be obstructed by the baby changing table in either an open or closed position. The clear floor space required for a baby changing table may overlap the water closet clearance since baby changing tables are considered convenience "fixtures" based on Advisory 604.8.1.1. The overlap is applicable only to the clear floor space and not to actual table itself. Baby changing tables must be dispersed throughout a space, however, an additional baby changing table is not required in a common use area of a toilet or bathing room when the only baby changing table is located in a toilet compartment. | projects 19" | Relocate baby changing table to eliminate protrusion when in the open position. | 2012 TAS Section: 226.1, 902.3, 604.3.2, 204.1, 226.1 Advisory, 226.2, 307.1, 604.8.1.1 Advisory, 902.1, 902.1 Advisory, 902.2 | | |

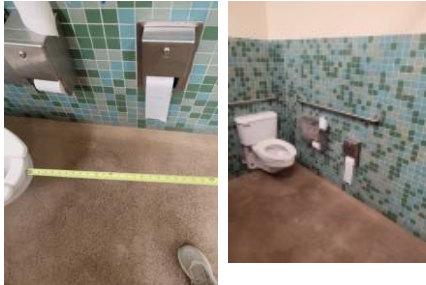
| Finding Number | Area Description | Lat/Long | Finding | As Built | Recommendation | Citation | Photos | Figure |
|---|--|---|--|--|---|--|---|---|
| 35 | Headquarters Area: HQ - Women's Restroom | [26.18571, -98.37984] | The toilet paper is not installed within the compliant range in front of the toilet. Toilet paper dispensers shall be 7 inches minimum and 9 inches maximum in front of the water closet measured to the centerline of the dispenser. The outlet of the dispenser shall be 15 inches minimum and 48 inches maximum above the finish floor and shall not be located behind grab bars. Dispensers shall not be of a type that controls delivery or that does not allow continuous paper flow. There shall be a clearance of 1 1/2 inches minimum below the grab bar. | mounted 4" and 17" from front of toilet | Remount toilet paper dispenser max 7" to 9" from front of toilet, 15" to 48" aff and min 12" above or 1.5" below grab bar. | 2015 ABAAS Section: 604.7 2012 TAS Section: 604.7 2010 ADAS Section: 604.7 | | |

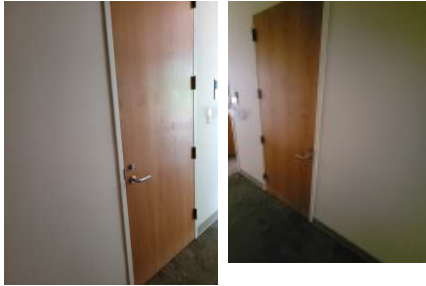
| Finding Number | Area Description | Lat/Long | Finding | As Built | Recommendation | Citation | Photos | Figure |
|---|---|---|--|---|---|---|--|---|
| 49 | Headquarters Area: HQ - Employee Spaces | [26.18571, -98.37984] | Element meets all standards and requirements | storage at admin complies | None | 2010 ADAS Section: N/A | | |

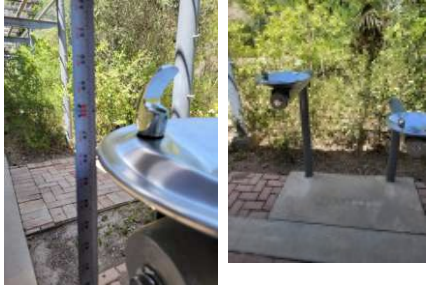
| Finding Number | Area Description | Lat/Long | Finding | As Built | Recommendation | Citation | Photos | Figure |
|---|--|---|--|---|--|--|--|---|
| 58 | Headquarters Area: HQ - Meeting Room | [26.18571, -98.37984] | The spout for the drinking fountain is too high. Spout outlets shall be 38 inches minimum and 43 inches maximum above the finish floor or ground for standing persons. | near meeting room - fountain spout 48" above finished floor | Remount fountain for standing persons to 38" min and 43" max aff to the spout. | 2015 ABAAS Section: 602.7 2012 TAS Section: 602.7 2010 ADAS Section: 602.7 | | |

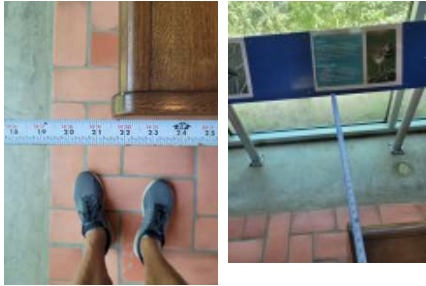
| Finding Number | Area Description | Lat/Long | Finding | As Built | Recommendation | Citation | Photos | Figure |
|---|---|---|---|---|---|--|--|--|
| 60 | Headquarters Area: HQ - Exhibit Hall | [26.18571, -98.37984] | The route of travel at this location does not provide a minimum width of 36 inches. The clear width shall be permitted to be reduced to 32 inches minimum for a length of 24 inches maximum provided that reduced width segments are separated by segments that are 48 inches long minimum and 36 inches wide minimum. | 21.5" width at 'Wet & Wild' display | Widen AR to compliant 36" clear width. | 2015 ABAAS Section: 403.5.1 2012 TAS Section: 403.5.1 2010 ADAS Section: 403.5.1 | | |

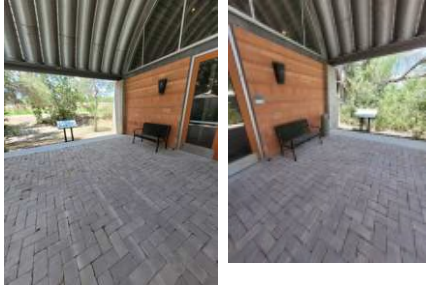
| Finding Number | Area Description | Lat/Long | Finding | As Built | Recommendation | Citation | Photos | Figure |
|---|--|---|---|---|--|--|--|---|
| 64 | Headquarters Area: HQ - Exhibit Hall | [26.18542, -98.37988] | Element meets all standards and requirements | exhibit hall patio - 2 benches, garbage, and 2 signs comply | None | 2010 ADAS Section: N/A | | |

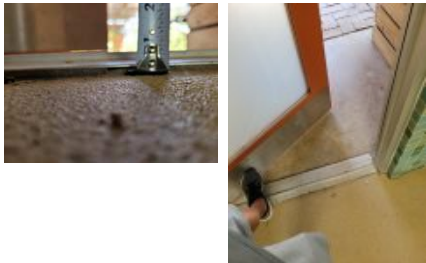
| Finding Number | Area Description | Lat/Long | Finding | As Built | Recommendation | Citation | Photos | Figure |
|---|--|---|--|--|--|--|---|---|
| 91 | Headquarters Area: Meeting Room - Women's Restroom | [26.18563, -98.38044] | The threshold has a vertical change greater than 1/4 inch high. Exterior doors are recommended to be maintained at 8.5 lbf as a smart practice. Force is to be measured at the operating hardware or 30 inches from the hinges, whichever is greater. | Women's door - 11 lbf, .75" threshold change in level | For all doors along the public circulation route, repair, bevel, or ramp CILs at door entries to max .25". For all doors along the public circulation route, inspect, adjust, and maintain 8.5 lbf to open exterior doors as a smart practice. | 2010 ADAS Section: 404.2.3, 404.2.7, 404.2.4, 404.2.11, 404.2.11 Exception | | |

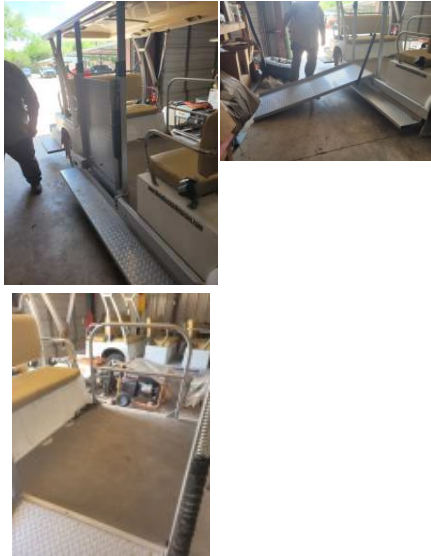
| Finding Number | Area Description | Lat/Long | Finding | As Built | Recommendation | Citation | Photos | Figure |
|---|---|---|--|--|--|---|--|---|
| 99 | Tram System: Tram | [26.1854801 , -98.380593 7] | Element meets all standards and requirements | Park has an accessible tram, employees are trained on how to operate the ramp and assist individuals in use of the tram system | None | 2010 ADAS Section: N/A | | |

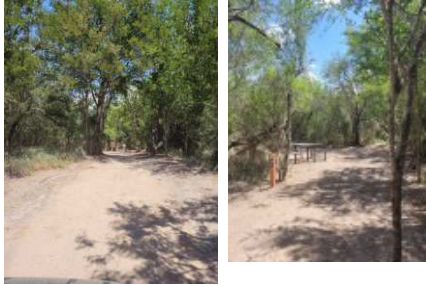
| Finding Number | Area Description | Lat/Long | Finding | As Built | Recommendation | Citation | Photos | Figure |
|---|---|---|---|---|---|---|--|---|
| 102 | Park Site: Park Elements | [26.1789199 , -98.383785 5] | Camping facilities shall provide camping units with mobility features complying with F244.2 in accordance with Table F244.2. Where a camping facility provides different types of camping units, Table F244.2 shall apply to each type of camping unit provided. Total Number of Camping Units Provided in Camping Facility Minimum Number of Camping Units with Mobility Features Required 1 1 2 to 25 2 26 to 50 3 51 to 75 4 76 to 100 5 101 to 150 7 151 to 200 8 201 and over 8, plus 2 percent of the number over 200 | 0 of 5 primitive campsites have accessible route, 0 of 5 have accessible features (accessible table, grill, lantern hook) | Create the required number of accessible camp sites per table F244.2 as a smart practice. Create AR with crushed and compacted stone or similar outdoor material from road to one of the primitive campsites. | 2015 ABAAS Section: F244.2 | | |

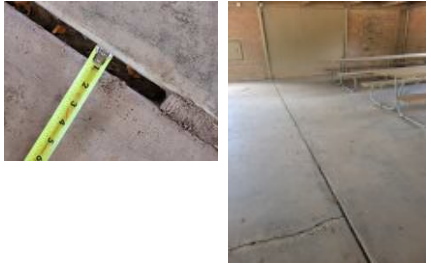
| Finding Number | Area Description | Lat/Long | Finding | As Built | Recommendation | Citation | Photos | Figure |
|---|---|---|--|---|--|--|--|---|
| 107 | Park Site: Pavilion | [26.1782242 , -98.387253 6] | There is a gap spaced greater than a 1/2 inch. Openings in floor or ground surfaces shall not allow passage of a sphere more than 1/2 inch diameter. Elongated openings shall be placed so that the long dimension is perpendicular to the dominant direction of travel. | 1" in center of pavilion | Correct or fill gaps to be max .5". | 2015 ABAAS Section: 302.3 2012 TAS Section: 302.3 2010 ADAS Section: 302.3 | | |

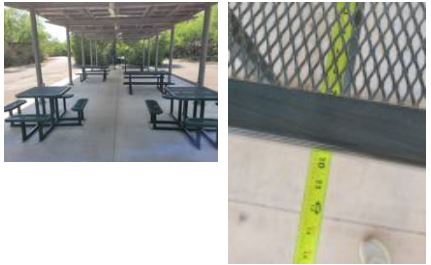
| Finding Number | Area Description | Lat/Long | Finding | As Built | Recommendation | Citation | Photos | Figure |
|---|---|---|--|---|--|--|--|---|
| 109 | Park Site: Pavilion | [26.1837459 , -98.380773 4] | Picnic tables shall provide at least one wheelchair space for each 24 linear feet (7320 mm) of usable table surface perimeter. Wheelchair spaces shall be 30 inches (760 mm) minimum by 48 inches (1220 mm) minimum. Wheelchair spaces shall be positioned for a forward approach to the table and provide knee and toe clearance complying with 306 under the table | Nature Center - 0 of 5 offer wheelchair space | Replace one picnic table with one of an accessible design as a smart practice. | 2015 ABAAS Section: 1011.4.2 | | |

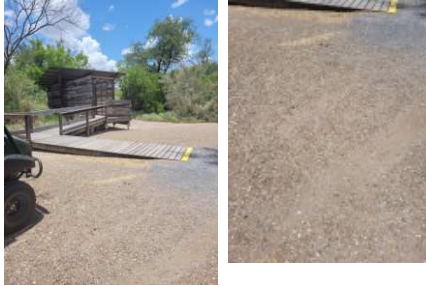
| Finding Number | Area Description | Lat/Long | Finding | As Built | Recommendation | Citation | Photos | Figure |
|---|---|---|--|--|--|---|---|---|
| 111 | Park Site: Bird Blind | [26.176804, -98.3900324] | There is no accessible route to the Green Jay Bird Blind At least one accessible route shall connect accessible buildings, accessible facilities, accessible elements, and accessible spaces that are on the same site. | no route to Green Jay Bird Blind due to loose gravel surface | Create an accessible route with crushed stone or other outdoor material from parking or walkway to bird blind entry. | 2015 ABAAS Section: F206.2.2 2012 TAS Section: 206.2.2 2010 ADAS Section: 206.2.2 | | |

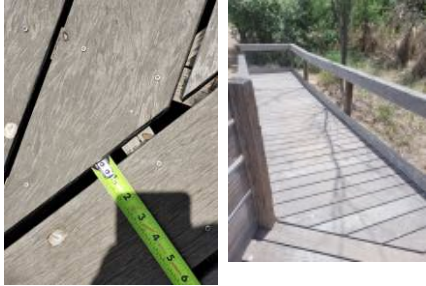
| Finding Number | Area Description | Lat/Long | Finding | As Built | Recommendation | Citation | Photos | Figure |
|---|---|---|--|--|--|---|---|---|
| 112 | Park Site: Bird Blind | [26.1768028, -98.3900297] | Openings in floor or ground surfaces shall not allow passage of a sphere more than 1/2 inch (13 mm) diameter except as allowed in 407.4.3, 409.4.3, 410.4, 810.5.3 and 810.10. Elongated openings shall be placed so that the long dimension is perpendicular to the dominant direction of travel. | Green Jay Bird Blind - five .5" gaps | Fill and maintain gaps to max .5". | 2015 ABAAS Section: 302.3 2012 TAS Section: 302.3 2010 ADAS Section: 302.3 | | |

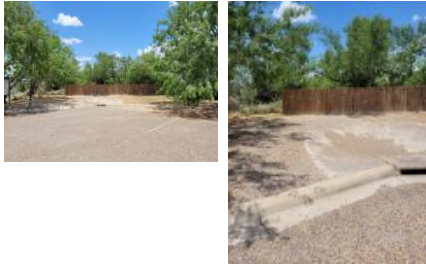
| Finding Number | Area Description | Lat/Long | Finding | As Built | Recommendation | Citation | Photos | Figure |
|---|---|---|---|---|---|---|--|---|
| 114 | Park Site: Bird Blind | [26.1789536 , -98.3865147] | There is no accessible route to the bird wall by Kingfisher Overlook. At least one accessible route shall connect accessible buildings, accessible facilities, accessible elements, and accessible spaces that are on the same site. | no accessible route to bird wall by Kingfisher Overlook, lacks path and route | Create an accessible route with crushed stone or other outdoor material from parking or walkway to the bird wall by Kingfisher Overlook. Create a curb ramp to be max running slope 8.33%, max cross slope 2.08%, having a top landing as wide as the ramp and 36" deep and side flares with a max slope 10%. | 2015 ABAAS Section: F206.2.2 2012 TAS Section: 206.2.2 2010 ADAS Section: 206.2.2 | | |

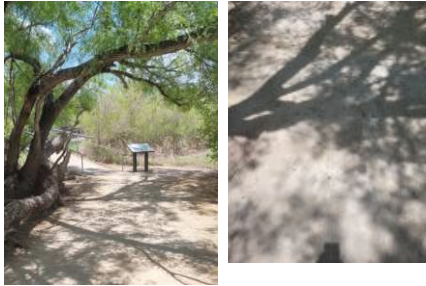
| Finding Number | Area Description | Lat/Long | Finding | As Built | Recommendation | Citation | Photos | Figure |
|---|---|---|--|--|--|---|--|---|
| 116 | Park Site: Hawk Tower | [26.168894, -98.3819107] | The surface of trails, passing spaces, and resting intervals shall be firm and stable | no route to Hawk Tower due to dirt/gravel surface from fork to tower | Replace surface of trail with one that is firm and stable as a smart practice. | 2015 ABAAS Section: 1017.2 | | |

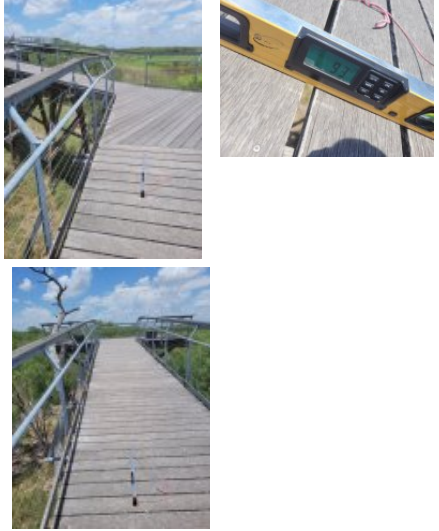
| Finding Number | Area Description | Lat/Long | Finding | As Built | Recommendation | Citation | Photos | Figure |
|---|---|--|---|---|---|--|--|---|
| 117 | Park Site: Hawk Tower | [26.1687688, -98.3811073], [26.169113, -98.3805253] | The ramp slope exceeds the maximum running slope (direction of travel) allowable of 8.33%. Ramps should have the least possible slope but in no case more than 8.3% (1:12). | Hawk Tower ramp - 9.1% at top of first run, 8.8% at second run, 9.6% slope at third turn, 10.4% slope at fourth turn, 9.2% slope approaching top, 9.3% slope at top | Correct slope of ramp to max 8.33%. | 2015 ABAAS Section: 405.2 2012 TAS Section: 405.2 2010 ADAS Section: 405.2 | | |

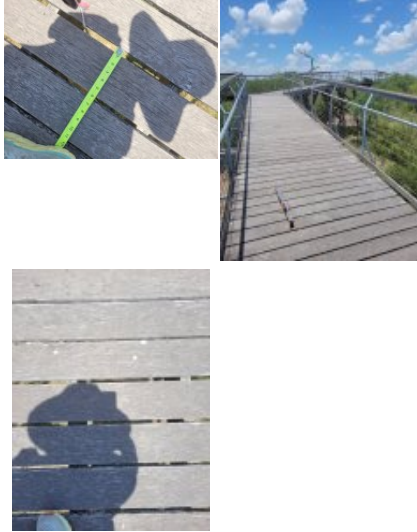
| Finding Number | Area Description | Lat/Long | Finding | As Built | Recommendation | Citation | Photos | Figure |
|---|---|--|--|---|---|--|--|---|
| 118 | Park Site: Hawk Tower | [26.1687279, -98.3811972], [26.1691082, -98.3805427] | Openings in floor or ground surfaces shall not allow passage of a sphere more than ½ inch (13 mm) diameter except as allowed in 407.4.3, 409.4.3, 410.4, 810.5.3 and 810.10. Elongated openings shall be placed so that the long dimension is perpendicular to the dominant direction of travel. | 17 instances of gaps along the ramp to Hawk Tower | Fill and maintain gaps to max .5". | 2015 ABAAS Section: 302.3 2012 TAS Section: 302.3 2010 ADAS Section: 302.3 | | |

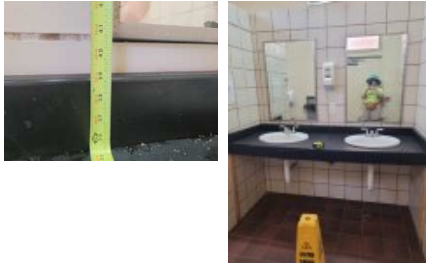
| Finding Number | Area Description | Lat/Long | Finding | As Built | Recommendation | Citation | Photos | Figure |
|---|--|---|--|---|--|--|---|---|
| 120 | Restrooms : Hackberry - Men's Restroom | [26.1773528 , -98.388525] | The mirror is mounted too high. Mirrors must have the bottom edge of the reflecting surface a maximum of 40 inches above the floor if above a sink or counter. Mirrors not located above lavatories or countertops shall be installed with the bottom edge of the reflecting surface 35 inches maximum above the finish floor or ground. | mirror 41.5" above finished floor | Lower mirror so bottom reflective surface is max 40" AFF and 74" at the top. | 2015 ABAAS Section: 603.3 2012 TAS Section: 603.3 2010 ADAS Section: 603.3 | | |

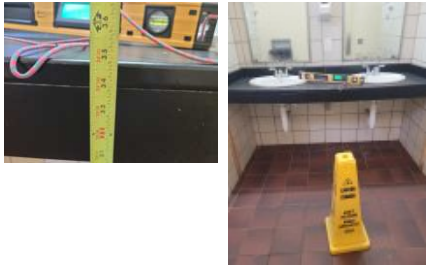
| Finding Number | Area Description | Lat/Long | Finding | As Built | Recommendation | Citation | Photos | Figure |
|---|--|---|--|---|--|--|---|---|
| 121 | Restrooms : Hackberry - Men's Restroom | [26.1773577 , -98.388519 6] | The top rim of the sink is too high. All lavatories/sinks that are designated to be accessible shall be a minimum 17 inches in horizontal depth and mounted with the rim or counter edge no higher than 34 inches above the finished floor. | rim 35.5" AFF | Lower sinks to max 34" above the finished floor (AFF) to front of rim. | 2015 ABAAS Section: 606.3 2012 TAS Section: 606.3 2010 ADAS Section: 606.3 | | |

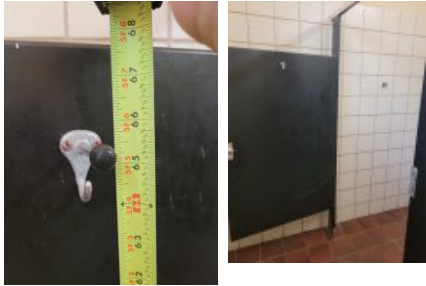
| Finding Number | Area Description | Lat/Long | Finding | As Built | Recommendation | Citation | Photos | Figure |
|---|--|---|--|--|---|--|--|--|
| 122 | Restrooms : Hackberry - Men's Restroom | [26.1773552 , -98.388525] | Where a high forward reach is over an obstruction, the clear floor space shall extend beneath the element for a distance not less than the required reach depth over the obstruction. The high forward reach shall be 48 inches (1220 mm) maximum where the reach depth is 20 inches (510 mm) maximum. Where the reach depth exceeds 20 inches (510 mm), the high forward reach shall be 44 inches (1120 mm) maximum and the reach depth shall be 25 inches (635 mm) maximum. Where a clear floor or ground space allows a parallel approach to an element and the high side reach is over an obstruction, the height of the obstruction shall be 34 inches (865 mm) maximum and the depth of the obstruction shall be 24 inches (610 mm) maximum. The high side reach shall be 48 inches (1220 mm) maximum for a reach depth of 10 inches (255 mm) maximum. Where the reach depth exceeds 10 inches (255 mm), the high side reach shall be 46 inches (1170 mm) maximum for a reach depth of 24 inches (610 mm) maximum. | hook in stall 65" above finished floor | Lower operating mechanisms to max 48" above the finished floor (AFF) to highest operable part. Lower _____ to max 44" above the finished floor (AFF) for a forward reach over counter. Lower _____ to max 46" above the finished floor (AFF) for a side reach over counter. | 2015 ABAAS Section: 308.2.1, 308.3.2 2012 TAS Section: 308.2.1, 308.3.2 2010 ADAS Section: 308.2.1, 308.3.2 | | |

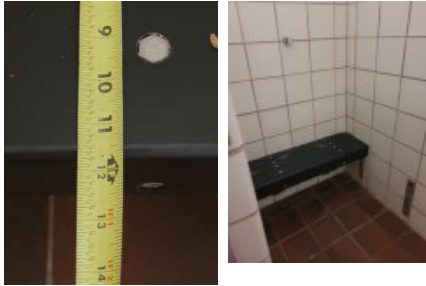
| Finding Number | Area Description | Lat/Long | Finding | As Built | Recommendation | Citation | Photos | Figure |
|---|--|---|--|---|--|---|---|---|
| 129 | Restrooms : Hackberry - Men's Restroom | [26.177348, -98.388530 4] | The bench is not deep enough or long enough or is missing. Benches shall be provided having seats that are 42 inches long minimum and 20 inches deep minimum and 24 inches deep maximum. The bench shall provide for back support or shall be affixed to a wall. Back support shall be 42 inches (1065 mm) long minimum and shall extend from a point 2 inches (51 mm) maximum above the seat surface to a point 18 inches (455 mm) minimum above the seat surface. Back support shall be 2½ inches (64 mm) maximum from the rear edge of the seat measured horizontally. The top of the bench seat surface shall be 17 inches (430 mm) minimum and 19 inches (485 mm) maximum above the finish floor or ground. Clear floor or ground space complying with 305 shall be provided and shall be positioned at the end of the bench seat and parallel to the short axis of the bench | 11.5" depth, lacks clear floor space | Replace bench in dressing area with one having a seat depth of 20" to 24" deep, 42" long, affixed to the wall or having a back and mounted 17" to 19" aff and provide required clear floor space on the short axis of the bench. | 2012 TAS Section: 903.4, 903.2, 903.3, 903.5 2010 ADAS Section: 903.4, 903.2, 903.3, 903.5 | | |

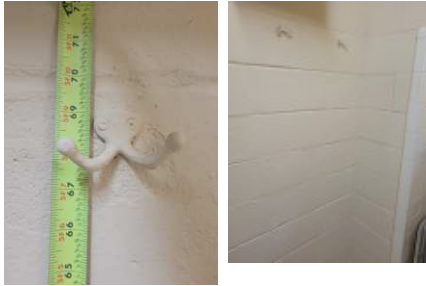
| Finding Number | Area Description | Lat/Long | Finding | As Built | Recommendation | Citation | Photos | Figure |
|---|---|---|--|---|---|--|---|---|
| 151 | Restrooms : Paixtle - Men's Restroom | [26.1766608 , -98.384752 5] | Coat hooks provided within the room shall be located within one of the reach ranges specified in 308. Shelves shall be 40 inches (1015 mm) minimum and 48 inches (1220 mm) maximum above the finish floor or ground. Where coat hooks or shelves are provided in dressing, fitting or locker rooms without individual compartments, at least one of each type shall comply with 803.5. Where coat hooks or shelves are provided in individual compartments at least one of each type complying with 803.5 shall be provided in individual compartments in dressing, fitting, or locker rooms required to comply with 222.1. | hooks 67" above finished floor | Remount at least one hook to max 48" aff. | 2015 ABAAS Section: 308.2.1, 308.1, F222.2, 803.5 2012 TAS Section: 308.2.1, 308.1, 222.2, 803.5 2010 ADAS Section: 308.2.1, 308.1, 222.2, 803.5 | | |

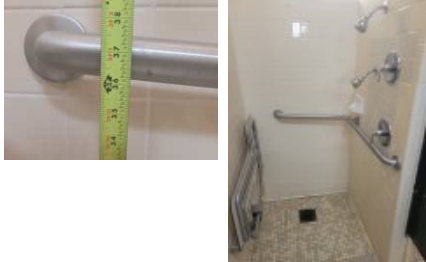
| Finding Number | Area Description | Lat/Long | Finding | As Built | Recommendation | Citation | Photos | Figure |
|---|---|---|---|--|---|---|--|---|
| 153 | Restrooms : Paixtle - Men's Restroom | [26.176632 , -98.384752 5] | Grab bars shall be installed in a horizontal position, 33 inches (840 mm) minimum and 36 inches (915 mm) maximum above the finish floor measured to the top of the gripping surface | mounted 37.5" above finished floor | Remount shower grab bar to 33" min. and 36" max. AFF. | 2015 ABAAS Section: 609.3 Exception, 609.4 2012 TAS Section: 609.4, 609.3 Exception 2010 ADAS Section: 609.4, 609.3 Exception | | |

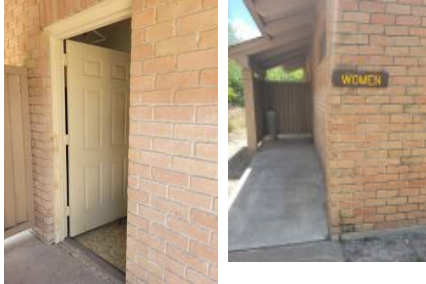
| Finding Number | Area Description | Lat/Long | Finding | As Built | Recommendation | Citation | Photos | Figure |
|---|---|---|---|--|---|---|--|---|
| 155 | Restrooms : Paixtle - Women's Restroom | [26.1766572 , -98.384732 3] | The restroom sign does not comply with one or more applicable requirements for the location, height, and properties of the sign. | lacks signage at entry, signage at front of building lacks raised characters, Braille, and International Symbol of Accessibility (ISA) | Acquire and mount signage, including Braille, raised lettering and access symbol mounted on wall, latch side of door, 48" to baseline of lowest character and 60" to baseline of highest character. | 2015 ABAAS Section: F216.2, 703.1, 703.2, 703.5, 703.6 2012 TAS Section: 216.2, 703.1, 703.2, 703.5, 703.6 2010 ADAS Section: 216.2, 703.1, 703.2, 703.5, 703.6 | | |

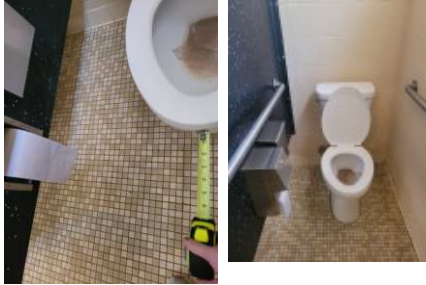
| Finding Number | Area Description | Lat/Long | Finding | As Built | Recommendation | Citation | Photos | Figure |
|---|---|---|---|--|--|--|---|---|
| 162 | Restrooms : Paixtle - Women's Restroom | [26.1766596 , -98.384743 1] | The toilet paper is not installed within the compliant range in front of the toilet. Toilet paper dispensers shall be 7 inches minimum and 9 inches maximum in front of the water closet measured to the centerline of the dispenser. The outlet of the dispenser shall be 15 inches minimum and 48 inches maximum above the finish floor and shall not be located behind grab bars. Dispensers shall not be of a type that controls delivery or that does not allow continuous paper flow. There shall be a clearance of 1 1/2 inches minimum below the grab bar. | toilet paper mounted 4" to front of toilet | Remount toilet paper dispenser max 7" to 9" from front of toilet, 15" to 48" aff and min 12" above or 1.5" below grab bar. | 2015 ABAAS Section: 604.7 2012 TAS Section: 604.7 2010 ADAS Section: 604.7 | | |

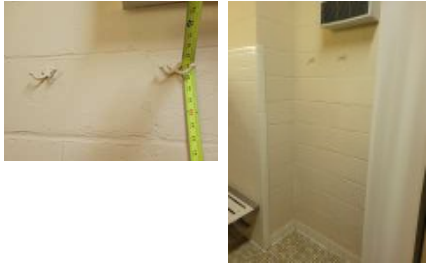
| Finding Number | Area Description | Lat/Long | Finding | As Built | Recommendation | Citation | Photos | Figure |
|---|---|---|---|--|--|--|---|---|
| 163 | Restrooms : Paixtle - Women's Restroom | [26.1766644 , -98.384759 2] | Coat hooks provided within the room shall be located within one of the reach ranges specified in 308. Shelves shall be 40 inches (1015 mm) minimum and 48 inches (1220 mm) maximum above the finish floor or ground. Where coat hooks or shelves are provided in dressing, fitting or locker rooms without individual compartments, at least one of each type shall comply with 803.5. Where coat hooks or shelves are provided in individual compartments at least one of each type complying with 803.5 shall be provided in individual compartments in dressing, fitting, or locker rooms required to comply with 222.1. | both 67" above finished floor | Remount at least one hook to max 48" aff. | 2015 ABAAS Section: 308.2.1, 308.1, F222.2, 803.5 2012 TAS Section: 308.2.1, 308.1, 222.2, 803.5 2010 ADAS Section: 308.2.1, 308.1, 222.2, 803.5 | | |

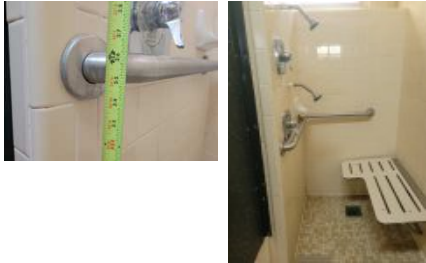
| Finding Number | Area Description | Lat/Long | Finding | As Built | Recommendation | Citation | Photos | Figure |
|---|---|---|--|---|---|---|---|---|
| 166 | Restrooms : Paixtle - Women's Restroom | [26.1766548 , -98.384732 3] | Grab bars shall be installed in a horizontal position, 33 inches (840 mm) minimum and 36 inches (915 mm) maximum above the finish floor measured to the top of the gripping surface | 36.25" above finished floor | Remount shower grab bar to 33" min. and 36" max. AFF. | 2015 ABAAS Section: 609.3 Exception, 609.4 2012 TAS Section: 609.4, 609.3 Exception 2010 ADAS Section: 609.4, 609.3 Exception | | |

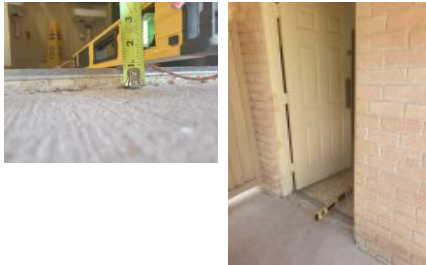
| Finding Number | Area Description | Lat/Long | Finding | As Built | Recommendation | Citation | Photos | Figure |
|---|---|---|--|---|---|---|---|---|
| 167 | Restrooms : Paixtle - Women's Restroom | [26.1766596 , -98.384759 2] | The threshold has a vertical change greater than 1/4 inch high. The sweep period for doors with closers shall be adjusted so that from an open position of 70 degrees, the door will take at least 3 seconds to move to a point 3 inches from the latch, measured to the leading edge of the door. | Door - .75" change in level at door, fast close | For all doors along the public circulation route, repair, bevel, or ramp CILs at door entries to max .25". For all doors along the public circulation route, inspect, adjust, and maintain closing speed on door closers. | 2010 ADAS Section: 404.2.3, 404.2.7, 404.2.4, 404.2.11, 404.2.11 Exception | | |

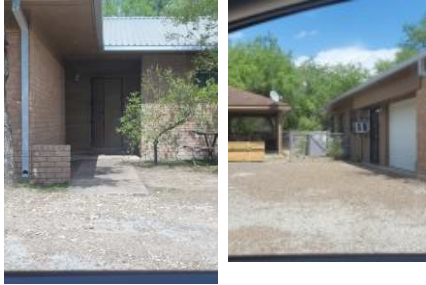
| Finding Number | Area Description | Lat/Long | Finding | As Built | Recommendation | Citation | Photos | Figure |
|---|---|---|---|---|--|---|--|---|
| 168 | Employee Areas: Residence | [26.1836978 , -98.380843 1] | Spaces and elements within employee work areas shall only be required to comply with 206.2.8, 207.1, and 215.3 and shall be designed and constructed so that individuals with disabilities can approach, enter, and exit the employee work area. Employee work areas, or portions of employee work areas, other than raised courtroom stations, that are less than 300 square feet (28 m2) and elevated 7 inches (180 mm) or more above the finish floor or ground where the elevation is essential to the function of the space shall not be required to comply with these requirements or to be on an accessible route. | gravel parking lot | Create AR with crushed and compacted stone or similar outdoor material from parking to residence entry. Provide a firm and stable surface for parking. | 2015 ABAAS Section: F203.9 2012 TAS Section: 203.9 2010 ADAS Section: 203.9 | | |

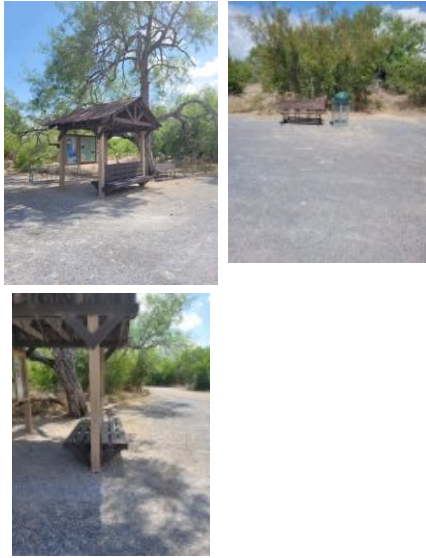
| Finding Number | Area Description | Lat/Long | Finding | As Built | Recommendation | Citation | Photos | Figure |
|---|---|---|---|---|--|---|--|---|
| 191 | Trails: Trailhead | [26.169698, -98.381946 9] | Element meets all standards and requirements | Rio Grande trailhead complies | None | 2010 ADAS Section: N/A | | |

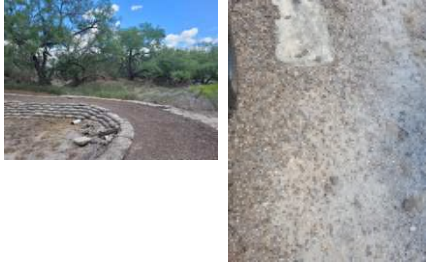
| Finding Number | Area Description | Lat/Long | Finding | As Built | Recommendation | Citation | Photos | Figure |
|---|---|---|--|---|---|---|---|---|
| 195 | Trails: Trail Surface | [26.1685521 , -98.382586 6] | Element meets all standards and requirements | Rio Grande Trail loop - portion of trail complies | None | 2010 ADAS Section: N/A | | |
