Access Audit Site Report

Prepared By
WT Group

Blanco State Park
101 Park Rd 23
Blanco, TX 78606
Accessibility Evaluation
Inspection Date: 02/09/2022
Inspectors: Tanya Scheibe

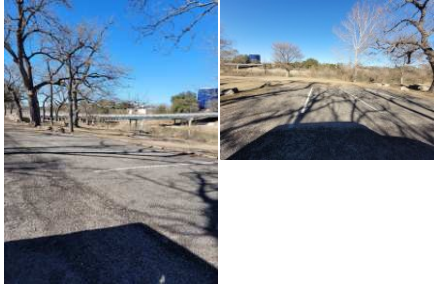
Finding Number	Area Description	Lat/Long	Finding	As Built	Recommendation	Citation	Photos	Figure																																										
1	Exterior : Parking	[30.0917676 , -98.430289 6]	There are no or not enough accessible parking stalls. Each lot where parking is provided for the public as clients, guests or employees, shall provide accessible parking and shall be located on the shortest accessible route of travel from adjacent parking to an accessible entrance. There are a total of 10 parking stalls in the parking lot that could be reasonably associated with this facility. There should be a minimum of 1 accessible stalls with a minimum of 1 being designed as van accessible.	Parking west side by group picnic area - 10 standard, 0 accessible	Create one or more 8' accessible parking stalls, with one 5' adjacent access aisle, with proper signage and striping based on the total number of stalls.	2015 ABAAS Section: F208.2 2012 TAS Section: 208.2 2010 ADAS Section: 208.2

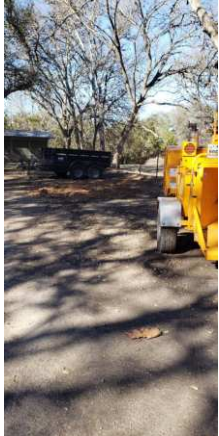
85	17																																																	
90	18																																																	
95	19																																																	
100	20																																																	
2	Exterior : Parking	[30.0905875 , -98.423371 7]	There are no or not enough accessible parking stalls. Each lot where parking is provided for the public as clients, guests or employees, shall provide accessible parking and shall be located on the shortest accessible route of travel from adjacent parking to an accessible entrance. There are a total of 5 parking stalls in the parking lot that could be reasonably associated with this facility. There should be a minimum of 1 accessible stalls with a minimum of 1 being designed as van accessible	Excess parking by screened shelters - parking lacks accessible parking spaces - 5 standard, 0 accessible	Create one or more 8' accessible parking stalls, with one 5' adjacent access aisle, with proper signage and striping based on the total number of stalls.	2015 ABAAS Section: F208.2 2012 TAS Section: 208.2 2010 ADAS Section: 208.2

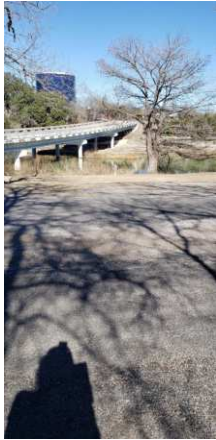
Finding Number	Area Description	Lat/Long	Finding	As Built	Recommendation	Citation	Photos	Figure
3	Exterior : Parking	[30.0921876 , -98.430814 9]	There are no or not enough accessible parking stalls. Each lot where parking is provided for the public as clients, guests or employees, shall provide accessible parking and shall be located on the shortest accessible route of travel from adjacent parking to an accessible entrance. There are a total of 5 parking stalls in the parking lot that could be reasonably associated with this facility. There should be a minimum of 1 accessible stalls with a minimum of 1 being designed as van accessible.	On campground side, before Kendalia Rd bridge - parking at picnicking lacks accessible parking spaces - 5 standard, 0 accessible	Create one or more 8' accessible parking stalls, with one 5' adjacent access aisle, with proper signage and striping based on the total number of stalls.	2015 ABAAS Section: F208.2 2012 TAS Section: 208.2 2010 ADAS Section: 208.2

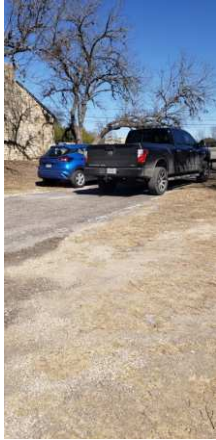
4	Exterior : Parking	[30.0964426 , -98.419051 2]	There are no or not enough accessible parking stalls. Each lot where parking is provided for the public as clients, guests or employees, shall provide accessible parking and shall be located on the shortest accessible route of travel from adjacent parking to an accessible entrance. There are a total of 7 parking stalls in the parking lot that could be reasonably associated with this facility. There should be a minimum of 1 accessible stalls with a minimum of 1 being designed as van accessible.	Employee lot near 4th Street bridge - Lacks accessible parking spaces - 7 standard, 0 accessible	Create one or more 8' accessible parking stalls, with one 5' adjacent access aisle, with proper signage and striping based on the total number of stalls.	2015 ABAAS Section: F208.2 2012 TAS Section: 208.2 2010 ADAS Section: 208.2

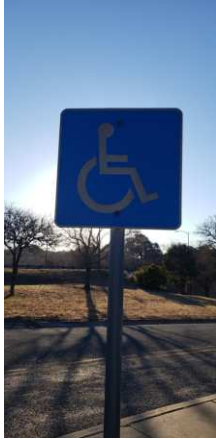
Finding Number	Area Description	Lat/Long	Finding	As Built	Recommendation	Citation	Photos	Figure
5	Headquarters (HQ) : HQ - Parking	[30.09295, -98.423840 3]	The accessible parking stall signage is incorrect and/or missing from each accessible parking space. Parking space identification signs shall include the International Symbol of Accessibility. Signs identifying van parking spaces shall contain the designation "van accessible." Signs shall be 60 inches minimum above the finish floor or ground surface measured to the bottom of the sign.	HQ parking - Lacks R7-8 sign	Acquire R7-8 sign and mount at appropriate heights and locations accessible parking signs where missing as a smart practice	2015 ABAAS Section: 502.6 2012 TAS Section: 502.6

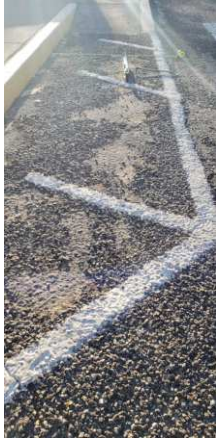
6	Headquarters (HQ) : HQ - Parking	[30.092957, -98.423855]	The parking stall contains abrupt edges and surface irregularities over a 1/4 inch vertical. Parking spaces and access aisles serving them shall be stable, firm, and slip resistant. Access aisles shall be at the same level as the parking spaces they serve. Changes in level are not permitted and shall not be sloped steeper than 2% in any direction.	HQ parking - Loose deteriorated asphalt	Resurface accessible stalls and access aisles with a firm, stable, and slip resistant material.	2015 ABAAS Section: 502.4 2012 TAS Section: 502.4 2010 ADAS Section: 502.4

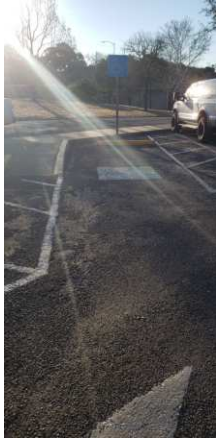
Finding Number	Area Description	Lat/Long	Finding	As Built	Recommendation	Citation	Photos	Figure
7	Headquarters (HQ) : HQ - Parking	[30.0929558, -98.4238711]	There are no van accessible parking stalls. 1 in every 6, minimum of one, required accessible stalls must be a van accessible stall. There are a total of 4 parking stalls in the parking lot that could be reasonably associated with this facility. There should be a minimum of 1 accessible stalls with a minimum of 1 being designed as van accessible.	HQ parking - Accessible stall is not a van accessible	Add van parking sign to 1 accessible stall and repaint stall and access aisle to 11' and 5' or 8' and 8'.	2015 ABAAS Section: F208.2, F208.2.4 2012 TAS Section: 208.2, 208.2.4 2010 ADAS Section: 208.2, 208.2.4

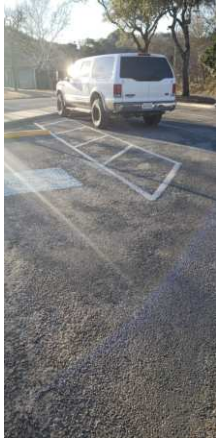
Finding Number	Area Description	Lat/Long	Finding	As Built	Recommendation	Citation	Photos	Figure
9	Headquarters (HQ) : HQ - Parking	[30.08939, -98.42437]	Element meets all standards and requirements	Parking at headquarters meets scoping requirements - 4 standard, 1 accessible	None	2010 ADAS Section: N/A

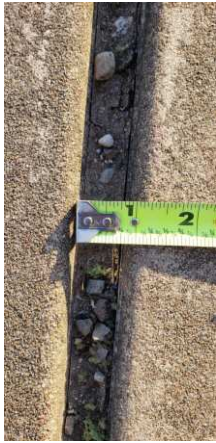
10	Headquarters (HQ) : HQ - Exterior Accessible Route	[30.092921, -98.423818]	There is a gap spaced greater than a 1/2 inch. Openings in floor or ground surfaces shall not allow passage of a sphere more than 1/2 inch diameter. Elongated openings shall be placed so that the long dimension is perpendicular to the dominant direction of travel.	Four 1" gaps at expansion joints	Correct or fill gaps to be max .5".	2015 ABAAS Section: 302.3 2012 TAS Section: 302.3 2010 ADAS Section: 302.3

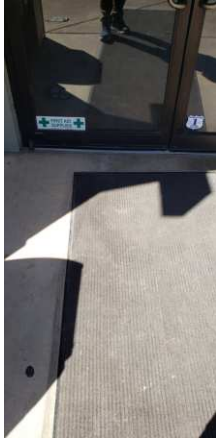
Finding Number	Area Description	Lat/Long	Finding	As Built	Recommendation	Citation	Photos	Figure
13	Headquarters (HQ) : HQ - Public Spaces	[30.0930683, -98.4238711]	The edges of the carpet are not fastened and/or are exposed without trim. Carpet or carpet tile shall be securely attached and shall have a firm cushion, pad, or backing or no cushion or pad. Carpet or carpet tile shall have a level loop, textured loop, level cut pile, or level cut/uncut pile texture. Pile height shall be 1/2 inch maximum. Exposed edges of carpet shall be fastened to floor surfaces and shall have trim on the entire length of the exposed edge.	Lacks secure floor mat	Secure edges of carpeting or mats to prevent trip hazard.	2015 ABAAS Section: 302.2 2012 TAS Section: 302.2 2010 ADAS Section: 302.2

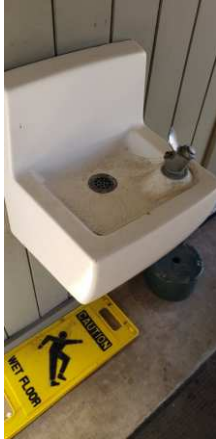
14	Headquarters (HQ) : HQ - Public Spaces	[30.093066, -98.4238604]	There is no drinking fountain for standing persons. Spout outlets of drinking fountains for standing persons shall be 38 inches minimum and 43 inches maximum above the finish floor or ground.	Lacks high bowl drinking fountain	Add second high bowl fountain for standing persons.	2015 ABAAS Section: 602.7 2012 TAS Section: 602.7 2010 ADAS Section: 602.7, 211.2

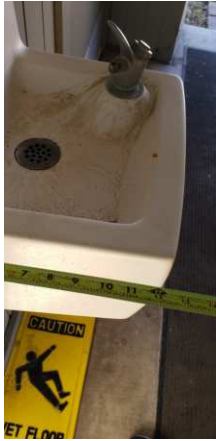
Finding Number	Area Description	Lat/Long	Finding	As Built	Recommendation	Citation	Photos	Figure
15	Headquarters (HQ) : HQ - Public Spaces	[30.0930799 , -98.4238577]	The spout is not positioned correctly from the vertical support. The spout shall be located 15 inches minimum from the vertical support and 5 inches maximum from the front edge of the unit, including bumpers.	10" from vertical support	Replace fountain with a compliant low bowl fountain.	2015 ABAAS Section: 602.5 2012 TAS Section: 602.5 2010 ADAS Section: 602.5

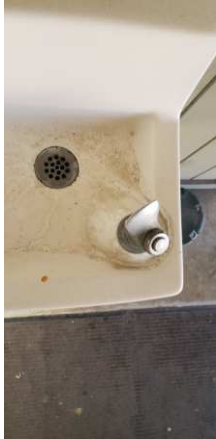
16	Headquarters (HQ) : HQ - Public Spaces	[30.0930776 , -98.4238657]	The angle of the water flow is too great from a spout located less than 3 inches from the front of the drinking fountain. The angle of the water stream shall be measured horizontally relative to the front face of the unit. Where spouts are located less than 3 inches from the front of the unit, the angle of the water stream shall be 30 degrees maximum. Where spouts are located between 3 inches and 5 inches maximum from the front of the unit, the angle of the water stream shall be 15 degrees maximum.	Drinking fountain inoperable, but spout position indicates water stream to exceed 30 degrees	Adjust spout flow to max 30 degrees measured from the front of the unit. See previous finding about replacement of unit.	2015 ABAAS Section: 602.6 2012 TAS Section: 602.6 2010 ADAS Section: 602.6

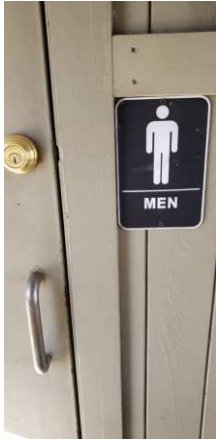
Finding Number	Area Description	Lat/Long	Finding	As Built	Recommendation	Citation	Photos	Figure
21	Headquarters (HQ) : HQ - Men's Restroom	[30.0930846 , -98.423869 8]	The tactile restroom wall sign is missing the International Symbol of Accessibility (ISA). Accessible toilet rooms or bathing rooms shall be identified by the International Symbol of Accessibility (ISA). Wall signs identifying permanent rooms and spaces of a building shall have be horizontal format and the characters raised 1/32 inch minimum and shall be sans serif uppercase characters a minimum of 5/8 inch and a maximum of 2 inches high. Contracted Grade 2 Braille shall be in a horizontal format and shall be placed a minimum of 3/8 inch and a maximum of 1/2 inch directly below the tactile characters; flush left or centered. Signs with raised characters or Braille shall be located 48 inches minimum above the finish floor or ground surface, measured from the baseline of the lowest tactile character and 60 inches maximum above the finish floor or ground surface, measured from the baseline of the highest tactile character.	Signage lacks ISA	Acquire and mount signage, including access symbol.	2015 ABAAS Section: F216.8 2012 TAS Section: 216.8 2010 ADAS Section: 216.8

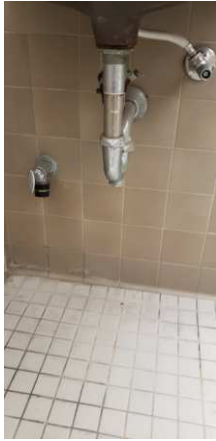
Finding Number	Area Description	Lat/Long	Finding	As Built	Recommendation	Citation	Photos	Figure
23	Headquarters (HQ) : HQ - Men's Restroom	[30.0930765 , -98.423877 8]	The water and drain pipes under the lavatory are not adequately insulated. Water supply and drain pipes under lavatories and sinks shall be insulated or otherwise configured to protect against contact. There shall be no sharp or abrasive surfaces under lavatories and sinks.	Sink lacks insulated pipes	Insulate exposed pipes under one sink.	2015 ABAAS Section: 606.5 2012 TAS Section: 606.5 2010 ADAS Section: 606.5

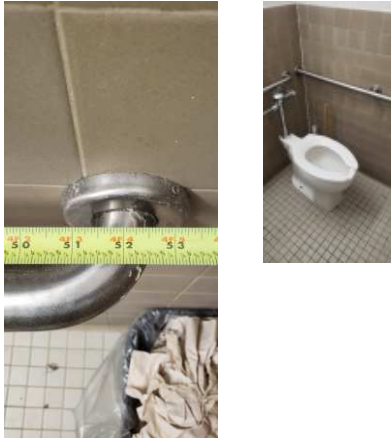
Finding Number	Area Description	Lat/Long	Finding	As Built	Recommendation	Citation	Photos	Figure
25	Headquarters (HQ) : HQ - Men's Restroom	[30.0930683 , -98.423876 5]	The side grab bars are not in the correct location. Grab bars on the side wall must be installed so that the end closest to the rear wall is maximum 12" from the rear wall. The end furthest from the rear wall must be mounted minimum 54" from the rear wall.	Side grab bar ends 52" from rear wall	Remount side grab bar to max 12" from the rear wall at the close end and min 54" on the far end, and 33" to 36" AFF.	2015 ABAAS Section: 604.5.1 2012 TAS Section: 604.5.1 2010 ADAS Section: 604.5.1

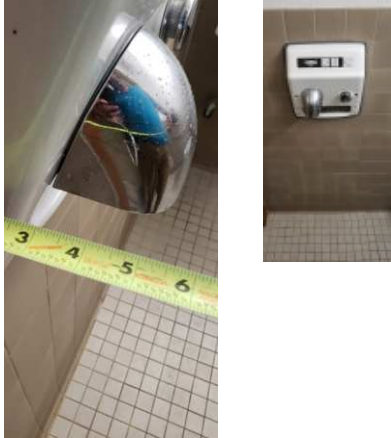
28	Headquarters (HQ) : HQ - Men's Restroom	[30.0930892 , -98.423868 4]	An item or items project more than 4 inches into the circulation path. Wall-mounted objects that have leading edges between 27 inches and 80 inches from the floor must not project more than 4 inches into the circulation path. Protruding objects that extend to the floor or within 27 inches of the floor are cane detectable and are therefore not hazardous. Where it is necessary or desirable to have objects protrude from the wall, a manner of cane detection must be provided.	Hand dryer protrudes 5"	Relocate protruding objects or place cane detectable warning or bollard at foot of item.	2015 ABAAS Section: 307.2 2012 TAS Section: 307.2 2010 ADAS Section: 307.2

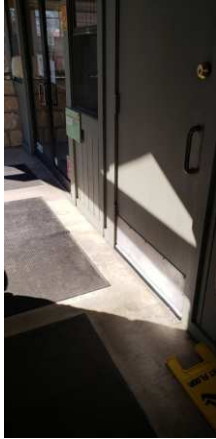
Finding Number	Area Description	Lat/Long	Finding	As Built	Recommendation	Citation	Photos	Figure
29	Headquarters (HQ) : HQ - Men's Restroom	[30.0930881 , -98.423868 4]	Minimum maneuvering clearances at doors and gates shall comply with 404.2.4. Maneuvering clearances shall extend the full width of the doorway and the required latch side or hinge side clearance. Exterior doors are recommended to be maintained at 8.5 lbf as a smart practice. Force is to be measured at the operating hardware or 30 inches from the hinges, whichever is greater.	HQ men's restroom door - 15 # push, loose mat in clearance	For all doors along the public circulation route, provide required maneuvering clearance on push and pull side of doors. For all doors along the public circulation route, secure rug in door clearance to prevent trip hazard. For all doors along the public circulation route, inspect, adjust, and maintain 8.5 lbf to open exterior doors as a smart practice.	2010 ADAS Section: 404.2.3, 404.2.7, 404.2.4, 404.2.11, 404.2.11 Exception

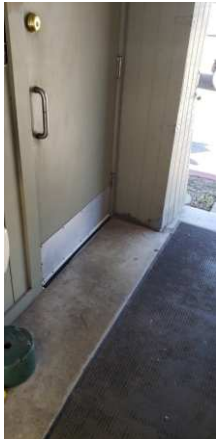
30	Headquarters (HQ) : HQ - Women's Restroom	[30.0930904 , -98.423872 5]	Minimum maneuvering clearances at doors and gates shall comply with 404.2.4. Maneuvering clearances shall extend the full width of the doorway and the required latch side or hinge side clearance. Exterior doors are recommended to be maintained at 8.5 lbf as a smart practice. Force is to be measured at the operating hardware or 30 inches from the hinges, whichever is greater.	HQ women's restroom door -15# push, loose mat	For all doors along the public circulation route, provide required maneuvering clearance on push and pull side of doors. For all doors along the public circulation route, secure rug in door clearance to prevent trip hazard. For all doors along the public circulation route, inspect, adjust, and maintain 8.5 lbf to open exterior doors as a smart practice.	2010 ADAS Section: 404.2.3, 404.2.7, 404.2.4, 404.2.11, 404.2.11 Exception

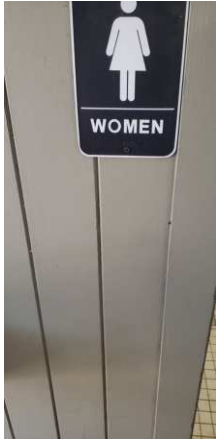
Finding Number	Area Description	Lat/Long	Finding	As Built	Recommendation	Citation	Photos	Figure
31	Headquarters (HQ) : HQ - Women's Restroom	[30.0930776 , -98.4238657]	The tactile restroom wall sign is missing the International Symbol of Accessibility (ISA). Accessible toilet rooms or bathing rooms shall be identified by the International Symbol of Accessibility (ISA). Wall signs identifying permanent rooms and spaces of a building shall have be horizontal format and the characters raised 1/32 inch minimum and shall be sans serif uppercase characters a minimum of 5/8 inch and a maximum of 2 inches high. Contracted Grade 2 Braille shall be in a horizontal format and shall be placed a minimum of 3/8 inch and a maximum of 1/2 inch directly below the tactile characters; flush left or centered. Signs with raised characters or Braille shall be located 48 inches minimum above the finish floor or ground surface, measured from the baseline of the lowest tactile character and 60 inches maximum above the finish floor or ground surface, measured from the baseline of the highest tactile character.	Signage lacks ISA	Acquire and mount signage, including access symbol. Acquire and mount signage, including Braille and access symbol mounted on wall, latch side of door, 48" to baseline of lowest character and 60" to baseline of highest character.	2015 ABAAS Section: F216.8 2012 TAS Section: 216.8 2010 ADAS Section: 216.8

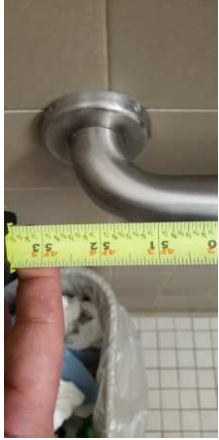
34	Headquarters (HQ) : HQ - Women's Restroom	[30.0930799 , -98.423865 7]	The side grab bars are not in the correct location. Grab bars on the side wall must be installed so that the end closest to the rear wall is maximum 12" from the rear wall. The end furthest from the rear wall must be mounted minimum 54" from the rear wall.	Side grab bar ends 52" from rear wall	Remount side grab bar to max 12" from the rear wall at the close end and min 54" on the far end, and 33" to 36" AFF.	2015 ABAAS Section: 604.5.1 2012 TAS Section: 604.5.1 2010 ADAS Section: 604.5.1

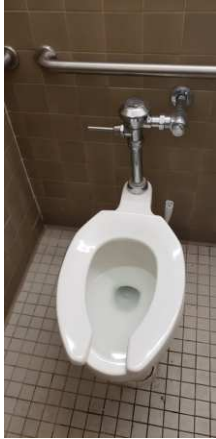
Finding Number	Area Description	Lat/Long	Finding	As Built	Recommendation	Citation	Photos	Figure
37	Headquarters (HQ) : HQ - Women's Restroom	[30.0930707 , -98.423871 1]	The flush handle is located on the wrong side of the toilet. Controls shall be operable with one hand and shall not require tight grasping, pinching or twisting. Controls for the flush valves shall be mounted on the wide side of toilet areas, no more than 44 inches above the floor.	Flush handle on wrong side	Remount flush mechanism on the open side, in the alternative, install an auto flush unit.	2015 ABAAS Section: 604.6 2012 TAS Section: 604.6 2010 ADAS Section: 604.6

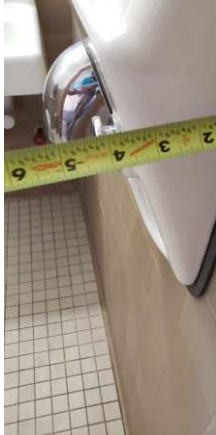
38	Headquarters (HQ) : HQ - Women's Restroom	[30.0930672 , -98.423868 4]	An item or items project more than 4 inches into the circulation path. Wall-mounted objects that have leading edges between 27 inches and 80 inches from the floor must not project more than 4 inches into the circulation path. Protruding objects that extend to the floor or within 27 inches of the floor are cane detectable and are therefore not hazardous. Where it is necessary or desirable to have objects protrude from the wall, a manner of cane detection must be provided.	Hand dryer protrudes 5"	Relocate protruding objects or place cane detectable warning or bollard at foot of item.	2015 ABAAS Section: 307.2 2012 TAS Section: 307.2 2010 ADAS Section: 307.2

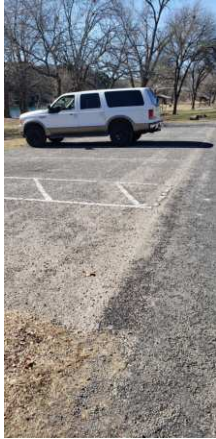
Finding Number	Area Description	Lat/Long	Finding	As Built	Recommendation	Citation	Photos	Figure
39	Day Use : Day Use - Parking	[30.0943238 , -98.421359 2]	Element meets all standards and requirements	Day use area restroom parking (HQ side of river) - meets scoping requirements - 8 standard, 1 accessible	None	2010 ADAS Section: N/A

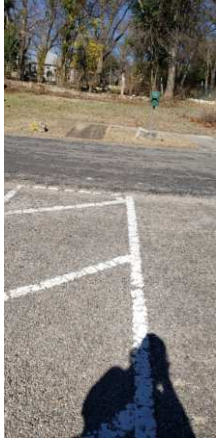
40	Day Use : Day Use - Parking	[30.0943517 , -98.421386]	The access aisle is not located on an accessible route of travel to the accessible building entrance. Accessible parking spaces serving a particular building shall be located on the shortest accessible route of travel from adjacent parking to an accessible entrance. In buildings with multiple accessible entrances with adjacent parking, accessible parking spaces shall be dispersed and located closest to the accessible entrances.	Day use area restroom parking (HQ side of river) - route from parking to restroom is through vehicular way	Reconfigure accessible stalls to avoid requiring pedestrians to cross vehicular way, in the alternative, leave as is with striped crosswalk.	2015 ABAAS Section: F208.3.1 2012 TAS Section: 208.3.1 2010 ADAS Section: 208.3.1

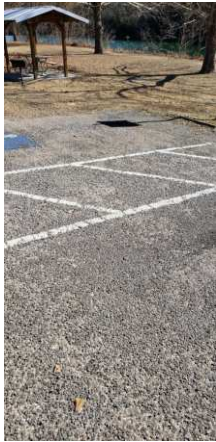
42	Day Use : Day Use - Parking	[30.0943424 , -98.421356 5]	The parking stall contains abrupt edges and surface irregularities over a 1/4 inch vertical. Parking spaces and access aisles serving them shall be stable, firm, and slip resistant. Access aisles shall be at the same level as the parking spaces they serve. Changes in level are not permitted and shall not be sloped steeper than 2% in any direction.	Day use area restroom parking (HQ side of river) - Deteriorated asphalt and gravel in accessible parking stall and AA	Resurface accessible stalls and access aisles with a firm, stable, and slip resistant material. Cost included in slope correction.	2015 ABAAS Section: 502.4 2012 TAS Section: 502.4 2010 ADAS Section: 502.4

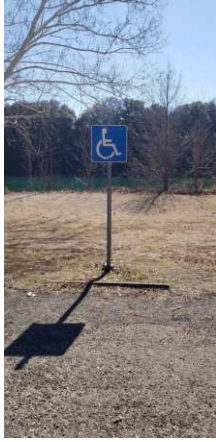
Finding Number	Area Description	Lat/Long	Finding	As Built	Recommendation	Citation	Photos	Figure																						
43	Day Use : Day Use - Parking	[30.0943285 , -98.4213176]	The accessible parking stall signage is incorrect and/or missing from each accessible parking space. Parking space identification signs shall include the International Symbol of Accessibility. Signs identifying van parking spaces shall contain the designation "van accessible." Signs shall be 60 inches minimum above the finish floor or ground surface measured to the bottom of the sign.	Day use area restroom parking (HQ side of river) - lacks R7-8 sign, lacks fine signage	Acquire R7-8 sign and mount at appropriate heights and locations accessible parking signs where missing as a smart practice. Acquire and mount correct fine sign for all stalls.	2015 ABAAS Section: 502.6 2012 TAS Section: 502.6

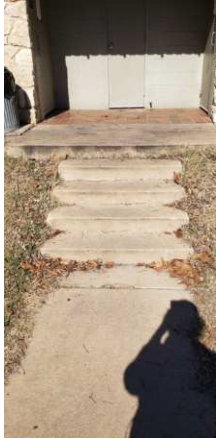
Finding Number	Area Description	Lat/Long	Finding	As Built	Recommendation	Citation	Photos	Figure
45	Day Use : Day Use - East Side Restroom Exterior Accessible Route	[30.0943145 , -98.421528 2]	Stairways must have handrails on both sides. Handrails and their extensions must be between 34 inches and 38 inches above the stair nosing or ground. The top handrails shall extend a minimum of 12 inches beyond the top nosing and shall be parallel with the floor or ground surface. At the bottom of a stair flight, handrails shall extend at the slope of the stair flight for a horizontal distance at least equal to one tread depth beyond the last riser nosing. Extension shall return to a wall, guard, or the landing surface, or shall be continuous to the handrail of an adjacent stair flight. The orientation of at least one handrail, including the extension, shall be in the direction of the run of the stair and perpendicular to the direction of the stair nosing. Handrail gripping surfaces with a circular cross section shall have an outside diameter of 1-1/4 inches minimum and 2 inches maximum. Handrail gripping surfaces with a non-circular cross section shall have a perimeter dimension of 4 inches minimum and 6 1/4 inches maximum, and a cross-section dimension of 2-1/4 inches maximum. The hand grip portion of handrails shall have a smooth surface with no sharp corners. Gripping surfaces (top or sides) shall be uninterrupted by newel posts, other construction elements or obstructions. Any wall or other surface adjacent to the handrail shall be free of sharp or abrasive elements. Handrails projecting from a wall shall have a space of 1-1/2 inches minimum between the wall and the handrail.	Day use HQ side restroom EAR - Stairway lacks handrails	Install handrails on both sides of stairway, mounted 34" to 38" AFF with top and bottom extensions and having a 1.25" – 2" in diameter, or a non-circular grip that has a perimeter dimension of 4"- 6.25" max with a min gap of 1.5" between handrail and wall.	2015 ABAAS Section: 505.2 2012 TAS Section: 505.2 2010 ADAS Section: 505.2

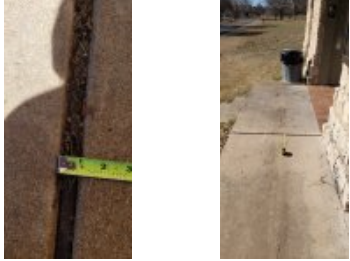
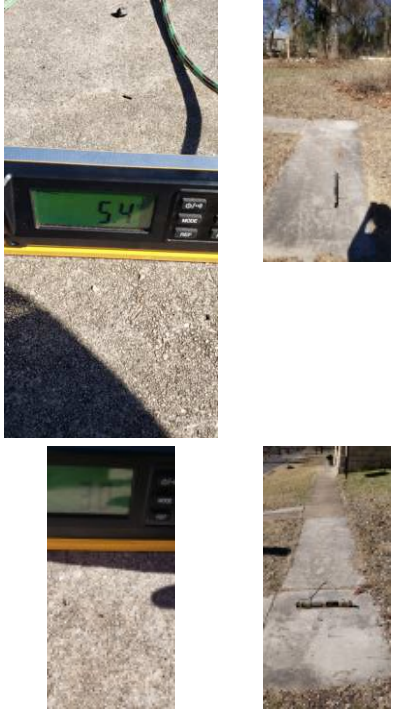
47	Day Use : Day Use - East Side Restroom Exterior Accessible Route	[30.0944283 , -98.4214276]	The accessible route has running slopes greater than 5% and has not been constructed as a ramp (i.e. handrails, edge protection, etc.). Cross slopes are greater than 2% across the width of the walk. When the slope in the direction of travel of any walk exceeds 1 unit vertical in 20 units horizontal (5-percent slope), it must be constructed as a ramp. Surface cross slopes must not exceed 1 unit vertical in 48 units horizontal (2-percent slope).	Day use HQ side restroom EAR - 5.4% run slope, 3% cross slope	Correct or repair sidewalk cross slope along AR to max 2.08%. Correct or repair sidewalk running slope along AR to max 5%.	2015 ABAAS Section: 403.3 2012 TAS Section: 403.3 2010 ADAS Section: 403.3

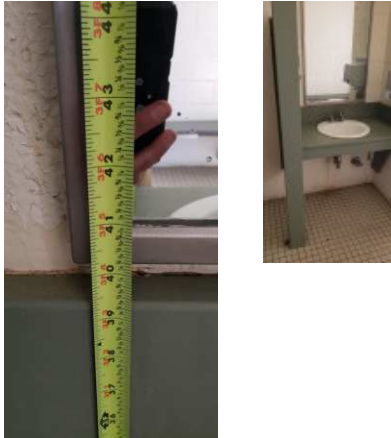
Finding Number	Area Description	Lat/Long	Finding	As Built	Recommendation	Citation	Photos	Figure
48	Day Use : Day Use - East Side Men's Restroom	[30.0943633, -98.4215765]	The mirror is mounted too high. Mirrors must have the bottom edge of the reflecting surface a maximum of 40 inches above the floor if above a sink or counter. Mirrors not located above lavatories or countertops shall be installed with the bottom edge of the reflecting surface 35 inches maximum above the finish floor or ground.	Bottom edge at 41" AFF	Lower mirror so reflective surface is max 40" AFF.	2015 ABAAS Section: 603.3 2012 TAS Section: 603.3 2010 ADAS Section: 603.3

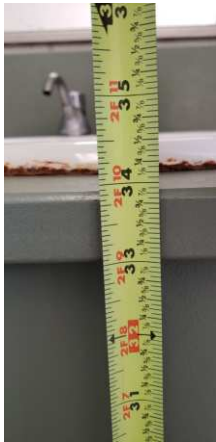
49	Day Use : Day Use - East Side Men's Restroom	[30.094354, -98.4215845]	The top rim of the sink is too high. All lavatories/sinks that are designated to be accessible shall be a minimum 17 inches in horizontal depth and mounted with the rim or counter edge no higher than 34 inches above the finished floor.	Rim of sink at 34.5" AFF	Lower sinks to max 34" above the finished floor (AFF) to front of rim.	2015 ABAAS Section: 606.3 2012 TAS Section: 606.3 2010 ADAS Section: 606.3

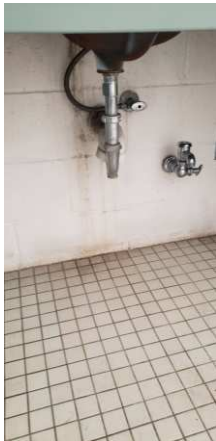
Finding Number	Area Description	Lat/Long	Finding	As Built	Recommendation	Citation	Photos	Figure
50	Day Use : Day Use - East Side Men's Restroom	[30.0943679 , -98.421573 8]	The self closing faucet controls do not stay open for a minimum of 10 seconds. Faucet controls and operating mechanisms shall be operable with one hand and shall not require tight grasping, pinching or twisting of the wrist. The force required to activate controls shall be no greater than 5 lb. Lever-operated, push-type and electronically controlled mechanisms are examples of acceptable designs. Self-closing valves are allowed if the faucet remains open for at least 10 seconds.	Self-closing faucet inoperable (water shut off), unable to test	Adjust timing of sink faucets to remain on for min 10 seconds.	2015 ABAAS Section: 606.4 2012 TAS Section: 606.4 2010 ADAS Section: 606.4		
51	Day Use : Day Use - East Side Men's Restroom	[30.0943563 , -98.421577 8]	The water and drain pipes under the lavatory are not adequately insulated. Water supply and drain pipes under lavatories and sinks shall be insulated or otherwise configured to protect against contact. There shall be no sharp or abrasive surfaces under lavatories and sinks.	Sink lacks insulated pipes	Insulate exposed pipes under one sink.	2015 ABAAS Section: 606.5 2012 TAS Section: 606.5 2010 ADAS Section: 606.5

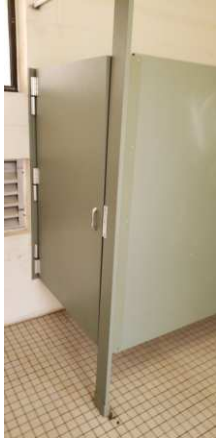
Finding Number	Area Description	Lat/Long	Finding	As Built	Recommendation	Citation	Photos	Figure
52	Day Use : Day Use - East Side Men's Restroom	[30.0943517 , -98.4215859]	There are not enough accessible toilet compartments. The room contains toilet compartments. A minimum of 1 must be wheelchair accessible .	Ambulatory only, lacks wheelchair accessible stall	Create a wheelchair accessible stall with grab bars and fixtures mounted in correct locations and at correct heights.	2015 ABAAS Section: F213.3.1 2012 TAS Section: 213.3.1 2010 ADAS Section: 213.3.1

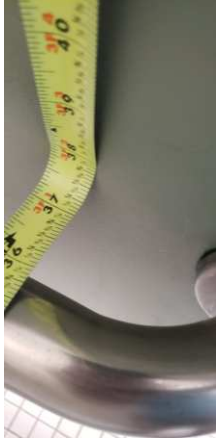
53	Day Use : Day Use - East Side Men's Restroom	[30.0943517 , -98.4215778]	The ambulatory stall is not between 35" to 37" wide and 60" deep.	37.5" wide	Correct ambulatory stall to be 35" to 37" wide and minimum 60" deep. In the alternative, use existing stall to create required wheelchair accessible stall.	2015 ABAAS Section: 604.8.2.1 2012 TAS Section: 604.8.2.1 2010 ADAS Section: 604.8.2.1

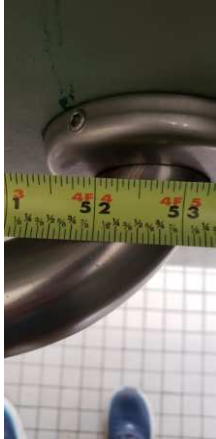
55	Day Use : Day Use - East Side Men's Restroom	[30.0943633 , -98.421583 2]	The side grab bars are not in the correct location. Grab bars on the side wall must be installed so that the end closest to the rear wall is maximum 12" from the rear wall. The end furthest from the rear wall must be mounted minimum 54" from the rear wall.	Side grab bar ends 52.5" from rear wall	Replace side grab bar with a 42" long bar mounted to max 12" from the rear wall at the close end and min 54" on the far end, and 33" to 36" AFF.	2015 ABAAS Section: 604.5.1 2012 TAS Section: 604.5.1 2010 ADAS Section: 604.5.1

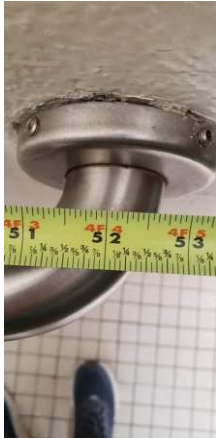
Finding Number	Area Description	Lat/Long	Finding	As Built	Recommendation	Citation	Photos	Figure
62	Day Use : Day Use - East Side Women's Restroom	[30.0943633, -98.4215832]	The side grab bars are not in the correct location. Grab bars on the side wall must be installed so that the end closest to the rear wall is maximum 12" from the rear wall. The end furthest from the rear wall must be mounted minimum 54" from the rear wall.	Side grab bar ends 52" from rear wall	Replace side grab bar with a 42" long bar mounted to max 12" from the rear wall at the close end and min 54" on the far end, and 33" to 36" AFF.	2015 ABAAS Section: 604.5.1 2012 TAS Section: 604.5.1 2010 ADAS Section: 604.5.1

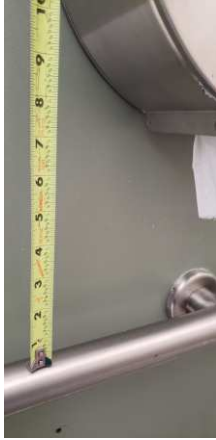
63	Day Use : Day Use - East Side Women's Restroom	[30.094361, -98.4215725]	The grab bar height and/or spacing fails. Grab bars must be mounted between 33" and 36" to the top of the gripping surface. There must be 1.5" of clearance between the grab bar and the wall. There must be a minimum of 1.5" of clearance below and minimum 12" above the grab bar to any dispenser or other obstruction.	Toilet paper 7" above grab bar and behind front of toilet	Remount toilet paper dispenser max 7" to 9" from front of toilet, 15" to 48" above the finished floor (AFF) and min 12" above or 1.5" below grab bar.	2015 ABAAS Section: 609.3, 609.4 2012 TAS Section: 609.4, 609.3 2010 ADAS Section: 609.3, 609.4

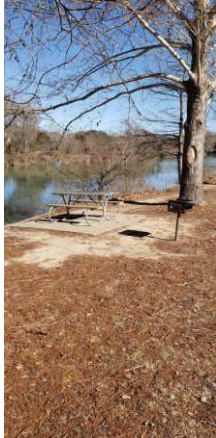
67	Day Use : Day Use - Picnic Area (Campground Side Of River)	[30.0920519 , -98.430453 3]	An accessible access route is not provided between elements, spaces and the facilities provided within the accessible camping unit. At least one outdoor recreation access route shall connect accessible elements, spaces and facilities provided within camping units with mobility features.	Lacks AR to 9 of 9 picnic tables and grills	Create AR with crushed and compacted stone or similar outdoor material to two picnic areas and one of each type of amenity. Replace tables with ones of an accessible design as a smart practice.	2015 ABAAS Section: F244.5.1

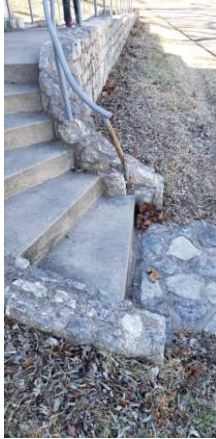
69	Day Use : Day Use - West Side Restroom Exterior Accessible Route	[30.0912942, -98.429530 6]	The handrail does not have a compliant extension at the bottom of the stair flight. At the bottom of a stair flight, handrails shall extend at the slope of the stair flight for a horizontal distance at least equal to one tread depth beyond the last riser nosing. Extension shall return to a wall, guard, or the landing surface, or shall be continuous to the handrail of an adjacent stair flight.	Campground side, day use restroom building stairs - Handrail lacks extensions	Install handrails on both sides of stairway, mounted 34" to 38" AFF with top and bottom extensions and having a 1.25" – 2" in diameter, or a non-circular grip that has a perimeter dimension of 4" - 6.25" max with a min gap of 1.5" between handrail and wall. Provide required extensions at the bottom of the stairway.	2015 ABAAS Section: 505.10.3 2012 TAS Section: 505.10.3 2010 ADAS Section: 505.10.3

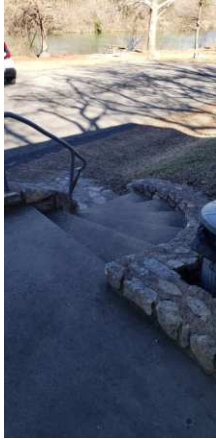
Finding Number	Area Description	Lat/Long	Finding	As Built	Recommendation	Citation	Photos	Figure
70	Day Use : Day Use - West Side Restroom Exterior Accessible Route	[30.0912826 , -98.429527 9]	Stairways must have handrails on both sides. Handrails and their extensions must be between 34 inches and 38 inches above the stair nosing or ground. The top handrails shall extend a minimum of 12 inches beyond the top nosing and shall be parallel with the floor or ground surface. At the bottom of a stair flight, handrails shall extend at the slope of the stair flight for a horizontal distance at least equal to one tread depth beyond the last riser nosing. Extension shall return to a wall, guard, or the landing surface, or shall be continuous to the handrail of an adjacent stair flight. The orientation of at least one handrail, including the extension, shall be in the direction of the run of the stair and perpendicular to the direction of the stair nosing. Handrail gripping surfaces with a circular cross section shall have an outside diameter of 1-1/4 inches minimum and 2 inches maximum. Handrail gripping surfaces with a non-circular cross section shall have a perimeter dimension of 4 inches minimum and 6 1/4 inches maximum, and a cross-section dimension of 2-1/4 inches maximum. The hand grip portion of handrails shall have a smooth surface with no sharp corners. Gripping surfaces (top or sides) shall be uninterrupted by newel posts, other construction elements or obstructions. Any wall or other surface adjacent to the handrail shall be free of sharp or abrasive elements. Handrails projecting from a wall shall have a space of 1-1/2 inches minimum between the wall and the handrail.	Campground side, day use restroom building stairs - Handrail on one side only	Install handrails on both sides of stairway, mounted 34" to 38" AFF with top and bottom extensions and having a 1.25" – 2" in diameter, or a non-circular grip that has a perimeter dimension of 4"- 6.25" max with a min gap of 1.5" between handrail and wall.	2015 ABAAS Section: 505.2 2012 TAS Section: 505.2 2010 ADAS Section: 505.2

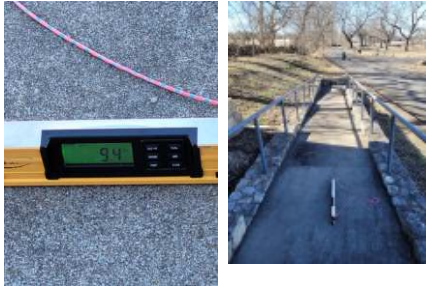
72	Day Use : Day Use - West Side Restroom Exterior Accessible Route	[30.0913116 , -98.4295869]	The ramps slope exceeds the maximum running slope (direction of travel) allowable of 8.33%. Ramps should have the least possible slope but in no case more than 8.3% (1:12).	Campground side, day use restroom building - 9.4% at top - rest of ramp complies	Correct slope of ramp to max 8.33%.	2015 ABAAS Section: 405.2 2012 TAS Section: 405.2 2010 ADAS Section: 405.2

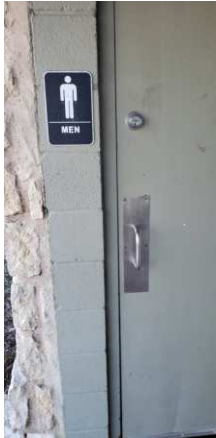
Finding Number	Area Description	Lat/Long	Finding	As Built	Recommendation	Citation	Photos	Figure
73	Day Use : Day Use - West Side Men's Restroom	[30.0912675 , -98.429578 8]	The tactile restroom wall sign is missing the International Symbol of Accessibility (ISA). Accessible toilet rooms or bathing rooms shall be identified by the International Symbol of Accessibility (ISA). Wall signs identifying permanent rooms and spaces of a building shall have be horizontal format and the characters raised 1/32 inch minimum and shall be sans serif uppercase characters a minimum of 5/8 inch and a maximum of 2 inches high. Contracted Grade 2 Braille shall be in a horizontal format and shall be placed a minimum of 3/8 inch and a maximum of 1/2 inch directly below the tactile characters; flush left or centered. Signs with raised characters or Braille shall be located 48 inches minimum above the finish floor or ground surface, measured from the baseline of the lowest tactile character and 60 inches maximum above the finish floor or ground surface, measured from the baseline of the highest tactile character.	Signage lacks ISA	Acquire and mount signage, including Braille and access symbol mounted on wall, latch side of door, 48" to baseline of lowest character and 60" to baseline of highest character.	2015 ABAAS Section: F216.8 2012 TAS Section: 216.8 2010 ADAS Section: 216.8

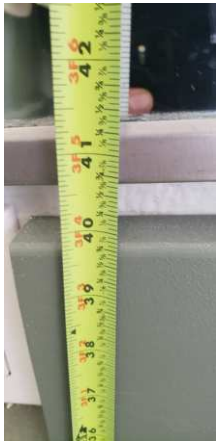
74	Day Use : Day Use - West Side Men's Restroom	[30.0912675 , -98.429573 5]	The mirror is mounted too high. Mirrors must have the bottom edge of the reflecting surface a maximum of 40 inches above the floor if above a sink or counter. Mirrors not located above lavatories or countertops shall be installed with the bottom edge of the reflecting surface 35 inches maximum above the finish floor or ground.	Bottom edge at 41" AFF	Lower mirror so reflective surface is max 40" AFF.	2015 ABAAS Section: 603.3 2012 TAS Section: 603.3 2010 ADAS Section: 603.3

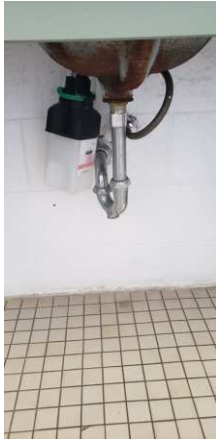
Finding Number	Area Description	Lat/Long	Finding	As Built	Recommendation	Citation	Photos	Figure
75	Day Use : Day Use - West Side Men's Restroom	[30.0912605 , -98.429574 8]	The water and drain pipes under the lavatory are not adequately insulated. Water supply and drain pipes under lavatories and sinks shall be insulated or otherwise configured to protect against contact. There shall be no sharp or abrasive surfaces under lavatories and sinks.	Sink lacks insulated pipes	Insulate exposed pipes under one sink.	2015 ABAAS Section: 606.5 2012 TAS Section: 606.5 2010 ADAS Section: 606.5

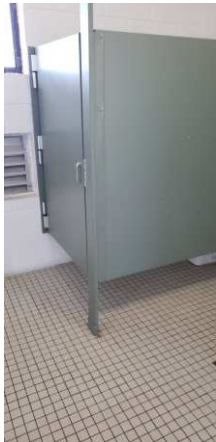
76	Day Use : Day Use - West Side Men's Restroom	[30.0912628 , -98.429573 5]	There are not enough accessible toilet compartments. The room contains toilet compartments. A minimum of 1 must be wheelchair accessible .	Ambulatory stall only, lacks wheelchair accessible stall	Create a wheelchair accessible stall with grab bars and fixtures mounted in correct locations and at correct heights.	2015 ABAAS Section: F213.3.1 2012 TAS Section: 213.3.1 2010 ADAS Section: 213.3.1

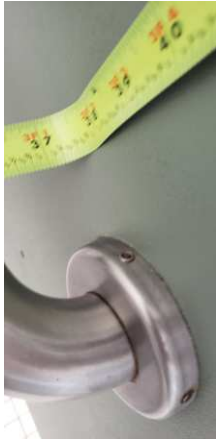
Finding Number	Area Description	Lat/Long	Finding	As Built	Recommendation	Citation	Photos	Figure
77	Day Use : Day Use - West Side Men's Restroom	[30.091264, -98.429565 4]	The ambulatory stall is not between 35" to 37" wide and 60" deep.	37.5" wide	Correct ambulatory stall to be 35" to 37" wide and minimum 60" deep. In the alternative, use existing stall to create the required wheelchair accessible stall.	2015 ABAAS Section: 604.8.2.1 2012 TAS Section: 604.8.2.1 2010 ADAS Section: 604.8.2.1

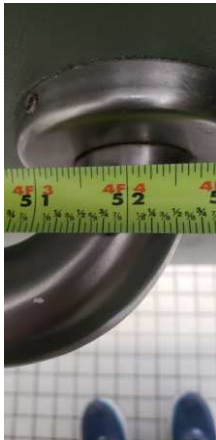
78	Day Use : Day Use - West Side Men's Restroom	[30.0912582, -98.429576 2]	The side grab bars are not in the correct location. Grab bars on the side wall must be installed so that the end closest to the rear wall is maximum 12" from the rear wall. The end furthest from the rear wall must be mounted minimum 54" from the rear wall.	Side grab bars 52" in length	Replace side grab bar with a 42" long bar mounted to max 12" from the rear wall at the close end and min 54" on the far end, and 33" to 36" AFF.	2015 ABAAS Section: 604.5.1 2012 TAS Section: 604.5.1 2010 ADAS Section: 604.5.1

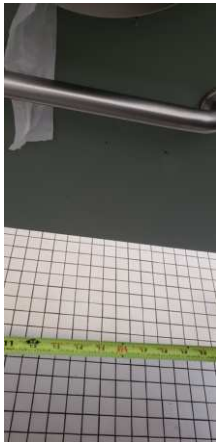
80	Day Use : Day Use - West Side Men's Restroom	[30.0912559, -98.429576 2]	The toilet paper is not installed within the compliant range in front of the toilet. Toilet paper dispensers shall be 7 inches minimum and 9 inches maximum in front of the water closet measured to the centerline of the dispenser. The outlet of the dispenser shall be 15 inches minimum and 48 inches maximum above the finish floor and shall not be located behind grab bars. Dispensers shall not be of a type that controls delivery or that does not allow continuous paper flow. There shall be a clearance of 1 1/2 inches minimum below the grab bar.	TP dispenser 13" from front of toilet	Remount toilet paper dispenser max 7" to 9" from front of toilet, 15" to 48" AFF and min 12" above or 1.5" below grab bar.	2015 ABAAS Section: 604.7 2012 TAS Section: 604.7 2010 ADAS Section: 604.7

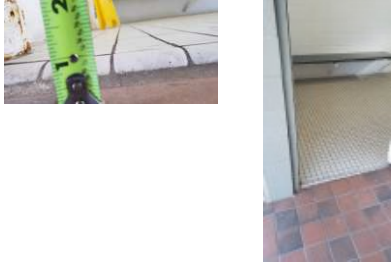
82	Day Use : Day Use - West Side Men's Restroom	[30.091257, -98.4295654]	The threshold has a vertical change greater than 1/4 inch high. Exterior doors are recommended to be maintained at 8.5 lbf as a smart practice. Force is to be measured at the operating hardware or 30 inches from the hinges, whichever is greater.	Men's restroom door - 1" change in level (CIL) at door, 10# push	For all doors along the public circulation route, repair, bevel, or ramp CILs at door entries to max .25". For all doors along the public circulation route, inspect, adjust, and maintain 8.5 lbf to open exterior doors as a smart practice.	2010 ADAS Section: 404.2.3, 404.2.7, 404.2.4, 404.2.11, 404.2.11 Exception

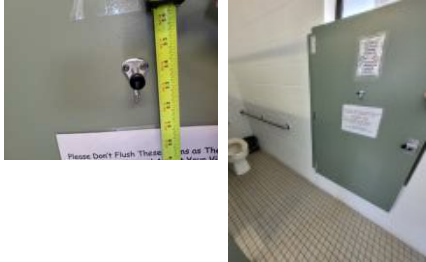
Finding Number	Area Description	Lat/Long	Finding	As Built	Recommendation	Citation	Photos	Figure
86	Day Use : Day Use - West Side Women's Restroom	[30.0912652 , -98.429568 1]	The operable part is positioned too high for either a side or front approach. Where a clear floor or ground space allows a parallel approach to an element and the side reach is unobstructed, the high side reach shall be 48 inches maximum and the low side reach shall be 15 inches minimum above the finish floor or ground. Where a forward reach is unobstructed, the high forward reach shall be 48 inches maximum and the low forward reach shall be 15 inches minimum above the finish floor or ground.	Hook in stall at 53" AFF	Remount operable parts to be in reach range of 15" min to 48" max.	2015 ABAAS Section: 308.1 2012 TAS Section: 308.1 2010 ADAS Section: 308.1

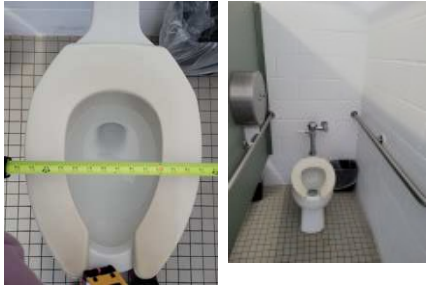
88	Day Use : Day Use - West Side Women's Restroom	[30.0912582 , -98.429576 2]	The toilet is not located within the range to the side wall or partition. The centerline of the toilet shall be 17 inches minimum and 19 inches maximum side wall or partition in the ambulatory accessible toilet compartment.	toilet centerline 19.5" from cement wall	Remount toilet to 17" to 19" from the side wall to center line in ambulatory stalls.	2015 ABAAS Section: 604.9.1 2012 TAS Section: 604.9.1 2010 ADAS Section: 604.9.1

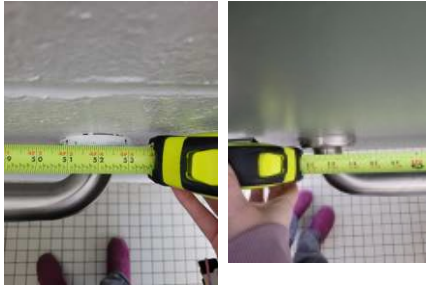
Finding Number	Area Description	Lat/Long	Finding	As Built	Recommendation	Citation	Photos	Figure
89	Day Use : Day Use - West Side Women's Restroom	[30.0912725 , -98.429588 7]	The side grab bars are not in the correct location. Grab bars on the side wall must be installed so that the end closest to the rear wall is maximum 12" from the rear wall. The end furthest from the rear wall must be mounted minimum 54" from the rear wall.	Both bars 52" in length	Replace side grab bar with a 42" long bar mounted to max 12" from the rear wall at the close end and min 54" on the far end, and 33" to 36" AFF.	2015 ABAAS Section: 604.5.1 2012 TAS Section: 604.5.1 2010 ADAS Section: 604.5.1

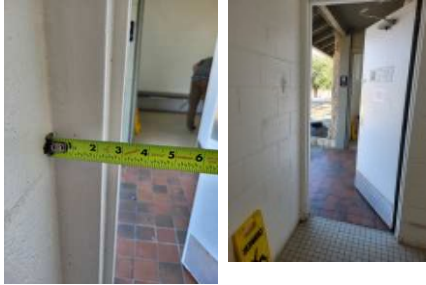
Finding Number	Area Description	Lat/Long	Finding	As Built	Recommendation	Citation	Photos	Figure																						
91	Day Use : Day Use - West Side Women's Restroom	[30.0912628 , -98.429568 1]	Minimum maneuvering clearances at doors and gates shall comply with 404.2.4. Maneuvering clearances shall extend the full width of the doorway and the required latch side or hinge side clearance. Exterior doors are recommended to be maintained at 8.5 lbf as a smart practice. Force is to be measured at the operating hardware or 30 inches from the hinges, whichever is greater.	Women's restroom door - 3" clearance on push, 10# push	For all doors along the public circulation route, provide required maneuvering clearance on push and pull side of doors. For all doors along the public circulation route, inspect, adjust, and maintain 8.5 lbf to open exterior doors as a smart practice.	2010 ADAS Section: 404.2.3, 404.2.7, 404.2.4, 404.2.11, 404.2.11 Exception

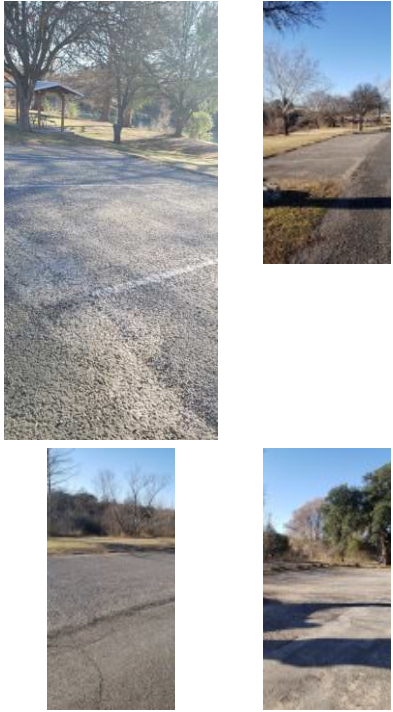
92	Day Use : Day Use - Picnic Area (HQ Side Of The River)	[30.0909867 , -98.425636]	There are no or not enough accessible parking stalls. Each lot where parking is provided for the public as clients, guests or employees, shall provide accessible parking and shall be located on the shortest accessible route of travel from adjacent parking to an accessible entrance. There are a total of 77 parking stalls in the parking lot that could be reasonably associated with this facility. There should be a minimum of 3 accessible stalls with a minimum of 1 being designed as van accessible.	Parking lacks required number of accessible parking spaces - 77 standard, 1 accessible NOTE: there is one stall with an accessible sign but it has no accessible features (surface is deteriorated, lacks striping, lacks access aisle, lacks connection to an AR)	Create three 8' accessible parking stalls, with one 5' adjacent access aisle, with proper signage and striping based on the total number of stalls.	2015 ABAAS Section: F208.2 2012 TAS Section: 208.2 2010 ADAS Section: 208.2

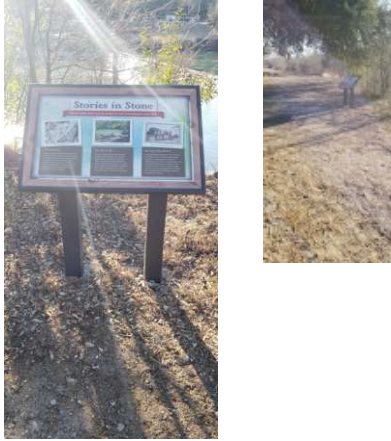
95	Day Use : Day Use - Picnic Area (HQ Side Of The River)	[30.0911155 , -98.426502 4]	There is no accessible route to the info sign. At least one accessible route shall connect accessible buildings, accessible facilities, accessible elements, and accessible spaces that are on the same site.	Lacks route to info sign	Create an accessible route with crushed stone or other outdoor material from parking or walkway to the info sign.	2015 ABAAS Section: F206.2.2 2012 TAS Section: 206.2.2 2010 ADAS Section: 206.2.2

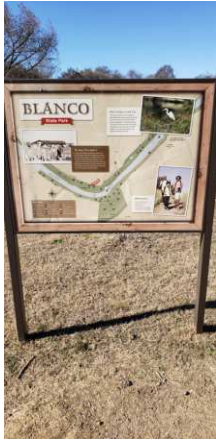
Finding Number	Area Description	Lat/Long	Finding	As Built	Recommendation	Citation	Photos	Figure																		
100	Trails: Trail	[30.0911236 , -98.426491 6]	The trailhead sign is missing the trail information. Trail information signs at trailheads shall include the following: 1. Length of the trail or trail segment; 2. Surface type; 3. Typical and minimum tread width; 4. Typical and maximum running slope; and 5. Typical and maximum cross slope.	Pumphouse Trail - Trailhead sign lacks required information - surface type, tread width, max running and max cross slope	Mount signage at all trail heads indicating length of accessible trail segment, surface type, typical and min. tread width, typical and max. running slope, typical and max. cross slope.	2015 ABAAS Section: 1017.10

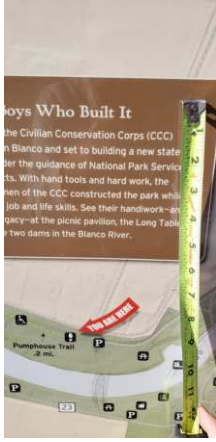
101	Trails: Trail	[30.0911224 , -98.426495 7]	Minimum character height shall comply with Table 703.5.5. Viewing distance shall be measured as the horizontal distance between the character and an obstruction preventing further approach towards the sign. Character height shall be based on the uppercase letter "I".	font size small	Replace signage with compliant signage having larger font size as a smart practice.	2015 ABAAS Section: 703.5.5 2012 TAS Section: 703.5.5 2010 ADAS Section: 703.5.5

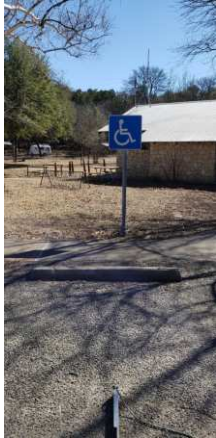
103	Campground Loop: Main Restroom Parking	[30.0896789 , -98.424402 2]	The accessible parking stall signage is incorrect and/or missing from each accessible parking space. Parking space identification signs shall include the International Symbol of Accessibility. Signs identifying van parking spaces shall contain the designation "van accessible." Signs shall be 60 inches minimum above the finish floor or ground surface measured to the bottom of the sign.	Campground loop restroom parking - lacks R7-8 sign	Acquire R7-8 sign and mount at appropriate heights and locations accessible parking signs where missing as a smart practice.	2015 ABAAS Section: 502.6 2012 TAS Section: 502.6

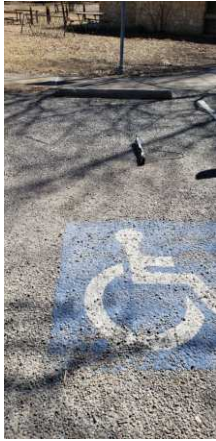
Finding Number	Area Description	Lat/Long	Finding	As Built	Recommendation	Citation	Photos	Figure
104	Campground Loop: Main Restroom Parking	[30.0896755, -98.424425]	The parking stall contains abrupt edges and surface irregularities over a 1/4 inch vertical. Parking spaces and access aisles serving them shall be stable, firm, and slip resistant. Access aisles shall be at the same level as the parking spaces they serve. Changes in level are not permitted and shall not be sloped steeper than 2% in any direction.	Campground loop restroom parking - Deteriorated asphalt and gravel	Resurface accessible stalls and access aisles with a firm, stable, and slip resistant material. Cost included in slope correction.	2015 ABAAS Section: 502.4 2012 TAS Section: 502.4 2010 ADAS Section: 502.4

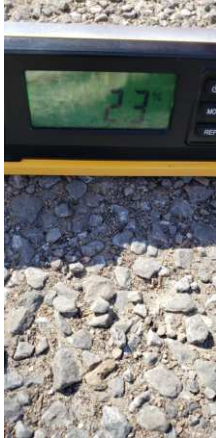
105	Campground Loop: Main Restroom Parking	[30.0896697, -98.4244558]	The cross slopes (narrow dimension) and/or running slopes (long dimension) of the access aisle exceeds 2%. The running slope and the cross slope in an accessible parking stall and the access aisle must not exceed 2%.	Campground loop restroom parking - 2.3% slope in AA	Repair or correct slope of parking space and access aisle to max 2.08% in any direction.	2015 ABAAS Section: 502.4 2012 TAS Section: 502.4 2010 ADAS Section: 502.4

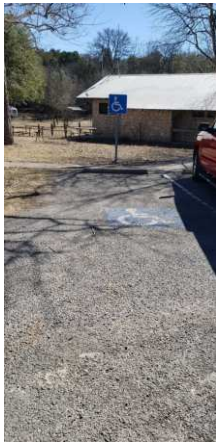
107	Campground Loop: Main Restroom Parking	[30.0896592 , -98.424463 9]	The access aisle is missing at the accessible parking stall. Access aisles serving parking spaces shall adjoin an accessible route. Two parking spaces shall be permitted to share a common access aisle.	Campground loop restroom parking - Lacks access aisle	Create one or more 8' accessible parking stalls, with one 5' adjacent access aisle, with proper signage and striping	2015 ABAAS Section: 502.3.1 2012 TAS Section: 502.3.1 2010 ADAS Section: 502.3.1

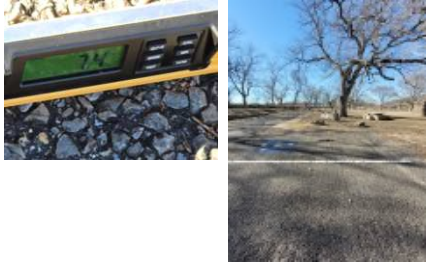
110	Campground Loop: Main Restroom Parking	[30.0913928, -98.4295011]	The cross slopes (narrow dimension) and/or running slopes (long dimension) of the access aisle exceeds 2%. The running slope and the cross slope in an accessible parking stall and the access aisle must not exceed 2%.	Parking across from restroom near Kendalia Road Bridge - Slope of 7.4% in stall	Repair or correct slope of parking space and access aisle to max 2.08% in any direction.	2015 ABAAS Section: 502.4 2012 TAS Section: 502.4 2010 ADAS Section: 502.4

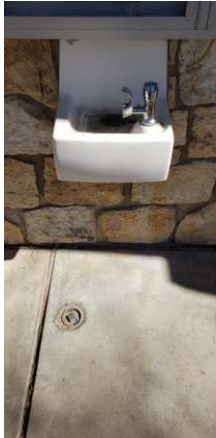
Finding Number	Area Description	Lat/Long	Finding	As Built	Recommendation	Citation	Photos	Figure
114	Campground Loop: Main Restroom Exterior Accessible Route	[30.0895014, -98.4243767]	There is no drinking fountain for standing persons. Spout outlets of drinking fountains for standing persons shall be 38 inches minimum and 43 inches maximum above the finish floor or ground.	Drinking fountain at camping loop restroom - Lacks high bowl drinking fountain	Add second high bowl fountain for standing persons.	2015 ABAAS Section: 602.7 2012 TAS Section: 602.7 2010 ADAS Section: 602.7, 211.2

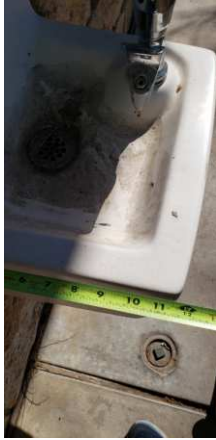
115	Campground Loop: Main Restroom Exterior Accessible Route	[30.089513, -98.4243687]	The spout is not positioned correctly from the vertical support. The spout shall be located 15 inches minimum from the vertical support and 5 inches maximum from the front edge of the unit, including bumpers.	Drinking fountain at camping loop restroom - 10" from vertical support, lacks knee clearance	Replace fountain with a compliant low bowl fountain.	2015 ABAAS Section: 602.5 2012 TAS Section: 602.5 2010 ADAS Section: 602.5

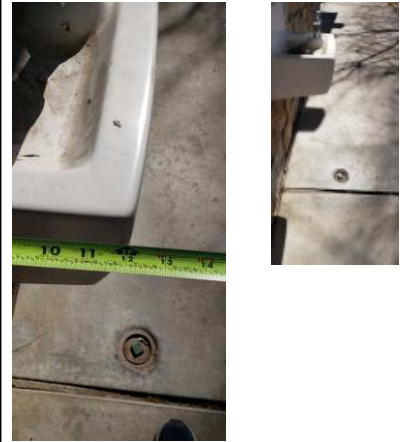
117	Campground Loop: Main Restroom Exterior Accessible Route	[30.0894944 , -98.424375 4]	An item or items project more than 4 inches into the circulation path. Wall-mounted objects that have leading edges between 27 inches and 80 inches from the floor must not project more than 4 inches into the circulation path. Protruding objects that extend to the floor or within 27 inches of the floor are cane detectable and are therefore not hazardous. Where it is necessary or desirable to have objects protrude from the wall, a manner of cane detection must be provided.	Drinking fountain at camping loop restroom - protrudes 12"	Place cane detectable warning or bollard at foot of new fountain when installed.	2015 ABAAS Section: 307.2 2012 TAS Section: 307.2 2010 ADAS Section: 307.2

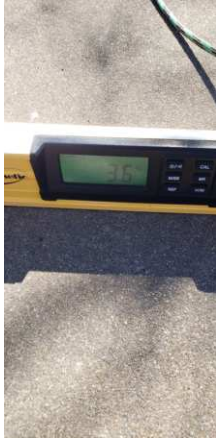
119	Campground Loop: Main Restroom Exterior Accessible Route	[30.0895687, -98.4245001]	The accessible route of travel contains cross slopes greater than 2%. Cross slopes shall not exceed one unit vertical in 48 units horizontal (2-percent slope).	Camping loop restroom - cross slopes of 3.6%, 3.0%, 2.9%, 4.5%	Correct or repair cross slope along AR to max 2.08%.	2015 ABAAS Section: 403.3 2012 TAS Section: 403.3 2010 ADAS Section: 403.3

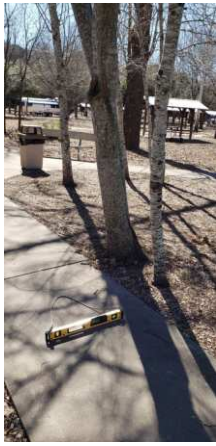
120	Campground Loop: Main Restroom Exterior Accessible Route	[30.0895803 , -98.424494 7]	The tree extends down too close to the route of travel. Any obstruction that overhangs a route of travel must be a minimum of 80 inches above the walking surface as measured from the bottom of the obstruction.	Tree extends over camp loop restroom EAR	Maintain overhead clearance to min. 80" above ground level.	2015 ABAAS Section: 307.3 2012 TAS Section: 307.3 2010 ADAS Section: 307.3
