Access Audit Site Report

Prepared By
WT Group

Blanco State Park
101 Park Rd 23
Blanco, TX 78606
Accessibility Evaluation
Inspection Date: 02/09/2022
Inspectors: Tanya Scheibe

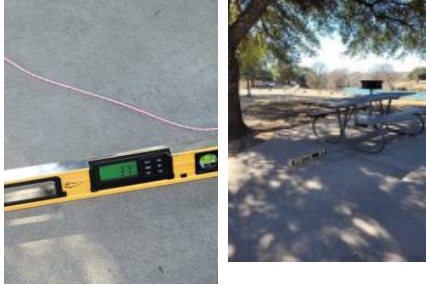
Finding Number	Area Description	Lat/Long	Finding	As Built	Recommendation	Citation	Photos	Figure
121	Campground Loop: Accessible Shelter - 43	[30.0904413 , -98.423985 1]	The surface of the clear ground space shall be firm and stable. The slope of the clear ground space surface shall not be steeper than 1:48 in any direction. EXCEPTION: Where the surface is other than asphalt, concrete, or boards, slopes not steeper than 1:20 shall be permitted when necessary for drainage.	3.7% slope on parking side of table, other side complies	Correct surface at the picnic table to firm, stable and having max slope of 2.08% or 5% if other than concrete asphalt or boards as a smart practice.	2015 ABAAS Section: 1011.2.2, 1011.2.3, 1011.2 EXCEPTION

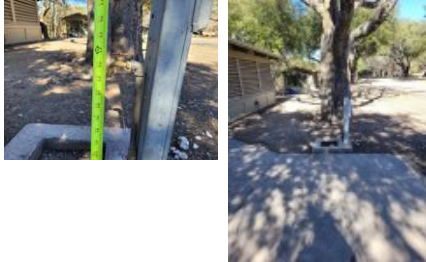
123	Campground Loop: Accessible Shelter - 43	[30.0904842 , -98.423962 3]	Water spouts at water hydrants and water utility hook-ups shall be 28 inches (710 mm) minimum and 36 inches (915 mm) maximum above the ground.	Water spout at 24" AGL	Remount water spouts to 28" min or 36" max above the ground as a smart practice.	2015 ABAAS Section: 1011.6

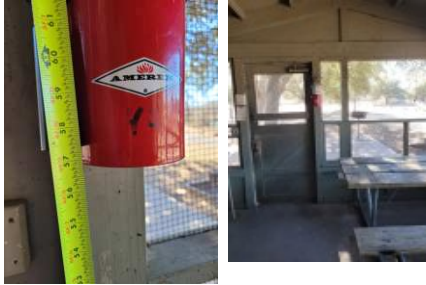
Finding Number	Area Description	Lat/Long	Finding	As Built	Recommendation	Citation	Photos	Figure
125	Campground Loop: Accessible Shelter - 43	[30.0904715 , -98.423978 4]	The operable part is positioned too high for either a side or front approach. Where a clear floor or ground space allows a parallel approach to an element and the side reach is unobstructed, the high side reach shall be 48 inches maximum and the low side reach shall be 15 inches minimum above the finish floor or ground. Where a forward reach is unobstructed, the high forward reach shall be 48 inches maximum and the low forward reach shall be 15 inches minimum above the finish floor or ground.	Fire extinguisher at 57" AFF and protrudes more than 4"	Relocate and remount operable parts to be in reach range of 15" min to 48" max.	2015 ABAAS Section: 308.1 2012 TAS Section: 308.1 2010 ADAS Section: 308.1

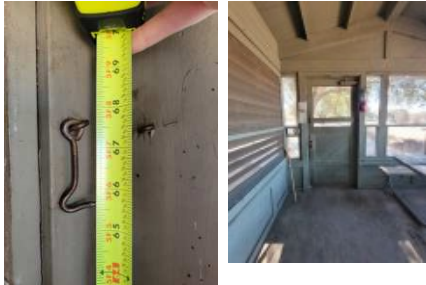
127	Campground Loop: Accessible Shelter - 43	[30.0904668 , -98.423967 7]	The threshold has a gap greater than 1/2 inch wide. The sweep period for doors with closers shall be adjusted so that from an open position of 70 degrees, the door will take at least 3 seconds to move to a point 3 inches from the latch, measured to the leading edge of the door. Hand-activated door opening hardware, handles, pulls, latches, locks, and other operating devices on accessible doors shall have a shape that is easy to grasp with one hand and does not require tight grasping, tight pinching or twisting of the wrist to operate. Hardware shall be 34 inches minimum and 48 inches maximum above the finish floor or ground.	Shelter door - fast close, interior lock hook at 67.5" AFF and requires tight pinch, 2" gap	For all doors along the public circulation fill gaps at door entries to max .5". For all doors along the public circulation route, inspect, adjust, and maintain closing speed on door closers. For all doors along the public circulation route, replace hardware with lever hardware or hardware operable without a tight pinch or grasp mounted 34" to 48" AFF.	2010 ADAS Section: 404.2.3, 404.2.7, 404.2.4, 404.2.11, 404.2.11 Exception

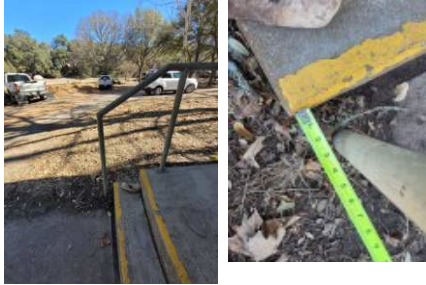
Finding Number	Area Description	Lat/Long	Finding	As Built	Recommendation	Citation	Photos	Figure
128	Campground Loop: Accessible Shelter - 47	[30.0905666 , -98.4235197]	The handrail does not have a compliant extension at the bottom of the stair flight. At the bottom of a stair flight, handrails shall extend at the slope of the stair flight for a horizontal distance at least equal to one tread depth beyond the last riser nosing. Extension shall return to a wall, guard, or the landing surface, or shall be continuous to the handrail of an adjacent stair flight.	Stair handrails lack bottom extensions	Install handrails on both sides of stairway, mounted 34" to 38" aff with top and bottom extensions and having a 1.25" – 2" in diameter, or a non-circular grip that has a perimeter dimension of 4"- 6.25" max with a min gap of 1.5" between handrail and wall Provide required extensions at the bottom of the stairway	2015 ABAAS Section: 505.10.3 2012 TAS Section: 505.10.3 2010 ADAS Section: 505.10.3

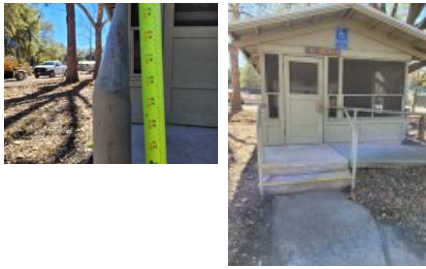
129	Campground Loop: Accessible Shelter - 47	[30.090562, -98.4235345]	The handrails as well as the handrail extensions are not at the correct height. The tops of handrails and their extensions must be between 34 inches and 38 inches above the stair nosing or ground.	Handrails at 40" AFF	Mount new handrails to 34" to 38" AFF.	2015 ABAAS Section: 505.4 2012 TAS Section: 505.4 2010 ADAS Section: 505.4

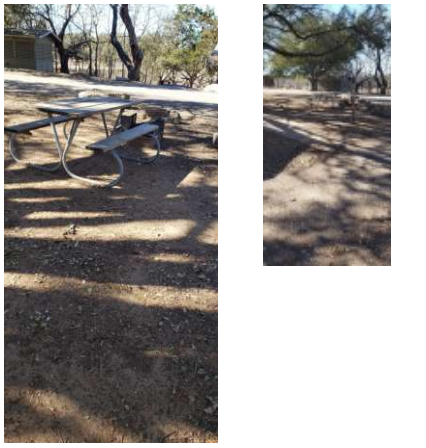
(a) stairs
130	Campground Loop: Accessible Shelter - 47	[30.0905457 , -98.4235305]	An accessible route is not provided between elements, spaces and the facilities provided within the accessible camping unit. At least one outdoor recreation access route shall connect accessible elements, spaces and facilities provided within camping units with mobility features.	Lacks ORAR to campsite elements, parking, or restrooms	Create AR with crushed and compacted stone or similar outdoor material to camp sites and one of each type of amenity.	2015 ABAAS Section: F244.5.1

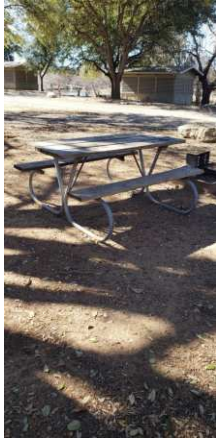
Finding Number	Area Description	Lat/Long	Finding	As Built	Recommendation	Citation	Photos	Figure
131	Campground Loop: Accessible Shelter - 47	[30.0905782 , -98.423502 3]	Picnic tables shall provide at least one wheelchair space for each 24 linear feet (7320 mm) of usable table surface perimeter. Wheelchair spaces shall be 30 inches (760 mm) minimum by 48 inches (1220 mm) minimum. Wheelchair spaces shall be positioned for a forward approach to the table and provide knee and toe clearance complying with 306 under the table	Picnic table is not of an accessible design	Replace picnic table with one of an accessible design as a smart practice.	2015 ABAAS Section: 1011.4.2

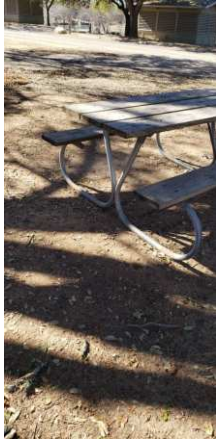
132	Campground Loop: Accessible Shelter - 47	[30.0905434 , -98.423514 4]	Picnic tables are required to have clear ground space 36 inches (915 mm) on all usable sides of the table measured from the back edge of the benches.	Picnic table lacks compliant CGS - located on dirt surface	Provide required 36" clear ground space around all usable portions of the table as a smart practice.	2015 ABAAS Section: 1011.2.1

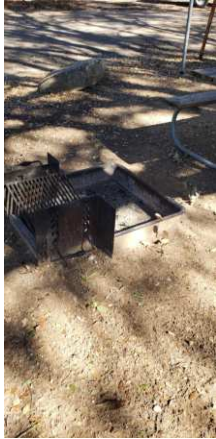
Finding Number	Area Description	Lat/Long	Finding	As Built	Recommendation	Citation	Photos	Figure
133	Campground Loop: Accessible Shelter - 47	[30.0905782 , -98.423538 5]	Clear ground space 48 inches (1220 mm) by 48 inches (1220 mm) should be provided on all usable sides of the fire ring, grill, fireplace, and woodstove. Center the space on each usable side of the grill, fireplace, and woodstove.	Fire ring lacks CGS due to dirt surface	Provide required 48" clear ground space centered along usable side of fire ring, grill, fireplace, or woodstove as a smart practice.	2015 ABAAS Section: 1011.2

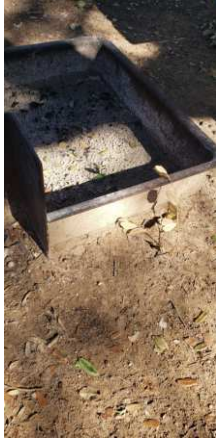
134	Campground Loop: Accessible Shelter - 47	[30.0905643 , -98.423538 5]	Fire building surfaces shall be 9 inches (230 mm) minimum above the ground.	Fire building surface at ground level	Correct fire building surface to be 9" min above the ground as a smart practice.	2015 ABAAS Section: 1011.5.1

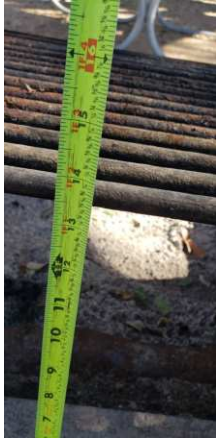
Finding Number	Area Description	Lat/Long	Finding	As Built	Recommendation	Citation	Photos	Figure
135	Campground Loop: Accessible Shelter - 47	[30.0905457 , -98.4235144]	Where provided, cooking surfaces shall be 15 inches (380 mm) minimum and 34 inches (865 mm) maximum above the ground.	Cooking surface at 14" AGL	Raise or lower cooking surface to be 15" min to 34" max above the ground; in the alternative, replace with a compliant surface as a smart practice.	2015 ABAAS Section: 1011.5.2

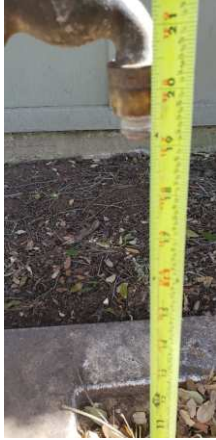
136	Campground Loop: Accessible Shelter - 47	[30.0905597 , -98.4235332]	Water spouts at water hydrants and water utility hook-ups shall be 28 inches (710 mm) minimum and 36 inches (915 mm) maximum above the ground.	Water spout at 19" AGL	Remount water spouts to 28" min or 36" max above the ground as a smart practice.	2015 ABAAS Section: 1011.6

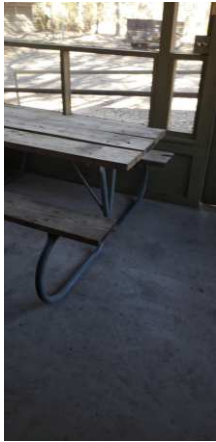
138	Campground Loop: Accessible Shelter - 47	[30.0905736, -98.4235278]	The top of the work surface is not within a compliant height range. The tops of tables and counters shall be 28 inches to 34 inches from the floor or ground.	Picnic table lacks knee clearance	Replace picnic table with one with knee and toe clearance, 19" deep at 27" high and 24" deep at 9" high, with a 36" AR around table.	2015 ABAAS Section: 902.3 2012 TAS Section: 902.3 2010 ADAS Section: 902.3

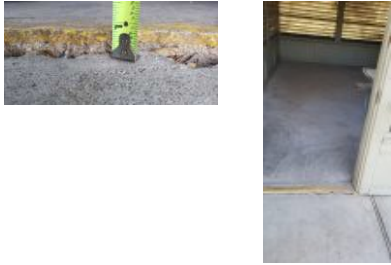
Finding Number	Area Description	Lat/Long	Finding	As Built	Recommendation	Citation	Photos	Figure
139	Campground Loop: Accessible Shelter - 47	[30.0905365, -98.4235305]	The threshold has a vertical change greater than 1/4 inch high. The sweep period for doors with closers shall be adjusted so that from an open position of 70 degrees, the door will take at least 3 seconds to move to a point 3 inches from the latch, measured to the leading edge of the door.	Shelter 47 door - 1" change in level (CIL) at door, fast close	For all doors along the public circulation route, repair, bevel, or ramp CILs at door entries to max .25". For all doors along the public circulation route, inspect, adjust, and maintain closing speed on door closers.	2010 ADAS Section: 404.2.3, 404.2.7, 404.2.4, 404.2.11, 404.2.11 Exception

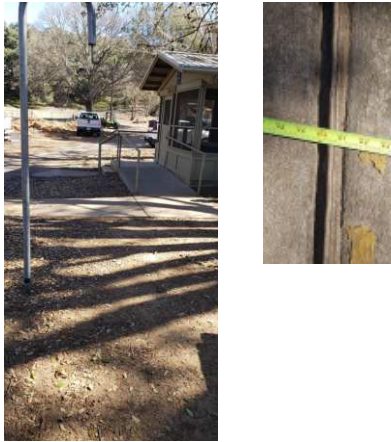
140	Campground Loop: Accessible Shelter - 47	[30.090555, -98.4235439]	The ramp does not have compliant handrails. Handrails are required on both sides of all surfaces that are sloped greater than 5 percent (1:20). Handrails must be between 34 inches and 38 inches above the ramp surface, must extend beyond the top and bottom of the ramp 12 inches and be parallel to the floor or ground surface. The diameter of the handrails must be between 1 inches and 2 inches in cross-sectional nominal dimension for circular handrails and handrail gripping surfaces with a non-circular cross section shall have a perimeter dimension of 4 inches minimum and 6 inches maximum, and a cross-section dimension of 2 inches maximum. The clear space between handrails and walls must 1-1/2 inches minimum.	Lacks handrails on bottom section of ramp	Install handrails that are rounded and/or extend to the ground, with handrail extensions and mounted 34" to 38" AFF.	2015 ABAAS Section: 505.1 2012 TAS Section: 505.1 2010 ADAS Section: 505.1

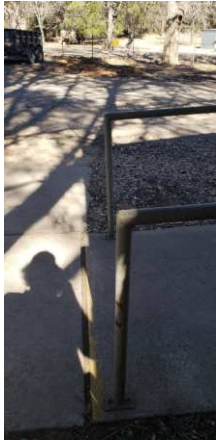
141	Campground Loop: Accessible Shelter - 47	[30.090555, -98.4235332]	The handrail does not extend past the ramp. Handrails must be between 34 inches and 38 inches above the ramp surface, must extend beyond the top and bottom of the ramp 12 inches horizontally, be parallel to the floor or ground surface and be in the same direction as the ramp runs. The 12 inches must be level and does not include the radius at the top of round handrails. Extensions shall return to a wall, guard, or the landing surface, or shall be continuous to the handrail of an adjacent ramp run.	Ramp handrails lack extensions	Provide handrail extensions that project 12" onto the ramp landing.	2015 ABAAS Section: 505.10.1 2012 TAS Section: 505.10.1 2010 ADAS Section: 505.10.1

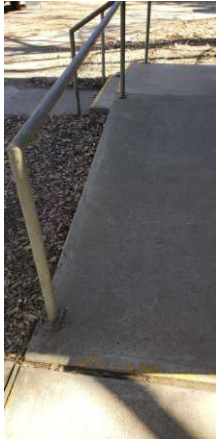
Finding Number	Area Description	Lat/Long	Finding	As Built	Recommendation	Citation	Photos	Figure
142	Campground Loop: Accessible Shelter - 47	[30.0905504 , -98.423549 2]	The ramp run has not been provided with edge protection. The floor or ground surface of the ramp run or landing shall extend 12 inches minimum beyond the inside face of a handrail or a curb or barrier shall be provided that prevents the passage of a 4 inch diameter sphere, where any portion of the sphere is within 4 inches of the finish floor or ground surface.	Lacks edge protection	Install rail along bottom edge of ramp that prevents a 4" sphere from passing through.	2015 ABAAS Section: 405.9, 405.9.1, 405.9.2 2012 TAS Section: 405.9.1, 405.9.2, 405.9 2010 ADAS Section: 405.9.2, 405.9.1, 405.9

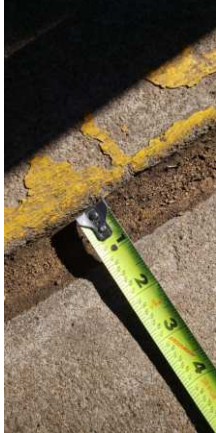
144	Campground Loop: Accessible Shelter - 47	[30.08939, -98.42437]	There is a gap spaced greater than a 1/2 inch. Openings in floor or ground surfaces shall not allow passage of a sphere more than 1/2 inch diameter. Elongated openings shall be placed so that the long dimension is perpendicular to the dominant direction of travel.	1" gap	Correct or fill gaps to be max .5".	2015 ABAAS Section: 302.3 2012 TAS Section: 302.3 2010 ADAS Section: 302.3

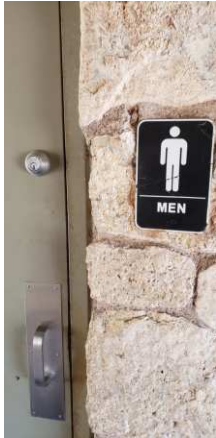
Finding Number	Area Description	Lat/Long	Finding	As Built	Recommendation	Citation	Photos	Figure
145	Campground Loop: Main Restroom - Men's Restroom	[30.0894875, -98.4243915]	The tactile restroom wall sign is missing the International Symbol of Accessibility (ISA). Accessible toilet rooms or bathing rooms shall be identified by the International Symbol of Accessibility (ISA). Wall signs identifying permanent rooms and spaces of a building shall have be horizontal format and the characters raised 1/32 inch minimum and shall be sans serif uppercase characters a minimum of 5/8 inch and a maximum of 2 inches high. Contracted Grade 2 Braille shall be in a horizontal format and shall be placed a minimum of 3/8 inch and a maximum of 1/2 inch directly below the tactile characters; flush left or centered. Signs with raised characters or Braille shall be located 48 inches minimum above the finish floor or ground surface, measured from the baseline of the lowest tactile character and 60 inches maximum above the finish floor or ground surface, measured from the baseline of the highest tactile character.	Signage lacks ISA	Acquire and mount signage, including access symbol. Acquire and mount signage, including Braille and access symbol mounted on wall, latch side of door, 48" to baseline of lowest character and 60" to baseline of highest character.	2015 ABAAS Section: F216.8 2012 TAS Section: 216.8 2010 ADAS Section: 216.8

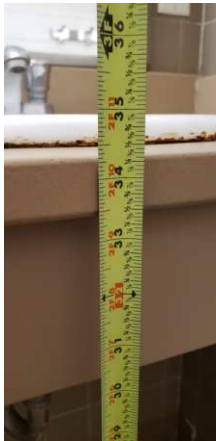
146	Campground Loop: Main Restroom - Men's Restroom	[30.0895002, -98.4243834]	The top rim of the sink is too high. All lavatories/sinks that are designated to be accessible shall be a minimum 17 inches in horizontal depth and mounted with the rim or counter edge no higher than 34 inches above the finished floor.	Sink rim at 35" AFF	Lower sinks to max 34" above the finished floor (AFF) to front of rim.	2015 ABAAS Section: 606.3 2012 TAS Section: 606.3 2010 ADAS Section: 606.3

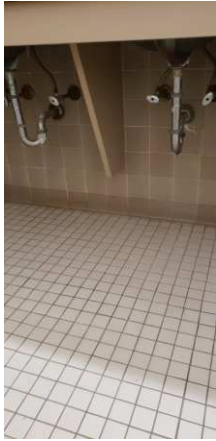
Finding Number	Area Description	Lat/Long	Finding	As Built	Recommendation	Citation	Photos	Figure
147	Campground Loop: Main Restroom - Men's Restroom	[30.0894991 , -98.4243807]	The water and drain pipes under the lavatory are not adequately insulated. Water supply and drain pipes under lavatories and sinks shall be insulated or otherwise configured to protect against contact. There shall be no sharp or abrasive surfaces under lavatories and sinks.	Sinks lack insulated pipes	Insulate exposed pipes under one sink.	2015 ABAAS Section: 606.5 2012 TAS Section: 606.5 2010 ADAS Section: 606.5

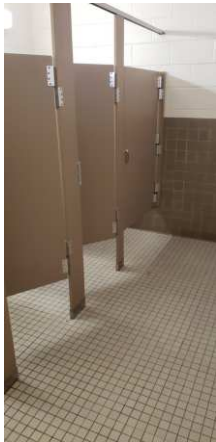
148	Campground Loop: Main Restroom - Men's Restroom	[30.0895165 , -98.4243807]	There are not enough accessible toilet compartments. The room contains toilet compartments. A minimum of 1 must be wheelchair accessible .	Ambulatory stall only, lacks wheelchair accessible stall	Create a wheelchair accessible stall with grab bars and fixtures mounted in correct locations and at correct heights.	2015 ABAAS Section: F213.3.1 2012 TAS Section: 213.3.1 2010 ADAS Section: 213.3.1

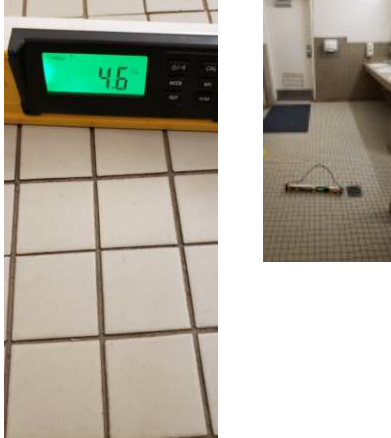
152	Campground Loop: Main Restroom - Men's Restroom	[30.0895084, -98.4243754]	The accessible route contains running slopes greater than 5 percent and cross slopes greater than 2 percent across the width of the walk and has not been constructed as a ramp (i.e. handrails, wheel guides, etc.). When the slope in the direction of travel of any walk exceeds 1 unit vertical in 20 units horizontal (5-percent slope), it must be constructed as ramp. Surface cross slopes must not exceed one unit vertical in 48 units. Horizontal (2-percent slope).	4.6% cross slope	Correct or repair slope to max 2.08% in restroom.	2015 ABAAS Section: 403.3 2012 TAS Section: 403.3 2010 ADAS Section: 403.3

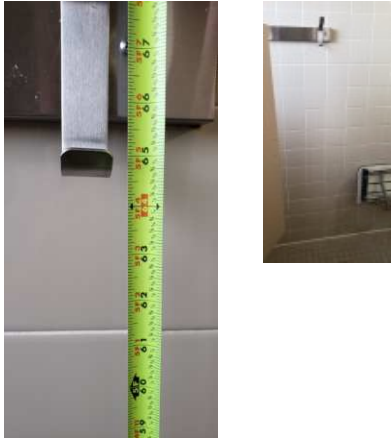
Finding Number	Area Description	Lat/Long	Finding	As Built	Recommendation	Citation	Photos	Figure
153	Campground Loop: Main Restroom - Men's Restroom	[30.0895014 , -98.4243807]	Coat hooks provided within the room shall be located within one of the reach ranges specified in 308. Shelves shall be 40 inches (1015 mm) minimum and 48 inches (1220 mm) maximum above the finish floor or ground. Where coat hooks or shelves are provided in dressing, fitting or locker rooms without individual compartments, at least one of each type shall comply with 803.5. Where coat hooks or shelves are provided in individual compartments at least one of each type complying with 803.5 shall be provided in individual compartments in dressing, fitting, or locker rooms required to comply with 222.1.	Coat hook at 65" AFF	Remount at least one hook to max 48" AFF.	2015 ABAAS Section: 308.2.1, 308.1, F222.2, 803.5 2012 TAS Section: 308.2.1, 308.1, 222.2, 803.5 2010 ADAS Section: 308.2.1, 308.1, 222.2, 803.5

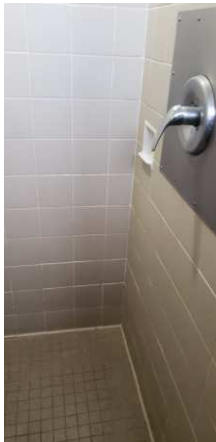
156	Campground Loop: Main Restroom - Men's Restroom	[30.0894921, -98.424402 2]	In transfer type compartments, grab bars shall be provided across the control wall and back wall to a point 18 inches (455 mm) from the control wall.	Shower lacks grab bars	Acquire and install grab bars to the correct location in the transfer shower.	2015 ABAAS Section: 608.3.1 2012 TAS Section: 608.3.1 2010 ADAS Section: 608.3.1

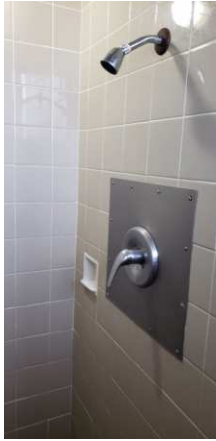
Finding Number	Area Description	Lat/Long	Finding	As Built	Recommendation	Citation	Photos	Figure
157	Campground Loop: Main Restroom - Men's Restroom	[30.0895037, -98.4243834]	There is no hand held sprayer unit. The sprayer unit must have a 59 inches hose and be mounted 48 inches maximum to the top of mounting bracket off the floor. The shower spray unit shall have an on/off control with a non-positive shutoff. If an adjustable-height shower head on a vertical bar is used, the bar shall be installed so as not to obstruct the use of grab bars.	Lacks hose - high fixed shower head only	Replace shower control with a compliant lever control with a shower head on a 59" hose and usable as hand held.	2015 ABAAS Section: 608.6 2012 TAS Section: 608.6 2010 ADAS Section: 608.6

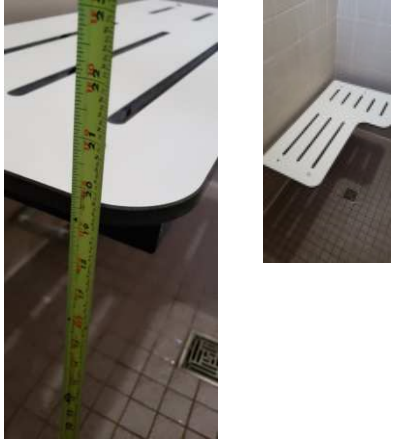
158	Campground Loop: Main Restroom - Men's Restroom	[30.0894921, -98.4243767]	The shower seat height is noncompliant. A seat in a standard roll-in shower compartment shall be a folding type, shall be installed on the side wall adjacent to the controls, and shall extend from the back wall to a point within 3 inches of the compartment entry. A seat in an alternate roll-in type shower compartment shall be a folding type, shall be installed on the front wall opposite the back wall, and shall extend from the adjacent side wall to a point within 3 inches of the compartment entry. The top of the seat shall be 17 inches minimum and 19 inches maximum above the bathroom finish floor.	Shower seat at 20" AFF	Remount shower seat to 17" to 19" AFF in the shower.	2015 ABAAS Section: 610.3 2012 TAS Section: 610.3 2010 ADAS Section: 610.3

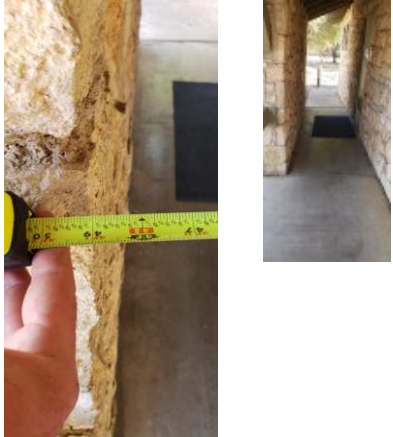
Finding Number	Area Description	Lat/Long	Finding	As Built	Recommendation	Citation	Photos	Figure
159	Campground Loop: Main Restroom - Men's Restroom	[30.0895107, -98.42437]	Minimum maneuvering clearances at doors and gates shall comply with 404.2.4. Maneuvering clearances shall extend the full width of the doorway and the required latch side or hinge side clearance. The doormat is not secured in place at the entry door. If carpet or carpet tile is used on a ground or floor surface, then it shall be securely attached; have a firm cushion, pad or backing or no cushion or pad; and have a level loop, textured loop, level-cut pile or level-cut/uncut pile texture. The maximum pile height shall be 1/2 inch. Exposed edges of carpet shall be fastened to floor surfaces and have trim along the entire length of the exposed edge. Recessed doormats shall be adequately anchored to prevent interference with wheelchair traffic. Exterior doors are recommended to be maintained at 8.5 lbf as a smart practice. Force is to be measured at the operating hardware or 30 inches from the hinges, whichever is greater.	Men's restroom door - wall 49" from door in pull side clearance, loose mat, 10# push	For all doors along the public circulation route, provide required maneuvering clearance on push and pull side of doors. For all doors along the public circulation route, secure rug in door clearance to prevent trip hazard. For all doors along the public circulation route, inspect, adjust, and maintain 8.5 lbf to open exterior doors as a smart practice.	2010 ADAS Section: 404.2.3, 404.2.7, 404.2.4, 404.2.11, 404.2.11 Exception

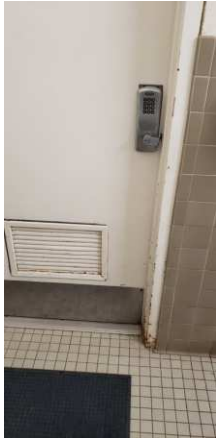
Finding Number	Area Description	Lat/Long	Finding	As Built	Recommendation	Citation	Photos	Figure
160	Campground Loop: Main Restroom - Men's Restroom	[30.0894956 , -98.424376 7]	The doormat is not secured in place at the entry door. If carpet or carpet tile is used on a ground or floor surface, then it shall be securely attached; have a firm cushion, pad or backing or no cushion or pad; and have a level loop, textured loop, level-cut pile or level-cut/uncut pile texture. The maximum pile height shall be 1/2 inch. Exposed edges of carpet shall be fastened to floor surfaces and have trim along the entire length of the exposed edge. Recessed doormats shall be adequately anchored to prevent interference with wheelchair traffic. Exterior doors are recommended to be maintained at 8.5 lbf as a smart practice. Force is to be measured at the operating hardware or 30 inches from the hinges, whichever is greater. Hand-activated door opening hardware, handles, pulls, latches, locks, and other operating devices on accessible doors shall have a shape that is easy to grasp with one hand and does not require tight grasping, tight pinching or twisting of the wrist to operate. Hardware shall be 34 inches minimum and 48 inches maximum above the finish floor or ground.	Shower door - loose mat, handle cut off, 10# push	For all doors along the public circulation route, secure rug in door clearance to prevent trip hazard. For all doors along the public circulation route, inspect, adjust, and maintain 8.5 lbf to open exterior doors as a smart practice. For all doors along the public circulation route, replace hardware with lever hardware or hardware operable without a tight pinch or grasp.	2010 ADAS Section: 404.2.3, 404.2.7, 404.2.4, 404.2.11, 404.2.11 Exception

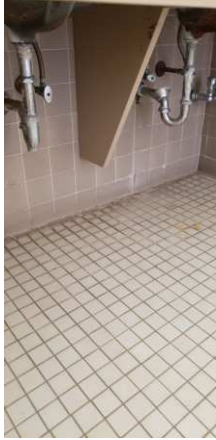
163	Campground Loop: Main Restroom - Women's Restroom	[30.0895026, -98.4243848]	The water and drain pipes under the lavatory are not adequately insulated. Water supply and drain pipes under lavatories and sinks shall be insulated or otherwise configured to protect against contact. There shall be no sharp or abrasive surfaces under lavatories and sinks.	Sinks lack insulated pipes	Insulate exposed pipes under one sink.	2015 ABAAS Section: 606.5 2012 TAS Section: 606.5 2010 ADAS Section: 606.5

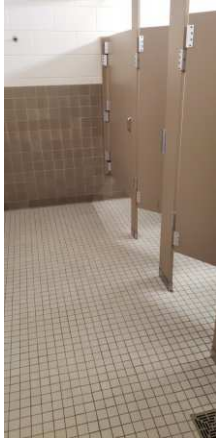
Finding Number	Area Description	Lat/Long	Finding	As Built	Recommendation	Citation	Photos	Figure
164	Campground Loop: Main Restroom - Women's Restroom	[30.0895014 , -98.4243646]	There are not enough accessible toilet compartments. The room contains toilet compartments. A minimum of 1 must be wheelchair accessible .	Ambulatory stall only, lacks wheelchair accessible stall	Create a wheelchair accessible stall with grab bars and fixtures mounted in correct locations and at correct heights.	2015 ABAAS Section: F213.3.1 2012 TAS Section: 213.3.1 2010 ADAS Section: 213.3.1

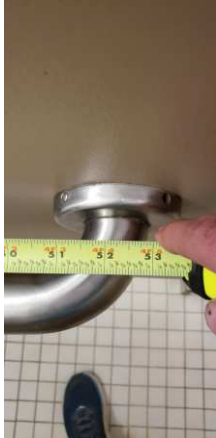
165	Campground Loop: Main Restroom - Women's Restroom	[30.0894991 , -98.424362]	The side grab bars are not in the correct location. Grab bars on the side wall must be installed so that the end closest to the rear wall is maximum 12" from the rear wall. The end furthest from the rear wall must be mounted minimum 54" from the rear wall.	Grab bars end 52" from rear wall	Remount side grab bar to max 12" from the rear wall at the close end and min 54" on the far end, and 33" to 36" AFF.	2015 ABAAS Section: 604.5.1 2012 TAS Section: 604.5.1 2010 ADAS Section: 604.5.1

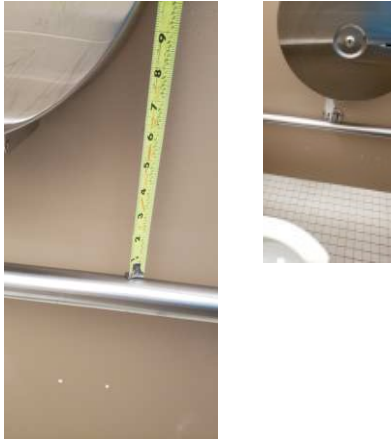
Finding Number	Area Description	Lat/Long	Finding	As Built	Recommendation	Citation	Photos	Figure
166	Campground Loop: Main Restroom - Women's Restroom	[30.0894956, -98.42437]	The grab bar height and/or spacing fails. Grab bars must be mounted between 33" and 36" to the top of the gripping surface. There must be 1.5" of clearance between the grab bar and the wall. There must be a minimum of 1.5" of clearance below and minimum 12" above the grab bar to any dispenser or other obstruction.	Toilet paper dispenser 5" above bar and too close to front of toilet	Remount toilet paper dispenser max 7" to 9" from front of toilet, 15" to 48" above the finished floor (AFF) and min 12" above or 1.5" below grab bar.	2015 ABAAS Section: 609.3, 609.4 2012 TAS Section: 609.4, 609.3 2010 ADAS Section: 609.3, 609.4

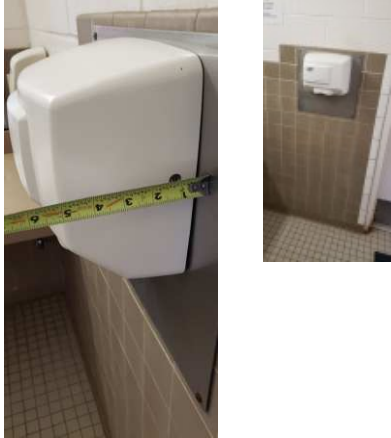
167	Campground Loop: Main Restroom - Women's Restroom	[30.0895084, -98.424362]	An item or items project more than 4 inches into the circulation path. Wall-mounted objects that have leading edges between 27 inches and 80 inches from the floor must not project more than 4 inches into the circulation path. Protruding objects that extend to the floor or within 27 inches of the floor are cane detectable and are therefore not hazardous. Where it is necessary or desirable to have objects protrude from the wall, a manner of cane detection must be provided.	Hand dryer protrudes 6"	Relocate protruding objects or place cane detectable warning or bollard at foot of item.	2015 ABAAS Section: 307.2 2012 TAS Section: 307.2 2010 ADAS Section: 307.2

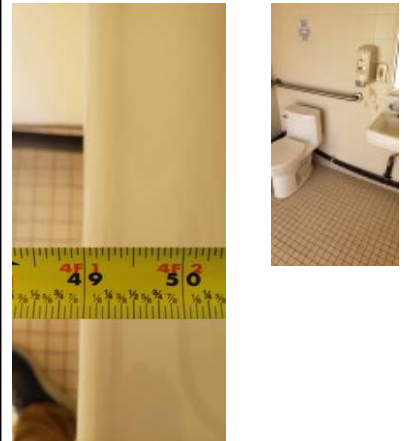
169	Campground Loop: Main Restroom - Unisex Bathroom	[30.0894968 , -98.424368 7]	The required 56 inches by 60 inches clear floor space for the water closet has been obstructed. The clear floor space around the water closet shall be 60 inches minimum measured perpendicular from the side wall and 56 inches minimum measured perpendicular from the rear wall.	Sink 49" from side wall - in toilet clearance	Renovate restroom to provide 60" by 56" clearance around the toilet. In the alternative, leave as is citing safe harbor.	2015 ABAAS Section: 604.3. 2012 TAS Section: 604.3.1 2010 ADAS Section: 604.3.1

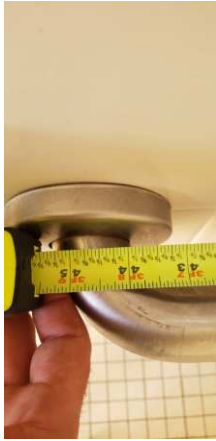
Finding Number	Area Description	Lat/Long	Finding	As Built	Recommendation	Citation	Photos	Figure
170	Campground Loop: Main Restroom - Unisex Bathroom	[30.0894968, -98.4243593]	The side grab bars are not in the correct location. Grab bars on the side wall must be installed so that the end closest to the rear wall is maximum 12" from the rear wall. The end furthest from the rear wall must be mounted minimum 54" from the rear wall.	Side grab bar ends 44.5" from rear wall	Remount side grab bar to max 12" from the rear wall at the close end and min 54" on the far end, and 33" to 36" AFF.	2015 ABAAS Section: 604.5.1 2012 TAS Section: 604.5.1 2010 ADAS Section: 604.5.1

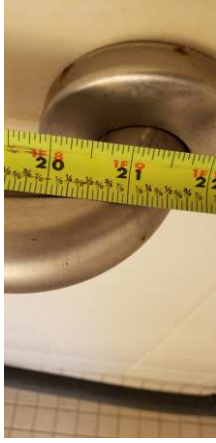
171	Campground Loop: Main Restroom - Unisex Bathroom	[30.0894863, -98.4243767]	The rear grab bar is not 36" long or is not mounted in the correct location. The rear grab bar must be a minimum of 36" long and extend from the toilet centerline a minimum 12" towards the wall side and a minimum 24" towards the open side of the toilet. Grab bars shall be installed in a horizontal position, 33 inches minimum and 36 inches maximum above the finish floor measured to the top of the gripping surface and the space between the grab bar and the top of the tank shall be 1-1/2 inches minimum.	21" from centerline	Remount rear grab bar to behind the toilet, 12" to one side of center and 24" to the other and 33" to 36" AFF.	2015 ABAAS Section: 604.5.2 2012 TAS Section: 604.5.2 2010 ADAS Section: 604.5.2

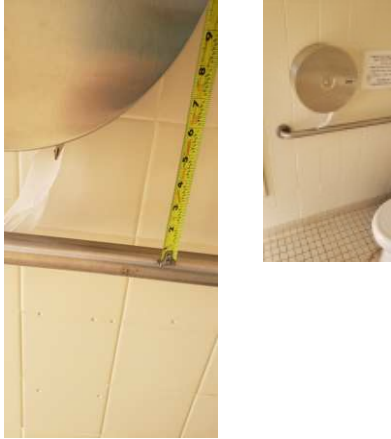
Finding Number	Area Description	Lat/Long	Finding	As Built	Recommendation	Citation	Photos	Figure
172	Campground Loop: Main Restroom - Unisex Bathroom	[30.0895002 , -98.4243807]	The grab bar height and/or spacing fails. Grab bars must be mounted between 33" and 36" to the top of the gripping surface. There must be 1.5" of clearance between the grab bar and the wall. There must be a minimum of 1.5" of clearance below and minimum 12" above the grab bar to any dispenser or other obstruction.	Toilet paper dispenser mounted 5" above grab bar	Remount toilet paper dispenser max 7" to 9" from front of toilet, 15" to 48" above the finished floor (AFF) and min 12" above or 1.5" below grab bar.	2015 ABAAS Section: 609.3, 609.4 2012 TAS Section: 609.4, 609.3 2010 ADAS Section: 609.3, 609.4

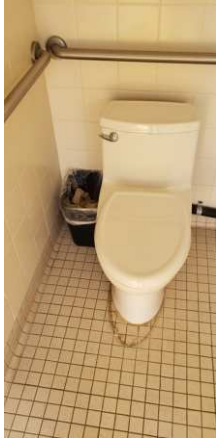
173	Campground Loop: Main Restroom - Unisex Bathroom	[30.0894852 , -98.4243807]	The flush handle is located on the wrong side of the toilet. Controls shall be operable with one hand and shall not require tight grasping, pinching or twisting. Controls for the flush valves shall be mounted on the wide side of toilet areas, no more than 44 inches above the floor.	Flush handle on closed side of toilet	Replace toilet tank with one having flush mechanism on the open side, in the alternative, install an auto flush unit.	2015 ABAAS Section: 604.6 2012 TAS Section: 604.6 2010 ADAS Section: 604.6

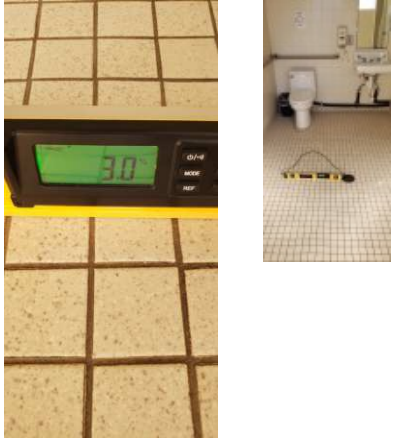
Finding Number	Area Description	Lat/Long	Finding	As Built	Recommendation	Citation	Photos	Figure
174	Campground Loop: Main Restroom - Unisex Bathroom	[30.089491, -98.424378]	The accessible route contains running slopes greater than 5 percent and cross slopes greater than 2 percent across the width of the walk and has not been constructed as a ramp (i.e. handrails, wheel guides, etc.). When the slope in the direction of travel of any walk exceeds 1 unit vertical in 20 units horizontal (5-percent slope), it must be constructed as ramp. Surface cross slopes must not exceed one unit vertical in 48 units. Horizontal (2-percent slope).	3% cross slope	Correct or repair slope to max 2.08% in restroom.	2015 ABAAS Section: 403.3 2012 TAS Section: 403.3 2010 ADAS Section: 403.3

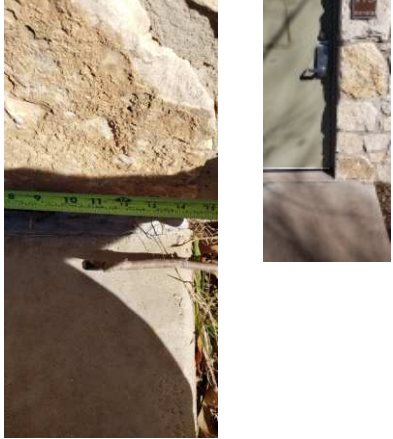
175	Campground Loop: Main Restroom - Unisex Bathroom	[30.0895002, -98.424378]	Minimum maneuvering clearances at doors and gates shall comply with 404.2.4. Maneuvering clearances shall extend the full width of the doorway and the required latch side or hinge side clearance. Exterior doors are recommended to be maintained at 8.5 lbf as a smart practice. Force is to be measured at the operating hardware or 30 inches from the hinges, whichever is greater.	Unisex restroom door - 14" pull side clearance, 15# push	For all doors along the public circulation route, provide required maneuvering clearance on push and pull side of doors. For all doors along the public circulation route, inspect, adjust, and maintain 8.5 lbf to open exterior doors as a smart practice.	2010 ADAS Section: 404.2.3, 404.2.7, 404.2.4, 404.2.11, 404.2.11 Exception

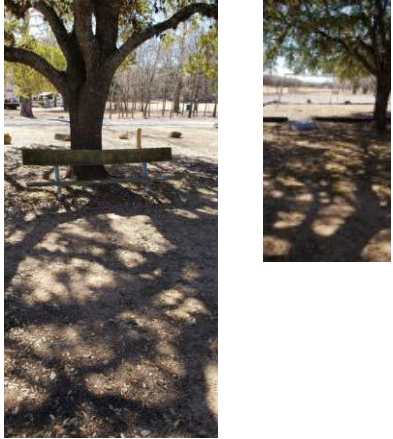
Finding Number	Area Description	Lat/Long	Finding	As Built	Recommendation	Citation	Photos	Figure
176	Park Site: Play Area	[30.0901883 , -98.4245336]	There is no accessible route to the play area bench and swings. At least one accessible route shall connect accessible buildings, accessible facilities, accessible elements, and accessible spaces that are on the same site.	Lacks accessible route to play area bench and swings	Create an accessible route with crushed stone or other outdoor material from parking or walkway to the play area bench and swings.	2015 ABAAS Section: F206.2.2 2012 TAS Section: 206.2.2 2010 ADAS Section: 206.2.2

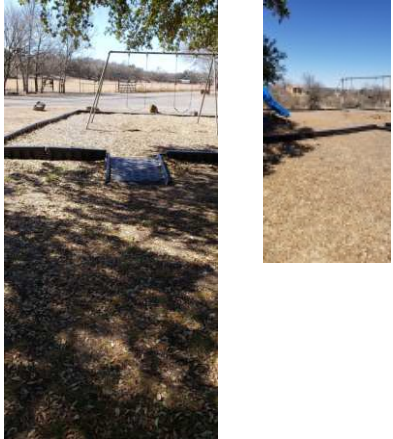
177	Park Site: Play Area	[30.0898147 , -98.4251881]	There is no accessible route to the play area. Accessible routes serving play areas shall comply with Chapter 4 and 1008.2 and shall be permitted to use the exceptions in 1008.2.1 through 1008.2.3. Where accessible routes serve ground level play components, the vertical clearance shall be 80 inches high (2030 mm) minimum.	Lacks AR to entrance of both play areas	Create an AR to the play area within the site.	2015 ABAAS Section: F206.2.2 2012 TAS Section: 1008.2 2010 ADAS Section: 206.2.2

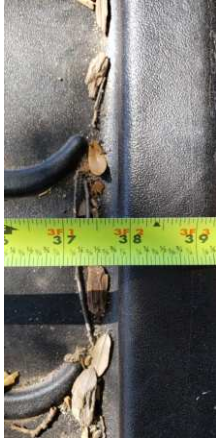
Finding Number	Area Description	Lat/Long	Finding	As Built	Recommendation	Citation	Photos	Figure
178	Park Site: Play Area	[30.089817, -98.4251586]	As a smart practice, play area should have a minimum 60" wide entry, free of changes in level, gaps, and slope.	West side - 38" wide, 15.8% slope East side - 37.5" wide, 8.2% slope, 1" gap	Widen the designated entry to 60" width as a smart practice. Correct or fill 1" gap at designated entry. Correct or repair running slope of designated entry to max 6.25%.	2015 ABAAS Section: F206.1 2012 TAS Section: 206.1 2010 ADAS Section: 206.1

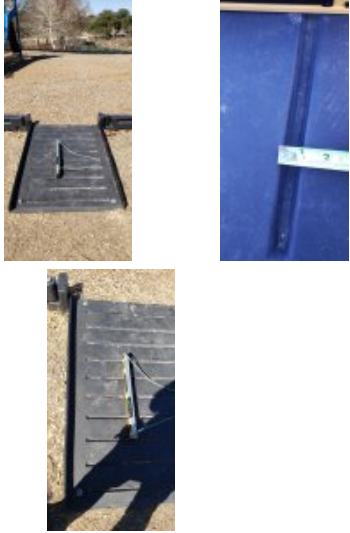
179	Park Site: Play Area	[30.0902243 , -98.424505 5]	Play area shall have signage listing designated ages of intended users	Both east or west side play areas lack signage listing ages of intended users	Acquire and install intended user signage and mount at designated entry as a smart practice.	2015 ABAAS Section: F240.1 2012 TAS Section: 240.1 2010 ADAS Section: 240.1

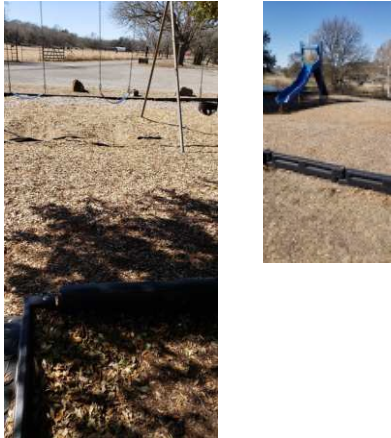
Finding Number	Area Description	Lat/Long	Finding	As Built	Recommendation	Citation	Photos	Figure
180	Park Site: Play Area	[30.089817, -98.4251908]	Compliance with ASTM F 1951 for accessibility for ground surfaces on accessible routes, clear floor or ground spaces, and turning spaces has not been determined. Ground surfaces shall comply with ASTM F 1951. Ground surfaces shall be inspected and maintained regularly and frequently to ensure continued compliance with ASTM F 1951.	Mulch surface for both east and west side play areas	Replace existing surface with an accessible surface such as EWF, PIP or tiles, with compliant slopes and CILs.	2012 TAS Section: 1008.2.6.1 2010 ADAS Section: 1008.2.6.1

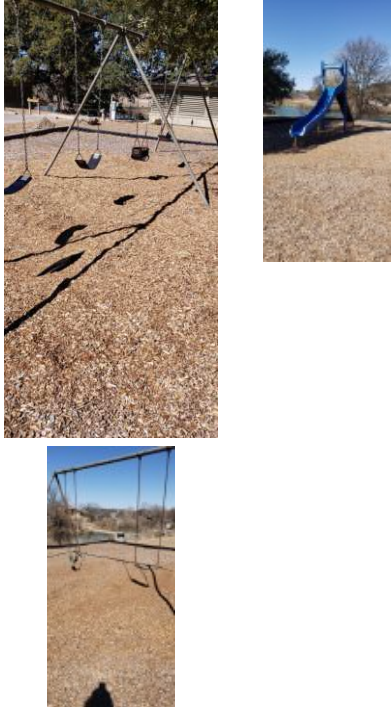
181	Park Site: Play Area	[30.0902348, -98.4244719]	Element meets all standards and requirements	Four swings at east side play area, and 4 swings at west side play area comply if surface and route corrected	None	2010 ADAS Section: N/A

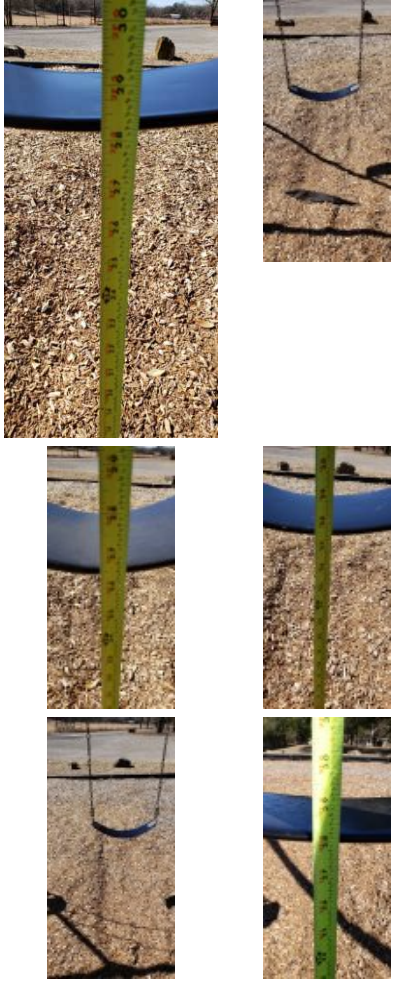
Finding Number	Area Description	Lat/Long	Finding	As Built	Recommendation	Citation	Photos	Figure
182	Park Site: Play Area	[30.089817, -98.425169 3]	The entry point or seat is not within the compliant range above the ground. The height of entry points and seats shall be 11 inches minimum and 24 inches maximum measured to the top of the surface from the ground or floor surface.	Swings (28", 26", 28", 28" AGL) exceed entry height range	Lower the seat, or raise the surface fill level to achieve entry height of 11" to 24" AGL to belt swing.	2012 TAS Section: 1008.4.4 2010 ADAS Section: 1008.4.4

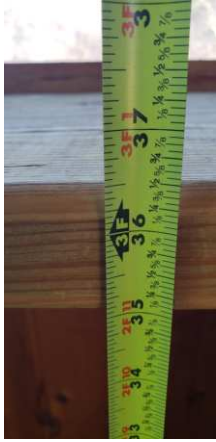
183	Park Site: Bird Blind	[30.0915831 , -98.427787 1]	Each distinct viewing location shall provide a viewing space adjacent to the clear ground space required by 1015.2 through which the point of interest is viewable. The viewing space shall be 32 inches (815 mm) maximum and 51 inches (1295 mm) minimum high above the ground and shall extend the full width of the clear ground space.	Railing height for viewing area is 36.5" AGL	Lower a 36" wide portion of railing to provide an unobstructed view between 32" and 51".	2015 ABAAS Section: 1015.3

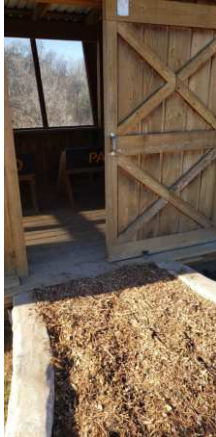
184	Park Site: Bird Blind	[30.0915947 , -98.427787 1]	Minimum maneuvering clearances at doors and gates shall comply with 404.2.4. Maneuvering clearances shall extend the full width of the doorway and the required latch side or hinge side clearance. Exterior doors are recommended to be maintained at 8.5 lbf as a smart practice. Force is to be measured at the operating hardware or 30 inches from the hinges, whichever is greater.	Exterior surface at sliding door fails to be firm and stable surface (mulch), and 30# push	For all doors along the public circulation route, provide required maneuvering clearance on push and pull side of doors. For all doors along the public circulation route, inspect, adjust, and maintain 8.5 lbf to open exterior doors as a smart practice.	2010 ADAS Section: 404.2.3, 404.2.7, 404.2.4, 404.2.11, 404.2.11 Exception

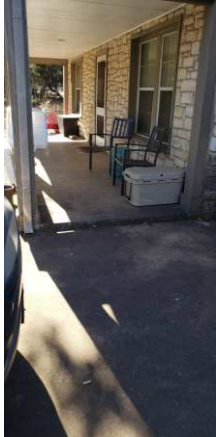
Finding Number	Area Description	Lat/Long	Finding	As Built	Recommendation	Citation	Photos	Figure
185	Park Site: Residence	[30.0965644 , -98.419299 3]	The building entrance is not located on an accessible route. When a building, or portion of a building, is required to be accessible, an accessible route of travel shall be provided to all portions of the building, to accessible building entrances and between the building and the public way. All walks, halls, corridors, aisles, skywalks, tunnels, and other spaces that are part of an accessible route must comply. An accessible route of travel must not pass through kitchens, storage rooms, restrooms, closets or other spaces used for similar purposes. At least one accessible route within the boundary of the site must be provided from public transportation stops, accessible parking and accessible passenger loading zones and public streets or sidewalks to the accessible building entrance they serve. The accessible route shall, to the maximum extent feasible, coincide with the route for the general public. At least one accessible route shall connect accessible buildings, facilities, elements and spaces that are on the same site. At least one accessible route shall connect accessible building or facility entrances with all accessible spaces and elements.	CIL to enter to residence	Repair, bevel, or ramp CIL along AR.	2015 ABAAS Section: F206.2.1 2012 TAS Section: 206.2.1 2010 ADAS Section: 206.2.1

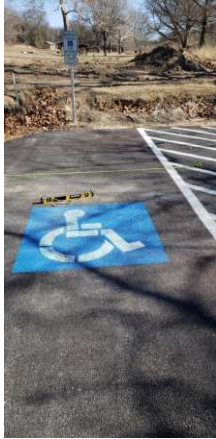
Finding Number	Area Description	Lat/Long	Finding	As Built	Recommendation	Citation	Photos	Figure
186	Park Site: Kayak Boat Launch	[30.08939, -98.42437]	Element meets all standards and requirements	Parking lot at kayak boat launch meets scoping requirements - 1 of 1	None	2010 ADAS Section: N/A

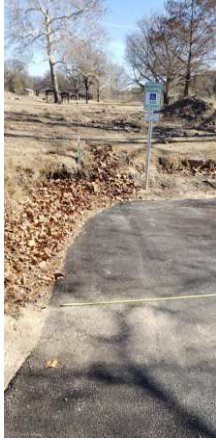
187	Park Site: Kayak Boat Launch	[30.0928107, -98.4227821]	The parking stall contains abrupt edges and surface irregularities over a 1/4 inch vertical. Parking spaces and access aisles serving them shall be stable, firm, and slip resistant. Access aisles shall be at the same level as the parking spaces they serve. Changes in level are not permitted and shall not be sloped steeper than 2% in any direction.	Leaves and debris in parking space	Establish protocols for regular and frequent inspection and maintenance of parking surface.	2015 ABAAS Section: 502.4 2012 TAS Section: 502.4 2010 ADAS Section: 502.4

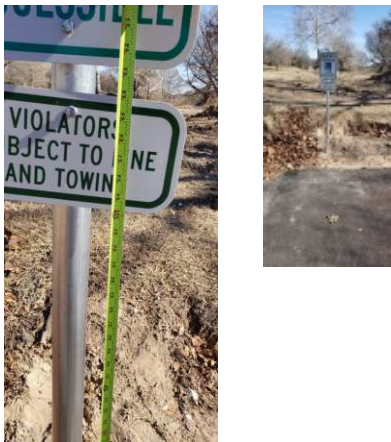
Finding Number	Area Description	Lat/Long	Finding	As Built	Recommendation	Citation	Photos	Figure
188	Park Site: Kayak Boat Launch	[30.0928084 , -98.422775 4]	The parking sign is mounted too low. Parking space identification signs shall include the International Symbol of Accessibility complying with. Signs identifying van parking spaces shall contain the designation "van accessible." Signs shall be 60 inches minimum above the finish floor or ground surface measured to the bottom of the sign.	Bottom edge of parking signs at 48" AGL	Raise existing accessible parking signs so lowest end of bottom sign is min 60" AFF.	2015 ABAAS Section: 502.6 2012 TAS Section: 502.6 2010 ADAS Section: 502.6

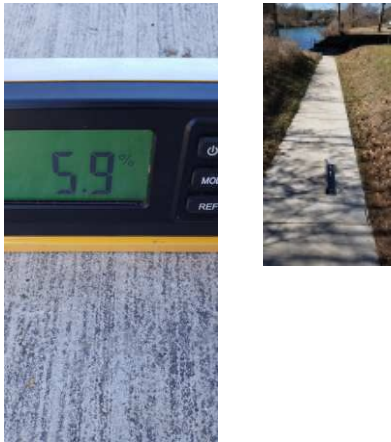
189	Park Site: Kayak Boat Launch	[30.0926123 , -98.422921 6]	The running slope of walking surfaces shall not be steeper than 1:20.	5.9% running slope	Correct running slope along the AR to max 5%.	2015 ABAAS Section: 403.3 2012 TAS Section: 403.3 2010 ADAS Section: 403.3

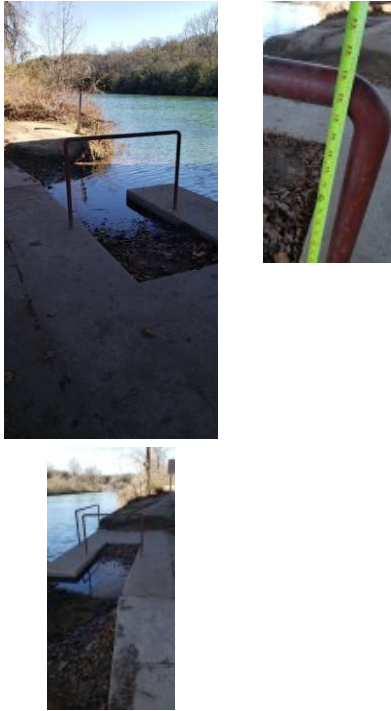
Finding Number	Area Description	Lat/Long	Finding	As Built	Recommendation	Citation	Photos	Figure
190	Park Site: Kayak Boat Launch	[30.0923837 , -98.423093 3]	Element meets all standards and requirements	kayak boat launch complies	None	2010 ADAS Section: N/A

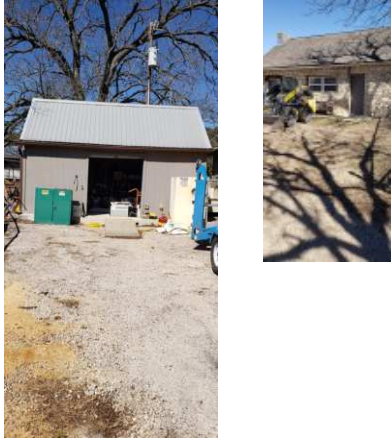
191	Park Site: Maintenance	[30.0966839 , -98.419000 2]	There is no accessible route to the garage storage and office. At least one accessible route shall connect accessible buildings, accessible facilities, accessible elements, and accessible spaces that are on the same site.	Lacks AR to garage storage and office	Create an accessible route with crushed stone or other outdoor material from parking or walkway to the garage storage and office.	2015 ABAAS Section: F206.2.2 2012 TAS Section: 206.2.2 2010 ADAS Section: 206.2.2

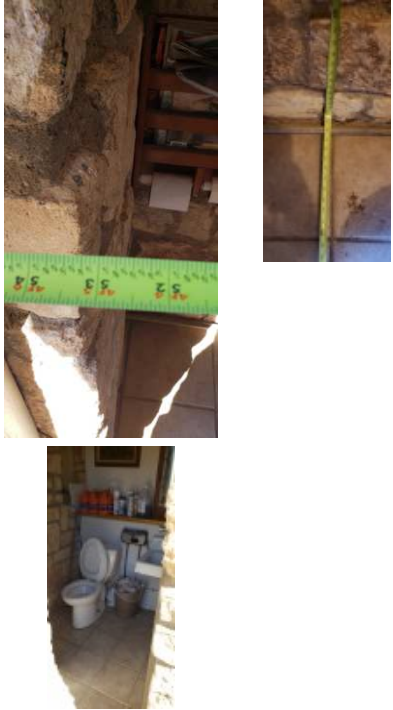
Finding Number	Area Description	Lat/Long	Finding	As Built	Recommendation	Citation	Photos	Figure
193	Park Site: Maintenance	[30.0967141 , -98.418992 2]	This restroom is not accessible. Where existing toilet rooms or bathing rooms do not comply, directional signs indicating the location of the nearest accessible toilet room or bathing room within the facility shall be provided. Signs shall include the International Symbol of Accessibility. Where existing toilet rooms or bathing rooms do comply), the accessible toilet rooms or bathing rooms shall be identified by the International Symbol of Where clustered single user toilet rooms or bathing facilities are permitted, accessible toilet rooms or bathing facilities shall be identified by the International Symbol of Accessibility unless all toilet rooms and bathing facilities are accessible.	Lacks directional signage to an accessible restroom - restroom dimensions are 53" by 60"	Restroom not accessible, acquire and mount signage directing patrons to accessible restroom.	2015 ABAAS Section: F216.8 2012 TAS Section: 216.8 2010 ADAS Section: 216.8

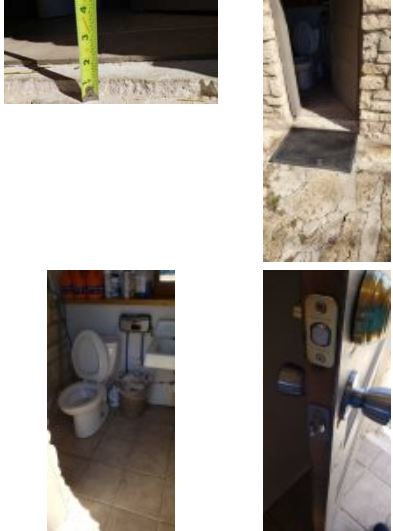
Finding Number	Area Description	Lat/Long	Finding	As Built	Recommendation	Citation	Photos	Figure
194	Park Site: Maintenance	[30.0967187 , -98.4190016]	Minimum maneuvering clearances at doors and gates shall comply with 404.2.4. Maneuvering clearances shall extend the full width of the doorway and the required latch side or hinge side clearance. The threshold has a vertical change greater than 1/4 inch high. Hand-activated door opening hardware, handles, pulls, latches, locks, and other operating devices on accessible doors shall have a shape that is easy to grasp with one hand and does not require tight grasping, tight pinching or twisting of the wrist to operate. Hardware shall be 34 inches minimum and 48 inches maximum above the finish floor or ground.	Restroom door - change in level (CIL) of 1" at door, loose mat, external door clearance surface is uneven flagstone, toilet and sink in interior clearance, knob	For all doors along the public circulation route, provide required maneuvering clearance on push and pull side of doors. For all doors along the public circulation route, secure rug in door clearance to prevent trip hazard. For all doors along the public circulation route, repair, bevel, or ramp CILs at door entries to max .25". For all doors along the public circulation route, replace hardware with lever hardware or hardware operable without a tight pinch or grasp.	2010 ADAS Section: 404.2.3, 404.2.7, 404.2.4, 404.2.11, 404.2.11 Exception

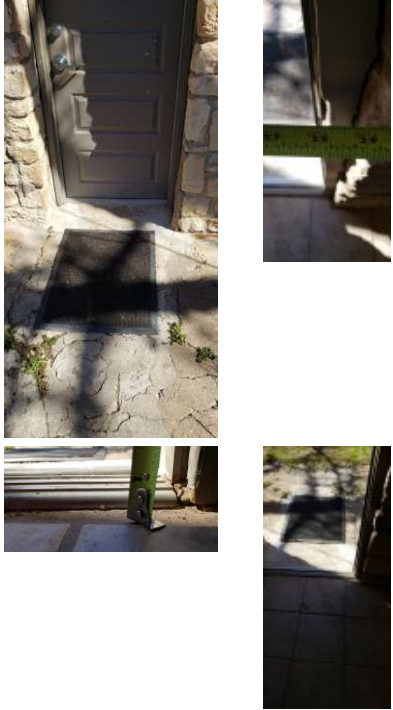
Finding Number	Area Description	Lat/Long	Finding	As Built	Recommendation	Citation	Photos	Figure
195	Park Site: Maintenance	[30.0967187 , -98.418986 8]	Spaces and elements within employee work areas shall only be required to comply with 206.2.8, 207.1, and 215.3 and shall be designed and constructed so that individuals with disabilities can approach, enter, and exit the employee work area. Employee work areas, or portions of employee work areas, other than raised courtroom stations, that are less than 300 square feet (28 m2) and elevated 7 inches (180 mm) or more above the finish floor or ground where the elevation is essential to the function of the space shall not be required to comply with these requirements or to be on an accessible route.	Management office door - loose mat, uneven flagstone surface in exterior clearance, 28" wide, 1.25" threshold	For employee spaces, relocate storage, furniture, and other obstacles at doorways to provide approach, enter and exit at the employee space. Provide required maneuvering clearance on push and pull side of doors. Secure rug at door to prevent trip hazard. Replace surface in door clearance to be firm, stable and smooth with max 2.08% slope. Repair, provide beveled threshold.	2015 ABAAS Section: F203.9 2012 TAS Section: 203.9 2010 ADAS Section: 203.9

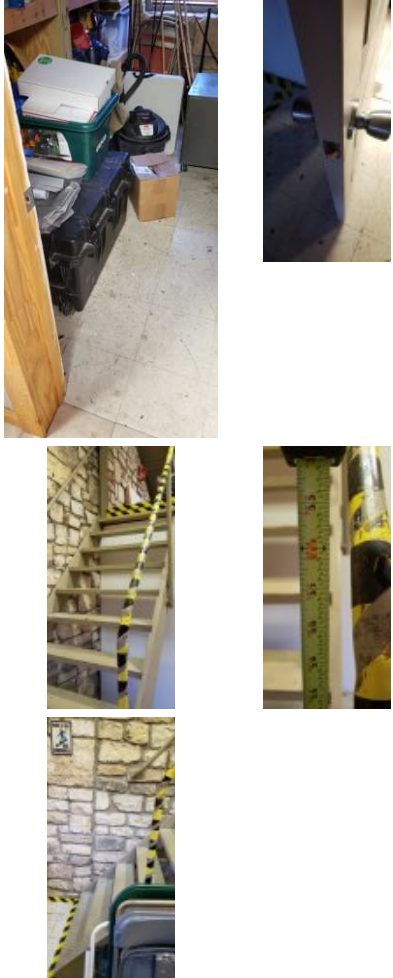
Finding Number	Area Description	Lat/Long	Finding	As Built	Recommendation	Citation	Photos	Figure
196	Park Site: Maintenance	[30.0967187 , -98.418994 9]	Spaces and elements within employee work areas shall only be required to comply with 206.2.8, 207.1, and 215.3 and shall be designed and constructed so that individuals with disabilities can approach, enter, and exit the employee work area. Employee work areas, or portions of employee work areas, other than raised courtroom stations, that are less than 300 square feet (28 m2) and elevated 7 inches (180 mm) or more above the finish floor or ground where the elevation is essential to the function of the space shall not be required to comply with these requirements or to be on an accessible route.	Management Office Building - items stored in storage closet pull side clearance, knob hardware; loft storage only accessed by stairs, hand rail - 32" AFF, does not go to end of stairs	For employee spaces, relocate storage, furniture, and other obstacles at doorways to provide approach, enter and exit at the employee space. Provide required maneuvering clearance on push and pull side of doors. Replace hardware with lever hardware or hardware operable without a tight pinch or grasp. Replace or remount handrails to 34" to 38" AFF. Provide required extensions at the bottom of the stairway. Stairs only to loft storage, leave as is, employee area only; reassign duties if an employee with a disability requires access here.	2015 ABAAS Section: F203.9 2012 TAS Section: 203.9 2010 ADAS Section: 203.9

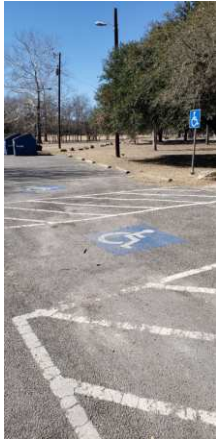
Finding Number	Area Description	Lat/Long	Finding	As Built	Recommendation	Citation	Photos	Figure
197	Park Site: Pavilion Parking	[30.0897985 , -98.424517 5]	Element meets all standards and requirements	Parking at pavilion meets scoping requirements - 11 standard, 2 accessible	None	2010 ADAS Section: N/A
