Access Audit Site Report

Prepared By
WT Group

Blanco State Park
101 Park Rd 23
Blanco, TX 78606
Accessibility Evaluation
Inspection Date: 02/09/2022
Inspectors: Tanya Scheibe

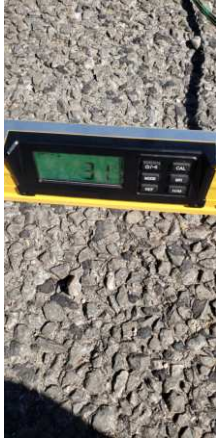
198	Park Site: Pavilion Parking	[30.0897869 , -98.424539]	The cross slopes (narrow dimension) and/or running slopes (long dimension) of the access aisle exceeds 2%. The running slope and the cross slope in an accessible parking stall and the access aisle must not exceed 2%.	3.1% slope in access aisle	Repair or correct slope of parking space and access aisle to max 2.08% in any direction.	2015 ABAAS Section: 502.4 2012 TAS Section: 502.4 2010 ADAS Section: 502.4

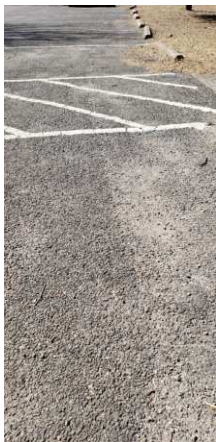
Finding Number	Area Description	Lat/Long	Finding	As Built	Recommendation	Citation	Photos	Figure
199	Park Site: Pavilion Parking	[30.0898112 , -98.424516 2]	The parking stall contains abrupt edges and surface irregularities over a 1/4 inch vertical. Parking spaces and access aisles serving them shall be stable, firm, and slip resistant. Access aisles shall be at the same level as the parking spaces they serve. Changes in level are not permitted and shall not be sloped steeper than 2% in any direction.	Parking surface contains deteriorated asphalt and gravel	Resurface accessible stalls and access aisles with a firm, stable, and slip resistant material.	2015 ABAAS Section: 502.4 2012 TAS Section: 502.4 2010 ADAS Section: 502.4

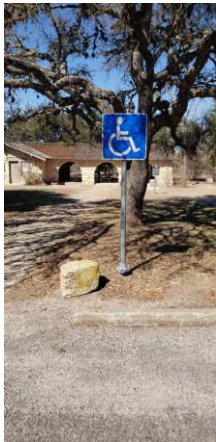
200	Park Site: Pavilion Parking	[30.0898228 , -98.424535]	The accessible parking stall signage is incorrect and/or missing from each accessible parking space. Parking space identification signs shall include the International Symbol of Accessibility. Signs identifying van parking spaces shall contain the designation "van accessible." Signs shall be 60 inches minimum above the finish floor or ground surface measured to the bottom of the sign.	Lacks R7-8 sign	Acquire R7-8 sign and mount at appropriate heights and locations accessible parking signs where missing as a smart practice	2015 ABAAS Section: 502.6 2012 TAS Section: 502.6

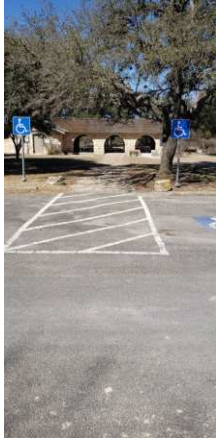
Finding Number	Area Description	Lat/Long	Finding	As Built	Recommendation	Citation	Photos	Figure
201	Park Site: Pavilion Parking	[30.0898193 , -98.424533 6]	The van stall is missing a sign identifying it as a van accessible stall. Parking space identification signs shall include the International Symbol of Accessibility. Signs identifying van parking spaces shall contain the designation "van accessible."	Lacks van accessible sign	Add one van parking sign to van accessible stall and ensure stall and access aisle are 11' and 5' or 8' and 8'.	2015 ABAAS Section: 502.6 2012 TAS Section: 502.6 2010 ADAS Section: 502.6

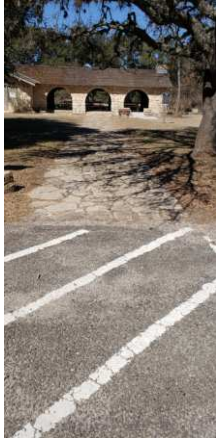
202	Park Site: Pavilion Parking	[30.0898367 , -98.424510 8]	The access aisle is not located on an accessible route of travel to the accessible building entrance. Accessible parking spaces serving a particular building shall be located on the shortest accessible route of travel from adjacent parking to an accessible entrance. In buildings with multiple accessible entrances with adjacent parking, accessible parking spaces shall be dispersed and located closest to the accessible entrances.	2 paths to the pavilion (one is paved and the other is uneven flagstone) - access aisles from parking lead to both but the parking bumper obstructs access to the paved AR	Relocate parking bumper obstructing paved route from access aisle to pavilion.	2015 ABAAS Section: F208.3.1 2012 TAS Section: 208.3.1 2010 ADAS Section: 208.3.1

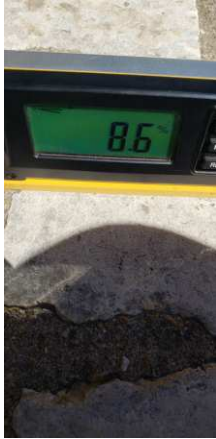
Finding Number	Area Description	Lat/Long	Finding	As Built	Recommendation	Citation	Photos	Figure
203	Park Site: Pavilion	[30.0900212 , -98.424737 5]	The running slope of walking surfaces shall not be steeper than 1:20.	Running slope of 8.6% slope on AR to pavilion, table obstructs landing at top of ramp	Correct running slope along the AR to max 5%. Relocate picnic table to provide unobstructed route of travel to pavilion.	2015 ABAAS Section: 403.3 2012 TAS Section: 403.3 2010 ADAS Section: 403.3

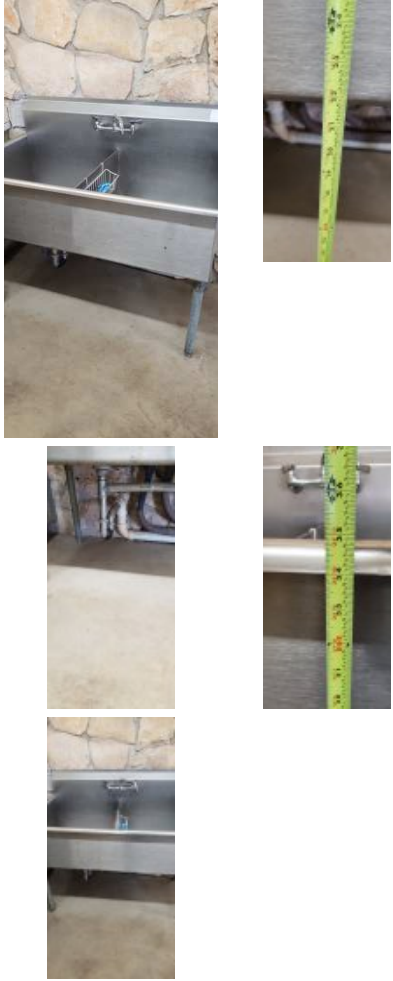
Finding Number	Area Description	Lat/Long	Finding	As Built	Recommendation	Citation	Photos	Figure
204	Park Site: Pavilion	[30.0900584 , -98.424788 4]	<p>The sink is not accessible. A clear floor space at least 30 inches by 48 shall be provided in front of a sink to allow forward approach. -The clear floor space shall be on an accessible route and shall extend a maximum of 19 inches underneath the sink.</p> <p>-Sinks shall be mounted with the counter or rim no higher than 34 inches above the finish floor. -Knee clearance at least 27 inches high, 30 inches wide and 19 inches deep shall be provided. -Hot water and drain pipes exposed under sinks shall be insulated or otherwise configured so as to protect against contact. There shall be no sharp or abrasive surfaces under sinks.</p> <p>-Faucet controls not require tight grasping, pinching or twisting of the wrist. -The force required to activate controls shall be not greater than 5 lb. Lever-operated, push-type and electronically controlled mechanisms are examples of acceptable designs. -Self-closing valves are allowed if the faucet remains open for at least 10 seconds.</p>	Only one sink - not of an accessible design, sink rim high, lacks knee clearance	Replace sink with one of an accessible design.	<p>2015 ABAAS Section: 606.2, 606.2 EXCEPTION S: 1, 606.2 EXCEPTIONS: 4, 606.2 EXCEPTIONS: 5, 606.2 EXCEPTIONS: 6, 606.2 EXCEPTIONS: 7, 606.3, 606.4, 606.5</p> <p>2012 TAS Section: 606.2, 606.2 Exception 1, 606.2 Exception 4, 606.2 Exception 5, 606.2 Exception 6, 606.2 Exception 7, 606.3, 606.4, 606.5</p> <p>2010 ADAS Section: 606.2, 606.2 Exception 1, 606.2 Exception 4, 606.2 Exception 5, 606.2 Exception 6, 606.2 Exception 7, 606.3, 606.4, 606.5</p>

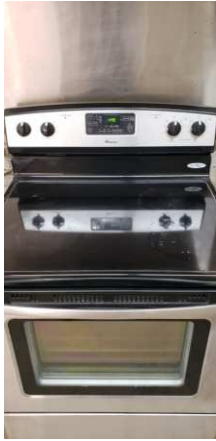
Finding Number	Area Description	Lat/Long	Finding	As Built	Recommendation	Citation	Photos	Figure
205	Park Site: Pavilion	[30.0900607, -98.424767]	The controls are located such that operation require reaching across burners. Where knee and toe space is provided, the underside of the range or cooktop shall be insulated or otherwise configured to prevent burns, abrasions, or electrical shock. The location of controls shall not require reaching across burners.	Range controls required reach over burners	Replace oven with one having controls on the front panel.	2015 ABAAS Section: 804.6.4 2012 TAS Section: 804.6.4 2010 ADAS Section: 804.6.4

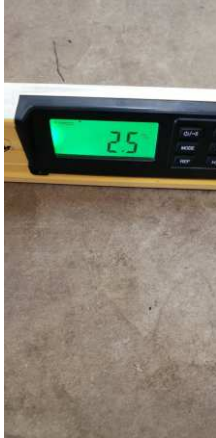
206	Park Site: Pavilion	[30.0900677, -98.4247616]	The accessible path of travel contains cross slopes greater than 2%. Surface cross slopes shall not exceed one unit vertical in 48 units horizontal (2-percent slope). When the slope in the direction of travel of any walk exceeds 1 unit vertical in 20 units horizontal (5-percent slope), it must be constructed as ramp.	2.5% cross slope	Correct or repair cross slope of AR to max 2.08%.	2015 ABAAS Section: F206.2.4, 403.3 2012 TAS Section: 206.2.4, 403.3 2010 ADAS Section: 206.2.4, 403.3

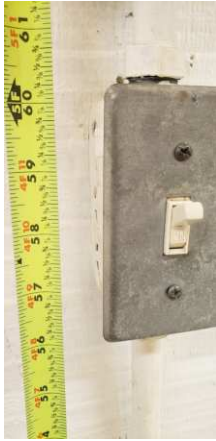
Finding Number	Area Description	Lat/Long	Finding	As Built	Recommendation	Citation	Photos	Figure
207	Park Site: Pavilion	[30.0900677, -98.4247911]	The operable part is positioned too high for either a side or front approach. Where a clear floor or ground space allows a parallel approach to an element and the side reach is unobstructed, the high side reach shall be 48 inches maximum and the low side reach shall be 15 inches minimum above the finish floor or ground. Where a forward reach is unobstructed, the high forward reach shall be 48 inches maximum and the low forward reach shall be 15 inches minimum above the finish floor or ground.	Light switch at 58" AFF	Remount operable parts to be in reach range of 15" min to 48" max.	2015 ABAAS Section: 308.1 2012 TAS Section: 308.1 2010 ADAS Section: 308.1

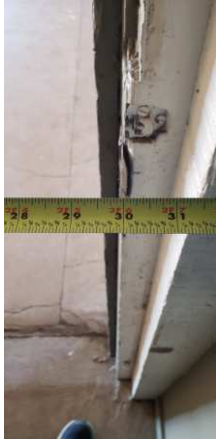
208	Park Site: Pavilion	[30.0900781, -98.424771]	Door openings shall provide a clear width of 32 inches (815 mm) minimum. Clear openings of doorways with swinging doors shall be measured between the face of the door and the stop, with the door open 90 degrees. Openings more than 24 inches (610 mm) deep shall provide a clear opening of 36 inches (915 mm) minimum. There shall be no projections into the required clear opening width lower than 34 inches (865 mm) above the finish floor or ground. Projections into the clear opening width between 34 inches (865 mm) and 80 inches (2030 mm) above the finish floor or ground shall not exceed 4 inches (100 mm). Hand-activated door opening hardware, handles, pulls, latches, locks, and other operating devices on accessible doors shall have a shape that is easy to grasp with one hand and does not require tight grasping, tight pinching or twisting of the wrist to operate. Hardware shall be 34 inches minimum and 48 inches maximum above the finish floor or ground.	Kitchen door - 30" wide, knob hardware	For all doors along the public circulation route, replace doors with doors having 80" overhead clearance and 32" clear width. For all doors along the public circulation route, replace hardware with lever hardware or hardware operable without a tight pinch or grasp.	2010 ADAS Section: 404.2.3, 404.2.7, 404.2.4, 404.2.11, 404.2.11 Exception

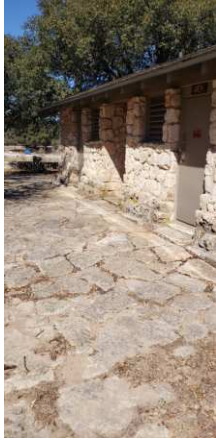
Finding Number	Area Description	Lat/Long	Finding	As Built	Recommendation	Citation	Photos	Figure
209	Park Site: Pavilion	[30.0900584 , -98.424793 8]	There is no accessible route to the pavilion restrooms. At least one accessible route shall connect accessible buildings, accessible facilities, accessible elements, and accessible spaces that are on the same site.	Lacks AR to pavilion restrooms - uneven flagstone surface	Create an accessible route with crushed stone or other outdoor material from parking or walkway to the pavilion restrooms.	2015 ABAAS Section: F206.2.2 2012 TAS Section: 206.2.2 2010 ADAS Section: 206.2.2

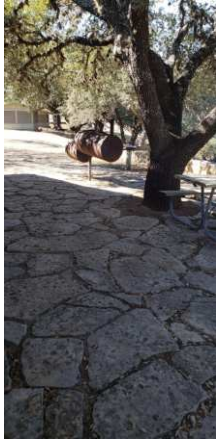
210	Park Site: Pavilion	[30.0901663 , -98.424749 5]	Where picnic facilities contain two or fewer picnic units, each picnic unit shall provide mobility features complying with F245.2.	Lacks ORAR to grill and picnic tables on overlook - flagstone and 8" CIL	Create an ORAR to shelter or picnic area and provide accessible features as a smart practice.	2015 ABAAS Section: F245.2.1

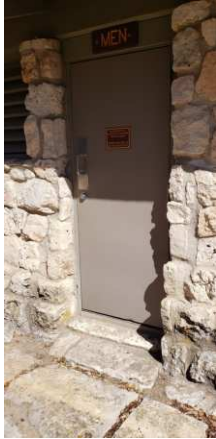
Finding Number	Area Description	Lat/Long	Finding	As Built	Recommendation	Citation	Photos	Figure
211	Park Site: Pavillion Mens Restroom	[30.0900793 , -98.424773 7]	The restroom is not compliant. The restroom does not have the required minimum clear floor space or maneuvering clearances for the toilet. The restroom does not have the required minimum clear floor space or maneuvering clearances for the lavatory. The entry door does not contain the required minimum maneuvering spaces on the pull/push sides. The entry door encroach into the required clear floor space for fixtures. Grab bars are missing and/or incorrectly installed. Accessories, such as toilet seat covers, paper towel holders, garbage cans, hand dryers, and mirrors are either too high or without clear floor space or both.	Restroom is not accessible	Create a compliant wheelchair accessible restroom and correct all features to be accessible if feasible.	2015 ABAAS Section: 603.1 2012 TAS Section: 603.1 2010 ADAS Section: 603.1

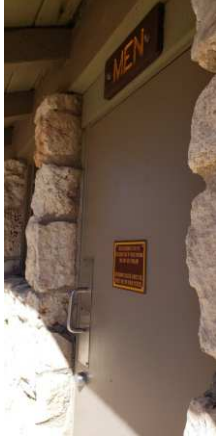
212	Park Site: Pavillion Mens Restroom	[30.0900584 , -98.424788 4]	The restroom sign does not comply with one or more applicable requirements for the location, height, and properties of the sign.	Signage above door, lacks Braille	Replace sign with one of contrasting colors that includes Braille, raised characters, and the symbol of accessibility (upon renovation) and mount on the wall, latch side of the door, 48" to the baseline of the lowest character and 60" to the baseline of the highest character.	2015 ABAAS Section: F216.2, 703.1, 703.2, 703.5, 703.6 2012 TAS Section: 216.2, 703.1, 703.2, 703.5, 703.6 2010 ADAS Section: 216.2, 703.1, 703.2, 703.5, 703.6

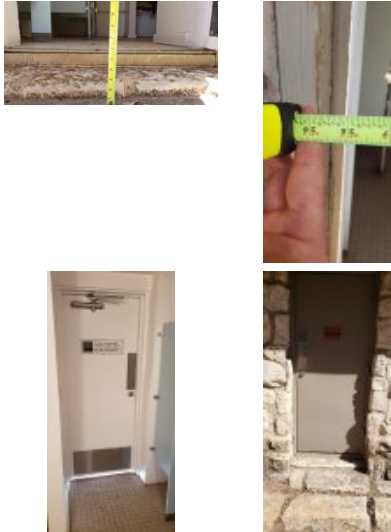
Finding Number	Area Description	Lat/Long	Finding	As Built	Recommendation	Citation	Photos	Figure
213	Park Site: Pavillion Mens Restroom	[30.0900723 , -98.424788 4]	Minimum maneuvering clearances at doors and gates shall comply with 404.2.4. Maneuvering clearances shall extend the full width of the doorway and the required latch side or hinge side clearance. Door openings shall provide a clear width of 32 inches (815 mm) minimum. Clear openings of doorways with swinging doors shall be measured between the face of the door and the stop, with the door open 90 degrees. Openings more than 24 inches (610 mm) deep shall provide a clear opening of 36 inches (915 mm) minimum. There shall be no projections into the required clear opening width lower than 34 inches (865 mm) above the finish floor or ground. Projections into the clear opening width between 34 inches (865 mm) and 80 inches (2030 mm) above the finish floor or ground shall not exceed 4 inches (100 mm). The threshold has a vertical change greater than 1/4 inch high. Exterior doors are recommended to be maintained at 8.5 lbf as a smart practice. Force is to be measured at the operating hardware or 30 inches from the hinges, whichever is greater.	Pavillion men's restroom - change in level (CIL) of 6", 28" wide, lacks push side clearance due to structural obstruction at 0", 10# push	For all doors along the public circulation route, provide required maneuvering clearance on push and pull side of doors. For all doors along the public circulation route, replace doors with doors having 80" overhead clearance and 32" clear width. For all doors along the public circulation route, repair, bevel, or ramp CILs at door entries to max .25". For all doors along the public circulation route, inspect, adjust, and maintain 8.5 lbf to open exterior doors as a smart practice.	2010 ADAS Section: 404.2.3, 404.2.7, 404.2.4, 404.2.11, 404.2.11 Exception

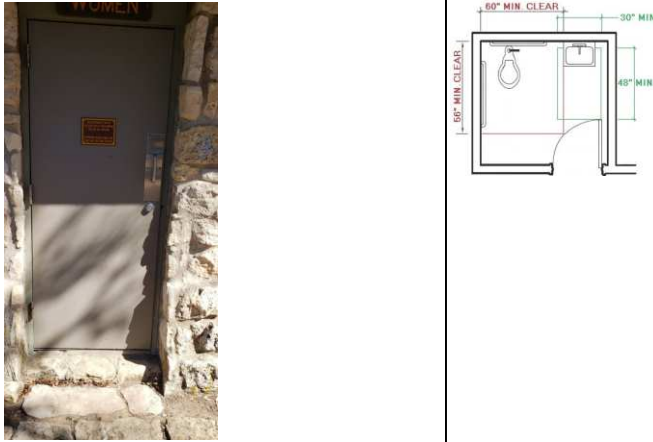
214	Park Site: Pavillion Womens Restroom	[30.0900607 , -98.424764 3]	The restroom is not compliant. The restroom does not have the required minimum clear floor space or maneuvering clearances for the toilet. The restroom does not have the required minimum clear floor space or maneuvering clearances for the lavatory. The entry door does not contain the required minimum maneuvering spaces on the pull/push sides. The entry door encroach into the required clear floor space for fixtures. Grab bars are missing and/or incorrectly installed. Accessories, such as toilet seat covers, paper towel holders, garbage cans, hand dryers, and mirrors are either too high or without clear floor space or both.	Lacks accessible restroom	Create a compliant wheelchair accessible restroom and correct all features to be accessible if feasible.	2015 ABAAS Section: 603.1 2012 TAS Section: 603.1 2010 ADAS Section: 603.1

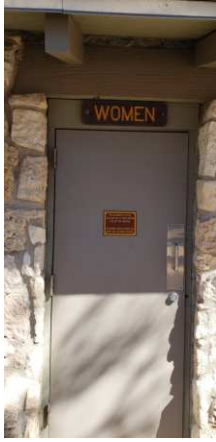
Finding Number	Area Description	Lat/Long	Finding	As Built	Recommendation	Citation	Photos	Figure
215	Park Site: Pavillion Womens Restroom	[30.0900723 , -98.424777 7]	The restroom sign does not comply with one or more applicable requirements for the location, height, and properties of the sign.	Signage mounted above door, lacks Braille	Replace sign with one of contrasting colors that includes Braille, raised characters, and the symbol of accessibility (upon renovation) and mount on the wall, latch side of the door, 48" to the baseline of the lowest character and 60" to the baseline of the highest character.	2015 ABAAS Section: F216.2, 703.1, 703.2, 703.5, 703.6 2012 TAS Section: 216.2, 703.1, 703.2, 703.5, 703.6 2010 ADAS Section: 216.2, 703.1, 703.2, 703.5, 703.6
