Access Audit Site Report

Bonham State Park
1363 State Park 24
Bonham, TX 75418
Accessibility Evaluation
Inspection Date: 10/15/2021
Inspectors: Tanya Scheibe

**TEXAS PARKS AND WILDLIFE DEPARTMENT
BONHAM STATE PARK**

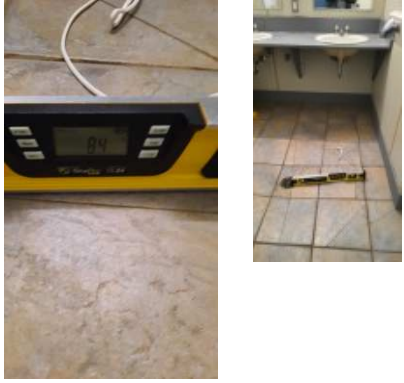
52	Headquarters Area: HQ Women's Restroom	[33.5474707, -96.1448877]	The accessible route contains running slopes greater than 5 percent and cross slopes greater than 2 percent across the width of the walk and has not been constructed as a ramp (i.e. handrails, wheel guides, etc.). When the slope in the direction of travel of any walk exceeds 1 unit vertical in 20 units horizontal (5-percent slope), it must be constructed as ramp. Surface cross slopes must not exceed one unit vertical in 48 units. Horizontal	8.4% slope at drain	Correct or repair slope to max 2.08% cross.	2015 ABAAS Section: 403.3 2012 TAS Section: 403.3 2010 ADAS Section: 403.3

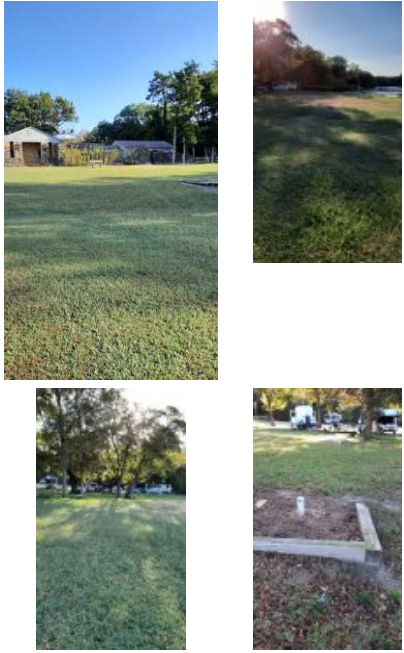
54	Headquarters Area: HQ Playground	[33.5461853, -96.1445793], [33.5463731, -96.1443111]	There is no accessible route to the volleyball, benches, and horseshoes. At least one accessible route shall connect accessible buildings, accessible facilities, accessible elements, and accessible spaces that are on the same site.	Lacks route to volleyball, 5 benches and horseshoes	Create an accessible route with crushed stone or other outdoor material from parking or walkway to the elements.	2015 ABAAS Section: F206.2.2 2012 TAS Section: 206.2.2 2010 ADAS Section: 206.2.2

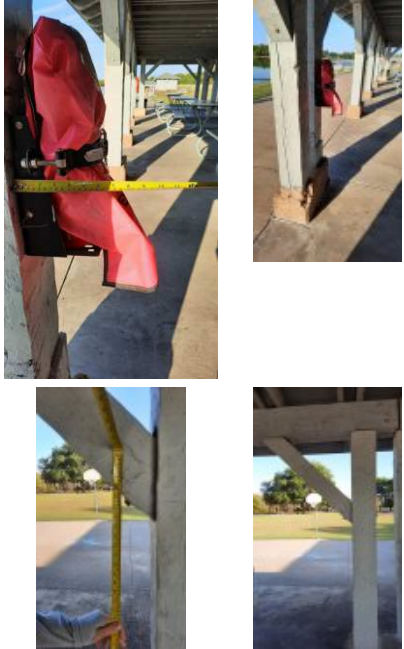
Finding Number	Area Description	Lat/Long	Finding	As Built	Recommendation	Citation	Photos	Figure
58	Headquarters Area: HQ Picnic Area	[33.5463507 , -96.145064 8]	Objects project more than 4 inches into the circulation path. Wall-mounted objects that have leading edges between 27 inches and 80 inches from the floor must not project more than 4 inches into the circulation path. Protruding objects that extend to the floor or within 27 inches of the floor are cane detectable and are therefore not hazardous. Where it is necessary or desirable to have objects protrude from the wall, a manner of cane detection must be provided.	Shelter - fire extinguisher protrudes, angle supports protrude	Provide cane detectable warning at base of objects in the shelter.	2015 ABAAS Section: 307.2 2012 TAS Section: 307.2 2010 ADAS Section: 307.2

<p>4" max 4" is the max. an object may project if the bottom is greater than 27" off the floor X > 27"</p>

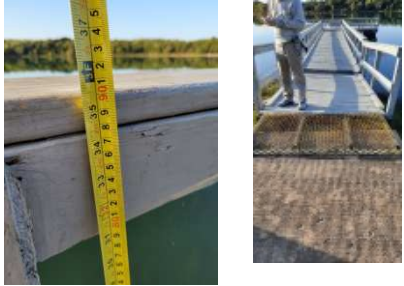
60	Headquarters Area: HQ Fishing and Beach	[33.5461842 , -96.145772 9]	Not enough of the railings, guards, or handrails are at the allowable height. At least 25 percent of the railings, guards, or handrails shall be 34 inches maximum above the ground or deck surface.	Lacks accessible railings, all railing at 35.5" above finish floor (AFF)	Lower 25% of the railing; dispersed through pier, to max 34".	2015 ABAAS Section: 1005.2.1 2010 ADAS Section: 1005.2.1

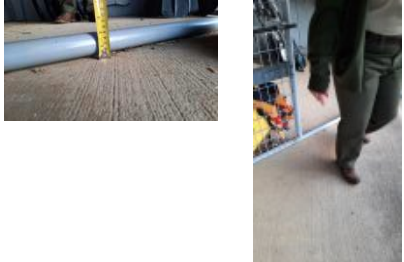
65	Headquarters Area: HQ Fishing and Beach	[33.5464055 , -96.145764 8]	The walkway contains abrupt vertical edges and/or variations over a 1/4 inch. Changes in level greater than 1/2 inch must be by way of a ramp.	Lacks accessible route into floatation device storage due to 2" bar at base of gate	Repair, bevel or ramp CIL along route.	2012 TAS Section: 303.2, 303.3 2010 ADAS Section: 303.2, 303.3

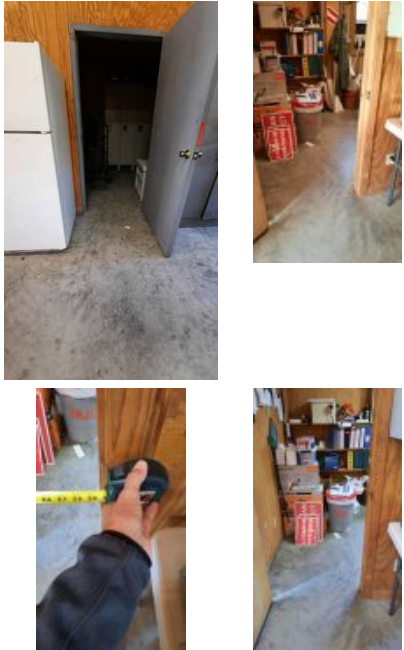
Finding Number	Area Description	Lat/Long	Finding	As Built	Recommendation	Citation	Photos	Figure
71	Employee Spaces: Maintenance	[33.5483335 , -96.143762 6]	Spaces and elements within employee work areas shall only be required to comply with 206.2.8, 207.1, and 215.3 and shall be designed and constructed so that individuals with disabilities can approach, enter, and exit the employee work area. Employee work areas, or portions of employee work areas, other than raised courtroom stations, that are less than 300 square feet (28 m2) and elevated 7 inches (180 mm) or more above the finish floor or ground where the elevation is essential to the function of the space shall not be required to comply with these requirements or to be on an accessible route.	Storage - fridge on pull side, knob, Office - table in pull side clearance, storage back on push, door width 29.5"	For employee spaces, relocate storage, furniture, and other obstacles at doorways to provide approach, enter and exit at the employee space. Provide required maneuvering clearance on push and pull side of doors. Replace doors with doors having 80" overhead clearance and 32" clear width. Replace hardware with lever hardware or hardware operable without a tight pinch or grasp.	2015 ABAAS Section: F203.9 2012 TAS Section: 203.9 2010 ADAS Section: 203.9

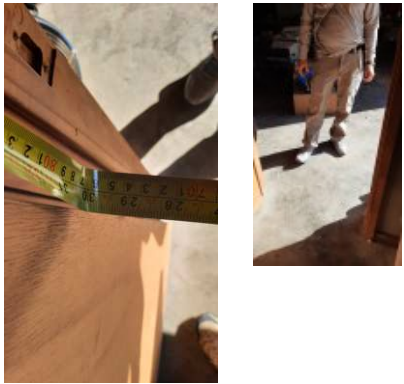
74	Employee Spaces: Maintenance	[33.5483268 , -96.143793 4]	The door opening does not provide at least 32 inches between the face of the door and the opposite stop. Door openings shall provide a clear width of 32 inches minimum. Clear openings of doorways with swinging doors shall be measured between the face of the door and the stop, with the door open 90 degrees.	Restroom door 30" wide	Replace door	2015 ABAAS Section: 404.2.3 2012 TAS Section: 404.2.3 2010 ADAS Section: 404.2.3

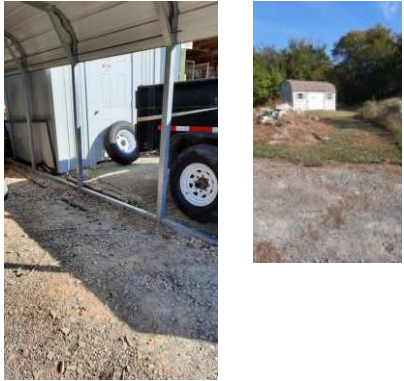
Finding Number	Area Description	Lat/Long	Finding	As Built	Recommendation	Citation	Photos	Figure
75	Employee Spaces: Maintenance	[33.5483525 , -96.1436606]	Spaces and elements within employee work areas shall only be required to comply with 206.2.8, 207.1, and 215.3 and shall be designed and constructed so that individuals with disabilities can approach, enter, and exit the employee work area. Employee work areas, or portions of employee work areas, other than raised courtroom stations, that are less than 300 square feet (28 m2) and elevated 7 inches (180 mm) or more above the finish floor or ground where the elevation is essential to the function of the space shall not be required to comply with these requirements or to be on an accessible route.	Outbuildings lack route	For employee spaces, relocate storage, furniture, and other obstacles at doorways to provide approach, enter and exit at the employee space.	2015 ABAAS Section: F203.9 2012 TAS Section: 203.9 2010 ADAS Section: 203.9

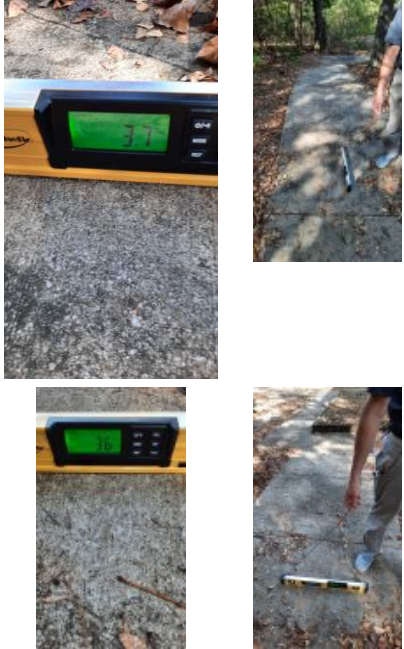
Finding Number	Area Description	Lat/Long	Finding	As Built	Recommendation	Citation	Photos	Figure
84	Group Picnic Area: Group Picnic	[33.548452, -96.145327 6]	The running slope of walking surfaces shall not be steeper than 1:20. The cross slope of walking surfaces shall not be steeper than 1:48.	Second landing slope 3.9% slope, 3rd landing 3.7% slope, bottom landing 3.6% slope	Correct cross slopes to max 2.08%.	2012 TAS Section: 403.3 2010 ADAS Section: 403.3

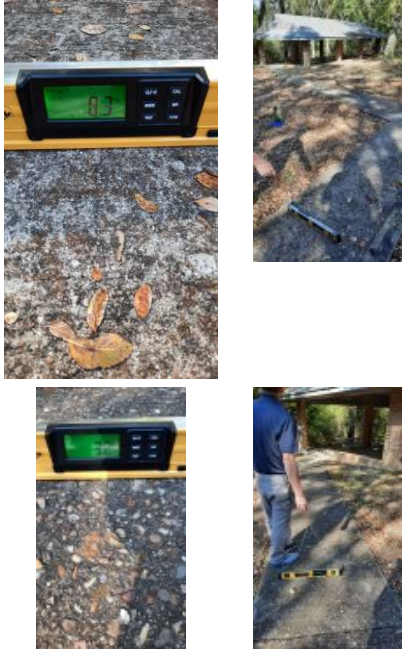
Finding Number	Area Description	Lat/Long	Finding	As Built	Recommendation	Citation	Photos	Figure
88	Group Picnic Area: Group Picnic	[33.5486621, -96.1455073]	The cross slope shall not be steeper than 1:48. EXCEPTION: Where the surface is other than concrete, asphalt, or boards, cross slopes not steeper than 1:20 shall be permitted when necessary for drainage.	8.3% slope and 3.2% slope to shelter	Correct or repair ORAR cross slope to max 2.08% or 5% for surfaces other than concrete, asphalt or board as a smart practices	2015 ABAAS Section: 1016.7.2, 1016.7.2 EXCEPTION

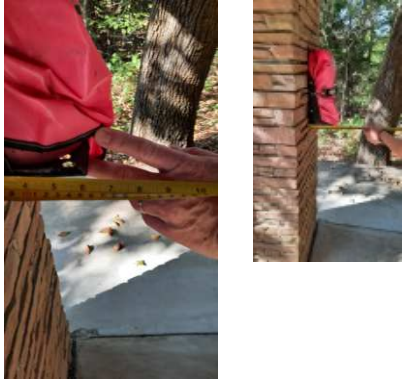
Finding Number	Area Description	Lat/Long	Finding	As Built	Recommendation	Citation	Photos	Figure
93	Group Picnic Area: Group Picnic	[33.5487493 , -96.145641 4]	Objects project more than 4 inches into the circulation path. Wall-mounted objects that have leading edges between 27 inches and 80 inches from the floor must not project more than 4 inches into the circulation path. Protruding objects that extend to the floor or within 27 inches of the floor are cane detectable and are therefore not hazardous. Where it is necessary or desirable to have objects protrude from the wall, a manner of cane detection must be provided.	Fire extinguisher protrudes more than 4"	Relocate object to not protrude into the circulation path.	2015 ABAAS Section: 307.2 2012 TAS Section: 307.2 2010 ADAS Section: 307.2

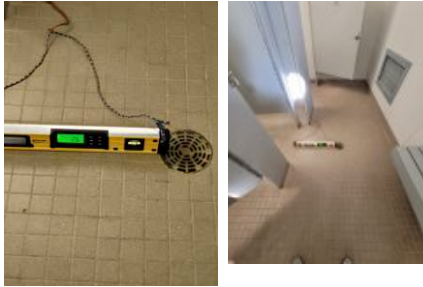
132	Group Barracks: Group Barracks Men's Restroom	[33.5463216 , -96.140466 2]	The accessible route contains running slopes greater than 5 percent and cross slopes greater than 2 percent across the width of the walk and has not been constructed as a ramp (i.e. handrails, wheel guides, etc.). When the slope in the direction of travel of any walk exceeds 1 unit vertical in 20 units horizontal (5-percent slope), it must be constructed as ramp. Surface cross slopes must not exceed one unit vertical in 48 units. Horizontal (2-percent slope).	2.6% slope to shower	Correct or repair slope to max. 2.08%	2015 ABAAS Section: 403.3 2012 TAS Section: 403.3 2010 ADAS Section: 403.3

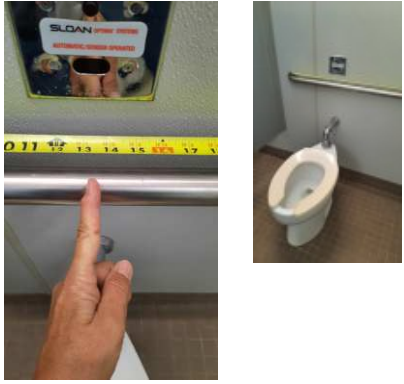
140	Group Barracks: Group Barracks Women's Restroom	[33.5463217 , -96.140464 8]	The rear grab bar is not 36" long or is not mounted in the correct location. The rear grab bar must be a minimum of 36" long and extend from the toilet centerline a minimum 12" towards the wall side and a minimum 24" towards the open side of the toilet. Grab bars shall be installed in a horizontal position, 33 inches minimum and 36 inches maximum above the finish floor measured to the top of the gripping surface and the space between the grab bar and the top of the tank shall be 1-1/2 inches minimum.	rear grab bar mounted 13.25" to center line	Remount rear grab bar to behind the toilet, 12" to one side of center and 24" to the other and 33" to 36" above finish floor (AFF)	2015 ABAAS Section: 604.5.2 2012 TAS Section: 604.5.2 2010 ADAS Section: 604.5.2

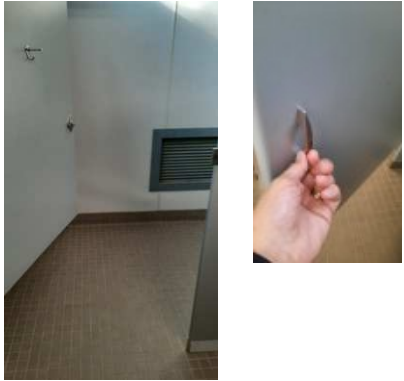
Finding Number	Area Description	Lat/Long	Finding	As Built	Recommendation	Citation	Photos	Figure
141	Group Barracks: Group Barracks Women's Restroom	[33.5463272 , -96.140464 8]	The stall door fails to comply with all of the door requirements. The stall door must be a minimum of 32" wide and have compliant hardware on both sides. The stall door must be self-closing.	Stall door not self closing and has small hardware	Adjust stall door to be self-closing Replace stall hardware with hardware operable without a tight pinch or grasp on both sides of the stall door	2015 ABAAS Section: 404.2.3, 404.2.7, 604.8.2.2 2012 TAS Section: 404.2.3, 404.2.7, 604.8.2.2 2010 ADAS Section: 404.2.3, 404.2.7, 604.8.2.2

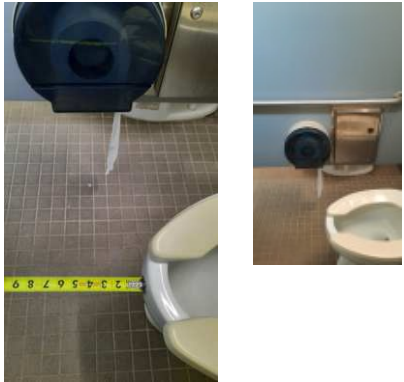
142	Group Barracks: Group Barracks Women's Restroom	[33.5463205 , -96.140462 1]	The toilet paper is not installed within the compliant range in front of the toilet. Toilet paper dispensers shall be 7 inches minimum and 9 inches maximum in front of the water closet measured to the centerline of the dispenser. The outlet of the dispenser shall be 15 inches minimum and 48 inches maximum above the finish floor and shall not be located behind grab bars. Dispensers shall not be of a type that controls delivery or that does not allow continuous paper flow. There shall be a clearance of 1 1/2 inches minimum below the grab bar.	Toilet paper dispenser is too close to toilet	Remount toilet paper dispenser max 7" to 9" from front of toilet, 15" to 48" aff and min 12" above or 1.5" below grab bar	2015 ABAAS Section: 604.7 2012 TAS Section: 604.7 2010 ADAS Section: 604.7

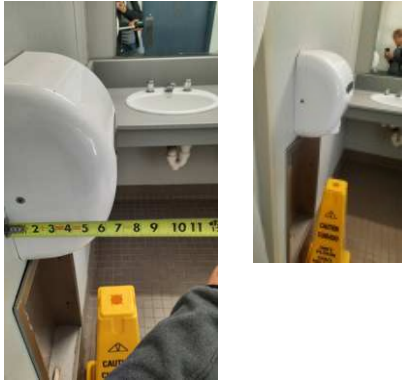
Finding Number	Area Description	Lat/Long	Finding	As Built	Recommendation	Citation	Photos	Figure
143	Group Barracks: Group Barracks Women's Restroom	[33.5463306 , -96.140467 5]	The hand dryer projects more than 4 inches into the circulation path. Wall-mounted objects that have leading edges between 27 inches and 80 inches from the floor must not project more than 4 inches into the circulation path. Protruding objects that extend to the floor or within 27 inches of the floor are cane detectable and are therefore not hazardous. Where it is necessary or desirable to have objects protrude from the wall, a manner of cane detection must be provided.	Hand dryer protrudes	Relocate protruding objects or place cane detectable warning or bollard at foot of item	2015 ABAAS Section: 307.2 2012 TAS Section: 307.2 2010 ADAS Section: 307.2

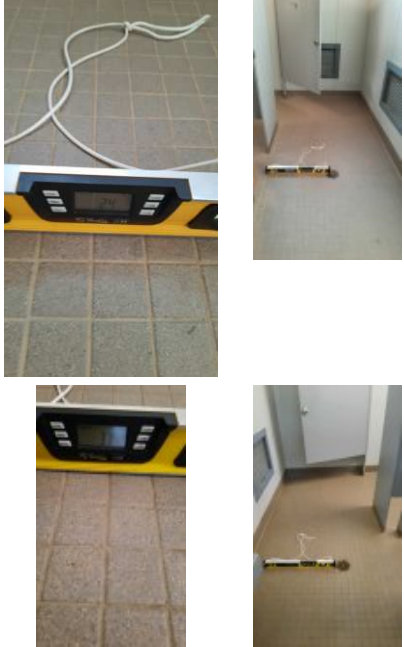
144	Group Barracks: Group Barracks Women's Restroom	[33.5463317 , -96.140462 1]	The accessible route contains running slopes greater than 5 percent and cross slopes greater than 2 percent across the width of the walk and has not been constructed as a ramp (i.e. handrails, wheel guides, etc.). When the slope in the direction of travel of any walk exceeds 1 unit vertical in 20 units horizontal (5-percent slope), it must be constructed as ramp. Surface cross slopes must not exceed one unit vertical in 48 units. Horizontal (2-percent slope).	2.4% at drain near accessible stall, 3.7% at drain near shower	Correct or repair slope to max 2.08% cross	2015 ABAAS Section: 403.3 2012 TAS Section: 403.3 2010 ADAS Section: 403.3

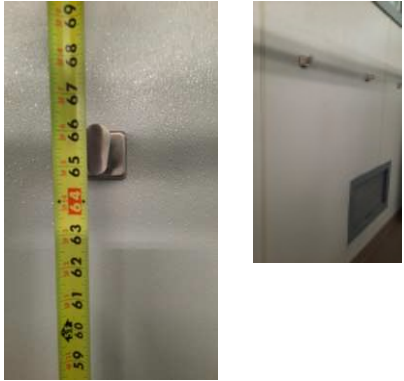
Finding Number	Area Description	Lat/Long	Finding	As Built	Recommendation	Citation	Photos	Figure
145	Group Barracks: Group Barracks Women's Restroom	[33.5463217 , -96.140464 8]	Coat hooks provided within the room shall be located within one of the reach ranges specified in 308. Shelves shall be 40 inches (1015 mm) minimum and 48 inches (1220 mm) maximum above the finish floor or ground. Where coat hooks or shelves are provided in dressing, fitting or locker rooms without individual compartments, at least one of each type shall comply with 803.5. Where coat hooks or shelves are provided in individual compartments at least one of each type complying with 803.5 shall be provided in individual compartments in dressing, fitting, or locker rooms required to comply with 222.1.	Hooks in main area at 66"	Remount at least one hook to max 48" aff.	2015 ABAAS Section: 308.2.1, 308.1, F222.2, 803.5 2012 TAS Section: 308.2.1, 308.1, 222.2, 803.5 2010 ADAS Section: 308.2.1, 308.1, 222.2, 803.5

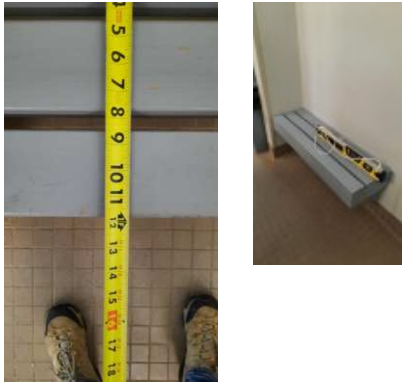
146	Group Barracks: Group Barracks Women's Restroom	[33.5463373 , -96.140467 5]	The bench is not deep enough or long enough or is missing. Benches shall be provided having seats that are 42 inches long minimum and 20 inches deep minimum and 24 inches deep maximum. The bench shall provide for back support or shall be affixed to a wall. Back support shall be 42 inches (1065 mm) long minimum and shall extend from a point 2 inches (51 mm) maximum above the seat surface to a point 18 inches (455 mm) minimum above the seat surface. Back support shall be 2½ inches (64 mm) maximum from the rear edge of the seat measured horizontally. The top of the bench seat surface shall be 17 inches (430 mm) minimum and 19 inches (485 mm) maximum above the finish floor or ground. Clear floor or ground space complying with 305 shall be provided and shall be positioned at the end of the bench seat and parallel to the short axis of the bench	Bench depth 12", 40" long	Replace bench in dressing area with one having a seat depth of 20" to 24" deep, 42" long, affixed to the wall or having a back and mounted 17" to 19" AFF and provide required clear floor space on the short axis of the bench.	2012 TAS Section: 903.4, 903.2, 903.3, 903.5 2010 ADAS Section: 903.4, 903.2, 903.3, 903.5

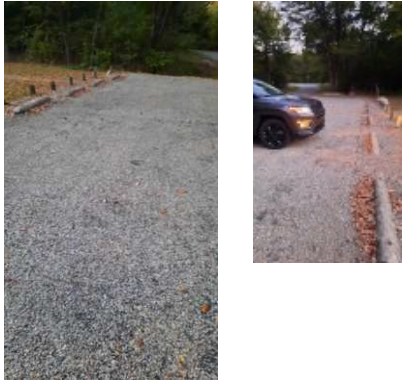
152	Group Camping: Group Camping Parking	[33.5452106, -96.1421465]	There are no accessible parking stalls. Each lot where parking is provided for the public as clients, guests or employees, shall provide accessible parking and shall be located on the shortest accessible route of travel from adjacent parking to an accessible entrance. There are a total of 8 parking stalls in the parking lot that could be reasonably associated with this facility. There should be a minimum of 1 accessible stalls with a minimum of 1 being designed as van accessible.	10 stalls, none accessible	Create one or more 8' accessible parking stalls, with one 5' adjacent access aisle, with proper signage and striping based on the total number of stalls	2015 ABAAS Section: F208.2 2012 TAS Section: 208.2 2010 ADAS Section: 208.2
