Access Audit Site Report

Brazos Bend State Park
21901 Farm to Market Rd 762
Needville, TX 77461
Accessibility Evaluation
Inspection Date: 06/14/2021
Inspectors: Tanya Scheibe

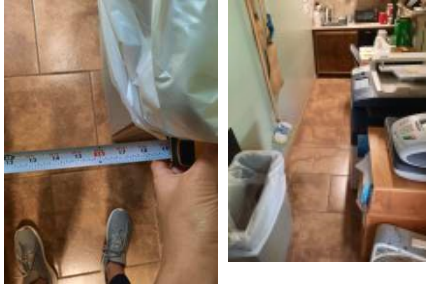
Finding Number	Area Description	Lat/Long	Finding	As Built	Recommendation	Citation	Photos	Figure
8	Headquarters Area: Headquarters	[29.3709993 , -95.631913 9]	The route of travel at this location does not provide a minimum width of 36 inches. The clear width shall be permitted to be reduced to 32 inches minimum for a length of 24 inches maximum provided that reduced width segments are separated by segments that are 48 inches long minimum and 36 inches wide minimum.	Break room - 18" between furnishings and storage	Relocate obstacles such as furnishings and storage to create AR through indicated rooms For deficit, leave as is, employee work area pursuant to 2010 Standards 106.5 Defined Terms, until an employee with a disability works here	2015 ABAAS Section: 403.5.1 2012 TAS Section: 403.5.1 2010 ADAS Section: 403.5.1

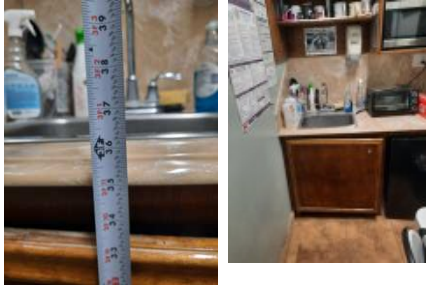
11	Headquarters Area: Headquarters	[29.3710087 , -95.631919 2]	The top rim of the sink is too high. All lavatories/sinks that are designated to be accessible shall be a minimum 17 inches in horizontal depth and mounted with the rim or counter edge no higher than 34 inches above the finished floor.	Break room - The top rim of the sink is 36" aff	Lower sinks to max 34" aff to front of rim	2015 ABAAS Section: 606.3 2012 TAS Section: 606.3 2010 ADAS Section: 606.3

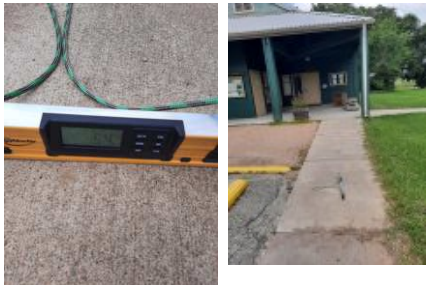
19	Headquarters Area: Headquarters	[29.3710209 , -95.631790 4]	The running slope of walking surfaces shall not be steeper than 1:20.	Running slope of 5.3% on walkway to main entry	Correct running slope along the AR to max 5%	2015 ABAAS Section: 403.3 2012 TAS Section: 403.3 2010 ADAS Section: 403.3

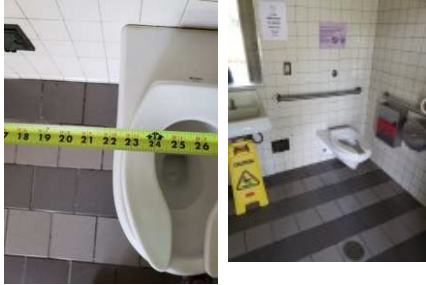
Finding Number	Area Description	Lat/Long	Finding	As Built	Recommendation	Citation	Photos	Figure
25	Headquarters Area: HQ Restrooms	[29.3709888 , -95.631897 8]	The required 56 inches by 60 inches clear floor space for the water closet has been obstructed. The clear floor space around the water closet shall be 60 inches minimum measured perpendicular from the side wall and 56 inches minimum measured perpendicular from the rear wall.	Left restroom - Sink in toilet clearance	Renovate restroom to provide 60" by 56" clearance around the toilet. Leave as is sink in toilet clearance if restroom constructed or last renovated prior to March 15, 2012 as it will meet safe harbor.	2015 ABAAS Section: 604.3. 2012 TAS Section: 604.3.1 2010 ADAS Section: 604.3.1

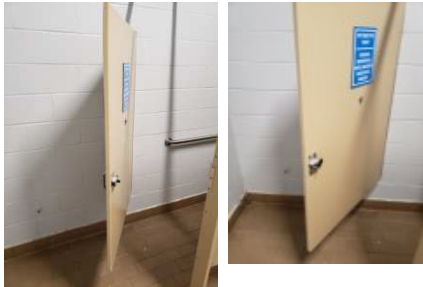
44	40 Acre Lake: 40 Acre Lake Restrooms	[29.370706, -95.6270845]	The stall door fails to comply with all of the door requirements. The stall door must be a minimum of 32" wide and have compliant hardware on both sides. The stall door must be self-closing.	Men's restroom - Lacks self-closing door, and lacks compliant hardware	Adjust stall door to be self-closing Replace stall hardware with hardware operable without a tight pinch or grasp on both sides of the stall door	2015 ABAAS Section: 404.2.3, 404.2.7, 604.8.2.2 2012 TAS Section: 404.2.3, 404.2.7, 604.8.2.2 2010 ADAS Section: 404.2.3, 404.2.7, 604.8.2.2

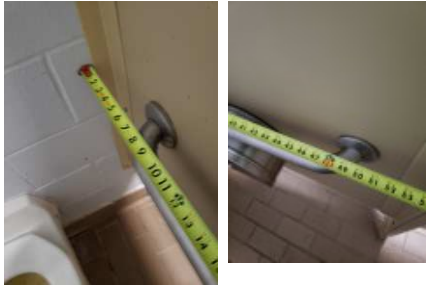
Finding Number	Area Description	Lat/Long	Finding	As Built	Recommendation	Citation	Photos	Figure
45	40 Acre Lake: 40 Acre Lake Restrooms	[29.3707025 , -95.627093 9]	The side grab bars are not in the correct location. Grab bars on the side wall must be installed so that the end closest to the rear wall is maximum 12" from the rear wall. The end furthest from the rear wall must be mounted minimum 54" from the rear wall.	Men's restroom - Side grab bar (right side) starts 8" from rear wall and ends 49" from rear wall	Remount side grab bar to max 12" from the rear wall at the close end and min 54" on the far end, and 33" to 36" aff	2015 ABAAS Section: 604.5.1 2012 TAS Section: 604.5.1 2010 ADAS Section: 604.5.1

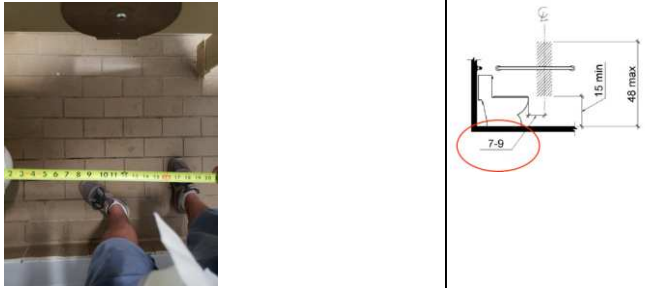
47	40 Acre Lake: 40 Acre Lake Restrooms	[29.3707083 , -95.627076 5]	The toilet paper is not installed within the compliant range in front of the toilet. Toilet paper dispensers shall be 7 inches minimum and 9 inches maximum in front of the water closet measured to the centerline of the dispenser. The outlet of the dispenser shall be 15 inches minimum and 48 inches maximum above the finish floor and shall not be located behind grab bars. Dispensers shall not be of a type that controls delivery or that does not allow continuous paper flow. There shall be a clearance of 1 1/2 inches minimum below the grab bar.	Men's restroom - Centerline of toilet paper dispenser is 13" from the front of the toilet	Remount toilet paper dispenser max 7" to 9" from front of toilet, 15" to 48" aff and min 12" above or 1.5" below grab bar	2015 ABAAS Section: 604.7 2012 TAS Section: 604.7 2010 ADAS Section: 604.7

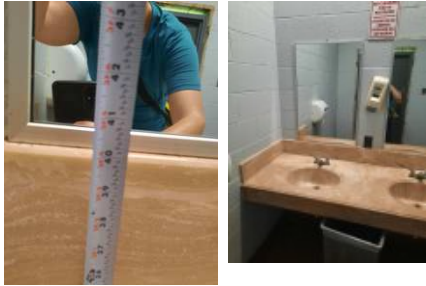
Finding Number	Area Description	Lat/Long	Finding	As Built	Recommendation	Citation	Photos	Figure
51	40 Acre Lake: 40 Acre Lake Restrooms	[29.3707095 , -95.627096 6]	The mirror is mounted too high. Mirrors must have the bottom edge of the reflecting surface a maximum of 40 inches above the floor if above a sink or counter. Mirrors not located above lavatories or countertops shall be installed with the bottom edge of the reflecting surface 35 inches maximum above the finish floor or ground.	Women's restroom - Bottom edge of reflecting surface of mirror is 40.75" aff	Lower mirror so reflective surface is max 40" aff	2015 ABAAS Section: 603.3 2012 TAS Section: 603.3 2010 ADAS Section: 603.3

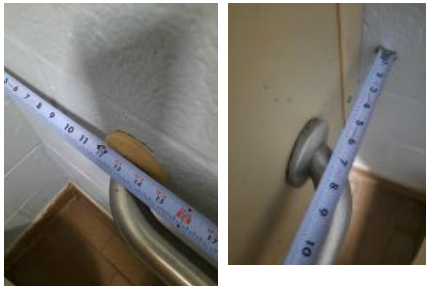
58	40 Acre Lake: 40 Acre Lake Restrooms	[29.3707153 , -95.627095 3]	The side grab bars are not in the correct location. Grab bars on the side wall must be installed so that the end closest to the rear wall is maximum 12" from the rear wall. The end furthest from the rear wall must be mounted minimum 54" from the rear wall.	Women's restroom - Right side grab bar starts 13" and left side bar starts 7" from rear wall	Remount side grab bar to max 12" from the rear wall at the close end and min 54" on the far end, and 33" to 36" aff	2015 ABAAS Section: 604.5.1 2012 TAS Section: 604.5.1 2010 ADAS Section: 604.5.1

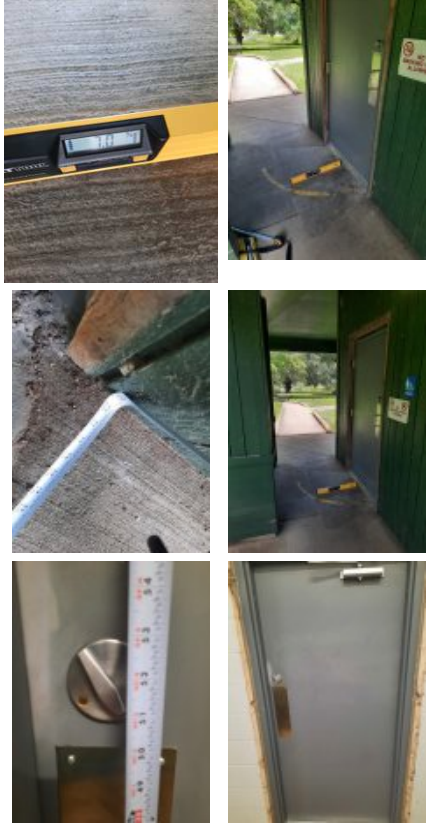
60	40 Acre Lake: 40 Acre Lake Restrooms	[29.3707055 , -95.6271015]	Minimum maneuvering clearances at doors and gates shall comply with 404.2.4. Maneuvering clearances shall extend the full width of the doorway and the required latch side or hinge side clearance. Floor or ground surface within required maneuvering clearances shall comply with 302. Changes in level are not permitted. EXCEPTIONS: 1. Slopes not steeper than 1:48 shall be permitted. Exterior doors are recommended to be maintained at 8.5 lbf as a smart practice. Force is to be measured at the operating hardware or 30 inches from the hinges, whichever is greater. Hand-activated door opening hardware, handles, pulls, latches, locks, and other operating devices on accessible doors shall have a shape that is easy to grasp with one hand and does not require tight grasping, tight pinching or twisting of the wrist to operate. Hardware shall be 34 inches minimum and 48 inches maximum above the finish floor or ground.	Women's restroom door - Lacks maneuvering clearance on push side (47" to wall - structural, and slope of 7% on landing), exceeds 8.5 lbs of force to open (12 lbf required), and lacks compliant hardware (deadbolt is 52" agl)	For all doors along the public circulation route, provide required maneuvering clearance on push and pull side of doors Correct or repair slope at doorway landing to max 2.08% in any direction for level For all doors along the public circulation route, inspect, adjust, and maintain 8.5 lbf to open exterior doors as a smart practice For all doors along the public circulation route, replace hardware with lever hardware or hardware operable without a tight pinch or grasp	2010 ADAS Section: 404.2.3, 404.2.7, 404.2.4, 404.2.11, 404.2.11 Exception

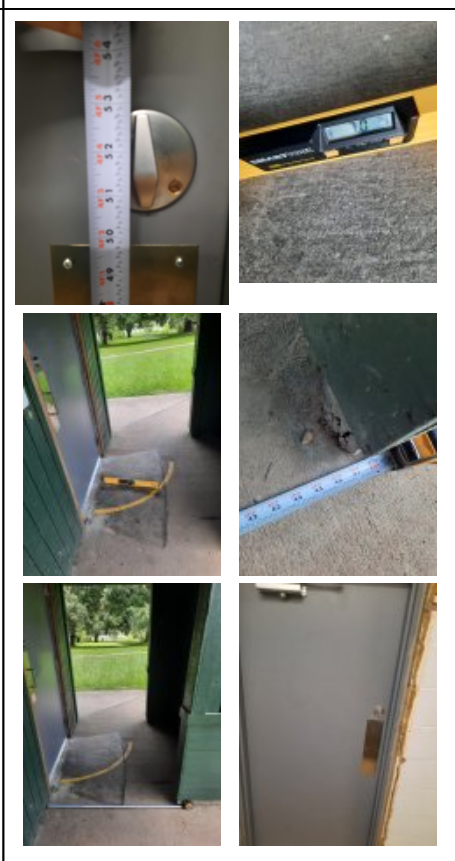
Finding Number	Area Description	Lat/Long	Finding	As Built	Recommendation	Citation	Photos	Figure
61	40 Acre Lake: 40 Acre Lake Restrooms	[29.3707041 , -95.627095]	Minimum maneuvering clearances at doors and gates shall comply with 404.2.4. Maneuvering clearances shall extend the full width of the doorway and the required latch side or hinge side clearance. Floor or ground surface within required maneuvering clearances shall comply with 302. Changes in level are not permitted. EXCEPTIONS: 1. Slopes not steeper than 1:48 shall be permitted. Exterior doors are recommended to be maintained at 8.5 lbf as a smart practice. Force is to be measured at the operating hardware or 30 inches from the hinges, whichever is greater. Hand-activated door opening hardware, handles, pulls, latches, locks, and other operating devices on accessible doors shall have a shape that is easy to grasp with one hand and does not require tight grasping, tight pinching or twisting of the wrist to operate. Hardware shall be 34 inches minimum and 48 inches maximum above the finish floor or ground.	Men's restroom door - Lacks maneuvering clearance on push side (47" to wall - structural, and slope of 7% on landing), exceeds 8.5 lbs of force to open (14 lbf required), and lacks compliant hardware (deadbolt is 52" agl)	For all doors along the public circulation route, provide required maneuvering clearance on push and pull side of doors Correct or repair slope at doorway landing to max 2.08% in any direction for level For all doors along the public circulation route, inspect, adjust, and maintain 8.5 lbf to open exterior doors as a smart practice For all doors along the public circulation route, replace hardware with lever hardware or hardware operable without a tight pinch or grasp	2010 ADAS Section: 404.2.3, 404.2.7, 404.2.4, 404.2.11, 404.2.11 Exception

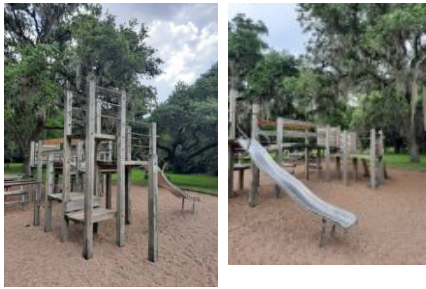
65	40 Acre Lake: 40 Acre Lake Playground	[29.3704944 , -95.626721 1]	There are not enough accessible elevated play components. Where Elevated Play Components are provided, at least 50 percent shall be on an accessible route. An accessible route may be a ramp of transfer system.	Less than 50% of EPCs connected via transfer	Add two more play components to the elevated structure, such as a steering wheel, periscope, or talk tube, to meet the 50% accessible standard for EPCs Adjust height of platform decks to max 8" for access to EPCs, in the alternative, install compliant transfer steps	2012 TAS Section: 240.2.2 2010 ADAS Section: 240.2.2

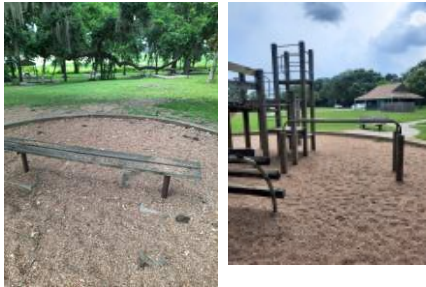
66	40 Acre Lake: 40 Acre Lake Playground	[29.3704862 , -95.626706 4]	A minimum of one of each type of ground level play components is not on an accessible route. Where ground level play components are provided, at least one of each type shall be on an accessible route and shall comply.	Lacks route to one of each type due to surface- 1 type (climber): 1 balance beam, 1 parallel bar	Provide an AR to one of each type of GLPC.	2012 TAS Section: 240.2.1.1 2010 ADAS Section: 240.2.1.1

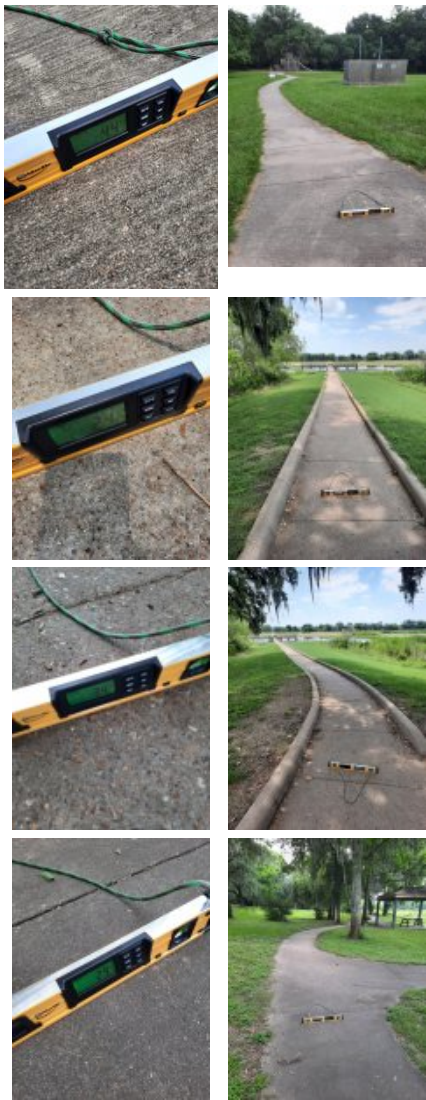
Finding Number	Area Description	Lat/Long	Finding	As Built	Recommendation	Citation	Photos	Figure
71	40 Acre Lake: 40 Acre - Fishing Pier	[29.3707525 , -95.626957] [29.3709301 , -95.626342 8]	The accessible route of travel on the accessible route contains cross slopes greater than 2%. Cross slopes shall not exceed one unit vertical in 48 units horizontal (2-percent slope).	Cross slopes of 4.4% (near restrooms), 2.4% (near pier), 3.4%, and 2.9% (near picnic area)	Correct or repair cross slope along AR to max 2.08%	2015 ABAAS Section: 403.3 2012 TAS Section: 403.3 2010 ADAS Section: 403.3

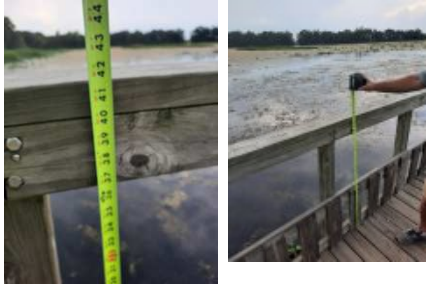
Finding Number	Area Description	Lat/Long	Finding	As Built	Recommendation	Citation	Photos	Figure
72	40 Acre Lake: 40 Acre - Fishing Pier	[29.3714516 , -95.625806 5]	Not enough of the railings, guards, or handrails are at the allowable height. At least 25 percent of the railings, guards, or handrails shall be 34 inches maximum above the ground or deck surface.	Lacks 25% of railings at 34" above deck surface (railings are 41.5" above deck surface)	Lower 25% of the railing; dispersed through pier, to max 34".	2015 ABAAS Section: 1005.2.1 2010 ADAS Section: 1005.2.1

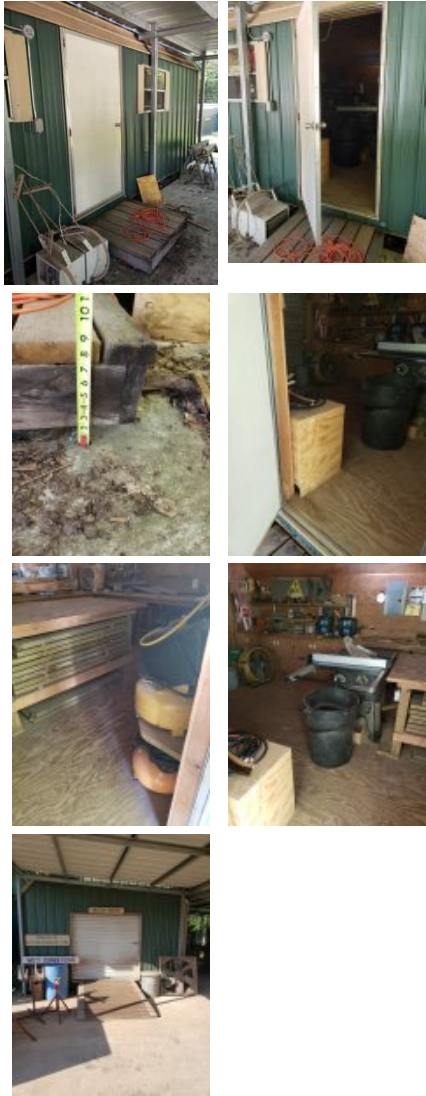
Finding Number	Area Description	Lat/Long	Finding	As Built	Recommendation	Citation	Photos	Figure
78	Employee Spaces: Maintenance	[29.3691901 , -95.596964 7]	Minimum maneuvering clearances at doors and gates shall comply with 404.2.4. Maneuvering clearances shall extend the full width of the doorway and the required latch side or hinge side clearance. The threshold has a vertical change greater than 1/4 inch high. Hand-activated door opening hardware, handles, pulls, latches, locks, and other operating devices on accessible doors shall have a shape that is easy to grasp with one hand and does not require tight grasping, tight pinching or twisting of the wrist to operate. Hardware shall be 34 inches minimum and 48 inches maximum above the finish floor or ground.	Wood shop door - boxes in push side clearance, lacks pull side clearance due to wooden platform/step lacks required dimensions for landing/MC and creates CIL), CIL/step at threshold, knobs	For all doors along the public circulation route, provide required maneuvering clearance on push and pull side of doors For all doors along the public circulation route, replace doors with doors having 80" overhead clearance and 32" clear width For all doors along the public circulation route, repair, bevel, or ramp CILs at door entries to max .25" For all doors along the public circulation route, repair, provide beveled threshold For all doors along the public circulation route, inspect, adjust, and maintain 5 lbf to open interior doors For all doors along the public circulation route, inspect, adjust, and maintain closing speed on door closers For all doors along the public circulation route, inspect, adjust, and maintain 8.5 lbf to open exterior doors as a smart practice For all doors along the public circulation route, replace hardware with lever hardware or hardware operable without a tight pinch or grasp For all doors along the public circulation route, provide kick plate on push side of door from floor to 10" aff For all doors along the public circulation route, replace doors with ones having sidelight viewing windows max 43" aff	2010 ADAS Section: 404.2.3, 404.2.7, 404.2.4, 404.2.11, 404.2.11 Exception

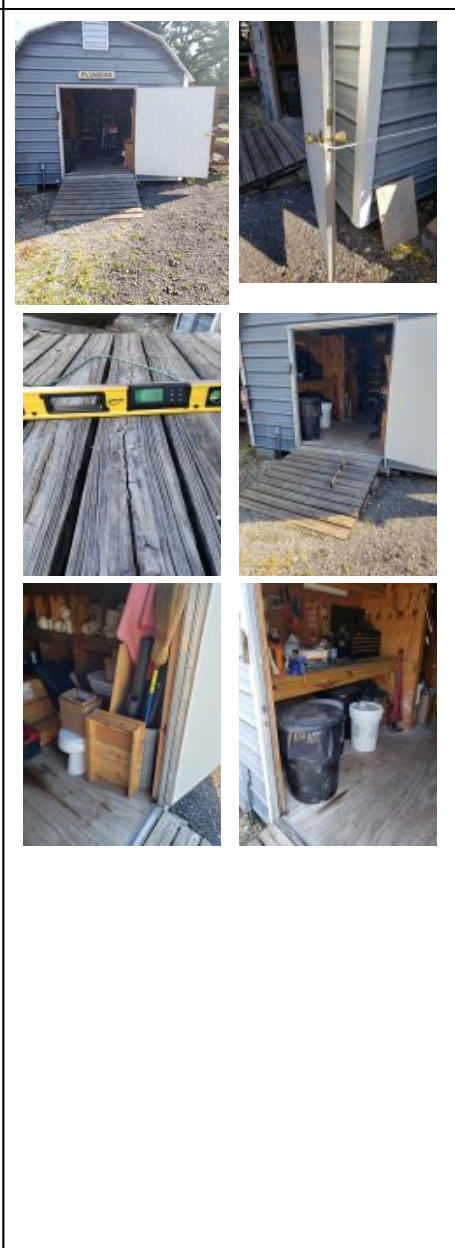
Finding Number	Area Description	Lat/Long	Finding	As Built	Recommendation	Citation	Photos	Figure
80	Employee Spaces: Maintenance	[29.3691831 , -95.596956 6]	Minimum maneuvering clearances at doors and gates shall comply with 404.2.4. Maneuvering clearances shall extend the full width of the doorway and the required latch side or hinge side clearance. Floor or ground surface within required maneuvering clearances shall comply with 302. Changes in level are not permitted. EXCEPTIONS: 1. Slopes not steeper than 1:48 shall be permitted. Hand-activated door opening hardware, handles, pulls, latches, locks, and other operating devices on accessible doors shall have a shape that is easy to grasp with one hand and does not require tight grasping, tight pinching or twisting of the wrist to operate. Hardware shall be 34 inches minimum and 48 inches maximum above the finish floor or ground. The accessible route contains loose gravel and/or surfaces that do not provide for a stable, firm slip resistant surface.	Plumbing building door - Lacks maneuvering clearance on push side (storage) and pull side (slope of 17.9%), lacks compliant hardware (knobs), and lacks firm and stable approach (deteriorated asphalt and loose gravel)	For all doors along the public circulation route, provide required maneuvering clearance on push and pull side of doors Correct or repair slope at doorway landing to max 2.08% in any direction for level For all doors along the public circulation route, replace hardware with lever hardware or hardware operable without a tight pinch or grasp Resurface AR where deterioration occurs	2010 ADAS Section: 404.2.3, 404.2.7, 404.2.4, 404.2.11, 404.2.11 Exception

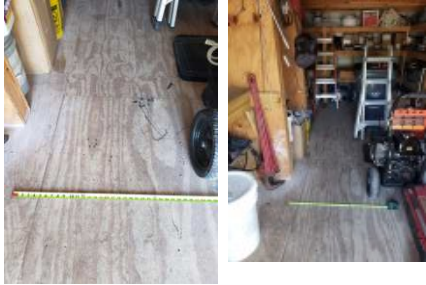
Finding Number	Area Description	Lat/Long	Finding	As Built	Recommendation	Citation	Photos	Figure
81	Employee Spaces: Maintenance	[29.3691738, -95.59697]	Employee Work Areas. Common use circulation paths within employee work areas shall comply with 402. EXCEPTIONS: 1. Common use circulation paths located within employee work areas that are less than 1000 square feet (93 m2) and defined by permanently installed partitions, counters, casework, or furnishings shall not be required to comply with 402. 2. Common use circulation paths located within employee work areas that are an integral component of work area equipment shall not be required to comply with 402. 3. Common use circulation paths located within exterior employee work areas that are fully exposed to the weather shall not be required to comply with 402.	Route reduces to 31"	Make corrections for compliant circulation path.	2015 ABAAS Section: F206.2.8, F206.2.8.1, F206.2.8.2 2012 TAS Section: 206.2.8, 206.2.8 Exception 1, 206.2.8 Exception 2, 206.2.8 Exception 3, 206.2.8 Advisory 1, 206.2.8 Advisory 2 2010 ADAS Section: 206.2.8, 206.2.8 Exception 1, 206.2.8 Exception 2, 206.2.8 Exception 3

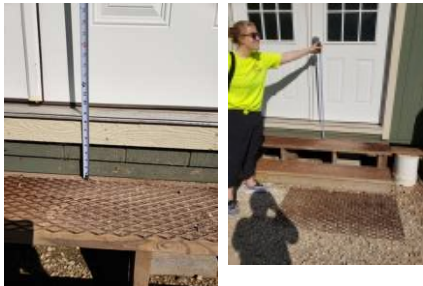
89	Employee Spaces: Maintenance	[29.3691784 , -95.596956 6]	Thresholds, if provided at doorways, shall be 1/2 inch (13 mm) high maximum. Raised thresholds and changes in level at doorways shall comply with 302 and 303. Changes in level of 1/4 inch (6.4 mm) high maximum shall be permitted to be vertical. Changes in level between 1/4 inch (6.4 mm) high minimum and 1/2 inch (13 mm) high maximum shall be beveled with a slope not steeper than 1:2. Changes in level greater than 1/2 inch (13 mm) high shall be ramped, and shall comply with 405 or 406.	Wood Yard door - CIL/step of 9"	Repair, bevel or ramp CIL at doorway	2015 ABAAS Section: 303.3, 404.2.5, 303.2, 303.4 2012 TAS Section: 303.3, 404.2.5, 303.2, 303.4 2010 ADAS Section: 303.3, 404.2.5, 303.2, 303.4

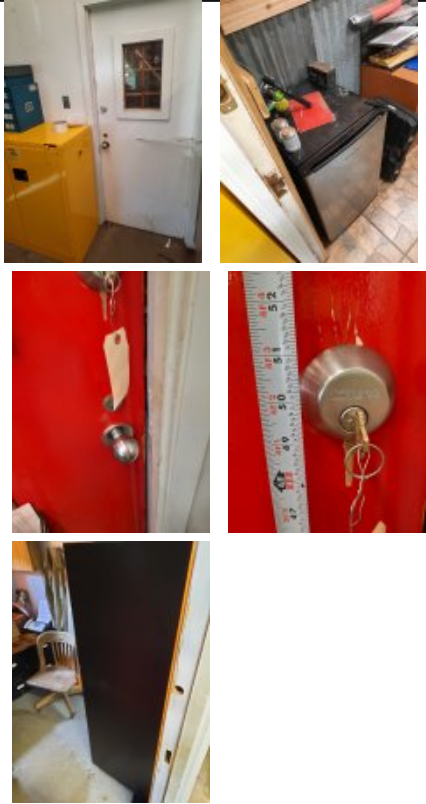
Finding Number	Area Description	Lat/Long	Finding	As Built	Recommendation	Citation	Photos	Figure
91	Employee Spaces: Maintenance	[29.369167, -95.596980 8]	Minimum maneuvering clearances at doors and gates shall comply with 404.2.4. Maneuvering clearances shall extend the full width of the doorway and the required latch side or hinge side clearance. The threshold has a vertical change greater than 1/4 inch high. Exterior doors are recommended to be maintained at 8.5 lbf as a smart practice. Force is to be measured at the operating hardware or 30 inches from the hinges, whichever is greater. Hand-activated door opening hardware, handles, pulls, latches, locks, and other operating devices on accessible doors shall have a shape that is easy to grasp with one hand and does not require tight grasping, tight pinching or twisting of the wrist to operate. Hardware shall be 34 inches minimum and 48 inches maximum above the finish floor or ground.	Lead ranger maintenance office exit door - Lacks maneuvering clearance on pull side (shelf), CIL of 3" at threshold, 13# push, knobs	For all doors along the public circulation route, provide required maneuvering clearance on push and pull side of doors For all doors along the public circulation route, repair, bevel, or ramp CILs at door entries to max .25" For all doors along the public circulation route, inspect, adjust, and maintain 8.5 lbf to open exterior doors as a smart practice For all doors along the public circulation route, replace hardware with lever hardware or hardware operable without a tight pinch or grasp	2010 ADAS Section: 404.2.3, 404.2.7, 404.2.4, 404.2.11, 404.2.11 Exception

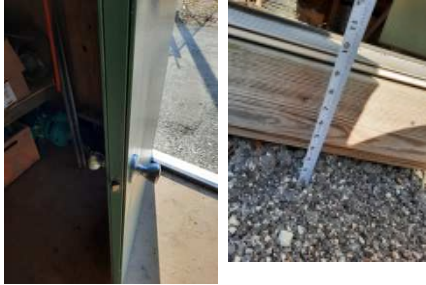
Finding Number	Area Description	Lat/Long	Finding	As Built	Recommendation	Citation	Photos	Figure
93	Employee Spaces: Maintenance	[29.3691808 , -95.5969727]	Minimum maneuvering clearances at doors and gates shall comply with 404.2.4. Maneuvering clearances shall extend the full width of the doorway and the required latch side or hinge side clearance. The threshold has a vertical change greater than 1/4 inch high. Hand-activated door opening hardware, handles, pulls, latches, locks, and other operating devices on accessible doors shall have a shape that is easy to grasp with one hand and does not require tight grasping, tight pinching or twisting of the wrist to operate. Hardware shall be 34 inches minimum and 48 inches maximum above the finish floor or ground.	Electrical shed door - CIL/step of 9.5", knobs	For all doors along the public circulation route, provide required maneuvering clearance on push and pull side of doors For all doors along the public circulation route, repair, bevel, or ramp CILs at door entries to max .25" For all doors along the public circulation route, replace hardware with lever hardware or hardware operable without a tight pinch or grasp	2010 ADAS Section: 404.2.3, 404.2.7, 404.2.4, 404.2.11, 404.2.11 Exception

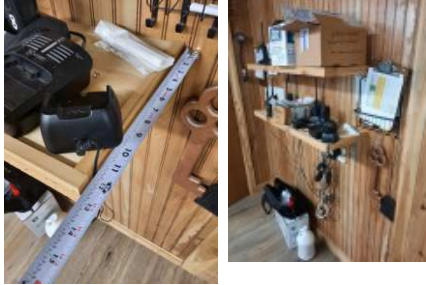
94	Employee Spaces: Maintenance	[29.3691738 , -95.5969754]	The shelf projects more than 4 inches into the circulation path. Wall-mounted objects that have leading edges between 27 inches and 80 inches from the floor must not project more than 4 inches into the circulation path. Protruding objects that extend to the floor or within 27 inches of the floor are cane detectable and are therefore not hazardous. Where it is necessary or desirable to have objects protrude from the wall, a manner of cane detection must be provided.	Ranger hut break room - Shelf protrudes 13"	Relocate protruding objects or place cane detectable warning or bollard at foot of item For deficit, leave as is, employee work area pursuant to 2010 Standards 106.5 Defined Terms, until an employee with a disability works here	2015 ABAAS Section: 307.2 2012 TAS Section: 307.2 2010 ADAS Section: 307.2

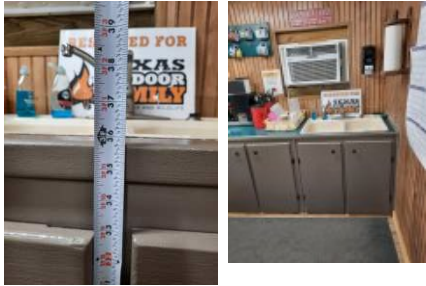
Finding Number	Area Description	Lat/Long	Finding	As Built	Recommendation	Citation	Photos	Figure
96	Employee Spaces: Maintenance	[29.3691866 , -95.5969808]	The top rim of the sink is too high. All lavatories/sinks that are designated to be accessible shall be a minimum 17 inches in horizontal depth and mounted with the rim or counter edge no higher than 34 inches above the finished floor.	Ranger hut break room - rim of the sink is 36" aff	Lower sinks to max 34" aff to front of rim	2015 ABAAS Section: 606.3 2012 TAS Section: 606.3 2010 ADAS Section: 606.3

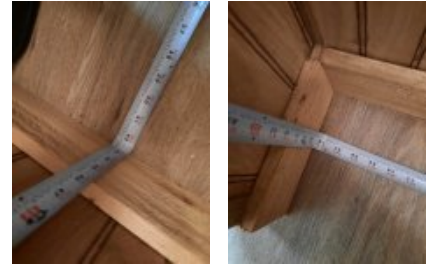
97	Employee Spaces: Maintenance	[29.3691901 , -95.5969593]	The restroom is not nearly compliant. The restroom does not have the required minimum clear floor space or maneuvering clearances for the toilet. The restroom does not have the required minimum clear floor space or maneuvering clearances for the lavatory. The entry door does not contain the required minimum maneuvering spaces on the pull/push sides. The entry door encroaches into the required clear floor space for fixtures. Grab bars are missing and/or incorrectly installed. Accessories, such as toilet seat covers, paper towel holders, garbage cans, hand dryers, and mirrors are either too high or without clear floor space or both.	Ranger hut - Lacks single accommodation restroom with required dimensions to be wheelchair accessible (42.5" x 58")	Create a compliant wheelchair accessible restroom and correct all features to be accessible if feasible.	2015 ABAAS Section: 603.1 2012 TAS Section: 603.1 2010 ADAS Section: 603.1

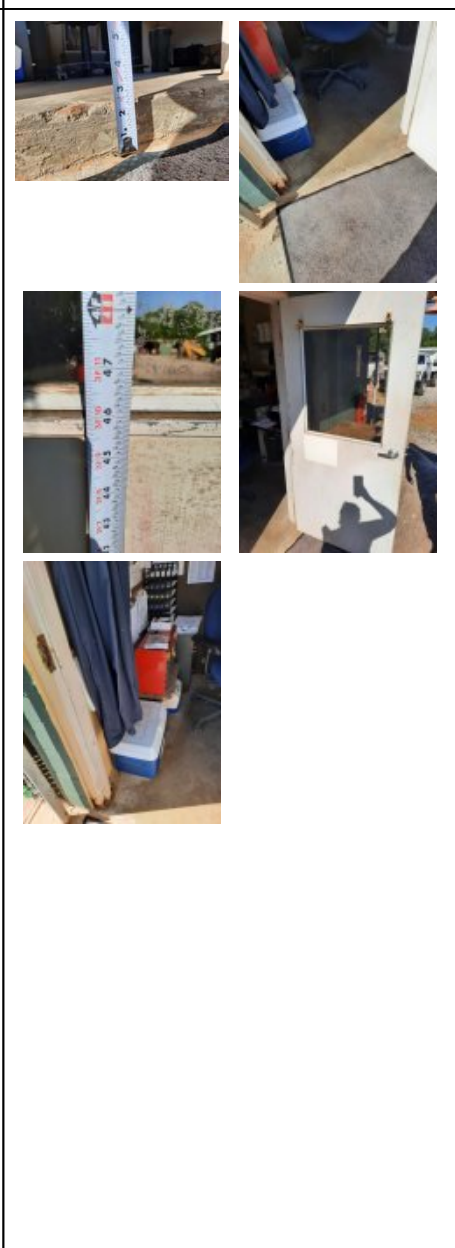
Finding Number	Area Description	Lat/Long	Finding	As Built	Recommendation	Citation	Photos	Figure
107	Employee Spaces: Maintenance	[29.3691667 , -95.596962]	Minimum maneuvering clearances at doors and gates shall comply with 404.2.4. Maneuvering clearances shall extend the full width of the doorway and the required latch side or hinge side clearance. The threshold has a vertical change greater than 1/4 inch high. Doors, gates, and side lights adjacent to doors or gates, containing one or more glazing panels that permit viewing through the panels shall have the bottom of at least one glazed panel located 43 inches (1090 mm) maximum above the finish floor. EXCEPTION: Vision lights with the lowest part more than 66 inches (1675 mm) from the finish floor or ground shall not be required to comply with 404.2.11.	UPO office door - Lacks maneuvering clearance on push side (storage), CIL of 2.5" at threshold, and vision panel exceeds height range (46.5" aff)	For all doors along the public circulation route, provide required maneuvering clearance on push and pull side of doors For all doors along the public circulation route, repair, bevel, or ramp CILs at door entries to max .25" For all doors along the public circulation route, replace doors with ones having sidelight viewing windows max 43" aff	2010 ADAS Section: 404.2.3, 404.2.7, 404.2.4, 404.2.11, 404.2.11 Exception

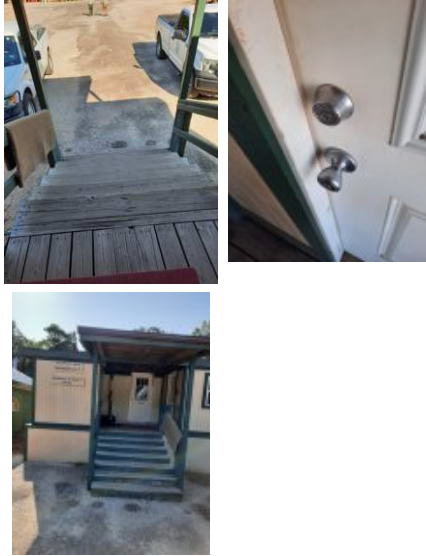
Finding Number	Area Description	Lat/Long	Finding	As Built	Recommendation	Citation	Photos	Figure
108	Employee Spaces: Maintenance	[29.3691808 , -95.596943 2]	Spaces and elements within employee work areas shall only be required to comply with 206.2.8, 207.1, and 215.3 and shall be designed and constructed so that individuals with disabilities can approach, enter, and exit the employee work area. Employee work areas, or portions of employee work areas, other than raised courtroom stations, that are less than 300 square feet (28 m2) and elevated 7 inches (180 mm) or more above the finish floor or ground where the elevation is essential to the function of the space shall not be required to comply with these requirements or to be on an accessible route.	Ranger hut laundry - 6 steps, knobs	For employee spaces, relocate storage, furniture, and other obstacles at doorways to provide approach, enter and exit at the employee space.	2015 ABAAS Section: F203.9 2012 TAS Section: 203.9 2010 ADAS Section: 203.9

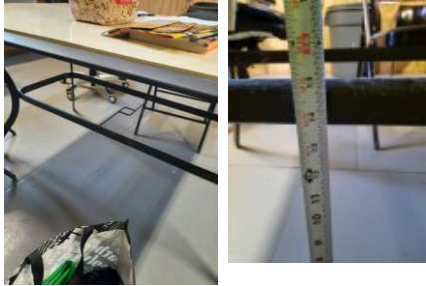
109	Employee Spaces: Maintenance	[29.3691854 , -95.597007 6]	Compliant knee and/or toe clearance is not provided. When seating for persons in wheelchairs is provided at fixed tables or counters, knee spaces at least 27 inches high, 30 inches wide and 17 inches deep shall be provided.	Work surface lacks knee clearance (support bar 14" aff)	Replace or add one work surface max 34" to surface and allowing knee and toe clearance	2015 ABAAS Section: 306.2.1, 306.3.1 2012 TAS Section: 306.2.1 2010 ADAS Section: 306.2.1

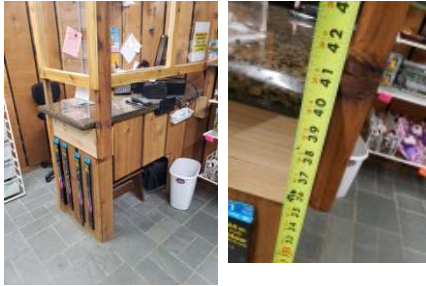
Finding Number	Area Description	Lat/Long	Finding	As Built	Recommendation	Citation	Photos	Figure
120	Creekfield Lake Area: Nature Center	[29.3763402, -95.5968493]	The transaction counter is too high. A portion of the counter surface that is 36 inches long minimum and 36 inches high maximum above the finish floor shall be provided. Knee and toe space must be provided for a forward approach. A 30 inch by 48 inch clear floor space on an accessible route must be provided for either a forward or parallel approach.	Transaction counter at 40.25" aff	Lower 36" wide segment of service counter to max 36" aff, in the alternative, train staff to come out from around the counter to provide customer service	2015 ABAAS Section: 904.4.2, 904.4.1 2012 TAS Section: 904.4.1, 904.4.2 2010 ADAS Section: 904.4.2, 904.4.1

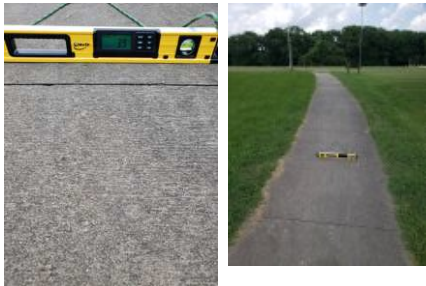
121	Creekfield Lake Area: Nature Center	[29.375894, -95.597136]	The accessible route of travel on the accessible route contains cross slopes greater than 2%. Cross slopes shall not exceed one unit vertical in 48 units horizontal (2-percent slope).	Cross slope of 3.9%	Correct or repair cross slope along AR to max 2.08%	2015 ABAAS Section: 403.3 2012 TAS Section: 403.3 2010 ADAS Section: 403.3

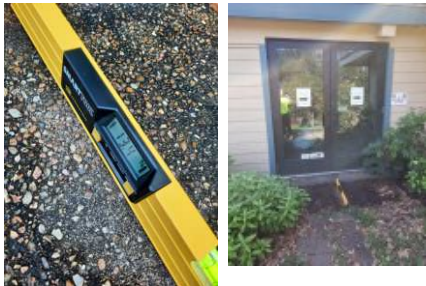
124	Creekfield Lake Area: Nature Center	[29.3763417 , -95.596844]	Minimum maneuvering clearances at doors and gates shall comply with 404.2.4. Maneuvering clearances shall extend the full width of the doorway and the required latch side or hinge side clearance. Floor or ground surface within required maneuvering clearances shall comply with 302. Changes in level are not permitted. EXCEPTIONS: 1. Slopes not steeper than 1:48 shall be permitted. Exterior doors are recommended to be maintained at 8.5 lbf as a smart practice. Force is to be measured at the operating hardware or 30 inches from the hinges, whichever is greater.	Double exit doors by office - slope of 13.4% in pull side clearance, left leaf - 14 lbf required, right leaf - 16 lbf required	For all doors along the public circulation route, provide required maneuvering clearance on push and pull side of doors Correct or repair slope at doorway landing to max 2.08% in any direction for level For all doors along the public circulation route, inspect, adjust, and maintain 8.5 lbf to open exterior doors as a smart practice	2010 ADAS Section: 404.2.3, 404.2.7, 404.2.4, 404.2.11, 404.2.11 Exception

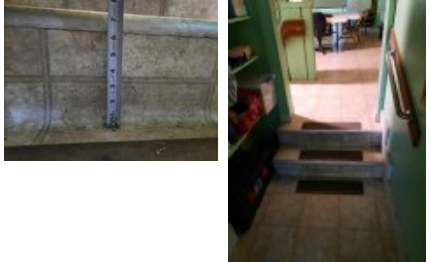
128	Creekfield Lake Area: Nature Center	[29.3763519 , -95.5968306]	Accessible routes shall coincide with or be located in the same area as general circulation paths. Where circulation paths are interior, required accessible routes shall also be interior.	2 steps 7"	Provide and accessible route through the building that coincides with the general circulation path.	2015 ABAAS Section: F206.3 2012 TAS Section: 206.3 2010 ADAS Section: 206.3

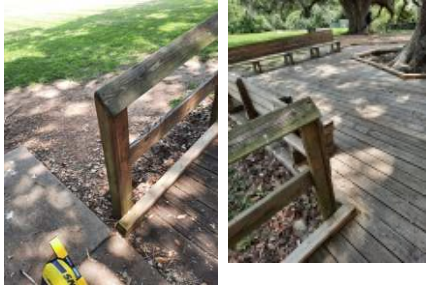
137	Creekfield Lake Area: Nature Center	[29.3763426 , -95.5968145]	The handrail does not extend past the ramp. Handrails must be between 34 inches and 38 inches above the ramp surface, must extend beyond the top and bottom of the ramp 12 inches horizontally, be parallel to the floor or ground surface and be in the same direction as the ramp runs. The 12 inches must be level and does not include the radius at the top of round handrails. Extensions shall return to a wall, guard, or the landing surface, or shall be continuous to the handrail of an adjacent ramp run.	Ramp to deck seating at front entry - handrails do not extend past the top and bottom of the ramp	Provide handrail extensions that project 12" onto the ramp landing	2015 ABAAS Section: 505.10.1 2012 TAS Section: 505.10.1 2010 ADAS Section: 505.10.1

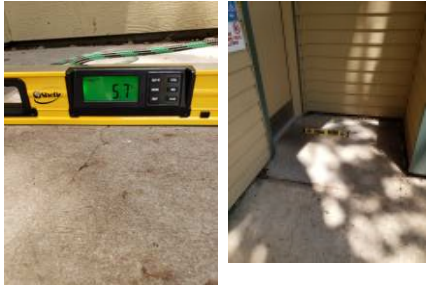
Finding Number	Area Description	Lat/Long	Finding	As Built	Recommendation	Citation	Photos	Figure
147	Creekfield Lake Area: Nature Center Restrooms	[29.3763519 , -95.596825 2]	The maneuvering clearance at the door exceeds 2% slope. Maneuvering clearance must be generally flat with a 2% maximum slope in any direction over the entire clearance surface. The maneuvering clearance must be clear of obstructions.	Men's restroom door - Lacks maneuvering clearance on push side (slope of 5.7%)	Correct or repair slope at doorway landing to max 2.08% in any direction for level	2015 ABAAS Section: 404.2.4.4, 404.2.4.4 EXCEPTIONS: 1 2012 TAS Section: 404.2.4.4 Exception 1, 404.2.4.4 2010 ADAS Section: 404.2.4.4, 404.2.4.4 Exception 1

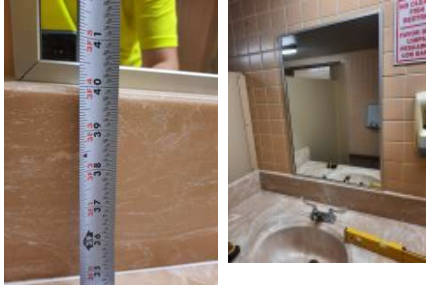
150	Creekfield Lake Area: Nature Center Restrooms	[29.3763472 , -95.596868 1]	The mirror is mounted too high. Mirrors must have the bottom edge of the reflecting surface a maximum of 40 inches above the floor if above a sink or counter. Mirrors not located above lavatories or countertops shall be installed with the bottom edge of the reflecting surface 35 inches maximum above the finish floor or ground.	Women's restroom - Bottom edge of reflecting surface of mirror is 40.5" aff	Lower mirror so reflective surface is max 40" aff	2015 ABAAS Section: 603.3 2012 TAS Section: 603.3 2010 ADAS Section: 603.3

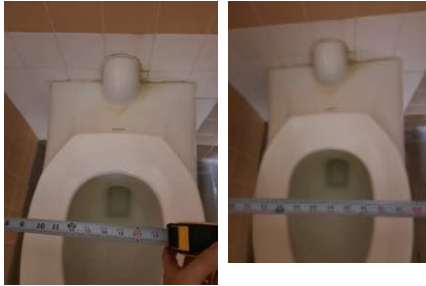
Finding Number	Area Description	Lat/Long	Finding	As Built	Recommendation	Citation	Photos	Figure
154	Creekfield Lake Area: Nature Center Restrooms	[29.3763426, -95.5968359]	The toilet is not located within the range to the side wall or partition. The centerline of the toilet shall be 17 inches minimum and 19 inches maximum side wall or partition in the ambulatory accessible toilet compartment.	Women's restroom - Centerline of the toilet is 21" from the right-side wall and 15" from the left-side wall	Remount toilet to 17" to 19" from the side wall to center line in ambulatory stalls	2015 ABAAS Section: 604.9.1 2012 TAS Section: 604.9.1 2010 ADAS Section: 604.9.1

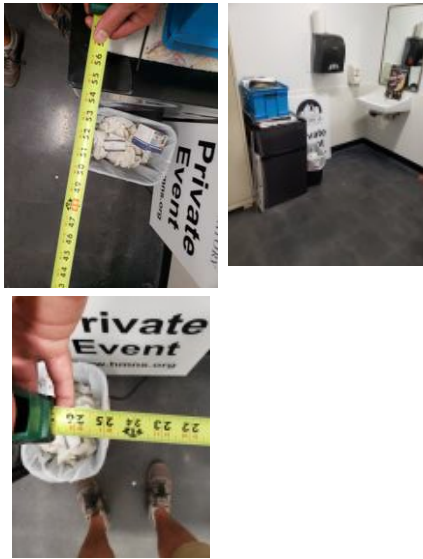
162	Creekfield Lake Area: George Observatory	[29.3750804 , -95.593617 3]	The operable part is not accessible because there is not adequate clear floor space for either a forward or side approach. The clear floor or ground space shall be 30 inches minimum by 48 inches minimum.	Mission Control Bathroom - Sink and paper towel dispenser lack clear floor space due to storage, garbage can, and mini fridge in cfs	Remove, or relocate storage in CFS at fixtures and operable parts along the AR	2015 ABAAS Section: 305.3 2012 TAS Section: 305.3 2010 ADAS Section: 305.3

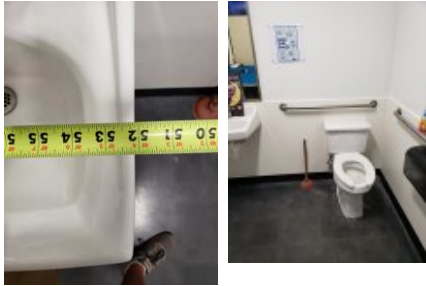
Finding Number	Area Description	Lat/Long	Finding	As Built	Recommendation	Citation	Photos	Figure
163	Creekfield Lake Area: George Observatory	[29.3751131 , -95.5936226]	The required 56 inches by 60 inches clear floor space for the water closet has been obstructed. The clear floor space around the water closet shall be 60 inches minimum measured perpendicular from the side wall and 56 inches minimum measured perpendicular from the rear wall.	Mission Control Bathroom - Sink in toilet clearance	Renovate restroom to provide 60" by 56" clearance around the toilet	2015 ABAAS Section: 604.3. 2012 TAS Section: 604.3.1 2010 ADAS Section: 604.3.1

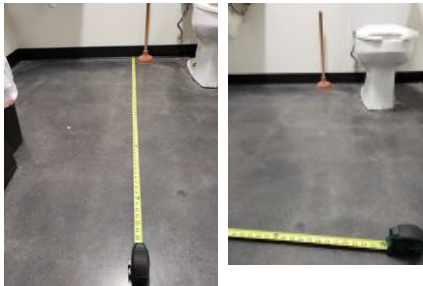
167	Creekfield Lake Area: George Observatory	[29.3751272 , -95.5936173]	There is insufficient turning space within this room or space. The space required for a wheelchair to make a 180-degree turn is a clear space of 60 inches in diameter or a T-shaped space.	Mission Control Bathroom - Lacks sufficient turning space within this room or space	Relocate obstacles to create turning space in restroom For deficit, leave as is, employee work area pursuant to 2010 Standards 106.5 Defined Terms, until an employee with a disability works here	2015 ABAAS Section: 304.3.1, 304.3.2 2012 TAS Section: 304.3.1, 304.3.2 2010 ADAS Section: 304.3.1, 304.3.2

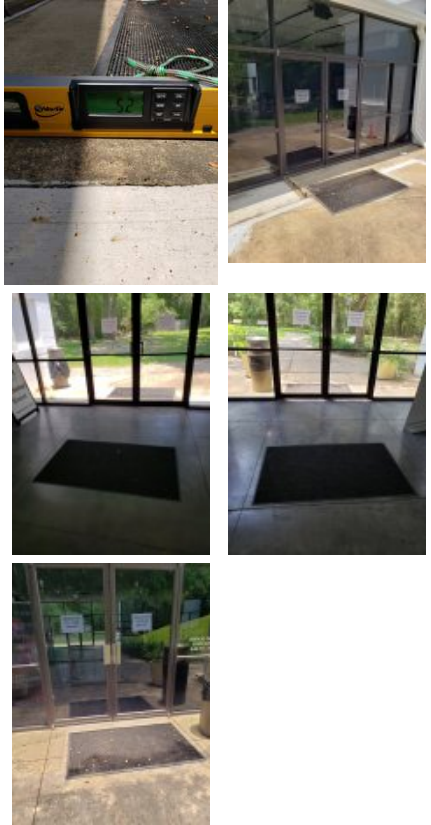
169	Creekfield Lake Area: George Observatory	[29.3751673 , -95.593646]	Minimum maneuvering clearances at doors and gates shall comply with 404.2.4. Maneuvering clearances shall extend the full width of the doorway and the required latch side or hinge side clearance. Floor or ground surface within required maneuvering clearances shall comply with 302. Changes in level are not permitted. EXCEPTIONS: 1. Slopes not steeper than 1:48 shall be permitted. The doormat is not secured in place at the entry door. If carpet or carpet tile is used on a ground or floor surface, then it shall be securely attached; have a firm cushion, pad or backing or no cushion or pad; and have a level loop, textured loop, level-cut pile or level-cut/uncut pile texture. The maximum pile height shall be 1/2 inch. Exposed edges of carpet shall be fastened to floor surfaces and have trim along the entire length of the exposed edge. Recessed doormats shall be adequately anchored to prevent interference with wheelchair traffic. Exterior doors are recommended to be maintained at 8.5 lbf as a smart practice. Force is to be measured at the operating hardware or 30 inches from the hinges, whichever is greater.	East double lobby doors - slope of 5.2% on pull side, lacks secure floor mat), 12# push West double lobby doors - lacks secure floor mat), 30# push	For all doors along the public circulation route, provide required maneuvering clearance on push and pull side of doors Remove or secure mat at door to prevent trip hazard Correct or repair slope at doorway landing to max 2.08% in any direction for level For all doors along the public circulation route, inspect, adjust, and maintain 8.5 lbf to open exterior doors as a smart practice	2010 ADAS Section: 404.2.3, 404.2.7, 404.2.4, 404.2.11, 404.2.11 Exception

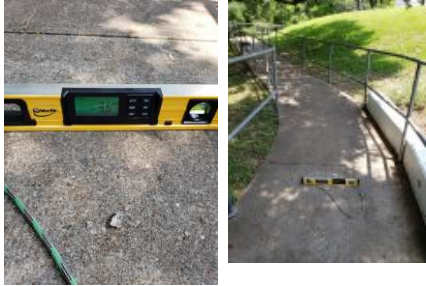
175	Creekfield Lake Area: George Observatory	[29.3751459 , -95.593424 2]	The ramp on the accessible route contains cross slopes greater than 2%. Surface cross slopes shall not exceed one unit vertical in 48 units horizontal (2-percent slope).	250' continuous ramp - Cross slope of 3.6%	Correct ramp cross slope to max 2.08%	2015 ABAAS Section: 405.3 2012 TAS Section: 405.3 2010 ADAS Section: 405.3

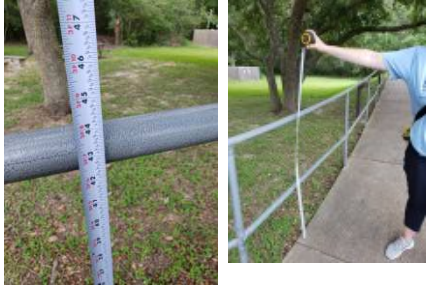
177	Creekfield Lake Area: George Observatory	[29.3749051 , -95.593410 8]	The handrail is mounted incorrectly. Handrails are measured at the top and must be between 34 inches and 38 inches above the ramp surface. Handrails must extend horizontally beyond the top and bottom of the ramp 12 inches minimum.	250' continuous ramp - Handrails at 44" agl	Remount handrails to 34" to 38" aff	2015 ABAAS Section: 505.4 2012 TAS Section: 505.4 2010 ADAS Section: 505.4

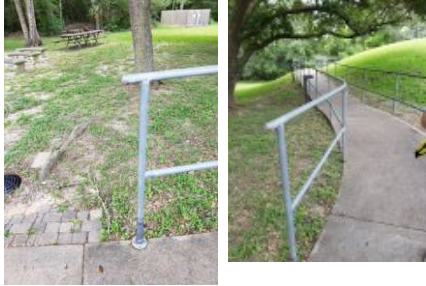
178	Creekfield Lake Area: George Observatory	[29.3751657 , -95.593457 7]	The handrail does not extend past the ramp. Handrails must be between 34 inches and 38 inches above the ramp surface, must extend beyond the top and bottom of the ramp 12 inches horizontally, be parallel to the floor or ground surface and be in the same direction as the ramp runs. The 12 inches must be level and does not include the radius at the top of round handrails. Extensions shall return to a wall, guard, or the landing surface, or shall be continuous to the handrail of an adjacent ramp run.	250' continuous ramp - The handrails do not extend past the bottom of the ramp	Provide handrail extensions that project 12" onto the ramp landing	2015 ABAAS Section: 505.10.1 2012 TAS Section: 505.10.1 2010 ADAS Section: 505.10.1

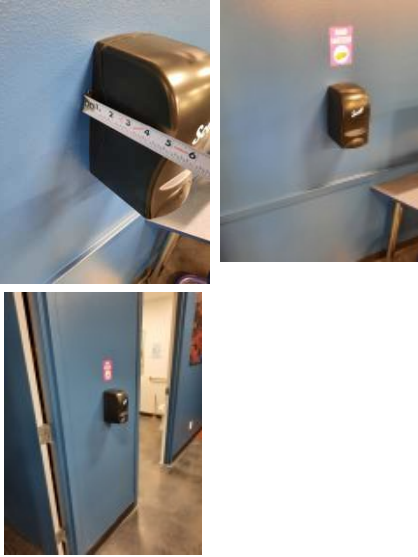
Finding Number	Area Description	Lat/Long	Finding	As Built	Recommendation	Citation	Photos	Figure
181	Creekfield Lake Area: George Observatory	[29.3750944 , -95.593628]	The had sanitizer dispenser projects more than 4 inches into the circulation path. Wall-mounted objects that have leading edges between 27 inches and 80 inches from the floor must not project more than 4 inches into the circulation path. Protruding objects that extend to the floor or within 27 inches of the floor are cane detectable and are therefore not hazardous. Where it is necessary or desirable to have objects protrude from the wall, a manner of cane detection must be provided.	Mission control computer room - Hand sanitizer dispensers (2) protrude 5"	Relocate protruding objects or place cane detectable warning or bollard at foot of item For deficit, leave as is, employee work area pursuant to 2010 Standards 106.5 Defined Terms, until an employee with a disability works here	2015 ABAAS Section: 307.2 2012 TAS Section: 307.2 2010 ADAS Section: 307.2

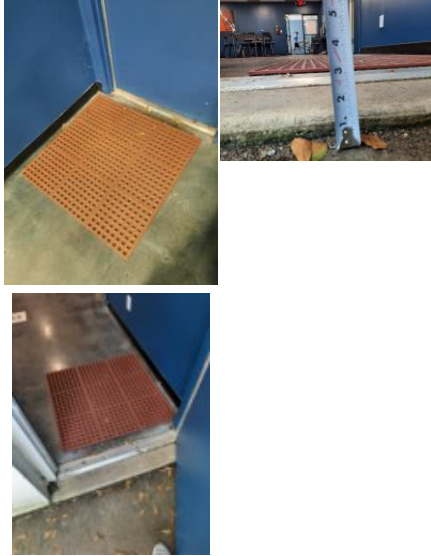
185	Creekfield Lake Area: George Observatory	[29.3751147, -95.593607 5]	Minimum maneuvering clearances at doors and gates shall comply with 404.2.4. Maneuvering clearances shall extend the full width of the doorway and the required latch side or hinge side clearance. The doormat is not secured in place at the entry door. If carpet or carpet tile is used on a ground or floor surface, then it shall be securely attached; have a firm cushion, pad or backing or no cushion or pad; and have a level loop, textured loop, level-cut pile or level-cut/uncut pile texture. The maximum pile height shall be 1/2 inch. Exposed edges of carpet shall be fastened to floor surfaces and have trim along the entire length of the exposed edge. Recessed doormats shall be adequately anchored to prevent interference with wheelchair traffic. The threshold has a vertical change greater than 1/4 inch high. Exterior doors are recommended to be maintained at 8.5 lbf as a smart practice. Force is to be measured at the operating hardware or 30 inches from the hinges, whichever is greater.	Mission control exit door - lacks secure floor mat, CIL of 1.5" in doorway, 11# push	For all doors along the public circulation route, provide required maneuvering clearance on push and pull side of doors Remove or secure mat at door to prevent trip hazard For all doors along the public circulation route, repair, bevel, or ramp CILs at door entries to max .25" For all doors along the public circulation route, inspect, adjust, and maintain 8.5 lbf to open exterior doors as a smart practice	2010 ADAS Section: 404.2.3, 404.2.7, 404.2.4, 404.2.11, 404.2.11 Exception

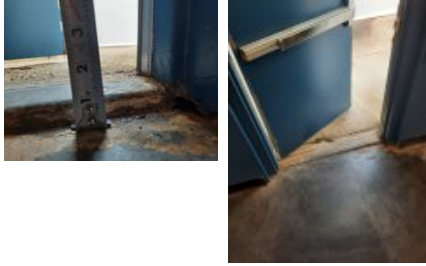
191	Creekfield Lake Area: George Observatory	[29.3751178, -95.5935958]	The threshold at a doorway shall be no higher than 1/2 inch. Changes in level between 1/4 inch and 1/2 inch must be beveled at 1:2 or less. 1/4 inch is the maximum vertical rise. All interior doors must be maintained so that the operating pressure does not exceed 5 lb. force to open.	Classroom exit door - CIL of 1" at threshold, 11# push	For all doors along the public circulation route, repair, provide beveled threshold For all doors along the public circulation route, inspect, adjust, and maintain 5 lbf to open interior doors	2010 ADAS Section: 404.2.3, 404.2.7, 404.2.4, 404.2.11, 404.2.11 Exception

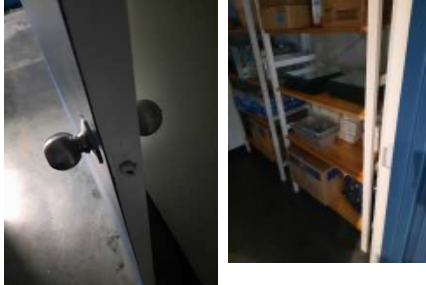
194	Creekfield Lake Area: George Observatory	[29.3750617 , -95.5936066]	Minimum maneuvering clearances at doors and gates shall comply with 404.2.4. Maneuvering clearances shall extend the full width of the doorway and the required latch side or hinge side clearance. All interior doors must be maintained so that the operating pressure does not exceed 5 lb. force to open. Hand-activated door opening hardware, handles, pulls, latches, locks, and other operating devices on accessible doors shall have a shape that is easy to grasp with one hand and does not require tight grasping, tight pinching or twisting of the wrist to operate. Hardware shall be 34 inches minimum and 48 inches maximum above the finish floor or ground.	Storage closet door - shelf in clearance on pull side (shelf), 11# push, knobs	For all doors along the public circulation route, provide required maneuvering clearance on push and pull side of doors For all doors along the public circulation route, inspect, adjust, and maintain 5 lbf to open interior doors For all doors along the public circulation route, replace hardware with lever hardware or hardware operable without a tight pinch or grasp	2010 ADAS Section: 404.2.3, 404.2.7, 404.2.4, 404.2.11, 404.2.11 Exception

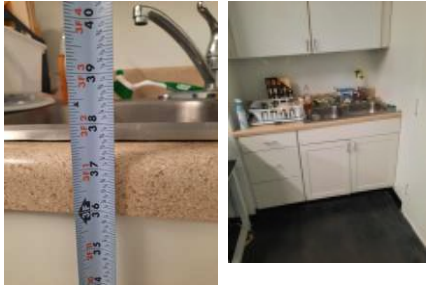
Finding Number	Area Description	Lat/Long	Finding	As Built	Recommendation	Citation	Photos	Figure
195	Creekfield Lake Area: George Observatory	[29.3750617 , -95.593617 3]	The top rim of the sink is too high. All lavatories/sinks that are designated to be accessible shall be a minimum 17 inches in horizontal depth and mounted with the rim or counter edge no higher than 34 inches above the finished floor.	Break room - rim of the sink is 38" aff	Lower sinks to max 34" aff to front of rim	2015 ABAAS Section: 606.3 2012 TAS Section: 606.3 2010 ADAS Section: 606.3

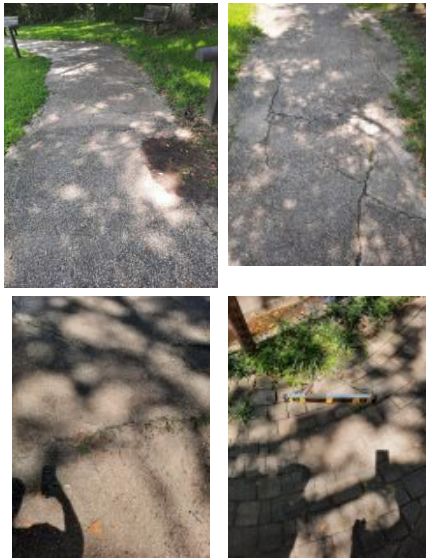
216	Creekfield Lake Area: George Observatory	[29.3752714, -95.5938163]	The accessible route contains loose gravel and/or surfaces that do not provide for a stable, firm slip resistant surface.	Lacks firm and stable surface on accessible route to west entry due to deterioration of asphalt and upheaval of pavers (tree roots)	Resurface AR where deterioration occurs	2015 ABAAS Section: 302.1 2012 TAS Section: 302.1 2010 ADAS Section: 302.1

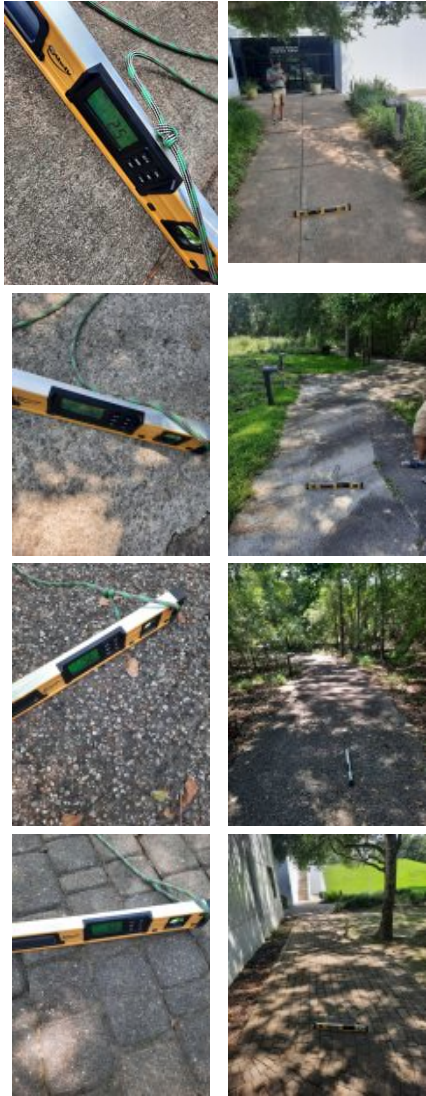
Finding Number	Area Description	Lat/Long	Finding	As Built	Recommendation	Citation	Photos	Figure
217	Creekfield Lake Area: George Observatory	[29.3752335 , -95.5938005]	The accessible route of travel on the accessible route contains cross slopes greater than 2%. Cross slopes shall not exceed one unit vertical in 48 units horizontal (2-percent slope).	west entrance: 2.5%, 5.6% , creek field trail entry: 5.5%, towards parking lot: 8% Cross slopes of 2.5%, 5.6% (near west entrance), 5.5% (near Creekfield Interpretive Trail entry), and 8% (near parking lot)	Correct or repair cross slope along AR to max 2.08%	2015 ABAAS Section: 403.3 2012 TAS Section: 403.3 2010 ADAS Section: 403.3

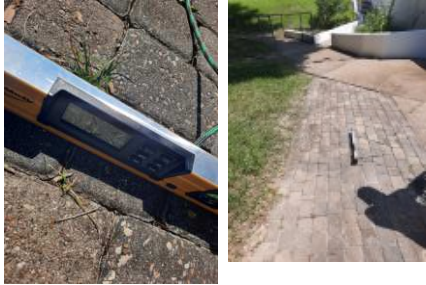
Finding Number	Area Description	Lat/Long	Finding	As Built	Recommendation	Citation	Photos	Figure
218	Creekfield Lake Area: George Observatory	[29.37517, -95.59356]	The running slope of walking surfaces shall not be steeper than 1:20.	Running slope of 5.5% near east entry	Correct running slope along the AR to max 5%	2015 ABAAS Section: 403.3 2012 TAS Section: 403.3 2010 ADAS Section: 403.3
