Access Audit Site Report

Brazos Bend State Park
21901 Farm to Market Rd 762
Needville, TX 77461
Accessibility Evaluation
Inspection Date: 06/14/2021
Inspectors: Tanya Scheibe

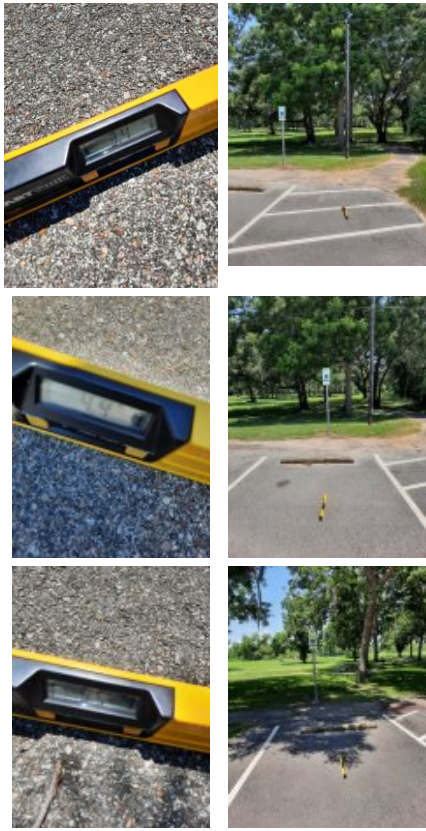
220	Elm Lake Area: Parking - Elm Lake	[29.3778852, -95.6049899]	The cross slopes (narrow dimension) and/or running slopes (long dimension) of the access aisle exceeds 2%. The running slope and the cross slope in an accessible parking stall and the access aisle must not exceed 2%.	Parking near picnic path - Slopes of 3.4% (access aisle or AA) and 4.3% (stall) Parking near grassy picnic area - Slopes of 5.5% (stall 1), 5.8% (AA 1), 5.6% (stall 2), and 5.2% (AA 2) Parking near shelter - Slope of 3.6% (stall 3) Parking near curve - Slopes of 2.4% (stall 1), 3.2% (AA 2), 2.9% (stall 3), 4.7% (AA 3), 3.8% (stall 4), and 3.6% (AA 4) Parking near restrooms - Slope of 4.4% (AA)	Resurface stalls and access aisles to eliminate slopes	2015 ABAAS Section: 502.4 2012 TAS Section: 502.4 2010 ADAS Section: 502.4

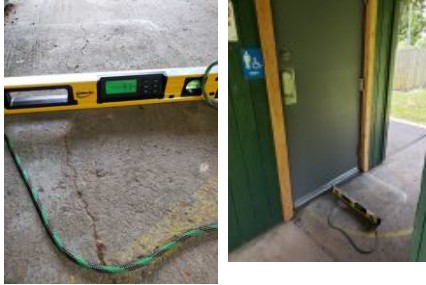
Finding Number	Area Description	Lat/Long	Finding	As Built	Recommendation	Citation	Photos	Figure
222	Elm Lake Area: Elm Lake Restrooms	[29.3778291 , -95.605113 2]	Floor or ground surface within required maneuvering clearances shall comply with 302. Changes in level are not permitted. EXCEPTIONS: 1. Slopes not steeper than 1:48 shall be permitted. 2. Changes in level at thresholds complying with 404.2.5 shall be permitted.	Men's restroom door - Lacks maneuvering clearance on pull side (slope of 7.7%)	Correct or repair slope at doorway landing to max 2.08% in any direction for level	2015 ABAAS Section: 404.2.4.4, 404.2.4.4 EX CEPTIONS: 1, 404.2.4.4 E XCEPTIONS: 2 2012 TAS Section: 404.2.4.4, 404.2.4.4 Exception 1, 404.2.4.4 Exception 2 2010 ADAS Section: 404.2.4.4, 404.2.4.4 Exception 1, 404.2.4.4 Exception 2

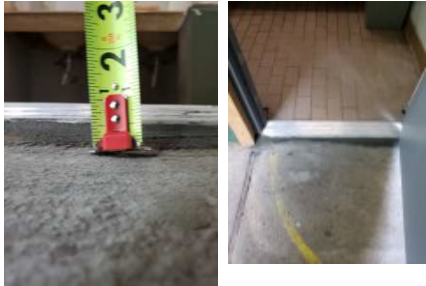
223	Elm Lake Area: Elm Lake Restrooms	[29.3778104 , -95.605124]	Thresholds, if provided at doorways, shall be 1/2 inch (13 mm) high maximum. Raised thresholds and changes in level at doorways shall comply with 302 and 303. Changes in level of 1/4 inch (6.4 mm) high maximum shall be permitted to be vertical Changes in level between 1/4 inch (6.4 mm) high minimum and 1/2 inch (13 mm) high maximum shall be beveled with a slope not steeper than 1:2. Changes in level greater than 1/2 inch (13 mm) high shall be ramped, and shall comply with 405 or 406.	Men's restroom door - CIL of 1" at threshold	Repair, bevel or ramp CIL at doorway	2015 ABAAS Section: 303.3, 404.2.5, 303.2, 303.4 2012 TAS Section: 303.3, 404.2.5, 303.2, 303.4 2010 ADAS Section: 303.3, 404.2.5, 303.2, 303.4

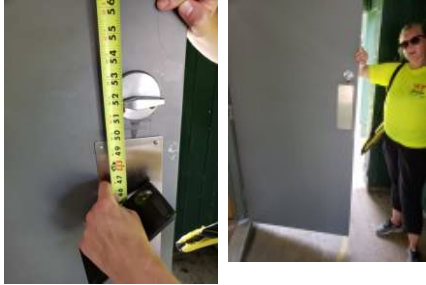
Finding Number	Area Description	Lat/Long	Finding	As Built	Recommendation	Citation	Photos	Figure
224	Elm Lake Area: Elm Lake Restrooms	[29.3778174 , -95.605129 3]	The door operating hardware is not located within the compliant range. Hand-activated door opening hardware, handles, pulls, latches, locks, and other operating devices on accessible doors shall have a shape that is easy to grasp with one hand and does not require tight grasping, tight pinching or twisting of the wrist to operate. Hardware shall be centered between 34 inches and 48 inches above the floor.	Men's restroom door - hardware (deadbolt) lacks required mounting height above ground level (centerline is 52" agl)	For all doors along the public circulation route, remount hardware to be 34" to 48" aff	2015 ABAAS Section: 404.2.7 2012 TAS Section: 404.2.7 2010 ADAS Section: 404.2.7

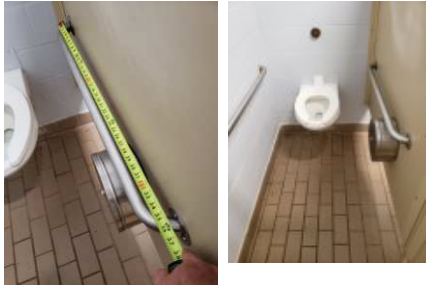
Finding Number	Area Description	Lat/Long	Finding	As Built	Recommendation	Citation	Photos	Figure
228	Elm Lake Area: Elm Lake Restrooms	[29.3778057 , -95.605107 9]	The side grab bar is not long enough. The side grab bar must extend at least 54 inches minimum beyond the rear wall and start a maximum of 12 inches from the rear wall. A 42 inch grab bar installed the maximum distance from the rear wall (12 inches) will leave the leading end 54 inches from the rear wall. Grab bars shall be installed in a horizontal position, 33 inches minimum and 36 inches maximum above the finish floor measured to the top of the gripping surface.	Men's restroom - 36" grab bars	Replace side grab bar with a 42" long grab bar, mounted max 12" from the rear wall at the close end and min 54" on the far end and 33" to 36" aff	2015 ABAAS Section: 604.5.1 2012 TAS Section: 604.5.1 2010 ADAS Section: 604.5.1

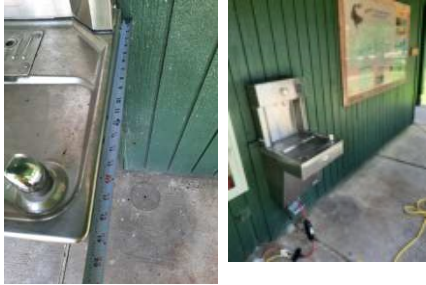
Finding Number	Area Description	Lat/Long	Finding	As Built	Recommendation	Citation	Photos	Figure
239	Elm Lake Area: Elm Lake Restrooms	[29.3778104 , -95.605124]	The drinking fountain projects more than 4 inches into the circulation path. Wall-mounted objects that have leading edges between 27 inches and 80 inches from the floor must not project more than 4 inches into the circulation path. Protruding objects that extend to the floor or within 27 inches of the floor are cane detectable and are therefore not hazardous. Where it is necessary or desirable to have objects protrude from the wall, a manner of cane detection must be provided.	Drinking fountain protrudes 19"	Relocate protruding objects or place cane detectable warning or bollard at foot of item For deficit, leave as is, employee work area pursuant to 2010 Standards 106.5 Defined Terms, until an employee with a disability works here	2015 ABAAS Section: 307.2 2012 TAS Section: 307.2 2010 ADAS Section: 307.2

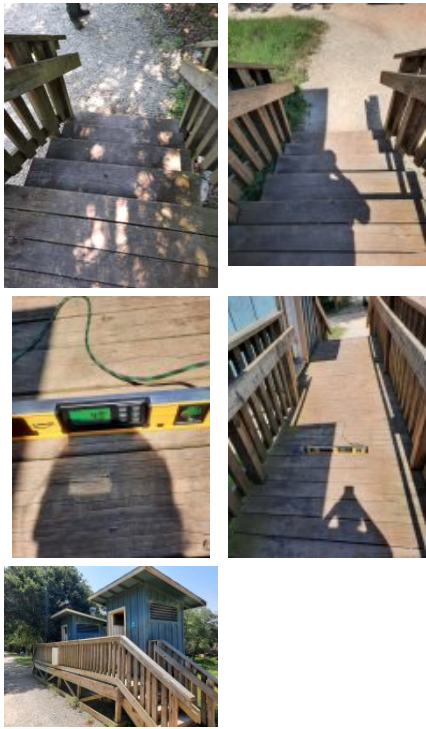
240	Elm Lake Area: Elm Lake Composting Toilet	[29.3741866 , -95.6082604]	The building entrance is not located on an accessible route. When a building, or portion of a building, is required to be accessible, an accessible route of travel shall be provided to all portions of the building, to accessible building entrances and between the building and the public way. All walks, halls, corridors, aisles, skywalks, tunnels, and other spaces that are part of an accessible route must comply. An accessible route of travel must not pass through kitchens, storage rooms, restrooms, closets or other spaces used for similar purposes. At least one accessible route within the boundary of the site must be provided from public transportation stops, accessible parking and accessible passenger loading zones and public streets or sidewalks to the accessible building entrance they serve. The accessible route shall, to the maximum extent feasible, coincide with the route for the general public. At least one accessible route shall connect accessible buildings, facilities, elements and spaces that are on the same site. At least one accessible route shall connect accessible building or facility entrances with all accessible spaces and elements.	4 steps on each side of deck to compost toilets, 4% cross slope on deck	Provide a ramp to access composting toilets and correct slope to max 2.08% on deck.	2015 ABAAS Section: F206.2.1 2012 TAS Section: 206.2.1 2010 ADAS Section: 206.2.1

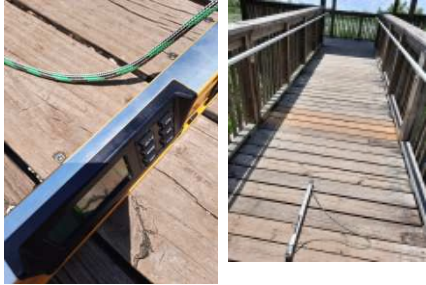
Finding Number	Area Description	Lat/Long	Finding	As Built	Recommendation	Citation	Photos	Figure
244	Elm Lake Area: Elm Lake Wild Life Viewing Platform	[29.377101, -95.605691 2]	The ramps slope exceeds the maximum running slope (direction of travel) allowable of 8.33%. Ramps should have the least possible slope but in no case more than 8.3% (1:12).	8.6%	Correct slope of ramp to max 8.33%	2015 ABAAS Section: 405.2 2012 TAS Section: 405.2 2010 ADAS Section: 405.2

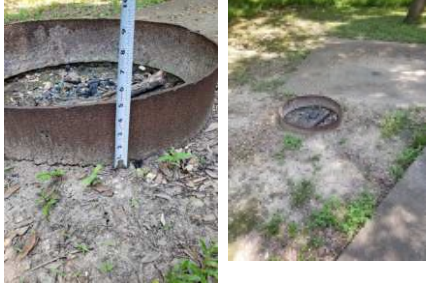
246	Camping Area: Camping	[29.3795119 , -95.595529 7]	Fire building surfaces shall be 9 inches (230 mm) minimum above the ground	Site 140 - Fire building surface lacks 9" minimum above surrounding ground level	Correct fire building surface to be 9" min above the ground as a smart practice.	2015 ABAAS Section: 1011.5.1

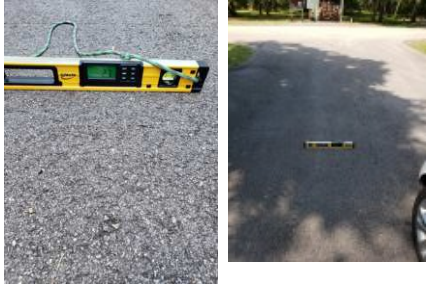
247	Camping Area: Camping	[29.3795154 , -95.595545 8]	The surface of parking spaces and pull-up spaces shall be firm and stable. The slope of the surface of parking spaces and pull-up spaces shall not be steeper than 1:48 in any direction. EXCEPTION: Where the surface is other than asphalt, concrete, or boards, slopes not steeper than 1:20 shall be permitted when necessary for drainage.	Site 140 - Slope of 2.7%	Correct surface of parking spaces to be firm and stable with slopes max of 2.08% or 5% for surfaces other than concrete, asphalt or boards as a smart practice.	2015 ABAAS Section: 1012.4, 1012.5, 1012.5 EXCEPTION

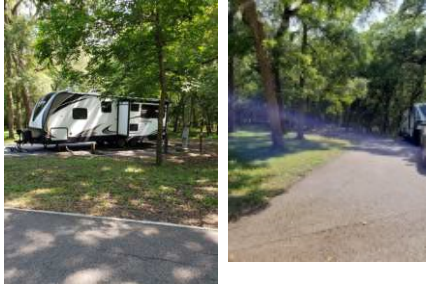
Finding Number	Area Description	Lat/Long	Finding	As Built	Recommendation	Citation	Photos	Figure
248	Camping Area: Camping	[29.379507, -95.595540 5]	Camping facilities shall provide camping units with mobility features complying with F244.2 in accordance with Table F244.2. Where a camping facility provides different types of camping units, Table F244.2 shall apply to each type of camping unit provided. Total Number of Camping Units Provided in Camping Facility Minimum Number of Camping Units with Mobility Features Required 1 1 2 to 25 2 26 to 50 3 51 to 75 4 76 to 100 5 101 to 150 7 151 to 200 8 201 and over 8, plus 2 percent of the number over 200	accessible designated RV Site 138 occupied, shared EAR with site 140; scoping for campsites complies- 7 of 77 electric campsites designated accessible	Ensure that this campsite includes compliant amenities as a smart practice	2015 ABAAS Section: F244.2

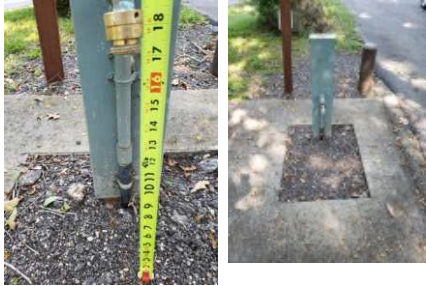
255	Camping Area: Camping	[29.3825515 , -95.5973214]	Water spouts at water hydrants and water utility hook-ups shall be 28 inches (710 mm) minimum and 36 inches (915 mm) maximum above the ground	Site 203 - Water spout is 17" above ground level	Remount water spouts to 28" min or 36" max above the ground as a smart practice	2015 ABAAS Section: 1011.6

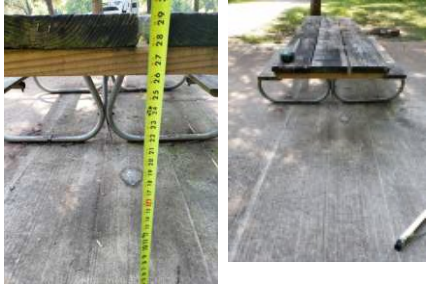
Finding Number	Area Description	Lat/Long	Finding	As Built	Recommendation	Citation	Photos	Figure
257	Camping Area: Camping	[29.3822289 , -95.5998507]	Picnic tables shall provide at least one wheelchair space for each 24 linear feet (7320 mm) of usable table surface perimeter. Wheelchair spaces shall be 30 inches (760 mm) minimum by 48 inches (1220 mm) minimum. Wheelchair spaces shall be positioned for a forward approach to the table and provide knee and toe clearance complying with 306 under the table	Site 233 - Picnic table of accessible design fails due to added board in knee clearance at wheelchair space	Replace picnic table with one of an accessible design as a smart practice	2015 ABAAS Section: 1011.4.2

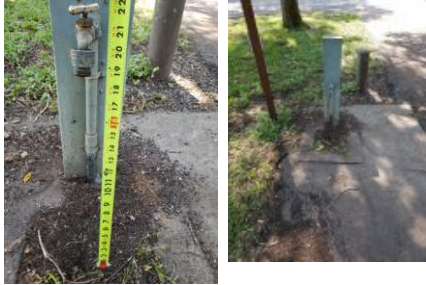
Finding Number	Area Description	Lat/Long	Finding	As Built	Recommendation	Citation	Photos	Figure
260	Camping Area: Camping	[29.3822231 , -95.599850 7]	Water spouts at water hydrants and water utility hook-ups shall be 28 inches (710 mm) minimum and 36 inches (915 mm) maximum above the ground	Site 233 - Water spout is 19" above ground level	Remount water spouts to 28" min or 36" max above the ground as a smart practice	2015 ABAAS Section: 1011.6

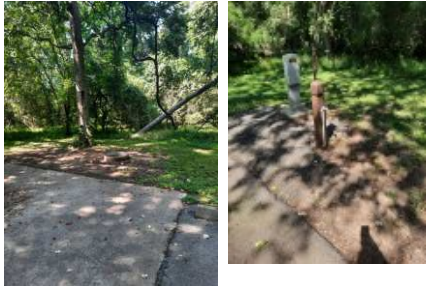
261	Camping Area: Camping	[29.3798826 , -95.596056]	Element meets all standards and requirements	1 of 2 dump stations (same location) meets all standards and requirements	None	2010 ADAS Section: N/A		
262	Camping Area: Camping	[29.3812789 , -95.594883 3]	An accessible access route is not provided between elements, spaces and the facilities provided within the accessible camping unit. At least one outdoor recreation access route shall connect accessible elements, spaces and facilities provided within camping units with mobility features. 48 inches (1220 mm) by 48 inches (1220 mm) on all usable sides of the fire ring, grill, fireplace, and woodstove. Center the space on each usable side of the grill, fireplace, and woodstove. 30 inches (760 mm) by 60 inches (1525 mm) with the long side of the space adjoining or overlapping an accessible parking space or pull-up space for recreational vehicles. Locate the space so that the hook-ups are at the rear center of the space. Bollards or other barriers shall not obstruct the clear ground space in front of the hook-ups.	Site 102 - Lacks accessible route to and clear ground space at campsite utility hook ups (water and electricity) and fire pit	Create AR with crushed and compacted stone or similar outdoor material to fire ring, with a 48" x 48" clear space around usable area Create AR with crushed and compacted stone or similar outdoor material to utilities, with a 30" x 60" clear space around usable area	2015 ABAAS Section: F244.5.1

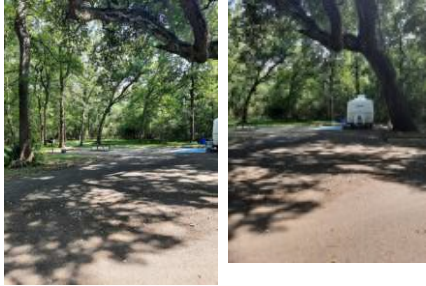
265	Camping Area: Camping	[29.3810023 , -95.595328 4]	An accessible access route is not provided between elements, spaces and the facilities provided within the accessible camping unit. At least one outdoor recreation access route shall connect accessible elements, spaces and facilities provided within camping units with mobility features.	Site 100 (occupied unable to test) - Lacks accessible route to fire ring	Create AR with crushed and compacted stone or similar outdoor material to camp sites and one of each type of amenity.	2015 ABAAS Section: F244.5.1

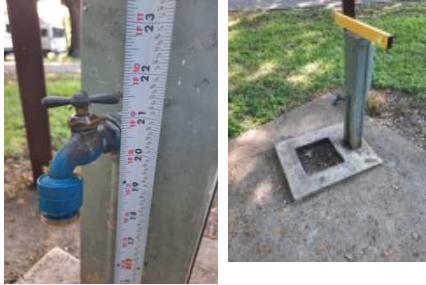
Finding Number	Area Description	Lat/Long	Finding	As Built	Recommendation	Citation	Photos	Figure																												
271	Camping Area: Camping	[29.3825176 , -95.599909 7]	Water spouts at water hydrants and water utility hook-ups shall be 28 inches (710 mm) minimum and 36 inches (915 mm) maximum above the ground	Site 231 - Water spout is 18" above ground level	Remount water spouts to 28" min or 36" max above the ground as a smart practice	2015 ABAAS Section: 1011.6

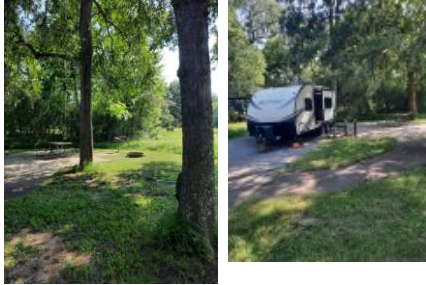
Finding Number	Area Description	Lat/Long	Finding	As Built	Recommendation	Citation	Photos	Figure
274	Camping Area: Camping	[29.381875, -95.5997976]	An accessible access route is not provided between elements, spaces and the facilities provided within the accessible camping unit. At least one outdoor recreation access route shall connect accessible elements, spaces and facilities provided within camping units with mobility features. 48 inches (1220 mm) by 48 inches (1220 mm) on all usable sides of the fire ring, grill, fireplace, and woodstove. Center the space on each usable side of the grill, fireplace, and woodstove.	Campsite 234 (occupied - unable to test) - Lacks accessible route to and 48" by 48" clear ground space on all usable sides of the fire ring	Create AR with crushed and compacted stone or similar outdoor material to fire ring, with a 48" x 48" clear space around usable area	2015 ABAAS Section: F244.5.1

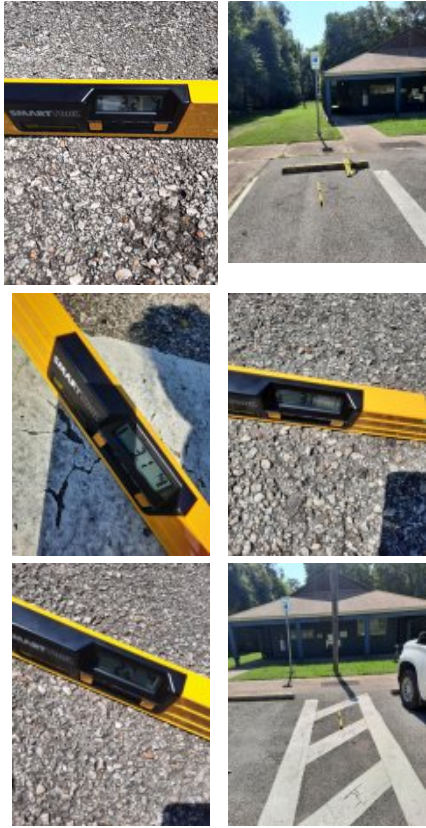
Finding Number	Area Description	Lat/Long	Finding	As Built	Recommendation	Citation	Photos	Figure
276	Camping Area: Parking - Camping Restrooms 1	[29.380531, -95.595775 1]	The cross slopes (narrow dimension) and/or running slopes (long dimension) of the access aisle exceeds 2%. The running slope and the cross slope in an accessible parking stall and the access aisle must not exceed 2%.	Slopes of 3.2% (stall 1), 3.1% (access aisle 1), 3% (stall 2), and 2.2% (access aisle 2)	Resurface stalls and access aisles to eliminate slopes	2015 ABAAS Section: 502.4 2012 TAS Section: 502.4 2010 ADAS Section: 502.4

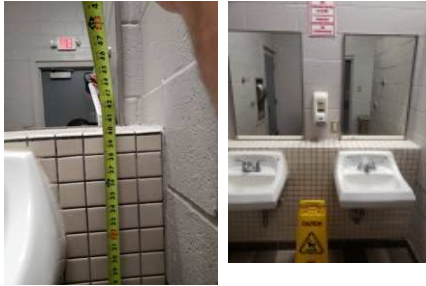
Finding Number	Area Description	Lat/Long	Finding	As Built	Recommendation	Citation	Photos	Figure
278	Camping Area: Camping Restrooms 1	[29.3804831 , -95.595603 5]	The mirror is mounted too high. Mirrors must have the bottom edge of the reflecting surface a maximum of 40 inches above the floor if above a sink or counter. Mirrors not located above lavatories or countertops shall be installed with the bottom edge of the reflecting surface 35 inches maximum above the finish floor or ground.	Men's restroom - Bottom edge of reflecting surface of mirror is 40.25" aff	Lower mirror so reflective surface is max 40" aff	2015 ABAAS Section: 603.3 2012 TAS Section: 603.3 2010 ADAS Section: 603.3

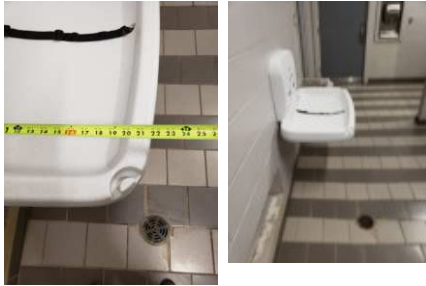
Finding Number	Area Description	Lat/Long	Finding	As Built	Recommendation	Citation	Photos	Figure
280	Camping Area: Camping Restrooms 1	[29.3804889 , -95.5955994]	The baby changing table is not compliant. Baby changing tables are work surfaces. If fixed or built-in baby changing tables are provided, at least 5%, but not less than one, must comply with TAS 902 based TAS 226.1. Baby changing tables cannot violate the protruding object requirements in either an open or closed position since either position is a potential hazard for persons with visual impairments. Baby changing tables are not prohibited from being located in wheelchair accessible toilet compartments; however, the minimum space required for the compartment cannot be obstructed by the baby changing table in either an open or closed position. The clear floor space required for a baby changing table may overlap the water closet clearance since baby changing tables are considered convenience "fixtures" based on Advisory 604.8.1.1. The overlap is applicable only to the clear floor space and not to actual table itself. Baby changing tables must be dispersed throughout a space, however, an additional baby changing table is not required in a common use area of a toilet or bathing room when the only baby changing table is located in a toilet compartment.	Men's restroom - Baby changing table protrudes 22" when in the open position	Remount baby changing table so that operable parts are max 48" and the changing surface in the open position is max 34". Relocate baby changing table to eliminate protrusion when in the open position. Place cane detectable warning on sides of baby changing table. Relocate baby changing table to a location where the fixture does not impede the required clearance at the toilet in both the open and closed positions.	2012 TAS Section: 226.1, 902.3, 604.3.2, 204.1, 226.1 Advisory, 226.2, 307.1, 604.8.1.1 Advisory, 902.1, 902.1 Advisory, 902.2

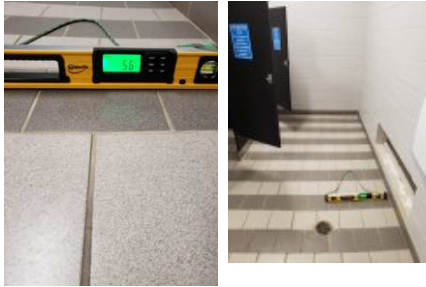
283	Camping Area: Camping Restrooms 1	[29.3804912 , -95.595596 8]	The accessible route contains running slopes greater than 5 percent and cross slopes greater than 2 percent across the width of the walk and has not been constructed as a ramp (i.e. handrails, wheel guides, etc.). When the slope in the direction of travel of any walk exceeds 1 unit vertical in 20 units horizontal (5-percent slope), it must be constructed as ramp. Surface cross slopes must not exceed one unit vertical in 48 units. Horizontal (2-percent slope).	Men's restroom - Slope of 5.6% near floor drain	Correct or repair slope to max 5% running and 2.08% cross	2015 ABAAS Section: 403.3 2012 TAS Section: 403.3 2010 ADAS Section: 403.3

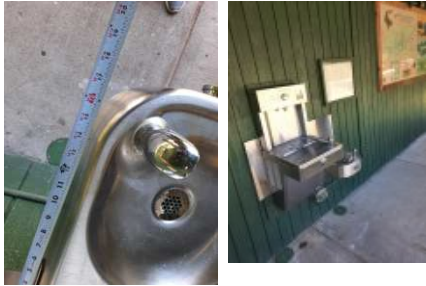
Finding Number	Area Description	Lat/Long	Finding	As Built	Recommendation	Citation	Photos	Figure
284	Camping Area: Camping Restrooms 1	[29.3804889 , -95.595623 6]	The drinking fountain projects more than 4 inches into the circulation path. Wall-mounted objects that have leading edges between 27 inches and 80 inches from the floor must not project more than 4 inches into the circulation path. Protruding objects that extend to the floor or within 27 inches of the floor are cane detectable and are therefore not hazardous. Where it is necessary or desirable to have objects protrude from the wall, a manner of cane detection must be provided.	Drinking fountain protrudes 18"	Relocate protruding objects or place cane detectable warning or bollard at foot of item	2015 ABAAS Section: 307.2 2012 TAS Section: 307.2 2010 ADAS Section: 307.2

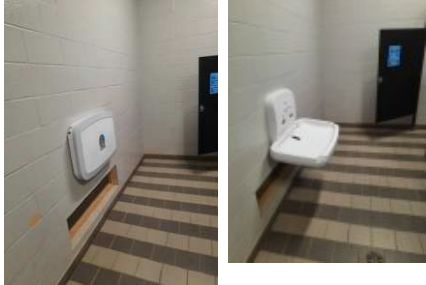
288	Camping Area: Camping Restrooms 1	[29.3804912 , -95.595594 1]	The baby changing table is not compliant. Baby changing tables are work surfaces. If fixed or built-in baby changing tables are provided, at least 5%, but not less than one, must comply with TAS 902 based TAS 226.1. Baby changing tables cannot violate the protruding object requirements in either an open or closed position since either position is a potential hazard for persons with visual impairments.	Women's restroom - Baby changing table protrudes more than 4" when in the open position	Relocate baby changing table to eliminate protrusion when in the open position.	2012 TAS Section: 226.1, 902.3, 604.3.2, 204.1, 226.1 Advisory, 226.2, 307.1, 604.8.1.1 Advisory, 902.1, 902.1 Advisory, 902.2

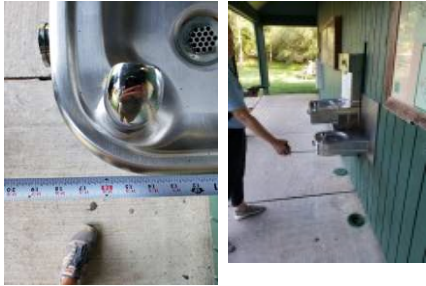
Finding Number	Area Description	Lat/Long	Finding	As Built	Recommendation	Citation	Photos	Figure
298	Camping Area: Camping Restrooms 2	[29.3820595 , -95.5982307]	The drinking fountain projects more than 4 inches into the circulation path. Wall-mounted objects that have leading edges between 27 inches and 80 inches from the floor must not project more than 4 inches into the circulation path. Protruding objects that extend to the floor or within 27 inches of the floor are cane detectable and are therefore not hazardous. Where it is necessary or desirable to have objects protrude from the wall, a manner of cane detection must be provided.	Drinking fountain protrudes 18"	Relocate protruding objects or place cane detectable warning or bollard at foot of item	2015 ABAAS Section: 307.2 2012 TAS Section: 307.2 2010 ADAS Section: 307.2

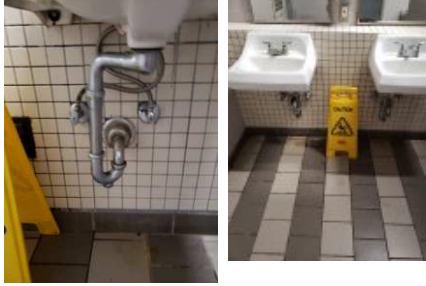
299	Camping Area: Camping Restrooms 2	[29.3820595 , -95.5982307]	The water and drain pipes under the lavatory are not adequately insulated. Water supply and drain pipes under lavatories and sinks shall be insulated or otherwise configured to protect against contact. There shall be no sharp or abrasive surfaces under lavatories and sinks.	Men's restroom - Sink lacks insulated pipes	Insulate exposed pipes under one sink	2015 ABAAS Section: 606.5 2012 TAS Section: 606.5 2010 ADAS Section: 606.5

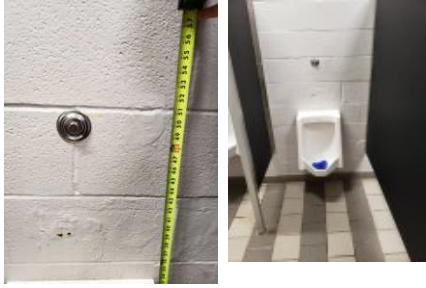
300	Camping Area: Camping Restrooms 2	[29.3820315 , -95.5982441]	The urinals flush handle is mounted too high. Flush controls shall be operable with one hand and shall not require tight grasping, pinching or twisting of the wrist and shall be mounted no more than 48 inches above the floor. The force required to activate controls shall be no greater than 5 lb. Electronic automatic flushing controls are acceptable and preferable.	Men's restroom - Urinal flush button at 49.5" aff	Lower flush handle at urinal to max 48" aff	2015 ABAAS Section: 605.4 2012 TAS Section: 605.4 2010 ADAS Section: 605.4

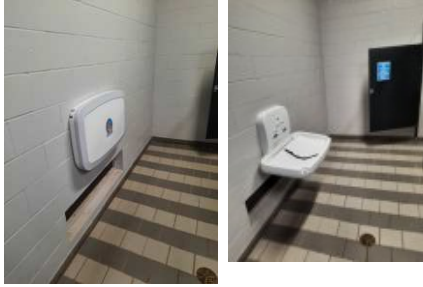
308	Camping Area: Camping Restrooms 2	[29.3820338 , -95.598230 7]	The baby changing table is not compliant. Baby changing tables are work surfaces. If fixed or built-in baby changing tables are provided, at least 5%, but not less than one, must comply with TAS 902 based TAS 226.1. Baby changing tables cannot violate the protruding object requirements in either an open or closed position since either position is a potential hazard for persons with visual impairments.	Women's restroom - Baby changing table protrudes more than 4" in open position	Relocate baby changing table to eliminate protrusion when in the open position.	2012 TAS Section: 226.1, 902.3, 604.3.2, 204.1, 226.1 Advisory, 226.2, 307.1, 604.8.1.1 Advisory, 902.1, 902.1 Advisory, 902.2

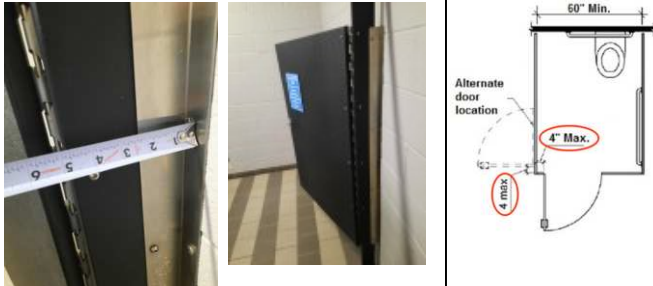
310	Camping Area: Camping Restrooms 2	[29.3820548 , -95.5982468]	The compartment door is located too far from the partition or wall. The door shall be located in front of the clear space and diagonal to the water closet. Where located in the front partition, the door opening shall be 4 inches maximum from the side wall or partition farthest from the water closet. Where located in the side wall or partition, the door opening shall be 4 inches maximum from the front partition. Toilet compartment doors shall not swing into the minimum required compartment area.	Women's restroom - 5" from wall	Rehang stall door to be max 4" from adjacent stall partition and on the stall wall farthest from the toilet	2015 ABAAS Section: 604.8.1.2 2012 TAS Section: 604.8.1.2 2010 ADAS Section: 604.8.1.2

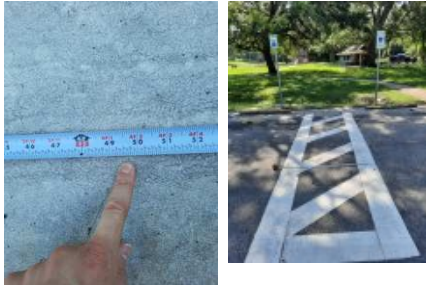
Finding Number	Area Description	Lat/Long	Finding	As Built	Recommendation	Citation	Photos	Figure
315	Camping Area: Parking- Camping Playground	[29.3812508 , -95.597330 8]	The access aisle is not a minimum 5 feet wide. A car accessible parking stall's access aisle must be a minimum of 5 feet wide measured from centerline to centerline. Where the access aisle is not adjacent to another parking space or access aisle, measurements shall be permitted to include the full width of the line defining the access aisle.	Access aisle 1 - 49.5" wide	Repaint access aisles to be 5' each	2015 ABAAS Section: 502.3.1 2012 TAS Section: 502.3.1 2010 ADAS Section: 502.3.1

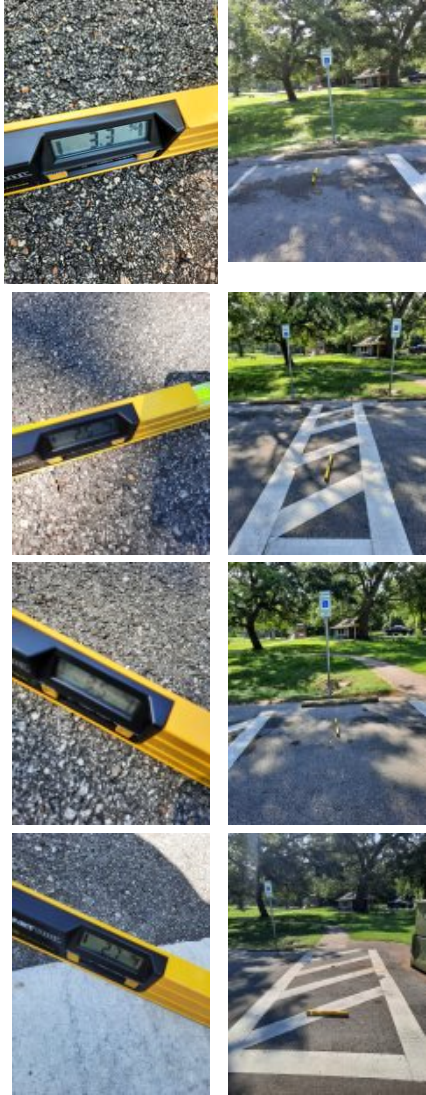
Finding Number	Area Description	Lat/Long	Finding	As Built	Recommendation	Citation	Photos	Figure
316	Camping Area: Parking- Camping Playground	[29.3812473 , -95.597332 1]	The cross slopes (narrow dimension) and/or running slopes (long dimension) of the access aisle exceeds 2%. The running slope and the cross slope in an accessible parking stall and the access aisle must not exceed 2%.	Slopes of 3.3% (stall 1), 2.5% (access aisle 1), 3.5% (stall 2), and 2.7% (access aisle 2)	Resurface stalls and access aisles to eliminate slopes	2015 ABAAS Section: 502.4 2012 TAS Section: 502.4 2010 ADAS Section: 502.4

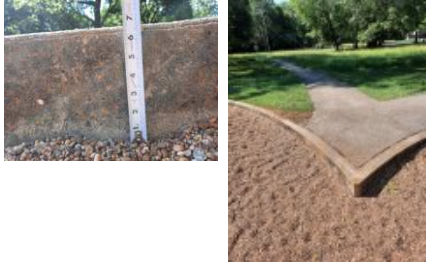
322	Camping Area: Camping Playground	[29.3812181 , -95.596683 1]	The walkway contains abrupt vertical edges and/or variations over a 1/4 inch. 1/4 inch is the maximum vertical rise. Changes in level between 1/4 inch and 1/2 inch must be beveled at 1:2 or less. Changes in level greater than 1/2 inch must be by way of a ramp.	CIL up to 6.5" at play area border due to low fill and kick-out	Frequently inspect and regularly maintain accessible portions of play area surface that are comprised of loose fill such as EWF so that surface is level with other surfaces	2012 TAS Section: 303.2, 303.3 2010 ADAS Section: 303.2, 303.3

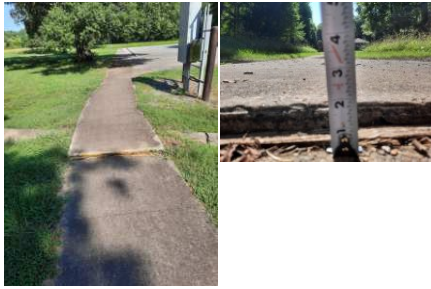
324	Camping Area: Camping Playground	[29.3814182 , -95.598195 6]	The walkway contains abrupt vertical edges and/or variations over a 1/4 inch. 1/4 inch is the maximum vertical rise. Changes in level between 1/4 inch and 1/2 inch must be beveled at 1:2 or less. Changes in level greater than 1/2 inch must be by way of a ramp.	CILs of 2.5" (towards dining hall), 1" (towards picnic table), and 2" (towards camping restrooms)	Repair, bevel or ramp CIL along AR	2012 TAS Section: 303.2, 303.3 2010 ADAS Section: 303.2, 303.3

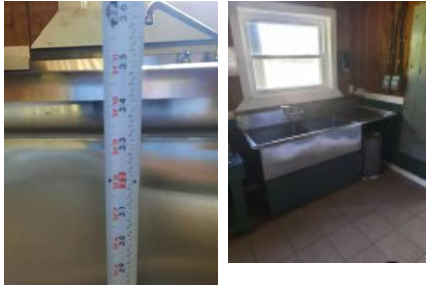
Finding Number	Area Description	Lat/Long	Finding	As Built	Recommendation	Citation	Photos	Figure
327	Camping Area: Camping Dining Hall	[29.3812508 , -95.598745 7]	The top rim of the sink is too high. All lavatories/sinks that are designated to be accessible shall be a minimum 17 inches in horizontal depth and mounted with the rim or counter edge no higher than 34 inches above the finished floor.	Rim of the sink is 35" aff	Lower sinks to max 34" aff to front of rim	2015 ABAAS Section: 606.3 2012 TAS Section: 606.3 2010 ADAS Section: 606.3

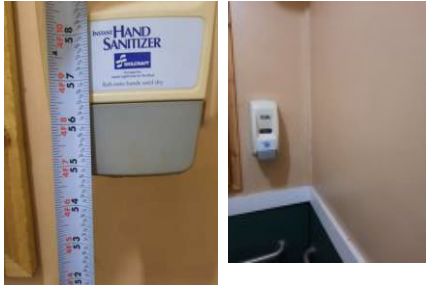
Finding Number	Area Description	Lat/Long	Finding	As Built	Recommendation	Citation	Photos	Figure
334	Camping Area: Camping Dining Hall	[29.3812555 , -95.598718 8]	Where a high forward reach is over an obstruction, the clear floor space shall extend beneath the element for a distance not less than the required reach depth over the obstruction. The high forward reach shall be 48 inches (1220 mm) maximum where the reach depth is 20 inches (510 mm) maximum. Where the reach depth exceeds 20 inches (510 mm), the high forward reach shall be 44 inches (1120 mm) maximum and the reach depth shall be 25 inches (635 mm) maximum. Where a clear floor or ground space allows a parallel approach to an element and the high side reach is over an obstruction, the height of the obstruction shall be 34 inches (865 mm) maximum and the depth of the obstruction shall be 24 inches (610 mm) maximum. The high side reach shall be 48 inches (1220 mm) maximum for a reach depth of 10 inches (255 mm) maximum. Where the reach depth exceeds 10 inches (255 mm), the high side reach shall be 46 inches (1170 mm) maximum for a reach depth of 24 inches (610 mm) maximum.	Hand sanitizer dispenser at 55" aff - obstructed	Lower hand sanitizer dispenser to max 44" aff for a forward reach over counter	2015 ABAAS Section: 308.2.1, 308.3.2 2012 TAS Section: 308.2.1, 308.3.2 2010 ADAS Section: 308.2.1, 308.3.2

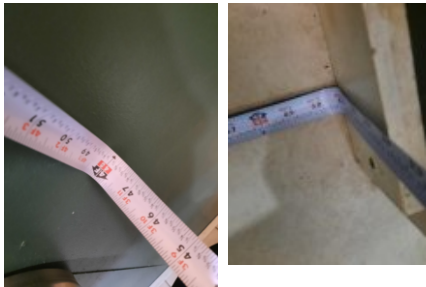
335	Camping Area: Camping Dining Hall	[29.3812555 , -95.598753 7]	The required 56 inches by 60 inches clear floor space for the water closet has been obstructed. The clear floor space around the water closet shall be 60 inches minimum measured perpendicular from the side wall and 56 inches minimum measured perpendicular from the rear wall.	Restroom - Lacks 60" clear floor space around toilet (48" wide x 51" deep)	Renovate restroom to provide 60" by 56" clearance around the toilet	2015 ABAAS Section: 604.3. 2012 TAS Section: 604.3.1 2010 ADAS Section: 604.3.1

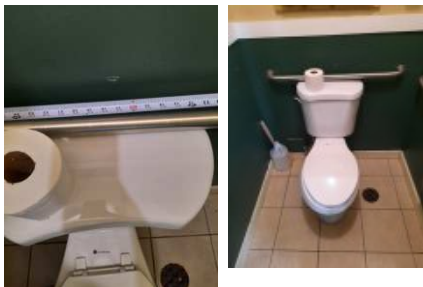
337	Camping Area: Camping Dining Hall	[29.3812485 , -95.598710 8]	The rear grab bar is not 36" long or is not mounted in the correct location. The rear grab bar must be a minimum of 36" long and extend from the toilet centerline a minimum 12" towards the wall side and a minimum 24" towards the open side of the toilet. Grab bars shall be installed in a horizontal position, 33 inches minimum and 36 inches maximum above the finish floor measured to the top of the gripping surface and the space between the grab bar and the top of the tank shall be 1-1/2 inches minimum.	Restroom - Rear grab bar extends 18.5" from centerline of toilet towards the open side of the toilet	Remount rear grab bar to behind the toilet, 12" to one side of center and 24" to the other and 33" to 36" aff Remount rear grab bar to behind the toilet, 12" to one side of center and 24" to the other and 33" to 36" aff	2015 ABAAS Section: 604.5.2 2012 TAS Section: 604.5.2 2010 ADAS Section: 604.5.2

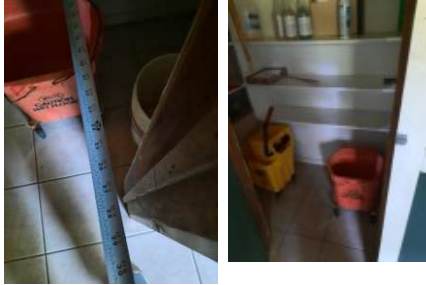
Finding Number	Area Description	Lat/Long	Finding	As Built	Recommendation	Citation	Photos	Figure
339	Camping Area: Camping Dining Hall	[29.3812415 , -95.598734 9]	Minimum maneuvering clearances at doors and gates shall comply with 404.2.4. Maneuvering clearances shall extend the full width of the doorway and the required latch side or hinge side clearance.	Storage closet door - Lacks maneuvering clearance on push side (closet is 27" deep from door)	Provide required maneuvering clearance on push side of door.	2015 ABAAS Section: 404.2.4.4, 404.2.4.1 2012 TAS Section: 404.2.4.4, 404.2.4.1 2010 ADAS Section: 404.2.4.4, 404.2.4.1

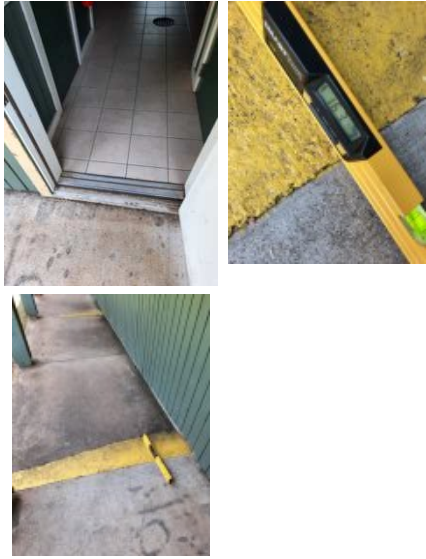
340	Camping Area: Camping Dining Hall	[29.3812532 , -95.598708 1]	Minimum maneuvering clearances at doors and gates shall comply with 404.2.4. Maneuvering clearances shall extend the full width of the doorway and the required latch side or hinge side clearance. Floor or ground surface within required maneuvering clearances shall comply with 302. Changes in level are not permitted. EXCEPTIONS: 1. Slopes not steeper than 1:48 shall be permitted. The threshold has a vertical change greater than 1/4 inch high. The sweep period for doors with closers shall be adjusted so that from an open position of 70 degrees, the door will take at least 3 seconds to move to a point 3 inches from the latch, measured to the leading edge of the door. Exterior doors are recommended to be maintained at 8.5 lbf as a smart practice. Force is to be measured at the operating hardware or 30 inches from the hinges, whichever is greater.	Kitchen door - Lacks maneuvering clearance on push side (7.5" - structural), slope of 16.3% in pull side clearance, CIL of 3.25" in doorway, 9# push, fast close	For all doors along the public circulation route, provide required maneuvering clearance on push and pull side of doors Correct or repair slope at doorway landing to max 2.08% in any direction for level For all doors along the public circulation route, repair, bevel, or ramp CILs at door entries to max .25" For all doors along the public circulation route, inspect, adjust, and maintain closing speed on door closers For all doors along the public circulation route, inspect, adjust, and maintain 8.5 lbf to open exterior doors as a smart practice	2010 ADAS Section: 404.2.3, 404.2.7, 404.2.4, 404.2.11, 404.2.11 Exception

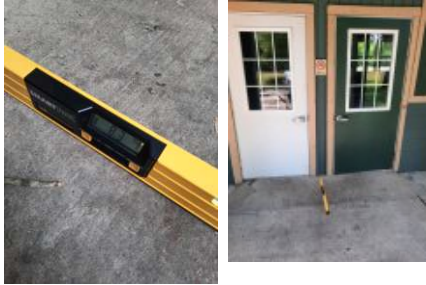
Finding Number	Area Description	Lat/Long	Finding	As Built	Recommendation	Citation	Photos	Figure
341	Camping Area: Camping Dining Hall	[29.381253, -95.598686 8]	Minimum maneuvering clearances at doors and gates shall comply with 404.2.4. Maneuvering clearances shall extend the full width of the doorway and the required latch side or hinge side clearance. Floor or ground surface within required maneuvering clearances shall comply with 302. Changes in level are not permitted. EXCEPTIONS: 1. Slopes not steeper than 1:48 shall be permitted. Exterior doors are recommended to be maintained at 8.5 lbf as a smart practice. Force is to be measured at the operating hardware or 30 inches from the hinges, whichever is greater.	Green (right) and white (left) window doors - slope of 8.3% in pull side clearance, 10# push - green/right door, 11# push - white/left door	For all doors along the public circulation route, provide required maneuvering clearance on push and pull side of doors Correct or repair slope at doorway landing to max 2.08% in any direction for level For all doors along the public circulation route, inspect, adjust, and maintain 8.5 lbf to open exterior doors as a smart practice	2010 ADAS Section: 404.2.3, 404.2.7, 404.2.4, 404.2.11, 404.2.11 Exception

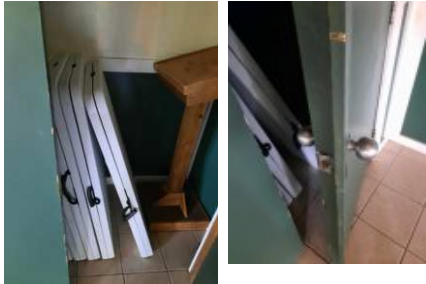
342	Camping Area: Camping Dining Hall	[29.3812555, -95.598745 7]	Minimum maneuvering clearances at doors and gates shall comply with 404.2.4. Maneuvering clearances shall extend the full width of the doorway and the required latch side or hinge side clearance. Hand-activated door opening hardware, handles, pulls, latches, locks, and other operating devices on accessible doors shall have a shape that is easy to grasp with one hand and does not require tight grasping, tight pinching or twisting of the wrist to operate. Hardware shall be 34 inches minimum and 48 inches maximum above the finish floor or ground.	Table storage closet door - storage in push side clearance, knobs	For all doors along the public circulation route, provide required maneuvering clearance on push and pull side of doors For all doors along the public circulation route, replace hardware with lever hardware or hardware operable without a tight pinch or grasp	2010 ADAS Section: 404.2.3, 404.2.7, 404.2.4, 404.2.11, 404.2.11 Exception

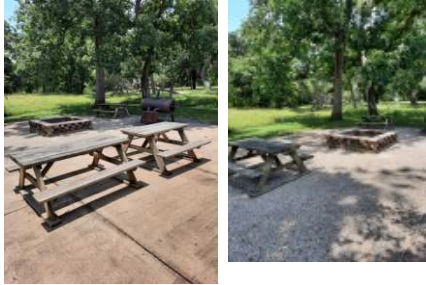
Finding Number	Area Description	Lat/Long	Finding	As Built	Recommendation	Citation	Photos	Figure
344	Camping Area: Camping Dining Hall	[29.381169, -95.598775 2]	Picnic tables shall provide at least one wheelchair space for each 24 linear feet (7320 mm) of usable table surface perimeter. Wheelchair spaces shall be 30 inches (760 mm) minimum by 48 inches (1220 mm) minimum. Wheelchair spaces shall be positioned for a forward approach to the table and provide knee and toe clearance complying with 306 under the table	4 of 4 picnic tables are not of an accessible design	Replace picnic table with one of an accessible design as a smart practice	2015 ABAAS Section: 1011.4.2

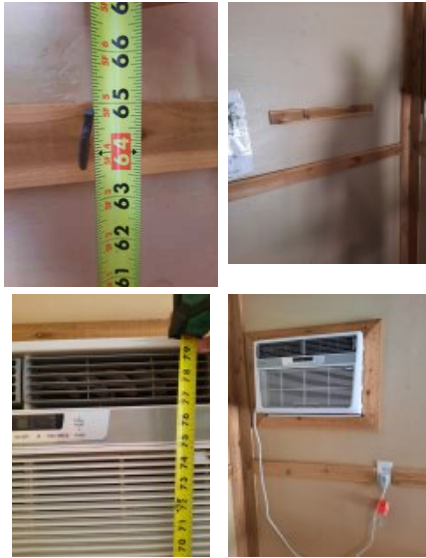
346	Camping Area: Cabins	[29.3804515, -95.596688 4]	The coat hooks and AC unit controls are positioned too high for either a side or front approach. Where a clear floor or ground space allows a parallel approach to an element and the side reach is unobstructed, the high side reach shall be 48 inches maximum and the low side reach shall be 15 inches minimum above the finish floor or ground. Where a forward reach is unobstructed, the high forward reach shall be 48 inches maximum and the low forward reach shall be 15 inches minimum above the finish floor or ground.	Cabin 3 - Coat hooks at 4" aff and AC unit controls at 76" aff	Remount operable parts to be in reach range of 15" min to 48" max	2015 ABAAS Section: 308.1 2012 TAS Section: 308.1 2010 ADAS Section: 308.1

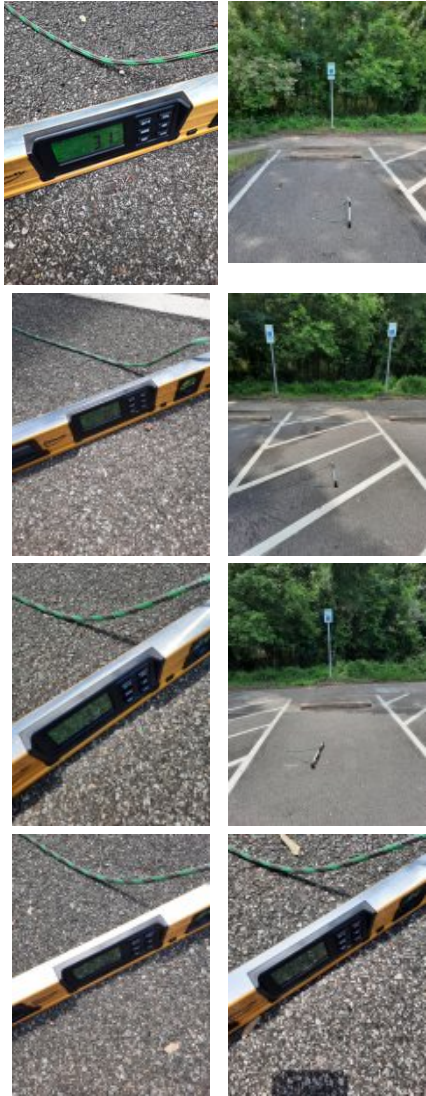
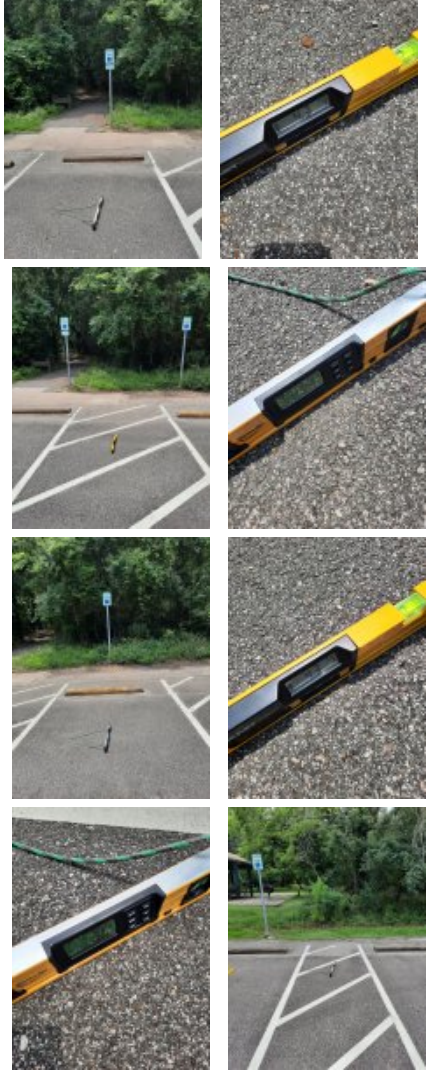
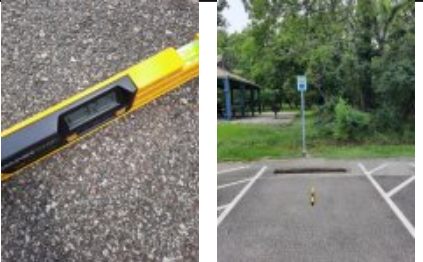
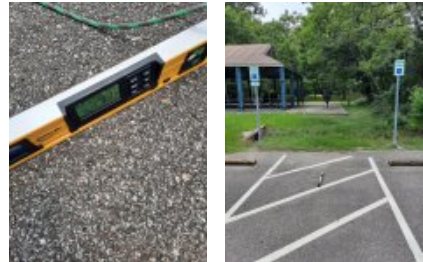
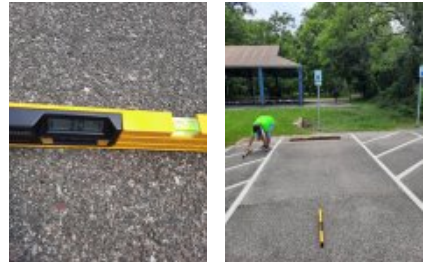
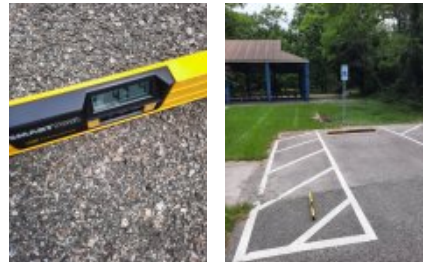
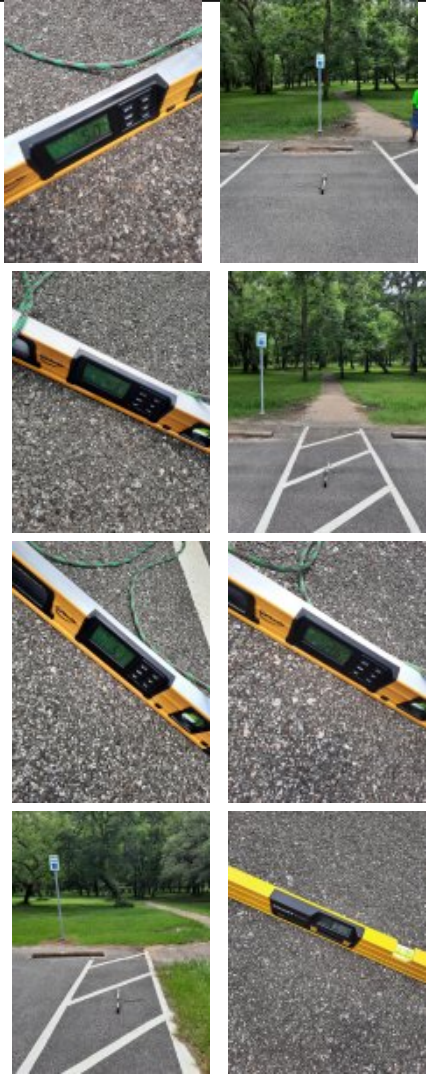
Finding Number	Area Description	Lat/Long	Finding	As Built	Recommendation	Citation	Photos	Figure
350	Hale Lake Area: Parking - Hale Lake	[29.3789416, -95.5839291], [29.3750337, -95.5819872]	The cross slopes (narrow dimension) and/or running slopes (long dimension) of the access aisle exceeds 2%. The running slope and the cross slope in an accessible parking stall and the access aisle must not exceed 2%.	Parking near Youth Group Camping trail - Slopes of 3.1% (stall 1), 3% (access aisle 1 or AA 1), 3.1% (stall 2), 3% (AA 2), 4.1% (stall 3), 4.3% (AA 3), 3.9% (stall 4), and 4.3% (AA 4) Parking near shelter - Slopes of 3.6% (AA 4), 3.2% (stall 3), 4.1% (AA 3), 3% (stall 2), and 4.7% (AA 2) Parking near picnic area - Slopes of 5% (stall 1), and 4.3% (AA 1) Parking near restrooms - Slopes of 5.1% (AA 1), 3.6% (AA 2), and 3.8% (stall 2)	Resurface stalls and access aisles to eliminate slopes	2015 ABAAS Section: 502.4 2012 TAS Section: 502.4 2010 ADAS Section: 502.4

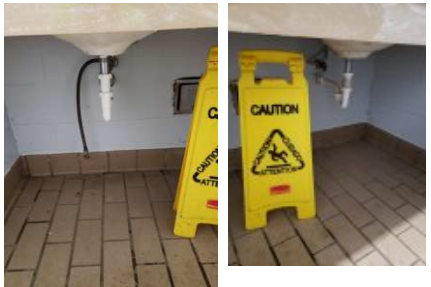
353	Hale Lake Area: Hale Lake Restrooms	[29.3757185 , -95.583188 9]	The water and drain pipes under the lavatory are not adequately insulated. Water supply and drain pipes under lavatories and sinks shall be insulated or otherwise configured to protect against contact. There shall be no sharp or abrasive surfaces under lavatories and sinks.	Men's restroom - Sink lacks insulated pipes	Insulate exposed pipes under one sink	2015 ABAAS Section: 606.5 2012 TAS Section: 606.5 2010 ADAS Section: 606.5

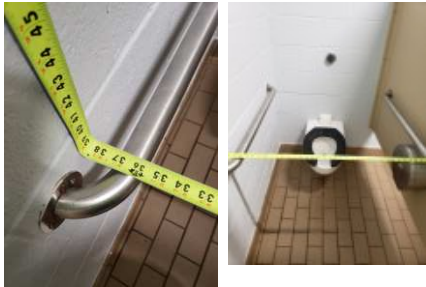
Finding Number	Area Description	Lat/Long	Finding	As Built	Recommendation	Citation	Photos	Figure
356	Hale Lake Area: Hale Lake Restrooms	[29.3757115 , -95.5831835]	There are not enough accessible toilet compartments. The room contains several toilet compartments. A minimum of 1 must be wheelchair accessible .	Men's restroom - ambulatory only	Create a wheelchair accessible stall with grab bars and fixtures mounted in correct locations and at correct heights	2015 ABAAS Section: F213.3.1 2012 TAS Section: 213.3.1 2010 ADAS Section: 213.3.1		
357	Hale Lake Area: Hale Lake Restrooms	[29.3757243 , -95.5831728]	The ambulatory stall is not between 35" to 37" wide and 60" deep.	Stall lacks required dimensions to be an ambulatory stall - 38.5" wide	Correct ambulatory stall to be 35" to 37" wide and minimum 60" deep	2015 ABAAS Section: 604.8.2.1 2012 TAS Section: 604.8.2.1 2010 ADAS Section: 604.8.2.1

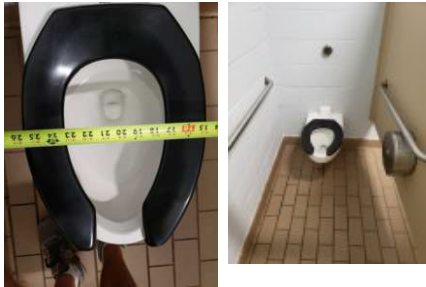
358	Hale Lake Area: Hale Lake Restrooms	[29.3757232 , -95.583162]	The toilet is not located within the range to the side wall or partition. The centerline of the toilet shall be 17 inches minimum and 19 inches maximum side wall or partition in the ambulatory accessible toilet compartment.	Men's restroom - Centerline of the toilet is 20.5" from the partition	Remount toilet to 17" to 19" from the side wall to center line in ambulatory stalls	2015 ABAAS Section: 604.9.1 2012 TAS Section: 604.9.1 2010 ADAS Section: 604.9.1

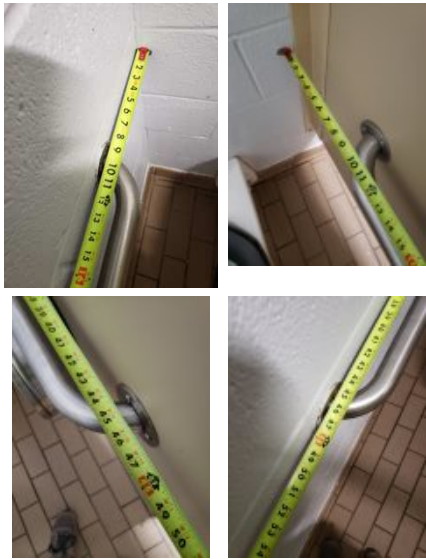
360	Hale Lake Area: Hale Lake Restrooms	[29.3757138 , -95.583186 2]	The side grab bars are not in the correct location. Grab bars on the side wall must be installed so that the end closest to the rear wall is maximum 12" from the rear wall. The end furthest from the rear wall must be mounted minimum 54" from the rear wall.	Men's restroom - Side grab bars end less than 54" from rear wall	Remount side grab bar to max 12" from the rear wall at the close end and min 54" on the far end, and 33" to 36" aff	2015 ABAAS Section: 604.5.1 2012 TAS Section: 604.5.1 2010 ADAS Section: 604.5.1

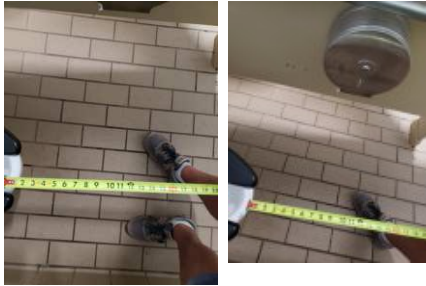
Finding Number	Area Description	Lat/Long	Finding	As Built	Recommendation	Citation	Photos	Figure
362	Hale Lake Area: Hale Lake Restrooms	[29.3757138 , -95.583188 9]	The toilet paper is not installed within the compliant range in front of the toilet. Toilet paper dispensers shall be 7 inches minimum and 9 inches maximum in front of the water closet measured to the centerline of the dispenser. The outlet of the dispenser shall be 15 inches minimum and 48 inches maximum above the finish floor and shall not be located behind grab bars. Dispensers shall not be of a type that controls delivery or that does not allow continuous paper flow. There shall be a clearance of 1 1/2 inches minimum below the grab bar.	Men's restroom - TP is 11" from front of toilet	Remount toilet paper dispenser max 7" to 9" from front of toilet, 15" to 48" aff and min 12" above or 1.5" below grab bar	2015 ABAAS Section: 604.7 2012 TAS Section: 604.7 2010 ADAS Section: 604.7

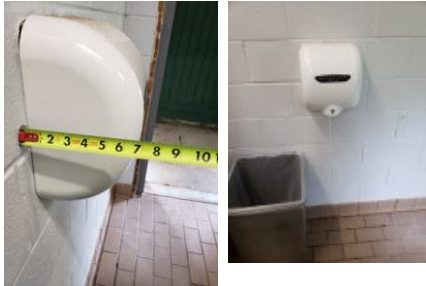
363	Hale Lake Area: Hale Lake Restrooms	[29.3757045 , -95.583178 1]	The hand dryer projects more than 4 inches into the circulation path. Wall-mounted objects that have leading edges between 27 inches and 80 inches from the floor must not project more than 4 inches into the circulation path. Protruding objects that extend to the floor or within 27 inches of the floor are cane detectable and are therefore not hazardous. Where it is necessary or desirable to have objects protrude from the wall, a manner of cane detection must be provided.	Men's restroom - Hand dryer protrudes 7"	Relocate protruding objects or place cane detectable warning or bollard at foot of item	2015 ABAAS Section: 307.2 2012 TAS Section: 307.2 2010 ADAS Section: 307.2

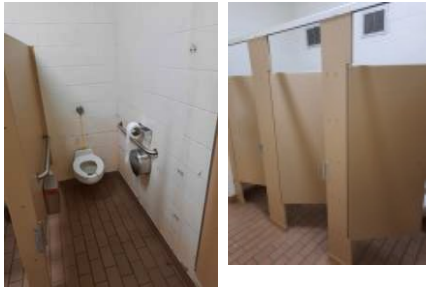
368	Hale Lake Area: Hale Lake Restrooms	[29.3757092 , -95.5831835]	There are not enough accessible toilet compartments. The room contains 3 toilet compartments. A minimum of 1 must be wheelchair accessible .	Women's restroom - ambulatory only	Create a wheelchair accessible stall with grab bars and fixtures mounted in correct locations and at correct heights	2015 ABAAS Section: F213.3.1 2012 TAS Section: 213.3.1 2010 ADAS Section: 213.3.1

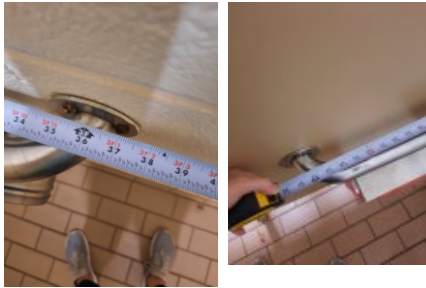
371	Hale Lake Area: Hale Lake Restrooms	[29.3757068 , -95.5831674]	The side grab bar is not long enough. The side grab bar must extend at least 54 inches minimum beyond the rear wall and start a maximum of 12 inches from the rear wall. A 42 inch grab bar installed the maximum distance from the rear wall (12 inches) will leave the leading end 54 inches from the rear wall. Grab bars shall be installed in a horizontal position, 33 inches minimum and 36 inches maximum above the finish floor measured to the top of the gripping surface.	Women's restroom - 36" grab bars	Replace side grab bar with a 42" long grab bar, mounted max 12" from the rear wall at the close end and min 54" on the far end and 33" to 36" aff	2015 ABAAS Section: 604.5.1 2012 TAS Section: 604.5.1 2010 ADAS Section: 604.5.1

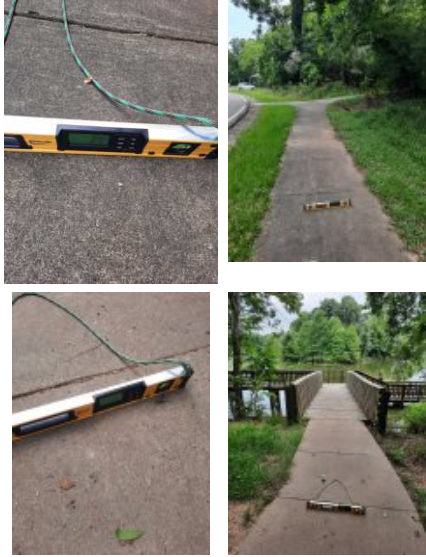
Finding Number	Area Description	Lat/Long	Finding	As Built	Recommendation	Citation	Photos	Figure
379	Hale Lake Area: Hale Lake Fishing Pier	[29.3785425 , -95.58410 01], [29.3782644 , -95.585309 8]	The accessible route of travel on the accessible route contains cross slopes greater than 2%. Cross slopes shall not exceed one unit vertical in 48 units horizontal (2-percent slope).	Cross slopes of 2.7% (walkway to pier) and 4.9% (near pier entry)	Correct or repair cross slope along AR to max 2.08%	2015 ABAAS Section: 403.3 2012 TAS Section: 403.3 2010 ADAS Section: 403.3

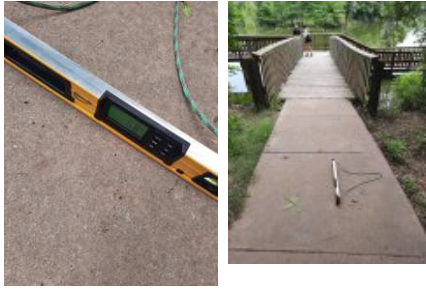
380	Hale Lake Area: Hale Lake Fishing Pier	[29.3782525 , -95.585313 9]	The running slope of walking surfaces shall not be steeper than 1:20.	Running slope of 6.8% (near pier entry)	Correct running slope along the AR to max 5%	2015 ABAAS Section: 403.3 2012 TAS Section: 403.3 2010 ADAS Section: 403.3

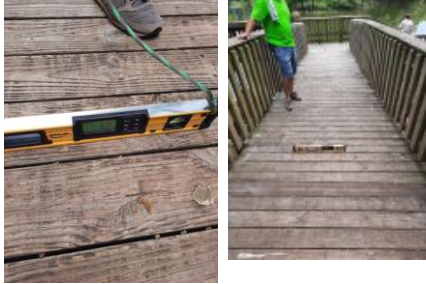
381	Hale Lake Area: Hale Lake Fishing Pier	[29.3782019 , -95.585333 3]	The 30 inches minimum by 48 inches minimum clear ground space required at the fishing pier is not flat (2% or 1:48 maximum slope) in all directions. Changes in level are not permitted at required clear floor or ground space except that slopes not steeper than 1:48 shall be permitted.	5.8% cross slope on pier	Correct or repair slope in CGS to max 2.08%	2015 ABAAS Section: 305.2 2012 TAS Section: 305.2 2010 ADAS Section: 305.2
