Access Audit Site Report

Brazos Bend State Park
21901 Farm to Market Rd 762
Needville, TX 77461
Accessibility Evaluation
Inspection Date: 06/14/2021
Inspectors: Tanya Scheibe

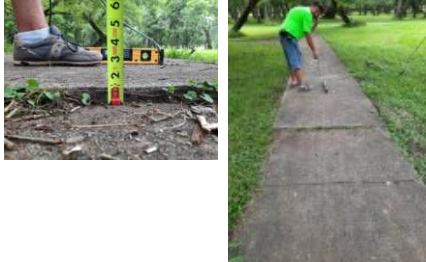
387	Hale Lake Area: Hale Lake Shelters	[29.3771092 , -95.583585 8]	The walkway contains abrupt vertical edges and/or variations over a 1/4 inch. 1/4 inch is the maximum vertical rise. Changes in level between 1/4 inch and 1/2 inch must be beveled at 1:2 or less. Changes in level greater than 1/2 inch must be by way of a ramp.	CILs of 2" (near shelter #2) and 1" (near restrooms)	Repair, bevel or ramp CIL along AR	2012 TAS Section: 303.2, 303.3 2010 ADAS Section: 303.2, 303.3

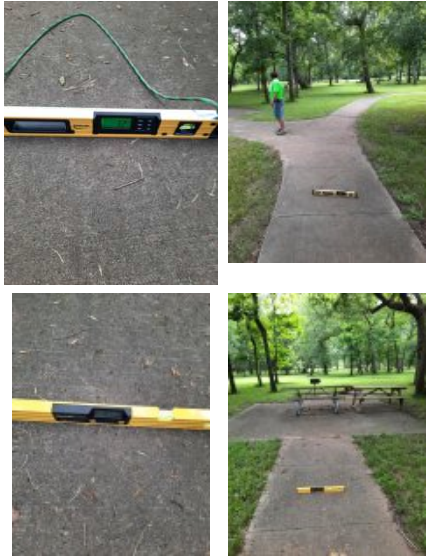
Finding Number	Area Description	Lat/Long	Finding	As Built	Recommendation	Citation	Photos	Figure
388	Hale Lake Area: Hale Lake Shelters	[29.377806, -95.583780 2]	The accessible route of travel on the accessible route contains cross slopes greater than 2%. Cross slopes shall not exceed one unit vertical in 48 units horizontal (2-percent slope).	Cross slopes of 3.2% (picnic area path) and 3.7% (near picnic area 16)	Correct or repair cross slope along AR to max 2.08%	2015 ABAAS Section: 403.3 2012 TAS Section: 403.3 2010 ADAS Section: 403.3
