Access Audit Site Report

Caprock Canyons State Park and Trailway

Accessibility Evaluation

Inspection Date: 05/19/2022

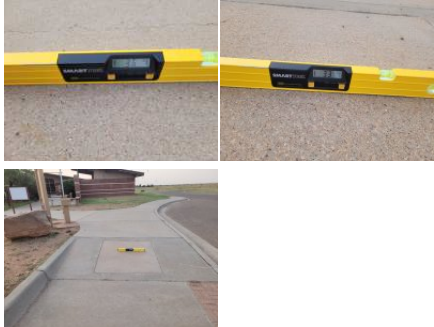
8	Headquarters Area: Discovery Center - Exterior Accessible Route	[34.4103836, -101.0537551]	The curb ramp on the accessible route contains cross slopes greater than 2%. Surface cross slopes shall not exceed one unit vertical in 48 units horizontal (2-percent slope).	3.6% at parking, 3.3% at loading zone	Correct curb ramp cross slope to max 2.08%	2015 ABAAS Section: 405.3 2012 TAS Section: 405.3 2010 ADAS Section: 405.3

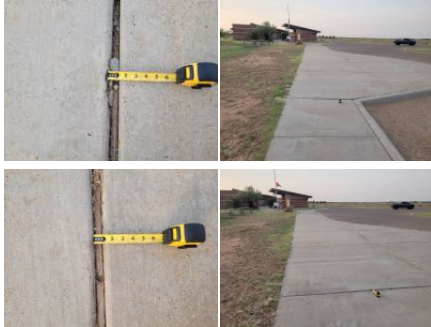
11	Headquarters Area: Discovery Center - Exterior Accessible Route	[34.4105141, -101.0539924]	There is a gap spaced greater than a 1/2 inch. Openings in floor or ground surfaces shall not allow passage of a sphere more than 1/2 inch diameter. Elongated openings shall be placed so that the long dimension is perpendicular to the dominant direction of travel.	1.25" gap near parking, a few 1" gaps between at joints where wood filler sinking/missing	Correct or fill gaps to be max .5"	2015 ABAAS Section: 302.3 2012 TAS Section: 302.3 2010 ADAS Section: 302.3

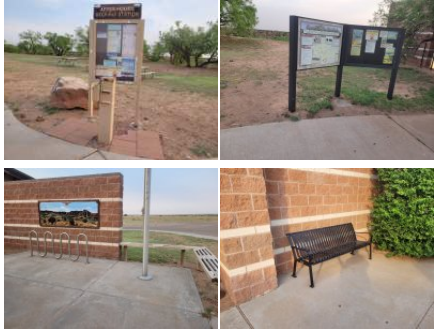
Finding Number	Area Description	Lat/Long	Finding	As Built	Recommendation	Citation	Photos	Figure
12	Headquarters Area: Discovery Center - Exterior Accessible Route	[34.4103946, -101.0537229], [34.410315, -101.0534345]	Element meets all standards and requirements	Pay station complies, park signs comply, bike rack and 3 benches comply	None	2010 ADAS Section: N/A

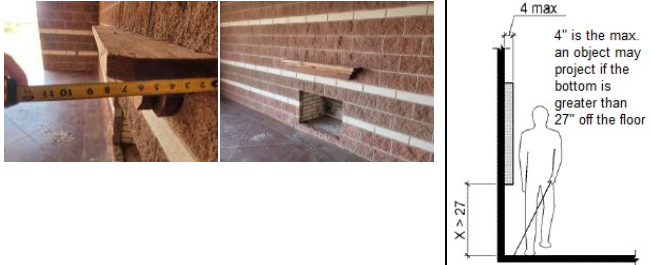
41	Headquarters Area: HQ - Public Spaces	[34.4103703, -101.0533755]	An object or objects project more than 4 inches into the circulation path. Wall-mounted objects that have leading edges between 27 inches and 80 inches from the floor must not project more than 4 inches into the circulation path. Protruding objects that extend to the floor or within 27 inches of the floor are cane detectable and are therefore not hazardous. Where it is necessary or desirable to have objects protrude from the wall, a manner of cane detection must be provided.	pavilion- mantle in outdoor learning area protrudes 8"	Relocate protruding objects or place cane detectable warning or bollard at foot of item.	2015 ABAAS Section: 307.2 2012 TAS Section: 307.2 2010 ADAS Section: 307.2

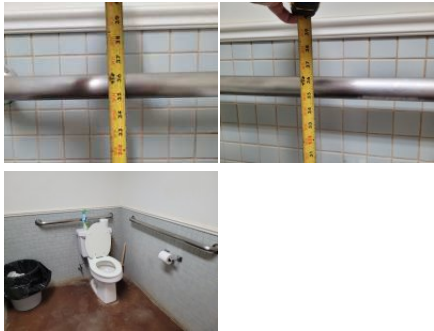
53	Headquarters Area: HQ - Employee Spaces	[34.4102364, -101.0531891]	The grab bar height and/or spacing fails. Grab bars must be mounted between 33" and 36" to the top of the gripping surface. There must be 1.5" of clearance between the grab bar and the wall. There must be a minimum of 1.5" of clearance below and minimum 12" above the grab bar to any dispenser or other obstruction.	new HQ employee restroom- both grab bars 36.25" AFF	Remount grab bars in accessible stall to 33" to 36" above the finished floor (AFF).	2015 ABAAS Section: 609.3, 609.4 2012 TAS Section: 609.4, 609.3 2010 ADAS Section: 609.3, 609.4

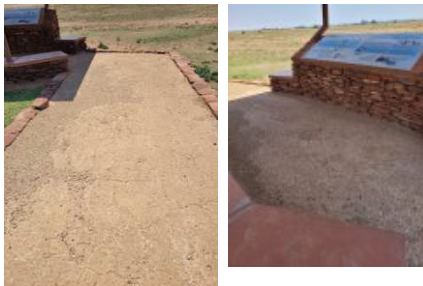
61	Headquarters Area: Prairie Wayside Panel	[34.4098152, -101.0556953]	The accessible route contains loose gravel and/or surfaces that do not provide for a stable, firm slip resistant surface.	Deteriorated route to prairie viewing and signage	Resurface AR where deterioration occurs	2015 ABAAS Section: 302.1 2012 TAS Section: 302.1 2010 ADAS Section: 302.1

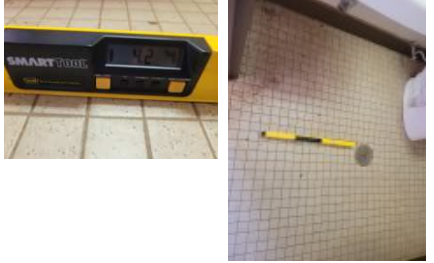
74	Headquarters Area: Discovery Center Restrooms	[34.4132724 , -101.0596 371]	The accessible route contains running slopes greater than 5 percent and cross slopes greater than 2 percent across the width of the walk and has not been constructed as a ramp (i.e. handrails, wheel guides, etc.). When the slope in the direction of travel of any walk exceeds 1 unit vertical in 20 units horizontal (5-percent slope), it must be constructed as ramp. Surface cross slopes must not exceed one unit vertical in 48 units. Horizontal (2-percent slope).	Discovery Center women's- 4.2% slope at drain and door clearance	Correct or repair slope to max 2.08% in restroom.	2015 ABAAS Section: 403.3 2012 TAS Section: 403.3 2010 ADAS Section: 403.3

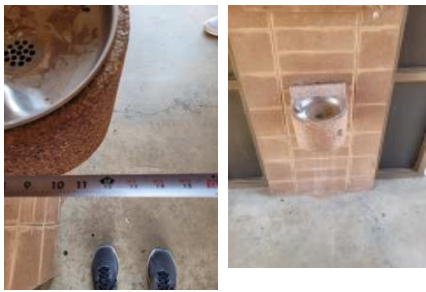
86	Headquarters Area: Discovery Center - Public Spaces	[34.413268, -101.0596371]	The spout is not positioned correctly from the vertical support. The spout shall be located 15 inches minimum from the vertical support and 5 inches maximum from the front edge of the unit, including bumpers.	Discovery Center-fountain spout 13" from wall	Remount or replace fountain to provide 15" from vertical support to the spout	2015 ABAAS Section: 602.5 2012 TAS Section: 602.5 2010 ADAS Section: 602.5

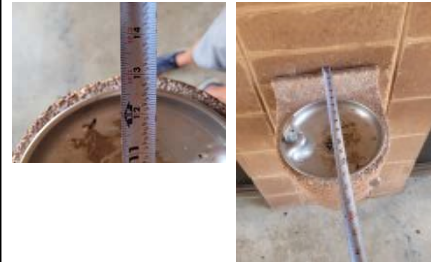
89	Headquarters Area: Discovery Center - Public Spaces	[34.4132569, -101.0596318]	An item or items project more than 4 inches into the circulation path. Wall-mounted objects that have leading edges between 27 inches and 80 inches from the floor must not project more than 4 inches into the circulation path. Protruding objects that extend to the floor or within 27 inches of the floor are cane detectable and are therefore not hazardous. Where it is necessary or desirable to have objects protrude from the wall, a manner of cane detection must be provided.	Discovery Center-fountain projects 13"	Relocate protruding objects or place cane detectable warning or bollard at foot of item.	2015 ABAAS Section: 307.2 2012 TAS Section: 307.2 2010 ADAS Section: 307.2

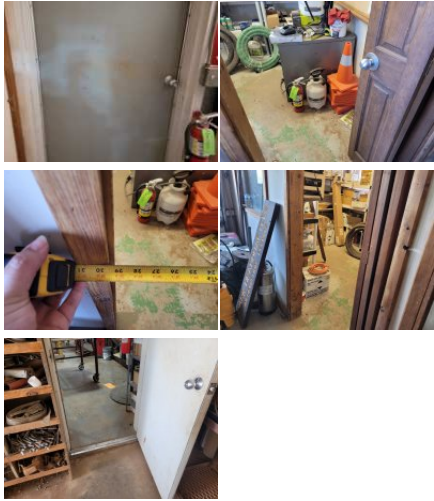
92	Employee Areas: Maintenance	[34.4110353, -101.0482324]	Spaces and elements within employee work areas shall only be required to comply with 206.2.8, 207.1, and 215.3 and shall be designed and constructed so that individuals with disabilities can approach, enter, and exit the employee work area. Employee work areas, or portions of employee work areas, other than raised courtroom stations, that are less than 300 square feet (28 m2) and elevated 7 inches (180 mm) or more above the finish floor or ground where the elevation is essential to the function of the space shall not be required to comply with these requirements or to be on an accessible route.	shop- 3 knobs, one door 29" wide, CIL at far bay	Replace doors with doors having 80" overhead clearance and 32" clear width. Repair, bevel, or ramp CILs at door entries to max .25". Replace hardware with lever hardware or hardware operable without a tight pinch or grasp.	2015 ABAAS Section: F203.9 2012 TAS Section: 203.9 2010 ADAS Section: 203.9

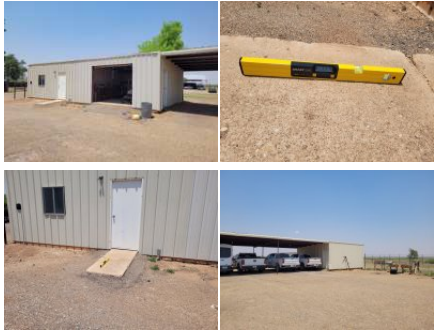
93	Employee Areas: Maintenance	[34.4113207, -101.0482592]	Spaces and elements within employee work areas shall only be required to comply with 206.2.8, 207.1, and 215.3 and shall be designed and constructed so that individuals with disabilities can approach, enter, and exit the employee work area. Employee work areas, or portions of employee work areas, other than raised courtroom stations, that are less than 300 square feet (28 m2) and elevated 7 inches (180 mm) or more above the finish floor or ground where the elevation is essential to the function of the space shall not be required to comply with these requirements or to be on an accessible route.	outbuildings- 3 doors have knobs, CIL at both doors to covered parking, 7.7% slope and CIL at entry	Correct slope in door clearance to max 2.08%. Repair, bevel, or ramp CILs at door entries to max .25". Replace hardware with lever hardware or hardware operable without a tight pinch or grasp.	2015 ABAAS Section: F203.9 2012 TAS Section: 203.9 2010 ADAS Section: 203.9

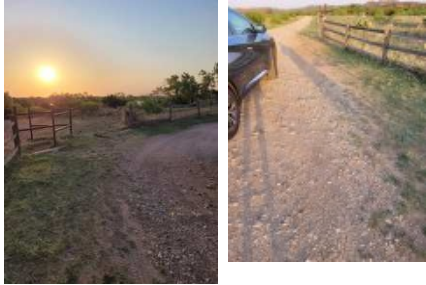
Finding Number	Area Description	Lat/Long	Finding	As Built	Recommendation	Citation	Photos	Figure
97	Folsom Historical Site: Historical Marker	[34.41536, -101.0705]	There are no accessible parking stalls. Each lot where parking is provided for the public as clients, guests or employees, shall provide accessible parking and shall be located on the shortest accessible route of travel from adjacent parking to an accessible entrance. There are approximately 10 parking stalls in the parking lot that could be reasonably associated with this facility. There should be a minimum of 1 accessible stall based on the total: 1-25: 1 accessible/1 van 26-35: 2 accessible/1 van 36-50: 3 accessible/1 van 51-100: 4 accessible/1 van 101-300: 8 accessible/2 van 301-500: 12 accessible/2 van 501-800: 16 accessible/3 van 801-1000: 20 accessible/4 van 1001-over: 20 accessible plus 1 for every 100 spaces/1 of every 6 should be a van stall	Folsom historical site - gravel and dirt surface, lacks stalls (approximately 10 standard, 0 accessible), no accessible route to site marker, narrow gate	Create one or more 8' accessible parking stalls, with one 5' adjacent access aisle, with proper signage and striping based on the total number of stalls. Create AR to site marker from accessible parking stall.	2015 ABAAS Section: F208.2 2010 ADAS Section: 208.2

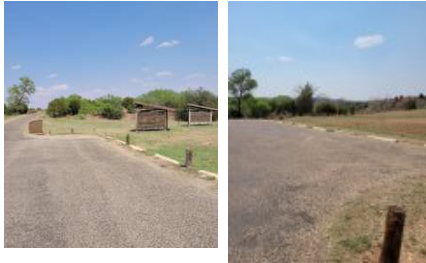
Finding Number	Area Description	Lat/Long	Finding	As Built	Recommendation	Citation	Photos	Figure
102	Lake Theo Day Use Area: Lake Theo - Parking	[34.4171436, -101.0684281]	There are no or not enough accessible parking stalls. Each lot where parking is provided for the public as clients, guests or employees, shall provide accessible parking and shall be located on the shortest accessible route of travel from adjacent parking to an accessible entrance. There are a total of 26 parking stalls in the parking lot that could be reasonably associated with this facility. There should be a minimum of 2 accessible stalls with a minimum of 1 being designed as van accessible.	near playground-lacks accessible parking - 0/26 stalls accessible	Create one or more 8' accessible parking stalls, with one 5' adjacent access aisle, with proper signage and striping based on the total number of stalls.	2015 ABAAS Section: F208.2 2012 TAS Section: 208.2 2010 ADAS Section: 208.2

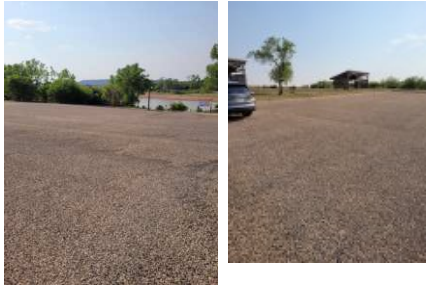
Finding Number	Area Description	Lat/Long	Finding	As Built	Recommendation	Citation	Photos	Figure
108	Lake Theo Day Use Area: Lake Theo - Parking	[34.4141276, -101.0648366]	There are no or not enough accessible parking stalls. Each lot where parking is provided for the public as clients, guests or employees, shall provide accessible parking and shall be located on the shortest accessible route of travel from adjacent parking to an accessible entrance. There are a total of at least 26 parking stalls in the parking lot that could be reasonably associated with this facility. There should be a minimum of 2 accessible stalls with a minimum of 1 being designed as van accessible.	near boat ramp- large unmarked parking area, 1 accessible stall	Create one or more 8' accessible parking stalls, with one 5' adjacent access aisle, with proper signage and striping based on the total number of stalls.	2015 ABAAS Section: F208.2 2012 TAS Section: 208.2 2010 ADAS Section: 208.2

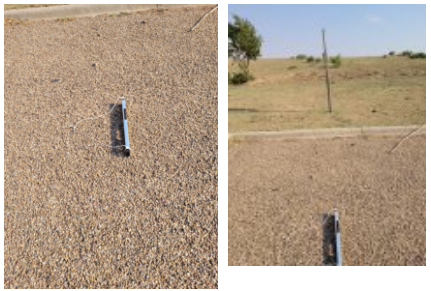
113	Lake Theo Day Use Area: Lake Theo - Parking	[34.4140159, -101.0645805]	The parking stall contains abrupt edges and surface irregularities over a 1/4 inch vertical. Parking spaces and access aisles serving them shall be stable, firm, and slip resistant. Access aisles shall be at the same level as the parking spaces they serve. Changes in level are not permitted and shall not be sloped steeper than 2% in any direction.	near boat ramp- loose stones, unstable surface	Resurface accessible stalls and access aisles with a firm, stable, and slip resistant material.	2015 ABAAS Section: 502.4 2012 TAS Section: 502.4 2010 ADAS Section: 502.4

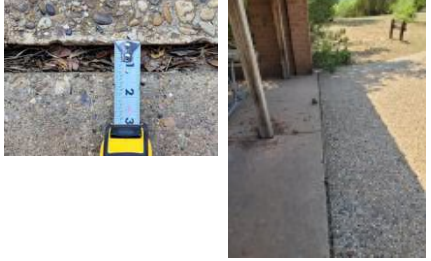
116	Lake Theo Day Use Area: Lake Theo - Shelters/Picnic Areas	[34.4166579, -101.0667571]	There is a gap spaced greater than a 1/2 inch. Openings in floor or ground surfaces shall not allow passage of a sphere more than 1/2 inch diameter. Elongated openings shall be placed so that the long dimension is perpendicular to the dominant direction of travel.	pavilion- 1" gap at entry	Correct or fill gaps to be max .5"	2015 ABAAS Section: 302.3 2012 TAS Section: 302.3 2010 ADAS Section: 302.3

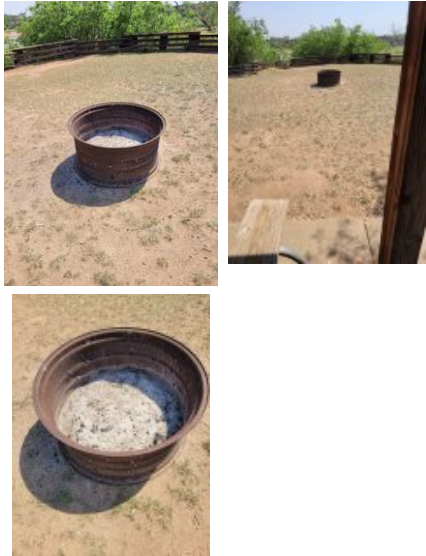
118	Lake Theo Day Use Area: Lake Theo - Shelters/Picnic Areas	[34.4165466, -101.0668054]	48 inches (1220 mm) by 48 inches (1220 mm) on all usable sides of the fire ring, grill, fireplace, and woodstove Center the space on each usable side of the grill, fireplace, and woodstove	group shelter- lacks route to fire ring and clear ground space; fire building surface complies	Provide required 48" clear ground space centered along usable side of fire ring, grill, fireplace, or woodstove as a smart practice.	2015 ABAAS Section: 1011.2

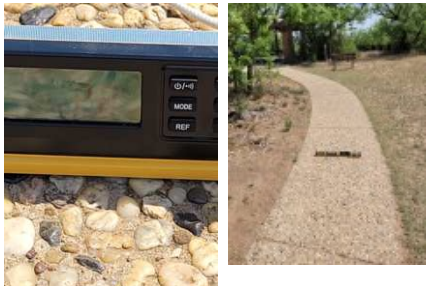
124	Lake Theo Day Use Area: Lake Theo - Shelters/Picnic Areas	[34.416769, -101.0668121]	The accessible route of travel contains cross slopes greater than 2%. Cross slopes shall not exceed one unit vertical in 48 units horizontal (2-percent slope).	Approaching pavilion- 2.8%	Correct or repair cross slope along AR to max 2.08%.	2015 ABAAS Section: 403.3 2012 TAS Section: 403.3 2010 ADAS Section: 403.3

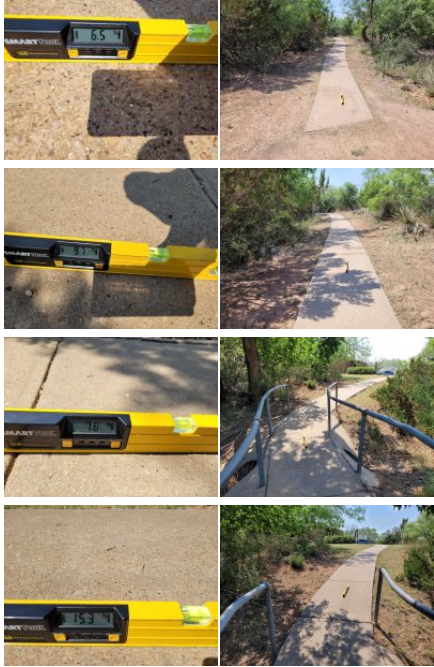
Finding Number	Area Description	Lat/Long	Finding	As Built	Recommendation	Citation	Photos	Figure
136	Lake Theo Day Use Area: Lake Theo - Fishing	[34.4168625, -101.0662805], [34.4166401, -101.0661557]	The running slope of walking surfaces shall not be steeper than 1:20.	6.5% at bottom of sidewalk, 9%, 7.8%, 15.3%	Correct running slope along the AR to max 5%.	2015 ABAAS Section: 403.3 2012 TAS Section: 403.3 2010 ADAS Section: 403.3

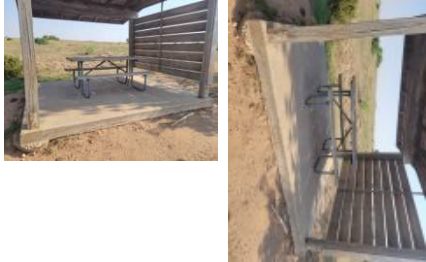
143	Lake Theo Day Use Area: Lake Theo - Boat Ramp	[34.4139053, -101.0646904]	There is insufficient turning space within this room or space. The space required for a wheelchair to make a 180-degree turn is a clear space of 60 inches in diameter or a T-shaped space.	Lacks turning space in picnic areas	Provide turning space within picnic area.	2015 ABAAS Section: 304.3.1, 304.3.2 2012 TAS Section: 304.3.1, 304.3.2 2010 ADAS Section: 304.3.1, 304.3.2

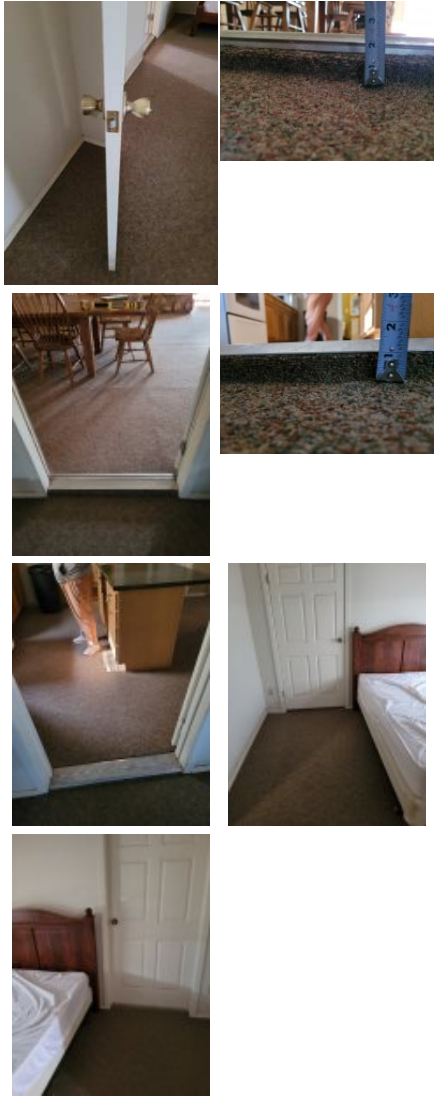
Finding Number	Area Description	Lat/Long	Finding	As Built	Recommendation	Citation	Photos	Figure
158	Lake Theo Day Use Area: Lake Theo - Bunkhouse	[34.4131345, -101.0671222]	<p>Minimum maneuvering clearances at doors and gates shall comply with 404.2.4. Maneuvering clearances shall extend the full width of the doorway and the required latch side or hinge side clearance. Maneuvering clearances shall have a max slope of 2.08%. Door openings shall provide a clear width of 32 inches (815 mm) minimum. Clear openings of doorways with swinging doors shall be measured between the face of the door and the stop, with the door open 90 degrees. Openings more than 24 inches (610 mm) deep shall provide a clear opening of 36 inches (915 mm) minimum. There shall be no projections into the required clear opening width lower than 34 inches (865 mm) above the finish floor or ground. Projections into the clear opening width between 34 inches (865 mm) and 80 inches (2030 mm) above the finish floor or ground shall not exceed 4 inches (100 mm). The threshold has a vertical change greater than 1/4 inch high. The threshold has a gap greater than 1/2 inch wide. The threshold at a doorway shall be no higher than 1/2 inch. Changes in level between 1/4 inch and 1/2 inch must be beveled at 1:2 or less. 1/4 inch is the maximum vertical rise. All interior doors must be maintained so that the operating pressure does not exceed 5 lb. force to open. The sweep period for doors with closers shall be adjusted so that from an open position of 70 degrees, the door will take at least 3 seconds to move to a point 3 inches from the latch, measured to the leading edge of the door. Exterior doors are recommended to be maintained at 8.5 lbf as a smart practice. Force is to be measured at the operating hardware or 30 inches from the hinges, whichever is greater. Hand-activated door opening hardware, handles, pulls, latches, locks, and other operating devices on accessible doors shall have a shape that is easy to grasp with one hand and does not require tight grasping, tight pinching or twisting of the wrist to operate.</p>	interior doors all have knobs, CIL from bedrooms to living space and kitchen, furniture in clearance on door between bathrooms on both sides	For all doors along the public circulation route, provide required maneuvering clearance on push and pull side of doors. For all doors along the public circulation route, repair, bevel, or ramp CILs at door entries to max .25". For all doors along the public circulation route, replace hardware with lever hardware or hardware operable without a tight pinch or grasp.	2010 ADAS Section: 404.2.3, 404.2.7, 404.2.4, 404.2.11, 404.2.11 Exception

Finding Number	Area Description	Lat/Long	Finding	As Built	Recommendation	Citation	Photos	Figure
			Hardware shall be 34 inches minimum and 48 inches maximum above the finish floor or ground. The bottom 10 inches on the push side must be smooth and free of obstructions (hold open devices). Opening hardware must be mounted between 30 and 44 inches above the floor or ground. Doors, gates, and side lights adjacent to doors or gates, containing one or more glazing panels that permit viewing through the panels shall have the bottom of at least one glazed panel located 43 inches (1090 mm) maximum above the finish floor. EXCEPTION: Vision lights with the lowest part more than 66 inches (1675 mm) from the finish floor or ground shall not be required to comply with 404.2.11. Egress doors shall provide a continuous and unobstructed way of egress travel from any point in a building or facility that provides an accessible route to an area of refuge, a horizontal exit, or a public way.

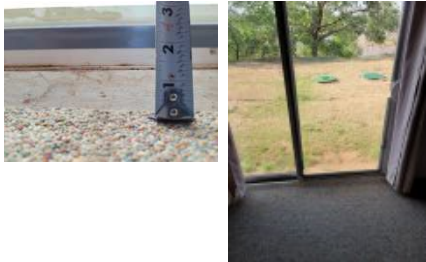
159	Lake Theo Day Use Area: Lake Theo - Bunkhouse	[34.4131369, -101.0671174]	The threshold has a vertical change greater than 1/4 inch high. The threshold at a doorway shall be no higher than 1/2 inch. Changes in level between 1/4 inch and 1/2 inch must be beveled at 1:2 or less. 1/4 inch is the maximum vertical rise. Egress doors shall provide a continuous and unobstructed way of egress travel from any point in a building or facility that provides an accessible route to an area of refuge, a horizontal exit, or a public way.	1.25" CIL at sliding door, lacks egress route	For all doors along the public circulation route, repair, bevel, or ramp CILs at door entries to max .25". For all doors along the public circulation route, repair, provide beveled threshold. For all doors along the public circulation route, enlarge cement pad at exit to allow 18" clearance on the latch side, and extend a pathway away from the building for emergency egress.	2010 ADAS Section: 404.2.3, 404.2.7, 404.2.4, 404.2.11, 404.2.11 Exception

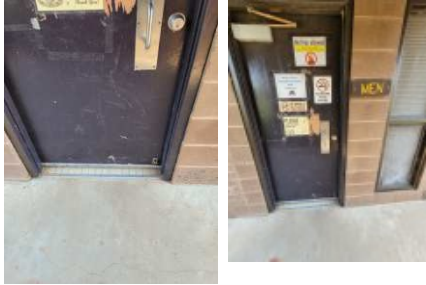
Finding Number	Area Description	Lat/Long	Finding	As Built	Recommendation	Citation	Photos	Figure
163	Lake Theo Day Use Area: Lake Theo - Men's Restroom	[34.4168393 , -101.0666 779]	Exterior doors are recommended to be maintained at 8.5 lbf as a smart practice. Force is to be measured at the operating hardware or 30 inches from the hinges, whichever is greater. The bottom 10 inches on the push side must be smooth and free of obstructions (hold open devices). Opening hardware must be mounted between 30 and 44 inches above the floor or ground.	men's- 10 lbf, lacks 10" smooth surface at bottom due to stopper	For all doors along the public circulation route, inspect, adjust, and maintain 8.5 lbf to open exterior doors as a smart practice. For all doors along the public circulation route, remove door holder to provide a smooth surface on the push side of door from floor to 10" AFF.	2010 ADAS Section: 404.2.3, 404.2.7, 404.2.4, 404.2.11, 404.2.11 Exception

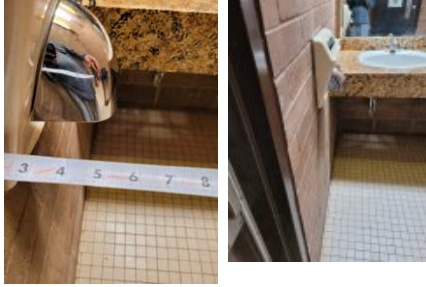
168	Lake Theo Day Use Area: Lake Theo - Men's Restroom	[34.4168415 , -101.06668 2]	An item or items project more than 4 inches into the circulation path. Wall-mounted objects that have leading edges between 27 inches and 80 inches from the floor must not project more than 4 inches into the circulation path. Protruding objects that extend to the floor or within 27 inches of the floor are cane detectable and are therefore not hazardous. Where it is necessary or desirable to have objects protrude from the wall, a manner of cane detection must be provided.	Hand dryer projects 5.25"	Relocate protruding objects or place cane detectable warning or bollard at foot of item.	2015 ABAAS Section: 307.2 2012 TAS Section: 307.2 2010 ADAS Section: 307.2

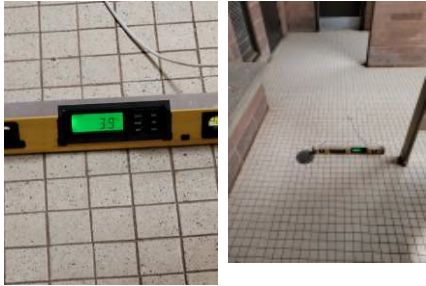
Finding Number	Area Description	Lat/Long	Finding	As Built	Recommendation	Citation	Photos	Figure
169	Lake Theo Day Use Area: Lake Theo - Men's Restroom	[34.4168393, -101.0666846]	The accessible route contains running slopes greater than 5 percent and cross slopes greater than 2 percent across the width of the walk and has not been constructed as a ramp (i.e. handrails, wheel guides, etc.). When the slope in the direction of travel of any walk exceeds 1 unit vertical in 20 units horizontal (5-percent slope), it must be constructed as ramp. Surface cross slopes must not exceed one unit vertical in 48 units. Horizontal (2-percent slope).	3.9% at drain	Correct or repair slope to max 2.08% in restroom.	2015 ABAAS Section: 403.3 2012 TAS Section: 403.3 2010 ADAS Section: 403.3

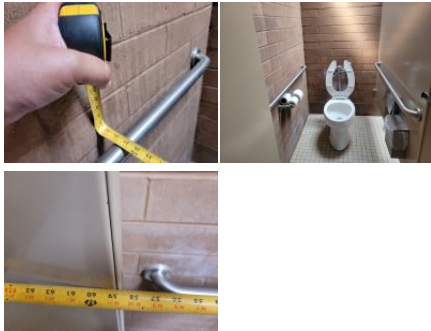
176	Lake Theo Day Use Area: Lake Theo - Women's Restroom	[34.4168393, -101.0666833]	The ambulatory stall is not between 35" to 37" wide and 60" deep.	40" wide, 58.5" deep	Correct ambulatory stall to be 35" to 37" wide and minimum 60" deep	2015 ABAAS Section: 604.8.2.1 2012 TAS Section: 604.8.2.1 2010 ADAS Section: 604.8.2.1

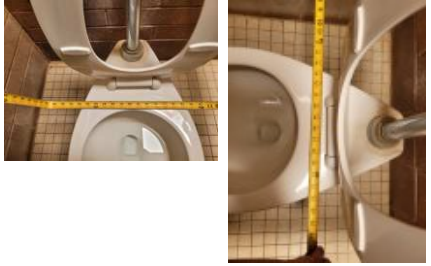
177	Lake Theo Day Use Area: Lake Theo - Women's Restroom	[34.4168449, -101.0666753]	The toilet is not located within the range to the side wall or partition. The centerline of the toilet shall be 17 inches minimum and 19 inches maximum side wall or partition in the ambulatory accessible toilet compartment.	centerline 19.5" and 20.5"	Remount toilet to 17" to 19" from the side wall to center line in ambulatory stalls.	2015 ABAAS Section: 604.9.1 2012 TAS Section: 604.9.1 2010 ADAS Section: 604.9.1

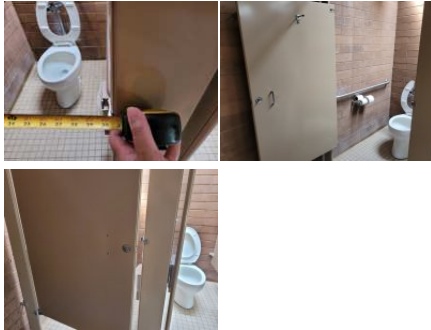
Finding Number	Area Description	Lat/Long	Finding	As Built	Recommendation	Citation	Photos	Figure
178	Lake Theo Day Use Area: Lake Theo - Women's Restroom	[34.4168415, -101.0666726]	The stall door fails to comply with all of the door requirements. The stall door must be a minimum of 32" wide and have compliant hardware on both sides. The stall door must be self-closing.	stall door 30.5" wide, not self-closing	Widen stall doors to 32" when opened to 90 degrees Adjust stall door to be self-closing	2015 ABAAS Section: 404.2.3, 404.2.7, 604.8.2.2 2012 TAS Section: 404.2.3, 404.2.7, 604.8.2.2 2010 ADAS Section: 404.2.3, 404.2.7, 604.8.2.2

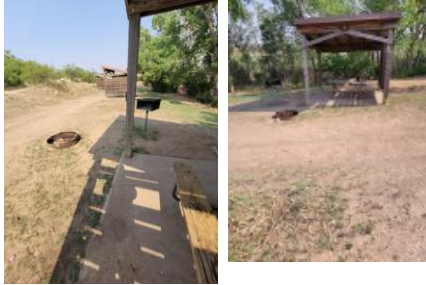
Finding Number	Area Description	Lat/Long	Finding	As Built	Recommendation	Citation	Photos	Figure
182	Lake Theo Day Use Area: Lake Theo - Camping	[34.4170871, -101.0645429]	An accessible access route is not provided between elements, spaces and the facilities provided within the accessible camping unit. At least one outdoor recreation access route shall connect accessible elements, spaces and facilities provided within camping units with mobility features.	campsites 1-10- lacks route to fire ring and grill	Create AR with crushed and compacted stone or similar outdoor material to camp sites and one of each type of amenity.	2015 ABAAS Section: F244.5.1

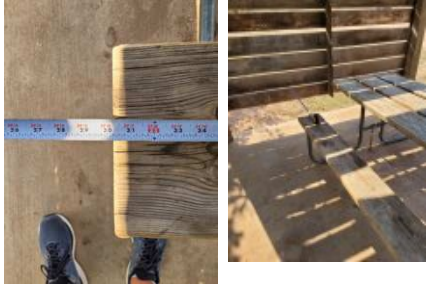
184	Lake Theo Day Use Area: Lake Theo - Camping	[34.4171037, -101.0645791]	36 inches (915 mm) on all usable sides of the table measured from the back edge of the benches.	campsites 1-10- 30" clear ground space around table	Provide required 36" clear ground space around all usable portions of the table as a smart practice.	2015 ABAAS Section: 1011.2.1

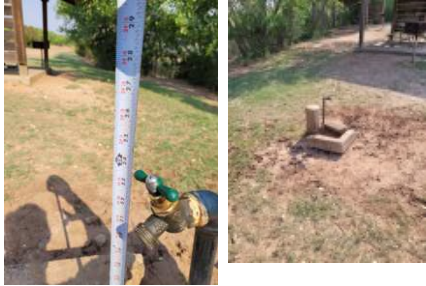
187	Lake Theo Day Use Area: Lake Theo - Camping	[34.4170905 , -101.0645 054]	Water spouts at water hydrants and water utility hook-ups shall be 28 inches (710 mm) minimum and 36 inches (915 mm) maximum above the ground.	campsites 1-10- water spout 20" above ground surface	Remount water spouts to 28" min or 36" max above the ground as a smart practice.	2015 ABAAS Section: 1011.6

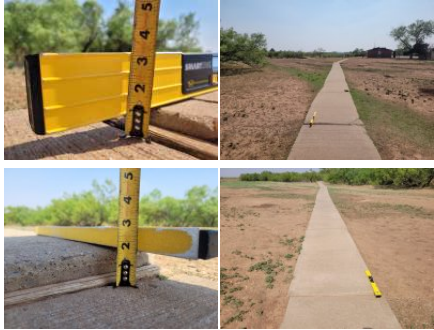
Finding Number	Area Description	Lat/Long	Finding	As Built	Recommendation	Citation	Photos	Figure
199	Honey Flat Camping Area: Honey Flat - Campsites 1-35	[34.4211945, -101.0536866]	The walkway contains abrupt vertical edges and/or variations over a 1/4 inch. 1/4 inch is the maximum vertical rise. Changes in level between 1/4 inch and 1/2 inch must be beveled at 1:2 or less. Changes in level greater than 1/2 inch must be by way of a ramp.	1" CIL, 1.5" both sides of shifted panel	Repair, bevel or ramp CIL along AR.	2012 TAS Section: 303.2, 303.3 2010 ADAS Section: 303.2, 303.3

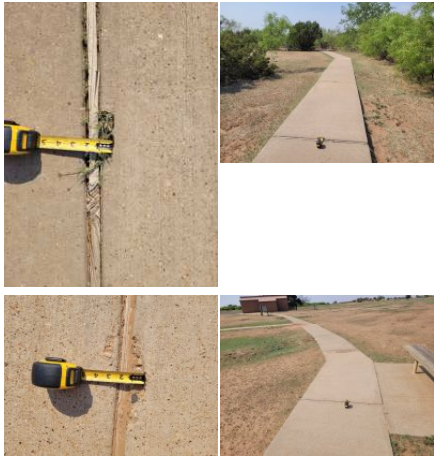
200	Honey Flat Camping Area: Honey Flat - Campsites 1-35	[34.4211534, -101.0528201], [34.4207108, -101.0542256]	There is a gap spaced greater than a 1/2 inch. Openings in floor or ground surfaces shall not allow passage of a sphere more than 1/2 inch diameter. Elongated openings shall be placed so that the long dimension is perpendicular to the dominant direction of travel.	4 - 1" gaps near site 25	Correct or fill gaps to be max .5"	2015 ABAAS Section: 302.3 2012 TAS Section: 302.3 2010 ADAS Section: 302.3

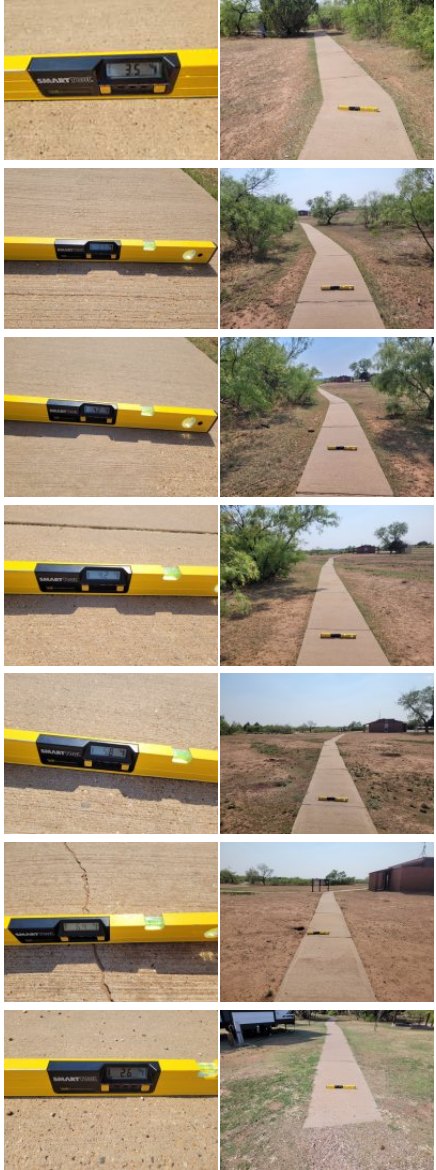
Finding Number	Area Description	Lat/Long	Finding	As Built	Recommendation	Citation	Photos	Figure
202	Honey Flat Camping Area: Honey Flat - Campsites 1-35	[34.4210288, -101.0541499], [34.421281, -101.0528759]	The accessible route of travel contains cross slopes greater than 2%. Cross slopes shall not exceed one unit vertical in 48 units horizontal (2-percent slope).	3.5% near site 25, 3.7% between site 25 and restroom, 4.2%, 4.2%, 5.8%, 6.4%, 2.6% near site 15, 2.8%, 3.8%, 3.5% near sign	Correct or repair cross slope along AR to max 2.08%.	2015 ABAAS Section: 403.3 2012 TAS Section: 403.3 2010 ADAS Section: 403.3

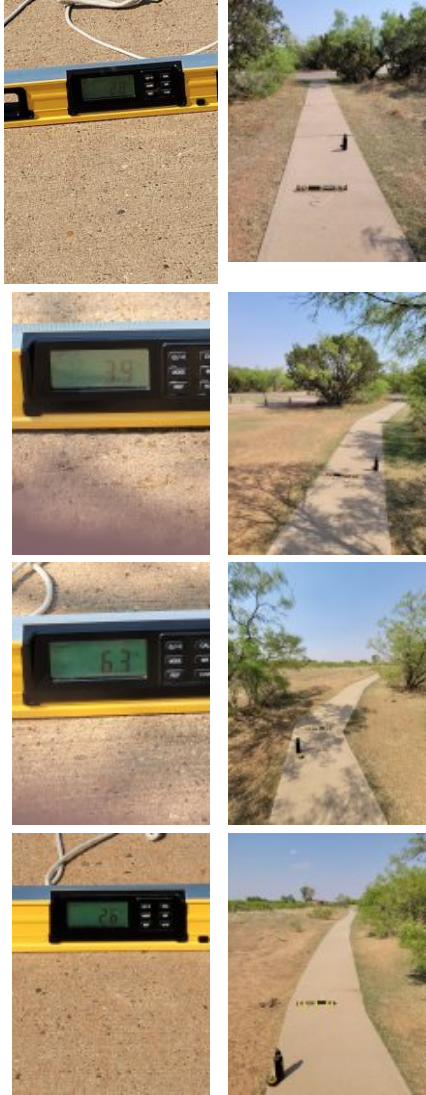
Finding Number	Area Description	Lat/Long	Finding	As Built	Recommendation	Citation	Photos	Figure
207	Honey Flat Camping Area: Honey Flat - Campsites 1-35	[34.4206362, -101.0546066], [34.4199359, -101.0552262]	The accessible route of travel contains cross slopes greater than 2%. Cross slopes shall not exceed one unit vertical in 48 units horizontal (2-percent slope).	Route from sites 7 - 9 - 2.8%, 3.9%, 6.3%, 2.6%, 5.2%; approaching playground - 8.9%, 8.1%, additional slopes to connecting path	Correct or repair cross slope along AR to max 2.08%.	2015 ABAAS Section: 403.3 2012 TAS Section: 403.3 2010 ADAS Section: 403.3

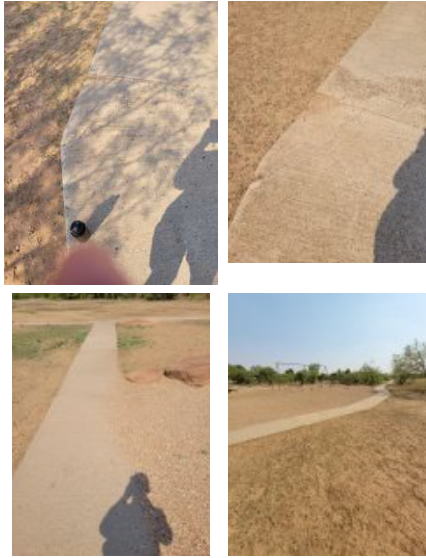
209	Honey Flat Camping Area: Honey Flat - Playground	[34.4206672, -101.0544199]	A minimum of one of each type of ground level play components is not on an accessible route. Where ground level play components are provided, at least one of each type shall be on an accessible route and shall comply.	Pebble surface, 4 swings and slide	Provide an AR to slide and swings for one of each type accessible. Replace playground surface with one that meets ASTM F1951.	2012 TAS Section: 240.2.1.1 2010 ADAS Section: 240.2.1.1

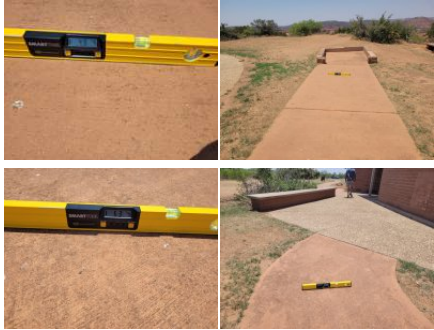
215	Honey Flat Camping Area: Honey Flat - Amphitheater	[34.4201056 , -101.0599 376]	The running slope of walking surfaces shall not be steeper than 1:20.	14.5% near shelter entry	Correct running slope along the AR to max 5%	2015 ABAAS Section: 403.3 2012 TAS Section: 403.3 2010 ADAS Section: 403.3

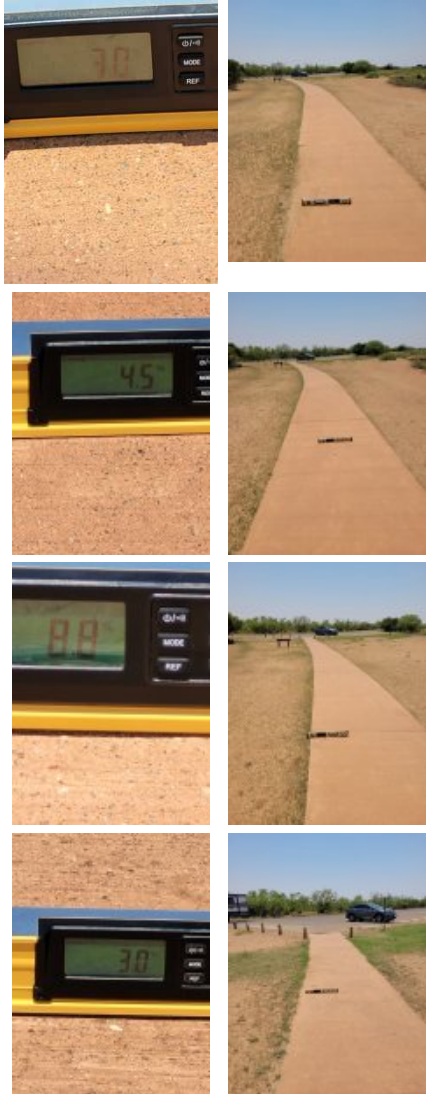
Finding Number	Area Description	Lat/Long	Finding	As Built	Recommendation	Citation	Photos	Figure
226	Honey Flat Camping Area: Honey Flat - Amphitheater	[34.4194554, -101.0599651], [34.4199952, -101.0599249]	The accessible route of travel contains cross slopes greater than 2%. Cross slopes shall not exceed one unit vertical in 48 units horizontal (2-percent slope).	Route from fossil display to parking - 3%, 4.5%, 8.8%, 3%	Correct or repair cross slope along AR to max 2.08%.	2015 ABAAS Section: 403.3 2012 TAS Section: 403.3 2010 ADAS Section: 403.3

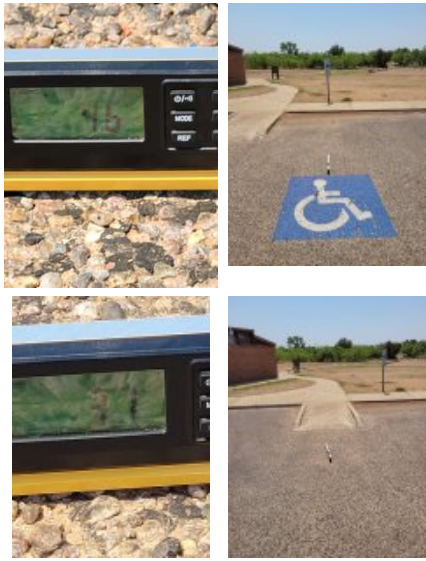
231	Honey Flat Camping Area: Honey Flat - Men's Restroom	[34.4210599, -101.0545611]	The cross slopes (narrow dimension) and/or running slopes (long dimension) of the access aisle exceeds 2%. The running slope and the cross slope in an accessible parking stall and the access aisle must not exceed 2%.	restroom parking-4.6% in stall area; 4.7% in aisle area	Repair or correct slope of parking space and access aisle to max 2.08% in any direction.	2015 ABAAS Section: 502.4 2012 TAS Section: 502.4 2010 ADAS Section: 502.4

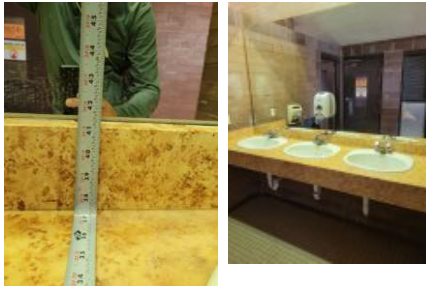
240	Honey Flat Camping Area: Honey Flat - Men's Restroom	[34.4210809, -101.0543746]	The mirror is mounted too high. Mirrors must have the bottom edge of the reflecting surface a maximum of 40 inches above the floor if above a sink or counter. Mirrors not located above lavatories or countertops shall be installed with the bottom edge of the reflecting surface 35 inches maximum above the finish floor or ground.	mirror 41.25" AFF	Lower mirror so bottom reflective surface is max 40" AFF and 74" at the top.	2015 ABAAS Section: 603.3 2012 TAS Section: 603.3 2010 ADAS Section: 603.3

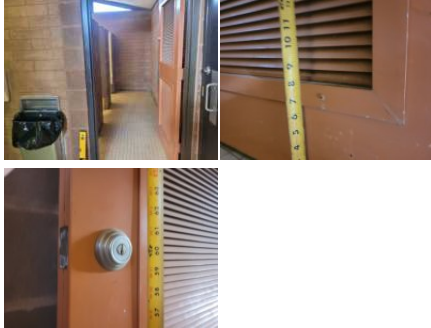
256	Honey Flat Camping Area: Honey Flat - Women's Restroom	[34.42107, -101.0544]	Minimum maneuvering clearances at doors and gates shall comply with 404.2.4. Maneuvering clearances shall extend the full width of the doorway and the required latch side or hinge side clearance. All interior doors must be maintained so that the operating pressure does not exceed 5 lb. force to open. The sweep period for doors with closers shall be adjusted so that from an open position of 70 degrees, the door will take at least 3 seconds to move to a point 3 inches from the latch, measured to the leading edge of the door. Hand-activated door opening hardware, handles, pulls, latches, locks, and other operating devices on accessible doors shall have a shape that is easy to grasp with one hand and does not require tight grasping, tight pinching or twisting of the wrist to operate. Hardware shall be 34 inches minimum and 48 inches maximum above the finish floor or ground. The bottom 10 inches on the push side must be smooth and free of obstructions (hold open devices). Opening hardware must be mounted between 30 and 44 inches above the floor or ground.	Shower room door - vent starts 8", wall pull side, lock high, 10#, closes fast	For all doors along the public circulation route, provide required maneuvering clearance on push and pull side of doors. For all doors along the public circulation route, inspect, adjust, and maintain 5 lbf to open interior doors. For all doors along the public circulation route, inspect, adjust, and maintain closing speed on door closers. For all doors along the public circulation route, replace hardware with lever hardware or hardware operable without a tight pinch or grasp installed 48" AFF. For all doors along the public circulation route, provide kick plate on push side of door from floor to 10" AFF.	2010 ADAS Section: 404.2.3, 404.2.7, 404.2.4, 404.2.11, 404.2.11 Exception

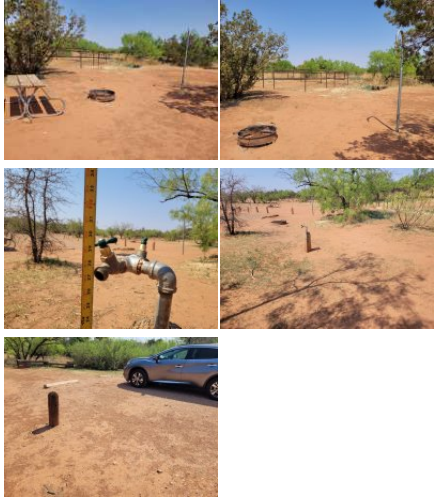
259	Wild Horse Camping Area: Wild Horse - Campsites 66-77	[34.4416837 , -101.05484 1]	At least one accessible route shall connect accessible buildings, accessible facilities, accessible elements, and accessible spaces that are on the same site. For areas of sport activity, an accessible route is required to connect to the boundary of each area of sport activity. The size of an area of sport activity includes only the space needed to play. Where multiple sports fields or courts are provided, an accessible route is required to each field or area of sport activity.	Lacks AR to trough	Provide an accessible route to each element within the site.	2010 ADAS Section: 206.2.2, 206.2

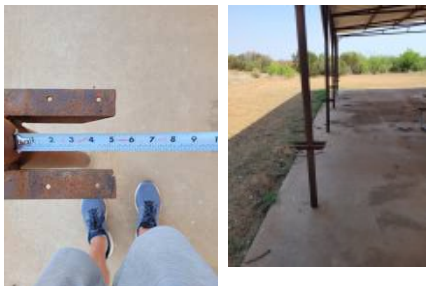
269	Wild Horse Camping Area: Wild Horse - Picnic Area	[34.44231, -101.0545892]	Objects project more than 4 inches into the circulation path. Wall-mounted objects that have leading edges between 27 inches and 80 inches from the floor must not project more than 4 inches into the circulation path. Protruding objects that extend to the floor or within 27 inches of the floor are cane detectable and are therefore not hazardous. Where it is necessary or desirable to have objects protrude from the wall, a manner of cane detection must be provided.	Some brackets protrude 5" above 27" AFF	Relocate object to not protrude into the circulation path.	2015 ABAAS Section: 307.2 2012 TAS Section: 307.2 2010 ADAS Section: 307.2

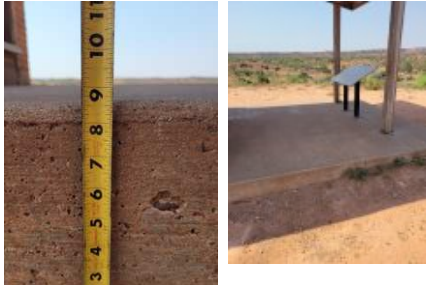
272	Wild Horse Camping Area: Wild Horse - Picnic Area	[34.4373806, -101.0568672]	Obstacles on outdoor recreation access routes, passing spaces, and resting intervals shall not exceed 1/2 inch (13 mm) in height measured vertically to the highest point. EXCEPTION: Where the surface is other than asphalt, concrete, or boards, obstacles shall be permitted to not exceed 1 inch (25 mm) in height measured vertically to the highest point.	Overlook near wild horse - 8.75" change in level	Repair, bevel or ramp CIL along the ORAR to max .5" or 1" for surfaces other than concrete, asphalt or boards as a smart practice.	2015 ABAAS Section: 1016.5, 1016.5 EXCEPTION

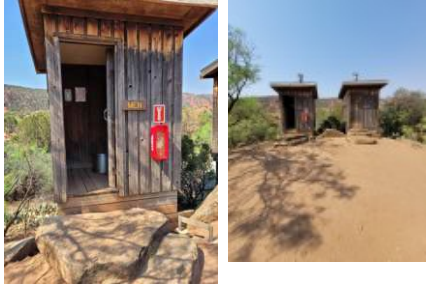
283	Little Red Tent Camping Area: Little Red - Restroom	[34.4421983, -101.0775167]	This restroom is not accessible. Where existing toilet rooms or bathing rooms do not comply, directional signs indicating the location of the nearest accessible toilet room or bathing room within the facility shall be provided. Signs shall include the International Symbol of Accessibility. Where existing toilet rooms or bathing rooms do comply), the accessible toilet rooms or bathing rooms shall be identified by the International Symbol of Where clustered single user toilet rooms or bathing facilities are permitted, accessible toilet rooms or bathing facilities shall be identified by the International Symbol of Accessibility unless all toilet rooms and bathing facilities are accessible.	Lacks signage to accessible park restrooms	Restroom not accessible, acquire and mount signage directing patrons to accessible restroom	2015 ABAAS Section: F216.8 2012 TAS Section: 216.8 2010 ADAS Section: 216.8

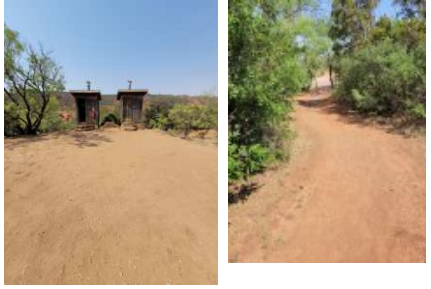
285	Little Red Tent Camping Area: Little Red - Restroom	[34.4421945, -101.0775153]	There is no accessible route to the restrooms. At least one accessible route shall connect accessible buildings, accessible facilities, accessible elements, and accessible spaces that are on the same site.	lacks AR to restrooms from parking	Create an accessible route with crushed stone or other outdoor material from parking or walkway to restrooms.	2015 ABAAS Section: F206.2.2 2012 TAS Section: 206.2.2 2010 ADAS Section: 206.2.2

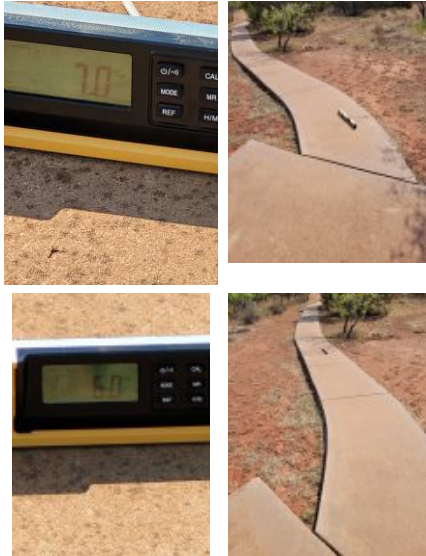
Finding Number	Area Description	Lat/Long	Finding	As Built	Recommendation	Citation	Photos	Figure
290	South Prong Tent Camping Area: South Prong - Restroom	[34.4402843, -101.0946651], [34.4403275, -101.0945994]	The running slope of walking surfaces shall not be steeper than 1:20.	From restrooms to parking - 7%, 6%	Correct running slope along the AR to max 5%.	2015 ABAAS Section: 403.3 2012 TAS Section: 403.3 2010 ADAS Section: 403.3

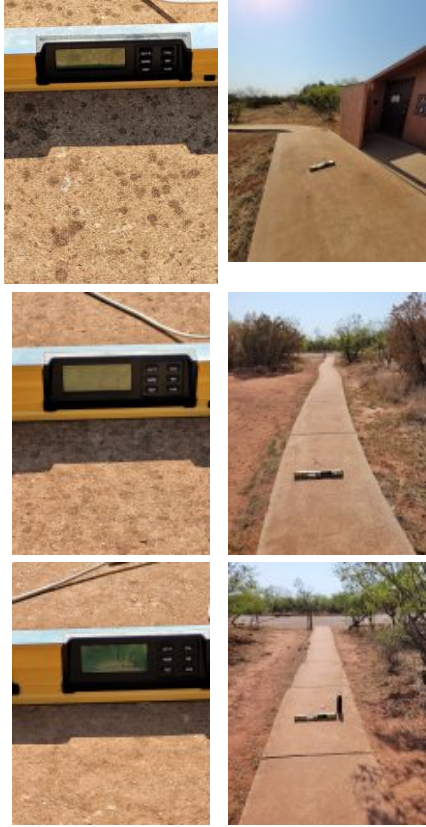
Finding Number	Area Description	Lat/Long	Finding	As Built	Recommendation	Citation	Photos	Figure
291	South Prong Tent Camping Area: South Prong - Restroom	[34.440275, -101.0947241], [34.4404918, -101.0939785]	The accessible route of travel contains cross slopes greater than 2%. Cross slopes shall not exceed one unit vertical in 48 units horizontal (2-percent slope).	From restrooms to parking - 4.4%, 2.3%, 4.6%	Correct or repair cross slope along AR to max 2.08%.	2015 ABAAS Section: 403.3 2012 TAS Section: 403.3 2010 ADAS Section: 403.3

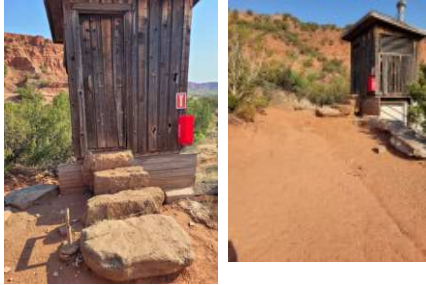
Finding Number	Area Description	Lat/Long	Finding	As Built	Recommendation	Citation	Photos	Figure
293	North Prong: Restroom	[34.4567588 , -101.082304]	The restroom is not compliant. The restroom does not have the required minimum clear floor space or maneuvering clearances for the toilet. The restroom does not have the required minimum clear floor space or maneuvering clearances for the lavatory. The entry door does not contain the required minimum maneuvering spaces on the pull/push sides. The entry door encroach into the required clear floor space for fixtures. Grab bars are missing and/or incorrectly installed. Accessories, such as toilet seat covers, paper towel holders, garbage cans, hand dryers, and mirrors are either too high or without clear floor space or both.	lacks route to restroom, stairs at restroom, no accessible features	Create a compliant wheelchair accessible restroom and correct all features to be accessible if feasible.	2015 ABAAS Section: 603.1 2012 TAS Section: 603.1 2010 ADAS Section: 603.1

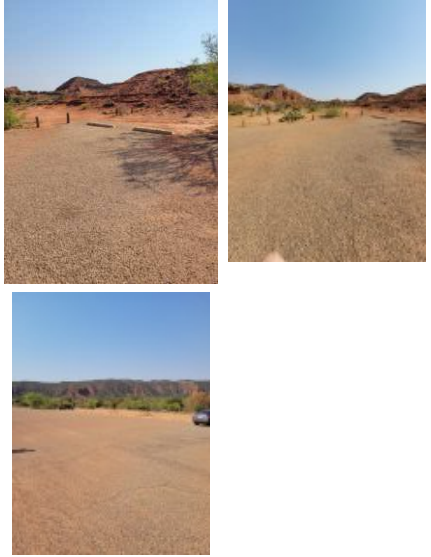
Finding Number	Area Description	Lat/Long	Finding	As Built	Recommendation	Citation	Photos	Figure
296	North Prong: Trailhead	[34.4467023 , -101.0821 893]	There are no accessible parking stalls. Each lot where parking is provided for the public as clients, guests or employees, shall provide accessible parking and shall be located on the shortest accessible route of travel from adjacent parking to an accessible entrance. There are approximately 42 parking stalls in the parking lot that could be reasonably associated with this facility. There should be a minimum of accessible stalls based on the total: 1-25: 1 accessible/1 van 26-35: 2 accessible/1 van 36-50: 3 accessible/1 van 51-100: 4 accessible/1 van 101-300: 8 accessible/2 van 301-500: 12 accessible/2 van 501-800: 16 accessible/3 van 801-1000: 20 accessible/4 van 1001-over: 20 accessible plus 1 for every 100 spaces/1 of every 6 should be a van stall	North prong trailhead - lacks accessible parking - approximately 42 standard, 0 accessible	Create one or more 8' accessible parking stalls, with one 5' adjacent access aisle, with proper signage and striping based on the total number of stalls.	2015 ABAAS Section: F208.2 2010 ADAS Section: 208.2

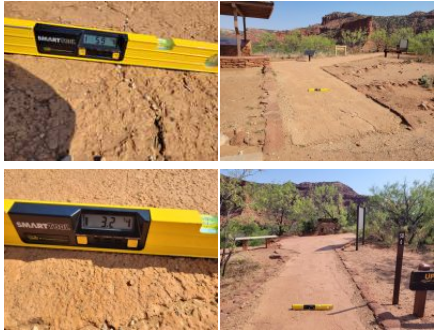
Finding Number	Area Description	Lat/Long	Finding	As Built	Recommendation	Citation	Photos	Figure
303	South Prong: Trailhead	[34.4411773, -101.0929785], [34.4410822, -101.0929772]	The cross slope shall not be steeper than 1:48. EXCEPTION: Where the surface is other than concrete, asphalt, or boards, cross slopes not steeper than 1:20 shall be permitted when necessary for drainage.	5.9% cross slope, 3.2%	Correct or repair ORAR cross slope to max 2.08% or 5% for surfaces other than concrete, asphalt or board as a smart practices	2015 ABAAS Section: 1016.7.2, 1016.7.2 EXCEPTION

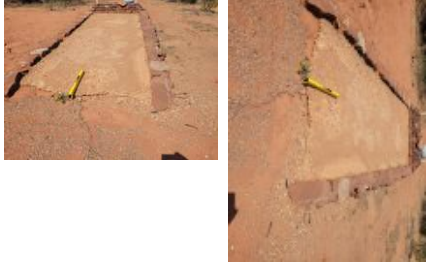
313	Trails: Trailhead	[34.4393109, -101.0701228]	The surface of outdoor recreation access routes, passing spaces, and resting intervals shall be firm and stable.	Deterioration at erosion scenic view sign	Repair surface or ORAR to be firm and stable as a smart practice.	2015 ABAAS Section: 1016.2

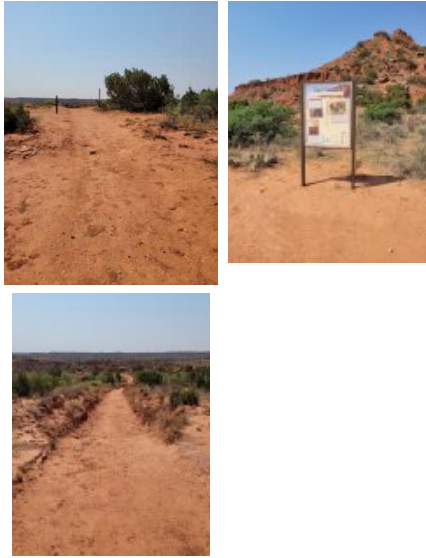
Finding Number	Area Description	Lat/Long	Finding	As Built	Recommendation	Citation	Photos	Figure
315	Trails: Trailhead	[34.4381728, -101.0689416]	The surface of outdoor recreation access routes, passing spaces, and resting intervals shall be firm and stable	Eagle Point Trailhead - lacks route to trailhead signage, natural surface	Repair surface or ORAR to be firm and stable as a smart practice.	2015 ABAAS Section: 1016.2

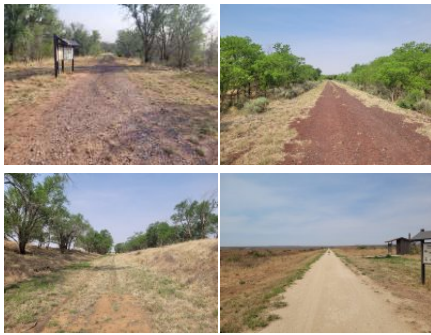
326	Trails: Caprock Canyon Trailway	[34.3723604, -101.059145]	The surface of trails, passing spaces, and resting intervals shall be firm and stable	trail surface varies - natural, gravel, dirt, crushed stone	Replace surface of trail with one that is firm and stable as a smart practice to connect to important site features. Leave as is majority of trail surface and designate park trails as accessible.	2015 ABAAS Section: 1017.2
