# Access Audit Site Report

**Colorado Bend State Park**  
**1201 Colorado Park Road**  
**Bend, TX 76824**  
**Accessibility Evaluation**  
**Inspection Date: 03/02/2022**  
**Inspectors: Tanya Scheibe**

Prepared By  
**WT Group**

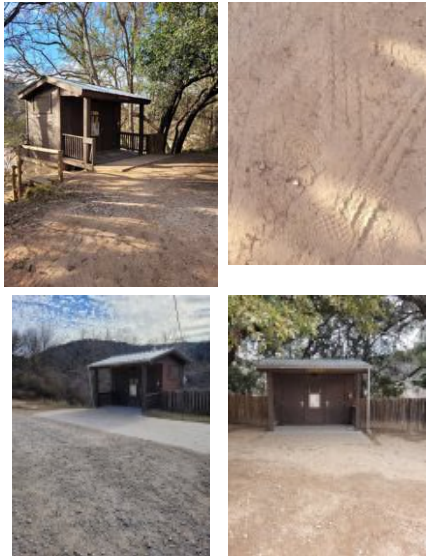
29	1-17 campsites side (Right from HQ) : Exterior Accessible Route in 1-17 Area	[31.0186968 , -98.447305 2]	There is no accessible route to restroom 1, 3, and 4 At least one accessible route shall connect accessible buildings, accessible facilities, accessible elements, and accessible spaces that are on the same site.	no route to restroom 4, no route to restroom 3, no route to restroom 1	Create an accessible route with crushed stone or other outdoor material from parking or walkway to restroom 1, 3, and 4	2015 ABAAS Section: F206.2.2  2012 TAS Section: 206.2.2  2010 ADAS Section: 206.2.2

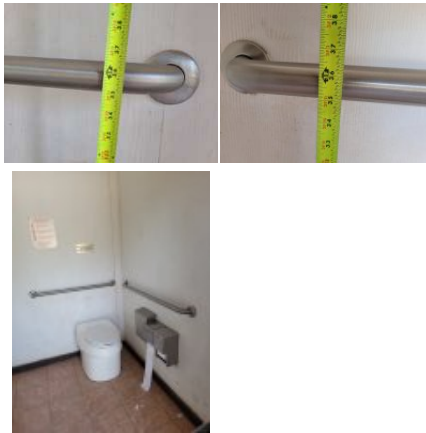
52	1-17 campsites side (Right from HQ) : Women's Restroom 3	[31.0218999 , -98.442824 6]	The grab bar height and/or spacing fails. Grab bars must be mounted between 33" and 36" to the top of the gripping surface. There must be 1.5" of clearance between the grab bar and the wall. There must be a minimum of 1.5" of clearance below and minimum 12" above the grab bar to any dispenser or other obstruction.	both mounted 36.5" aff	Remount grab bars in accessible stall to 33" to 36" above the finished floor (AFF).	2015 ABAAS Section: 609.3, 609.4  2012 TAS Section: 609.4, 609.3  2010 ADAS Section: 609.3, 609.4

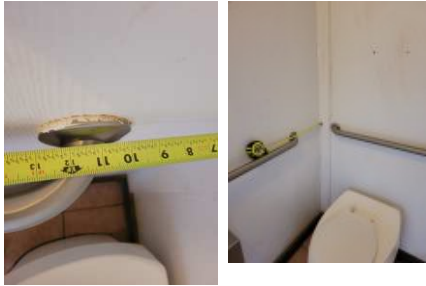
54	1-17 campsites side (Right from HQ) : Men's Restroom 4	[31.0186807 , -98.447341 4]	The side grab bars are not in the correct location. Grab bars on the side wall must be installed so that the end closest to the rear wall is maximum 12" from the rear wall. The end furthest from the rear wall must be mounted minimum 54" from the rear wall.	42" grab bar mounted 11.5" from wall	Remount side grab bar to max 12" from the rear wall at the close end and min 54" on the far end, and 33" to 36" aff.	2015 ABAAS Section: 604.5.1 2012 TAS Section: 604.5.1 2010 ADAS Section: 604.5.1

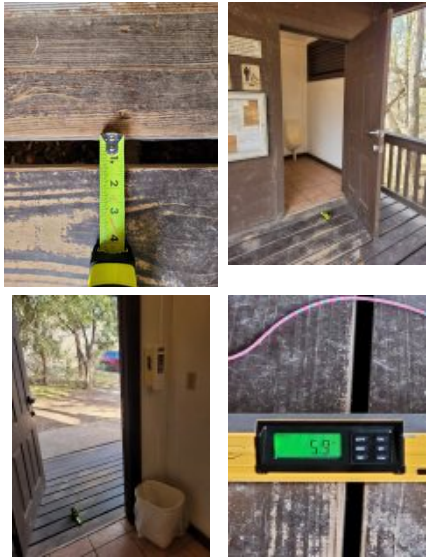
56	1-17 campsites side (Right from HQ) : Men's Restroom 4	[31.0186646 , -98.4473629]	Minimum maneuvering clearances at doors and gates shall comply with 404.2.4. Maneuvering clearances shall extend the full width of the doorway and the required latch side or hinge side clearance. Maneuvering clearances shall have a max slope of 2.08%. The threshold has a vertical change greater than 1/4 inch high.	clearance on push reduced by hand sanitizer and trash, 1.25" gap, 5.9% slope	For all doors along the public circulation route, provide required maneuvering clearance on push and pull side of doors. For all doors along the public circulation route, correct slope in door clearance to max 2.08%. For all doors along the public circulation route, repair, bevel, or ramp CILs at door entries to max .25".	2010 ADAS Section: 404.2.3, 404.2.7, 404.2.4, 404.2.11, 404.2.11 Exception

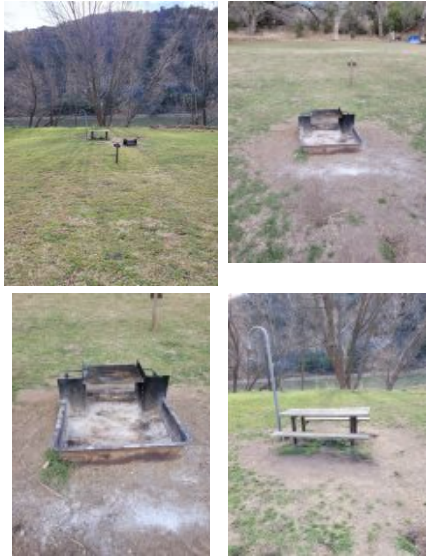
63	1-17 campsites side (Right from HQ) : Campsite 8	[31.0191565 , -98.445176 9]	The surface of outdoor recreation access routes, passing spaces, and resting intervals shall be firm and stable	site 8 - non compliant surface, sample site lacks any accessible features	Repair surface or ORAR to be firm and stable as a smart practice. Create required number of accessible campsites per previous finding.	2015 ABAAS Section: 1016.2

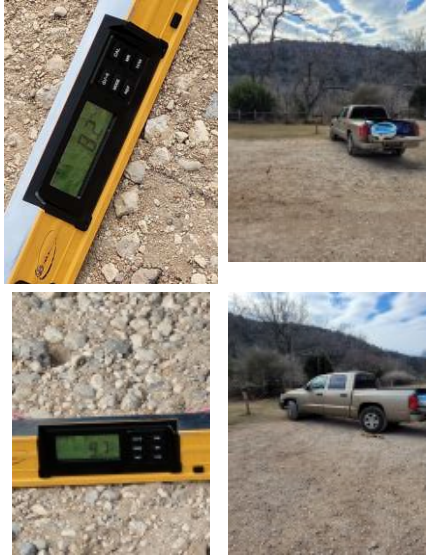
Finding Number	Area Description	Lat/Long	Finding	As Built	Recommendation	Citation	Photos	Figure
64	1-17 campsites side (Right from HQ) : Campsite 8	[31.0191703 , -98.4451796]	The surface of parking spaces and pull-up spaces shall be firm and stable. The slope of the surface of parking spaces and pull-up spaces shall not be steeper than 1:48 in any direction. EXCEPTION: Where the surface is other than asphalt, concrete, or boards, slopes not steeper than 1:20 shall be permitted when necessary for drainage.	site 8 - non accessible/gravel surface, left stall - 8.2% slope, right stall - 9.7% slope	Correct surface of parking spaces at the three new accessible sites to be firm and stable with slopes max of 2.08% or 5% for surfaces other than concrete, asphalt or boards as a smart practice.	2015 ABAAS Section: 1012.4, 1012.5, 1012.5 EXCEPTION

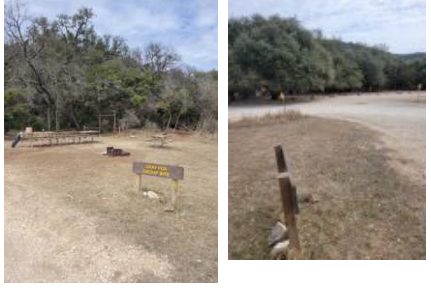
74	18-39 campsites side (Left from HQ): Grey Fox Group Site	[31.0268176 , -98.441003 4]	An accessible access route is not provided between elements, spaces and the facilities provided within the accessible camping unit. At least one outdoor recreation access route shall connect accessible elements, spaces and facilities provided within camping units with mobility features.	Grey Fox - non accessible surface, no amenities connected, bathroom across gravel lot	Create AR with crushed and compacted stone or similar outdoor material to camp sites and one of each type of amenity.	2015 ABAAS Section: F244.5.1

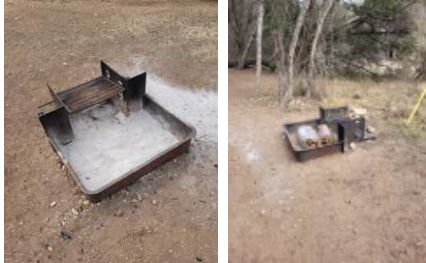
78	18-39 campsites side (Left from HQ): Grey Fox Group Site	[31.0270325, -98.441000 7]	Fire building surfaces shall be 9 inches (230 mm) minimum above the ground.	Grey Fox - fire building surface is ground level, 2 of 2	Correct fire building surface to be 9" min above the ground as a smart practice. In the alternative, replace fire ring with a compliant accessible fire ring.	2015 ABAAS Section: 1011.5.1

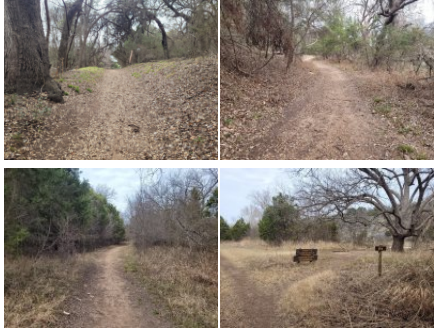
88	18-39 campsites side (Left from HQ): Primitive/ Shelter Campsites	[31.03648, -98.44479]	Camping facilities shall provide camping units with mobility features complying with F244.2 in accordance with Table F244.2. Where a camping facility provides different types of camping units, Table F244.2 shall apply to each type of camping unit provided. Total Number of Camping Units Provided in Camping Facility Minimum Number of Camping Units with Mobility Features Required 1 1 2 to 25 2 26 to 50 3 51 to 75 4 76 to 100 5 101 to 150 7 151 to 200 8 201 and over 8, plus 2 percent of the number over 200	pack in campsites not accessible, steep natural trail to campsites, no amenities	Create the required number of accessible camp sites per table F244.2 as a smart practice. In the alternative, leave as is and make other camp sites accessible.	2015 ABAAS Section: F244.2

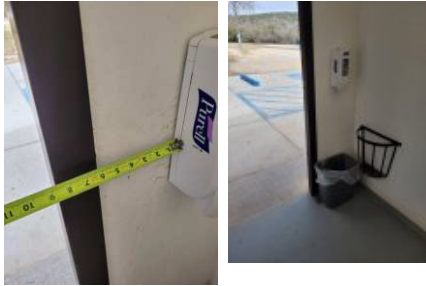
Finding Number	Area Description	Lat/Long	Finding	As Built	Recommendation	Citation	Photos	Figure
92	18-39 campsites side (Left from HQ): Men's Across RV	[31.0242375 , -98.441804]	Minimum maneuvering clearances at doors and gates shall comply with 404.2.4. Maneuvering clearances shall extend the full width of the doorway and the required latch side or hinge side clearance.	Door - hand sanitizer reduces clearance on push to 9", trash in clearance on push	Provide required maneuvering clearance on push side of door Relocate obstacles to provide 48" maneuvering clearance around door.	2015 ABAAS Section: 404.2.4.4, 404.2.4.1  2012 TAS Section: 404.2.4.4, 404.2.4.1  2010 ADAS Section: 404.2.4.4, 404.2.4.1

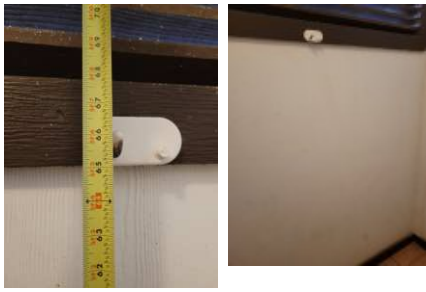
95	18-39 campsites side (Left from HQ): Women's Restroom 1	[31.0263648 , -98.440524 6]	The operable part is positioned too high for either a side or front approach. Where a clear floor or ground space allows a parallel approach to an element and the side reach is unobstructed, the high side reach shall be 48 inches maximum and the low side reach shall be 15 inches minimum above the finish floor or ground. Where a forward reach is unobstructed, the high forward reach shall be 48 inches maximum and the low forward reach shall be 15 inches minimum above the finish floor or ground.	hook 66" AFF	Remount operable parts to be in reach range of 15" min to 48" max	2015 ABAAS Section: 308.1  2012 TAS Section: 308.1  2010 ADAS Section: 308.1

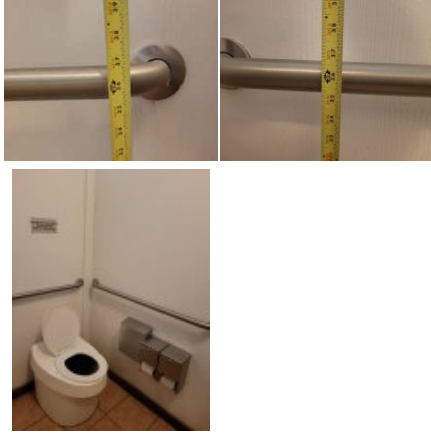
97	18-39 campsites side (Left from HQ): Women's Restroom 1	[31.0264073 , -98.440564 8]	The grab bar height and/or spacing fails. Grab bars must be mounted between 33" and 36" to the top of the gripping surface. There must be 1.5" of clearance between the grab bar and the wall. There must be a minimum of 1.5" of clearance below and minimum 12" above the grab bar to any dispenser or other obstruction.	both 37" AFF	Remount grab bars in accessible stall to 33" to 36" above the finished floor (AFF).	2015 ABAAS Section: 609.3, 609.4  2012 TAS Section: 609.4, 609.3  2010 ADAS Section: 609.3, 609.4

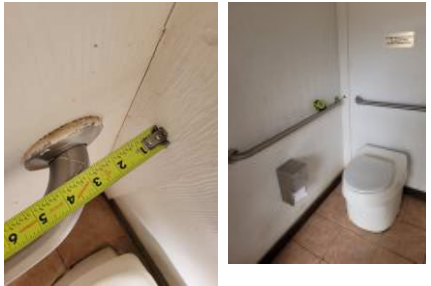
100	18-39 campsites side (Left from HQ): Men's Restroom 1	[31.0264337 , -98.440591 6]	The side grab bars are not in the correct location. Grab bars on the side wall must be installed so that the end closest to the rear wall is maximum 12" from the rear wall. The end furthest from the rear wall must be mounted minimum 54" from the rear wall.	42" grab bar mounted 3" from wall, extends 45" from rear wall to grab bar end	Remount side grab bar to max 12" from the rear wall at the close end and min 54" on the far end, and 33" to 36" aff.	2015 ABAAS Section: 604.5.1  2012 TAS Section: 604.5.1  2010 ADAS Section: 604.5.1

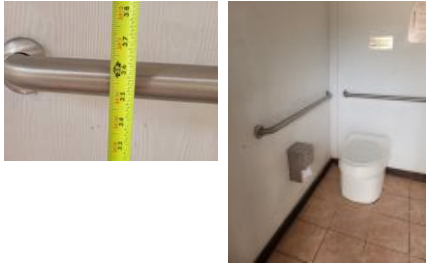
102	18-39 campsites side (Left from HQ): Men's Restroom 1	[31.0264291 , -98.440558 1]	The grab bar height and/or spacing fails. Grab bars must be mounted between 33" and 36" to the top of the gripping surface. There must be 1.5" of clearance between the grab bar and the wall. There must be a minimum of 1.5" of clearance below and minimum 12" above the grab bar to any dispenser or other obstruction.	side grab bar 36.5" AFF	Remount grab bars in accessible stall to 33" to 36" above the finished floor (AFF).	2015 ABAAS Section: 609.3, 609.4  2012 TAS Section: 609.4, 609.3  2010 ADAS Section: 609.3, 609.4

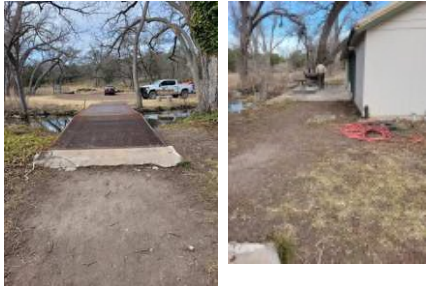
107	Gorman Falls/ Conference Center : Conference Center	[31.0569731 , -98.481860 1]	Spaces and elements within employee work areas shall only be required to comply with 206.2.8, 207.1, and 215.3 and shall be designed and constructed so that individuals with disabilities can approach, enter, and exit the employee work area. Employee work areas, or portions of employee work areas, other than raised courtroom stations, that are less than 300 square feet (28 m2) and elevated 7 inches (180 mm) or more above the finish floor or ground where the elevation is essential to the function of the space shall not be required to comply with these requirements or to be on an accessible route.	no route to center due to surface	For employee spaces, provide an accessible route to entry.	2015 ABAAS Section: F203.9 2012 TAS Section: 203.9 2010 ADAS Section: 203.9

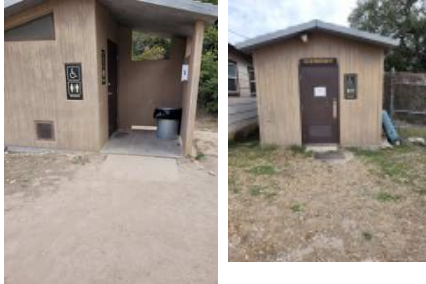
112	Gorman Falls/ Conference Center : Unisex Restroom By Conference Center Entry Gate	[31.0585539, -98.501567 6]	There is no accessible route to the the conference center gate restroom or the restroom at maintenance. At least one accessible route shall connect accessible buildings, accessible facilities, accessible elements, and accessible spaces that are on the same site.	no route to restroom by conference center entry due to surface, no route to maintenance restroom	Create an accessible route with crushed stone or other outdoor material from parking or walkway to conference center gate restroom and the restroom at maintenance.	2015 ABAAS Section: F206.2.2 2012 TAS Section: 206.2.2 2010 ADAS Section: 206.2.2

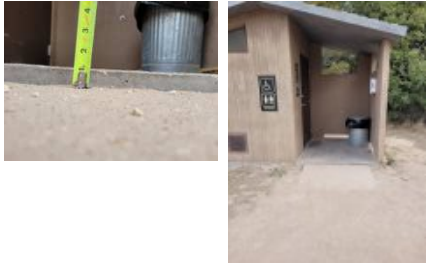
Finding Number	Area Description	Lat/Long	Finding	As Built	Recommendation	Citation	Photos	Figure
113	Gorman Falls/ Conference Center : Unisex Restroom By Conference Center Entry Gate	[31.0585539 , -98.5015596]	The walkway contains abrupt vertical edges and/or variations over a 1/4 inch. 1/4 inch is the maximum vertical rise. Changes in level between 1/4 inch and 1/2 inch must be beveled at 1:2 or less. Changes in level greater than 1/2 inch must be by way of a ramp.	Restroom building by conference center gate - 1" change in level (CIL) at entry	Repair, bevel or ramp CIL along AR	2012 TAS Section: 303.2, 303.3  2010 ADAS Section: 303.2, 303.3

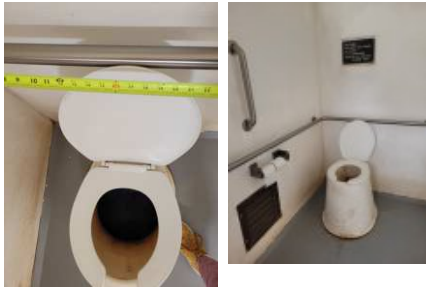
114	Gorman Falls/ Conference Center : Unisex Restroom By Conference Center Entry Gate	[31.0585551 , -98.5015596]	The rear grab bar is not 36" long or is not mounted in the correct location. The rear grab bar must be a minimum of 36" long and extend from the toilet centerline a minimum 12" towards the wall side and a minimum 24" towards the open side of the toilet. Grab bars shall be installed in a horizontal position, 33 inches minimum and 36 inches maximum above the finish floor measured to the top of the gripping surface and the space between the grab bar and the top of the tank shall be 1-1/2 inches minimum.	16" centerline from side wall	Remount rear grab bar to behind the toilet, 12" to one side of center and 24" to the other and 33" to 36" aff	2015 ABAAS Section: 604.5.2  2012 TAS Section: 604.5.2  2010 ADAS Section: 604.5.2

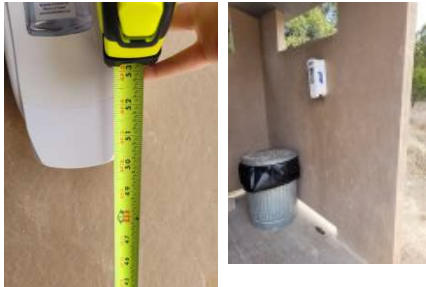
115	Gorman Falls/ Conference Center : Unisex Restroom By Conference Center Entry Gate	[31.0585562 , -98.501565]	The operable part is positioned too high for either a side or front approach. Where a clear floor or ground space allows a parallel approach to an element and the side reach is unobstructed, the high side reach shall be 48 inches maximum and the low side reach shall be 15 inches minimum above the finish floor or ground. Where a forward reach is unobstructed, the high forward reach shall be 48 inches maximum and the low forward reach shall be 15 inches minimum above the finish floor or ground.	hand sanitizer - 50" AFF	Remount operable parts to be in reach range of 15" min to 48" max	2015 ABAAS Section: 308.1  2012 TAS Section: 308.1  2010 ADAS Section: 308.1

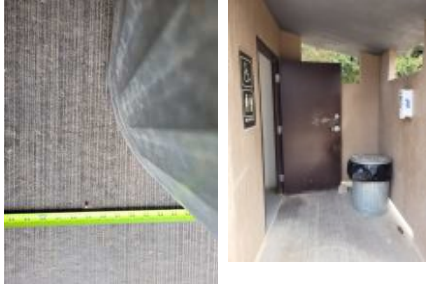
Finding Number	Area Description	Lat/Long	Finding	As Built	Recommendation	Citation	Photos	Figure
116	Gorman Falls/ Conference Center : Unisex Restroom By Conference Center Entry Gate	[31.0585608 , -98.5015623]	Minimum maneuvering clearances at doors and gates shall comply with 404.2.4. Maneuvering clearances shall extend the full width of the doorway and the required latch side or hinge side clearance.	Door - trash in back clearance on pull 40"	Relocate storage, furniture and other obstacles to create 60" maneuvering clearance around door	2015 ABAAS Section: 404.2.4.1 , 404.2.4.4  2012 TAS Section: 404.2.4.4, 404.2.4.1  2010 ADAS Section: 404.2.4.4, 404.2.4.1

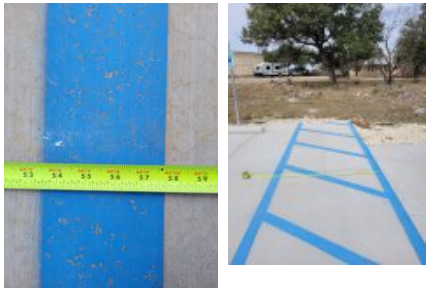
118	Maintenance/ Police : Maintenance/ Police - Parking	[31.0519329 , -98.500791 1]	The access aisle is not a minimum 5 feet wide. A car accessible parking stall's access aisle must be a minimum of 5 feet wide measured from centerline to centerline. Where the access aisle is not adjacent to another parking space or access aisle, measurements shall be permitted to include the full width of the line defining the access aisle.	police parking - 56" width access aisle, space provided, just needs repainted	Repaint access aisles to be 5' each	2015 ABAAS Section: 502.3.1  2012 TAS Section: 502.3.1  2010 ADAS Section: 502.3.1

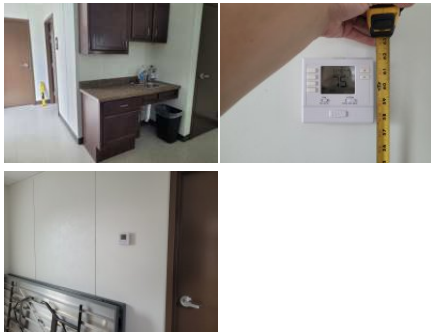
119	Maintenance/ Police : Law Enforcement Building	[31.0519892 , -98.500583 3]	Element meets all standards and requirements	both law enforcement offices comply	None	2010 ADAS Section: N/A		
120	Maintenance/ Police : Law Enforcement Building	[31.0519754 , -98.500599 4]	The operable part is positioned too high for either a side or front approach. Where a clear floor or ground space allows a parallel approach to an element and the side reach is unobstructed, the high side reach shall be 48 inches maximum and the low side reach shall be 15 inches minimum above the finish floor or ground. Where a forward reach is unobstructed, the high forward reach shall be 48 inches maximum and the low forward reach shall be 15 inches minimum above the finish floor or ground.	thermostat 61" AFF	Remount operable parts to be in reach range of 15" min to 48" max	2015 ABAAS Section: 308.1  2012 TAS Section: 308.1  2010 ADAS Section: 308.1

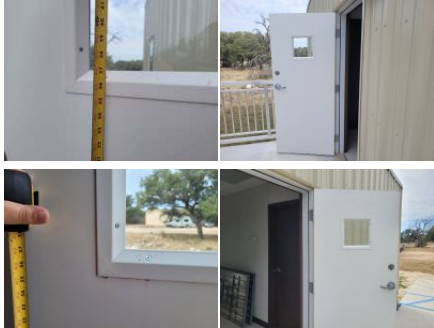
122	Maintenance/ Police : Law Enforcement Building	[31.05243, -98.50056]	The vision light panels (glazing/window) are mounted too high. Doors, gates, and side lights adjacent to doors or gates, containing one or more glazing panels that permit viewing through the panels shall have the bottom of at least one glazed panel located 43 inches maximum above the finish floor.	both entry doors - windows 57" AFF	Replace doors with ones having sidelight viewing windows max 43" aff	2015 ABAAS Section: 404.2.11 2012 TAS Section: 404.2.11 2010 ADAS Section: 404.2.11

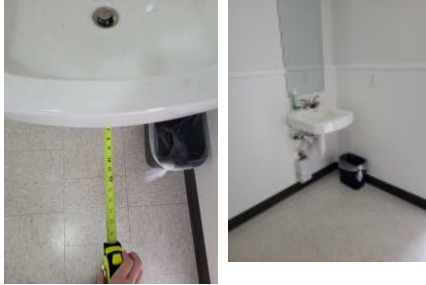
Finding Number	Area Description	Lat/Long	Finding	As Built	Recommendation	Citation	Photos	Figure
123	Maintenance/ Police : Law Enforcement Building	[31.0519754 , -98.500647 6]	Knee clearance at 27 inches off the floor is not 8 inches minimum deep. The knee clearance, measured from the bottom of the apron or the outside bottom edge of the lavatory, must be 27 inches at a point located 8 inches back from the front edge and continuing to 11 inches minimum in depth at 9 inches above the floor. The top of the lavatory rim may be no higher than 34 inches.	police restroom - 7" knee clearance at sink	Replace sink with one providing 27" knee clearance that is a min 8" deep	2015 ABAAS Section: 306.3.1, 306.3.2, 306.3.3, 306.3.4 , 306.3.5  2012 TAS Section: 306.3.2, 306.3.3, 306.3.4, 306.3.5, 306.3.1  2010 ADAS Section: 306.3.3, 306.3.2, 306.3.4, 306.3.5, 306.3.1

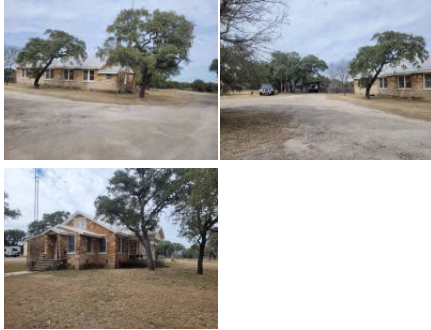
Finding Number	Area Description	Lat/Long	Finding	As Built	Recommendation	Citation	Photos	Figure
125	Maintenance/ Police : Residence	[31.05241, -98.50086]	There is no accessible route between the buildings. At least one accessible route shall connect accessible buildings, facilities, elements and spaces that are on the same site.	residence has CIL to enter, gravel driveway	Create an accessible route with crushed and compacted stone or similar outdoor material to building within the site. Provide a ramp for access into the house upon request.	2015 ABAAS Section: F206.2.2  2012 TAS Section: 206.2.2  2010 ADAS Section: 206.2.2

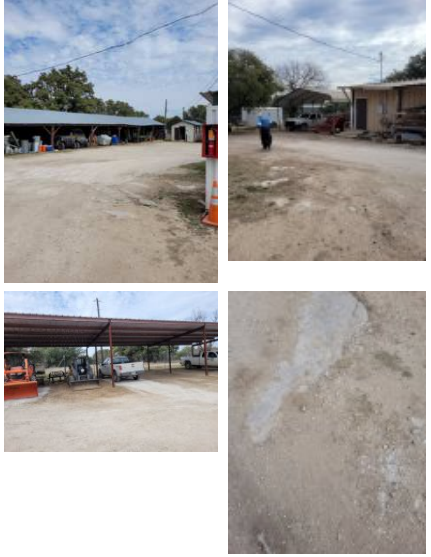
126	Maintenance/ Police : Maintenance	[31.0518054, -98.5008354]	There is no accessible route to the car ports. At least one accessible route shall connect accessible buildings, accessible facilities, accessible elements, and accessible spaces that are on the same site.	no route to 3 of 3 car ports at maintenance due to surface	Create an accessible route with crushed stone or other outdoor material from parking or walkway to employee work areas.	2015 ABAAS Section: F206.2.2  2012 TAS Section: 206.2.2  2010 ADAS Section: 206.2.2

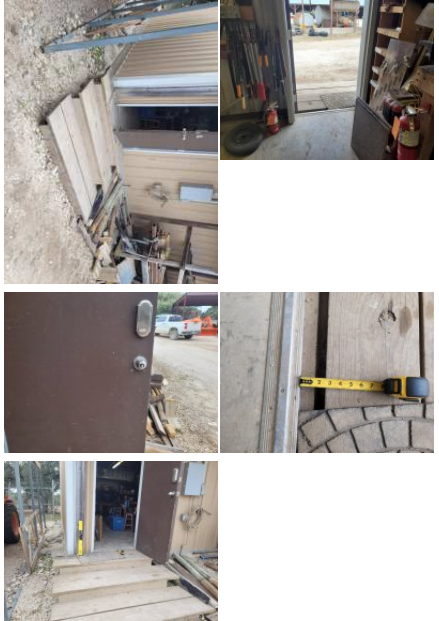
Finding Number	Area Description	Lat/Long	Finding	As Built	Recommendation	Citation	Photos	Figure
127	Maintenance/ Police : Maintenance	[31.0516572 , -98.500654 3]	Spaces and elements within employee work areas shall only be required to comply with 206.2.8, 207.1, and 215.3 and shall be designed and constructed so that individuals with disabilities can approach, enter, and exit the employee work area. Employee work areas, or portions of employee work areas, other than raised courtroom stations, that are less than 300 square feet (28 m2) and elevated 7 inches (180 mm) or more above the finish floor or ground where the elevation is essential to the function of the space shall not be required to comply with these requirements or to be on an accessible route.	shop - steps pull side, storage push side, knob, gap	For employee spaces, relocate storage, furniture, and other obstacles at doorways to provide approach, enter and exit at the employee space. Provide required maneuvering clearance on push and pull side of doors. Ramp steps at door entries to max .25". Fill gaps at door entries to max .5". Replace hardware with lever hardware or hardware operable without a tight pinch or grasp.	2015 ABAAS Section: F203.9  2012 TAS Section: 203.9  2010 ADAS Section: 203.9

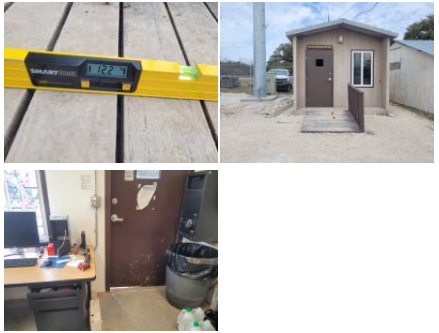
128	Maintenance/ Police : Maintenance	[31.0518019 , -98.500624 8]	Spaces and elements within employee work areas shall only be required to comply with 206.2.8, 207.1, and 215.3 and shall be designed and constructed so that individuals with disabilities can approach, enter, and exit the employee work area. Employee work areas, or portions of employee work areas, other than raised courtroom stations, that are less than 300 square feet (28 m2) and elevated 7 inches (180 mm) or more above the finish floor or ground where the elevation is essential to the function of the space shall not be required to comply with these requirements or to be on an accessible route.	office - 12.2% slope, change in level (CIL) at base of ramp, desk push side	For employee spaces, relocate storage, furniture, and other obstacles at doorways to provide approach, enter and exit at the employee space. Provide required maneuvering clearance on push and pull side of doors. Correct slope in door clearance to max 2.08%. Repair, bevel, or ramp CILs at ramp entries to max .25". Fill gaps at door entries to max .5".	2015 ABAAS Section: F203.9  2012 TAS Section: 203.9  2010 ADAS Section: 203.9

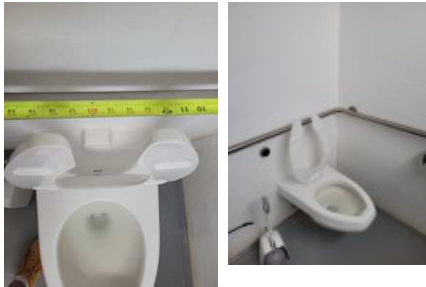
132	Maintenance/ Police : Maintenance	[31.0519685 , -98.500425]	The rear grab bar is not 36" long or is not mounted in the correct location. The rear grab bar must be a minimum of 36" long and extend from the toilet centerline a minimum 12" towards the wall side and a minimum 24" towards the open side of the toilet. Grab bars shall be installed in a horizontal position, 33 inches minimum and 36 inches maximum above the finish floor measured to the top of the gripping surface and the space between the grab bar and the top of the tank shall be 1-1/2 inches minimum.	rear grab bar 15" from side partition to center of toilet	Remount rear grab bar to behind the toilet, 12" to one side of center and 24" to the other and 33" to 36" aff	2015 ABAAS Section: 604.5.2  2012 TAS Section: 604.5.2  2010 ADAS Section: 604.5.2

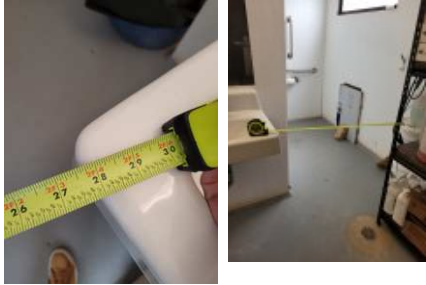
Finding Number	Area Description	Lat/Long	Finding	As Built	Recommendation	Citation	Photos	Figure
134	Maintenance/ Police : Maintenance	[31.0519881 , -98.500427 7]	The route of travel at this location does not provide a minimum width of 36 inches. The clear width shall be permitted to be reduced to 32 inches minimum for a length of 24 inches maximum provided that reduced width segments are separated by segments that are 48 inches long minimum and 36 inches wide minimum.	28" width within restroom due to cleaning supplies	Widen AR to compliant 36" clear width.	2015 ABAAS Section: 403.5.1  2012 TAS Section: 403.5.1  2010 ADAS Section: 403.5.1

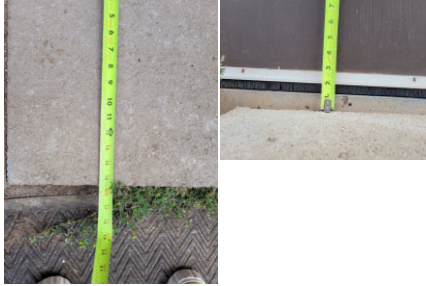
136	Maintenance/ Police : Maintenance	[31.0519915 , -98.500423 7]	Minimum maneuvering clearances at doors and gates shall comply with 404.2.4. Maneuvering clearances shall extend the full width of the doorway and the required latch side or hinge side clearance. Maneuvering clearances shall have a max slope of 2.08%. The threshold has a gap greater than 1/2 inch wide.	Entry door - 15.5" clearance on pull on backside due to surface, 1" change in level (CIL)	For all doors along the public circulation route, provide required maneuvering clearance on push and pull side of doors. For all doors along the public circulation fill gaps at door entries to max .5".	2010 ADAS Section: 404.2.3, 404.2.7, 404.2.4, 404.2.11, 404.2.11 Exception
