Access Audit Site Report

Cooper Lake State Park - South Sulphur Unit

Accessibility Evaluation

Inspection Date: 10/19/2021

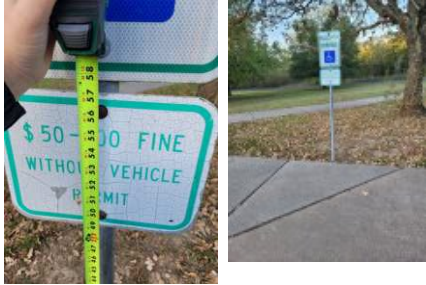
Finding Number	Area Description	Lat/Long	Finding	As Built	Recommendation	Citation	Photos	Figure
3	Headquarters Area: HQ Parking	[33.2879067 , -95.6581179]	The parking sign is mounted too low. Parking space identification signs shall include the International Symbol of Accessibility complying with. Signs identifying van parking spaces shall contain the designation "van accessible." Signs shall be 60 inches minimum above the finish floor or ground surface measured to the bottom of the sign.	sign 58" above ground level (agl)	Raise existing accessible parking signs so lowest end of bottom sign is min 60" agl	2015 ABAAS Section: 502.6 2012 TAS Section: 502.6 2010 ADAS Section: 502.6

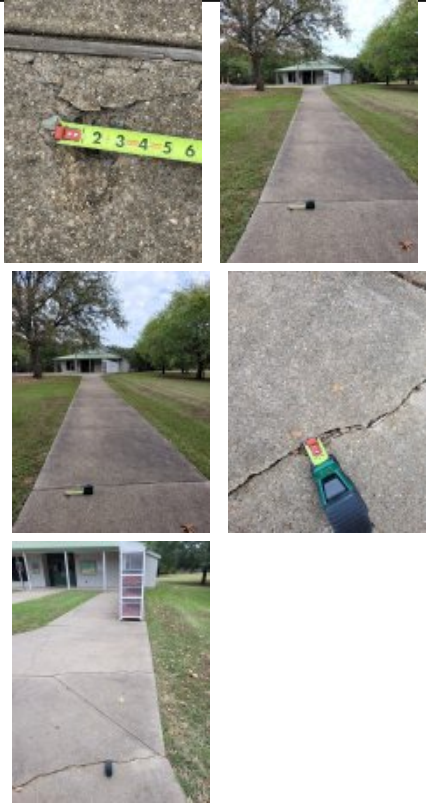
Finding Number	Area Description	Lat/Long	Finding	As Built	Recommendation	Citation	Photos	Figure
6	Headquarters Area: HQ Exterior Accessible Route	[33.2879605, -95.658248]	There is a gap spaced greater than a 1/2 inch. Openings in floor or ground surfaces shall not allow passage of a sphere more than 1/2 inch diameter. Elongated openings shall be placed so that the long dimension is perpendicular to the dominant direction of travel.	1" gap along side lot, 1" gap by accessible parking on side, on residence end in center of path - 1" gap, .75" gap at left corner of path, 3" gap going towards firewood lockers at corner, .75" gap at corner by firewood	Correct or fill gaps to be max .5"	2015 ABAAS Section: 302.3 2012 TAS Section: 302.3 2010 ADAS Section: 302.3

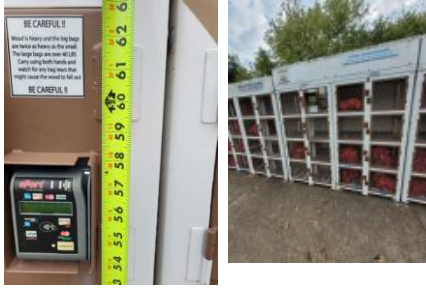
8	Headquarters Area: HQ Exterior Accessible Route	[33.2877789, -95.658075]	The clear floor space only allows for a forward approach and the element is out of reach range. Where a forward reach is unobstructed, the high forward reach shall be 48 inches maximum and the low forward reach shall be 15 inches minimum above the finish floor or ground.	58" aff to cards swipe for firewood	Lower operable part to 48 inches maximum.	2015 ABAAS Section: 308.2.1 2012 TAS Section: 308.2.1 2010 ADAS Section: 308.2.1

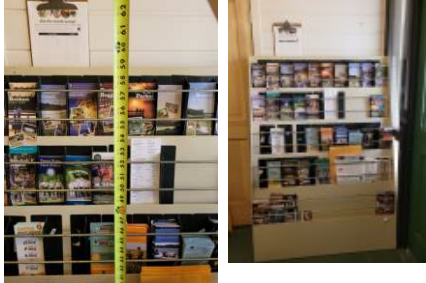
16	Headquarters Area: HQ Building	[33.2877543 , -95.657924 8]	The operable part is positioned too high for either a side or front approach. Where a clear floor or ground space allows a parallel approach to an element and the side reach is unobstructed, the high side reach shall be 48 inches maximum and the low side reach shall be 15 inches minimum above the finish floor or ground. Where a forward reach is unobstructed, the high forward reach shall be 48 inches maximum and the low forward reach shall be 15 inches minimum above the finish floor or ground.	58" aff to top brochures	Remount operable parts to be in reach range of 15" min to 48" max	2015 ABAAS Section: 308.1 2012 TAS Section: 308.1 2010 ADAS Section: 308.1

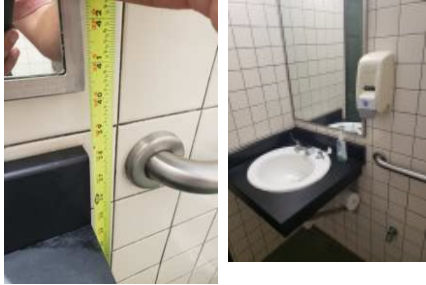
Finding Number	Area Description	Lat/Long	Finding	As Built	Recommendation	Citation	Photos	Figure
20	Headquarters Area: HQ Mens Restrooms	[33.2877318 , -95.657916 7]	The mirror is mounted too high. Mirrors must have the bottom edge of the reflecting surface a maximum of 40 inches above the floor if above a sink or counter. Mirrors not located above lavatories or countertops shall be installed with the bottom edge of the reflecting surface 35 inches maximum above the finish floor or ground.	mirrors 41" aff	Lower mirror so reflective surface is max 40" aff	2015 ABAAS Section: 603.3 2012 TAS Section: 603.3 2010 ADAS Section: 603.3

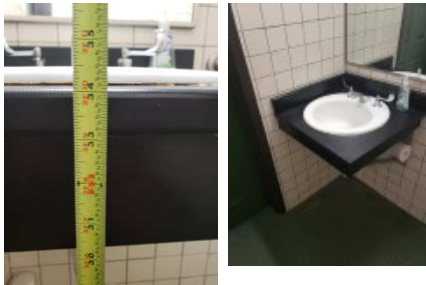
21	Headquarters Area: HQ Mens Restrooms	[33.2877274 , -95.657903 3]	The top rim of the sink is too high. All lavatories/sinks that are designated to be accessible shall be a minimum 17 inches in horizontal depth and mounted with the rim or counter edge no higher than 34 inches above the finished floor.	rim of sink - 34.5" aff	Lower sinks to max 34" aff to front of rim	2015 ABAAS Section: 606.3 2012 TAS Section: 606.3 2010 ADAS Section: 606.3

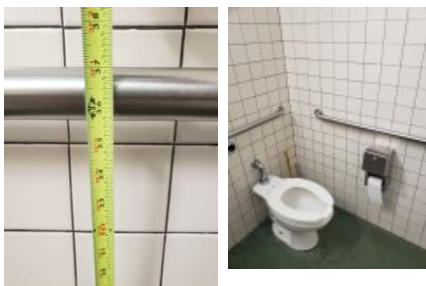
22	Headquarters Area: HQ Mens Restrooms	[33.2877588 , -95.657908 7]	The grab bar height and/or spacing fails. Grab bars must be mounted between 33" and 36" to the top of the gripping surface. There must be 1.5" of clearance between the grab bar and the wall. There must be a minimum of 1.5" of clearance below and minimum 12" above the grab bar to any dispenser or other obstruction.	grip surface 37" above finished floor (aff)	Remount grab bars in accessible stall to 33" to 36" aff	2015 ABAAS Section: 609.3, 609.4 2012 TAS Section: 609.4, 609.3 2010 ADAS Section: 609.3, 609.4

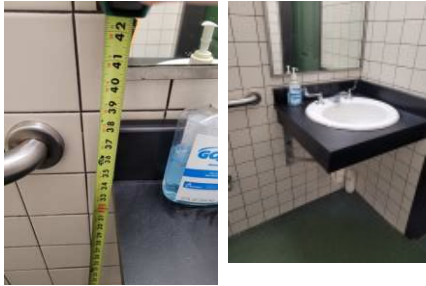
Finding Number	Area Description	Lat/Long	Finding	As Built	Recommendation	Citation	Photos	Figure
26	Headquarters Area: HQ Womens Restroom	[33.2877498 , -95.657930 1]	The mirror is mounted too high. Mirrors must have the bottom edge of the reflecting surface a maximum of 40 inches above the floor if above a sink or counter. Mirrors not located above lavatories or countertops shall be installed with the bottom edge of the reflecting surface 35 inches maximum above the finish floor or ground.	mirror 41" aff	Lower mirror so reflective surface is max 40" aff	2015 ABAAS Section: 603.3 2012 TAS Section: 603.3 2010 ADAS Section: 603.3

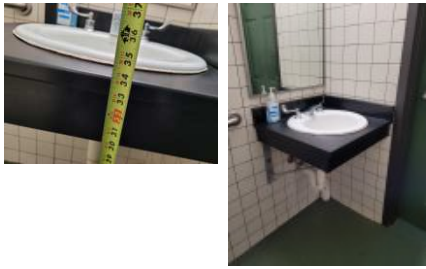
27	Headquarters Area: HQ Womens Restroom	[33.2877632 , -95.657919 4]	The top rim of the sink is too high. All lavatories/sinks that are designated to be accessible shall be a minimum 17 inches in horizontal depth and mounted with the rim or counter edge no higher than 34 inches above the finished floor.	Sink rim at 35" aff	Lower sinks to max 34" aff to front of rim	2015 ABAAS Section: 606.3 2012 TAS Section: 606.3 2010 ADAS Section: 606.3

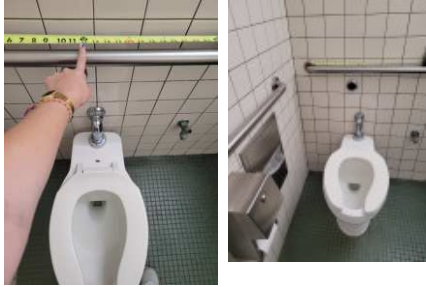
28	Headquarters Area: HQ Womens Restroom	[33.2877318 , -95.657924 8]	The rear grab bar is not 36" long or is not mounted in the correct location. The rear grab bar must be a minimum of 36" long and extend from the toilet centerline a minimum 12" towards the wall side and a minimum 24" towards the open side of the toilet. Grab bars shall be installed in a horizontal position, 33 inches minimum and 36 inches maximum above the finish floor measured to the top of the gripping surface and the space between the grab bar and the top of the tank shall be 1-1/2 inches minimum.	13" at toilet centerline, lacks 24" to open side	Remount rear grab bar to behind the toilet, 12" to one side of center and 24" to the other and 33" to 36" aff	2015 ABAAS Section: 604.5.2 2012 TAS Section: 604.5.2 2010 ADAS Section: 604.5.2

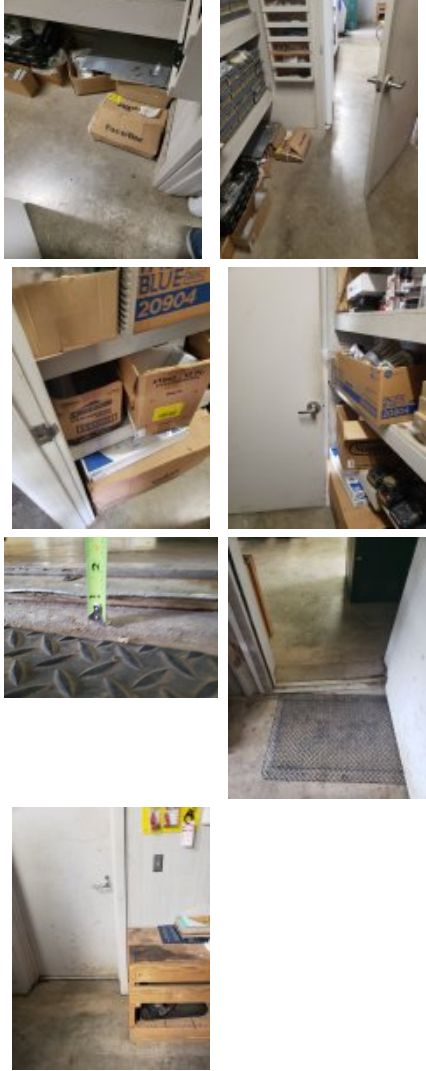
Finding Number	Area Description	Lat/Long	Finding	As Built	Recommendation	Citation	Photos	Figure
35	Employee Spaces: Maintenance	[33.2838417 , -95.671963 4]	Spaces and elements within employee work areas shall only be required to comply with 206.2.8, 207.1, and 215.3 and shall be designed and constructed so that individuals with disabilities can approach, enter, and exit the employee work area. Employee work areas, or portions of employee work areas, other than raised courtroom stations, that are less than 300 square feet (28 m2) and elevated 7 inches (180 mm) or more above the finish floor or ground where the elevation is essential to the function of the space shall not be required to comply with these requirements or to be on an accessible route.	Front door - 1" gap, 5.2% slope, 6% slope, loose mat; office door - desk in pull side clearance; storage door right - box in pull side clearance; storage door left - shelves in pull side clearance; door to garage - 1" CIL, 20lbf, box in pull side clearance	For employee spaces, relocate storage, furniture, and other obstacles at doorways to provide approach, enter and exit at the employee space. Secure rug at door to prevent trip hazard. Correct slope in door clearance to max 2.08%. Repair, bevel, or ramp CILs at door entries to max .25". Fill gaps at door entries to max .5". Inspect, adjust, and maintain 5 lbf to open interior doors.	2015 ABAAS Section: F203.9 2012 TAS Section: 203.9 2010 ADAS Section: 203.9

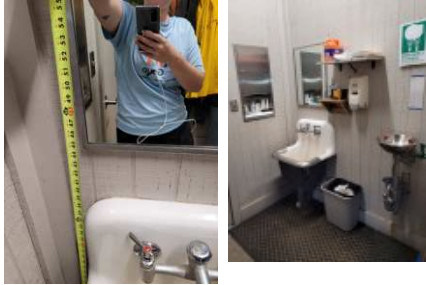
Finding Number	Area Description	Lat/Long	Finding	As Built	Recommendation	Citation	Photos	Figure
39	Employee Spaces: Maintenance	[33.283808, -95.672017 1]	The mirror is mounted too high. Mirrors must have the bottom edge of the reflecting surface a maximum of 40 inches above the floor if above a sink or counter. Mirrors not located above lavatories or countertops shall be installed with the bottom edge of the reflecting surface 35 inches maximum above the finish floor or ground.	mirror 45" aff	Lower mirror so reflective surface is max 40" aff	2015 ABAAS Section: 603.3 2012 TAS Section: 603.3 2010 ADAS Section: 603.3

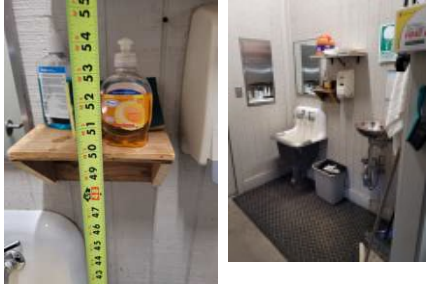
Finding Number	Area Description	Lat/Long	Finding	As Built	Recommendation	Citation	Photos	Figure
41	Employee Spaces: Maintenance	[33.283826, -95.671963 4]	Where a high forward reach is over an obstruction, the clear floor space shall extend beneath the element for a distance not less than the required reach depth over the obstruction. The high forward reach shall be 48 inches (1220 mm) maximum where the reach depth is 20 inches (510 mm) maximum. Where the reach depth exceeds 20 inches (510 mm), the high forward reach shall be 44 inches (1120 mm) maximum and the reach depth shall be 25 inches (635 mm) maximum. Where a clear floor or ground space allows a parallel approach to an element and the high side reach is over an obstruction, the height of the obstruction shall be 34 inches (865 mm) maximum and the depth of the obstruction shall be 24 inches (610 mm) maximum. The high side reach shall be 48 inches (1220 mm) maximum for a reach depth of 10 inches (255 mm) maximum. Where the reach depth exceeds 10 inches (255 mm), the high side reach shall be 46 inches (1170 mm) maximum for a reach depth of 24 inches (610 mm) maximum.	soap - 50" aff	Lower soap to max 44" aff for a forward reach over obstruction	2015 ABAAS Section: 308.2.1, 308.3.2 2012 TAS Section: 308.2.1, 308.3.2 2010 ADAS Section: 308.2.1, 308.3.2

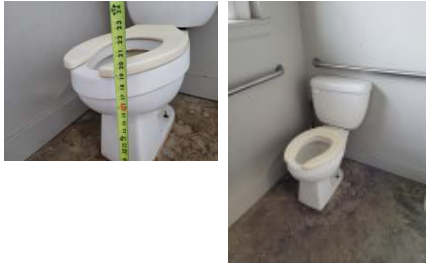
Finding Number	Area Description	Lat/Long	Finding	As Built	Recommendation	Citation	Photos	Figure
43	Employee Spaces: Maintenance	[33.2838305, -95.6719688]	The toilet seat is not located within the range allowed off the floor. The height of accessible water closets shall be a minimum of 17 inches and a maximum of 19 inches measured to the top of a maximum 2-inch high toilet seat.	toilet 20" aff	Replace toilet seat, or re-set or replace toilet to 17" to 19" aff	2015 ABAAS Section: 604.4 2012 TAS Section: 604.4 2010 ADAS Section: 604.4

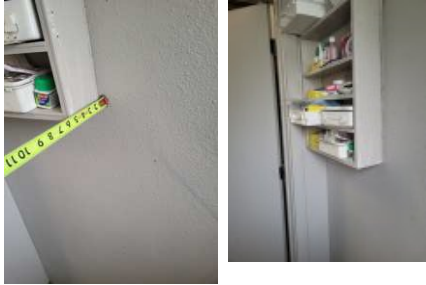
Finding Number	Area Description	Lat/Long	Finding	As Built	Recommendation	Citation	Photos	Figure
46	Employee Spaces: Maintenance	[33.2838193 , -95.6719608]	The shelf projects more than 4 inches into the circulation path. Wall-mounted objects that have leading edges between 27 inches and 80 inches from the floor must not project more than 4 inches into the circulation path. Protruding objects that extend to the floor or within 27 inches of the floor are cane detectable and are therefore not hazardous. Where it is necessary or desirable to have objects protrude from the wall, a manner of cane detection must be provided.	shelf protrudes 5"	Relocate protruding objects or place cane detectable warning or bollard at foot of item	2015 ABAAS Section: 307.2 2012 TAS Section: 307.2 2010 ADAS Section: 307.2

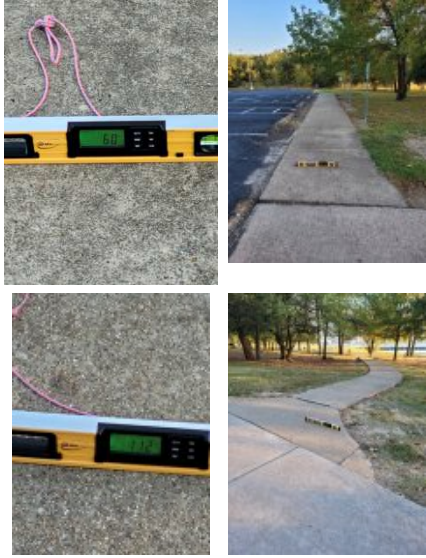
56	Heron Harbor Day Use Area: HH - Exterior Accessible Route	[33.2923606, -95.652732], [33.2922451, -95.652394]	The accessible route of travel on the accessible route contains cross slopes greater than 2%. Cross slopes shall not exceed one unit vertical in 48 units horizontal (2-percent slope).	6% slope on sidewalk along accessible parking. turn between picnic from lot closer to playground - 11.2% slope	Correct or repair cross slope along AR to max 2.08%	2015 ABAAS Section: 403.3 2012 TAS Section: 403.3 2010 ADAS Section: 403.3

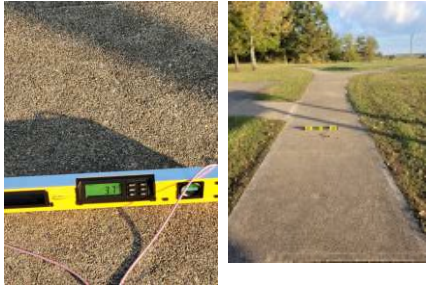
Finding Number	Area Description	Lat/Long	Finding	As Built	Recommendation	Citation	Photos	Figure
57	Heron Harbor Day Use Area: HH - Exterior Accessible Route	[33.2928202 , -95.652359 2]	The accessible route of travel on the accessible route contains cross slopes greater than 2%. Cross slopes shall not exceed one unit vertical in 48 units horizontal (2-percent slope).	3.7% cross slope on path by basketball court	Correct or repair cross slope along AR to max 2.08%	2015 ABAAS Section: 403.3 2012 TAS Section: 403.3 2010 ADAS Section: 403.3

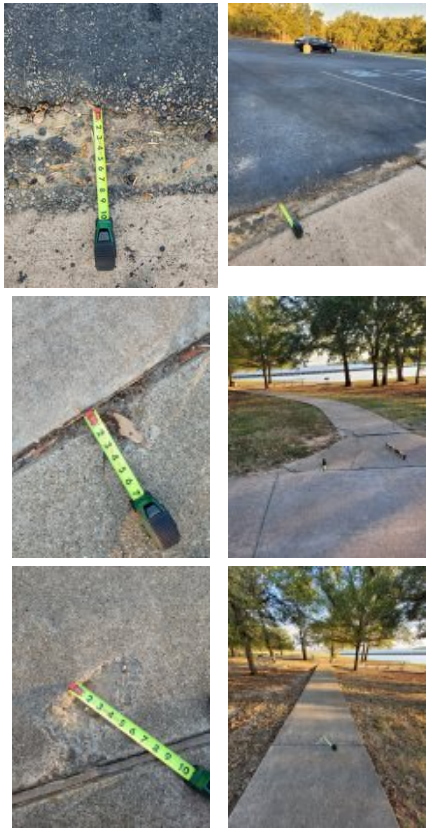
58	Heron Harbor Day Use Area: HH - Exterior Accessible Route	[33.2922317 , -95.65242 62], [33.2933448 , -95.652325 6]	There is a gap spaced greater than a 1/2 inch. Openings in floor or ground surfaces shall not allow passage of a sphere more than 1/2 inch diameter. Elongated openings shall be placed so that the long dimension is perpendicular to the dominant direction of travel.	8" gap from lot to path. where path/sidewalk turns towards lake and picnic - 4" gap at turn. between picnic - 4" gap. 2nd single covered picnic from dam - 2" gap on path in front. after 2nd single shelter to dam 2" gap on path. 1" gap on top corner by dam. in front of wood short pier in cove - 1.5" gap	Correct or fill gaps to be max .5"	2015 ABAAS Section: 302.3 2012 TAS Section: 302.3 2010 ADAS Section: 302.3

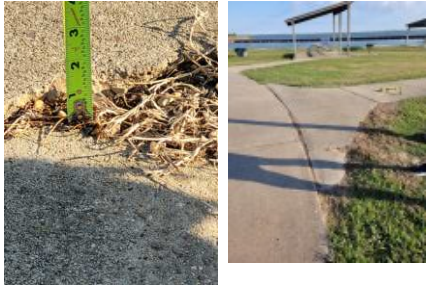
Finding Number	Area Description	Lat/Long	Finding	As Built	Recommendation	Citation	Photos	Figure
63	Heron Harbor Day Use Area: HH - Exterior Accessible Route	[33.2918763, -95.6517825]	The walkway contains abrupt vertical edges and/or variations over a 1/4 inch. 1/4 inch is the maximum vertical rise. Changes in level between 1/4 inch and 1/2 inch must be beveled at 1:2 or less. Changes in level greater than 1/2 inch must be by way of a ramp.	2" CIL at turn to swimming by swing side	Repair, bevel or ramp CIL along AR	2012 TAS Section: 303.2, 303.3 2010 ADAS Section: 303.2, 303.3

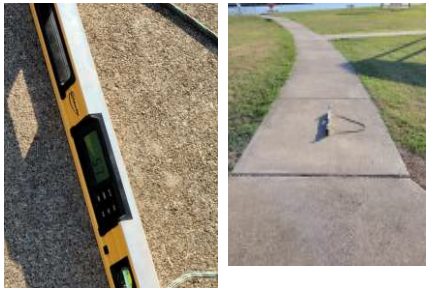
64	Heron Harbor Day Use Area: HH - Exterior Accessible Route	[33.2918786, -95.6517677]	The running slope of walking surfaces shall not be steeper than 1:20.	5.7% slope on path to swimming	Correct running slope along the AR to max 5%	2015 ABAAS Section: 403.3 2012 TAS Section: 403.3 2010 ADAS Section: 403.3

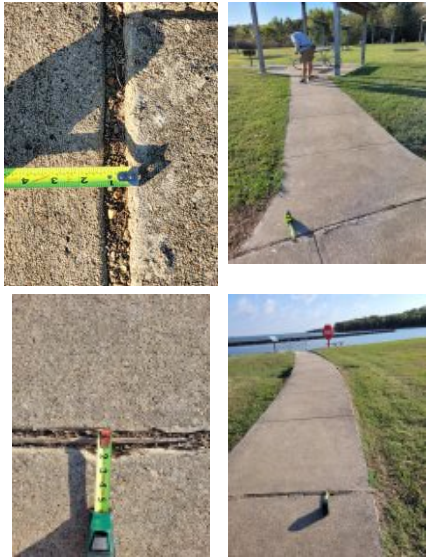
65	Heron Harbor Day Use Area: HH - Exterior Accessible Route	[33.2918999, -95.6516953], [33.2919638, -95.6515867]	There is a gap spaced greater than a 1/2 inch. Openings in floor or ground surfaces shall not allow passage of a sphere more than 1/2 inch diameter. Elongated openings shall be placed so that the long dimension is perpendicular to the dominant direction of travel.	1.25" gap at entry to covered picnic by playground. 2" gap close to ramp beach access	Correct or fill gaps to be max .5"	2015 ABAAS Section: 302.3 2012 TAS Section: 302.3 2010 ADAS Section: 302.3

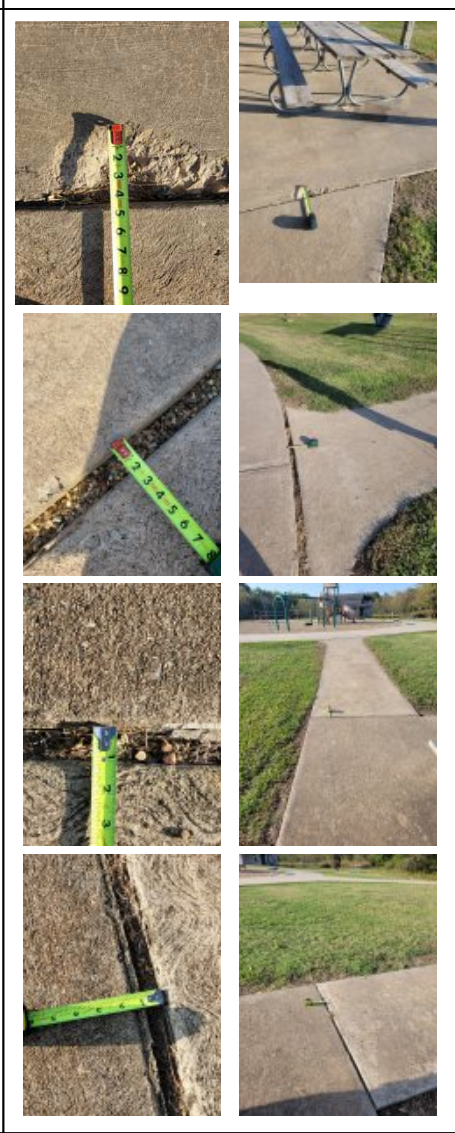
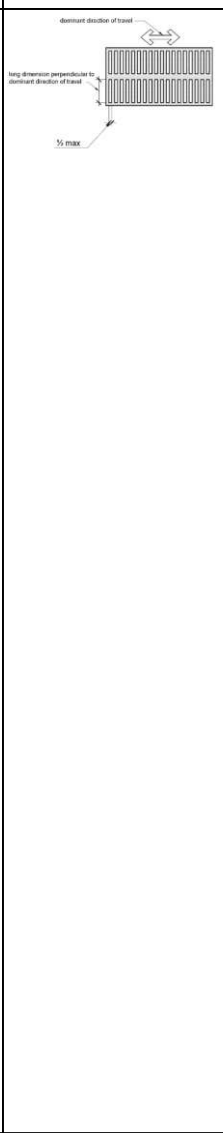
Finding Number	Area Description	Lat/Long	Finding	As Built	Recommendation	Citation	Photos	Figure
68	Heron Harbor Day Use Area: HH - Exterior Accessible Route	[33.2920164, -95.6519837], [33.2919604, -95.6517905]	There is a gap spaced greater than a 1/2 inch. Openings in floor or ground surfaces shall not allow passage of a sphere more than 1/2 inch diameter. Elongated openings shall be placed so that the long dimension is perpendicular to the dominant direction of travel.	3" gap at playground shelter, 2" at entry, 2" at entry to non covered, 1" at grill to non covered	Correct or fill gaps to be max .5"	2015 ABAAS Section: 302.3 2012 TAS Section: 302.3 2010 ADAS Section: 302.3

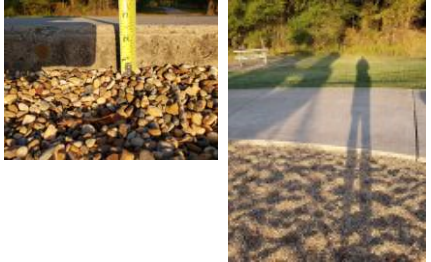
71	Heron Harbor Day Use Area: HH - Playground	[33.2918214 , -95.6519756]	The walkway contains abrupt vertical edges and/or variations over a 1/4 inch. 1/4 inch is the maximum vertical rise. Changes in level between 1/4 inch and 1/2 inch must be beveled at 1:2 or less. Changes in level greater than 1/2 inch must be by way of a ramp.	up to 2.5" CIL at border due to low surface fill	Frequently inspect and regularly maintain accessible portions of play area surface that are comprised of loose fill such as EWF so that surface is level with other surfaces	2012 TAS Section: 303.2, 303.3 2010 ADAS Section: 303.2, 303.3

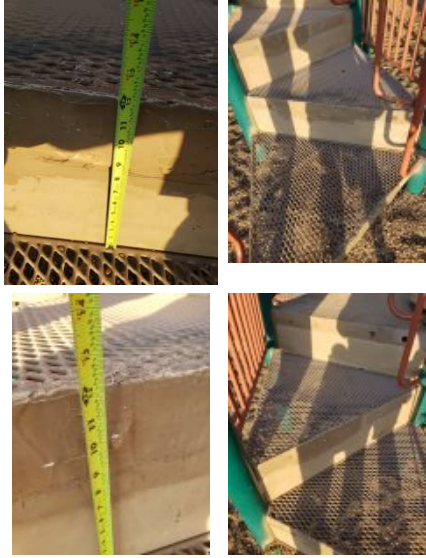
73	Heron Harbor Day Use Area: HH - Playground	[33.2918797 , -95.651954 2]	The steps on the transfer platform are greater than 8"	N/A	Correct transfer step riser height to 8" max and uniform	2015 ABAAS Section: 1008.3.2.2 2012 TAS Section: 1008.3.2.2 2010 ADAS Section: 1008.3.2.2

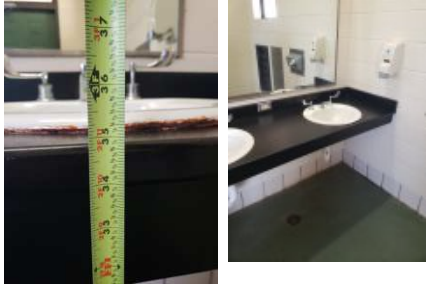
Finding Number	Area Description	Lat/Long	Finding	As Built	Recommendation	Citation	Photos	Figure
79	Heron Harbor Day Use Area: HH - Men's Restroom	[33.2915815, -95.652158]	The top rim of the sink is too high. All lavatories/sinks that are designated to be accessible shall be a minimum 17 inches in horizontal depth and mounted with the rim or counter edge no higher than 34 inches above the finished floor.	sink rim - 35.5" aff	Lower sinks to max 34" aff to front of rim	2015 ABAAS Section: 606.3 2012 TAS Section: 606.3 2010 ADAS Section: 606.3

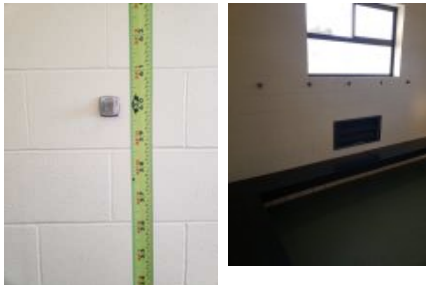
80	Heron Harbor Day Use Area: HH - Men's Restroom	[33.291586, -95.6521741]	Where a high forward reach is over an obstruction, the clear floor space shall extend beneath the element for a distance not less than the required reach depth over the obstruction. The high forward reach shall be 48 inches (1220 mm) maximum where the reach depth is 20 inches (510 mm) maximum. Where the reach depth exceeds 20 inches (510 mm), the high forward reach shall be 44 inches (1120 mm) maximum and the reach depth shall be 25 inches (635 mm) maximum.	all towel hooks 60" aff	Lower operating mechanisms in men's restroom to max 48" aff to highest operable part; leave as is if employee only operated	2015 ABAAS Section: 308.2.1, 308.3.2 2012 TAS Section: 308.2.1, 308.3.2 2010 ADAS Section: 308.2.1, 308.3.2

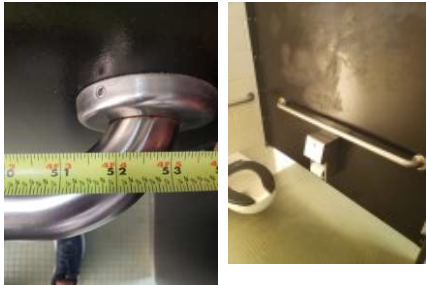
81	Heron Harbor Day Use Area: HH - Men's Restroom	[33.2915905, -95.6521741]	The side grab bars are not in the correct location. Grab bars on the side wall must be installed so that the end closest to the rear wall is maximum 12" from the rear wall. The end furthest from the rear wall must be mounted minimum 54" from the rear wall.	grab bar sizing complies, but is mounted 52" from wall	Remount side grab bar to max 12" from the rear wall at the close end and min 54" on the far end, and 33" to 36" aff	2015 ABAAS Section: 604.5.1 2012 TAS Section: 604.5.1 2010 ADAS Section: 604.5.1

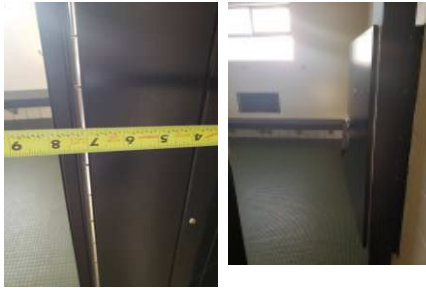
83	Heron Harbor Day Use Area: HH - Men's Restroom	[33.2916017 , -95.6521687]	The compartment door is located too far from the partition or wall. The door shall be located in front of the clear space and diagonal to the water closet. Where located in the front partition, the door opening shall be 4 inches maximum from the side wall or partition farthest from the water closet. Where located in the side wall or partition, the door opening shall be 4 inches maximum from the front partition. Toilet compartment doors shall not swing into the minimum required compartment area.	60" wide, 7" from wall	Rehang stall door to be max 4" from adjacent stall partition and on the stall wall farthest from the toilet	2015 ABAAS Section: 604.8.1.2 2012 TAS Section: 604.8.1.2 2010 ADAS Section: 604.8.1.2

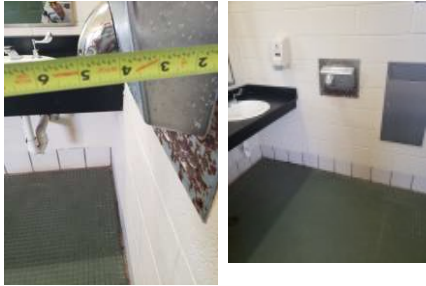
Finding Number	Area Description	Lat/Long	Finding	As Built	Recommendation	Citation	Photos	Figure
85	Heron Harbor Day Use Area: HH - Men's Restroom	[33.2915927 , -95.6521687]	The hand dryer projects more than 4 inches into the circulation path. Wall-mounted objects that have leading edges between 27 inches and 80 inches from the floor must not project more than 4 inches into the circulation path. Protruding objects that extend to the floor or within 27 inches of the floor are cane detectable and are therefore not hazardous. Where it is necessary or desirable to have objects protrude from the wall, a manner of cane detection must be provided.	hand dryer projects 5"	Relocate protruding objects or place cane detectable warning or bollard at foot of item	2015 ABAAS Section: 307.2 2012 TAS Section: 307.2 2010 ADAS Section: 307.2

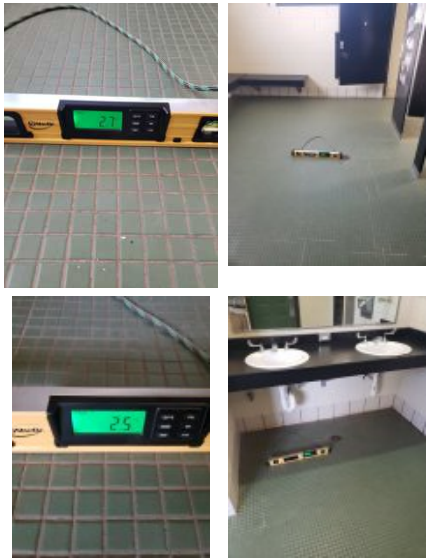
86	Heron Harbor Day Use Area: HH - Men's Restroom	[33.2915837 , -95.6521848]	The accessible route contains running slopes greater than 5 percent and cross slopes greater than 2 percent across the width of the walk and has not been constructed as a ramp (i.e. handrails, wheel guides, etc.). When the slope in the direction of travel of any walk exceeds 1 unit vertical in 20 units horizontal (5-percent slope), it must be constructed as ramp. Surface cross slopes must not exceed one unit vertical in 48 units. Horizontal (2-percent slope).	2.7% cross slope, 2.5% cross slope	Correct or repair slope to max 2.08% in restroom.	2015 ABAAS Section: 403.3 2012 TAS Section: 403.3 2010 ADAS Section: 403.3

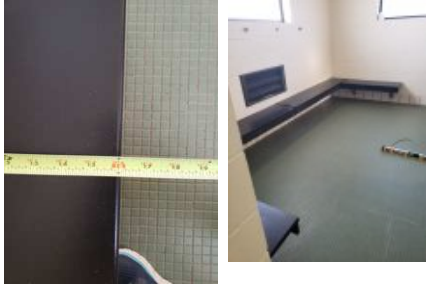
Finding Number	Area Description	Lat/Long	Finding	As Built	Recommendation	Citation	Photos	Figure
87	Heron Harbor Day Use Area: HH - Men's Restroom	[33.2916062 , -95.652195 6]	The bench is not deep enough or long enough or is missing. Benches shall be provided having seats that are 42 inches long minimum and 20 inches deep minimum and 24 inches deep maximum. The bench shall provide for back support or shall be affixed to a wall. Back support shall be 42 inches (1065 mm) long minimum and shall extend from a point 2 inches (51 mm) maximum above the seat surface to a point 18 inches (455 mm) minimum above the seat surface. Back support shall be 2½ inches (64 mm) maximum from the rear edge of the seat measured horizontally. The top of the bench seat surface shall be 17 inches (430 mm) minimum and 19 inches (485 mm) maximum above the finish floor or ground.	bench is 16" deep	Replace bench in dressing area with one having a seat depth of 20" to 24" deep, 42" long, affixed to the wall or having a back and mounted 17" to 19" aff	2012 TAS Section: 903.4, 903.2, 903.3, 903.5 2010 ADAS Section: 903.4, 903.2, 903.3, 903.5

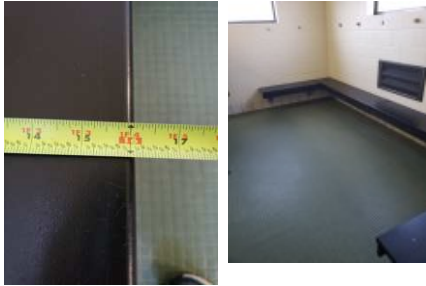
Finding Number	Area Description	Lat/Long	Finding	As Built	Recommendation	Citation	Photos	Figure
90	Heron Harbor Day Use Area: HH - Women's Restroom	[33.2915857 , -95.652189]	The bench is not deep enough or long enough or is missing. Benches shall be provided having seats that are 42 inches long minimum and 20 inches deep minimum and 24 inches deep maximum. The bench shall provide for back support or shall be affixed to a wall. Back support shall be 42 inches (1065 mm) long minimum and shall extend from a point 2 inches (51 mm) maximum above the seat surface to a point 18 inches (455 mm) minimum above the seat surface. Back support shall be 2½ inches (64 mm) maximum from the rear edge of the seat measured horizontally. The top of the bench seat surface shall be 17 inches (430 mm) minimum and 19 inches (485 mm) maximum above the finish floor or ground.	bench is 16" deep	Replace bench in dressing area with one having a seat depth of 20" to 24" deep, 42" long, affixed to the wall or having a back and mounted 17" to 19" aff	2012 TAS Section: 903.4, 903.2, 903.3, 903.5 2010 ADAS Section: 903.4, 903.2, 903.3, 903.5

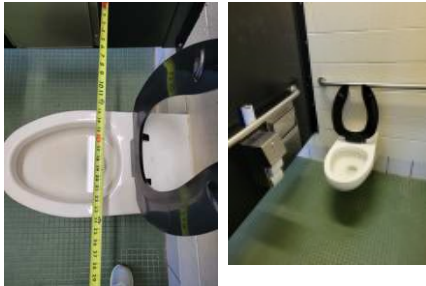
96	Heron Harbor Day Use Area: HH - Women's Restroom	[33.2915927, -95.6521661]	The toilet is not located within the range allowed from the side wall or partition. The centerline of the toilet must be 16 to 18 inches from the side wall.	18.5" centerline	Remount toilets to 16" to 18" from the side wall to centerline	2015 ABAAS Section: 604.2 2012 TAS Section: 604.2 2010 ADAS Section: 604.2

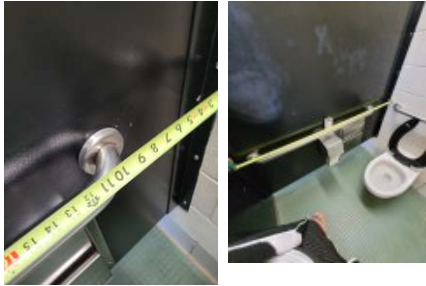
97	Heron Harbor Day Use Area: HH - Women's Restroom	[33.291586, -95.6521768]	The side grab bars are not in the correct location. Grab bars on the side wall must be installed so that the end closest to the rear wall is maximum 12" from the rear wall. The end furthest from the rear wall must be mounted minimum 54" from the rear wall.	side grab bar mounted too close, making the end furthest from the rear wall 52" from rear wall	Remount side grab bar to max 12" from the rear wall at the close end and min 54" on the far end, and 33" to 36" aff	2015 ABAAS Section: 604.5.1 2012 TAS Section: 604.5.1 2010 ADAS Section: 604.5.1

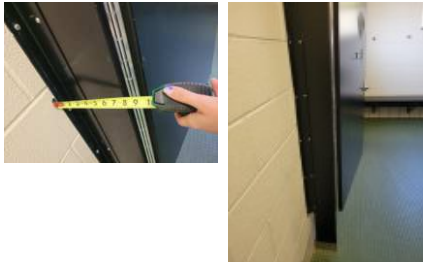
100	Heron Harbor Day Use Area: HH - Women's Restroom	[33.2915837, -95.6521687]	The compartment door is located too far from the partition or wall. The door shall be located in front of the clear space and diagonal to the water closet. Where located in the front partition, the door opening shall be 4 inches maximum from the side wall or partition farthest from the water closet. Where located in the side wall or partition, the door opening shall be 4 inches maximum from the front partition. Toilet compartment doors shall not swing into the minimum required compartment area.	8" from wall	Rehang stall door to be max 4" from adjacent stall partition and on the stall wall farthest from the toilet	2015 ABAAS Section: 604.8.1.2 2012 TAS Section: 604.8.1.2 2010 ADAS Section: 604.8.1.2

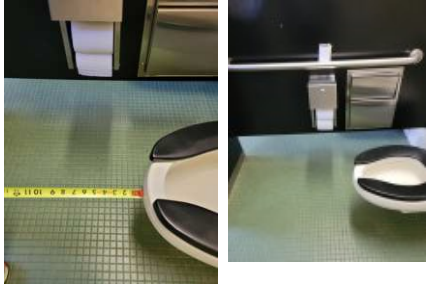
Finding Number	Area Description	Lat/Long	Finding	As Built	Recommendation	Citation	Photos	Figure
101	Heron Harbor Day Use Area: HH - Women's Restroom	[33.2915815 , -95.6521821]	The toilet paper is not installed within the compliant range in front of the toilet. Toilet paper dispensers shall be 7 inches minimum and 9 inches maximum in front of the water closet measured to the centerline of the dispenser. The outlet of the dispenser shall be 15 inches minimum and 48 inches maximum above the finish floor and shall not be located behind grab bars. Dispensers shall not be of a type that controls delivery or that does not allow continuous paper flow. There shall be a clearance of 1 1/2 inches minimum below the grab bar.	toilet paper mounted too close to centerline	Remount toilet paper dispenser max 7" to 9" from front of toilet, 15" to 48" aff and min 12" above or 1.5" below grab bar	2015 ABAAS Section: 604.7 2012 TAS Section: 604.7 2010 ADAS Section: 604.7

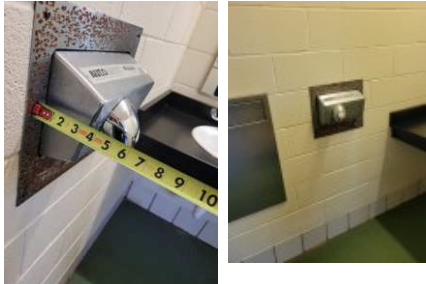
102	Heron Harbor Day Use Area: HH - Women's Restroom	[33.2915949 , -95.6521607]	The hand dryer projects more than 4 inches into the circulation path. Wall-mounted objects that have leading edges between 27 inches and 80 inches from the floor must not project more than 4 inches into the circulation path. Protruding objects that extend to the floor or within 27 inches of the floor are cane detectable and are therefore not hazardous. Where it is necessary or desirable to have objects protrude from the wall, a manner of cane detection must be provided.	hand dryer projects 6"	Relocate protruding objects or place cane detectable warning or bollard at foot of item	2015 ABAAS Section: 307.2 2012 TAS Section: 307.2 2010 ADAS Section: 307.2

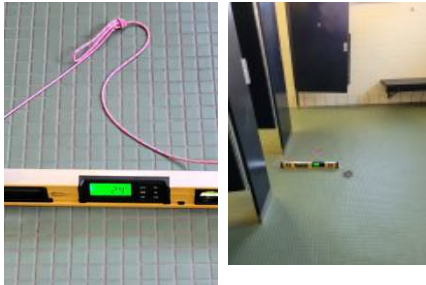
103	Heron Harbor Day Use Area: HH - Women's Restroom	[33.2915927 , -95.6521714]	The accessible route contains running slopes greater than 5 percent and cross slopes greater than 2 percent across the width of the walk and has not been constructed as a ramp (i.e. handrails, wheel guides, etc.). When the slope in the direction of travel of any walk exceeds 1 unit vertical in 20 units horizontal (5-percent slope), it must be constructed as ramp. Surface cross slopes must not exceed one unit vertical in 48 units. Horizontal (2-percent slope).	2.4% cross slope in front of stalls	Correct or repair slope to max 2.08% in restroom.	2015 ABAAS Section: 403.3 2012 TAS Section: 403.3 2010 ADAS Section: 403.3

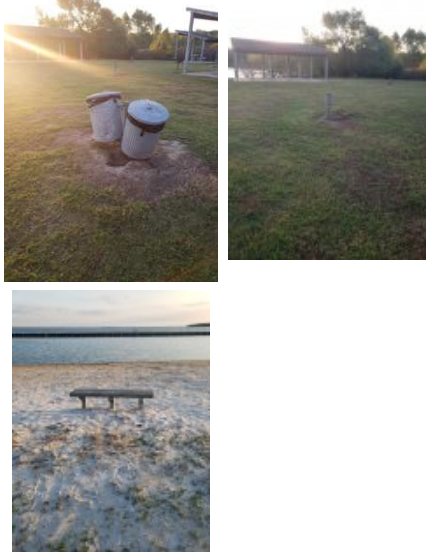
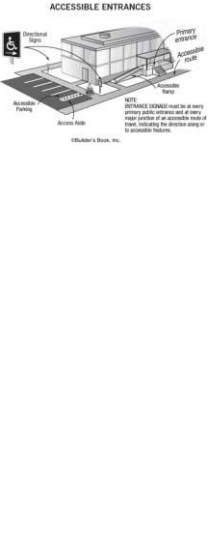
105	Heron Harbor Day Use Area: HH - Picnic Areas	[33.2920265 , -95.6514714]	There is no accessible route to the water spigots, trash bins, and benches. At least one accessible route shall connect accessible buildings, accessible facilities, accessible elements, and accessible spaces that are on the same site.	0 of 10 water spigots on AR, 0 of 3 trash can sets on AR, 0 of 4 beach benches on AR	Create an accessible route with crushed stone or other outdoor material from parking or walkway to beach side amenities.	2015 ABAAS Section: F206.2.2 2012 TAS Section: 206.2.2 2010 ADAS Section: 206.2.2

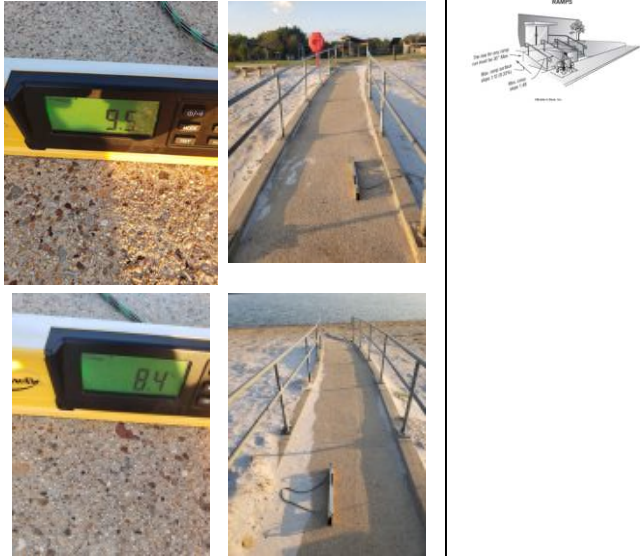
113	Heron Harbor Day Use Area: HH - Swimming	[33.2920691 , -95.651479 4]	The ramp slope exceeds the maximum running slope (direction of travel) allowable of 8.33%. Ramps should have the least possible slope but in no case more than 8.3% (1:12).	Running slopes between 8.4% and 9.5% running for 25'	Correct slope of ramp to max 8.33%	2015 ABAAS Section: 405.2 2012 TAS Section: 405.2 2010 ADAS Section: 405.2

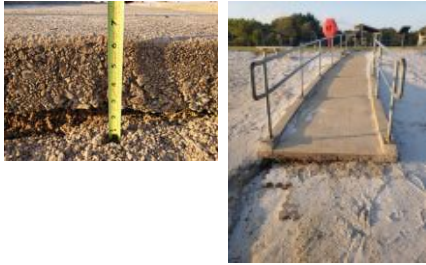
Finding Number	Area Description	Lat/Long	Finding	As Built	Recommendation	Citation	Photos	Figure
114	Heron Harbor Day Use Area: HH - Swimming	[33.292105, -95.651455 3]	There is a change in level is greater than 1/4 inch. 1/4 inch is the maximum vertical rise. Changes in level between 1/4 inch and 1/2 inch must be beveled at 1:2 or less. Changes in level greater than 1/2 inch must be by way of a ramp.	6" CIL at end of ramp	Install a ramp for CIL of .5" or higher	2015 ABAAS Section: 303.3 2012 TAS Section: 303.3 2010 ADAS Section: 303.3

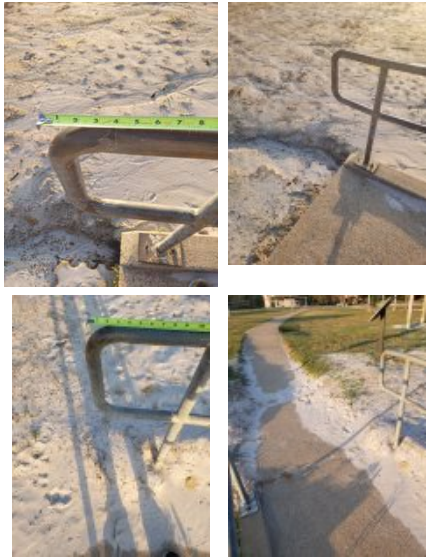
115	Heron Harbor Day Use Area: HH - Swimming	[33.2920994, -95.651456 6]	The handrail does not extend past the ramp. Handrails must be between 34 inches and 38 inches above the ramp surface, must extend beyond the top and bottom of the ramp 12 inches horizontally, be parallel to the floor or ground surface and be in the same direction as the ramp runs. The 12 inches must be level and does not include the radius at the top of round handrails. Extensions shall return to a wall, guard, or the landing surface, or shall be continuous to the handrail of an adjacent ramp run.	extensions 4" at bottom 4" at top	Provide handrail extensions that project 12" onto the ramp landing	2015 ABAAS Section: 505.10.1 2012 TAS Section: 505.10.1 2010 ADAS Section: 505.10.1

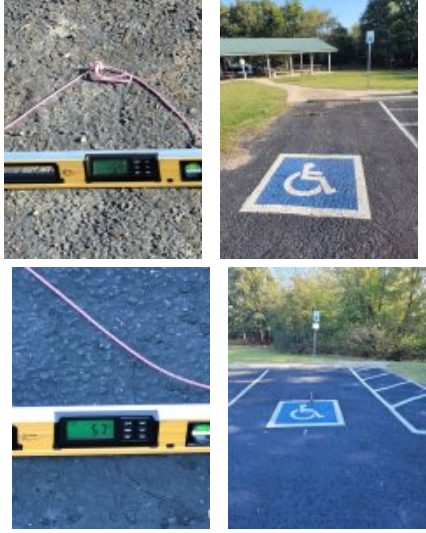
119	Gulls Bluff Day Use Area: GB - Parking	[33.2941912 , -95.6544245], [33.2945835 , -95.653884]	The cross slopes (narrow dimension) and/or running slopes (long dimension) of the access aisle exceeds 2%. The running slope and the cross slope in an accessible parking stall and the access aisle must not exceed 2%.	by restroom, stall - 2.2% slope, access aisle - 3.3% slope. By Pavilion - 5.4% slope. Pavilion side, end stall - 5.7% slope	Repair or correct slope of parking space and access aisle to max 2.08% in any direction	2015 ABAAS Section: 502.4 2012 TAS Section: 502.4 2010 ADAS Section: 502.4

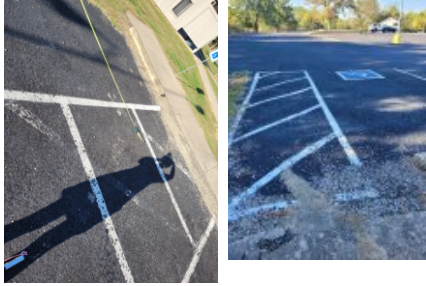
120	Gulls Bluff Day Use Area: GB - Parking	[33.2941912, -95.6544379], [33.2945443, -95.6538009]	The parking stall contains abrupt edges and surface irregularities over a 1/4 inch vertical. Parking spaces and access aisles serving them shall be stable, firm, and slip resistant. Access aisles shall be at the same level as the parking spaces they serve. Changes in level are not permitted and shall not be sloped steeper than 2% in any direction.	restroom building stall - loose gravel in stall and access aisle. end Pavilion - loose gravel in access aisle and stall	Maintain accessible stalls and access aisles with a firm, stable, and slip resistant material	2015 ABAAS Section: 502.4 2012 TAS Section: 502.4 2010 ADAS Section: 502.4

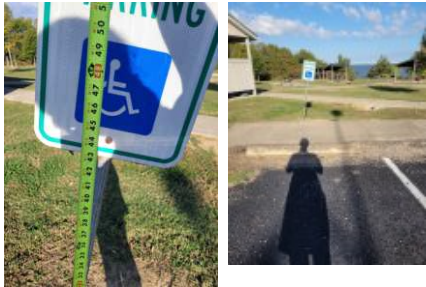
121	Gulls Bluff Day Use Area: GB - Parking	[33.294208, -95.6544553]	The parking sign is mounted too low. Parking space identification signs shall include the International Symbol of Accessibility complying with. Signs identifying van parking spaces shall contain the designation "van accessible." Signs shall be 60 inches minimum above the finish floor or ground surface measured to the bottom of the sign.	restroom building - 45" above ground level (agl)	Raise existing accessible parking signs so lowest end of bottom sign is min 60" agl	2015 ABAAS Section: 502.6 2012 TAS Section: 502.6 2010 ADAS Section: 502.6

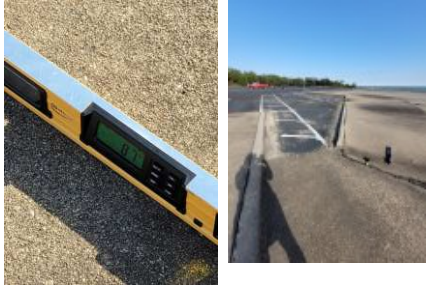
128	Gulls Bluff Day Use Area: GB - Parking	[33.2940936 , -95.652475 8]	The running slope of walking surfaces shall not be steeper than 1:20.	boat ramp lot - 8.7% slope at the pathway connected to accessible right stall	Correct running slope along the AR to max 5%	2015 ABAAS Section: 403.3 2012 TAS Section: 403.3 2010 ADAS Section: 403.3

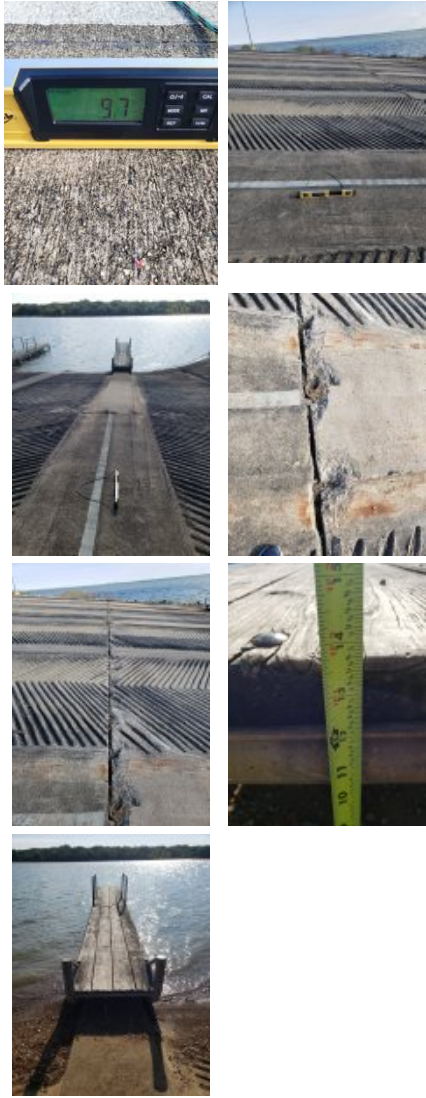
Finding Number	Area Description	Lat/Long	Finding	As Built	Recommendation	Citation	Photos	Figure
130	Gulls Bluff Day Use Area: GB - Boat Ramp	[33.2941923 , -95.652025 2]	There is no accessible route to/on the boating facility. Accessible routes serving recreational boating facilities, including gangways and floating piers, shall comply with accessible route requirements except as modified by section Recreational Boating Facilities - Accessible Routes.	9.7% slope with large cracks and gaps, 14" CIL at pier	Create an outdoor accessible route to the boat pier or make corrections for a compliant route. Correct running slopes to max 5% and cross to max 2.08%. For changes in level 6" or greater, provide a ramp for access. Correct or fill gaps to be max .5".	2015 ABAAS Section: 1003.2 2010 ADAS Section: 1003.2

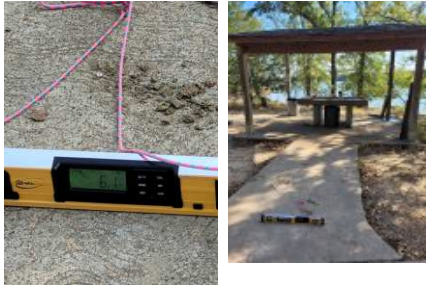
Finding Number	Area Description	Lat/Long	Finding	As Built	Recommendation	Citation	Photos	Figure
136	Gulls Bluff Day Use Area: GB - Fish Cleaning	[33.2936206 , -95.652675 7]	The accessible route of travel on the accessible route contains cross slopes greater than 2%. Cross slopes shall not exceed one unit vertical in 48 units horizontal (2-percent slope).	6% cross slope at entry	Correct or repair cross slope along AR to max 2.08%	2015 ABAAS Section: 403.3 2012 TAS Section: 403.3 2010 ADAS Section: 403.3

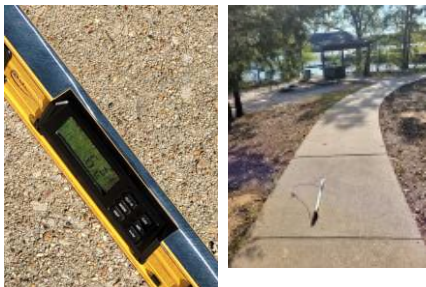
137	Gulls Bluff Day Use Area: GB - Fish Cleaning	[33.2936565 , -95.652848 7]	The running slope of walking surfaces shall not be steeper than 1:20.	6.2% slope seven panels from fish cleaning station	Correct running slope along the AR to max 5%	2015 ABAAS Section: 403.3 2012 TAS Section: 403.3 2010 ADAS Section: 403.3

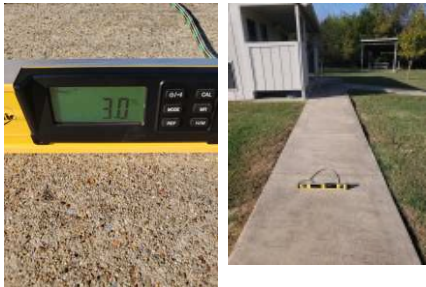
138	Gulls Bluff Day Use Area: GB - Shelters	[33.2942304 , -95.65456 39], [33.2943033 , -95.654597 5]	The cross slope shall not be steeper than 1:48. EXCEPTION: Where the surface is other than concrete, asphalt, or boards, cross slopes not steeper than 1:20 shall be permitted when necessary for drainage. The running slope of any segment of an outdoor recreation access route shall not be steeper than 1:10 (10%). Where the running slope of a segment of an outdoor recreation access route is steeper than 1:20 (5%), the maximum length of the segment shall be in accordance with Table 1016.7.1, and a resting interval complying with 1016.8 shall be provided at the top and bottom of each segment. 5% to 8.33% - max length 50' 8.33% to 10% - max length 30'	3% cross slope	Correct or repair ORAR cross slope to max 2.08% as a smart practice.	2015 ABAAS Section: 1016.7.2, 1016.7.2 EXCEPTION

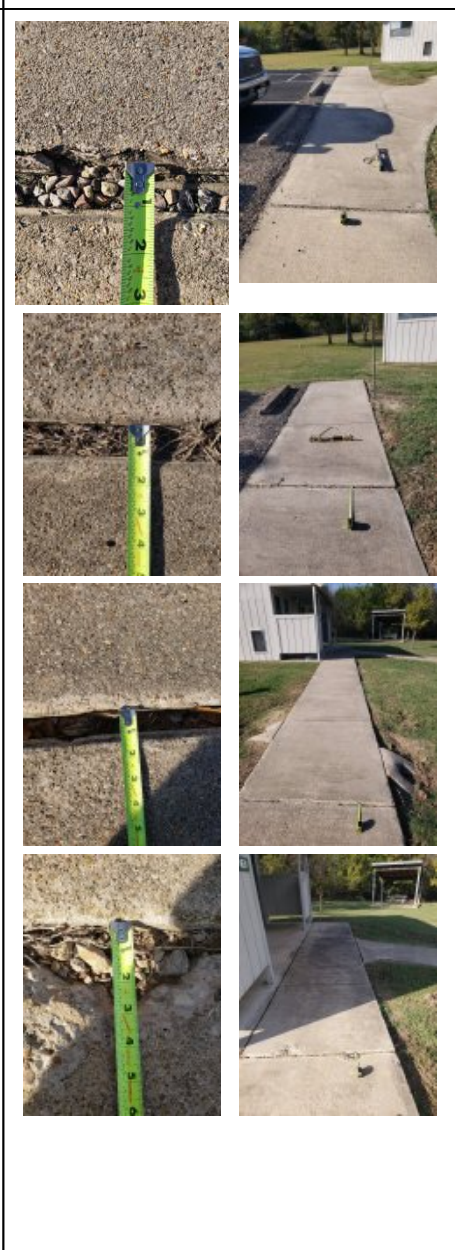
Finding Number	Area Description	Lat/Long	Finding	As Built	Recommendation	Citation	Photos	Figure
139	Gulls Bluff Day Use Area: GB - Shelters	[33.2942035, -95.6544701], [33.2943862, -95.6545961]	Openings in the surface of outdoor recreation access routes shall not allow the passage of a sphere more than 1/2 inch (13 mm) in diameter. Advisory: Spaces between the boards in a boardwalk and drainage grates are examples of openings. Where possible, drainage grates should be located outside the minimum clear width of the outdoor recreation access route. Elongated openings should be placed so that the long dimension is perpendicular, or as close to perpendicular as possible, to the dominant direction of travel	Gaps from parking past the restrooms to the uncovered accessible picnic pad closest to parking lot - 1", 1", 1", 3", 4", 1", 1", 1", 1"	Correct or fill gaps along the ORAR to max .5" as a smart practice.	2015 ABAAS Section: 1016.6, Advisory 1016.6

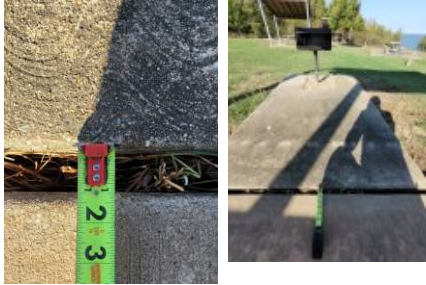
Finding Number	Area Description	Lat/Long	Finding	As Built	Recommendation	Citation	Photos	Figure
141	Gulls Bluff Day Use Area: GB - Shelters	[33.2944624, -95.6546364]	Openings in the surface of outdoor recreation access routes shall not allow the passage of a sphere more than 1/2 inch (13 mm) in diameter. Advisory: Spaces between the boards in a boardwalk and drainage grates are examples of openings. Where possible, drainage grates should be located outside the minimum clear width of the outdoor recreation access route. Elongated openings should be placed so that the long dimension is perpendicular, or as close to perpendicular as possible, to the dominant direction of travel	1" gap to grill	Correct or fill gaps along the ORAR to max .5" as a smart practice.	2015 ABAAS Section: 1016.6, Advisory 1016.6

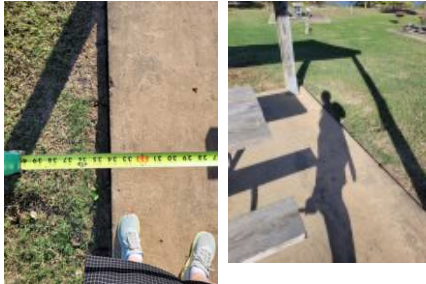
142	Gulls Bluff Day Use Area: GB - Shelters	[33.294458, -95.6546055]	Picnic tables are required to have clear ground space 36 inches (915 mm) on all usable sides of the table measured from the back edge of the benches.	at single covered shelter on AR - 34" CGS around table	Provide required 36" clear ground space around all usable portions of the table as a smart practice.	2015 ABAAS Section: 1011.2.1

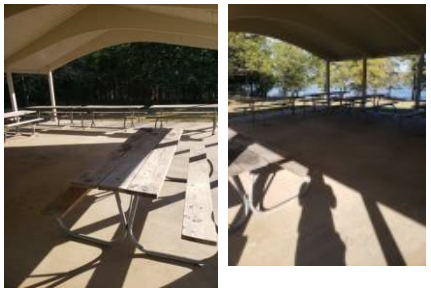
146	Gulls Bluff Day Use Area: GB - Group Shelter	[33.2948324, -95.65399]	Picnic tables shall provide at least one wheelchair space for each 24 linear feet (7320 mm) of usable table surface perimeter. Wheelchair spaces shall be 30 inches (760 mm) minimum by 48 inches (1220 mm) minimum. Wheelchair spaces shall be positioned for a forward approach to the table and provide knee and toe clearance complying with 306 under the table	0 of 12 tables accessible	Replace picnic table with one of an accessible design as a smart practice	2015 ABAAS Section: 1011.4.2

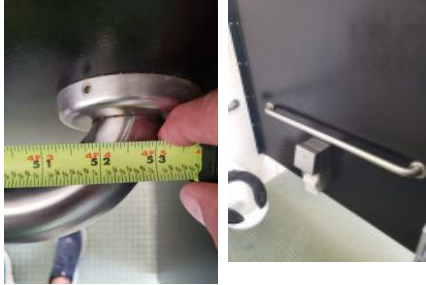
Finding Number	Area Description	Lat/Long	Finding	As Built	Recommendation	Citation	Photos	Figure
152	Gulls Bluff Day Use Area: GB - Men's Restroom	[33.2941755 , -95.6545774]	The side grab bars are not in the correct location. Grab bars on the side wall must be installed so that the end closest to the rear wall is maximum 12" from the rear wall. The end furthest from the rear wall must be mounted minimum 54" from the rear wall.	52.5" to end of bar from rear wall	Remount side grab bar to max 12" from the rear wall at the close end and min 54" on the far end, and 33" to 36" aff	2015 ABAAS Section: 604.5.1 2012 TAS Section: 604.5.1 2010 ADAS Section: 604.5.1

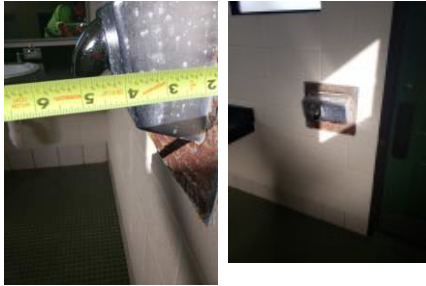
Finding Number	Area Description	Lat/Long	Finding	As Built	Recommendation	Citation	Photos	Figure
155	Gulls Bluff Day Use Area: GB - Men's Restroom	[33.2941979 , -95.654585 4]	The hand dryer projects more than 4 inches into the circulation path. Wall-mounted objects that have leading edges between 27 inches and 80 inches from the floor must not project more than 4 inches into the circulation path. Protruding objects that extend to the floor or within 27 inches of the floor are cane detectable and are therefore not hazardous. Where it is necessary or desirable to have objects protrude from the wall, a manner of cane detection must be provided.	hand dryer 5"	Relocate protruding objects or place cane detectable warning or bollard at foot of item	2015 ABAAS Section: 307.2 2012 TAS Section: 307.2 2010 ADAS Section: 307.2

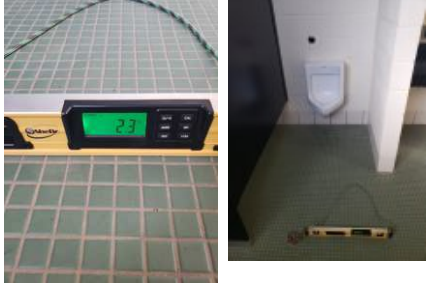
156	Gulls Bluff Day Use Area: GB - Men's Restroom	[33.2941889 , -95.65458]	The accessible route contains running slopes greater than 5 percent and cross slopes greater than 2 percent across the width of the walk and has not been constructed as a ramp (i.e. handrails, wheel guides, etc.). When the slope in the direction of travel of any walk exceeds 1 unit vertical in 20 units horizontal (5-percent slope), it must be constructed as ramp. Surface cross slopes must not exceed one unit vertical in 48 units. Horizontal (2-percent slope).	2.3% cross slope	Correct or repair slope to max 2.08% in restroom.	2015 ABAAS Section: 403.3 2012 TAS Section: 403.3 2010 ADAS Section: 403.3

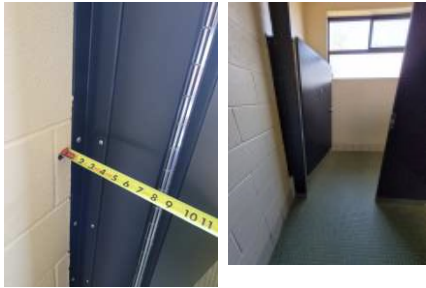
164	Gulls Bluff Day Use Area: GB - Women's Restroom	[33.2941889 , -95.6545827]	The compartment door is located too far from the partition or wall. The door shall be located in front of the clear space and diagonal to the water closet. Where located in the front partition, the door opening shall be 4 inches maximum from the side wall or partition farthest from the water closet. Where located in the side wall or partition, the door opening shall be 4 inches maximum from the front partition. Toilet compartment doors shall not swing into the minimum required compartment area.	8" partition to wall	Rehang stall door to be max 4" from adjacent stall partition and on the stall wall farthest from the toilet	2015 ABAAS Section: 604.8.1.2 2012 TAS Section: 604.8.1.2 2010 ADAS Section: 604.8.1.2

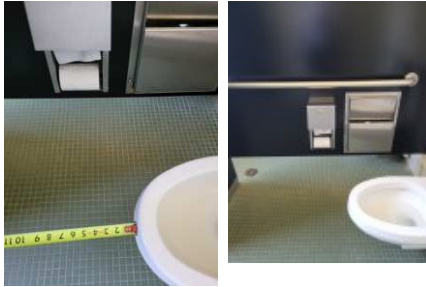
165	Gulls Bluff Day Use Area: GB - Women's Restroom	[33.2941755 , -95.6545613]	The toilet paper is not installed within the compliant range in front of the toilet. Toilet paper dispensers shall be 7 inches minimum and 9 inches maximum in front of the water closet measured to the centerline of the dispenser. The outlet of the dispenser shall be 15 inches minimum and 48 inches maximum above the finish floor and shall not be located behind grab bars. Dispensers shall not be of a type that controls delivery or that does not allow continuous paper flow. There shall be a clearance of 1 1/2 inches minimum below the grab bar.	toilet paper too close	Remount toilet paper dispenser max 7" to 9" from front of toilet, 15" to 48" aff and min 12" above or 1.5" below grab bar	2015 ABAAS Section: 604.7 2012 TAS Section: 604.7 2010 ADAS Section: 604.7
