Access Audit Site Report

Cooper Lake State Park - South Sulphur Unit

Accessibility Evaluation

Inspection Date: 10/19/2021

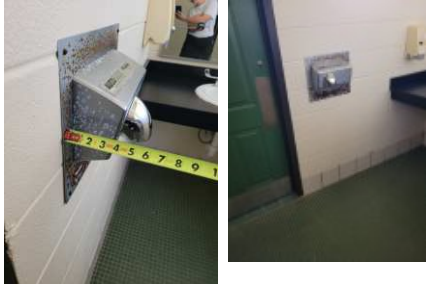
Finding Number	Area Description	Lat/Long	Finding	As Built	Recommendation	Citation	Photos	Figure
166	Gulls Bluff Day Use Area: GB - Women's Restroom	[33.2941934 , -95.654582 7]	The hand dryer projects more than 4 inches into the circulation path. Wall-mounted objects that have leading edges between 27 inches and 80 inches from the floor must not project more than 4 inches into the circulation path. Protruding objects that extend to the floor or within 27 inches of the floor are cane detectable and are therefore not hazardous. Where it is necessary or desirable to have objects protrude from the wall, a manner of cane detection must be provided.	hand dryer projects 6"	Relocate protruding objects or place cane detectable warning or bollard at foot of item	2015 ABAAS Section: 307.2 2012 TAS Section: 307.2 2010 ADAS Section: 307.2

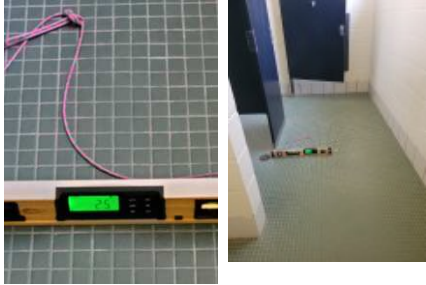
167	Gulls Bluff Day Use Area: GB - Women's Restroom	[33.2941844 , -95.654561 3]	The accessible route contains running slopes greater than 5 percent and cross slopes greater than 2 percent across the width of the walk and has not been constructed as a ramp (i.e. handrails, wheel guides, etc.). When the slope in the direction of travel of any walk exceeds 1 unit vertical in 20 units horizontal (5-percent slope), it must be constructed as ramp. Surface cross slopes must not exceed one unit vertical in 48 units. Horizontal (2-percent slope).	2.5% cross slope by toilet	Correct or repair slope to max 2.08% in restroom.	2015 ABAAS Section: 403.3 2012 TAS Section: 403.3 2010 ADAS Section: 403.3

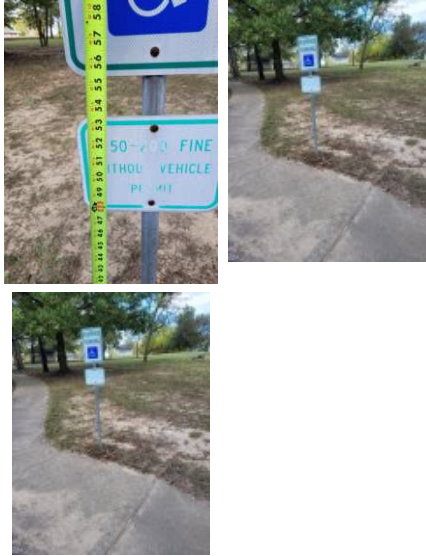
Finding Number	Area Description	Lat/Long	Finding	As Built	Recommendation	Citation	Photos	Figure
171	Eagle Point Shelters Area: EP - Parking	[33.2938302 , -95.665086 3]	The parking sign is mounted too low. Parking space identification signs shall include the International Symbol of Accessibility complying with. Signs identifying van parking spaces shall contain the designation "van accessible." Signs shall be 60 inches minimum above the finish floor or ground surface measured to the bottom of the sign.	fine signage - 41" agl, standard - 55.5" agl	Raise existing accessible parking signs so lowest end of bottom sign is min 60" aff.	2015 ABAAS Section: 502.6 2012 TAS Section: 502.6 2010 ADAS Section: 502.6

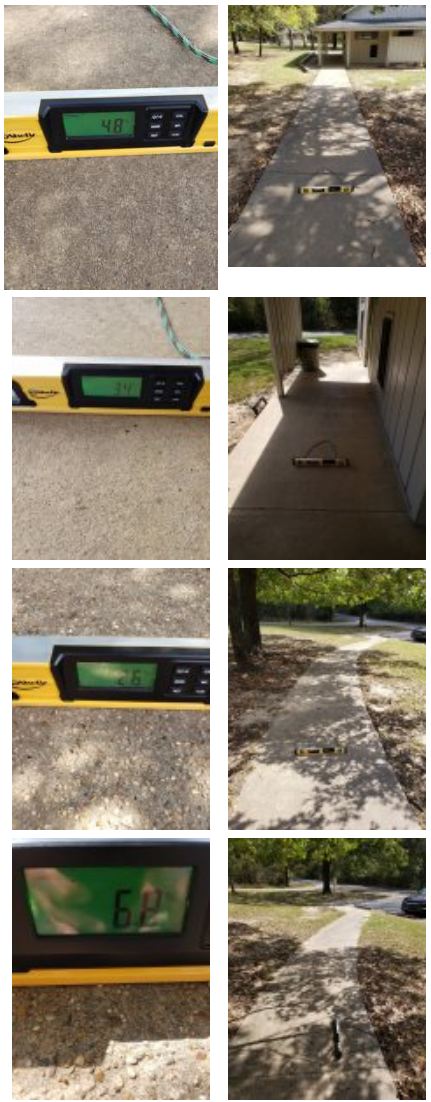
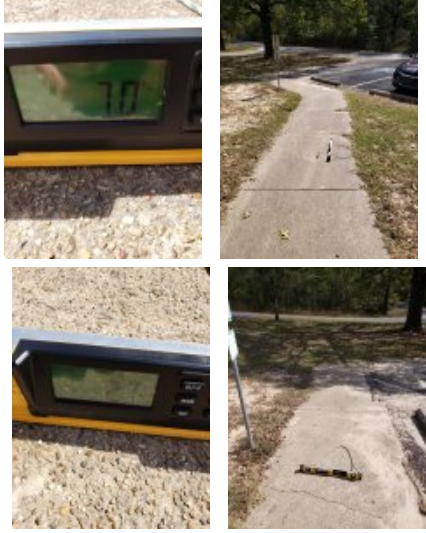
Finding Number	Area Description	Lat/Long	Finding	As Built	Recommendation	Citation	Photos	Figure
187	Eagle Point Shelters Area: EP - Restroom Exterior Accessible Route	[33.2938493, -95.6650675], [33.2939804, -95.6653062]	The running slope of walking surfaces shall not be steeper than 1:20. The cross slope of walking surfaces shall not be steeper than 1:48.	Cross slopes - 4.8%, 3.4%, 2.6%, 2.7%; running slopes - 6.8%, 7%	Correct running slopes to max 5% and cross to max 2.08%.	2012 TAS Section: 403.3 2010 ADAS Section: 403.3

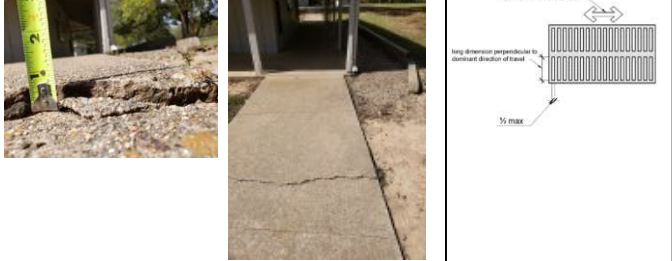
188	Eagle Point Shelters Area: EP - Restroom Exterior Accessible Route	[33.2939771 , -95.6653008]	The concrete expansion joint is spaced greater than a 1/2 inch. Openings in floor or ground surfaces shall not allow passage of a sphere more than 1/2 inch diameter. Elongated openings shall be placed so that the long dimension is perpendicular to the dominant direction of travel.	.75" CIL near restroom	Correct or fill gaps to be max .5"	2015 ABAAS Section: 302.3 2012 TAS Section: 302.3 2010 ADAS Section: 302.3

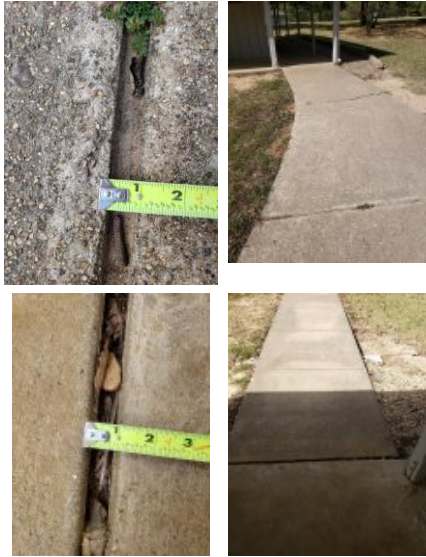
Finding Number	Area Description	Lat/Long	Finding	As Built	Recommendation	Citation	Photos	Figure
189	Eagle Point Shelters Area: EP - Restroom Exterior Accessible Route	[33.2939748 , -95.665290 1]	The concrete expansion joint is spaced greater than a 1/2 inch. Openings in floor or ground surfaces shall not allow passage of a sphere more than 1/2 inch diameter. Elongated openings shall be placed so that the long dimension is perpendicular to the dominant direction of travel.	approaching restroom - 1" gap, 1" gap	Correct or fill gaps to be max .5"	2015 ABAAS Section: 302.3 2012 TAS Section: 302.3 2010 ADAS Section: 302.3

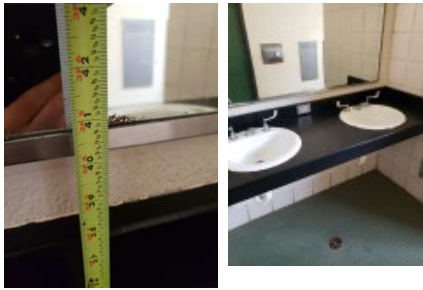
191	Eagle Point Shelters Area: EP - Men's Restroom	[33.2939603 , -95.6653867]	The mirror is mounted too high. Mirrors must have the bottom edge of the reflecting surface a maximum of 40 inches above the floor if above a sink or counter. Mirrors not located above lavatories or countertops shall be installed with the bottom edge of the reflecting surface 35 inches maximum above the finish floor or ground.	mirror mounted 41" aff	Lower mirror so reflective surface is max 40" aff	2015 ABAAS Section: 603.3 2012 TAS Section: 603.3 2010 ADAS Section: 603.3

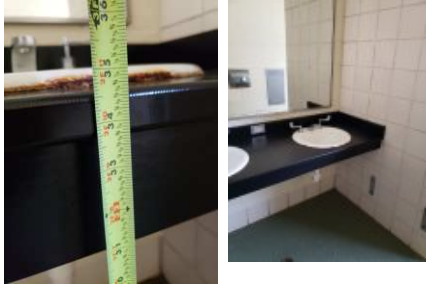
Finding Number	Area Description	Lat/Long	Finding	As Built	Recommendation	Citation	Photos	Figure
192	Eagle Point Shelters Area: EP - Men's Restroom	[33.2939513, -95.6654215]	The top rim of the sink is too high. All lavatories/sinks that are designated to be accessible shall be a minimum 17 inches in horizontal depth and mounted with the rim or counter edge no higher than 34 inches above the finished floor.	sink rim - 35" aff	Lower sinks to max 34" aff to front of rim	2015 ABAAS Section: 606.3 2012 TAS Section: 606.3 2010 ADAS Section: 606.3

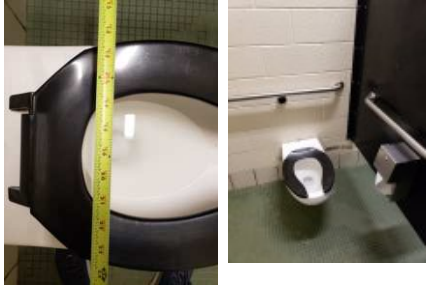
193	Eagle Point Shelters Area: EP - Men's Restroom	[33.2939603, -95.6653867]	The toilet is not located within the range allowed from the side wall or partition. The centerline of the toilet must be 16 to 18 inches from the side wall.	centerline - 19"	Remount toilets to 16" to 18" from the side wall to centerline	2015 ABAAS Section: 604.2 2012 TAS Section: 604.2 2010 ADAS Section: 604.2

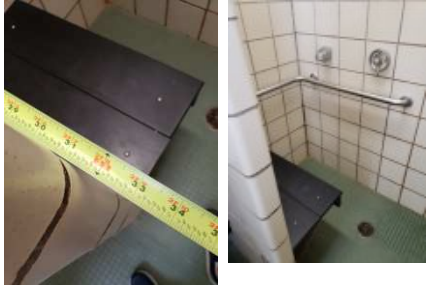
201	Eagle Point Shelters Area: EP - Men's Restroom	[33.2939715 , -95.6653974]	Transfer type shower compartments shall be 36 inches (915 mm) by 36 inches (915 mm) clear inside dimensions measured at the center points of opposing sides and shall have a 36 inch (915 mm) wide minimum entry on the face of the shower compartment. Clearance of 36 inches (915 mm) wide minimum by 48 inches (1220 mm) long minimum measured from the control wall shall be provided.	shower 32" wide	Enlarge transfer shower to compliant 36" by 36" clear inside dimension	2015 ABAAS Section: 608.2.1 2012 TAS Section: 608.2.1 2010 ADAS Section: 608.2.1

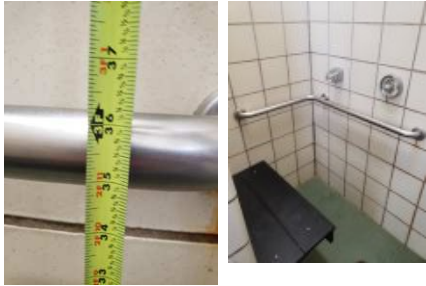
Finding Number	Area Description	Lat/Long	Finding	As Built	Recommendation	Citation	Photos	Figure
202	Eagle Point Shelters Area: EP - Men's Restroom	[33.2939692 , -95.6654028]	Grab bars shall be installed in a horizontal position, 33 inches (840 mm) minimum and 36 inches (915 mm) maximum above the finish floor measured to the top of the gripping surface	grab bars mounted 36.25" aff	Remount shower grab bar to 33" min and 36" max aff	2015 ABAAS Section: 609.3 Exception, 609.4 2012 TAS Section: 609.4, 609.3 Exception 2010 ADAS Section: 609.4, 609.3 Exception

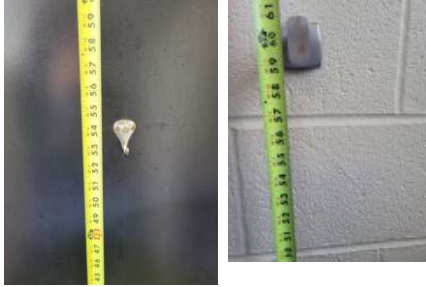
204	Eagle Point Shelters Area: EP - Women's Restroom	[33.2939558 , -95.6654028]	Coat hooks provided within the room shall be located within one of the reach ranges specified in 308. Shelves shall be 40 inches (1015 mm) minimum and 48 inches (1220 mm) maximum above the finish floor or ground. Where coat hooks or shelves are provided in dressing, fitting or locker rooms without individual compartments, at least one of each type shall comply with 803.5. Where coat hooks or shelves are provided in individual compartments at least one of each type complying with 803.5 shall be provided in individual compartments in dressing, fitting, or locker rooms required to comply with 222.1.	stall hook - 54" aff, hall hook - 60" aff	Remount at least one hook to max 48" aff	2015 ABAAS Section: 308.2.1, 308.1, F222.2, 803.5 2012 TAS Section: 308.2.1, 308.1, 222.2, 803.5 2010 ADAS Section: 308.2.1, 308.1, 222.2, 803.5

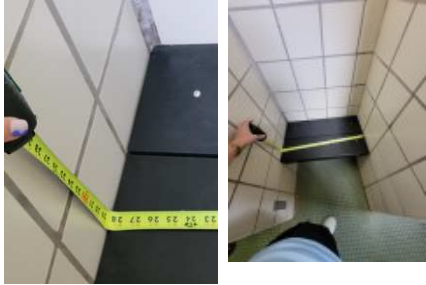
Finding Number	Area Description	Lat/Long	Finding	As Built	Recommendation	Citation	Photos	Figure
205	Eagle Point Shelters Area: EP - Women's Restroom	[33.2939558 , -95.6654054]	The bench is not deep enough or long enough or is missing. Benches shall be provided having seats that are 42 inches long minimum and 20 inches deep minimum and 24 inches deep maximum. The bench shall provide for back support or shall be affixed to a wall. Back support shall be 42 inches (1065 mm) long minimum and shall extend from a point 2 inches (51 mm) maximum above the seat surface to a point 18 inches (455 mm) minimum above the seat surface. Back support shall be 2½ inches (64 mm) maximum from the rear edge of the seat measured horizontally. The top of the bench seat surface shall be 17 inches (430 mm) minimum and 19 inches (485 mm) maximum above the finish floor or ground.	bench 28" wide	Replace bench in dressing area with one having a seat depth of 20" to 24" deep, 42" long, affixed to the wall or having a back and mounted 17" to 19" aff	2012 TAS Section: 903.4, 903.2, 903.3, 903.5 2010 ADAS Section: 903.4, 903.2, 903.3, 903.5

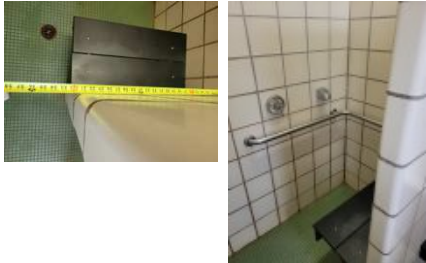
206	Eagle Point Shelters Area: EP - Women's Restroom	[33.2939625 , -95.6654081]	Transfer type shower compartments shall be 36 inches (915 mm) by 36 inches (915 mm) clear inside dimensions measured at the center points of opposing sides and shall have a 36 inch (915 mm) wide minimum entry on the face of the shower compartment. Clearance of 36 inches (915 mm) wide minimum by 48 inches (1220 mm) long minimum measured from the control wall shall be provided.	shower 31" by 36"	Enlarge transfer shower to compliant 36" by 36" clear inside dimension	2015 ABAAS Section: 608.2.1 2012 TAS Section: 608.2.1 2010 ADAS Section: 608.2.1

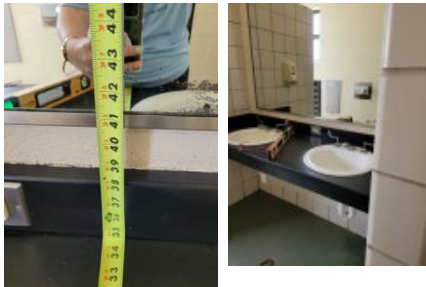
208	Eagle Point Shelters Area: EP - Women's Restroom	[33.2939468, -95.6654135]	The mirror is mounted too high. Mirrors must have the bottom edge of the reflecting surface a maximum of 40 inches above the floor if above a sink or counter. Mirrors not located above lavatories or countertops shall be installed with the bottom edge of the reflecting surface 35 inches maximum above the finish floor or ground.	mirror 41.5" aff	Lower mirror so reflective surface is max 40" aff	2015 ABAAS Section: 603.3 2012 TAS Section: 603.3 2010 ADAS Section: 603.3

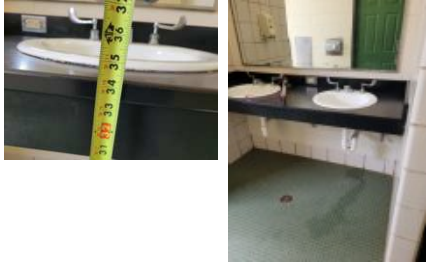
Finding Number	Area Description	Lat/Long	Finding	As Built	Recommendation	Citation	Photos	Figure
209	Eagle Point Shelters Area: EP - Women's Restroom	[33.2939647, -95.6653947]	The top rim of the sink is too high. All lavatories/sinks that are designated to be accessible shall be a minimum 17 inches in horizontal depth and mounted with the rim or counter edge no higher than 34 inches above the finished floor.	sink rim 35.5" aff	Lower sinks to max 34" aff to front of rim	2015 ABAAS Section: 606.3 2012 TAS Section: 606.3 2010 ADAS Section: 606.3

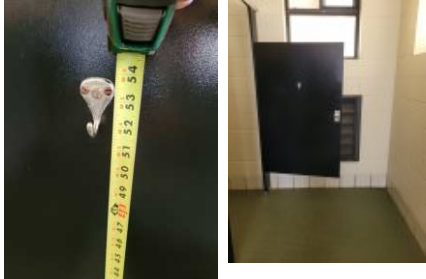
210	Eagle Point Shelters Area: EP - Women's Restroom	[33.293967, -95.6653893]	The operable part is positioned too high for either a side or front approach. Where a clear floor or ground space allows a parallel approach to an element and the side reach is unobstructed, the high side reach shall be 48 inches maximum and the low side reach shall be 15 inches minimum above the finish floor or ground. Where a forward reach is unobstructed, the high forward reach shall be 48 inches maximum and the low forward reach shall be 15 inches minimum above the finish floor or ground.	stall hook - 52" aff	Remount operable parts to be in reach range of 15" min to 48" max	2015 ABAAS Section: 308.1 2012 TAS Section: 308.1 2010 ADAS Section: 308.1

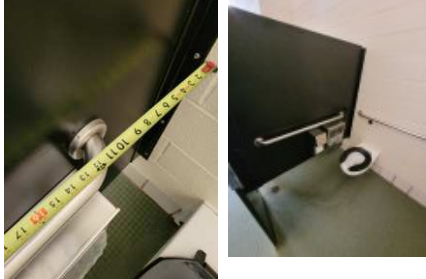
211	Eagle Point Shelters Area: EP - Women's Restroom	[33.2939603, -95.6654001]	The side grab bars are not in the correct location. Grab bars on the side wall must be installed so that the end closest to the rear wall is maximum 12" from the rear wall. The end furthest from the rear wall must be mounted minimum 54" from the rear wall.	side bar extends 53"	Remount side grab bar to max 12" from the rear wall at the close end and min 54" on the far end, and 33" to 36" aff	2015 ABAAS Section: 604.5.1 2012 TAS Section: 604.5.1 2010 ADAS Section: 604.5.1

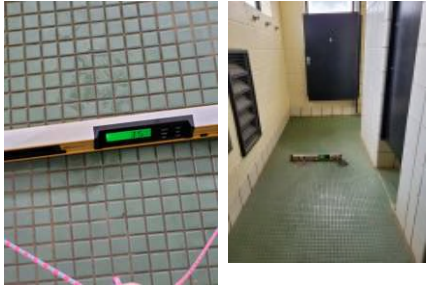
Finding Number	Area Description	Lat/Long	Finding	As Built	Recommendation	Citation	Photos	Figure
218	Eagle Point Shelters Area: EP - Women's Restroom	[33.2939636 , -95.6654054]	The accessible route contains running slopes greater than 5 percent and cross slopes greater than 2 percent across the width of the walk and has not been constructed as a ramp (i.e. handrails, wheel guides, etc.). When the slope in the direction of travel of any walk exceeds 1 unit vertical in 20 units horizontal (5-percent slope), it must be constructed as ramp. Surface cross slopes must not exceed one unit vertical in 48 units. Horizontal (2-percent slope).	3.5% cross slope outside of shower stall	Correct or repair slope to max 5% running and 2.08% cross	2015 ABAAS Section: 403.3 2012 TAS Section: 403.3 2010 ADAS Section: 403.3

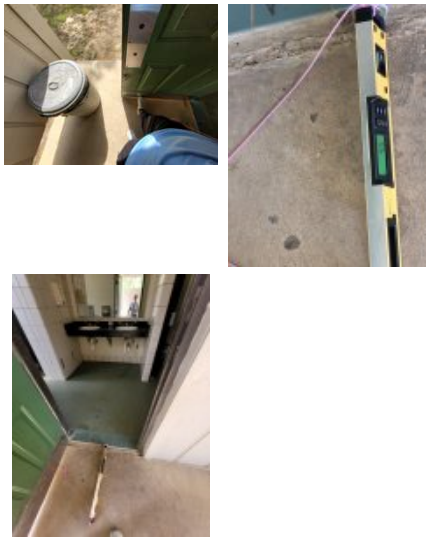
219	Eagle Point Shelters Area: EP - Women's Restroom	[33.2939603 , -95.6654162]	Minimum maneuvering clearances at doors and gates shall comply with 404.2.4. Maneuvering clearances shall extend the full width of the doorway and the required latch side or hinge side clearance. Maneuvering clearances shall have a max slope of 2.08%. The sweep period for doors with closers shall be adjusted so that from an open position of 70 degrees, the door will take at least 3 seconds to move to a point 3 inches from the latch, measured to the leading edge of the door. Exterior doors are recommended to be maintained at 8.5 lbf as a smart practice. Force is to be measured at the operating hardware or 30 inches from the hinges, whichever is greater.	women's- fast close, 15# push, trash can in clearance, 4.5% slope	For all doors along the public circulation route, provide required maneuvering clearance on push and pull side of doors. For all doors along the public circulation route, correct slope in door clearance to max 2.08%. For all doors along the public circulation route, inspect, adjust, and maintain closing speed on door closers. For all doors along the public circulation route, inspect, adjust, and maintain 8.5 lbf to open exterior doors as a smart practice.	2010 ADAS Section: 404.2.3, 404.2.7, 404.2.4, 404.2.11, 404.2.11 Exception

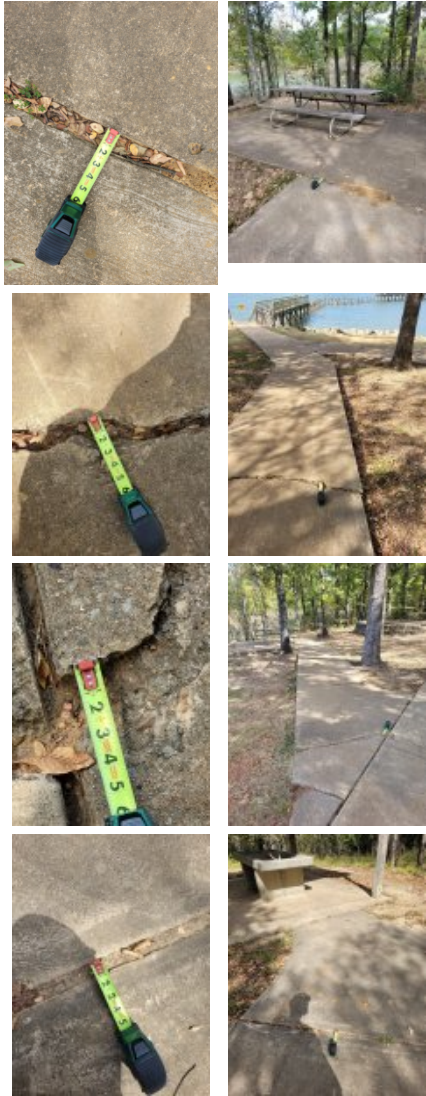
Finding Number	Area Description	Lat/Long	Finding	As Built	Recommendation	Citation	Photos	Figure
222	Sunset Cove Day Use Area: SC - Day Use Exterior Accessible Route	[33.2921711 , -95.666709]	There is a gap spaced greater than a 1/2 inch. Openings in floor or ground surfaces shall not allow passage of a sphere more than 1/2 inch diameter. Elongated openings shall be placed so that the long dimension is perpendicular to the dominant direction of travel.	Further from water paved picnic area - 1.5" gap at entry, path from further picnic to closer has 2" gap in middle, 3" gap at closer paved picnic slab, 1" gap at fish clean, 1" gap at turn before fish clean, 1.5" gap at turn to restroom from parking, 1" gap after sign	Correct or fill gaps to be max .5"	2015 ABAAS Section: 302.3 2012 TAS Section: 302.3 2010 ADAS Section: 302.3

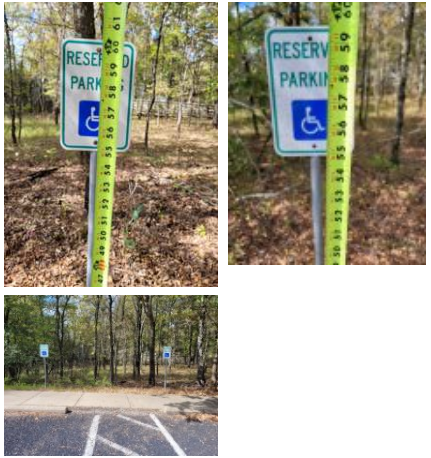
227	Sunset Cove Day Use Area: SC - Parking	[33.2920445, -95.6662544]	The parking sign is mounted too low. Parking space identification signs shall include the International Symbol of Accessibility complying with. Signs identifying van parking spaces shall contain the designation "van accessible." Signs shall be 60 inches minimum above the finish floor or ground surface measured to the bottom of the sign.	both at 55" agl	Raise existing accessible parking signs so lowest end of bottom sign is min 60" aff	2015 ABAAS Section: 502.6 2012 TAS Section: 502.6 2010 ADAS Section: 502.6

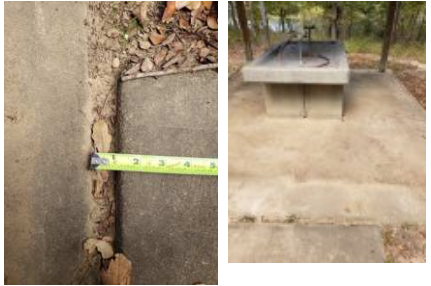
Finding Number	Area Description	Lat/Long	Finding	As Built	Recommendation	Citation	Photos	Figure
229	Sunset Cove Day Use Area: SC - Fish Cleaning	[33.2922586 , -95.6670604]	Openings in floor or ground surfaces shall not allow passage of a sphere more than 1/2 inch (13 mm) diameter except as allowed in 407.4.3, 409.4.3, 410.4, 810.5.3 and 810.10. Elongated openings shall be placed so that the long dimension is perpendicular to the dominant direction of travel. Floor or ground surface within required maneuvering clearances shall comply with 302. Changes in level are not permitted.	1" gap at entry	Correct or fill gap in doorway to max .5"	2010 ADAS Section: 302.3, 404.2.4.4

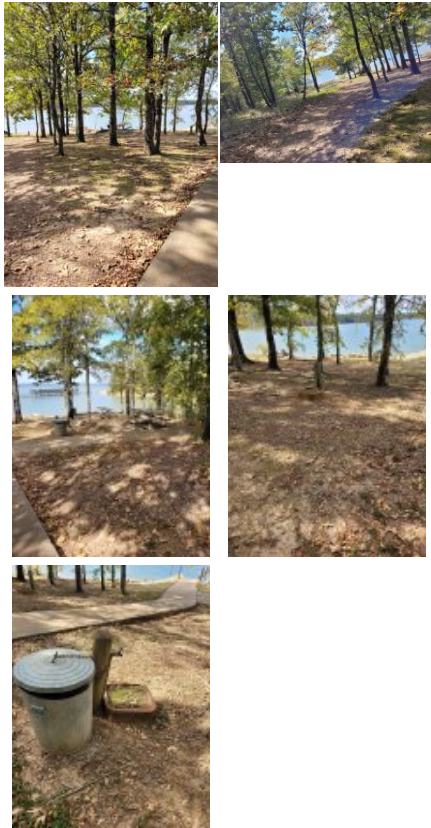
230	Sunset Cove Day Use Area: SC - Picnic Areas	[33.2921936 , -95.6669879]	An accessible access route is not provided between elements, spaces and the facilities provided within the accessible camping unit. At least one outdoor recreation access route shall connect accessible elements, spaces and facilities provided within camping units with mobility features.	Lacks route to 4 of 6 picnic tables and 2 of 2 water spigots	Create AR with crushed and compacted stone or similar outdoor material to picnic sites and one of each type of amenity.	2015 ABAAS Section: F244.5.1

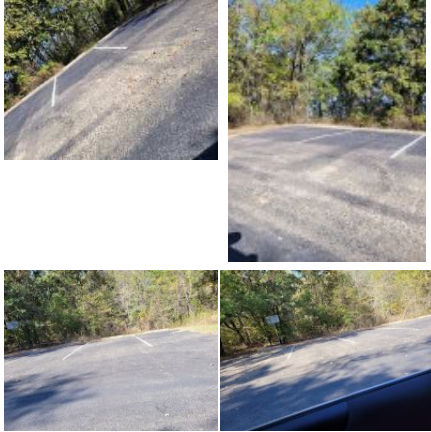
Finding Number	Area Description	Lat/Long	Finding	As Built	Recommendation	Citation	Photos	Figure
236	Bright Star Camping Area: BS - Parking	[33.2888249 , -95.67422 72], [33.289697, -95.672776 1]	There are no accessible parking stalls. Each lot where parking is provided for the public as clients, guests or employees, shall provide accessible parking and shall be located on the shortest accessible route of travel from adjacent parking to an accessible entrance. There are a total of 10 parking stalls in the parking lot that could be reasonably associated with this facility. There should be a minimum of 1 accessible stalls with a minimum of 1 being designed as van accessible.	Lacks accessible stalls in the 2 small lots within Bright Star camping (4 stall lot and 6 stall lot)	Create one or more 8' accessible parking stalls, with one 5' adjacent access aisle, with proper signage and striping based on the total number of stalls	2015 ABAAS Section: F208.2 2012 TAS Section: 208.2 2010 ADAS Section: 208.2

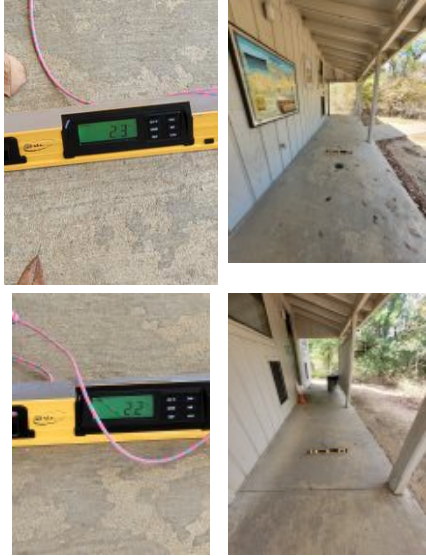
244	Bright Star Camping Area: BS - Exterior Accessible Route	[33.2870984, -95.6725388]	The accessible route of travel on the accessible route contains cross slopes greater than 2%. Cross slopes shall not exceed one unit vertical in 48 units horizontal (2-percent slope).	2.3% slope at map, 2.2% slope at turn to men's restroom	Correct or repair cross slope along AR to max 2.08%	2015 ABAAS Section: 403.3 2012 TAS Section: 403.3 2010 ADAS Section: 403.3

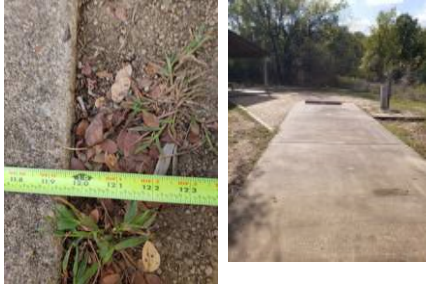
Finding Number	Area Description	Lat/Long	Finding	As Built	Recommendation	Citation	Photos	Figure
252	Bright Star Camping Area: BS - Campsites	[33.2889202 , -95.671891]	Parking spaces and pull-up spaces for recreational vehicles shall be 20 feet (6100 mm) wide minimum. EXCEPTION: Where two adjacent parking spaces are provided for recreational vehicles, one parking space shall be permitted to be 16 feet (4880 mm) wide minimum.	Campsite 39 - 10' wide parking space	Correct RV parking space to be 20' wide minimum; or 16' for two adjacent spaces as a smart practice.	2015 ABAAS Section: 1012.2, 1012.2 EXCEPTION

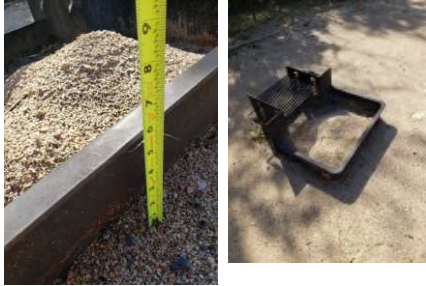
253	Bright Star Camping Area: BS - Campsites	[33.2884919 , -95.6713143]	Fire building surfaces shall be 9 inches (230 mm) minimum above the ground	Site 41 - fire building surface is less than 6"	Correct fire building surface to be 9" min above the ground as a smart practice.	2015 ABAAS Section: 1011.5.1

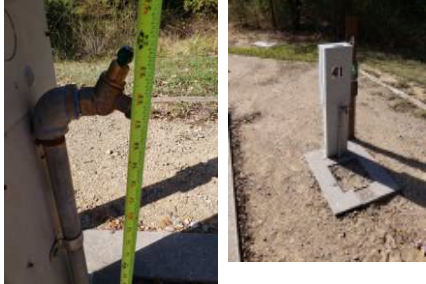
255	Bright Star Camping Area: BS - Campsites	[33.2884897 , -95.6713036]	Water spouts at water hydrants and water utility hook-ups shall be 28 inches (710 mm) minimum and 36 inches (915 mm) maximum above the ground	Site 41 - water spigot - 23" AGL	Remount water spouts to 28" min or 36" max above the ground as a smart practice	2015 ABAAS Section: 1011.6

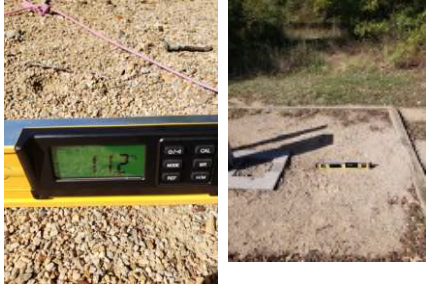
Finding Number	Area Description	Lat/Long	Finding	As Built	Recommendation	Citation	Photos	Figure
256	Bright Star Camping Area: BS - Campsites	[33.2885121, -95.6713264]	The 30 inches minimum by 48 inches minimum clear floor space required at the operable part is not flat (2% or 1:48 maximum slope) in all directions. Changes in level are not permitted at required clear floor or ground space except that slopes not steeper than 1:48 shall be permitted.	Site 41 - Slope of 11.2% in CGS of utility hookups	Correct or repair slope in CFS to max 2.08%	2015 ABAAS Section: 305.2 2012 TAS Section: 305.2 2010 ADAS Section: 305.2

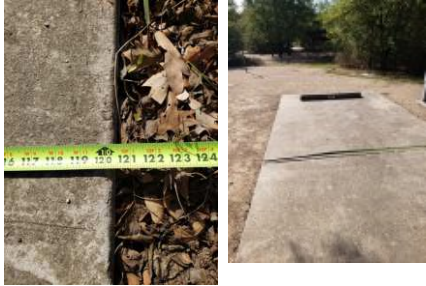
257	Bright Star Camping Area: BS - Campsites	[33.288539, -95.6713304]	Parking spaces and pull-up spaces for recreational vehicles shall be 20 feet (6100 mm) wide minimum. EXCEPTION: Where two adjacent parking spaces are provided for recreational vehicles, one parking space shall be permitted to be 16 feet (4880 mm) wide minimum.	Campsite 41 - 10' wide parking space	Correct RV parking space to be 20' wide minimum; or 16' for two adjacent spaces as a smart practice.	2015 ABAAS Section: 1012.2, 1012.2 EXCEPTION

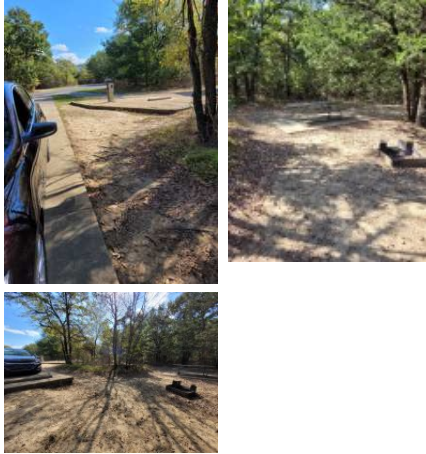
258	Bright Star Camping Area: BS - Campsites	[33.2873227, -95.6728539]	An accessible access route is not provided between elements, spaces and the facilities provided within the accessible camping unit. At least one outdoor recreation access route shall connect accessible elements, spaces and facilities provided within camping units with mobility features.	Site 22 - Lacks route to table and fire ring, surface extends to features at site 23 (the set is rented together as 22D)	Create AR with crushed and compacted stone or similar outdoor material to camp sites and one of each type of amenity.	2015 ABAAS Section: F244.5.1

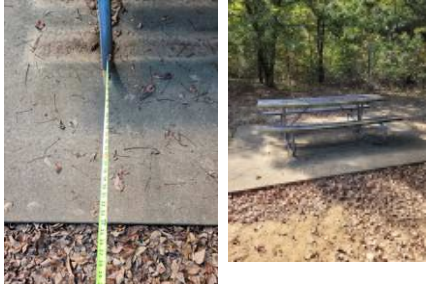
Finding Number	Area Description	Lat/Long	Finding	As Built	Recommendation	Citation	Photos	Figure
259	Bright Star Camping Area: BS - Campsites	[33.2872924 , -95.672851 2]	36 inches (915 mm) on all usable sides of the table measured from the back edge of the benches	Site 22- 24" CGS around table, surface extends to features at site 23 (the set is rented together as 22D)	Provide required 36" clear ground space around all usable portions of the table as a smart practice	2015 ABAAS Section: 1011.2.1

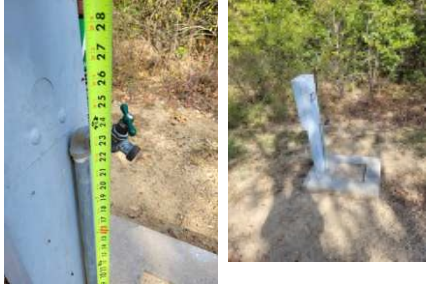
262	Bright Star Camping Area: BS - Campsites	[33.2873215 , -95.672860 6]	Water spouts at water hydrants and water utility hook-ups shall be 28 inches (710 mm) minimum and 36 inches (915 mm) maximum above the ground	Site 22 - water spout at 24", surface extends to features at site 23 (the set is rented together as 22D)	Remount water spouts to 28" min or 36" max above the ground as a smart practice	2015 ABAAS Section: 1011.6

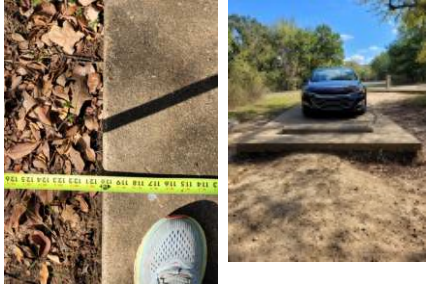
Finding Number	Area Description	Lat/Long	Finding	As Built	Recommendation	Citation	Photos	Figure
263	Bright Star Camping Area: BS - Campsites	[33.287344, -95.6727627]	Parking spaces and pull-up spaces for recreational vehicles shall be 20 feet (6100 mm) wide minimum. EXCEPTION: Where two adjacent parking spaces are provided for recreational vehicles, one parking space shall be permitted to be 16 feet (4880 mm) wide minimum.	Site 22 - parking space 10" wide, surface extends to features at site 23 (the set is rented together as 22D)	Correct RV parking space to be 20' wide minimum; or 16' for two adjacent spaces as a smart practice.	2015 ABAAS Section: 1012.2, 1012.2 EXCEPTION

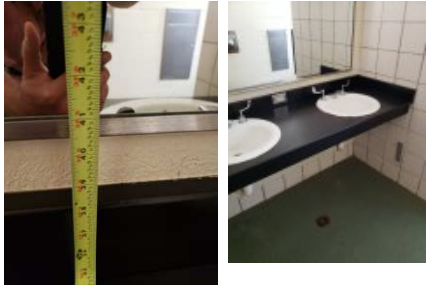
Finding Number	Area Description	Lat/Long	Finding	As Built	Recommendation	Citation	Photos	Figure
268	Bright Star Camping Area: BS - Men's Restroom	[33.2870771 , -95.672564 3]	The mirror is mounted too high. Mirrors must have the bottom edge of the reflecting surface a maximum of 40 inches above the floor if above a sink or counter. Mirrors not located above lavatories or countertops shall be installed with the bottom edge of the reflecting surface 35 inches maximum above the finish floor or ground.	mirror - 41" aff	Lower mirror so reflective surface is max 40" aff	2015 ABAAS Section: 603.3 2012 TAS Section: 603.3 2010 ADAS Section: 603.3

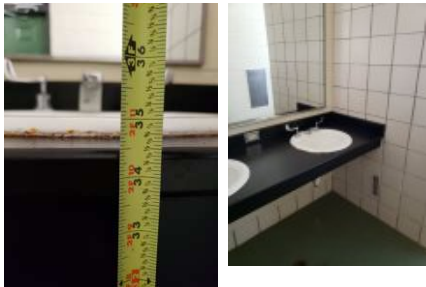
269	Bright Star Camping Area: BS - Men's Restroom	[33.2870682 , -95.672569 6]	The top rim of the sink is too high. All lavatories/sinks that are designated to be accessible shall be a minimum 17 inches in horizontal depth and mounted with the rim or counter edge no higher than 34 inches above the finished floor.	rim 35" aff	Lower sinks to max 34" aff to front of rim	2015 ABAAS Section: 606.3 2012 TAS Section: 606.3 2010 ADAS Section: 606.3

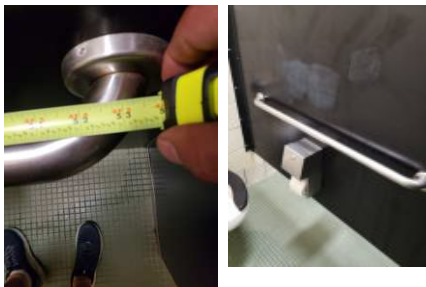
270	Bright Star Camping Area: BS - Men's Restroom	[33.2870727 , -95.672550 8]	The side grab bars are not in the correct location. Grab bars on the side wall must be installed so that the end closest to the rear wall is maximum 12" from the rear wall. The end furthest from the rear wall must be mounted minimum 54" from the rear wall.	grab bar ends 53" from rear wall	Remount side grab bar to max 12" from the rear wall at the close end and min 54" on the far end, and 33" to 36" aff	2015 ABAAS Section: 604.5.1 2012 TAS Section: 604.5.1 2010 ADAS Section: 604.5.1

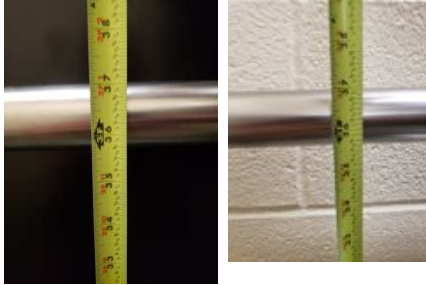
Finding Number	Area Description	Lat/Long	Finding	As Built	Recommendation	Citation	Photos	Figure
271	Bright Star Camping Area: BS - Men's Restroom	[33.2870682 , -95.672564 3]	The grab bar height and/or spacing fails. Grab bars must be mounted between 33" and 36" to the top of the gripping surface. There must be 1.5" of clearance between the grab bar and the wall. There must be a minimum of 1.5" of clearance below and minimum 12" above the grab bar to any dispenser or other obstruction.	both grab bars mounted 37" aff	Remount grab bars in accessible stall to 33" to 36" aff	2015 ABAAS Section: 609.3, 609.4 2012 TAS Section: 609.4, 609.3 2010 ADAS Section: 609.3, 609.4

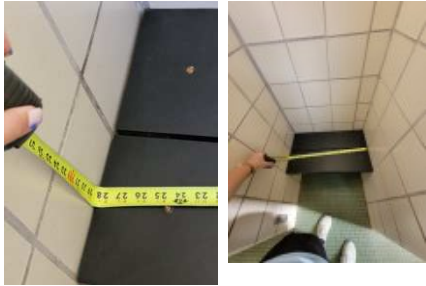
280	Bright Star Camping Area: BS - Women's Restroom	[33.2870861 , -95.6725723]	The bench is not deep enough or long enough or is missing. Benches shall be provided having seats that are 42 inches long minimum and 20 inches deep minimum and 24 inches deep maximum. The bench shall provide for back support or shall be affixed to a wall. Back support shall be 42 inches (1065 mm) long minimum and shall extend from a point 2 inches (51 mm) maximum above the seat surface to a point 18 inches (455 mm) minimum above the seat surface. Back support shall be 2½ inches (64 mm) maximum from the rear edge of the seat measured horizontally. The top of the bench seat surface shall be 17 inches (430 mm) minimum and 19 inches (485 mm) maximum above the finish floor or ground.	28" wide bench	Replace bench in dressing area with one having a seat depth of 20" to 24" deep, 42" long, affixed to the wall or having a back and mounted 17" to 19" aff	2012 TAS Section: 903.4, 903.2, 903.3, 903.5 2010 ADAS Section: 903.4, 903.2, 903.3, 903.5

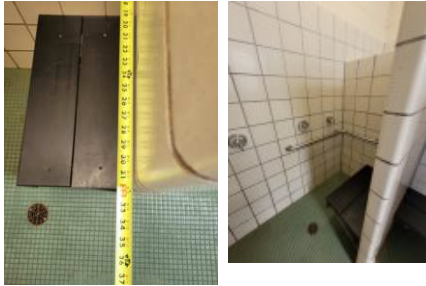
Finding Number	Area Description	Lat/Long	Finding	As Built	Recommendation	Citation	Photos	Figure
281	Bright Star Camping Area: BS - Women's Restroom	[33.2870839 , -95.672564 3]	Transfer type shower compartments shall be 36 inches (915 mm) by 36 inches (915 mm) clear inside dimensions measured at the center points of opposing sides and shall have a 36 inch (915 mm) wide minimum entry on the face of the shower compartment. Clearance of 36 inches (915 mm) wide minimum by 48 inches (1220 mm) long minimum measured from the control wall shall be provided.	31" x 36" shower dimension	Enlarge transfer shower to compliant 36" by 36" clear inside dimension	2015 ABAAS Section: 608.2.1 2012 TAS Section: 608.2.1 2010 ADAS Section: 608.2.1

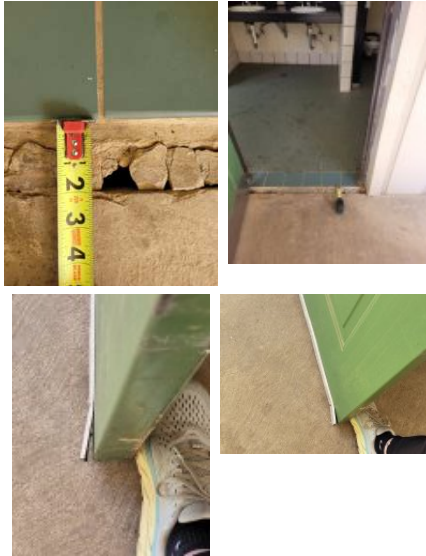
282	Bright Star Camping Area: BS - Women's Restroom	[33.2870581 , -95.672564 3]	The threshold has a gap greater than 1/2 inch wide. The bottom 10 inches on the push side must be smooth and free of obstructions (hold open devices). Opening hardware must be mounted between 30 and 44 inches above the floor or ground.	BS women's restroom door - 2" gap at entry, broken metal on pull side	For all doors along the public circulation route, fill gaps at door entries to max .5". For all doors along the public circulation route, provide kick plate on push side of door from floor to 10" AFF.	2010 ADAS Section: 404.2.3, 404.2.7, 404.2.4, 404.2.11, 404.2.11 Exception

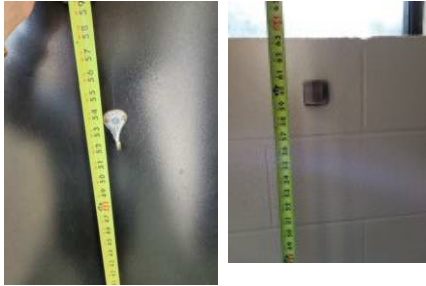
Finding Number	Area Description	Lat/Long	Finding	As Built	Recommendation	Citation	Photos	Figure
283	Bright Star Camping Area: BS - Women's Restroom	[33.2870547 , -95.672548 2]	Coat hooks provided within the room shall be located within one of the reach ranges specified in 308. Shelves shall be 40 inches (1015 mm) minimum and 48 inches (1220 mm) maximum above the finish floor or ground. Where coat hooks or shelves are provided in dressing, fitting or locker rooms without individual compartments, at least one of each type shall comply with 803.5. Where coat hooks or shelves are provided in individual compartments at least one of each type complying with 803.5 shall be provided in individual compartments in dressing, fitting, or locker rooms required to comply with 222.1.	stall hook - 52" aff, hall hook - 60" aff	Remount at least one hook to max 48" aff and shelves to 40" - 48" aff	2015 ABAAS Section: 308.2.1, 308.1, F222.2, 803.5 2012 TAS Section: 308.2.1, 308.1, 222.2, 803.5 2010 ADAS Section: 308.2.1, 308.1, 222.2, 803.5

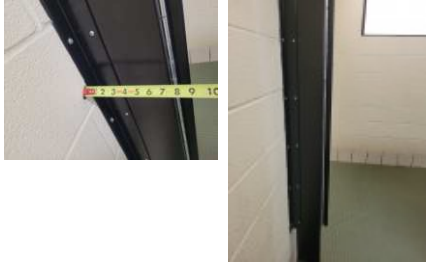
Finding Number	Area Description	Lat/Long	Finding	As Built	Recommendation	Citation	Photos	Figure
291	Bright Star Camping Area: BS - Women's Restroom	[33.2870704, -95.672583]	The compartment door is located too far from the partition or wall. The door shall be located in front of the clear space and diagonal to the water closet. Where located in the front partition, the door opening shall be 4 inches maximum from the side wall or partition farthest from the water closet. Where located in the side wall or partition, the door opening shall be 4 inches maximum from the front partition. Toilet compartment doors shall not swing into the minimum required compartment area.	door 7.5" from wall	Rehang stall door to be max 4" from adjacent stall partition and on the stall wall farthest from the toilet	2015 ABAAS Section: 604.8.1.2 2012 TAS Section: 604.8.1.2 2010 ADAS Section: 604.8.1.2

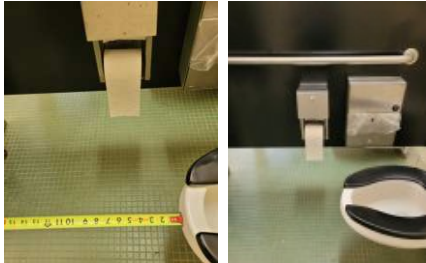
292	Bright Star Camping Area: BS - Women's Restroom	[33.2870592, -95.6725643]	The toilet paper is not installed within the compliant range in front of the toilet. Toilet paper dispensers shall be 7 inches minimum and 9 inches maximum in front of the water closet measured to the centerline of the dispenser. The outlet of the dispenser shall be 15 inches minimum and 48 inches maximum above the finish floor and shall not be located behind grab bars. Dispensers shall not be of a type that controls delivery or that does not allow continuous paper flow. There shall be a clearance of 1 1/2 inches minimum below the grab bar.	TP too close to front of toilet	Remount toilet paper dispenser max 7" to 9" from front of toilet, 15" to 48" aff and min 12" above or 1.5" below grab bar	2015 ABAAS Section: 604.7 2012 TAS Section: 604.7 2010 ADAS Section: 604.7

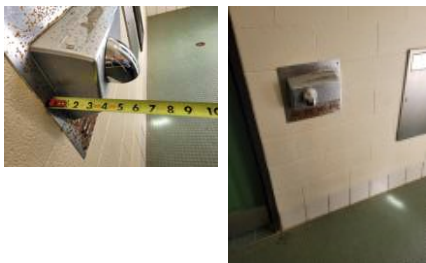
293	Bright Star Camping Area: BS - Women's Restroom	[33.287057, -95.6725589]	The hand dryer projects more than 4 inches into the circulation path. Wall-mounted objects that have leading edges between 27 inches and 80 inches from the floor must not project more than 4 inches into the circulation path. Protruding objects that extend to the floor or within 27 inches of the floor are cane detectable and are therefore not hazardous. Where it is necessary or desirable to have objects protrude from the wall, a manner of cane detection must be provided.	hand dryer projects 6"	Relocate protruding objects or place cane detectable warning or bollard at foot of item	2015 ABAAS Section: 307.2 2012 TAS Section: 307.2 2010 ADAS Section: 307.2

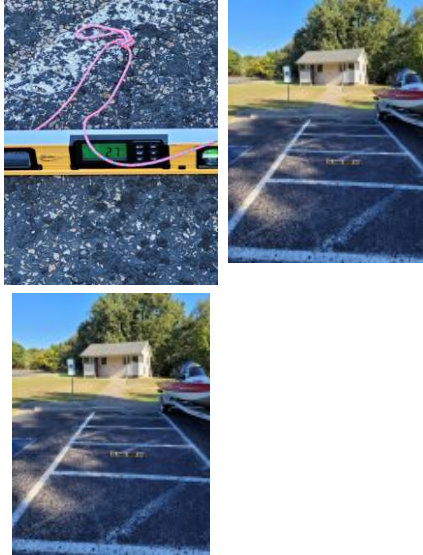
295	Honey Creek Day Use Area: HC - Parking	[33.2889482 , -95.676434 7]	The cross slopes (narrow dimension) and/or running slopes (long dimension) of the access aisle exceeds 2%. The running slope and the cross slope in an accessible parking stall and the access aisle must not exceed 2%.	access aisle - 2.7% slope	Repair or correct slope of parking space and access aisle to max 2.08% in any direction	2015 ABAAS Section: 502.4 2012 TAS Section: 502.4 2010 ADAS Section: 502.4

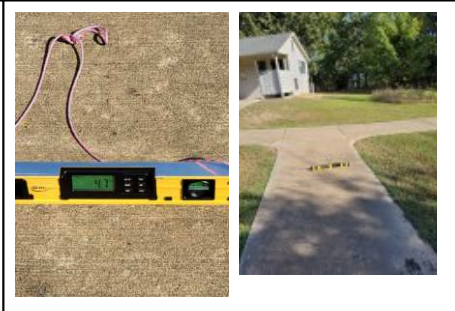
299	Honey Creek Day Use Area: HC - Exterior Accessible Route	[33.2890255, -95.676373]	The accessible route of travel on the accessible route contains cross slopes greater than 2%. Cross slopes shall not exceed one unit vertical in 48 units horizontal (2-percent slope).	4.7% slope on right path to fish clean	Correct or repair cross slope along AR to max 2.08%	2015 ABAAS Section: 403.3 2012 TAS Section: 403.3 2010 ADAS Section: 403.3

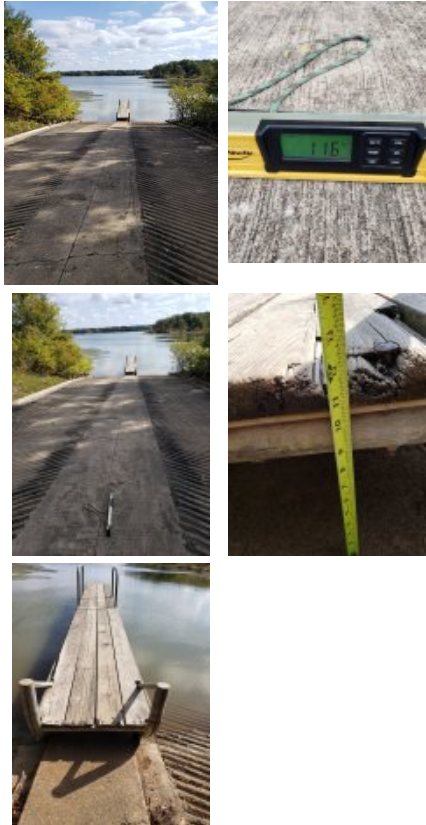
Finding Number	Area Description	Lat/Long	Finding	As Built	Recommendation	Citation	Photos	Figure
303	Honey Creek Day Use Area: HC - Boat Ramp	[33.2900154 , -95.6762214]	The minimum number of boarding piers are not accessible. Where boarding piers are provided at boat launch ramps, at least 5 percent, but no fewer than one, of the boarding piers be accessible.	Boarding pier not accessible - 11.6% slope and 12" CIL	Provide 5%, but not less than one accessible boarding pier at boat launches.	2015 ABAAS Section: F235.3 2010 ADAS Section: 235.3

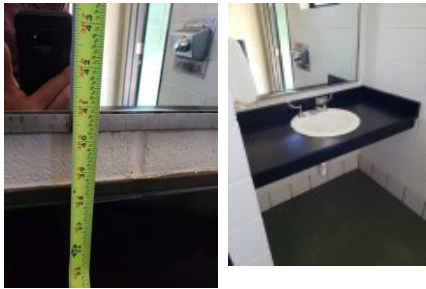
310	Honey Creek Day Use Area: HC - Men's Restroom	[33.2891634 , -95.676351 5]	The mirror is mounted too high. Mirrors must have the bottom edge of the reflecting surface a maximum of 40 inches above the floor if above a sink or counter. Mirrors not located above lavatories or countertops shall be installed with the bottom edge of the reflecting surface 35 inches maximum above the finish floor or ground.	mirror mounted 41" aff	Lower mirror so reflective surface is max 40" aff	2015 ABAAS Section: 603.3 2012 TAS Section: 603.3 2010 ADAS Section: 603.3

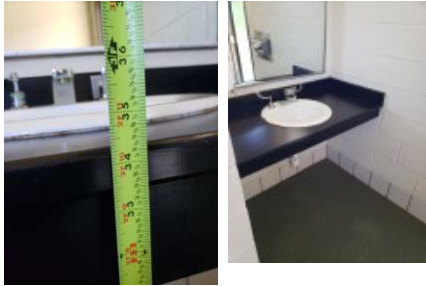
Finding Number	Area Description	Lat/Long	Finding	As Built	Recommendation	Citation	Photos	Figure
311	Honey Creek Day Use Area: HC - Men's Restroom	[33.2891758 , -95.676351 5]	The top rim of the sink is too high. All lavatories/sinks that are designated to be accessible shall be a minimum 17 inches in horizontal depth and mounted with the rim or counter edge no higher than 34 inches above the finished floor.	sink rim - 35" aff	Lower sinks to max 34" aff to front of rim	2015 ABAAS Section: 606.3 2012 TAS Section: 606.3 2010 ADAS Section: 606.3

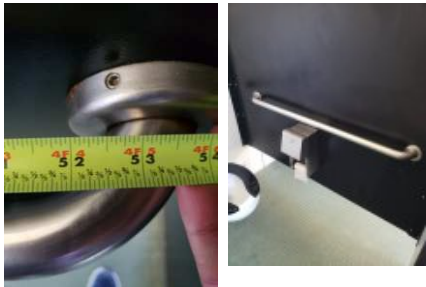
312	Honey Creek Day Use Area: HC - Men's Restroom	[33.2891668 , -95.676363 6]	The side grab bars are not in the correct location. Grab bars on the side wall must be installed so that the end closest to the rear wall is maximum 12" from the rear wall. The end furthest from the rear wall must be mounted minimum 54" from the rear wall.	42" bar, ends 53" from wall	Remount side grab bar to max 12" from the rear wall at the close end and min 54" on the far end, and 33" to 36" aff	2015 ABAAS Section: 604.5.1 2012 TAS Section: 604.5.1 2010 ADAS Section: 604.5.1

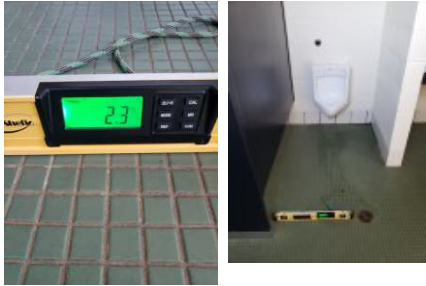
Finding Number	Area Description	Lat/Long	Finding	As Built	Recommendation	Citation	Photos	Figure
317	Honey Creek Day Use Area: HC - Men's Restroom	[33.2891814 , -95.676364 9]	The accessible route contains running slopes greater than 5 percent and cross slopes greater than 2 percent across the width of the walk and has not been constructed as a ramp (i.e. handrails, wheel guides, etc.). When the slope in the direction of travel of any walk exceeds 1 unit vertical in 20 units horizontal (5-percent slope), it must be constructed as ramp. Surface cross slopes must not exceed one unit vertical in 48 units. Horizontal (2-percent slope).	2.3% cross slope	Correct or repair slope to max 5% running and 2.08% cross	2015 ABAAS Section: 403.3 2012 TAS Section: 403.3 2010 ADAS Section: 403.3

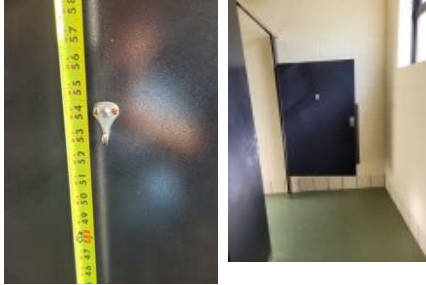
Finding Number	Area Description	Lat/Long	Finding	As Built	Recommendation	Citation	Photos	Figure
321	Honey Creek Day Use Area: HC - Women's Restroom	[33.2891713 , -95.676362 3]	The operable part is positioned too high for either a side or front approach. Where a clear floor or ground space allows a parallel approach to an element and the side reach is unobstructed, the high side reach shall be 48 inches maximum and the low side reach shall be 15 inches minimum above the finish floor or ground. Where a forward reach is unobstructed, the high forward reach shall be 48 inches maximum and the low forward reach shall be 15 inches minimum above the finish floor or ground.	hook in stall - 53" aff	Remount operable parts to be in reach range of 15" min to 48" max	2015 ABAAS Section: 308.1 2012 TAS Section: 308.1 2010 ADAS Section: 308.1

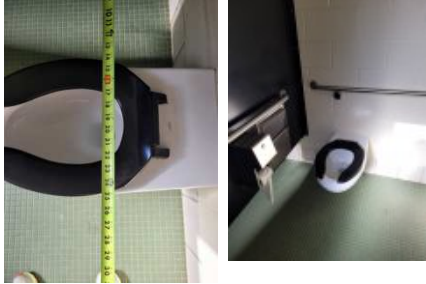
322	Honey Creek Day Use Area: HC - Women's Restroom	[33.2891713 , -95.676351 5]	The toilet is not located within the range allowed from the side wall or partition. The centerline of the toilet must be 16 to 18 inches from the side wall.	20" from wall/partition	Remount toilets to 16" to 18" from the side wall to centerline	2015 ABAAS Section: 604.2 2012 TAS Section: 604.2 2010 ADAS Section: 604.2

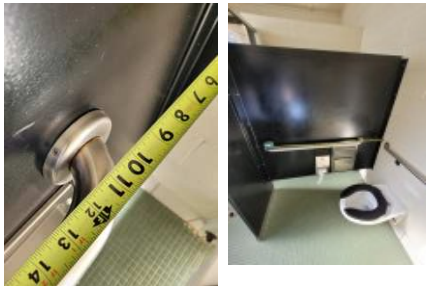
323	Honey Creek Day Use Area: HC - Women's Restroom	[33.2891668 , -95.676346 2]	The side grab bars are not in the correct location. Grab bars on the side wall must be installed so that the end closest to the rear wall is maximum 12" from the rear wall. The end furthest from the rear wall must be mounted minimum 54" from the rear wall.	Side bar ends 53" from rear wall to grab bar end	Remount side grab bar to max 12" from the rear wall at the close end and min 54" on the far end, and 33" to 36" aff	2015 ABAAS Section: 604.5.1 2012 TAS Section: 604.5.1 2010 ADAS Section: 604.5.1

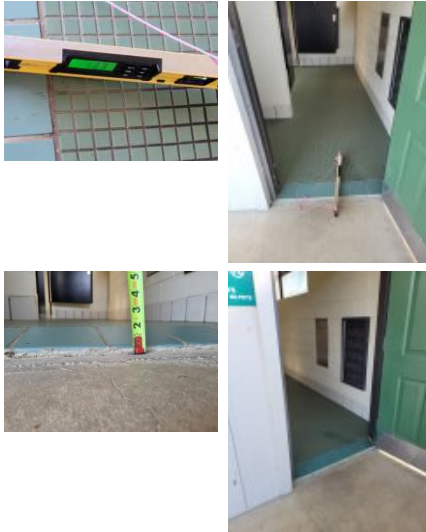
Finding Number	Area Description	Lat/Long	Finding	As Built	Recommendation	Citation	Photos	Figure
329	Honey Creek Day Use Area: HC - Women's Restroom	[33.2891713 , -95.6763623]	Minimum maneuvering clearances at doors and gates shall comply with 404.2.4. Maneuvering clearances shall extend the full width of the doorway and the required latch side or hinge side clearance. Maneuvering clearances shall have a max slope of 2.08%. The threshold has a vertical change greater than 1/4 inch high. Exterior doors are recommended to be maintained at 8.5 lbf as a smart practice. Force is to be measured at the operating hardware or 30 inches from the hinges, whichever is greater.	Honey Creek women's restroom door - 11 lbf, 13.3% slope up, .5" CIL	For all doors along the public circulation route, correct slope in door clearance to max 2.08%. For all doors along the public circulation route, repair, bevel, or ramp CILs at door entries to max .25". For all doors along the public circulation route, inspect, adjust, and maintain 8.5 lbf to open exterior doors as a smart practice.	2010 ADAS Section: 404.2.3, 404.2.7, 404.2.4, 404.2.11, 404.2.11 Exception

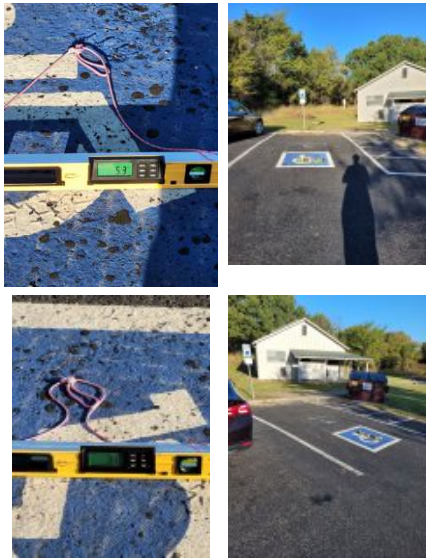
332	Deer Haven Camping Area: DH Parking	[33.2902475 , -95.678548 3]	The cross slopes (narrow dimension) and/or running slopes (long dimension) of the access aisle exceeds 2%. The running slope and the cross slope in an accessible parking stall and the access aisle must not exceed 2%.	stall - 5.3% slope, 3.4% slope. access aisle - 5.9% slope, 3.9% slope	Repair or correct slope of parking space and access aisle to max 2.08% in any direction	2015 ABAAS Section: 502.4 2012 TAS Section: 502.4 2010 ADAS Section: 502.4

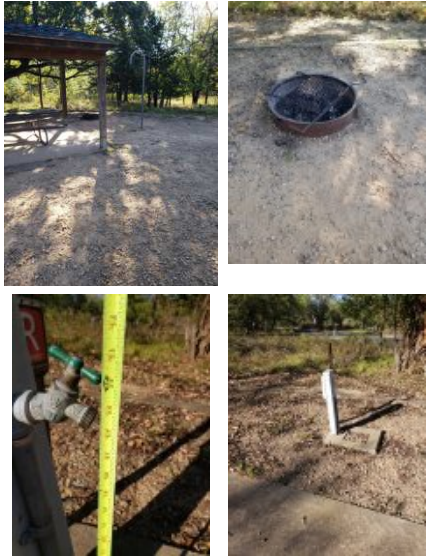
340	Deer Haven Camping Area: DH - Campsites	[33.2888294 , -95.679106 2]	Camping facilities shall provide camping units with mobility features complying with F244.2 in accordance with Table F244.2. Where a camping facility provides different types of camping units, Table F244.2 shall apply to each type of camping unit provided. Total Number of Camping Units Provided in Camping Facility Minimum Number of Camping Units with Mobility Features Required 1 1 2 to 25 2 26 to 50 3 51 to 75 4 76 to 100 5 101 to 150 7 151 to 200 8 201 and over 8, plus 2 percent of the number over 200	Site 51 - non accessible surface (sand/rock), CIL at table area, hook is well out of reach range, fire pit is below grade, water faucet and hookup too low and not accessible (the front desk thought this site was accessible but there are no accessible features)	Create the required number of accessible camp sites per table F244.2 as a smart practice	2015 ABAAS Section: F244.2

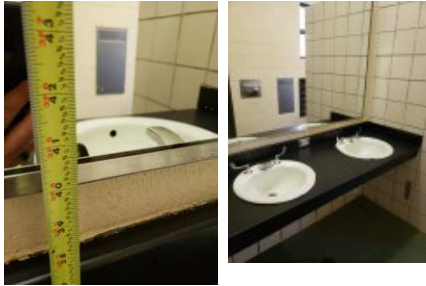
Finding Number	Area Description	Lat/Long	Finding	As Built	Recommendation	Citation	Photos	Figure
345	Deer Haven Camping Area: DH - Men's Restroom	[33.2903461, -95.6786797]	The mirror is mounted too high. Mirrors must have the bottom edge of the reflecting surface a maximum of 40 inches above the floor if above a sink or counter. Mirrors not located above lavatories or countertops shall be installed with the bottom edge of the reflecting surface 35 inches maximum above the finish floor or ground.	mirror mounted 40.75" aff	Lower mirror so reflective surface is max 40" aff	2015 ABAAS Section: 603.3 2012 TAS Section: 603.3 2010 ADAS Section: 603.3

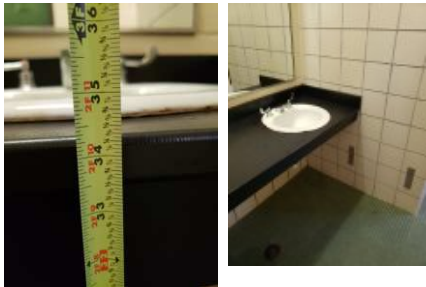
346	Deer Haven Camping Area: DH - Men's Restroom	[33.2903641, -95.6786582]	The top rim of the sink is too high. All lavatories/sinks that are designated to be accessible shall be a minimum 17 inches in horizontal depth and mounted with the rim or counter edge no higher than 34 inches above the finished floor.	sink rim is 35" aff	Lower sinks to max 34" aff to front of rim	2015 ABAAS Section: 606.3 2012 TAS Section: 606.3 2010 ADAS Section: 606.3

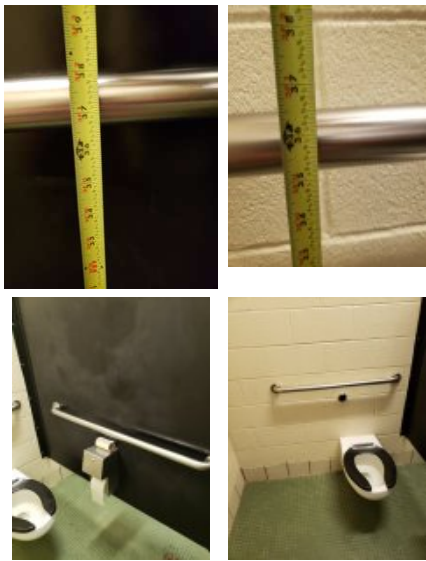
347	Deer Haven Camping Area: DH - Men's Restroom	[33.290373, -95.678669]	The grab bar height and/or spacing fails. Grab bars must be mounted between 33" and 36" to the top of the gripping surface. There must be 1.5" of clearance between the grab bar and the wall. There must be a minimum of 1.5" of clearance below and minimum 12" above the grab bar to any dispenser or other obstruction.	side bar 37" aff, rear bar 36" aff	Remount grab bars in accessible stall to 33" to 36" aff	2015 ABAAS Section: 609.3, 609.4 2012 TAS Section: 609.4, 609.3 2010 ADAS Section: 609.3, 609.4
