Access Audit Site Report

Cooper Lake State Park - South Sulphur Unit

Accessibility Evaluation

Inspection Date: 10/19/2021

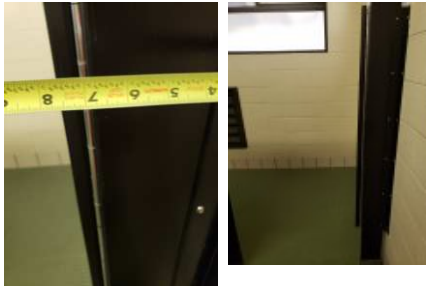
349	Deer Haven Camping Area: DH - Men's Restroom	[33.2903641 , -95.6786743]	The compartment door is located too far from the partition or wall. The door shall be located in front of the clear space and diagonal to the water closet. Where located in the front partition, the door opening shall be 4 inches maximum from the side wall or partition farthest from the water closet. Where located in the side wall or partition, the door opening shall be 4 inches maximum from the front partition. Toilet compartment doors shall not swing into the minimum required compartment area.	door 7" from wall	Rehang stall door to be max 4" from adjacent stall partition and on the stall wall farthest from the toilet	2015 ABAAS Section: 604.8.1.2 2012 TAS Section: 604.8.1.2 2010 ADAS Section: 604.8.1.2

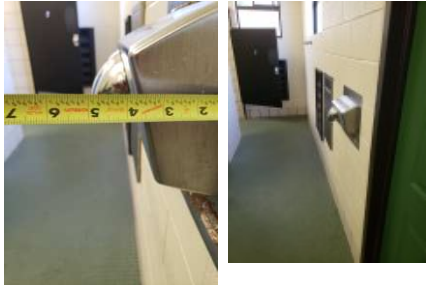
350	Deer Haven Camping Area: DH - Men's Restroom	[33.2903618 , -95.678669]	The hand dryer projects more than 4 inches into the circulation path. Wall-mounted objects that have leading edges between 27 inches and 80 inches from the floor must not project more than 4 inches into the circulation path. Protruding objects that extend to the floor or within 27 inches of the floor are cane detectable and are therefore not hazardous. Where it is necessary or desirable to have objects protrude from the wall, a manner of cane detection must be provided.	hand dryer projects 5"	Relocate protruding objects or place cane detectable warning or bollard at foot of item	2015 ABAAS Section: 307.2 2012 TAS Section: 307.2 2010 ADAS Section: 307.2

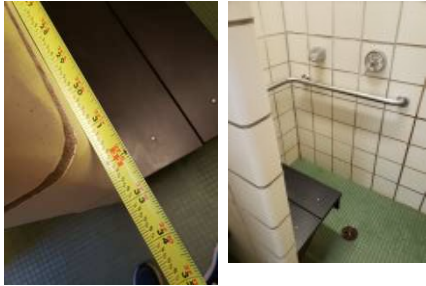
Finding Number	Area Description	Lat/Long	Finding	As Built	Recommendation	Citation	Photos	Figure
353	Deer Haven Camping Area: DH - Men's Restroom	[33.2903551, -95.6786609]	Transfer type shower compartments shall be 36 inches (915 mm) by 36 inches (915 mm) clear inside dimensions measured at the center points of opposing sides and shall have a 36 inch (915 mm) wide minimum entry on the face of the shower compartment. Clearance of 36 inches (915 mm) wide minimum by 48 inches (1220 mm) long minimum measured from the control wall shall be provided.	shower 36" by 32"	Enlarge transfer shower to compliant 36" by 36" clear inside dimension	2015 ABAAS Section: 608.2.1 2012 TAS Section: 608.2.1 2010 ADAS Section: 608.2.1

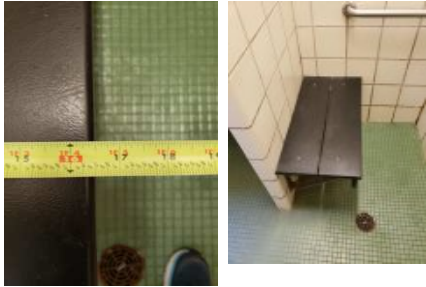
354	Deer Haven Camping Area: DH - Men's Restroom	[33.2903416, -95.6786636]	The shower seat does not have a compliant space between it and the seat wall. The folding seat must be mounted 17-19 inches above the floor, and have a maximum space of 2-1/2 inches between the edge of the seat and the seat wall and 1-1/2 inches maximum to the side wall.	bench end is 16.5" from wall	Remount shower seat to the correct location and height in the shower	2015 ABAAS Section: 610.3.1 2012 TAS Section: 610.3.1 2010 ADAS Section: 610.3.1

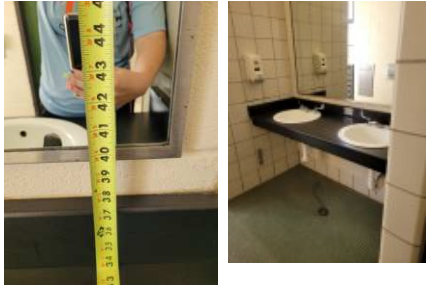
Finding Number	Area Description	Lat/Long	Finding	As Built	Recommendation	Citation	Photos	Figure
358	Deer Haven Camping Area: DH - Women's Restroom	[33.2903685, -95.678669]	The mirror is mounted too high. Mirrors must have the bottom edge of the reflecting surface a maximum of 40 inches above the floor if above a sink or counter. Mirrors not located above lavatories or countertops shall be installed with the bottom edge of the reflecting surface 35 inches maximum above the finish floor or ground.	mirror 40.5" aff	Lower mirror so reflective surface is max 40" aff	2015 ABAAS Section: 603.3 2012 TAS Section: 603.3 2010 ADAS Section: 603.3

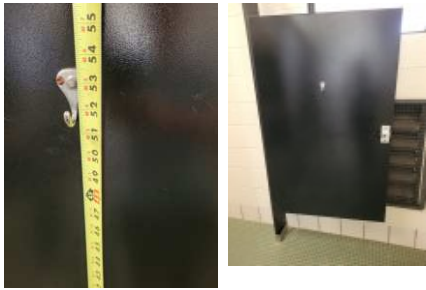
359	Deer Haven Camping Area: DH - Women's Restroom	[33.2903529, -95.6786636]	The operable part is positioned too high for either a side or front approach. Where a clear floor or ground space allows a parallel approach to an element and the side reach is unobstructed, the high side reach shall be 48 inches maximum and the low side reach shall be 15 inches minimum above the finish floor or ground. Where a forward reach is unobstructed, the high forward reach shall be 48 inches maximum and the low forward reach shall be 15 inches minimum above the finish floor or ground.	hook in stall - 51.5" aff	Remount operable parts to be in reach range of 15" min to 48" max	2015 ABAAS Section: 308.1 2012 TAS Section: 308.1 2010 ADAS Section: 308.1

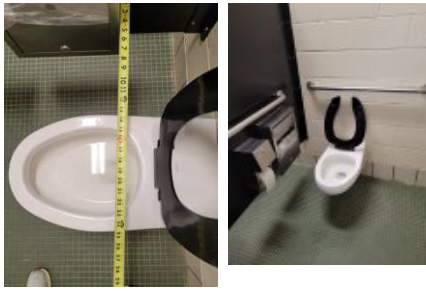
360	Deer Haven Camping Area: DH - Women's Restroom	[33.2903663, -95.678669]	The toilet is not located within the range allowed from the side wall or partition. The centerline of the toilet must be 16 to 18 inches from the side wall.	19" to partition	Remount toilets to 16" to 18" from the side wall to centerline	2015 ABAAS Section: 604.2 2012 TAS Section: 604.2 2010 ADAS Section: 604.2

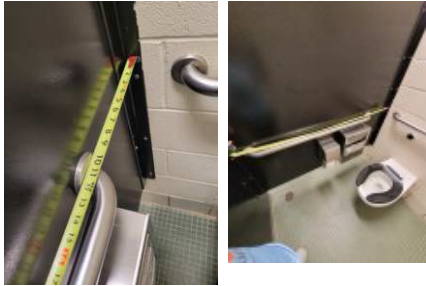
Finding Number	Area Description	Lat/Long	Finding	As Built	Recommendation	Citation	Photos	Figure
361	Deer Haven Camping Area: DH - Women's Restroom	[33.2903753 , -95.678674 3]	The side grab bars are not in the correct location. Grab bars on the side wall must be installed so that the end closest to the rear wall is maximum 12" from the rear wall. The end furthest from the rear wall must be mounted minimum 54" from the rear wall.	Side bar extends 53" from rear wall	Remount side grab bar to max 12" from the rear wall at the close end and min 54" on the far end, and 33" to 36" aff	2015 ABAAS Section: 604.5.1 2012 TAS Section: 604.5.1 2010 ADAS Section: 604.5.1

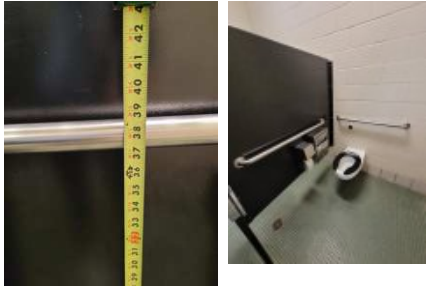
362	Deer Haven Camping Area: DH - Women's Restroom	[33.2903596 , -95.678693 1]	The grab bar height and/or spacing fails. Grab bars must be mounted between 33" and 36" to the top of the gripping surface. There must be 1.5" of clearance between the grab bar and the wall. There must be a minimum of 1.5" of clearance below and minimum 12" above the grab bar to any dispenser or other obstruction.	both mounted 38" aff	Remount grab bars in accessible stall to 33" to 36" aff	2015 ABAAS Section: 609.3, 609.4 2012 TAS Section: 609.4, 609.3 2010 ADAS Section: 609.3, 609.4

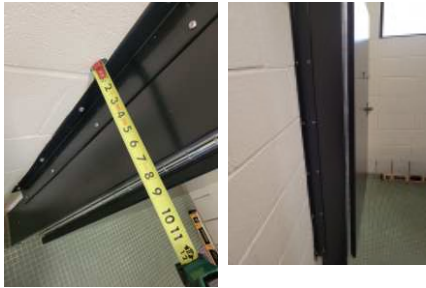
365	Deer Haven Camping Area: DH - Women's Restroom	[33.2903641 , -95.678658 2]	The compartment door is located too far from the partition or wall. The door shall be located in front of the clear space and diagonal to the water closet. Where located in the front partition, the door opening shall be 4 inches maximum from the side wall or partition farthest from the water closet. Where located in the side wall or partition, the door opening shall be 4 inches maximum from the front partition. Toilet compartment doors shall not swing into the minimum required compartment area.	door 7.5" from wall	Rehang stall door to be max 4" from adjacent stall partition and on the stall wall farthest from the toilet	2015 ABAAS Section: 604.8.1.2 2012 TAS Section: 604.8.1.2 2010 ADAS Section: 604.8.1.2

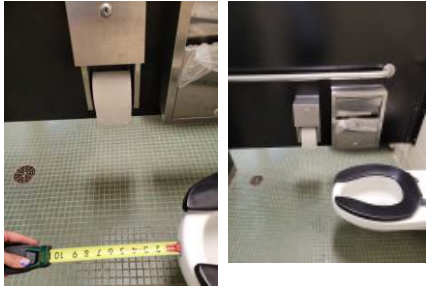
366	Deer Haven Camping Area: DH - Women's Restroom	[33.2903629 , -95.678675 7]	The toilet paper is not installed within the compliant range in front of the toilet. Toilet paper dispensers shall be 7 inches minimum and 9 inches maximum in front of the water closet measured to the centerline of the dispenser. The outlet of the dispenser shall be 15 inches minimum and 48 inches maximum above the finish floor and shall not be located behind grab bars. Dispensers shall not be of a type that controls delivery or that does not allow continuous paper flow. There shall be a clearance of 1 1/2 inches minimum below the grab bar.	toilet paper too close to toilet	Remount toilet paper dispenser max 7" to 9" from front of toilet, 15" to 48" aff and min 12" above or 1.5" below grab bar	2015 ABAAS Section: 604.7 2012 TAS Section: 604.7 2010 ADAS Section: 604.7

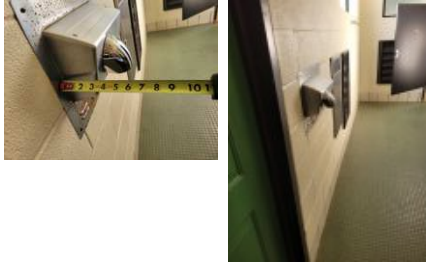
Finding Number	Area Description	Lat/Long	Finding	As Built	Recommendation	Citation	Photos	Figure
367	Deer Haven Camping Area: DH - Women's Restroom	[33.2903596 , -95.678679 7]	The hand dryer projects more than 4 inches into the circulation path. Wall-mounted objects that have leading edges between 27 inches and 80 inches from the floor must not project more than 4 inches into the circulation path. Protruding objects that extend to the floor or within 27 inches of the floor are cane detectable and are therefore not hazardous. Where it is necessary or desirable to have objects protrude from the wall, a manner of cane detection must be provided.	hand dryer projects 6"	Relocate protruding objects or place cane detectable warning or bollard at foot of item	2015 ABAAS Section: 307.2 2012 TAS Section: 307.2 2010 ADAS Section: 307.2

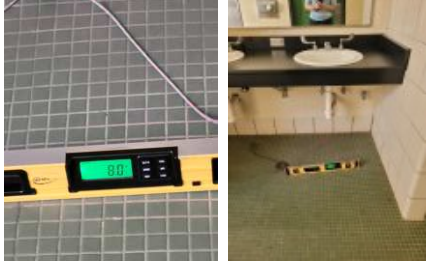
368	Deer Haven Camping Area: DH - Women's Restroom	[33.2903596 , -95.678674 3]	The accessible route contains running slopes greater than 5 percent and cross slopes greater than 2 percent across the width of the walk and has not been constructed as a ramp (i.e. handrails, wheel guides, etc.). When the slope in the direction of travel of any walk exceeds 1 unit vertical in 20 units horizontal (5-percent slope), it must be constructed as ramp. Surface cross slopes must not exceed one unit vertical in 48 units. Horizontal (2-percent slope).	8% cross slope at sink	Correct or repair slope to max 5% running and 2.08% cross	2015 ABAAS Section: 403.3 2012 TAS Section: 403.3 2010 ADAS Section: 403.3

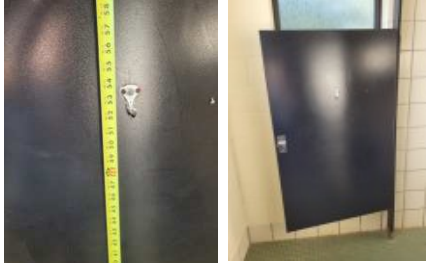
369	Deer Haven Camping Area: DH - Women's Restroom	[33.2903596 , -95.678682 4]	Coat hooks provided within the room shall be located within one of the reach ranges specified in 308. Shelves shall be 40 inches (1015 mm) minimum and 48 inches (1220 mm) maximum above the finish floor or ground. Where coat hooks or shelves are provided in dressing, fitting or locker rooms without individual compartments, at least one of each type shall comply with 803.5. Where coat hooks or shelves are provided in individual compartments at least one of each type complying with 803.5 shall be provided in individual compartments in dressing, fitting, or locker rooms required to comply with 222.1.	shower door hook - 52" aff, hall hooks - 60" aff	Remount at least one hook to max 48" aff	2015 ABAAS Section: 308.2.1, 308.1, F222.2, 803.5 2012 TAS Section: 308.2.1, 308.1, 222.2, 803.5 2010 ADAS Section: 308.2.1, 308.1, 222.2, 803.5

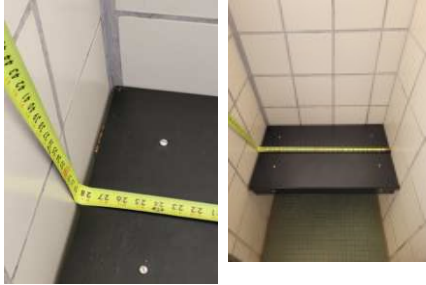
Finding Number	Area Description	Lat/Long	Finding	As Built	Recommendation	Citation	Photos	Figure
370	Deer Haven Camping Area: DH - Women's Restroom	[33.2903596 , -95.678674 3]	The bench is not deep enough or long enough or is missing. Benches shall be provided having seats that are 42 inches long minimum and 20 inches deep minimum and 24 inches deep maximum. The bench shall provide for back support or shall be affixed to a wall. Back support shall be 42 inches (1065 mm) long minimum and shall extend from a point 2 inches (51 mm) maximum above the seat surface to a point 18 inches (455 mm) minimum above the seat surface. Back support shall be 2½ inches (64 mm) maximum from the rear edge of the seat measured horizontally. The top of the bench seat surface shall be 17 inches (430 mm) minimum and 19 inches (485 mm) maximum above the finish floor or ground.	bench is 28" in length	Replace bench in dressing area with one having a seat depth of 20" to 24" deep, 42" long, affixed to the wall or having a back and mounted 17" to 19" aff	2012 TAS Section: 903.4, 903.2, 903.3, 903.5 2010 ADAS Section: 903.4, 903.2, 903.3, 903.5

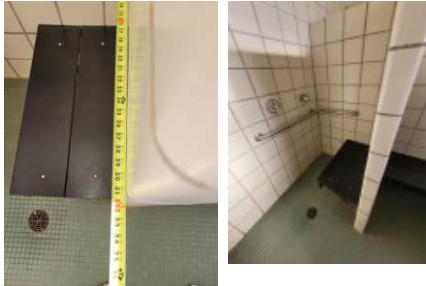
371	Deer Haven Camping Area: DH - Women's Restroom	[33.2903551 , -95.678671 6]	Transfer type shower compartments shall be 36 inches (915 mm) by 36 inches (915 mm) clear inside dimensions measured at the center points of opposing sides and shall have a 36 inch (915 mm) wide minimum entry on the face of the shower compartment. Clearance of 36 inches (915 mm) wide minimum by 48 inches (1220 mm) long minimum measured from the control wall shall be provided.	shower 36" by 31"	Enlarge transfer shower to compliant 36" by 36" clear inside dimension	2015 ABAAS Section: 608.2.1 2012 TAS Section: 608.2.1 2010 ADAS Section: 608.2.1

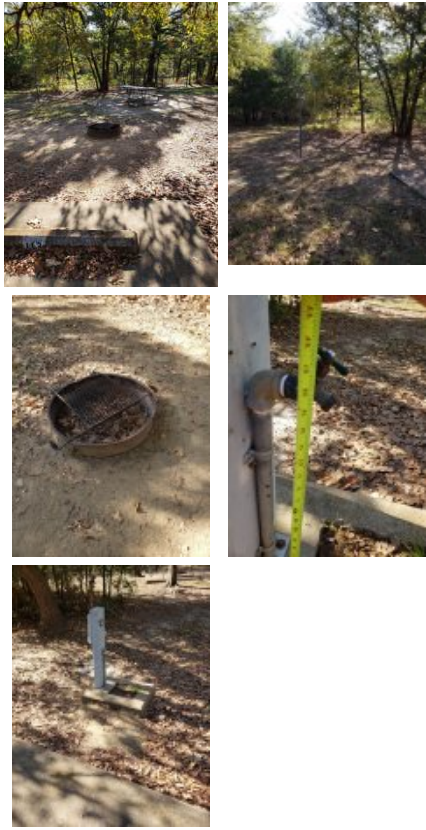
378	Buggy Whip Equestrian Camping Area: BW - Campsites	[33.2863552 , -95.680331 9]	Camping facilities shall provide camping units with mobility features complying with F244.2 in accordance with Table F244.2. Where a camping facility provides different types of camping units, Table F244.2 shall apply to each type of camping unit provided. Total Number of Camping Units Provided in Camping Facility Minimum Number of Camping Units with Mobility Features Required 1 1 2 to 25 2 26 to 50 3 51 to 75 4 76 to 100 5 101 to 150 7 151 to 200 8 201 and over 8, plus 2 percent of the number over 200	site 113 (double site shared with 114) - no elements connect to AR	Create the required number of accessible camp sites per table F244.2 as a smart practice	2015 ABAAS Section: F244.2

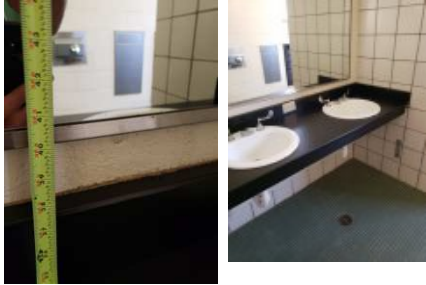
Finding Number	Area Description	Lat/Long	Finding	As Built	Recommendation	Citation	Photos	Figure
381	Buggy Whip Equestrian Camping Area: BW - Men's Restroom	[33.2874381, -95.6810025]	The mirror is mounted too high. Mirrors must have the bottom edge of the reflecting surface a maximum of 40 inches above the floor if above a sink or counter. Mirrors not located above lavatories or countertops shall be installed with the bottom edge of the reflecting surface 35 inches maximum above the finish floor or ground.	mirror 41" aff	Lower mirror so reflective surface is max 40" aff	2015 ABAAS Section: 603.3 2012 TAS Section: 603.3 2010 ADAS Section: 603.3

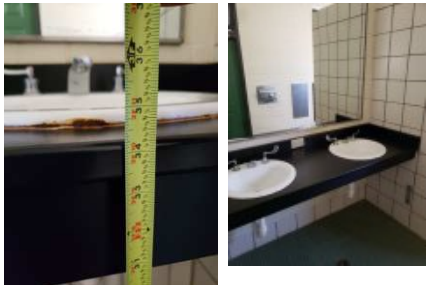
382	Buggy Whip Equestrian Camping Area: BW - Men's Restroom	[33.2874314, -95.6809944]	The top rim of the sink is too high. All lavatories/sinks that are designated to be accessible shall be a minimum 17 inches in horizontal depth and mounted with the rim or counter edge no higher than 34 inches above the finished floor.	sink rim is 35" aff	Lower sinks to max 34" aff to front of rim	2015 ABAAS Section: 606.3 2012 TAS Section: 606.3 2010 ADAS Section: 606.3

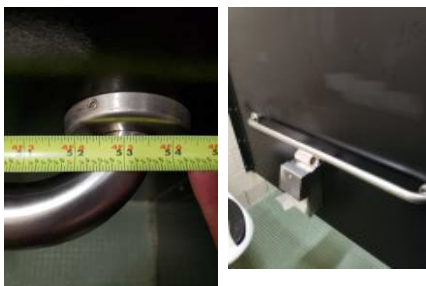
383	Buggy Whip Equestrian Camping Area: BW - Men's Restroom	[33.2874269, -95.6809971]	The side grab bars are not in the correct location. Grab bars on the side wall must be installed so that the end closest to the rear wall is maximum 12" from the rear wall. The end furthest from the rear wall must be mounted minimum 54" from the rear wall.	42" bar extends to 53"	Remount side grab bar to max 12" from the rear wall at the close end and min 54" on the far end, and 33" to 36" aff	2015 ABAAS Section: 604.5.1 2012 TAS Section: 604.5.1 2010 ADAS Section: 604.5.1

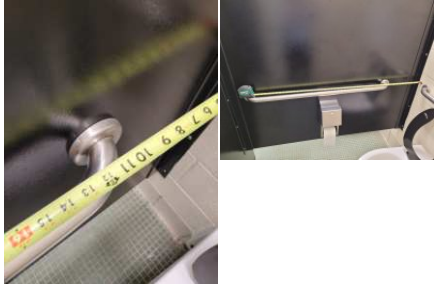
Finding Number	Area Description	Lat/Long	Finding	As Built	Recommendation	Citation	Photos	Figure
396	Buggy Whip Equestrian Camping Area: BW - Women's Restroom	[33.2874202, -95.6809944]	The side grab bars are not in the correct location. Grab bars on the side wall must be installed so that the end closest to the rear wall is maximum 12" from the rear wall. The end furthest from the rear wall must be mounted minimum 54" from the rear wall.	side bar extends 53"	Remount side grab bar to max 12" from the rear wall at the close end and min 54" on the far end, and 33" to 36" aff	2015 ABAAS Section: 604.5.1 2012 TAS Section: 604.5.1 2010 ADAS Section: 604.5.1

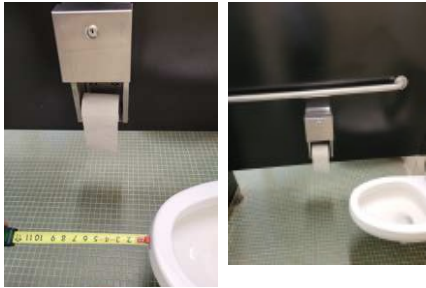
400	Buggy Whip Equestrian Camping Area: BW - Women's Restroom	[33.287428, -95.6809944]	The toilet paper is not installed within the compliant range in front of the toilet. Toilet paper dispensers shall be 7 inches minimum and 9 inches maximum in front of the water closet measured to the centerline of the dispenser. The outlet of the dispenser shall be 15 inches minimum and 48 inches maximum above the finish floor and shall not be located behind grab bars. Dispensers shall not be of a type that controls delivery or that does not allow continuous paper flow. There shall be a clearance of 1 1/2 inches minimum below the grab bar.	TP too close to front of toilet	Remount toilet paper dispenser max 7" to 9" from front of toilet, 15" to 48" aff and min 12" above or 1.5" below grab bar	2015 ABAAS Section: 604.7 2012 TAS Section: 604.7 2010 ADAS Section: 604.7

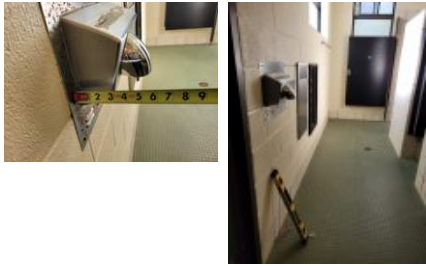
401	Buggy Whip Equestrian Camping Area: BW - Women's Restroom	[33.287428, -95.680981]	The hand dryer projects more than 4 inches into the circulation path. Wall-mounted objects that have leading edges between 27 inches and 80 inches from the floor must not project more than 4 inches into the circulation path. Protruding objects that extend to the floor or within 27 inches of the floor are cane detectable and are therefore not hazardous. Where it is necessary or desirable to have objects protrude from the wall, a manner of cane detection must be provided.	hand dryer projects 6"	Relocate protruding objects or place cane detectable warning or bollard at foot of item	2015 ABAAS Section: 307.2 2012 TAS Section: 307.2 2010 ADAS Section: 307.2

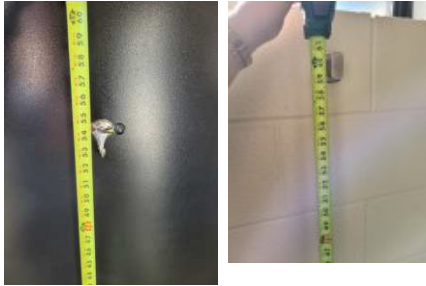
Finding Number	Area Description	Lat/Long	Finding	As Built	Recommendation	Citation	Photos	Figure
402	Buggy Whip Equestrian Camping Area: BW - Women's Restroom	[33.2874404 , -95.680970 3]	Coat hooks provided within the room shall be located within one of the reach ranges specified in 308. Shelves shall be 40 inches (1015 mm) minimum and 48 inches (1220 mm) maximum above the finish floor or ground. Where coat hooks or shelves are provided in dressing, fitting or locker rooms without individual compartments, at least one of each type shall comply with 803.5. Where coat hooks or shelves are provided in individual compartments at least one of each type complying with 803.5 shall be provided in individual compartments in dressing, fitting, or locker rooms required to comply with 222.1.	stall hook - 54" aff, hallway hook 60" aff	Remount at least one hook to max 48" aff	2015 ABAAS Section: 308.2.1, 308.1, F222.2, 803.5 2012 TAS Section: 308.2.1, 308.1, 222.2, 803.5 2010 ADAS Section: 308.2.1, 308.1, 222.2, 803.5

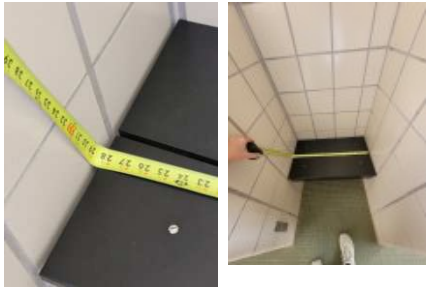
403	Buggy Whip Equestrian Camping Area: BW - Women's Restroom	[33.2874292 , -95.680997 1]	The bench is not deep enough or long enough or is missing. Benches shall be provided having seats that are 42 inches long minimum and 20 inches deep minimum and 24 inches deep maximum. The bench shall provide for back support or shall be affixed to a wall. Back support shall be 42 inches (1065 mm) long minimum and shall extend from a point 2 inches (51 mm) maximum above the seat surface to a point 18 inches (455 mm) minimum above the seat surface. Back support shall be 2½ inches (64 mm) maximum from the rear edge of the seat measured horizontally. The top of the bench seat surface shall be 17 inches (430 mm) minimum and 19 inches (485 mm) maximum above the finish floor or ground.	bench 28" width	Replace bench in dressing area with one having a seat depth of 20" to 24" deep, 42" long, affixed to the wall or having a back and mounted 17" to 19" aff	2012 TAS Section: 903.4, 903.2, 903.3, 903.5 2010 ADAS Section: 903.4, 903.2, 903.3, 903.5

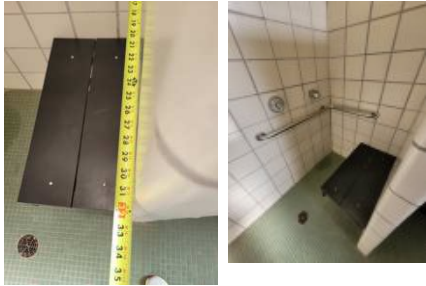
Finding Number	Area Description	Lat/Long	Finding	As Built	Recommendation	Citation	Photos	Figure
404	Buggy Whip Equestrian Camping Area: BW - Women's Restroom	[33.2874314 , -95.680989 1]	Transfer type shower compartments shall be 36 inches (915 mm) by 36 inches (915 mm) clear inside dimensions measured at the center points of opposing sides and shall have a 36 inch (915 mm) wide minimum entry on the face of the shower compartment. Clearance of 36 inches (915 mm) wide minimum by 48 inches (1220 mm) long minimum measured from the control wall shall be provided.	shower 32" by 36"	Enlarge transfer shower to compliant 36" by 36" clear inside dimension	2015 ABAAS Section: 608.2.1 2012 TAS Section: 608.2.1 2010 ADAS Section: 608.2.1

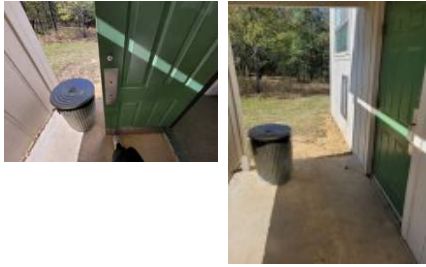
405	Buggy Whip Equestrian Camping Area: BW - Women's Restroom	[33.2874314 , -95.680991 8]	Minimum maneuvering clearances at doors and gates shall comply with 404.2.4. Maneuvering clearances shall extend the full width of the doorway and the required latch side or hinge side clearance. Exterior doors are recommended to be maintained at 8.5 lbf as a smart practice. Force is to be measured at the operating hardware or 30 inches from the hinges, whichever is greater.	Women's restroom door - 11# push, trash in back clearance	For all doors along the public circulation route, provide required maneuvering clearance on push and pull side of doors For all doors along the public circulation route, inspect, adjust, and maintain 8.5 lbf to open exterior doors as a smart practice	2010 ADAS Section: 404.2.3, 404.2.7, 404.2.4, 404.2.11, 404.2.11 Exception

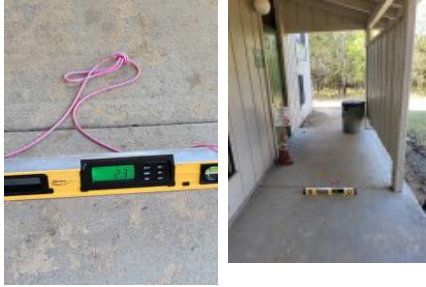
406	Buggy Whip Equestrian Camping Area: BW Restroom Exterior Accessible Route	[33.2873967 , -95.680958 2]	The accessible route of travel on the accessible route contains cross slopes greater than 2%. Cross slopes shall not exceed one unit vertical in 48 units horizontal (2-percent slope).	2.3% slope outside of men's restroom	Correct or repair cross slope along AR to max 2.08%	2015 ABAAS Section: 403.3 2012 TAS Section: 403.3 2010 ADAS Section: 403.3

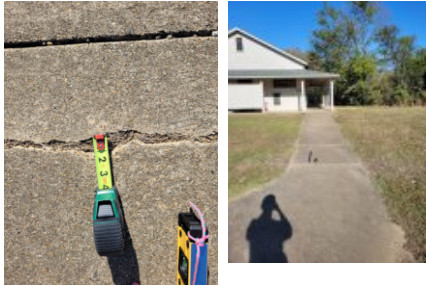
Finding Number	Area Description	Lat/Long	Finding	As Built	Recommendation	Citation	Photos	Figure
407	Buggy Whip Equestrian Camping Area: BW Restroom Exterior Accessible Route	[33.2873597 , -95.680860 3]	There is a gap spaced greater than a 1/2 inch. Openings in floor or ground surfaces shall not allow passage of a sphere more than 1/2 inch diameter. Elongated openings shall be placed so that the long dimension is perpendicular to the dominant direction of travel.	1.5" gap at beginning of path from lot	Correct or fill gaps to be max .5"	2015 ABAAS Section: 302.3 2012 TAS Section: 302.3 2010 ADAS Section: 302.3

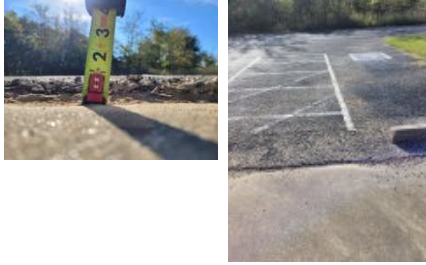
408	Buggy Whip Equestrian Camping Area: BW Restroom Exterior Accessible Route	[33.2873328 , -95.680836 2]	The walkway contains abrupt vertical edges and/or variations over a 1/4 inch. 1/4 inch is the maximum vertical rise. Changes in level between 1/4 inch and 1/2 inch must be beveled at 1:2 or less. Changes in level greater than 1/2 inch must be by way of a ramp.	.75" CIL from lot to walking path	Repair, bevel or ramp CIL along AR	2012 TAS Section: 303.2, 303.3 2010 ADAS Section: 303.2, 303.3

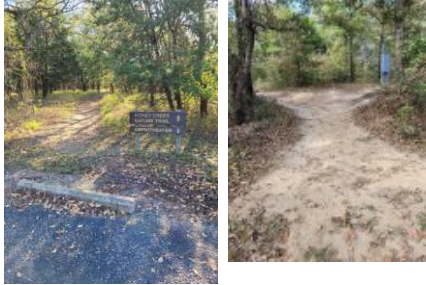
Finding Number	Area Description	Lat/Long	Finding	As Built	Recommendation	Citation	Photos	Figure
412	Trails: Trail Surface	[33.2890547 , -95.6786958]	The surface of trails, passing spaces, and resting intervals shall be firm and stable	Honey Creek Interpretive Trail - surface not accessible, natural surface	Replace surface of trail with one that is firm and stable as a smart practice.	2015 ABAAS Section: 1017.2

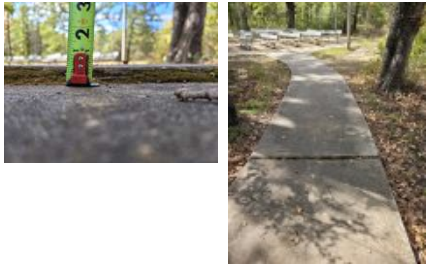
414	Trails: Trail Surface	[33.2889381 , -95.6774459]	Tread obstacles on trails, passing spaces, and resting intervals shall not exceed 1/2 inch (13 mm) in height measured vertically to the highest point. EXCEPTION: Where the surface is other than asphalt, concrete, or boards, tread obstacles shall be permitted to not exceed 2 inches (50 mm) in height measured vertically to the highest point.	.75 CIL at amphitheater entry on Honey Creek Trail	Repair, bevel or ramp tread obstacle along pathway to max .5" or 2" depending on surface type.	2015 ABAAS Section: 1017.5

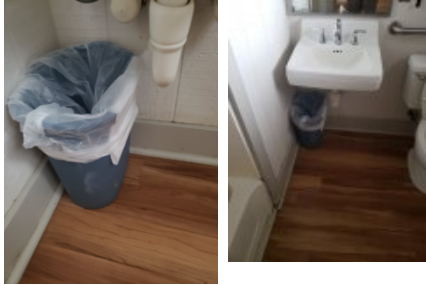
Finding Number	Area Description	Lat/Long	Finding	As Built	Recommendation	Citation	Photos	Figure
419	Pecan Ridge Cabin Area: PR - Cabin 3	[33.2964959 , -95.660120 1]	Knee clearance at 27 inches off the floor is not 8 inches minimum deep. The knee clearance, measured from the bottom of the apron or the outside bottom edge of the lavatory, must be 27 inches at a point located 8 inches back from the front edge and continuing to 11 inches minimum in depth at 9 inches above the floor. The top of the lavatory rim may be no higher than 34 inches.	trash can in toe clearance	Remove storage to provide 8" deep knee clearance	2015 ABAAS Section: 306.3.1, 306.3.2, 306.3.3, 306.3.4 , 306.3.5 2012 TAS Section: 306.3.2, 306.3.3, 306.3.4, 306.3.5, 306.3.1 2010 ADAS Section: 306.3.3, 306.3.2, 306.3.4, 306.3.5, 306.3.1

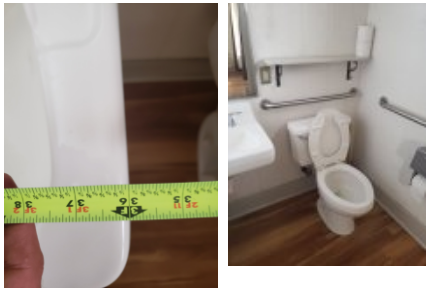
420	Pecan Ridge Cabin Area: PR - Cabin 3	[33.2964858 , -95.660134 9]	The required 56 inches by 60 inches clear floor space for the water closet has been obstructed. The clear floor space around the water closet shall be 60 inches minimum measured perpendicular from the side wall and 56 inches minimum measured perpendicular from the rear wall.	sink 36"	Relocate sink to provide required 60" clearance around toilet	2015 ABAAS Section: 604.3. 2012 TAS Section: 604.3.1 2010 ADAS Section: 604.3.1

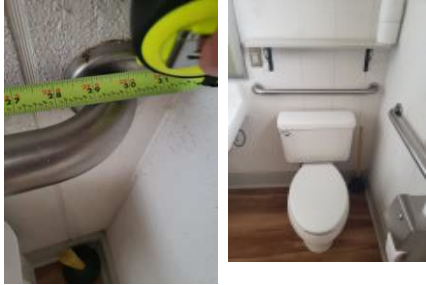
Finding Number	Area Description	Lat/Long	Finding	As Built	Recommendation	Citation	Photos	Figure
421	Pecan Ridge Cabin Area: PR - Cabin 3	[33.2964959 , -95.660129 5]	The rear grab bar is not 36" long or is not mounted in the correct location. The rear grab bar must be a minimum of 36" long and extend from the toilet centerline a minimum 12" towards the wall side and a minimum 24" towards the open side of the toilet. Grab bars shall be installed in a horizontal position, 33 inches minimum and 36 inches maximum above the finish floor measured to the top of the gripping surface and the space between the grab bar and the top of the tank shall be 1-1/2 inches minimum.	Bar extends 29.5" towards wall	Replace rear grab bar with one 36" long, mounted behind the toilet, 12" to one side of center and 24" to the other and 33" to 36" aff	2015 ABAAS Section: 604.5.2 2012 TAS Section: 604.5.2 2010 ADAS Section: 604.5.2

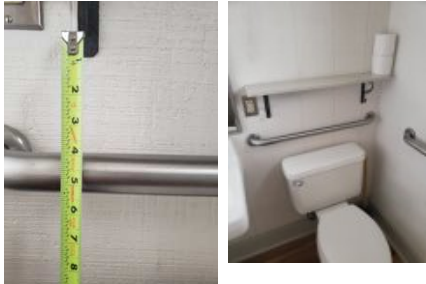
422	Pecan Ridge Cabin Area: PR - Cabin 3	[33.2965004 , -95.660124 2]	The grab bar height and/or spacing fails. Grab bars must be mounted between 33" and 36" to the top of the gripping surface. There must be 1.5" of clearance between the grab bar and the wall. There must be a minimum of 1.5" of clearance below and minimum 12" above the grab bar to any dispenser or other obstruction.	shelf 4" over rear bar	Remount shelf to provide min 12" above or 1.5" below grab bar	2015 ABAAS Section: 609.3, 609.4 2012 TAS Section: 609.4, 609.3 2010 ADAS Section: 609.3, 609.4

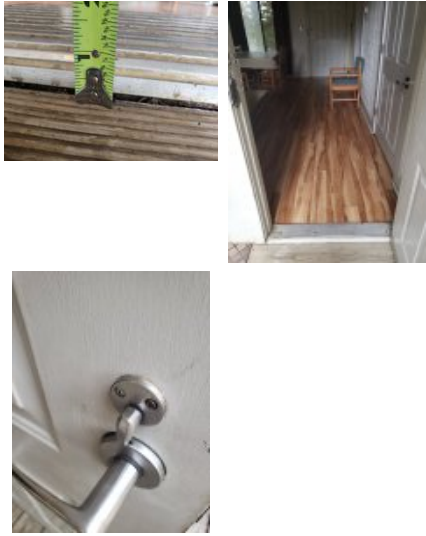
Finding Number	Area Description	Lat/Long	Finding	As Built	Recommendation	Citation	Photos	Figure
427	Pecan Ridge Cabin Area: PR - Cabin 3	[33.2964847 , -95.6601134]	The threshold has a vertical change greater than 1/4 inch high. Hand-activated door opening hardware, handles, pulls, latches, locks, and other operating devices on accessible doors shall have a shape that is easy to grasp with one hand and does not require tight grasping, tight pinching or twisting of the wrist to operate. Hardware shall be 34 inches minimum and 48 inches maximum above the finish floor or ground.	front door - 1" CIL, lock hardware requires a tight pinch or grasp	For all doors along the public circulation route, repair, bevel, or ramp CILs at door entries to max .25" For all doors along the public circulation route, replace hardware with lever hardware or hardware operable without a tight pinch or grasp	2010 ADAS Section: 404.2.3, 404.2.7, 404.2.4, 404.2.11, 404.2.11 Exception

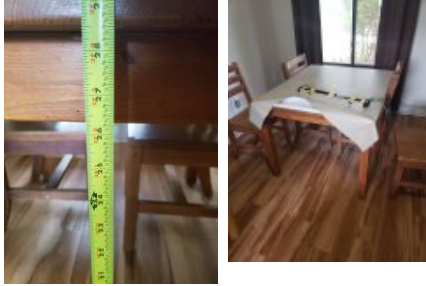
428	Pecan Ridge Cabin Area: PR - Cabin 3	[33.2964992 , -95.6601268]	The top of the work surface is not within a compliant height range. The tops of tables and counters shall be 28 inches to 34 inches from the floor or ground.	the only table inside has no knee clearance	Provide tables and work surfaces at 28" to 34" aff with required knee and toe clearances	2015 ABAAS Section: 902.3 2012 TAS Section: 902.3 2010 ADAS Section: 902.3

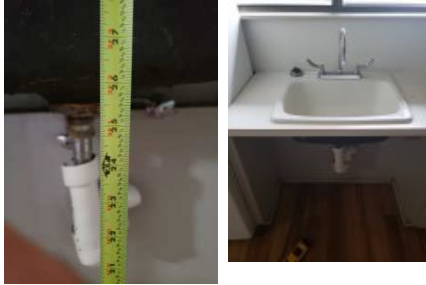
Finding Number	Area Description	Lat/Long	Finding	As Built	Recommendation	Citation	Photos	Figure
429	Pecan Ridge Cabin Area: PR - Cabin 3	[33.2964992 , -95.6601067]	The sink is not accessible. A clear floor space at least 30 inches by 48 shall be provided in front of a sink to allow forward approach. -The clear floor space shall be on an accessible route and shall extend a maximum of 19 inches underneath the sink. -Sinks shall be mounted with the counter or rim no higher than 34 inches above the finish floor. -Knee clearance at least 27 inches high, 30 inches wide and 19 inches deep shall be provided. -Hot water and drain pipes exposed under sinks shall be insulated or otherwise configured so as to protect against contact. There shall be no sharp or abrasive surfaces under sinks. -Faucet controls not require tight grasping, pinching or twisting of the wrist. -The force required to activate controls shall be not greater than 5 lb. Lever-operated, push-type and electronically controlled mechanisms are examples of acceptable designs. -Self-closing valves are allowed if the faucet remains open for at least 10 seconds.	knee clearance 26"	Raise sink bowl to provide 27" knee clearance, in the alternative, acquire a shallower model	<p>2015 ABAAS Section: 606.2, 606.2 EXCEPTION S: 1, 606.2 E XCEPTIONS: 4, 606.2 EXC EPTIONS: 5, 606.2 EXCEP TIONS: 6, 606.2 EXCEP TIONS: 7, 606.3, 606.4, 606.5</p> <p>2012 TAS Section: 606.2, 606.2 Exception 1, 606.2 Exception 4, 606.2 Exception 5, 606.2 Exception 6, 606.2 Exception 7, 606.3, 606.4, 606.5</p> <p>2010 ADAS Section: 606.2, 606.2 Exception 1, 606.2 Exception 4, 606.2 Exception 5, 606.2 Exception 6, 606.2 Exception 7, 606.3, 606.4, 606.5</p>

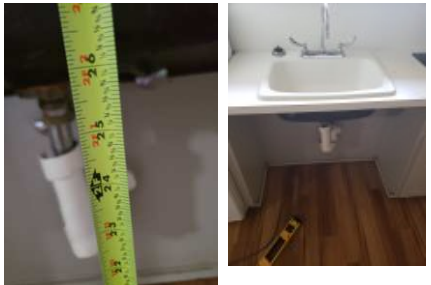
431	Pecan Ridge Cabin Area: PR - Cabin 3	[33.2965004 , -95.660108 1]	Knee and toe space has not been provided at the sink. Kitchen sinks must be provided with a clear floor space positioned for a forward approach including knee and toe clearance.	knee clearance 26"	Remove base cabinet and lower sink height to max 34" aff	2015 ABAAS Section: 606.2, 804.4 2012 TAS Section: 606.2, 804.4 2010 ADAS Section: 606.2, 804.4

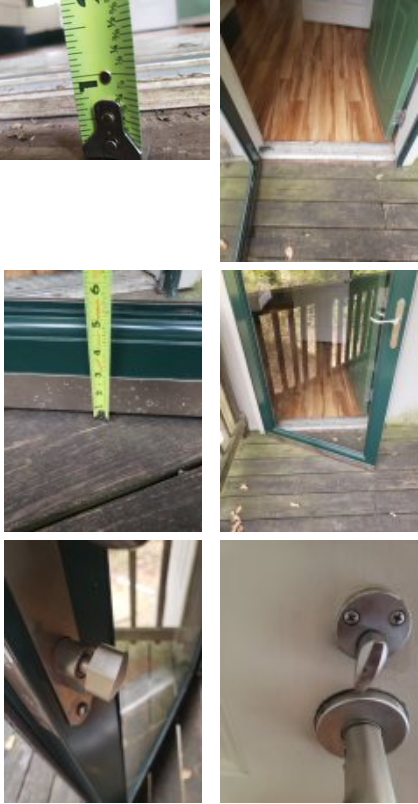
Finding Number	Area Description	Lat/Long	Finding	As Built	Recommendation	Citation	Photos	Figure
432	Pecan Ridge Cabin Area: PR - Cabin 3	[33.2964981 , -95.6601134]	The threshold has a vertical change greater than 1/4 inch high. Hand-activated door opening hardware, handles, pulls, latches, locks, and other operating devices on accessible doors shall have a shape that is easy to grasp with one hand and does not require tight grasping, tight pinching or twisting of the wrist to operate. Hardware shall be 34 inches minimum and 48 inches maximum above the finish floor or ground. The bottom 10 inches on the push side must be smooth and free of obstructions (hold open devices). Opening hardware must be mounted between 30 and 44 inches above the floor or ground.	door from bedroom to porch - 1" CIL, storm door has glass within bottom 10" of push side - requires kick plate, lock hardware requires tight pinch	For all doors along the public circulation route, repair, bevel, or ramp CILs at door entries to max .25". For all doors along the public circulation route, replace hardware with lever hardware or hardware operable without a tight pinch or grasp and having a max profile of 4". For all doors along the public circulation route, provide kick plate on push side of door from floor to 10" AFF.	2010 ADAS Section: 404.2.3, 404.2.7, 404.2.4, 404.2.11, 404.2.11 Exception

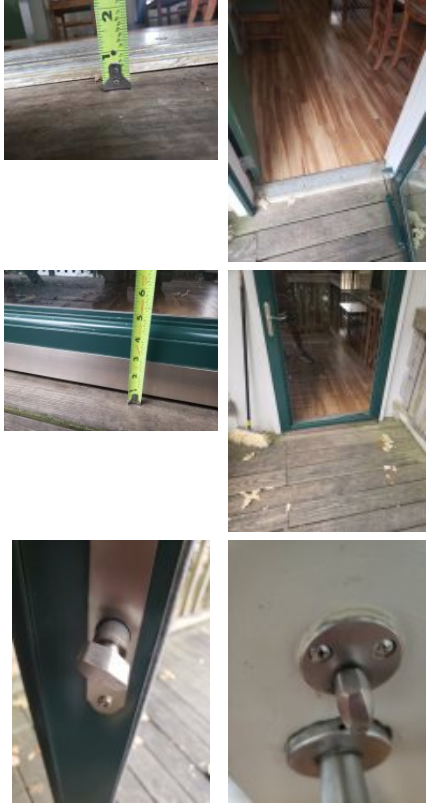
Finding Number	Area Description	Lat/Long	Finding	As Built	Recommendation	Citation	Photos	Figure
433	Pecan Ridge Cabin Area: PR - Cabin 3	[33.2964959, -95.6601081]	The threshold has a vertical change greater than 1/4 inch high. Hand-activated door opening hardware, handles, pulls, latches, locks, and other operating devices on accessible doors shall have a shape that is easy to grasp with one hand and does not require tight grasping, tight pinching or twisting of the wrist to operate. Hardware shall be 34 inches minimum and 48 inches maximum above the finish floor or ground. The bottom 10 inches on the push side must be smooth and free of obstructions (hold open devices). Opening hardware must be mounted between 30 and 44 inches above the floor or ground.	door from living room to porch - 1" CIL, storm door has glass within bottom 10" of push side - requires kick plate, lock hardware requires tight pinch	For all doors along the public circulation route, repair, bevel, or ramp CILs at door entries to max .25" For all doors along the public circulation route, replace hardware with lever hardware or hardware operable without a tight pinch or grasp For all doors along the public circulation route, provide kick plate on push side of door from floor to 10" aff	2010 ADAS Section: 404.2.3, 404.2.7, 404.2.4, 404.2.11, 404.2.11 Exception

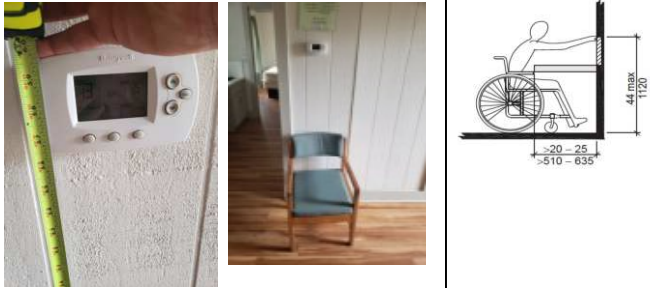
434	Pecan Ridge Cabin Area: PR - Cabin 3	[33.2884, -95.65837]	The clear floor space only allows for a forward approach and the element is out of reach range. Where a high forward reach is over an obstruction, the clear floor space shall extend beneath the element for a distance not less than the reach depth over the obstruction. Where the reach depth exceeds 20 inches, the high forward reach shall be 44 inches maximum and the reach depth shall be 25 inches maximum.	thermostat obstructed and high	Relocate storage and lower operable part to 48" maximum	2015 ABAAS Section: 308.2.2 2012 TAS Section: 308.2.2 2010 ADAS Section: 308.2.2

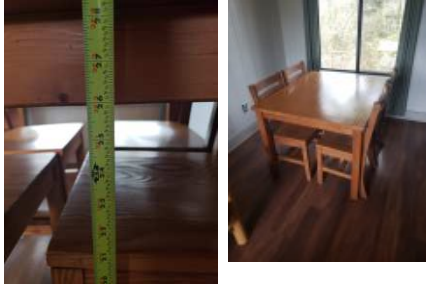
Finding Number	Area Description	Lat/Long	Finding	As Built	Recommendation	Citation	Photos	Figure
438	Pecan Ridge Cabin Area: PR - Cabin 6	[33.2959545, -95.661248]	The top of the work surface is not within a compliant height range. The tops of tables and counters shall be 28 inches to 34 inches from the floor or ground.	the only table inside has no knee clearance	Provide tables and work surfaces at 28" to 34" aff with required knee and toe clearances	2015 ABAAS Section: 902.3 2012 TAS Section: 902.3 2010 ADAS Section: 902.3

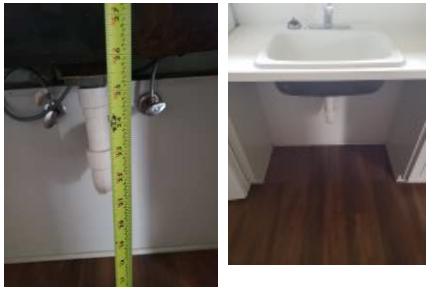
440	Pecan Ridge Cabin Area: PR - Cabin 6	[33.2959645, -95.6612292]	Knee and toe space has not been provided at the sink. Kitchen sinks must be provided with a clear floor space positioned for a forward approach including knee and toe clearance.	kitchen- knee clearance 26"	Remove base cabinet and lower sink height to max 34" aff	2015 ABAAS Section: 606.2, 804.4 2012 TAS Section: 606.2, 804.4 2010 ADAS Section: 606.2, 804.4

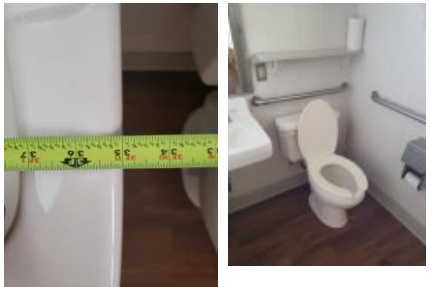
442	Pecan Ridge Cabin Area: PR - Cabin 6	[33.2959578 , -95.6612453]	The required 56 inches by 60 inches clear floor space for the water closet has been obstructed. The clear floor space around the water closet shall be 60 inches minimum measured perpendicular from the side wall and 56 inches minimum measured perpendicular from the rear wall.	restroom- sink in toilet clearance	Relocate sink to provide required 60" clearance around toilet	2015 ABAAS Section: 604.3. 2012 TAS Section: 604.3.1 2010 ADAS Section: 604.3.1

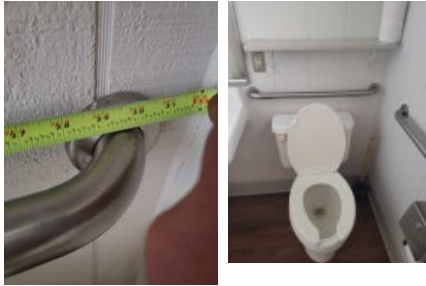
Finding Number	Area Description	Lat/Long	Finding	As Built	Recommendation	Citation	Photos	Figure
443	Pecan Ridge Cabin Area: PR - Cabin 6	[33.2959668 , -95.6612426]	The rear grab bar is not 36" long or is not mounted in the correct location. The rear grab bar must be a minimum of 36" long and extend from the toilet centerline a minimum 12" towards the wall side and a minimum 24" towards the open side of the toilet. Grab bars shall be installed in a horizontal position, 33 inches minimum and 36 inches maximum above the finish floor measured to the top of the gripping surface and the space between the grab bar and the top of the tank shall be 1-1/2 inches minimum.	restroom- 29.5" towards wall	Replace rear grab bar with one 36" long, mounted behind the toilet, 12" to one side of center and 24" to the other and 33" to 36" aff	2015 ABAAS Section: 604.5.2 2012 TAS Section: 604.5.2 2010 ADAS Section: 604.5.2

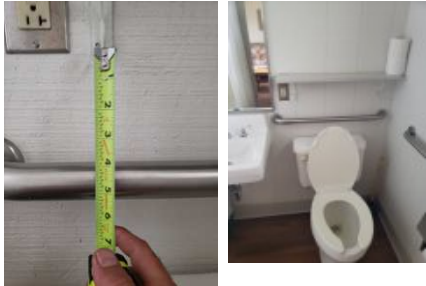
444	Pecan Ridge Cabin Area: PR - Cabin 6	[33.2959601 , -95.66124]	The grab bar height and/or spacing fails. Grab bars must be mounted between 33" and 36" to the top of the gripping surface. There must be 1.5" of clearance between the grab bar and the wall. There must be a minimum of 1.5" of clearance below and minimum 12" above the grab bar to any dispenser or other obstruction.	restroom- shelf bracket 4" above grab bar	Remount shelf a min 12" above grab bar.	2015 ABAAS Section: 609.3, 609.4 2012 TAS Section: 609.4, 609.3 2010 ADAS Section: 609.3, 609.4

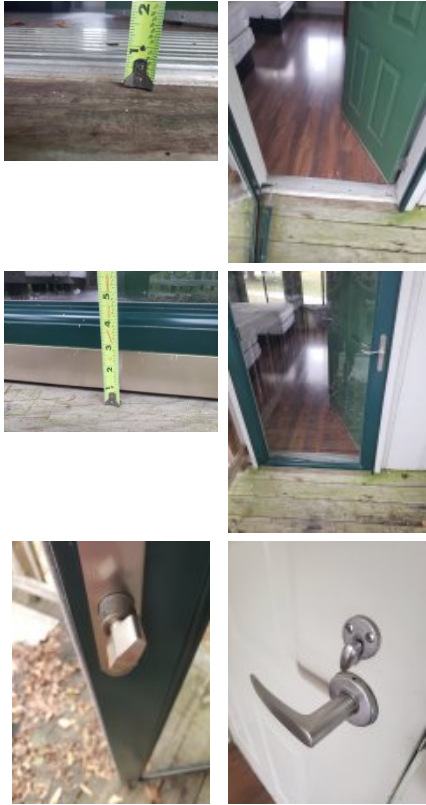
Finding Number	Area Description	Lat/Long	Finding	As Built	Recommendation	Citation	Photos	Figure
448	Pecan Ridge Cabin Area: PR - Cabin 6	[33.29595, -95.661245 3]	The threshold has a vertical change greater than 1/4 inch high. Hand-activated door opening hardware, handles, pulls, latches, locks, and other operating devices on accessible doors shall have a shape that is easy to grasp with one hand and does not require tight grasping, tight pinching or twisting of the wrist to operate. Hardware shall be 34 inches minimum and 48 inches maximum above the finish floor or ground. The bottom 10 inches on the push side must be smooth and free of obstructions (hold open devices). Opening hardware must be mounted between 30 and 44 inches above the floor or ground.	door from bedroom to porch - 1" CIL, storm door glass in 10" toe kick, lock hardware not operable with tight pinch or grasp.	For all doors along the public circulation route, repair, bevel, or ramp CILs at door entries to max .25" For all doors along the public circulation route, replace hardware with lever hardware or hardware operable without a tight pinch or grasp For all doors along the public circulation route, provide kick plate on push side of door from floor to 10" aff	2010 ADAS Section: 404.2.3, 404.2.7, 404.2.4, 404.2.11, 404.2.11 Exception

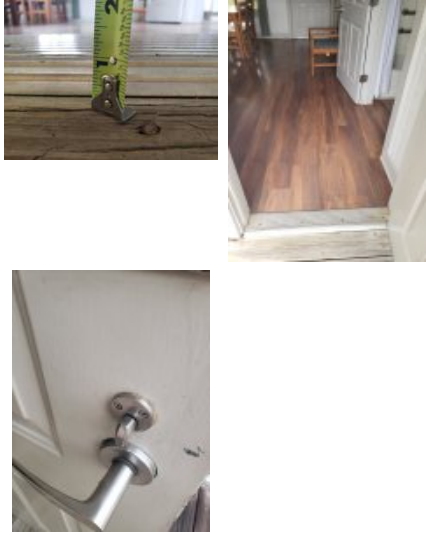
Finding Number	Area Description	Lat/Long	Finding	As Built	Recommendation	Citation	Photos	Figure
452	Pecan Ridge Cabin Area: PR - Cabin 6	[33.2959612, -95.6612453]	The threshold has a vertical change greater than 1/4 inch high. Hand-activated door opening hardware, handles, pulls, latches, locks, and other operating devices on accessible doors shall have a shape that is easy to grasp with one hand and does not require tight grasping, tight pinching or twisting of the wrist to operate. Hardware shall be 34 inches minimum and 48 inches maximum above the finish floor or ground. The bottom 10 inches on the push side must be smooth and free of obstructions (hold open devices). Opening hardware must be mounted between 30 and 44 inches above the floor or ground.	front door - 1" CIL, lock hardware not operable with tight pinch or grasp	For all doors along the public circulation route, repair, bevel, or ramp CILs at door entries to max .25" For all doors along the public circulation route, replace hardware with lever hardware or hardware operable without a tight pinch or grasp For all doors along the public circulation route, provide kick plate on push side of door from floor to 10" aff	2010 ADAS Section: 404.2.3, 404.2.7, 404.2.4, 404.2.11, 404.2.11 Exception

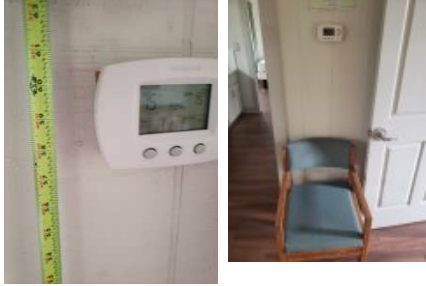
453	Pecan Ridge Cabin Area: PR - Cabin 6	[33.2959634, -95.6612346]	The clear floor space only allows for a forward approach and the element is out of reach range. Where a high forward reach is over an obstruction, the clear floor space shall extend beneath the element for a distance not less than the reach depth over the obstruction. Where the reach depth exceeds 20 inches, the high forward reach shall be 44 inches maximum and the reach depth shall be 25 inches maximum.	thermostat obstructed and high	Relocate chair and lower operable part to 48" aff max.	2015 ABAAS Section: 308.2.2 2012 TAS Section: 308.2.2 2010 ADAS Section: 308.2.2

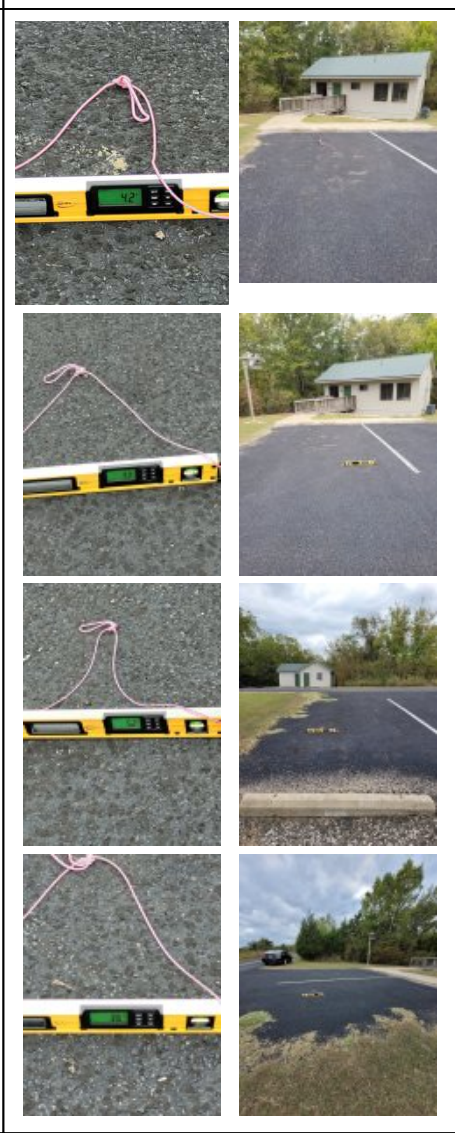
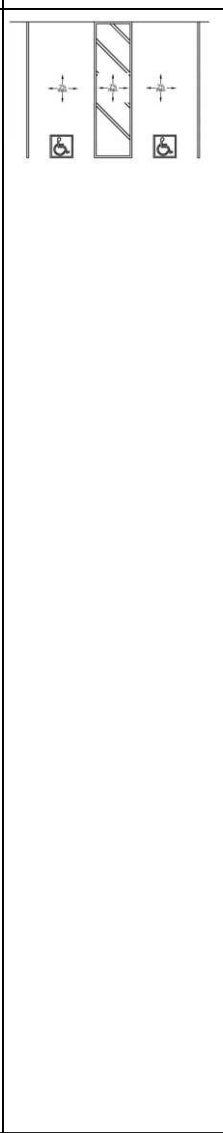
Finding Number	Area Description	Lat/Long	Finding	As Built	Recommendation	Citation	Photos	Figure
456	Pecan Ridge Cabin Area: PR - Cabin 7 Parking	[33.2955655 , -95.661107 2]	The cross slopes (narrow dimension) and/or running slopes (long dimension) of the access aisle exceeds 2%. The running slope and the cross slope in an accessible parking stall and the access aisle must not exceed 2%.	left stall - 4.2%, 3.3%. right stall - 5.2%, 3.6%	Repair or correct slope of parking space and access aisle to max 2.08% in any direction	2015 ABAAS Section: 502.4 2012 TAS Section: 502.4 2010 ADAS Section: 502.4

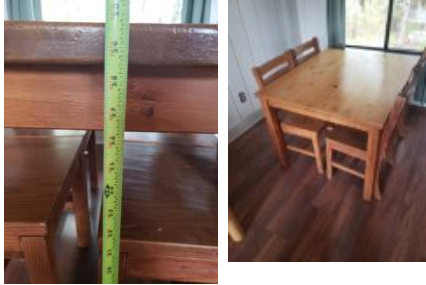
Finding Number	Area Description	Lat/Long	Finding	As Built	Recommendation	Citation	Photos	Figure
457	Pecan Ridge Cabin Area: PR - Cabin 7	[33.2956283 , -95.6612614]	The top of the work surface is not within a compliant height range. The tops of tables and counters shall be 28 inches to 34 inches from the floor or ground.	the only table inside has no knee clearance	Provide tables and work surfaces at 28" to 34" aff with required knee and toe clearances	2015 ABAAS Section: 902.3 2012 TAS Section: 902.3 2010 ADAS Section: 902.3

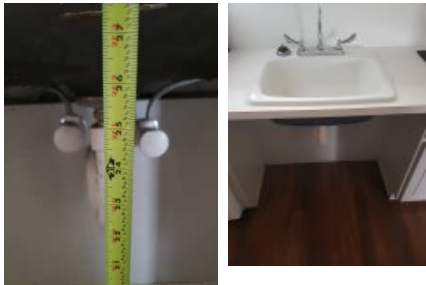
458	Pecan Ridge Cabin Area: PR - Cabin 7	[33.2956283 , -95.6612668]	Knee and toe space has not been provided at the sink. Kitchen sinks must be provided with a clear floor space positioned for a forward approach including knee and toe clearance.	knee clearance 26"	Remove base cabinet and lower sink height to max 34" aff	2015 ABAAS Section: 606.2, 804.4 2012 TAS Section: 606.2, 804.4 2010 ADAS Section: 606.2, 804.4

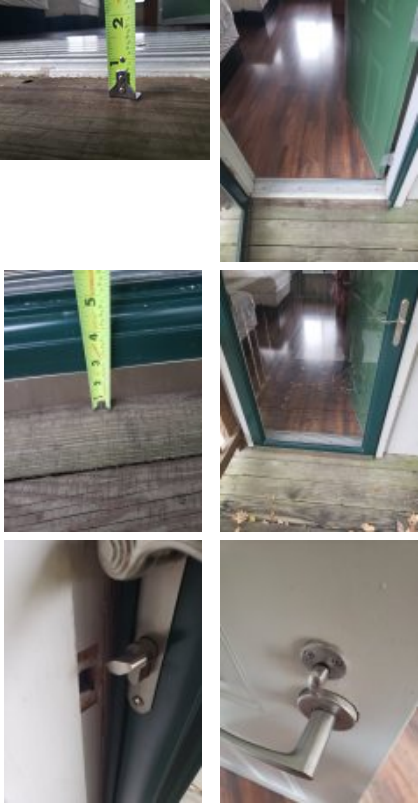
Finding Number	Area Description	Lat/Long	Finding	As Built	Recommendation	Citation	Photos	Figure
459	Pecan Ridge Cabin Area: PR - Cabin 7	[33.2956283 , -95.661258 7]	The threshold has a vertical change greater than 1/4 inch high. Hand-activated door opening hardware, handles, pulls, latches, locks, and other operating devices on accessible doors shall have a shape that is easy to grasp with one hand and does not require tight grasping, tight pinching or twisting of the wrist to operate. Hardware shall be 34 inches minimum and 48 inches maximum above the finish floor or ground. The bottom 10 inches on the push side must be smooth and free of obstructions (hold open devices). Opening hardware must be mounted between 30 and 44 inches above the floor or ground.	door from bedroom to porch - 1" CIL, storm door glass in 10" toe kick, lock hardware not operable with tight pinch or grasp	For all doors along the public circulation route, repair, bevel, or ramp CILs at door entries to max .25". For all doors along the public circulation route, replace hardware with lever hardware or hardware operable without a tight pinch or grasp. For all doors along the public circulation route, provide kick plate on push side of door from floor to 10" AFF.	2010 ADAS Section: 404.2.3, 404.2.7, 404.2.4, 404.2.11, 404.2.11 Exception

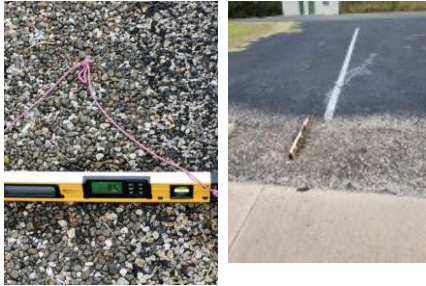
Finding Number	Area Description	Lat/Long	Finding	As Built	Recommendation	Citation	Photos	Figure
462	Pecan Ridge Cabin Area: PR - Cabin 7	[33.2955778 , -95.661138]	The running slope of walking surfaces shall not be steeper than 1:20.	8.6% running slope from lot to sidewalk	Correct running slope along the AR to max 5%	2015 ABAAS Section: 403.3 2012 TAS Section: 403.3 2010 ADAS Section: 403.3

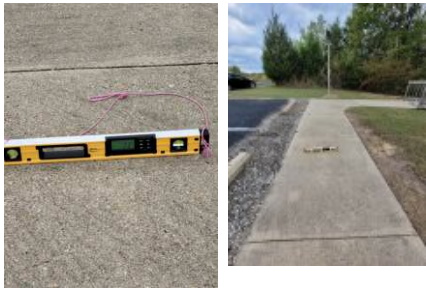
463	Pecan Ridge Cabin Area: PR - Cabin 7	[33.2955733 , -95.6611541]	The accessible route of travel on the accessible route contains cross slopes greater than 2%. Cross slopes shall not exceed one unit vertical in 48 units horizontal (2-percent slope).	2.2% slope in front of parking	Correct or repair cross slope along AR to max 2.08%	2015 ABAAS Section: 403.3 2012 TAS Section: 403.3 2010 ADAS Section: 403.3

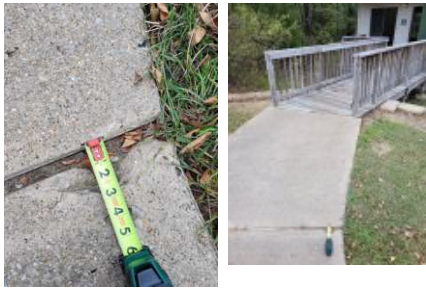
464	Pecan Ridge Cabin Area: PR - Cabin 7	[33.2955565 , -95.661185]	There is a gap spaced greater than a 1/2 inch. Openings in floor or ground surfaces shall not allow passage of a sphere more than 1/2 inch diameter. Elongated openings shall be placed so that the long dimension is perpendicular to the dominant direction of travel.	3" gap towards entry	Correct or fill gaps to be max .5"	2015 ABAAS Section: 302.3 2012 TAS Section: 302.3 2010 ADAS Section: 302.3

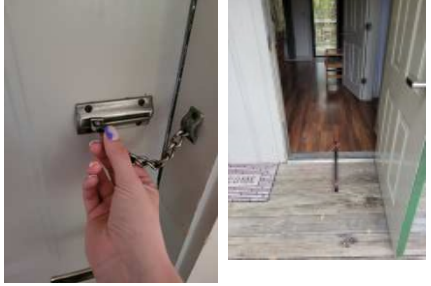
467	Pecan Ridge Cabin Area: PR - Cabin 7	[33.2956305, -95.6612668]	The operating hardware is not accessible because it requires tight grasping, pinching or twisting of the wrist to operate. Hand-activated hardware, handles, pulls, latches, locks, and other operating devices on accessible elements shall have a shape that is easy to grasp with one hand and does not require tight grasping, tight pinching or twisting of the wrist to operate.	restroom- lock requires pinch	For all doors along the public circulation route, replace hardware with lever hardware where indicated	2015 ABAAS Section: 309.4 2012 TAS Section: 309.4 2010 ADAS Section: 309.4

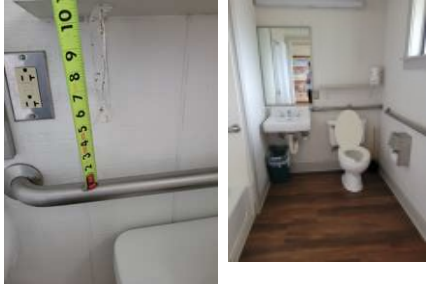
471	Pecan Ridge Cabin Area: PR - Cabin 7	[33.295635, -95.6612561]	The grab bar height and/or spacing fails. Grab bars must be mounted between 33" and 36" to the top of the gripping surface. There must be 1.5" of clearance between the grab bar and the wall. There must be a minimum of 1.5" of clearance below and minimum 12" above the grab bar to any dispenser or other obstruction.	shelf 6" above grab bar	Remount shelf a min 12" above grab bar	2015 ABAAS Section: 609.3, 609.4 2012 TAS Section: 609.4, 609.3 2010 ADAS Section: 609.3, 609.4

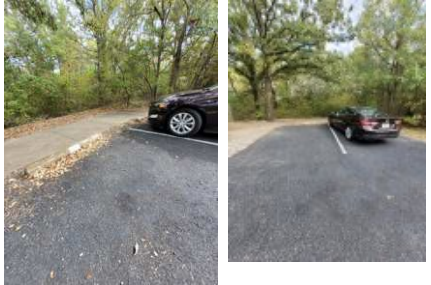
473	Pecan Ridge Cabin Area: PR - Cabin 8 Parking	[33.2958345 , -95.661741 5]	There are no accessible parking stalls. Each lot where parking is provided for the public as clients, guests or employees, shall provide accessible parking and shall be located on the shortest accessible route of travel from adjacent parking to an accessible entrance. There are a total of 2 parking stalls in the parking lot that could be reasonably associated with this facility. There should be a minimum of 1 accessible stalls with a minimum of 1 being designed as van accessible.	0 of 2 stalls marked accessible	Create one or more 8' accessible parking stalls, with one 5' adjacent access aisle, with proper signage and striping based on the total number of stalls	2015 ABAAS Section: F208.2 2012 TAS Section: 208.2 2010 ADAS Section: 208.2
