Access Audit Site Report

Cooper Lake State Park - South Sulphur Unit

Accessibility Evaluation

Inspection Date: 10/19/2021

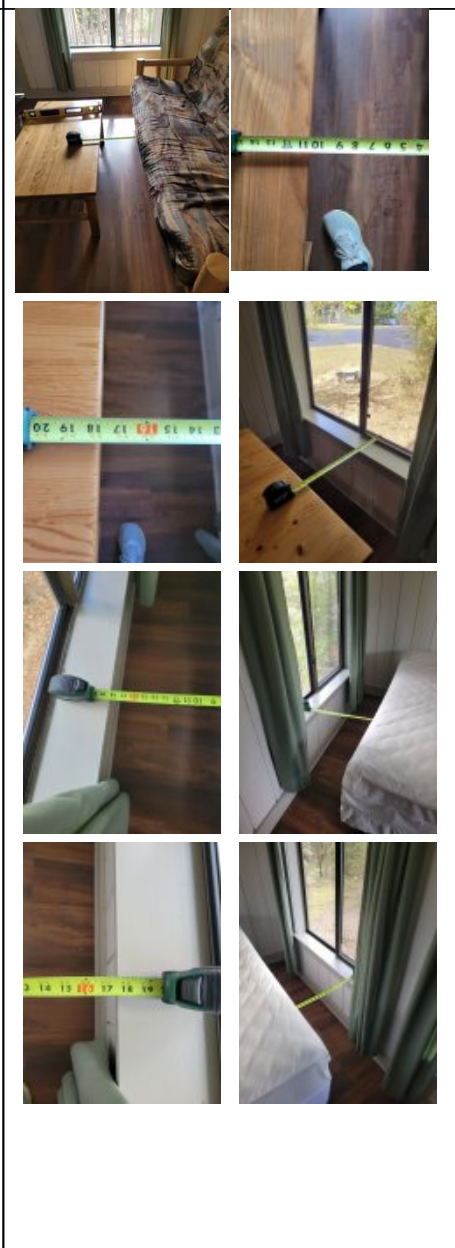
Finding Number	Area Description	Lat/Long	Finding	As Built	Recommendation	Citation	Photos	Figure
			<p>inches maximum provided that reduced width segments are separated by segments that are 48 inches long minimum and 36 inches wide minimum.</p>	<p>between back window and bed, 17.5 between front window and bed</p>		<p>2012 TAS Section: 403.5.1 2010 ADAS Section: 403.5.1</p>

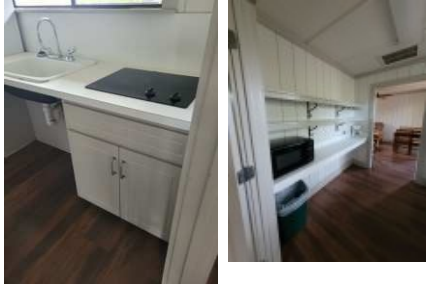
Finding Number	Area Description	Lat/Long	Finding	As Built	Recommendation	Citation	Photos	Figure
479	Pecan Ridge Cabin Area: PR - Cabin 8	[33.2958468 , -95.661720 1]	The storage space is not within reach range. At least 50% of the storage space must be a minimum of 15 inches and a maximum of 48 inches off the floor with an unobstructed approach. For side approach, the maximum reach range is 46 inches high over an obstruction that is a maximum of 34 inches tall and 24 inches deep.	shelves are all above 48" aff	Lower 50% of shelving, or relocate supplies to within reach range, max 48" aff	2015 ABAAS Section: 804.5 2012 TAS Section: 804.5 2010 ADAS Section: 804.5

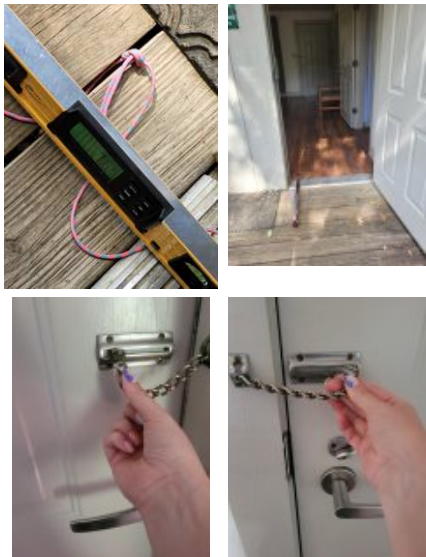
481	Pecan Ridge Cabin Area: PR - Cabin 8	[33.2958558 , -95.661708]	Minimum maneuvering clearances at doors and gates shall comply with 404.2.4. Maneuvering clearances shall extend the full width of the doorway and the required latch side or hinge side clearance. Maneuvering clearances shall have a max slope of 2.08%. Exterior doors are recommended to be maintained at 8.5 lbf as a smart practice. Force is to be measured at the operating hardware or 30 inches from the hinges, whichever is greater. Hand-activated door opening hardware, handles, pulls, latches, locks, and other operating devices on accessible doors shall have a shape that is easy to grasp with one hand and does not require tight grasping, tight pinching or twisting of the wrist to operate. Hardware shall be 34 inches minimum and 48 inches maximum above the finish floor or ground.	exterior doors, entry - 7.6% slope, require pinch. back porch door off living room - requires pinch, 25# push. bedroom door to porch - require pinch, 6.3% slope	For all doors along the public circulation route, correct slope in door clearance to max 2.08%. For all doors along the public circulation route, inspect, adjust, and maintain 8.5 lbf to open exterior doors as a smart practice. For all doors along the public circulation route, replace hardware with lever hardware or hardware operable without a tight pinch or grasp.	2010 ADAS Section: 404.2.3, 404.2.7, 404.2.4, 404.2.11, 404.2.11 Exception

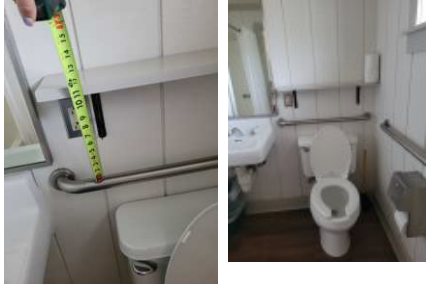
Finding Number	Area Description	Lat/Long	Finding	As Built	Recommendation	Citation	Photos	Figure
486	Pecan Ridge Cabin Area: PR - Cabin 8	[33.2958524 , -95.661712]	The grab bar height and/or spacing fails. Grab bars must be mounted between 33" and 36" to the top of the gripping surface. There must be 1.5" of clearance between the grab bar and the wall. There must be a minimum of 1.5" of clearance below and minimum 12" above the grab bar to any dispenser or other obstruction.	shelf 6" above rear grab bar	Remount shelf min 12" above grab bar	2015 ABAAS Section: 609.3, 609.4 2012 TAS Section: 609.4, 609.3 2010 ADAS Section: 609.3, 609.4

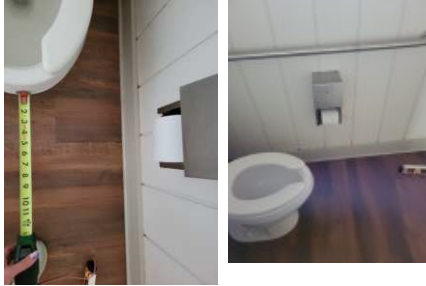
487	Pecan Ridge Cabin Area: PR - Cabin 8	[33.2958592 , -95.6617094]	The toilet paper is not installed within the compliant range in front of the toilet. Toilet paper dispensers shall be 7 inches minimum and 9 inches maximum in front of the water closet measured to the centerline of the dispenser. The outlet of the dispenser shall be 15 inches minimum and 48 inches maximum above the finish floor and shall not be located behind grab bars. Dispensers shall not be of a type that controls delivery or that does not allow continuous paper flow. There shall be a clearance of 1 1/2 inches minimum below the grab bar.	TP too close to front of toilet	Remount toilet paper dispenser max 7" to 9" from front of toilet, 15" to 48" aff and min 12" above or 1.5" below grab bar	2015 ABAAS Section: 604.7 2012 TAS Section: 604.7 2010 ADAS Section: 604.7

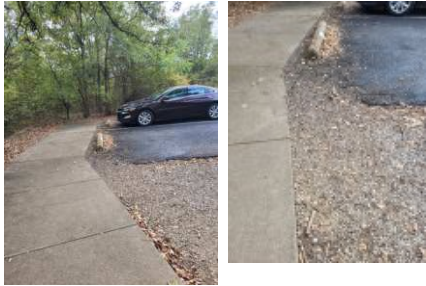
Finding Number	Area Description	Lat/Long	Finding	As Built	Recommendation	Citation	Photos	Figure
489	Pecan Ridge Cabin Area: PR - Cabin 8	[33.2958491 , -95.661714 7]	The building entrance is not located on an accessible route. When a building, or portion of a building, is required to be accessible, an accessible route of travel shall be provided to all portions of the building, to accessible building entrances and between the building and the public way. All walks, halls, corridors, aisles, skywalks, tunnels, and other spaces that are part of an accessible route must comply. An accessible route of travel must not pass through kitchens, storage rooms, restrooms, closets or other spaces used for similar purposes. At least one accessible route within the boundary of the site must be provided from public transportation stops, accessible parking and accessible passenger loading zones and public streets or sidewalks to the accessible building entrance they serve. The accessible route shall, to the maximum extent feasible, coincide with the route for the general public. At least one accessible route shall connect accessible buildings, facilities, elements and spaces that are on the same site. At least one accessible route shall connect accessible building or facility entrances with all accessible spaces and elements.	no AR from lot to cabin 8	Create AR with crushed and compacted stone or similar outdoor material from parking or sidewalk to building entrance	2015 ABAAS Section: F206.2.1 2012 TAS Section: 206.2.1 2010 ADAS Section: 206.2.1

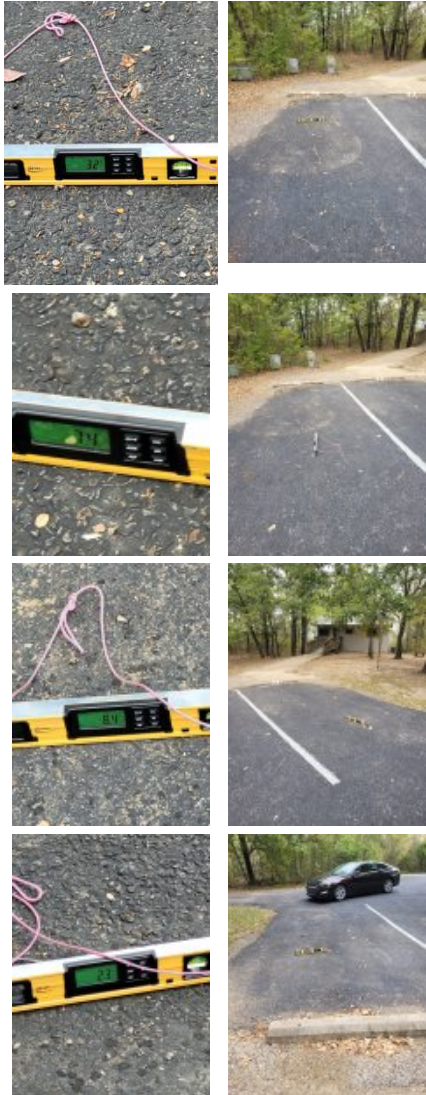
Finding Number	Area Description	Lat/Long	Finding	As Built	Recommendation	Citation	Photos	Figure
493	Pecan Ridge Cabin Area: PR - Cabin 12 Parking	[33.2954904 , -95.662614 6]	The cross slopes (narrow dimension) and/or running slopes (long dimension) of the access aisle exceeds 2%. The running slope and the cross slope in an accessible parking stall and the access aisle must not exceed 2%.	left stall - 3.2%, 7.4%. right stall - 8.4%,2.3%	Repair or correct slope of parking space and access aisle to max 2.08% in any direction	2015 ABAAS Section: 502.4 2012 TAS Section: 502.4 2010 ADAS Section: 502.4

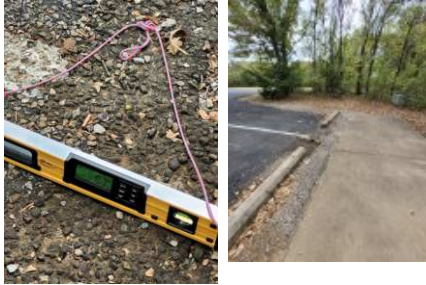
Finding Number	Area Description	Lat/Long	Finding	As Built	Recommendation	Citation	Photos	Figure
494	Pecan Ridge Cabin Area: PR - Cabin 12	[33.2956204 , -95.662709 8]	The running slope of walking surfaces shall not be steeper than 1:20.	8.7% slope from parking to entry	Correct running slope along the AR to max 5%	2015 ABAAS Section: 403.3 2012 TAS Section: 403.3 2010 ADAS Section: 403.3

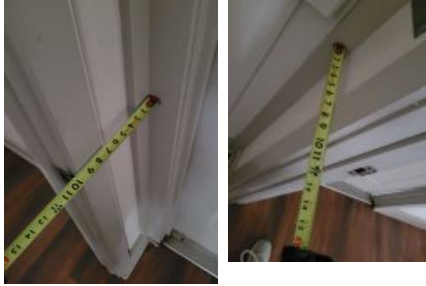
507	Pecan Ridge Cabin Area: PR - Cabin 12	[33.2957157 , -95.662693 7]	Minimum maneuvering clearances at doors and gates shall comply with 404.2.4. Maneuvering clearances shall extend the full width of the doorway and the required latch side or hinge side clearance.	door has 9.5" clearance on push and pull due to wall	For all doors along the public circulation route, provide required maneuvering clearance on push and pull side of doors	2010 ADAS Section: 404.2.3, 404.2.7, 404.2.4, 404.2.11, 404.2.11 Exception

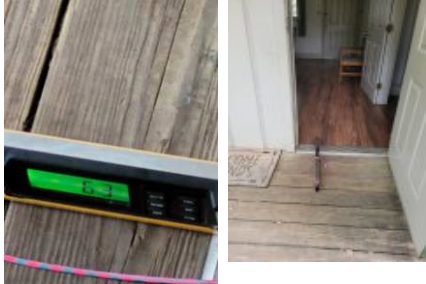
508	Pecan Ridge Cabin Area: PR - Cabin 12	[33.2957213 , -95.662695 1]	Minimum maneuvering clearances at doors and gates shall comply with 404.2.4. Maneuvering clearances shall extend the full width of the doorway and the required latch side or hinge side clearance. Maneuvering clearances shall have a max slope of 2.08%. The sweep period for doors with closers shall be adjusted so that from an open position of 70 degrees, the door will take at least 3 seconds to move to a point 3 inches from the latch, measured to the	exterior doors, entry - 6.3% slope, require pinch. back porch door off living room - require pinch, requires pinch on glass door. bedroom door to porch - require pinch, 3.6% slope, glass door fast close and requires	For all doors along the public circulation route, correct slope in door clearance to max 2.08%. For all doors along the public circulation route, inspect, adjust, and maintain closing speed on door closers. For all doors along the public circulation route, replace hardware with lever hardware or hardware operable without a tight pinch or grasp.	2010 ADAS Section: 404.2.3, 404.2.7, 404.2.4, 404.2.11, 404.2.11 Exception

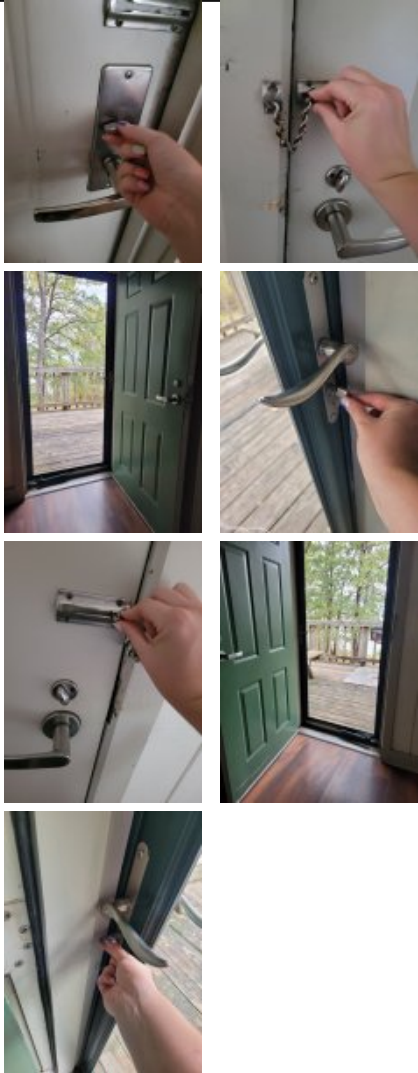
Finding Number	Area Description	Lat/Long	Finding	As Built	Recommendation	Citation	Photos	Figure
			<p>leading edge of the door. Hand-activated door opening hardware, handles, pulls, latches, locks, and other operating devices on accessible doors shall have a shape that is easy to grasp with one hand and does not require tight grasping, tight pinching or twisting of the wrist to operate. Hardware shall be 34 inches minimum and 48 inches maximum above the finish floor or ground.</p>	<p>pinch</p>

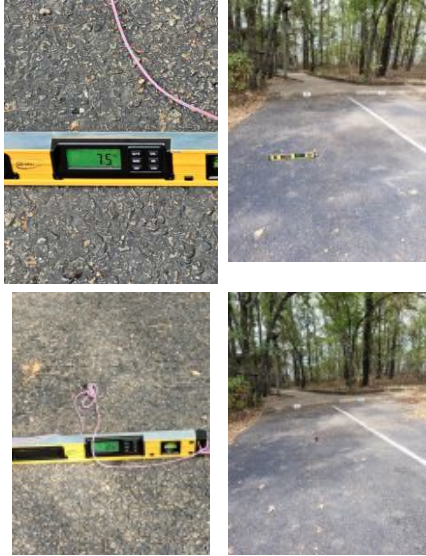
Finding Number	Area Description	Lat/Long	Finding	As Built	Recommendation	Citation	Photos	Figure
513	Pecan Ridge Cabin Area: PR - Cabin 13 Parking	[33.2954265 , -95.662842 6]	The surface of parking spaces and pull-up spaces shall be firm and stable. The slope of the surface of parking spaces and pull-up spaces shall not be steeper than 1:48 in any direction. EXCEPTION: Where the surface is other than asphalt, concrete, or boards, slopes not steeper than 1:20 shall be permitted when necessary for drainage.	left stall - 7.5%, 2.5%	Correct surface of parking spaces to be firm and stable with slopes max of 2.08% or 5% for surfaces other than concrete, asphalt or boards as a smart practice.	2015 ABAAS Section: 1012.4, 1012.5, 1012.5 EXCEPTION

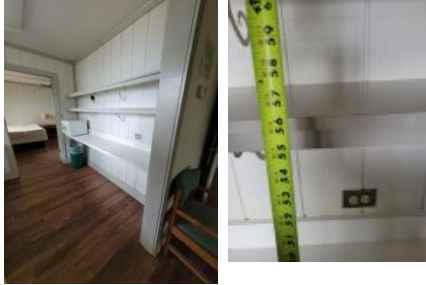
Finding Number	Area Description	Lat/Long	Finding	As Built	Recommendation	Citation	Photos	Figure
518	Pecan Ridge Cabin Area: PR - Cabin 13	[33.2955038 , -95.662878 8]	The storage space is not within reach range. At least 50% of the storage space must be a minimum of 15 inches and a maximum of 48 inches off the floor with an unobstructed approach. For side approach, the maximum reach range is 46 inches high over an obstruction that is a maximum of 34 inches tall and 24 inches deep.	shelves are all above 48" aff	Lower 50% of shelving, or relocate supplies to within reach range, max 48" aff	2015 ABAAS Section: 804.5 2012 TAS Section: 804.5 2010 ADAS Section: 804.5

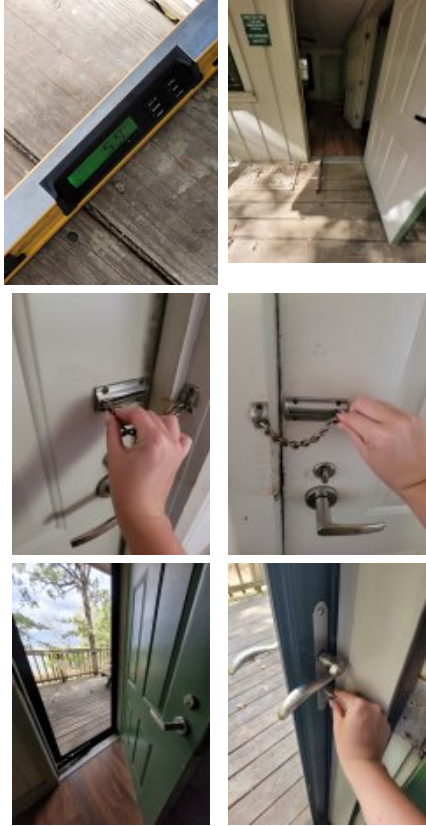
519	Pecan Ridge Cabin Area: PR - Cabin 13	[33.2955106 , -95.662900 3]	Minimum maneuvering clearances at doors and gates shall comply with 404.2.4. Maneuvering clearances shall extend the full width of the doorway and the required latch side or hinge side clearance. Maneuvering clearances shall have a max slope of 2.08%. The sweep period for doors with closers shall be adjusted so that from an open position of 70 degrees, the door will take at least 3 seconds to move to a point 3 inches from the latch, measured to the leading edge of the door. Exterior doors are recommended to be maintained at 8.5 lbf as a smart practice. Force is to be measured at the operating hardware or 30 inches from the hinges, whichever is greater. Hand-activated door opening hardware, handles, pulls, latches, locks, and other operating devices on accessible doors shall have a shape that is easy to grasp with one hand and does not require tight grasping, tight pinching or twisting of the wrist to operate. Hardware shall be 34 inches minimum and 48 inches maximum above the finish floor or ground.	cabin 8 exterior entry doors - 5.9% slope, require pinch; back porch door off living room - require pinch, 25 lbf, requires pinch on glass door; bedroom door to porch - require pinch, 3.6% slope, glass door fast close and requires pinch	For all doors along the public circulation route, correct slope in door clearance to max 2.08%. For all doors along the public circulation route, inspect, adjust, and maintain closing speed on door closers. For all doors along the public circulation route, inspect, adjust, and maintain 8.5 lbf to open exterior doors as a smart practice. For all doors along the public circulation route, replace hardware with lever hardware or hardware operable without a tight pinch or grasp.	2010 ADAS Section: 404.2.3, 404.2.7, 404.2.4, 404.2.11, 404.2.11 Exception

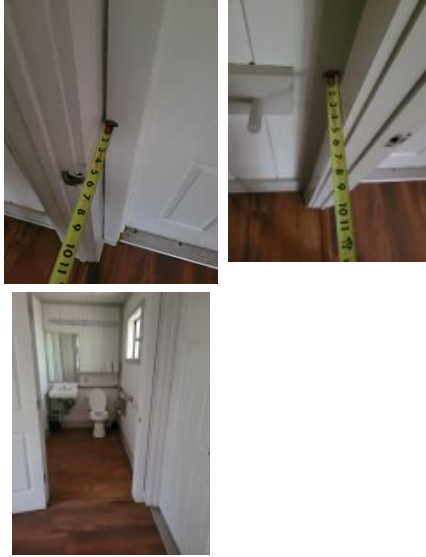
Finding Number	Area Description	Lat/Long	Finding	As Built	Recommendation	Citation	Photos	Figure
521	Pecan Ridge Cabin Area: PR - Cabin 13	[33.2955094 , -95.662882 8]	Minimum maneuvering clearances at doors and gates shall comply with 404.2.4. Maneuvering clearances shall extend the full width of the doorway and the required latch side or hinge side clearance.	5" clearance on push and pull due to wall	For all doors along the public circulation route, provide required maneuvering clearance on push and pull side of doors	2010 ADAS Section: 404.2.3, 404.2.7, 404.2.4, 404.2.11, 404.2.11 Exception

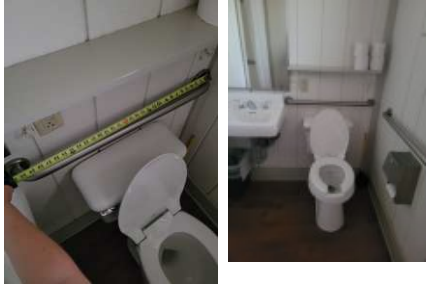
Finding Number	Area Description	Lat/Long	Finding	As Built	Recommendation	Citation	Photos	Figure
523	Pecan Ridge Cabin Area: PR - Cabin 13	[33.2954881 , -95.662880 1]	The rear grab bar is not 36" long or is not mounted in the correct location. The rear grab bar must be a minimum of 36" long and extend from the toilet centerline a minimum 12" towards the wall side and a minimum 24" towards the open side of the toilet. Grab bars shall be installed in a horizontal position, 33 inches minimum and 36 inches maximum above the finish floor measured to the top of the gripping surface and the space between the grab bar and the top of the tank shall be 1-1/2 inches minimum.	31" grab bar, 15" towards wall	Replace rear grab bar with one 36" long, mounted behind the toilet, 12" to one side of center and 24" to the other and 33" to 36" aff	2015 ABAAS Section: 604.5.2 2012 TAS Section: 604.5.2 2010 ADAS Section: 604.5.2

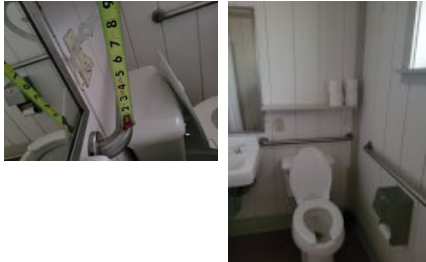
524	Pecan Ridge Cabin Area: PR - Cabin 13	[33.2955094 , -95.662873 4]	The grab bar height and/or spacing fails. Grab bars must be mounted between 33" and 36" to the top of the gripping surface. There must be 1.5" of clearance between the grab bar and the wall. There must be a minimum of 1.5" of clearance below and minimum 12" above the grab bar to any dispenser or other obstruction.	shelf 6" above grab bar	Remount shelf a min 12" above grab bar	2015 ABAAS Section: 609.3, 609.4 2012 TAS Section: 609.4, 609.3 2010 ADAS Section: 609.3, 609.4
