# Access Audit Site Report

**Davis Mountains State Park/Complex**

**Accessibility Evaluation**

**Inspection Date: 09/23/2021**

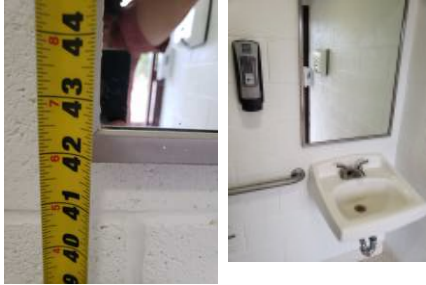
Finding Number	Area Description	Lat/Long	Finding	As Built	Recommendation	Citation	Photos	Figure
17	Davis Mountains Headquarters: DM HQ Men's Restroom	[30.5990594, -103.9294776]	The mirror is mounted too high. Mirrors must have the bottom edge of the reflecting surface a maximum of 40 inches above the floor if above a sink or counter. Mirrors not located above lavatories or countertops shall be installed with the bottom edge of the reflecting surface 35 inches maximum above the finish floor or ground.	Bottom edge of reflecting surface of mirror is 42.5" aff	Lower mirror so bottom reflective surface is max 40" AFF and 74" at the top.	2015 ABAAS Section: 603.3  2012 TAS Section: 603.3  2010 ADAS Section: 603.3

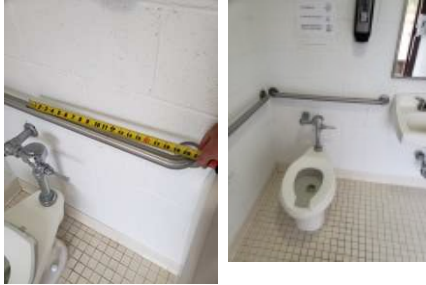
Finding Number	Area Description	Lat/Long	Finding	As Built	Recommendation	Citation	Photos	Figure
24	Davis Mountains Headquarters: DM HQ Men's Restroom	[30.5990652, -103.9294829]	The rear grab bar is not 36" long or is not mounted in the correct location. The rear grab bar must be a minimum of 36" long and extend from the toilet centerline a minimum 12" towards the wall side and a minimum 24" towards the open side of the toilet. Grab bars shall be installed in a horizontal position, 33 inches minimum and 36 inches maximum above the finish floor measured to the top of the gripping surface and the space between the grab bar and the top of the tank shall be 1-1/2 inches minimum.	Rear grab bar extends 20" from centerline of toilet towards the open side of the toilet	Remount rear grab bar to behind the toilet, 12" to the wall side of center and 24" to the open side and 33" to 36" AFF.	2015 ABAAS Section: 604.5.2 2012 TAS Section: 604.5.2 2010 ADAS Section: 604.5.2

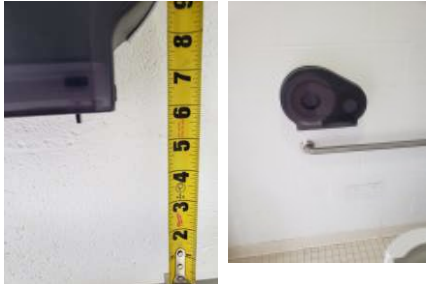
25	Davis Mountains Headquarters: DM HQ Men's Restroom	[30.5990606, -103.9294856]	The grab bar height and/or spacing fails. Grab bars must be mounted between 33" and 36" to the top of the gripping surface. There must be 1.5" of clearance between the grab bar and the wall. There must be a minimum of 1.5" of clearance below and minimum 12" above the grab bar to any dispenser or other obstruction.	Toilet paper dispenser mounted 6" above side grab bar	Remount toilet paper dispenser max 7" to 9" from front of toilet, 15" to 48" above the finished floor (AFF) and min 12" above or 1.5" below grab bar.	2015 ABAAS Section: 609.3, 609.4 2012 TAS Section: 609.4, 609.3 2010 ADAS Section: 609.3, 609.4

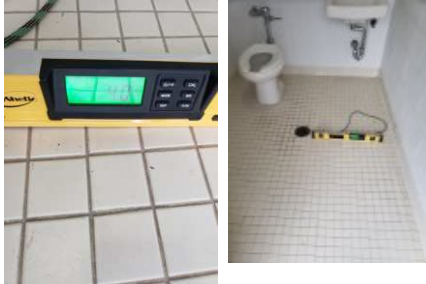
26	Davis Mountains Headquarters: DM HQ Men's Restroom	[30.5990698, -103.929487]	The accessible route contains running slopes greater than 5 percent and cross slopes greater than 2 percent across the width of the walk and has not been constructed as a ramp (i.e. handrails, wheel guides, etc.). When the slope in the direction of travel of any walk exceeds 1 unit vertical in 20 units horizontal (5-percent slope), it must be constructed as ramp. Surface cross slopes must not exceed one unit vertical in 48 units. Horizontal (2-percent slope).	Slope of 4% near floor drain	Correct or repair slope to max 2.08% in restroom.	2015 ABAAS Section: 403.3 2012 TAS Section: 403.3 2010 ADAS Section: 403.3

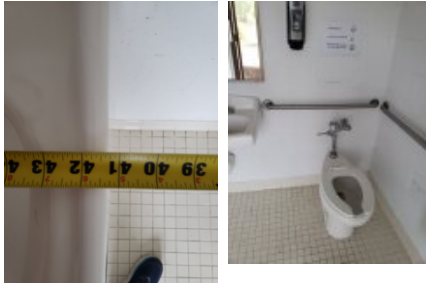
31	Davis Mountains Headquarters: DM HQ Women's Restroom	[30.5990663, -103.9294883]	The required 56 inches by 60 inches clear floor space for the water closet has been obstructed. The clear floor space around the water closet shall be 60 inches minimum measured perpendicular from the side wall and 56 inches minimum measured perpendicular from the rear wall.	Lacks 60" clear floor space around toilet - 41.25" to sink	Relocate sink to provide required 60" clearance around toilet. In the alternative, leave as is citing safe harbor.	2015 ABAAS Section: 604.3. 2012 TAS Section: 604.3.1 2010 ADAS Section: 604.3.1

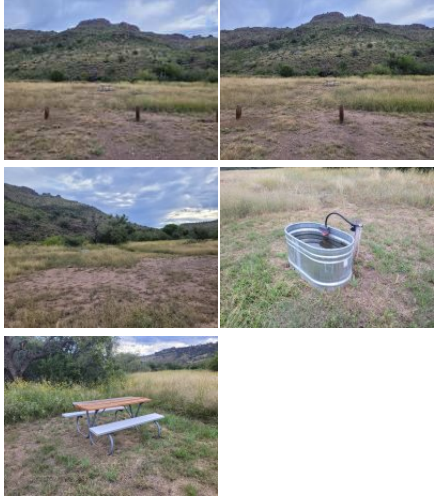
38	Davis Mountains Primitive Equestrian Camping Area: DM Equestrian Camping	[30.60095, -103.9259]	Camping facilities shall provide camping units with mobility features complying with F244.2 in accordance with Table F244.2. Where a camping facility provides different types of camping units, Table F244.2 shall apply to each type of camping unit provided. Total Number of Camping Units Provided in Camping Facility Minimum Number of Camping Units with Mobility Features Required 1 1 2 to 25 2 26 to 50 3 51 to 75 4 76 to 100 5 101 to 150 7 151 to 200 8 201 and over 8, plus 2 percent of the number over 200	Lacks camping units with mobility features (less than 25 standard, 0 accessible campsites)	Create the required number of accessible camp sites per table F244.2 as a smart practice.	2015 ABAAS Section: F244.2

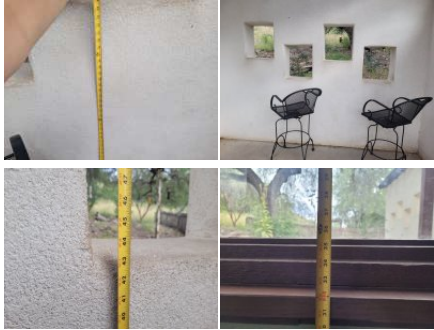
51	Davis Mountains Wildlife Viewing: DM Wildlife Viewing	[30.59628, -103.9348]	Each distinct viewing location shall provide a viewing space adjacent to the clear ground space required by 1015.2 through which the point of interest is viewable. The viewing space shall be 32 inches (815 mm) maximum and 51 inches (1295 mm) minimum high above the ground and shall extend the full width of the clear ground space. EXCEPTION: Guards or similar safety barriers shall be permitted to obstruct the viewing space to the extent the obstruction is necessary for the guard or safety barrier to serve its intended purpose.	no opening between 32" and 51", lowest at 43"; interior at 36"	Provide a viewing window at max 32" above the floor with a clear floor space for "parking"	2015 ABAAS Section: 1015.3, 1015.3 EXCEPTION

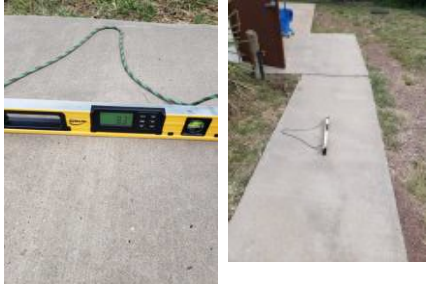
Finding Number	Area Description	Lat/Long	Finding	As Built	Recommendation	Citation	Photos	Figure
66	Davis Mountains Wildlife Viewing: DM Wildlife Viewing Men's Restroom	[30.5950433 , -103.9361 496]	The running slope of walking surfaces shall not be steeper than 1:20.	Running slope of 8.3%	Correct running slope along the AR to max 5%	2015 ABAAS Section: 403.3  2012 TAS Section: 403.3  2010 ADAS Section: 403.3

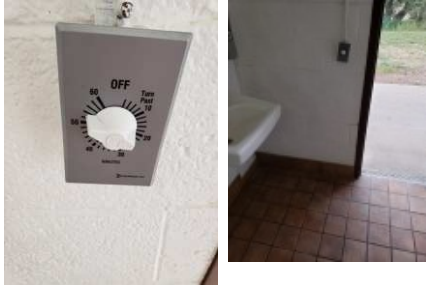
67	Davis Mountains Wildlife Viewing: DM Wildlife Viewing Men's Restroom	[30.5950583 , -103.93611 2]	Exterior doors exceed 8.5 lbs of force to open; fire doors shall have a minimum opening force allowable by the appropriate administrative authority	Men's restroom door - 18# push	Inspect, adjust, and maintain 8.5 lbf to open exterior doors as a smart practice.	2010 ADAS Section: 404.2.9		
68	Davis Mountains Wildlife Viewing: DM Wildlife Viewing Men's Restroom	[30.5950585 , -103.9361 102]	The operable part is not accessible because it requires tight grasping, pinching or twisting of the wrist.	light/heat dial requires pinch and twist	Replace operable part with one usable without a tight pinch or grasp	2015 ABAAS Section: 309.4  2012 TAS Section: 309.4  2010 ADAS Section: 309.4

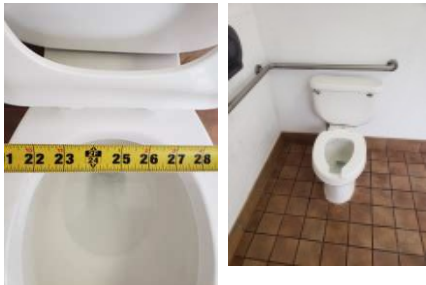
69	Davis Mountains Wildlife Viewing: DM Wildlife Viewing Men's Restroom	[30.5950608 , -103.93612 1]	The toilet is not located within the range allowed from the side wall or partition. The centerline of the toilet must be 16 to 18 inches from the side wall.	centerline 24.5"	Remount toilets to 16" to 18" from the side wall to centerline	2015 ABAAS Section: 604.2  2012 TAS Section: 604.2  2010 ADAS Section: 604.2

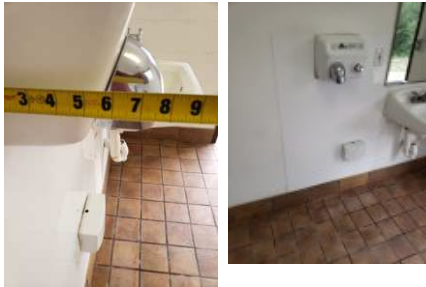
84	Davis Mountains Wildlife Viewing: DM Wildlife Viewing Women's Restroom	[30.5950595, -103.9360852]	The hand dryer projects more than 4 inches into the circulation path. Wall-mounted objects that have leading edges between 27 inches and 80 inches from the floor must not project more than 4 inches into the circulation path. Protruding objects that extend to the floor or within 27 inches of the floor are cane detectable and are therefore not hazardous. Where it is necessary or desirable to have objects protrude from the wall, a manner of cane detection must be provided.	Hand dryer protrudes 8"	Relocate protruding objects or place cane detectable warning or bollard at foot of item.	2015 ABAAS Section: 307.2 2012 TAS Section: 307.2 2010 ADAS Section: 307.2

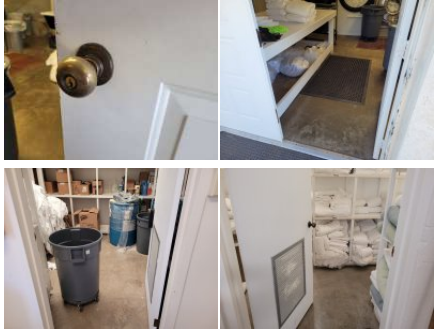
Finding Number	Area Description	Lat/Long	Finding	As Built	Recommendation	Citation	Photos	Figure
90	Davis Mountains Maintenance: DM Maintenance-Laundry	[30.5905964, -103.9440406]	Spaces and elements within employee work areas shall only be required to comply with 206.2.8, 207.1, and 215.3 and shall be designed and constructed so that individuals with disabilities can approach, enter, and exit the employee work area. Employee work areas, or portions of employee work areas, other than raised courtroom stations, that are less than 300 square feet (28 m2) and elevated 7 inches (180 mm) or more above the finish floor or ground where the elevation is essential to the function of the space shall not be required to comply with these requirements or to be on an accessible route.	Entry - table in pull side clearance, knob hardware Storage rooms (2) - shelf in pull side clearance, knob hardware	For employee spaces, relocate storage, furniture, and other obstacles at doorways to provide approach, enter and exit at the employee space. For all doors along the public circulation route, provide required maneuvering clearance on push and pull side of doors. For all doors along the public circulation route, replace hardware with lever hardware or hardware operable without a tight pinch or grasp.	2015 ABAAS Section: F203.9 2012 TAS Section: 203.9 2010 ADAS Section: 203.9

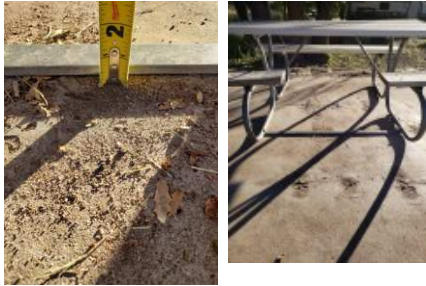
Finding Number	Area Description	Lat/Long	Finding	As Built	Recommendation	Citation	Photos	Figure
95	Davis Mountains Campsites 36-45: DM Campsite 36	[30.5961179 , -103.9330 161]	Picnic tables shall provide at least one wheelchair space for each 24 linear feet (7320 mm) of usable table surface perimeter. Wheelchair spaces shall be 30 inches (760 mm) minimum by 48 inches (1220 mm) minimum. Wheelchair spaces shall be positioned for a forward approach to the table and provide knee and toe clearance complying with 306 under the table	CIL of .5" at bar under table	Replace picnic table with one of an accessible design as a smart practice.	2015 ABAAS Section: 1011.4.2

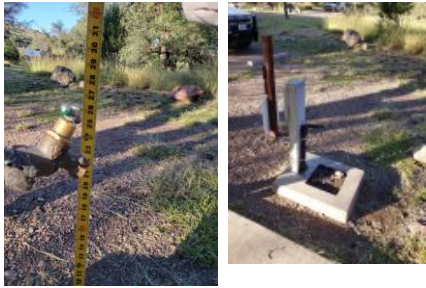
97	Davis Mountains Campsites 36-45: DM Campsite 36	[30.5960269 , -103.9331 723]	Water spouts at water hydrants and water utility hook-ups shall be 28 inches (710 mm) minimum and 36 inches (915 mm) maximum above the ground	Water spout is 26" above ground level	Remount water spouts to 28" min or 36" max above the ground as a smart practice.	2015 ABAAS Section: 1011.6

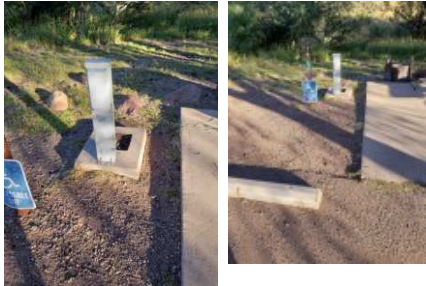
98	Davis Mountains Campsites 36-45: DM Campsite 36	[30.5960095 , -103.9331 616]	30 inches (760 mm) by 60 inches (1525 mm) with the long side of the space adjoining or overlapping an accessible parking space or pull-up space for recreational vehicles Locate the space so that the hook-ups are at the rear center of the space. Bollards or other barriers shall not obstruct the clear ground space in front of the hook-ups	Lacks accessible route to and clear ground space at campsite utility hook ups	Create AR with crushed and compacted stone or similar outdoor material to water spouts, with a 30" x 60" clear space around usable area	2015 ABAAS Section: 1011.2

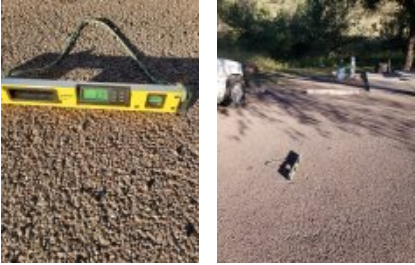
100	Davis Mountains Campsites 36-45: DM Campsite 36	[30.5959681, -103.9331665]	The parking space slopes greater than 1:48 (2.08%). Where the surface is other than asphalt, concrete, or boards, slopes not steeper than 1:20 (5%) shall be permitted when necessary for drainage.	Slope of 2.7% in parking space	Repair or correct slope of clear space to max 2.08% in any direction.	2015 ABAAS Section: 1012.5

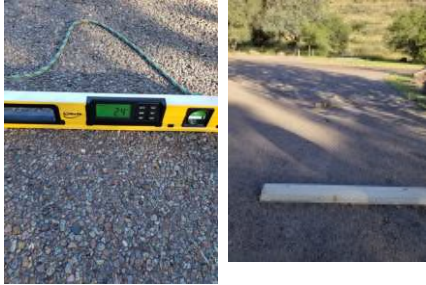
Finding Number	Area Description	Lat/Long	Finding	As Built	Recommendation	Citation	Photos	Figure
102	Davis Mountains Campsites 36-45: DM Campsite 39	[30.5962219 , -103.9323 529]	The cross slope shall not be steeper than 1:48. EXCEPTION: Where the surface is other than concrete, asphalt, or boards, cross slopes not steeper than 1:20 shall be permitted when necessary for drainage.	Cross slope of 2.4% at parking	Correct or repair ORAR cross slope to max 2.08% as a smart practice.	2015 ABAAS Section: 1016.7.2, 1016.7.2 EXCEPTION

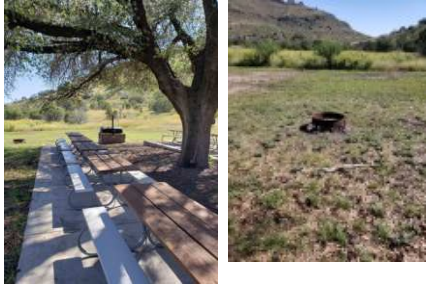
Finding Number	Area Description	Lat/Long	Finding	As Built	Recommendation	Citation	Photos	Figure
106	Davis Mountains Campsites 46-61: DM Campsites 46-61 Group Picnic Area	[30.5977769 , -103.92793 8]	Where picnic facilities contain two or fewer picnic units, each picnic unit shall provide mobility features complying with F245.2.	Lacks accessible route to BBQ pit or fire pit	Create an ORAR to shelter or picnic area and provide accessible features as a smart practice.	2015 ABAAS Section: F245.2.1

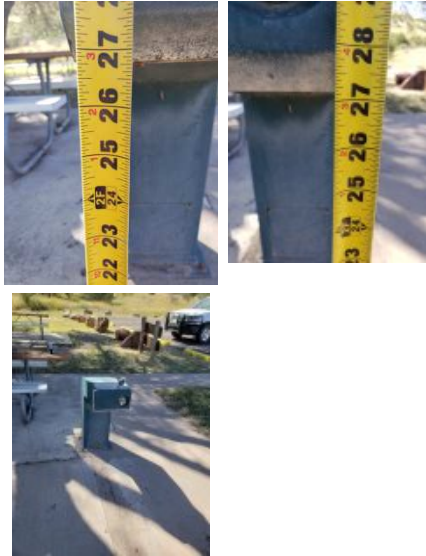
Finding Number	Area Description	Lat/Long	Finding	As Built	Recommendation	Citation	Photos	Figure
109	Davis Mountains Campsites 46-61: DM Campsites 46-61 Group Picnic Area	[30.5978208, -103.9279085]	There is not enough knee clearance under the drinking fountain. The drinking fountain must have a clear knee space between the bottom of the apron and the floor not less than 27 inches in height, 30 inches in width, and 8 inches in depth.	Drinking fountain lacks knee clearance - one side of fountain is 26.75" above ground level (AGL)	Raise drinking fountain to provide required 27" knee clearance.	2015 ABAAS Section: 602.2 2012 TAS Section: 602.2 2010 ADAS Section: 602.2

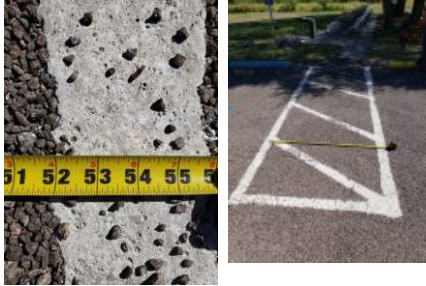
111	Davis Mountains Campsites 46-61: DM Campsites 46-61 Group Picnic Area	[30.597718, -103.9280278]	The access aisle is not a minimum 5 feet wide. A car accessible parking stall's access aisle must be a minimum of 5 feet wide measured from centerline to centerline. Where the access aisle is not adjacent to another parking space or access aisle, measurements shall be permitted to include the full width of the line defining the access aisle.	access aisle 54" wide	Repaint access aisle to be 5'.	2015 ABAAS Section: 502.3.1 2012 TAS Section: 502.3.1 2010 ADAS Section: 502.3.1

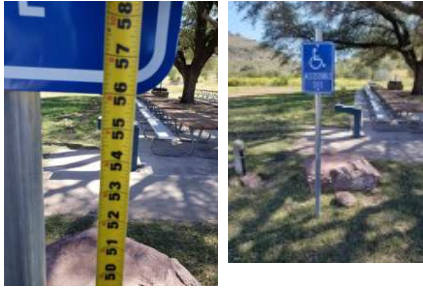
114	Davis Mountains Campsites 46-61: DM Campsites 46-61 Group Picnic Area	[30.5977076 , -103.9280 386]	The parking sign is mounted too low. Parking space identification signs shall include the International Symbol of Accessibility complying with. Signs identifying van parking spaces shall contain the designation "van accessible." Signs shall be 60 inches minimum above the finish floor or ground surface measured to the bottom of the sign.	The parking sign is mounted low at 56" above ground level	Raise existing accessible parking signs so lowest end of bottom sign is min 60" AGL.	2015 ABAAS Section: 502.6  2012 TAS Section: 502.6  2010 ADAS Section: 502.6

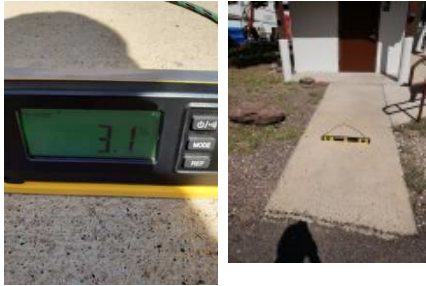
Finding Number	Area Description	Lat/Long	Finding	As Built	Recommendation	Citation	Photos	Figure
115	Davis Mountains Campsites 46-61: DM Campsites 46-61 Group Picnic Area	[30.5976915, -103.9280225]	The accessible route of travel contains cross slopes greater than 2%. Cross slopes shall not exceed one unit vertical in 48 units horizontal (2-percent slope).	Cross slope of 3.1% on path to bathroom	Correct or repair cross slope along AR to max 2.08%	2015 ABAAS Section: 403.3 2012 TAS Section: 403.3 2010 ADAS Section: 403.3

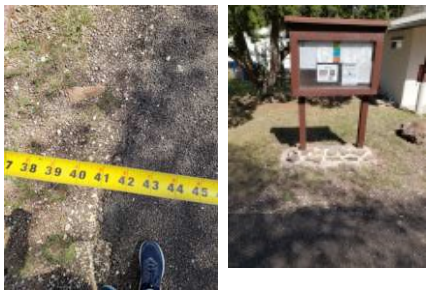
116	Davis Mountains Campsites 46-61: DM Campsites 46-61 Group Picnic Area	[30.5977042, -103.9280292]	There is no accessible route to the informational sign. At least one accessible route shall connect accessible buildings, accessible facilities, accessible elements, and accessible spaces that are on the same site.	Lacks accessible route to and clear ground space at informational sign	Create an accessible route with crushed stone or other outdoor material from parking or walkway to the informational sign Provide 30" by 48" deep CFS for a forward or side approach to informational signs	2015 ABAAS Section: F206.2.2 2012 TAS Section: 206.2.2 2010 ADAS Section: 206.2.2

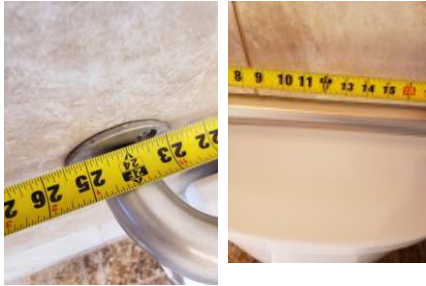
Finding Number	Area Description	Lat/Long	Finding	As Built	Recommendation	Citation	Photos	Figure
120	Davis Mountains Campsites 46-61: DM Campsites 46-61 Men's Restroom	[30.5977296, -103.9282505]	The rear grab bar is not 36" long or is not mounted in the correct location. The rear grab bar must be a minimum of 36" long and extend from the toilet centerline a minimum 12" towards the wall side and a minimum 24" towards the open side of the toilet. Grab bars shall be installed in a horizontal position, 33 inches minimum and 36 inches maximum above the finish floor measured to the top of the gripping surface and the space between the grab bar and the top of the tank shall be 1-1/2 inches minimum.	Rear grab bar is 24" long and extends 12" in both directions from centerline of toilet	Replace rear grab bar with one 36" long, mounted behind the toilet, 12" to one side of center and 24" to the other and 33" to 36" AFF.	2015 ABAAS Section: 604.5.2 2012 TAS Section: 604.5.2 2010 ADAS Section: 604.5.2

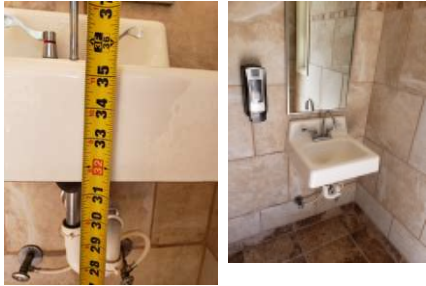
Finding Number	Area Description	Lat/Long	Finding	As Built	Recommendation	Citation	Photos	Figure
125	Davis Mountains Campsites 46-61: DM Campsites 46-61 Women's Restroom	[30.5977263, -103.9282487]	The top rim of the sink is too high. All lavatories/sinks that are designated to be accessible shall be a minimum 17 inches in horizontal depth and mounted with the rim or counter edge no higher than 34 inches above the finished floor.	sink 35.5"	Lower sinks to max 34" above the finished floor (AFF) to front of rim.	2015 ABAAS Section: 606.3 2012 TAS Section: 606.3 2010 ADAS Section: 606.3

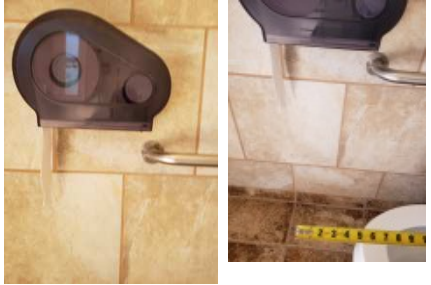
Finding Number	Area Description	Lat/Long	Finding	As Built	Recommendation	Citation	Photos	Figure
130	Davis Mountains Campsites 46-61: DM Campsites 46-61 Women's Restroom	[30.597732, -103.92825 14]	The toilet paper is not installed within the compliant range in front of the toilet. Toilet paper dispensers shall be 7 inches minimum and 9 inches maximum in front of the water closet measured to the centerline of the dispenser. The outlet of the dispenser shall be 15 inches minimum and 48 inches maximum above the finish floor and shall not be located behind grab bars. Dispensers shall not be of a type that controls delivery or that does not allow continuous paper flow. There shall be a clearance of 1 1/2 inches minimum below the grab bar.	toilet paper too close, 5"	Remount toilet paper dispenser 7" to 9" from front of toilet, 15" to 48" AFF and min 12" above or 1.5" below grab bar.	2015 ABAAS Section: 604.7 2012 TAS Section: 604.7 2010 ADAS Section: 604.7

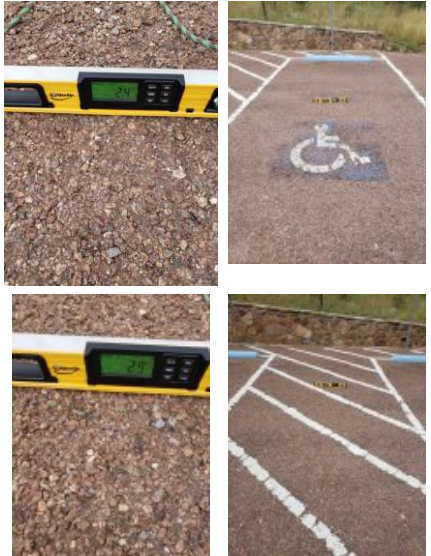
135	Davis Mountains Campsites 17-27: DM Amphitheater Parking	[30.593217, -103.9311794]	The cross slopes (narrow dimension) and/or running slopes (long dimension) of the access aisle exceeds 2%. The running slope and the cross slope in an accessible parking stall and the access aisle must not exceed 2%.	Slopes: 2.4% in stall 1, 2.9% access aisle 1, 3% stall 2, 2.5% stall 3, and 4% stall 4	Repair or correct slope of parking space and access aisle to max 2.08% in any direction.	2015 ABAAS Section: 502.4 2012 TAS Section: 502.4 2010 ADAS Section: 502.4

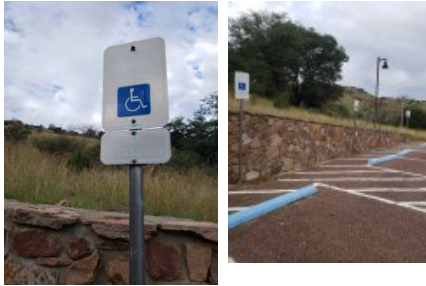
Finding Number	Area Description	Lat/Long	Finding	As Built	Recommendation	Citation	Photos	Figure
137	Davis Mountains Campsites 17-27: DM Amphitheater Parking	[30.5931732, -103.9311606]	The accessible parking stall signage is incorrect and/or missing from each accessible parking space. Parking space identification signs shall include the International Symbol of Accessibility. Signs identifying van parking spaces shall contain the designation "van accessible." Signs shall be 60 inches minimum above the finish floor or ground surface measured to the bottom of the sign.	All 4 accessible parking signs are faded and hard to read	Acquire and mount at appropriate heights and locations accessible parking signs for all the stalls	2015 ABAAS Section: 502.6  2012 TAS Section: 502.6

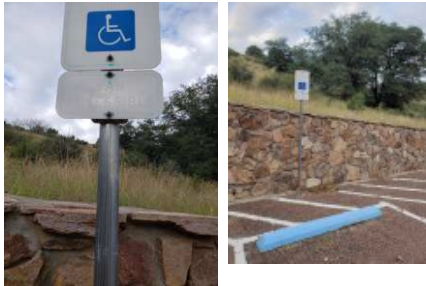
138	Davis Mountains Campsites 17-27: DM Amphitheater Parking	[30.5932009, -103.9312223]	The van stall is missing a sign identifying it as a van accessible stall. Parking space identification signs shall include the International Symbol of Accessibility. Signs identifying van parking spaces shall contain the designation "van accessible."	Van accessible sign present, but faded and hard to read	Replace faded one van parking sign.	2015 ABAAS Section: 502.6  2012 TAS Section: 502.6  2010 ADAS Section: 502.6

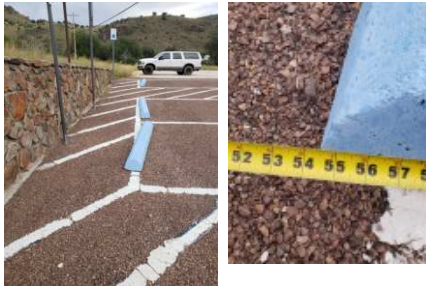
139	Davis Mountains Campsites 17-27: DM Amphitheater	[30.5931201, -103.9311982]	The accessible route is constructed such that a park vehicle can obstruct the minimum 36 inch width. Parking spaces and access aisles shall be designed so that cars and vans, when parked, cannot obstruct the required clear width of adjacent accessible routes.	Parking bumper encroaches into accessible route clear width	Relocate parking bumpers to ensure compliant clear width of accessible route	2015 ABAAS Section: 502.7  2012 TAS Section: 502.7  2010 ADAS Section: 502.7

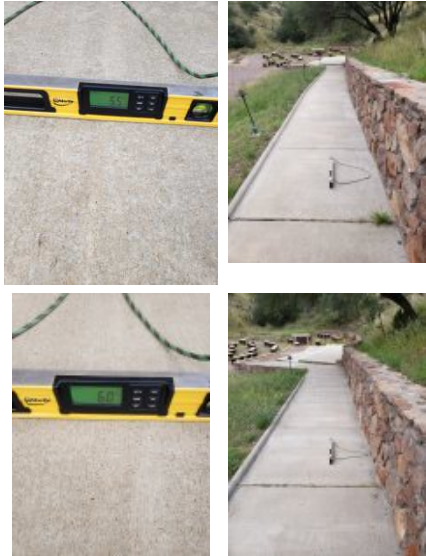
Finding Number	Area Description	Lat/Long	Finding	As Built	Recommendation	Citation	Photos	Figure																
140	Davis Mountains Campsites 17-27: DM Amphitheater	[30.592761, -103.93087 37]	The running slope of walking surfaces shall not be steeper than 1:20.	Running slopes of 5.5% and 6%	Correct running slope along the AR to max 5%.	2015 ABAAS Section: 403.3  2012 TAS Section: 403.3  2010 ADAS Section: 403.3

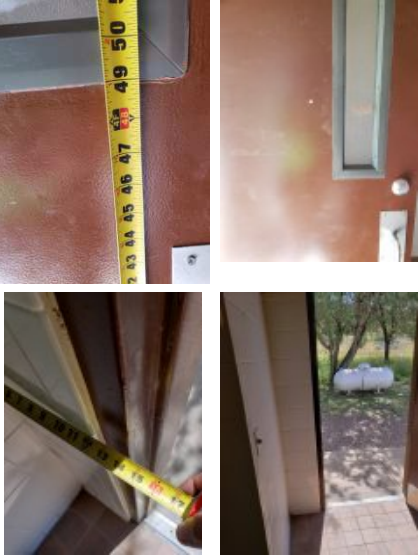
Finding Number	Area Description	Lat/Long	Finding	As Built	Recommendation	Citation	Photos	Figure
146	Davis Mountains Campsites 17-27: DM Campsites 17-27 Men's Restroom	[30.5953942, -103.9323328]	Minimum maneuvering clearances at doors and gates shall comply with 404.2.4. Maneuvering clearances shall extend the full width of the doorway and the required latch side or hinge side clearance. The sweep period for doors with closers shall be adjusted so that from an open position of 70 degrees, the door will take at least 3 seconds to move to a point 3 inches from the latch, measured to the leading edge of the door. Exterior doors are recommended to be maintained at 8.5 lbf as a smart practice. Force is to be measured at the operating hardware or 30 inches from the hinges, whichever is greater. Doors, gates, and side lights adjacent to doors or gates, containing one or more glazing panels that permit viewing through the panels shall have the bottom of at least one glazed panel located 43 inches (1090 mm) maximum above the finish floor. EXCEPTION: Vision lights with the lowest part more than 66 inches (1675 mm) from the finish floor or ground shall not be required to comply with 404.2.11.	Accessible restroom door - 14" to wall on pull side clearance, 18# push, fast close, vision panel at 50" AFF	For all doors along the public circulation route, provide required maneuvering clearance on push and pull side of doors For all doors along the public circulation route, inspect, adjust, and maintain closing speed on door closers For all doors along the public circulation route, inspect, adjust, and maintain 8.5 lbf to open exterior doors as a smart practice For all doors along the public circulation route, replace doors with ones having sidelight viewing windows max 43" aff	2010 ADAS Section: 404.2.3, 404.2.7, 404.2.4, 404.2.11, 404.2.11 Exception

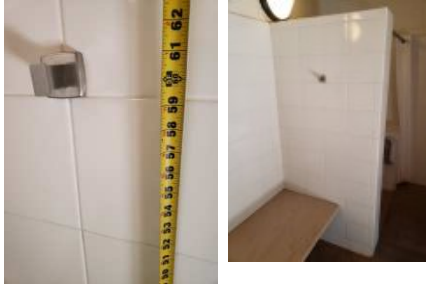
Finding Number	Area Description	Lat/Long	Finding	As Built	Recommendation	Citation	Photos	Figure
147	Davis Mountains Campsites 17-27: DM Campsites 17-27 Men's Restroom	[30.5954127, -103.9323743]	Where a high forward reach is over an obstruction, the clear floor space shall extend beneath the element for a distance not less than the required reach depth over the obstruction. The high forward reach shall be 48 inches (1220 mm) maximum where the reach depth is 20 inches (510 mm) maximum. Where the reach depth exceeds 20 inches (510 mm), the high forward reach shall be 44 inches (1120 mm) maximum and the reach depth shall be 25 inches (635 mm) maximum. Where a clear floor or ground space allows a parallel approach to an element and the high side reach is over an obstruction, the height of the obstruction shall be 34 inches (865 mm) maximum and the depth of the obstruction shall be 24 inches (610 mm) maximum. The high side reach shall be 48 inches (1220 mm) maximum for a reach depth of 10 inches (255 mm) maximum. Where the reach depth exceeds 10 inches (255 mm), the high side reach shall be 46 inches (1170 mm) maximum for a reach depth of 24 inches (610 mm) maximum.	Coat hook 60" AFF over bench	Lower coat hook to max 46" above the finished floor (AFF) for a side reach over bench.	2015 ABAAS Section: 308.2.1, 308.3.2  2012 TAS Section: 308.2.1, 308.3.2  2010 ADAS Section: 308.2.1, 308.3.2

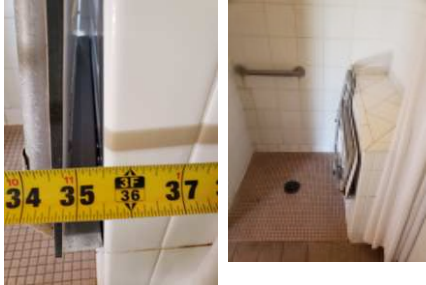
148	Davis Mountains Campsites 17-27: DM Campsites 17-27 Men's Restroom	[30.5954173, -103.9323542]	Transfer type shower compartments shall be 36 inches (915 mm) by 36 inches (915 mm) clear inside dimensions measured at the center points of opposing sides and shall have a 36 inch (915 mm) wide minimum entry on the face of the shower compartment. Clearance of 36 inches (915 mm) wide minimum by 48 inches (1220 mm) long minimum measured from the control wall shall be provided.	dimensions in transfer shower 35.5" wide	Enlarge transfer shower to compliant 36" by 36" clear inside dimension.	2015 ABAAS Section: 608.2.1  2012 TAS Section: 608.2.1  2010 ADAS Section: 608.2.1

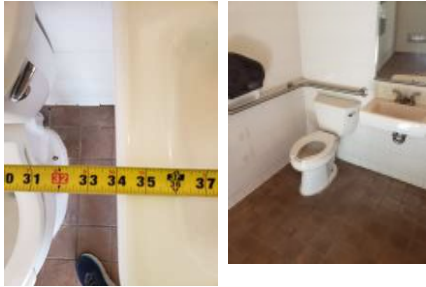
153	Davis Mountains Campsites 17-27: DM Campsites 17-27 Men's Restroom	[30.5954179, -103.9323663]	The required 56 inches by 60 inches clear floor space for the water closet has been obstructed. The clear floor space around the water closet shall be 60 inches minimum measured perpendicular from the side wall and 56 inches minimum measured perpendicular from the rear wall.	Lacks 60" clear floor space around toilet - 34" to sink	Relocate sink to provide required 60" clearance around the toilet. In the alternative, leave as is citing safe harbor.	2015 ABAAS Section: 604.3. 2012 TAS Section: 604.3.1 2010 ADAS Section: 604.3.1

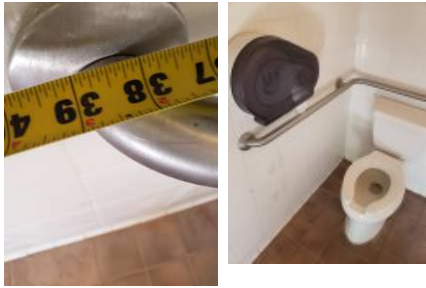
154	Davis Mountains Campsites 17-27: DM Campsites 17-27 Men's Restroom	[30.5954081, -103.9323489]	The side grab bars are not in the correct location. Grab bars on the side wall must be installed so that the end closest to the rear wall is maximum 12" from the rear wall. The end furthest from the rear wall must be mounted minimum 54" from the rear wall.	Side grab bar ends 38" from rear wall	Remount side grab bar to max 12" from the rear wall at the close end and min 54" on the far end, and 33" to 36" AFF.	2015 ABAAS Section: 604.5.1 2012 TAS Section: 604.5.1 2010 ADAS Section: 604.5.1

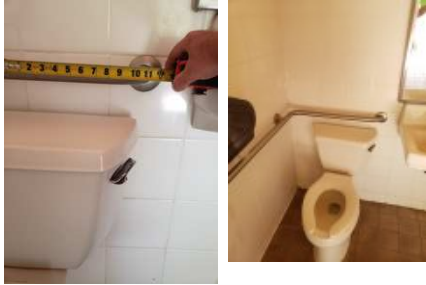
Finding Number	Area Description	Lat/Long	Finding	As Built	Recommendation	Citation	Photos	Figure
155	Davis Mountains Campsites 17-27: DM Campsites 17-27 Men's Restroom	[30.5954081, -103.9323757]	The rear grab bar is not 36" long or is not mounted in the correct location. The rear grab bar must be a minimum of 36" long and extend from the toilet centerline a minimum 12" towards the wall side and a minimum 24" towards the open side of the toilet. Grab bars shall be installed in a horizontal position, 33 inches minimum and 36 inches maximum above the finish floor measured to the top of the gripping surface and the space between the grab bar and the top of the tank shall be 1-1/2 inches minimum.	Rear grab bar extends 11" from centerline of toilet towards the open side of the toilet	Remount rear grab bar to behind the toilet, 12" to one side of center and 24" to the other and 33" to 36" AFF.	2015 ABAAS Section: 604.5.2  2012 TAS Section: 604.5.2  2010 ADAS Section: 604.5.2

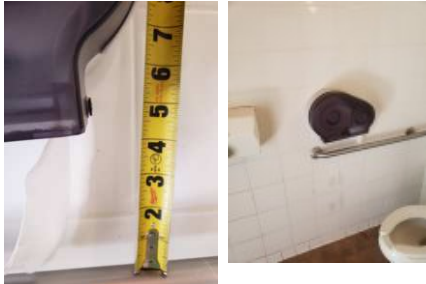
156	Davis Mountains Campsites 17-27: DM Campsites 17-27 Men's Restroom	[30.5954196, -103.932369]	The grab bar height and/or spacing fails. Grab bars must be mounted between 33" and 36" to the top of the gripping surface. There must be 1.5" of clearance between the grab bar and the wall. There must be a minimum of 1.5" of clearance below and minimum 12" above the grab bar to any dispenser or other obstruction.	toilet paper dispenser 4" above side grab bar and too close to toilet	Remount toilet paper dispenser max 7" to 9" from front of toilet, 15" to 48" aff and min 12" above or 1.5" below grab bar.	2015 ABAAS Section: 609.3, 609.4  2012 TAS Section: 609.4, 609.3  2010 ADAS Section: 609.3, 609.4

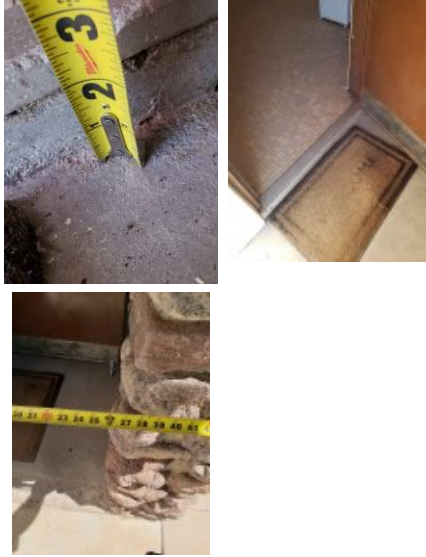
Finding Number	Area Description	Lat/Long	Finding	As Built	Recommendation	Citation	Photos	Figure
157	Davis Mountains Campsites 17-27: DM Campsites 17-27 Men's Restroom	[30.5954104, -103.9323623]	Minimum maneuvering clearances at doors and gates shall comply with 404.2.4. Maneuvering clearances shall extend the full width of the doorway and the required latch side or hinge side clearance. The threshold has a vertical change greater than 1/4 inch high. The sweep period for doors with closers shall be adjusted so that from an open position of 70 degrees, the door will take at least 3 seconds to move to a point 3 inches from the latch, measured to the leading edge of the door. Exterior doors are recommended to be maintained at 8.5 lbf as a smart practice. Force is to be measured at the operating hardware or 30 inches from the hinges, whichever is greater. The doormat is not secured in place at the entry door. If carpet or carpet tile is used on a ground or floor surface, then it shall be securely attached; have a firm cushion, pad or backing or no cushion or pad; and have a level loop, textured loop, level-cut pile or level-cut/uncut pile texture. The maximum pile height shall be 1/2 inch. Exposed edges of carpet shall be fastened to floor surfaces and have trim along the entire length of the exposed edge. Recessed doormats shall be adequately anchored to prevent interference with wheelchair traffic.	Non-accessible door - Lacks maneuvering clearance on pull side (37"), CIL of 2", lacks secure floor mat, exceeds 8.5 lbs of force to open (15 lbf required), and lacks compliant closing speed	For all doors along the public circulation route, provide required maneuvering clearance on push and pull side of doors For all doors along the public circulation route, repair, bevel, or ramp CILs at door entries to max .25" For all doors along the public circulation route, inspect, adjust, and maintain closing speed on door closers For all doors along the public circulation route, inspect, adjust, and maintain 8.5 lbf to open exterior doors as a smart practice Remove or secure mat at door to prevent trip hazard	2010 ADAS Section: 404.2.3, 404.2.7, 404.2.4, 404.2.11, 404.2.11 Exception

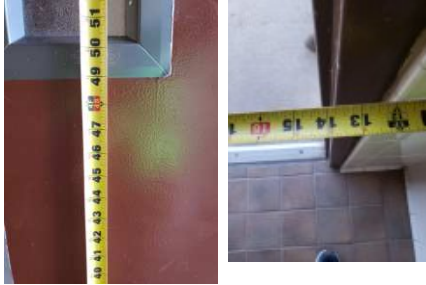
Finding Number	Area Description	Lat/Long	Finding	As Built	Recommendation	Citation	Photos	Figure
160	Davis Mountains Campsites 17-27: DM Campsites 17-27 Women's Restroom	[30.595415, -103.93236 5]	Minimum maneuvering clearances at doors and gates shall comply with 404.2.4. Maneuvering clearances shall extend the full width of the doorway and the required latch side or hinge side clearance. Exterior doors are recommended to be maintained at 8.5 lbf as a smart practice. Force is to be measured at the operating hardware or 30 inches from the hinges, whichever is greater. Doors, gates, and side lights adjacent to doors or gates, containing one or more glazing panels that permit viewing through the panels shall have the bottom of at least one glazed panel located 43 inches (1090 mm) maximum above the finish floor. EXCEPTION: Vision lights with the lowest part more than 66 inches (1675 mm) from the finish floor or ground shall not be required to comply with 404.2.11.	Accessible door - 14" to wall on pull side 20# push, and vision panel at 50.5"	For all doors along the public circulation route, provide required maneuvering clearance on push and pull side of doors For all doors along the public circulation route, inspect, adjust, and maintain 8.5 lbf to open exterior doors as a smart practice For all doors along the public circulation route, replace doors with ones having sidelight viewing windows max 43" aff	2010 ADAS Section: 404.2.3, 404.2.7, 404.2.4, 404.2.11, 404.2.11 Exception

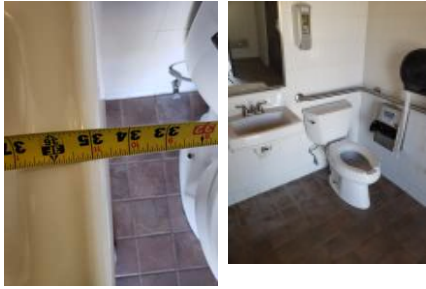
162	Davis Mountains Campsites 17-27: DM Campsites 17-27 Women's Restroom	[30.5954127, -103.9323 676]	The required 56 inches by 60 inches clear floor space for the water closet has been obstructed. The clear floor space around the water closet shall be 60 inches minimum measured perpendicular from the side wall and 56 inches minimum measured perpendicular from the rear wall.	Lacks 60" clear floor space around toilet due to 34.5" to sink	Relocate sink for required 60" clearance around toilet. In the alternative, leave as is citing safe harbor.	2015 ABAAS Section: 604.3. 2012 TAS Section: 604.3.1 2010 ADAS Section: 604.3.1

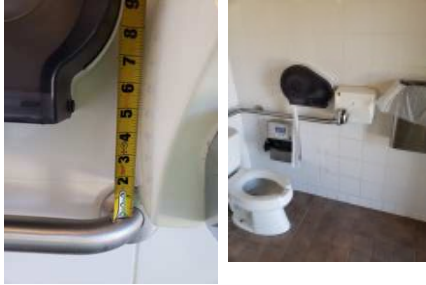
Finding Number	Area Description	Lat/Long	Finding	As Built	Recommendation	Citation	Photos	Figure
166	Davis Mountains Campsites 17-27: DM Campsites 17-27 Women's Restroom	[30.5954358, -103.9323542]	The grab bar height and/or spacing fails. Grab bars must be mounted between 33" and 36" to the top of the gripping surface. There must be 1.5" of clearance between the grab bar and the wall. There must be a minimum of 1.5" of clearance below and minimum 12" above the grab bar to any dispenser or other obstruction.	TP 4" above side grab bar - hand dryer would also be on the bar if the bar was compliant	Remount toilet paper dispenser max 7" to 9" from front of toilet, 15" to 48" aff and min 12" above or 1.5" below grab bar. Relocate hand dryer upon remounting of grab bar.	2015 ABAAS Section: 609.3, 609.4  2012 TAS Section: 609.4, 609.3  2010 ADAS Section: 609.3, 609.4

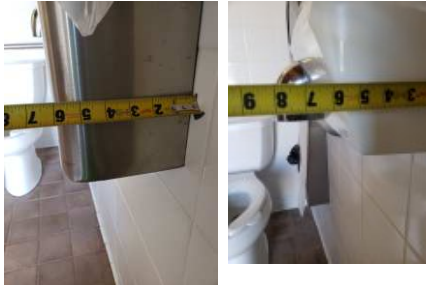
168	Davis Mountains Campsites 17-27: DM Campsites 17-27 Women's Restroom	[30.5954127, -103.9323703]	The garbage can and hand dryer project more than 4 inches into the circulation path. Wall-mounted objects that have leading edges between 27 inches and 80 inches from the floor must not project more than 4 inches into the circulation path. Protruding objects that extend to the floor or within 27 inches of the floor are cane detectable and are therefore not hazardous. Where it is necessary or desirable to have objects protrude from the wall, a manner of cane detection must be provided.	Garbage can protrudes 6" and hand dryer protrudes 8"	Relocate protruding objects or place cane detectable warning or bollard at foot of items.	2015 ABAAS Section: 307.2  2012 TAS Section: 307.2  2010 ADAS Section: 307.2

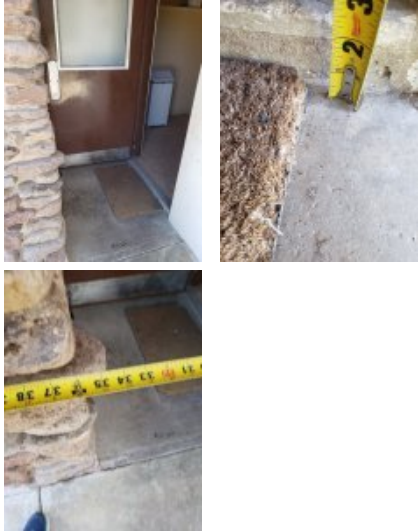
Finding Number	Area Description	Lat/Long	Finding	As Built	Recommendation	Citation	Photos	Figure
171	Davis Mountains Campsites 17-27: DM Campsites 17-27 Women's Restroom	[30.59543, -103.9324]	Minimum maneuvering clearances at doors and gates shall comply with 404.2.4. Maneuvering clearances shall extend the full width of the doorway and the required latch side or hinge side clearance. The threshold has a vertical change greater than 1/4 inch high. The sweep period for doors with closers shall be adjusted so that from an open position of 70 degrees, the door will take at least 3 seconds to move to a point 3 inches from the latch, measured to the leading edge of the door. Exterior doors are recommended to be maintained at 8.5 lbf as a smart practice. Force is to be measured at the operating hardware or 30 inches from the hinges, whichever is greater. The doormat is not secured in place at the entry door. If carpet or carpet tile is used on a ground or floor surface, then it shall be securely attached; have a firm cushion, pad or backing or no cushion or pad; and have a level loop, textured loop, level-cut pile or level-cut/uncut pile texture. The maximum pile height shall be 1/2 inch. Exposed edges of carpet shall be fastened to floor surfaces and have trim along the entire length of the exposed edge. Recessed doormats shall be adequately anchored to prevent interference with wheelchair traffic.	Non-accessible door - Lacks maneuvering clearance on pull side (37"), lacks secure floor mat, CIL of 2", 12# push, fast close	For all doors along the public circulation route, provide required maneuvering clearance on push and pull side of doors For all doors along the public circulation route, repair, bevel, or ramp CILs at door entries to max .25" For all doors along the public circulation route, inspect, adjust, and maintain closing speed on door closers For all doors along the public circulation route, inspect, adjust, and maintain 8.5 lbf to open exterior doors as a smart practice Remove or secure mat at door to prevent trip hazard	2010 ADAS Section: 404.2.3, 404.2.7, 404.2.4, 404.2.11, 404.2.11 Exception

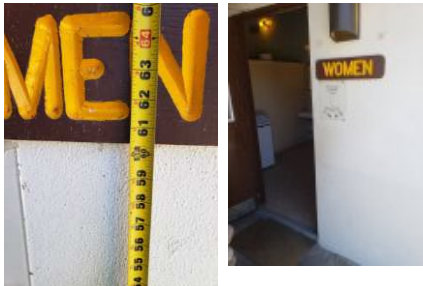
173	Davis Mountains Campsites 17-27: DM Campsites 17-27 Women's Restroom	[30.5953942, -103.9323703]	The restroom sign does not comply with one or more applicable requirements for the location, height, and properties of the sign.	Inaccessible restroom -Lacks compliant signage	Replace sign with one of contrasting colors that includes Braille, raised characters and mount on the wall, latch side of the door, 48" to the baseline of the lowest character and 60" to the baseline of the highest character	2015 ABAAS Section: F216.2, 703.1, 703.2, 703.5, 703.6 2012 TAS Section: 216.2, 703.1, 703.2, 703.5, 703.6 2010 ADAS Section: 216.2, 703.1, 703.2, 703.5, 703.6

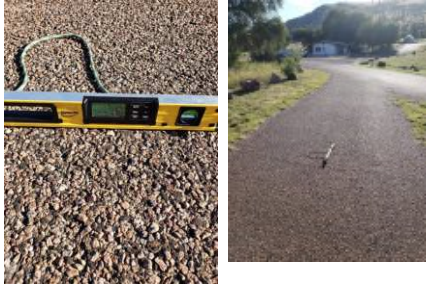
Finding Number	Area Description	Lat/Long	Finding	As Built	Recommendation	Citation	Photos	Figure
174	Davis Mountains Campsites 1-15: DM Campsite 1	[30.595385, -103.93313 48]	The parking space slopes greater than 1:48 (2.08%). Where the surface is other than asphalt, concrete, or boards, slopes not steeper than 1:20 (5%) shall be permitted when necessary for drainage.	Slope of 3.6%	Repair or correct slope of parking space and access aisle to max 2.08% in any direction.	2015 ABAAS Section: 1012.5

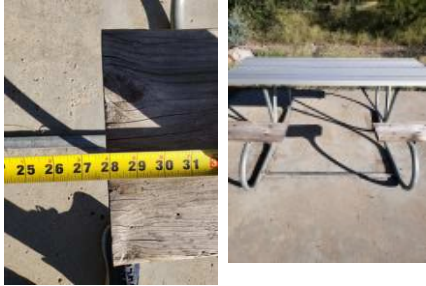
175	Davis Mountains Campsites 1-15: DM Campsite 1	[30.5954589, -103.9331 589]	Picnic tables shall provide at least one wheelchair space for each 24 linear feet (7320 mm) of usable table surface perimeter. Wheelchair spaces shall be 30 inches (760 mm) minimum by 48 inches (1220 mm) minimum. Wheelchair spaces shall be positioned for a forward approach to the table and provide knee and toe clearance complying with 306 under the table	Lacks picnic table of an accessible design - wheelchair space is only 28" wide, and has change in level in clear ground space due to cross bar	Replace picnic table with one of an accessible design as a smart practice.	2015 ABAAS Section: 1011.4.2

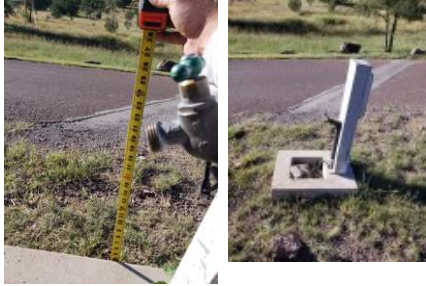
176	Davis Mountains Campsites 1-15: DM Campsite 1	[30.595445, -103.93316 69]	Water spouts at water hydrants and water utility hook-ups shall be 28 inches (710 mm) minimum and 36 inches (915 mm) maximum above the ground	Water spout is 20" above ground level	Remount water spouts to 28" min or 36" max above the ground as a smart practice.	2015 ABAAS Section: 1011.6

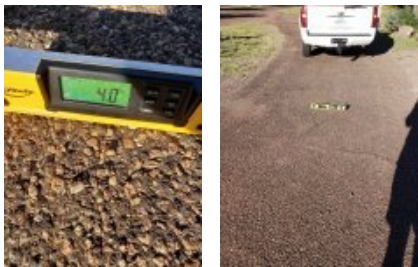
Finding Number	Area Description	Lat/Long	Finding	As Built	Recommendation	Citation	Photos	Figure
178	Davis Mountains Campsites 1-15: DM Campsite 2	[30.5953032, -103.9335139]	The parking space slopes greater than 1:48 (2.08%). Where the surface is other than asphalt, concrete, or boards, slopes not steeper than 1:20 (5%) shall be permitted when necessary for drainage.	Slope of 4% in parking space	Repair or correct slope of parking space and access aisle to max 2.08% in any direction	2015 ABAAS Section: 1012.5

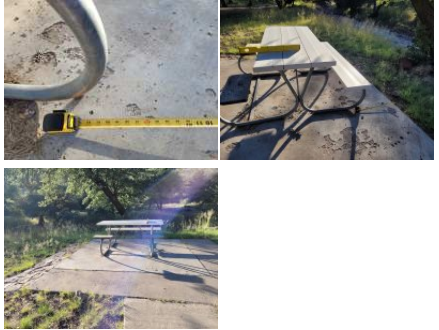
Finding Number	Area Description	Lat/Long	Finding	As Built	Recommendation	Citation	Photos	Figure
207	Davis Mountains Campsites 62-94: DM Campsite 64	[30.5933602 , -103.9397 276]	36 inches (915 mm) on all usable sides of the table measured from the back edge of the benches	Lacks 36" clear ground space around picnic table - space available on pad if table is repositioned	Reposition picnic table to provide required 36" clear ground space around all usable portions of the table as a smart practice.	2015 ABAAS Section: 1011.2.1

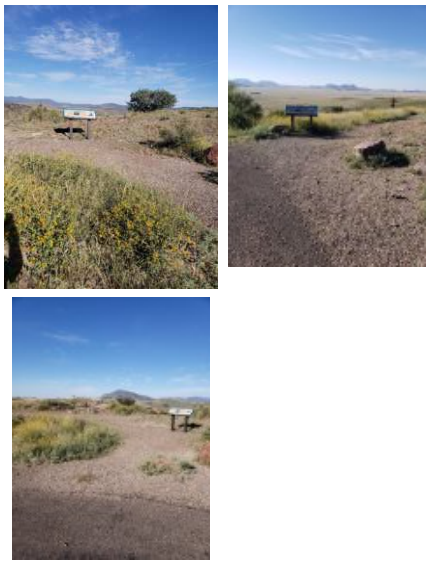
Finding Number	Area Description	Lat/Long	Finding	As Built	Recommendation	Citation	Photos	Figure
211	Davis Mountains Skyline Drive: DM Skyline Overlook 1	[30.5956482, -103.9230564]	There is no accessible route to the informational sign and bench. At least one accessible route shall connect accessible buildings, accessible facilities, accessible elements, and accessible spaces that are on the same site.	Lacks accessible route (gravel and rock path) to informational sign and bench	Create an accessible route with crushed stone or other outdoor material from parking or walkway to the informational sign and bench.	2015 ABAAS Section: F206.2.2 2012 TAS Section: 206.2.2 2010 ADAS Section: 206.2.2

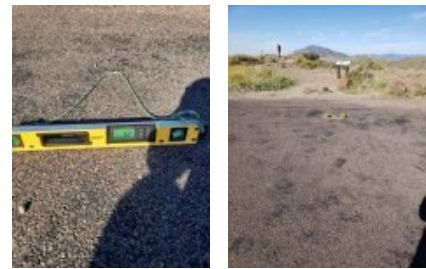
212	Davis Mountains Skyline Drive: DM Skyline Overlook 1	[30.5954591, -103.9231968]	The cross slopes (narrow dimension) and/or running slopes (long dimension) of the accessible stall exceeds 2%. The running slope and the cross slope in an accessible parking stall and the access aisle must not exceed 2%.	Slope of 6.2% in parking lot	Correct or repair slope of stall to max 2.08% in any direction.	2015 ABAAS Section: 502.4 2012 TAS Section: 502.4 2010 ADAS Section: 502.4

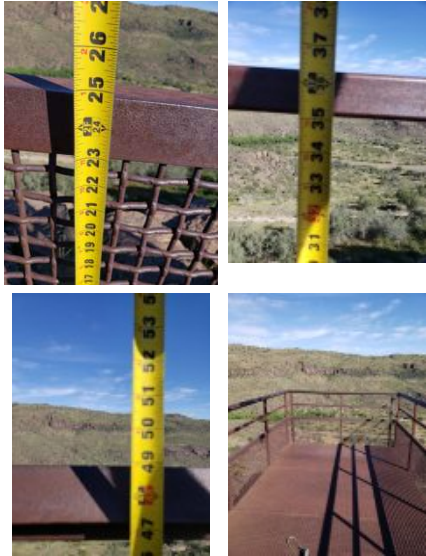
Finding Number	Area Description	Lat/Long	Finding	As Built	Recommendation	Citation	Photos	Figure
213	Davis Mountains Skyline Drive: DM Skyline Overlook 2	[30.5990652, -103.9109301]	Each distinct viewing location shall provide a viewing space adjacent to the clear ground space required by 1015.2 through which the point of interest is viewable. The viewing space shall be 32 inches (815 mm) maximum and 51 inches (1295 mm) minimum high above the ground and shall extend the full width of the clear ground space. EXCEPTION: Guards or similar safety barriers shall be permitted to obstruct the viewing space to the extent the obstruction is necessary for the guard or safety barrier to serve its intended purpose.	Overlook lacks line of sight - rails at 25", 36" and 49"	Lower a 32" wide portion of railing to max 32" for unobstructed viewing as a smart practice	2015 ABAAS Section: 1015.3, 1015.3 EXCEPTION

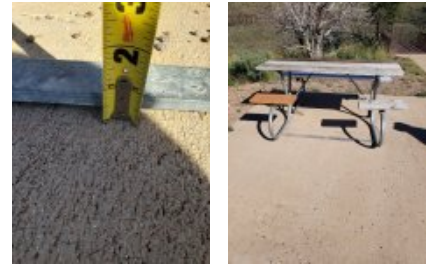
215	Davis Mountains Skyline Drive: DM Skyline Overlook 2	[30.5989695, -103.9109203]	Picnic tables shall provide at least one wheelchair space for each 24 linear feet (7320 mm) of usable table surface perimeter. Wheelchair spaces shall be 30 inches (760 mm) minimum by 48 inches (1220 mm) minimum. Wheelchair spaces shall be positioned for a forward approach to the table and provide knee and toe clearance complying with 306 under the table	change in level in wheelchair space due to support bar	Replace picnic table with one of an accessible design as a smart practice.	2015 ABAAS Section: 1011.4.2

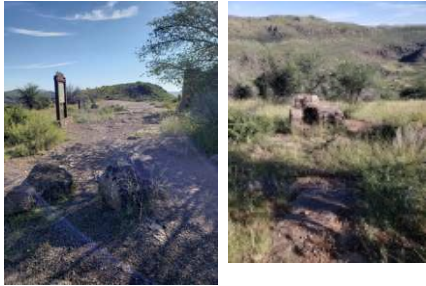
Finding Number	Area Description	Lat/Long	Finding	As Built	Recommendation	Citation	Photos	Figure
216	Davis Mountains Skyline Drive: DM Skyline Overlook 3	[30.5991564, -103.9068008]	There is no accessible route to the signs. At least one accessible route shall connect accessible buildings, accessible facilities, accessible elements, and accessible spaces that are on the same site.	gravel and rock path to signs	Create an accessible route with crushed stone or other outdoor material from parking or walkway to signs	2015 ABAAS Section: F206.2.2  2012 TAS Section: 206.2.2  2010 ADAS Section: 206.2.2

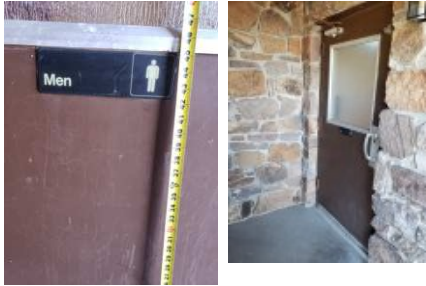
Finding Number	Area Description	Lat/Long	Finding	As Built	Recommendation	Citation	Photos	Figure
219	Davis Mountains Skyline Drive: DM Skyline Men's Restroom	[30.5977446, -103.9133535]	The restroom sign does not comply with one or more applicable requirements for the location, height, and properties of the sign.	Lacks compliant signage	Acquire and mount signage, including Braille and raised lettering mounted on wall, latch side of door, 48" to baseline of lowest character and 60" to baseline of highest character.	2015 ABAAS Section: F216.2, 703.1, 703.2, 703.5, 703.6  2012 TAS Section: 216.2, 703.1, 703.2, 703.5, 703.6  2010 ADAS Section: 216.2, 703.1, 703.2, 703.5, 703.6

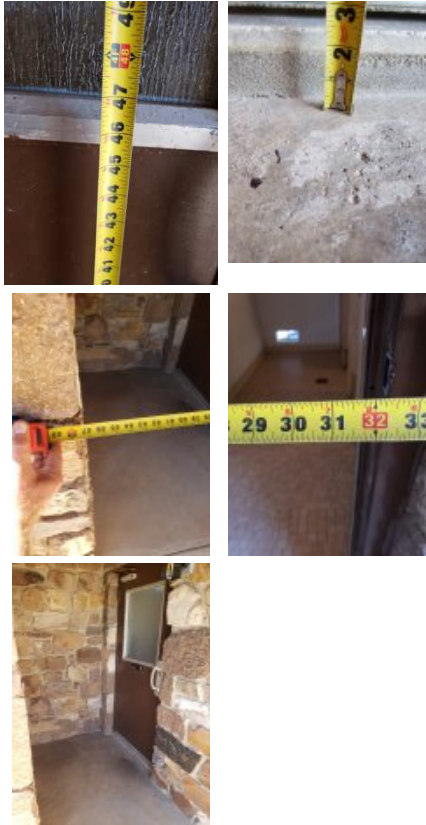
Finding Number	Area Description	Lat/Long	Finding	As Built	Recommendation	Citation	Photos	Figure
222	Davis Mountains Skyline Drive: DM Skyline Women's Restroom	[30.5977473, -103.9133544]	<p>Minimum maneuvering clearances at doors and gates shall comply with 404.2.4. Maneuvering clearances shall extend the full width of the doorway and the required latch side or hinge side clearance. The threshold has a vertical change greater than 1/4 inch high. The sweep period for doors with closers shall be adjusted so that from an open position of 70 degrees, the door will take at least 3 seconds to move to a point 3 inches from the latch, measured to the leading edge of the door. Exterior doors are recommended to be maintained at 8.5 lbf as a smart practice. Force is to be measured at the operating hardware or 30 inches from the hinges, whichever is greater. Doors, gates, and side lights adjacent to doors or gates, containing one or more glazing panels that permit viewing through the panels shall have the bottom of at least one glazed panel located 43 inches (1090 mm) maximum above the finish floor.</p> <p>EXCEPTION: Vision lights with the lowest part more than 66 inches (1675 mm) from the finish floor or ground shall not be required to comply with 404.2.11.</p>	Women's restroom door - 46" to wall on pull side, change in level of 2" at threshold, 15# push, fast close, window at 47" aff	<p>For all doors along the public circulation route, provide required maneuvering clearance on push and pull side of doors</p> <p>For all doors along the public circulation route, repair, bevel, or ramp CILs at door entries to max .25"</p> <p>For all doors along the public circulation route, inspect, adjust, and maintain closing speed on door closers</p> <p>For all doors along the public circulation route, inspect, adjust, and maintain 8.5 lbf to open</p> <p>For all exterior doors as a smart practice</p> <p>For all doors along the public circulation route, replace doors with ones having sidelight viewing windows max 43" aff</p>	2010 ADAS Section: 404.2.3, 404.2.7, 404.2.4, 404.2.11, 404.2.11 Exception

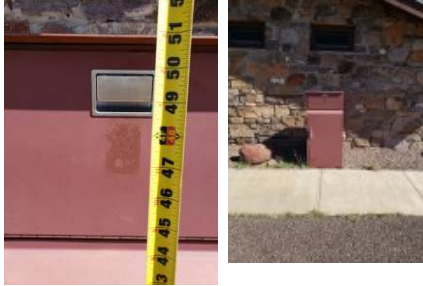
226	Davis Mountains Skyline Drive: DM Skyline Trail	[30.5977146, -103.9133642]	The garbage can handle is positioned too high for either a side or front approach. Where a clear floor or ground space allows a parallel approach to an element and the side reach is unobstructed, the high side reach shall be 48 inches maximum and the low side reach shall be 15 inches minimum above the finish floor or ground. Where a forward reach is unobstructed, the high forward reach shall be 48 inches maximum and the low forward reach shall be 15 inches minimum above the finish floor or ground.	Garbage can handle (49" AGL) exceeds reach range	Replace garbage can or add a second one having operable parts in reach range of max 48" above the ground.	2015 ABAAS Section: 308.1  2012 TAS Section: 308.1  2010 ADAS Section: 308.1

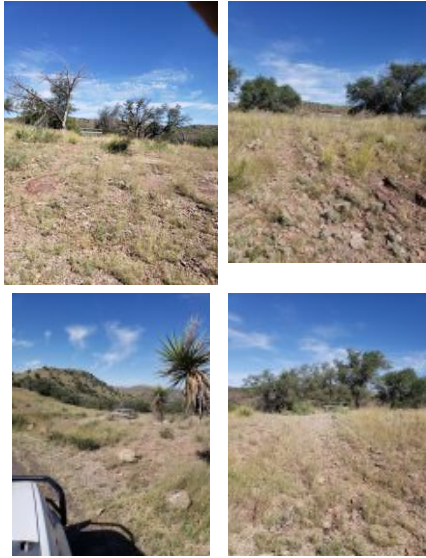
Finding Number	Area Description	Lat/Long	Finding	As Built	Recommendation	Citation	Photos	Figure
228	Davis Mountains Skyline Drive: DM Skyline Trail	[30.5979616, -103.9150701]	There is no accessible route to the picnic tables. At least one accessible route shall connect accessible buildings, accessible facilities, accessible elements, and accessible spaces that are on the same site.	Lacks accessible route to 4 of 4 picnic tables	Create an accessible route with crushed stone or other outdoor material from parking or walkway to 1 picnic table and replace with one of an accessible design.	2015 ABAAS Section: F206.2.2 2012 TAS Section: 206.2.2 2010 ADAS Section: 206.2.2

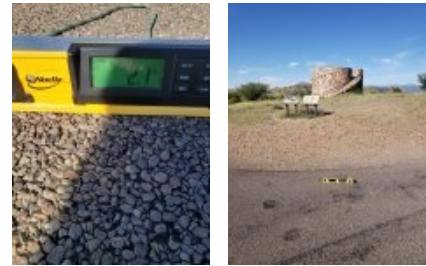
230	Davis Mountains Skyline Drive: Lookout Tower	[30.5996968, -103.9084982]	The cross slopes (narrow dimension) and/or running slopes (long dimension) of the accessible stall exceeds 2%. The running slope and the cross slope in an accessible parking stall and the access aisle must not exceed 2%.	Slope of 2.7% in parking lot	Correct or repair slope of stall to max 2.08% in any direction and create an accessible parking stall.	2015 ABAAS Section: 502.4 2012 TAS Section: 502.4 2010 ADAS Section: 502.4
