# Access Audit Site Report

**Davis Mountains State Park/Complex**

**Accessibility Evaluation**

**Inspection Date: 09/23/2021**

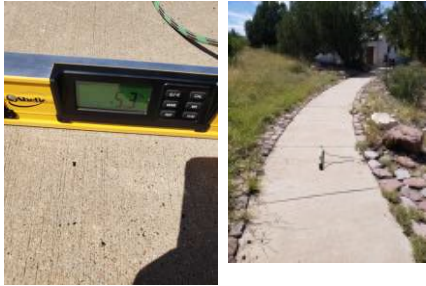
Finding Number	Area Description	Lat/Long	Finding	As Built	Recommendation	Citation	Photos	Figure
235	Davis Mountains Interpretive Center: DM Interpretive Center	[30.5957106, -103.9302018]	The running slope of walking surfaces shall not be steeper than 1:20.	Running slope of 5.3% from parking	Correct running slope along the AR to max 5%.	2015 ABAAS Section: 403.3 2012 TAS Section: 403.3 2010 ADAS Section: 403.3

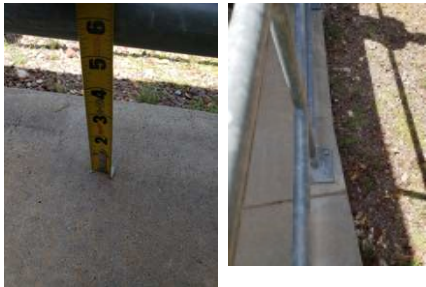
236	Davis Mountains Interpretive Center: DM Interpretive Center	[30.5955997, -103.9303439]	The ramp run has not been provided with edge protection. The floor or ground surface of the ramp run or landing shall extend 12 inches minimum beyond the inside face of a handrail or a curb or barrier shall be provided that prevents the passage of a 4 inch diameter sphere, where any portion of the sphere is within 4 inches of the finish floor or ground surface.	Lacks edge protection on ramp	Install rail along bottom edge of ramp that prevents a 4" sphere from passing through.	2015 ABAAS Section: 405.9, 405.9.1, 405.9.2 2012 TAS Section: 405.9.1, 405.9.2, 405.9 2010 ADAS Section: 405.9.2, 405.9.1, 405.9

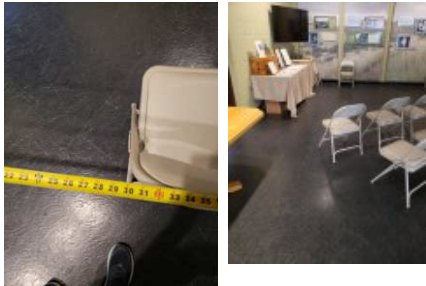
237	Davis Mountains Interpretive Center: DM Interpretive Center	[30.5955212, -103.9304204]	The route of travel at this location does not provide a minimum width of 36 inches. The clear width shall be permitted to be reduced to 32 inches minimum for a length of 24 inches maximum provided that reduced width segments are separated by segments that are 48 inches long minimum and 36 inches wide minimum.	Lacks 36" wide route of travel (chair location narrows route to 30")	Relocate chairs/obstacles to widen AR to compliant 36" clear width.	2015 ABAAS Section: 403.5.1 2012 TAS Section: 403.5.1 2010 ADAS Section: 403.5.1

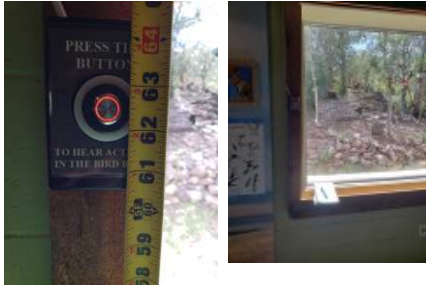
Finding Number	Area Description	Lat/Long	Finding	As Built	Recommendation	Citation	Photos	Figure
238	Davis Mountains Interpretive Center: DM Interpretive Center	[30.5955328, -103.9304365]	The bird microphone button is positioned too high for either a side or front approach. Where a clear floor or ground space allows a parallel approach to an element and the side reach is unobstructed, the high side reach shall be 48 inches maximum and the low side reach shall be 15 inches minimum above the finish floor or ground. Where a forward reach is unobstructed, the high forward reach shall be 48 inches maximum and the low forward reach shall be 15 inches minimum above the finish floor or ground.	Bird microphone button at 62.5" AFF	Remount operable parts to be in reach range of 15" min to 48" max.	2015 ABAAS Section: 308.1 2012 TAS Section: 308.1 2010 ADAS Section: 308.1

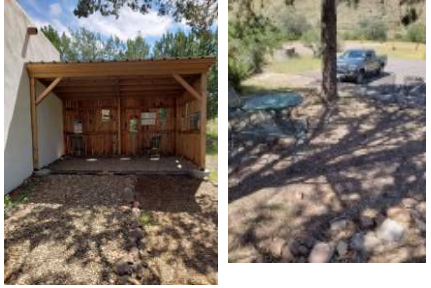
248	Davis Mountains Interpretive Center: DM Interpretive Center	[30.5954958, -103.9304016]	There is no accessible route to the outdoor wildlife viewing area. At least one accessible route shall connect accessible buildings, accessible facilities, accessible elements, and accessible spaces that are on the same site.	Lacks accessible route to outdoor wildlife viewing area	Create an accessible route with crushed stone or other outdoor material from parking or walkway to outdoor wildlife viewing area.	2015 ABAAS Section: F206.2.2 2012 TAS Section: 206.2.2 2010 ADAS Section: 206.2.2

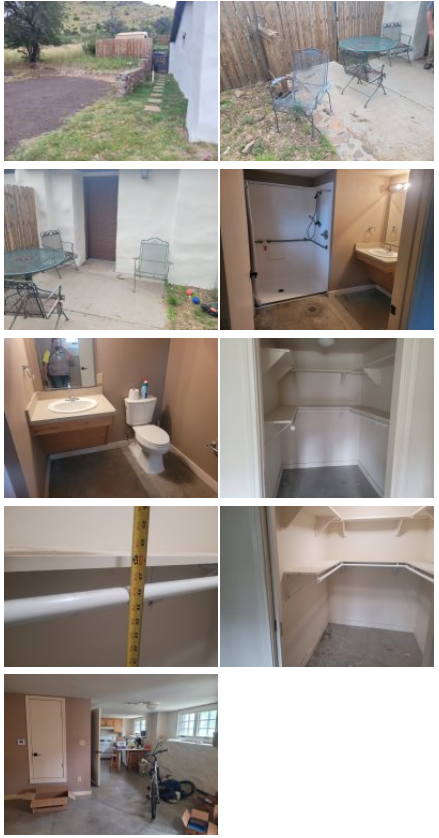
Finding Number	Area Description	Lat/Long	Finding	As Built	Recommendation	Citation	Photos	Figure
252	Davis Mountains Residences: Duplex Staff Housing	[30.59535, -103.936]	The building entrance is not located on an accessible route. When a building, or portion of a building, is required to be accessible, an accessible route of travel shall be provided to all portions of the building, to accessible building entrances and between the building and the public way. All walks, halls, corridors, aisles, skywalks, tunnels, and other spaces that are part of an accessible route must comply. An accessible route of travel must not pass through kitchens, storage rooms, restrooms, closets or other spaces used for similar purposes. At least one accessible route within the boundary of the site must be provided from public transportation stops, accessible parking and accessible passenger loading zones and public streets or sidewalks to the accessible building entrance they serve. The accessible route shall, to the maximum extent feasible, coincide with the route for the general public. At least one accessible route shall connect accessible buildings, facilities, elements and spaces that are on the same site. At least one accessible route shall connect accessible building or facility entrances with all accessible spaces and elements.	side with updates lacks AR, could access from other residence	Create AR with crushed and compacted stone or similar outdoor material from parking to building entrance	2015 ABAAS Section: F206.2.1  2012 TAS Section: 206.2.1  2010 ADAS Section: 206.2.1

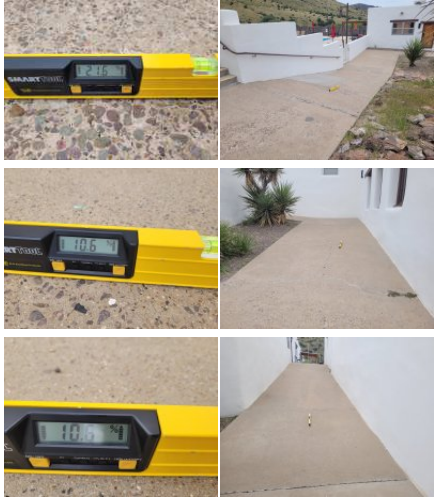
Finding Number	Area Description	Lat/Long	Finding	As Built	Recommendation	Citation	Photos	Figure
258	Indian Lodge State Park: IL Exterior Accessible Route	[30.5928531 , -103.94334 5]	The running slope of walking surfaces shall not be steeper than 1:20. The ramp does not have compliant handrails. Handrails are required on both sides of all surfaces that are sloped greater than 5 percent (1:20). Handrails must be between 34 inches and 38 inches above the ramp surface, must extend beyond the top and bottom of the ramp 12 inches and be parallel to the floor or ground surface. The diameter of the handrails must be between 1 inches and 2 inches in cross-sectional nominal dimension for circular handrails and handrail gripping surfaces with a non-circular cross section shall have a perimeter dimension of 4 inches minimum and 6 inches maximum, and a cross-section dimension of 2 inches maximum. The clear space between handrails and walls must 1-1/2 inches minimum.	Path to pool - on interior of site has multiple steep ramps with running slopes of 21.6%, 10.6%, and 10.6% with no handrails both sides - courtyard area to be addressed in current plans	Correct running slope along the AR to max 5%, in the alternative, treat as ramps and correct slope to max 8.33% and add handrails on both side.	2015 ABAAS Section: 403.3  2012 TAS Section: 403.3  2010 ADAS Section: 403.3

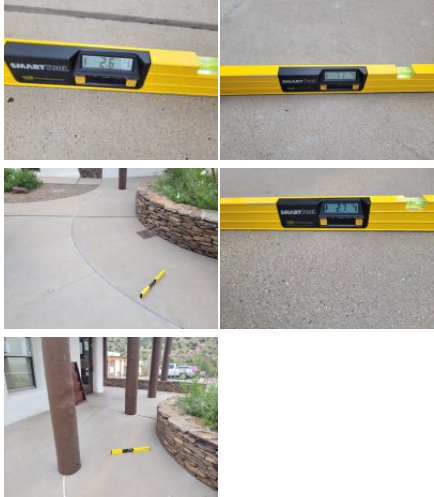
Finding Number	Area Description	Lat/Long	Finding	As Built	Recommendation	Citation	Photos	Figure
260	Indian Lodge State Park: IL Exterior Accessible Route	[30.5926623, -103.9435182]	The accessible route of travel on the accessible route contains cross slopes greater than 2%. Cross slopes shall not exceed one unit vertical in 48 units horizontal (2-percent slope).	Cross slopes of 2.6% around curve, 7% near assembly room, and 2.7%	Correct or repair cross slope along AR to max 2.08%.	2015 ABAAS Section: 403.3  2012 TAS Section: 403.3  2010 ADAS Section: 403.3

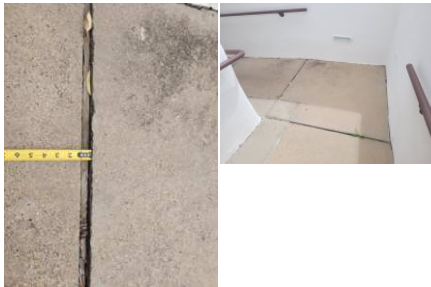
269	Indian Lodge State Park: IL Exterior Accessible Route	[30.59279, -103.9438]	There is a gap spaced greater than a 1/2 inch. Openings in floor or ground surfaces shall not allow passage of a sphere more than 1/2 inch diameter. Elongated openings shall be placed so that the long dimension is perpendicular to the dominant direction of travel.	Ramp from restaurant to historic lobby - Gaps of 1" at expansion joints on ramp	Correct or fill gaps to be max .5".	2015 ABAAS Section: 302.3  2012 TAS Section: 302.3  2010 ADAS Section: 302.3

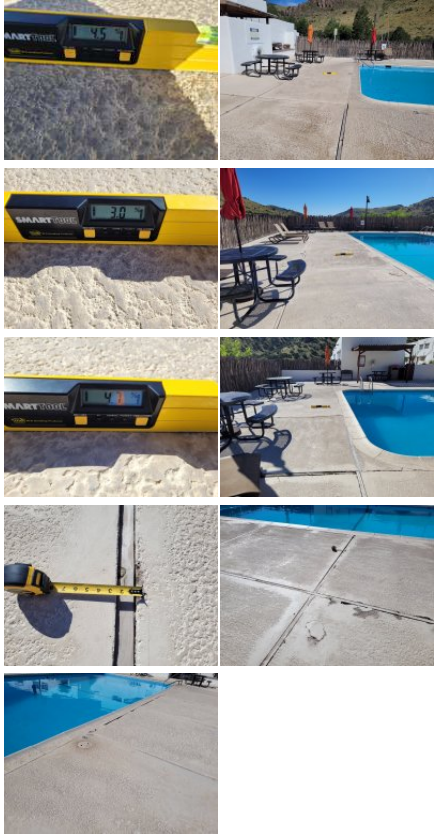
Finding Number	Area Description	Lat/Long	Finding	As Built	Recommendation	Citation	Photos	Figure
277	Indian Lodge State Park: IL Swimming Pool	[30.5929319 , -103.9433 204]	An accessible route on the deck shall be maintained for access to all areas of the pool accessed by the public.	Cross slopes of 4.5%, 3%, 4.8%, gaps up to 2.25" at expansion joints	Maintain an accessible route along the pool deck that is min 36" clear width and having 80" overhead clearance and turning spaces and free of gaps and CIL. Correct or repair pool deck cross slope along AR to max 2.08%	2010 ADAS Section: 403.5.1, 304.3.1, 307.4, 206.2.2

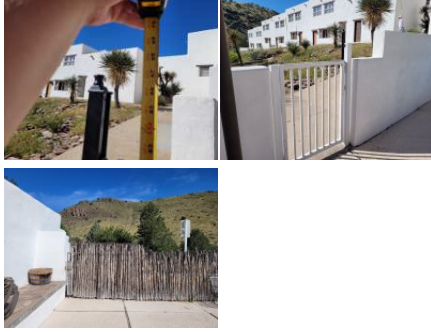
280	Indian Lodge State Park: IL Swimming Pool	[30.5928926, -103.9432574]	In addition to entrances required by 206.4.2 through 206.4.9, at least 60 percent of all public entrances shall comply with 404.	Main gate - hardware requires pinching to operate and is mounted 62" AGL Gate entry by accessible parking - uses key code and gate is extremely difficult to open	Make corrections to entries to achieve 60% of public entries being accessible For all doors along the public circulation route, replace hardware with lever hardware or hardware operable without a tight pinch or grasp. For all doors along the public circulation route, replace hardware with lever hardware where indicated, mounted 34" to 48" aff For all doors along the public circulation route, inspect, adjust, and maintain 8.5 lbf to open exterior doors as a smart practice.	2010 ADAS Section: 206.4.1

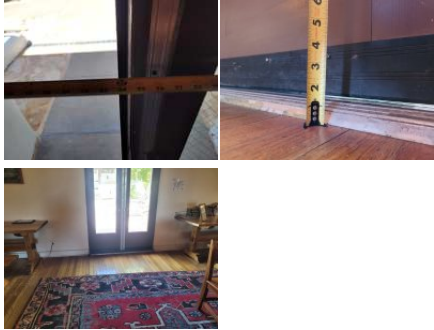
Finding Number	Area Description	Lat/Long	Finding	As Built	Recommendation	Citation	Photos	Figure
299	Indian Lodge State Park: IL Lodge Public Rooms	[30.5929023, -103.9435544]	<p>Door openings shall provide a clear width of 32 inches (815 mm) minimum. Clear openings of doorways with swinging doors shall be measured between the face of the door and the stop, with the door open 90 degrees. Openings more than 24 inches (610 mm) deep shall provide a clear opening of 36 inches (915 mm) minimum. There shall be no projections into the required clear opening width lower than 34 inches (865 mm) above the finish floor or ground. Projections into the clear opening width between 34 inches (865 mm) and 80 inches (2030 mm) above the finish floor or ground shall not exceed 4 inches (100 mm). The threshold has a vertical change greater than 1/4 inch high. The sweep period for doors with closers shall be adjusted so that from an open position of 70 degrees, the door will take at least 3 seconds to move to a point 3 inches from the latch, measured to the leading edge of the door. Exterior doors are recommended to be maintained at 8.5 lbf as a smart practice. Force is to be measured at the operating hardware or 30 inches from the hinges, whichever is greater. Hand-activated door opening hardware, handles, pulls, latches, locks, and other operating devices on accessible doors shall have a shape that is easy to grasp with one hand and does not require tight grasping, tight pinching or twisting of the wrist to operate. Hardware shall be 34 inches minimum and 48 inches maximum above the finish floor or ground.</p>	Lobby to patio doors - each leaf is 25.5" wide, CIL of 1" at threshold, knob hardware, 10# push, fast close	<p>For all doors along the public circulation route, replace doors with doors having 80" overhead clearance and 32" clear width For all doors along the public circulation route, repair, bevel, or ramp CILs at door entries to max .25" For all doors along the public circulation route, inspect, adjust, and maintain closing speed on door closers For all doors along the public circulation route, inspect, adjust, and maintain 8.5 lbf to open exterior doors as a smart practice For all doors along the public circulation route, replace hardware with lever hardware or hardware operable without a tight pinch or grasp</p>	2010 ADAS Section: 404.2.3, 404.2.7, 404.2.4, 404.2.11, 404.2.11 Exception

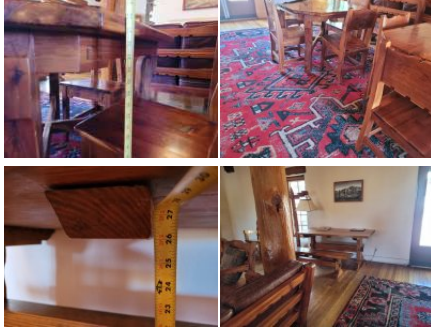
302	Indian Lodge State Park: IL Lodge Public Rooms	[30.5929157, -103.9435417]	The top of the work surface is not within a compliant height range. The tops of tables and counters shall be 28 inches to 34 inches from the floor or ground.	Lobby - Supports prevent knee clearance at square tables and knee clearance height is only 26" high at both types of tables	Provide tables and work surfaces at 28" to 34" aff with required knee and toe clearances.	2015 ABAAS Section: 902.3 2012 TAS Section: 902.3 2010 ADAS Section: 902.3

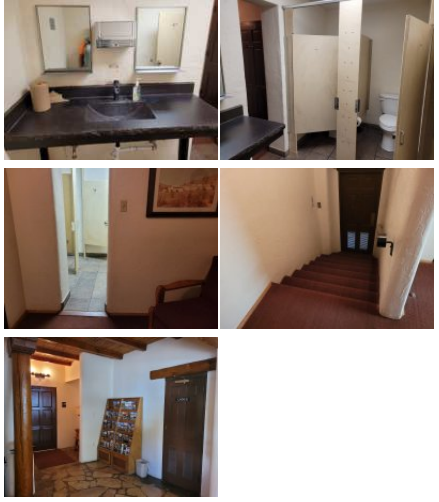
Finding Number	Area Description	Lat/Long	Finding	As Built	Recommendation	Citation	Photos	Figure
305	Indian Lodge State Park: IL Lodge Public Rooms	[30.5928592, -103.9435122]	This restroom is not accessible. Where existing toilet rooms or bathing rooms do not comply, directional signs indicating the location of the nearest accessible toilet room or bathing room within the facility shall be provided. Signs shall include the International Symbol of Accessibility. Where existing toilet rooms or bathing rooms do comply), the accessible toilet rooms or bathing rooms shall be identified by the International Symbol of Where clustered single user toilet rooms or bathing facilities are permitted, accessible toilet rooms or bathing facilities shall be identified by the International Symbol of Accessibility unless all toilet rooms and bathing facilities are accessible.	Lobby Women's RR - Lacks signage directing patrons to an accessible restroom	Restroom not accessible, acquire and mount signage directing patrons to accessible restroom.	2015 ABAAS Section: F216.8 2012 TAS Section: 216.8 2010 ADAS Section: 216.8

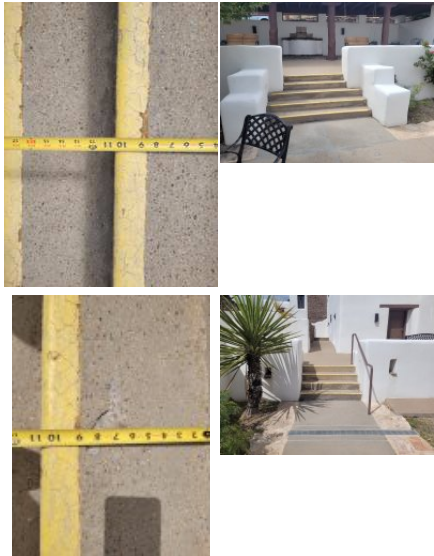
329	Indian Lodge State Park: IL Lodge Public Rooms	[30.5928996, -103.9437509]	Treads shall be 11 inches (280 mm) deep minimum and uniform	Both sets of stairs at upper patio - 10.5" deep treads	Correct tread depth on stairs to 11" minimum and consistent, leave as is if technically infeasible.	2015 ABAAS Section: 504.2 2012 TAS Section: 504.2 2010 ADAS Section: 504.2

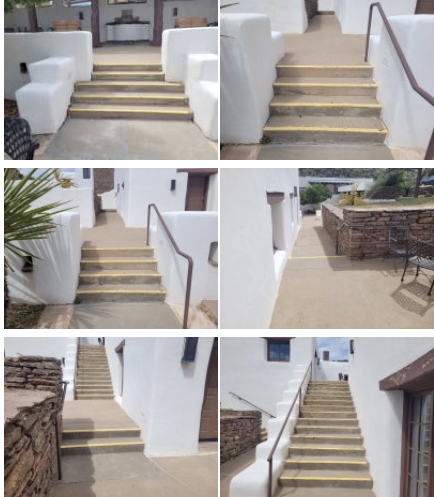
Finding Number	Area Description	Lat/Long	Finding	As Built	Recommendation	Citation	Photos	Figure
330	Indian Lodge State Park: IL Lodge Public Rooms	[30.5928534, -103.9437389]	Stairways must have handrails on both sides. Handrails and their extensions must be between 34 inches and 38 inches above the stair nosing or ground. The top handrails shall extend a minimum of 12 inches beyond the top nosing and shall be parallel with the floor or ground surface. At the bottom of a stair flight, handrails shall extend at the slope of the stair flight for a horizontal distance at least equal to one tread depth beyond the last riser nosing. Extension shall return to a wall, guard, or the landing surface, or shall be continuous to the handrail of an adjacent stair flight. The orientation of at least one handrail, including the extension, shall be in the direction of the run of the stair and perpendicular to the direction of the stair nosing. Handrail gripping surfaces with a circular cross section shall have an outside diameter of 1-1/4 inches minimum and 2 inches maximum. Handrail gripping surfaces with a non-circular cross section shall have a perimeter dimension of 4 inches minimum and 6 1/4 inches maximum, and a cross-section dimension of 2-1/4 inches maximum. The hand grip portion of handrails shall have a smooth surface with no sharp corners. Gripping surfaces (top or sides) shall be uninterrupted by newel posts, other construction elements or obstructions. Any wall or other surface adjacent to the handrail shall be free of sharp or abrasive elements. Handrails projecting from a wall shall have a space of 1-1/2 inches minimum between the wall and the handrail.	both stairs at upper patio - lacks handrails (5 total) on both sides of stairways - lacks one side on stairs to upper patio and rooms, one side on stairs at both sets near Room 112, and one side on stairs to upper rooms by Room 112	Install handrails on both sides of stairway, mounted 34" to 38" aff with top and bottom extensions and having a 1.25" – 2" in diameter, or a non-circular grip that has a perimeter dimension of 4"- 6.25" max with a min gap of 1.5" between handrail and wall	2015 ABAAS Section: 505.2 2012 TAS Section: 505.2 2010 ADAS Section: 505.2

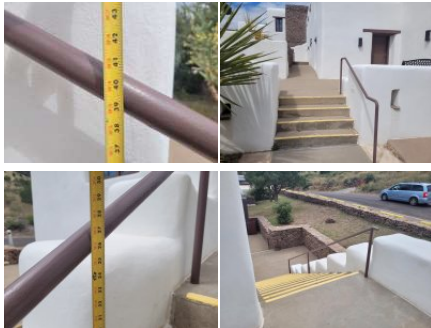
(a) stairs

333	Indian Lodge State Park: IL Lodge Public Rooms	[30.5929273, -103.9437 603]	The handrails as well as the handrail extensions are not at the correct height. The tops of handrails and their extensions must be between 34 inches and 38 inches above the stair nosing or ground.	stairs to upper patio and rooms - handrail mounted to 40.5" AGL stairs to upper rooms near Room 112 handrail mounted to 27.5" AGL	Replace or remount handrails to 34" to 38" AFF.	2015 ABAAS Section: 505.4  2012 TAS Section: 505.4  2010 ADAS Section: 505.4

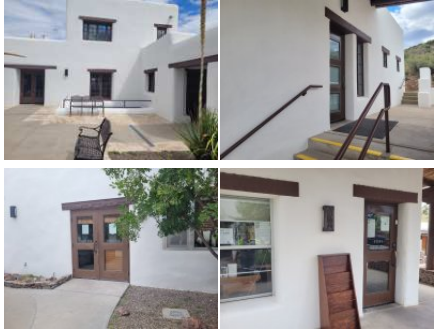
Finding Number	Area Description	Lat/Long	Finding	As Built	Recommendation	Citation	Photos	Figure
334	Indian Lodge State Park: IL Lodge Public Rooms	[30.5929342, -103.9437523]	There is no ISA at this entrance. In existing buildings and facilities where not all entrances are accessible, entrances to buildings and facilities that are accessible to and usable by persons with disabilities shall be identified with an International Symbol of Accessibility (ISA). Typically this is 6 inches by 6 inches in size.	Lacks signage for designated accessible entrance	Mount signage at entrance designating it as accessible.	2015 ABAAS Section: F216.6  2012 TAS Section: 216.6  2010 ADAS Section: 216.6

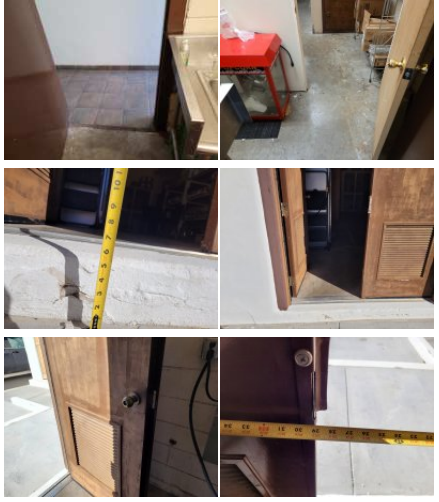
Finding Number	Area Description	Lat/Long	Finding	As Built	Recommendation	Citation	Photos	Figure
340	Indian Lodge State Park: IL Lodge Employee Spaces	[30.5927622, -103.9434975]	Spaces and elements within employee work areas shall only be required to comply with 206.2.8, 207.1, and 215.3 and shall be designed and constructed so that individuals with disabilities can approach, enter, and exit the employee work area. Employee work areas, or portions of employee work areas, other than raised courtroom stations, that are less than 300 square feet (28 m2) and elevated 7 inches (180 mm) or more above the finish floor or ground where the elevation is essential to the function of the space shall not be required to comply with these requirements or to be on an accessible route.	Entry to employee spaces - sink in maneuvering clearance on pull side Interior door - storage in maneuvering clearance on pull side, knob hardware Exterior door - 29" clear width, 6" change in level (CIL) in doorway, knob hardware	For employee spaces, relocate storage, furniture, and other obstacles at doorways to provide approach, enter and exit at the employee space. For all doors along the public circulation route, provide required maneuvering clearance on push and pull side of doors. For all doors along the public circulation route, replace doors with doors having 80" overhead clearance and 32" clear width. For all doors along the public circulation ramp CILs at door entries to max .25". For all doors along the public circulation route, replace hardware with lever hardware or hardware operable without a tight pinch or grasp.	2015 ABAAS Section: F203.9  2012 TAS Section: 203.9  2010 ADAS Section: 203.9

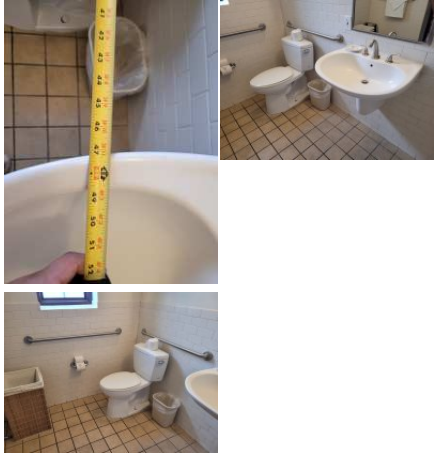
Finding Number	Area Description	Lat/Long	Finding	As Built	Recommendation	Citation	Photos	Figure
346	Indian Lodge State Park: IL Lodge Room 118	[30.593232, -103.94387 16]	The required 56 inches by 60 inches clear floor space for the water closet has been obstructed. The clear floor space around the water closet shall be 60 inches minimum measured perpendicular from the side wall and 56 inches minimum measured perpendicular from the rear wall.	Restroom - lacks 56" by 60" clear floor space for the toilet due to storage (sink at 47", garbage can, and hamper in clearance) - may meet safe harbor	Remove storage items from toilet clearance. Leave as is sink citing safe harbor.	2015 ABAAS Section: 604.3. 2012 TAS Section: 604.3.1 2010 ADAS Section: 604.3.1

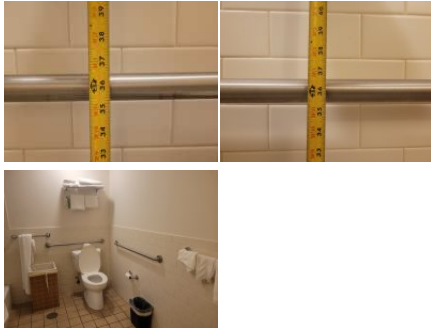
368	Indian Lodge State Park: IL Lodge Room 119	[30.593187, -103.943936]	The grab bar height and/or spacing fails. Grab bars must be mounted between 33" and 36" to the top of the gripping surface. There must be 1.5" of clearance between the grab bar and the wall. There must be a minimum of 1.5" of clearance below and minimum 12" above the grab bar to any dispenser or other obstruction.	Restroom - Gripping surface of both grab bars is 36.5" AFF	Remount grab bars in accessible restroom to 33" to 36" AFF	2015 ABAAS Section: 609.3, 609.4 2012 TAS Section: 609.4, 609.3 2010 ADAS Section: 609.3, 609.4

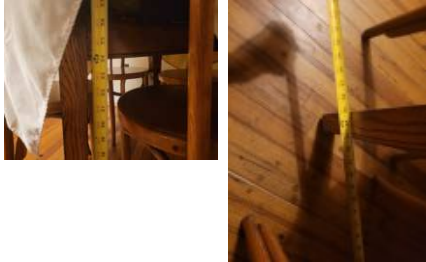
Finding Number	Area Description	Lat/Long	Finding	As Built	Recommendation	Citation	Photos	Figure
375	Indian Lodge State Park: IL Lodge Room 119	[30.5932043 , -103.9439 534]	The top of the work surface is not within a compliant height range. The tops of tables and counters shall be 28 inches to 34 inches from the floor or ground.	Table lacks knee clearance due to 23" width and 24" high	Provide tables and work surfaces at 28" to 34" aff with required knee and toe clearances.	2015 ABAAS Section: 902.3  2012 TAS Section: 902.3  2010 ADAS Section: 902.3

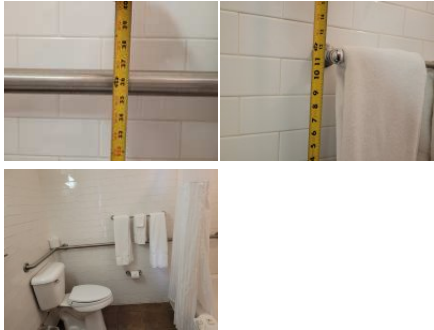
391	Indian Lodge State Park: IL Lodge Room 220	[30.5927137, -103.9433781]	The grab bar height and/or spacing fails. Grab bars must be mounted between 33" and 36" to the top of the gripping surface. There must be 1.5" of clearance between the grab bar and the wall. There must be a minimum of 1.5" of clearance below and minimum 12" above the grab bar to any dispenser or other obstruction.	Restroom - grab bars mounted to 36.75" AFF, and towel bar is 11" above it	Remount grab bars in accessible restroom to 33" to 36" aff Remount towel bar 15" to 48" aff and min 12" above or 1.5" below grab bar	2015 ABAAS Section: 609.3, 609.4 2012 TAS Section: 609.4, 609.3 2010 ADAS Section: 609.3, 609.4

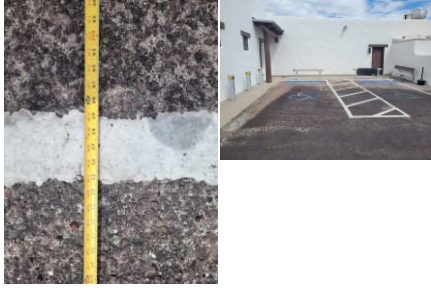
Finding Number	Area Description	Lat/Long	Finding	As Built	Recommendation	Citation	Photos	Figure
409	Indian Lodge State Park: IL Parking - Black Bear Resaurant	[30.5926375, -103.9437094]	The access aisle is not a minimum 5 feet wide. A car accessible parking stall's access aisle must be a minimum of 5 feet wide measured from centerline to centerline. Where the access aisle is not adjacent to another parking space or access aisle, measurements shall be permitted to include the full width of the line defining the access aisle.	Lacks width requirement for access aisles (57" wide)	Repaint access aisles to be 5' each.	2015 ABAAS Section: 502.3.1  2012 TAS Section: 502.3.1  2010 ADAS Section: 502.3.1

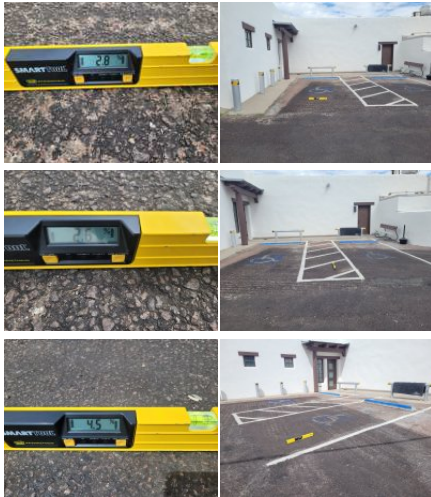
411	Indian Lodge State Park: IL Parking - Black Bear Resaurant	[30.5926387, -103.9437053]	The cross slopes (narrow dimension) and/or running slopes (long dimension) of the access aisle exceeds 2%. The running slope and the cross slope in an accessible parking stall and the access aisle must not exceed 2%.	Slopes: 2.8% left stall, 2.6% access aisle, 4.5% right stall	Repair or correct slope of parking space and access aisle to max 2.08% in any direction.	2015 ABAAS Section: 502.4  2012 TAS Section: 502.4  2010 ADAS Section: 502.4

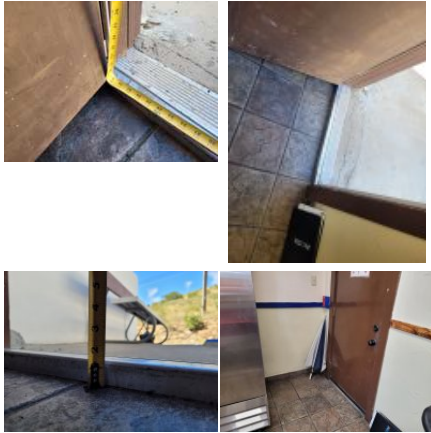
413	Indian Lodge State Park: IL Black Bear Restaurant	[30.59263, -103.9436]	Minimum maneuvering clearances at doors and gates shall comply with 404.2.4. Maneuvering clearances shall extend the full width of the doorway and the required latch side or hinge side clearance. Door openings shall provide a clear width of 32 inches (815 mm) minimum. Clear openings of doorways with swinging doors shall be measured between the face of the door and the stop, with the door open 90 degrees. Openings more than 24 inches (610 mm) deep shall provide a clear opening of 36 inches (915 mm) minimum. There shall be no projections into the required clear opening width lower than 34 inches (865 mm) above the finish floor or ground. Projections into the clear opening width between 34 inches (865 mm) and 80 inches (2030 mm) above the finish floor or ground shall not exceed 4 inches (100 mm). The threshold has a vertical change greater than 1/4 inch high. Hand-activated door opening hardware, handles, pulls, latches, locks, and other operating devices on accessible doors shall have a shape that is easy to grasp with one hand and does not require tight grasping, tight pinching or twisting of the wrist to operate. Hardware shall be 34 inches minimum and 48 inches maximum above the finish floor or ground.	Side door (not public) - rough, short ramp in maneuvering clearance on push side, 29" wide, CIL of 1" at threshold, knob hardware	For all doors along the public circulation route, provide required maneuvering clearance on push and pull side of doors. For all doors along the public circulation route, replace doors with doors having 80" overhead clearance and 32" clear width. For all doors along the public circulation route, repair, bevel, or ramp CILs at door entries to max .25". For all doors along the public circulation route, replace hardware with lever hardware or hardware operable without a tight pinch or grasp.	2010 ADAS Section: 404.2.3, 404.2.7, 404.2.4, 404.2.11, 404.2.11 Exception

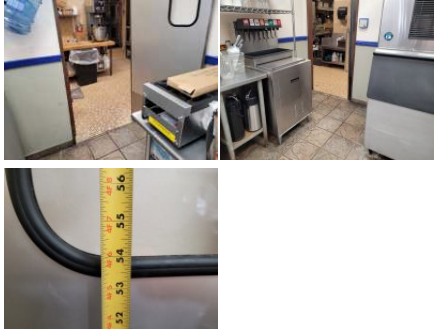
Finding Number	Area Description	Lat/Long	Finding	As Built	Recommendation	Citation	Photos	Figure
421	Indian Lodge State Park: IL Black Bear Restaurant	[30.5926642, -103.9436322]	Minimum maneuvering clearances at doors and gates shall comply with 404.2.4. Maneuvering clearances shall extend the full width of the doorway and the required latch side or hinge side clearance. Doors, gates, and side lights adjacent to doors or gates, containing one or more glazing panels that permit viewing through the panels shall have the bottom of at least one glazed panel located 43 inches (1090 mm) maximum above the finish floor. EXCEPTION: Vision lights with the lowest part more than 66 inches (1675 mm) from the finish floor or ground shall not be required to comply with 404.2.11.	Kitchen swinging doors - storage in maneuvering clearance on both sides, vision panels 54" aff	For all doors along the public circulation route, provide required maneuvering clearance on push and pull side of doors For all doors along the public circulation route, replace doors with ones having sidelight viewing windows max 43" aff	2010 ADAS Section: 404.2.3, 404.2.7, 404.2.4, 404.2.11, 404.2.11 Exception

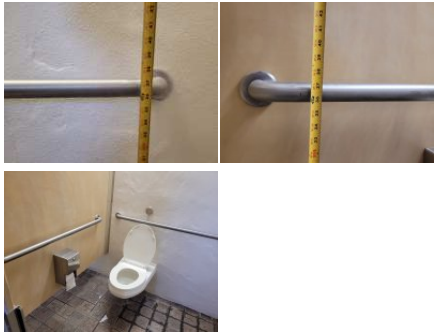
426	Indian Lodge State Park: IL Black Bear Restaurant - Men's Restroom	[30.5927264, -103.9437416]	The grab bar height and/or spacing fails. Grab bars must be mounted between 33" and 36" to the top of the gripping surface. There must be 1.5" of clearance between the grab bar and the wall. There must be a minimum of 1.5" of clearance below and minimum 12" above the grab bar to any dispenser or other obstruction.	Both grab bars at 37.25" AFF	Remount grab bars in accessible stall to 33" to 36" AFF.	2015 ABAAS Section: 609.3, 609.4  2012 TAS Section: 609.4, 609.3  2010 ADAS Section: 609.3, 609.4

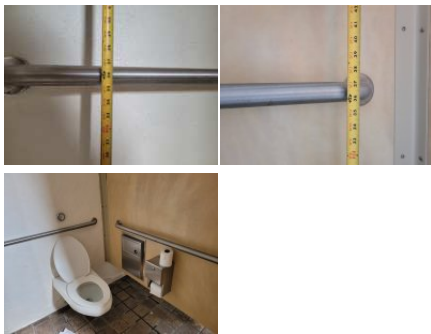
Finding Number	Area Description	Lat/Long	Finding	As Built	Recommendation	Citation	Photos	Figure
435	Indian Lodge State Park: IL Black Bear Restaurant - Women's Restroom	[30.5926918, -103.9437268]	The grab bar height and/or spacing fails. Grab bars must be mounted between 33" and 36" to the top of the gripping surface. There must be 1.5" of clearance between the grab bar and the wall. There must be a minimum of 1.5" of clearance below and minimum 12" above the grab bar to any dispenser or other obstruction.	side grab bar is 37" AFF, rear grab bar is 36.5" AFF	Remount grab bars in accessible stall to 33" to 36" AFF	2015 ABAAS Section: 609.3, 609.4  2012 TAS Section: 609.4, 609.3  2010 ADAS Section: 609.3, 609.4

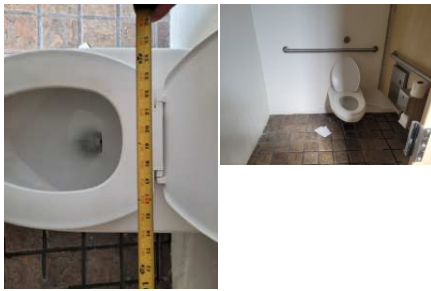
437	Indian Lodge State Park: IL Black Bear Restaurant - Women's Restroom	[30.5926883, -103.9437281]	The toilet is not located within the range allowed from the side wall or partition. The centerline of the toilet must be 16 to 18 inches from the side wall.	Centerline of the toilet is 19.25" towards the partition	Remount toilets to 16" to 18" from the side wall to centerline.	2015 ABAAS Section: 604.2  2012 TAS Section: 604.2  2010 ADAS Section: 604.2
