# Access Audit Site Report

**Eisenhower State Park**  
**50 Park Rd 20**  
**Denison, TX 75020**  
**Accessibility Evaluation**  
**Inspection Date: 10/13/2021**  
**Inspectors: Tanya Scheibe**

**TEXAS PARKS AND WILDLIFE DEPARTMENT  
EISENHOWER STATE PARK**

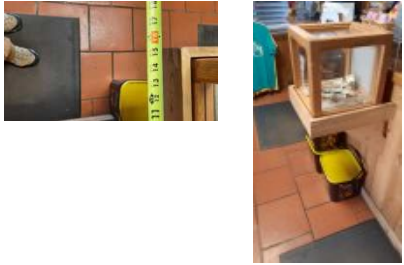
Finding Number	Area Description	Lat/Long	Finding	As Built	Recommendation	Citation	Photos	Figure
5	Headquarters: HQ Building	[33.8103601 , -96.599957 4]	The donation box projects more than 4 inches into the circulation path. Wall-mounted objects that have leading edges between 27 inches and 80 inches from the floor must not project more than 4 inches into the circulation path. Protruding objects that extend to the floor or within 27 inches of the floor are cane detectable and are therefore not hazardous. Where it is necessary or desirable to have objects protrude from the wall, a manner of cane detection must be provided.	Shop - donation box protrudes	Relocate protruding objects or place cane detectable warning or bollard at foot of item.	2015 ABAAS Section: 307.2  2012 TAS Section: 307.2  2010 ADAS Section: 307.2

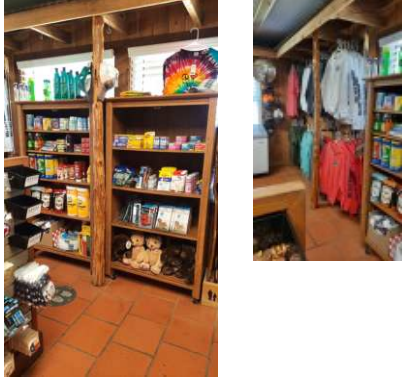
6	Headquarters: HQ Building	[33.8103569 , -96.599978 8]	The merchandise is positioned too high for either a side or front approach. Where a clear floor or ground space allows a parallel approach to an element and the side reach is unobstructed, the high side reach shall be 48 inches maximum and the low side reach shall be 15 inches minimum above the finish floor or ground. Where a forward reach is unobstructed, the high forward reach shall be 48 inches maximum and the low forward reach shall be 15 inches minimum above the finish floor or ground.	Shop - some merchandise high	Relocate merchandise to be within reach range of 15" min to 48" max.	2015 ABAAS Section: 308.1  2012 TAS Section: 308.1  2010 ADAS Section: 308.1

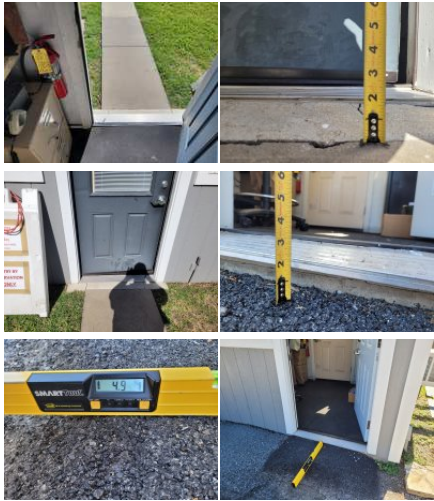
15	Headquarters: HQ Building	[33.8105082, -96.5998984]	Spaces and elements within employee work areas shall only be required to comply with 206.2.8, 207.1, and 215.3 and shall be designed and constructed so that individuals with disabilities can approach, enter, and exit the employee work area. Employee work areas, or portions of employee work areas, other than raised courtroom stations, that are less than 300 square feet (28 m2) and elevated 7 inches (180 mm) or more above the finish floor or ground where the elevation is essential to the function of the space shall not be required to comply with these requirements or to be on an accessible route.	Fee booth - one door has step, file cabinet pull side; other door has slope and change in level	For employee spaces, relocate storage, furniture, and other obstacles at doorways to provide approach, enter and exit at the employee space. Correct slope to 2.08% slope max. Correct Change in Level (CIL) at two locations.	2015 ABAAS Section: F203.9  2012 TAS Section: 203.9  2010 ADAS Section: 203.9

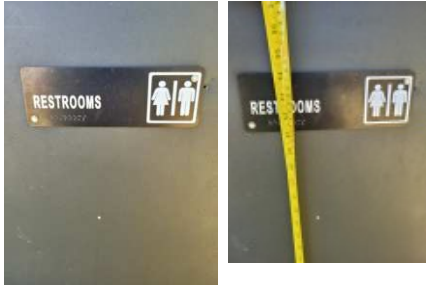
Finding Number	Area Description	Lat/Long	Finding	As Built	Recommendation	Citation	Photos	Figure
21	Headquarters: HQ Restrooms	[33.8103443 , -96.599952]	The restroom sign does not comply with one or more applicable requirements for the location, height, and properties of the sign.	Lacks raised lettering and Braille. Sign on pull side	Replace sign with one of contrasting colors that includes Braille, raised characters and mount on the wall, latch side of the door, 48" to the baseline of the lowest character and 60" to the baseline of the highest character	2015 ABAAS Section: F216.2, 703.1, 703.2, 703.5, 703.6  2012 TAS Section: 216.2, 703.1, 703.2, 703.5, 703.6  2010 ADAS Section: 216.2, 703.1, 703.2, 703.5, 703.6

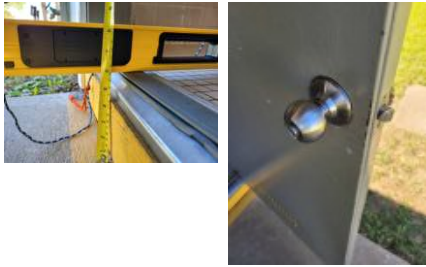
22	Headquarters: HQ Restrooms	[33.8103758 , -96.599970 8]	The threshold has a vertical change greater than 1/4 inch high. The sweep period for doors with closers shall be adjusted so that from an open position of 70 degrees, the door will take at least 3 seconds to move to a point 3 inches from the latch, measured to the leading edge of the door. Exterior doors are recommended to be maintained at 8.5 lbf as a smart practice. Force is to be measured at the operating hardware or 30 inches from the hinges, whichever is greater. Hand-activated door opening hardware, handles, pulls, latches, locks, and other operating devices on accessible doors shall have a shape that is easy to grasp with one hand and does not require tight grasping, tight pinching or twisting of the wrist to operate. Hardware shall be 34 inches minimum and 48 inches maximum above the finish floor or ground.	Restroom door - 6" threshold, knob, 9.5# push, fast close	For all doors along the public circulation route, repair, bevel, or ramp CILs at door entries to max .25". For all doors along the public circulation route, inspect, adjust, and maintain closing speed on door closers. For all doors along the public circulation route, inspect, adjust, and maintain 8.5 lbf to open exterior doors as a smart practice. For all doors along the public circulation route, replace hardware with lever hardware or hardware operable without a tight pinch or grasp.	2010 ADAS Section: 404.2.3, 404.2.7, 404.2.4, 404.2.11, 404.2.11 Exception

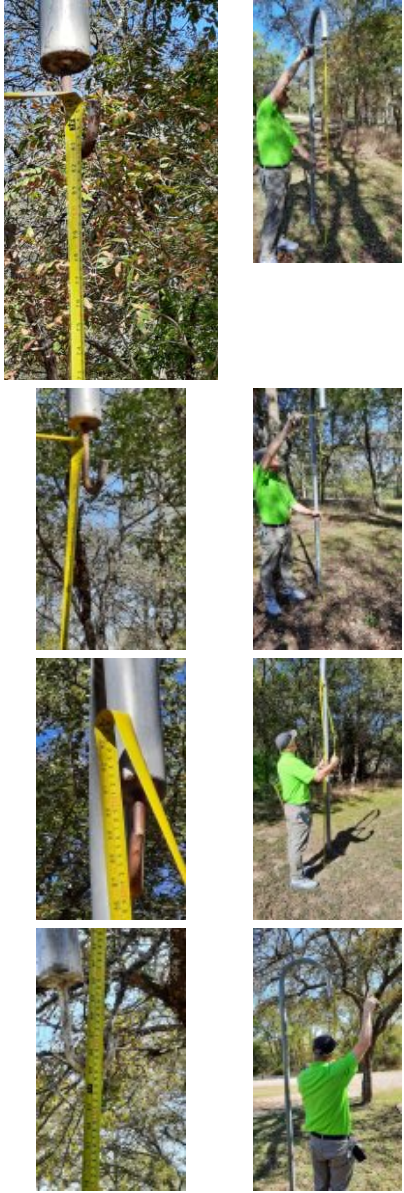
<p>52</p>	<p>Bois D'Arc Ridge Camping Area: BDR - Campsites</p>	<p>[33.817011, -96.606228 4]</p>	<p>A minimum of one of each type of outdoor constructed feature does not have mobility features. Where provided, at least one of each type of outdoor constructed features with mobility features must be provided.</p>	<p>Sites: 107 - hook at 89", 103 - hook at 85", 99 - hook at 80", 83 hook at 87"</p>	<p>Lower lantern hook at each accessible site to max 48" above the ground.</p>	<p>2015 ABAAS Section: F244.2.3.1, F245.2.5.1</p>

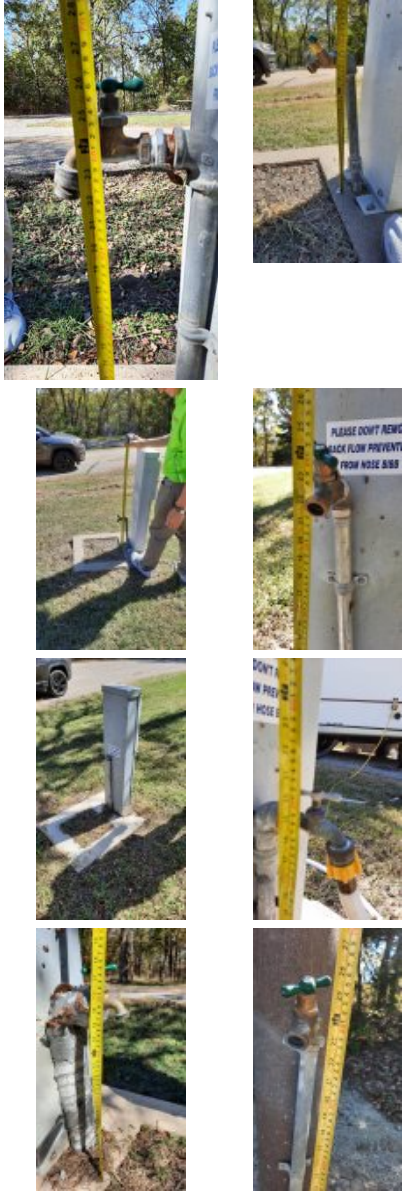
55	Bois D'Arc Ridge Camping Area: BDR - Campsites	[33.8170263 , -96.606229 7]	Water spouts at water hydrants and water utility hook-ups shall be 28 inches (710 mm) minimum and 36 inches (915 mm) maximum above the ground	Sites: 99 - 22", 83 - 14", 107 - 24", 106 - 20.5", 103 - 15"	Remount water spouts to 28" min or 36" max above the ground as a smart practice	2015 ABAAS Section: 1011.6

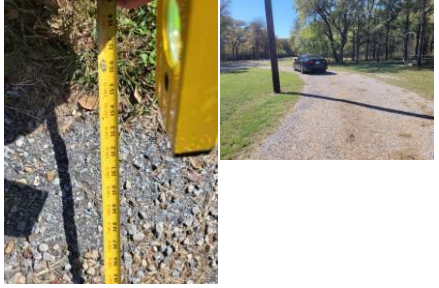
62	Bois D'Arc Ridge Camping Area: BDR - Campsites	[33.8162505 , -96.607798 8]	Parking spaces and pull-up spaces for recreational vehicles shall be 20 feet (6100 mm) wide minimum. EXCEPTION: Where two adjacent parking spaces are provided for recreational vehicles, one parking space shall be permitted to be 16 feet (4880 mm) wide minimum.	Site 70 - Parking space lacks width - 13' wide	Correct RV parking space to be 20' wide minimum; or 16' for two adjacent spaces as a smart practice.	2015 ABAAS Section: 1012.2, 1012.2 EXCEPTION

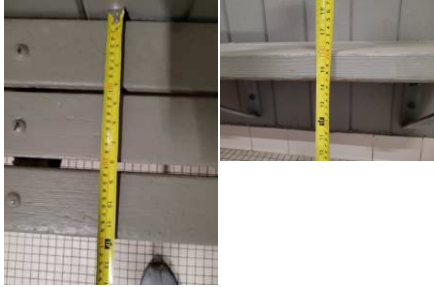
<p>93</p>	<p>Bois D'Arc Ridge Camping Area: BDR - Men's Restroom</p>	<p>[33.8167828 , -96.606603 9]</p>	<p>The bench is not deep enough or long enough or is missing. Benches shall be provided having seats that are 42 inches long minimum and 20 inches deep minimum and 24 inches deep maximum. The bench shall provide for back support or shall be affixed to a wall. Back support shall be 42 inches (1065 mm) long minimum and shall extend from a point 2 inches (51 mm) maximum above the seat surface to a point 18 inches (455 mm) minimum above the seat surface. Back support shall be 2½ inches (64 mm) maximum from the rear edge of the seat measured horizontally. The top of the bench seat surface shall be 17 inches (430 mm) minimum and 19 inches (485 mm) maximum above the finish floor or ground. Clear floor or ground space complying with 305 shall be provided and shall be positioned at the end of the bench seat and parallel to the short axis of the bench</p>	<p>Lacks compliant bench - 12" deep, 16" high</p>	<p>Replace bench in dressing area with one having a seat depth of 20" to 24" deep, 42" long, affixed to the wall or having a back and mounted 17" to 19" AFF and provide required clear floor space on the short axis of the bench.</p>	<p>2012 TAS Section: 903.4, 903.2, 903.3, 903.5  2010 ADAS Section: 903.4, 903.2, 903.3, 903.5</p>

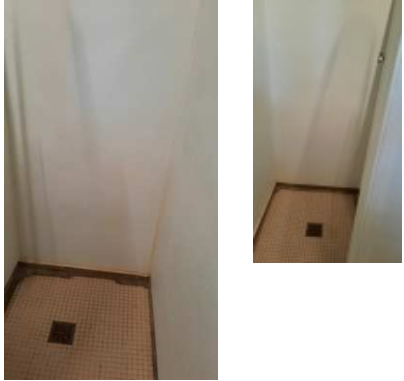
101	Bois D'Arc Ridge Camping Area: BDR - Women's Restroom	[33.8167896 , -96.606598 5]	There are no accessible bathing or shower facilities. Where facilities for bathing are provided for the public, clients or employees, including showers or bathtubs, at least one shower or bathtub and support facilities such as lockers, and not less than 1 percent of all facilities, shall be accessible.	Lacks accessible shower	Create an accessible shower in locker/bathing room.	2015 ABAAS Section: F213.3.6  2012 TAS Section: 213.3.6  2010 ADAS Section: 213.3.6

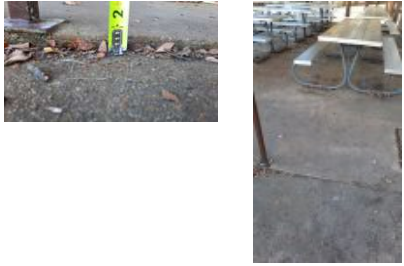
110	Cedar Hollow Group Trailer Area: CH - Group Picnic	[33.8195158 , -96.613824 4]	The walkway contains abrupt vertical edges and/or variations over a 1/4 inch. 1/4 inch is the maximum vertical rise. Changes in level between 1/4 inch and 1/2 inch must be beveled at 1:2 or less. Changes in level greater than 1/2 inch must be by way of a ramp.	Shelter - .75" at entry	Repair, bevel or ramp change in level at shelter.	2012 TAS Section: 303.2, 303.3  2010 ADAS Section: 303.2, 303.3

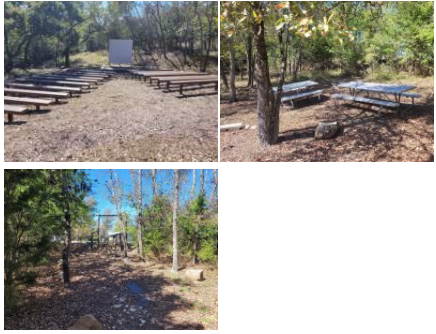
113	Cedar Hollow Group Trailer Area: CH - Amphitheater	[33.8190824 , -96.613121 6]	At least one accessible route shall connect accessible buildings, accessible facilities, accessible elements, and accessible spaces that are on the same site. For areas of sport activity, an accessible route is required to connect to the boundary of each area of sport activity. The size of an area of sport activity includes only the space needed to play. Where multiple sports fields or courts are provided, an accessible route is required to each field or area of sport activity.	Amphitheater lacks route, steps, lacks AR to picnic area, lacks accessible tables and fire ring	Provide an accessible route to each element within the site and replace amenities with ones of an accessible design.	2010 ADAS Section: 206.2.2, 206.2

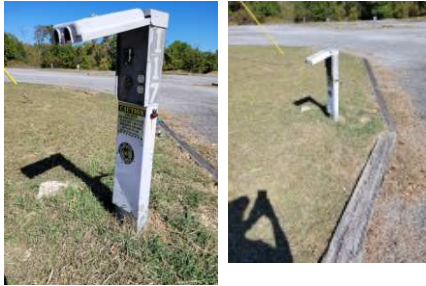
Finding Number	Area Description	Lat/Long	Finding	As Built	Recommendation	Citation	Photos	Figure																				
118	Cedar Hollow Group Trailer Area: CH - Day Use Area	[33.8196731 , -96.613355]	30 inches (760 mm) by 60 inches (1525 mm) with the long side of the space adjoining or overlapping an accessible parking space or pull-up space for recreational vehicles. Locate the space so that the hook-ups are at the rear center of the space. Bollards or other barriers shall not obstruct the clear ground space in front of the hook-ups	Lacks AR and Clear Ground Space (CGS)	Provide required 30" by 60" clear ground space with hook ups at the rear of the space as a smart practice	2015 ABAAS Section: 1011.2

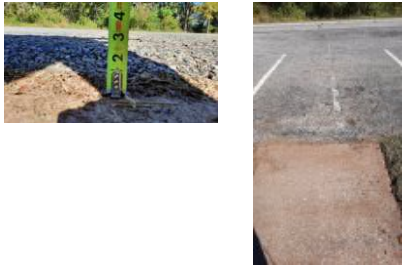
132	Deer Haven Camping Area: DH - Parking and Exterior Accessible Route	[33.822798, -96.610957 1]	The walkway contains abrupt vertical edges and/or variations over a 1/4 inch. 1/4 inch is the maximum vertical rise. Changes in level between 1/4 inch and 1/2 inch must be beveled at 1:2 or less. Changes in level greater than 1/2 inch must be by way of a ramp.	2" change in level from parking to restroom	Repair, bevel or ramp CIL along the route.	2012 TAS Section: 303.2, 303.3  2010 ADAS Section: 303.2, 303.3

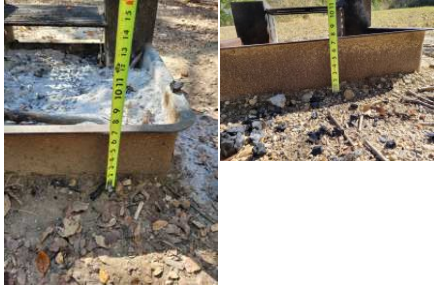
142	Deer Haven Camping Area: DH - Shelter Campsites - 1, 3 & 19	[33.8229765, -96.6122929]	Fire building surfaces shall be 9 inches (230 mm) minimum above the ground.	Fire building surface too low	Correct fire building surface to be 9" min above the ground as a smart practice. In the alternative, replace fire ring with a compliant accessible fire ring.	2015 ABAAS Section: 1011.5.1

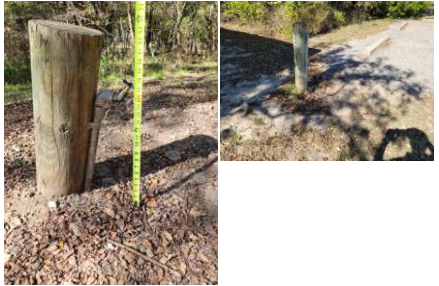
144	Deer Haven Camping Area: DH - Shelter Campsites - 1, 3 & 19	[33.8229774 , -96.6122942]	Water spouts at water hydrants and water utility hook-ups shall be 28 inches (710 mm) minimum and 36 inches (915 mm) maximum above the ground	Water spigot at 16" AFF, site 1 & 3 no CFS	Remount water spouts to 28" min or 36" max above the ground as a smart practice	2015 ABAAS Section: 1011.6

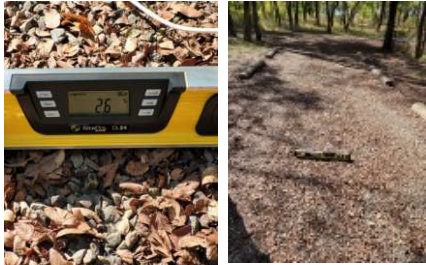
146	Deer Haven Camping Area: DH - Shelter Campsites - 1, 3 & 19	[33.822991, -96.6122003]	The surface of parking spaces and pull-up spaces shall be firm and stable. The slope of the surface of parking spaces and pull-up spaces shall not be steeper than 1:48 in any direction. EXCEPTION: Where the surface is other than asphalt, concrete, or boards, slopes not steeper than 1:20 shall be permitted when necessary for drainage.	Loose gravel surface	Maintain surface at parking to be firm and stable.	2015 ABAAS Section: 1012.4, 1012.5, 1012.5 EXCEPTION

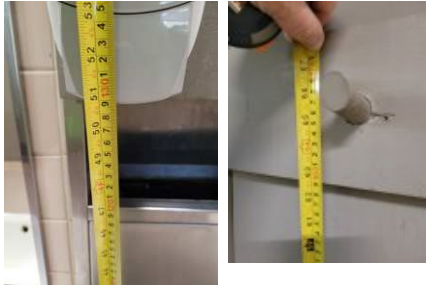
Finding Number	Area Description	Lat/Long	Finding	As Built	Recommendation	Citation	Photos	Figure
154	Deer Haven Camping Area: DH - Men's Restroom	[33.8227035, -96.6109866]	The operable part is positioned too high for either a side or front approach. Where a clear floor or ground space allows a parallel approach to an element and the side reach is unobstructed, the high side reach shall be 48 inches maximum and the low side reach shall be 15 inches minimum above the finish floor or ground. Where a forward reach is unobstructed, the high forward reach shall be 48 inches maximum and the low forward reach shall be 15 inches minimum above the finish floor or ground.	51" to soap dispenser, 65" to coat hook	Remount operable parts to be in reach range of 15" min to 48" max. Lower soap dispenser to max 44" aff for a forward reach over sink.	2015 ABAAS Section: 308.1 2012 TAS Section: 308.1 2010 ADAS Section: 308.1

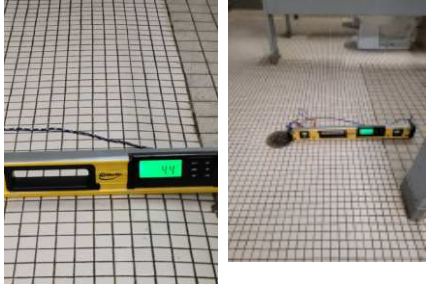
Finding Number	Area Description	Lat/Long	Finding	As Built	Recommendation	Citation	Photos	Figure
159	Deer Haven Camping Area: DH - Men's Restroom	[33.8227417 , -96.6109866]	The accessible route contains running slopes greater than 5 percent and cross slopes greater than 2 percent across the width of the walk and has not been constructed as a ramp (i.e. handrails, wheel guides, etc.). When the slope in the direction of travel of any walk exceeds 1 unit vertical in 20 units horizontal (5-percent slope), it must be constructed as ramp. Surface cross slopes must not exceed one unit vertical in 48 units. Horizontal (2-percent slope).	4.4% slope	Correct or repair slope to max 2.08%.	2015 ABAAS Section: 403.3  2012 TAS Section: 403.3  2010 ADAS Section: 403.3

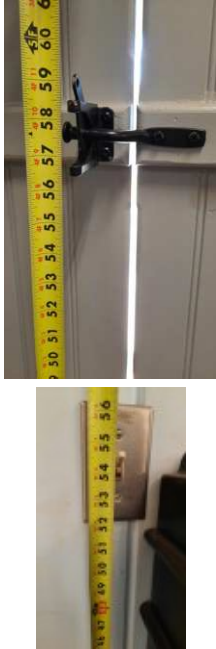
Finding Number	Area Description	Lat/Long	Finding	As Built	Recommendation	Citation	Photos	Figure
178	Deer Haven Camping Area: DH - Group Building	[33.8223508, -96.6106862]	The latch and switch are positioned too high for either a side or front approach. Where a clear floor or ground space allows a parallel approach to an element and the side reach is unobstructed, the high side reach shall be 48 inches maximum and the low side reach shall be 15 inches minimum above the finish floor or ground. Where a forward reach is unobstructed, the high forward reach shall be 48 inches maximum and the low forward reach shall be 15 inches minimum above the finish floor or ground.	Main room - Shutter latches at 57.5", switches at 54.75" in on position	Remount operable parts to be in reach range of 15" min to 48" max.	2015 ABAAS Section: 308.1 2012 TAS Section: 308.1 2010 ADAS Section: 308.1

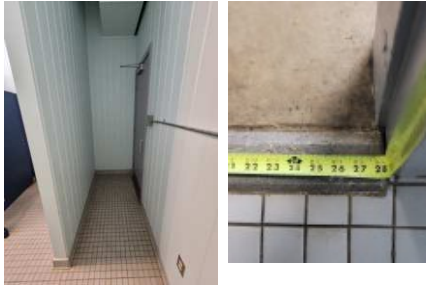
Finding Number	Area Description	Lat/Long	Finding	As Built	Recommendation	Citation	Photos	Figure
188	Deer Haven Camping Area: DH - Group Building Women's Restroom	[33.8224024 , -96.610670 1]	Minimum maneuvering clearances at doors and gates shall comply with 404.2.4. Maneuvering clearances shall extend the full width of the doorway and the required latch side or hinge side clearance. Maneuvering clearances shall have a max slope of 2.08%. Door openings shall provide a clear width of 32 inches (815 mm) minimum. Clear openings of doorways with swinging doors shall be measured between the face of the door and the stop, with the door open 90 degrees. Openings more than 24 inches (610 mm) deep shall provide a clear opening of 36 inches (915 mm) minimum. There shall be no projections into the required clear opening width lower than 34 inches (865 mm) above the finish floor or ground. Projections into the clear opening width between 34 inches (865 mm) and 80 inches (2030 mm) above the finish floor or ground shall not exceed 4 inches (100 mm). All interior doors must be maintained so that the operating pressure does not exceed 5 lbf to open.	Women's Restroom - door lacks maneuvering clearance due to wall, 28" wide, 18.5# push	For all doors along the public circulation route, provide required maneuvering clearance on push and pull side of doors. For all doors along the public circulation route, replace doors with doors having 80" overhead clearance and 32" clear width. For all doors along the public circulation route, inspect, adjust, and maintain 5 lbf to open interior doors.	2010 ADAS Section: 404.2.3, 404.2.7, 404.2.4, 404.2.11, 404.2.11 Exception

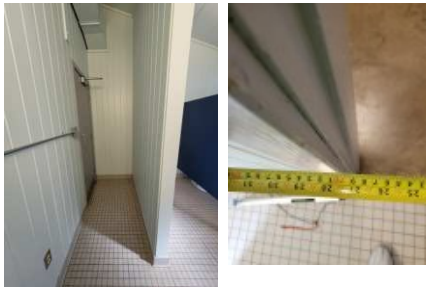
191	Deer Haven Camping Area: DH - Group Building Men's Restroom	[33.822404, -96.6106594]	Minimum maneuvering clearances at doors and gates shall comply with 404.2.4. Maneuvering clearances shall extend the full width of the doorway and the required latch side or hinge side clearance. Maneuvering clearances shall have a max slope of 2.08%. Door openings shall provide a clear width of 32 inches (815 mm) minimum. Clear openings of doorways with swinging doors shall be measured between the face of the door and the stop, with the door open 90 degrees. Openings more than 24 inches (610 mm) deep shall provide a clear opening of 36 inches (915 mm) minimum. There shall be no projections into the required clear opening width lower than 34 inches (865 mm) above the finish floor or ground. Projections into the clear opening width between 34 inches (865 mm) and 80 inches (2030 mm) above the finish floor or ground shall not exceed 4 inches (100 mm). All interior doors must be maintained so that the operating pressure does not exceed 5 lbf to open.	Men's Restroom - door lacks maneuvering clearance due to wall, 28" wide, 12# push	For all doors along the public circulation route, provide required maneuvering clearance on push and pull side of doors. For all doors along the public circulation route, replace doors with doors having 80" overhead clearance and 32" clear width. For all doors along the public circulation route, inspect, adjust, and maintain 5 lbf to open interior doors.	2010 ADAS Section: 404.2.3, 404.2.7, 404.2.4, 404.2.11, 404.2.11 Exception

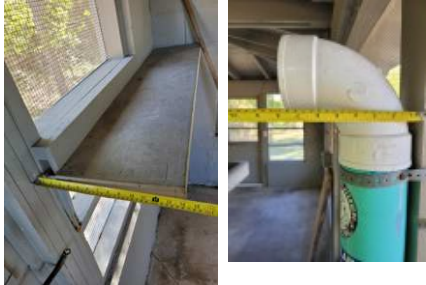
Hinged Door
195	Deer Haven Camping Area: DH - Fishing	[33.8213782, -96.61122]	The shelves and pipe projects more than 4 inches into the circulation path. Wall-mounted objects that have leading edges between 27 inches and 80 inches from the floor must not project more than 4 inches into the circulation path. Protruding objects that extend to the floor or within 27 inches of the floor are cane detectable and are therefore not hazardous. Where it is necessary or desirable to have objects protrude from the wall, a manner of cane detection must be provided.	Fish Cleaning Station House- two 14" shelf and 8" fishing line pipe projects	Relocate protruding objects or place cane detectable warning or bollard at foot of items.	2015 ABAAS Section: 307.2  2012 TAS Section: 307.2  2010 ADAS Section: 307.2

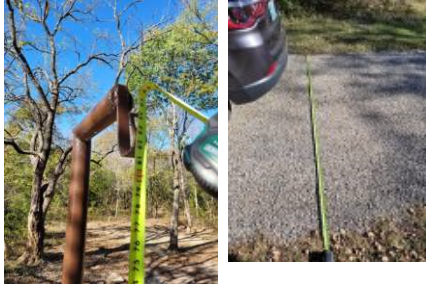
Finding Number	Area Description	Lat/Long	Finding	As Built	Recommendation	Citation	Photos	Figure
235	Fossil Ridge Camping Area: FR - Campsites	[33.82514, -96.616879 4]	A minimum of one of each type of outdoor constructed feature does not have mobility features. Where provided, at least one of each type of outdoor constructed features with mobility features must be provided.	Site 144 - 84" AFF to hook	Provide accessible outdoor constructed features at the required number of camp units based on the total number provided.	2015 ABAAS Section: F244.2.3.1, F245.2.5.1

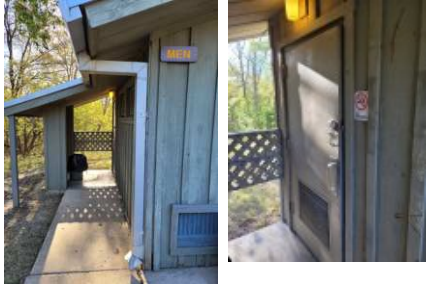
Finding Number	Area Description	Lat/Long	Finding	As Built	Recommendation	Citation	Photos	Figure
240	Fossil Ridge Camping Area: FR - Men's Restroom	[33.8248473 , -96.6166809]	The restroom sign does not comply with one or more applicable requirements for the location, height, and properties of the sign.	Lacks ISA sign - no Braille, no raised characters	Replace sign with one of contrasting colors that includes Braille, raised characters, and the symbol of accessibility and mount on the wall, latch side of the door, 48" to the baseline of the lowest character and 60" to the baseline of the highest character	2015 ABAAS Section: F216.2, 703.1, 703.2, 703.5, 703.6  2012 TAS Section: 216.2, 703.1, 703.2, 703.5, 703.6  2010 ADAS Section: 216.2, 703.1, 703.2, 703.5, 703.6

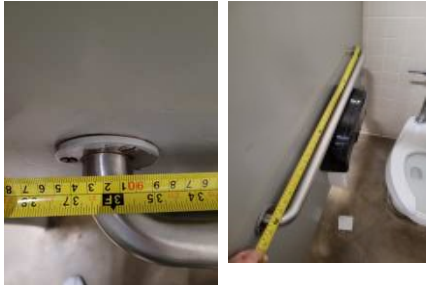
Finding Number	Area Description	Lat/Long	Finding	As Built	Recommendation	Citation	Photos	Figure
248	Fossil Ridge Camping Area: FR - Men's Restroom	[33.824856, -96.616675 6]	Grab bars shall comply with 609. A side-wall grab bar complying with 604.5.1 shall be provided on both sides of the compartment. The space between the wall and the grab bar shall be 1½ inches (38 mm). The space between the grab bar and projecting objects below and at the ends shall be 1½ inches (38 mm) minimum. The space between the grab bar and projecting objects above shall be 12 inches (305 mm) minimum. Grab bars shall be installed in a horizontal position, 33 inches (840 mm) minimum and 36 inches (915 mm) maximum above the finish floor measured to the top of the gripping surface, except that at water closets for children's use complying with 604.9, grab bars shall be installed in a horizontal position 18 inches (455 mm) minimum and 27 inches (685 mm) max	36" long grab bar	Replace or add side grab bars with a 42" long grab bar, mounted max 12" from the rear wall at the close end and min 54" on the far end and 33" to 36" aff	2015 ABAAS Section: 604.8.2.3, 609.3, 609.4  2012 TAS Section: 609.4, 609.3, 604.8.2.3  2010 ADAS Section: 609.3, 609.4, 604.8.2.3

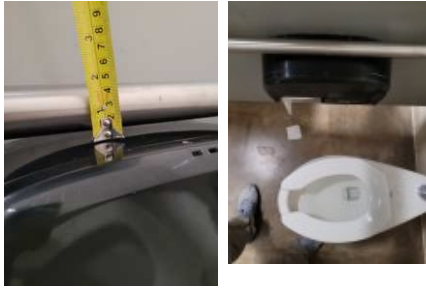
250	Fossil Ridge Camping Area: FR - Men's Restroom	[33.8248588, -96.616689]	The grab bar height and/or spacing fails. Grab bars must be mounted between 33" and 36" to the top of the gripping surface. There must be 1.5" of clearance between the grab bar and the wall. There must be a minimum of 1.5" of clearance below and minimum 12" above the grab bar to any dispenser or other obstruction.	.5" between grab bar and toilet paper dispenser, TP mounted behind toilet	Remount toilet paper dispenser max 7" to 9" from front of toilet, 15" to 48" aff and min 12" above or 1.5" below grab bar	2015 ABAAS Section: 609.3, 609.4  2012 TAS Section: 609.4, 609.3  2010 ADAS Section: 609.3, 609.4

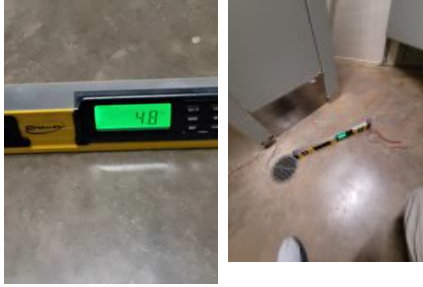
253	Fossil Ridge Camping Area: FR - Men's Restroom	[33.8248477 , -96.6166917]	The accessible route contains running slopes greater than 5 percent and cross slopes greater than 2 percent across the width of the walk and has not been constructed as a ramp (i.e. handrails, wheel guides, etc.). When the slope in the direction of travel of any walk exceeds 1 unit vertical in 20 units horizontal (5-percent slope), it must be constructed as ramp. Surface cross slopes must not exceed one unit vertical in 48 units. Horizontal (2-percent slope).	4.8% slope at drain	Correct or repair slope to max 5% running and 2.08% cross	2015 ABAAS Section: 403.3 2012 TAS Section: 403.3 2010 ADAS Section: 403.3

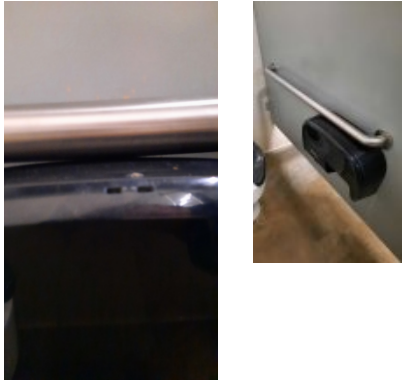
Finding Number	Area Description	Lat/Long	Finding	As Built	Recommendation	Citation	Photos	Figure
264	Fossil Ridge Camping Area: FR - Women's Restroom	[33.8248493, -96.6166836]	The toilet paper dispenser is mounted too close to the bottom of the grab bar, minimizing the gripping surface. Adjacent elements shall be positioned to provide unobstructed use of grab bars. The space between the grab bar and projecting objects below and at the ends shall be 1-1/2 inches minimum. The space between the grab bar and projecting objects above shall be 12 inches minimum.	TP too close below grab bar	Remount toilet paper dispenser max 7" to 9" from front of toilet, 15" to 48" aff and min 12" above or 1.5" below grab bar.	2015 ABAAS Section: 609.3 2012 TAS Section: 609.3 2010 ADAS Section: 609.3

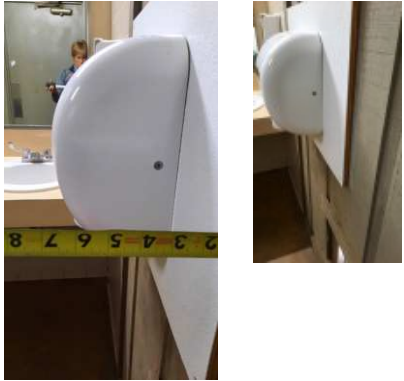
265	Fossil Ridge Camping Area: FR - Women's Restroom	[33.8248355, -96.6166877]	An object or objects project more than 4 inches into the circulation path. Wall-mounted objects that have leading edges between 27 inches and 80 inches from the floor must not project more than 4 inches into the circulation path. Protruding objects that extend to the floor or within 27 inches of the floor are cane detectable and are therefore not hazardous. Where it is necessary or desirable to have objects protrude from the wall, a manner of cane detection must be provided.	Hand dryer protrudes 7"	Relocate protruding objects or place cane detectable warning or bollard at foot of item.	2015 ABAAS Section: 307.2 2012 TAS Section: 307.2 2010 ADAS Section: 307.2

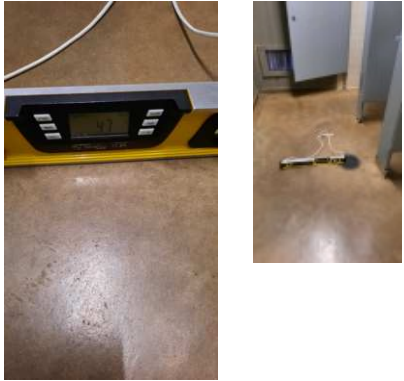
266	Fossil Ridge Camping Area: FR - Women's Restroom	[33.824843, -96.6166756]	The accessible route contains running slopes greater than 5 percent and cross slopes greater than 2 percent across the width of the walk and has not been constructed as a ramp (i.e. handrails, wheel guides, etc.). When the slope in the direction of travel of any walk exceeds 1 unit vertical in 20 units horizontal (5-percent slope), it must be constructed as ramp. Surface cross slopes must not exceed one unit vertical in 48 units. Horizontal (2-percent slope).	4.7% slope at drain	Correct or repair slope to max 5% running and 2.08% cross	2015 ABAAS Section: 403.3 2012 TAS Section: 403.3 2010 ADAS Section: 403.3

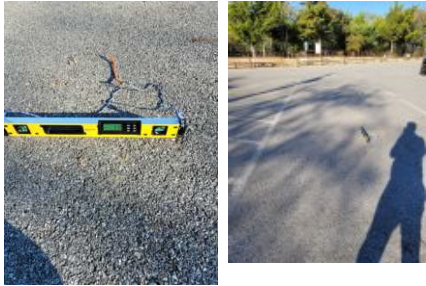
Finding Number	Area Description	Lat/Long	Finding	As Built	Recommendation	Citation	Photos	Figure
267	Fossil Ridge Camping Area: FR - OHV Trailhead	[33.8235771 , -96.617469 5]	The cross slopes (narrow dimension) and/or running slopes (long dimension) of the access aisle exceeds 2%. The running slope and the cross slope in an accessible parking stall and the access aisle must not exceed 2%.	3.0% slope	Repair or correct slope of parking space and access aisle to max 2.08% in any direction	2015 ABAAS Section: 502.4  2012 TAS Section: 502.4  2010 ADAS Section: 502.4

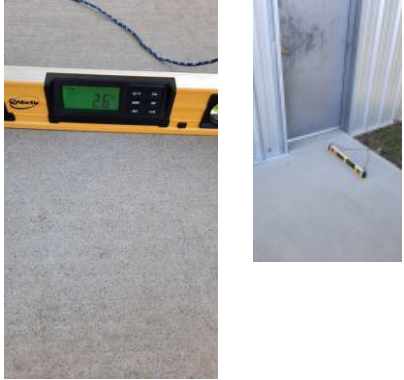
Finding Number	Area Description	Lat/Long	Finding	As Built	Recommendation	Citation	Photos	Figure
271	Fossil Ridge Camping Area: FR - OHV Trailhead	[33.823465, -96.617348 8]	Spaces and elements within employee work areas shall only be required to comply with 206.2.8, 207.1, and 215.3 and shall be designed and constructed so that individuals with disabilities can approach, enter, and exit the employee work area. Employee work areas, or portions of employee work areas, other than raised courtroom stations, that are less than 300 square feet (28 m2) and elevated 7 inches (180 mm) or more above the finish floor or ground where the elevation is essential to the function of the space shall not be required to comply with these requirements or to be on an accessible route.	Garage - 2.6% slope on exterior, pipe chase ok	For employee spaces, relocate storage, furniture, and other obstacles at doorways to provide approach, enter and exit at the employee space. Correct slope in door clearance to max 2.08%.	2015 ABAAS Section: F203.9 2012 TAS Section: 203.9 2010 ADAS Section: 203.9

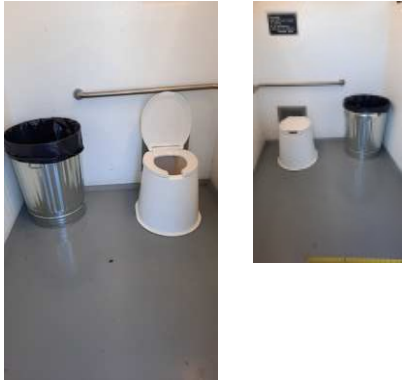
Finding Number	Area Description	Lat/Long	Finding	As Built	Recommendation	Citation	Photos	Figure
275	Fossil Ridge Camping Area: FR - OHV Trailhead	[33.823496, -96.617445 4]	The required 56 inches by 60 inches clear floor space for the water closet has been obstructed. The clear floor space around the water closet shall be 60 inches minimum measured perpendicular from the side wall and 56 inches minimum measured perpendicular from the rear wall.	Both restrooms (RR) have garbage can in side clearance	Relocate trashcans to provide required 60" clearance around toilet.	2015 ABAAS Section: 604.3.  2012 TAS Section: 604.3.1  2010 ADAS Section: 604.3.1

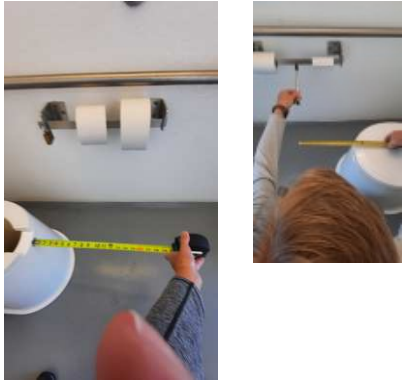
277	Fossil Ridge Camping Area: FR - OHV Trailhead	[33.823504, -96.617434 6]	The toilet paper is not installed within the compliant range in front of the toilet. Toilet paper dispensers shall be 7 inches minimum and 9 inches maximum in front of the water closet measured to the centerline of the dispenser. The outlet of the dispenser shall be 15 inches minimum and 48 inches maximum above the finish floor and shall not be located behind grab bars. Dispensers shall not be of a type that controls delivery or that does not allow continuous paper flow. There shall be a clearance of 1 1/2 inches minimum below the grab bar.	TP in both restrooms too far	Remount toilet paper dispenser max 7" to 9" from front of toilet, 15" to 48" aff and min 12" above or 1.5" below grab bar	2015 ABAAS Section: 604.7  2012 TAS Section: 604.7  2010 ADAS Section: 604.7

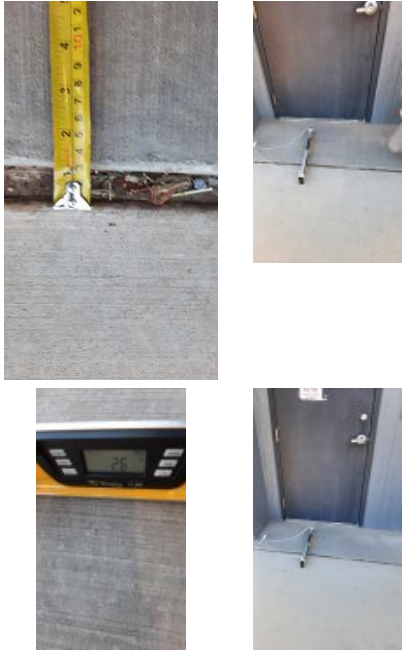
Finding Number	Area Description	Lat/Long	Finding	As Built	Recommendation	Citation	Photos	Figure
278	Fossil Ridge Camping Area: FR - OHV Trailhead	[33.8234995 , -96.617441 4]	<p>Minimum maneuvering clearances at doors and gates shall comply with 404.2.4. Maneuvering clearances shall extend the full width of the doorway and the required latch side or hinge side clearance. Door openings shall provide a clear width of 32 inches (815 mm) minimum. Clear openings of doorways with swinging doors shall be measured between the face of the door and the stop, with the door open 90 degrees. Openings more than 24 inches (610 mm) deep shall provide a clear opening of 36 inches (915 mm) minimum. There shall be no projections into the required clear opening width lower than 34 inches (865 mm) above the finish floor or ground. Projections into the clear opening width between 34 inches (865 mm) and 80 inches (2030 mm) above the finish floor or ground shall not exceed 4 inches (100 mm). The threshold has a vertical change greater than 1/4 inch high. The threshold at a doorway shall be no higher than 1/2 inch. Changes in level between 1/4 inch and 1/2 inch must be beveled at 1:2 or less. 1/4 inch is the maximum vertical rise. All interior doors must be maintained so that the operating pressure does not exceed 5 lb. force to open. The sweep period for doors with closers shall be adjusted so that from an open position of 70 degrees, the door will take at least 3 seconds to move to a point 3 inches from the latch, measured to the leading edge of the door. Exterior doors are recommended to be maintained at 8.5 lbf as a smart practice. Force is to be measured at the operating hardware or 30 inches from the hinges, whichever is greater. Hand-activated door opening hardware, handles, pulls, latches, locks, and other operating devices on accessible doors shall have a shape that is easy to grasp with one hand and does not require tight grasping, tight pinching or twisting of the wrist to operate. Hardware shall be 34 inches minimum and 48 inches maximum above the finish floor or</p>	Restroom doors - gap back on pull of 1", women's has 2.6% slope	For all doors along the public circulation route, provide 2.08% max. slope in maneuvering clearance on push and pull side of doors For all doors along the public circulation route, fill gaps at door entries to max .5"	2010 ADAS Section: 404.2.3, 404.2.7, 404.2.4, 404.2.11, 404.2.11 Exception

Finding Number	Area Description	Lat/Long	Finding	As Built	Recommendation	Citation	Photos	Figure
			ground. The bottom 10 inches on the push side must be smooth and free of obstructions (hold open devices). Opening hardware must be mounted between 30 and 44 inches above the floor or ground. Doors, gates, and side lights adjacent to doors or gates, containing one or more glazing panels that permit viewing through the panels shall have the bottom of at least one glazed panel located 43 inches (1090 mm) maximum above the finish floor. EXCEPTION: Vision lights with the lowest part more than 66 inches (1675 mm) from the finish floor or ground shall not be required to comply with 404.2.11.

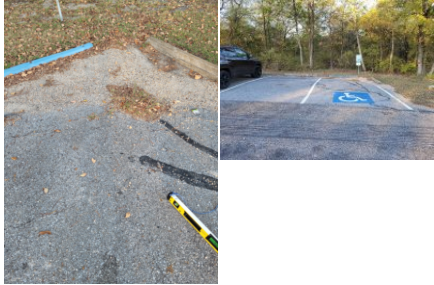
Finding Number	Area Description	Lat/Long	Finding	As Built	Recommendation	Citation	Photos	Figure
282	Elm Point Camping Area: EP - Day Use Area Parking and Exterior Accessible Route	[33.828863, -96.618693 9]	The parking stall contains abrupt edges and surface irregularities over a 1/4 inch vertical. Parking spaces and access aisles serving them shall be stable, firm, and slip resistant. Access aisles shall be at the same level as the parking spaces they serve. Changes in level are not permitted and shall not be sloped steeper than 2% in any direction.	Loose gravel	Maintain stalls and aisles to be free of loose gravel.	2015 ABAAS Section: 502.4 2012 TAS Section: 502.4 2010 ADAS Section: 502.4

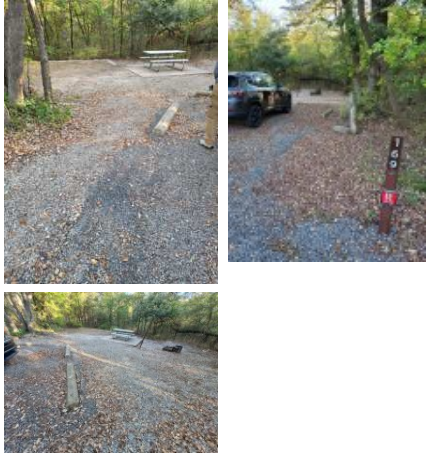
Finding Number	Area Description	Lat/Long	Finding	As Built	Recommendation	Citation	Photos	Figure
287	Elm Point Camping Area: EP - Campsites	[33.828466, -96.620236 2]	An accessible access route is not provided between elements, spaces and the facilities provided within the accessible camping unit. At least one outdoor recreation access route shall connect accessible elements, spaces and facilities provided within camping units with mobility features.	Site 169 - Lacks AR	Create AR with crushed and compacted stone or similar outdoor material to camp sites and one of each type of amenity.	2015 ABAAS Section: F244.5.1

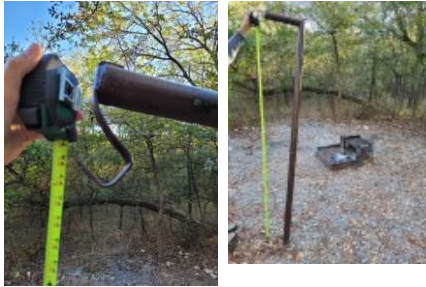
293	Elm Point Camping Area: EP - Campsites	[33.8284606 , -96.620229 5]	A minimum of one of each type of outdoor constructed feature does not have mobility features. Where provided, at least one of each type of outdoor constructed features with mobility features must be provided.	Site 169 - 78" AFF to hook	Provide accessible outdoor constructed features at the required number of camp units based on the total number provided.	2015 ABAAS Section: F244.2.3.1, F245.2.5.1

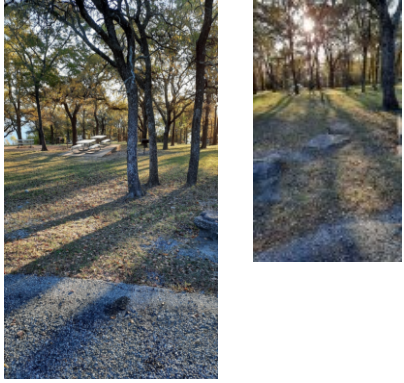
Finding Number	Area Description	Lat/Long	Finding	As Built	Recommendation	Citation	Photos	Figure
297	Elm Point Camping Area: EP - Day Use Picnic Area	[33.8282525 , -96.6176707]	There is no accessible route to the picnic. At least one accessible route shall connect accessible buildings, accessible facilities, accessible elements, and accessible spaces that are on the same site.	Lacks accessible route to 18+ picnic areas, 3 water spigots	Create an accessible route with crushed stone or other outdoor material from parking or walkway to four picnic tables and replace with ones of an accessible design and having a 36" route around the table as a smart practice. Provide a route to at least one water spigot.	2015 ABAAS Section: F206.2.2  2012 TAS Section: 206.2.2  2010 ADAS Section: 206.2.2

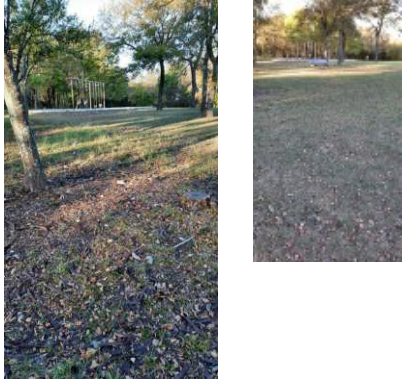
299	Elm Point Camping Area: EP - Day Use Picnic Area	[33.8279741 , -96.6183935]	There is no accessible route to the swing set or bench. At least one accessible route shall connect accessible buildings, accessible facilities, accessible elements, and accessible spaces that are on the same site.	Lacks route to swing set or bench	Create an accessible route with crushed stone or other outdoor material from parking or walkway to the swing set or bench	2015 ABAAS Section: F206.2.2  2012 TAS Section: 206.2.2  2010 ADAS Section: 206.2.2

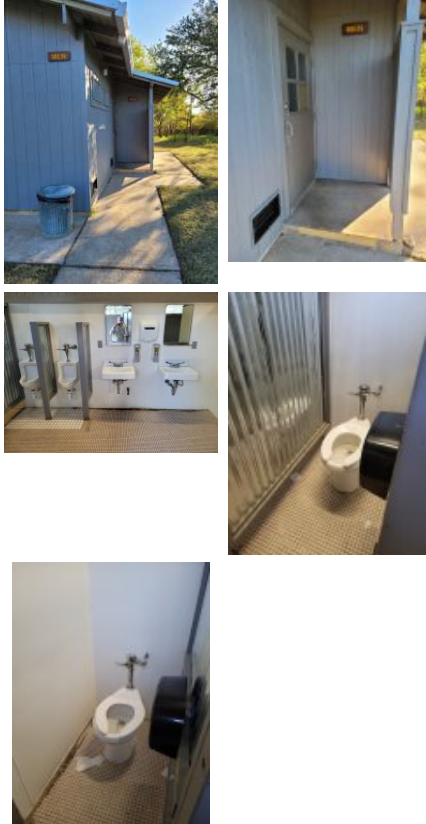
Finding Number	Area Description	Lat/Long	Finding	As Built	Recommendation	Citation	Photos	Figure
303	Elm Point Camping Area: EP - Men's Restroom	[33.826973, -96.618735]	This restroom is not accessible. Where existing toilet rooms or bathing rooms do not comply, directional signs indicating the location of the nearest accessible toilet room or bathing room within the facility shall be provided. Signs shall include the International Symbol of Accessibility. Where existing toilet rooms or bathing rooms do comply), the accessible toilet rooms or bathing rooms shall be identified by the International Symbol of Where clustered single user toilet rooms or bathing facilities are permitted, accessible toilet rooms or bathing facilities shall be identified by the International Symbol of Accessibility unless all toilet rooms and bathing facilities are accessible.	Lacks accessible features	Restroom not accessible, acquire and mount signage directing patrons to accessible restroom until renovations occur.	2015 ABAAS Section: F216.8 2012 TAS Section: 216.8 2010 ADAS Section: 216.8

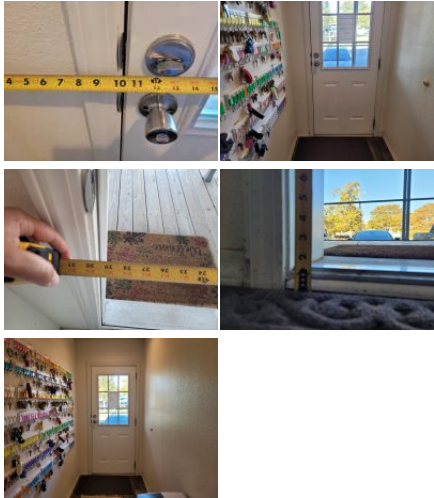
Finding Number	Area Description	Lat/Long	Finding	As Built	Recommendation	Citation	Photos	Figure
311	Eisenhower Yacht Club: Yacht Club- Office	[33.8211008 , -96.604759 6]	<p>Minimum maneuvering clearances at doors and gates shall comply with 404.2.4. Maneuvering clearances shall extend the full width of the doorway and the required latch side or hinge side clearance. Maneuvering clearances shall have a max slope of 2.08%. Door openings shall provide a clear width of 32 inches (815 mm) minimum. Clear openings of doorways with swinging doors shall be measured between the face of the door and the stop, with the door open 90 degrees. Openings more than 24 inches (610 mm) deep shall provide a clear opening of 36 inches (915 mm) minimum. There shall be no projections into the required clear opening width lower than 34 inches (865 mm) above the finish floor or ground. Projections into the clear opening width between 34 inches (865 mm) and 80 inches (2030 mm) above the finish floor or ground shall not exceed 4 inches (100 mm). The threshold at a doorway shall be no higher than 1/2 inch. Changes in level between 1/4 inch and 1/2 inch must be beveled at 1:2 or less. 1/4 inch is the maximum vertical rise. Hand-activated door opening hardware, handles, pulls, latches, locks, and other operating devices on accessible doors shall have a shape that is easy to grasp with one hand and does not require tight grasping, tight pinching or twisting of the wrist to operate. Hardware shall be 34 inches minimum and 48 inches maximum above the finish floor or ground.</p>	Employee entry - wall pull side, knob, 29.5" wide, .75" threshold, recessed greater than 24"	<p>For all doors along the public circulation route, provide required maneuvering clearance on push and pull side of doors. For all doors along the public circulation route, replace doors with doors having 80" overhead clearance and 32" clear width or 36" clear width for recessed doors. For all doors along the public circulation route, provide beveled threshold. For all doors along the public circulation route, replace hardware with lever hardware or hardware operable without a tight pinch or grasp.</p>	2010 ADAS Section: 404.2.3, 404.2.7, 404.2.4, 404.2.11, 404.2.11 Exception

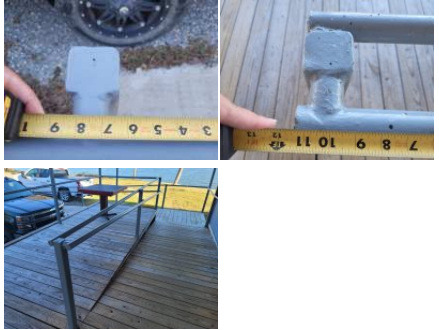
Finding Number	Area Description	Lat/Long	Finding	As Built	Recommendation	Citation	Photos	Figure
323	Eisenhower Yacht Club: Yacht Club- Office	[33.8210985 , -96.604763 4]	The handrail does not extend past the ramp. Handrails must be between 34 inches and 38 inches above the ramp surface, must extend beyond the top and bottom of the ramp 12 inches horizontally, be parallel to the floor or ground surface and be in the same direction as the ramp runs. The 12 inches must be level and does not include the radius at the top of round handrails. Extensions shall return to a wall, guard, or the landing surface, or shall be continuous to the handrail of an adjacent ramp run.	Handrails extends 6.5" at bottom, 11.25" at top	Provide handrail extensions that project 12" onto the ramp landings	2015 ABAAS Section: 505.10.1  2012 TAS Section: 505.10.1  2010 ADAS Section: 505.10.1

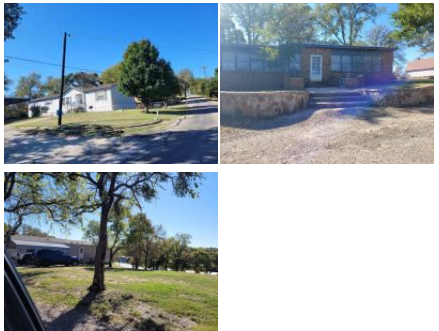
327	Eisenhower Yacht Club: Yacht Club- Office	[33.8213133, -96.60641 04], [33.8212251, -96.607156 1]	The building entrance is not located on an accessible route. When a building, or portion of a building, is required to be accessible, an accessible route of travel shall be provided to all portions of the building, to accessible building entrances and between the building and the public way. All walks, halls, corridors, aisles, skywalks, tunnels, and other spaces that are part of an accessible route must comply. An accessible route of travel must not pass through kitchens, storage rooms, restrooms, closets or other spaces used for similar purposes. At least one accessible route within the boundary of the site must be provided from public transportation stops, accessible parking and accessible passenger loading zones and public streets or sidewalks to the accessible building entrance they serve. The accessible route shall, to the maximum extent feasible, coincide with the route for the general public. At least one accessible route shall connect accessible buildings, facilities, elements and spaces that are on the same site. At least one accessible route shall connect accessible building or facility entrances with all accessible spaces and elements.	Lacks AR to concessionaire staff residences present - no access	Create AR with crushed and compacted stone or similar outdoor material from parking or sidewalk to building entrance	2015 ABAAS Section: F206.2.1  2012 TAS Section: 206.2.1  2010 ADAS Section: 206.2.1

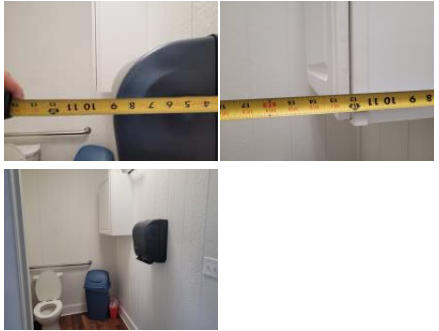
Finding Number	Area Description	Lat/Long	Finding	As Built	Recommendation	Citation	Photos	Figure
345	Eisenhower Yacht Club: Yacht Club - Store	[33.8205222 , -96.604484 9]	The paper towels and cabinet projects more than 4 inches into the circulation path. Wall-mounted objects that have leading edges between 27 inches and 80 inches from the floor must not project more than 4 inches into the circulation path. Protruding objects that extend to the floor or within 27 inches of the floor are cane detectable and are therefore not hazardous. Where it is necessary or desirable to have objects protrude from the wall, a manner of cane detection must be provided.	Paper towels and cabinet protrude	Relocate protruding objects or place cane detectable warning or bollard at foot of item.	2015 ABAAS Section: 307.2  2012 TAS Section: 307.2  2010 ADAS Section: 307.2

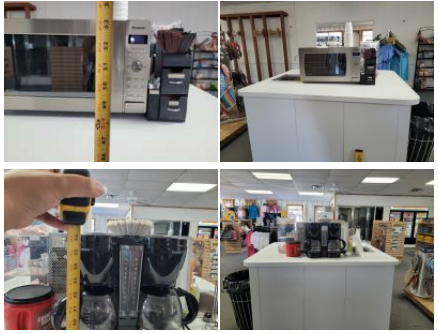
347	Eisenhower Yacht Club: Yacht Club - Store	[33.8205353 , -96.604490 3]	The microwave and coffee pot are positioned too high for either a side or front approach. Where a clear floor or ground space allows a parallel approach to an element and the side reach is unobstructed, the high side reach shall be 48 inches maximum and the low side reach shall be 15 inches minimum above the finish floor or ground. Where a forward reach is unobstructed, the high forward reach shall be 48 inches maximum and the low forward reach shall be 15 inches minimum above the finish floor or ground.	Public Space - Microwave and coffee pot high with reach over counter	Relocate microwave and coffee pot to be in reach range of 15" min to 48" max.	2015 ABAAS Section: 308.1  2012 TAS Section: 308.1  2010 ADAS Section: 308.1

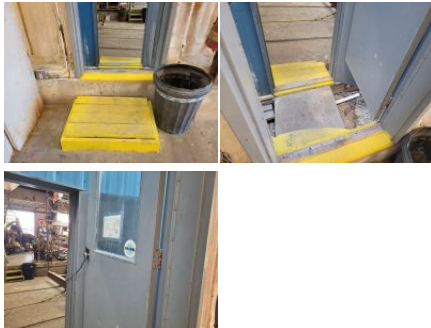
360	Eisenhower Yacht Club: Yacht Club- Shop	[33.8203898 , -96.607829 7]	Spaces and elements within employee work areas shall only be required to comply with 206.2.8, 207.1, and 215.3 and shall be designed and constructed so that individuals with disabilities can approach, enter, and exit the employee work area. Employee work areas, or portions of employee work areas, other than raised courtroom stations, that are less than 300 square feet (28 m2) and elevated 7 inches (180 mm) or more above the finish floor or ground where the elevation is essential to the function of the space shall not be required to comply with these requirements or to be on an accessible route.	Doors between buildings have steps, knobs, are tied open during use	For employee spaces, relocate storage, furniture, and other obstacles at doorways to provide approach, enter and exit at the employee space. Provide ramps for access between buildings. Replace door knobs with lever hardware.	2015 ABAAS Section: F203.9  2012 TAS Section: 203.9  2010 ADAS Section: 203.9

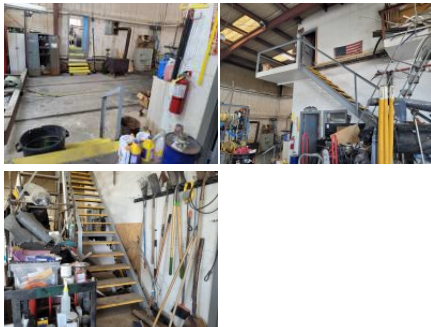
361	Eisenhower Yacht Club: Yacht Club- Shop	[33.8203897 , -96.607835]	There is no accessible route between elements in the building. An accessible route of travel must connect all elements and spaces within a building or facility.	Stairs between areas, noncompliance stairs to upper level	No AR to employee area, leave as is, and reassign duties if an employee with disabilities requires access here.	2015 ABAAS Section: F206.2.4  2012 TAS Section: 206.2.4  2010 ADAS Section: 206.2.4

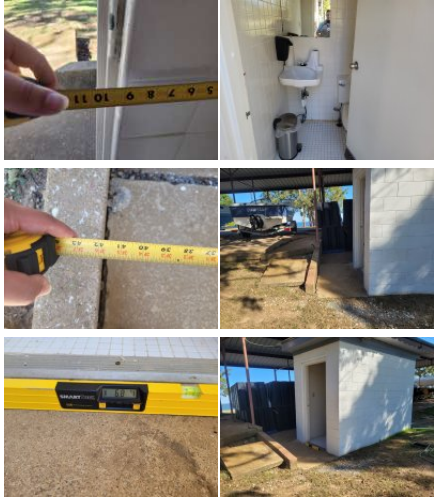
Finding Number	Area Description	Lat/Long	Finding	As Built	Recommendation	Citation	Photos	Figure
367	Eisenhower Yacht Club: Yacht Club - Restroom Building	[33.8211357 , -96.6060659]	Minimum maneuvering clearances at doors and gates shall comply with 404.2.4. Maneuvering clearances shall extend the full width of the doorway and the required latch side or hinge side clearance. Hand-activated door opening hardware, handles, pulls, latches, locks, and other operating devices on accessible doors shall have a shape that is easy to grasp with one hand and does not require tight grasping, tight pinching or twisting of the wrist to operate. Hardware shall be 34 inches minimum and 48 inches maximum above the finish floor or ground.	Women's - wall pull side, fixtures back pull side, knob, door does not open to 90 degrees, wall back push side, building sloping and door swings open easily, 6.8% slope	For all doors along the public circulation route, provide required maneuvering clearance and ground slope on push and pull side of doors For all doors along the public circulation route, inspect, adjust, and maintain closing speed on door closers For all doors along the public circulation route, replace hardware with lever hardware or hardware operable without a tight pinch or grasp	2010 ADAS Section: 404.2.3, 404.2.7, 404.2.4, 404.2.11, 404.2.11 Exception

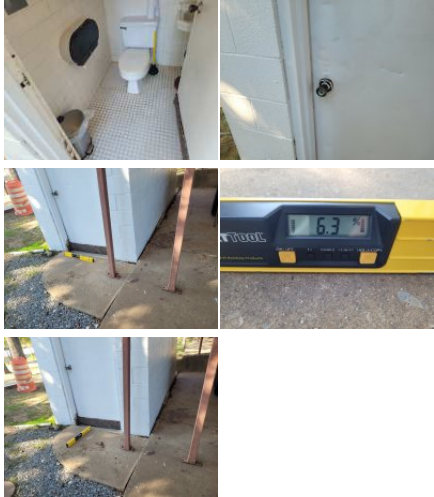
Finding Number	Area Description	Lat/Long	Finding	As Built	Recommendation	Citation	Photos	Figure																																										
368	Eisenhower Yacht Club: Yacht Club - Restroom Building	[33.8211432 , -96.6060617]	Minimum maneuvering clearances at doors and gates shall comply with 404.2.4. Maneuvering clearances shall extend the full width of the doorway and the required latch side or hinge side clearance. Door openings shall provide a clear width of 32 inches (815 mm) minimum. Clear openings of doorways with swinging doors shall be measured between the face of the door and the stop, with the door open 90 degrees. Openings more than 24 inches (610 mm) deep shall provide a clear opening of 36 inches (915 mm) minimum. There shall be no projections into the required clear opening width lower than 34 inches (865 mm) above the finish floor or ground. Projections into the clear opening width between 34 inches (865 mm) and 80 inches (2030 mm) above the finish floor or ground shall not exceed 4 inches (100 mm). Hand-activated door opening hardware, handles, pulls, latches, locks, and other operating devices on accessible doors shall have a shape that is easy to grasp with one hand and does not require tight grasping, tight pinching or twisting of the wrist to operate. Hardware shall be 34 inches minimum and 48 inches maximum above the finish floor or ground.	Men's- wall pull side, fixtures back pull side, knob, building sloping and door swings closed easily, 6.4% slope, multiple CIL and gaps	For all doors along the public circulation route, provide required maneuvering clearance and ground slope on push and pull side of doors For all doors along the public circulation route, inspect, adjust, and maintain closing speed on door closers For all doors along the public circulation route, replace hardware with lever hardware or hardware operable without a tight pinch or grasp	2010 ADAS Section: 404.2.3, 404.2.7, 404.2.4, 404.2.11, 404.2.11 Exception

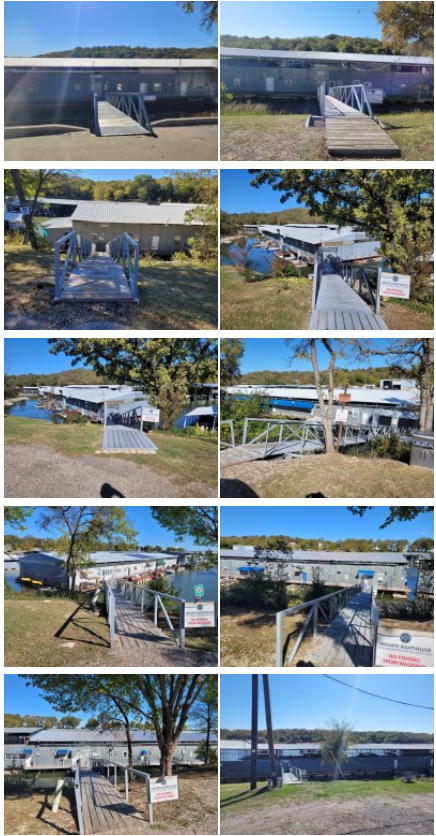
Finding Number	Area Description	Lat/Long	Finding	As Built	Recommendation	Citation	Photos	Figure																												
373	Eisenhower Yacht Club: Yacht Club- Boathouses	[33.8201762 , -96.607198 9]	The minimum number of boat slips is not provided. Where the number of boat slips is not identified, each 40 feet of boat slip edge provided along the perimeter of the pier shall be counted as one boat slip.	boathouses 5, 8, 9, 14, 15, 16, 17, 18, 22 have gangway only, seperate doors or each boat slip, doors have knobs, no wider boarding piers within, some have gates on gangways	Provide the required number of boat slips based on the total provided. Ensure pier and boat slip piers are 60" wide at boarding locations and do not reduce to less than 36" wide.	2015 ABAAS Section: F235.2  2010 ADAS Section: 235.2
