# Access Audit Site Report

**Eisenhower State Park**  
**50 Park Rd 20**  
**Denison, TX 75020**  
**Accessibility Evaluation**  
**Inspection Date: 10/13/2021**  
**Inspectors: Tanya Scheibe**

**TEXAS PARKS AND WILDLIFE DEPARTMENT  
EISENHOWER STATE PARK**

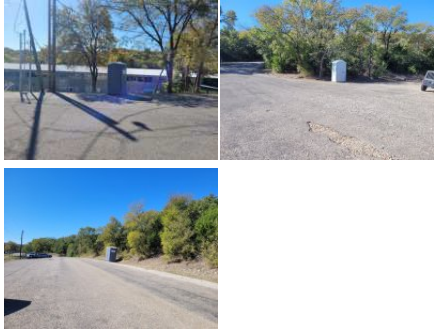
Finding Number	Area Description	Lat/Long	Finding	As Built	Recommendation	Citation	Photos	Figure
376	Eisenhower Yacht Club: Yacht Club- Boathouses	[33.8156856 , -96.606033 2]	The portable public restroom is not compliant. 5% of portable toilets must be accessible, minimum of 1. If sanitary facilities are provided, they must be made accessible to persons with disabilities. If public restrooms are desired, It is recommended that the portable unit be replaced with a permanent built in compliant restroom. The utilization of an accessible portable unit may be a temporary solution and is not recommended as a permanent solution.	Portable toilets provided at multiple locations, none accessible	Replace 5% of portable toilets with compliant models and place along AR	2015 ABAAS Section: F213.1  2012 TAS Section: 213.1  2010 ADAS Section: 213.1, 213.2 Exception 3

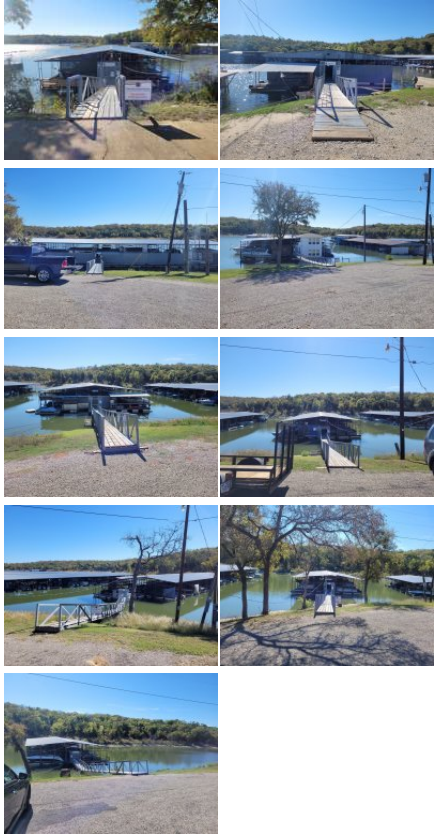
Finding Number	Area Description	Lat/Long	Finding	As Built	Recommendation	Citation	Photos	Figure																												
378	Eisenhower Yacht Club: Yacht Club- Boathouses	[33.8206161, -96.6049995]	The minimum number of boat slips is not provided. Where the number of boat slips is not identified, each 40 feet of boat slip edge provided along the perimeter of the pier shall be counted as one boat slip.	Boathouses 1, 6, 23, 24, 27, 28, 29, 30, 31 have gangway only, gates on gangways lack maneuvering and have knobs, no wider boarding piers within, doors have knobs where provided	Provide the required number of boat slips based on the total provided. Ensure pier and boat slip piers are 60" wide at boarding locations and do not reduce to less than 36" wide.	2015 ABAAS Section: F235.2  2010 ADAS Section: 235.2
