Access Audit Site Report

Estero Llano Grande State Park
3301 S International Blvd
Weslaco, TX 78596
Accessibility Evaluation
Inspection Date: 07/13/2022
Inspectors: Tanya Scheibe

Prepared By
WT Group

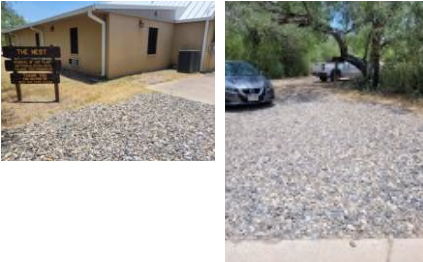
6	Exterior: Exterior Accessible Route	[26.1229756 , -97.960270 7]	There is no accessible route to The Nest. At least one accessible route shall connect accessible buildings, accessible facilities, accessible elements, and accessible spaces that are on the same site.	Lacks route to Camp Thicket: The Nest (west side)	Create an accessible route with crushed stone or other outdoor material from parking or walkway to The Nest.	2015 ABAAS Section: F206.2.2 2012 TAS Section: 206.2.2 2010 ADAS Section: 206.2.2

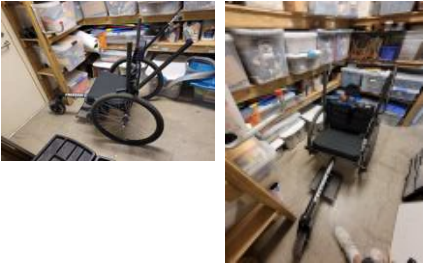
Finding Number	Area Description	Lat/Long	Finding	As Built	Recommendation	Citation	Photos	Figure
9	Exterior: Exterior Accessible Route	[26.1264048 , -97.956695 3]	Element meets all standards and requirements	Park HQ Storage Area: grit wheelchair - employee stated it is available upon request, information on requesting chair is provided online	None	2010 ADAS Section: N/A

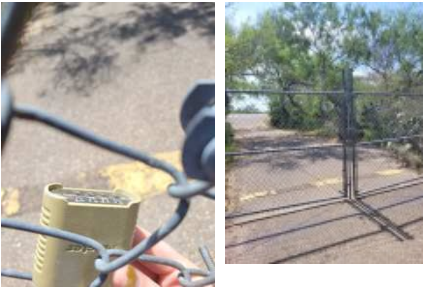
10	Exterior: Exterior Accessible Route	[26.122742, -97.961424]	The operable part is not accessible because it requires tight grasping, pinching or twisting of the wrist.	Camp Thicket: North Entrance - employee said they give guests the pass code and they let themselves in, lock requires tight pinch	Consider providing a different security system that doesn't require tight pinch or grasp.	2015 ABAAS Section: 309.4 2012 TAS Section: 309.4 2010 ADAS Section: 309.4

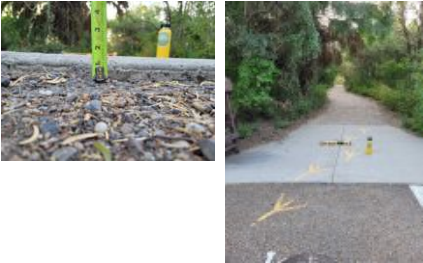
Finding Number	Area Description	Lat/Long	Finding	As Built	Recommendation	Citation	Photos	Figure
12	Exterior: Exterior Accessible Route	[26.126406, -97.956634 9]	The change in level where the gutter meets the curb ramp is greater than 1/4 inch. 1/4 inch is the maximum vertical rise. Changes in level between 1/4 inch and 1/2 inch must be beveled at 1:2 or less. Changes in level greater than 1/2 inch must be by way of a ramp.	Entrance brick walkway - 1.5" change in level at entry to Visitors Center	Repair, bevel or ramp CIL at gutter.	2015 ABAAS Section: 303.3 2012 TAS Section: 303.3 2010 ADAS Section: 303.3

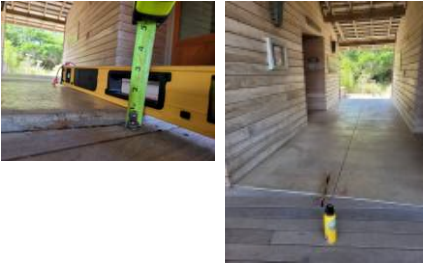
Finding Number	Area Description	Lat/Long	Finding	As Built	Recommendation	Citation	Photos	Figure
23	Headquarters Area: HQ - Exterior Accessible Route	[26.1264506 , -97.956537]	The walkway contains abrupt vertical edges and/or variations over a 1/4 inch. 1/4 inch is the maximum vertical rise. Changes in level between 1/4 inch and 1/2 inch must be beveled at 1:2 or less. Changes in level greater than 1/2 inch must be by way of a ramp.	.75" change in level at entry to restrooms from HQ	Repair, bevel or ramp CIL along the route.	2012 TAS Section: 303.2, 303.3 2010 ADAS Section: 303.2, 303.3

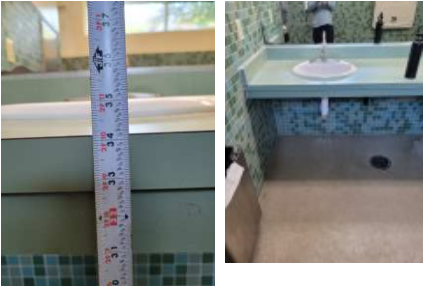
24	Headquarters Area: HQ - Men's Restrooms	[26.1264807 , -97.956494 1]	The top rim of the sink is too high. All lavatories/sinks that are designated to be accessible shall be a minimum 17 inches in horizontal depth and mounted with the rim or counter edge no higher than 34 inches above the finished floor.	sink rim 35" AFF	Lower sinks to max 34" above the finished floor (AFF) to front of rim.	2015 ABAAS Section: 606.3 2012 TAS Section: 606.3 2010 ADAS Section: 606.3

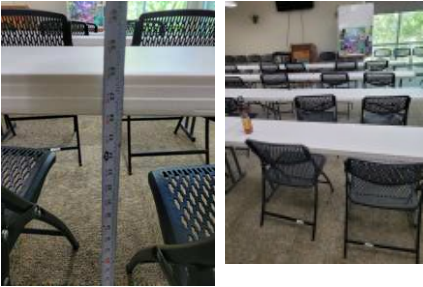
36	Headquarters Area: HQ - Public Spaces	[26.1265156 , -97.956520 9]	The top of the work surface is not within a compliant height range. The tops of tables and counters shall be 28 inches to 34 inches from the floor or ground.	Ibis Room - table has 26" knee clearance	Provide tables and work surfaces at 28" to 34" aff with required knee and toe clearances	2015 ABAAS Section: 902.3 2012 TAS Section: 902.3 2010 ADAS Section: 902.3

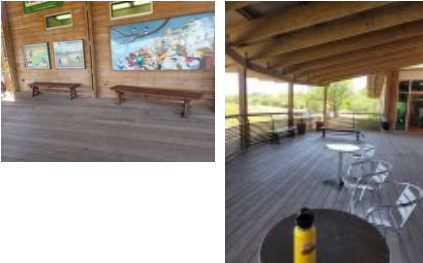
40	Headquarters Area: HQ - Observation Deck	[26.1264024 , -97.956533]	Element meets all standards and requirements	4 of 4 benches at HQ comply	None	2010 ADAS Section: N/A

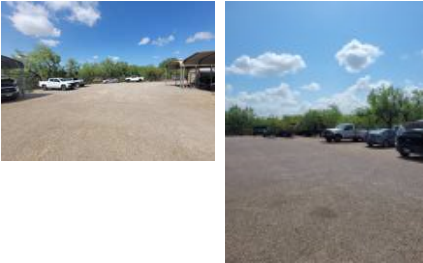
Finding Number	Area Description	Lat/Long	Finding	As Built	Recommendation	Citation	Photos	Figure
42	Employee Areas: Maintenance	[26.1275752 , -97.9555553]	There are no or not enough accessible parking stalls. Each lot where parking is provided for the public as clients, guests or employees, shall provide accessible parking and shall be located on the shortest accessible route of travel from adjacent parking to an accessible entrance.	no accessible stalls, gravel lot	Create one or more 8' accessible parking stalls, with one 5' adjacent access aisle, with proper signage and striping based on the total number of stalls.	2015 ABAAS Section: F208.2 2012 TAS Section: 208.2 2010 ADAS Section: 208.2

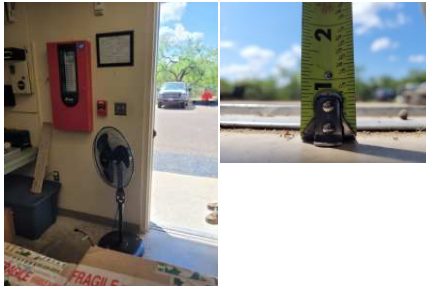
49	Employee Areas: Maintenance	[26.1275318 , -97.9556143]	Spaces and elements within employee work areas shall only be required to comply with 206.2.8, 207.1, and 215.3 and shall be designed and constructed so that individuals with disabilities can approach, enter, and exit the employee work area. Employee work areas, or portions of employee work areas, other than raised courtroom stations, that are less than 300 square feet (28 m2) and elevated 7 inches (180 mm) or more above the finish floor or ground where the elevation is essential to the function of the space shall not be required to comply with these requirements or to be on an accessible route.	door to back garage - .5" lipped threshold, fan in clearance on push	For employee spaces, relocate storage, furniture, and other obstacles at doorways to provide approach, enter and exit at the employee space. Repair, provide beveled threshold.	2015 ABAAS Section: F203.9 2012 TAS Section: 203.9 2010 ADAS Section: 203.9

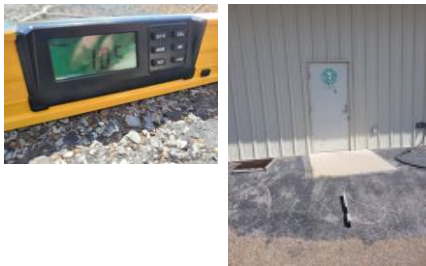
50	Employee Areas: Maintenance	[26.1275655 , -97.9554883]	Spaces and elements within employee work areas shall only be required to comply with 206.2.8, 207.1, and 215.3 and shall be designed and constructed so that individuals with disabilities can approach, enter, and exit the employee work area. Employee work areas, or portions of employee work areas, other than raised courtroom stations, that are less than 300 square feet (28 m2) and elevated 7 inches (180 mm) or more above the finish floor or ground where the elevation is essential to the function of the space shall not be required to comply with these requirements or to be on an accessible route.	10.5% slope at entry to second garage	Correct slope in door clearance to max 2.08%.	2015 ABAAS Section: F203.9 2012 TAS Section: 203.9 2010 ADAS Section: 203.9

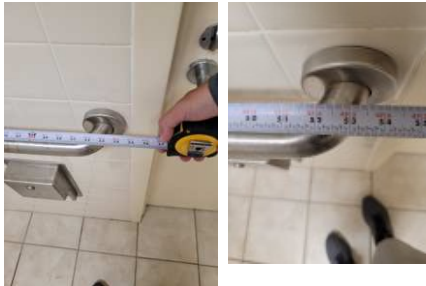
53	Employee Areas: Maintenance	[26.1274933 , -97.9556573]	The side grab bars are not in the correct location. Grab bars on the side wall must be installed so that the end closest to the rear wall is maximum 12" from the rear wall. The end furthest from the rear wall must be mounted minimum 54" from the rear wall.	Restroom off break room - side grab bar 52.75" from rear wall	Remount side grab bar to max 12" from the rear wall at the close end and min 54" on the far end, and 33" to 36" aff.	2015 ABAAS Section: 604.5.1 2012 TAS Section: 604.5.1 2010 ADAS Section: 604.5.1

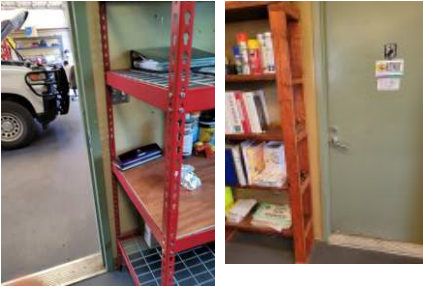
55	Employee Areas: Maintenance	[26.12739, -97.95552]	Spaces and elements within employee work areas shall only be required to comply with 206.2.8, 207.1, and 215.3 and shall be designed and constructed so that individuals with disabilities can approach, enter, and exit the employee work area. Employee work areas, or portions of employee work areas, other than raised courtroom stations, that are less than 300 square feet (28 m2) and elevated 7 inches (180 mm) or more above the finish floor or ground where the elevation is essential to the function of the space shall not be required to comply with these requirements or to be on an accessible route.	office in maintenance shop - clearance reduced by storage on push and pull	For employee spaces, relocate storage, furniture, and other obstacles at doorways to provide approach, enter and exit at the employee space. Provide required maneuvering clearance on push and pull side of doors.	2015 ABAAS Section: F203.9 2012 TAS Section: 203.9 2010 ADAS Section: 203.9

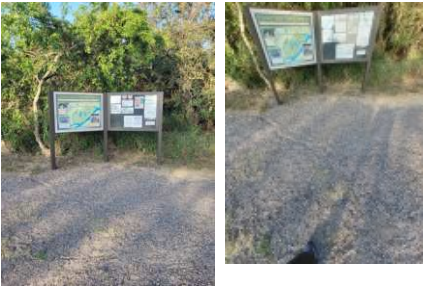
62	Park Site: Park Elements	[26.12684, -97.95794]	There is no accessible route to the kiosk. At least one accessible route shall connect accessible buildings, accessible facilities, accessible elements, and accessible spaces that are on the same site.	no route to sign by entry parking, near parking lot	Create an accessible route with crushed stone or other outdoor material from parking or walkway to kiosk.	2015 ABAAS Section: F206.2.2 2012 TAS Section: 206.2.2 2010 ADAS Section: 206.2.2

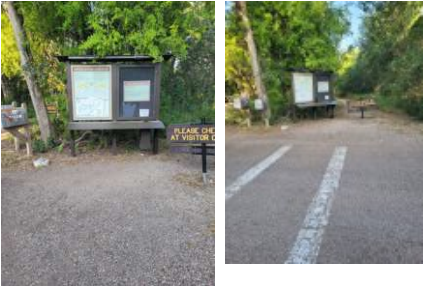
63	Park Site: Park Elements	[26.12656, -97.9578]	There is no accessible route to the kiosk. At least one accessible route shall connect accessible buildings, accessible facilities, accessible elements, and accessible spaces that are on the same site.	lacks route and clear ground space at self pay station near parking lot	Create an accessible route with crushed stone or other outdoor material from parking or walkway to kiosk.	2015 ABAAS Section: F206.2.2 2012 TAS Section: 206.2.2 2010 ADAS Section: 206.2.2

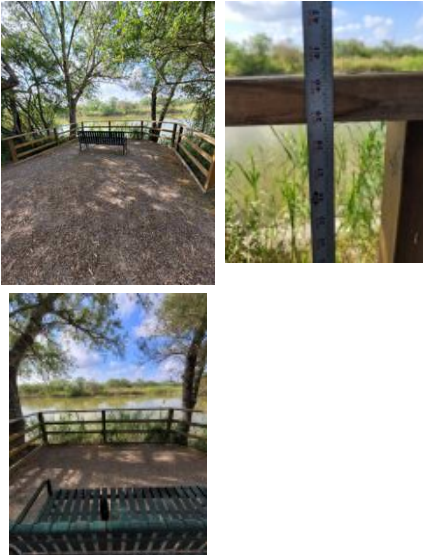
Finding Number	Area Description	Lat/Long	Finding	As Built	Recommendation	Citation	Photos	Figure
66	Park Site: Park Elements	[26.12602, -97.95163]	A turning space complying with 304.3 (60" by 60" or T shaped) shall be provided within viewing areas. The surface of clear ground spaces and turning spaces shall be firm and stable. The slope of the surface of clear ground spaces and turning spaces shall not be steeper than 1:48 in any direction. EXCEPTION: Where the surface is other than asphalt, concrete, or boards, slopes not steeper than 1:20 shall be permitted when necessary for drainage.	Overlook along Alligator Lake Trail - no route to viewing area, clear ground space at bench is loose gravel, railing 40.25" above ground level	Repair surface of viewing are clear ground space to be firm, stable and having max 2.08% slope or 5% for surfaces other than concrete, asphalt or boards as a smart practice. Provide an outdoor recreation access route to the viewing area. Lower a 36" wide portion of railing to max 32" AGL for unobstructed viewing as a smart practice.	2015 ABAAS Section: 1015.4, 1015.5, 1015.6, 1015.6 EXCEPTION

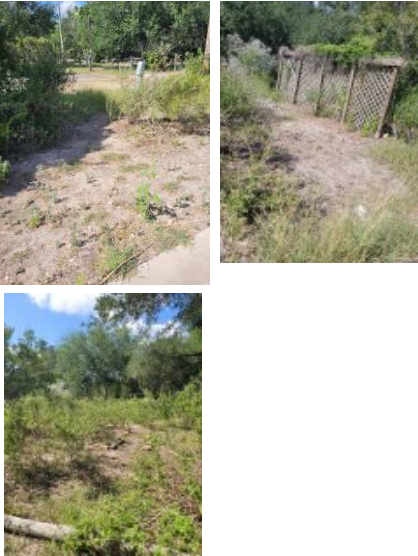
Finding Number	Area Description	Lat/Long	Finding	As Built	Recommendation	Citation	Photos	Figure
68	Park Site: Butterfly Garden	[26.1262844 , -97.957642 1]	The surface of trails, passing spaces, and resting intervals shall be firm and stable	Tropical Area butterfly garden lacks accessible surface	Replace surface of trail with one that is firm and stable as a smart practice.	2015 ABAAS Section: 1017.2

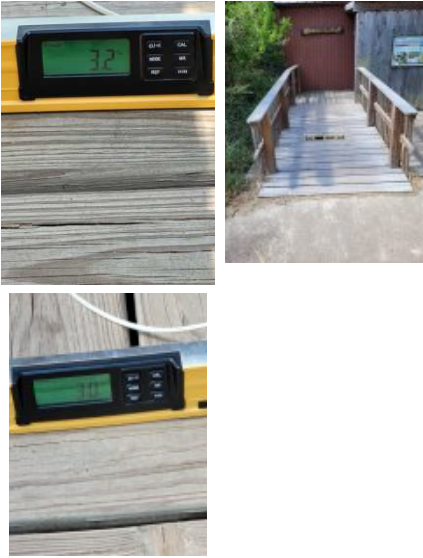
Finding Number	Area Description	Lat/Long	Finding	As Built	Recommendation	Citation	Photos	Figure
70	Park Site: Indigo Blind	[26.1236354 , -97.9581249]	The ramp on the accessible route contains cross slopes greater than 2%. Surface cross slopes shall not exceed one unit vertical in 48 units horizontal (2-percent slope).	entry ramp - cross slopes - 3.2%, 3%	Correct ramp cross slope to max 2.08%	2015 ABAAS Section: 405.3 2012 TAS Section: 405.3 2010 ADAS Section: 405.3

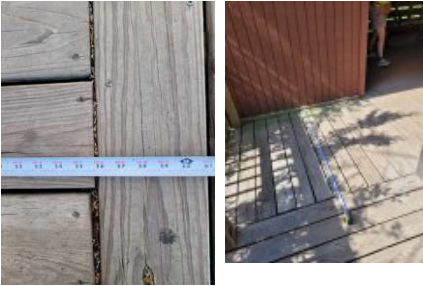
Finding Number	Area Description	Lat/Long	Finding	As Built	Recommendation	Citation	Photos	Figure
72	Park Site: Indigo Blind	[26.1236727 , -97.958099 4]	The landing at the change of direction is not the correct size. Landings at a change of direction shall have a dimension in the direction of ramp run of not less than 60 inches by 60 inches.	Entry ramp - landing at change of direction only 55.75"	Enlarge landing on ramp where directions change to 60" by 60"	2015 ABAAS Section: 405.7.4 2012 TAS Section: 405.7.4 2010 ADAS Section: 405.7.4

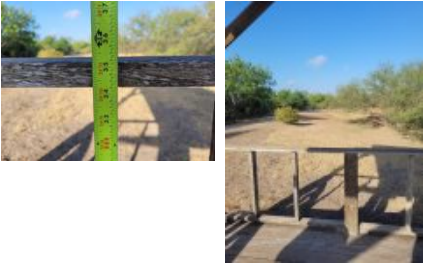
74	Park Site: Pavilion	[26.1241267 , -97.955619 7]	Each distinct viewing location shall provide a viewing space adjacent to the clear ground space required by 1015.2 through which the point of interest is viewable. The viewing space shall be 32 inches (815 mm) maximum and 51 inches (1295 mm) minimum high above the ground and shall extend the full width of the clear ground space.	railing at Ibis Pond Pavilion after boardwalk 35.5" AFF	Lower a 36" wide portion of railing to provide an unobstructed view between 32" and 51"	2015 ABAAS Section: 1015.3

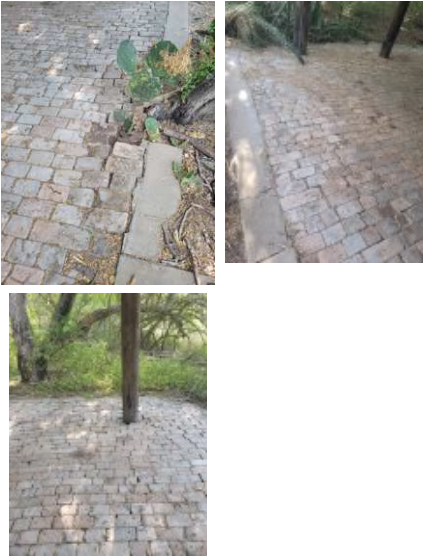
Finding Number	Area Description	Lat/Long	Finding	As Built	Recommendation	Citation	Photos	Figure
76	Park Site: Pavilion	[26.1260677, -97.95187]	There is a gap spaced greater than a 1/2 inch. Openings in floor or ground surfaces shall not allow passage of a sphere more than 1/2 inch diameter. Elongated openings shall be placed so that the long dimension is perpendicular to the dominant direction of travel.	Alligator Lake Pavilion pavers need reset within	Reset or replace pavers to provide level surface in pavilion as a smart practice.	2015 ABAAS Section: 302.3 2012 TAS Section: 302.3 2010 ADAS Section: 302.3

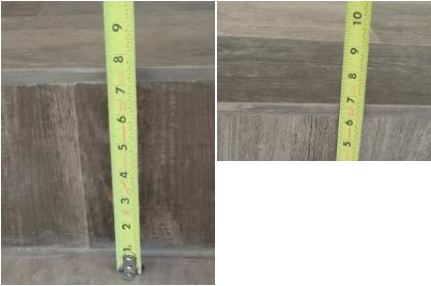
Finding Number	Area Description	Lat/Long	Finding	As Built	Recommendation	Citation	Photos	Figure
78	Camp Thicket Group Area: North Complex - Public Spaces	[26.1243049 , -97.960163 4]	There is a change in level greater than 1/4 inch. 1/4 inch is the maximum vertical rise. Changes in level between 1/4 inch and 1/2 inch must be beveled at 1:2 or less. Changes in level greater than 1/2 inch must be by way of a ramp.	Warbler - no route to the stage, two 7" steps	Provide a ramp for access to the stage.	2015 ABAAS Section: 303.3 2012 TAS Section: 303.3 2010 ADAS Section: 303.3

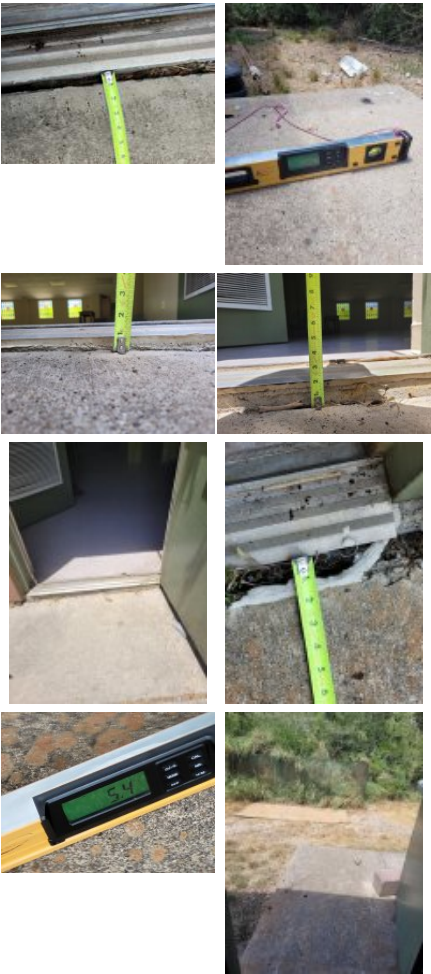
82	Camp Thicket Group Area: North Complex - Public Spaces	[26.1243145 , -97.9601848]	Minimum maneuvering clearances at doors and gates shall comply with 404.2.4. Maneuvering clearances shall extend the full width of the doorway and the required latch side or hinge side clearance. Maneuvering clearances shall have a max slope of 2.08%. The threshold has a vertical change greater than 1/4 inch high. Exterior doors are recommended to be maintained at 8.5 lbf as a smart practice. Force is to be measured at the operating hardware or 30 inches from the hinges, whichever is greater.	Warbler hall: side door by stage - 1" gap, 5% slope, 1.5" change in level storage room side - 13lbf, 1.5" change in level exit door by women's within church space - 14lbf, 1" gap, 5.4% slope	For all doors along the public circulation route, provide required maneuvering clearance on push and pull side of doors. For all doors along the public circulation route, correct slope in door clearance to max 2.08%. For all doors along the public circulation route, repair, bevel, or ramp CILs at door entries to max .25". For all doors along the public circulation route, inspect, adjust, and maintain 8.5 lbf to open exterior doors as a smart practice.	2010 ADAS Section: 404.2.3, 404.2.7, 404.2.4, 404.2.11, 404.2.11 Exception

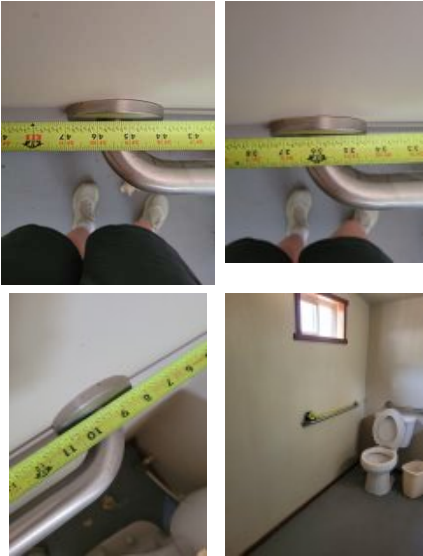
Finding Number	Area Description	Lat/Long	Finding	As Built	Recommendation	Citation	Photos	Figure
89	Camp Thicket Group Area: North Complex - Public Spaces	[26.1241989 , -97.961032 4]	The side grab bars are not in the correct location. Grab bars on the side wall must be installed so that the end closest to the rear wall is maximum 12" from the rear wall. The end furthest from the rear wall must be mounted minimum 54" from the rear wall.	Cha Cha Restroom - 36" grab bar mounted 10.5" from wall, extends 45.5" to grab bar end	Replace side grab bar with a 42" long bar mounted to max 12" from the rear wall at the close end and min 54" on the far end, and 33" to 36" aff.	2015 ABAAS Section: 604.5.1 2012 TAS Section: 604.5.1 2010 ADAS Section: 604.5.1

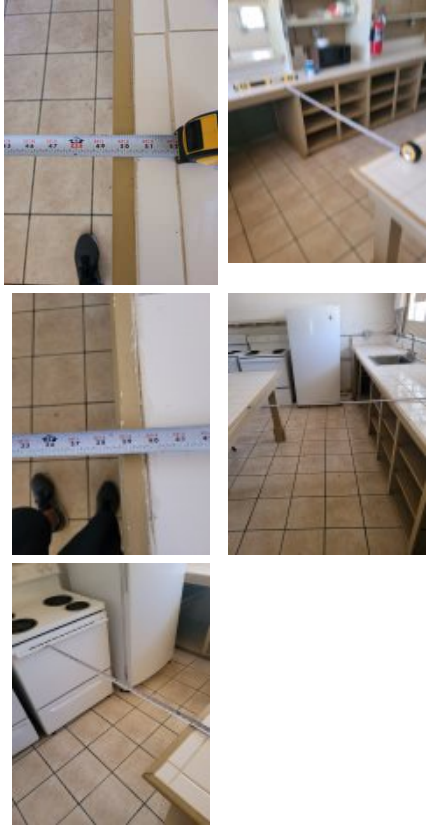
95	Camp Thicket Group Area: North Complex - Public Spaces	[26.1242567, -97.961021 7]	The U-shaped kitchen is not wide enough. In U-shaped kitchens enclosed on three contiguous sides, clearance between all opposing base cabinets, counter tops, appliances, or walls within kitchen work areas shall be 60 inches.	Cha Cha Kitchen - 49.5" and 38.75" between counters; 38" between work surface and oven	Renovate U shaped kitchen to provide required 60" clearance between cabinets, counter tops and appliances	2015 ABAAS Section: 804.2.2 2012 TAS Section: 804.2.2 2010 ADAS Section: 804.2.2

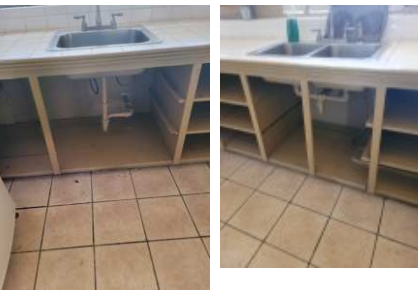
97	Camp Thicket Group Area: North Complex - Public Spaces	[26.1242375, -97.961086]	The water and drain pipes under the lavatory are not adequately insulated. Water supply and drain pipes under lavatories and sinks shall be insulated or otherwise configured to protect against contact. There shall be no sharp or abrasive surfaces under lavatories and sinks.	Cha Cha Kitchen - both sinks lack insulation	Insulate exposed pipes under one sink	2015 ABAAS Section: 606.5 2012 TAS Section: 606.5 2010 ADAS Section: 606.5

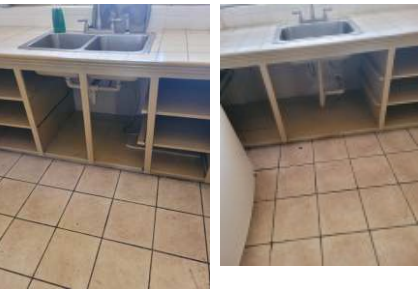
98	Camp Thicket Group Area: North Complex - Public Spaces	[26.1242615, -97.961080 7]	Knee and toe space has not been provided at the sink. Kitchen sinks must be provided with a clear floor space positioned for a forward approach including knee and toe clearance.	Cha Cha Kitchen - both lack knee and toe clearance	Remove under sink cabinet at one sink for knee clearance.	2015 ABAAS Section: 606.2, 804.4 2012 TAS Section: 606.2, 804.4 2010 ADAS Section: 606.2, 804.4

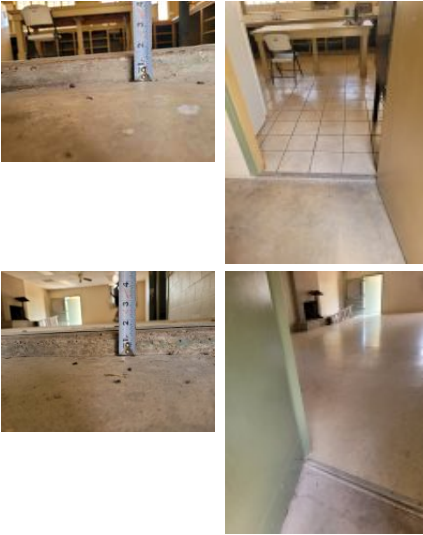
100	Camp Thicket Group Area: North Complex - Public Spaces	[26.1242459 , -97.9610546]	The threshold at a doorway shall be no higher than 1/2 inch. Changes in level between 1/4 inch and 1/2 inch must be beveled at 1:2 or less. 1/4 inch is the maximum vertical rise. Hand-activated door opening hardware, handles, pulls, latches, locks, and other operating devices on accessible doors shall have a shape that is easy to grasp with one hand and does not require tight grasping, tight pinching or twisting of the wrist to operate. Hardware shall be 34 inches minimum and 48 inches maximum above the finish floor or ground.	Cha Cha Kitchen - 2 doors to kitchen - knobs, 1.75 change in level into kitchen, 1.75" change in level into group hall	For all doors along the public circulation route, repair, bevel, or ramp CILs at door entries to max .25". For all doors along the public circulation route, replace hardware with lever hardware or hardware operable without a tight pinch or grasp.	2010 ADAS Section: 404.2.3, 404.2.7, 404.2.4, 404.2.11, 404.2.11 Exception

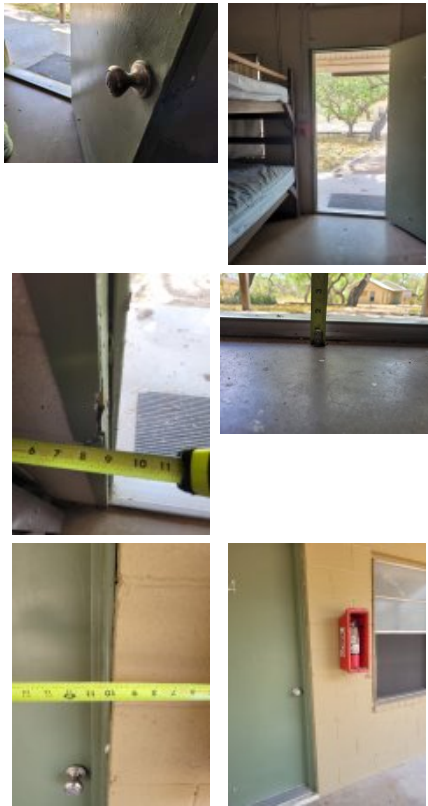
Finding Number	Area Description	Lat/Long	Finding	As Built	Recommendation	Citation	Photos	Figure
104	Camp Thicket Group Area: North Complex - Public Spaces	[26.1242182 , -97.9607186]	Minimum maneuvering clearances at doors and gates shall comply with 404.2.4. Maneuvering clearances shall extend the full width of the doorway and the required latch side or hinge side clearance. Maneuvering clearances shall have a max slope of 2.08%. The threshold has a vertical change greater than 1/4 inch high. Hand-activated door opening hardware, handles, pulls, latches, locks, and other operating devices on accessible doors shall have a shape that is easy to grasp with one hand and does not require tight grasping, tight pinching or twisting of the wrist to operate. Hardware shall be 34 inches minimum and 48 inches maximum above the finish floor or ground.	King fisher cabin - knob, 1.5" change in level (CIL) on exterior, loose mat, 9" clearance on pull, 11" clearance on push due to fire extinguisher	For all doors along the public circulation route, provide required maneuvering clearance on push and pull side of doors. For all doors along the public circulation route, secure rug in door clearance to prevent trip hazard. For all doors along the public circulation route, repair, bevel, or ramp CILs at door entries to max .25". For all doors along the public circulation route, replace hardware with lever hardware or hardware operable without a tight pinch or grasp.	2010 ADAS Section: 404.2.3, 404.2.7, 404.2.4, 404.2.11, 404.2.11 Exception

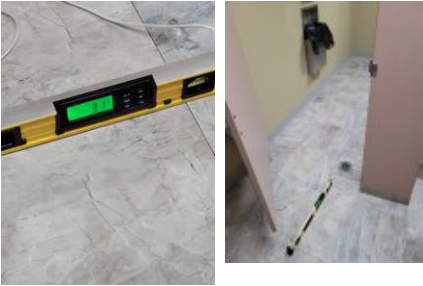
Finding Number	Area Description	Lat/Long	Finding	As Built	Recommendation	Citation	Photos	Figure
109	Camp Thicket Group Area: North Complex - Men's Restroom	[26.1242953 , -97.960184 8]	The accessible route contains running slopes greater than 5 percent and cross slopes greater than 2 percent across the width of the walk and has not been constructed as a ramp (i.e. handrails, wheel guides, etc.). When the slope in the direction of travel of any walk exceeds 1 unit vertical in 20 units horizontal (5-percent slope), it must be constructed as ramp. Surface cross slopes must not exceed one unit vertical in 48 units. Horizontal (2-percent slope).	Chapel Men's Restroom - 3.1% slope near drain	Correct or repair slope to max 5% running and 2.08% cross.	2015 ABAAS Section: 403.3 2012 TAS Section: 403.3 2010 ADAS Section: 403.3

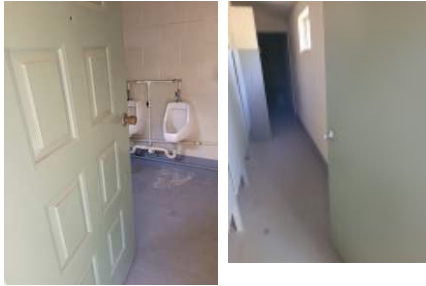
Finding Number	Area Description	Lat/Long	Finding	As Built	Recommendation	Citation	Photos	Figure
115	Camp Thicket Group Area: North Complex - Men's Restroom	[26.1238178, -97.9612655]	The door operating hardware is not accessible. Hand-activated door opening hardware, handles, pulls, latches, locks, and other operating devices on accessible doors shall have a shape that is easy to grasp with one hand and does not require tight grasping, tight pinching or twisting of the wrist to operate. Hardware shall be 34 inches minimum and 48 inches maximum above the finish floor or ground.	bird bath 4 restrooms and shower- men's and women's knobs	Replace hardware with lever hardware or hardware operable without a tight pinch or grasp	2015 ABAAS Section: 404.2.7 2012 TAS Section: 404.2.7 2010 ADAS Section: 404.2.7

Operating hardware must be centered between 34" and 48" above the floor or ground

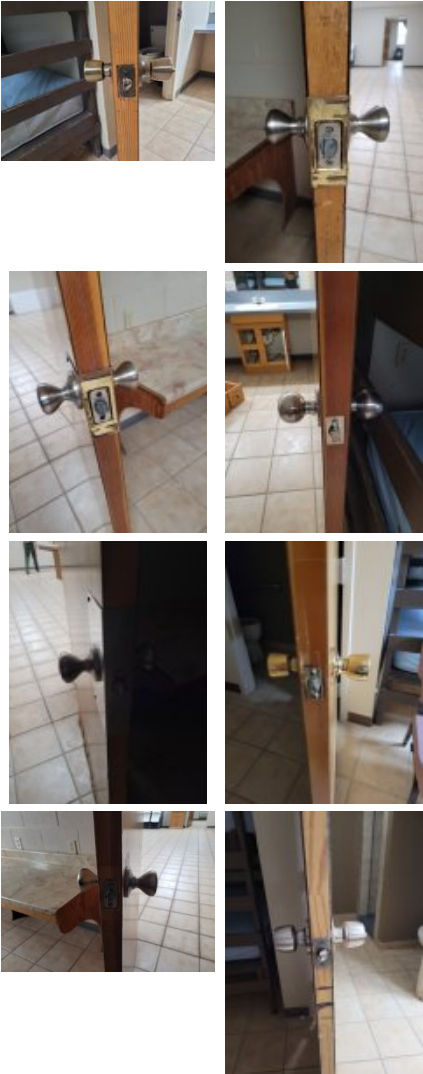
Finding Number	Area Description	Lat/Long	Finding	As Built	Recommendation	Citation	Photos	Figure
125	Camp Thicket Group Area: South Complex - Public Spaces	[26.1229756 , -97.9603458]	The door operating hardware is not accessible. Hand-activated door opening hardware, handles, pulls, latches, locks, and other operating devices on accessible doors shall have a shape that is easy to grasp with one hand and does not require tight grasping, tight pinching or twisting of the wrist to operate. Hardware shall be 34 inches minimum and 48 inches maximum above the finish floor or ground.	The nest, rooms 1-4 - 8 knobs total	Replace hardware with lever hardware or hardware operable without a tight pinch or grasp	2015 ABAAS Section: 404.2.7 2012 TAS Section: 404.2.7 2010 ADAS Section: 404.2.7

<p>Operating hardware must be centered between 34" and 48" above the floor or ground</p>

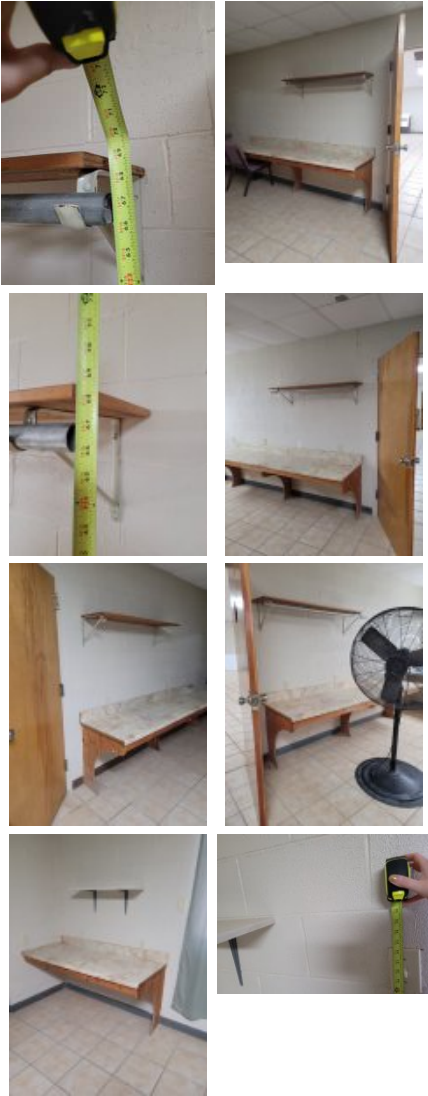
Finding Number	Area Description	Lat/Long	Finding	As Built	Recommendation	Citation	Photos	Figure
126	Camp Thicket Group Area: South Complex - Public Spaces	[26.1229756 , -97.9603028]	The operable part is positioned too high for either a side or front approach. Where a clear floor or ground space allows a parallel approach to an element and the side reach is unobstructed, the high side reach shall be 48 inches maximum and the low side reach shall be 15 inches minimum above the finish floor or ground. Where a forward reach is unobstructed, the high forward reach shall be 48 inches maximum and the low forward reach shall be 15 inches minimum above the finish floor or ground.	The nest for rooms 1-5 - shelf and rod - rod at 66" AFF, shelf 69" (5 instances of this), 5 - light 56" AFF	Remount operable parts to be in reach range of 15" min to 48" max. in at least one room.	2015 ABAAS Section: 308.1 2012 TAS Section: 308.1 2010 ADAS Section: 308.1

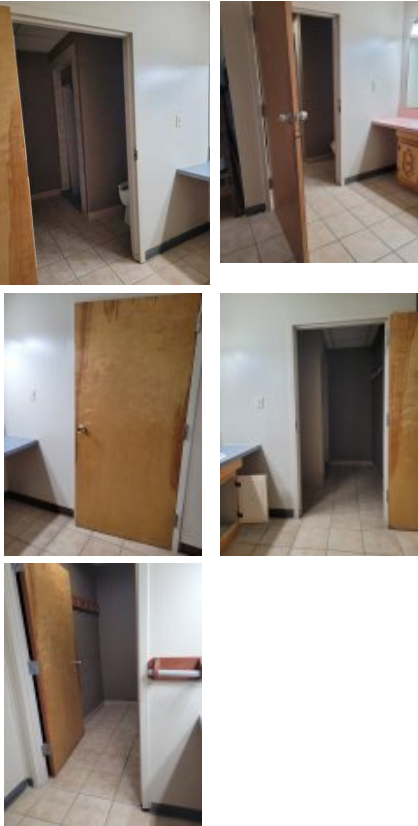
Finding Number	Area Description	Lat/Long	Finding	As Built	Recommendation	Citation	Photos	Figure
130	Camp Thicket Group Area: South Complex - Public Spaces	[26.1229804 , -97.9603028]	The restroom sign does not comply with one or more applicable requirements for the location, height, and properties of the sign.	1-5 no sign (5 instances)	Acquire and mount signage, including Braille and raised lettering and mount on wall, latch side of door, 48" to baseline of lowest character and 60" to baseline of highest character.	2015 ABAAS Section: F216.2, 703.1, 703.2, 703.5, 703.6 2012 TAS Section: 216.2, 703.1, 703.2, 703.5, 703.6 2010 ADAS Section: 216.2, 703.1, 703.2, 703.5, 703.6

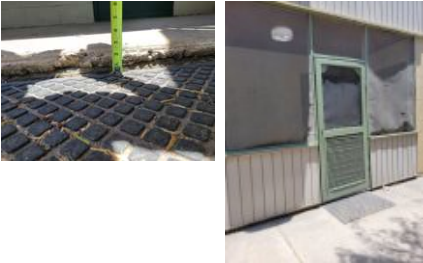
Finding Number	Area Description	Lat/Long	Finding	As Built	Recommendation	Citation	Photos	Figure
135	Camp Thicket Group Area: South Complex - Public Spaces	[26.1229756 , -97.960292 1]	Thresholds, if provided at doorways, shall be 1/2 inch (13 mm) high maximum. Raised thresholds and changes in level at doorways shall comply with 302 and 303. Changes in level of ¼ inch (6.4 mm) high maximum shall be permitted to be vertical. Changes in level between ¼ inch (6.4 mm) high minimum and ½ inch (13 mm) high maximum shall be beveled with a slope not steeper than 1:2. Changes in level greater than ½ inch (13 mm) high shall be ramped, and shall comply with 405 or 406.	The Nest - 2" change in level on breezeway door	Repair, bevel or ramp CIL at doorway	2015 ABAAS Section: 303.3, 404.2.5, 303.2, 303.4 2012 TAS Section: 303.3, 404.2.5, 303.2, 303.4 2010 ADAS Section: 303.3, 404.2.5, 303.2, 303.4

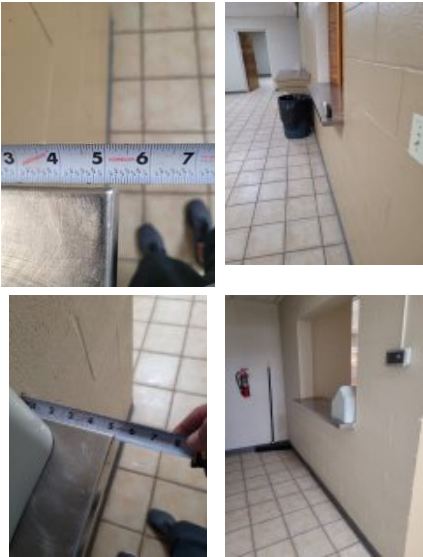
136	Camp Thicket Group Area: South Complex - Public Spaces	[26.1229659 , -97.960324 3]	An item or items project more than 4 inches into the circulation path. Wall-mounted objects that have leading edges between 27 inches and 80 inches from the floor must not project more than 4 inches into the circulation path. Protruding objects that extend to the floor or within 27 inches of the floor are cane detectable and are therefore not hazardous. Where it is necessary or desirable to have objects protrude from the wall, a manner of cane detection must be provided.	The Nest - 2 of 2 kitchen service counters project 5.25"	Relocate protruding objects or place cane detectable warning or bollard at foot of item.	2015 ABAAS Section: 307.2 2012 TAS Section: 307.2 2010 ADAS Section: 307.2

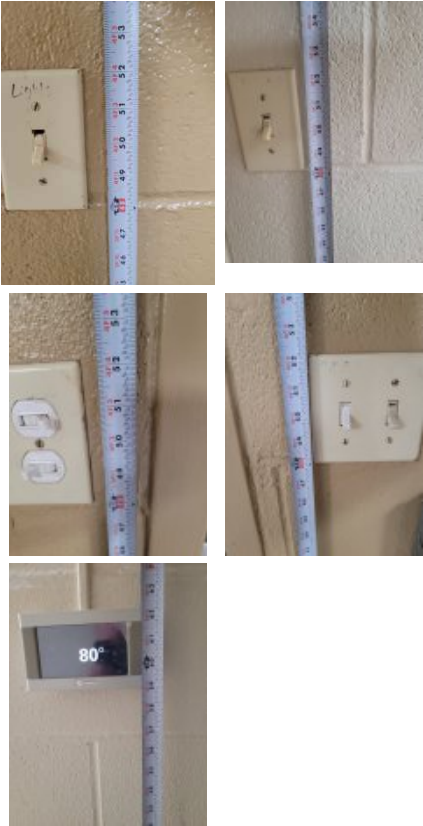
Finding Number	Area Description	Lat/Long	Finding	As Built	Recommendation	Citation	Photos	Figure
137	Camp Thicket Group Area: South Complex - Public Spaces	[26.1229081 , -97.9603458]	The operable part is positioned too high for either a side or front approach. Where a clear floor or ground space allows a parallel approach to an element and the side reach is unobstructed, the high side reach shall be 48 inches maximum and the low side reach shall be 15 inches minimum above the finish floor or ground. Where a forward reach is unobstructed, the high forward reach shall be 48 inches maximum and the low forward reach shall be 15 inches minimum above the finish floor or ground.	The Nest - 4 of 4 light switches 50" AFF; thermostat 60" AFF	Remount operable parts to be in reach range of 15" min to 48" max. Leave as is light switches citing safe harbor.	2015 ABAAS Section: 308.1 2012 TAS Section: 308.1 2010 ADAS Section: 308.1

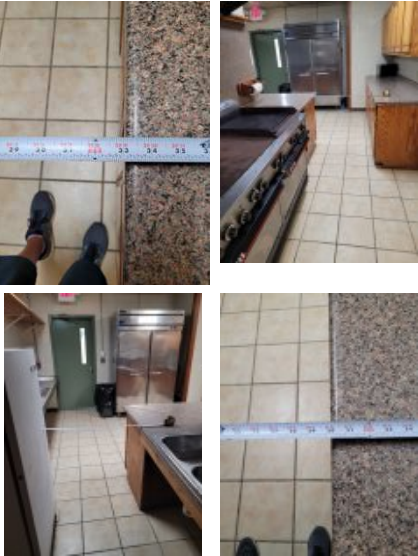
Finding Number	Area Description	Lat/Long	Finding	As Built	Recommendation	Citation	Photos	Figure
140	Camp Thicket Group Area: South Complex - Public Spaces	[26.1229178 , -97.960335]	The U-shaped kitchen is not wide enough. In U-shaped kitchens enclosed on three contiguous sides, clearance between all opposing base cabinets, counter tops, appliances, or walls within kitchen work areas shall be 60 inches.	The Nest - 33" width on grill side; 30" near small fridge	Renovate U shaped kitchen to provide required 60" clearance between cabinets, counter tops and appliances	2015 ABAAS Section: 804.2.2 2012 TAS Section: 804.2.2 2010 ADAS Section: 804.2.2

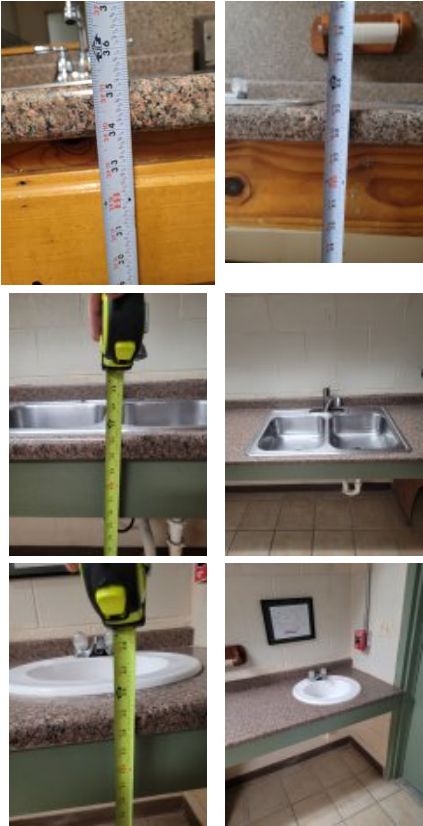
Finding Number	Area Description	Lat/Long	Finding	As Built	Recommendation	Citation	Photos	Figure
141	Camp Thicket Group Area: South Complex - Public Spaces	[26.1229852 , -97.960292 1]	The top rim of the sink is too high. All lavatories/sinks that are designated to be accessible shall be a minimum 17 inches in horizontal depth and mounted with the rim or counter edge no higher than 34 inches above the finished floor.	The Nest - small sink near stove/oven 35.25" AFF; 3 compartment sink 35.25" AFF; 3 sinks near front door 35.25" AFF	Lower one of each type of sink to max 34" above the finished floor (AFF) to front of rim.	2015 ABAAS Section: 606.3 2012 TAS Section: 606.3 2010 ADAS Section: 606.3

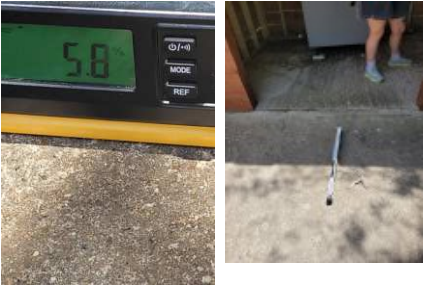
Finding Number	Area Description	Lat/Long	Finding	As Built	Recommendation	Citation	Photos	Figure
146	Camp Thicket Group Area: South Complex - Public Spaces	[26.12295, -97.96043]	The running slope of walking surfaces shall not be steeper than 1:20.	The Nest - 5.8% slope on route to ice machine	Correct running slope along the AR to max 5%	2015 ABAAS Section: 403.3 2012 TAS Section: 403.3 2010 ADAS Section: 403.3

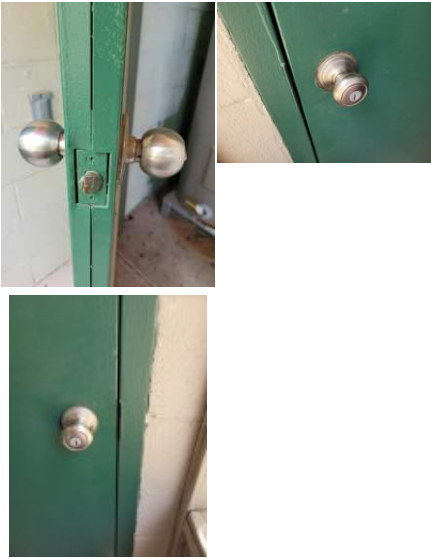
147	Camp Thicket Group Area: South Complex - Employee Spaces	[26.1230237, -97.9603136]	Spaces and elements within employee work areas shall only be required to comply with 206.2.8, 207.1, and 215.3 and shall be designed and constructed so that individuals with disabilities can approach, enter, and exit the employee work area. Employee work areas, or portions of employee work areas, other than raised courtroom stations, that are less than 300 square feet (28 m2) and elevated 7 inches (180 mm) or more above the finish floor or ground where the elevation is essential to the function of the space shall not be required to comply with these requirements or to be on an accessible route.	doors on nest at entry - waterheater and storage - 3 knobs	Replace hardware with lever hardware or hardware operable without a tight pinch or grasp.	2015 ABAAS Section: F203.9 2012 TAS Section: 203.9 2010 ADAS Section: 203.9

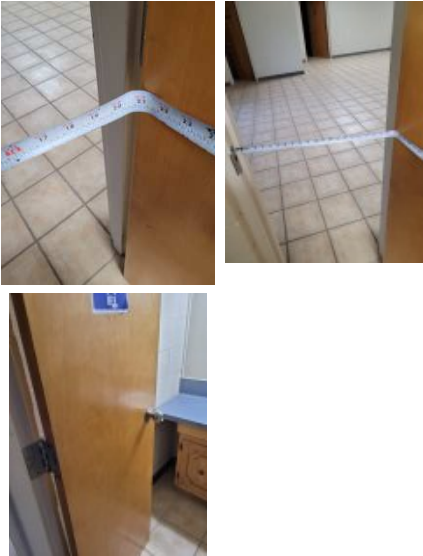
Finding Number	Area Description	Lat/Long	Finding	As Built	Recommendation	Citation	Photos	Figure
150	Camp Thicket Group Area: South Complex- Men's Restroom	[26.1229926 , -97.960205 3]	Door openings shall provide a clear width of 32 inches (815 mm) minimum. Clear openings of doorways with swinging doors shall be measured between the face of the door and the stop, with the door open 90 degrees. Openings more than 24 inches (610 mm) deep shall provide a clear opening of 36 inches (915 mm) minimum. There shall be no projections into the required clear opening width lower than 34 inches (865 mm) above the finish floor or ground. Projections into the clear opening width between 34 inches (865 mm) and 80 inches (2030 mm) above the finish floor or ground shall not exceed 4 inches (100 mm). Hand-activated door opening hardware, handles, pulls, latches, locks, and other operating devices on accessible doors shall have a shape that is easy to grasp with one hand and does not require tight grasping, tight pinching or twisting of the wrist to operate. Hardware shall be 34 inches minimum and 48 inches maximum above the finish floor or ground.	The Nest - 21" width, knob	For all doors along the public circulation route, replace doors with doors having 80" overhead clearance and 32" clear width. For all doors along the public circulation route, replace hardware with lever hardware or hardware operable without a tight pinch or grasp.	2010 ADAS Section: 404.2.3, 404.2.7, 404.2.4, 404.2.11, 404.2.11 Exception

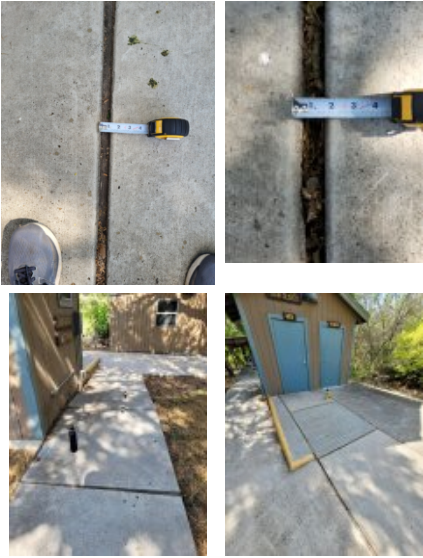
Finding Number	Area Description	Lat/Long	Finding	As Built	Recommendation	Citation	Photos	Figure
161	Pauraque Event Center: Pauraque - Public Spaces	[26.12338, -97.95731]	There is a gap spaced greater than a 1/2 inch. Openings in floor or ground surfaces shall not allow passage of a sphere more than 1/2 inch diameter. Elongated openings shall be placed so that the long dimension is perpendicular to the dominant direction of travel.	large 1"- 1.75" gaps (4 total) from shuffle board to restrooms	Correct or fill gaps to be max .5"	2015 ABAAS Section: 302.3 2012 TAS Section: 302.3 2010 ADAS Section: 302.3

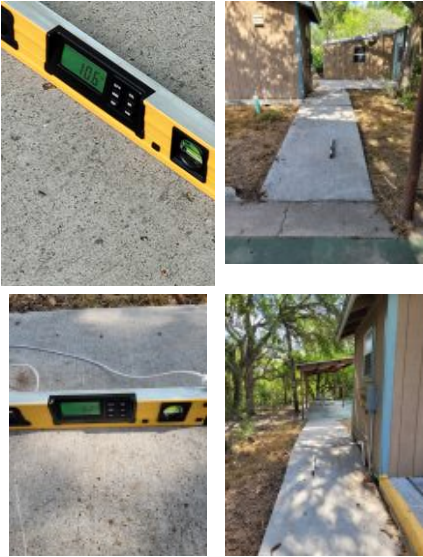
162	Pauraque Event Center: Pauraque - Public Spaces	[26.12339, -97.95742]	The running slope of walking surfaces shall not be steeper than 1:20.	10.6%, 9.2% slope from shuffle board to restrooms	Correct running slope along the AR to max 5%	2015 ABAAS Section: 403.3 2012 TAS Section: 403.3 2010 ADAS Section: 403.3

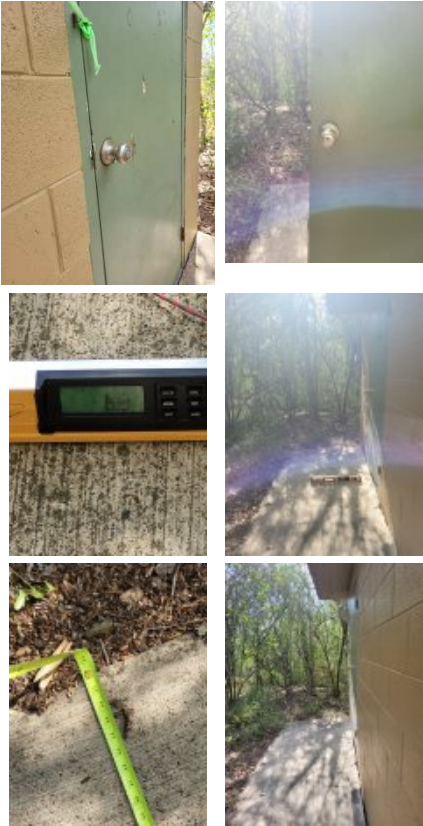
Finding Number	Area Description	Lat/Long	Finding	As Built	Recommendation	Citation	Photos	Figure
167	Pauraque Event Center: Pauraque - Women's Restroom	[26.1239762 , -97.957348 4]	Minimum maneuvering clearances at doors and gates shall comply with 404.2.4. Maneuvering clearances shall extend the full width of the doorway and the required latch side or hinge side clearance. Maneuvering clearances shall have a max slope of 2.08%. Hand-activated door opening hardware, handles, pulls, latches, locks, and other operating devices on accessible doors shall have a shape that is easy to grasp with one hand and does not require tight grasping, tight pinching or twisting of the wrist to operate. Hardware shall be 34 inches minimum and 48 inches maximum above the finish floor or ground.	Women's - knob; men's - knob, 6.3% slope, latch approach, 48" back clearance	For all doors along the public circulation route, provide required maneuvering clearance on push and pull side of doors. For all doors along the public circulation route, replace hardware with lever hardware or hardware operable without a tight pinch or grasp.	2010 ADAS Section: 404.2.3, 404.2.7, 404.2.4, 404.2.11, 404.2.11 Exception

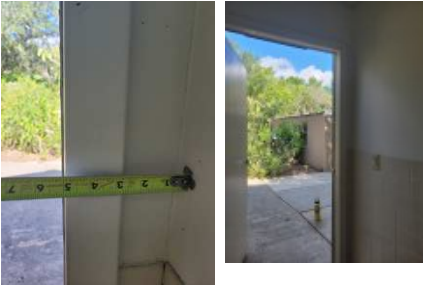
Finding Number	Area Description	Lat/Long	Finding	As Built	Recommendation	Citation	Photos	Figure
170	Pauraque Event Center: Bird Bath Restroom - Womens	[26.123409, -97.957567]	Minimum maneuvering clearances at doors and gates shall comply with 404.2.4. Maneuvering clearances shall extend the full width of the doorway and the required latch side or hinge side clearance.	Door - 5" clearance on push	Provide required maneuvering clearance on push side of door	2015 ABAAS Section: 404.2.4.4, 404.2.4.1 2012 TAS Section: 404.2.4.4, 404.2.4.1 2010 ADAS Section: 404.2.4.4, 404.2.4.1

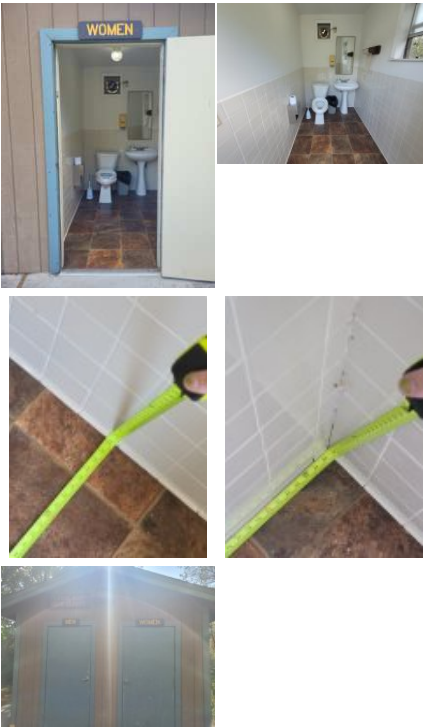
171	Pauraque Event Center: Bird Bath Restroom - Womens	[26.1234283, -97.9574812]	50% of the single accommodation restrooms provided in this grouping are not nearly compliant. The restrooms do not have the required minimum clear floor space or maneuvering clearances for the toilet, The restrooms do not have the required minimum clear floor space or maneuvering clearances for the lavatory, The entry doors do not contain the required minimum maneuvering spaces on the pull/push sides, The entry doors encroach into the required clear floor space for fixtures, Grab bars are missing and/or incorrectly installed, Accessories, such as toilet seat covers, paper towel holders, garbage cans, hand dryers, and mirrors are either too high or without clear floor space or both, The restrooms contain floor level changes greater than a 1/2 inch, the showers are too small and missing numerous accessible elements.	non compliant restroom - women's 56 x 86.5", lacks directional signage	Create compliant wheelchair accessible restrooms and correct all features to be accessible if feasible to meet 50% compliant restrooms in this location.	2015 ABAAS Section: 603.1 2012 TAS Section: 603.1 2010 ADAS Section: 603.1

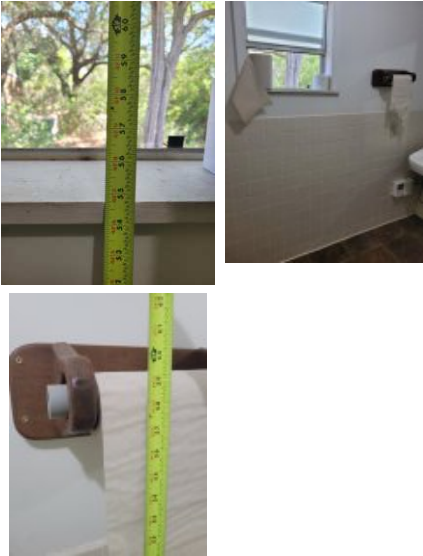
Finding Number	Area Description	Lat/Long	Finding	As Built	Recommendation	Citation	Photos	Figure
174	Pauraque Event Center: Bird Bath Restroom - Mens	[26.1233428 , -97.9573994]	Where a high forward reach is over an obstruction, the clear floor space shall extend beneath the element for a distance not less than the required reach depth over the obstruction. The high forward reach shall be 48 inches (1220 mm) maximum where the reach depth is 20 inches (510 mm) maximum. Where the reach depth exceeds 20 inches (510 mm), the high forward reach shall be 44 inches (1120 mm) maximum and the reach depth shall be 25 inches (635 mm) maximum. Where a clear floor or ground space allows a parallel approach to an element and the high side reach is over an obstruction, the height of the obstruction shall be 34 inches (865 mm) maximum and the depth of the obstruction shall be 24 inches (610 mm) maximum. The high side reach shall be 48 inches (1220 mm) maximum for a reach depth of 10 inches (255 mm) maximum. Where the reach depth exceeds 10 inches (255 mm), the high side reach shall be 46 inches (1170 mm) maximum for a reach depth of 24 inches (610 mm) maximum.	supplies in window 54.75" AFF, paper towels 57" AFF	Lower operating mechanisms to max 48" above the finished floor (AFF) to highest operable part.	2015 ABAAS Section: 308.2.1, 308.3.2 2012 TAS Section: 308.2.1, 308.3.2 2010 ADAS Section: 308.2.1, 308.3.2

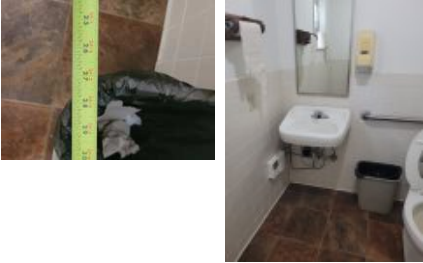
175	Pauraque Event Center: Bird Bath Restroom - Mens	[26.1233512 , -97.9574087]	The operable part is not accessible because there is not adequate clear floor space for either a forward or side approach. The clear floor or ground space shall be 30 inches minimum by 48 inches minimum.	27" width under sink due to trash	Remove, or relocate storage in CFS at fixtures and operable parts along the AR	2015 ABAAS Section: 305.3 2012 TAS Section: 305.3 2010 ADAS Section: 305.3

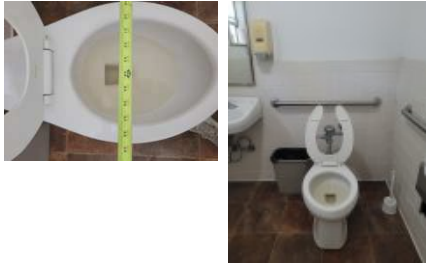
Finding Number	Area Description	Lat/Long	Finding	As Built	Recommendation	Citation	Photos	Figure
176	Pauraque Event Center: Bird Bath Restroom - Mens	[26.1226432 , -97.9573202]	The toilet is not located within the range allowed from the side wall or partition. The centerline of the toilet must be 16 to 18 inches from the side wall.	24" centerline	Remount toilets to 16" to 18" from the side wall to centerline	2015 ABAAS Section: 604.2 2012 TAS Section: 604.2 2010 ADAS Section: 604.2

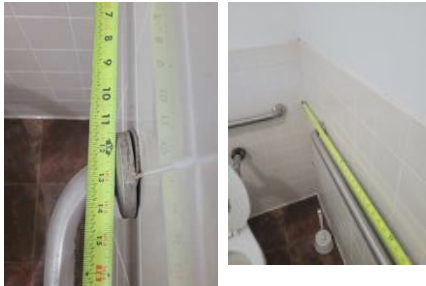
177	Pauraque Event Center: Bird Bath Restroom - Mens	[26.1233344 , -97.9574101]	The side grab bars are not in the correct location. Grab bars on the side wall must be installed so that the end closest to the rear wall is maximum 12" from the rear wall. The end furthest from the rear wall must be mounted minimum 54" from the rear wall.	mounted 13" from rear wall	Remount side grab bar to max 12" from the rear wall at the close end and min 54" on the far end, and 33" to 36" aff.	2015 ABAAS Section: 604.5.1 2012 TAS Section: 604.5.1 2010 ADAS Section: 604.5.1

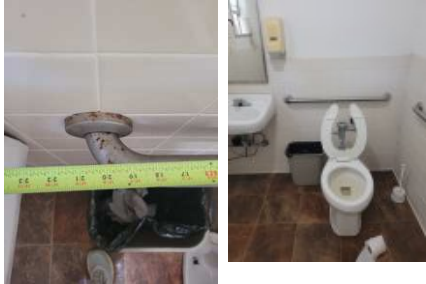
178	Pauraque Event Center: Bird Bath Restroom - Mens	[26.1233428 , -97.9574047]	The rear grab bar is not 36" long or is not mounted in the correct location. The rear grab bar must be a minimum of 36" long and extend from the toilet centerline a minimum 12" towards the wall side and a minimum 24" towards the open side of the toilet. Grab bars shall be installed in a horizontal position, 33 inches minimum and 36 inches maximum above the finish floor measured to the top of the gripping surface and the space between the grab bar and the top of the tank shall be 1-1/2 inches minimum.	20.5" from centerline to open side	Remount rear grab bar to behind the toilet, 12" to the wall side of center and 24" to the open side and 33" to 36" AFF.	2015 ABAAS Section: 604.5.2 2012 TAS Section: 604.5.2 2010 ADAS Section: 604.5.2

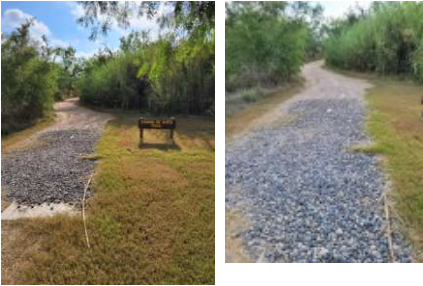
Finding Number	Area Description	Lat/Long	Finding	As Built	Recommendation	Citation	Photos	Figure
181	Trails: Trail Surface	[26.12693, -97.95303]	The surface of trails, passing spaces, and resting intervals shall be firm and stable	Park Trail near Grebe Marsh - not accessible, natural surface	Replace surface of trail with one that is firm and stable as a smart practice.	2015 ABAAS Section: 1017.2

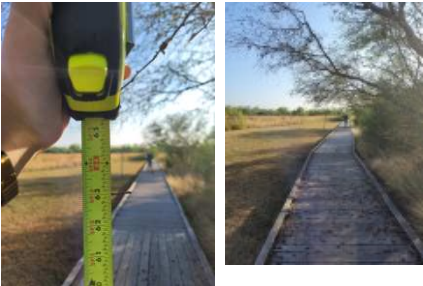
182	Trails: ADA Accessible Trails	[26.1253308, -97.9558745]	The tree limb extends down too close to the route of travel. Any obstruction that overhangs a route of travel must be a minimum of 80 inches above the walking surface as measured from the bottom of the obstruction.	Ibis Pond Boardwalk South - tree overhangs in overhead at 63" by changing water, changing birds sign	Maintain overhead clearance of min. 80".	2015 ABAAS Section: 307.3 2012 TAS Section: 307.3 2010 ADAS Section: 307.3

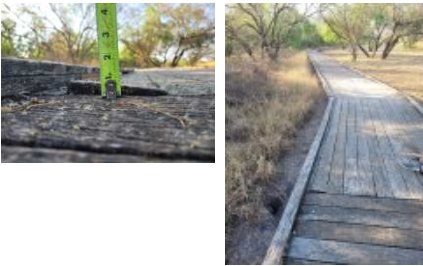
183	Trails: ADA Accessible Trails	[26.1252585, -97.9542089]	Tread obstacles on trails, passing spaces, and resting intervals shall not exceed 1/2 inch (13 mm) in height measured vertically to the highest point. EXCEPTION: Where the surface is other than asphalt, concrete, or boards, tread obstacles shall be permitted to not exceed 2 inches (50 mm) in height measured vertically to the highest point.	Ibis Pond Boardwalk South - after picnic table- .75" CIL	Repair, bevel or ramp tread obstacle along pathway to max .5" as a smart practice.	2015 ABAAS Section: 1017.5

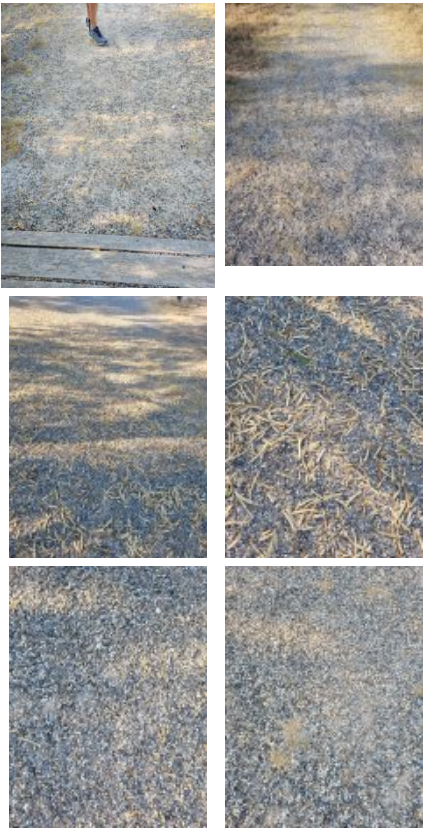
185	Trails: ADA Accessible Trails	[26.124854, -97.954026 5]	The surface of trails, passing spaces, and resting intervals shall be firm and stable	trails by alligator pond listed as accessible but they are dirt and pebble surface; no AR to Ibis Pond Boardwalk South, no AR to any of the amenities beyond the cement path after HQ due to surface	Replace surface of trail with one that is firm and stable as a smart practice.	2015 ABAAS Section: 1017.2
