Access Audit Site Report

Estero Llano Grande State Park
3301 S International Blvd
Weslaco, TX 78596
Accessibility Evaluation
Inspection Date: 07/13/2022
Inspectors: Tanya Scheibe

Prepared By
WT Group

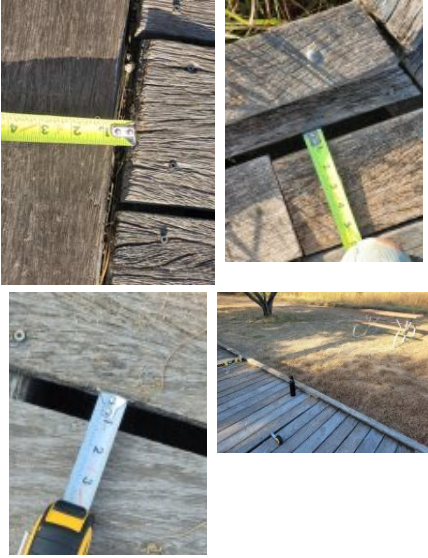
186	Trails: ADA Accessible Trails	[26.1252393 , -97.954179 4]	Tread obstacles on trails, passing spaces, and resting intervals shall not exceed 1/2 inch (13 mm) in height measured vertically to the highest point. EXCEPTION: Where the surface is other than asphalt, concrete, or boards, tread obstacles shall be permitted to not exceed 2 inches (50 mm) in height measured vertically to the highest point.	Ibis Pond Boardwalk South - after changing water changing birds turn - two .75" gaps, by picnic table 1" gap, beyond picnic table, 2" gap, approaching end 2" , .75" gap approaching end, 1"	Repair, bevel or ramp tread obstacle along pathway to max .5" as a smart practice.	2015 ABAAS Section: 1017.5

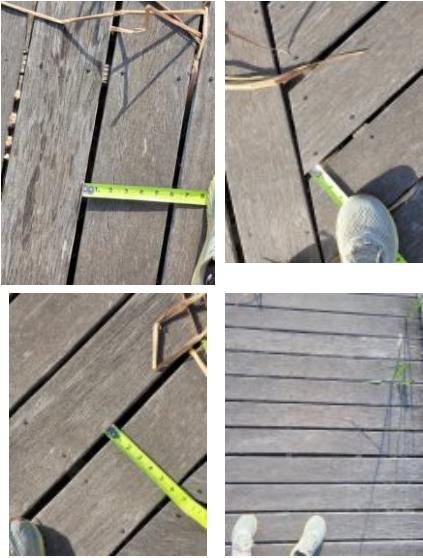
Finding Number	Area Description	Lat/Long	Finding	As Built	Recommendation	Citation	Photos	Figure
189	Trails: ADA Accessible Trails	[26.125798, -97.955979 1]	Tread obstacles on trails, passing spaces, and resting intervals shall not exceed 1/2 inch (13 mm) in height measured vertically to the highest point. EXCEPTION: Where the surface is other than asphalt, concrete, or boards, tread obstacles shall be permitted to not exceed 2 inches (50 mm) in height measured vertically to the highest point.	Ibis Pond Boardwalk - multiple half inch gaps - 76 in total	Repair, bevel or ramp tread obstacle along pathway to max .5" as a smart practice.	2015 ABAAS Section: 1017.5

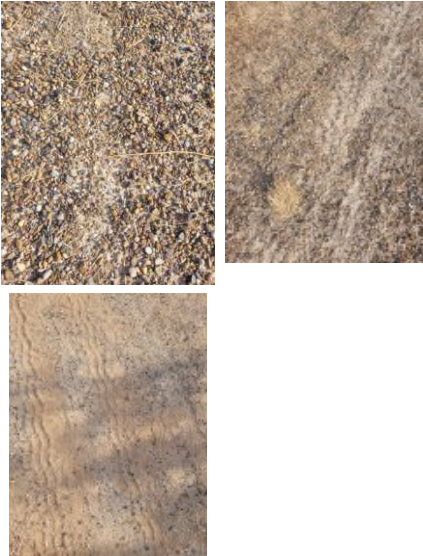
Finding Number	Area Description	Lat/Long	Finding	As Built	Recommendation	Citation	Photos	Figure
191	Trails: ADA Accessible Trails	[26.12522, -97.95452]	The surface of trails, passing spaces, and resting intervals shall be firm and stable	curlew trail not accessible	Replace surface of trail with one that is firm and stable as a smart practice.	2015 ABAAS Section: 1017.2
