Access Audit Site Report

Fort Boggy State Park
4994 Highway 75 South
Centerville, TX 75833
Accessibility Evaluation
Inspection Date: 09/15/2022
Inspectors: Tanya Scheibe

Prepared By
WT Group

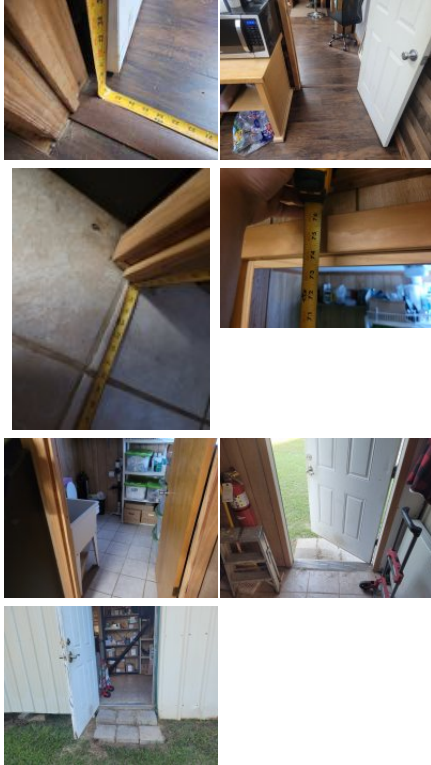
20	Headquarters Area: HQ - Employee Spaces	[31.1873617 , -95.976672 6]	Spaces and elements within employee work areas shall only be required to comply with 206.2.8, 207.1, and 215.3 and shall be designed and constructed so that individuals with disabilities can approach, enter, and exit the employee work area. Employee work areas, or portions of employee work areas, other than raised courtroom stations, that are less than 300 square feet (28 m2) and elevated 7 inches (180 mm) or more above the finish floor or ground where the elevation is essential to the function of the space shall not be required to comply with these requirements or to be on an accessible route.	Back office - 28.5" wide, knob, shelf pull side; restroom/storage - 27" wide, knob, sink pull side, 73.5" overhead; rear door - lacks egress, steps	For employee spaces, relocate storage, furniture, and other obstacles at doorways to provide approach, enter and exit at the employee space. Provide required maneuvering clearance on push and pull side of doors. Replace doors with doors having 80" overhead clearance and 32" clear width. Replace hardware with lever hardware or hardware operable without a tight pinch or grasp. Enlarge cement pad at exit to allow 18" clearance on the latch side, and extend a pathway away from the building for emergency egress.	2015 ABAAS Section: F203.9 2012 TAS Section: 203.9 2010 ADAS Section: 203.9

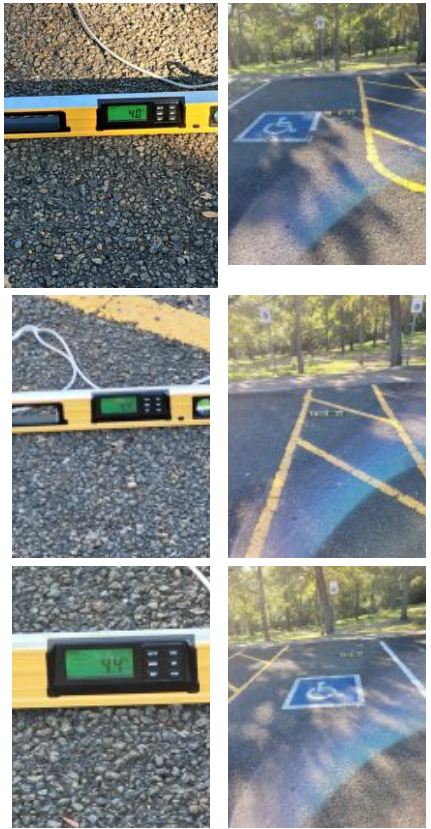
Finding Number	Area Description	Lat/Long	Finding	As Built	Recommendation	Citation	Photos	Figure
31	Day Use Area: Day Use - Parking	[31.1823453 , -95.977885 4]	Element meets all standards and requirements	Group Pavilion - 2 accessible, 14 standard, meets scoping	None	2010 ADAS Section: N/A		
32	Day Use Area: Day Use - Parking	[31.1823384 , -95.977889 4]	The cross slopes (narrow dimension) and/or running slopes (long dimension) of the access aisle exceeds 2%. The running slope and the cross slope in an accessible parking stall and the access aisle must not exceed 2%.	Group Pavilion - left 4%, aisle 4.4%, right 4.4%	Repair or correct slope of parking space and access aisle to max 2.08% in any direction.	2015 ABAAS Section: 502.4 2012 TAS Section: 502.4 2010 ADAS Section: 502.4

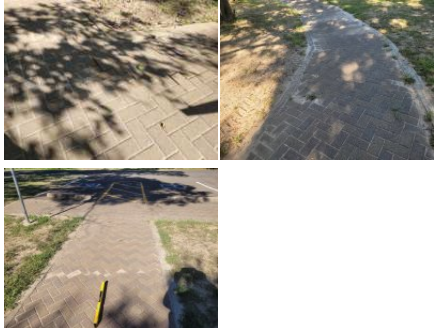
90	Day Use Area: Day Use - Showers	[31.18355, -95.97737]	The walkway contains abrupt vertical edges and/or variations over a 1/4 inch. 1/4 inch is the maximum vertical rise. Changes in level between 1/4 inch and 1/2 inch must be beveled at 1:2 or less. Changes in level greater than 1/2 inch must be by way of a ramp.	Pavers heaving near turn to parking, pavers sunken near park host	Repair, or reset pavers for a compliant route.	2012 TAS Section: 303.2, 303.3 2010 ADAS Section: 303.2, 303.3

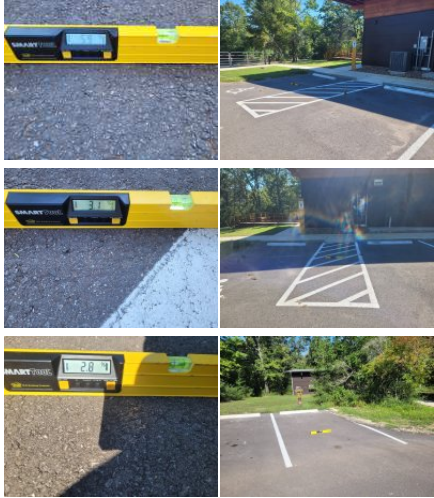
95	Cabins (1-5): Parking	[31.18289, -95.97936]	The cross slopes (narrow dimension) and/or running slopes (long dimension) of the access aisle exceeds 2%. The running slope and the cross slope in an accessible parking stall and the access aisle must not exceed 2%.	5.9% van stall, 3.1% van aisle, 2.8% cabin stall	Repair or correct slope of parking space and access aisle to max 2.08% in any direction.	2015 ABAAS Section: 502.4 2012 TAS Section: 502.4 2010 ADAS Section: 502.4

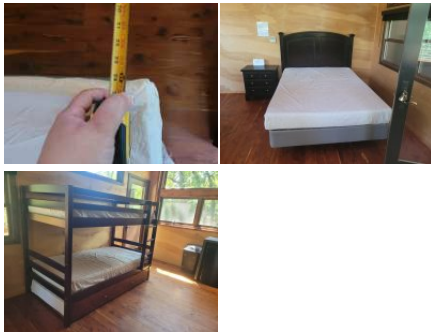
103	Cabins (1-5): Cabin 1	[31.1831258 , -95.978721 8]	The required clear space on both sides of the bed has not been provided. Accessible sleeping rooms shall have a 30 inch minimum by 48 inch minimum clear width space located along both sides of a bed.	24" wide at full bed, access one side at bunk beds	Relocate furniture to provide a 30 inch minimum by 48 inch minimum clear width space located along both sides of a bed.	2015 ABAAS Section: 806.2.3 2012 TAS Section: 806.2.3 2010 ADAS Section: 806.2.3

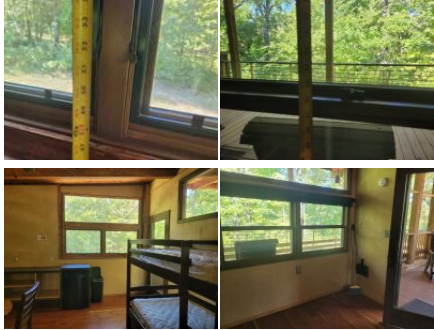
Finding Number	Area Description	Lat/Long	Finding	As Built	Recommendation	Citation	Photos	Figure
111	Cabins (1-5): Cabin 5	[31.1831419 , -95.979507 7]	The operable part is positioned too high for either a side or front approach. Where a clear floor or ground space allows a parallel approach to an element and the side reach is unobstructed, the high side reach shall be 48 inches maximum and the low side reach shall be 15 inches minimum above the finish floor or ground. Where a forward reach is unobstructed, the high forward reach shall be 48 inches maximum and the low forward reach shall be 15 inches minimum above the finish floor or ground.	Window hardware high at 52"	Remount operable parts to be in reach range of 15" min to 48" max.	2015 ABAAS Section: 308.1 2012 TAS Section: 308.1 2010 ADAS Section: 308.1

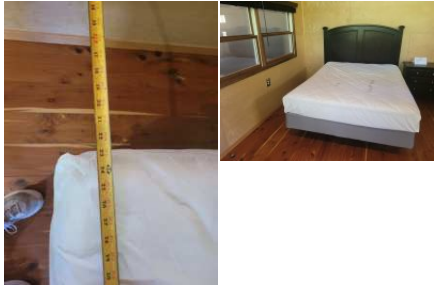
Finding Number	Area Description	Lat/Long	Finding	As Built	Recommendation	Citation	Photos	Figure
114	Cabins (1-5): Cabin 5	[31.1831281 , -95.979523 8]	The required clear space on both sides of the bed has not been provided. Accessible sleeping rooms shall have a 30 inch minimum by 48 inch minimum clear width space located along both sides of a bed.	23" one side of full bed, access one side at bunk beds	Relocate furniture to provide a 30 inch minimum by 48 inch minimum clear width space located along both sides of a bed.	2015 ABAAS Section: 806.2.3 2012 TAS Section: 806.2.3 2010 ADAS Section: 806.2.3

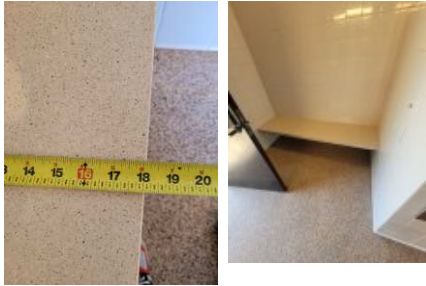
Finding Number	Area Description	Lat/Long	Finding	As Built	Recommendation	Citation	Photos	Figure
129	Cabins (1-5): New Restrooms	[31.183174, -95.978826 4]	The bench is not deep enough or long enough or is missing. Benches shall be provided having seats that are 42 inches long minimum and 20 inches deep minimum and 24 inches deep maximum. The bench shall provide for back support or shall be affixed to a wall. Back support shall be 42 inches (1065 mm) long minimum and shall extend from a point 2 inches (51 mm) maximum above the seat surface to a point 18 inches (455 mm) minimum above the seat surface. Back support shall be 2½ inches (64 mm) maximum from the rear edge of the seat measured horizontally. The top of the bench seat surface shall be 17 inches (430 mm) minimum and 19 inches (485 mm) maximum above the finish floor or ground. Clear floor or ground space complying with 305 shall be provided and shall be positioned at the end of the bench seat and parallel to the short axis of the bench	Left Restroom - bench has 8" depth	Replace bench in dressing area with one having a seat depth of 20" to 24" deep, 42" long, affixed to the wall or having a back and mounted 17" to 19" AFF and provide required clear floor space on the short axis of the bench.	2012 TAS Section: 903.4, 903.2, 903.3, 903.5 2010 ADAS Section: 903.4, 903.2, 903.3, 903.5

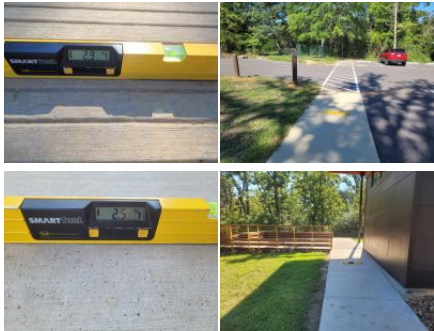
132	Cabins (1-5): New Restroom Exterior Accessible Route	[31.182818, -95.979177 6]	The cross slope of walking surfaces shall not be steeper than 1:48.	2.9% cross to trail, 2.5% along deck side of building	Correct cross slopes to max 2.08%.	2012 TAS Section: 403.3 2010 ADAS Section: 403.3

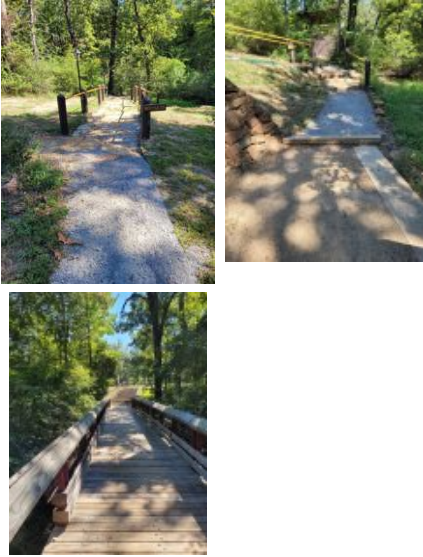
Finding Number	Area Description	Lat/Long	Finding	As Built	Recommendation	Citation	Photos	Figure
136	Cabins (1-5): Route to Cabins 2, 3, 4	[31.18355, -95.97842]	The surface of outdoor recreation access routes, passing spaces, and resting intervals shall be firm and stable	Route from day use to cabins not accessible; stairs, uneven surface, changes in level and areas of loose gravel	Repair surface or ORAR to be firm and stable as a smart practice.	2015 ABAAS Section: 1016.2
