Access Audit Site Report

Ft. Leaton State Historic Site

Accessibility Evaluation

Inspection Date: 09/22/2021

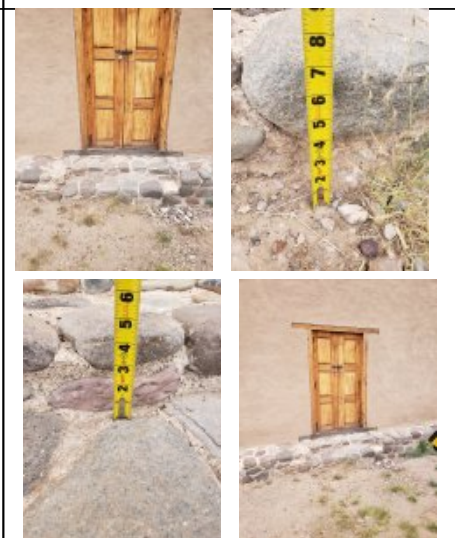
Finding Number	Area Description	Lat/Long	Finding	As Built	Recommendation	Citation	Photos	Figure
			<p>Projections into the clear opening width between 34 inches (865 mm) and 80 inches (2030 mm) above the finish floor or ground shall not exceed 4 inches (100 mm). The threshold has a vertical change greater than 1/4 inch high. The building entrance is not located on an accessible route. When a building, or portion of a building, is required to be accessible, an accessible route of travel shall be provided to all portions of the building, to accessible building entrances and between the building and the public way. At least one accessible route within the boundary of the site must be provided from public transportation stops, accessible parking and accessible passenger loading zones and public streets or sidewalks to the accessible building entrance they serve. The accessible route shall, to the maximum extent feasible, coincide with the route for the general public. At least one accessible route shall connect accessible buildings, facilities, elements and spaces that are on the same site. At least one accessible route shall connect accessible building or facility entrances with all accessible spaces and elements. The stair risers are not uniform in height. Stair riser heights shall be 7 inches maximum and 4 inches minimum. On any given flight of stairs, all steps shall have uniform riser height and uniform tread widths.</p>

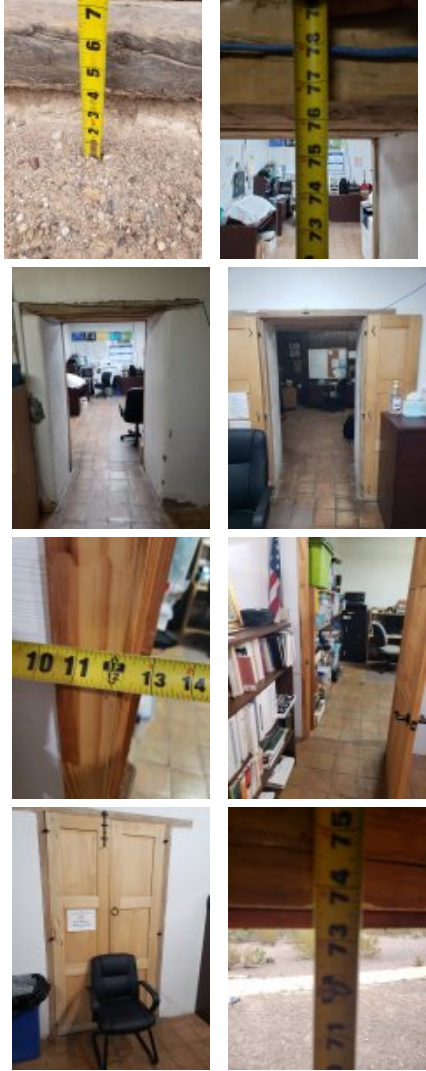
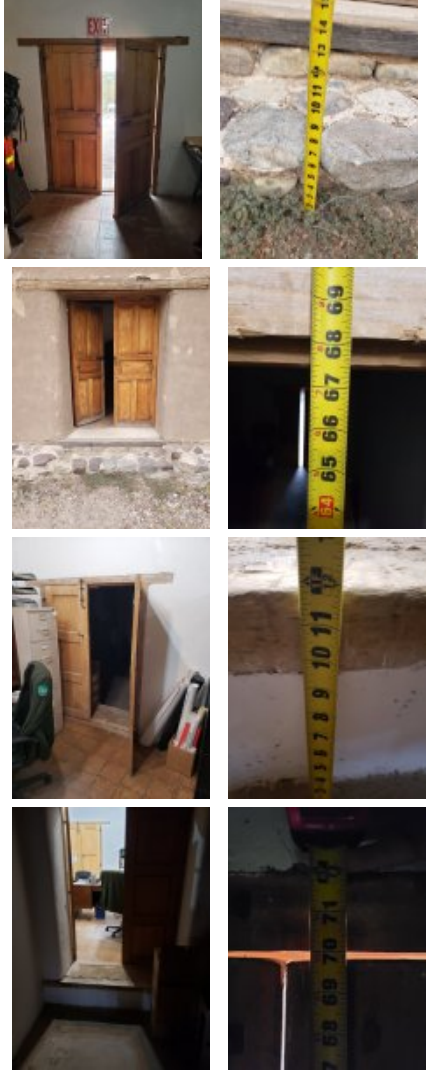
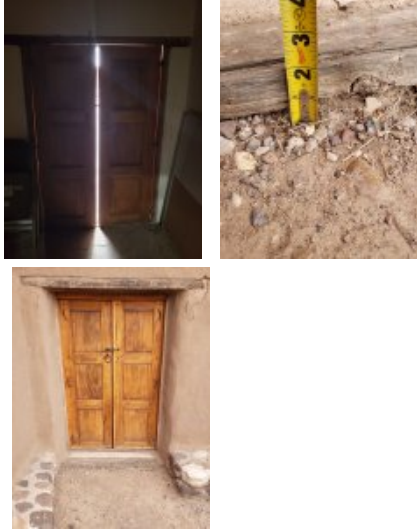
Finding Number	Area Description	Lat/Long	Finding	As Built	Recommendation	Citation	Photos	Figure
57	Fort Leaton: Employee Spaces	[29.5425333, -104.3263421]	Spaces and elements within employee work areas shall only be required to comply with 206.2.8, 207.1, and 215.3 and shall be designed and constructed so that individuals with disabilities can approach, enter, and exit the employee work area. Employee work areas, or portions of employee work areas, other than raised courtroom stations, that are less than 300 square feet (28 m2) and elevated 7 inches (180 mm) or more above the finish floor or ground where the elevation is essential to the function of the space shall not be required to comply with these requirements or to be on an accessible route.	Entrance to back area - 28" wide, desk in pull side maneuvering clearance Exterior door - bookshelf in pull side, lacks push side maneuvering clearance, 7" CIL push side, 71" tall Door between spaces - 76" tall Door to end office - 12" pull side maneuvering clearance (structural) and bookcase stored in pull side maneuvering clearance Door from office to exhibit - door locked and closed at all times, furniture in front of door but compliant otherwise Exterior double door - 73" head clearance, lacks accessible route, CIL due to cobble stone steps (vary in size) Double door to storage area - 67" high, fuel cabinet in pull side maneuvering clearance, 12" CIL push side Exterior door from storage - 70" headroom, lacks push side maneuvering clearance, lacks accessible route, 2" CIL on push side	For employee spaces, relocate storage, furniture, and other obstacles at doorways to provide approach, enter and exit at the employee space. Provide required maneuvering clearance on push and pull side of doors. Replace doors with doors having 80" overhead clearance and 32" clear width. Repair, bevel, or ramp CILs at door entries to max .25".	2015 ABAAS Section: F203.9 2012 TAS Section: 203.9 2010 ADAS Section: 203.9

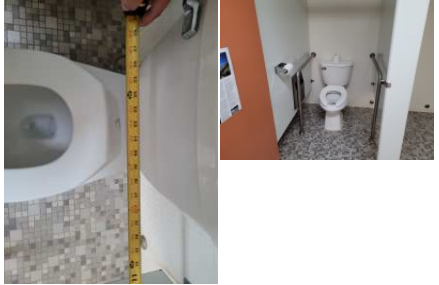
Finding Number	Area Description	Lat/Long	Finding	As Built	Recommendation	Citation	Photos	Figure
83	Fort Leaton: Women's Restroom	[29.5425544, -104.3264548]	The toilet is not located within the range to the side wall or partition. The centerline of the toilet shall be 17 inches minimum and 19 inches maximum side wall or partition in the ambulatory accessible toilet compartment.	22" from one side	Remount toilet to 17" to 19" from the side wall to center line in ambulatory stalls.	2015 ABAAS Section: 604.9.1 2012 TAS Section: 604.9.1 2010 ADAS Section: 604.9.1

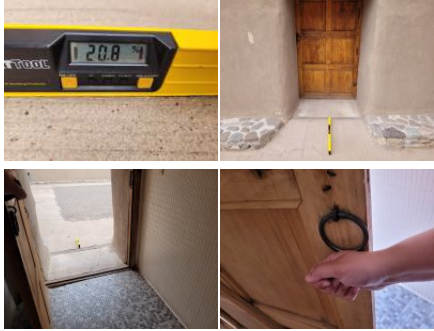
89	Fort Leaton: Women's Restroom	[29.542556, -104.326451]	Minimum maneuvering clearances at doors and gates shall comply with 404.2.4. Maneuvering clearances shall extend the full width of the doorway and the required latch side or hinge side clearance. Maneuvering clearances shall have a max slope of 2.08%. The sweep period for doors with closers shall be adjusted so that from an open position of 70 degrees, the door will take at least 3 seconds to move to a point 3 inches from the latch, measured to the leading edge of the door. Exterior doors are recommended to be maintained at 8.5 lbf as a smart practice. Force is to be measured at the operating hardware or 30 inches from the hinges, whichever is greater. Hand-activated door opening hardware, handles, pulls, latches, locks, and other operating devices on accessible doors shall have a shape that is easy to grasp with one hand and does not require tight grasping, tight pinching or twisting of the wrist to operate. Hardware shall be 34 inches minimum and 48 inches maximum above the finish floor or ground.	Women's restroom door - 20.8% in push side maneuvering clearance, recessed push side, recessed/wall pull side, 11# push, hardware does not comply, closes fast	For all doors along the public circulation route, provide required maneuvering clearance on push and pull side of doors. For all doors along the public circulation route, correct slope in door clearance to max 2.08%. For all doors along the public circulation route, inspect, adjust, and maintain closing speed on door closers. For all doors along the public circulation route, inspect, adjust, and maintain 8.5 lbf to open exterior doors as a smart practice. For all doors along the public circulation route, replace hardware with lever hardware or hardware operable without a tight pinch or grasp.	2010 ADAS Section: 404.2.3, 404.2.7, 404.2.4, 404.2.11, 404.2.11 Exception

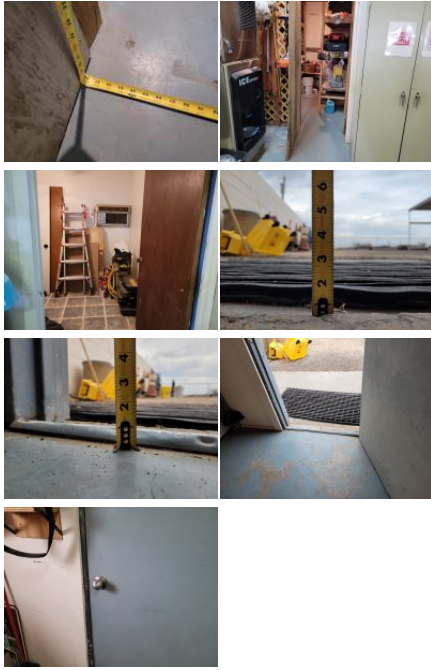
91	Maintenance: Maintenance	[29.5444561, -104.3284986]	Spaces and elements within employee work areas shall only be required to comply with 206.2.8, 207.1, and 215.3 and shall be designed and constructed so that individuals with disabilities can approach, enter, and exit the employee work area. Employee work areas, or portions of employee work areas, other than raised courtroom stations, that are less than 300 square feet (28 m2) and elevated 7 inches (180 mm) or more above the finish floor or ground where the elevation is essential to the function of the space shall not be required to comply with these requirements or to be on an accessible route.	Supplies room - 28" wide, cabinet in pull side maneuvering clearance, shelf back push side Office - knob, storage Shop front entry - knob, CIL, threshold, loose floor mat	For employee spaces, relocate storage, furniture, and other obstacles at doorways to provide approach, enter and exit at the employee space. Provide required maneuvering clearance on push and pull side of doors. Secure rug at door to prevent trip hazard. Replace doors with doors having 80" overhead clearance and 32" clear width. Repair, bevel, or ramp CILs at door entries to max .25". Repair, provide beveled threshold. Replace hardware with lever hardware or hardware operable without a tight pinch or grasp.	2015 ABAAS Section: F203.9 2012 TAS Section: 203.9 2010 ADAS Section: 203.9

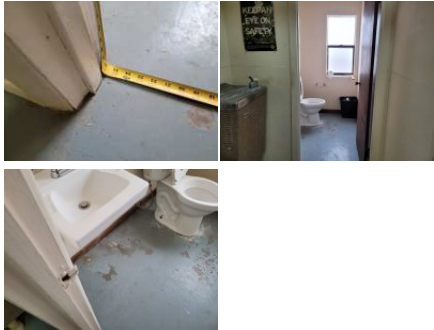
Finding Number	Area Description	Lat/Long	Finding	As Built	Recommendation	Citation	Photos	Figure
94	Maintenance: Maintenance	[29.54441, -104.3286]	Minimum maneuvering clearances at doors and gates shall comply with 404.2.4. Maneuvering clearances shall extend the full width of the doorway and the required latch side or hinge side clearance. Door openings shall provide a clear width of 32 inches (815 mm) minimum. Clear openings of doorways with swinging doors shall be measured between the face of the door and the stop, with the door open 90 degrees. Openings more than 24 inches (610 mm) deep shall provide a clear opening of 36 inches (915 mm) minimum. There shall be no projections into the required clear opening width lower than 34 inches (865 mm) above the finish floor or ground. Projections into the clear opening width between 34 inches (865 mm) and 80 inches (2030 mm) above the finish floor or ground shall not exceed 4 inches (100 mm). Hand-activated door opening hardware, handles, pulls, latches, locks, and other operating devices on accessible doors shall have a shape that is easy to grasp with one hand and does not require tight grasping, tight pinching or twisting of the wrist to operate. Hardware shall be 34 inches minimum and 48 inches maximum above the finish floor or ground.	Maintenance restroom door - 26.5" wide, knob, sink in pull side maneuvering clearance	Provide required maneuvering clearance on push and pull side of doors. Replace doors with doors having 80" overhead clearance and 32" clear width. Replace hardware with lever hardware or hardware operable without a tight pinch or grasp.	2010 ADAS Section: 404.2.3, 404.2.7, 404.2.4, 404.2.11, 404.2.11 Exception
