Access Audit Site Report

Fort Parker State Park

Accessibility Evaluation

Inspection Date: 03/03/2022

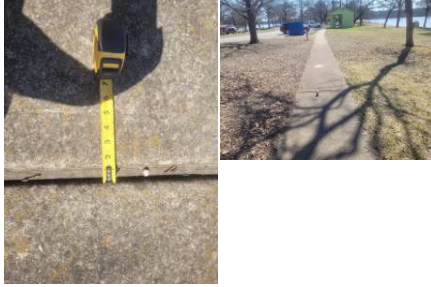
123	Rec Hall/ Nature Center: Rec Hall/Nature Center - Exterior Accessible Route	[31.5963792 , -96.536126 6]	There is a gap spaced greater than a 1/2 inch. Openings in floor or ground surfaces shall not allow passage of a sphere more than 1/2 inch diameter. Elongated openings shall be placed so that the long dimension is perpendicular to the dominant direction of travel.	1" gap between Rec Hall and green restrooms	Correct or fill gaps to be max .5".	2015 ABAAS Section: 302.3 2012 TAS Section: 302.3 2010 ADAS Section: 302.3

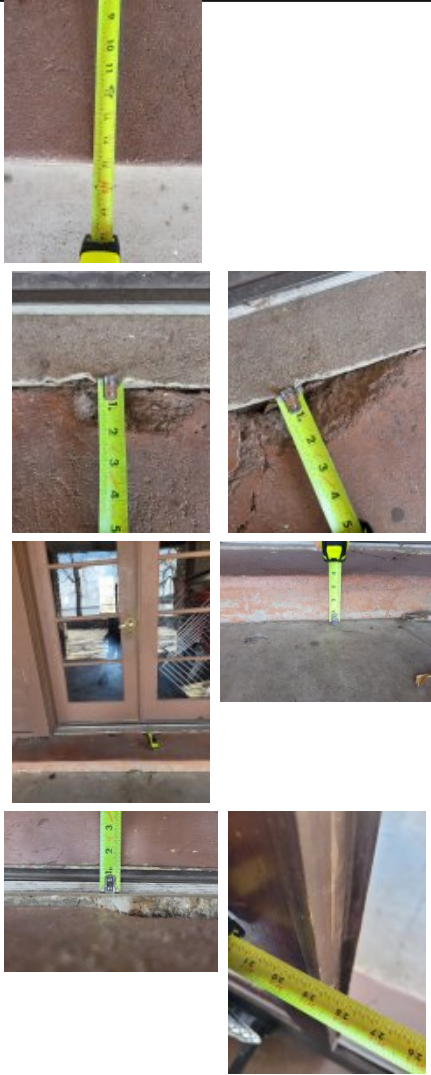
Finding Number	Area Description	Lat/Long	Finding	As Built	Recommendation	Citation	Photos	Figure
127	Rec Hall/ Nature Center: Rec Hall/ Nature Center - Public Spaces	[31.5967038 , -96.536329 1]	Minimum maneuvering clearances at doors and gates shall comply with 404.2.4. Maneuvering clearances shall extend the full width of the doorway and the required latch side or hinge side clearance. Door openings shall provide a clear width of 32 inches (815 mm) minimum. Clear openings of doorways with swinging doors shall be measured between the face of the door and the stop, with the door open 90 degrees. Openings more than 24 inches (610 mm) deep shall provide a clear opening of 36 inches (915 mm) minimum. There shall be no projections into the required clear opening width lower than 34 inches (865 mm) above the finish floor or ground. Projections into the clear opening width between 34 inches (865 mm) and 80 inches (2030 mm) above the finish floor or ground shall not exceed 4 inches (100 mm). The threshold has a vertical change greater than 1/4 inch high. The threshold has a gap greater than 1/2 inch wide. Exterior doors are recommended to be maintained at 8.5 lbf as a smart practice. Force is to be measured at the operating hardware or 30 inches from the hinges, whichever is greater. Hand-activated door opening hardware, handles, pulls, latches, locks, and other operating devices on accessible doors shall have a shape that is easy to grasp with one hand and does not require tight grasping, tight pinching or twisting of the wrist to operate. Hardware shall be 34 inches minimum and 48 inches maximum above the finish floor or ground.	Glass doors off main room: Closest to kitchen - 18# push, 29" width, 1.25" CIL at threshold, 3.5" CIL on exterior, push maneuvering clearance on back is reduced by CIL to 15"; Middle door - 29" width, 3.5" CIL step, 15" clearance on push back due to step, 1.25" CIL at threshold; End door - 1.25" gap, 2" gap, 3.5" step up, 1.25" CIL, 29" width, 20# push, lock at 54" AFF	For all doors along the public circulation route, provide required maneuvering clearance on push and pull side of doors. For all doors along the public circulation route, replace doors with doors having 80" overhead clearance and 32" clear width. For all doors along the public circulation route, repair, bevel, or ramp CILs at door entries to max .25". For all doors along the public circulation route, fill gaps at door entries to max .5". For all doors along the public circulation route, inspect, adjust, and maintain 8.5 lbf to open exterior doors as a smart practice. For all doors along the public circulation route, replace hardware with lever hardware or hardware operable without a tight pinch or grasp 34" to 48" AFF.	2010 ADAS Section: 404.2.3, 404.2.7, 404.2.4, 404.2.11, 404.2.11 Exception

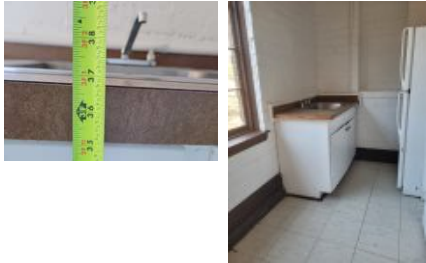
Finding Number	Area Description	Lat/Long	Finding	As Built	Recommendation	Citation	Photos	Figure
132	Rec Hall/ Nature Center: Rec Hall/ Nature Center - Public Spaces	[31.5966992 , -96.536334 5]	The top rim of the sink is too high. All lavatories/sinks that are designated to be accessible shall be a minimum 17 inches in horizontal depth and mounted with the rim or counter edge no higher than 34 inches above the finished floor.	kitchen- sink rim at 36.75" AFF	Lower sinks to max 34" above the finished floor (AFF) to front of rim.	2015 ABAAS Section: 606.3 2012 TAS Section: 606.3 2010 ADAS Section: 606.3

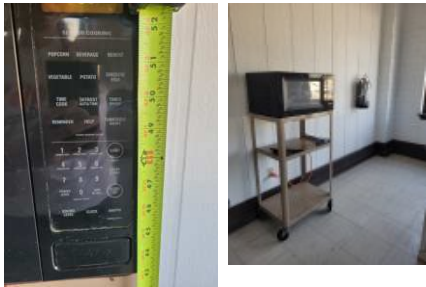
138	Rec Hall/ Nature Center: Rec Hall/ Nature Center - Public Spaces	[31.5967152 , -96.536331 8]	The operable part is positioned too high for either a side or front approach. Where a clear floor or ground space allows a parallel approach to an element and the side reach is unobstructed, the high side reach shall be 48 inches maximum and the low side reach shall be 15 inches minimum above the finish floor or ground. Where a forward reach is unobstructed, the high forward reach shall be 48 inches maximum and the low forward reach shall be 15 inches minimum above the finish floor or ground.	kitchen- 51" to top microwave buttons	Relocate microwave for operable parts to be in reach range of 15" min to 48" max.	2015 ABAAS Section: 308.1 2012 TAS Section: 308.1 2010 ADAS Section: 308.1

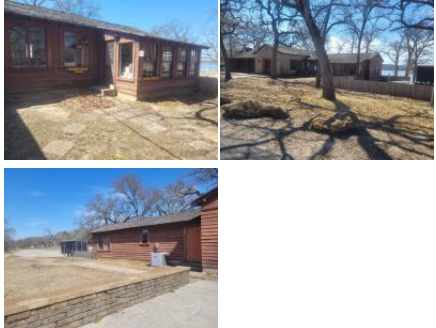
144	Rec Hall/ Nature Center: Rec Hall/ Nature Center - Employee Spaces	[31.5967049, -96.5363176]	Existing building scheduled for significant remodel.	nature center and rec Hall slated for remodel, nature center entry along paver stones and has steps, door connects from rec hall side, entry from patio has stairs, used for storage currently, includes restroom	Leave as is and make corrections to building upon remodel to provide accessible facility.	Capture Section: 1

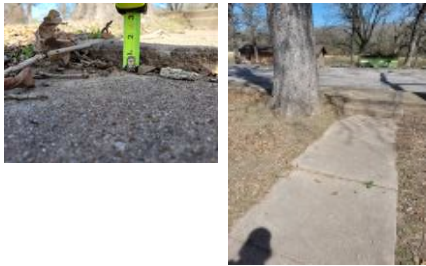
152	Park Site: Park Elements	[31.5957591 , -96.535811 5]	The walkway contains abrupt vertical edges and/or variations over a 1/4 inch. 1/4 inch is the maximum vertical rise. Changes in level between 1/4 inch and 1/2 inch must be beveled at 1:2 or less. Changes in level greater than 1/2 inch must be by way of a ramp.	1.5" CIL at pathway to shelter by tree	Repair, bevel or ramp CIL along AR.	2012 TAS Section: 303.2, 303.3 2010 ADAS Section: 303.2, 303.3

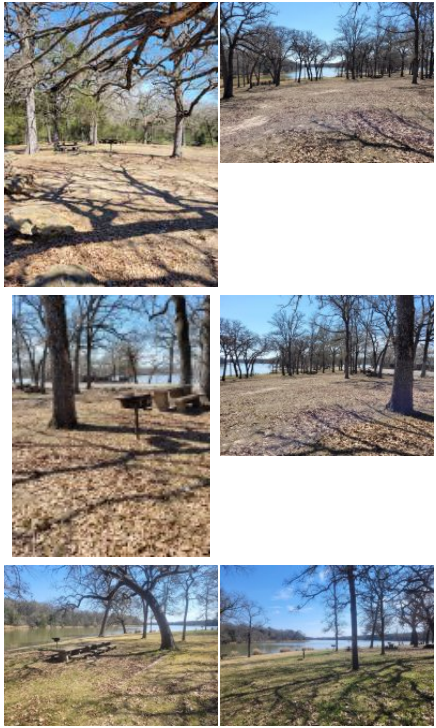
157	Park Site: Park Elements	[31.5964799 , -96.535669 3]	There is no accessible route to the picnic tables and grills. At least one accessible route shall connect accessible buildings, accessible facilities, accessible elements, and accessible spaces that are on the same site.	Day use area - lacks AR to 58 of 58 tables and 29 of 29 grills, and water spout	Create an accessible route with crushed stone or other outdoor material from parking or walkway to 12 picnic tables and 6 grills, and water spout.	2015 ABAAS Section: F206.2.2 2012 TAS Section: 206.2.2 2010 ADAS Section: 206.2.2

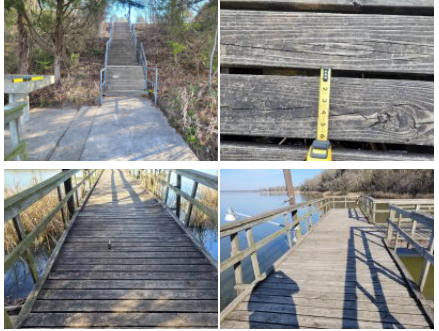
175	Park Site: Fishing	[31.5922464 , -96.531125 7]	Accessible routes serving fishing piers and platforms, including gangways and floating piers, shall comply with Chapter 4. EXCEPTIONS: 1. Accessible routes serving floating fishing piers and platforms shall be permitted to use Exceptions 1, 2, 5, 6, 7 and 8 in 1003.2.1. 2. Where the total length of the gangway or series of gangways serving as part of a required accessible route is 30 feet (9145 mm) minimum, gangways shall not be required to comply with 405.2.	Fishing pier at group barracks - Stairs only to access pier and fish cleaning station, gaps between boards frequently, gaps at knots and damaged boards	Create an outdoor accessible route to the fishing pier or make corrections for a compliant route.	2015 ABAAS Section: 1005.1, 1005.1 EXCEPTIONS: 1, 1005.1 EXCEPTIONS: 2 2010 ADAS Section: 1005.1, 1005.1 Exception 1, 1005.1 Exception 2

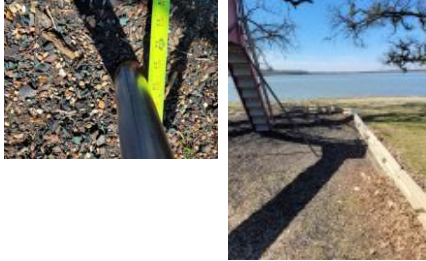
195	Playground: Play Area	[31.5970133, -96.536633 6]	The accessible route to the ground level play component(s) is not wide enough. At ground level play components, the clear width of accessible routes shall be 60 inches minimum.	37" between slide and barrier at GLPC	Enlarge border or relocate play elements to provide 60" clear width AR.	2012 TAS Section: 1008.2.4.1 2010 ADAS Section: 1008.2.4.1

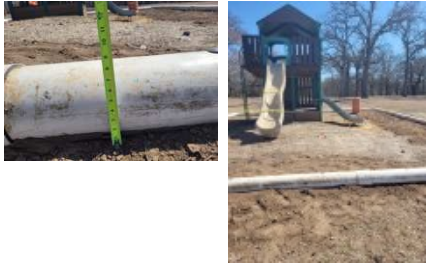
Finding Number	Area Description	Lat/Long	Finding	As Built	Recommendation	Citation	Photos	Figure
196	Playground: Play Area	[31.5976564 , -96.536651]	The walkway contains abrupt vertical edges and/or variations over a 1/4 inch. 1/4 inch is the maximum vertical rise. Changes in level between 1/4 inch and 1/2 inch must be beveled at 1:2 or less. Changes in level greater than 1/2 inch must be by way of a ramp.	7" CIL at EPC area border	For changes in level 6" or greater, provide a ramp for access.	2012 TAS Section: 303.2, 303.3 2010 ADAS Section: 303.2, 303.3

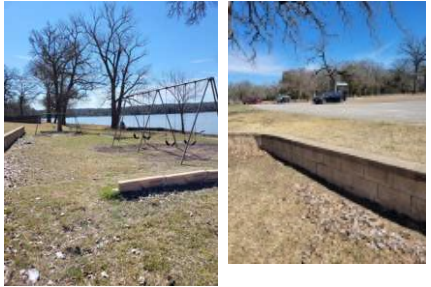
199	Playground: Play Area	[31.5970247, -96.5366295], [31.5976553, -96.536651]	The ground level play components are not dispersed throughout the play area. Where two or more required ground level play components are provided, they shall be dispersed throughout the play area and integrated with other play components.	N/A	Relocate accessible GLPCs to be dispersed through play area.	2012 TAS Section: 240.2.1 2010 ADAS Section: 240.2.1

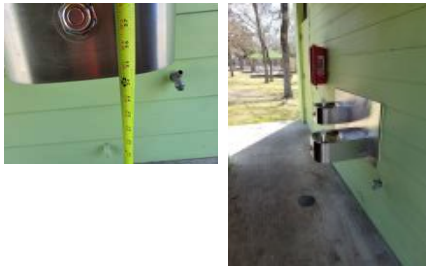
205	Green Restroom Building in Day Use Area: Green Restroom - Exterior Accessible Route	[31.5961463 , -96.536122 6]	There is not enough knee clearance under the drinking fountain. The drinking fountain must have a clear knee space between the bottom of the apron and the floor not less than 27 inches in height, 30 inches in width, and 8 inches in depth.	Drinking fountain at green restroom - 24.25" knee clearance	Raise drinking fountain to provide required 27" knee clearance.	2015 ABAAS Section: 602.2 2012 TAS Section: 602.2 2010 ADAS Section: 602.2

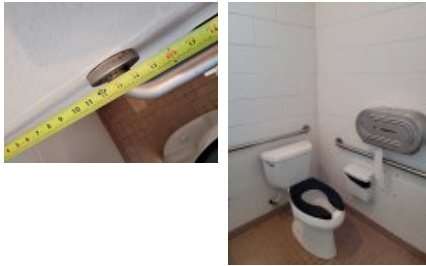
217	Green Restroom Building in Day Use Area: Women's - Green Restroom By Rec	[31.5961509 , -96.5361199]	The side grab bars are not in the correct location. Grab bars on the side wall must be installed so that the end closest to the rear wall is maximum 12" from the rear wall. The end furthest from the rear wall must be mounted minimum 54" from the rear wall.	Grab bar mounted 13" from rear wall	Remount side grab bar to max 12" from the rear wall at the close end and min 54" on the far end, and 33" to 36" AFF.	2015 ABAAS Section: 604.5.1 2012 TAS Section: 604.5.1 2010 ADAS Section: 604.5.1

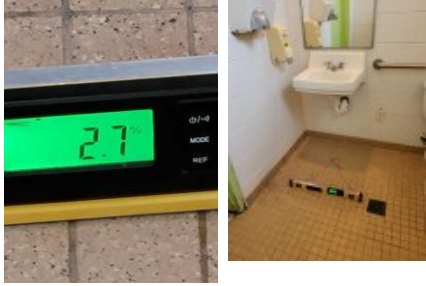
220	Green Restroom Building in Day Use Area: Women's - Green Restroom By Rec	[31.5961452 , -96.536121 3]	The accessible route contains running slopes greater than 5 percent and cross slopes greater than 2 percent across the width of the walk and has not been constructed as a ramp (i.e. handrails, wheel guides, etc.). When the slope in the direction of travel of any walk exceeds 1 unit vertical in 20 units horizontal (5-percent slope), it must be constructed as ramp. Surface cross slopes must not exceed one unit vertical in 48 units. Horizontal (2-percent slope).	Slope of 2.7% in front of sink	Correct or repair slope to max 2.08% in restroom.	2015 ABAAS Section: 403.3 2012 TAS Section: 403.3 2010 ADAS Section: 403.3

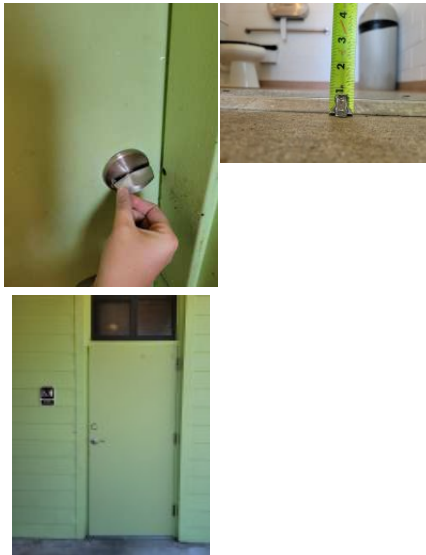
221	Green Restroom Building in Day Use Area: Women's - Green Restroom By Rec	[31.5961326 , -96.536117 2]	The threshold has a vertical change greater than 1/4 inch high. The sweep period for doors with closers shall be adjusted so that from an open position of 70 degrees, the door will take at least 3 seconds to move to a point 3 inches from the latch, measured to the leading edge of the door. Hand-activated door opening hardware, handles, pulls, latches, locks, and other operating devices on accessible doors shall have a shape that is easy to grasp with one hand and does not require tight grasping, tight pinching or twisting of the wrist to operate. Hardware shall be 34 inches minimum and 48 inches maximum above the finish floor or ground.	Restroom door - fast close, deadbolt requires pinch, .75" CIL	For all doors along the public circulation route, repair, bevel, or ramp CILs at door entries to max .25". For all doors along the public circulation route, inspect, adjust, and maintain closing speed on door closers. For all doors along the public circulation route, replace hardware with lever hardware or hardware operable without a tight pinch or grasp.	2010 ADAS Section: 404.2.3, 404.2.7, 404.2.4, 404.2.11, 404.2.11 Exception

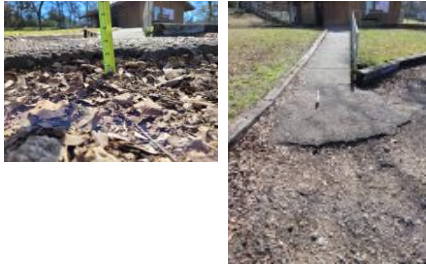
232	Campground Restroom Buildings: RV Campground Restrooms - Exterior Accessible Route	[31.6004264 , -96.536735 5]	There is a change in level greater than 1/4 inch. 1/4 inch is the maximum vertical rise. Changes in level between 1/4 inch and 1/2 inch must be beveled at 1:2 or less. Changes in level greater than 1/2 inch must be by way of a ramp.	Ramp to RV restroom, women's side - 3" CIL at entry	Repair, bevel or ramp CIL along accessible route (AR) to max .25".	2015 ABAAS Section: 303.3 2012 TAS Section: 303.3 2010 ADAS Section: 303.3

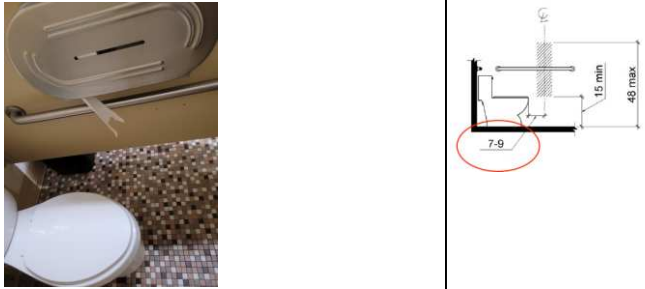
242	Campground Restroom Buildings: RV Campground - Men's Restroom	[31.6003842 , -96.536661 7]	The toilet paper is not installed within the compliant range in front of the toilet. Toilet paper dispensers shall be 7 inches minimum and 9 inches maximum in front of the water closet measured to the centerline of the dispenser. The outlet of the dispenser shall be 15 inches minimum and 48 inches maximum above the finish floor and shall not be located behind grab bars. Dispensers shall not be of a type that controls delivery or that does not allow continuous paper flow. There shall be a clearance of 1 1/2 inches minimum below the grab bar.	TP dispenser too close to the front of toilet	Remount toilet paper dispenser max 7" to 9" from front of toilet, 15" to 48" AFF and min 12" above or 1.5" below grab bar.	2015 ABAAS Section: 604.7 2012 TAS Section: 604.7 2010 ADAS Section: 604.7

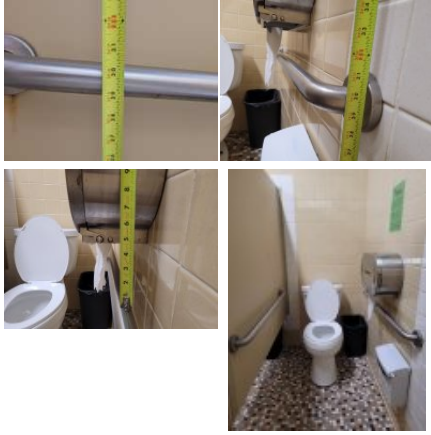
253	Campground Restroom Buildings: RV Campground - Women's Restroom	[31.6003853 , -96.5366591]	The grab bar height and/or spacing fails. Grab bars must be mounted between 33" and 36" to the top of the gripping surface. There must be 1.5" of clearance between the grab bar and the wall. There must be a minimum of 1.5" of clearance below and minimum 12" above the grab bar to any dispenser or other obstruction.	Both bars mounted 30.5" AFF, toilet paper 4.5" above grab bar	Remount grab bars in accessible stall to 33" to 36" above the finished floor (AFF). Remount toilet paper dispenser max 7" to 9" from front of toilet, 15" to 48" above the finished floor (AFF) and min 12" above or 1.5" below grab bar.	2015 ABAAS Section: 609.3, 609.4 2012 TAS Section: 609.4, 609.3 2010 ADAS Section: 609.3, 609.4

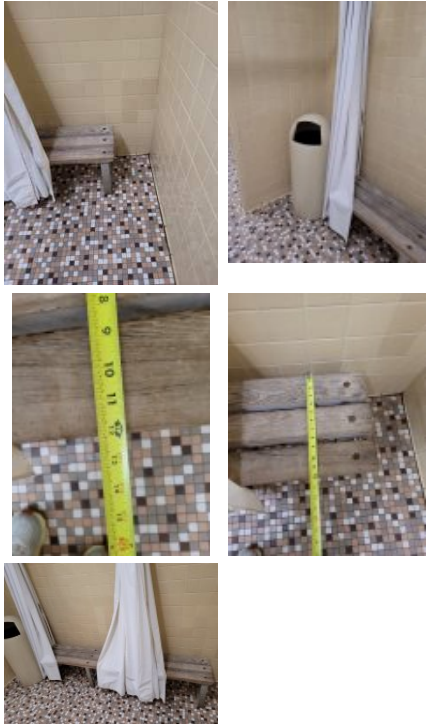
Finding Number	Area Description	Lat/Long	Finding	As Built	Recommendation	Citation	Photos	Figure
257	Campground Restroom Buildings: RV Campground - Women's Restroom	[31.6003819 , -96.536665 8]	The bench is not deep enough or long enough or is missing. Benches shall be provided having seats that are 42 inches long minimum and 20 inches deep minimum and 24 inches deep maximum. The bench shall provide for back support or shall be affixed to a wall. Back support shall be 42 inches (1065 mm) long minimum and shall extend from a point 2 inches (51 mm) maximum above the seat surface to a point 18 inches (455 mm) minimum above the seat surface. Back support shall be 2½ inches (64 mm) maximum from the rear edge of the seat measured horizontally. The top of the bench seat surface shall be 17 inches (430 mm) minimum and 19 inches (485 mm) maximum above the finish floor or ground. Clear floor or ground space complying with 305 shall be provided and shall be positioned at the end of the bench seat and parallel to the short axis of the bench	bench lacks CFS, 12" depth	Replace bench in dressing area with one having a seat depth of 20" to 24" deep, 42" long, affixed to the wall or having a back and mounted 17" to 19" AFF and provide required clear floor space on the short axis of the bench.	2012 TAS Section: 903.4, 903.2, 903.3, 903.5 2010 ADAS Section: 903.4, 903.2, 903.3, 903.5

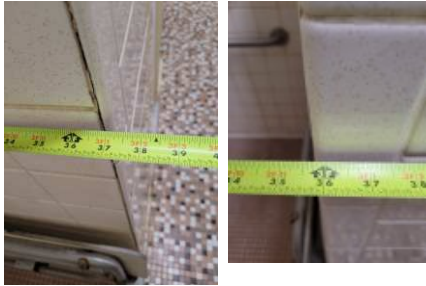
Finding Number	Area Description	Lat/Long	Finding	As Built	Recommendation	Citation	Photos	Figure
258	Campground Restroom Buildings: RV Campground - Women's Restroom	[31.6003887, -96.5366671]	Transfer type shower compartments shall be 36 inches (915 mm) by 36 inches (915 mm) clear inside dimensions measured at the center points of opposing sides and shall have a 36 inch (915 mm) wide minimum entry on the face of the shower compartment. Clearance of 36 inches (915 mm) wide minimum by 48 inches (1220 mm) long minimum measured from the control wall shall be provided.	shower 37" depth x 35.75" width	Renovate transfer shower to compliant 36" by 36" clear inside dimension.	2015 ABAAS Section: 608.2.1 2012 TAS Section: 608.2.1 2010 ADAS Section: 608.2.1

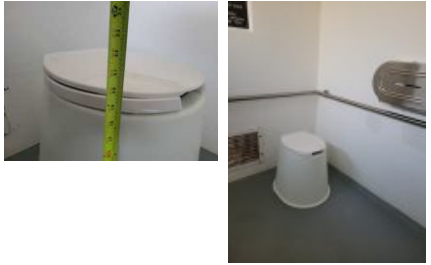
Finding Number	Area Description	Lat/Long	Finding	As Built	Recommendation	Citation	Photos	Figure
266	Campground Restroom Buildings: Women's Composting Toilet by site 44	[31.6072465 , -96.543788 4]	The toilet seat is not located within the range allowed off the floor. The height of accessible water closets shall be a minimum of 17 inches and a maximum of 19 inches measured to the top of a maximum 2-inch high toilet seat.	Toilet seat at 19.75" AFF	Replace toilet seat, or re-set or replace toilet to 17" to 19" above the finished floor (AFF).	2015 ABAAS Section: 604.4 2012 TAS Section: 604.4 2010 ADAS Section: 604.4

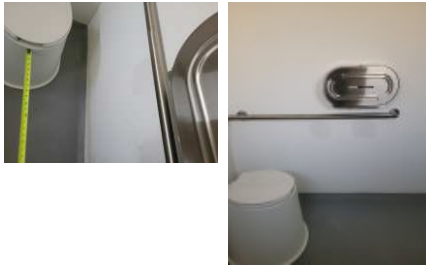
268	Campground Restroom Buildings: Women's Composting Toilet by site 44	[31.6072431 , -96.543792 4]	The toilet paper is not installed within the compliant range in front of the toilet. Toilet paper dispensers shall be 7 inches minimum and 9 inches maximum in front of the water closet measured to the centerline of the dispenser. The outlet of the dispenser shall be 15 inches minimum and 48 inches maximum above the finish floor and shall not be located behind grab bars. Dispensers shall not be of a type that controls delivery or that does not allow continuous paper flow. There shall be a clearance of 1 1/2 inches minimum below the grab bar.	TP dispenser too far from the front of the toilet	Remount toilet paper dispenser max 7" to 9" from front of toilet, 15" to 48" AFF and min 12" above or 1.5" below grab bar.	2015 ABAAS Section: 604.7 2012 TAS Section: 604.7 2010 ADAS Section: 604.7

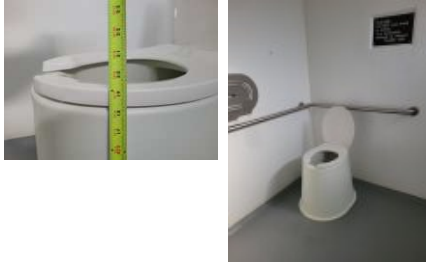
Finding Number	Area Description	Lat/Long	Finding	As Built	Recommendation	Citation	Photos	Figure
271	Campground Restroom Buildings: Men's Composting Toilet By Site 44	[31.607234, -96.543785 7]	The toilet seat is not located within the range allowed off the floor. The height of accessible water closets shall be a minimum of 17 inches and a maximum of 19 inches measured to the top of a maximum 2-inch high toilet seat.	Toilet seat at 19.25" AFF	Replace toilet seat, or re-set or replace toilet to 17" to 19" above the finished floor (AFF).	2015 ABAAS Section: 604.4 2012 TAS Section: 604.4 2010 ADAS Section: 604.4

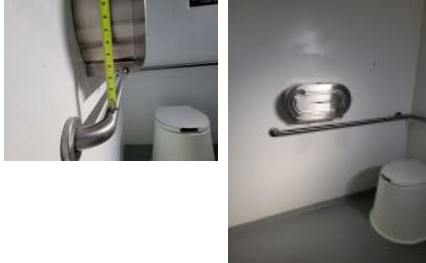
272	Campground Restroom Buildings: Men's Composting Toilet By Site 44	[31.6072397, -96.543784 3]	The grab bar height and/or spacing fails. Grab bars must be mounted between 33" and 36" to the top of the gripping surface. There must be 1.5" of clearance between the grab bar and the wall. There must be a minimum of 1.5" of clearance below and minimum 12" above the grab bar to any dispenser or other obstruction.	Toilet paper 3.5" above bar	Remount toilet paper dispenser max 7" to 9" from front of toilet, 15" to 48" above the finished floor (AFF) and min 12" above or 1.5" below grab bar.	2015 ABAAS Section: 609.3, 609.4 2012 TAS Section: 609.4, 609.3 2010 ADAS Section: 609.3, 609.4

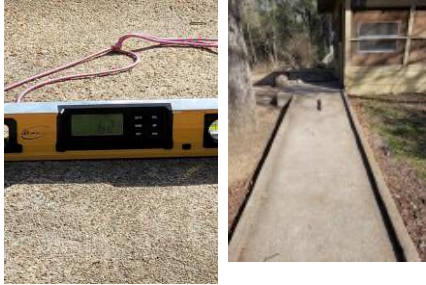
Finding Number	Area Description	Lat/Long	Finding	As Built	Recommendation	Citation	Photos	Figure
273	Campsites : Campsites	[31.6017149 , -96.536647]	The running slope of walking surfaces shall not be steeper than 1:20.	Shelter 8 sloped entry - 6.2% slope at top	Correct running slope along the AR to max 5%.	2015 ABAAS Section: 403.3 2012 TAS Section: 403.3 2010 ADAS Section: 403.3

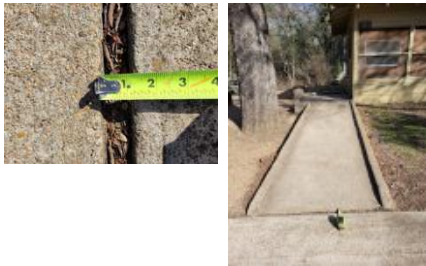
274	Campsites : Campsites	[31.6017274 , -96.536645 6]	There is a gap spaced greater than a 1/2 inch. Openings in floor or ground surfaces shall not allow passage of a sphere more than 1/2 inch diameter. Elongated openings shall be placed so that the long dimension is perpendicular to the dominant direction of travel.	1.25" gap at sloped entry to Shelter 8	Correct or fill gaps to be max .5".	2015 ABAAS Section: 302.3 2012 TAS Section: 302.3 2010 ADAS Section: 302.3

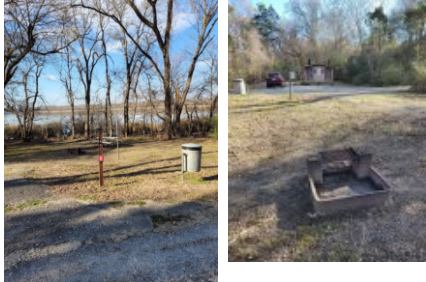
275	Campsites : Campsites	[31.6071095 , -96.543989 5]	An accessible access route is not provided between elements, spaces and the facilities provided within the accessible camping unit. At least one outdoor recreation access route shall connect accessible elements, spaces and facilities provided within camping units with mobility features.	Site 43 - Lacks AR to amenities	Create AR with crushed and compacted stone or similar outdoor material to camp sites and one of each type of amenity.	2015 ABAAS Section: F244.5.1

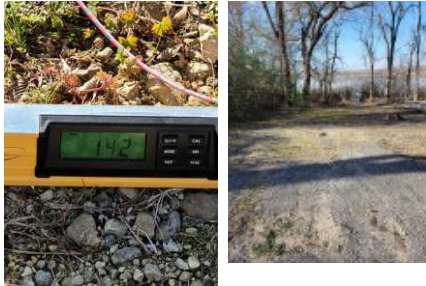
Finding Number	Area Description	Lat/Long	Finding	As Built	Recommendation	Citation	Photos	Figure
280	Campsites : Campsites	[31.6070889 , -96.544029 8]	Camping facilities shall provide camping units with mobility features complying with F244.2 in accordance with Table F244.2. Where a camping facility provides different types of camping units, Table F244.2 shall apply to each type of camping unit provided. Total Number of Camping Units Provided in Camping Facility Minimum Number of Camping Units with Mobility Features Required 1 1 2 to 25 2 26 to 50 3 51 to 75 4 76 to 100 5 101 to 150 7 151 to 200 8 201 and over 8, plus 2 percent of the number over 200	Lacks ADA sites - 10 water only sites	Create the required number of accessible camp sites per table F244.2 as a smart practice.	2015 ABAAS Section: F244.2		
281	Campsites : Campsites	[31.6070478 , -96.544064 6]	The surface of parking spaces and pull-up spaces shall be firm and stable. The slope of the surface of parking spaces and pull-up spaces shall not be steeper than 1:48 in any direction. EXCEPTION: Where the surface is other than asphalt, concrete, or boards, slopes not steeper than 1:20 shall be permitted when necessary for drainage.	Site 43 - 14.2% slope, lacks firm and stable surface	Correct surface of parking spaces to be firm and stable with slopes max of 2.08% or 5% for surfaces other than concrete, asphalt or boards as a smart practice.	2015 ABAAS Section: 1012.4, 1012.5, 1012.5 EXCEPTION

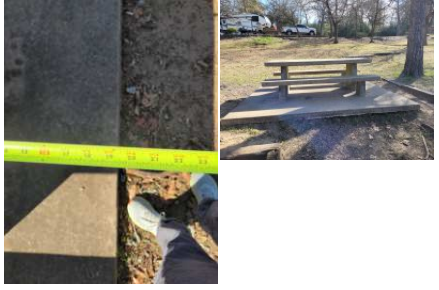
Finding Number	Area Description	Lat/Long	Finding	As Built	Recommendation	Citation	Photos	Figure
284	Campsites : Campsites	[31.6007634 , -96.536913 9]	36 inches (915 mm) on all usable sides of the table measured from the back edge of the benches.	RV site 6- 19" space around table	Provide required 36" clear ground space around all usable portions of the table as a smart practice.	2015 ABAAS Section: 1011.2.1

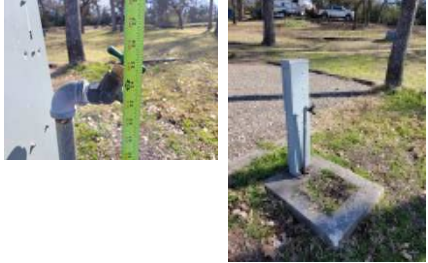
287	Campsites : Campsites	[31.6007725 , -96.53693]	Water spouts at water hydrants and water utility hook-ups shall be 28 inches (710 mm) minimum and 36 inches (915 mm) maximum above the ground	RV site 6- water spout at 25" AGL	Remount water spouts to 28" min or 36" max above the ground as a smart practice.	2015 ABAAS Section: 1011.6

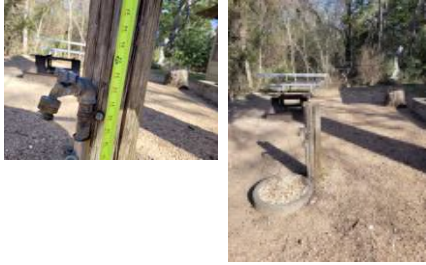
Finding Number	Area Description	Lat/Long	Finding	As Built	Recommendation	Citation	Photos	Figure
292	Campsites : Shelters	[31.601716, -96.536567 9]	Water spouts at water hydrants and water utility hook-ups shall be 28 inches (710 mm) minimum and 36 inches (915 mm) maximum above the ground.	Shelter 8 - Water spout at 22.5" AFF	Remount water spouts to 28" min or 36" max above the ground as a smart practice.	2015 ABAAS Section: 1011.6

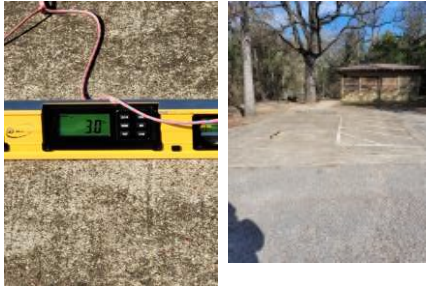
293	Campsites : Shelters	[31.6017286 , -96.536558 5]	The surface of parking spaces and pull-up spaces shall be firm and stable. The slope of the surface of parking spaces and pull-up spaces shall not be steeper than 1:48 in any direction. EXCEPTION: Where the surface is other than asphalt, concrete, or boards, slopes not steeper than 1:20 shall be permitted when necessary for drainage.	Shelter 8 - 3% in stall	Correct surface of parking spaces to be firm and stable with slopes max of 2.08% or 5% for surfaces other than concrete, asphalt or boards as a smart practice.	2015 ABAAS Section: 1012.4, 1012.5, 1012.5 EXCEPTION

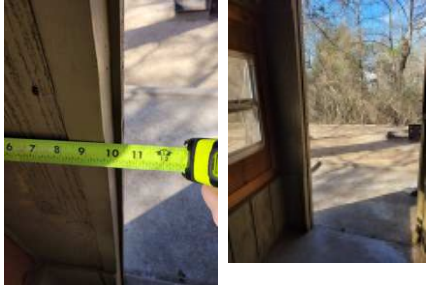
294	Campsites : Shelters	[31.6017274 , -96.536585 3]	Minimum maneuvering clearances at doors and gates shall comply with 404.2.4. Maneuvering clearances shall extend the full width of the doorway and the required latch side or hinge side clearance. Exterior doors are recommended to be maintained at 8.5 lbf as a smart practice. Force is to be measured at the operating hardware or 30 inches from the hinges, whichever is greater.	Shelter 8 - Door requires excessive force to open, 9.75" clearance on push	For all doors along the public circulation route, provide required maneuvering clearance on push and pull side of doors. For all doors along the public circulation route, inspect, adjust, and maintain 8.5 lbf to open exterior doors as a smart practice.	2010 ADAS Section: 404.2.3, 404.2.7, 404.2.4, 404.2.11, 404.2.11 Exception

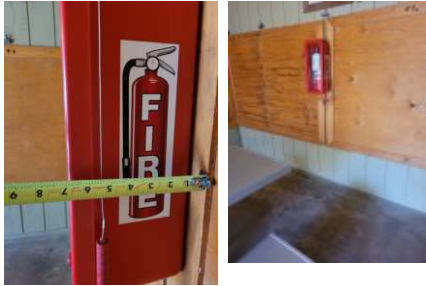
Finding Number	Area Description	Lat/Long	Finding	As Built	Recommendation	Citation	Photos	Figure
295	Campsites : Shelters	[31.6017457 , -96.536586 6]	An item or items project more than 4 inches into the circulation path. Wall-mounted objects that have leading edges between 27 inches and 80 inches from the floor must not project more than 4 inches into the circulation path. Protruding objects that extend to the floor or within 27 inches of the floor are cane detectable and are therefore not hazardous. Where it is necessary or desirable to have objects protrude from the wall, a manner of cane detection must be provided.	Shelter 8 - Fire extinguisher projects 6.5"	Relocate protruding objects or place cane detectable warning or bollard at foot of item.	2015 ABAAS Section: 307.2 2012 TAS Section: 307.2 2010 ADAS Section: 307.2

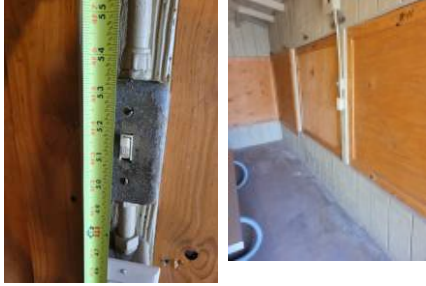
296	Campsites : Shelters	[31.6017457 , -96.536575 9]	The operable part is positioned too high for either a side or front approach. Where a clear floor or ground space allows a parallel approach to an element and the side reach is unobstructed, the high side reach shall be 48 inches maximum and the low side reach shall be 15 inches minimum above the finish floor or ground. Where a forward reach is unobstructed, the high forward reach shall be 48 inches maximum and the low forward reach shall be 15 inches minimum above the finish floor or ground.	Shelter 8 - Light switch at 51.5" AFF	Remount operable parts to be in reach range of 15" min to 48" max.	2015 ABAAS Section: 308.1 2012 TAS Section: 308.1 2010 ADAS Section: 308.1

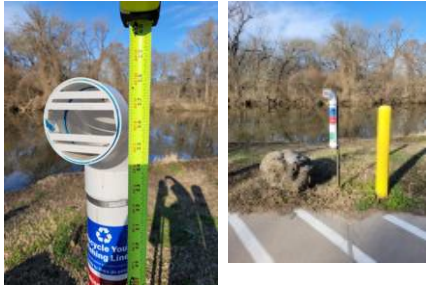
Finding Number	Area Description	Lat/Long	Finding	As Built	Recommendation	Citation	Photos	Figure
299	Campsites : Scout Camping	[31.6067189 , -96.551886]	The operable part is positioned too high for either a side or front approach. Where a clear floor or ground space allows a parallel approach to an element and the side reach is unobstructed, the high side reach shall be 48 inches maximum and the low side reach shall be 15 inches minimum above the finish floor or ground. Where a forward reach is unobstructed, the high forward reach shall be 48 inches maximum and the low forward reach shall be 15 inches minimum above the finish floor or ground.	Scout camping boat ramp - fishing line recycle station at 55" AFF	Remount operable parts to be in reach range of 15" min to 48" max.	2015 ABAAS Section: 308.1 2012 TAS Section: 308.1 2010 ADAS Section: 308.1

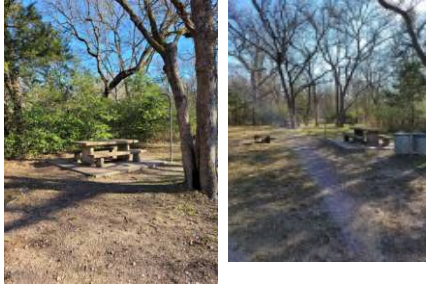
Finding Number	Area Description	Lat/Long	Finding	As Built	Recommendation	Citation	Photos	Figure
303	Campsites : Scout Camping	[31.6067691 , -96.551051 8]	Picnic tables shall provide at least one wheelchair space for each 24 linear feet (7320 mm) of usable table surface perimeter. Wheelchair spaces shall be 30 inches (760 mm) minimum by 48 inches (1220 mm) minimum. Wheelchair spaces shall be positioned for a forward approach to the table and provide knee and toe clearance complying with 306 under the table	0 of 3 picnic tables are of an accessible design	Replace picnic table with one of an accessible design as a smart practice.	2015 ABAAS Section: 1011.4.2

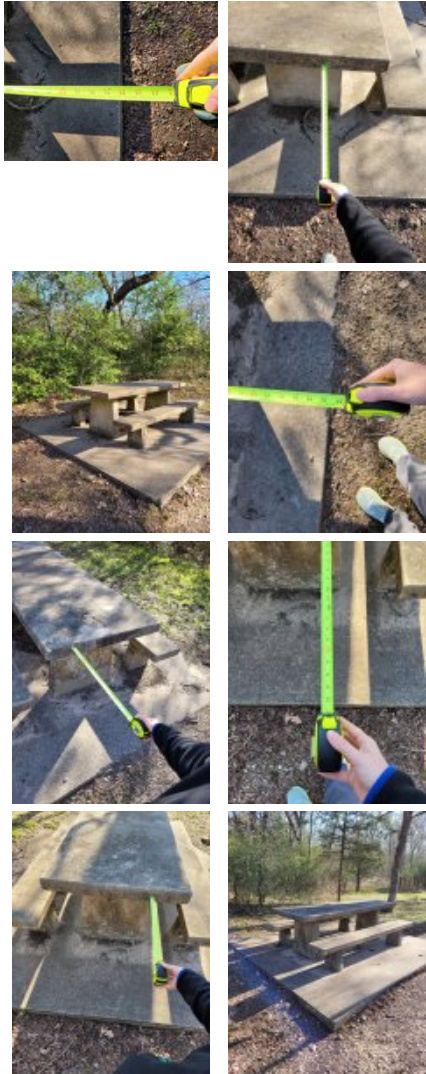
Finding Number	Area Description	Lat/Long	Finding	As Built	Recommendation	Citation	Photos	Figure
304	Campsites : Scout Camping	[31.6067668 , -96.551108 1]	36 inches (915 mm) on all usable sides of the table measured from the back edge of the benches.	0 of 3 tables offer wheelchair space, 22" width at usable portion	Provide required 36" clear ground space around all usable portions of the table as a smart practice.	2015 ABAAS Section: 1011.2.1

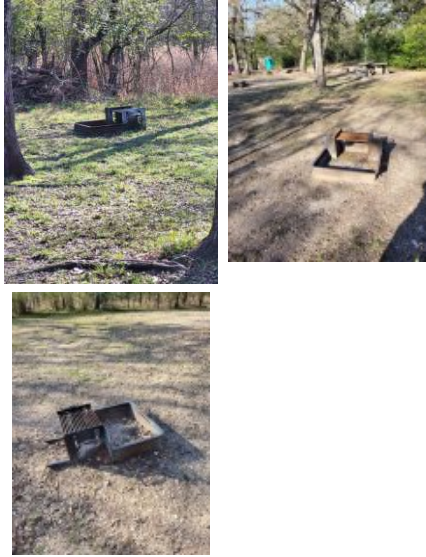
Finding Number	Area Description	Lat/Long	Finding	As Built	Recommendation	Citation	Photos	Figure
305	Campsites : Scout Camping	[31.6068171 , -96.551129 6]	48 inches (1220 mm) by 48 inches (1220 mm) on all usable sides of the fire ring, grill, fireplace, and woodstove Center the space on each usable side of the grill, fireplace, and woodstove	0 of 3 fire pits offer firm surface	Create AR with crushed and compacted stone or similar outdoor material to 20% of fire rings, with a 48" x 48" clear space around usable area.	2015 ABAAS Section: 1011.2

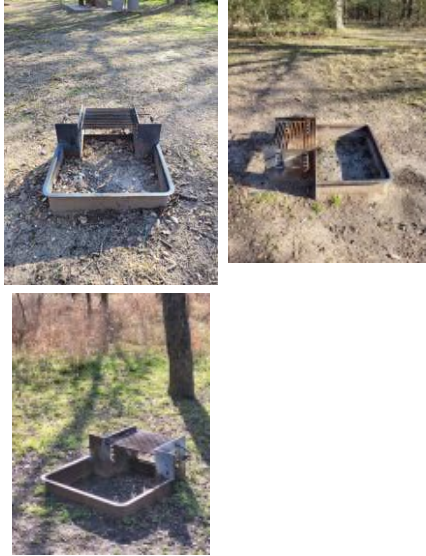
306	Campsites : Scout Camping	[31.6068308 , -96.551105 4]	Fire building surfaces shall be 9 inches (230 mm) minimum above the ground.	3 of 3 fire pits have fire building surfaces at ground level	Correct fire building surface to be 9" min above the ground as a smart practice.	2015 ABAAS Section: 1011.5.1

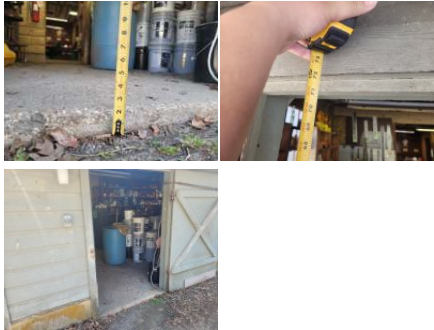
Finding Number	Area Description	Lat/Long	Finding	As Built	Recommendation	Citation	Photos	Figure
316	Employee Areas: Maintenance	[31.5921413, -96.528658]	Door openings shall provide a clear width of 32 inches (815 mm) minimum. Clear openings of doorways with swinging doors shall be measured between the face of the door and the stop, with the door open 90 degrees. Openings more than 24 inches (610 mm) deep shall provide a clear opening of 36 inches (915 mm) minimum. There shall be no projections into the required clear opening width lower than 34 inches (865 mm) above the finish floor or ground. Projections into the clear opening width between 34 inches (865 mm) and 80 inches (2030 mm) above the finish floor or ground shall not exceed 4 inches (100 mm). The threshold has a vertical change greater than 1/4 inch high.	Shop building entry - 2" CIL, 71" overhead	For all doors along the public circulation route, replace doors with doors having 80" overhead clearance and 32" clear width. For all doors along the public circulation route, repair, bevel, or ramp CILs at door entries to max .25".	2010 ADAS Section: 404.2.3, 404.2.7, 404.2.4, 404.2.11, 404.2.11 Exception

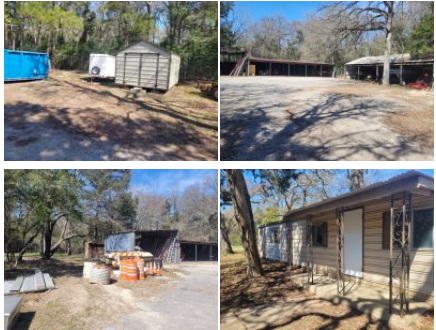
Finding Number	Area Description	Lat/Long	Finding	As Built	Recommendation	Citation	Photos	Figure
324	Employee Areas: Maintenance	[31.5924679 , -96.528680 8]	There is no accessible route between the buildings. At least one accessible route shall connect accessible buildings, facilities, elements and spaces that are on the same site.	Lacks AR to all maintenance buildings	Create AR with crushed and compacted stone or similar outdoor material from building to building within the site	2015 ABAAS Section: F206.2.2 2012 TAS Section: 206.2.2 2010 ADAS Section: 206.2.2
