# Access Audit Site Report

**Franklin Mountains State Park  
Tom Mays Unit  
El Paso, TX 79911  
Accessibility Evaluation  
Inspection Date: 10/19/2022  
Inspectors: Tanya Scheibe**

Prepared By  
**WT Group**

**TEXAS PARKS AND WILDLIFE DEPARTMENT  
FRANKLIN MOUNTAINS STATE PARK**

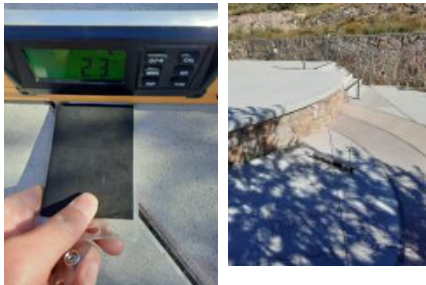
4	Headquarters/Visitor's Center: HQ - Exterior Accessible Route	[31.9103198, -106.5179 879]	The running slope of walking surfaces shall not be steeper than 1:20. The cross slope of walking surfaces shall not be steeper than 1:48.	Cross slope of 2.3% near stage at Visitor Center	Correct cross slopes to max 2.08%.	2012 TAS Section: 403.3  2010 ADAS Section: 403.3

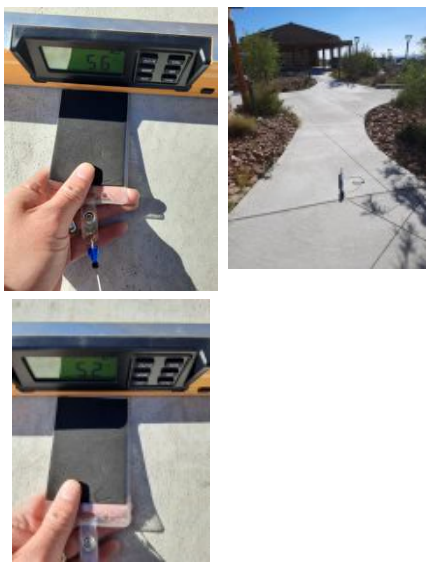
5	Headquarters/Visitor's Center: HQ - Exterior Accessible Route	[31.9104159, -106.51808 4]	The running slope of walking surfaces shall not be steeper than 1:20. The cross slope of walking surfaces shall not be steeper than 1:48.	Running slopes of 5.6% to 5.3% for 12' on route between restrooms and interpretive center	Correct running slopes to max 5%.	2012 TAS Section: 403.3  2010 ADAS Section: 403.3

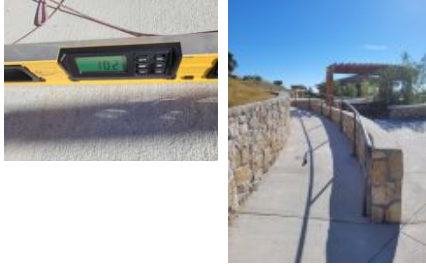
9	Headquarters/Visitor's Center: HQ - Exterior Accessible Route	[31.9105021, -106.5179114]	The ramp slope exceeds the maximum running slope (direction of travel) allowable of 8.33%. Ramps should have the least possible slope but in no case more than 8.3% (1:12).	Ramp to stage - 10.2% running slope at bottom	Correct slope of ramp to max 8.33%.	2015 ABAAS Section: 405.2 2012 TAS Section: 405.2 2010 ADAS Section: 405.2

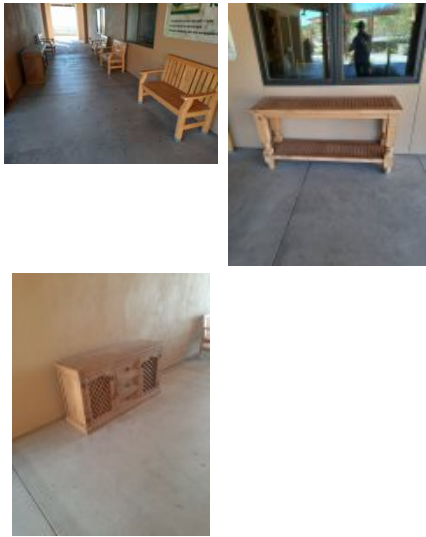
18	Headquarters/Visitor's Center: HQ - Public Spaces	[31.9105208, -106.518151]	Element meets all standards and requirements	4 of 4 wooden benches, shelf, and cabinet at Visitor Center comply	None	2010 ADAS Section: N/A

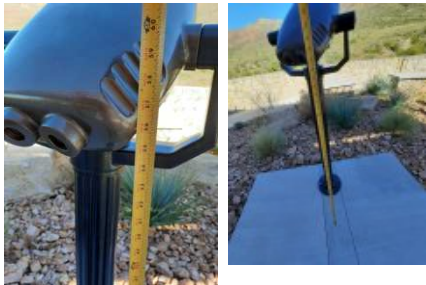
19	Headquarters/Visitor's Center: HQ - Public Spaces	[31.9106401, -106.5179618]	Eyepieces on viewing scopes shall be 43 inches (1090 mm) minimum and 51 inches (1295 mm) maximum above the ground	Viewing scope at Visitors Center exceeds reach range - 57" above ground level (AGL)	Lower eyepiece on viewing scope to min 43" and max 51"; in the alternative, add a second scope that meets the standard as a smart practice.	2015 ABAAS Section: 1011.8

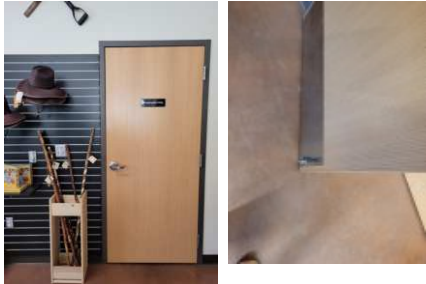
29	Headquarters/Visitor's Center: HQ - Employee Spaces	[31.910605, -106.5181183]	Spaces and elements within employee work areas shall only be required to comply with 206.2.8, 207.1, and 215.3 and shall be designed and constructed so that individuals with disabilities can approach, enter, and exit the employee work area. Employee work areas, or portions of employee work areas, other than raised courtroom stations, that are less than 300 square feet (28 m2) and elevated 7 inches (180 mm) or more above the finish floor or ground where the elevation is essential to the function of the space shall not be required to comply with these requirements or to be on an accessible route.	Employee door facing back - clearance on pull side reduced by walking sticks, 10# push, hold open device on push side	For employee spaces, relocate storage, furniture, and other obstacles at doorways to provide approach, enter and exit at the employee space. Provide required maneuvering clearance on push and pull side of doors. Inspect, adjust, and maintain 5 lbf to open interior doors. Remove door holder to provide a smooth surface on the push side of door from floor to 10" AFF.	2015 ABAAS Section: F203.9 2012 TAS Section: 203.9 2010 ADA Section: 203.9

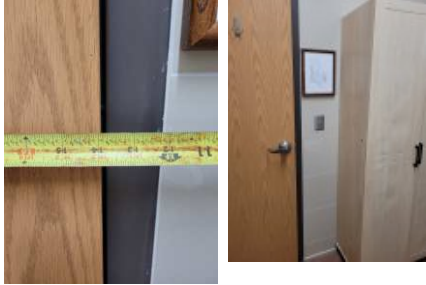
31	Headquarters/Visitor's Center: HQ - Employee Spaces	[31.9105948, -106.5181107]	Minimum maneuvering clearances at doors and gates shall comply with 404.2.4. Maneuvering clearances shall extend the full width of the doorway and the required latch side or hinge side clearance. All interior doors must be maintained so that the operating pressure does not exceed 5 lbf to open.	Employee restroom door - 15# push, 14" clearance on pull	For all doors along the public circulation route, provide required maneuvering clearance on push and pull side of doors. For all doors along the public circulation route, inspect, adjust, and maintain 5 lbf to open interior doors.	2010 ADAS Section: 404.2.3, 404.2.7, 404.2.4, 404.2.11, 404.2.11 Exception

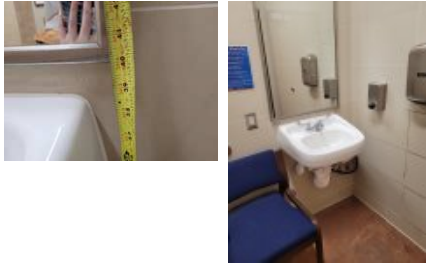
Finding Number	Area Description	Lat/Long	Finding	As Built	Recommendation	Citation	Photos	Figure
33	Headquarters/Visitor's Center: HQ - Employee Spaces	[31.910596, -106.5181276]	The mirror is mounted too high. Mirrors must have the bottom edge of the reflecting surface a maximum of 40 inches above the floor if above a sink or counter. Mirrors not located above lavatories or countertops shall be installed with the bottom edge of the reflecting surface 35 inches maximum above the finish floor or ground.	Bottom edge of mirror at 40.5" above the finished floor (AFF)	Lower mirror so bottom reflective surface is max 40" AFF and 74" at the top.	2015 ABAAS Section: 603.3  2012 TAS Section: 603.3  2010 ADAS Section: 603.3

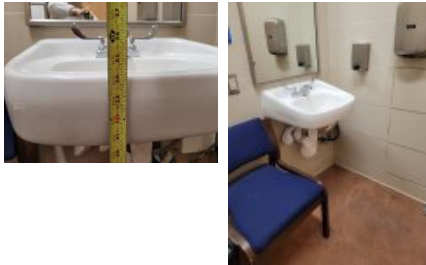
34	Headquarters/Visitor's Center: HQ - Employee Spaces	[31.9106029, -106.5181115]	The top rim of the sink is too high. All lavatories/sinks that are designated to be accessible shall be a minimum 17 inches in horizontal depth and mounted with the rim or counter edge no higher than 34 inches above the finished floor.	Rim of sink at 34.25" above the finished floor (AFF)	Lower sinks to max 34" above the finished floor (AFF) to front of rim. In the alternative, leave as is citing construction tolerance.	2015 ABAAS Section: 606.3  2012 TAS Section: 606.3  2010 ADAS Section: 606.3

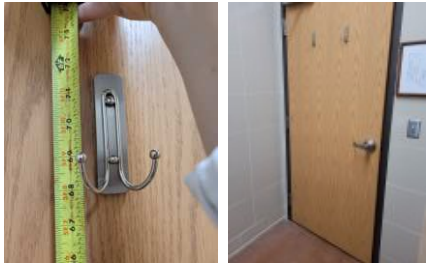
35	Headquarters/Visitor's Center: HQ - Employee Spaces	[31.9105801, -106.5180873]	The operable part is positioned too high for either a side or front approach. Where a clear floor or ground space allows a parallel approach to an element and the side reach is unobstructed, the high side reach shall be 48 inches maximum and the low side reach shall be 15 inches minimum above the finish floor or ground. Where a forward reach is unobstructed, the high forward reach shall be 48 inches maximum and the low forward reach shall be 15 inches minimum above the finish floor or ground.	Hooks at 68" above the finished floor (AFF)	Remount operable parts to be in reach range of 15" min to 48" max.	2015 ABAAS Section: 308.1  2012 TAS Section: 308.1  2010 ADAS Section: 308.1

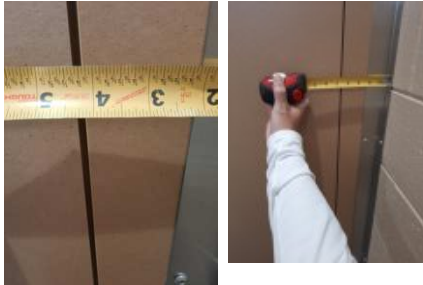
46	Headquarters/Visitor's Center: HQ - Men's Restroom	[31.9104985 , -106.518089]	The compartment door is located too far from the partition or wall. The door shall be located in front of the clear space and diagonal to the water closet. Where located in the front partition, the door opening shall be 4 inches maximum from the side wall or partition farthest from the water closet. Where located in the side wall or partition, the door opening shall be 4 inches maximum from the front partition. Toilet compartment doors shall not swing into the minimum required compartment area.	stall door mounted 4.25" from wall	Rehang stall door to be max 4" from adjacent stall partition and on the stall wall farthest from the toilet. In the alternative, leave as is citing construction tolerance.	2015 ABAAS Section: 604.8.1.2  2012 TAS Section: 604.8.1.2  2010 ADAS Section: 604.8.1.2

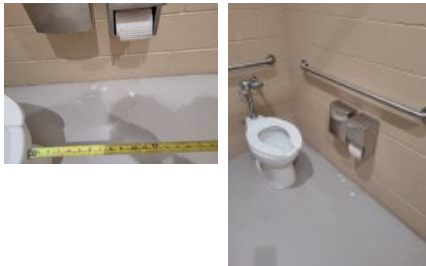
51	Headquarters/Visitor's Center: HQ - Women's Restroom	[31.9105094, -106.5181076]	The toilet paper is not installed within the compliant range in front of the toilet. Toilet paper dispensers shall be 7 inches minimum and 9 inches maximum in front of the water closet measured to the centerline of the dispenser. The outlet of the dispenser shall be 15 inches minimum and 48 inches maximum above the finish floor and shall not be located behind grab bars. Dispensers shall not be of a type that controls delivery or that does not allow continuous paper flow. There shall be a clearance of 1 1/2 inches minimum below the grab bar.	TP too far from front of toilet	Remount toilet paper dispenser 7" to 9" from front of toilet, 15" to 48" AFF and min 12" above or 1.5" below grab bar.	2015 ABAAS Section: 604.7  2012 TAS Section: 604.7  2010 ADAS Section: 604.7

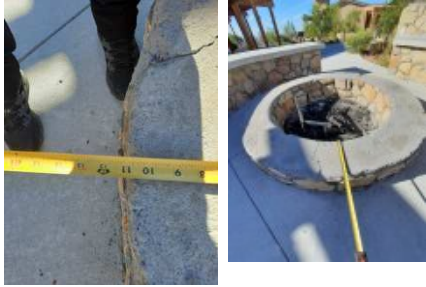
57	Interpretive Building: Interpretive - Public Spaces	[31.9101719, -106.5180236]	Where fire rings, grills, or fireplaces are constructed with raised edges or walls, the depth of the raised edge or wall shall be 10 inches (255 mm) maximum.	Fire ring at interpretive center has 11" deep wall	Correct depth of raised wall or edge to 10" max as a smart practice.	2015 ABAAS Section: 1011.5.3

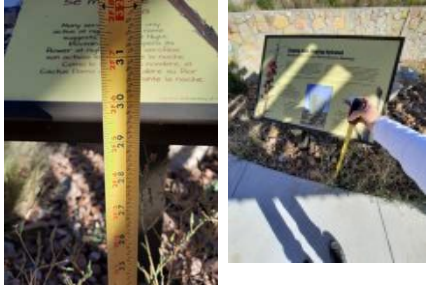
59	Interpretive Building: Interpretive - Public Spaces	[31.9102085, -106.5180659]	Visual characters shall be 40 inches (1015 mm) minimum above the finish floor or ground. EXCEPTION: Visual characters indicating elevator car controls shall not be required to comply with 703.5.6.	"Staying cool, staying hydrated" info sign at Interpretive Center is low	Remount signage to min 40" AFF as a smart practice.	2015 ABAAS Section: 703.5.6, 703.5.6 EXCEPTION  2012 TAS Section: 703.5.6, 703.5.6 Exception  2010 ADAS Section: 703.5.6, 703.5.6 Exception

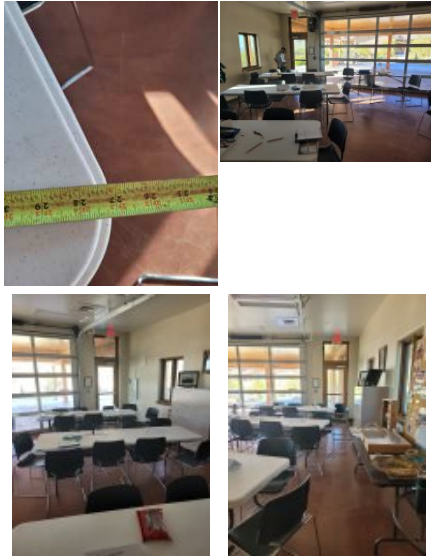
67	Interpretive Building: Interpretive - Public Spaces	[31.9101438 , -106.5181 747]	The route of travel at this location does not provide a minimum width of 36 inches. The clear width shall be permitted to be reduced to 32 inches minimum for a length of 24 inches maximum provided that reduced width segments are separated by segments that are 48 inches long minimum and 36 inches wide minimum.	Training in place at time of audit - tables reduce route to 27" width by doors	Reposition tables to widen AR to compliant 36" clear width.	2015 ABAAS Section: 403.5.1  2012 TAS Section: 403.5.1  2010 ADAS Section: 403.5.1

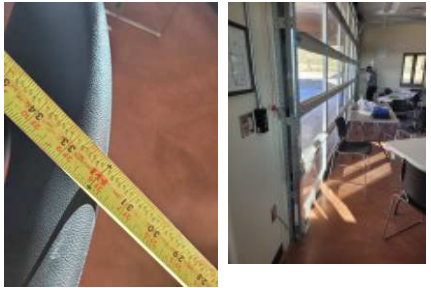
68	Interpretive Building: Interpretive - Public Spaces	[31.9101597 , -106.5181 908]	The operable part is not accessible because there is not adequate clear floor space for either a forward or side approach. The clear floor or ground space shall be 30 inches minimum by 48 inches minimum.	32" clearance at garage door due to tables	Remove, or relocate storage in CFS at fixtures and operable parts.	2015 ABAAS Section: 305.3  2012 TAS Section: 305.3  2010 ADAS Section: 305.3

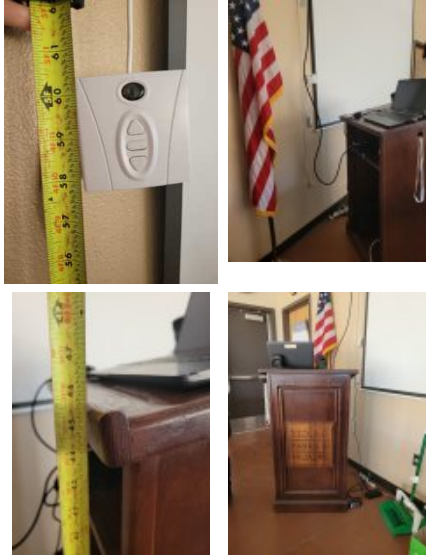
Finding Number	Area Description	Lat/Long	Finding	As Built	Recommendation	Citation	Photos	Figure
69	Interpretive Building: Interpretive - Public Spaces	[31.9101427, -106.5181868]	The operable part is positioned too high for either a side or front approach. Where a clear floor or ground space allows a parallel approach to an element and the side reach is unobstructed, the high side reach shall be 48 inches maximum and the low side reach shall be 15 inches minimum above the finish floor or ground. Where a forward reach is unobstructed, the high forward reach shall be 48 inches maximum and the low forward reach shall be 15 inches minimum above the finish floor or ground.	Controls for screen at 58" above the finished floor (AFF), podium screen controls at 45.5" AFF	Remount operable parts to be in reach range of 15" min to 48" max.	2015 ABAAS Section: 308.1  2012 TAS Section: 308.1  2010 ADAS Section: 308.1

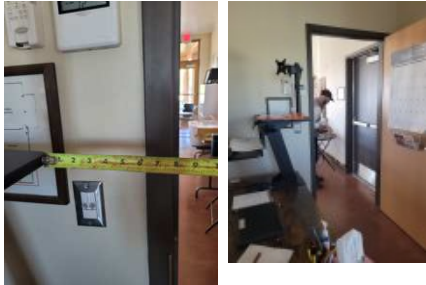
70	Interpretive Building: Interpretive - Public Spaces	[31.9102797, -106.5183274]	Element meets all standards and requirements	Bike racks comply	None	2010 ADAS Section: N/A		
71	Interpretive Building: Interpretive - Employee Spaces	[31.910095, -106.5181854]	Spaces and elements within employee work areas shall only be required to comply with 206.2.8, 207.1, and 215.3 and shall be designed and constructed so that individuals with disabilities can approach, enter, and exit the employee work area. Employee work areas, or portions of employee work areas, other than raised courtroom stations, that are less than 300 square feet (28 m2) and elevated 7 inches (180 mm) or more above the finish floor or ground where the elevation is essential to the function of the space shall not be required to comply with these requirements or to be on an accessible route.	Office - 8" clearance on pull side due to desk	For employee spaces, relocate storage, furniture, and other obstacles at doorways to provide approach, enter and exit at the employee space. Provide required maneuvering clearance on push and pull side of doors.	2015 ABAAS Section: F203.9  2012 TAS Section: 203.9  2010 ADAS Section: 203.9

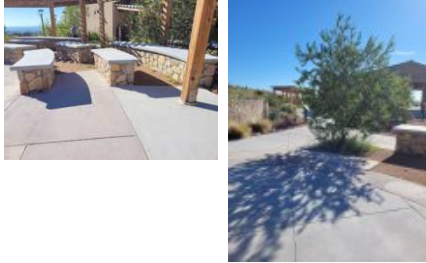
Finding Number	Area Description	Lat/Long	Finding	As Built	Recommendation	Citation	Photos	Figure																
74	Interpretive Building: Interpretive - Amphitheater	[31.9104, -106.518]	Based on the number of seats provided in this area there should be a minimum of two wheelchair seating spaces. Wheelchair spaces shall be provided in assembly areas with fixed seating.	Lacks designated wheelchair seating, but clear floor space (CFS) exists	Acquire and mount signage, including access symbol, designating specified number of wheelchair seats. Individual spaces shall be 36" wide, where two adjacent spaces are provided, they shall be 33" wide. Spaces shall be 48" deep when entered from the front or rear; if entered from the side, they shall be 60" deep	2015 ABAAS Section: F221.2  2012 TAS Section: 221.2  2010 ADAS Section: 221.2, 802.1.2, 802.1.3

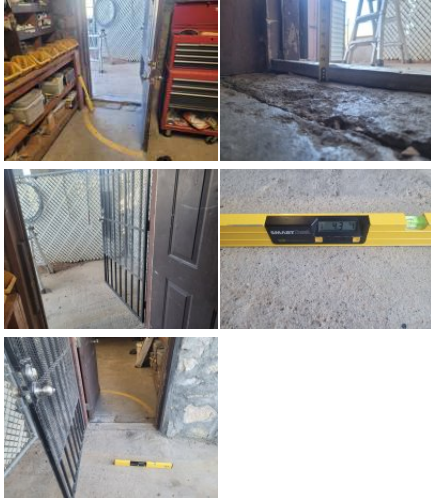
76	Employee Areas: Maintenance	[31.9160604, -106.5151542]	Minimum maneuvering clearances at doors and gates shall comply with 404.2.4. Maneuvering clearances shall extend the full width of the doorway and the required latch side or hinge side clearance. Maneuvering clearances shall have a max slope of 2.08%. The threshold at a doorway shall be no higher than 1/2 inch. Changes in level between 1/4 inch and 1/2 inch must be beveled at 1:2 or less. 1/4 inch is the maximum vertical rise. Hand-activated door opening hardware, handles, pulls, latches, locks, and other operating devices on accessible doors shall have a shape that is easy to grasp with one hand and does not require tight grasping, tight pinching or twisting of the wrist to operate. Hardware shall be 34 inches minimum and 48 inches maximum above the finish floor or ground.	Shop entry door - knobs on both doors, 4.3% slope in pull side clearance, shelf in pull side, 1" threshold	For all doors along the public circulation route, provide required maneuvering clearance on push and pull side of doors. For all doors along the public circulation route, correct slope in door clearance to max 2.08%. For all doors along the public circulation route, provide beveled threshold. For all doors along the public circulation route, replace hardware with lever hardware or hardware operable without a tight pinch or grasp.	2010 ADAS Section: 404.2.3, 404.2.7, 404.2.4, 404.2.11, 404.2.11 Exception

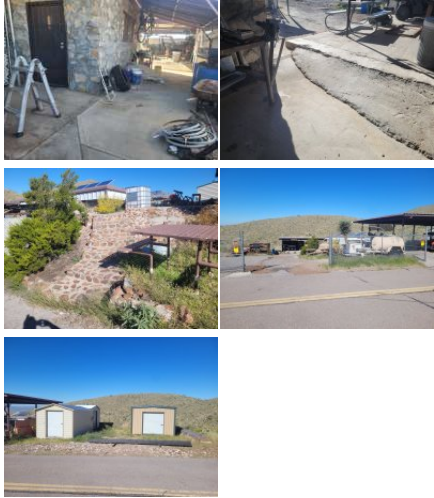
Finding Number	Area Description	Lat/Long	Finding	As Built	Recommendation	Citation	Photos	Figure
77	Employee Areas: Maintenance	[31.9160561, -106.5151391]	The building entrance is not located on an accessible route. When a building, or portion of a building, is required to be accessible, an accessible route of travel shall be provided to all portions of the building, to accessible building entrances and between the building and the public way. All walks, halls, corridors, aisles, skywalks, tunnels, and other spaces that are part of an accessible route must comply. An accessible route of travel must not pass through kitchens, storage rooms, restrooms, closets or other spaces used for similar purposes. At least one accessible route within the boundary of the site must be provided from public transportation stops, accessible parking and accessible passenger loading zones and public streets or sidewalks to the accessible building entrance they serve. The accessible route shall, to the maximum extent feasible, coincide with the route for the general public. At least one accessible route shall connect accessible buildings, facilities, elements and spaces that are on the same site. At least one accessible route shall connect accessible building or facility entrances with all accessible spaces and elements.	Routes to shop and other areas are steep and difficult, no AR to outbuildings	Create AR with crushed and compacted stone or similar outdoor material from parking or sidewalk to building entrances.	2015 ABAAS Section: F206.2.1  2012 TAS Section: 206.2.1  2010 ADAS Section: 206.2.1

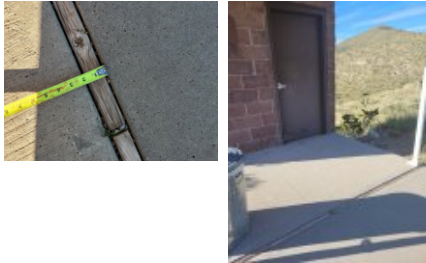
Finding Number	Area Description	Lat/Long	Finding	As Built	Recommendation	Citation	Photos	Figure
85	Restroom 1 Area: RR 1 - Exterior Accessible Route	[31.9142708, -106.5174208]	There is a gap spaced greater than a 1/2 inch. Openings in floor or ground surfaces shall not allow passage of a sphere more than 1/2 inch diameter. Elongated openings shall be placed so that the long dimension is perpendicular to the dominant direction of travel.	2" gap on walkway at Restroom 1 building	Correct or fill gaps to be max .5".	2015 ABAAS Section: 302.3 2012 TAS Section: 302.3 2010 ADAS Section: 302.3

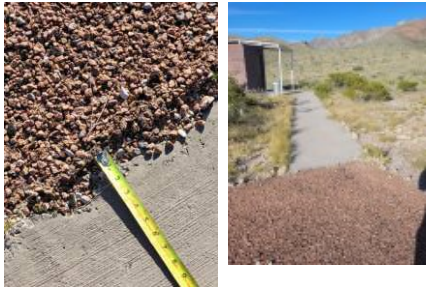
86	Restroom 1 Area: RR 1 - Exterior Accessible Route	[31.9141985, -106.517451]	There is a gap spaced greater than a 1/2 inch. Openings in floor or ground surfaces shall not allow passage of a sphere more than 1/2 inch diameter. Elongated openings shall be placed so that the long dimension is perpendicular to the dominant direction of travel.	2" gap at Restroom 1 building where parking meets path	Correct or fill gaps to be max .5".	2015 ABAAS Section: 302.3 2012 TAS Section: 302.3 2010 ADAS Section: 302.3

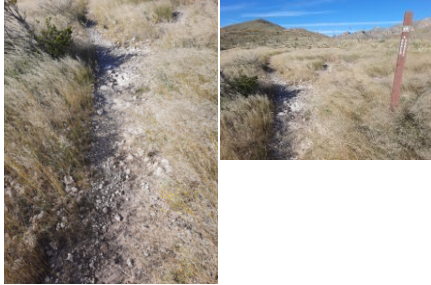
Finding Number	Area Description	Lat/Long	Finding	As Built	Recommendation	Citation	Photos	Figure
91	Restroom 1 Area: RR 1 - Trails	[31.9143036 , -106.51679 2]	The surface of trails, passing spaces, and resting intervals shall be firm and stable	Upper Sunset Trail lacks firm and stable surface - natural surface	Replace surface of trail with one that is firm and stable.	2015 ABAAS Section: 1017.2

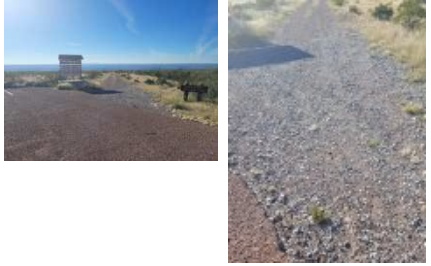
92	Restroom 1 Area: RR 1 - Trails	[31.9141632 , -106.5181 184]	The surface of trails, passing spaces, and resting intervals shall be firm and stable	Lower Sunset Trail - not accessible surface, natural	Replace trails surface with one that is firm and stable.	2015 ABAAS Section: 1017.2

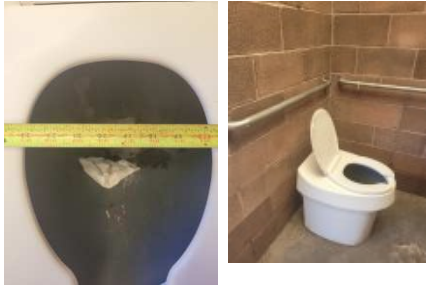
Finding Number	Area Description	Lat/Long	Finding	As Built	Recommendation	Citation	Photos	Figure
94	Restroom 1 Area: RR 1 - Single User Restroom	[31.9142932 , -106.5174 483]	The toilet is not located within the range allowed from the side wall or partition. The centerline of the toilet must be 16 to 18 inches from the side wall.	Centerline of toilet is 19.5" from wall	Remount toilets to 16" to 18" from the side wall to centerline.	2015 ABAAS Section: 604.2  2012 TAS Section: 604.2  2010 ADAS Section: 604.2

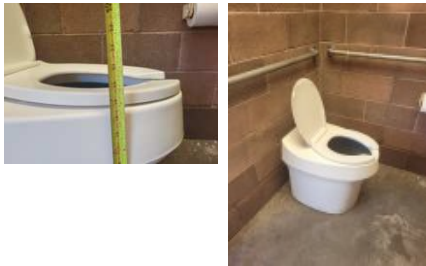
95	Restroom 1 Area: RR 1 - Single User Restroom	[31.9142932 , -106.5174 402]	The toilet seat is not located within the range allowed off the floor. The height of accessible water closets shall be a minimum of 17 inches and a maximum of 19 inches measured to the top of a maximum 2-inch high toilet seat.	Toilet seat at 19.5" above the finished floor (AFF)	Replace toilet seat, or re-set or replace toilet to 17" to 19" above the finished floor (AFF).	2015 ABAAS Section: 604.4  2012 TAS Section: 604.4  2010 ADAS Section: 604.4

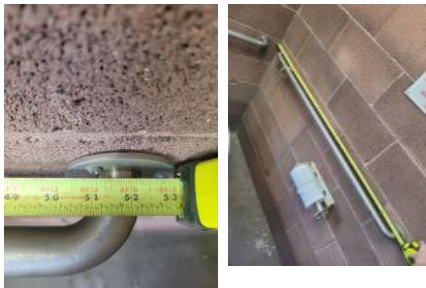
96	Restroom 1 Area: RR 1 - Single User Restroom	[31.9142852 , -106.5174 429]	The side grab bars are not in the correct location. Grab bars on the side wall must be installed so that the end closest to the rear wall is maximum 12" from the rear wall. The end furthest from the rear wall must be mounted minimum 54" from the rear wall.	Side grab bar ends 51.5" from rear wall	Remount side grab bar to max 12" from the rear wall at the close end and min 54" on the far end, and 33" to 36" AFF.	2015 ABAAS Section: 604.5.1  2012 TAS Section: 604.5.1  2010 ADAS Section: 604.5.1

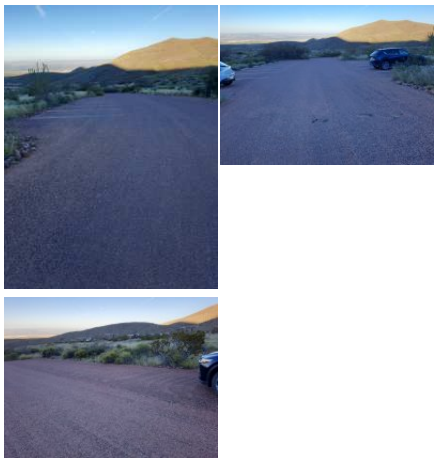
Finding Number	Area Description	Lat/Long	Finding	As Built	Recommendation	Citation	Photos	Figure																																																															
99	Sneeds Cory Climbing Area: Sneeds Cory - Parking	[31.9168049 , -106.5094 732]	There are no or not enough accessible parking stalls. Each lot where parking is provided for the public as clients, guests or employees, shall provide accessible parking and shall be located on the shortest accessible route of travel from adjacent parking to an accessible entrance. There are a total of 27 parking stalls in the parking lot that could be reasonably associated with this facility. There should be a minimum of 2 accessible stalls with a minimum of 1 being designed as van accessible.	Sneed Climbing Area parking lacks accessible parking spaces - 27 standard, 0 accessible	Create two or more 8' accessible parking stalls, with one 5' adjacent access aisle, with proper signage and striping based on the total number of stalls.	2015 ABAAS Section: F208.2  2012 TAS Section: 208.2  2010 ADAS Section: 208.2

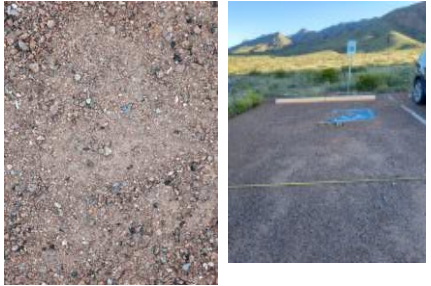
Finding Number	Area Description	Lat/Long	Finding	As Built	Recommendation	Citation	Photos	Figure
107	Restroom 2 Area: RR 2 - Parking	[31.916282, -106.5143839]	The parking stall contains abrupt edges and surface irregularities over a 1/4 inch vertical. Parking spaces and access aisles serving them shall be stable, firm, and slip resistant. Access aisles shall be at the same level as the parking spaces they serve. Changes in level are not permitted and shall not be sloped steeper than 2% in any direction.	Loose gravel and dirt on surface that was rough stone and binding agent, very deteriorated	Resurface accessible stalls and access aisles with a firm, stable, and slip resistant material.	2015 ABAAS Section: 502.4 2012 TAS Section: 502.4 2010 ADAS Section: 502.4

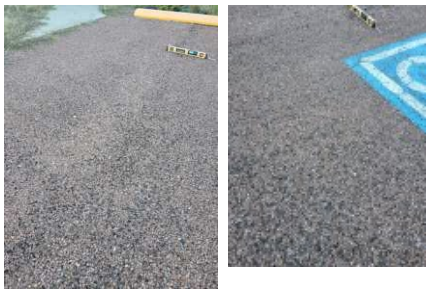
Finding Number	Area Description	Lat/Long	Finding	As Built	Recommendation	Citation	Photos	Figure
111	Restroom 2 Area: RR 2 - Parking	[31.9161285, -106.5137966]	The parking stall contains abrupt edges and surface irregularities over a 1/4 inch vertical. Parking spaces and access aisles serving them shall be stable, firm, and slip resistant. Access aisles shall be at the same level as the parking spaces they serve. Changes in level are not permitted and shall not be sloped steeper than 2% in any direction.	Restroom 2 picnic area upper parking - loose gravel on rough surface	Resurface accessible stalls and access aisles with a firm, stable, and slip resistant material.	2015 ABAAS Section: 502.4 2012 TAS Section: 502.4 2010 ADAS Section: 502.4

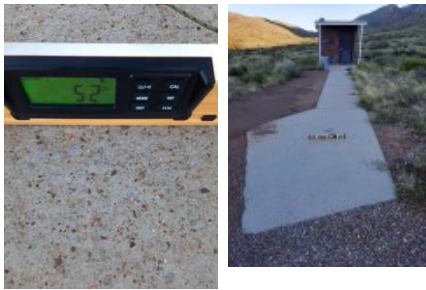
113	Restroom 2 Area: RR 2 - Exterior Accessible Route	[31.9162745, -106.513806]	The running slope of walking surfaces shall not be steeper than 1:20. The cross slope of walking surfaces shall not be steeper than 1:48.	Cross slope of 5.2% at first cement panel on route to restrooms	Correct cross slopes to max 2.08%.	2012 TAS Section: 403.3 2010 ADAS Section: 403.3

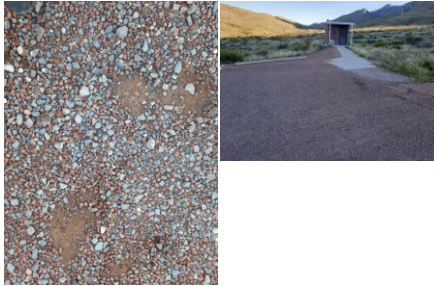
Finding Number	Area Description	Lat/Long	Finding	As Built	Recommendation	Citation	Photos	Figure
114	Restroom 2 Area: RR 2 - Exterior Accessible Route	[31.9162467, -106.5137987]	The accessible route contains loose gravel and/or surface materials that do not provide for a stable, firm slip resistant surface. Floor and ground surfaces shall be stable, firm, and slip resistant.	Restroom 2 walkway - loose gravel between parking surface and cement walkway to restrooms, parking space adjacent to walkway requires route of travel through loose gravel section	Create AR with crushed and compacted stone or similar outdoor material from parking or sidewalk to the building.	2015 ABAAS Section: 302.1 2012 TAS Section: 302.1 2010 ADAS Section: 302.1

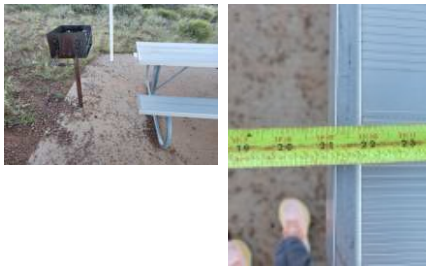
116	Restroom 2 Area: RR 2 - Picnic Areas	[31.9160416, -106.5137705]	The clear floor space for the element is obstructed. The clear floor or ground space shall be 30 inches minimum by 48 inches minimum and free of obstructions.	Site 10 - Picnic table reduces clear ground space of grill to 21.25"	Relocate or reposition picnic table to allow clear floor space.	2015 ABAAS Section: 305.3 2012 TAS Section: 305.3 2010 ADAS Section: 305.3

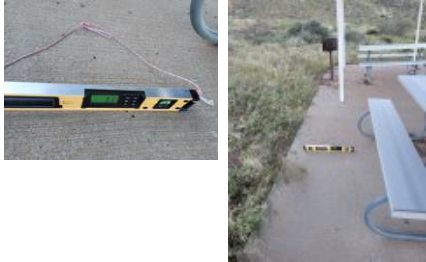
Finding Number	Area Description	Lat/Long	Finding	As Built	Recommendation	Citation	Photos	Figure
117	Restroom 2 Area: RR 2 - Picnic Areas	[31.916045, -106.51366 78]	The running slope of walking surfaces shall not be steeper than 1:20. The cross slope of walking surfaces shall not be steeper than 1:48.	Site 10 - 3.1% slope on circulation path at entry by table	Correct cross slope to max 2.08%.	2012 TAS Section: 403.3  2010 ADAS Section: 403.3

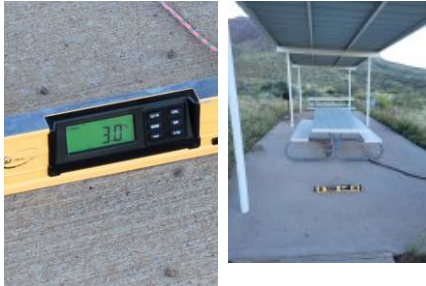
118	Restroom 2 Area: RR 2 - Picnic Areas	[31.9160504 , -106.5136 726]	The 30 inches minimum by 48 inches minimum clear floor space required at the operable part is not flat (2% or 1:48 maximum slope) in all directions. Changes in level are not permitted at required clear floor or ground space except that slopes not steeper than 1:48 shall be permitted.	Site 10 - 3% slope in clear floor space (CFS) picnic table wheelchair space	Correct or repair slope in CFS to max 2.08%	2015 ABAAS Section: 305.2  2012 TAS Section: 305.2  2010 ADAS Section: 305.2

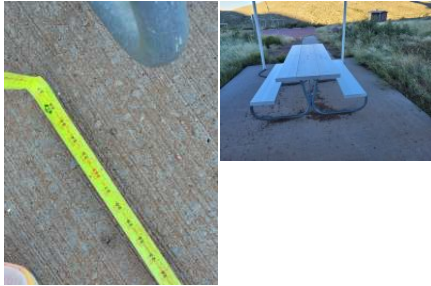
Finding Number	Area Description	Lat/Long	Finding	As Built	Recommendation	Citation	Photos	Figure
121	Restroom 2 Area: RR 2 - Picnic Areas	[31.9160377 , -106.51365 9]	The route of travel at this location does not provide the required minimum width. The minimum clear width for sidewalks and walks is 36 inches.	Site 10 - Route reduces to 34" around picnic table without chain	Relocate or reposition picnic table to widen EAR to min 36" clear width.	2015 ABAAS Section: 403.5.1  2012 TAS Section: 403.5.1  2010 ADAS Section: 403.5.1

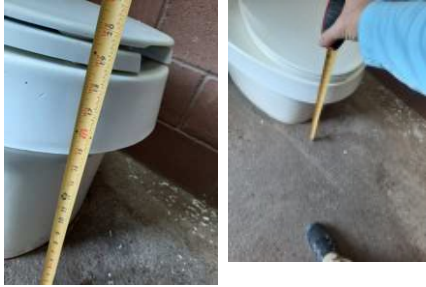
126	Restroom 2 Area: RR 2 - Single User Restroom	[31.9163729 , -106.5137 764]	The toilet seat is not located within the range allowed off the floor. The height of accessible water closets shall be a minimum of 17 inches and a maximum of 19 inches measured to the top of a maximum 2-inch high toilet seat.	Seat at 19.5" above the finished floor (AFF)	Replace toilet seat, or re-set or replace toilet to 17" to 19" above the finished floor (AFF).	2015 ABAAS Section: 604.4  2012 TAS Section: 604.4  2010 ADAS Section: 604.4

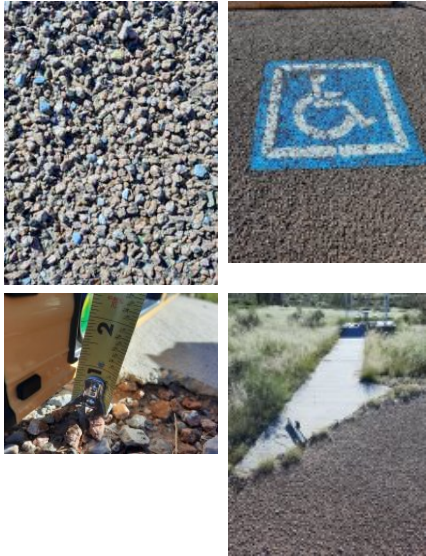
Finding Number	Area Description	Lat/Long	Finding	As Built	Recommendation	Citation	Photos	Figure																		
132	Camping Area (Restroom 3 Area): Camping/RR 3 - Parking	[31.9279086 , -106.5111 617]	The parking stall contains abrupt edges and surface irregularities over a 1/4 inch vertical. Parking spaces and access aisles serving them shall be stable, firm, and slip resistant. Access aisles shall be at the same level as the parking spaces they serve. Changes in level are not permitted and shall not be sloped steeper than 2% in any direction.	Rough stone surface with binding agent has loose rock on surface, CIL of .75" and plant overgrowth at transition from parking surface to shelter walkway	Resurface accessible stalls and access aisles with a firm, stable, and slip resistant material.	2015 ABAAS Section: 502.4  2012 TAS Section: 502.4  2010 ADAS Section: 502.4

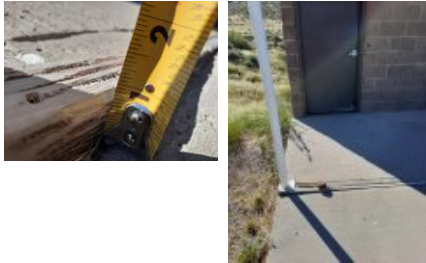
Finding Number	Area Description	Lat/Long	Finding	As Built	Recommendation	Citation	Photos	Figure
143	Camping Area (Restroom 3 Area): Camping/RR 3 - Exterior Accessible Route	[31.9278767, -106.5107282]	The walkway contains abrupt vertical edges and/or variations over a 1/4 inch. 1/4 inch is the maximum vertical rise. Changes in level between 1/4 inch and 1/2 inch must be beveled at 1:2 or less. Changes in level greater than 1/2 inch must be by way of a ramp.	Up to .75" change in level (CIL) on route due to upheaval of joint filling board	Repair, bevel or ramp CIL along route.	2012 TAS Section: 303.2, 303.3  2010 ADAS Section: 303.2, 303.3

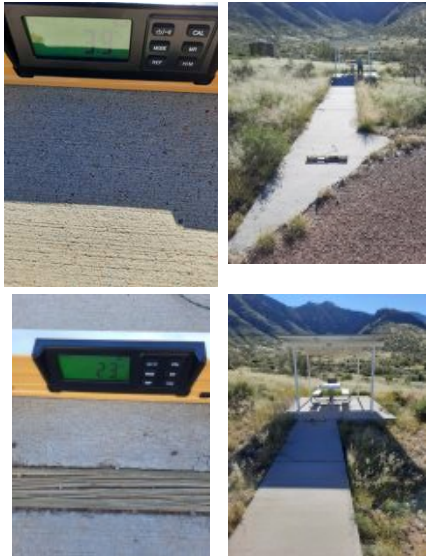
144	Camping Area (Restroom 3 Area): Camping/RR 3 - Exterior Accessible Route	[31.9278855, -106.5110725]	The running slope of walking surfaces shall not be steeper than 1:20. The cross slope of walking surfaces shall not be steeper than 1:48.	Cross slope of 3.9% to 2.3% for 35' on walkway to accessible shelter 21	Correct cross slopes to max 2.08%.	2012 TAS Section: 403.3  2010 ADAS Section: 403.3

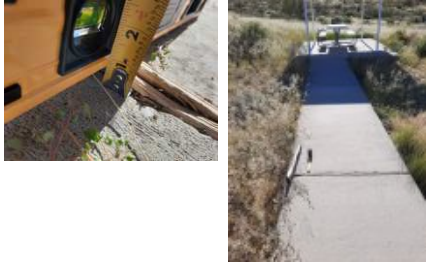
149	Camping Area (Restroom 3 Area): Camping/RR 3 - Picnic Areas	[31.9278367, -106.5110048]	The walkway contains abrupt vertical edges and/or variations over a 1/4 inch. 1/4 inch is the maximum vertical rise. Changes in level between 1/4 inch and 1/2 inch must be beveled at 1:2 or less. Changes in level greater than 1/2 inch must be by way of a ramp.	Accessible shelter 21 at Camping/RR3 - .75" change in elevation (CIL) due to upheaval of expansion joint board	Repair, bevel or ramp CIL along AR.	2012 TAS Section: 303.2, 303.3  2010 ADAS Section: 303.2, 303.3

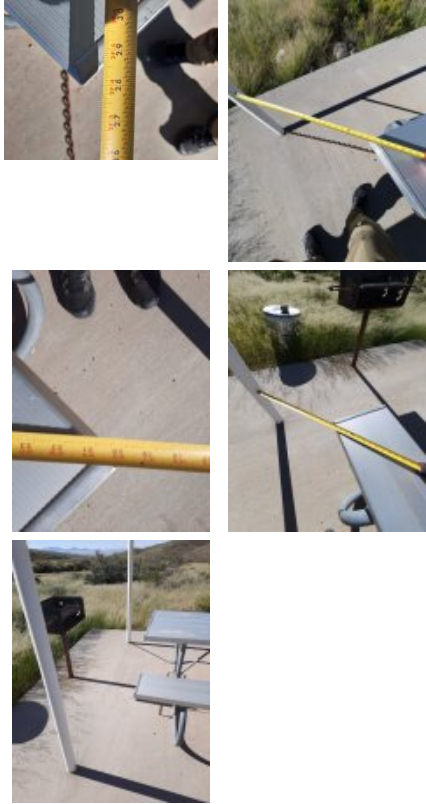
Finding Number	Area Description	Lat/Long	Finding	As Built	Recommendation	Citation	Photos	Figure
150	Camping Area (Restroom 3 Area): Camping/RR 3 - Picnic Areas	[31.9278345, -106.5110101]	Where picnic facilities contain two or fewer picnic units, each picnic unit shall provide mobility features complying with F245.2.	Accessible shelter 21 at Camping/RR3 - Lacks route to grill and garbage can due to route reducing less than 36" and picnic table chain on ground	Relocate or reposition picnic table and remove chain to provide 36" route to grill and garbage can.	2015 ABAAS Section: F245.2.1

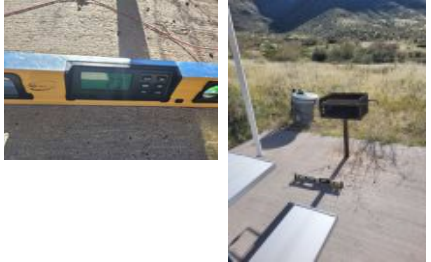
Finding Number	Area Description	Lat/Long	Finding	As Built	Recommendation	Citation	Photos	Figure
152	Camping Area (Restroom 3 Area): Camping/RR 3 - Picnic Areas	[31.9283495, -106.5105115]	The 30 inches minimum by 48 inches minimum clear floor space required at the operable part is not flat (2% or 1:48 maximum slope) in all directions. Changes in level are not permitted at required clear floor or ground space except that slopes not steeper than 1:48 shall be permitted.	Site 23 - Slope of 2.3% in clear ground space (CGS) of grill	Correct or repair slope in CFS to max 2.08%. In the alternative, leave as is citing construction tolerance.	2015 ABAAS Section: 305.2  2012 TAS Section: 305.2  2010 ADAS Section: 305.2

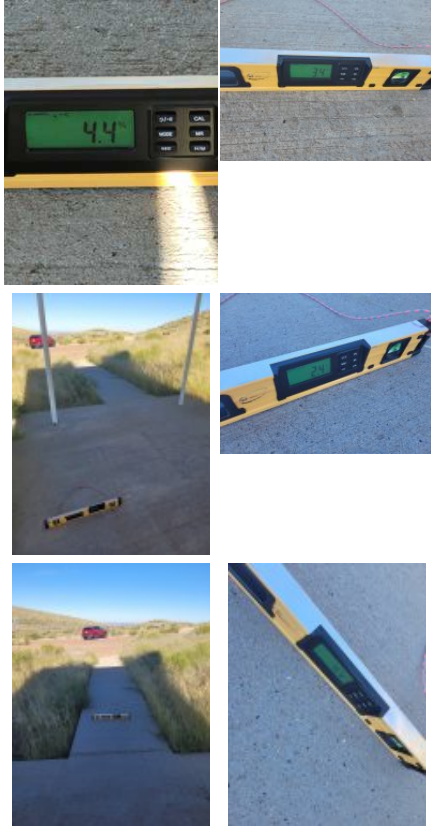
153	Camping Area (Restroom 3 Area): Camping/RR 3 - Picnic Areas	[31.9283945, -106.5105826]	The cross slope shall not be steeper than 1:48. EXCEPTION: Where the surface is other than concrete, asphalt, or boards, cross slopes not steeper than 1:20 shall be permitted when necessary for drainage.	Consistent cross slopes within site 23 - 4.4% slope, 3.4%; on path to site 23 - 2.4%, 4.4%, 10.2%	Correct or repair ORAR cross slope to max 2.08% as a smart practice.	2015 ABAAS Section: 1016.7.2, 1016.7.2 EXCEPTION

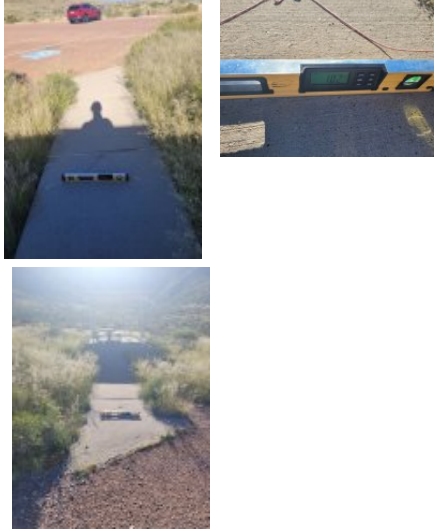
154	Camping Area (Restroom 3 Area): Camping/RR 3 - Picnic Areas	[31.9284029, -106.5105961]	The clear width of outdoor recreation access routes shall be 36 inches (915 mm) minimum.	Site 23 - width reduced by plant overgrowth	Widen ORAR to min 36" clear width as a smart practice.	2015 ABAAS Section: 1016.3

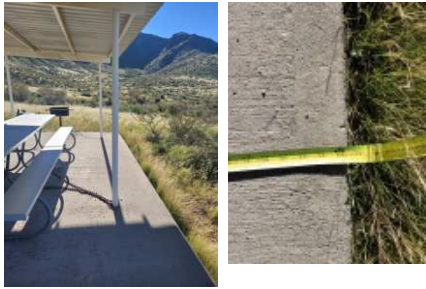
157	Camping Area (Restroom 3 Area): Camping/RR 3 - Picnic Areas	[31.9283454, -106.5105 061]	Where picnic facilities contain two or fewer picnic units, each picnic unit shall provide mobility features complying with F245.2.	Site 23 - route around table reduced to 24" due to chain and pole	Relocate or reposition picnic tables to provide 36" clear width on all usable sides of picnic table and in shelter.	2015 ABAAS Section: F245.2.1

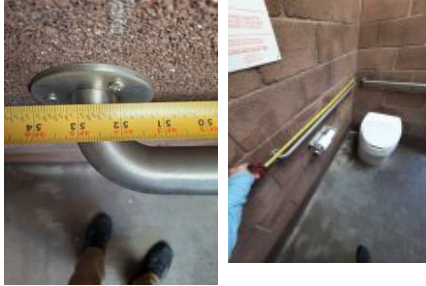
162	Camping Area (Restroom 3 Area): Camping/RR 3 - Single User Restroom	[31.9278644 , -106.5107 203]	The side grab bars are not in the correct location. Grab bars on the side wall must be installed so that the end closest to the rear wall is maximum 12" from the rear wall. The end furthest from the rear wall must be mounted minimum 54" from the rear wall.	Bar ends 52.75" from rear wall	Remount side grab bar to max 12" from the rear wall at the close end and min 54" on the far end, and 33" to 36" AFF.	2015 ABAAS Section: 604.5.1  2012 TAS Section: 604.5.1  2010 ADAS Section: 604.5.1

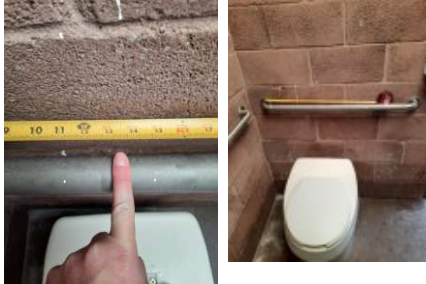
163	Camping Area (Restroom 3 Area): Camping/RR 3 - Single User Restroom	[31.9278541 , -106.5107 216]	The rear grab bar is not 36" long or is not mounted in the correct location. The rear grab bar must be a minimum of 36" long and extend from the toilet centerline a minimum 12" towards the wall side and a minimum 24" towards the open side of the toilet. Grab bars shall be installed in a horizontal position, 33 inches minimum and 36 inches maximum above the finish floor measured to the top of the gripping surface and the space between the grab bar and the top of the tank shall be 1-1/2 inches minimum.	Rear grab bar extends 13.5" towards wall	Remount rear grab bar to behind the toilet, 12" to the wall side of center and 24" to the open side and 33" to 36" AFF.	2015 ABAAS Section: 604.5.2  2012 TAS Section: 604.5.2  2010 ADAS Section: 604.5.2

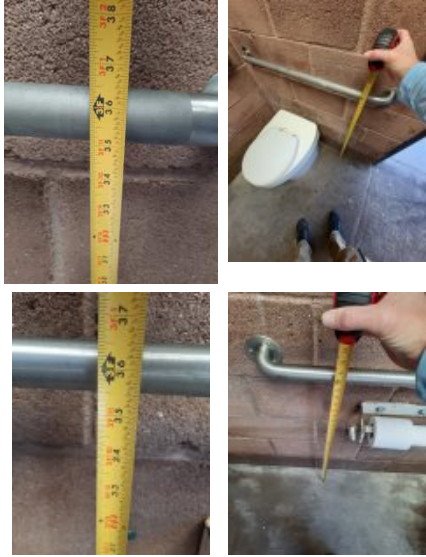
Finding Number	Area Description	Lat/Long	Finding	As Built	Recommendation	Citation	Photos	Figure
164	Camping Area (Restroom 3 Area): Camping/RR 3 - Single User Restroom	[31.9278553, -106.5107283]	The grab bar height and/or spacing fails. Grab bars must be mounted between 33" and 36" to the top of the gripping surface. There must be 1.5" of clearance between the grab bar and the wall. There must be a minimum of 1.5" of clearance below and minimum 12" above the grab bar to any dispenser or other obstruction.	Both bars 36.5" AFF	Remount grab bars in accessible stall to 33" to 36" above the finished floor (AFF). Pricing included in previous findings.	2015 ABAAS Section: 609.3, 609.4  2012 TAS Section: 609.4, 609.3  2010 ADAS Section: 609.3, 609.4

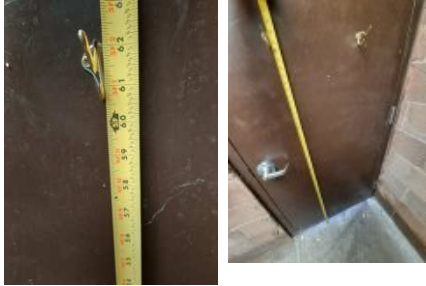
167	Camping Area (Restroom 3 Area): Camping/RR 3 - Single User Restroom	[31.9278586, -106.5107096]	The operable part is positioned too high for either a side or front approach. Where a clear floor or ground space allows a parallel approach to an element and the side reach is unobstructed, the high side reach shall be 48 inches maximum and the low side reach shall be 15 inches minimum above the finish floor or ground. Where a forward reach is unobstructed, the high forward reach shall be 48 inches maximum and the low forward reach shall be 15 inches minimum above the finish floor or ground.	RR3 single user restroom - hooks on door at 61" above the finished floor (AFF)	Remount operable parts to be in reach range of 15" min to 48" max.	2015 ABAAS Section: 308.1  2012 TAS Section: 308.1  2010 ADAS Section: 308.1

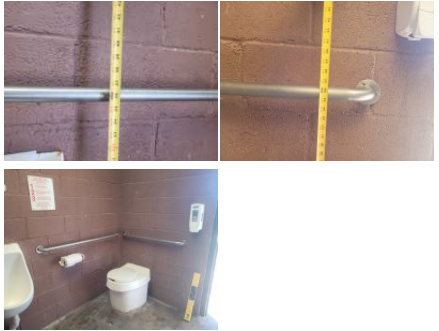
Finding Number	Area Description	Lat/Long	Finding	As Built	Recommendation	Citation	Photos	Figure
179	Group Camping Area (Restroom 4 Area): Group Camp/RR 4 - Men's Restroom	[31.9312176, -106.5130437]	The grab bar height and/or spacing fails. Grab bars must be mounted between 33" and 36" to the top of the gripping surface. There must be 1.5" of clearance between the grab bar and the wall. There must be a minimum of 1.5" of clearance below and minimum 12" above the grab bar to any dispenser or other obstruction.	Side and rear bars at 36.5" above the finished floor (AFF)	Remount grab bars in accessible stall to 33" to 36" above the finished floor (AFF). Pricing included in previous findings.	2015 ABAAS Section: 609.3, 609.4  2012 TAS Section: 609.4, 609.3  2010 ADAS Section: 609.3, 609.4

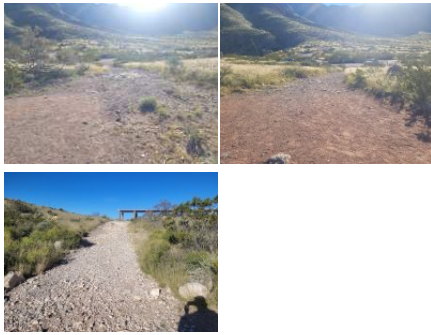
192	Group Camping Area (Restroom 4 Area): Group Camp/RR 4 - Sample Group Campsite	[31.93091, -106.5144]	An accessible access route is not provided between elements, spaces and the facilities provided within the accessible camping unit. At least one outdoor recreation access route shall connect accessible elements, spaces and facilities provided within camping units with mobility features.	Large Shelter, Site #39 - very rough, steep surface with large rocks and large tread obstacles	Create AR with crushed and compacted stone or similar outdoor material to shelter and one of each type of amenity as a smart practice.	2015 ABAAS Section: F244.5.1

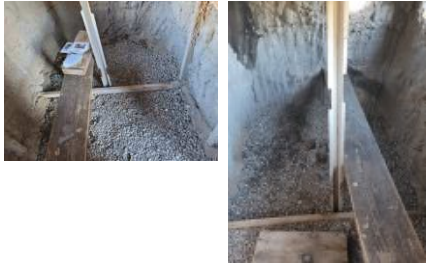
Finding Number	Area Description	Lat/Long	Finding	As Built	Recommendation	Citation	Photos	Figure
221	Nature Walk Trail Area: Nature Walk - Bird Blind	[31.9216713, -106.5136994]	The element is not accessible because there is not adequate clear floor space for an approach. The clear floor or ground space shall be 30 inches minimum by 48 inches minimum.	Lacks clear floor space (CFS) within bird blind	Provide 30" by 48" clear ground space (CGS) within bird blind at viewing ports if feasible.	2015 ABAAS Section: 305.3  2012 TAS Section: 305.3  2010 ADAS Section: 305.3

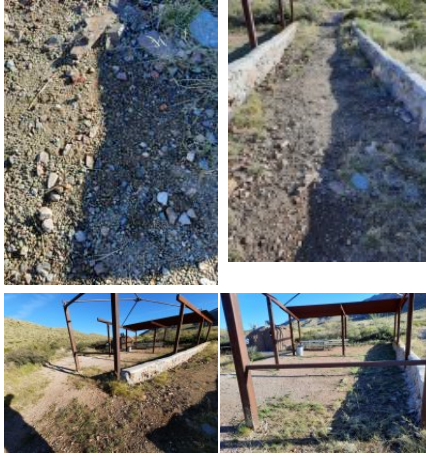
223	Nature Walk Trail Area: Nature Walk - Picnic Areas	[31.921586, -106.5136785]	The surface of the route to and into the picnic area or shelter must be firm and stable.	Route and shelter surface are natural with large stones and plant overgrowth	Replace or correct surface to be firm and stable.	2015 ABAAS Section: 1016.1, 1016.1 EXCEPTION S 1, 1016.1 EXCEPTION S 2, 1016.1 EXCEPTION S 3

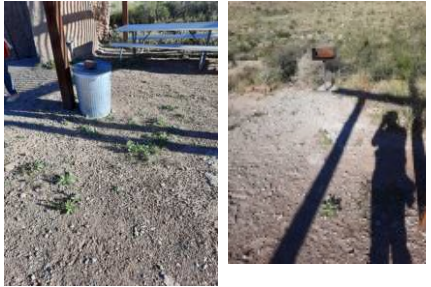
225	Nature Walk Trail Area: Nature Walk - Picnic Areas	[31.9215815 , -106.5136 839]	Where picnic facilities contain two or fewer picnic units, each picnic unit shall provide mobility features complying with F245.2.	Lacks route to grill and garbage can due to non-compliant surface	Create an ORAR to shelter or picnic area and provide accessible features as a smart practice. Pricing provided in previous shelter surface finding.	2015 ABAAS Section: F245.2.1

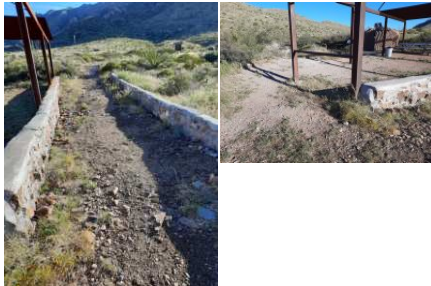
227	Nature Walk Trail Area: Nature Walk - Picnic Areas	[31.9215928 , -106.5136 785]	Picnic facilities shall provide outdoor recreation access routes complying with 1016 in accordance with F245.4 and 245.4 of IAC	Lacks route to picnic shelter	Create ORAR with crushed and compacted stone or similar outdoor material from parking or sidewalk to shelter or picnic area. Pricing included in route to bird blind finding.	2015 ABAAS Section: F245.4

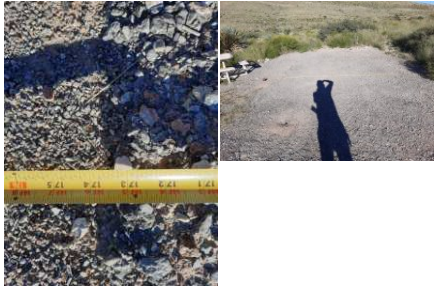
Finding Number	Area Description	Lat/Long	Finding	As Built	Recommendation	Citation	Photos	Figure
233	RV Area: RV Area - Sample Campsite RV3	[31.9265, -106.5125]	Camping facilities shall provide camping units with mobility features complying with F244.2 in accordance with Table F244.2. Where a camping facility provides different types of camping units, Table F244.2 shall apply to each type of camping unit provided. Total Number of Camping Units Provided in Camping Facility Minimum Number of Camping Units with Mobility Features Required 1 1 2 to 25 2 26 to 50 3 51 to 75 4 76 to 100 5 101 to 150 7 151 to 200 8 201 and over 8, plus 2 percent of the number over 200	5 RV campsites, 0 accessible	Create the required number of accessible camp sites per table F244.2 as a smart practice.	2015 ABAAS Section: F244.2		
234	RV Area: RV Area - Sample Campsite RV3	[31.9264812, -106.5125 241]	Parking spaces and pull-up spaces for recreational vehicles shall be 20 feet (6100 mm) wide minimum. EXCEPTION: Where two adjacent parking spaces are provided for recreational vehicles, one parking space shall be permitted to be 16 feet (4880 mm) wide minimum.	RV parking space - 173" wide	Correct RV parking space to be 20' wide minimum; or 16' for two adjacent spaces as a smart practice.	2015 ABAAS Section: 1012.2, 1012.2 EXCEPTION

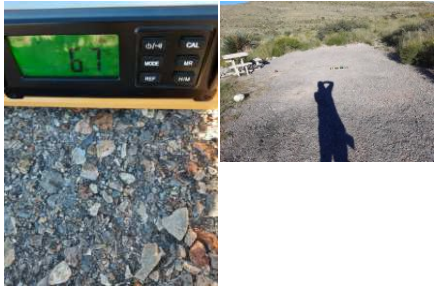
235	RV Area: RV Area - Sample Campsite RV3	[31.9264784, -106.5125 268]	The surface of parking spaces and pull-up spaces shall be firm and stable. The slope of the surface of parking spaces and pull-up spaces shall not be steeper than 1:48 in any direction. EXCEPTION: Where the surface is other than asphalt, concrete, or boards, slopes not steeper than 1:20 shall be permitted when necessary for drainage.	6.7% slope in middle of parking space	Correct surface of parking spaces to be firm and stable with slopes max of 2.08% or 5% for surfaces other than concrete, asphalt or boards as a smart practice.	2015 ABAAS Section: 1012.4, 1012.5, 1012.5 EXCEPTION

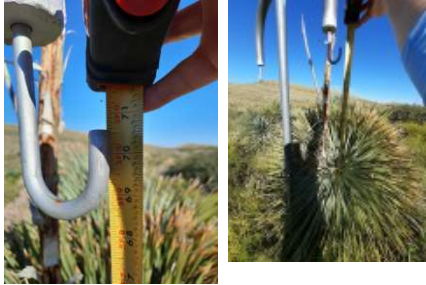
Finding Number	Area Description	Lat/Long	Finding	As Built	Recommendation	Citation	Photos	Figure																																																																				
236	RV Area: RV Area - Sample Campsite RV3	[31.9264402 , -106.512604]	The operable part is positioned too high for either a side or front approach. Where a clear floor or ground space allows a parallel approach to an element and the side reach is unobstructed, the high side reach shall be 48 inches maximum and the low side reach shall be 15 inches minimum above the finish floor or ground. Where a forward reach is unobstructed, the high forward reach shall be 48 inches maximum and the low forward reach shall be 15 inches minimum above the finish floor or ground.	Camp hook at Sample RV site #3 at 70.5" above ground level (AGL)	Remount operable parts to be in reach range of 15" min to 48" max.	2015 ABAAS Section: 308.1  2012 TAS Section: 308.1  2010 ADAS Section: 308.1

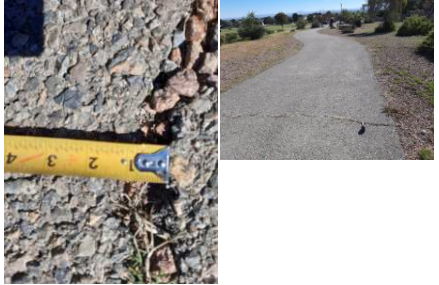
Finding Number	Area Description	Lat/Long	Finding	As Built	Recommendation	Citation	Photos	Figure
241	Tin Mine Trail : Trail Surface	[31.93253, -106.4495]	There are openings in the surface of the trails, passing spaces, and resting intervals that allow the passage of a sphere more than 1/2 inch in diameter. Openings in the surface of trails, passing spaces, and resting intervals shall not allow the passage of a sphere more than 1/2 inch (13 mm) in diameter.	1.25" opening near trailhead	Correct for fill gaps to max .5" as a smart practice.	2015 ABAAS Section: 1017.6

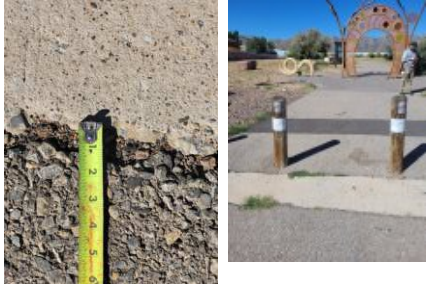
243	Tin Mine Trail : Trail Surface	[31.9324539 , -106.44919 2]	Openings in the surface of outdoor recreation access routes shall not allow the passage of a sphere more than 1/2 inch (13 mm) in diameter. Advisory: Spaces between the boards in a boardwalk and drainage grates are examples of openings. Where possible, drainage grates should be located outside the minimum clear width of the outdoor recreation access route. Elongated openings should be placed so that the long dimension is perpendicular, or as close to perpendicular as possible, to the dominant direction of travel	1.5" gap at trail entry by parking	Correct or fill gaps along the ORAR to max .5" as a smart practice.	2015 ABAAS Section: 1016.6, Advisory 1016.6
