Access Audit Site Report

Galveston Island State Park

Accessibility Evaluation

Inspection Date: 08/17/2022

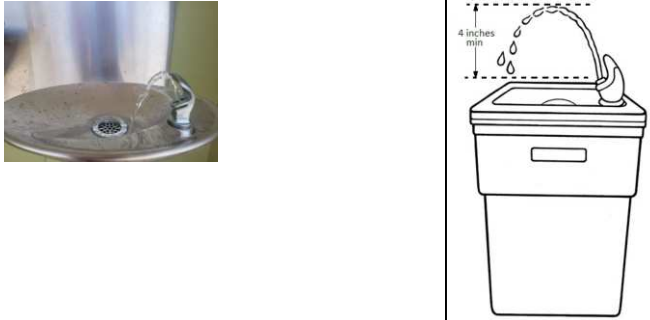
50	Beachside - Main RV Camping Loop: Main - Men's Restroom	[29.1900126 , -94.960625 1]	The water flow from the spout is too low. The spout shall provide a flow of water 4 inches high minimum.	Low flow	Adjust spout flow height to min. 4".	2015 ABAAS Section: 602.6 2012 TAS Section: 602.6 2010 ADAS Section: 602.6

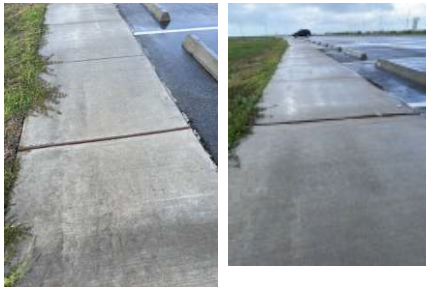
81	Beachside - Tent Platform (61-70) and Primitive Camping (71-85) Loop: Primitive Camping Area (71-85)	[29.1900676 , -94.963672 9]	The walkway contains abrupt vertical edges and/or variations over a 1/4 inch. 1/4 inch is the maximum vertical rise. Changes in level between 1/4 inch and 1/2 inch must be beveled at 1:2 or less. Changes in level greater than 1/2 inch must be by way of a ramp.	Material used to fill gaps needs maintenance to prevent CILs	Repair, bevel or ramp CIL along AR.	2012 TAS Section: 303.2, 303.3 2010 ADAS Section: 303.2, 303.3

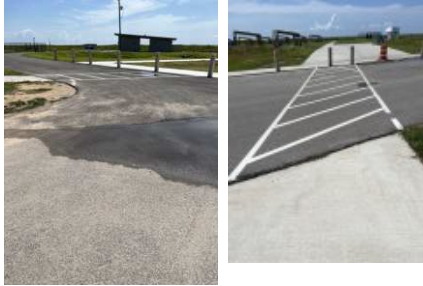
94	Beachside - Day Use Area: Day Use - Parking	[29.1915768 , -94.958500 8]	The accessible route of travel that crosses or adjoins the vehicular way and the walking surface is not separated by curbs, railings, or other elements between the pedestrian areas and vehicular areas. If a walk crosses or adjoins a vehicular way, and the walking surfaces are not separated by curbs, railings or other elements between the pedestrian areas and vehicular areas, the boundary between the areas shall be defined by a continuous detectable warning which is 36 inches wide.	Lacks detectable warning at 2 crosswalk areas from parking at day use	Install detectable warning where accessible route crosses the vehicular way as a smart practice.	2012 TAS Section: 705.1 2010 ADAS Section: 705

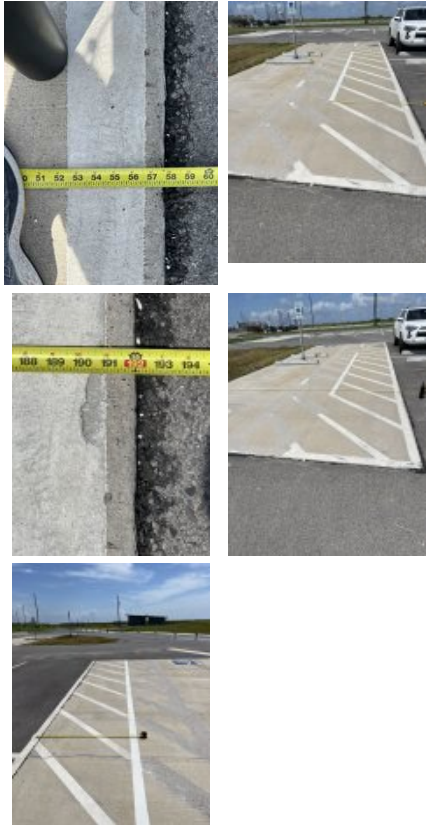
Finding Number	Area Description	Lat/Long	Finding	As Built	Recommendation	Citation	Photos	Figure
96	Beachside - Day Use Area: Day Use - Parking	[29.1920123 , -94.958106 5]	The access aisle is not a minimum 5 feet wide. A car accessible parking stall's access aisle must be a minimum of 5 feet wide measured from centerline to centerline. Where the access aisle is not adjacent to another parking space or access aisle, measurements shall be permitted to include the full width of the line defining the access aisle.	east side- 54.5" width, both sections with 2 accessible stalls	Repaint access aisles to be 5' each.	2015 ABAAS Section: 502.3.1 2012 TAS Section: 502.3.1 2010 ADAS Section: 502.3.1

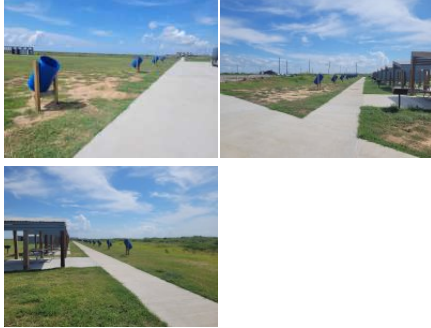
119	Beachside - Day Use Area: Day Use - Shelter/Picnic Area	[29.19121, -94.95869]	At least one accessible route shall connect accessible buildings, accessible facilities, accessible elements, and accessible spaces that are on the same site. For areas of sport activity, an accessible route is required to connect to the boundary of each area of sport activity. The size of an area of sport activity includes only the space needed to play. Where multiple sports fields or courts are provided, an accessible route is required to each field or area of sport activity.	0 of 29 garbage cans reachable from sidewalk	Relocate 20% of garbage receptacles along route.	2010 ADAS Section: 206.2.2, 206.2

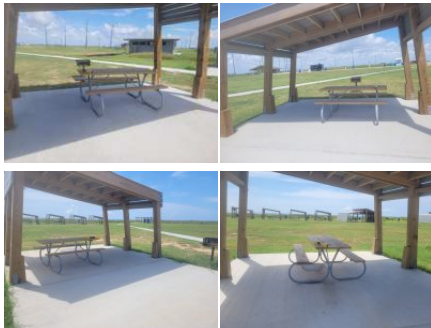
123	Beachside - Day Use Area: Day Use - Shelter/Picnic Area	[29.1914208, -94.9572688]	Picnic tables shall provide at least one wheelchair space for each 24 linear feet (7320 mm) of usable table surface perimeter. Wheelchair spaces shall be 30 inches (760 mm) minimum by 48 inches (1220 mm) minimum. Wheelchair spaces shall be positioned for a forward approach to the table and provide knee and toe clearance complying with 306 under the table	Each of these 4 shelters with routes lacks accessible table (20 total shelters)	Replace picnic table with one of an accessible design as a smart practice.	2015 ABAAS Section: 1011.4.2

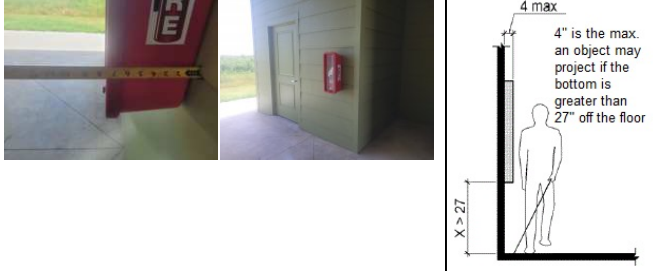
131	Beachside - Day Use Area: Day Use - East (#1) Men's Restroom	[29.1918, -94.95724]	An object or objects project more than 4 inches into the circulation path. Wall-mounted objects that have leading edges between 27 inches and 80 inches from the floor must not project more than 4 inches into the circulation path. Protruding objects that extend to the floor or within 27 inches of the floor are cane detectable and are therefore not hazardous. Where it is necessary or desirable to have objects protrude from the wall, a manner of cane detection must be provided.	Fire extinguisher protrudes 7.5"	Relocate protruding objects or place cane detectable warning or bollard at foot of item.	2015 ABAAS Section: 307.2 2012 TAS Section: 307.2 2010 ADAS Section: 307.2

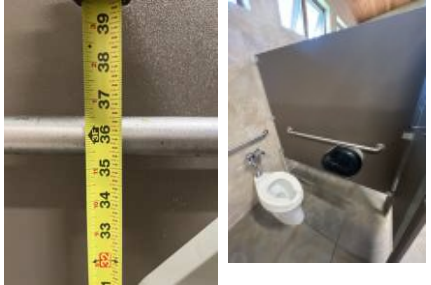
135	Beachside - Day Use Area: Day Use - East (#1) Men's Restroom	[29.1918373 , -94.957197 2]	The grab bar height and/or spacing fails. Grab bars must be mounted between 33" and 36" to the top of the gripping surface. There must be 1.5" of clearance between the grab bar and the wall. There must be a minimum of 1.5" of clearance below and minimum 12" above the grab bar to any dispenser or other obstruction.	Side grab bar 36.5" AFF	Remount grab bars in accessible stall to 33" to 36" above the finished floor (AFF).	2015 ABAAS Section: 609.3, 609.4 2012 TAS Section: 609.4, 609.3 2010 ADAS Section: 609.3, 609.4

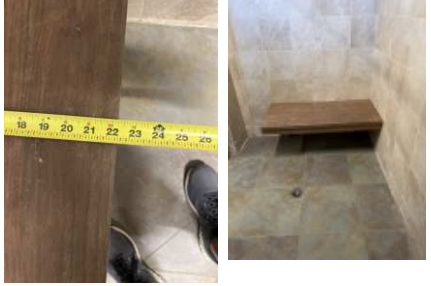
137	Beachside - Day Use Area: Day Use - East (#1) Men's Restroom	[29.191855, -94.9571986]	The bench is not deep enough or long enough or is missing. Benches shall be provided having seats that are 42 inches long minimum and 20 inches deep minimum and 24 inches deep maximum. The bench shall provide for back support or shall be affixed to a wall. Back support shall be 42 inches (1065 mm) long minimum and shall extend from a point 2 inches (51 mm) maximum above the seat surface to a point 18 inches (455 mm) minimum above the seat surface. Back support shall be 2 1/2 inches (64 mm) maximum from the rear edge of the seat measured horizontally. The top of the bench seat surface shall be 17 inches (430 mm) minimum and 19 inches (485 mm) maximum above the finish floor or ground. Clear floor or ground space complying with 305 shall be provided and shall be positioned at the end of the bench seat and parallel to the short axis of the bench	Bench 22.25" depth	Replace bench in dressing area with one having a seat depth of 20" to 24" deep, 42" long, affixed to the wall or having a back and mounted 17" to 19" AFF and provide required clear floor space on the short axis of the bench.	2012 TAS Section: 903.4, 903.2, 903.3, 903.5 2010 ADAS Section: 903.4, 903.2, 903.3, 903.5

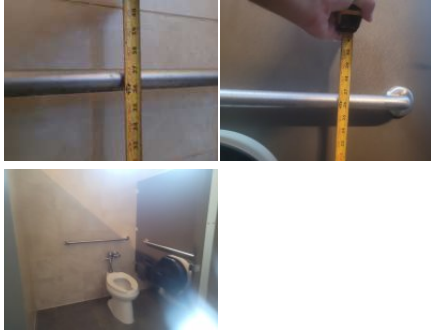
147	Beachside - Day Use Area: Day Use - East (#1) Women's Restroom	[29.19185, -94.95721]	The grab bar height and/or spacing fails. Grab bars must be mounted between 33" and 36" to the top of the gripping surface. There must be 1.5" of clearance between the grab bar and the wall. There must be a minimum of 1.5" of clearance below and minimum 12" above the grab bar to any dispenser or other obstruction.	Both grab bars 37" AFF	Remount grab bars in accessible stall to 33" to 36" above the finished floor (AFF).	2015 ABAAS Section: 609.3, 609.4 2012 TAS Section: 609.4, 609.3 2010 ADAS Section: 609.3, 609.4

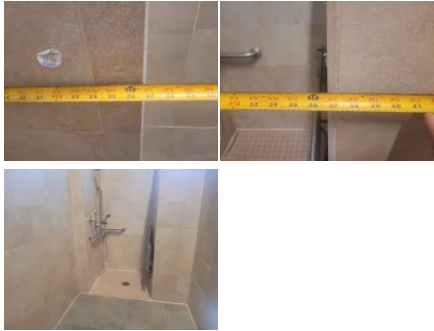
152	Beachside - Day Use Area: Day Use - East (#1) Women's Restroom	[29.19185, -94.95718]	Transfer type shower compartments shall be 36 inches (915 mm) by 36 inches (915 mm) clear inside dimensions measured at the center points of opposing sides and shall have a 36 inch (915 mm) wide minimum entry on the face of the shower compartment. Clearance of 36 inches (915 mm) wide minimum by 48 inches (1220 mm) long minimum measured from the control wall shall be provided.	transfer shower 36.5" wide, 36.5" deep	Correct transfer shower to compliant 36" by 36" clear inside dimension	2015 ABAAS Section: 608.2.1 2012 TAS Section: 608.2.1 2010 ADAS Section: 608.2.1

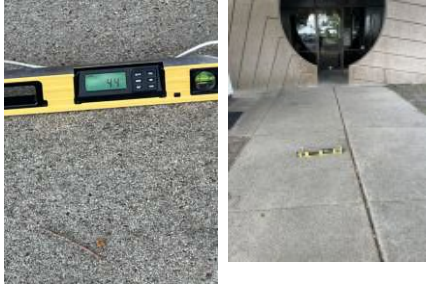
157	Bayside - Entrance: Entrance - Parking	[29.1988517, -94.9564047]	The accessible route of travel contains cross slopes greater than 2%. Cross slopes shall not exceed one unit vertical in 48 units horizontal (2-percent slope).	4.4% approaching entry	Correct or repair cross slope along AR to max 2.08%.	2015 ABAAS Section: 403.3 2012 TAS Section: 403.3 2010 ADAS Section: 403.3

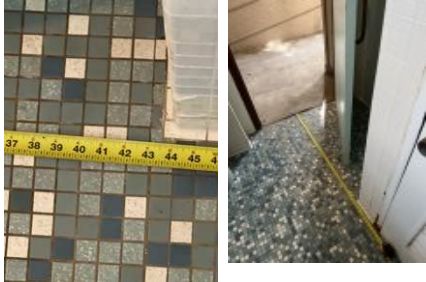
162	Bayside - Entrance: Entrance - Men's Restroom	[29.1989009 , -94.9562976]	Minimum maneuvering clearances at doors and gates shall comply with 404.2.4. Maneuvering clearances shall extend the full width of the doorway and the required latch side or hinge side clearance. The sweep period for doors with closers shall be adjusted so that from an open position of 70 degrees, the door will take at least 3 seconds to move to a point 3 inches from the latch, measured to the leading edge of the door. Exterior doors are recommended to be maintained at 8.5 lbf as a smart practice. Force is to be measured at the operating hardware or 30 inches from the hinges, whichever is greater. The bottom 10 inches on the push side must be smooth and free of obstructions (hold open devices). Opening hardware must be mounted between 30 and 44 inches above the floor or ground.	Men's - 20 lbf, fast closing, bottom not smooth on push; women's - 15 lbf, stopper, clearance 44" on push	For all doors along the public circulation route, provide required maneuvering clearance on push and pull side of doors. For all doors along the public circulation route, inspect, adjust, and maintain closing speed on door closers. For all doors along the public circulation route, inspect, adjust, and maintain 8.5 lbf to open exterior doors as a smart practice. For all doors along the public circulation route, remove door holder to provide a smooth surface on the push side of door from floor to 10" AFF.	2010 ADAS Section: 404.2.3, 404.2.7, 404.2.4, 404.2.11, 404.2.11 Exception

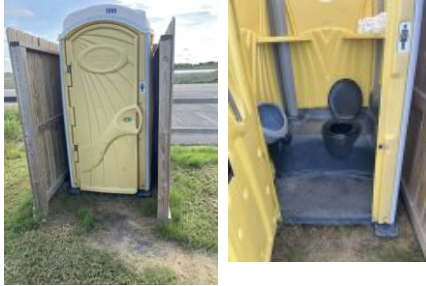
184	Bayside - Oak Bayou Area: Oak - Shelter/Picnic Area	[29.2042329 , -94.956568 4]	The portable public restroom is not compliant. 5% of portable toilets must be accessible, minimum of 1. If sanitary facilities are provided, they must be made accessible to persons with disabilities. If public restrooms are desired, It is recommended that the portable unit be replaced with a permanent built in compliant restroom. The utilization of an accessible portable unit may be a temporary solution and is not recommended as a permanent solution.	Restroom not accessible, lacks route	Replace 5% of portable toilets with compliant models and place along AR.	2015 ABAAS Section: F213.1 2012 TAS Section: 213.1 2010 ADAS Section: 213.1, 213.2 Exception 3

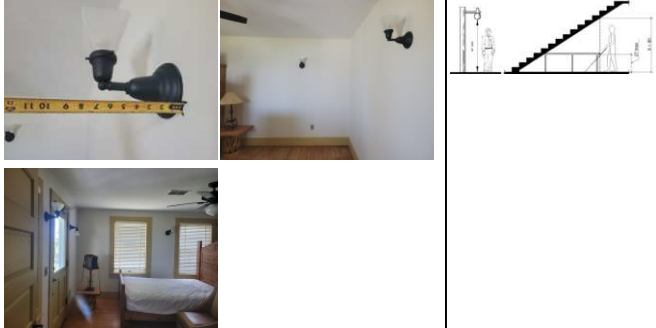
235	Bayside Area: Stewart House	[29.2090995 , -94.952878 9]	An item or items project more than 4 inches into the circulation path. Wall-mounted objects that have leading edges between 27 inches and 80 inches from the floor must not project more than 4 inches into the circulation path. Protruding objects that extend to the floor or within 27 inches of the floor are cane detectable and are therefore not hazardous. Where it is necessary or desirable to have objects protrude from the wall, a manner of cane detection must be provided.	Bedroom at porch - 5 wall sconces protrude 7"	Relocate protruding objects or place cane detectable warning or bollard at foot of item.	2015 ABAAS Section: 307.2 2012 TAS Section: 307.2 2010 ADAS Section: 307.2

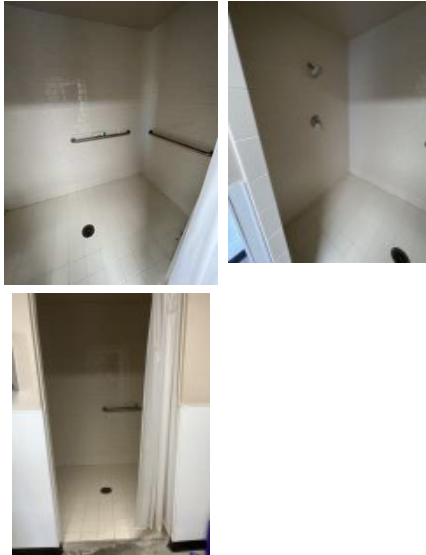
Finding Number	Area Description	Lat/Long	Finding	As Built	Recommendation	Citation	Photos	Figure
290	Employee Areas: Maintenance	[29.2064298, -94.9549978]	There are no accessible bathing or shower facilities. Where facilities for bathing are provided for the public, clients or employees, including showers or bathtubs, at least one shower or bathtub and support facilities such as lockers, and not less than 1 percent of all facilities, shall be accessible.	Shower is not accessible, large space with grab bars on far wall opposite control wall	Create an accessible shower in locker/bathing room	2015 ABAAS Section: F213.3.6 2012 TAS Section: 213.3.6 2010 ADAS Section: 213.3.6

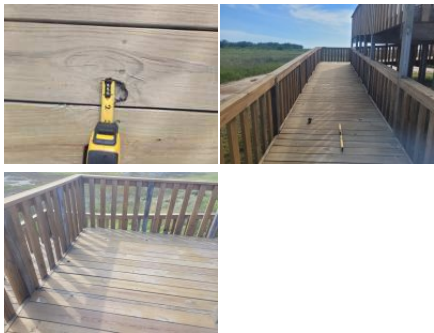
302	Trails: Trail Surface	[29.2013934 , -94.962942 2]	There are openings in the surface of the trails, passing spaces, and resting intervals that allow the passage of a sphere more than 1/2 inch in diameter. Openings in the surface of trails, passing spaces, and resting intervals shall not allow the passage of a sphere more than 1/2 inch (13 mm) in diameter.	7 gaps at knots on accessible viewing area	Correct for fill gaps to max .5" as a smart practice.	2015 ABAAS Section: 1017.6
