Access Audit Site Report

Goose Island State Park

Accessibility Evaluation

Inspection Date: 10/07/2021

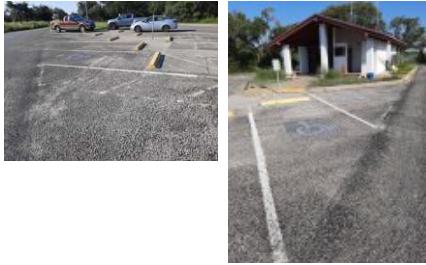
Finding Number	Area Description	Lat/Long	Finding	As Built	Recommendation	Citation	Photos	Figure
1	Headquarters Area: Headquarters Building Parking	[28.1334053, -96.984288]	The access aisle is not a minimum 5 feet wide. A car accessible parking stall's access aisle must be a minimum of 5 feet wide measured from centerline to centerline. Where the access aisle is not adjacent to another parking space or access aisle, measurements shall be permitted to include the full width of the line defining the access aisle.	1 stall has an access aisle that does not extend the full length of the space	Repaint access aisles to be 5' each	2015 ABAAS Section: 502.3.1 2012 TAS Section: 502.3.1 2010 ADAS Section: 502.3.1

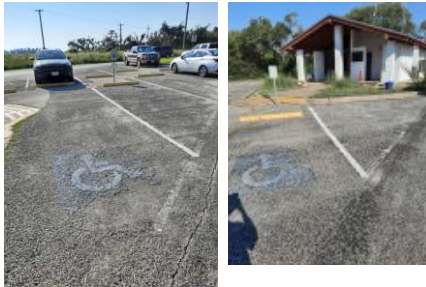
2	Headquarters Area: Headquarters Building Parking	[28.13295, -96.98463]	There are no van accessible parking stalls. 1 in every 6, minimum of one, required accessible stalls must be a van accessible stall. There are a total of 7 parking stalls in the parking lot that could be reasonably associated with this facility. There should be a minimum of 1 accessible stalls with a minimum of 1 being designed as van accessible.	Both accessible parking stalls and access aisles lack required widths for a van accessible stall	Add van parking sign to 1 accessible stall and repaint stall and access aisle to 11' and 5' or 8' and 8' per the table	2015 ABAAS Section: F208.2, F208.2.4 2012 TAS Section: 208.2, 208.2.4 2010 ADAS Section: 208.2, 208.2.4

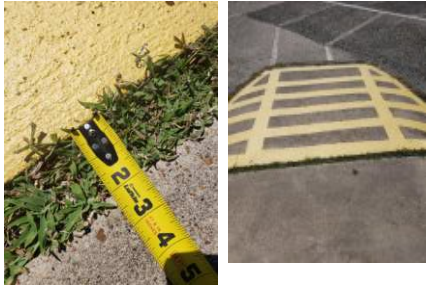
Finding Number	Area Description	Lat/Long	Finding	As Built	Recommendation	Citation	Photos	Figure
6	Headquarters Area: Headquarters EAR	[28.1334278 , -96.984332 3]	There is a gap spaced greater than a 1/2 inch. Openings in floor or ground surfaces shall not allow passage of a sphere more than 1/2 inch diameter. Elongated openings shall be placed so that the long dimension is perpendicular to the dominant direction of travel.	2" gap	Correct or fill gaps to be max .5"	2015 ABAAS Section: 302.3 2012 TAS Section: 302.3 2010 ADAS Section: 302.3

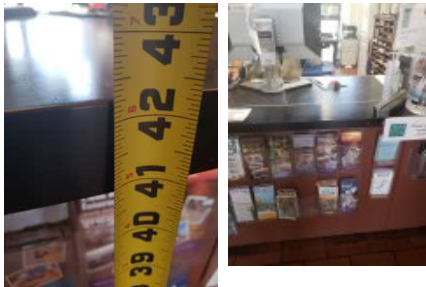
9	Headquarters Area: Headquarters Building	[28.1335461 , -96.984316 2]	The transaction counter is too high. A portion of the counter surface that is 36 inches long minimum and 36 inches high maximum above the finish floor shall be provided. Knee and toe space must be provided for a forward approach. A 30 inch by 48 inch clear floor space on an accessible route must be provided for either a forward or parallel approach.	Service counter 42" aff	Lower 36" wide segment of service counter to max 36" aff	2015 ABAAS Section: 904.4.2, 904.4.1 2012 TAS Section: 904.4.1, 904.4.2 2010 ADAS Section: 904.4.2, 904.4.1

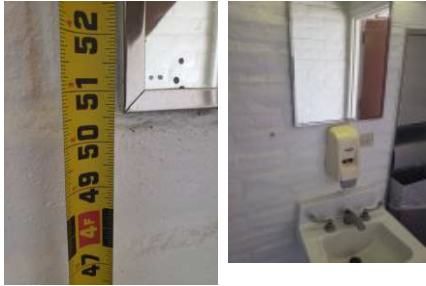
Finding Number	Area Description	Lat/Long	Finding	As Built	Recommendation	Citation	Photos	Figure
12	Headquarters Area: Headquarters Bathroom Left	[28.1335744 , -96.984329 6]	The mirror is mounted too high. Mirrors must have the bottom edge of the reflecting surface a maximum of 40 inches above the floor if above a sink or counter. Mirrors not located above lavatories or countertops shall be installed with the bottom edge of the reflecting surface 35 inches maximum above the finish floor or ground.	Bottom edge of reflecting surface of mirror is 51" aff	Lower mirror so reflective surface is max 40" aff	2015 ABAAS Section: 603.3 2012 TAS Section: 603.3 2010 ADAS Section: 603.3

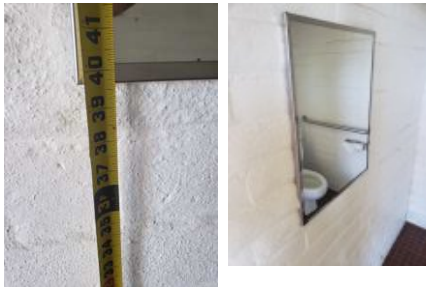
13	Headquarters Area: Headquarters Bathroom Left	[28.1335697 , -96.984313 5]	The mirror is mounted too high. Mirrors not located above lavatories or countertops shall be installed with the bottom edge of the reflecting surface 35 inches maximum above the finish floor or ground.	Bottom edge mirror not above sink is 40" aff	Lower mirror not over a sink or counter to max 35" aff to the reflective surface	2015 ABAAS Section: 603.3 2012 TAS Section: 603.3 2010 ADAS Section: 603.3

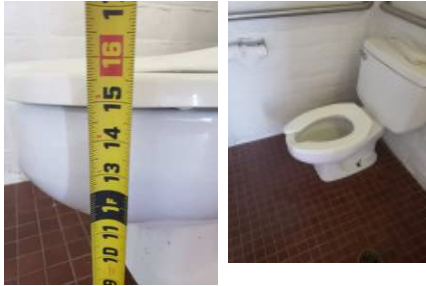
Finding Number	Area Description	Lat/Long	Finding	As Built	Recommendation	Citation	Photos	Figure
16	Headquarters Area: Headquarters Bathroom Left	[28.1335484 , -96.984316 2]	The toilet seat is not located within the range allowed off the floor. The height of accessible water closets shall be a minimum of 17 inches and a maximum of 19 inches measured to the top of a maximum 2-inch high toilet seat.	Toilet seat is 15.5" aff	Replace toilet seat, or re-set or replace toilet to 17" to 19" aff	2015 ABAAS Section: 604.4 2012 TAS Section: 604.4 2010 ADAS Section: 604.4

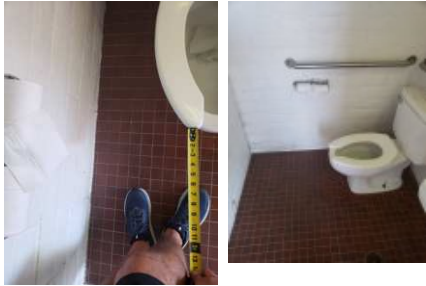
Finding Number	Area Description	Lat/Long	Finding	As Built	Recommendation	Citation	Photos	Figure
20	Headquarters Area: Headquarters Bathroom Left	[28.1335437 , -96.984316 2]	The toilet paper is not installed within the compliant range in front of the toilet. Toilet paper dispensers shall be 7 inches minimum and 9 inches maximum in front of the water closet measured to the centerline of the dispenser. The outlet of the dispenser shall be 15 inches minimum and 48 inches maximum above the finish floor and shall not be located behind grab bars. Dispensers shall not be of a type that controls delivery or that does not allow continuous paper flow. There shall be a clearance of 1 1/2 inches minimum below the grab bar.	Centerline of toilet paper dispenser is 4" from the front of the toilet	Remount toilet paper dispenser max 7" to 9" from front of toilet, 15" to 48" aff and min 12" above or 1.5" below grab bar	2015 ABAAS Section: 604.7 2012 TAS Section: 604.7 2010 ADAS Section: 604.7

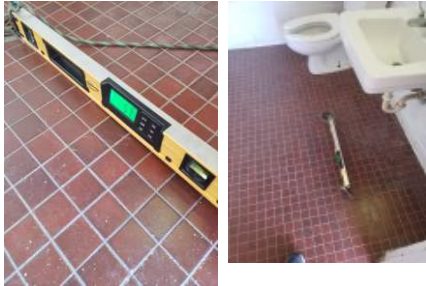
21	Headquarters Area: Headquarters Bathroom Left	[28.133565, -96.984318 9]	The accessible route contains running slopes greater than 5 percent and cross slopes greater than 2 percent across the width of the walk and has not been constructed as a ramp (i.e. handrails, wheel guides, etc.). When the slope in the direction of travel of any walk exceeds 1 unit vertical in 20 units horizontal (5-percent slope), it must be constructed as ramp. Surface cross slopes must not exceed one unit vertical in 48 units. Horizontal (2-percent slope).	Slope of 5.7% near the floor drain	Correct or repair slope to max 5% running and 2.08% cross	2015 ABAAS Section: 403.3 2012 TAS Section: 403.3 2010 ADAS Section: 403.3

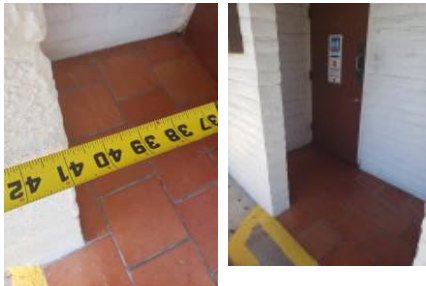
22	Headquarters Area: Headquarters Bathroom Left	[28.1335555 , -96.984324 2]	Minimum maneuvering clearances at doors and gates shall comply with 404.2.4. Maneuvering clearances shall extend the full width of the doorway and the required latch side or hinge side clearance. Exterior doors are recommended to be maintained at 8.5 lbf as a smart practice. Force is to be measured at the operating hardware or 30 inches from the hinges, whichever is greater.	HQ restroom left door - wall 41" back in pull side clearance, 28 lbf	For all doors along the public circulation route, provide required maneuvering clearance on push and pull side of doors For all doors along the public circulation route, inspect, adjust, and maintain 8.5 lbf to open exterior doors as a smart practice	2010 ADAS Section: 404.2.3, 404.2.7, 404.2.4, 404.2.11, 404.2.11 Exception

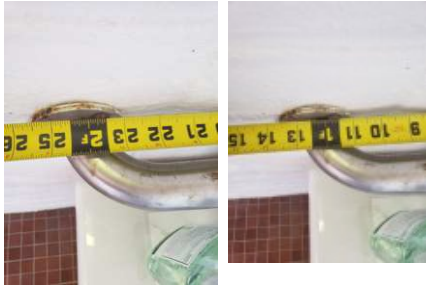
Finding Number	Area Description	Lat/Long	Finding	As Built	Recommendation	Citation	Photos	Figure
30	Headquarters Area: Headquarters Bathroom Right	[28.1335603 , -96.984324 2]	The rear grab bar is not 36" long or is not mounted in the correct location. The rear grab bar must be a minimum of 36" long and extend from the toilet centerline a minimum 12" towards the wall side and a minimum 24" towards the open side of the toilet. Grab bars shall be installed in a horizontal position, 33 inches minimum and 36 inches maximum above the finish floor measured to the top of the gripping surface and the space between the grab bar and the top of the tank shall be 1-1/2 inches minimum.	Rear grab bar is 24" long and extends 12" from centerline of toilet to open side of the toilet	Replace rear grab bar with one 36" long, mounted behind the toilet, 12" to one side of center and 24" to the other and 33" to 36" aff	2015 ABAAS Section: 604.5.2 2012 TAS Section: 604.5.2 2010 ADAS Section: 604.5.2

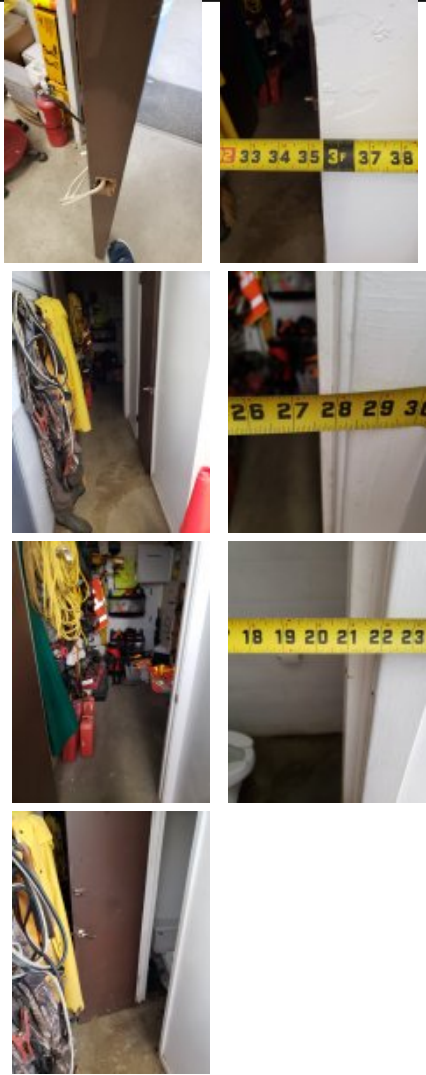
Finding Number	Area Description	Lat/Long	Finding	As Built	Recommendation	Citation	Photos	Figure
34	Employee Spaces: Maintenance	[28.1335839 , -96.986105 2]	<p>Minimum maneuvering clearances at doors and gates shall comply with 404.2.4. Maneuvering clearances shall extend the full width of the doorway and the required latch side or hinge side clearance. Maneuvering clearances shall have a max slope of 2.08%. Door openings shall provide a clear width of 32 inches (815 mm) minimum. Clear openings of doorways with swinging doors shall be measured between the face of the door and the stop, with the door open 90 degrees. Openings more than 24 inches (610 mm) deep shall provide a clear opening of 36 inches (915 mm) minimum. There shall be no projections into the required clear opening width lower than 34 inches (865 mm) above the finish floor or ground. Projections into the clear opening width between 34 inches (865 mm) and 80 inches (2030 mm) above the finish floor or ground shall not exceed 4 inches (100 mm). The threshold has a vertical change greater than 1/4 inch high. All interior doors must be maintained so that the operating pressure does not exceed 5 lbf to open. The sweep period for doors with closers shall be adjusted so that from an open position of 70 degrees, the door will take at least 3 seconds to move to a point 3 inches from the latch, measured to the leading edge of the door. Hand-activated door opening hardware, handles, pulls, latches, locks, and other operating devices on accessible doors shall have a shape that is easy to grasp with one hand and does not require tight grasping, tight pinching or twisting of the wrist to operate. Hardware shall be 34 inches minimum and 48 inches maximum above the finish floor or ground.</p>	<p>Maintenance door - Lacks pull side clearance, CILs of 3" and 3", knobs, lacks secure floor mat Office door - refrigerator in pull side clearance, 15 lbf, fast close, knobs, and lacks secure floor mat Storage door - storage in push and pull side clearances, 27.5" clear width Restroom door - storage in push and pull side clearances, 21" clear width Hall to bathroom and storage closet lacks 36" wide route of travel (35.5") and is obstructed with hanging storage</p>	<p>For all doors along the public circulation route, provide required maneuvering clearance on push and pull side of doors. For all doors along the public circulation route, secure rug in door clearance to prevent trip hazard. For all doors along the public circulation route, replace doors with doors having 80" overhead clearance and 32" clear width. For all doors along the public circulation route, repair, bevel, or ramp CILs at door entries to max .25". For all doors along the public circulation route, inspect, adjust, and maintain 5 lbf to open interior doors. For all doors along the public circulation route, inspect, adjust, and maintain closing speed on door closers. For all doors along the public circulation route, replace hardware with lever hardware or hardware operable without a tight pinch or grasp.</p>	2010 ADAS Section: 404.2.3, 404.2.7, 404.2.4, 404.2.11, 404.2.11 Exception

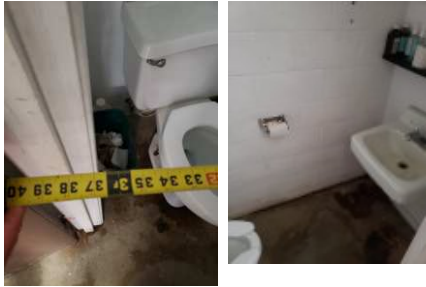
38	Employee Spaces: Maintenance	[28.1335839 , -96.986089 1]	This restroom is not accessible. Where existing toilet rooms or bathing rooms do not comply, directional signs indicating the location of the nearest accessible toilet room or bathing room within the facility shall be provided. Signs shall include the International Symbol of Accessibility. Where existing toilet rooms or bathing rooms do comply), the accessible toilet rooms or bathing rooms shall be identified by the International Symbol of Where clustered single user toilet rooms or bathing facilities are permitted, accessible toilet rooms or bathing facilities shall be identified by the International Symbol of Accessibility unless all toilet rooms and bathing facilities are accessible.	This restroom is not accessible, 37" wide and lacks directional sign to an accessible restroom	Restroom not accessible, acquire and mount signage directing patrons to accessible restroom	2015 ABAAS Section: F216.8 2012 TAS Section: 216.8 2010 ADAS Section: 216.8

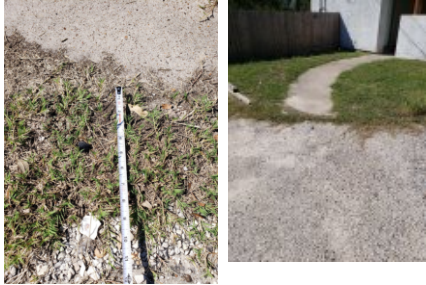
Finding Number	Area Description	Lat/Long	Finding	As Built	Recommendation	Citation	Photos	Figure
43	Employee Spaces: Residence	[28.1381347 , -96.987086 9]	The path of contains multiple issues and is not accessible. The path of travel exceeds the maximum allowable cross and running slope requirements. It also contains changes in level and/or gaps that exceed the allowable maximum requirements. The path of travel does not meet the minimum width requirements for clearances, turning spaces, and/or passing spaces. The floor or ground surface is not firm, stable, and slip resistant.	Accessible route is obstructed by 9" wide section of grass	Maintain a route of travel that is firm, stable, and slip resistant	2015 ABAAS Section: 403.1 2010 ADAS Section: 403.1

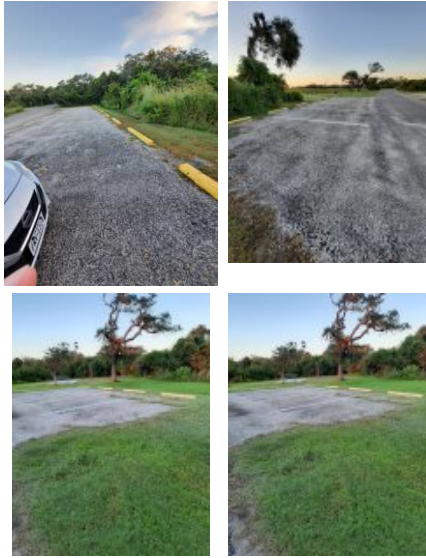
Finding Number	Area Description	Lat/Long	Finding	As Built	Recommendation	Citation	Photos	Figure																		
44	Wooded Area: Wooded Area Campsites	[28.1350551 , -96.986681 9]	Camping facilities shall provide camping units with mobility features complying with F244.2 in accordance with Table F244.2. Where a camping facility provides different types of camping units, Table F244.2 shall apply to each type of camping unit provided. Total Number of Camping Units Provided in Camping Facility Minimum Number of Camping Units with Mobility Features Required 1 1 2 to 25 2 26 to 50 3 51 to 75 4 76 to 100 5 101 to 150 7 151 to 200 8 201 and over 8, plus 2 percent of the number over 200	0 campsites accessible in wooded area- 23 campsites are water only, 57 are water and electric in this area (total of 101 with water and electric in park)	Create the required number of accessible camp sites of each type per table F244.2 as a smart practice	2015 ABAAS Section: F244.2																				
45	Wooded Area: Wooded Area Campsites Parking	[28.1364766 , -96.985853 1]	There are no accessible parking stalls. Each lot where parking is provided for the public as clients, guests or employees, shall provide accessible parking and shall be located on the shortest accessible route of travel from adjacent parking to an accessible entrance. There are a total of 20 parking stalls in the parking lot that could be reasonably associated with this facility. There should be a minimum of 1 accessible stalls with a minimum of 1 being designed as van accessible.	Lacks accessible parking stalls (20 standard, 0 accessible)	Create one or more 8' accessible parking stalls, with one 5' adjacent access aisle, with proper signage and striping based on the total number of stalls	2015 ABAAS Section: F208.2 2012 TAS Section: 208.2 2010 ADAS Section: 208.2

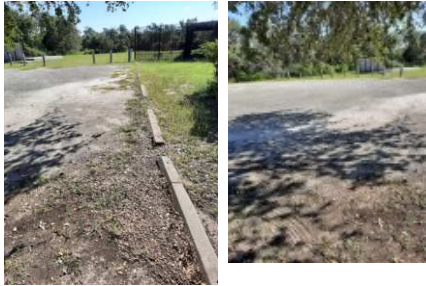
Finding Number	Area Description	Lat/Long	Finding	As Built	Recommendation	Citation	Photos	Figure
47	Youth Group Area: Youth Group Area Parking	[28.1372674 , -96.9882315]	There are no accessible parking stalls. Each lot where parking is provided for the public as clients, guests or employees, shall provide accessible parking and shall be located on the shortest accessible route of travel from adjacent parking to an accessible entrance. There are a total of 6 parking stalls in the parking lot that could be reasonably associated with this facility. There should be a minimum of 1 accessible stalls with a minimum of 1 being designed as van accessible.	Lacks accessible parking stalls (6 standard, 0 accessible)	Create one or more 8' accessible parking stalls, with one 5' adjacent access aisle, with proper signage and striping based on the total number of stalls	2015 ABAAS Section: F208.2 2012 TAS Section: 208.2 2010 ADAS Section: 208.2

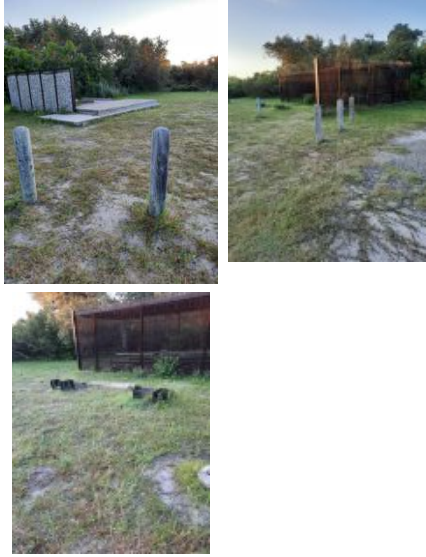
48	Youth Group Area: Youth Group Area	[28.1372004 , -96.9880015]	There is no accessible route to the fire pit, grills, and activity area. At least one accessible route shall connect accessible buildings, accessible facilities, accessible elements, and accessible spaces that are on the same site.	There is no accessible route to the fire pit, grills, and activity area	Create an accessible route with crushed stone or other outdoor material from parking or walkway to the fire pit, grills, and activity area.	2015 ABAAS Section: F206.2.2 2012 TAS Section: 206.2.2 2010 ADAS Section: 206.2.2

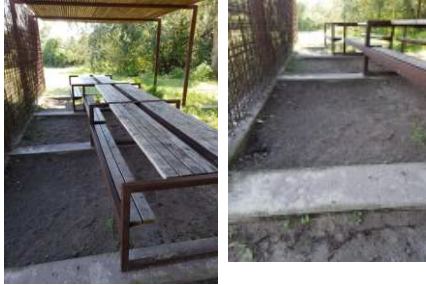
Finding Number	Area Description	Lat/Long	Finding	As Built	Recommendation	Citation	Photos	Figure
49	Youth Group Area: Youth Group Area	[28.1370881 , -96.988064 6]	Picnic tables shall provide at least one wheelchair space for each 24 linear feet (7320 mm) of usable table surface perimeter. Wheelchair spaces shall be 30 inches (760 mm) minimum by 48 inches (1220 mm) minimum. Wheelchair spaces shall be positioned for a forward approach to the table and provide knee and toe clearance complying with 306 under the table	3 of 3 picnic tables are not of accessible design	Replace picnic table with one of an accessible design as a smart practice	2015 ABAAS Section: 1011.4.2

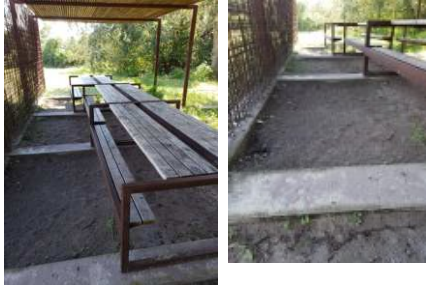
50	Youth Group Area: Youth Group Area	[28.1370928 , -96.988075 3]	The surface of the clear ground space shall be firm and stable The slope of the clear ground space surface shall not be steeper than 1:48 in any direction. EXCEPTION: Where the surface is other than asphalt, concrete, or boards, slopes not steeper than 1:20 shall be permitted when necessary for drainage	Shelter - Ground surface is sand with CILs (cement dividers)	Correct surface at Youth Group Area picnic tables to firm, stable, free of CIL, and having max slope of 2.08% or 5% if other than concrete asphalt or boards as a smart practice	2015 ABAAS Section: 1011.2.2, 1011.2.3, 1011.2 EXCEPTION

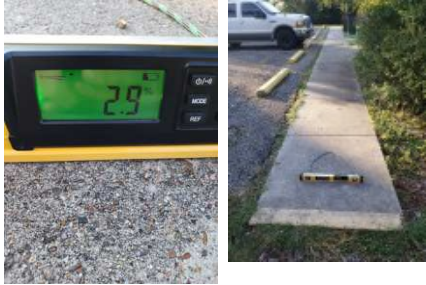
Finding Number	Area Description	Lat/Long	Finding	As Built	Recommendation	Citation	Photos	Figure
51	Warbler Way: Warbler Way EAR	[28.1369544 , -96.988610 4]	The accessible route of travel on the accessible route contains cross slopes greater than 2%. Cross slopes shall not exceed one unit vertical in 48 units horizontal (2-percent slope).	Cross slope of 2.9%	Correct or repair cross slope along AR to max 2.08%	2015 ABAAS Section: 403.3 2012 TAS Section: 403.3 2010 ADAS Section: 403.3

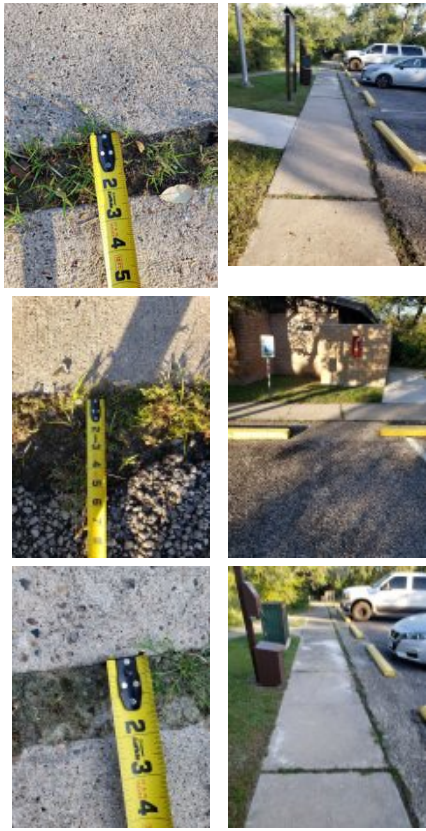
52	Warbler Way: Warbler Way EAR	[28.1367699 , -96.988528 6]	There is a gap spaced greater than a 1/2 inch. Openings in floor or ground surfaces shall not allow passage of a sphere more than 1/2 inch diameter. Elongated openings shall be placed so that the long dimension is perpendicular to the dominant direction of travel.	Multiple gaps from access aisle to route - 2.5", 4", 2", 2", 2", 2", 2", 2"	Correct or fill gaps to be max .5"	2015 ABAAS Section: 302.3 2012 TAS Section: 302.3 2010 ADAS Section: 302.3

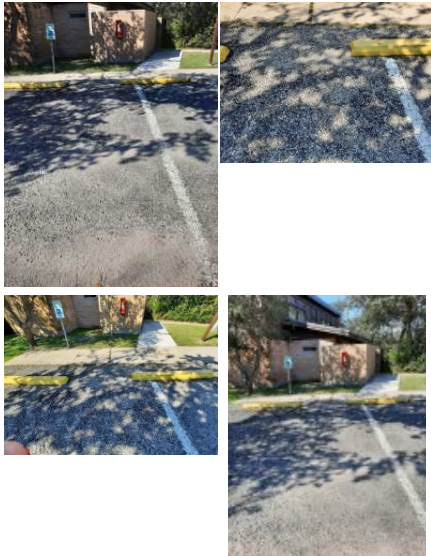
55	Warbler Way: Warbler Way Restroom Parking	[28.1367983, -96.9885004]	The access aisle is missing at the accessible parking stall. Access aisles serving parking spaces shall adjoin an accessible route. Two parking spaces shall be permitted to share a common access aisle.	Access aisle missing or paint is faded and deteriorated	Create one or more 8' accessible parking stalls, with one 5' adjacent access aisle, with proper signage and striping	2015 ABAAS Section: 502.3.1 2012 TAS Section: 502.3.1 2010 ADAS Section: 502.3.1

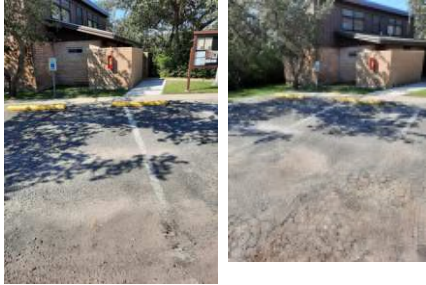
Finding Number	Area Description	Lat/Long	Finding	As Built	Recommendation	Citation	Photos	Figure
61	Warbler Way: Warbler Way Restroom Parking	[28.13295, -96.98463]	The accessible route is constructed such that a park vehicle can obstruct the minimum 36 inch width. Parking spaces and access aisles shall be designed so that cars and vans, when parked, cannot obstruct the required clear width of adjacent accessible routes.	Placement of yellow parking bumper to the right of the identified accessible stall may obstruct the possible/intended access aisle	Relocate parking and stripe a no parking zone or access aisle at entry to AR to prevent cars from blocking AR	2015 ABAAS Section: 502.7 2012 TAS Section: 502.7 2010 ADAS Section: 502.7

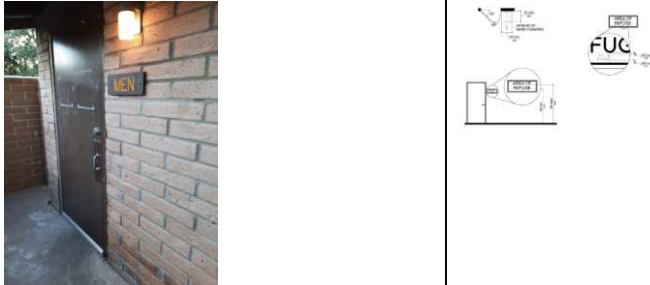
62	Warbler Way: Warbler Way Men's Restroom	[28.1367179 , -96.988588 9]	The restroom sign does not comply with one or more applicable requirements for the location, height, and properties of the sign.	Lacks compliant signage - lacks Braille, raised characters, symbol of accessibility	Replace sign with one of contrasting colors that includes Braille, raised characters, and the symbol of accessibility and mount on the wall, latch side of the door, 48" to the baseline of the lowest character and 60" to the baseline of the highest character.	2015 ABAAS Section: F216.2, 703.1, 703.2, 703.5, 703.6 2012 TAS Section: 216.2, 703.1, 703.2, 703.5, 703.6 2010 ADAS Section: 216.2, 703.1, 703.2, 703.5, 703.6

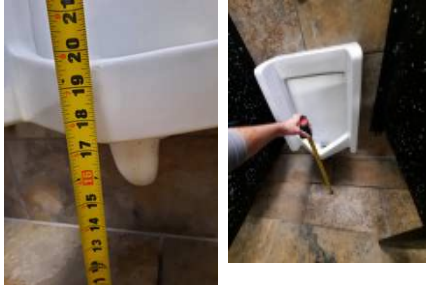
65	Warbler Way: Warbler Way Men's Restroom	[28.1367072 , -96.988588 9]	The rim of the urinal is too high. Wall-hung urinals must be provided with an elongated rim projecting a minimum of 13 1/2 inches from the wall and a maximum of 17 inches above the floor.	Rim of the urinal at 19.75" above the finished floor	Lower urinal so that rim height is max 17" aff	2015 ABAAS Section: 605.2 2012 TAS Section: 605.2 2010 ADAS Section: 605.2

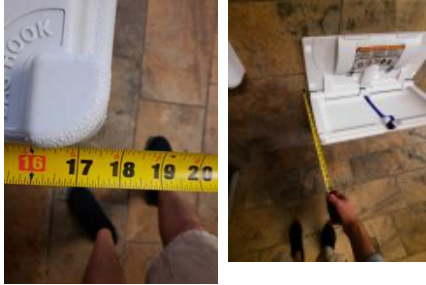
Finding Number	Area Description	Lat/Long	Finding	As Built	Recommendation	Citation	Photos	Figure
68	Warbler Way: Warbler Way Men's Restroom	[28.1367061 , -96.988579 6]	The baby changing table is not compliant. Baby changing tables are work surfaces. If fixed or built-in baby changing tables are provided, at least 5%, but not less than one, must comply with TAS 902 based TAS 226.1. Baby changing tables cannot violate the protruding object requirements in either an open or closed position since either position is a potential hazard for persons with visual impairments. Baby changing tables are not prohibited from being located in wheelchair accessible toilet compartments; however, the minimum space required for the compartment cannot be obstructed by the baby changing table in either an open or closed position. The clear floor space required for a baby changing table may overlap the water closet clearance since baby changing tables are considered convenience "fixtures" based on Advisory 604.8.1.1. The overlap is applicable only to the clear floor space and not to actual table itself. Baby changing tables must be dispersed throughout a space, however, an additional baby changing table is not required in a common use area of a toilet or bathing room when the only baby changing table is located in a toilet compartment.	Changing table protrudes 17.5" when in the open position	Relocate baby changing table to eliminate protrusion when in the open position.	2012 TAS Section: 226.1, 902.3, 604.3.2, 204.1, 226.1 Advisory, 226.2, 307.1, 604.8.1.1 Advisory, 902.1, 902.1 Advisory, 902.2

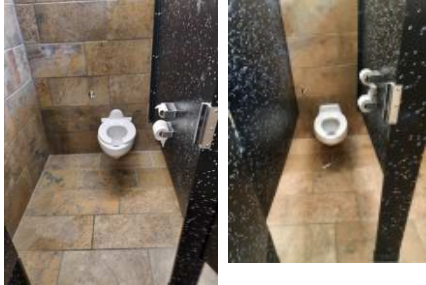
69	Warbler Way: Warbler Way Men's Restroom	[28.1367203 , -96.988594 3]	There are not enough accessible toilet compartments. The room contains 2 toilet compartments. A minimum of 1 must be wheelchair accessible .	Lacks a wheelchair accessible toilet compartment	Create a wheelchair accessible stall with grab bars and fixtures mounted in correct locations and at correct heights	2015 ABAAS Section: F213.3.1 2012 TAS Section: 213.3.1 2010 ADAS Section: 213.3.1

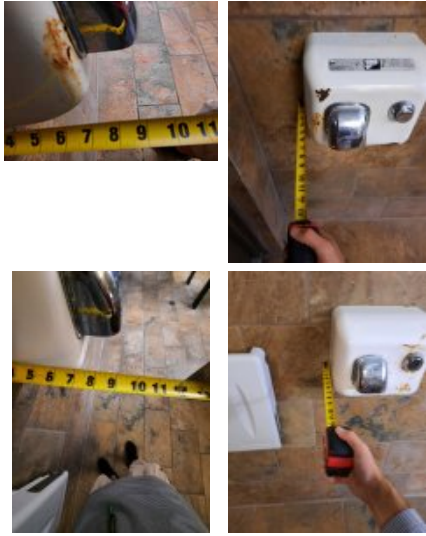
Finding Number	Area Description	Lat/Long	Finding	As Built	Recommendation	Citation	Photos	Figure
70	Warbler Way: Warbler Way Men's Restroom	[28.1367061 , -96.988588 9]	The hand dryer projects more than 4 inches into the circulation path. Wall-mounted objects that have leading edges between 27 inches and 80 inches from the floor must not project more than 4 inches into the circulation path. Protruding objects that extend to the floor or within 27 inches of the floor are cane detectable and are therefore not hazardous. Where it is necessary or desirable to have objects protrude from the wall, a manner of cane detection must be provided.	The hand dryer projects 9"	Relocate protruding objects or place cane detectable warning or bollard at foot of item	2015 ABAAS Section: 307.2 2012 TAS Section: 307.2 2010 ADAS Section: 307.2

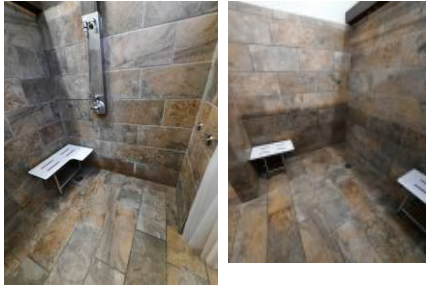
Finding Number	Area Description	Lat/Long	Finding	As Built	Recommendation	Citation	Photos	Figure
72	Warbler Way: Warbler Way Men's Restroom	[28.1367108 , -96.988591 6]	The alternate shower is missing grab bars. In alternate roll-in type shower compartments, grab bars shall be provided on the back wall and the side wall farthest from the compartment entry. Grab bars shall not be provided above the seat. Grab bars shall be installed 6 inches maximum from adjacent walls.	Lacks grab bars	Install grab bars in shower on the back wall and the side wall farthest from the compartment entry.	2015 ABAAS Section: 608.3.3 2010 ADAS Section: 608.3.3

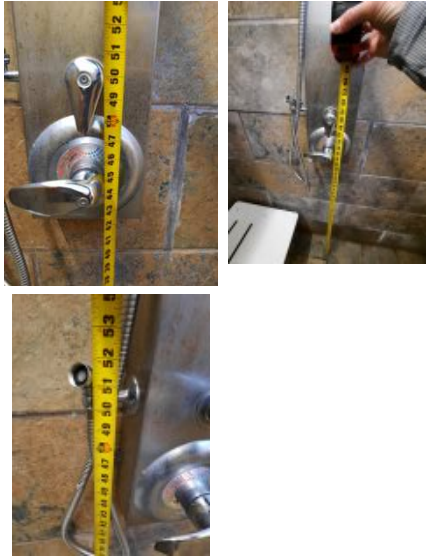
73	Warbler Way: Warbler Way Men's Restroom	[28.1367084 , -96.988599 7]	The hand held sprayer unit is mounted too high. The sprayer unit must have a 59 inches hose and be mounted 48 inches maximum to the top of mounting bracket off the floor. The shower spray unit shall have an on/off control with a non-positive shutoff. If an adjustable-height shower head on a vertical bar is used, the bar shall be installed so as not to obstruct the use of grab bars.	Hose control diverter at 49" AFF and shower spray/hose bracket at 50.5" AFF	Lower shower controls to max 48" aff	2015 ABAAS Section: 608.6 2012 TAS Section: 608.6 2010 ADAS Section: 608.6

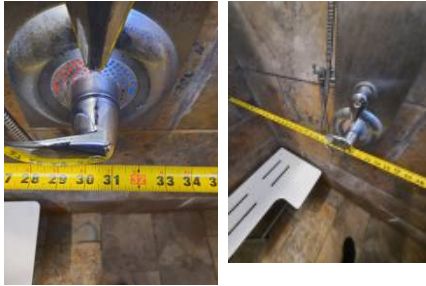
Finding Number	Area Description	Lat/Long	Finding	As Built	Recommendation	Citation	Photos	Figure
74	Warbler Way: Warbler Way Men's Restroom	[28.1367037 , -96.988580 9]	The operable parts of controls are not located correctly. In standard roll-in type shower compartments, the controls, faucets, and shower spray unit shall be located above the grab bar, but no higher than 48 inches (1220 mm) above the shower floor. Where a seat is provided, the controls, faucets, and shower spray unit shall be installed on the back wall adjacent to the seat wall and shall be located 27 inches (685 mm) maximum from the seat wall. Advisory 608.5.2 Standard Roll-In Type Shower Compartments. In standard roll-in type showers without seats, the shower head and operable parts can be located on any of the three walls of the shower without adversely affecting accessibility.	Shower controls are 31" from seat wall	Remount shower controls to the correct location in the roll in shower	2015 ABAAS Section: 608.5.2 2012 TAS Section: 608.5.2 2010 ADAS Section: 608.5.2

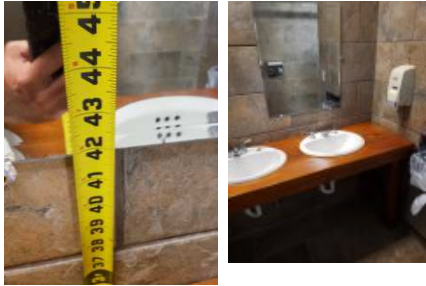
Finding Number	Area Description	Lat/Long	Finding	As Built	Recommendation	Citation	Photos	Figure
77	Warbler Way: Warbler Way Women's Restroom	[28.1367155 , -96.988588 9]	The mirror is mounted too high. Mirrors must have the bottom edge of the reflecting surface a maximum of 40 inches above the floor if above a sink or counter. Mirrors not located above lavatories or countertops shall be installed with the bottom edge of the reflecting surface 35 inches maximum above the finish floor or ground.	Bottom edge of reflecting surface of mirror is 42" aff	Lower mirror so bottom reflective surface is max 40" AFF and 74" at the top.	2015 ABAAS Section: 603.3 2012 TAS Section: 603.3 2010 ADAS Section: 603.3

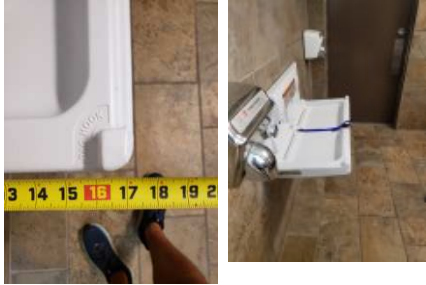
Finding Number	Area Description	Lat/Long	Finding	As Built	Recommendation	Citation	Photos	Figure
80	Warbler Way: Warbler Way Women's Restroom	[28.1367037 , -96.988583 6]	The baby changing table is not compliant. Baby changing tables are work surfaces. If fixed or built-in baby changing tables are provided, at least 5%, but not less than one, must comply with TAS 902 based TAS 226.1. Baby changing tables cannot violate the protruding object requirements in either an open or closed position since either position is a potential hazard for persons with visual impairments. Baby changing tables are not prohibited from being located in wheelchair accessible toilet compartments; however, the minimum space required for the compartment cannot be obstructed by the baby changing table in either an open or closed position. The clear floor space required for a baby changing table may overlap the water closet clearance since baby changing tables are considered convenience "fixtures" based on Advisory 604.8.1.1. The overlap is applicable only to the clear floor space and not to actual table itself. Baby changing tables must be dispersed throughout a space, however, an additional baby changing table is not required in a common use area of a toilet or bathing room when the only baby changing table is located in a toilet compartment.	Baby changing table protrudes 17" when in the open position	Relocate baby changing table to eliminate protrusion when in the open position.	2012 TAS Section: 226.1, 902.3, 604.3.2, 204.1, 226.1 Advisory, 226.2, 307.1, 604.8.1.1 Advisory, 902.1, 902.1 Advisory, 902.2

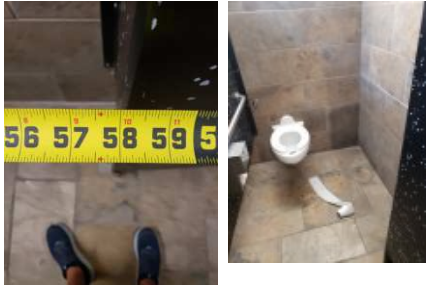
Finding Number	Area Description	Lat/Long	Finding	As Built	Recommendation	Citation	Photos	Figure
82	Warbler Way: Warbler Way Women's Restroom	[28.1367013 , -96.988591 6]	The ambulatory stall is not between 35" to 37" wide and 60" deep.	ambulatory stall is 48" wide x 58" deep	Correct ambulatory stall to be 35" to 37" wide and minimum 60" deep	2015 ABAAS Section: 604.8.2.1 2012 TAS Section: 604.8.2.1 2010 ADAS Section: 604.8.2.1

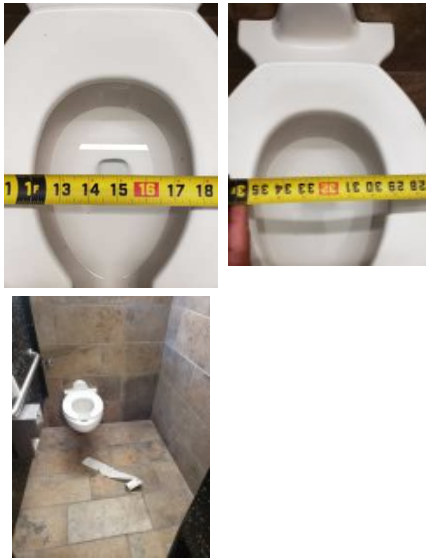
83	Warbler Way: Warbler Way Women's Restroom	[28.136699, -96.988602 4]	The toilet is not located within the range to the side wall or partition. The centerline of the toilet shall be 17 inches minimum and 19 inches maximum side wall or partition in the ambulatory accessible toilet compartment.	Centerline of the toilet is 15" from the partition and 32" from the side wall	Remount toilet to 17" to 19" from the side wall to center line in ambulatory stalls	2015 ABAAS Section: 604.9.1 2012 TAS Section: 604.9.1 2010 ADAS Section: 604.9.1

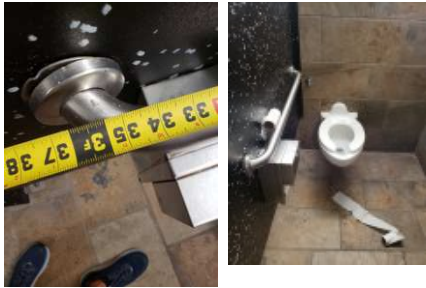
85	Warbler Way: Warbler Way Women's Restroom	[28.1367155 , -96.988586 3]	Grab bars shall comply with 609. A side-wall grab bar complying with 604.5.1 shall be provided on both sides of the compartment. The space between the wall and the grab bar shall be 1½ inches (38 mm). The space between the grab bar and projecting objects below and at the ends shall be 1½ inches (38 mm) minimum. The space between the grab bar and projecting objects above shall be 12 inches (305 mm) minimum. Grab bars shall be installed in a horizontal position, 33 inches (840 mm) minimum and 36 inches (915 mm) maximum above the finish floor measured to the top of the gripping surface, except that at water closets for children's use complying with 604.9, grab bars shall be installed in a horizontal position 18 inches (455 mm) minimum and 27 inches (685 mm) max	Lacks grab bars on one side, provided bar 36" long	Replace or add side grab bars with a 42" long grab bar, mounted max 12" from the rear wall at the close end and min 54" on the far end and 33" to 36" aff	2015 ABAAS Section: 604.8.2.3, 609.3, 609.4 2012 TAS Section: 609.4, 609.3, 604.8.2.3 2010 ADAS Section: 609.3, 609.4, 604.8.2.3

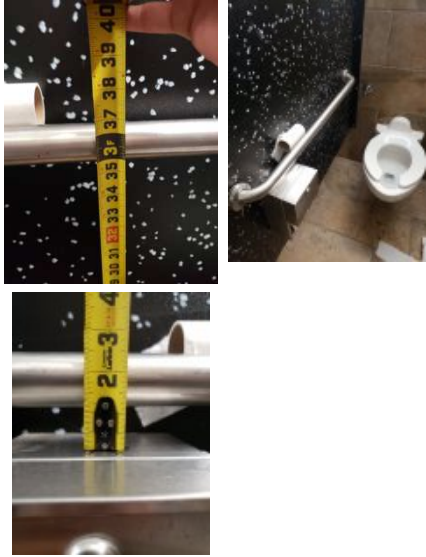
Finding Number	Area Description	Lat/Long	Finding	As Built	Recommendation	Citation	Photos	Figure
86	Warbler Way: Warbler Way Women's Restroom	[28.1367108 , -96.988575 5]	The grab bar height and/or spacing fails. Grab bars must be mounted between 33" and 36" to the top of the gripping surface. There must be 1.5" of clearance between the grab bar and the wall. There must be a minimum of 1.5" of clearance below and minimum 12" above the grab bar to any dispenser or other obstruction.	Gripping surface of grab bar is 37" aff, and lacks 1.5" clearance below the bar due to toilet paper dispenser location	Remount grab bars in accessible stall to 33" to 36" aff Remount toilet paper dispenser max 7" to 9" from front of toilet, 15" to 48" aff and min 12" above or 1.5" below grab bar	2015 ABAAS Section: 609.3, 609.4 2012 TAS Section: 609.4, 609.3 2010 ADAS Section: 609.3, 609.4

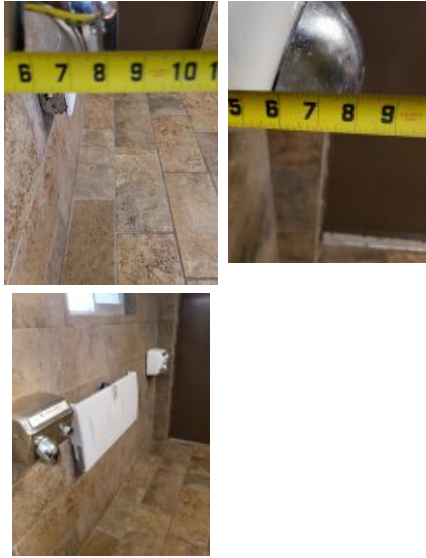
Finding Number	Area Description	Lat/Long	Finding	As Built	Recommendation	Citation	Photos	Figure
88	Warbler Way: Warbler Way Women's Restroom	[28.1367155 , -96.988586 3]	The hand dryers project more than 4 inches into the circulation path. Wall-mounted objects that have leading edges between 27 inches and 80 inches from the floor must not project more than 4 inches into the circulation path. Protruding objects that extend to the floor or within 27 inches of the floor are cane detectable and are therefore not hazardous. Where it is necessary or desirable to have objects protrude from the wall, a manner of cane detection must be provided.	Hand dryers protrude 8" and 8.5"	Relocate protruding objects or place cane detectable warning or bollard at foot of item	2015 ABAAS Section: 307.2 2012 TAS Section: 307.2 2010 ADAS Section: 307.2

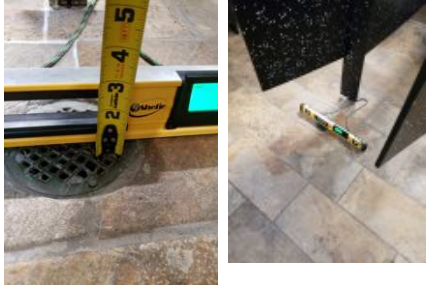
89	Warbler Way: Warbler Way Women's Restroom	[28.1367061 , -96.988599 7]	There is a change in level greater than 1/4 inch. 1/4 inch is the maximum vertical rise. Changes in level between 1/4 inch and 1/2 inch must be beveled at 1:2 or less. Changes in level greater than 1/2 inch must be by way of a ramp.	CIL of .25" at floor drain	Repair, bevel or ramp CIL along accessible route (AR) to max .25".	2015 ABAAS Section: 303.3 2012 TAS Section: 303.3 2010 ADAS Section: 303.3

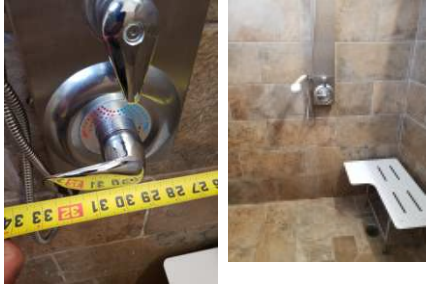
Finding Number	Area Description	Lat/Long	Finding	As Built	Recommendation	Citation	Photos	Figure
92	Warbler Way: Warbler Way Women's Restroom	[28.1367108 , -96.988602 4]	The operable parts of controls are not located correctly. In standard roll-in type shower compartments, the controls, faucets, and shower spray unit shall be located above the grab bar, but no higher than 48 inches (1220 mm) above the shower floor. Where a seat is provided, the controls, faucets, and shower spray unit shall be installed on the back wall adjacent to the seat wall and shall be located 27 inches (685 mm) maximum from the seat wall. Advisory 608.5.2 Standard Roll-In Type Shower Compartments. In standard roll-in type showers without seats, the shower head and operable parts can be located on any of the three walls of the shower without adversely affecting accessibility.	Operable parts of controls are 32" from seat wall	Remount shower controls to the correct location in the roll in shower	2015 ABAAS Section: 608.5.2 2012 TAS Section: 608.5.2 2010 ADAS Section: 608.5.2

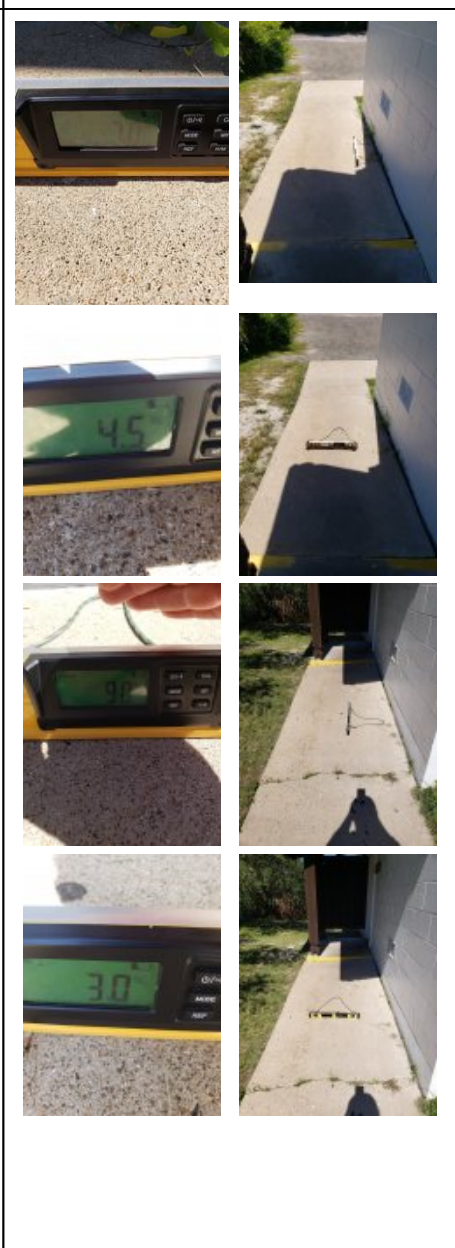
Finding Number	Area Description	Lat/Long	Finding	As Built	Recommendation	Citation	Photos	Figure
94	Bayberry: Bayberry EAR	[28.1352337 , -96.986537 1]	The running slope of walking surfaces shall not be steeper than 1:20. The cross slope of walking surfaces shall not be steeper than 1:48.	Running slopes of 7% and 9%, cross slopes of 4.5% and 3%	Correct running slopes to max 5% and cross to max 2.08%.	2012 TAS Section: 403.3 2010 ADAS Section: 403.3

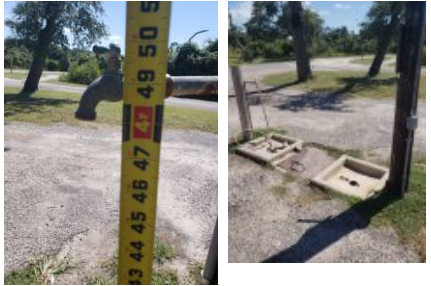
Finding Number	Area Description	Lat/Long	Finding	As Built	Recommendation	Citation	Photos	Figure																				
97	Bayberry: Dump Station	[28.1342143 , -96.9852134]	The element is not accessible because there is not adequate clear floor space for an approach. The clear floor or ground space shall be 30 inches minimum by 48 inches minimum.	water spout handle at 50" AGL, surface is deteriorated asphalt gravel and sand	Provide a 30" by 48" clear ground space at utility hookups Remount water spout to 28" to 36" agl as a smart practice.	2015 ABAAS Section: 305.3 2012 TAS Section: 305.3 2010 ADAS Section: 305.3

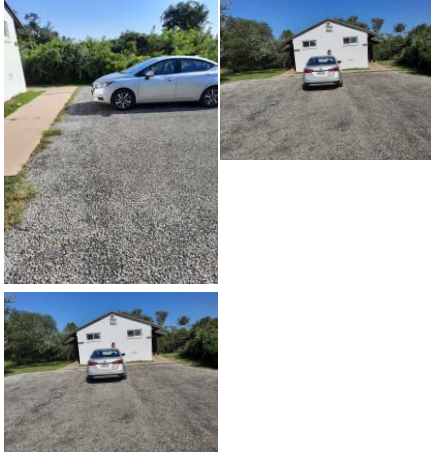
98	Bayberry: Bayberry Restroom Parking	[28.1351915 , -96.986509]	There are no accessible parking stalls. Each lot where parking is provided for the public as clients, guests or employees, shall provide accessible parking and shall be located on the shortest accessible route of travel from adjacent parking to an accessible entrance. There are a total of 5 parking stalls in the parking lot that could be reasonably associated with this facility. There should be a minimum of 1 accessible stalls with a minimum of 1 being designed as van accessible.	Lacks accessible stalls (approximately 5 standard, 0 accessible)	Create one or more 8' accessible parking stalls, with one 5' adjacent access aisle, with proper signage and striping based on the total number of stalls	2015 ABAAS Section: F208.2 2012 TAS Section: 208.2 2010 ADAS Section: 208.2

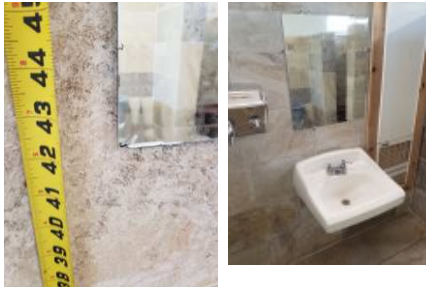
100	Bayberry: Bayberry Men's Restroom	[28.1352704 , -96.986565 2]	The mirror is mounted too high. Mirrors must have the bottom edge of the reflecting surface a maximum of 40 inches above the floor if above a sink or counter. Mirrors not located above lavatories or countertops shall be installed with the bottom edge of the reflecting surface 35 inches maximum above the finish floor or ground.	Bottom edge of reflecting surface of mirror is 42" aff	Lower mirror so reflective surface is max 40" aff	2015 ABAAS Section: 603.3 2012 TAS Section: 603.3 2010 ADAS Section: 603.3

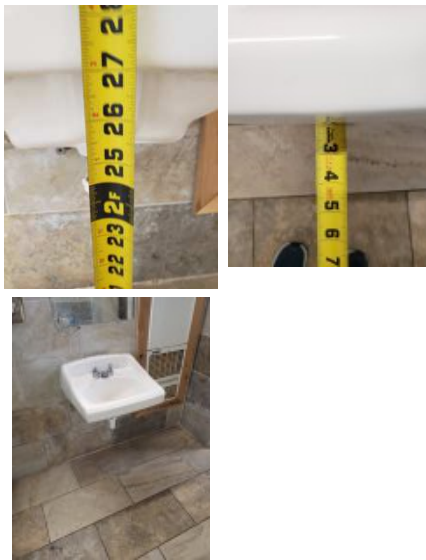
Finding Number	Area Description	Lat/Long	Finding	As Built	Recommendation	Citation	Photos	Figure
101	Bayberry: Bayberry Men's Restroom	[28.1352633 , -96.986571 9]	Knee clearance at 27 inches off the floor is not 8 inches minimum deep. The knee clearance, measured from the bottom of the apron or the outside bottom edge of the lavatory, must be 27 inches at a point located 8 inches back from the front edge and continuing to 11 inches minimum in depth at 9 inches above the floor. The top of the lavatory rim may be no higher than 34 inches.	Sink lacks 8" deep knee clearance	Raise sink to provide 27" knee clearance that is a min 8" deep	2015 ABAAS Section: 306.3.1, 306.3.2, 306.3.3, 306.3.4 , 306.3.5 2012 TAS Section: 306.3.2, 306.3.3, 306.3.4, 306.3.5, 306.3.1 2010 ADAS Section: 306.3.3, 306.3.2, 306.3.4, 306.3.5, 306.3.1

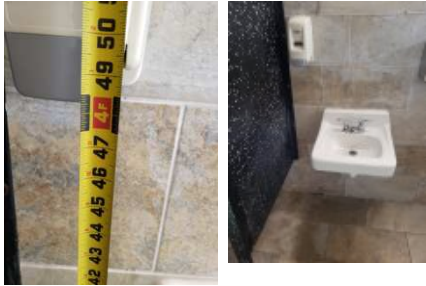
Finding Number	Area Description	Lat/Long	Finding	As Built	Recommendation	Citation	Photos	Figure
103	Bayberry: Bayberry Men's Restroom	[28.1352692 , -96.986559 8]	Where a high forward reach is over an obstruction, the clear floor space shall extend beneath the element for a distance not less than the required reach depth over the obstruction. The high forward reach shall be 48 inches (1220 mm) maximum where the reach depth is 20 inches (510 mm) maximum. Where the reach depth exceeds 20 inches (510 mm), the high forward reach shall be 44 inches (1120 mm) maximum and the reach depth shall be 25 inches (635 mm) maximum. Where a clear floor or ground space allows a parallel approach to an element and the high side reach is over an obstruction, the height of the obstruction shall be 34 inches (865 mm) maximum and the depth of the obstruction shall be 24 inches (610 mm) maximum. The high side reach shall be 48 inches (1220 mm) maximum for a reach depth of 10 inches (255 mm) maximum. Where the reach depth exceeds 10 inches (255 mm), the high side reach shall be 46 inches (1170 mm) maximum for a reach depth of 24 inches (610 mm) maximum.	Soap dispenser 48.5" aff	Lower soap dispenser to max 44" above the finished floor (AFF) for a forward reach over counter.	2015 ABAAS Section: 308.2.1, 308.3.2 2012 TAS Section: 308.2.1, 308.3.2 2010 ADAS Section: 308.2.1, 308.3.2

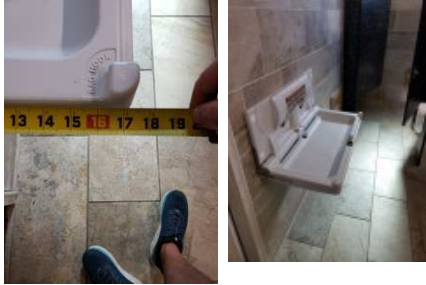
Finding Number	Area Description	Lat/Long	Finding	As Built	Recommendation	Citation	Photos	Figure
104	Bayberry: Bayberry Men's Restroom	[28.1352585 , -96.986571 9]	The baby changing table is not compliant. Baby changing tables are work surfaces. If fixed or built-in baby changing tables are provided, at least 5%, but not less than one, must comply with TAS 902 based TAS 226.1. Baby changing tables cannot violate the protruding object requirements in either an open or closed position since either position is a potential hazard for persons with visual impairments. Baby changing tables are not prohibited from being located in wheelchair accessible toilet compartments; however, the minimum space required for the compartment cannot be obstructed by the baby changing table in either an open or closed position. The clear floor space required for a baby changing table may overlap the water closet clearance since baby changing tables are considered convenience "fixtures" based on Advisory 604.8.1.1. The overlap is applicable only to the clear floor space and not to actual table itself. Baby changing tables must be dispersed throughout a space, however, an additional baby changing table is not required in a common use area of a toilet or bathing room when the only baby changing table is located in a toilet compartment.	Baby changing table protrudes 17.5" when in the open position	Relocate baby changing table to eliminate protrusion when in the open position.	2012 TAS Section: 226.1, 902.3, 604.3.2, 204.1, 226.1 Advisory, 226.2, 307.1, 604.8.1.1 Advisory, 902.1, 902.1 Advisory, 902.2

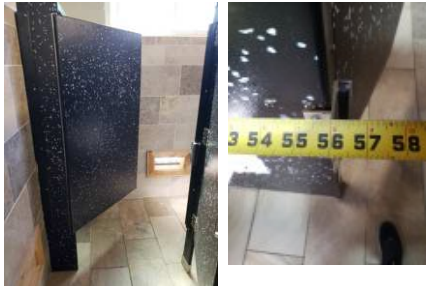
107	Bayberry: Bayberry Men's Restroom	[28.1352562 , -96.986571 9]	The door to the ambulatory compartment swings into the minimum required compartment area. Toilet compartment doors shall not swing into the minimum required compartment area.	Door swings in - 56" to door opening	Replace stall door of ambulatory stall with one that swings out and is self-closing	2015 ABAAS Section: 604.8.2.2 2012 TAS Section: 604.8.2.2 2010 ADAS Section: 604.8.2.2

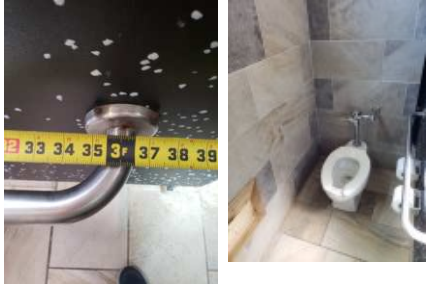
Finding Number	Area Description	Lat/Long	Finding	As Built	Recommendation	Citation	Photos	Figure
108	Bayberry: Bayberry Men's Restroom	[28.1352609 , -96.986574 6]	Grab bars shall comply with 609. A side-wall grab bar complying with 604.5.1 shall be provided on both sides of the compartment. The space between the wall and the grab bar shall be 1½ inches (38 mm). The space between the grab bar and projecting objects below and at the ends shall be 1½ inches (38 mm) minimum. The space between the grab bar and projecting objects above shall be 12 inches (305 mm) minimum. Grab bars shall be installed in a horizontal position, 33 inches (840 mm) minimum and 36 inches (915 mm) maximum above the finish floor measured to the top of the gripping surface, except that at water closets for children's use complying with 604.9, grab bars shall be installed in a horizontal position 18 inches (455 mm) minimum and 27 inches (685 mm) max	Lacks grab bar on one side, existing bar is 36" long	Replace or add side grab bars with a 42" long grab bar, mounted max 12" from the rear wall at the close end and min 54" on the far end and 33" to 36" aff	2015 ABAAS Section: 604.8.2.3, 609.3, 609.4 2012 TAS Section: 609.4, 609.3, 604.8.2.3 2010 ADAS Section: 609.3, 609.4, 604.8.2.3

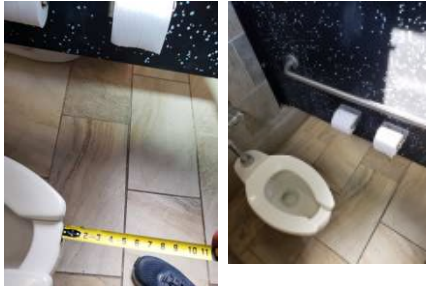
110	Bayberry: Bayberry Men's Restroom	[28.1352491 , -96.986577 3]	The toilet paper is not installed within the compliant range in front of the toilet. Toilet paper dispensers shall be 7 inches minimum and 9 inches maximum in front of the water closet measured to the centerline of the dispenser. The outlet of the dispenser shall be 15 inches minimum and 48 inches maximum above the finish floor and shall not be located behind grab bars. Dispensers shall not be of a type that controls delivery or that does not allow continuous paper flow. There shall be a clearance of 1 1/2 inches minimum below the grab bar.	TP too close to front of toilet	Remount toilet paper dispenser max 7" to 9" from front of toilet, 15" to 48" aff and min 12" above or 1.5" below grab bar	2015 ABAAS Section: 604.7 2012 TAS Section: 604.7 2010 ADAS Section: 604.7

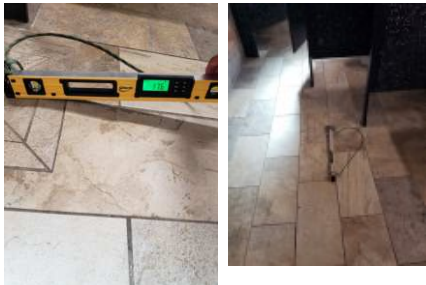
112	Bayberry: Bayberry Men's Restroom	[28.1352633 , -96.986558 5]	The accessible route contains running slopes greater than 5 percent and cross slopes greater than 2 percent across the width of the walk and has not been constructed as a ramp (i.e. handrails, wheel guides, etc.). When the slope in the direction of travel of any walk exceeds 1 unit vertical in 20 units horizontal (5-percent slope), it must be constructed as ramp. Surface cross slopes must not exceed one unit vertical in 48 units. Horizontal (2-percent slope).	Slope of 17.6% near floor drain	Correct or repair slope to max 5% running and 2.08% cross	2015 ABAAS Section: 403.3 2012 TAS Section: 403.3 2010 ADAS Section: 403.3

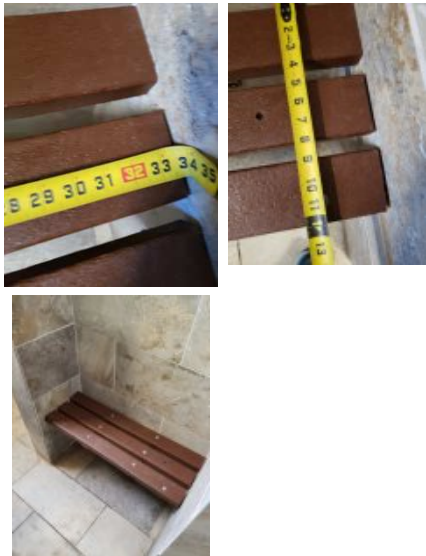
113	Bayberry: Bayberry Men's Restroom	[28.1352538 , -96.986561 2]	The bench is not deep enough or long enough or is missing. Benches shall be provided having seats that are 42 inches long minimum and 20 inches deep minimum and 24 inches deep maximum. The bench shall provide for back support or shall be affixed to a wall. Back support shall be 42 inches (1065 mm) long minimum and shall extend from a point 2 inches (51 mm) maximum above the seat surface to a point 18 inches (455 mm) minimum above the seat surface. Back support shall be 2 1/2 inches (64 mm) maximum from the rear edge of the seat measured horizontally. The top of the bench seat surface shall be 17 inches (430 mm) minimum and 19 inches (485 mm) maximum above the finish floor or ground.	bench 33.5" long x 12" deep	Replace bench in dressing area with one having a seat depth of 20" to 24" deep, 42" long, affixed to the wall or having a back and mounted 17" to 19" aff	2012 TAS Section: 903.4, 903.2, 903.3, 903.5 2010 ADAS Section: 903.4, 903.2, 903.3, 903.5

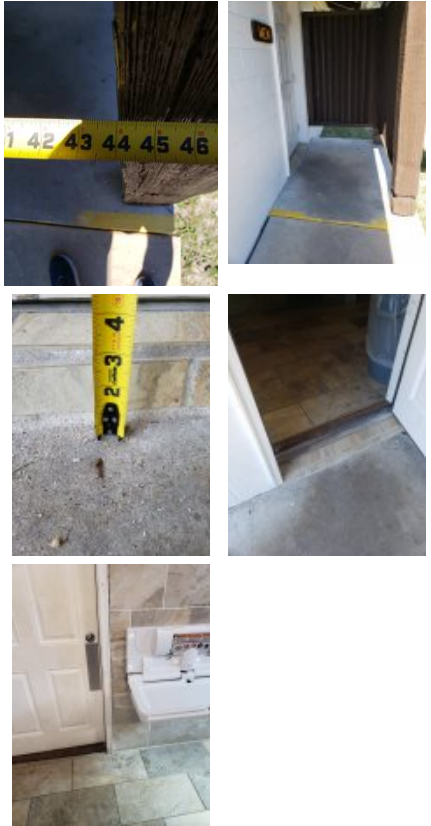
115	Bayberry: Bayberry Men's Restroom	[28.1352763 , -96.986558 5]	Minimum maneuvering clearances at doors and gates shall comply with 404.2.4. Maneuvering clearances shall extend the full width of the doorway and the required latch side or hinge side clearance. The sweep period for doors with closers shall be adjusted so that from an open position of 70 degrees, the door will take at least 3 seconds to move to a point 3 inches from the latch, measured to the leading edge of the door.	men's- wall 44" back in pull side clearance, changing table in push side clearance, fast close	For all doors along the public circulation route, provide required maneuvering clearance on push and pull side of doors For all doors along the public circulation route, inspect, adjust, and maintain closing speed on door closers	2010 ADAS Section: 404.2.3, 404.2.7, 404.2.4, 404.2.11, 404.2.11 Exception
