Access Audit Site Report

Goose Island State Park

Accessibility Evaluation

Inspection Date: 10/07/2021

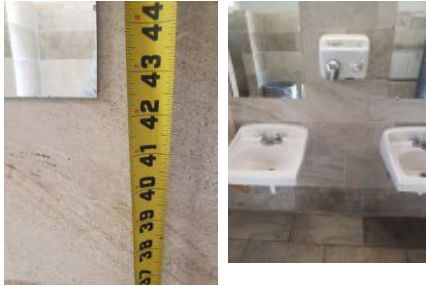
Finding Number	Area Description	Lat/Long	Finding	As Built	Recommendation	Citation	Photos	Figure
118	Bayberry: Bayberry Women's Restroom	[28.1352633 , -96.986566 6]	The mirror is mounted too high. Mirrors must have the bottom edge of the reflecting surface a maximum of 40 inches above the floor if above a sink or counter. Mirrors not located above lavatories or countertops shall be installed with the bottom edge of the reflecting surface 35 inches maximum above the finish floor or ground.	Bottom edge of reflecting surface of mirror is 42.5" aff	Lower mirror so reflective surface is max 40" aff	2015 ABAAS Section: 603.3 2012 TAS Section: 603.3 2010 ADAS Section: 603.3

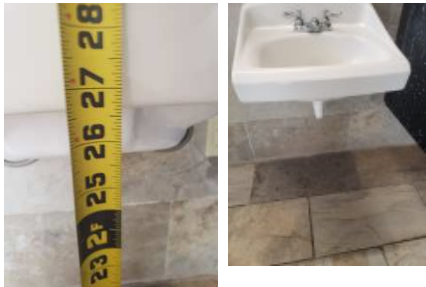
119	Bayberry: Bayberry Women's Restroom	[28.1352633 , -96.986566 6]	Knee clearance at 27 inches off the floor is not 8 inches minimum deep. The knee clearance, measured from the bottom of the apron or the outside bottom edge of the lavatory, must be 27 inches at a point located 8 inches back from the front edge and continuing to 11 inches minimum in depth at 9 inches above the floor. The top of the lavatory rim may be no higher than 34 inches.	Sink lacks knee clearance	Raise sink bowl to provide 27" knee clearance, in the alternative, acquire a shallower model	2015 ABAAS Section: 306.3.1, 306.3.2, 306.3.3, 306.3.4 , 306.3.5 2012 TAS Section: 306.3.2, 306.3.3, 306.3.4, 306.3.5, 306.3.1 2010 ADAS Section: 306.3.3, 306.3.2, 306.3.4, 306.3.5, 306.3.1

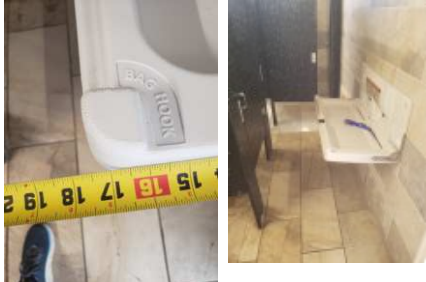
121	Bayberry: Bayberry Women's Restroom	[28.1352597 , -96.986570 6]	The baby changing table is not compliant. Baby changing tables are work surfaces. If fixed or built-in baby changing tables are provided, at least 5%, but not less than one, must comply with TAS 902 based TAS 226.1. Baby changing tables cannot violate the protruding object requirements in either an open or closed position since either position is a potential hazard for persons with visual impairments. Baby changing tables are not prohibited from being located in wheelchair accessible toilet compartments; however, the minimum space required for the compartment cannot be obstructed by the baby changing table in either an open or closed position. The clear floor space required for a baby changing table may overlap the water closet clearance since baby changing tables are considered convenience "fixtures" based on Advisory 604.8.1.1. The overlap is applicable only to the clear floor space and not to actual table itself. Baby changing tables must be dispersed throughout a space, however, an additional baby changing table is not required in a common use area of a toilet or bathing room when the only baby changing table is located in a toilet compartment.	Baby changing table protrudes 17.5" when in the open position	Relocate baby changing table to eliminate protrusion when in the open position.	2012 TAS Section: 226.1, 902.3, 604.3.2, 204.1, 226.1 Advisory, 226.2, 307.1, 604.8.1.1 Advisory, 902.1, 902.1 Advisory, 902.2

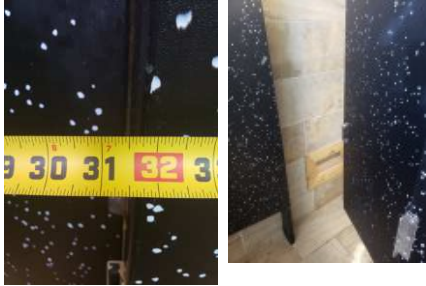
123	Bayberry: Bayberry Women's Restroom	[28.1352704 , -96.986569 2]	The stall door fails to comply with all of the door requirements. The stall door must be a minimum of 32" wide and have compliant hardware on both sides. The stall door must be self-closing.	Stall door is 31.5" wide	Widen stall doors to 32" when opened to 90 degrees	2015 ABAAS Section: 404.2.3, 404.2.7, 604.8.2.2 2012 TAS Section: 404.2.3, 404.2.7, 604.8.2.2 2010 ADAS Section: 404.2.3, 404.2.7, 604.8.2.2

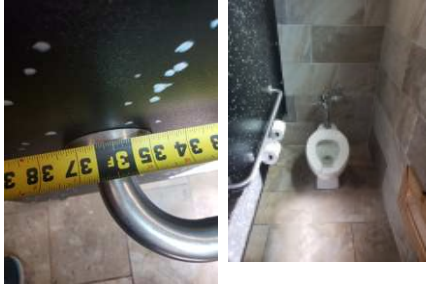
Finding Number	Area Description	Lat/Long	Finding	As Built	Recommendation	Citation	Photos	Figure
125	Bayberry: Bayberry Women's Restroom	[28.1352585 , -96.986553 1]	Grab bars shall comply with 609. A side-wall grab bar complying with 604.5.1 shall be provided on both sides of the compartment. The space between the wall and the grab bar shall be 1½ inches (38 mm). The space between the grab bar and projecting objects below and at the ends shall be 1½ inches (38 mm) minimum. The space between the grab bar and projecting objects above shall be 12 inches (305 mm) minimum. Grab bars shall be installed in a horizontal position, 33 inches (840 mm) minimum and 36 inches (915 mm) maximum above the finish floor measured to the top of the gripping surface, except that at water closets for children's use complying with 604.9, grab bars shall be installed in a horizontal position 18 inches (455 mm) minimum and 27 inches (685 mm) max	Lacks grab bar on one side, existing bar is 36" long	Replace or add side grab bars with a 42" long grab bar, mounted max 12" from the rear wall at the close end and min 54" on the far end and 33" to 36" aff	2015 ABAAS Section: 604.8.2.3, 609.3, 609.4 2012 TAS Section: 609.4, 609.3, 604.8.2.3 2010 ADAS Section: 609.3, 609.4, 604.8.2.3

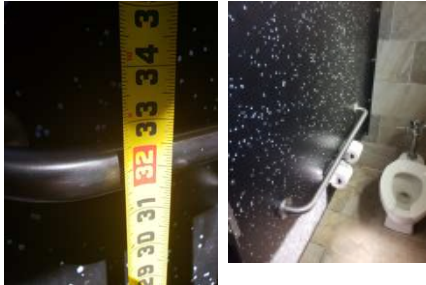
126	Bayberry: Bayberry Women's Restroom	[28.1352633 , -96.986563 9]	The grab bar height and/or spacing fails. Grab bars must be mounted between 33" and 36" to the top of the gripping surface. There must be 1.5" of clearance between the grab bar and the wall. There must be a minimum of 1.5" of clearance below and minimum 12" above the grab bar to any dispenser or other obstruction.	Grab bar is 32.5" aff	Remount grab bars in accessible stall to 33" to 36" aff	2015 ABAAS Section: 609.3, 609.4 2012 TAS Section: 609.4, 609.3 2010 ADAS Section: 609.3, 609.4

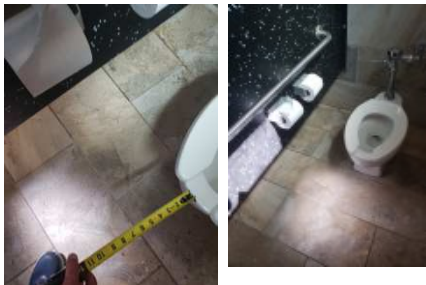
127	Bayberry: Bayberry Women's Restroom	[28.1352633 , -96.986566 6]	The toilet paper is not installed within the compliant range in front of the toilet. Toilet paper dispensers shall be 7 inches minimum and 9 inches maximum in front of the water closet measured to the centerline of the dispenser. The outlet of the dispenser shall be 15 inches minimum and 48 inches maximum above the finish floor and shall not be located behind grab bars. Dispensers shall not be of a type that controls delivery or that does not allow continuous paper flow. There shall be a clearance of 1 1/2 inches minimum below the grab bar.	TP is 5" from front of toilet	Remount toilet paper dispenser max 7" to 9" from front of toilet, 15" to 48" aff and min 12" above or 1.5" below grab bar	2015 ABAAS Section: 604.7 2012 TAS Section: 604.7 2010 ADAS Section: 604.7

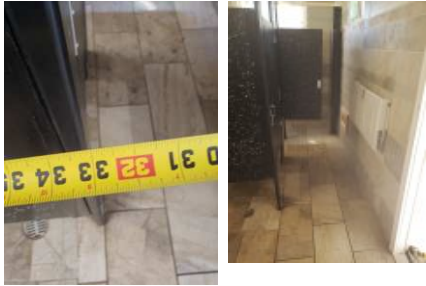
Finding Number	Area Description	Lat/Long	Finding	As Built	Recommendation	Citation	Photos	Figure
128	Bayberry: Bayberry Women's Restroom	[28.1352633 , -96.986563 9]	The route of travel at this location does not provide a minimum width of 36 inches. The clear width shall be permitted to be reduced to 32 inches minimum for a length of 24 inches maximum provided that reduced width segments are separated by segments that are 48 inches long minimum and 36 inches wide minimum.	Lacks 36" wide route of travel, 33" between stalls and wall	Widen AR to compliant 36" clear width	2015 ABAAS Section: 403.5.1 2012 TAS Section: 403.5.1 2010 ADAS Section: 403.5.1

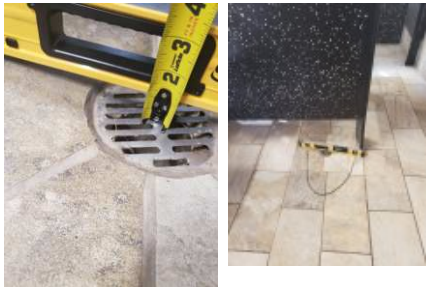
129	Bayberry: Bayberry Women's Restroom	[28.1352514 , -96.986555 8]	There is a change in level greater than 1/4 inch. 1/4 inch is the maximum vertical rise. Changes in level between 1/4 inch and 1/2 inch must be beveled at 1:2 or less. Changes in level greater than 1/2 inch must be by way of a ramp.	CIL of 1.5" at recessed floor drain	Repair, bevel or ramp CIL along AR to max .25"	2015 ABAAS Section: 303.3 2012 TAS Section: 303.3 2010 ADAS Section: 303.3

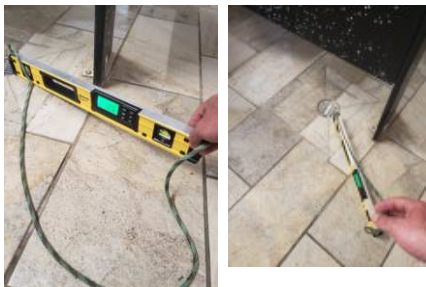
130	Bayberry: Bayberry Women's Restroom	[28.1352491 , -96.986571 9]	The accessible route contains running slopes greater than 5 percent and cross slopes greater than 2 percent across the width of the walk and has not been constructed as a ramp (i.e. handrails, wheel guides, etc.). When the slope in the direction of travel of any walk exceeds 1 unit vertical in 20 units horizontal (5-percent slope), it must be constructed as ramp. Surface cross slopes must not exceed one unit vertical in 48 units. Horizontal (2-percent slope).	Slope of 12% near floor drain	Correct or repair slope to max 2.08% in restroom.	2015 ABAAS Section: 403.3 2012 TAS Section: 403.3 2010 ADAS Section: 403.3

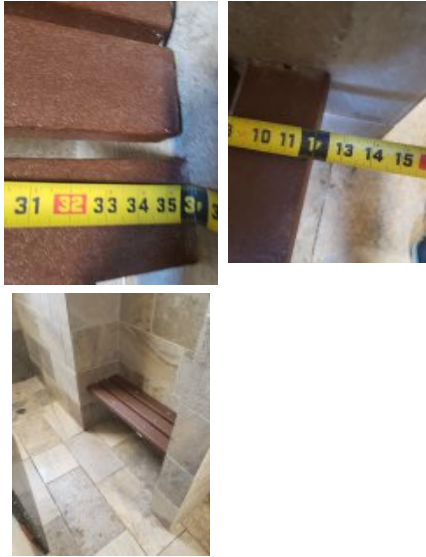
Finding Number	Area Description	Lat/Long	Finding	As Built	Recommendation	Citation	Photos	Figure
131	Bayberry: Bayberry Women's Restroom	[28.1352491 , -96.986569 2]	The bench is not deep enough or long enough or is missing. Benches shall be provided having seats that are 42 inches long minimum and 20 inches deep minimum and 24 inches deep maximum. The bench shall provide for back support or shall be affixed to a wall. Back support shall be 42 inches (1065 mm) long minimum and shall extend from a point 2 inches (51 mm) maximum above the seat surface to a point 18 inches (455 mm) minimum above the seat surface. Back support shall be 2½ inches (64 mm) maximum from the rear edge of the seat measured horizontally. The top of the bench seat surface shall be 17 inches (430 mm) minimum and 19 inches (485 mm) maximum above the finish floor or ground.	bench 36" long x 12" deep	Replace bench in dressing area with one having a seat depth of 20" to 24" deep, 42" long, affixed to the wall or having a back and mounted 17" to 19" aff	2012 TAS Section: 903.4, 903.2, 903.3, 903.5 2010 ADAS Section: 903.4, 903.2, 903.3, 903.5

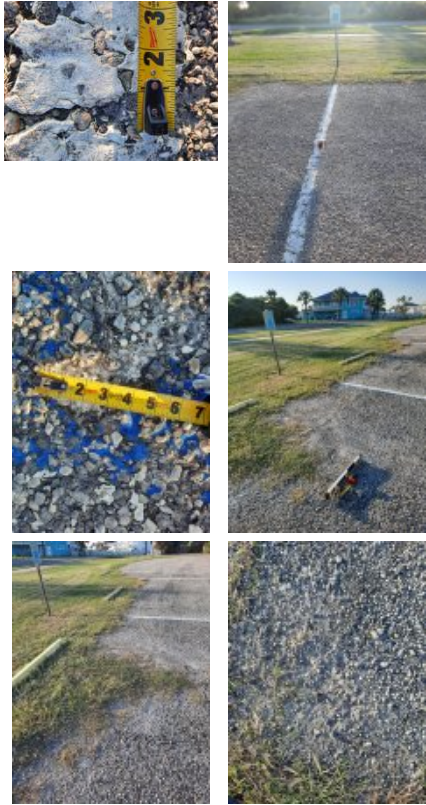
Finding Number	Area Description	Lat/Long	Finding	As Built	Recommendation	Citation	Photos	Figure
136	Day Use Area: Recreation Hall and Day Use Parking	[28.1296905 , -96.985740 4]	The parking stall contains abrupt edges and surface irregularities over a 1/4 inch vertical. Parking spaces and access aisles serving them shall be stable, firm, and slip resistant. Access aisles shall be at the same level as the parking spaces they serve. Changes in level are not permitted and shall not be sloped steeper than 2% in any direction.	Multiple gaps and changes in level (CIL) due to deterioration of paint and/or the parking surface being rough concrete with loose rock, weeds, grass, dirt/sand on top	Resurface stalls and access aisles to eliminate gaps and cracks	2015 ABAAS Section: 502.4 2012 TAS Section: 502.4 2010 ADAS Section: 502.4

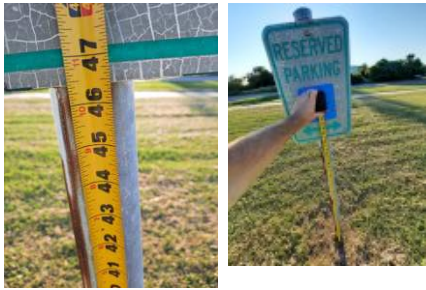
137	Day Use Area: Recreation Hall and Day Use Parking	[28.1296763 , -96.985724 3]	The parking sign is mounted too low. Parking space identification signs shall include the International Symbol of Accessibility complying with. Signs identifying van parking spaces shall contain the designation "van accessible." Signs shall be 60 inches minimum above the finish floor or ground surface measured to the bottom of the sign.	parking sign 46.5" agl	Raise existing accessible parking signs so lowest end of bottom sign is min 60" aff	2015 ABAAS Section: 502.6 2012 TAS Section: 502.6 2010 ADAS Section: 502.6

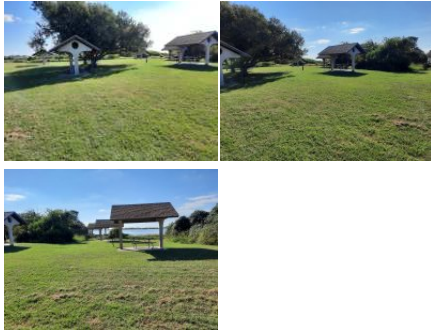
Finding Number	Area Description	Lat/Long	Finding	As Built	Recommendation	Citation	Photos	Figure
147	Day Use Area: Day Use Amenities	[28.1300984 , -96.984436]	An accessible access route is not provided between elements, spaces and the facilities provided within the accessible camping unit. At least one outdoor recreation access route shall connect accessible elements, spaces and facilities provided within camping units with mobility features.	Lacks accessible route to 15 of 17 picnic shelters	Create AR with crushed and compacted stone or similar outdoor material to 2 more picnic shelters.	2015 ABAAS Section: F244.5.1

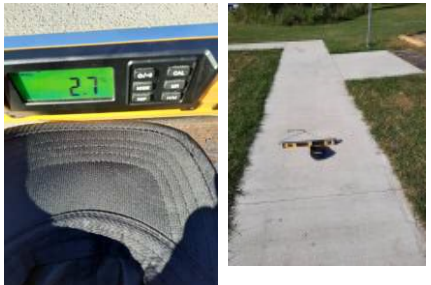
148	Day Use Area: Day Use Amenities	[28.1302289 , -96.984943 9]	The running slope of walking surfaces shall not be steeper than 1:20. The cross slope of walking surfaces shall not be steeper than 1:48.	Cross slope of 2.7%	Correct running slopes to max 5% and cross to max 2.08%.	2012 TAS Section: 403.3 2010 ADAS Section: 403.3

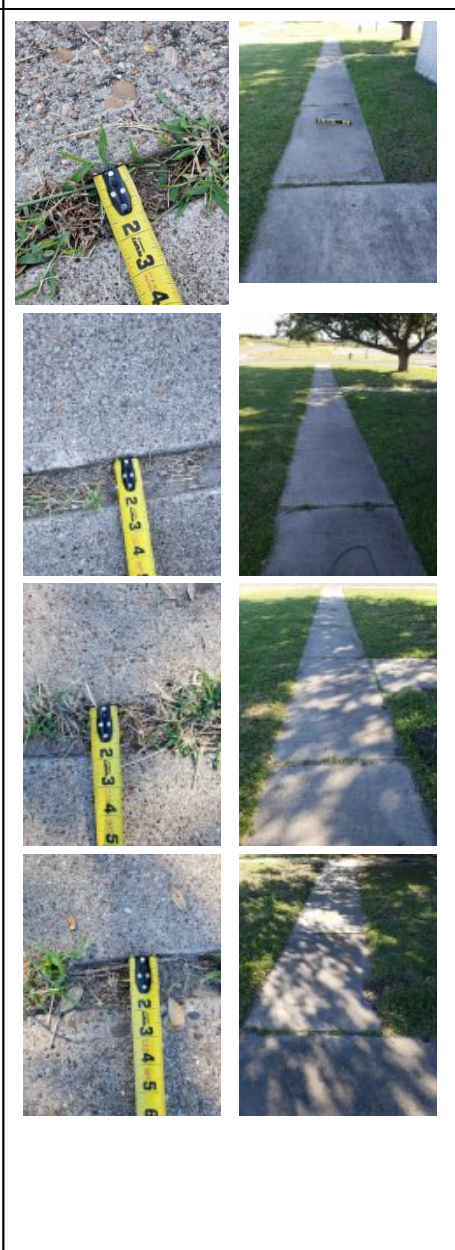
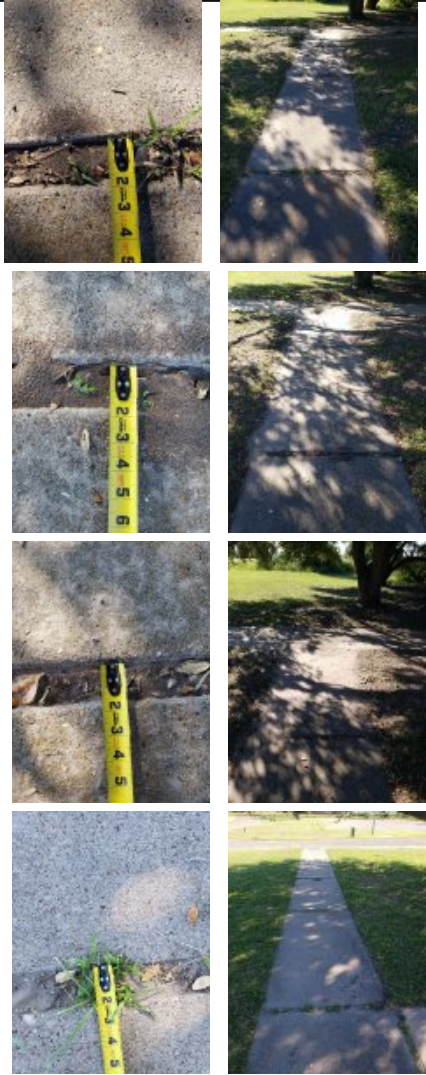
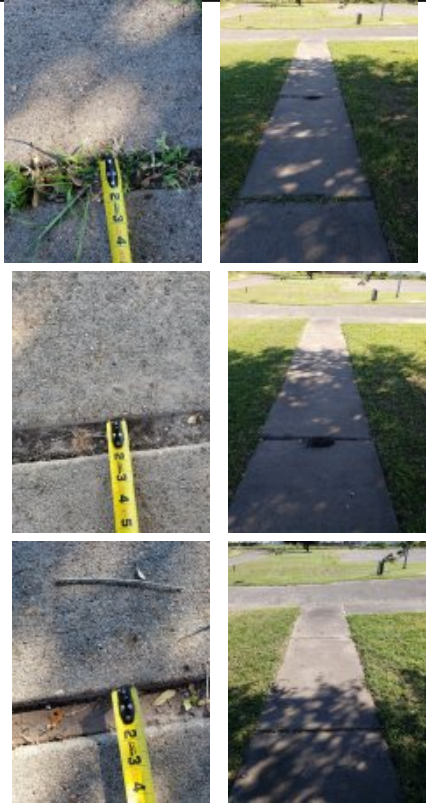
Finding Number	Area Description	Lat/Long	Finding	As Built	Recommendation	Citation	Photos	Figure
150	Day Use Area: Day Use Recreation Hall EAR	[28.1303812 , -96.985218 7]	There is a gap spaced greater than a 1/2 inch. Openings in floor or ground surfaces shall not allow passage of a sphere more than 1/2 inch diameter. Elongated openings shall be placed so that the long dimension is perpendicular to the dominant direction of travel.	Eleven gaps of 2" on walkways around Rec Hall	Correct or fill gaps to be max .5"	2015 ABAAS Section: 302.3 2012 TAS Section: 302.3 2010 ADAS Section: 302.3

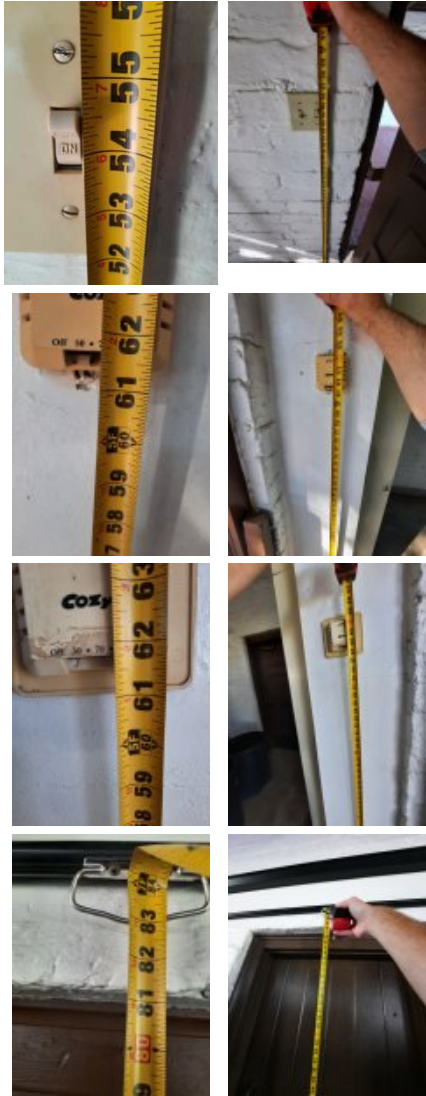
Finding Number	Area Description	Lat/Long	Finding	As Built	Recommendation	Citation	Photos	Figure
154	Day Use Area: Day Use Recreation Hall	[28.1303079 , -96.985432]	The light switch, two thermostats, one outlet, and the projector screen handle are positioned too high for either a side or front approach. Where a clear floor or ground space allows a parallel approach to an element and the side reach is unobstructed, the high side reach shall be 48 inches maximum and the low side reach shall be 15 inches minimum above the finish floor or ground. Where a forward reach is unobstructed, the high forward reach shall be 48 inches maximum and the low forward reach shall be 15 inches minimum above the finish floor or ground.	Light switch - 54.5" aff, one thermostat - 61.5" aff, another thermostat - 61.75" aff, projector screen handle - 83" aff	Remount operable parts to be in reach range of 15" min to 48" max	2015 ABAAS Section: 308.1 2012 TAS Section: 308.1 2010 ADAS Section: 308.1

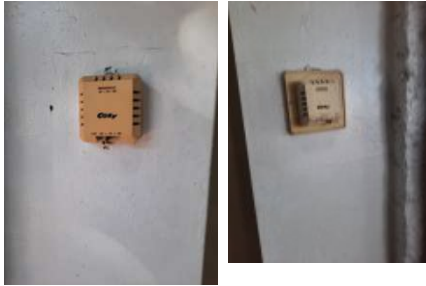
Finding Number	Area Description	Lat/Long	Finding	As Built	Recommendation	Citation	Photos	Figure
155	Day Use Area: Day Use Recreation Hall	[28.1303339 , -96.985429 3]	The fire extinguisher and two thermostats are not accessible because they require tight grasping, pinching or twisting of the wrist.	thermostats require tight pinch	Replace thermostats with an operable part usable without a tight pinch or grasp	2015 ABAAS Section: 309.4 2012 TAS Section: 309.4 2010 ADAS Section: 309.4

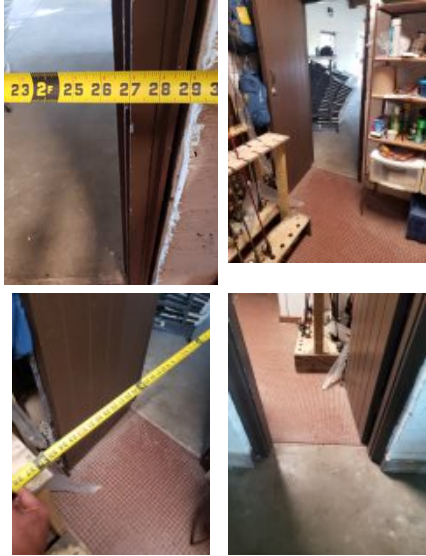
156	Day Use Area: Day Use Recreation Hall	[28.130315, -96.985423 9]	Spaces and elements within employee work areas shall only be required to comply with 206.2.8, 207.1, and 215.3 and shall be designed and constructed so that individuals with disabilities can approach, enter, and exit the employee work area. Employee work areas, or portions of employee work areas, other than raised courtroom stations, that are less than 300 square feet (28 m2) and elevated 7 inches (180 mm) or more above the finish floor or ground where the elevation is essential to the function of the space shall not be required to comply with these requirements or to be on an accessible route.	Employee-only, locked closet door - stored equipment in maneuvering clearance, 27" wide	For employee spaces, relocate storage, furniture, and other obstacles at doorways to provide approach, enter and exit at the employee space. Replace doors with doors having 80" overhead clearance and 32" clear width.	2015 ABAAS Section: F203.9 2012 TAS Section: 203.9 2010 ADAS Section: 203.9

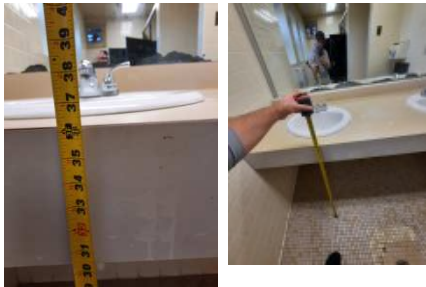
161	Day Use Area: Day Use Recreational Hall Women's Restroom	[28.1303103 , -96.98544]	The top rim of the sink is too high. All lavatories/sinks that are designated to be accessible shall be a minimum 17 inches in horizontal depth and mounted with the rim or counter edge no higher than 34 inches above the finished floor.	Rim of the sink is 37" above finished floor	Lower sinks to max 34" aff to front of rim	2015 ABAAS Section: 606.3 2012 TAS Section: 606.3 2010 ADAS Section: 606.3

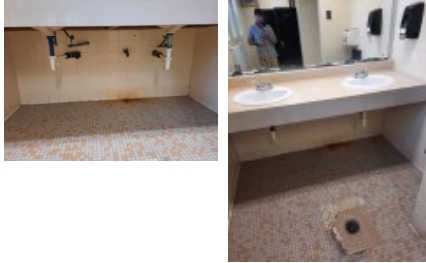
162	Day Use Area: Day Use Recreational Hall Women's Restroom	[28.1303268 , -96.985423 9]	The water and drain pipes under the lavatory are not adequately insulated. Water supply and drain pipes under lavatories and sinks shall be insulated or otherwise configured to protect against contact. There shall be no sharp or abrasive surfaces under lavatories and sinks.	pipes lack insulation	Insulate exposed pipes under one sink	2015 ABAAS Section: 606.5 2012 TAS Section: 606.5 2010 ADAS Section: 606.5

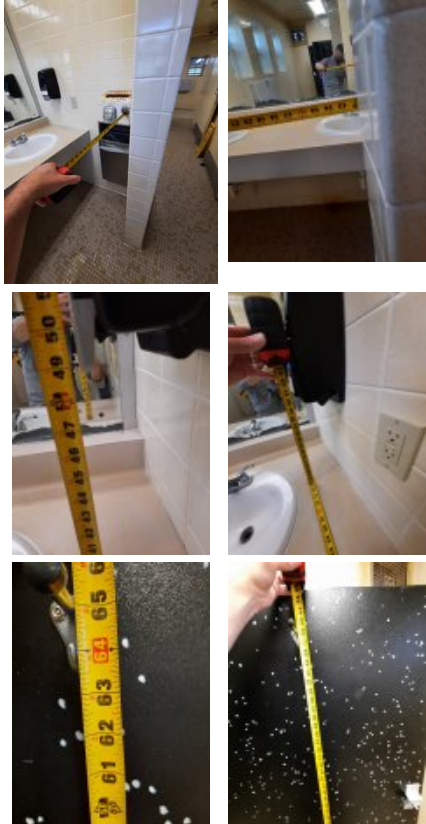
Finding Number	Area Description	Lat/Long	Finding	As Built	Recommendation	Citation	Photos	Figure
163	Day Use Area: Day Use Recreational Hall Women's Restroom	[28.1303197 , -96.985423 9]	Where a high forward reach is over an obstruction, the clear floor space shall extend beneath the element for a distance not less than the required reach depth over the obstruction. The high forward reach shall be 48 inches (1220 mm) maximum where the reach depth is 20 inches (510 mm) maximum. Where the reach depth exceeds 20 inches (510 mm), the high forward reach shall be 44 inches (1120 mm) maximum and the reach depth shall be 25 inches (635 mm) maximum. Where a clear floor or ground space allows a parallel approach to an element and the high side reach is over an obstruction, the height of the obstruction shall be 34 inches (865 mm) maximum and the depth of the obstruction shall be 24 inches (610 mm) maximum. The high side reach shall be 48 inches (1220 mm) maximum for a reach depth of 10 inches (255 mm) maximum. Where the reach depth exceeds 10 inches (255 mm), the high side reach shall be 46 inches (1170 mm) maximum for a reach depth of 24 inches (610 mm) maximum.	soap dispenser is 49" aff, coat hooks in stall at 64.25" aff	Lower operating mechanisms to max 48" above the finished floor (AFF) to highest operable part. Lower soap dispenser to max 46" above the finished floor (AFF) for a side reach over counter.	2015 ABAAS Section: 308.2.1, 308.3.2 2012 TAS Section: 308.2.1, 308.3.2 2010 ADAS Section: 308.2.1, 308.3.2

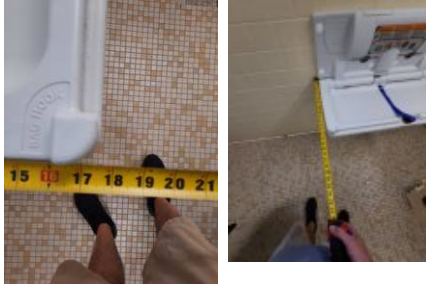
Finding Number	Area Description	Lat/Long	Finding	As Built	Recommendation	Citation	Photos	Figure
164	Day Use Area: Day Use Recreational Hall Women's Restroom	[28.130315, -96.985407 8]	The baby changing table is not compliant. Baby changing tables are work surfaces. If fixed or built-in baby changing tables are provided, at least 5%, but not less than one, must comply with TAS 902 based TAS 226.1. Baby changing tables cannot violate the protruding object requirements in either an open or closed position since either position is a potential hazard for persons with visual impairments. Baby changing tables are not prohibited from being located in wheelchair accessible toilet compartments; however, the minimum space required for the compartment cannot be obstructed by the baby changing table in either an open or closed position. The clear floor space required for a baby changing table may overlap the water closet clearance since baby changing tables are considered convenience "fixtures" based on Advisory 604.8.1.1. The overlap is applicable only to the clear floor space and not to actual table itself. Baby changing tables must be dispersed throughout a space, however, an additional baby changing table is not required in a common use area of a toilet or bathing room when the only baby changing table is located in a toilet compartment.	Changing table protrudes 17.5" when in the open position	Relocate baby changing table to eliminate protrusion when in the open position.	2012 TAS Section: 226.1, 902.3, 604.3.2, 204.1, 226.1 Advisory, 226.2, 307.1, 604.8.1.1 Advisory, 902.1, 902.1 Advisory, 902.2

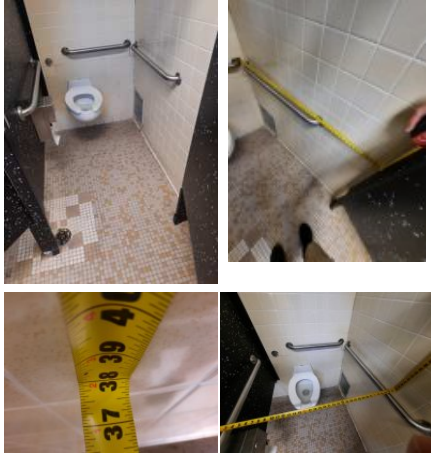
Finding Number	Area Description	Lat/Long	Finding	As Built	Recommendation	Citation	Photos	Figure
165	Day Use Area: Day Use Recreational Hall Women's Restroom	[28.130315, -96.985415 9]	There are not enough accessible toilet compartments. The room contains 2 toilet compartments. A minimum of 1 must be wheelchair accessible .	Lacks accessible toilet compartment	Create a wheelchair accessible stall with grab bars and fixtures mounted in correct locations and at correct heights	2015 ABAAS Section: F213.3.1 2012 TAS Section: 213.3.1 2010 ADAS Section: 213.3.1

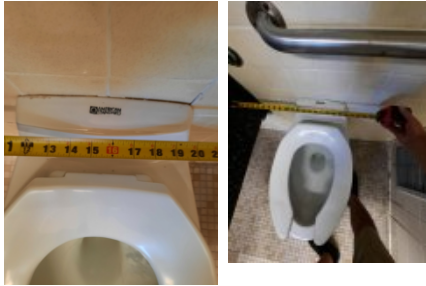
Finding Number	Area Description	Lat/Long	Finding	As Built	Recommendation	Citation	Photos	Figure
167	Day Use Area: Day Use Recreational Hall Women's Restroom	[28.1303126 , -96.985423 9]	The toilet is not located within the range to the side wall or partition. The centerline of the toilet shall be 17 inches minimum and 19 inches maximum side wall or partition in the ambulatory accessible toilet compartment.	Centerline of toilet is 15" from one wall	Remount toilet to 17" to 19" from the side wall to center line in ambulatory stalls	2015 ABAAS Section: 604.9.1 2012 TAS Section: 604.9.1 2010 ADAS Section: 604.9.1

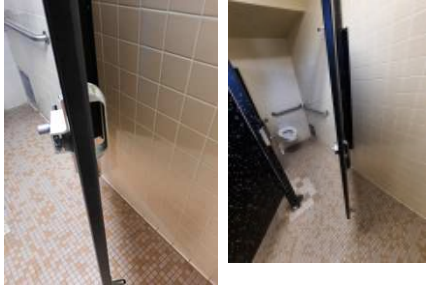
168	Day Use Area: Day Use Recreational Hall Women's Restroom	[28.1303197 , -96.985429 3]	The stall door fails to comply with all of the door requirements. The stall door must be a minimum of 32" wide and have compliant hardware on both sides. The stall door must be self-closing.	Stall door is not self-closing and lacks exterior hardware	Adjust stall door to be self-closing Replace stall hardware with hardware operable without a tight pinch or grasp on both sides of the stall door	2015 ABAAS Section: 404.2.3, 404.2.7, 604.8.2.2 2012 TAS Section: 404.2.3, 404.2.7, 604.8.2.2 2010 ADAS Section: 404.2.3, 404.2.7, 604.8.2.2

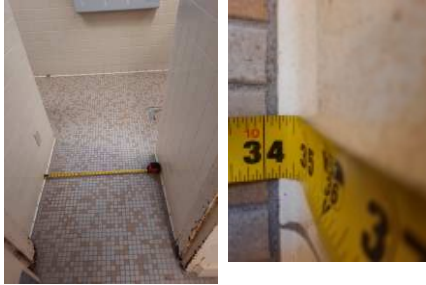
Finding Number	Area Description	Lat/Long	Finding	As Built	Recommendation	Citation	Photos	Figure
171	Day Use Area: Day Use Recreational Hall Women's Restroom	[28.1303197 , -96.985445 4]	The route of travel at this location does not provide a minimum width of 36 inches. The clear width shall be permitted to be reduced to 32 inches minimum for a length of 24 inches maximum provided that reduced width segments are separated by segments that are 48 inches long minimum and 36 inches wide minimum.	Lacks a 36" wide route of travel to all aspects of the room	Widen AR to compliant 36" clear width	2015 ABAAS Section: 403.5.1 2012 TAS Section: 403.5.1 2010 ADAS Section: 403.5.1

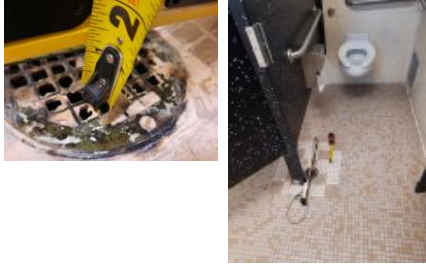
172	Day Use Area: Day Use Recreational Hall Women's Restroom	[28.130315, -96.985430 6]	There is a change in level greater than 1/4 inch. 1/4 inch is the maximum vertical rise. Changes in level between 1/4 inch and 1/2 inch must be beveled at 1:2 or less. Changes in level greater than 1/2 inch must be by way of a ramp.	CIL of 1.25" at recessed floor drain near stalls	Repair, bevel or ramp CIL along AR to max .25"	2015 ABAAS Section: 303.3 2012 TAS Section: 303.3 2010 ADAS Section: 303.3

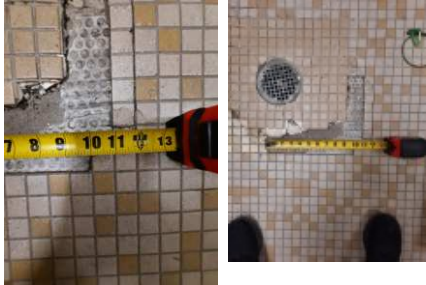
173	Day Use Area: Day Use Recreational Hall Women's Restroom	[28.1303316 , -96.985421 3]	Openings in floor or ground surfaces shall not allow passage of a sphere more than 1/2 inch (13 mm) diameter except as allowed in 407.4.3, 409.4.3, 410.4, 810.5.3 and 810.10. Elongated openings shall be placed so that the long dimension is perpendicular to the dominant direction of travel.	Gap of 11" at drain near sinks	Fill and maintain gaps to max .5"	2015 ABAAS Section: 302.3 2012 TAS Section: 302.3 2010 ADAS Section: 302.3

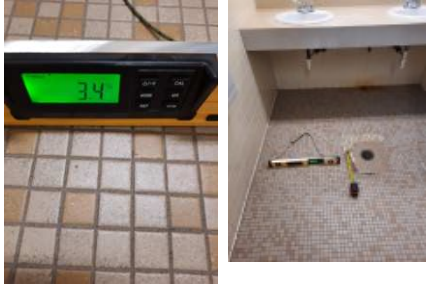
Finding Number	Area Description	Lat/Long	Finding	As Built	Recommendation	Citation	Photos	Figure
174	Day Use Area: Day Use Recreational Hall Women's Restroom	[28.1303103 , -96.985446 7]	The accessible route contains running slopes greater than 5 percent and cross slopes greater than 2 percent across the width of the walk and has not been constructed as a ramp (i.e. handrails, wheel guides, etc.). When the slope in the direction of travel of any walk exceeds 1 unit vertical in 20 units horizontal (5-percent slope), it must be constructed as ramp. Surface cross slopes must not exceed one unit vertical in 48 units. Horizontal (2-percent slope).	Cross slope of 3.4% near sinks	Correct or repair slope to max 2.08% in restroom.	2015 ABAAS Section: 403.3 2012 TAS Section: 403.3 2010 ADAS Section: 403.3

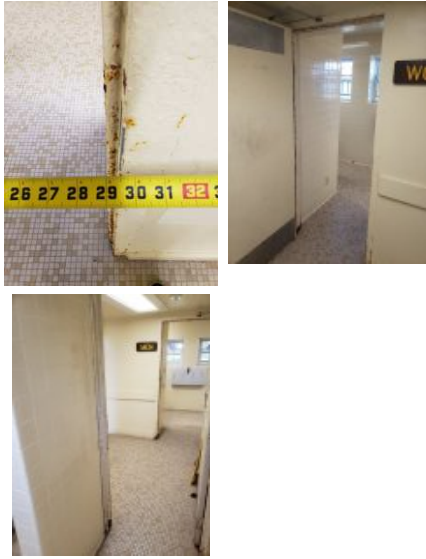
175	Day Use Area: Day Use Recreational Hall Women's Restroom	[28.1303103 , -96.98544]	Minimum maneuvering clearances at doors and gates shall comply with 404.2.4. Maneuvering clearances shall extend the full width of the doorway and the required latch side or hinge side clearance. Door openings shall provide a clear width of 32 inches (815 mm) minimum. Clear openings of doorways with swinging doors shall be measured between the face of the door and the stop, with the door open 90 degrees. Openings more than 24 inches (610 mm) deep shall provide a clear opening of 36 inches (915 mm) minimum. There shall be no projections into the required clear opening width lower than 34 inches (865 mm) above the finish floor or ground. Projections into the clear opening width between 34 inches (865 mm) and 80 inches (2030 mm) above the finish floor or ground shall not exceed 4 inches (100 mm). All interior doors must be maintained so that the operating pressure does not exceed 5 lb. force to open.	women's- lacks clearance on push side, 29" clear width, 10# push	For all doors along the public circulation route, provide required maneuvering clearance on push and pull side of doors For all doors along the public circulation route, replace doors with doors having 80" overhead clearance and 32" clear width For all doors along the public circulation route, inspect, adjust, and maintain 5 lbf to open interior doors	2010 ADAS Section: 404.2.3, 404.2.7, 404.2.4, 404.2.11, 404.2.11 Exception

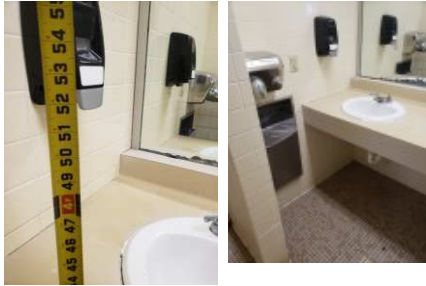
Finding Number	Area Description	Lat/Long	Finding	As Built	Recommendation	Citation	Photos	Figure
179	Day Use Area: Day Use Recreation Hall Men's Restroom	[28.1303103 , -96.985407 8]	Where a high forward reach is over an obstruction, the clear floor space shall extend beneath the element for a distance not less than the required reach depth over the obstruction. The high forward reach shall be 48 inches (1220 mm) maximum where the reach depth is 20 inches (510 mm) maximum. Where the reach depth exceeds 20 inches (510 mm), the high forward reach shall be 44 inches (1120 mm) maximum and the reach depth shall be 25 inches (635 mm) maximum. Where a clear floor or ground space allows a parallel approach to an element and the high side reach is over an obstruction, the height of the obstruction shall be 34 inches (865 mm) maximum and the depth of the obstruction shall be 24 inches (610 mm) maximum. The high side reach shall be 48 inches (1220 mm) maximum for a reach depth of 10 inches (255 mm) maximum. Where the reach depth exceeds 10 inches (255 mm), the high side reach shall be 46 inches (1170 mm) maximum for a reach depth of 24 inches (610 mm) maximum.	soap 52"	Lower soap dispenser to max 46" aff for a side reach over counter	2015 ABAAS Section: 308.2.1, 308.3.2 2012 TAS Section: 308.2.1, 308.3.2 2010 ADAS Section: 308.2.1, 308.3.2

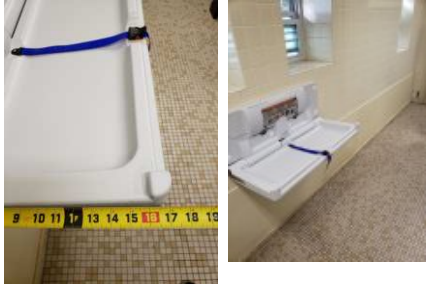
Finding Number	Area Description	Lat/Long	Finding	As Built	Recommendation	Citation	Photos	Figure
180	Day Use Area: Day Use Recreation Hall Men's Restroom	[28.1303339 , -96.985413 2]	The baby changing table is not compliant. Baby changing tables are work surfaces. If fixed or built-in baby changing tables are provided, at least 5%, but not less than one, must comply with TAS 902 based TAS 226.1. Baby changing tables cannot violate the protruding object requirements in either an open or closed position since either position is a potential hazard for persons with visual impairments. Baby changing tables are not prohibited from being located in wheelchair accessible toilet compartments; however, the minimum space required for the compartment cannot be obstructed by the baby changing table in either an open or closed position. The clear floor space required for a baby changing table may overlap the water closet clearance since baby changing tables are considered convenience "fixtures" based on Advisory 604.8.1.1. The overlap is applicable only to the clear floor space and not to actual table itself. Baby changing tables must be dispersed throughout a space, however, an additional baby changing table is not required in a common use area of a toilet or bathing room when the only baby changing table is located in a toilet compartment.	Baby changing table protrudes 17" when in the open position	Relocate baby changing table to eliminate protrusion when in the open position.	2012 TAS Section: 226.1, 902.3, 604.3.2, 204.1, 226.1 Advisory, 226.2, 307.1, 604.8.1.1 Advisory, 902.1, 902.1 Advisory, 902.2

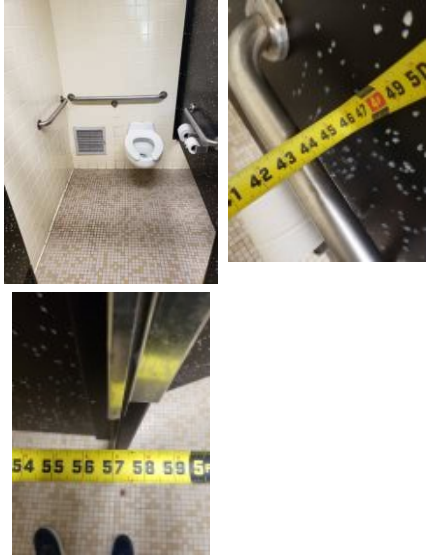
Finding Number	Area Description	Lat/Long	Finding	As Built	Recommendation	Citation	Photos	Figure
181	Day Use Area: Day Use Recreation Hall Men's Restroom	[28.1303197 , -96.985402 5]	There are not enough accessible toilet compartments. The room contains 0 toilet compartments. A minimum of 1 must be wheelchair accessible .	Lacks toilet stall with required dimensions to be wheelchair accessible (stall is 46" wide x 57" deep)	Create a wheelchair accessible stall with grab bars and fixtures mounted in correct locations and at correct heights	2015 ABAAS Section: F213.3.1 2012 TAS Section: 213.3.1 2010 ADAS Section: 213.3.1

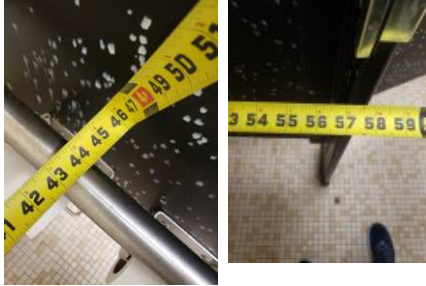
182	Day Use Area: Day Use Recreation Hall Men's Restroom	[28.1303268 , -96.98544]	The ambulatory stall is not between 35" to 37" wide and 60" deep.	Stall lacks required dimensions to be an ambulatory stall (stall is 46" wide x 57" deep)	Correct ambulatory stall to be 35" to 37" wide and minimum 60" deep	2015 ABAAS Section: 604.8.2.1 2012 TAS Section: 604.8.2.1 2010 ADAS Section: 604.8.2.1

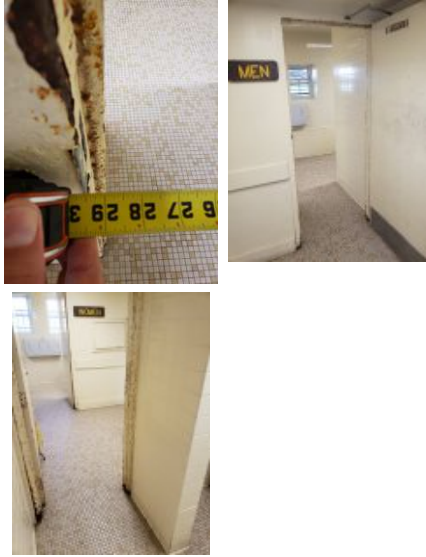
Finding Number	Area Description	Lat/Long	Finding	As Built	Recommendation	Citation	Photos	Figure
187	Day Use Area: Day Use Recreation Hall Men's Restroom	[28.1303268 , -96.985426 6]	Minimum maneuvering clearances at doors and gates shall comply with 404.2.4. Maneuvering clearances shall extend the full width of the doorway and the required latch side or hinge side clearance. Door openings shall provide a clear width of 32 inches (815 mm) minimum. Clear openings of doorways with swinging doors shall be measured between the face of the door and the stop, with the door open 90 degrees. Openings more than 24 inches (610 mm) deep shall provide a clear opening of 36 inches (915 mm) minimum. There shall be no projections into the required clear opening width lower than 34 inches (865 mm) above the finish floor or ground. Projections into the clear opening width between 34 inches (865 mm) and 80 inches (2030 mm) above the finish floor or ground shall not exceed 4 inches (100 mm). All interior doors must be maintained so that the operating pressure does not exceed 5 lb. force to open. The sweep period for doors with closers shall be adjusted so that from an open position of 70 degrees, the door will take at least 3 seconds to move to a point 3 inches from the latch, measured to the leading edge of the door.	men's- lacks clearance on push side, 29" clear width, and door was rusted open	For all doors along the public circulation route, provide required maneuvering clearance on push and pull side of doors For all doors along the public circulation route, replace doors with doors having 80" overhead clearance and 32" clear width For all doors along the public circulation route, inspect, adjust, and maintain 5 lbf to open interior doors For all doors along the public circulation route, inspect, adjust, and maintain closing speed on door closers	2010 ADAS Section: 404.2.3, 404.2.7, 404.2.4, 404.2.11, 404.2.11 Exception

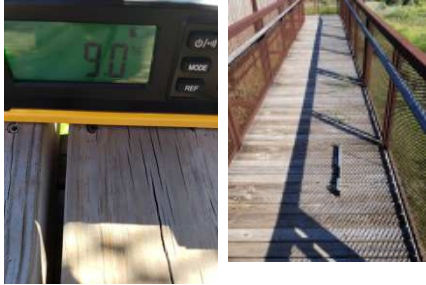
Finding Number	Area Description	Lat/Long	Finding	As Built	Recommendation	Citation	Photos	Figure
189	Day Use Area: Day Use Area Wildlife Viewing Area	[28.1309548 , -96.984159 3]	The ramps slope exceeds the maximum running slope (direction of travel) allowable of 8.33%. Ramps should have the least possible slope but in no case more than 8.3% (1:12).	Running slope of 9% on upper part of ramp	Correct slope of ramp to max 8.33%	2015 ABAAS Section: 405.2 2012 TAS Section: 405.2 2010 ADAS Section: 405.2

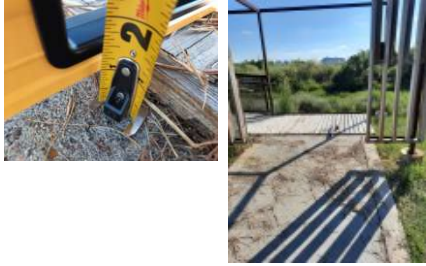
190	Day Use Area: Day Use Area Wildlife Viewing Area	[28.13295, -96.98463]	The walkway contains abrupt vertical edges and/or variations over a 1/4 inch. 1/4 inch is the maximum vertical rise. Changes in level between 1/4 inch and 1/2 inch must be beveled at 1:2 or less. Changes in level greater than 1/2 inch must be by way of a ramp.	CIL of .5" at transition from parking to accessible route due to plants/weeds, CIL of 1" at transition from accessible route to wildlife viewing platform	Repair, bevel or ramp CIL along AR	2012 TAS Section: 303.2, 303.3 2010 ADAS Section: 303.2, 303.3

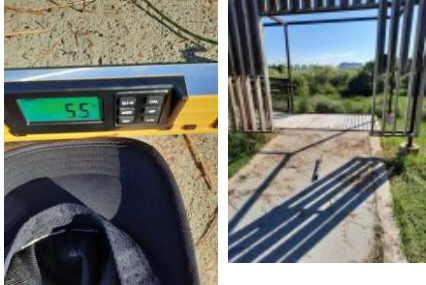
191	Day Use Area: Day Use Area Wildlife Viewing Area	[28.1307928 , -96.984190 1]	The running slope of walking surfaces shall not be steeper than 1:20.	Running slope of 5.5% on accessible route to wildlife viewing platform	Correct running slope along the AR to max 5%	2015 ABAAS Section: 403.3 2012 TAS Section: 403.3 2010 ADAS Section: 403.3

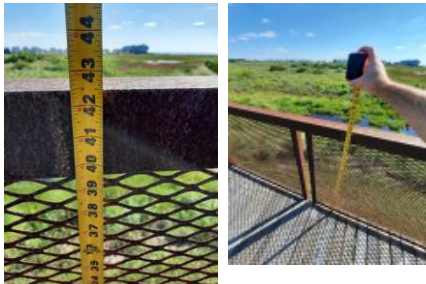
192	Day Use Area: Day Use Area Wildlife Viewing Area	[28.1309986 , -96.984163 3]	Each distinct viewing location shall provide a viewing space adjacent to the clear ground space required by 1015.2 through which the point of interest is viewable. The viewing space shall be 32 inches (815 mm) maximum and 51 inches (1295 mm) minimum high above the ground and shall extend the full width of the clear ground space.	Railings are 42.5" above the deck surface	Lower a 36" wide portion of railing to provide an unobstructed view between 32" and 51"	2015 ABAAS Section: 1015.3

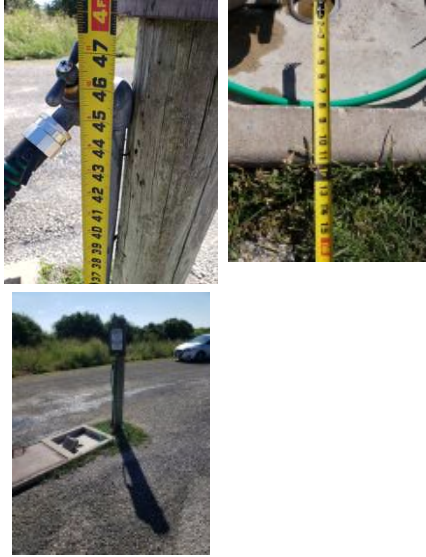
Finding Number	Area Description	Lat/Long	Finding	As Built	Recommendation	Citation	Photos	Figure
193	Day Use Area: Dump Station	[28.131668, -96.984125 7]	Water spouts at water hydrants and water utility hook-ups shall be 28 inches (710 mm) minimum and 36 inches (915 mm) maximum above the ground. The accessible route contains loose gravel and/or surfaces that do not provide for a stable, firm slip resistant surface.	Water spout is 44.5" aff, deterioration of rough surface in clear floor space	Remount water spouts to 28" min or 36" max above the ground as a smart practice. Resurface AR where deterioration occurs	2015 ABAAS Section: 1011.6

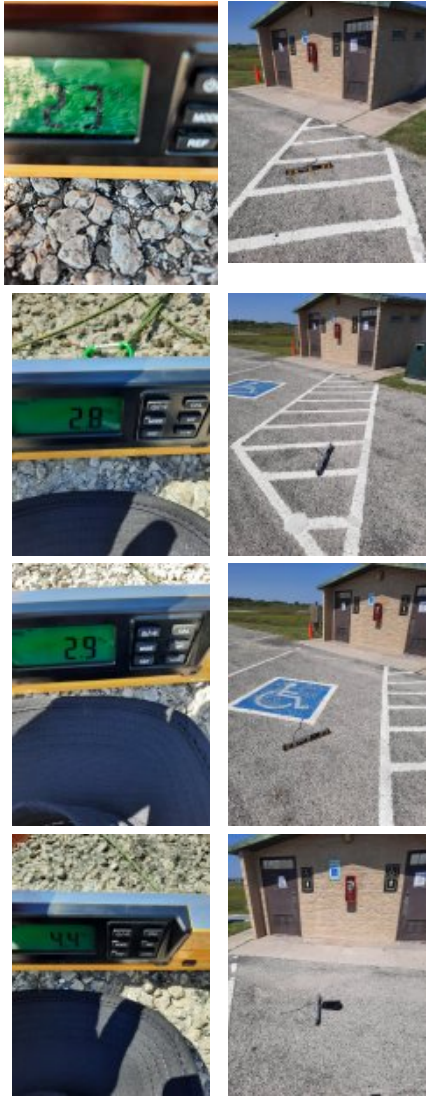
Finding Number	Area Description	Lat/Long	Finding	As Built	Recommendation	Citation	Photos	Figure
194	Bayfront Camping Area: Bayfront Fishing Pier Restroom #1 Parking	[28.1252766 , -96.9801561]	The cross slopes (narrow dimension) and/or running slopes (long dimension) of the access aisle exceeds 2%. The running slope and the cross slope in an accessible parking stall and the access aisle must not exceed 2%.	Slopes of 2.3% at head and 2.8% at foot of access aisle, 2.9% at foot and 4.4% at head of stall	Repair or correct slope of parking space and access aisle to max 2.08% in any direction	2015 ABAAS Section: 502.4 2012 TAS Section: 502.4 2010 ADAS Section: 502.4

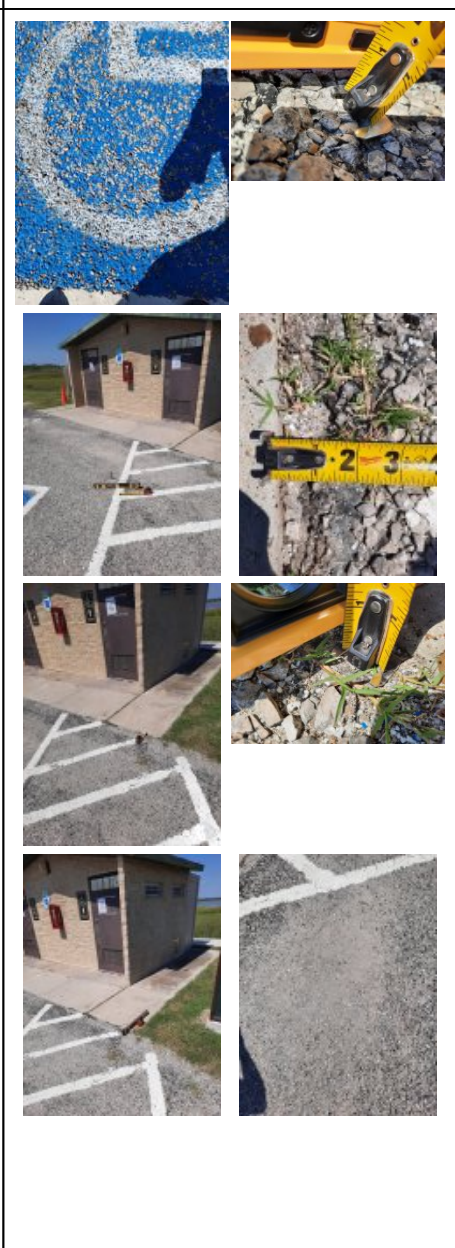
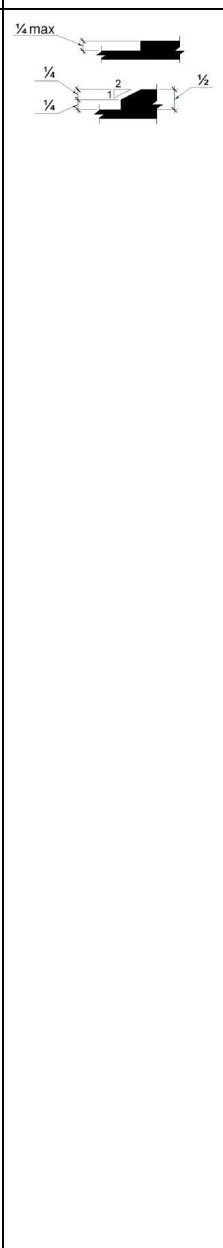
Finding Number	Area Description	Lat/Long	Finding	As Built	Recommendation	Citation	Photos	Figure
195	Bayfront Camping Area: Bayfront Fishing Pier Restroom #1 Parking	[28.1252743 , -96.980156 1]	The parking stall contains abrupt edges and surface irregularities over a 1/4 inch vertical. Parking spaces and access aisles serving them shall be stable, firm, and slip resistant. Access aisles shall be at the same level as the parking spaces they serve. Changes in level are not permitted and shall not be sloped steeper than 2% in any direction.	Multiple gaps and changes in level (CIL) due to deterioration of paint and/or the parking surface being rough concrete with loose rock, weeds, grass, dirt/sand on top	Resurface stalls and access aisles to eliminate gaps and cracks	2015 ABAAS Section: 502.4 2012 TAS Section: 502.4 2010 ADAS Section: 502.4

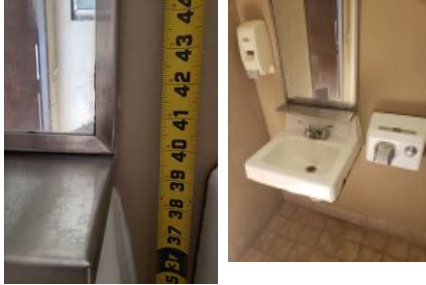
Finding Number	Area Description	Lat/Long	Finding	As Built	Recommendation	Citation	Photos	Figure
199	Bayfront Camping Area: Bayfront Fishing Pier Restroom #1 Men's	[28.1253121 , -96.9801909]	The mirror is mounted too high. Mirrors must have the bottom edge of the reflecting surface a maximum of 40 inches above the floor if above a sink or counter. Mirrors not located above lavatories or countertops shall be installed with the bottom edge of the reflecting surface 35 inches maximum above the finish floor or ground.	Bottom edge of reflecting surface of mirror is 40.5" aff	Lower mirror so reflective surface is max 40" aff	2015 ABAAS Section: 603.3 2012 TAS Section: 603.3 2010 ADAS Section: 603.3

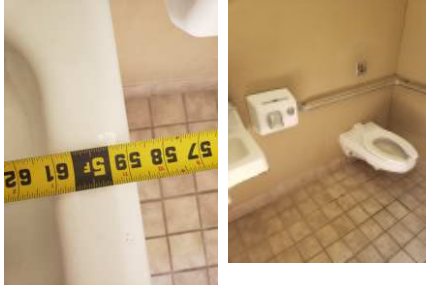
200	Bayfront Camping Area: Bayfront Fishing Pier Restroom #1 Men's	[28.1253097 , -96.9801883]	The required 56 inches by 60 inches clear floor space for the water closet has been obstructed. The clear floor space around the water closet shall be 60 inches minimum measured perpendicular from the side wall and 56 inches minimum measured perpendicular from the rear wall.	Sink is 59" from wall in toilet clearance	Relocate sink to provide required 60" clearance around toilet; leave as is if constructed or last altered before March 15, 2012 as it meets safe harbor	2015 ABAAS Section: 604.3. 2012 TAS Section: 604.3.1 2010 ADAS Section: 604.3.1

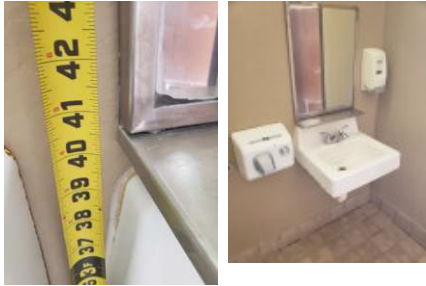
Finding Number	Area Description	Lat/Long	Finding	As Built	Recommendation	Citation	Photos	Figure
203	Bayfront Camping Area: Bayfront Fishing Pier Restroom #1 Women's	[28.1253097 , -96.980195]	The mirror is mounted too high. Mirrors must have the bottom edge of the reflecting surface a maximum of 40 inches above the floor if above a sink or counter. Mirrors not located above lavatories or countertops shall be installed with the bottom edge of the reflecting surface 35 inches maximum above the finish floor or ground.	Bottom edge of reflecting surface of mirror is 41" aff	Lower mirror so reflective surface is max 40" aff	2015 ABAAS Section: 603.3 2012 TAS Section: 603.3 2010 ADAS Section: 603.3

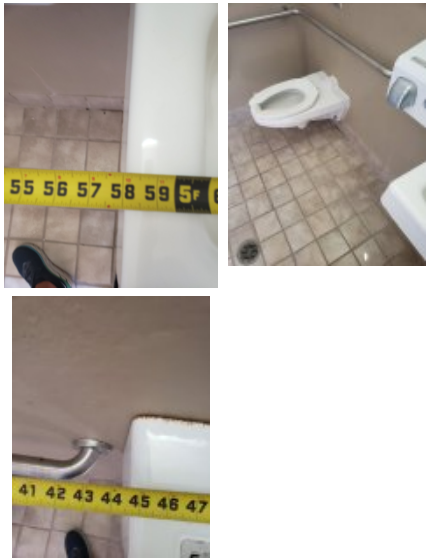
204	Bayfront Camping Area: Bayfront Fishing Pier Restroom #1 Women's	[28.1253121 , -96.9801909]	The required 56 inches by 60 inches clear floor space for the water closet has been obstructed. The clear floor space around the water closet shall be 60 inches minimum measured perpendicular from the side wall and 56 inches minimum measured perpendicular from the rear wall.	Sink is 58" from wall within toilet clearance	Relocate sink and hand dryer to provide required 60" clearance around toilet; leave as is if restroom constructed or last altered before March 15, 2012 as this will meet safe harbor	2015 ABAAS Section: 604.3. 2012 TAS Section: 604.3.1 2010 ADAS Section: 604.3.1

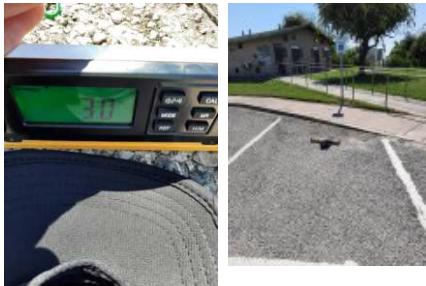
207	Bayfront Camping Area: Bayfront Trout Restroom #2 Parking	[28.1251489 , -96.983350 6]	The cross slopes (narrow dimension) and/or running slopes (long dimension) of the access aisle exceeds 2%. The running slope and the cross slope in an accessible parking stall and the access aisle must not exceed 2%.	Slope of 3% at head of stall	Repair or correct slope of parking space and access aisle to max 2.08% in any direction	2015 ABAAS Section: 502.4 2012 TAS Section: 502.4 2010 ADAS Section: 502.4

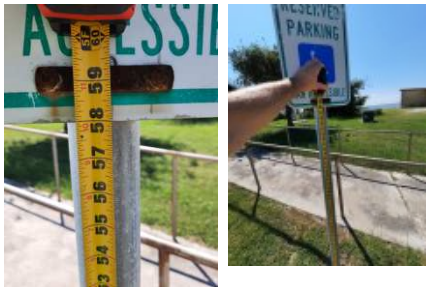
208	Bayfront Camping Area: Bayfront Trout Restroom #2 Parking	[28.1251442 , -96.983350 6]	The parking sign is mounted too low. Parking space identification signs shall include the International Symbol of Accessibility complying with. Signs identifying van parking spaces shall contain the designation "van accessible." Signs shall be 60 inches minimum above the finish floor or ground surface measured to the bottom of the sign.	The parking sign is 58" above ground level	Raise existing accessible parking signs so lowest end of bottom sign is min 60" aff	2015 ABAAS Section: 502.6 2012 TAS Section: 502.6 2010 ADAS Section: 502.6

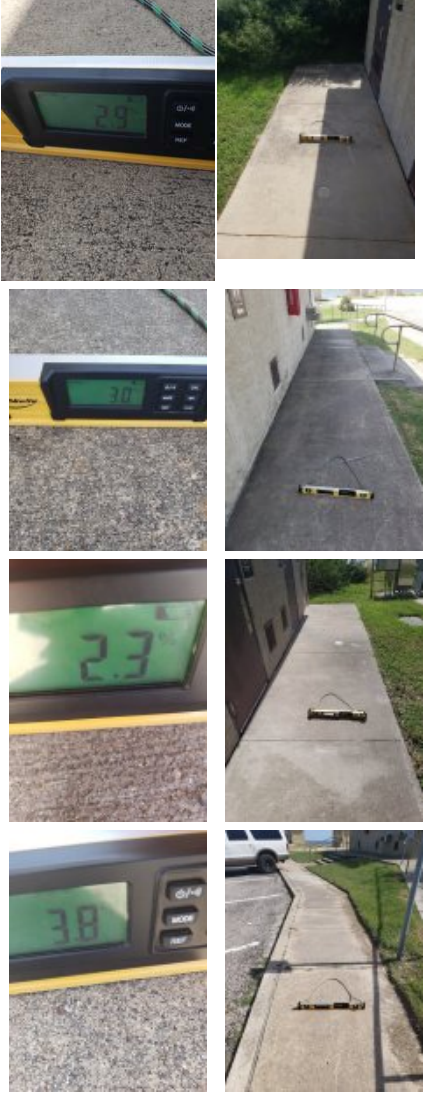
209	Bayfront Camping Area: Bayfront Trout Restroom #2 Parking	[28.12486, -96.98311]	The accessible route of travel on the accessible route contains cross slopes greater than 2%. Cross slopes shall not exceed one unit vertical in 48 units horizontal (2-percent slope).	Cross slopes of 2.9%, 3%, 2.3%, 3.8%	Correct or repair cross slope along AR to max 2.08%	2015 ABAAS Section: 403.3 2012 TAS

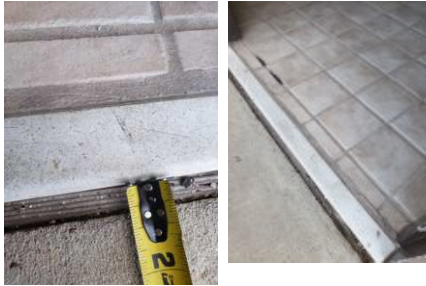
Finding Number	Area Description	Lat/Long	Finding	As Built	Recommendation	Citation	Photos	Figure
213	Bayfront Camping Area: Bayfront Trout Restroom #2 Women's	[28.1253145 , -96.980193 6]	Openings in floor or ground surfaces shall not allow passage of a sphere more than 1/2 inch (13 mm) diameter except as allowed in 407.4.3, 409.4.3, 410.4, 810.5.3 and 810.10. Elongated openings shall be placed so that the long dimension is perpendicular to the dominant direction of travel. Exterior doors are recommended to be maintained at 8.5 lbf as a smart practice. Force is to be measured at the operating hardware or 30 inches from the hinges, whichever is greater.	Bayfront Trout women's restroom door - 18 lbf, gap of .5"	For all doors along the public circulation route, fill and maintain gaps at doorways to max .5" For all doors along the public circulation route, inspect, adjust, and maintain 8.5 lbf to open exterior doors as a smart practice	2010 ADAS Section: 404.2.3, 404.2.7, 404.2.4, 404.2.11, 404.2.11 Exception

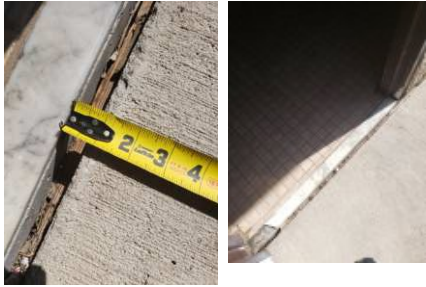
215	Bayfront Camping Area: Bayfront Trout Restroom #2 Shower	[28.125, -96.98327]	Openings in floor or ground surfaces shall not allow passage of a sphere more than 1/2 inch (13 mm) diameter except as allowed in 407.4.3, 409.4.3, 410.4, 810.5.3 and 810.10. Elongated openings shall be placed so that the long dimension is perpendicular to the dominant direction of travel. Exterior doors are recommended to be maintained at 8.5 lbf as a smart practice. Force is to be measured at the operating hardware or 30 inches from the hinges, whichever is greater.	shower- Gap of .75", 18 lbf	For all doors along the public circulation route, fill and maintain gaps at doorways to max .5" For all doors along the public circulation route, inspect, adjust, and maintain 8.5 lbf to open exterior doors as a smart practice	2010 ADAS Section: 404.2.3, 404.2.7, 404.2.4, 404.2.11, 404.2.11 Exception
