Access Audit Site Report

Goose Island State Park

Accessibility Evaluation

Inspection Date: 10/07/2021

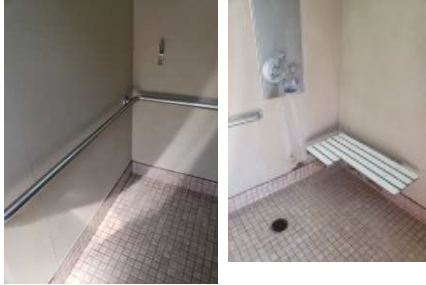
Finding Number	Area Description	Lat/Long	Finding	As Built	Recommendation	Citation	Photos	Figure
216	Bayfront Camping Area: Bayfront Trout Restroom #2 Shower	[28.1250046 , -96.9832674]	Standard Roll-In Type Shower Compartments. Where a seat is provided in standard roll-in type shower compartments, grab bars shall be provided on the back wall and the side wall opposite the seat. Grab bars shall not be provided above the seat. Where a seat is not provided in standard roll-in type shower compartments, grab bars shall be provided on three walls. Grab bars shall be installed 6 inches (150 mm) maximum from adjacent walls. Alternate Roll-In Type Shower Compartments. In alternate roll-in type shower compartments, grab bars shall be provided on the back wall and the side wall farthest from the compartment entry. Grab bars shall not be provided above the seat. Grab bars shall be installed 6 inches (150 mm) maximum from adjacent walls. Grab bars shall be installed in a horizontal position, 33 inches (840 mm) minimum and 36 inches (915 mm) maximum above the finish floor measured to the top of the gripping surface, except that at water closets for children's use complying with 604.9, grab bars shall be installed in a horizontal position 18 inches (455 mm) minimum and 27 inches (685 mm) maximum above the finish floor measured to the top of the gripping surface.	back wall grab bar ends too short before seat location	Remount grab bars to the correct location in the shower, mounted 33" to 36" aff and max 6" from adjacent walls	2015 ABAAS Section: 608.3.2, 608.3.3, 609.4 2012 TAS Section: 609.4, 608.3.2, 608.3.3 2010 ADAS Section: 609.4, 608.3.2, 608.3.3

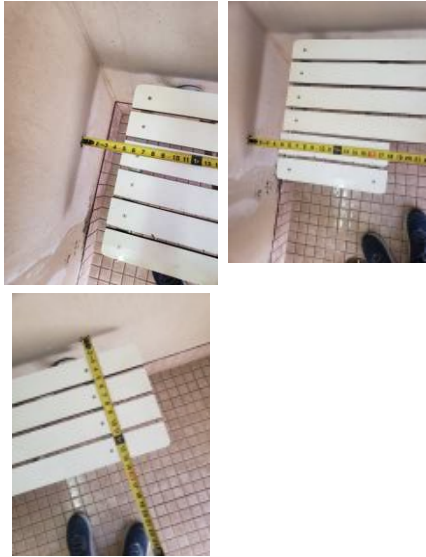
Finding Number	Area Description	Lat/Long	Finding	As Built	Recommendation	Citation	Photos	Figure
217	Bayfront Camping Area: Bayfront Trout Restroom #2 Shower	[28.1250022 , -96.9832621]	The shower seat does not have a compliant space between it and the wall. The folding seat must be mounted 17-19 inches above the floor, and have a maximum space of 1-1/2 inches between the edge of the seat and the side wall and 2-1/2 inches maximum to the seat wall.	The shower seat lacks required dimensions and spacing between it and the wall	Remount shower seat to the correct location and height in the shower	2015 ABAAS Section: 610.3.2 2012 TAS Section: 610.3.2 2010 ADAS Section: 610.3.2

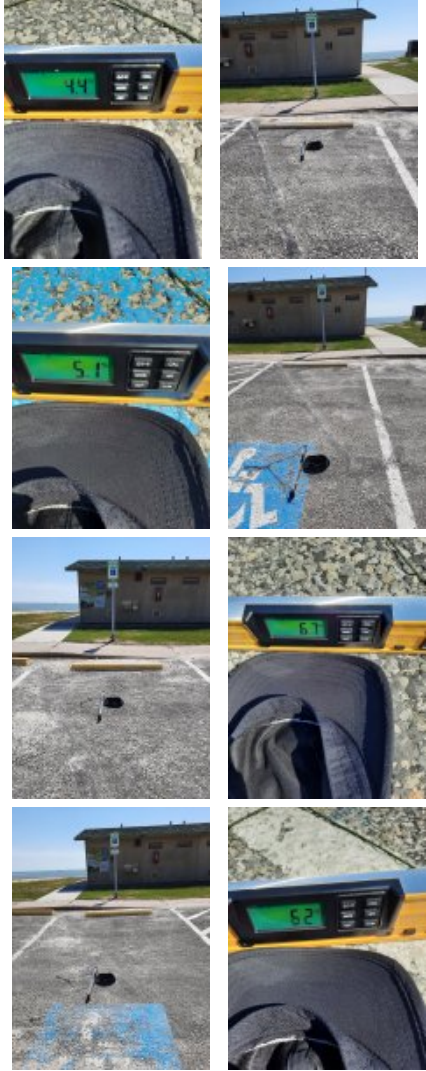
Finding Number	Area Description	Lat/Long	Finding	As Built	Recommendation	Citation	Photos	Figure
218	Bayfront Camping Area: Bayfront Redfish Restroom #3 Parking	[28.127914, -96.987818 4]	The cross slopes (narrow dimension) and/or running slopes (long dimension) of the access aisle exceeds 2%. The running slope and the cross slope in an accessible parking stall and the access aisle must not exceed 2%.	Slopes of 7.9% at head and 6.7% at middle of left stall, slopes of 6.2% at foot and 5.6% at head of access aisle, and slopes of 4.4% at head and 5.1% at foot of right stall	Repair or correct slope of parking space and access aisle to max 2.08% in any direction	2015 ABAAS Section: 502.4 2012 TAS Section: 502.4 2010 ADAS Section: 502.4

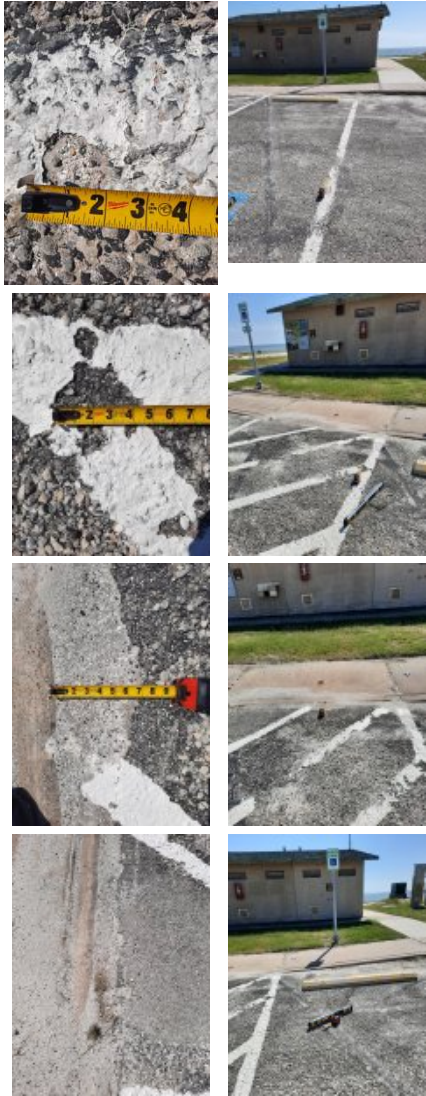
Finding Number	Area Description	Lat/Long	Finding	As Built	Recommendation	Citation	Photos	Figure
219	Bayfront Camping Area: Bayfront Redfish Restroom #3 Parking	[28.127914, -96.987822 4]	The parking stall contains abrupt edges and surface irregularities over a 1/4 inch vertical. Parking spaces and access aisles serving them shall be stable, firm, and slip resistant. Access aisles shall be at the same level as the parking spaces they serve. Changes in level are not permitted and shall not be sloped steeper than 2% in any direction.	Multiple gaps and changes in level (CIL) due to deterioration of paint and/or the parking surface being rough concrete with loose rock, weeds, grass, dirt/sand on top	Resurface stalls and access aisles to eliminate gaps and cracks	2015 ABAAS Section: 502.4 2012 TAS Section: 502.4 2010 ADAS Section: 502.4

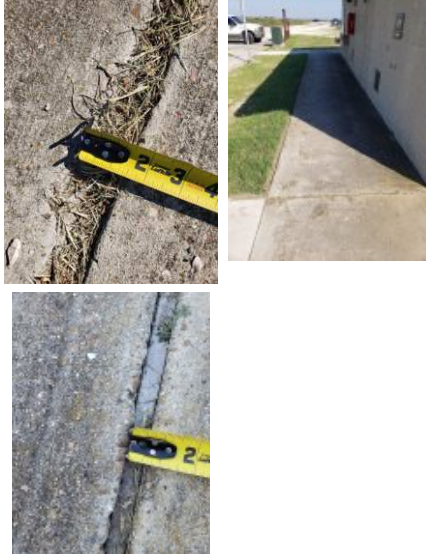
220	Bayfront Camping Area: Bayfront Redfish Restroom #3 EAR	[28.1278928 , -96.987829 9]	There is a gap spaced greater than a 1/2 inch. Openings in floor or ground surfaces shall not allow passage of a sphere more than 1/2 inch diameter. Elongated openings shall be placed so that the long dimension is perpendicular to the dominant direction of travel.	Gaps of 1.5" and .5"	Correct or fill gaps to be max .5"	2015 ABAAS Section: 302.3 2012 TAS Section: 302.3 2010 ADAS Section: 302.3

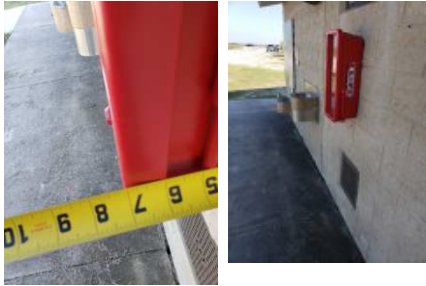
Finding Number	Area Description	Lat/Long	Finding	As Built	Recommendation	Citation	Photos	Figure
221	Bayfront Camping Area: Bayfront Redfish Restroom #3 EAR	[28.1278266 , -96.987875 5]	Objects project more than 4 inches into the circulation path. Wall-mounted objects that have leading edges between 27 inches and 80 inches from the floor must not project more than 4 inches into the circulation path. Protruding objects that extend to the floor or within 27 inches of the floor are cane detectable and are therefore not hazardous. Where it is necessary or desirable to have objects protrude from the wall, a manner of cane detection must be provided.	Fire extinguisher protrudes 7"	Relocate object to not protrude into the circulation path	2015 ABAAS Section: 307.2 2012 TAS Section: 307.2 2010 ADAS Section: 307.2

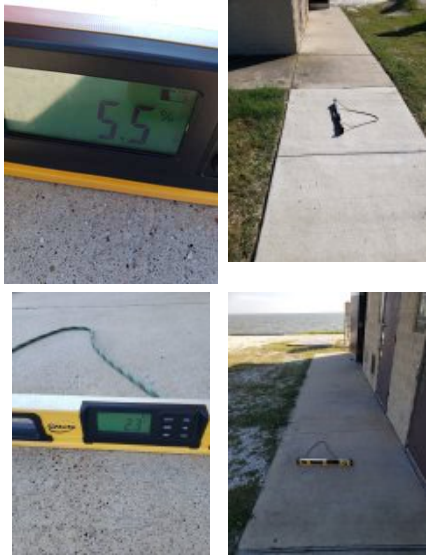
Finding Number	Area Description	Lat/Long	Finding	As Built	Recommendation	Citation	Photos	Figure
224	Bayfront Camping Area: Bayfront Redfish Restroom #3 EAR	[28.1278313 , -96.987884 9]	The running slope of walking surfaces shall not be steeper than 1:20. The cross slope of walking surfaces shall not be steeper than 1:48.	Running slope 5.5% and cross slope 2.3%	Correct running slopes to max 5% and cross to max 2.08%.	2012 TAS Section: 403.3 2010 ADAS Section: 403.3

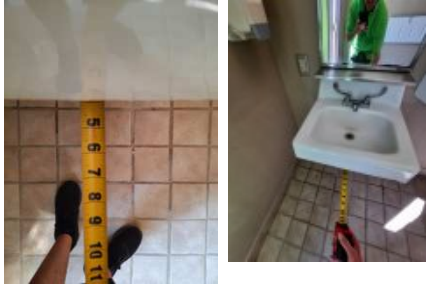
Finding Number	Area Description	Lat/Long	Finding	As Built	Recommendation	Citation	Photos	Figure
225	Bayfront Camping Area: Bayfront Redfish Restroom #3 Men's	[28.1278242 , -96.987813 8]	Knee clearance at 27 inches off the floor is not 8 inches minimum deep. The knee clearance, measured from the bottom of the apron or the outside bottom edge of the lavatory, must be 27 inches at a point located 8 inches back from the front edge and continuing to 11 inches minimum in depth at 9 inches above the floor. The top of the lavatory rim may be no higher than 34 inches.	4" deep knee clearance at sink	Raise sink bowl to provide 27" knee clearance, in the alternative, acquire a shallower model	2015 ABAAS Section: 306.3.1, 306.3.2, 306.3.3, 306.3.4 , 306.3.5 2012 TAS Section: 306.3.2, 306.3.3, 306.3.4, 306.3.5, 306.3.1 2010 ADAS Section: 306.3.3, 306.3.2, 306.3.4, 306.3.5, 306.3.1

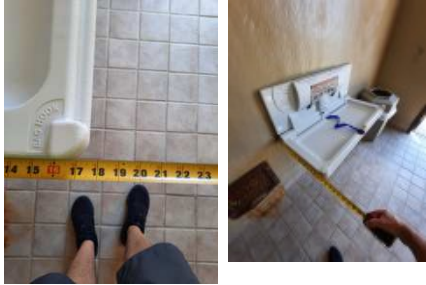
Finding Number	Area Description	Lat/Long	Finding	As Built	Recommendation	Citation	Photos	Figure
226	Bayfront Camping Area: Bayfront Redfish Restroom #3 Men's	[28.1278219 , -96.987819 1]	The baby changing table is not compliant. Baby changing tables are work surfaces. If fixed or built-in baby changing tables are provided, at least 5%, but not less than one, must comply with TAS 902 based TAS 226.1. Baby changing tables cannot violate the protruding object requirements in either an open or closed position since either position is a potential hazard for persons with visual impairments. Baby changing tables are not prohibited from being located in wheelchair accessible toilet compartments; however, the minimum space required for the compartment cannot be obstructed by the baby changing table in either an open or closed position. The clear floor space required for a baby changing table may overlap the water closet clearance since baby changing tables are considered convenience "fixtures" based on Advisory 604.8.1.1. The overlap is applicable only to the clear floor space and not to actual table itself. Baby changing tables must be dispersed throughout a space, however, an additional baby changing table is not required in a common use area of a toilet or bathing room when the only baby changing table is located in a toilet compartment.	Changing table protrudes more than 4" in the open position	Relocate baby changing table to eliminate protrusion when in the open position.	2012 TAS Section: 226.1, 902.3, 604.3.2, 204.1, 226.1 Advisory, 226.2, 307.1, 604.8.1.1 Advisory, 902.1, 902.1 Advisory, 902.2

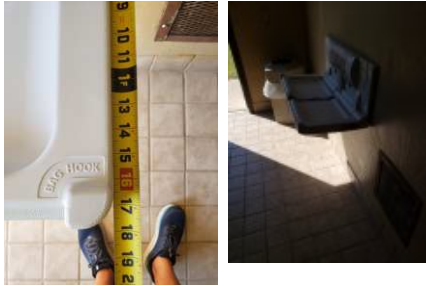
Finding Number	Area Description	Lat/Long	Finding	As Built	Recommendation	Citation	Photos	Figure
230	Bayfront Camping Area: Bayfront Redfish Restroom #3 Women's	[28.1278077 , -96.987816 5]	The baby changing table is not compliant. Baby changing tables are work surfaces. If fixed or built-in baby changing tables are provided, at least 5%, but not less than one, must comply with TAS 902 based TAS 226.1. Baby changing tables cannot violate the protruding object requirements in either an open or closed position since either position is a potential hazard for persons with visual impairments. Baby changing tables are not prohibited from being located in wheelchair accessible toilet compartments; however, the minimum space required for the compartment cannot be obstructed by the baby changing table in either an open or closed position. The clear floor space required for a baby changing table may overlap the water closet clearance since baby changing tables are considered convenience "fixtures" based on Advisory 604.8.1.1. The overlap is applicable only to the clear floor space and not to actual table itself. Baby changing tables must be dispersed throughout a space, however, an additional baby changing table is not required in a common use area of a toilet or bathing room when the only baby changing table is located in a toilet compartment.	Baby changing table protrudes 18" when in the open position	Relocate baby changing table to eliminate protrusion when in the open position.	2012 TAS Section: 226.1, 902.3, 604.3.2, 204.1, 226.1 Advisory, 226.2, 307.1, 604.8.1.1 Advisory, 902.1, 902.1 Advisory, 902.2

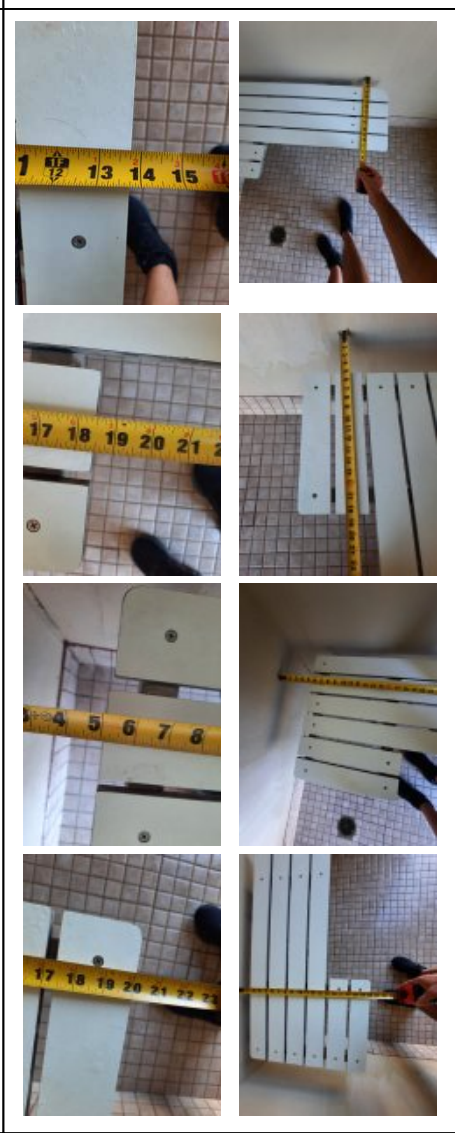
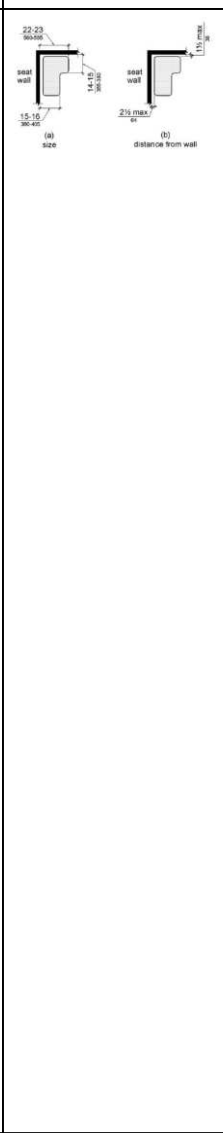
Finding Number	Area Description	Lat/Long	Finding	As Built	Recommendation	Citation	Photos	Figure
237	Bayfront Camping Area: Bayfront Redfish Restroom #3 Shower	[28.1278219 , -96.987829 9]	The shower seat does not have a compliant space between it and the wall. The folding seat must be mounted 17-19 inches above the floor, and have a maximum space of 1-1/2 inches between the edge of the seat and the side wall and 2-1/2 inches maximum to the seat wall.	The shower seat lacks required dimensions and spacing between it and the wall	Remount shower seat to the correct location and height in the shower	2015 ABAAS Section: 610.3.2 2012 TAS Section: 610.3.2 2010 ADAS Section: 610.3.2

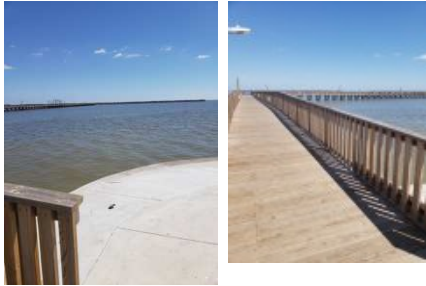
Finding Number	Area Description	Lat/Long	Finding	As Built	Recommendation	Citation	Photos	Figure
238	Bayfront Camping Area: Bayfront Fishing Pier Parking	[28.124891, -96.978128 3]	Not enough of the railings, guards, or handrails are at the allowable height. At least 25 percent of the railings, guards, or handrails shall be 34 inches maximum above the ground or deck surface.	lowered railings provided throughout pier length, seems to have less than 25% of railings lowered	Ensure 25% of the railings are lowered; dispersed through pier, to max 34".	2015 ABAAS Section: 1005.2.1 2010 ADAS Section: 1005.2.1

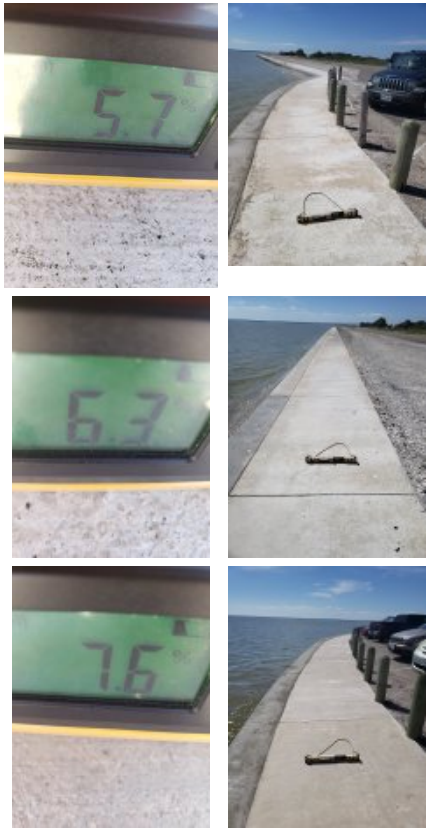
239	Bayfront Camping Area: Bayfront Fishing Pier Parking	[28.13295, -96.98463]	The accessible route of travel on the accessible route contains cross slopes greater than 2%. Cross slopes shall not exceed one unit vertical in 48 units horizontal (2-percent slope).	path along retaining wall has very steep cross slope from 5 to 8%	Correct or repair cross slope along AR to max 2.08%	2015 ABAAS Section: 403.3 2012 TAS Section: 403.3 2010 ADAS Section: 403.3

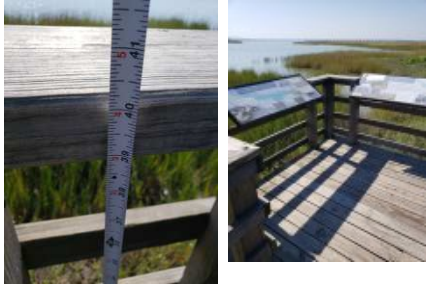
242	Bayfront Camping Area: Bayfront Goose Island Boardwalk	[28.128347, -96.989664 5]	Each distinct viewing location shall provide a viewing space adjacent to the clear ground space required by 1015.2 through which the point of interest is viewable. The viewing space shall be 32 inches (815 mm) maximum and 51 inches (1295 mm) minimum high above the ground and shall extend the full width of the clear ground space.	All railings are 40" above deck surface	Lower a 36" wide portion of railing to provide an unobstructed view between 32" and 51"	2015 ABAAS Section: 1015.3

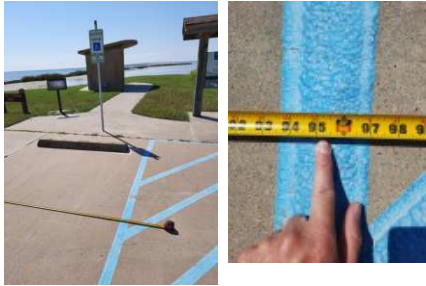
Finding Number	Area Description	Lat/Long	Finding	As Built	Recommendation	Citation	Photos	Figure
244	Bayfront Camping Area: Bayfront Nature Viewing Area Parking	[28.1281057 , -96.989554 5]	The accessible parking stall is not wide enough. Each parking space must be at least 8' feet wide and shall be marked to define the width. The measurements of parking spaces and access aisles shall be made from the centerline of the markings. Where the parking space is not adjacent to another parking space or access aisle, the measurement shall be permitted to include the full width of the line defining the parking space.	stall 95.25" wide	Repaint stalls to be 8' wide each	2015 ABAAS Section: 502.2 2012 TAS Section: 502.2 2010 ADAS Section: 502.2

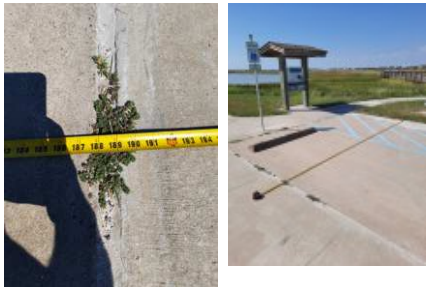
245	Bayfront Camping Area: Bayfront Nature Viewing Area Parking	[28.1281223 , -96.989543 8]	There are no van accessible parking stalls. 1 in every 6, minimum of one, required accessible stalls must be a van accessible stall. There are a total of 1 parking stalls in the parking lot that could be reasonably associated with this facility. There should be a minimum of 1 accessible stalls with a minimum of 1 being designed as van accessible.	Total width of stall and access aisle is 188" and does not comply with the width requirements of a van accessible stall	Add van parking sign to 1 accessible stall and repaint stall and access aisle to 11' and 5' or 8' and 8' per the table	2015 ABAAS Section: F208.2, F208.2.4 2012 TAS Section: 208.2, 208.2.4 2010 ADAS Section: 208.2, 208.2.4

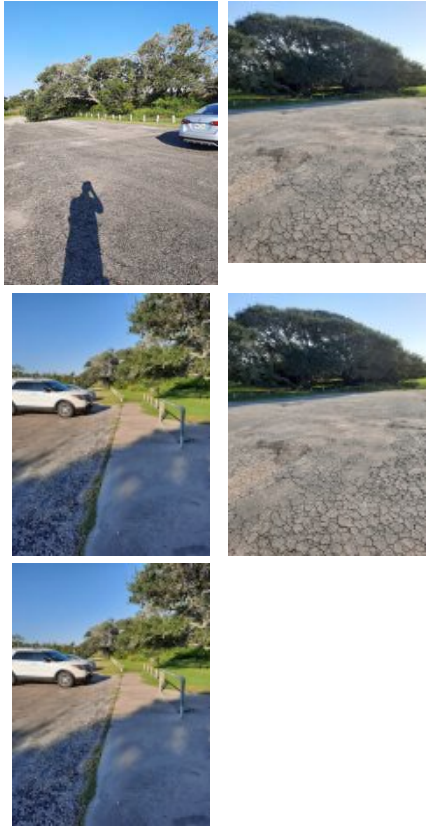
Finding Number	Area Description	Lat/Long	Finding	As Built	Recommendation	Citation	Photos	Figure
252	The Big Tree: The Big Tree Parking	[28.1519351, -96.9768395]	There are no accessible parking stalls. Each lot where parking is provided for the public as clients, guests or employees, shall provide accessible parking and shall be located on the shortest accessible route of travel from adjacent parking to an accessible entrance. There are approximately 10 parking stalls in the parking lot that could be reasonably associated with this facility. There should be a minimum of 1 accessible stalls with a minimum of 1 being designed as van accessible.	Lacks accessible parking stalls (approximately 10 standard, 0 accessible)	Create one or more 8' accessible parking stalls, with one 5' adjacent access aisle, with proper signage and striping based on the total number of stalls	2015 ABAAS Section: F208.2 2012 TAS Section: 208.2 2010 ADAS Section: 208.2

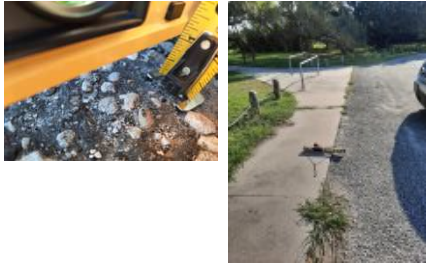
253	The Big Tree: The Big Tree	[28.1520204, -96.9768479]	The walkway contains abrupt vertical edges and/or variations over a 1/4 inch. 1/4 inch is the maximum vertical rise. Changes in level between 1/4 inch and 1/2 inch must be beveled at 1:2 or less. Changes in level greater than 1/2 inch must be by way of a ramp.	CIL of 1" along transition from parking to accessible route	Repair, bevel or ramp CIL along AR	2012 TAS Section: 303.2, 303.3 2010 ADAS Section: 303.2, 303.3

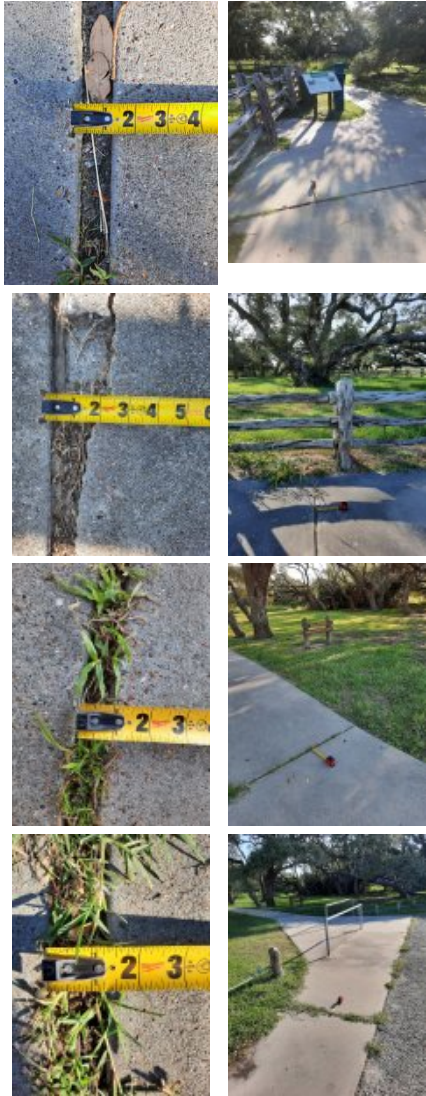
Finding Number	Area Description	Lat/Long	Finding	As Built	Recommendation	Citation	Photos	Figure
254	The Big Tree: The Big Tree	[28.1523649 , -96.976679 5]	There is a gap spaced greater than a 1/2 inch. Openings in floor or ground surfaces shall not allow passage of a sphere more than 1/2 inch diameter. Elongated openings shall be placed so that the long dimension is perpendicular to the dominant direction of travel.	Multiple gaps (5) greater than .5" along accessible route	Correct or fill gaps to be max .5"	2015 ABAAS Section: 302.3 2012 TAS Section: 302.3 2010 ADAS Section: 302.3

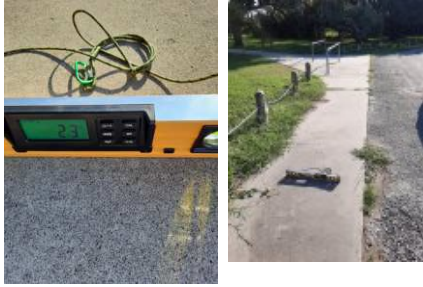
255	The Big Tree: The Big Tree	[28.1520268 , -96.976835 3]	The accessible route of travel on the accessible route contains cross slopes greater than 2%. Cross slopes shall not exceed one unit vertical in 48 units horizontal (2-percent slope).	Cross slope of 2.3%	Correct or repair cross slope along AR to max 2.08%	2015 ABAAS Section: 403.3 2012 TAS Section: 403.3 2010 ADAS Section: 403.3

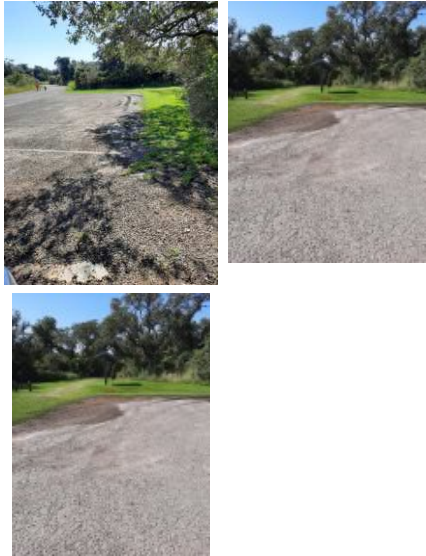
Finding Number	Area Description	Lat/Long	Finding	As Built	Recommendation	Citation	Photos	Figure																																																												
259	Trails And Trailheads: Turk's Cap Trailhead Parking (South)	[28.1343419 , -96.9883034]	There are no accessible parking stalls. Each lot where parking is provided for the public as clients, guests or employees, shall provide accessible parking and shall be located on the shortest accessible route of travel from adjacent parking to an accessible entrance. There are a total of 7 parking stalls in the parking lot that could be reasonably associated with this facility. There should be a minimum of 1 accessible stalls with a minimum of 1 being designed as van accessible.	Lacks accessible stalls (7 standard, 0 accessible)	Create one or more 8' accessible parking stalls, with one 5' adjacent access aisle, with proper signage and striping based on the total number of stalls	2015 ABAAS Section: F208.2 2012 TAS Section: 208.2 2010 ADAS Section: 208.2

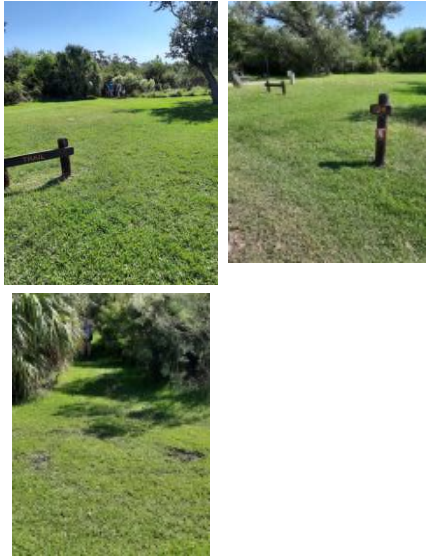
Finding Number	Area Description	Lat/Long	Finding	As Built	Recommendation	Citation	Photos	Figure
261	Trails And Trailheads: Warbler Way Campsites Unnamed Nature Trail	[28.13564, -96.98833]	The surface of trails, passing spaces, and resting intervals shall be firm and stable	Lacks firm and stable surface	Replace surface of trail with one that is firm and stable as a smart practice.	2015 ABAAS Section: 1017.2

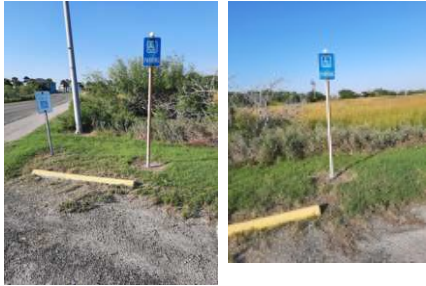
Finding Number	Area Description	Lat/Long	Finding	As Built	Recommendation	Citation	Photos	Figure
266	Boat Ramps: Boat Ramp Parking	[28.1289289 , -96.985710 9]	The van stall is missing a sign identifying it as a van accessible stall. Parking space identification signs shall include the International Symbol of Accessibility. Signs identifying van parking spaces shall contain the designation "van accessible."	Lacks van stall	Add one van parking sign to one accessible stall and repaint stall and access aisle to 11' and 5' or 8' and 8'	2015 ABAAS Section: 502.6 2012 TAS Section: 502.6 2010 ADAS Section: 502.6

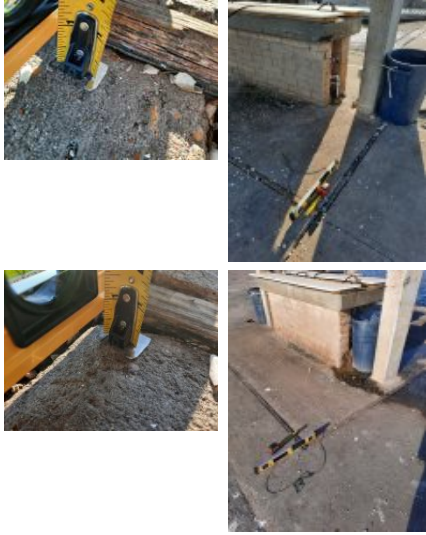
Finding Number	Area Description	Lat/Long	Finding	As Built	Recommendation	Citation	Photos	Figure
269	Boat Ramps: St Charles Bay Boat Ramp Fish Cleaning Station	[28.1285776 , -96.985580 8]	There is a change in level greater than 1/4 inch. 1/4 inch is the maximum vertical rise. Changes in level between 1/4 inch and 1/2 inch must be beveled at 1:2 or less. Changes in level greater than 1/2 inch must be by way of a ramp.	CIL of 1" and .75" at perimeter of fish cleaning station	Repair, bevel or ramp CIL along AR to max .25"	2015 ABAAS Section: 303.3 2012 TAS Section: 303.3 2010 ADAS Section: 303.3

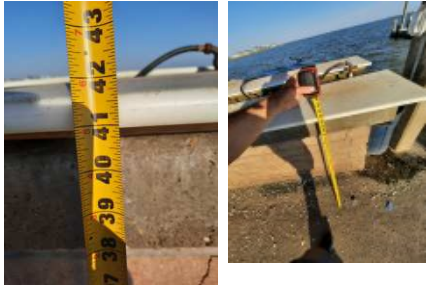
Finding Number	Area Description	Lat/Long	Finding	As Built	Recommendation	Citation	Photos	Figure
272	Boat Ramps: St Charles Bay Boat Ramp Fish Cleaning Station	[28.1285788 , -96.985583 5]	The top of the work surface is not within a compliant height range. The tops of tables and counters shall be 28 inches to 34 inches from the floor or ground.	Fish cleaning station work surface at 41.5" aff and lacks knee clearance	Provide tables and work surfaces at 28" to 34" aff with required knee and toe clearances	2015 ABAAS Section: 902.3 2012 TAS Section: 902.3 2010 ADAS Section: 902.3
