Access Audit Site Report

Government Canyon State Natural Area

Accessibility Evaluation

Inspection Date: 03/22/2022

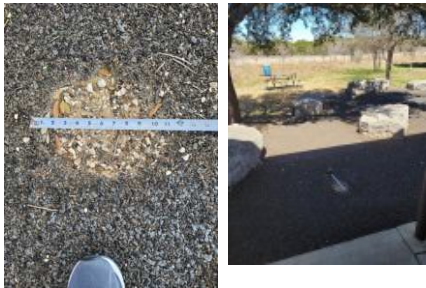
22	Headquarters Area: HQ - Public Spaces	[29.549163, -98.7650523]	There is a gap spaced greater than a 1/2 inch. Openings in floor or ground surfaces shall not allow passage of a sphere more than 1/2 inch diameter. Elongated openings shall be placed so that the long dimension is perpendicular to the dominant direction of travel.	11" gap at rock garden	Correct or fill gaps to be max .5"	2015 ABAAS Section: 302.3 2012 TAS Section: 302.3 2010 ADAS Section: 302.3

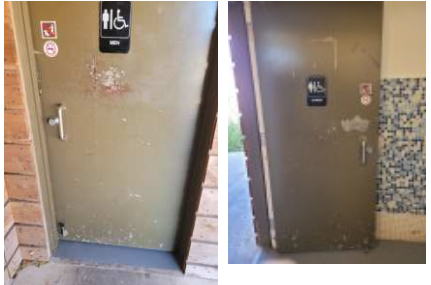
24	Headquarters Area: HQ - Men's Restroom	[29.5493074, -98.7648687]	The door has a door stop which prevents it from having a smooth surface at the bottom. Swinging door surfaces within 10 inches of the finish floor or ground measured vertically must have a smooth surface on the push side extending the full width of the door. Parts creating horizontal or vertical joints in these surfaces shall be within 1/16 inch of the same plane as the other. Cavities created by added kick plates shall be capped. This is required to allow those that use wheelchairs to use their footrests to push the door open without getting trapped or injured by the gate material. All gates, including ticket gates, shall meet all applicable specifications for doors.	Men's and women's restroom doors have stoppers on push at visitor center	Remove door stop from push side of doors for a smooth surface on the bottom 10".	2015 ABAAS Section: 404.2.10 2012 TAS Section: 404.2.10 2010 ADAS Section: 404.2.10

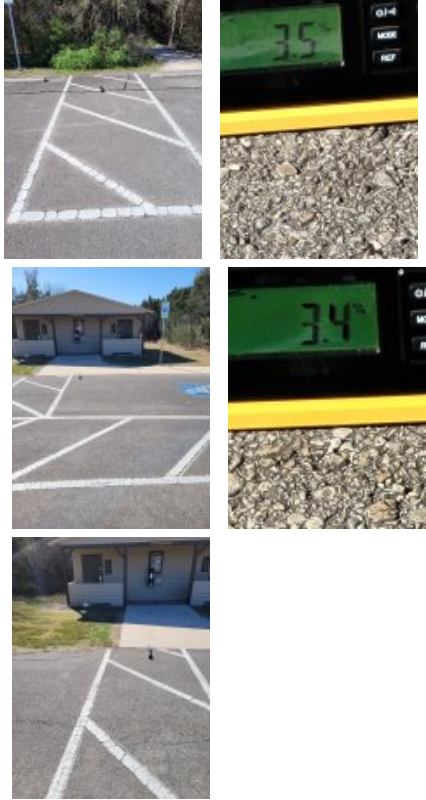
Finding Number	Area Description	Lat/Long	Finding	As Built	Recommendation	Citation	Photos	Figure
45	Day Use Area: Day Use - Parking Lot C and Exterior Accessible Route	[29.5487623 , -98.75893 82], [29.5487462 , -98.759667 8]	The parking stall contains abrupt edges and surface irregularities over a 1/4 inch vertical. Parking spaces and access aisles serving them shall be stable, firm, and slip resistant. Access aisles shall be at the same level as the parking spaces they serve. Changes in level are not permitted and shall not be sloped steeper than 2% in any direction.	7.75" and 8" gaps at restroom, 1" gap middle stall at play area	Repair, bevel and ramp CIL and gaps in stalls and access aisles	2015 ABAAS Section: 502.4 2012 TAS Section: 502.4 2010 ADAS Section: 502.4		
46	Day Use Area: Day Use - Parking Lot C and Exterior Accessible Route	[29.5486802 , -98.758913 7]	The accessible route of travel contains cross slopes greater than 2%. Cross slopes shall not exceed one unit vertical in 48 units horizontal (2-percent slope).	From parking to restroom - 2.6% cross	Correct or repair cross slope along AR to max 2.08%.	2015 ABAAS Section: 403.3 2012 TAS Section: 403.3 2010 ADAS Section: 403.3

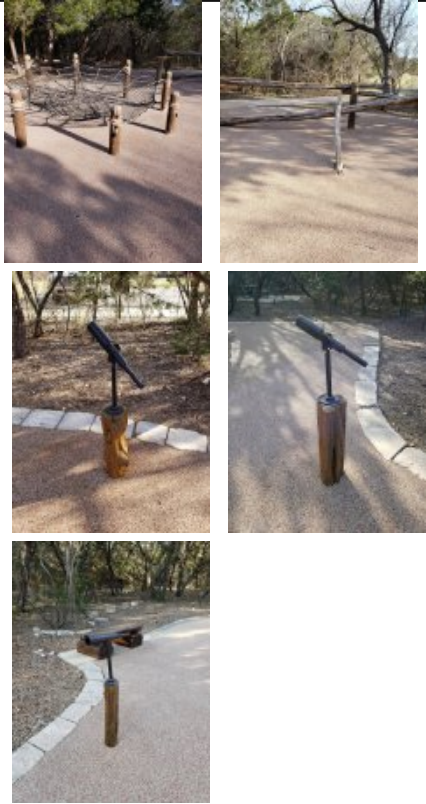
Finding Number	Area Description	Lat/Long	Finding	As Built	Recommendation	Citation	Photos	Figure
49	Day Use Area: Day Use - Playground	[29.5487241 , -98.759976 2]	Where play components require transfer to entry points or seats, at least one means of support for transferring shall be provided.	5 of 6 ground level play components lack transfer supports; concrete block does have support	Provide transfer supports for transfer onto play component.	2012 TAS Section: 1008.4.5 2010 ADAS Section: 1008.4.5

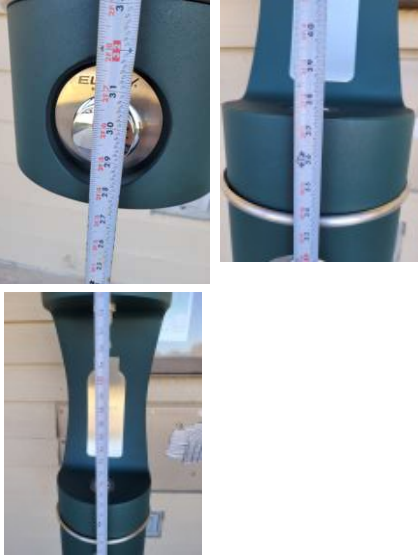
Finding Number	Area Description	Lat/Long	Finding	As Built	Recommendation	Citation	Photos	Figure
60	Day Use Area: Day Use - Men's Restroom	[29.5486131 , -98.758906]	Element meets all standards and requirements	water bottle filler complies	None	2010 ADAS Section: N/A

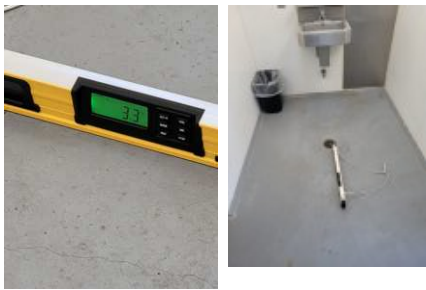
Finding Number	Area Description	Lat/Long	Finding	As Built	Recommendation	Citation	Photos	Figure
63	Day Use Area: Day Use - Women's Restroom	[29.5485999 , -98.758900 7]	The accessible route contains running slopes greater than 5 percent and cross slopes greater than 2 percent across the width of the walk and has not been constructed as a ramp (i.e. handrails, wheel guides, etc.). When the slope in the direction of travel of any walk exceeds 1 unit vertical in 20 units horizontal (5-percent slope), it must be constructed as ramp. Surface cross slopes must not exceed one unit vertical in 48 units. Horizontal (2-percent slope).	3.3% at drain near sink	Correct or repair slope to max 2.08% in restroom.	2015 ABAAS Section: 403.3 2012 TAS Section: 403.3 2010 ADAS Section: 403.3

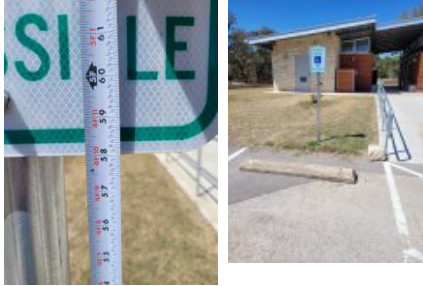
74	Camping Area: Camping - Parking Lot D and Exterior Accessible Route	[29.5504099 , -98.755904 6]	The parking sign is mounted too low. Parking space identification signs shall include the International Symbol of Accessibility complying with. Signs identifying van parking spaces shall contain the designation "van accessible." Signs shall be 60 inches minimum above the finish floor or ground surface measured to the bottom of the sign.	sign mounted 58" above ground level	Raise existing accessible parking signs so lowest end of bottom sign is min 60" above ground level (agl) measured from the surface of the stall.	2015 ABAAS Section: 502.6 2012 TAS Section: 502.6 2010 ADAS Section: 502.6

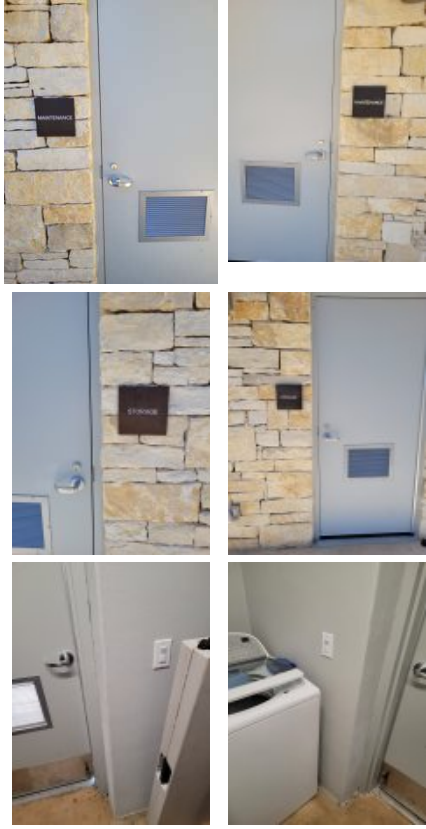
Finding Number	Area Description	Lat/Long	Finding	As Built	Recommendation	Citation	Photos	Figure
75	Camping Area: Camping - Parking Lot D and Exterior Accessible Route	[29.5505427 , -98.755990 5]	Spaces and elements within employee work areas shall only be required to comply with 206.2.8, 207.1, and 215.3 and shall be designed and constructed so that individuals with disabilities can approach, enter, and exit the employee work area. Employee work areas, or portions of employee work areas, other than raised courtroom stations, that are less than 300 square feet (28 m2) and elevated 7 inches (180 mm) or more above the finish floor or ground where the elevation is essential to the function of the space shall not be required to comply with these requirements or to be on an accessible route.	4 of 4 maintenance/storage doors: equipment or storage in push maneuvering clearance, stopper on push	For employee spaces, relocate storage, furniture, and other obstacles at doorways to provide approach, enter and exit at the employee space. Provide required maneuvering clearance on push and pull side of doors. Remove door holder to provide a smooth surface on the push side of door from floor to 10" AFF.	2015 ABAAS Section: F203.9 2012 TAS Section: 203.9 2010 ADAS Section: 203.9

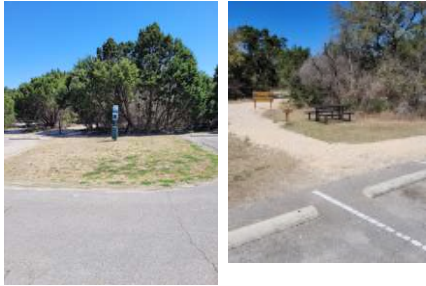
Finding Number	Area Description	Lat/Long	Finding	As Built	Recommendation	Citation	Photos	Figure
77	Camping Area: Camping - Parking Lot D and Exterior Accessible Route	[29.5505656 , -98.75572 25], [29.550229, -98.755752]	There is no accessible route to the dog waste station and picnic table. At least one accessible route shall connect accessible buildings, accessible facilities, accessible elements, and accessible spaces that are on the same site.	Lacks route to dog waste station and picnic table	Create an accessible route with crushed stone or other outdoor material from parking or walkway to dog waste station and picnic table.	2015 ABAAS Section: F206.2.2 2012 TAS Section: 206.2.2 2010 ADAS Section: 206.2.2

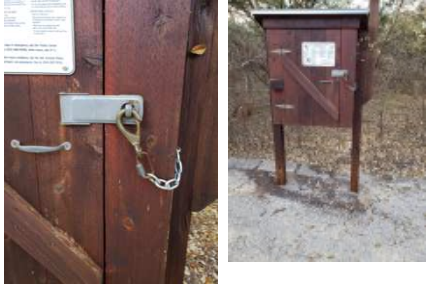
88	Camping Area: Camping - Campsite 1	[29.5496961 , -98.757377 2]	The operable part is not accessible because it requires tight grasping, pinching or twisting of the wrist.	Latch not operable without pinch	Replace operable part with one usable without a tight pinch or grasp	2015 ABAAS Section: 309.4 2012 TAS Section: 309.4 2010 ADAS Section: 309.4

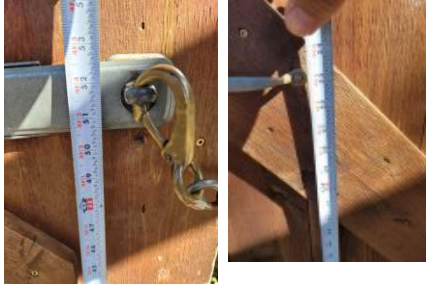
Finding Number	Area Description	Lat/Long	Finding	As Built	Recommendation	Citation	Photos	Figure
89	Camping Area: Camping - Campsite 14	[29.5504331 , -98.754272 9]	The operable part is not accessible because it requires tight grasping, pinching or twisting of the wrist.	Hardware installed at 51.5" and 53" above ground surface, locking hardware requires pinch	Replace operable part with one usable without a tight pinch or grasp Install hardware a max. of 48" above ground surface.	2015 ABAAS Section: 309.4 2012 TAS Section: 309.4 2010 ADAS Section: 309.4

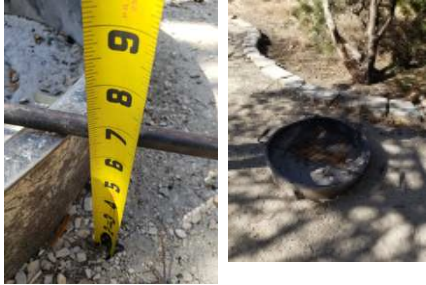
Finding Number	Area Description	Lat/Long	Finding	As Built	Recommendation	Citation	Photos	Figure
93	Camping Area: Camping - Campsite 14	[29.5504313 , -98.754283 2]	Where provided, cooking surfaces shall be 15 inches (380 mm) minimum and 34 inches (865 mm) maximum above the ground	Grill is 7" above ground surface	Raise or lower cooking surface to be 15" min to 34" max above the ground; in the alternative, replace with a compliant surface as a smart practice	2015 ABAAS Section: 1011.5.2

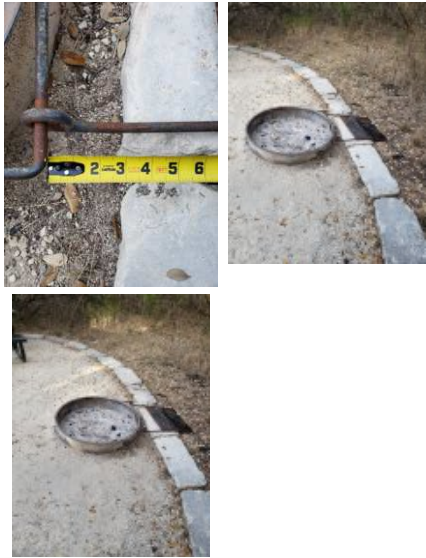
95	Camping Area: Camping - Campsite 16	[29.5507919 , -98.755055 7]	Clear ground space 48 inches (1220 mm) by 48 inches (1220 mm) should be provided on all usable sides of the fire ring, grill, fireplace, and woodstove. Center the space on each usable side of the grill, fireplace, and woodstove.	3" clear ground space on grill side	Provide required 48" clear ground space centered along usable side of fire ring, grill, fireplace, or woodstove as a smart practice.	2015 ABAAS Section: 1011.2

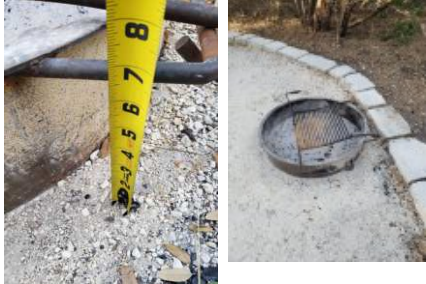
102	Camping Area: Camping - Campsite 18	[29.5506788 , -98.755624 4]	Where provided, cooking surfaces shall be 15 inches (380 mm) minimum and 34 inches (865 mm) maximum above the ground	Grill is 7" above ground surface	Raise or lower cooking surface to be 15" min to 34" max above the ground; in the alternative, replace with a compliant surface as a smart practice	2015 ABAAS Section: 1011.5.2

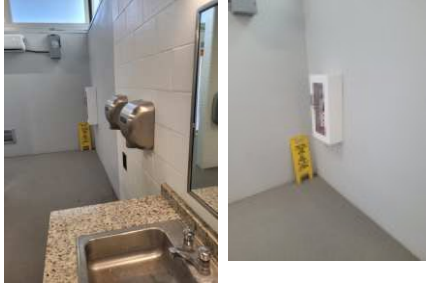
109	Camping Area: Camping - Men's Restroom	[29.5505493 , -98.755986 5]	An item or items project more than 4 inches into the circulation path. Wall-mounted objects that have leading edges between 27 inches and 80 inches from the floor must not project more than 4 inches into the circulation path. Protruding objects that extend to the floor or within 27 inches of the floor are cane detectable and are therefore not hazardous. Where it is necessary or desirable to have objects protrude from the wall, a manner of cane detection must be provided.	Dyers and fire extinguisher project more than 4"	Relocate protruding objects or place cane detectable warning or bollard at foot of items.	2015 ABAAS Section: 307.2 2012 TAS Section: 307.2 2010 ADAS Section: 307.2

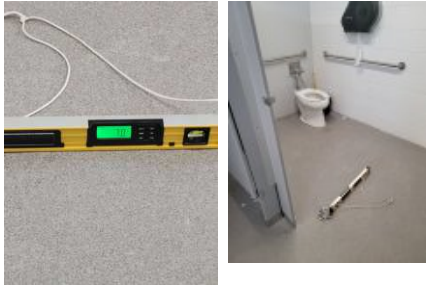
Finding Number	Area Description	Lat/Long	Finding	As Built	Recommendation	Citation	Photos	Figure
110	Camping Area: Camping - Men's Restroom	[29.5505559 , -98.755981 1]	The accessible route contains running slopes greater than 5 percent and cross slopes greater than 2 percent across the width of the walk and has not been constructed as a ramp (i.e. handrails, wheel guides, etc.). When the slope in the direction of travel of any walk exceeds 1 unit vertical in 20 units horizontal (5-percent slope), it must be constructed as ramp. Surface cross slopes must not exceed one unit vertical in 48 units. Horizontal (2-percent slope).	7% near drain in accessible stall	Correct or repair slope to max 2.08% in restroom.	2015 ABAAS Section: 403.3 2012 TAS Section: 403.3 2010 ADAS Section: 403.3

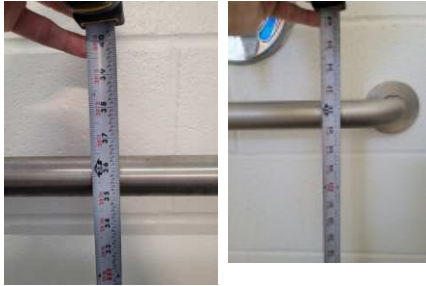
Finding Number	Area Description	Lat/Long	Finding	As Built	Recommendation	Citation	Photos	Figure
121	Camping Area: Camping - Shower Rooms	[29.5505452 , -98.755983 8]	Grab bars shall be installed in a horizontal position, 33 inches (840 mm) minimum and 36 inches (915 mm) maximum above the finish floor measured to the top of the gripping surface	Family Shower Room - grab bars high - back 36.25" AFF, side 36.5" AFF	Remount shower grab bar to 33" min. and 36" max. AFF.	2015 ABAAS Section: 609.3 Exception, 609.4 2012 TAS Section: 609.4, 609.3 Exception 2010 ADAS Section: 609.4, 609.3 Exception

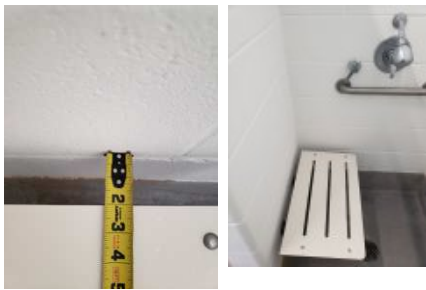
Finding Number	Area Description	Lat/Long	Finding	As Built	Recommendation	Citation	Photos	Figure
128	Camping Area: Camping - Shower Rooms	[29.5505456 , -98.755979 7]	The shower seat does not have a compliant space between it and the seat wall. The folding seat must be mounted 17-19 inches above the floor, and have a maximum space of 2-1/2 inches between the edge of the seat and the seat wall and 1-1/2 inches maximum to the side wall.	Shower A - Installed 2" from side wall	Remount shower seat to the correct location and height in the shower.	2015 ABAAS Section: 610.3.1 2012 TAS Section: 610.3.1 2010 ADAS Section: 610.3.1

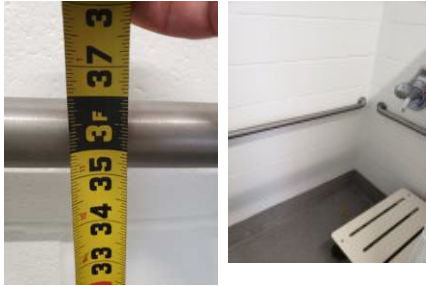
Finding Number	Area Description	Lat/Long	Finding	As Built	Recommendation	Citation	Photos	Figure
130	Camping Area: Camping - Shower Rooms	[29.550546, -98.755985 1]	Grab bars shall be installed in a horizontal position, 33 inches (840 mm) minimum and 36 inches (915 mm) maximum above the finish floor measured to the top of the gripping surface	Shower B - grab bars at 36.5" AFF	Remount shower grab bar to 33" min. and 36" max. AFF.	2015 ABAAS Section: 609.3 Exception, 609.4 2012 TAS Section: 609.4, 609.3 Exception 2010 ADAS Section: 609.4, 609.3 Exception

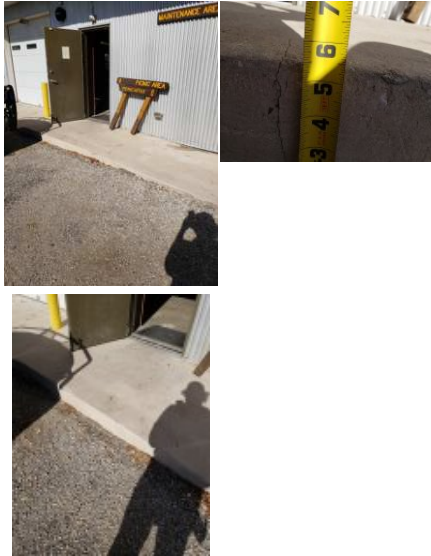
132	Employee Spaces: Maintenance	[29.5376978 , -98.751002 9]	Spaces and elements within employee work areas shall only be required to comply with 206.2.8, 207.1, and 215.3 and shall be designed and constructed so that individuals with disabilities can approach, enter, and exit the employee work area. Employee work areas, or portions of employee work areas, other than raised courtroom stations, that are less than 300 square feet (28 m2) and elevated 7 inches (180 mm) or more above the finish floor or ground where the elevation is essential to the function of the space shall not be required to comply with these requirements or to be on an accessible route.	Main entry - deteriorated asphalt to the entrance; 5.5" change in level	For employee spaces, relocate storage, furniture, and other obstacles at doorways to provide approach, enter and exit at the employee space.	2015 ABAAS Section: F203.9 2012 TAS Section: 203.9 2010 ADAS Section: 203.9

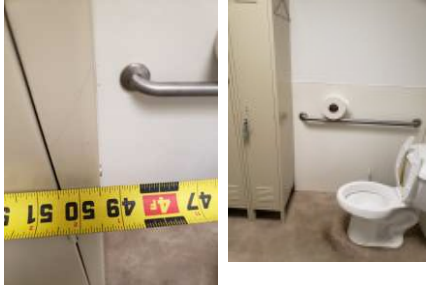
135	Employee Spaces: Maintenance	[29.5377026 , -98.7510029]	The required 56 inches by 60 inches clear floor space for the water closet has been obstructed. The clear floor space around the water closet shall be 60 inches minimum measured perpendicular from the side wall and 56 inches minimum measured perpendicular from the rear wall.	Employee Restroom - cabinet at 49.5" in toilet clearance	Relocate cabinet to provide required 60" clearance around toilet.	2015 ABAAS Section: 604.3. 2012 TAS Section: 604.3.1 2010 ADAS Section: 604.3.1
