Access Audit Site Report

Guadalupe River State Park
3350 Park Rd 31
Spring Branch, TX 78070
Accessibility Evaluation
Inspection Date: 03/21/2022
Inspectors: Tanya Scheibe

Prepared By
WT Group

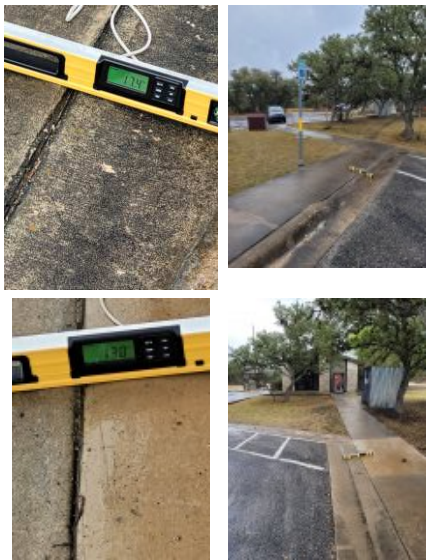
8	Headquarters Area: HQ Exterior Accessible Route	[29.85349, -98.50436]	The curb ramp on the accessible route contains landing slopes greater than 2%. Landing slopes shall not exceed one unit vertical in 48 units horizontal (2-percent slope).	West lot at head quarters - ramp at west accessible stall 17.4%; ramp at east accessible stall at HQ 13%	Correct curb ramp landing slope to max 2.08%	2015 ABAAS Section: 405.3 2012 TAS Section: 405.3 2010 ADAS Section: 405.3

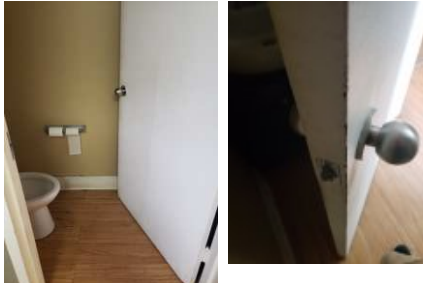
37	Employee Areas: Maintenance	[29.8637537 , -98.4879058]	Minimum maneuvering clearances at doors and gates shall comply with 404.2.4. Maneuvering clearances shall extend the full width of the doorway and the required latch side or hinge side clearance. Hand-activated door opening hardware, handles, pulls, latches, locks, and other operating devices on accessible doors shall have a shape that is easy to grasp with one hand and does not require tight grasping, tight pinching or twisting of the wrist to operate. Hardware shall be 34 inches minimum and 48 inches maximum above the finish floor or ground.	Restroom door - lacks pull clearance, knobs	For all doors along the public circulation route, provide required maneuvering clearance on push and pull side of doors. For all doors along the public circulation route, replace hardware with lever hardware or hardware operable without a tight pinch or grasp.	2010 ADAS Section: 404.2.3, 404.2.7, 404.2.4, 404.2.11, 404.2.11 Exception

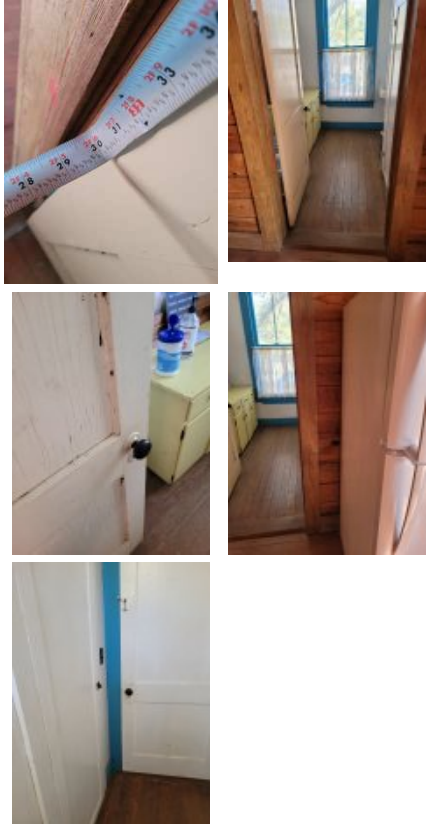
Finding Number	Area Description	Lat/Long	Finding	As Built	Recommendation	Citation	Photos	Figure
53	Rust House: Rust House	[29.86334, -98.48988]	<p>Minimum maneuvering clearances at doors and gates shall comply with 404.2.4. Maneuvering clearances shall extend the full width of the doorway and the required latch side or hinge side clearance. Door openings shall provide a clear width of 32 inches (815 mm) minimum. Clear openings of doorways with swinging doors shall be measured between the face of the door and the stop, with the door open 90 degrees. Openings more than 24 inches (610 mm) deep shall provide a clear opening of 36 inches (915 mm) minimum. There shall be no projections into the required clear opening width lower than 34 inches (865 mm) above the finish floor or ground. Projections into the clear opening width between 34 inches (865 mm) and 80 inches (2030 mm) above the finish floor or ground shall not exceed 4 inches (100 mm). Hand-activated door opening hardware, handles, pulls, latches, locks, and other operating devices on accessible doors shall have a shape that is easy to grasp with one hand and does not require tight grasping, tight pinching or twisting of the wrist to operate. Hardware shall be 34 inches minimum and 48 inches maximum above the finish floor or ground.</p>	restroom - 30" width, knobs, maneuvering clearance on push due to equipment and on pull by closet	<p>For all doors along the public circulation route, provide required maneuvering clearance on push and pull side of doors. For all doors along the public circulation route, replace doors with doors having 80" overhead clearance and 32" clear width. For all doors along the public circulation route, replace hardware with lever hardware or hardware operable without a tight pinch or grasp.</p>	2010 ADAS Section: 404.2.3, 404.2.7, 404.2.4, 404.2.11, 404.2.11 Exception

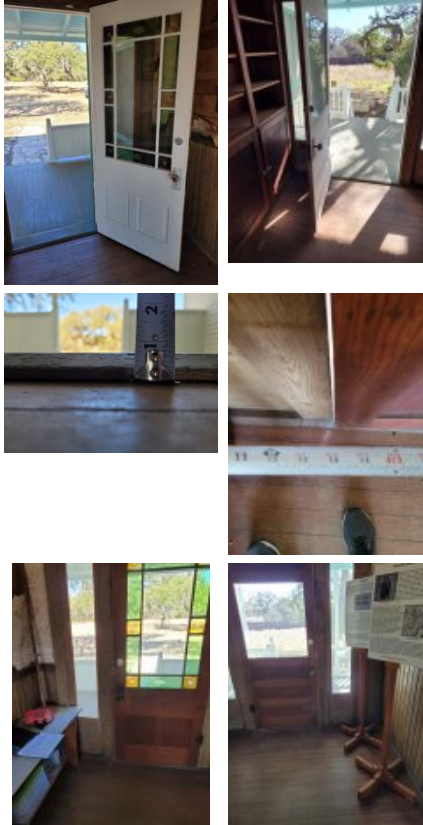
57	Rust House: Rust House	[29.8632, -98.49004]	Minimum maneuvering clearances at doors and gates shall comply with 404.2.4. Maneuvering clearances shall extend the full width of the doorway and the required latch side or hinge side clearance. The threshold at a doorway shall be no higher than 1/2 inch. Changes in level between 1/4 inch and 1/2 inch must be beveled at 1:2 or less. 1/4 inch is the maximum vertical rise. Hand-activated door opening hardware, handles, pulls, latches, locks, and other operating devices on accessible doors shall have a shape that is easy to grasp with one hand and does not require tight grasping, tight pinching or twisting of the wrist to operate. Hardware shall be 34 inches minimum and 48 inches maximum above the finish floor or ground.	2 of 2 foyer doors - knobs, threshold .75" rough bevel, lacks maneuvering clearance on pull due to furniture/storage	For all doors along the public circulation route, provide required maneuvering clearance on push and pull side of doors. For all doors along the public circulation route, repair, bevel, or ramp CILs at door entries to max .25". For all doors along the public circulation route, repair, provide beveled threshold. For all doors along the public circulation route, replace hardware with lever hardware or hardware operable without a tight pinch or grasp.	2010 ADAS Section: 404.2.3, 404.2.7, 404.2.4, 404.2.11, 404.2.11 Exception

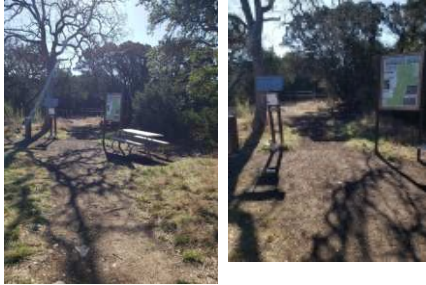
71	Park Elements: Trails	[29.87115, -98.48346]	The surface of outdoor recreation access routes, passing spaces, and resting intervals shall be firm and stable	bald cypress trail - no accessible route to trail head sign	Provide ORAR to trailhead features as a smart practice.	2015 ABAAS Section: 1016. 2

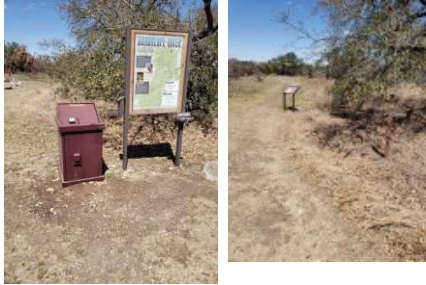
Finding Number	Area Description	Lat/Long	Finding	As Built	Recommendation	Citation	Photos	Figure
74	Park Elements: Trails	[29.8514085 , -98.5017728]	The surface of outdoor recreation access routes, passing spaces, and resting intervals shall be firm and stable	Painted bunting- no accessible route to trail head sign or garbage	Provide ORAR to trailhead features as a smart practice.	2015 ABAAS Section: 1016.2

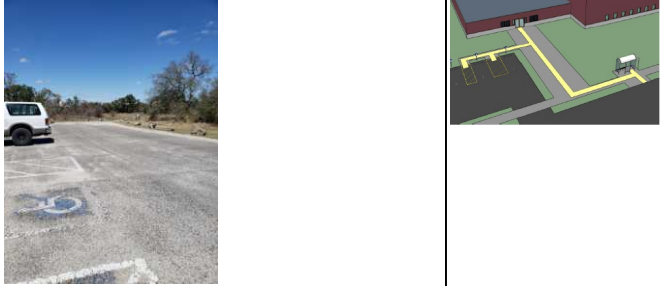
76	Park Elements: Trails	[29.8604484 , -98.4998792]	The accessible parking is not located on the shortest accessible route to the building. Accessible parking spaces serving a particular building or facility entrance shall be located on the shortest accessible route of travel from the parking to an accessible entrance.	west painted bunting trailhead- furthest parking stall from trail head	Relocate stalls to be on the shortest AR to the building entry or park features	2015 ABAAS Section: F208.3.1 2012 TAS Section: 208.3.1 2010 ADAS Section: 208.3.1

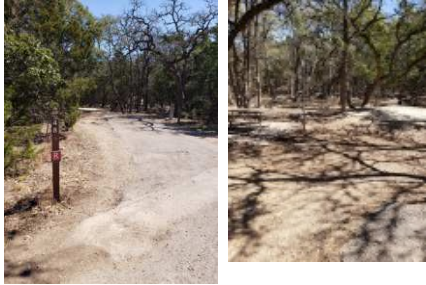
Finding Number	Area Description	Lat/Long	Finding	As Built	Recommendation	Citation	Photos	Figure
79	Turkey Sink Camping Area: Turkey Sink - Campsite	[29.8684987 , -98.4851378]	Camping facilities shall provide camping units with mobility features complying with F244.2 in accordance with Table F244.2. Where a camping facility provides different types of camping units, Table F244.2 shall apply to each type of camping unit provided. Total Number of Camping Units Provided in Camping Facility Minimum Number of Camping Units with Mobility Features Required 1 1 2 to 25 2 26 to 50 3 51 to 75 4 76 to 100 5 101 to 150 7 151 to 200 8 201 and over 8, plus 2 percent of the number over 200	Campsite 48 is shown as a representative site for this area. Sites in this area do not have accessible features or accessible routes. 0 of 48 campsites are accessible in this section of park.	Create the required number of accessible camp sites per table F244.2 as a smart practice	2015 ABAAS Section: F244.2

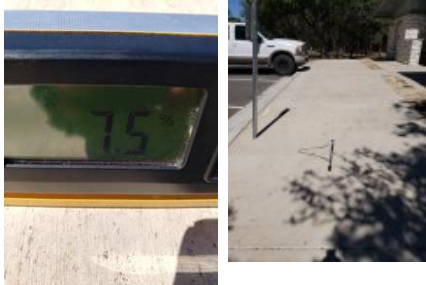
80	Turkey Sink Camping Area: Turkey Sink - Restroom Parking	[29.8680964 , -98.4852035]	The running slope of walking surfaces shall not be steeper than 1:20.	7.5% run slope leading to restrooms	Correct running slope along the AR to max 5%	2015 ABAAS Section: 403.3 2012 TAS Section: 403.3 2010 ADAS Section: 403.3

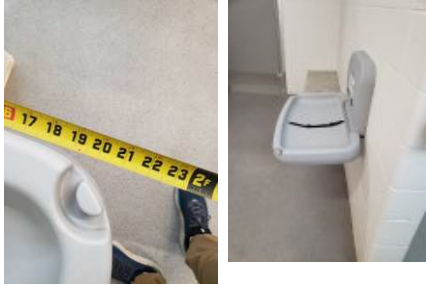
Finding Number	Area Description	Lat/Long	Finding	As Built	Recommendation	Citation	Photos	Figure
85	Turkey Sink Camping Area: Turkey Sink - Men's Restroom	[29.8680429 , -98.485296]	The baby changing table is not compliant. Baby changing tables are work surfaces. If fixed or built-in baby changing tables are provided, at least 5%, but not less than one, must comply with TAS 902 based TAS 226.1. Baby changing tables cannot violate the protruding object requirements in either an open or closed position since either position is a potential hazard for persons with visual impairments. Baby changing tables are not prohibited from being located in wheelchair accessible toilet compartments; however, the minimum space required for the compartment cannot be obstructed by the baby changing table in either an open or closed position. The clear floor space required for a baby changing table may overlap the water closet clearance since baby changing tables are considered convenience "fixtures" based on Advisory 604.8.1.1. The overlap is applicable only to the clear floor space and not to actual table itself. Baby changing tables must be dispersed throughout a space, however, an additional baby changing table is not required in a common use area of a toilet or bathing room when the only baby changing table is located in a toilet compartment.	changing table protrudes 22" when open	Relocate baby changing table to eliminate protrusion when in the open position.	2012 TAS Section: 226.1, 902.3, 604.3.2, 204.1, 226.1 Advisory, 226.2, 307.1, 604.8.1.1 Advisory, 902.1, 902.1 Advisory, 902.2

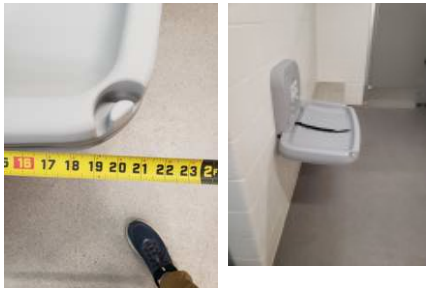
Finding Number	Area Description	Lat/Long	Finding	As Built	Recommendation	Citation	Photos	Figure
88	Turkey Sink Camping Area: Turkey Sink - Women's Restroom	[29.8680243 , -98.485320 2]	Exterior doors exceed 8.5 lbs of force to open; fire doors shall have a minimum opening force allowable by the appropriate administrative authority	women's- 18# push	Inspect, adjust, and maintain 8.5 lbf to open exterior doors as a smart practice	2010 ADAS Section: 404.2.9		
89	Turkey Sink Camping Area: Turkey Sink - Women's Restroom	[29.8680615 , -98.485266 5]	The baby changing table is not compliant. Baby changing tables are work surfaces. If fixed or built-in baby changing tables are provided, at least 5%, but not less than one, must comply with TAS 902 based TAS 226.1. Baby changing tables cannot violate the protruding object requirements in either an open or closed position since either position is a potential hazard for persons with visual impairments. Baby changing tables are not prohibited from being located in wheelchair accessible toilet compartments; however, the minimum space required for the compartment cannot be obstructed by the baby changing table in either an open or closed position. The clear floor space required for a baby changing table may overlap the water closet clearance since baby changing tables are considered convenience "fixtures" based on Advisory 604.8.1.1. The overlap is applicable only to the clear floor space and not to actual table itself. Baby changing tables must be dispersed throughout a space, however, an additional baby changing table is not required in a common use area of a toilet or bathing room when the only baby changing table is located in a toilet compartment.	changing table protrudes 21" when open	Relocate baby changing table to eliminate protrusion when in the open position.	2012 TAS Section: 226.1, 902.3, 604.3.2, 204.1, 226.1 Advisory, 226.2, 307.1, 604.8.1.1 Advisory, 902.1, 902.1 Advisory, 902.2

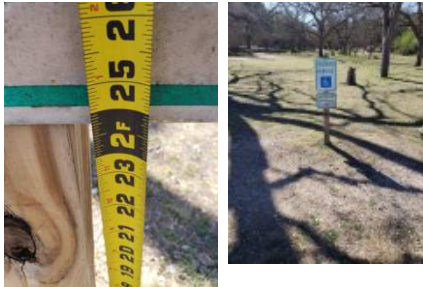
96	Wagon Ford Walk-In Tent Area: Wagon Ford - Parking	[29.8703176, -98.4833139]	The parking sign is mounted too low. Parking space identification signs shall include the International Symbol of Accessibility complying with. Signs identifying van parking spaces shall contain the designation "van accessible." Signs shall be 60 inches minimum above the finish floor or ground surface measured to the bottom of the sign.	sign 24" above ground surface	Raise existing accessible parking signs so lowest end of bottom sign is min 60" above ground level (agl) measured from the surface of the stall.	2015 ABAAS Section: 502.6 2012 TAS Section: 502.6 2010 ADAS Section: 502.6

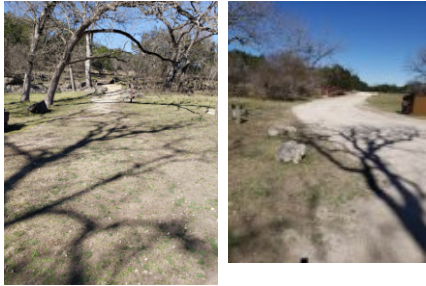
Finding Number	Area Description	Lat/Long	Finding	As Built	Recommendation	Citation	Photos	Figure
97	Wagon Ford Walk-In Tent Area: Wagon Ford - Parking	[29.8702804, -98.4835928]	The surface of outdoor recreation access routes, passing spaces, and resting intervals shall be firm and stable	No accessible route to trail head from parking	Provide and ORAR from parking to trail and trailhead features as a smart practice.	2015 ABAAS Section: 1016.2

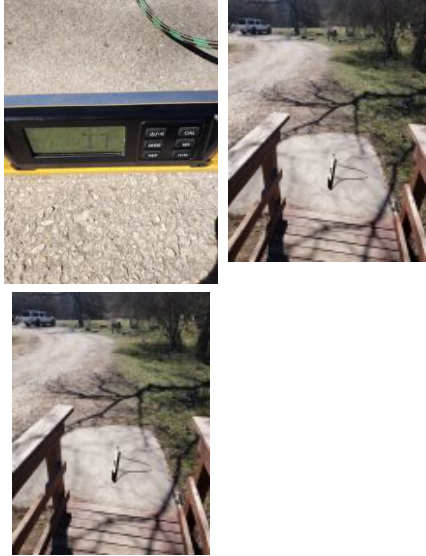
99	Wagon Ford Walk-In Tent Area: Wagon Ford - Parking	[29.8704002, -98.4837551]	The landing at the bottom of the ramp has a slope greater than 2%. Bottom landings shall have a dimension in the direction of ramp run of not less than 60 inches and have a slope of less than 2% in any direction.	7.7% slope at landing	Correct ramp landing slope to max 2.08%	2015 ABAAS Section: 405.7.1, 405.7.1 EXCEPTION 2012 TAS Section: 405.7.1, 405.7.1 Exception 2010 ADAS Section: 405.7.1, 405.7.1 Exception

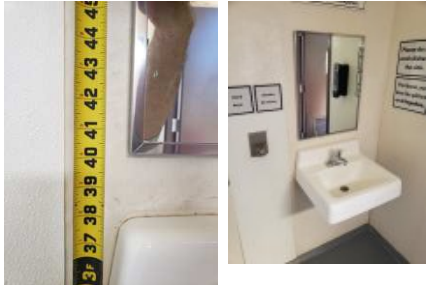
101	Wagon Ford Walk-In Tent Area: Wagon Ford - Left Restroom	[29.8704595 , -98.4840139]	The mirror is mounted too high. Mirrors must have the bottom edge of the reflecting surface a maximum of 40 inches above the floor if above a sink or counter. Mirrors not located above lavatories or countertops shall be installed with the bottom edge of the reflecting surface 35 inches maximum above the finish floor or ground.	mirror 40.5" above finished floor (AFF)	Lower mirror so reflective surface is max 40" aff	2015 ABAAS Section: 603.3 2012 TAS Section: 603.3 2010 ADAS Section: 603.3

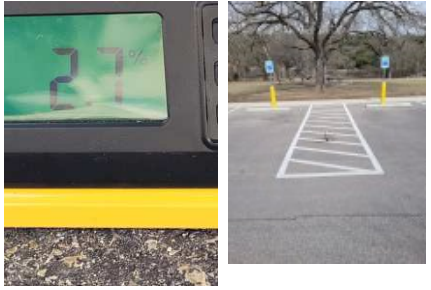
Finding Number	Area Description	Lat/Long	Finding	As Built	Recommendation	Citation	Photos	Figure
105	Day Use Area: Day Use - Parking	[29.8743529 , -98.485172 6]	Element meets all standards and requirements	north of bath house- parking scoping complies- 5 accessible, 68 standard	None	2010 ADAS Section: N/A		
106	Day Use Area: Day Use - Parking	[29.8743367 , -98.485127]	The cross slopes (narrow dimension) and/or running slopes (long dimension) of the access aisle exceeds 2%. The running slope and the cross slope in an accessible parking stall and the access aisle must not exceed 2%.	north of bath house- 2.7% middle access aisle	Repair or correct slope of parking space and access aisle to max 2.08% in any direction.	2015 ABAAS Section: 502.4 2012 TAS Section: 502.4 2010 ADAS Section: 502.4

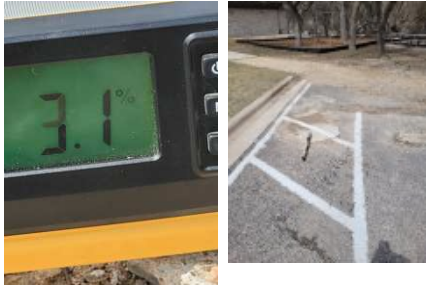
Finding Number	Area Description	Lat/Long	Finding	As Built	Recommendation	Citation	Photos	Figure
109	Day Use Area: Day Use - Parking	[29.8739064 , -98.484695 2]	The cross slopes (narrow dimension) and/or running slopes (long dimension) of the access aisle exceeds 2%. The running slope and the cross slope in an accessible parking stall and the access aisle must not exceed 2%.	south of bath house- 3.1% access aisle	Repair or correct slope of parking space and access aisle to max 2.08% in any direction.	2015 ABAAS Section: 502.4 2012 TAS Section: 502.4 2010 ADAS Section: 502.4

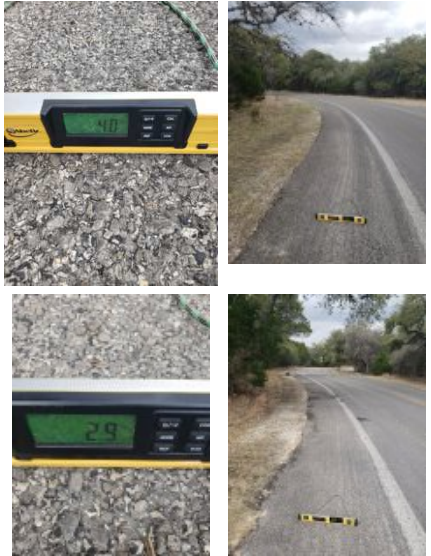
114	Day Use Area: Day Use - Parking	[29.8723481 , -98.485137 8]	The accessible route of travel contains cross slopes greater than 2%. Cross slopes shall not exceed one unit vertical in 48 units horizontal (2-percent slope).	overflow parking- exterior accessible route from overflow parking to picnic area - 4% cross slope, 2.9% cross slope	Correct or repair cross slope along AR to max 2.08%.	2015 ABAAS Section: 403.3 2012 TAS Section: 403.3 2010 ADAS Section: 403.3

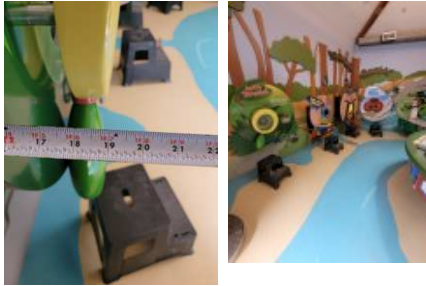
Finding Number	Area Description	Lat/Long	Finding	As Built	Recommendation	Citation	Photos	Figure
115	Day Use Area: Day Use - Discovery Center	[29.8738901 , -98.486283 1]	An item or items project more than 4 inches into the circulation path. Wall-mounted objects that have leading edges between 27 inches and 80 inches from the floor must not project more than 4 inches into the circulation path. Protruding objects that extend to the floor or within 27 inches of the floor are cane detectable and are therefore not hazardous. Where it is necessary or desirable to have objects protrude from the wall, a manner of cane detection must be provided.	displays project up to 19"	Relocate protruding objects or place cane detectable warning or bollard at foot of item	2015 ABAAS Section: 307.2 2012 TAS Section: 307.2 2010 ADAS Section: 307.2

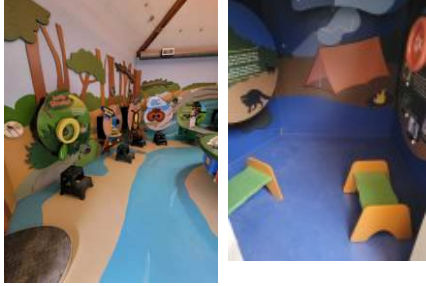
116	Day Use Area: Day Use - Discovery Center	[29.8738482 , -98.486355 5]	The operable part is not accessible because there is not adequate clear floor space for either a forward or side approach. The clear floor or ground space shall be 30 inches minimum by 48 inches minimum.	Step stools at displays	Remove, or relocate storage in CFS at fixtures and operable parts along the AR	2015 ABAAS Section: 305.3 2012 TAS Section: 305.3 2010 ADAS Section: 305.3

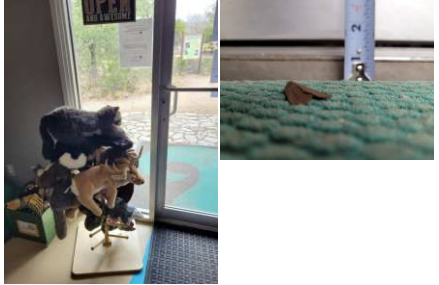
Finding Number	Area Description	Lat/Long	Finding	As Built	Recommendation	Citation	Photos	Figure
118	Day Use Area: Day Use - Discovery Center	[29.8739274 , -98.486267 3]	Minimum maneuvering clearances at doors and gates shall comply with 404.2.4. Maneuvering clearances shall extend the full width of the doorway and the required latch side or hinge side clearance. The threshold at a doorway shall be no higher than 1/2 inch. Changes in level between 1/4 inch and 1/2 inch must be beveled at 1:2 or less. 1/4 inch is the maximum vertical rise. Exterior doors are recommended to be maintained at 8.5 lbf as a smart practice. Force is to be measured at the operating hardware or 30 inches from the hinges, whichever is greater.	entry- lacks maneuvering clearance on push due to storage, 14# push, 1.25" threshold	For all doors along the public circulation route, provide required maneuvering clearance on push and pull side of doors. For all doors along the public circulation route, repair, provide beveled threshold. For all doors along the public circulation route, inspect, adjust, and maintain 8.5 lbf to open exterior doors as a smart practice.	2010 ADAS Section: 404.2.3, 404.2.7, 404.2.4, 404.2.11, 404.2.11 Exception

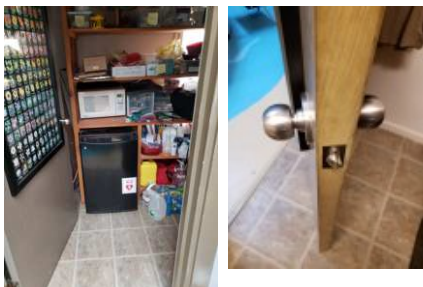
123	Day Use Area: Day Use - Discovery Center	[29.8738855 , -98.486307 2]	Spaces and elements within employee work areas shall only be required to comply with 206.2.8, 207.1, and 215.3 and shall be designed and constructed so that individuals with disabilities can approach, enter, and exit the employee work area. Employee work areas, or portions of employee work areas, other than raised courtroom stations, that are less than 300 square feet (28 m2) and elevated 7 inches (180 mm) or more above the finish floor or ground where the elevation is essential to the function of the space shall not be required to comply with these requirements or to be on an accessible route.	Supply closet - storage in pull clearance, knobs	For employee spaces, relocate storage, furniture, and other obstacles at doorways to provide approach, enter and exit at the employee space. Replace hardware with lever hardware or hardware operable without a tight pinch or grasp.	2015 ABAAS Section: F203.9 2012 TAS Section: 203.9 2010 ADAS Section: 203.9

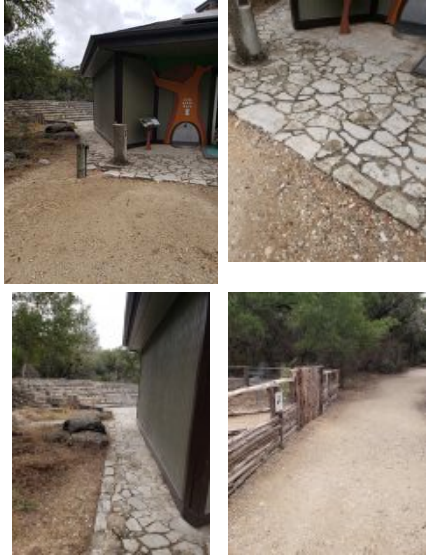
Finding Number	Area Description	Lat/Long	Finding	As Built	Recommendation	Citation	Photos	Figure
128	Day Use Area: Day Use - Discovery Center	[29.8738296 , -98.486355 5]	There is no accessible route to the discovery center, amphitheater or garden. At least one accessible route shall connect accessible buildings, accessible facilities, accessible elements, and accessible spaces that are on the same site.	no accessible route to discovery center, amphitheater or garden; path is sand, gravel, and flagstone	Create an accessible route with crushed stone or other outdoor material from parking or walkway to discovery center, amphitheater or garden.	2015 ABAAS Section: F206.2.2 2012 TAS Section: 206.2.2 2010 ADAS Section: 206.2.2

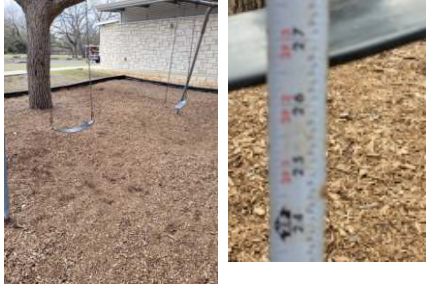
Finding Number	Area Description	Lat/Long	Finding	As Built	Recommendation	Citation	Photos	Figure
130	Day Use Area: Day Use - Playground	[29.8741, -98.48463]	A minimum of one of each type of ground level play components is not on an accessible route. Where ground level play components are provided, at least one of each type shall be on an accessible route and shall comply.	Seat entry 26.5" above ground surface	Lower the seat, or raise the surface fill level to achieve entry height of 11" to 24" above ground level.	2012 TAS Section: 240.2.1.1 2010 ADAS Section: 240.2.1.1

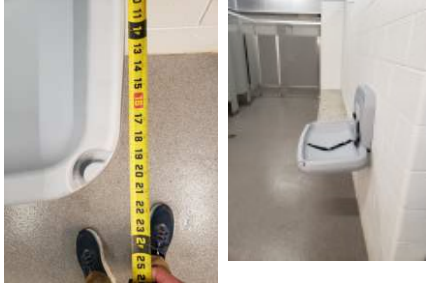
142	Day Use Area: Day Use - Women's Restroom	[29.8741832 , -98.484805 2]	The baby changing table is not compliant. Baby changing tables are work surfaces. If fixed or built-in baby changing tables are provided, at least 5%, but not less than one, must comply with TAS 902 based TAS 226.1. Baby changing tables cannot violate the protruding object requirements in either an open or closed position since either position is a potential hazard for persons with visual impairments. Baby changing tables are not prohibited from being located in wheelchair accessible toilet compartments; however, the minimum space required for the compartment cannot be obstructed by the baby changing table in either an open or closed position. The clear floor space required for a baby changing table may overlap the water closet clearance since baby changing tables are considered convenience "fixtures" based on Advisory 604.8.1.1. The overlap is applicable only to the clear floor space and not to actual table itself. Baby changing tables must be dispersed throughout a space, however, an additional baby changing table is not required in a common use area of a toilet or bathing room when the only baby changing table is located in a toilet compartment.	changing table protrudes 21.5" when open	Relocate baby changing table to eliminate protrusion when in the open position.	2012 TAS Section: 226.1, 902.3, 604.3.2, 204.1, 226.1 Advisory, 226.2, 307.1, 604.8.1.1 Advisory, 902.1, 902.1 Advisory, 902.2

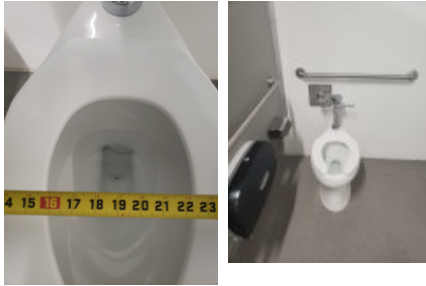
Finding Number	Area Description	Lat/Long	Finding	As Built	Recommendation	Citation	Photos	Figure
143	Day Use Area: Day Use - Women's Restroom	[29.8742018 , -98.484826 6]	The toilet is not located within the range allowed from the side wall or partition. The centerline of the toilet must be 16 to 18 inches from the side wall.	Centerline 19"	Remount toilets to 16" to 18" from the side wall to centerline	2015 ABAAS Section: 604.2 2012 TAS Section: 604.2 2010 ADAS Section: 604.2

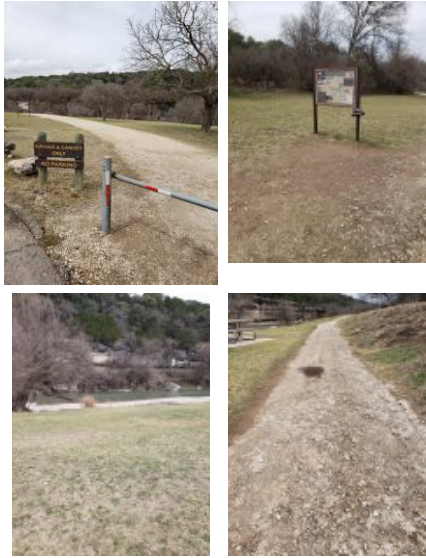
Finding Number	Area Description	Lat/Long	Finding	As Built	Recommendation	Citation	Photos	Figure
146	Day Use Area: Day Use - Picnic Area	[29.8741366 , -98.483869 1]	There is no accessible route to the canoe and kayak launch and trailhead sign. At least one accessible route shall connect accessible buildings, accessible facilities, accessible elements, and accessible spaces that are on the same site.	no accessible route to canoe and kayak launch or trailhead sign; sand, gravel and deteriorated asphalt	Create an accessible route with crushed stone or other outdoor material from parking or walkway to canoe and kayak launch and sign.	2015 ABAAS Section: F206.2.2 2012 TAS Section: 206.2.2 2010 ADAS Section: 206.2.2

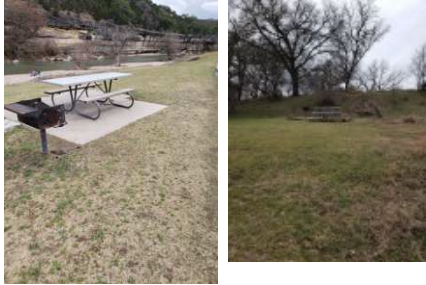
Finding Number	Area Description	Lat/Long	Finding	As Built	Recommendation	Citation	Photos	Figure
154	Day Use Area: Day Use - Picnic Area	[29.8753437 , -98.485896 8]	There is no accessible route to the picnic tables and grills. At least one accessible route shall connect accessible buildings, accessible facilities, accessible elements, and accessible spaces that are on the same site.	0 of 42 tables are accessible - no accessible route to picnic tables and grills in grass area	Create an accessible route with crushed stone or other outdoor material from parking or walkway to picnic tables and grills. Replace 20% of tables with ones that are accessible as a smart practice.	2015 ABAAS Section: F206.2.2 2012 TAS Section: 206.2.2 2010 ADAS Section: 206.2.2

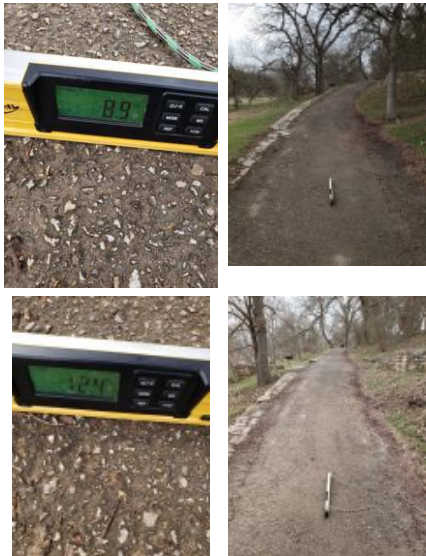
155	Day Use Area: Day Use - Picnic Area	[29.8752554 , -98.486258 9]	The ramp is too long and too high without an intermediate landing. The maximum rise for a ramp with an 8.33% slope is 30 inches. The maximum rise for any is 30 inches and the maximum length is 30 feet.	Ramp to picnic area 8.9% slope or higher	Shorten ramp run to max 30' or a max of 30" rise	2015 ABAAS Section: 405.6 2012 TAS Section: 405.6 2010 ADAS Section: 405.6

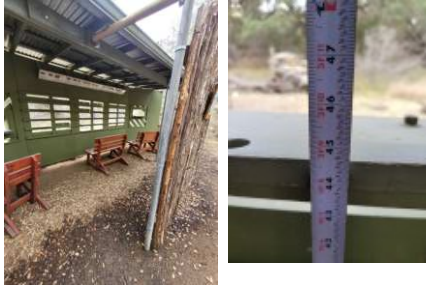
166	Day Use Area: Day Use - Bird Blind	[29.87474, -98.48658]	Each distinct viewing location shall provide a viewing space adjacent to the clear ground space required by 1015.2 through which the point of interest is viewable. The viewing space shall be 32 inches (815 mm) maximum and 51 inches (1295 mm) minimum high above the ground and shall extend the full width of the clear ground space. EXCEPTION: Guards or similar safety barriers shall be permitted to obstruct the viewing space to the extent the obstruction is necessary for the guard or safety barrier to serve its intended purpose.	44.75" above ground surface to lowest viewing point with clear ground space	Lower a 32" wide portion of railing to max 32" for unobstructed viewing as a smart practice.	2015 ABAAS Section: 1015.3, 1015.3 EXCEPTION

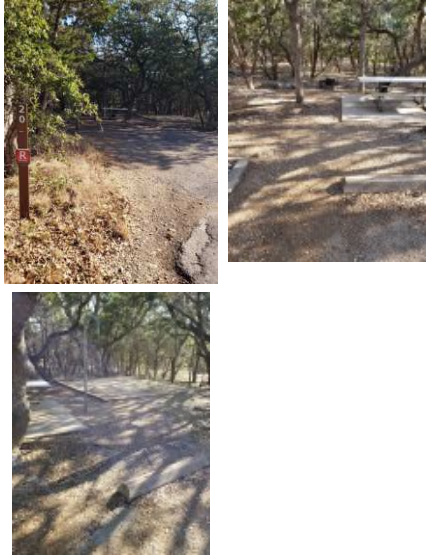
Finding Number	Area Description	Lat/Long	Finding	As Built	Recommendation	Citation	Photos	Figure
172	Cedar Sage Camping Area: Cedar Sage - Campsite	[29.8715457 , -98.488184 8]	Camping facilities shall provide camping units with mobility features complying with F244.2 in accordance with Table F244.2. Where a camping facility provides different types of camping units, Table F244.2 shall apply to each type of camping unit provided. Total Number of Camping Units Provided in Camping Facility Minimum Number of Camping Units with Mobility Features Required 1 1 2 to 25 2 26 to 50 3 51 to 75 4 76 to 100 5 101 to 150 7 151 to 200 8 201 and over 8, plus 2 percent of the number over 200	Campsite 20 is shown as a representative site for this area; lacks accessible features or route; 0 of 37 campsites	Create the required number of accessible camp sites per table F244.2 as a smart practice	2015 ABAAS Section: F244.2

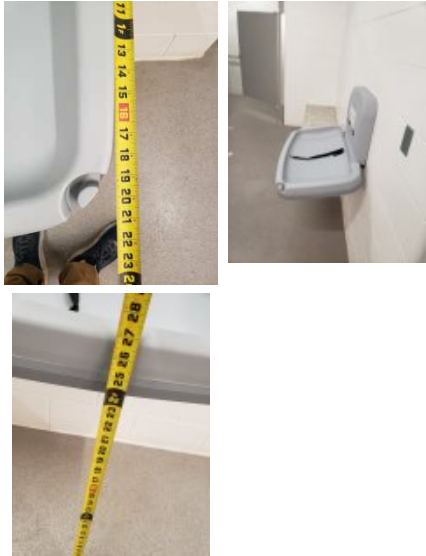
Finding Number	Area Description	Lat/Long	Finding	As Built	Recommendation	Citation	Photos	Figure
174	Cedar Sage Camping Area: Cedar Sage - Men's Restroom	[29.8713759, -98.4886434]	The baby changing table is not compliant. Baby changing tables are work surfaces. If fixed or built-in baby changing tables are provided, at least 5%, but not less than one, must comply with TAS 902 based TAS 226.1. Baby changing tables cannot violate the protruding object requirements in either an open or closed position since either position is a potential hazard for persons with visual impairments. Baby changing tables are not prohibited from being located in wheelchair accessible toilet compartments; however, the minimum space required for the compartment cannot be obstructed by the baby changing table in either an open or closed position. The clear floor space required for a baby changing table may overlap the water closet clearance since baby changing tables are considered convenience "fixtures" based on Advisory 604.8.1.1. The overlap is applicable only to the clear floor space and not to actual table itself. Baby changing tables must be dispersed throughout a space, however, an additional baby changing table is not required in a common use area of a toilet or bathing room when the only baby changing table is located in a toilet compartment.	changing table protrudes 21" when open, 24" knee clearance	Remount baby changing table so that operable parts are max 48" and the changing surface in the open position is max 34" while providing min 27" knee clearance. Relocate baby changing table to eliminate protrusion when in the open position.	2012 TAS Section: 226.1, 902.3, 604.3.2, 204.1, 226.1 Advisory, 226.2, 307.1, 604.8.1.1 Advisory, 902.1, 902.1 Advisory, 902.2

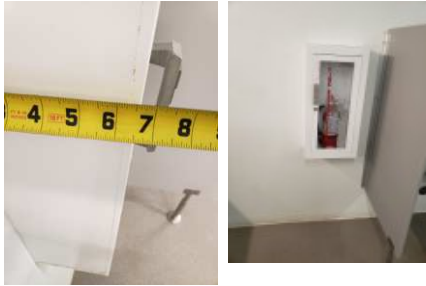
Finding Number	Area Description	Lat/Long	Finding	As Built	Recommendation	Citation	Photos	Figure
176	Cedar Sage Camping Area: Cedar Sage - Men's Restroom	[29.8713456 , -98.488678 3]	An item or items project more than 4 inches into the circulation path. Wall-mounted objects that have leading edges between 27 inches and 80 inches from the floor must not project more than 4 inches into the circulation path. Protruding objects that extend to the floor or within 27 inches of the floor are cane detectable and are therefore not hazardous. Where it is necessary or desirable to have objects protrude from the wall, a manner of cane detection must be provided.	Fire extinguisher 6 5"	Relocate protruding objects or place cane detectable warning or bollard at foot of item	2015 ABAAS Section: 307.2 2012 TAS Section: 307.2 2010 ADAS Section: 307.2

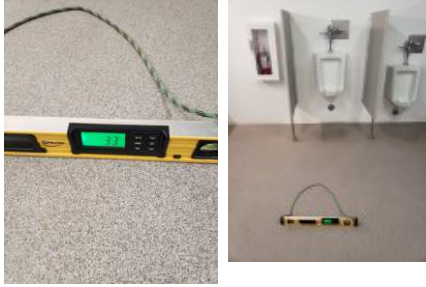
177	Cedar Sage Camping Area: Cedar Sage - Men's Restroom	[29.8713922 , -98.488603 2]	The accessible route contains running slopes greater than 5 percent and cross slopes greater than 2 percent across the width of the walk and has not been constructed as a ramp (i.e. handrails, wheel guides, etc.). When the slope in the direction of travel of any walk exceeds 1 unit vertical in 20 units horizontal (5-percent slope), it must be constructed as ramp. Surface cross slopes must not exceed one unit vertical in 48 units. Horizontal (2-percent slope).	3.3% near urinals	Correct or repair slope to max 2.08% in restroom.	2015 ABAAS Section: 403.3 2012 TAS Section: 403.3 2010 ADAS Section: 403.3

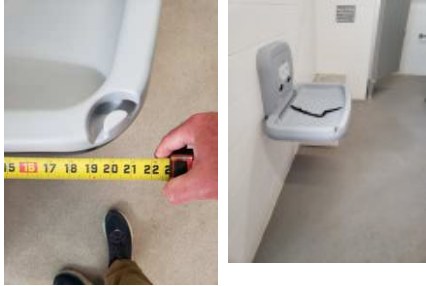
180	Cedar Sage Camping Area: Cedar Sage - Women's Restroom	[29.8713782 , -98.488640 7]	The baby changing table is not compliant. Baby changing tables are work surfaces. If fixed or built-in baby changing tables are provided, at least 5%, but not less than one, must comply with TAS 902 based TAS 226.1. Baby changing tables cannot violate the protruding object requirements in either an open or closed position since either position is a potential hazard for persons with visual impairments. Baby changing tables are not prohibited from being located in wheelchair accessible toilet compartments; however, the minimum space required for the compartment cannot be obstructed by the baby changing table in either an open or closed position. The clear floor space required for a baby changing table may overlap the water closet clearance since baby changing tables are considered convenience "fixtures" based on Advisory 604.8.1.1. The overlap is applicable only to the clear floor space and not to actual table itself. Baby changing tables must be dispersed throughout a space, however, an additional baby changing table is not required in a common use area of a toilet or bathing room when the only baby changing table is located in a toilet compartment.	changing table protrudes 21" when open	Relocate baby changing table to eliminate protrusion when in the open position.	2012 TAS Section: 226.1, 902.3, 604.3.2, 204.1, 226.1 Advisory, 226.2, 307.1, 604.8.1.1 Advisory, 902.1, 902.1 Advisory, 902.2

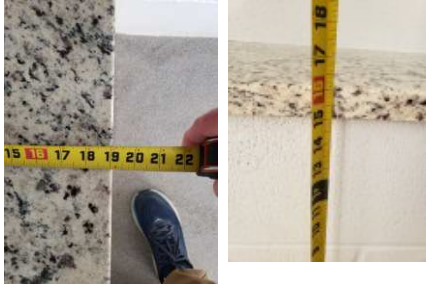
Finding Number	Area Description	Lat/Long	Finding	As Built	Recommendation	Citation	Photos	Figure
185	Cedar Sage Camping Area: Cedar Sage - Shower Rooms	[29.8713736, -98.4886246]	The bench is not deep enough or long enough or is missing. Benches shall be provided having seats that are 42 inches long minimum and 20 inches deep minimum and 24 inches deep maximum. The bench shall provide for back support or shall be affixed to a wall. Back support shall be 42 inches (1065 mm) long minimum and shall extend from a point 2 inches (51 mm) maximum above the seat surface to a point 18 inches (455 mm) minimum above the seat surface. Back support shall be 2½ inches (64 mm) maximum from the rear edge of the seat measured horizontally. The top of the bench seat surface shall be 17 inches (430 mm) minimum and 19 inches (485 mm) maximum above the finish floor or ground. Clear floor or ground space complying with 305 shall be provided and shall be positioned at the end of the bench seat and parallel to the short axis of the bench	Shower F - bench 19" deep, 16" high	Replace bench in dressing area with one having a seat depth of 20" to 24" deep, 42" long, affixed to the wall or having a back and mounted 17" to 19" aff and provide required clear floor space on the short axis of the bench.	2012 TAS Section: 903.4, 903.2, 903.3, 903.5 2010 ADAS Section: 903.4, 903.2, 903.3, 903.5

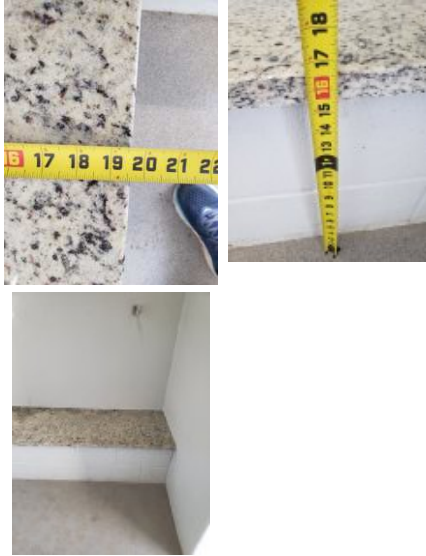
186	Cedar Sage Camping Area: Cedar Sage - Shower Rooms	[29.871327, -98.4886676]	The bench is not deep enough or long enough or is missing. Benches shall be provided having seats that are 42 inches long minimum and 20 inches deep minimum and 24 inches deep maximum. The bench shall provide for back support or shall be affixed to a wall. Back support shall be 42 inches (1065 mm) long minimum and shall extend from a point 2 inches (51 mm) maximum above the seat surface to a point 18 inches (455 mm) minimum above the seat surface. Back support shall be 2½ inches (64 mm) maximum from the rear edge of the seat measured horizontally. The top of the bench seat surface shall be 17 inches (430 mm) minimum and 19 inches (485 mm) maximum above the finish floor or ground. Clear floor or ground space complying with 305 shall be provided and shall be positioned at the end of the bench seat and parallel to the short axis of the bench	Shower A - bench 19" deep, 16" high	Replace bench in dressing area with one having a seat depth of 20" to 24" deep, 42" long, affixed to the wall or having a back and mounted 17" to 19" aff and provide required clear floor space on the short axis of the bench.	2012 TAS Section: 903.4, 903.2, 903.3, 903.5 2010 ADAS Section: 903.4, 903.2, 903.3, 903.5

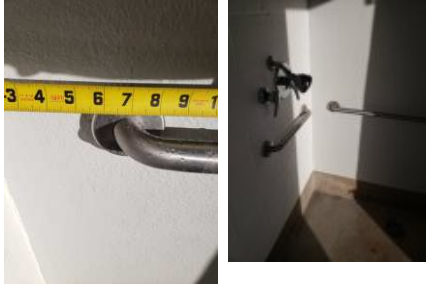
Finding Number	Area Description	Lat/Long	Finding	As Built	Recommendation	Citation	Photos	Figure
187	Cedar Sage Camping Area: Cedar Sage - Shower Rooms	[29.8713084 , -98.488667 6]	Standard Roll-In Type Shower Compartments. Where a seat is provided in standard roll-in type shower compartments, grab bars shall be provided on the back wall and the side wall opposite the seat. Grab bars shall not be provided above the seat. Where a seat is not provided in standard roll-in type shower compartments, grab bars shall be provided on three walls. Grab bars shall be installed 6 inches (150 mm) maximum from adjacent walls. Alternate Roll-In Type Shower Compartments. In alternate roll-in type shower compartments, grab bars shall be provided on the back wall and the side wall farthest from the compartment entry. Grab bars shall not be provided above the seat. Grab bars shall be installed 6 inches (150 mm) maximum from adjacent walls. Grab bars shall be installed in a horizontal position, 33 inches (840 mm) minimum and 36 inches (915 mm) maximum above the finish floor measured to the top of the gripping surface, except that at water closets for children's use complying with 604.9, grab bars shall be installed in a horizontal position 18 inches (455 mm) minimum and 27 inches (685 mm) maximum above the finish floor measured to the top of the gripping surface.	Shower F - grab bar 7" from wall	Remount grab bars to the correct location in the shower, mounted 33" to 36" AFF and max 6" from adjacent walls.	2015 ABAAS Section: 608.3.2, 608.3.3, 609.4 2012 TAS Section: 609.4, 608.3.2, 608.3.3 2010 ADAS Section: 609.4, 608.3.2, 608.3.3

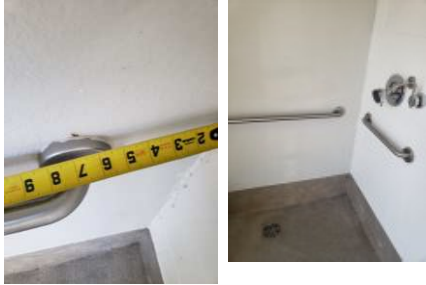
Finding Number	Area Description	Lat/Long	Finding	As Built	Recommendation	Citation	Photos	Figure
188	Cedar Sage Camping Area: Cedar Sage - Shower Rooms	[29.8713922 , -98.488624 6]	Standard Roll-In Type Shower Compartments. Where a seat is provided in standard roll-in type shower compartments, grab bars shall be provided on the back wall and the side wall opposite the seat. Grab bars shall not be provided above the seat. Where a seat is not provided in standard roll-in type shower compartments, grab bars shall be provided on three walls. Grab bars shall be installed 6 inches (150 mm) maximum from adjacent walls. Alternate Roll-In Type Shower Compartments. In alternate roll-in type shower compartments, grab bars shall be provided on the back wall and the side wall farthest from the compartment entry. Grab bars shall not be provided above the seat. Grab bars shall be installed 6 inches (150 mm) maximum from adjacent walls. Grab bars shall be installed in a horizontal position, 33 inches (840 mm) minimum and 36 inches (915 mm) maximum above the finish floor measured to the top of the gripping surface, except that at water closets for children's use complying with 604.9, grab bars shall be installed in a horizontal position 18 inches (455 mm) minimum and 27 inches (685 mm) maximum above the finish floor measured to the top of the gripping surface.	shower A - grab bar 7" from wall	Remount grab bars to the correct location in the shower, mounted 33" to 36" AFF and max 6" from adjacent walls.	2015 ABAAS Section: 608.3.2, 608.3.3, 609.4 2012 TAS Section: 609.4, 608.3.2, 608.3.3 2010 ADAS Section: 609.4, 608.3.2, 608.3.3

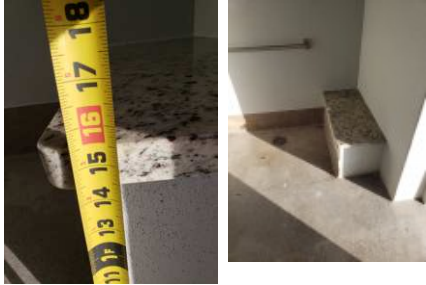
Finding Number	Area Description	Lat/Long	Finding	As Built	Recommendation	Citation	Photos	Figure
189	Cedar Sage Camping Area: Cedar Sage - Shower Rooms	[29.8713549 , -98.488646 1]	Where a seat is provided in a standard roll-in shower compartment, it shall be a folding type, shall be installed on the side wall adjacent to the controls, and shall extend from the back wall to a point within 3 inches (75 mm) of the compartment entry. Where a seat is provided in an alternate roll-in type shower compartment, it shall be a folding type, shall be installed on the front wall opposite the back wall, and shall extend from the adjacent side wall to a point within 3 inches (75 mm) of the compartment entry. In transfer-type showers, the seat shall extend from the back wall to a point within 3 inches (75 mm) of the compartment entry. The top of the seat shall be 17 inches (430 mm) minimum and 19 inches (485 mm) maximum above the bathroom finish floor. Seats shall comply with 610.3.1 or 610.3.2.	Shower F - 15.5" AFF, not compliant seat	Provide the correct seat based on shower type.	2015 ABAAS Section: 610.3 2012 TAS Section: 610.3 2010 ADAS Section: 610.3

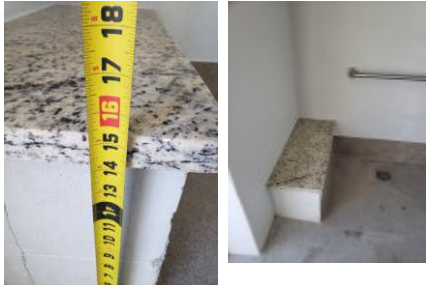
190	Cedar Sage Camping Area: Cedar Sage - Shower Rooms	[29.8713177 , -98.488656 8]	Where a seat is provided in a standard roll-in shower compartment, it shall be a folding type, shall be installed on the side wall adjacent to the controls, and shall extend from the back wall to a point within 3 inches (75 mm) of the compartment entry. Where a seat is provided in an alternate roll-in type shower compartment, it shall be a folding type, shall be installed on the front wall opposite the back wall, and shall extend from the adjacent side wall to a point within 3 inches (75 mm) of the compartment entry. In transfer-type showers, the seat shall extend from the back wall to a point within 3 inches (75 mm) of the compartment entry. The top of the seat shall be 17 inches (430 mm) minimum and 19 inches (485 mm) maximum above the bathroom finish floor. Seats shall comply with 610.3.1 or 610.3.2.	Shower A - 15.5" AFF, not compliant seat	Provide the correct seat based on shower type.	2015 ABAAS Section: 610.3 2012 TAS Section: 610.3 2010 ADAS Section: 610.3

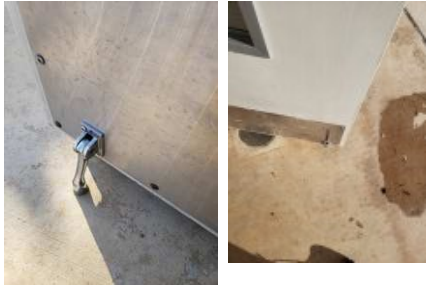
Finding Number	Area Description	Lat/Long	Finding	As Built	Recommendation	Citation	Photos	Figure
191	Cedar Sage Camping Area: Cedar Sage - Shower Rooms	[29.8713549 , -98.488624 6]	The door has a door stop which prevents it from having a smooth surface at the bottom. Swinging door surfaces within 10 inches of the finish floor or ground measured vertically must have a smooth surface on the push side extending the full width of the door. Parts creating horizontal or vertical joints in these surfaces shall be within 1/16 inch of the same plane as the other. Cavities created by added kick plates shall be capped. This is required to allow those that use wheelchairs to use their footrests to push the door open without getting trapped or injured by the gate material. All gates, including ticket gates, shall meet all applicable specifications for doors.	Shower room A and F have a hold open device within 10" of the finished floor	The door has a door stop which prevents it from having a smooth surface at the bottom.	2015 ABAAS Section: 404.2.10 2012 TAS Section: 404.2.10 2010 ADAS Section: 404.2.10

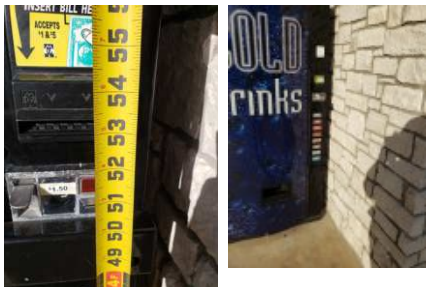
193	Cedar Sage Camping Area: Cedar Sage - Shower Rooms	[29.8713922 , -98.488710 5]	The operable part is positioned too high for either a side or front approach. Where a clear floor or ground space allows a parallel approach to an element and the side reach is unobstructed, the high side reach shall be 48 inches maximum and the low side reach shall be 15 inches minimum above the finish floor or ground. Where a forward reach is unobstructed, the high forward reach shall be 48 inches maximum and the low forward reach shall be 15 inches minimum above the finish floor or ground.	Vending machine payment 53" above ground surface	Remount operable parts to be in reach range of 15" min to 48" max.	2015 ABAAS Section: 308.1 2012 TAS Section: 308.1 2010 ADAS Section: 308.1
