# Access Audit Site Report

**Hill Country State Natural Area**  
**10600 Bandera Creek Rd**  
**Bandera, TX 78003**  
**Accessibility Evaluation**  
**Inspection Date: 03/23/2022**  
**Inspectors: Tanya Scheibe**

Prepared By  
**WT Group**

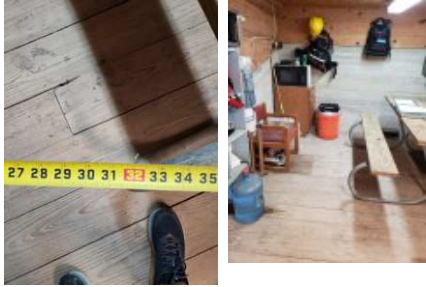
34	Employee Areas: Maintenance	[29.6254324 , -99.174415 4]	The route of travel at this location does not provide a minimum width of 36 inches. The clear width shall be permitted to be reduced to 32 inches minimum for a length of 24 inches maximum provided that reduced width segments are separated by segments that are 48 inches long minimum and 36 inches wide minimum.	hilltop break room- 32" to rear of space, furniture reduces clear width	Widen AR to compliant 36" clear width	2015 ABAAS Section: 403.5.1  2012 TAS Section: 403.5.1  2010 ADAS Section: 403.5.1

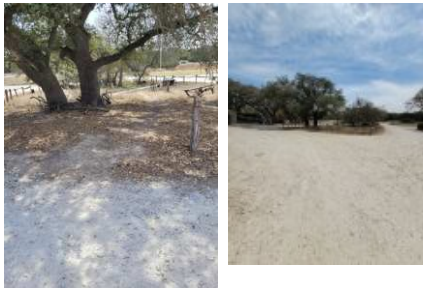
46	Headquarters Area: HQ - Parking	[29.62785, -99.181]	There is no accessible route to the restroom. At least one accessible route shall connect accessible buildings, accessible facilities, accessible elements, and accessible spaces that are on the same site.	Lacks accessible route through cut through area from parking to restroom	Create an accessible route with crushed stone or other outdoor material from parking or walkway to restroom.	2015 ABAAS Section: F206.2.2  2012 TAS Section: 206.2.2  2010 ADAS Section: 206.2.2

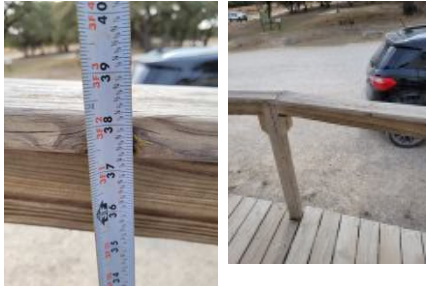
56	Headquarters Area: HQ - Public Spaces	[29.628024, -99.181196]	The handrail is mounted incorrectly. Handrails are measured at the top and must be between 34 inches and 38 inches above the ramp surface. Handrails must extend horizontally beyond the top and bottom of the ramp 12 inches minimum.	38.25" above ground surface	Remount handrails to 34" to 38" aff	2015 ABAAS Section: 505.4 2012 TAS Section: 505.4 2010 ADAS Section: 505.4

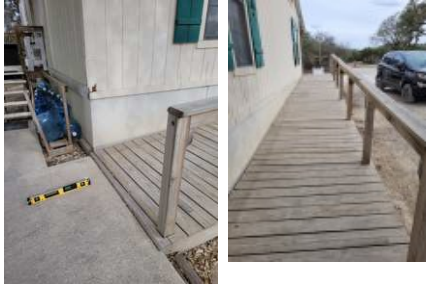
Finding Number	Area Description	Lat/Long	Finding	As Built	Recommendation	Citation	Photos	Figure
59	Headquarters Area: HQ - Public Spaces	[29.6280263 , -99.181196]	The ramp run has not been provided with edge protection. The floor or ground surface of the ramp run or landing shall extend 12 inches minimum beyond the inside face of a handrail or a curb or barrier shall be provided that prevents the passage of a 4 inch diameter sphere, where any portion of the sphere is within 4 inches of the finish floor or ground surface.	Lacks edge protection	Install rail along bottom edge of ramp that prevents a 4" sphere from passing through	2015 ABAAS Section: 405.9, 405.9.1, 405.9.2  2012 TAS Section: 405.9.1, 405.9.2, 405.9  2010 ADAS Section: 405.9.2, 405.9.1, 405.9

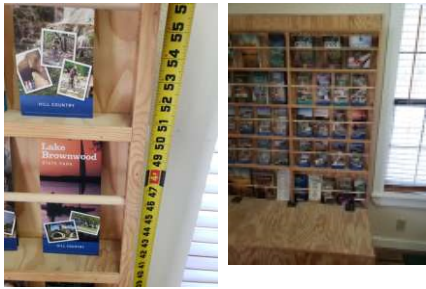
67	Headquarters Area: HQ - Public Spaces	[29.6280473 , -99.181112 9]	The operable part is positioned too high for either a side or front approach. Where a clear floor or ground space allows a parallel approach to an element and the side reach is unobstructed, the high side reach shall be 48 inches maximum and the low side reach shall be 15 inches minimum above the finish floor or ground. Where a forward reach is unobstructed, the high forward reach shall be 48 inches maximum and the low forward reach shall be 15 inches minimum above the finish floor or ground.	Top row of maps only available over 48" above finished floor	Remount operable parts to be in reach range of 15" min to 48" max	2015 ABAAS Section: 308.1 2012 TAS Section: 308.1 2010 ADAS Section: 308.1

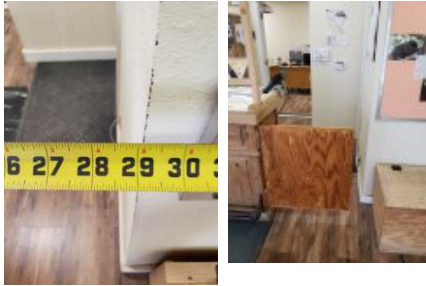
Finding Number	Area Description	Lat/Long	Finding	As Built	Recommendation	Citation	Photos	Figure
68	Headquarters Area: HQ - Employee Spaces	[29.6280391 , -99.181153 1]	Spaces and elements within employee work areas shall only be required to comply with 206.2.8, 207.1, and 215.3 and shall be designed and constructed so that individuals with disabilities can approach, enter, and exit the employee work area. Employee work areas, or portions of employee work areas, other than raised courtroom stations, that are less than 300 square feet (28 m2) and elevated 7 inches (180 mm) or more above the finish floor or ground where the elevation is essential to the function of the space shall not be required to comply with these requirements or to be on an accessible route.	Passage to employee area reduced to 29"	For employee spaces, replace doors with doors having 80" overhead clearance and 32" clear width.	2015 ABAAS Section: F203.9  2012 TAS Section: 203.9  2010 ADAS Section: 203.9

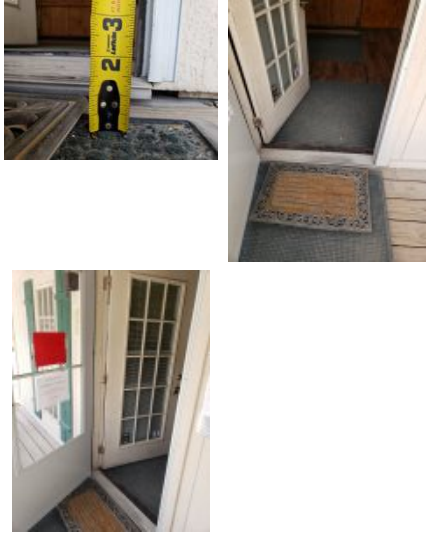
Finding Number	Area Description	Lat/Long	Finding	As Built	Recommendation	Citation	Photos	Figure
71	Headquarters Area: HQ - Employee Spaces	[29.6280461 , -99.1811129]	The threshold has a vertical change greater than 1/4 inch high. Secure mat/carpet at door.	Front door exterior- 2" change in level, loose mats on both sides	For all doors along the public circulation route, repair, bevel, or ramp CILs at door entries to max .25". Secure mat/carpet at door.	2010 ADAS Section: 404.2.3, 404.2.7, 404.2.4, 404.2.11, 404.2.11 Exception

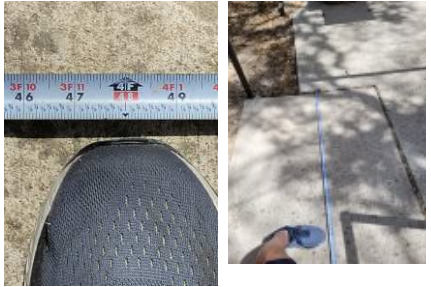
74	Headquarters Area: HQ - Restrooms	[29.6279307, -99.1809412]	The landing is not the correct length. Landings shall have a dimension in the direction of ramp run of not less than 60 inches.	landing 48" depth	Enlarge landing to be 60" deep and as wide as the ramp	2015 ABAAS Section: 405.7.3 2012 TAS Section: 405.7.3 2010 ADAS Section: 405.7.3

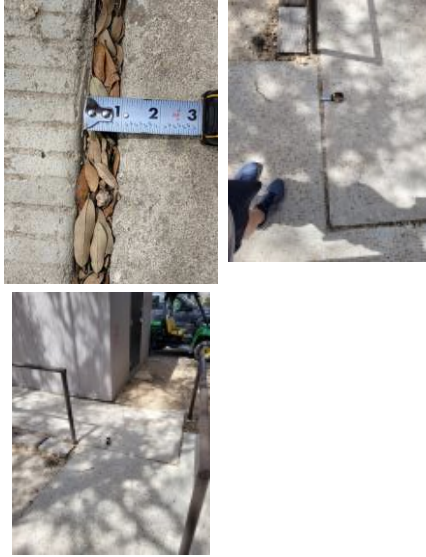
Finding Number	Area Description	Lat/Long	Finding	As Built	Recommendation	Citation	Photos	Figure
76	Headquarters Area: HQ - Restrooms	[29.6279307 , -99.180946 6]	Openings in floor or ground surfaces shall not allow passage of a sphere more than 1/2 inch (13 mm) diameter except as allowed in 407.4.3, 409.4.3, 410.4, 810.5.3 and 810.10. Elongated openings shall be placed so that the long dimension is perpendicular to the dominant direction of travel.	1" gap	Fill and maintain gaps to max .5"	2015 ABAAS Section: 302.3  2012 TAS Section: 302.3  2010 ADAS Section: 302.3

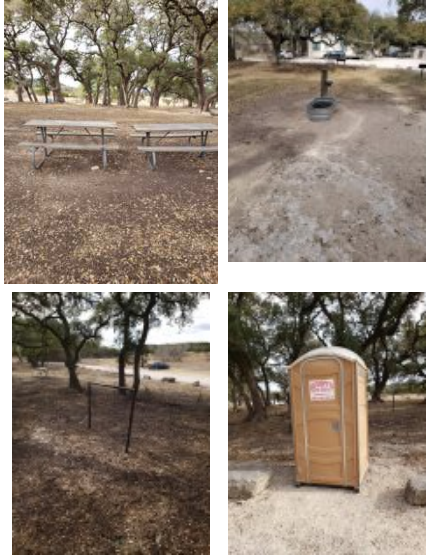
Finding Number	Area Description	Lat/Long	Finding	As Built	Recommendation	Citation	Photos	Figure
84	Bar-O Day Use: Bar-O - Park Elements	[29.6278235 , -99.181783 4]	There is no accessible route to the site amenities. At least one accessible route shall connect accessible buildings, accessible facilities, accessible elements, and accessible spaces that are on the same site.	no accessible route to 8 picnic tables (0 accessible), 5 hitching posts, 1 trough, and 1 portable toilet	Create an accessible route with crushed stone or other outdoor material from parking or walkway to amenities. Replace 20% of picnic tables with ones of an accessible design as a smart practice	2015 ABAAS Section: F206.2.2  2012 TAS Section: 206.2.2  2010 ADAS Section: 206.2.2

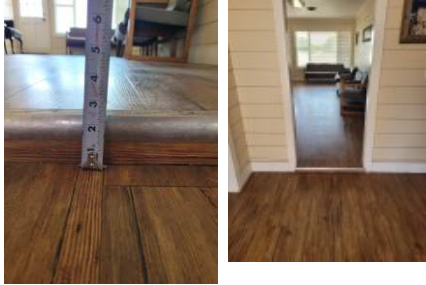
Finding Number	Area Description	Lat/Long	Finding	As Built	Recommendation	Citation	Photos	Figure
93	Group Lodge: Group Lodge - Public Spaces	[29.6485789 , -99.200119]	There is a change in level greater than 1/4 inch. 1/4 inch is the maximum vertical rise. Changes in level between 1/4 inch and 1/2 inch must be beveled at 1:2 or less. Changes in level greater than 1/2 inch must be by way of a ramp.	main room- 2.5" change in level entering main room	Repair, bevel or ramp CIL along accessible route (AR) to max .25".	2015 ABAAS Section: 303.3  2012 TAS Section: 303.3  2010 ADAS Section: 303.3

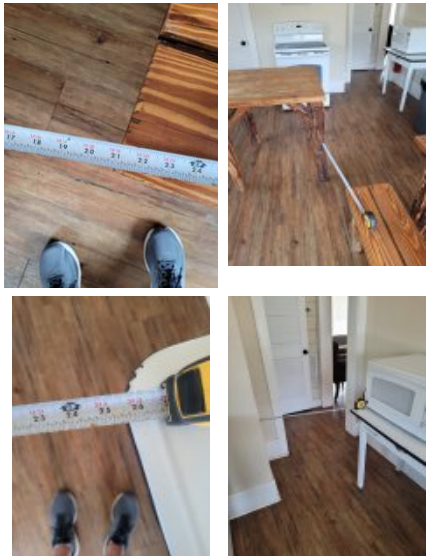
99	Group Lodge: Group Lodge - Public Spaces	[29.6485649 , -99.200116 3]	The route of travel at this location does not provide a minimum width of 36 inches. The clear width shall be permitted to be reduced to 32 inches minimum for a length of 24 inches maximum provided that reduced width segments are separated by segments that are 48 inches long minimum and 36 inches wide minimum.	kitchen- reduces 21" at bench and table, 25.5" at microwave	Widen AR to compliant 36" clear width	2015 ABAAS Section: 403.5.1  2012 TAS Section: 403.5.1  2010 ADAS Section: 403.5.1

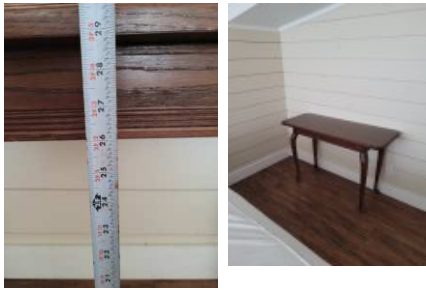
105	Group Lodge: Group Lodge - Public Spaces	[29.64858, -99.200125 7]	The top of the work surface is not within a compliant height range. The tops of tables and counters shall be 28 inches to 34 inches from the floor or ground.	kitchen- table lacks knee clearance	Provide tables and work surfaces at 28" to 34" aff with required knee and toe clearances	2015 ABAAS Section: 902.3  2012 TAS Section: 902.3  2010 ADAS Section: 902.3

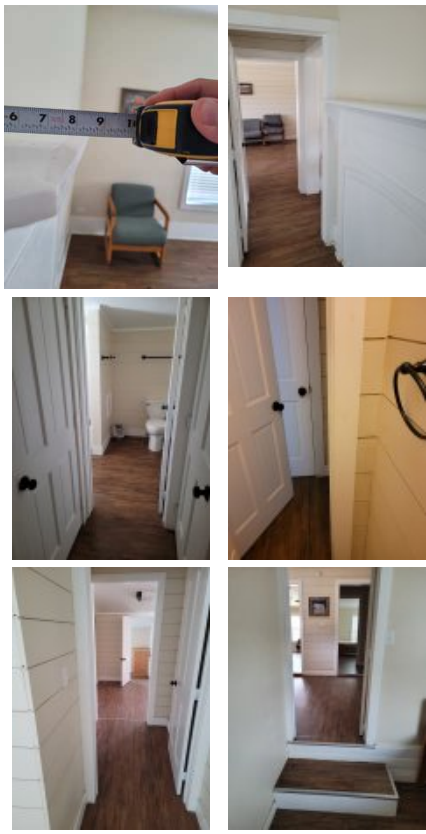
Finding Number	Area Description	Lat/Long	Finding	As Built	Recommendation	Citation	Photos	Figure
111	Group Lodge: Group Lodge - Public Spaces	[29.648601, -99.200115]	Minimum maneuvering clearances at doors and gates shall comply with 404.2.4. Maneuvering clearances shall extend the full width of the doorway and the required latch side or hinge side clearance.	8.5" shelf projection in push maneuvering clearance front bedroom 1; maneuvering clearance large restroom push; maneuvering clearance push small restroom; maneuvering clearance push front bedroom 2; maneuvering clearance on stairs on push back bedroom	For all doors along the public circulation route, provide required maneuvering clearance on push and pull side of doors.	2010 ADAS Section: 404.2.3, 404.2.7, 404.2.4, 404.2.11, 404.2.11 Exception

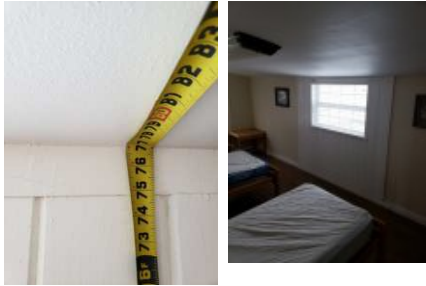
Finding Number	Area Description	Lat/Long	Finding	As Built	Recommendation	Citation	Photos	Figure
113	Group Lodge: Group Lodge - Public Spaces	[29.6485789 , -99.200129 7]	The ceiling extends down too close to the route of travel. Any obstruction that overhangs a route of travel must be a minimum of 80 inches above the walking surface as measured from the bottom of the obstruction.	rear bedroom - ceiling height slopes down to 77"	Raise ceiling to min 80", leave as is if technically infeasible	2015 ABAAS Section: 307.4  2012 TAS Section: 307.4  2010 ADAS Section: 307.4

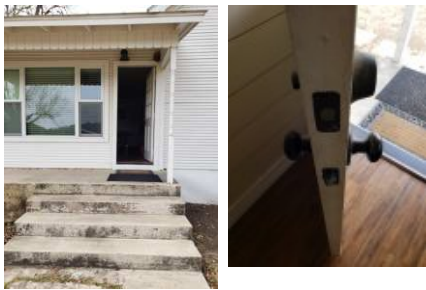
Finding Number	Area Description	Lat/Long	Finding	As Built	Recommendation	Citation	Photos	Figure
118	Group Lodge: Group Lodge - Public Spaces	[29.6485998 , -99.200074 8]	Minimum maneuvering clearances at doors and gates shall comply with 404.2.4. Maneuvering clearances shall extend the full width of the doorway and the required latch side or hinge side clearance. Maneuvering clearances shall have a max slope of 2.08%. The threshold has a vertical change greater than 1/4 inch high. Hand-activated door opening hardware, handles, pulls, latches, locks, and other operating devices on accessible doors shall have a shape that is easy to grasp with one hand and does not require tight grasping, tight pinching or twisting of the wrist to operate. Hardware shall be 34 inches minimum and 48 inches maximum above the finish floor or ground.	Front entrance - stairs only, knobs, loose mat	For all doors along the public circulation route, provide required maneuvering clearance on push and pull side of doors. For all doors along the public circulation route, repair, bevel, or ramp CILs at door entries to max .25". For all doors along the public circulation route, replace hardware with lever hardware or hardware operable without a tight pinch or grasp. For all doors along the public circulation route, secure rugs at doorways.	2010 ADAS Section: 404.2.3, 404.2.7, 404.2.4, 404.2.11, 404.2.11 Exception

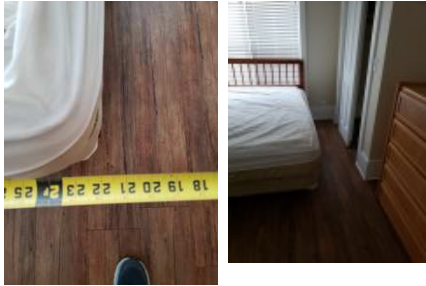
Finding Number	Area Description	Lat/Long	Finding	As Built	Recommendation	Citation	Photos	Figure
121	Group Lodge: Group Lodge - Public Spaces	[29.6485998 , -99.200119]	The route of travel at this location does not provide a minimum width of 36 inches. The clear width shall be permitted to be reduced to 32 inches minimum for a length of 24 inches maximum provided that reduced width segments are separated by segments that are 48 inches long minimum and 36 inches wide minimum.	front bedroom 1- 22" to closet	Widen AR to compliant 36" clear width	2015 ABAAS Section: 403.5.1  2012 TAS Section: 403.5.1  2010 ADAS Section: 403.5.1

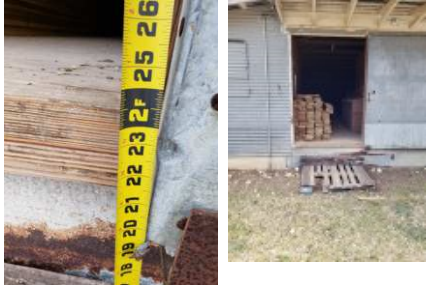
Finding Number	Area Description	Lat/Long	Finding	As Built	Recommendation	Citation	Photos	Figure
127	Group Lodge: Group Lodge - Storage Barn	[29.6485311 , -99.200289 3]	Spaces and elements within employee work areas shall only be required to comply with 206.2.8, 207.1, and 215.3 and shall be designed and constructed so that individuals with disabilities can approach, enter, and exit the employee work area. Employee work areas, or portions of employee work areas, other than raised courtroom stations, that are less than 300 square feet (28 m2) and elevated 7 inches (180 mm) or more above the finish floor or ground where the elevation is essential to the function of the space shall not be required to comply with these requirements or to be on an accessible route.	24" change in level at door, no accessible route	For employee spaces, relocate storage, furniture, and other obstacles at doorways to provide approach, enter and exit at the employee space.	2015 ABAAS Section: F203.9  2012 TAS Section: 203.9  2010 ADAS Section: 203.9

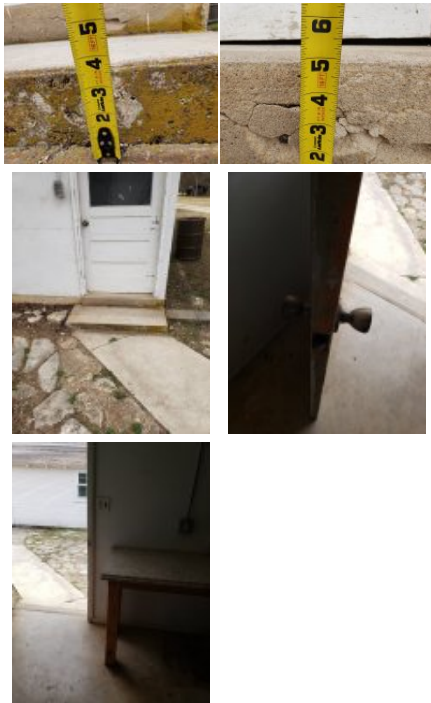
130	Group Lodge: Group Lodge - Cook Shack	[29.6485334 , -99.200316 2]	Minimum maneuvering clearances at doors and gates shall comply with 404.2.4. Maneuvering clearances shall extend the full width of the doorway and the required latch side or hinge side clearance. The threshold has a vertical change greater than 1/4 inch high. Hand-activated door opening hardware, handles, pulls, latches, locks, and other operating devices on accessible doors shall have a shape that is easy to grasp with one hand and does not require tight grasping, tight pinching or twisting of the wrist to operate. Hardware shall be 34 inches minimum and 48 inches maximum above the finish floor or ground.	Two steps to door, 3.5" and 5" change in level, knobs, counter in pull side maneuvering clearance	For all doors along the public circulation route, provide required maneuvering clearance on push and pull side of doors. For all doors along the public circulation route, repair, bevel, or ramp CILs at door entries to max .25". For all doors along the public circulation route, replace hardware with lever hardware or hardware operable without a tight pinch or grasp.	2010 ADAS Section: 404.2.3, 404.2.7, 404.2.4, 404.2.11, 404.2.11 Exception
