Access Audit Site Report

Hueco Tanks State Park and Historic Site

Accessibility Evaluation

Inspection Date: 10/19/2022

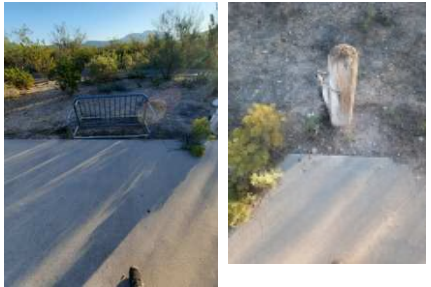
10	Headquarters Area: HQ - Public Spaces	[31.92606, -106.0422]	Element meets all standards and requirements	Bike rack and HQ parking area water spigot comply	None	2010 ADAS Section: N/A

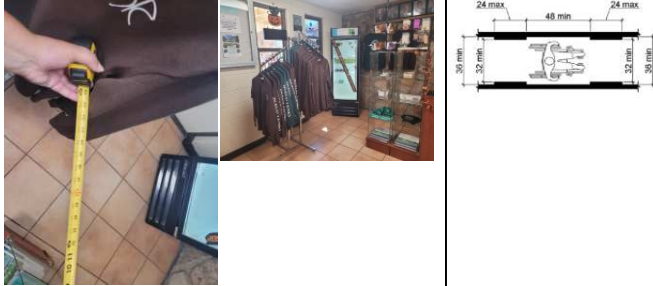
16	Headquarters Area: HQ - Public Spaces	[31.9264455, -106.0424376]	The route of travel at this location does not provide a minimum width of 36 inches. The clear width shall be permitted to be reduced to 32 inches minimum for a length of 24 inches maximum provided that reduced width segments are separated by segments that are 48 inches long minimum and 36 inches wide minimum.	Route reduces to access fridge	Relocate merchandise racks to widen AR to compliant 36" clear width.	2015 ABAAS Section: 403.5.1 2012 TAS Section: 403.5.1 2010 ADAS Section: 403.5.1

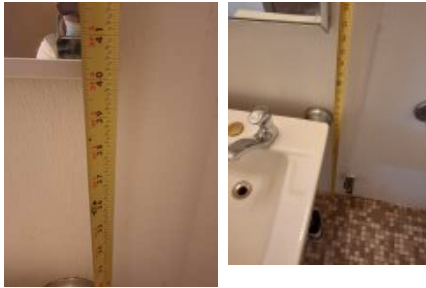
24	Headquarters Area: HQ - Men's Restroom	[31.9264137, -106.0424322]	The mirror is mounted too high. Mirrors must have the bottom edge of the reflecting surface a maximum of 40 inches above the floor if above a sink or counter. Mirrors not located above lavatories or countertops shall be installed with the bottom edge of the reflecting surface 35 inches maximum above the finish floor or ground.	Bottom edge of mirror at 40.5"	Lower mirror so bottom reflective surface is max 40" AFF and 74" at the top.	2015 ABAAS Section: 603.3 2012 TAS Section: 603.3 2010 ADAS Section: 603.3

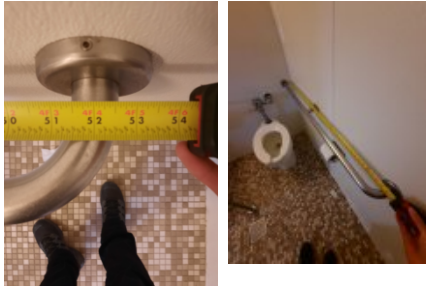
29	Headquarters Area: HQ - Men's Restroom	[31.9264411, -106.0424483]	The side grab bars are not in the correct location. Grab bars on the side wall must be installed so that the end closest to the rear wall is maximum 12" from the rear wall. The end furthest from the rear wall must be mounted minimum 54" from the rear wall.	Side bar ends 52" from rear wall	Remount side grab bar to max 12" from the rear wall at the close end and min 54" on the far end, and 33" to 36" AFF.	2015 ABAAS Section: 604.5.1 2012 TAS Section: 604.5.1 2010 ADAS Section: 604.5.1

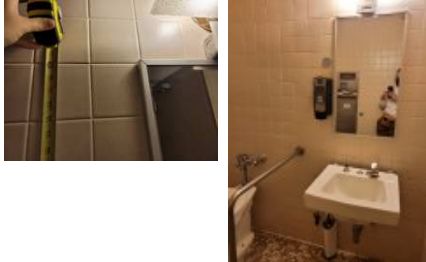
36	Headquarters Area: HQ - Women's Restroom	[31.9264481, -106.0424376]	The mirror is mounted too high. Mirrors must have the bottom edge of the reflecting surface a maximum of 40 inches above the floor if above a sink or counter. Mirrors not located above lavatories or countertops shall be installed with the bottom edge of the reflecting surface 35 inches maximum above the finish floor or ground.	Top of mirror at 72" above the finished floor (AFF)	Replace mirror mount to max 40" AFF to the bottom reflective surface and 74" to the top.	2015 ABAAS Section: 603.3 2012 TAS Section: 603.3 2010 ADAS Section: 603.3

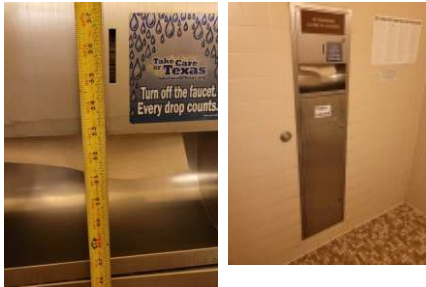
38	Headquarters Area: HQ - Women's Restroom	[31.926439, -106.0424322]	Where a high forward reach is over an obstruction, the clear floor space shall extend beneath the element for a distance not less than the required reach depth over the obstruction. The high forward reach shall be 48 inches (1220 mm) maximum where the reach depth is 20 inches (510 mm) maximum. Where the reach depth exceeds 20 inches (510 mm), the high forward reach shall be 44 inches (1120 mm) maximum and the reach depth shall be 25 inches (635 mm) maximum. Where a clear floor or ground space allows a parallel approach to an element and the high side reach is over an obstruction, the height of the obstruction shall be 34 inches (865 mm) maximum and the depth of the obstruction shall be 24 inches (610 mm) maximum. The high side reach shall be 48 inches (1220 mm) maximum for a reach depth of 10 inches (255 mm) maximum. Where the reach depth exceeds 10 inches (255 mm), the high side reach shall be 46 inches (1170 mm) maximum for a reach depth of 24 inches (610 mm) maximum.	Paper towels at 53"	Leave as is paper towels citing safe harbor.	2015 ABAAS Section: 308.2.1, 308.3.2 2012 TAS Section: 308.2.1, 308.3.2 2010 ADAS Section: 308.2.1, 308.3.2

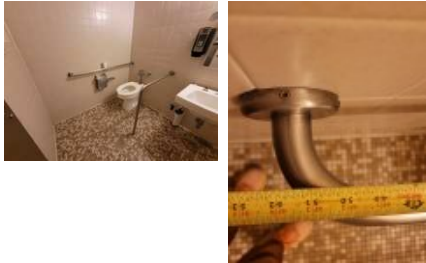
Finding Number	Area Description	Lat/Long	Finding	As Built	Recommendation	Citation	Photos	Figure
39	Headquarters Area: HQ - Women's Restroom	[31.9264527, -106.0424215]	The side grab bars are not in the correct location. Grab bars on the side wall must be installed so that the end closest to the rear wall is maximum 12" from the rear wall. The end furthest from the rear wall must be mounted minimum 54" from the rear wall.	Non-compliant grab bars present; side grab bar extends 51" from rear wall	Replace side grab bar with a 42" long bar mounted to max 12" from the rear wall at the close end and min 54" on the far end, and 33" to 36" AFF.	2015 ABAAS Section: 604.5.1 2012 TAS Section: 604.5.1 2010 ADAS Section: 604.5.1

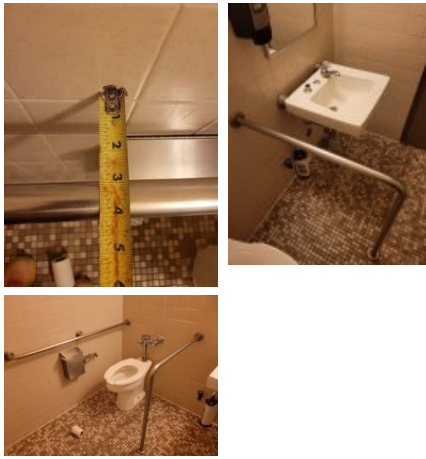
41	Headquarters Area: HQ - Women's Restroom	[31.9264459, -106.0424295]	The grab bar height and/or spacing fails. Grab bars must be mounted between 33" and 36" to the top of the gripping surface. There must be 1.5" of clearance between the grab bar and the wall. There must be a minimum of 1.5" of clearance below and minimum 12" above the grab bar to any dispenser or other obstruction.	Wall-side grab bar has 3" spacing between it and the wall; other side grab bar is free standing	Replace existing side grab bar with one having 1.5" of clearance between the grab bar and the wall, 33" to 36" above the finished floor (AFF). Cost included in previous finding.	2015 ABAAS Section: 609.3, 609.4 2012 TAS Section: 609.4, 609.3 2010 ADAS Section: 609.3, 609.4

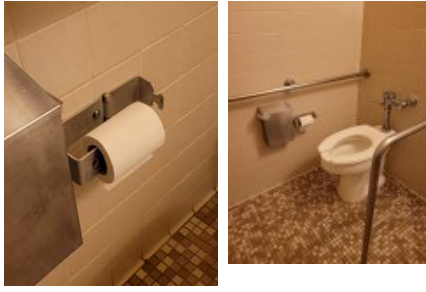
44	Headquarters Area: HQ - Women's Restroom	[31.9264436, -106.0424483]	The toilet paper dispenser does not allow a continuous flow. Toilet paper dispensers shall be 7 inches minimum and 9 inches maximum in front of the water closet measured to the centerline of the dispenser. The outlet of the dispenser shall be 15 inches minimum and 48 inches maximum above the finish floor and shall not be located behind grab bars. Dispensers shall not be of a type that controls delivery or that does not allow continuous paper flow. There shall be a clearance of 1 1/2 inches minimum below the grab bar.	Flat bar TP dispenser does not allow continuous delivery	Replace toilet paper dispenser with one that provides continuous flow of paper.	2015 ABAAS Section: 604.7 2012 TAS Section: 604.7 2010 ADAS Section: 604.7

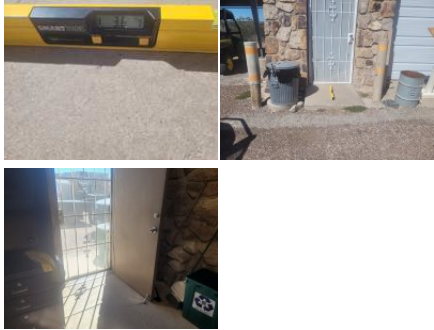
Finding Number	Area Description	Lat/Long	Finding	As Built	Recommendation	Citation	Photos	Figure
46	Employee Areas: Maintenance	[31.9267744, -106.0403329]	The threshold has a vertical change greater than 1/4 inch high. Hand-activated door opening hardware, handles, pulls, latches, locks, and other operating devices on accessible doors shall have a shape that is easy to grasp with one hand and does not require tight grasping, tight pinching or twisting of the wrist to operate. Hardware shall be 34 inches minimum and 48 inches maximum above the finish floor or ground. The bottom 10 inches on the push side must be smooth and free of obstructions (hold open devices). Opening hardware must be mounted between 30 and 44 inches above the floor or ground.	Shop entry - knob, door stop push side, CIL of 2"	For all doors along the public circulation route, repair, bevel, or ramp CILs at door entries to max .25". For all doors along the public circulation route, replace hardware with lever hardware or hardware operable without a tight pinch or grasp. For all doors along the public circulation route, provide kick plate on push side of door from floor to 10" AFF.	2010 ADAS Section: 404.2.3, 404.2.7, 404.2.4, 404.2.11, 404.2.11 Exception

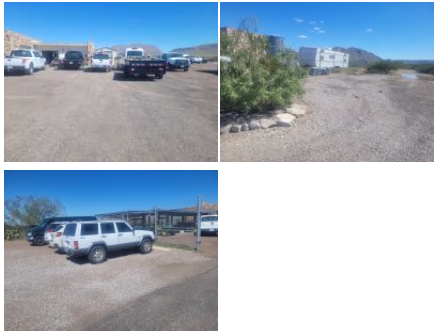
54	Employee Areas: Maintenance	[31.9267, -106.0404]	There are no or not enough accessible parking stalls. Each lot where parking is provided for the public as clients, guests or employees, shall provide accessible parking and shall be located on the shortest accessible route of travel from adjacent parking to an accessible entrance. There are a total of 10 parking stalls in the parking lot that could be reasonably associated with this facility. There should be a minimum of 1 accessible stalls with a minimum of 1 being designed as van accessible.	No marked stalls in gate, approximately 10 stalls outside gate	Create one or more 8' accessible parking stalls, with one 5' adjacent access aisle, with proper signage and striping based on the total number of stalls.	2015 ABAAS Section: F208.2 2012 TAS Section: 208.2 2010 ADAS Section: 208.2

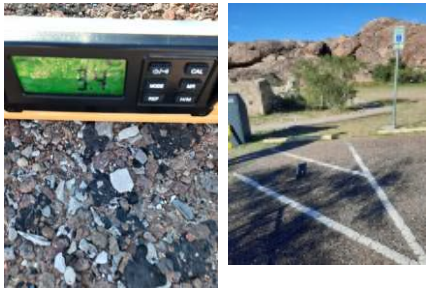
58	Interpretive Center: Interpretive - Parking	[31.9250588, -106.0417785]	The cross slopes (narrow dimension) and/or running slopes (long dimension) of the access aisle exceeds 2%. The running slope and the cross slope in an accessible parking stall and the access aisle must not exceed 2%.	Access aisle (AA) - 3.4%	Repair or correct slope of parking space and access aisle to max 2.08% in any direction.	2015 ABAAS Section: 502.4 2012 TAS Section: 502.4 2010 ADAS Section: 502.4

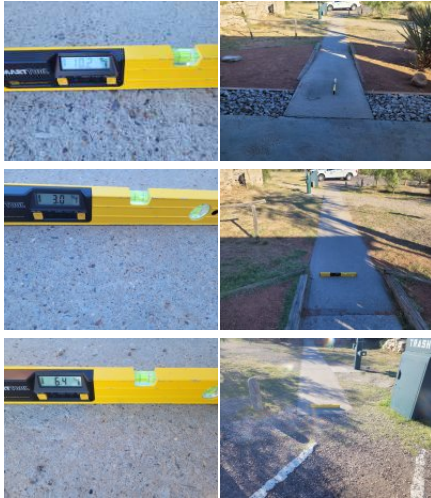
Finding Number	Area Description	Lat/Long	Finding	As Built	Recommendation	Citation	Photos	Figure
66	Interpretive Center: Interpretive - Exterior Accessible Route	[31.9249162, -106.0417268]	The running slope of walking surfaces shall not be steeper than 1:20. The cross slope of walking surfaces shall not be steeper than 1:48.	10.2% running slope on ramp, 3.3% cross slope, 6.4% cross slope	Correct running slopes to max 5% and cross to max 2.08%.	2012 TAS Section: 403.3 2010 ADAS Section: 403.3

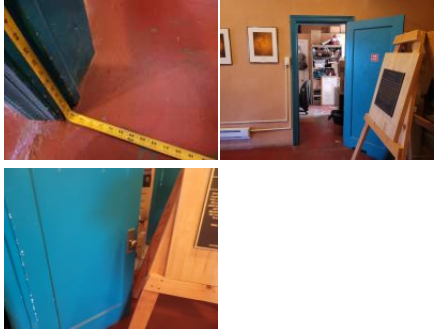
Finding Number	Area Description	Lat/Long	Finding	As Built	Recommendation	Citation	Photos	Figure
84	Interpretive Center: Interpretive - Employee Spaces	[31.9248282, -106.0416846]	Spaces and elements within employee work areas shall only be required to comply with 206.2.8, 207.1, and 215.3 and shall be designed and constructed so that individuals with disabilities can approach, enter, and exit the employee work area. Employee work areas, or portions of employee work areas, other than raised courtroom stations, that are less than 300 square feet (28 m2) and elevated 7 inches (180 mm) or more above the finish floor or ground where the elevation is essential to the function of the space shall not be required to comply with these requirements or to be on an accessible route.	Interpretive Center Office - 30" wide, knob, storage in pull side clearance	For employee spaces, relocate storage, furniture, and other obstacles at doorways to provide approach, enter and exit at the employee space. Provide required maneuvering clearance on push and pull side of doors. Replace doors with doors having 80" overhead clearance and 32" clear width. Replace hardware with lever hardware or hardware operable without a tight pinch or grasp.	2015 ABAAS Section: F203.9 2012 TAS Section: 203.9 2010 ADAS Section: 203.9

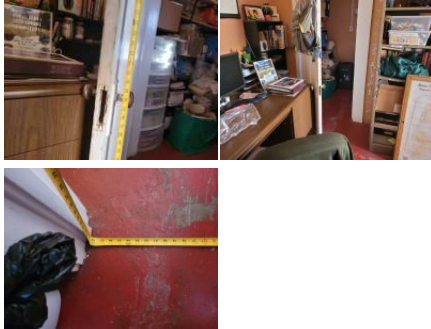
Finding Number	Area Description	Lat/Long	Finding	As Built	Recommendation	Citation	Photos	Figure
88	Interpretive Center: Interpretive - Employee Spaces	[31.9248244, -106.0416858]	Minimum maneuvering clearances at doors and gates shall comply with 404.2.4. Maneuvering clearances shall extend the full width of the doorway and the required latch side or hinge side clearance. Door openings shall provide a clear width of 32 inches (815 mm) minimum. Clear openings of doorways with swinging doors shall be measured between the face of the door and the stop, with the door open 90 degrees. Openings more than 24 inches (610 mm) deep shall provide a clear opening of 36 inches (915 mm) minimum. There shall be no projections into the required clear opening width lower than 34 inches (865 mm) above the finish floor or ground. Projections into the clear opening width between 34 inches (865 mm) and 80 inches (2030 mm) above the finish floor or ground shall not exceed 4 inches (100 mm). Hand-activated door opening hardware, handles, pulls, latches, locks, and other operating devices on accessible doors shall have a shape that is easy to grasp with one hand and does not require tight grasping, tight pinching or twisting of the wrist to operate. Hardware shall be 34 inches minimum and 48 inches maximum above the finish floor or ground.	Restroom/storage door - shelf and desk pull side, knob at 28", 28" wide	For all doors along the public circulation route, provide required maneuvering clearance on push and pull side of doors. For all doors along the public circulation route, replace doors with doors having 80" overhead clearance and 32" clear width. For all doors along the public circulation route, replace hardware with lever hardware or hardware operable without a tight pinch or grasp mounted to 34" to 48" AFF.	2010 ADAS Section: 404.2.3, 404.2.7, 404.2.4, 404.2.11, 404.2.11 Exception

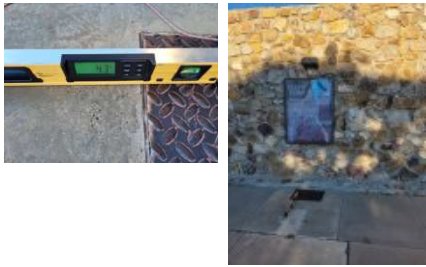
Finding Number	Area Description	Lat/Long	Finding	As Built	Recommendation	Citation	Photos	Figure
96	Campground: Campground - Exterior Accessible Route	[31.91963, -106.0364]	Element meets all standards and requirements	Garbage by women's restroom entry complies	None	2010 ADAS Section: N/A		
97	Campground: Campground - Exterior Accessible Route	[31.91966, -106.0364]	The 30 inches minimum by 48 inches minimum clear floor space required at the operable part is not flat (2% or 1:48 maximum slope) in all directions. Changes in level are not permitted at required clear floor or ground space except that slopes not steeper than 1:48 shall be permitted.	4.3% slope in clear floor space (CFS) for sign at restroom	Correct or repair slope in CFS to max 2.08%.	2015 ABAAS Section: 305.2 2012 TAS Section: 305.2 2010 ADAS Section: 305.2

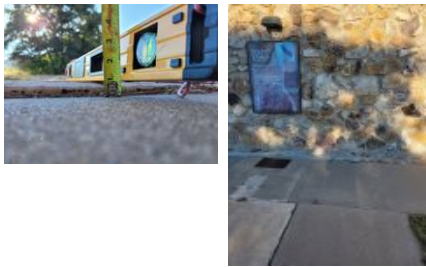
98	Campground: Campground - Exterior Accessible Route	[31.919605, -106.0364174]	The walkway contains abrupt vertical edges and/or variations over a 1/4 inch. 1/4 inch is the maximum vertical rise. Changes in level between 1/4 inch and 1/2 inch must be beveled at 1:2 or less. Changes in level greater than 1/2 inch must be by way of a ramp.	.75" change in elevation (CIL) on route to restroom building by sign	Repair, bevel or ramp CIL along AR.	2012 TAS Section: 303.2, 303.3 2010 ADAS Section: 303.2, 303.3

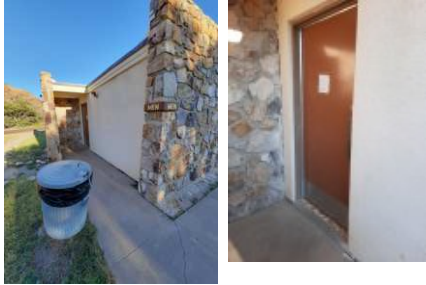
Finding Number	Area Description	Lat/Long	Finding	As Built	Recommendation	Citation	Photos	Figure
102	Campground: Campground - Men's Restroom	[31.9195924, -106.0364343]	The restroom sign does not comply with one or more applicable requirements for the location, height, and properties of the sign.	Lacks signage near door, existing sign lacks Braille, raised characters, ISA	Replace sign with one of contrasting colors that includes Braille, raised characters, and the symbol of accessibility and mount on the wall, latch side of the door, 48" to the baseline of the lowest character and 60" to the baseline of the highest character.	2015 ABAAS Section: F216.2, 703.1, 703.2, 703.5, 703.6 2012 TAS Section: 216.2, 703.1, 703.2, 703.5, 703.6 2010 ADAS Section: 216.2, 703.1, 703.2, 703.5, 703.6

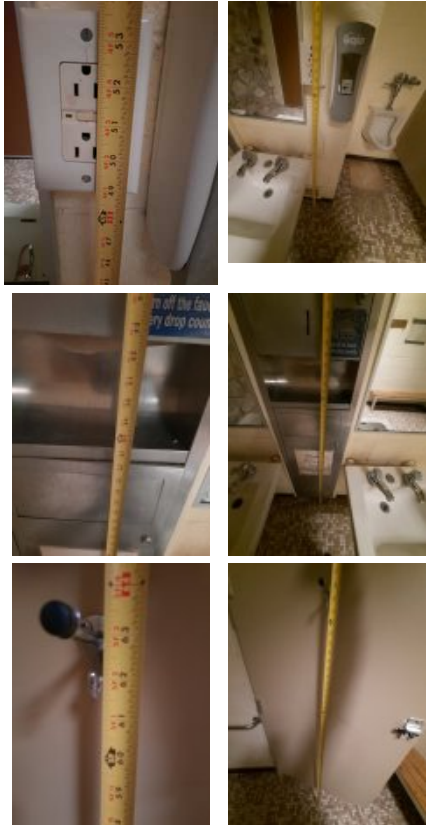
Finding Number	Area Description	Lat/Long	Finding	As Built	Recommendation	Citation	Photos	Figure
106	Campground: Campground - Men's Restroom	[31.9196038 , -106.0364 437]	Where a high forward reach is over an obstruction, the clear floor space shall extend beneath the element for a distance not less than the required reach depth over the obstruction. The high forward reach shall be 48 inches (1220 mm) maximum where the reach depth is 20 inches (510 mm) maximum. Where the reach depth exceeds 20 inches (510 mm), the high forward reach shall be 44 inches (1120 mm) maximum and the reach depth shall be 25 inches (635 mm) maximum. Where a clear floor or ground space allows a parallel approach to an element and the high side reach is over an obstruction, the height of the obstruction shall be 34 inches (865 mm) maximum and the depth of the obstruction shall be 24 inches (610 mm) maximum. The high side reach shall be 48 inches (1220 mm) maximum for a reach depth of 10 inches (255 mm) maximum. Where the reach depth exceeds 10 inches (255 mm), the high side reach shall be 46 inches (1170 mm) maximum for a reach depth of 24 inches (610 mm) maximum.	Outlet is at 50.5", paper towel dispenser at 51.5", hook in stall (lowest in restroom) at 62.25"	Lower coat hook to max 48" above the finished floor (AFF) to highest operable part. Leave as is outlet citing safe harbor. Lower paper towel dispenser to max 44" above the finished floor (AFF) for a forward reach over sink.	2015 ABAAS Section: 308.2.1, 308.3.2 2012 TAS Section: 308.2.1, 308.3.2 2010 ADAS Section: 308.2.1, 308.3.2

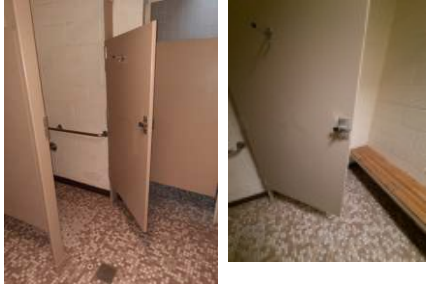
Finding Number	Area Description	Lat/Long	Finding	As Built	Recommendation	Citation	Photos	Figure
110	Campground: Campground - Men's Restroom	[31.9196084 , -106.03643 7]	The stall door fails to comply with all of the door requirements. The stall door must be a minimum of 32" wide and have compliant hardware on both sides. The stall door must be self-closing.	Lacks self-closing door and interior hardware other than lock	Adjust stall door to be self-closing. Replace stall hardware with hardware operable without a tight pinch or grasp on both sides of the stall door.	2015 ABAAS Section: 404.2.3, 404.2.7, 604.8.2.2 2012 TAS Section: 404.2.3, 404.2.7, 604.8.2.2 2010 ADAS Section: 404.2.3, 404.2.7, 604.8.2.2

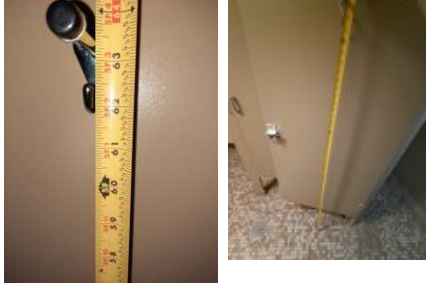
115	Campground: Campground - Men's Restroom	[31.9196123, -106.0364464]	Coat hooks provided within the room shall be located within one of the reach ranges specified in 308. Shelves shall be 40 inches (1015 mm) minimum and 48 inches (1220 mm) maximum above the finish floor or ground. Where coat hooks or shelves are provided in dressing, fitting or locker rooms without individual compartments, at least one of each type shall comply with 803.5. Where coat hooks or shelves are provided in individual compartments at least one of each type complying with 803.5 shall be provided in individual compartments in dressing, fitting, or locker rooms required to comply with 222.1.	Hook in shower compartment at 62.5"	Remount at least one hook to max 48" AFF.	2015 ABAAS Section: 308.2.1, 308.1, F222.2, 803.5 2012 TAS Section: 308.2.1, 308.1, 222.2, 803.5 2010 ADAS Section: 308.2.1, 308.1, 222.2, 803.5

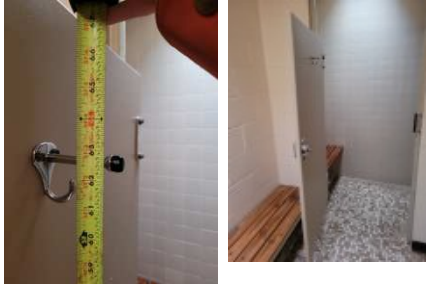
Finding Number	Area Description	Lat/Long	Finding	As Built	Recommendation	Citation	Photos	Figure
119	Campground: Campground - Women's Restroom	[31.9196143, -106.0364397]	Coat hooks provided within the room shall be located within one of the reach ranges specified in 308. Shelves shall be 40 inches (1015 mm) minimum and 48 inches (1220 mm) maximum above the finish floor or ground. Where coat hooks or shelves are provided in dressing, fitting or locker rooms without individual compartments, at least one of each type shall comply with 803.5. Where coat hooks or shelves are provided in individual compartments at least one of each type complying with 803.5 shall be provided in individual compartments in dressing, fitting, or locker rooms required to comply with 222.1.	Hook on shower door at 61.5"	Remount at least one hook to max 48" AFF.	2015 ABAAS Section: 308.2.1, 308.1, F222.2, 803.5 2012 TAS Section: 308.2.1, 308.1, 222.2, 803.5 2010 ADAS Section: 308.2.1, 308.1, 222.2, 803.5

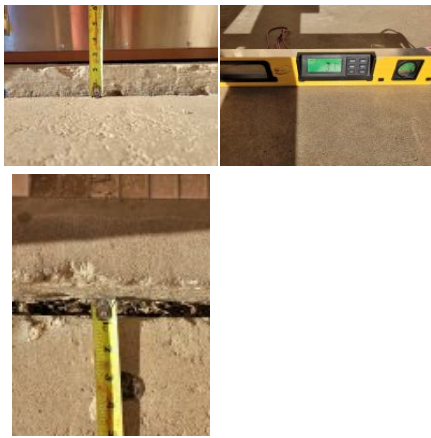
122	Campground: Campground - Women's Restroom	[31.9196172 , -106.0364 322]	Minimum maneuvering clearances at doors and gates shall comply with 404.2.4. Maneuvering clearances shall extend the full width of the doorway and the required latch side or hinge side clearance. Maneuvering clearances shall have a max slope of 2.08%. The threshold has a vertical change greater than 1/4 inch high. The threshold has a gap greater than 1/2 inch wide. The bottom 10 inches on the push side must be smooth and free of obstructions (hold open devices). Opening hardware must be mounted between 30 and 44 inches above the floor or ground.	Women's restroom door - 2.25" change in level (CIL), door holder on push side, 3.1% slope on exterior side clearance, .75" gap	For all doors along the public circulation route, provide required maneuvering clearance on push and pull side of doors. For all doors along the public circulation route, correct slope in door clearance to max 2.08%. For all doors along the public circulation route, repair, bevel, or ramp CILs at door entries to max .25". For all doors along the public circulation route, fill gaps at door entries to max .5". For all doors along the public circulation route, remove door holder to provide a smooth surface on the push side of door from floor to 10" AFF.	2010 ADAS Section: 404.2.3, 404.2.7, 404.2.4, 404.2.11, 404.2.11 Exception

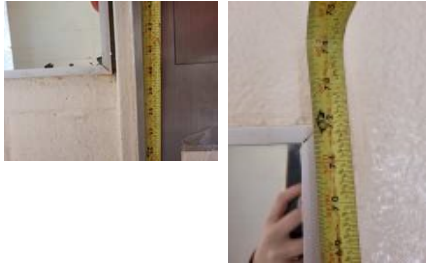
Finding Number	Area Description	Lat/Long	Finding	As Built	Recommendation	Citation	Photos	Figure
124	Campground: Campground - Women's Restroom	[31.9196113 , -106.0364 329]	The mirror is mounted too high. Mirrors must have the bottom edge of the reflecting surface a maximum of 40 inches above the floor if above a sink or counter. Mirrors not located above lavatories or countertops shall be installed with the bottom edge of the reflecting surface 35 inches maximum above the finish floor or ground.	Bottom edge at 40.5" above the finished floor (AFF), 71.5" AFF to top edge	Replace mirror mount to max 40" AFF to the bottom reflective surface and 74" to the top.	2015 ABAAS Section: 603.3 2012 TAS Section: 603.3 2010 ADAS Section: 603.3

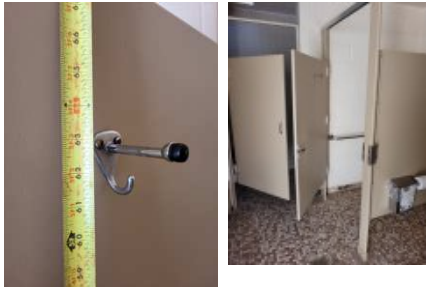
126	Campground: Campground - Women's Restroom	[31.9195999 , -106.03644 1]	The operable part is positioned too high for either a side or front approach. Where a clear floor or ground space allows a parallel approach to an element and the side reach is unobstructed, the high side reach shall be 48 inches maximum and the low side reach shall be 15 inches minimum above the finish floor or ground. Where a forward reach is unobstructed, the high forward reach shall be 48 inches maximum and the low forward reach shall be 15 inches minimum above the finish floor or ground.	Hook in stall at 61" above the finished floor (AFF)	Remount operable parts to be in reach range of 15" min to 48" max.	2015 ABAAS Section: 308.1 2012 TAS Section: 308.1 2010 ADAS Section: 308.1

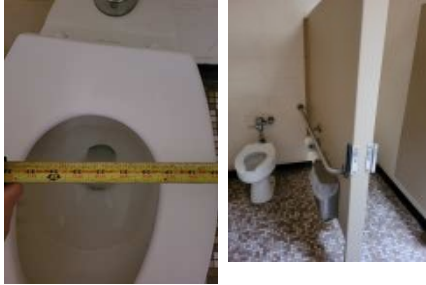
Finding Number	Area Description	Lat/Long	Finding	As Built	Recommendation	Citation	Photos	Figure
129	Campground: Campground - Women's Restroom	[31.9196045, -106.0364356]	The toilet is not located within the range to the side wall or partition. The centerline of the toilet shall be 17 inches minimum and 19 inches maximum side wall or partition in the ambulatory accessible toilet compartment.	Centerline of toilet is 22" towards partition	Remount toilet to 17" to 19" from the side wall to center line in ambulatory stalls, or 16" to 18" in new wheelchair stall.	2015 ABAAS Section: 604.9.1 2012 TAS Section: 604.9.1 2010 ADAS Section: 604.9.1

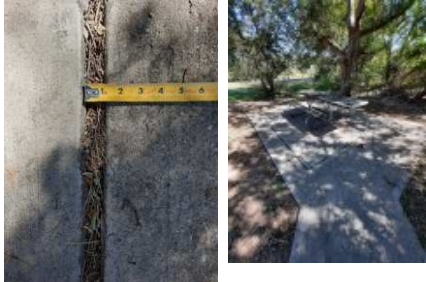
137	Campground: Campground - Sample Campsite	[31.9192732 , -106.0364 456]	Openings in the surface of outdoor recreation access routes shall not allow the passage of a sphere more than 1/2 inch (13 mm) in diameter. Advisory: Spaces between the boards in a boardwalk and drainage grates are examples of openings. Where possible, drainage grates should be located outside the minimum clear width of the outdoor recreation access route. Elongated openings should be placed so that the long dimension is perpendicular, or as close to perpendicular as possible, to the dominant direction of travel	Sample campsite 15 - gap of 1" on all 4 sides of accessible picnic table and in CFS of table	Correct or fill gaps along the ORAR to max .5" as a smart practice.	2015 ABAAS Section: 1016.6, Advisory 1016.6

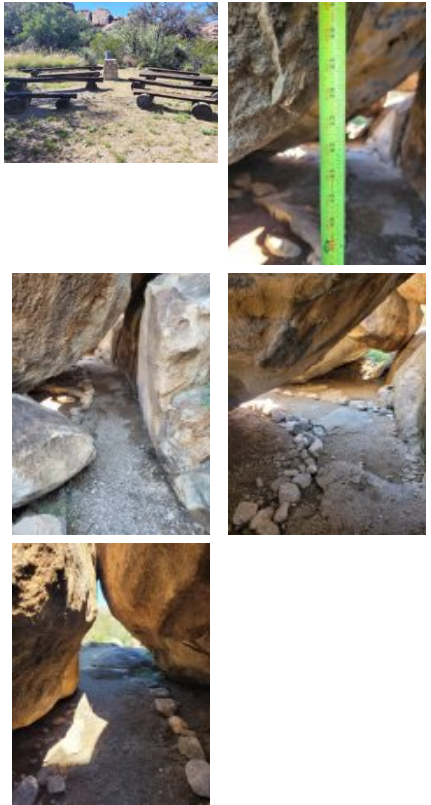
142	Campground: Campground - Amphitheater	[31.92092, -106.0386]	Based on the number of seats provided in this area of approximately 40, there should be a minimum of two wheelchair seating spaces. Wheelchair spaces shall be provided in assembly areas with fixed seating.	non accessible surface at amphitheater, lacks designated accessible seating	Provide designated wheelchair seating on a firm and stable surface with an adjacent companion seat.	2015 ABAAS Section: F221.2, F221.2.1.1 2012 TAS Section: 221.2, 221.2.1.1 2010 ADAS Section: 221.2, 221.2.1.1

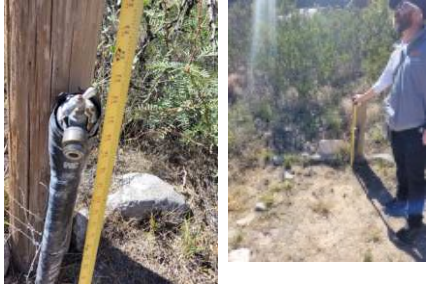
Finding Number	Area Description	Lat/Long	Finding	As Built	Recommendation	Citation	Photos	Figure
143	Campground: Campground - Amphitheater	[31.9208689 , -106.0382 282]	There is no accessible route to the water spigot. At least one accessible route shall connect accessible buildings, accessible facilities, accessible elements, and accessible spaces that are on the same site. Water spouts at water hydrants and water utility hook-ups shall be 28 inches (710 mm) minimum and 36 inches (915 mm) maximum above the ground.	Water spigot at amphitheater - lacks route and is 19" above ground level	Create an accessible route with crushed stone or other outdoor material from parking or walkway to water spigot. Remount water spouts to 28" min or 36" max above the ground as a smart practice. Leave as is if operated by employees only.	2015 ABAAS Section: F206.2.2 2012 TAS Section: 206.2.2 2010 ADAS Section: 206.2.2

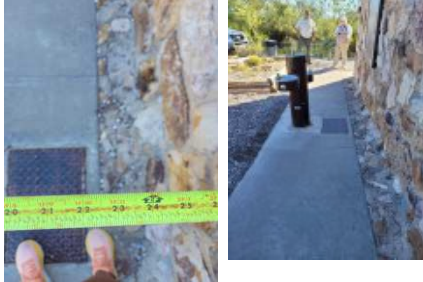
146	Restrooms at Gate: Gate - Exterior Accessible Route	[31.9266172, -106.0452697]	The route of travel at this location does not provide the required minimum width. The minimum clear width for sidewalks and walks is 36 inches.	Northside restroom- 22.5" width at fountain due to fountain placement	Widen EAR to min 36" clear width, or relocate drinking fountain.	2015 ABAAS Section: 403.5.1 2012 TAS Section: 403.5.1 2010 ADAS Section: 403.5.1

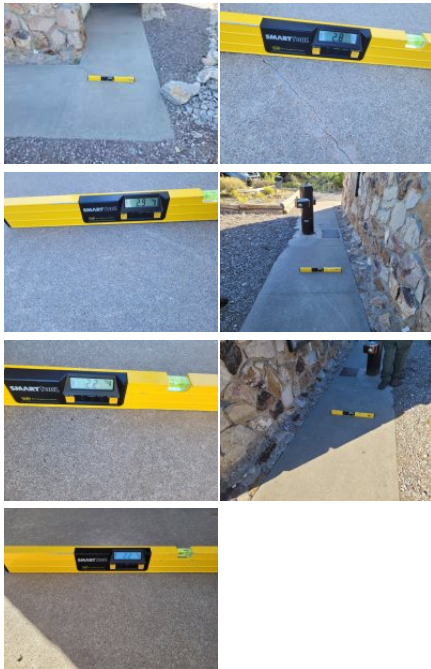
148	Restrooms at Gate: Gate - Exterior Accessible Route	[31.9266218, -106.0452651]	The running slope of walking surfaces shall not be steeper than 1:20. The cross slope of walking surfaces shall not be steeper than 1:48.	Northside restrooms- 2.8% cross slope at women's turn, 2.9% near fountain, 2.2% at men's turn, 2.2% at men's restroom	Correct cross slopes to max 2.08%.	2012 TAS Section: 403.3 2010 ADAS Section: 403.3

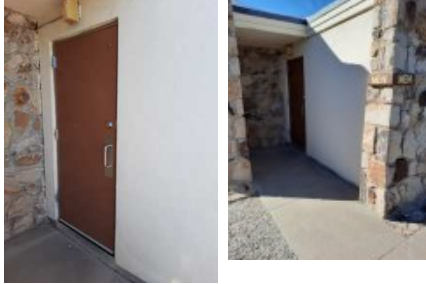
151	Restrooms at Gate: Gate - Men's Restroom	[31.9266067 , -106.0452 651]	The restroom sign does not comply with one or more applicable requirements for the location, height, and properties of the sign.	Lacks signage near door, existing sign lacks Braille, ISA, raised characters	Replace sign with one of contrasting colors that includes Braille, raised characters, and the symbol of accessibility and mount on the wall, latch side of the door, 48" to the baseline of the lowest character and 60" to the baseline of the highest character.	2015 ABAAS Section: F216.2, 703.1, 703.2, 703.5, 703.6 2012 TAS Section: 216.2, 703.1, 703.2, 703.5, 703.6 2010 ADAS Section: 216.2, 703.1, 703.2, 703.5, 703.6

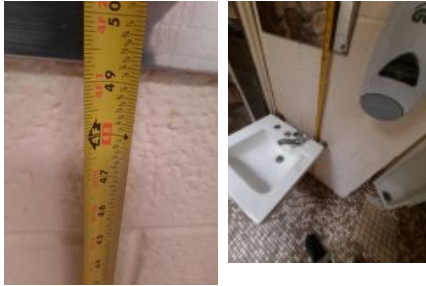
Finding Number	Area Description	Lat/Long	Finding	As Built	Recommendation	Citation	Photos	Figure
152	Restrooms at Gate: Gate - Men's Restroom	[31.9265999, -106.0452571]	The mirror is mounted too high. Mirrors must have the bottom edge of the reflecting surface a maximum of 40 inches above the floor if above a sink or counter. Mirrors not located above lavatories or countertops shall be installed with the bottom edge of the reflecting surface 35 inches maximum above the finish floor or ground.	Bottom edge of mirror at 49.5"	Replace mirror mount to max 40" AFF to the bottom reflective surface and 74" to the top.	2015 ABAAS Section: 603.3 2012 TAS Section: 603.3 2010 ADAS Section: 603.3

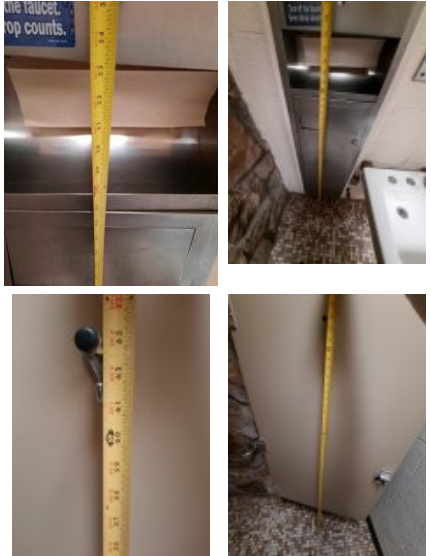
155	Restrooms at Gate: Gate - Men's Restroom	[31.92665, -106.0453]	The operable part is positioned too high for either a side or front approach. Where a clear floor or ground space allows a parallel approach to an element and the side reach is unobstructed, the high side reach shall be 48 inches maximum and the low side reach shall be 15 inches minimum above the finish floor or ground. Where a forward reach is unobstructed, the high forward reach shall be 48 inches maximum and the low forward reach shall be 15 inches minimum above the finish floor or ground.	Paper towel dispenser at 53.25", hook in stall at 61.75"	Remount hook to 48" max. Leave as is paper towels citing safe harbor.	2015 ABAAS Section: 308.1 2012 TAS Section: 308.1 2010 ADAS Section: 308.1

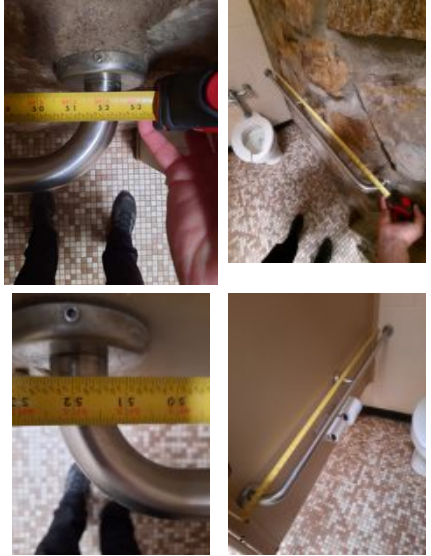
160	Restrooms at Gate: Gate - Men's Restroom	[31.9266022, -106.0452718]	The side grab bars are not in the correct location. Grab bars on the side wall must be installed so that the end closest to the rear wall is maximum 12" from the rear wall. The end furthest from the rear wall must be mounted minimum 54" from the rear wall.	Both bars end 52" from rear wall	Remount one side grab bars to max 12" from the rear wall at the close end and min 54" on the far end, and 33" to 36" AFF.	2015 ABAAS Section: 604.5.1 2012 TAS Section: 604.5.1 2010 ADAS Section: 604.5.1

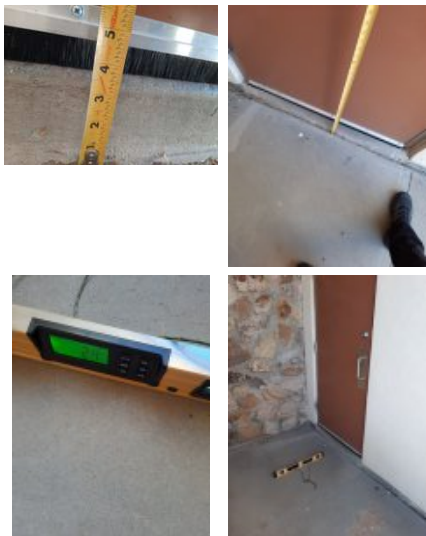
Finding Number	Area Description	Lat/Long	Finding	As Built	Recommendation	Citation	Photos	Figure
165	Restrooms at Gate: Gate - Men's Restroom	[31.9266, -106.045259]	Minimum maneuvering clearances at doors and gates shall comply with 404.2.4. Maneuvering clearances shall extend the full width of the doorway and the required latch side or hinge side clearance. Maneuvering clearances shall have a max slope of 2.08%. The threshold has a vertical change greater than 1/4 inch high.	Men's restroom at gate door - 3.5" change in elevation (CIL), 2.4% slope in pull side clearance	For all doors along the public circulation route, provide required maneuvering clearance on push and pull side of doors. For all doors along the public circulation route, correct slope in door clearance to max 2.08%. For all doors along the public circulation route, repair, bevel, or ramp CILs at door entries to max .25".	2010 ADAS Section: 404.2.3, 404.2.7, 404.2.4, 404.2.11, 404.2.11 Exception

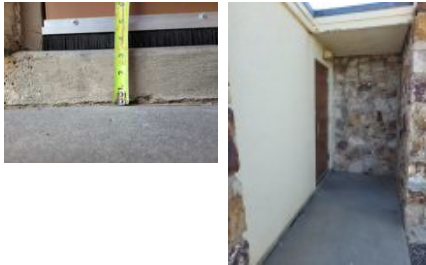
166	Restrooms at Gate: Gate - Women's Restroom	[31.9265934, -106.0452879]	The threshold has a vertical change greater than 1/4 inch high. Exterior doors are recommended to be maintained at 8.5 lbf as a smart practice. Force is to be measured at the operating hardware or 30 inches from the hinges, whichever is greater.	Women's restroom at gate door - 15# push, 3.25" change in elevation (CIL)	For all doors along the public circulation route, repair, bevel, or ramp CILs at door entries to max .25". For all doors along the public circulation route, inspect, adjust, and maintain 8.5 lbf to open exterior doors as a smart practice.	2010 ADAS Section: 404.2.3, 404.2.7, 404.2.4, 404.2.11, 404.2.11 Exception

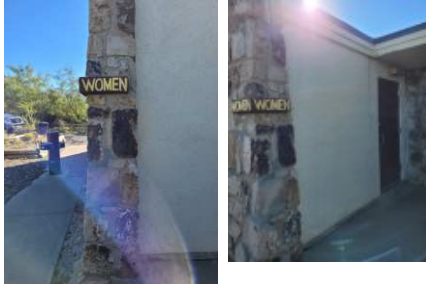
Finding Number	Area Description	Lat/Long	Finding	As Built	Recommendation	Citation	Photos	Figure
167	Restrooms at Gate: Gate - Women's Restroom	[31.9266032, -106.0452893]	The restroom sign does not comply with one or more applicable requirements for the location, height, and properties of the sign.	Lacks signage at door - lacks braille, ISA, raised characters	Replace sign with one of contrasting colors that includes Braille, raised characters, and the symbol of accessibility and mount on the wall, latch side of the door, 48" to the baseline of the lowest character and 60" to the baseline of the highest character.	2015 ABAAS Section: F216.2, 703.1, 703.2, 703.5, 703.6 2012 TAS Section: 216.2, 703.1, 703.2, 703.5, 703.6 2010 ADAS Section: 216.2, 703.1, 703.2, 703.5, 703.6

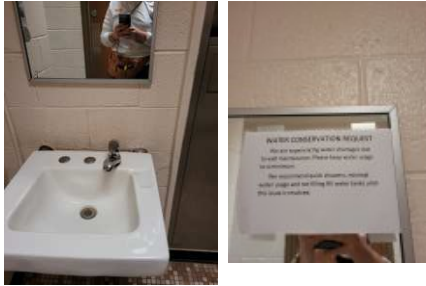
Finding Number	Area Description	Lat/Long	Finding	As Built	Recommendation	Citation	Photos	Figure
169	Restrooms at Gate: Gate - Women's Restroom	[31.9266054 , -106.0452 933]	The self closing faucet controls do not stay open for a minimum of 10 seconds. Faucet controls and operating mechanisms shall be operable with one hand and shall not require tight grasping, pinching or twisting of the wrist. The force required to activate controls shall be no greater than 5 lb. Lever-operated, push-type and electronically controlled mechanisms are examples of acceptable designs. Self-closing valves are allowed if the faucet remains open for at least 10 seconds.	Self-closing faucet stays on for 3 seconds - water conservation in effect	Adjust timing of sink faucets to remain on for min. 10 seconds on accessible sink.	2015 ABAAS Section: 606.4 2012 TAS Section: 606.4 2010 ADAS Section: 606.4

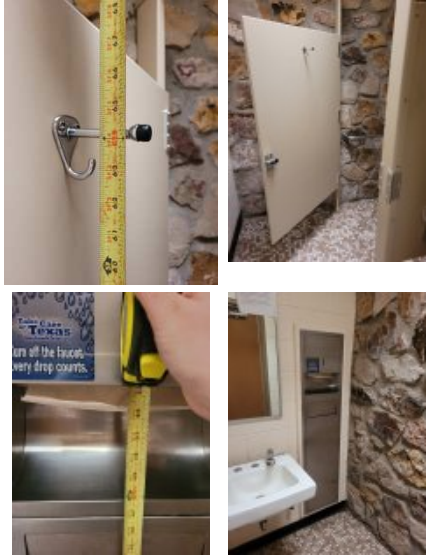
171	Restrooms at Gate: Gate - Women's Restroom	[31.9265872 , -106.0452 893]	The operable part is positioned too high for either a side or front approach. Where a clear floor or ground space allows a parallel approach to an element and the side reach is unobstructed, the high side reach shall be 48 inches maximum and the low side reach shall be 15 inches minimum above the finish floor or ground. Where a forward reach is unobstructed, the high forward reach shall be 48 inches maximum and the low forward reach shall be 15 inches minimum above the finish floor or ground.	Hook at 62.75" above the finished floor (AFF), paper towels at 52" AFF	Remount hook to 48" max. Leave as is paper towels citing safe harbor.	2015 ABAAS Section: 308.1 2012 TAS Section: 308.1 2010 ADAS Section: 308.1

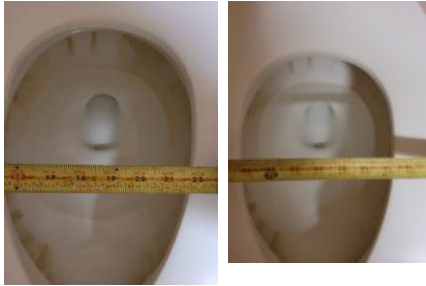
Finding Number	Area Description	Lat/Long	Finding	As Built	Recommendation	Citation	Photos	Figure
174	Restrooms at Gate: Gate - Women's Restroom	[31.9266032, -106.0452893]	The toilet is not located within the range to the side wall or partition. The centerline of the toilet shall be 17 inches minimum and 19 inches maximum side wall or partition in the ambulatory accessible toilet compartment.	Centerline of toilet is 18.5" to rock wall side, 22" to partition side	Remount toilet to 17" to 19" from the side wall to center line in ambulatory stalls, or 16" to 18" in new wheelchair stall.	2015 ABAAS Section: 604.9.1 2012 TAS Section: 604.9.1 2010 ADAS Section: 604.9.1

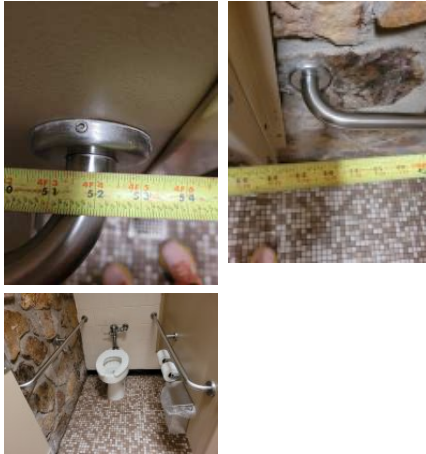
Finding Number	Area Description	Lat/Long	Finding	As Built	Recommendation	Citation	Photos	Figure
176	Restrooms at Gate: Gate - Women's Restroom	[31.9266009, -106.0452893]	The side grab bars are not in the correct location. Grab bars on the side wall must be installed so that the end closest to the rear wall is maximum 12" from the rear wall. The end furthest from the rear wall must be mounted minimum 54" from the rear wall.	Both bars extend 52" from rear wall	Remount one side grab bar to max 12" from the rear wall at the close end and min 54" on the far end, and 33" to 36" AFF.	2015 ABAAS Section: 604.5.1 2012 TAS Section: 604.5.1 2010 ADAS Section: 604.5.1

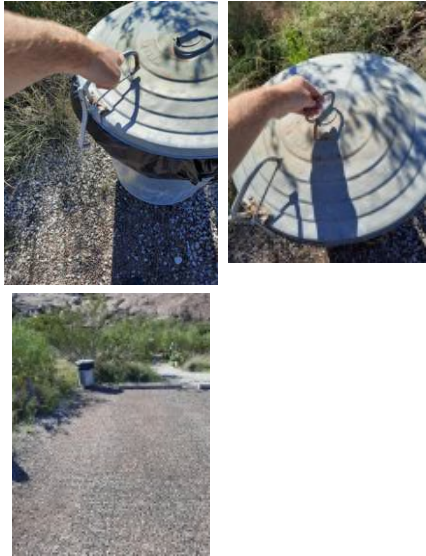
Finding Number	Area Description	Lat/Long	Finding	As Built	Recommendation	Citation	Photos	Figure
179	Restrooms at Gate: Gate - Elements	[31.9262187, -106.044]	The operable part is not accessible because it requires tight grasping, pinching or twisting of the wrist.	Garbage can at parking lot between restrooms at gate and shelter 4 requires two hands and tight grasp to open	Replace operable part with one usable without a tight pinch or grasp.	2015 ABAAS Section: 309.4 2012 TAS Section: 309.4 2010 ADAS Section: 309.4

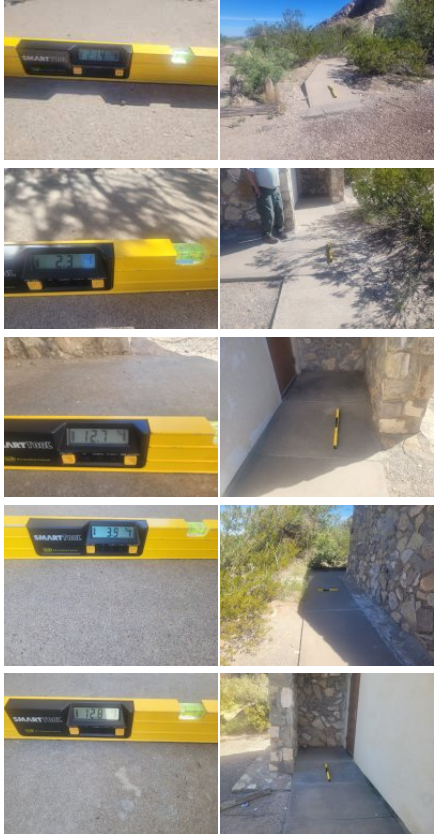
Finding Number	Area Description	Lat/Long	Finding	As Built	Recommendation	Citation	Photos	Figure
183	West Restrooms: West RR - Exterior Accessible Route	[31.9216095 , -106.0489 987]	The running slope of walking surfaces shall not be steeper than 1:20. The cross slope of walking surfaces shall not be steeper than 1:48.	21.4% running slope at start of path, 2.3% cross at turn, 12.7% running by women's restroom, 3.9% cross to men's restroom, 12.8% running at men's restroom	Correct running slopes to max 5% and cross to max 2.08%.	2012 TAS Section: 403.3 2010 ADAS Section: 403.3

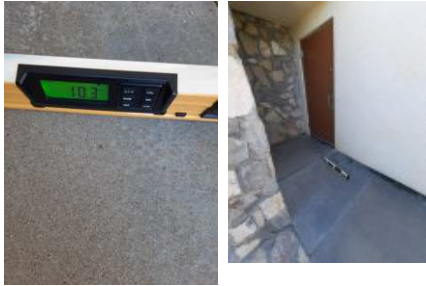
Finding Number	Area Description	Lat/Long	Finding	As Built	Recommendation	Citation	Photos	Figure
186	West Restrooms: West RR - Men's Restroom	[31.9216533 , -106.0489 228]	Minimum maneuvering clearances at doors and gates shall comply with 404.2.4. Maneuvering clearances shall extend the full width of the doorway and the required latch side or hinge side clearance. Maneuvering clearances shall have a max slope of 2.08%. The sweep period for doors with closers shall be adjusted so that from an open position of 70 degrees, the door will take at least 3 seconds to move to a point 3 inches from the latch, measured to the leading edge of the door. Exterior doors are recommended to be maintained at 8.5 lbf as a smart practice. Force is to be measured at the operating hardware or 30 inches from the hinges, whichever is greater.	West Restrooms Men's Restroom door - 10.2% slope in pull side clearance, fast close, 12# push	For all doors along the public circulation route, provide required maneuvering clearance on push and pull side of doors. For all doors along the public circulation route, correct slope in door clearance to max 2.08%. For all doors along the public circulation route, inspect, adjust, and maintain closing speed on door closers. For all doors along the public circulation route, inspect, adjust, and maintain 8.5 lbf to open exterior doors as a smart practice.	2010 ADAS Section: 404.2.3, 404.2.7, 404.2.4, 404.2.11, 404.2.11 Exception

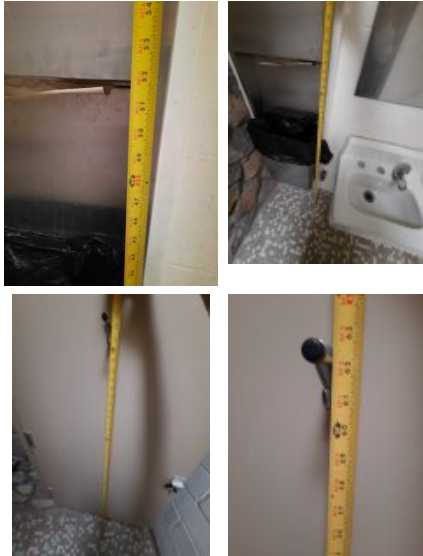
192	West Restrooms: West RR - Men's Restroom	[31.9216346, -106.0489257]	The operable part is positioned too high for either a side or front approach. Where a clear floor or ground space allows a parallel approach to an element and the side reach is unobstructed, the high side reach shall be 48 inches maximum and the low side reach shall be 15 inches minimum above the finish floor or ground. Where a forward reach is unobstructed, the high forward reach shall be 48 inches maximum and the low forward reach shall be 15 inches minimum above the finish floor or ground.	Paper towel dispenser at 51.75", hook in stall at 61.25"	Remount hook to 48" max. Leave as is paper towels citing safe harbor.	2015 ABAAS Section: 308.1 2012 TAS Section: 308.1 2010 ADAS Section: 308.1

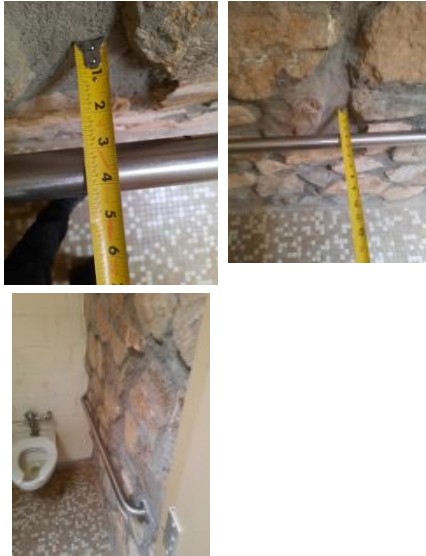
Finding Number	Area Description	Lat/Long	Finding	As Built	Recommendation	Citation	Photos	Figure
198	West Restrooms: West RR - Men's Restroom	[31.9216425, -106.0489337]	The grab bar height and/or spacing fails. Grab bars must be mounted between 33" and 36" to the top of the gripping surface. There must be 1.5" of clearance between the grab bar and the wall. There must be a minimum of 1.5" of clearance below and minimum 12" above the grab bar to any dispenser or other obstruction.	Due to uneven rock wall, grab bar spacing is up to 3" depending on how far or close to the bar the rocks protrude	Replace grab bars in accessible stall with one having 1.5" of clearance between the grab bar and the wall, 33" to 36" above the finished floor (AFF). Add rear bar.	2015 ABAAS Section: 609.3, 609.4 2012 TAS Section: 609.4, 609.3 2010 ADAS Section: 609.3, 609.4

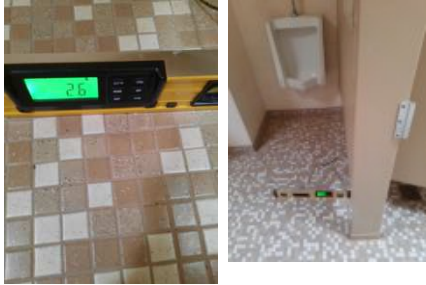
Finding Number	Area Description	Lat/Long	Finding	As Built	Recommendation	Citation	Photos	Figure
200	West Restrooms: West RR - Men's Restroom	[31.9216437, -106.0489122]	The accessible route contains running slopes greater than 5 percent and cross slopes greater than 2 percent across the width of the walk and has not been constructed as a ramp (i.e. handrails, wheel guides, etc.). When the slope in the direction of travel of any walk exceeds 1 unit vertical in 20 units horizontal (5-percent slope), it must be constructed as ramp. Surface cross slopes must not exceed one unit vertical in 48 units. Horizontal (2-percent slope).	2.6% slope in front of urinal near floor drain in stall	Correct or repair slope to max 2.08% in restroom.	2015 ABAAS Section: 403.3 2012 TAS Section: 403.3 2010 ADAS Section: 403.3

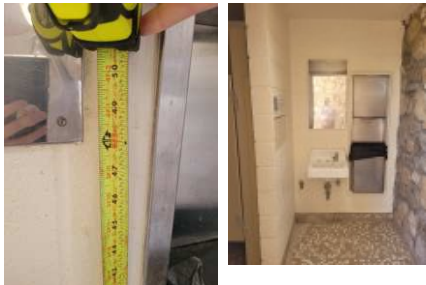
202	West Restrooms: West RR - Women's Restroom	[31.9216533, -106.0489249]	The mirror is mounted too high. Mirrors must have the bottom edge of the reflecting surface a maximum of 40 inches above the floor if above a sink or counter. Mirrors not located above lavatories or countertops shall be installed with the bottom edge of the reflecting surface 35 inches maximum above the finish floor or ground.	Bottom of mirror at 48" above the finished floor (AFF)	Replace mirror mount to max 40" AFF to the bottom reflective surface and 74" to the top.	2015 ABAAS Section: 603.3 2012 TAS Section: 603.3 2010 ADAS Section: 603.3

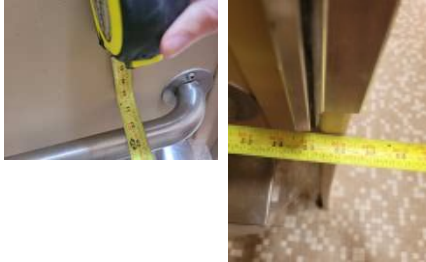
Finding Number	Area Description	Lat/Long	Finding	As Built	Recommendation	Citation	Photos	Figure
206	West Restrooms: West RR - Women's Restroom	[31.9216453 , -106.04893 7]	The ambulatory stall is not between 35" to 37" wide and 60" deep.	Ambulatory stall lacks required dimensions - 39" x 55.5"	Correct ambulatory stall to be 35" to 37" wide and minimum 60" deep. In the alternative, use existing stall to create required wheelchair accessible stall.	2015 ABAAS Section: 604.8.2.1 2012 TAS Section: 604.8.2.1 2010 ADAS Section: 604.8.2.1

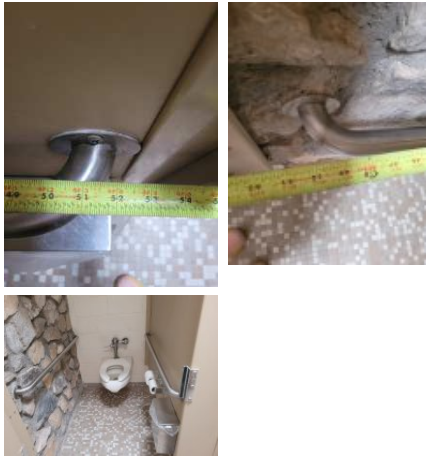
209	West Restrooms: West RR - Women's Restroom	[31.9216464 , -106.0489 464]	The side grab bars are not in the correct location. Grab bars on the side wall must be installed so that the end closest to the rear wall is maximum 12" from the rear wall. The end furthest from the rear wall must be mounted minimum 54" from the rear wall.	Rock side bar ends 50" from rear wall, TP side bar ends 51" from rear wall	Remount one side grab bar to max 12" from the rear wall at the close end and min 54" on the far end, and 33" to 36" AFF.	2015 ABAAS Section: 604.5.1 2012 TAS Section: 604.5.1 2010 ADAS Section: 604.5.1

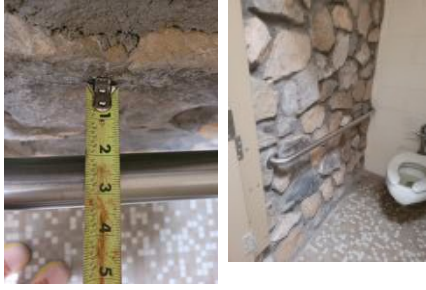
Finding Number	Area Description	Lat/Long	Finding	As Built	Recommendation	Citation	Photos	Figure
210	West Restrooms: West RR - Women's Restroom	[31.9216464 , -106.0489 209]	The grab bar height and/or spacing fails. Grab bars must be mounted between 33" and 36" to the top of the gripping surface. There must be 1.5" of clearance between the grab bar and the wall. There must be a minimum of 1.5" of clearance below and minimum 12" above the grab bar to any dispenser or other obstruction.	Bar is 2" from wall on rock side	Replace grab bars in accessible stall to have 1.5" of clearance between the grab bar and the wall, 33" to 36" above the finished floor (AFF). Add rear grab bar.	2015 ABAAS Section: 609.3, 609.4 2012 TAS Section: 609.4, 609.3 2010 ADAS Section: 609.3, 609.4

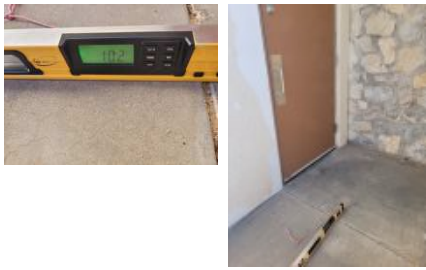
212	West Restrooms: West RR - Women's Restroom	[31.9216365 , -106.0489 185]	Minimum maneuvering clearances at doors and gates shall comply with 404.2.4. Maneuvering clearances shall extend the full width of the doorway and the required latch side or hinge side clearance. Maneuvering clearances shall have a max slope of 2.08%.	West restroom women's door - 10.2% slope in clearance on pull side	For all doors along the public circulation route, provide required maneuvering clearance on push and pull side of doors. For all doors along the public circulation route, correct slope in door clearance to max 2.08%.	2010 ADAS Section: 404.2.3, 404.2.7, 404.2.4, 404.2.11, 404.2.11 Exception

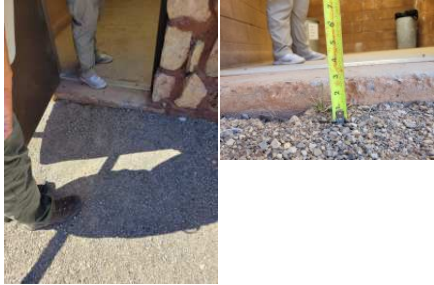
Finding Number	Area Description	Lat/Long	Finding	As Built	Recommendation	Citation	Photos	Figure
213	Pond Trail Restrooms: Clivus/Backcountry Toilet	[31.9201389, -106.0419496]	Minimum maneuvering clearances at doors and gates shall comply with 404.2.4. Maneuvering clearances shall extend the full width of the doorway and the required latch side or hinge side clearance. Maneuvering clearances shall have a max slope of 2.08%. The threshold has a vertical change greater than 1/4 inch high. Exterior doors are recommended to be maintained at 8.5 lbf as a smart practice. Force is to be measured at the operating hardware or 30 inches from the hinges, whichever is greater.	Pond Trail restroom door - surface on exterior is not accessible, 3" change in elevation (CIL), 16# push	For all doors along the public circulation route, provide required maneuvering clearance on push and pull side of doors. For all doors along the public circulation route, repair, bevel, or ramp CILs at door entries to max .25". For all doors along the public circulation route, inspect, adjust, and maintain 8.5 lbf to open exterior doors as a smart practice.	2010 ADAS Section: 404.2.3, 404.2.7, 404.2.4, 404.2.11, 404.2.11 Exception

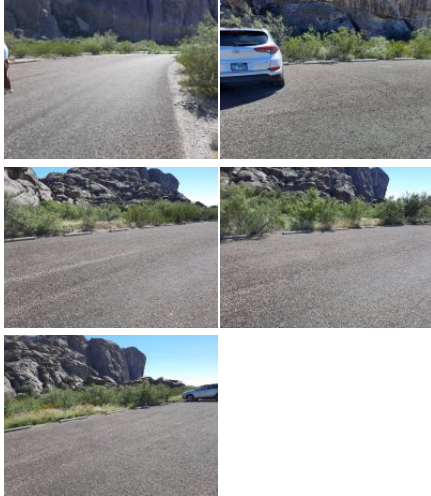
223	Trails: Trails - Parking areas along road	[31.92351, -106.0484]	There are no or not enough accessible parking stalls. Each lot where parking is provided for the public as clients, guests or employees, shall provide accessible parking and shall be located on the shortest accessible route of travel from adjacent parking to an accessible entrance. There are a total of 39 parking stalls in the parking lot that could be reasonably associated with this facility. There should be a minimum of 2 accessible stalls with a minimum of 1 being designed as van accessible.	Northside Parking - 39 standard, 0 accessible	Create two or more 8' accessible parking stalls, with one 5' adjacent access aisle, with proper signage and striping based on the total number of stalls.	2015 ABAAS Section: F208.2 2012 TAS Section: 208.2 2010 ADAS Section: 208.2

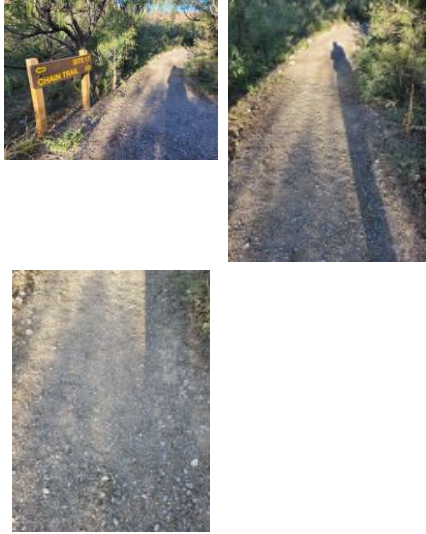
Finding Number	Area Description	Lat/Long	Finding	As Built	Recommendation	Citation	Photos	Figure
224	Trails: Trails - Chain Trail	[31.923225, -106.0407107]	The surface of trails, passing spaces, and resting intervals shall be firm and stable	Chain Trail - lacks accessible surface	Replace trail surface with one that is firm and stable as a smart practice.	2015 ABAAS Section: 1017.2

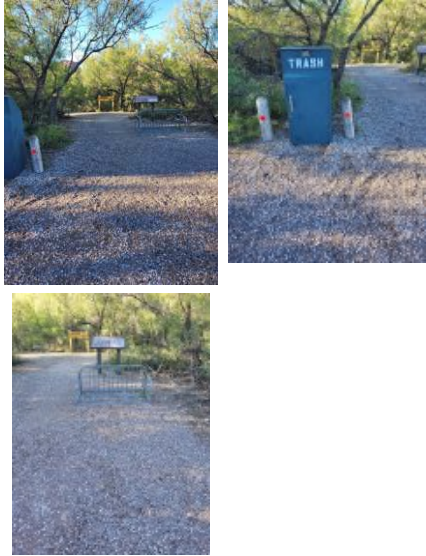
225	Trails: Trails - Chain Trail	[31.9232728, -106.0406611]	The surface of outdoor recreation access routes, passing spaces, and resting intervals shall be firm and stable	Lacks route to Chain Trail trailhead due to non-compliant surface; lacks route to bike rack, sign, and garbage	Repair surface or ORAR to be firm and stable as a smart practice to trailhead and each element.	2015 ABAAS Section: 1016.2
