Access Audit Site Report

Huntsville State Park

Accessibility Evaluation

Inspection Date: 06/14/2021

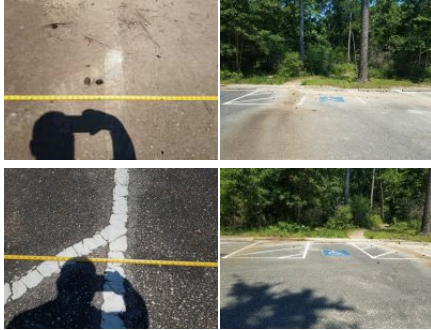
| Finding Number | Area Description | Lat/Long | Finding | As Built | Recommendation | Citation | Photos | Figure |
|---|--|---|---|---|---|--|---|--|
| 26 | Headquarters Area: Parking - Trailhead At HQ | [30.6261925 , -95.527159 8] | The accessible parking stall is not wide enough. Each parking space must be at least 8' feet wide and shall be marked to define the width. The measurements of parking spaces and access aisles shall be made from the centerline of the markings. Where the parking space is not adjacent to another parking space or access aisle, the measurement shall be permitted to include the full width of the line defining the parking space. | Lacks 8' width requirement for accessible parking stall (5th stall - 93.5" and 4th stall - 94") | Repaint stalls to be 8' wide each | 2015 ABAAS Section: 502.2 2012 TAS Section: 502.2 2010 ADAS Section: 502.2 | | |

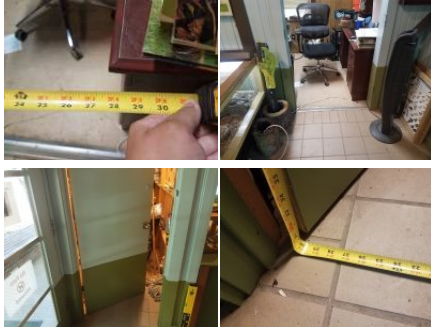
| Finding Number | Area Description | Lat/Long | Finding | As Built | Recommendation | Citation | Photos | Figure |
|---|--|---|---|--|--|---|---|---|
| 33 | Headquarters Area: Nature Center | [30.6263726, -95.52788] | Spaces and elements within employee work areas shall only be required to comply with 206.2.8, 207.1, and 215.3 and shall be designed and constructed so that individuals with disabilities can approach, enter, and exit the employee work area. Employee work areas, or portions of employee work areas, other than raised courtroom stations, that are less than 300 square feet (28 m2) and elevated 7 inches (180 mm) or more above the finish floor or ground where the elevation is essential to the function of the space shall not be required to comply with these requirements or to be on an accessible route. | office 28" at desk; storage- 29", knob, wall pull side | For employee spaces, relocate storage, furniture, and other obstacles at doorways to provide approach, enter and exit at the employee space. | 2015 ABAAS Section: F203.9 2012 TAS Section: 203.9 2010 ADAS Section: 203.9 | | |

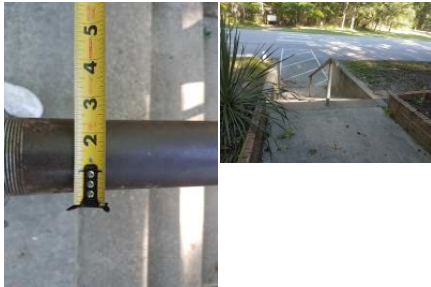
| Finding Number | Area Description | Lat/Long | Finding | As Built | Recommendation | Citation | Photos | Figure |
|---|---|---|---|---|--|---|---|---|
| 58 | Headquarters Area: Nature Center | [30.6263079 , -95.527798 2] | The handrail gripping diameter is noncompliant. Handrail gripping surfaces with a circular cross section shall have an outside diameter of 1 1/4 inches minimum and 2 inches maximum. Handrail gripping surfaces with a non-circular cross section shall have a perimeter dimension of 4 inches minimum and 6 1/4 inches maximum, and a cross-section dimension of 2 1/4 inches maximum. | Handrails lack compliant gripping surface diameter (2.5") | Install handrails on both sides of stairway, mounted 34" to 38" aff with top and bottom extensions and having a 1.25" – 2" in diameter, or a non-circular grip that has a perimeter dimension of 4" - 6.25" max with a min gap of 1.5" between handrail and wall | 2015 ABAAS Section: 505.7 2012 TAS Section: 505.7 2010 ADAS Section: 505.7 | | (a) (b) |

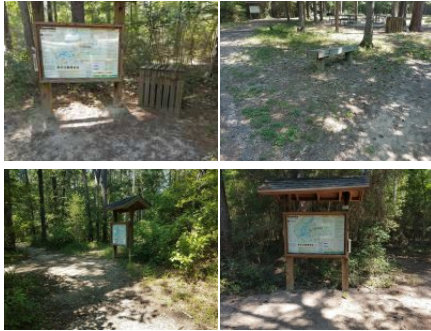
| Finding Number | Area Description | Lat/Long | Finding | As Built | Recommendation | Citation | Photos | Figure |
|---|---|---|--|--|---|---|---|---|
| 62 | Headquarters Area: Nature Center | [30.6263968 , -95.528169 7] | The operable part is not accessible because there is not adequate clear floor space for either a forward or side approach. The clear floor or ground space shall be 30 inches minimum by 48 inches minimum. | Lacks clear ground space at trailhead features (3 signs, garbage can, and bench) | Provide required 30" by 48" CFS at operable parts | 2015 ABAAS Section: 305.3 2012 TAS Section: 305.3 2010 ADAS Section: 305.3 | | |

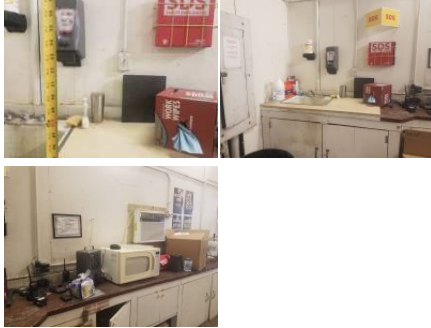
| Finding Number | Area Description | Lat/Long | Finding | As Built | Recommendation | Citation | Photos | Figure |
|---|---|---|---|---|---|--|--|--|
| 77 | Employee Spaces: Maintenance | [30.6223241, -95.5326074] | The fan switch, soap dispenser, MSDS binder, and AC unit are positioned too high for either a side or front approach. Where a clear floor or ground space allows a parallel approach to an element and the side reach is unobstructed, the high side reach shall be 48 inches maximum and the low side reach shall be 15 inches minimum above the finish floor or ground. Where a forward reach is unobstructed, the high forward reach shall be 48 inches maximum and the low forward reach shall be 15 inches minimum above the finish floor or ground. | mower shop break room- Fan switch, soap dispenser, MSDS binder, and AC unit (all obstructed) exceed reach range | Remount operable parts to be in reach range of 15" min to 48" max | 2015 ABAAS Section: 308.1 2012 TAS Section: 308.1 2010 ADAS Section: 308.1 | | |

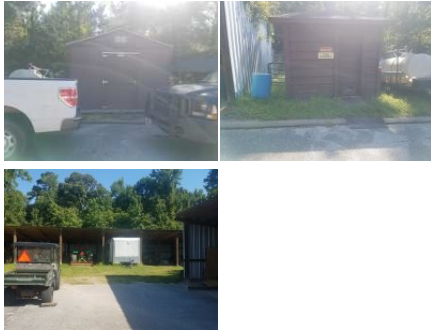
| Finding Number | Area Description | Lat/Long | Finding | As Built | Recommendation | Citation | Photos | Figure |
|---|---|---|---|--|--|---|--|---|
| 84 | Employee Spaces: Maintenance | [30.6227742 , -95.532745 5] | There is no accessible route between the buildings. At least one accessible route shall connect accessible buildings, facilities, elements and spaces that are on the same site. | Lacks accessible route to shed, toxic materials building, and vehicle storage site. | Create AR with crushed and compacted stone or similar outdoor material from building to building within the site | 2015 ABAAS Section: F206.2.2 2012 TAS Section: 206.2.2 2010 ADAS Section: 206.2.2 | | |

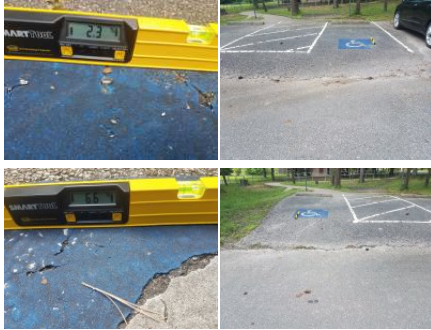
| Finding Number | Area Description | Lat/Long | Finding | As Built | Recommendation | Citation | Photos | Figure |
|---|---|---|---|--|---|--|--|--|
| 91 | Raven Hill Camping Area: Parking - Raven Hill | [30.6177031 , -95.5289837] | The cross slopes (narrow dimension) and/or running slopes (long dimension) of the access aisle exceeds 2%. The running slope and the cross slope in an accessible parking stall and the access aisle must not exceed 2%. | Slopes of 2.3% in right stall and 6.6% in left stall | Repair or correct slope of parking space and access aisle to max 2.08% in any direction | 2015 ABAAS Section: 502.4 2012 TAS Section: 502.4 2010 ADAS Section: 502.4 | | |

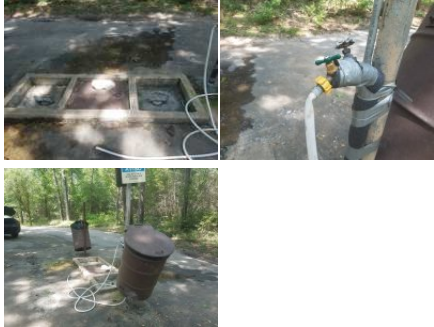
| Finding Number | Area Description | Lat/Long | Finding | As Built | Recommendation | Citation | Photos | Figure |
|---|--|---|---|--|---|--|---|---|
| 125 | Raven Hill Camping Area: Raven Hill Camping | [30.6202446 , -95.527482] | The spigot is not accessible because it requires tight grasping, pinching or twisting of the wrist. The foot operated drain cover is not accessible because it is not within the required reach range of 15" to 48". | Dump site amenities difficult to operate without tight pinch or grasp, foot operated dump station | Replace spigot hardware with an operable part usable without a tight pinch or grasp. Provide hardware to operate the drain cover that is between 15" and 48" aff. | 2015 ABAAS Section: 309.4 2012 TAS Section: 309.4 2010 ADAS Section: 309.4 | | |

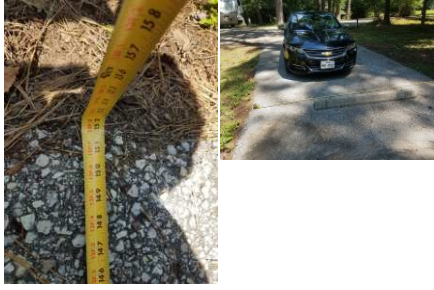
| Finding Number | Area Description | Lat/Long | Finding | As Built | Recommendation | Citation | Photos | Figure |
|---|--|---|---|---|---|---|--|---|
| 149 | Raven Hill Camping Area: Raven Hill Camping | [30.6174053 , -95.5295617] | Parking spaces and pull-up spaces for recreational vehicles shall be 20 feet (6100 mm) wide minimum. EXCEPTION: Where two adjacent parking spaces are provided for recreational vehicles, one parking space shall be permitted to be 16 feet (4880 mm) wide minimum. | Site 50 - Parking space for recreational vehicles lacks required 20' width (12' 8") | Correct RV parking space to be 20' wide minimum; or 16' for two adjacent spaces as a smart practice. | 2015 ABAAS Section: 1012.2, 1012.2 EXCEPTION | | |

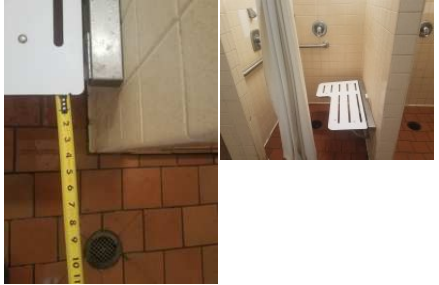
| Finding Number | Area Description | Lat/Long | Finding | As Built | Recommendation | Citation | Photos | Figure |
|---|--|---|--|--|---|--|--|---|
| 166 | Coloneh Camping Area: Coloneh Trailhead Area Restrooms | [30.617036, -95.5255116] | Where a seat is provided in a standard roll-in shower compartment, it shall be a folding type, shall be installed on the side wall adjacent to the controls, and shall extend from the back wall to a point within 3 inches (75 mm) of the compartment entry. Where a seat is provided in an alternate roll-in type shower compartment, it shall be a folding type, shall be installed on the front wall opposite the back wall, and shall extend from the adjacent side wall to a point within 3 inches (75 mm) of the compartment entry. In transfer-type showers, the seat shall extend from the back wall to a point within 3 inches (75 mm) of the compartment entry. The top of the seat shall be 17 inches (430 mm) minimum and 19 inches (485 mm) maximum above the bathroom finish floor. Seats shall comply with 610.3.1 or 610.3.2. | Men's showers - The shower seat (4") exceeds 3" maximum from compartment entry | Remount shower bench so that the front edge is within 3" of the opening | 2015 ABAAS Section: 610.3 2012 TAS Section: 610.3 2010 ADAS Section: 610.3 | | |

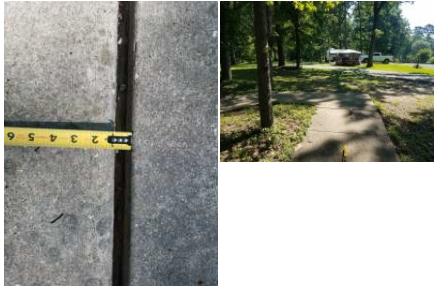
| Finding Number | Area Description | Lat/Long | Finding | As Built | Recommendation | Citation | Photos | Figure |
|---|---|---|--|---|---|--|---|---|
| 231 | Coloneh Camping Area: Coloneh Camping Restrooms | [30.6153903, -95.529241 3] | There is a gap spaced greater than a 1/2 inch. Openings in floor or ground surfaces shall not allow passage of a sphere more than 1/2 inch diameter. Elongated openings shall be placed so that the long dimension is perpendicular to the dominant direction of travel. | Gap of 1" at turn | Correct or fill gaps to be max .5" | 2015 ABAAS Section: 302.3 2012 TAS Section: 302.3 2010 ADAS Section: 302.3 | | |

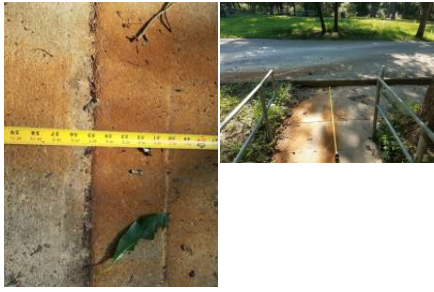
| Finding Number | Area Description | Lat/Long | Finding | As Built | Recommendation | Citation | Photos | Figure |
|---|---|---|--|---|--|---|--|---|
| 259 | Coloneh Camping Area: Coloneh Campsites | [30.6168271 , -95.524538] | The landing is not the correct length. Landings shall have a dimension in the direction of ramp run of not less than 60 inches. | Lacks landing that is 60" deep and as wide as the ramp (55" deep) | Enlarge landing to be 60" deep and as wide as the ramp | 2015 ABAAS Section: 405.7.3 2012 TAS Section: 405.7.3 2010 ADAS Section: 405.7.3 | | |

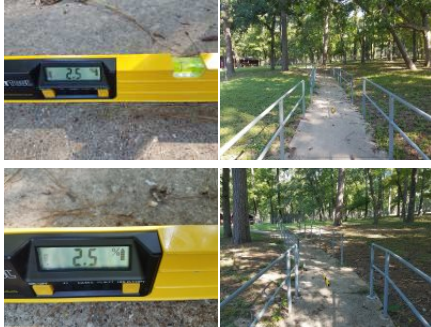
| Finding Number | Area Description | Lat/Long | Finding | As Built | Recommendation | Citation | Photos | Figure |
|---|---|--|--|--|--|---|---|---|
| 264 | Coloneh Camping Area: Coloneh Campsites | [30.6170487, -95.5252313], [30.6169379, -95.5249524] | The landing at the bottom of the ramp has a slope greater than 2%. Bottom landings shall have a dimension in the direction of ramp run of not less than 60 inches and have a slope of less than 2% in any direction. | Slopes of 2.5% (2nd landing) and 2.5% (3rd landing) | Correct ramp landing slope to max 2.08% | 2015 ABAAS Section: 405.7.1, 405.7.1 EXCEPTION 2012 TAS Section: 405.7.1, 405.7.1 Exception 2010 ADAS Section: 405.7.1, 405.7.1 Exception | | |

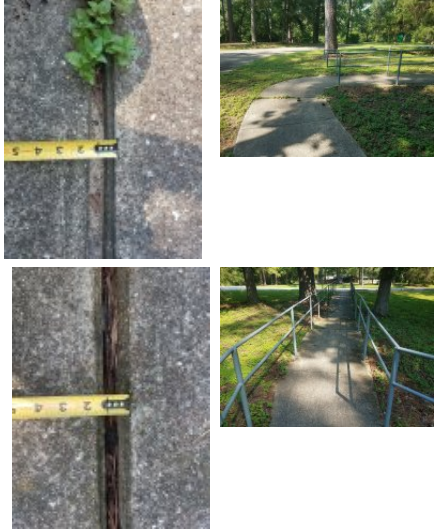
| Finding Number | Area Description | Lat/Long | Finding | As Built | Recommendation | Citation | Photos | Figure |
|---|---|---|---|---|--|--|---|---|
| 312 | Day Use Area: Group Shelter | [30.6180609 , -95.532367 3] | The accessible path of travel between the building entrance and the accessible parking contains cross slopes greater than 2%. Surface cross slopes shall not exceed one unit vertical in 48 units horizontal (2-percent slope). When the slope in the direction of travel of any walk exceeds 1 unit vertical in 20 units horizontal (5-percent slope), it must be constructed as ramp. | Cross slope of 2.9% between ramps | Correct or repair sidewalk cross slope along AR to max 2.08% | 2015 ABAAS Section: 403.3 2012 TAS Section: 403.3 2010 ADAS Section: 403.3 | | |

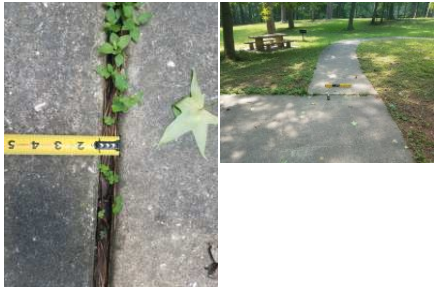
| Finding Number | Area Description | Lat/Long | Finding | As Built | Recommendation | Citation | Photos | Figure |
|---|---|---|--|---|---|--|---|---|
| 327 | Day Use Area: Picnic Areas | [30.61878, -95.53216] | There is a gap spaced greater than a 1/2 inch. Openings in floor or ground surfaces shall not allow passage of a sphere more than 1/2 inch diameter. Elongated openings shall be placed so that the long dimension is perpendicular to the dominant direction of travel. | Gap of 1" near north table | Correct or fill gaps to be max .5" | 2015 ABAAS Section: 302.3 2012 TAS Section: 302.3 2010 ADAS Section: 302.3 | | |

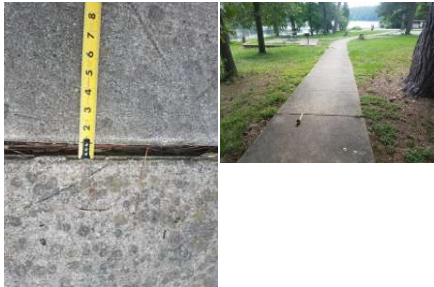
| Finding Number | Area Description | Lat/Long | Finding | As Built | Recommendation | Citation | Photos | Figure |
|---|---|---|--|---|---|--|---|---|
| 328 | Day Use Area: Picnic Areas | [30.6143035 , -95.534673 3] | There is a gap spaced greater than a 1/2 inch. Openings in floor or ground surfaces shall not allow passage of a sphere more than 1/2 inch diameter. Elongated openings shall be placed so that the long dimension is perpendicular to the dominant direction of travel. | Gap of 1" near boat ramp tables | Correct or fill gaps to be max .5" | 2015 ABAAS Section: 302.3 2012 TAS Section: 302.3 2010 ADAS Section: 302.3 | | |

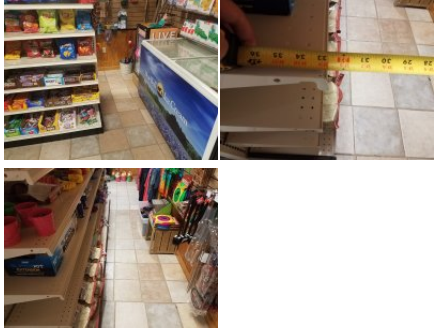
| Finding Number | Area Description | Lat/Long | Finding | As Built | Recommendation | Citation | Photos | Figure |
|---|---|---|--|--|--|--|--|--|
| 362 | Day Use Area: Park Store | [30.6155749 , -95.532811 2] | The route of travel at this location does not provide a minimum width of 36 inches. The clear width shall be permitted to be reduced to 32 inches minimum for a length of 24 inches maximum provided that reduced width segments are separated by segments that are 48 inches long minimum and 36 inches wide minimum. | Lacks 36" wide route of travel (33" between/around shelves) | Widen AR to compliant 36" clear width | 2015 ABAAS Section: 403.5.1 2012 TAS Section: 403.5.1 2010 ADAS Section: 403.5.1 | | |

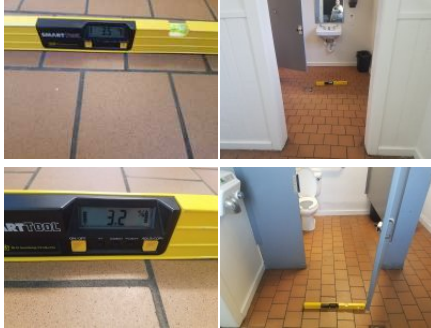
| Finding Number | Area Description | Lat/Long | Finding | As Built | Recommendation | Citation | Photos | Figure |
|---|---|---|--|---|---|--|---|---|
| 387 | Day Use Area: Lodge | [30.6132873 , -95.533778 2] | The accessible route contains running slopes greater than 5 percent and cross slopes greater than 2 percent across the width of the walk and has not been constructed as a ramp (i.e. handrails, wheel guides, etc.). When the slope in the direction of travel of any walk exceeds 1 unit vertical in 20 units horizontal (5-percent slope), it must be constructed as ramp. Surface cross slopes must not exceed one unit vertical in 48 units. Horizontal (2-percent slope). | Women's restroom - Slope of 3.5% near floor drain near sink (slope in sink CFS) and 3.2% near floor drain near stall door | Correct or repair slope to max 5% running and 2.08% cross | 2015 ABAAS Section: 403.3 2012 TAS Section: 403.3 2010 ADAS Section: 403.3 | | |

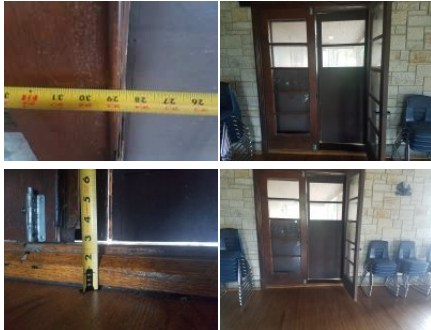
| Finding Number | Area Description | Lat/Long | Finding | As Built | Recommendation | Citation | Photos | Figure |
|---|---|---|---|--|--|--|---|---|
| 390 | Day Use Area: Lodge | [30.61325, -95.53376] | Door openings shall provide a clear width of 32 inches (815 mm) minimum. Clear openings of doorways with swinging doors shall be measured between the face of the door and the stop, with the door open 90 degrees. Openings more than 24 inches (610 mm) deep shall provide a clear opening of 36 inches (915 mm) minimum. There shall be no projections into the required clear opening width lower than 34 inches (865 mm) above the finish floor or ground. Projections into the clear opening width between 34 inches (865 mm) and 80 inches (2030 mm) above the finish floor or ground shall not exceed 4 inches (100 mm). The threshold at a doorway shall be no higher than 1/2 inch. Changes in level between 1/4 inch and 1/2 inch must be beveled at 1:2 or less. 1/4 inch is the maximum vertical rise. | Banquet room to patio doors - 28.75" wide, and CIL of 1.25" at threshold | For all doors along the public circulation route, replace doors with doors having 80" overhead clearance and 32" clear width For all doors along the public circulation route, repair, provide beveled threshold | 2010 ADAS Section: 404.2.3, 404.2.7, 404.2.4, 404.2.11, 404.2.11 Exception | | |

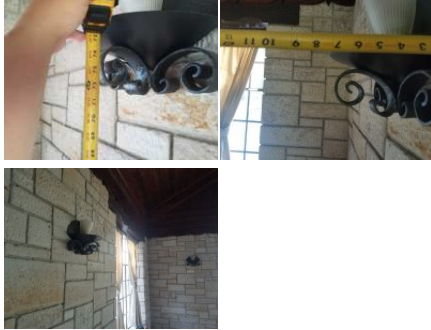
| Finding Number | Area Description | Lat/Long | Finding | As Built | Recommendation | Citation | Photos | Figure |
|---|---|---|---|--|--|--|---|---|
| 391 | Day Use Area: Lodge | [30.6132781, -95.5337835] | The light sconces projects more than 4 inches into the circulation path. Wall-mounted objects that have leading edges between 27 inches and 80 inches from the floor must not project more than 4 inches into the circulation path. Protruding objects that extend to the floor or within 27 inches of the floor are cane detectable and are therefore not hazardous. Where it is necessary or desirable to have objects protrude from the wall, a manner of cane detection must be provided. | Light sconces protrude 7" | Relocate protruding objects or place cane detectable warning or bollard at foot of item | 2015 ABAAS Section: 307.2 2012 TAS Section: 307.2 2010 ADAS Section: 307.2 | | |

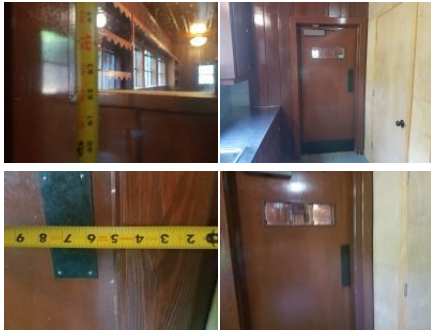
| Finding Number | Area Description | Lat/Long | Finding | As Built | Recommendation | Citation | Photos | Figure |
|---|---|---|--|--|---|---|--|---|
| 394 | Day Use Area: Lodge | [30.61324, -95.53374] | Minimum maneuvering clearances at doors and gates shall comply with 404.2.4. Maneuvering clearances shall extend the full width of the doorway and the required latch side or hinge side clearance. Doors, gates, and side lights adjacent to doors or gates, containing one or more glazing panels that permit viewing through the panels shall have the bottom of at least one glazed panel located 43 inches (1090 mm) maximum above the finish floor. EXCEPTION: Vision lights with the lowest part more than 66 inches (1675 mm) from the finish floor or ground shall not be required to comply with 404.2.11. | Lodge kitchen right door - Lacks maneuvering clearance on push side (5" to wall - structural), and vision panel at 62" aff | For all doors along the public circulation route, provide required maneuvering clearance on push and pull side of doors For all doors along the public circulation route, replace doors with ones having sidelight viewing windows max 43" aff | 2010 ADAS Section: 404.2.3, 404.2.7, 404.2.4, 404.2.11, 404.2.11 Exception | | |

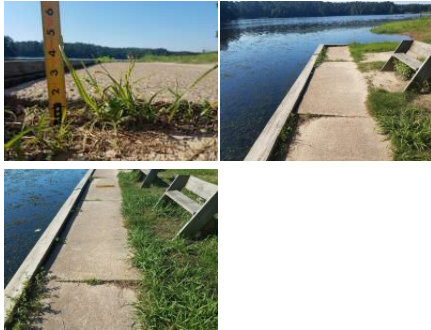
| Finding Number | Area Description | Lat/Long | Finding | As Built | Recommendation | Citation | Photos | Figure |
|---|---|---|--|---|---|--|---|---|
| 441 | Day Use Area: Day Use Area Park Amenities | [30.6153381 , -95.532240 5] | The walkway contains abrupt vertical edges and/or variations over a 1/4 inch. 1/4 inch is the maximum vertical rise. Changes in level between 1/4 inch and 1/2 inch must be beveled at 1:2 or less. Changes in level greater than 1/2 inch must be by way of a ramp. | Multiple CILs up to 1.5" due to upheaval of cement panels on walkway near water | Repair, bevel or ramp CIL along AR | 2012 TAS Section: 303.2, 303.3 2010 ADAS Section: 303.2, 303.3 | | |

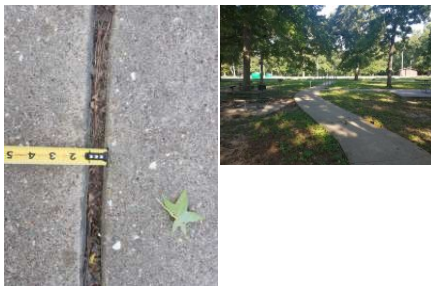
| Finding Number | Area Description | Lat/Long | Finding | As Built | Recommendation | Citation | Photos | Figure |
|---|---|---|--|---|---|--|---|---|
| 443 | Day Use Area: Day Use Area Park Amenities | [30.6149693 , -95.532708 1] | There is a gap spaced greater than a 1/2 inch. Openings in floor or ground surfaces shall not allow passage of a sphere more than 1/2 inch diameter. Elongated openings shall be placed so that the long dimension is perpendicular to the dominant direction of travel. | Gap of 1" near accessible picnic table and ramp | Correct or fill gaps to be max .5" | 2015 ABAAS Section: 302.3 2012 TAS Section: 302.3 2010 ADAS Section: 302.3 | | |

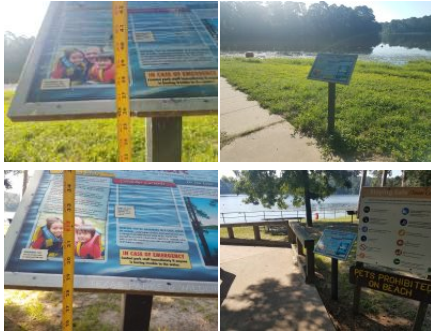
| Finding Number | Area Description | Lat/Long | Finding | As Built | Recommendation | Citation | Photos | Figure |
|---|---|---|---|--|---|---|--|---|
| 453 | Day Use Area: Day Use Area Park Amenities | [30.6147245 , -95.53254 66], [30.614376, -95.532967 7] | Visual characters shall be 40 inches (1015 mm) minimum above the finish floor or ground. EXCEPTION: Visual characters indicating elevator car controls shall not be required to comply with 703.5.6. | Visual characters of swimming informational sign lack 40" minimum above the finish floor or ground (33.5") | Remount signage to min 40" aff. | 2015 ABAAS Section: 703.5.6, 703.5.6 EXCEPTION 2012 TAS Section: 703.5.6, 703.5.6 Exception 2010 ADAS Section: 703.5.6, 703.5.6 Exception | | |

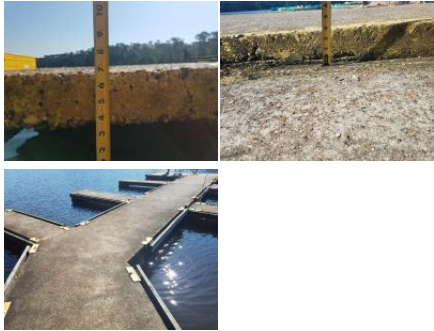
| Finding Number | Area Description | Lat/Long | Finding | As Built | Recommendation | Citation | Photos | Figure | | | | | | | | | | | | | | | | | | | | | | | | | | | | |
|--|--|---|--|--|--|---|--|---|--|--|---|---|---|---|---|---|---|---|---|---|---|---|---|---|---|---|---|---|---|---|---|---|---|---|---|---|
| 468 | Day Use Area: Boat Rental | [30.6159026 , -95.532108 5] | The minimum number of boarding piers are not accessible. Where boarding piers are provided at boat launch ramps, at least 5 percent, but no fewer than one, of the boarding piers be accessible. | CIL of 7" to access all slips on this dock | Repair, bevel, or ramp CIL along AR | 2015 ABAAS Section: F235.3 2010 ADAS Section: 235.3 |

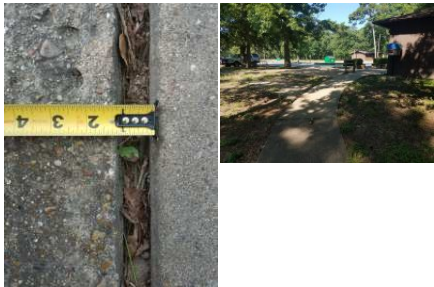
| Finding Number | Area Description | Lat/Long | Finding | As Built | Recommendation | Citation | Photos | Figure |
|---|---|---|--|---|---|--|--|---|
| 473 | Day Use Area: Boat Rental | [30.6155177 , -95.532686 2] | There is a gap spaced greater than a 1/2 inch. Openings in floor or ground surfaces shall not allow passage of a sphere more than 1/2 inch diameter. Elongated openings shall be placed so that the long dimension is perpendicular to the dominant direction of travel. | Gap of 1" near store | Correct or fill gaps to be max .5" | 2015 ABAAS Section: 302.3 2012 TAS Section: 302.3 2010 ADAS Section: 302.3 | | |

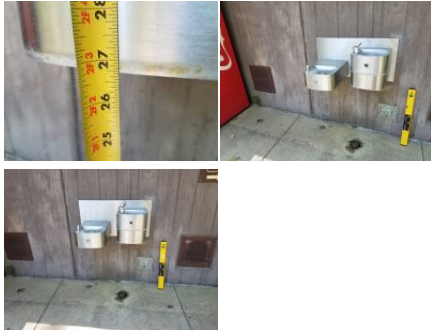
| Finding Number | Area Description | Lat/Long | Finding | As Built | Recommendation | Citation | Photos | Figure |
|---|---|---|---|---|---|--|--|---|
| 507 | Shelter Sites: Shelter Sites Restroom | [30.616886, -95.536095 6] | There is not enough knee clearance under the drinking fountain. The drinking fountain must have a clear knee space between the bottom of the apron and the floor not less than 27 inches in height, 30 inches in width, and 8 inches in depth. | Drinking fountain lacks 8" deep knee clearance | Remount fountain to provide 9" high toe and 27" high knee clearance | 2015 ABAAS Section: 602.2 2012 TAS Section: 602.2 2010 ADAS Section: 602.2 | | |

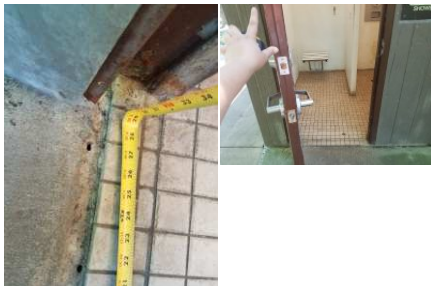
| Finding Number | Area Description | Lat/Long | Finding | As Built | Recommendation | Citation | Photos | Figure |
|---|---|---|---|---|---|--|--|---|
| 508 | Shelter Sites: Shelter Sites Restroom | [30.6168738 , -95.536088 5] | The door opening does not provide at least 32 inches between the face of the door and the opposite stop. Door openings shall provide a clear width of 32 inches minimum. Clear openings of doorways with swinging doors shall be measured between the face of the door and the stop, with the door open 90 degrees. There shall be no projections into the required clear opening width lower than 34 inches above the finish floor or ground. Projections into the clear opening width between 34 inches and 80 inches above the finish floor or ground shall not exceed 4 inches. | Inaccessible shower door - 29" width | Replace door with one having 32" clear width | 2015 ABAAS Section: 404.2.3 2012 TAS Section: 404.2.3 2010 ADAS Section: 404.2.3 | | |

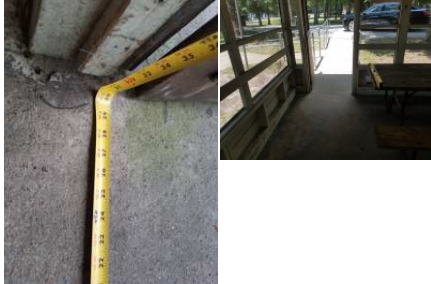
| Finding Number | Area Description | Lat/Long | Finding | As Built | Recommendation | Citation | Photos | Figure |
|---|---|--|---|--|---|--|---|---|
| 517 | Shelter Sites: Shelter Campsites | [30.6173222 , -95.536919] | The door opening does not provide at least 32 inches between the face of the door and the opposite stop. Door openings shall provide a clear width of 32 inches minimum. Clear openings of doorways with swinging doors shall be measured between the face of the door and the stop, with the door open 90 degrees. There shall be no projections into the required clear opening width lower than 34 inches above the finish floor or ground. Projections into the clear opening width between 34 inches and 80 inches above the finish floor or ground shall not exceed 4 inches. | Site 20 shelter door - 30" width | Replace door with one having 32" clear width | 2015 ABAAS Section: 404.2.3 2012 TAS Section: 404.2.3 2010 ADAS Section: 404.2.3 | | |

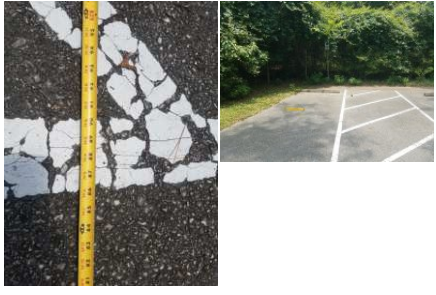
| Finding Number | Area Description | Lat/Long | Finding | As Built | Recommendation | Citation | Photos | Figure |
|---|--|---|---|--|---|--|--|--|
| 564 | Shelter Sites: Shelter Campsites | [30.6175969 , -95.536027 2] | The accessible parking stall is not wide enough. Each parking space must be at least 8' feet wide and shall be marked to define the width. The measurements of parking spaces and access aisles shall be made from the centerline of the markings. Where the parking space is not adjacent to another parking space or access aisle, the measurement shall be permitted to include the full width of the line defining the parking space. | Site 23 - Lacks width requirement for accessible parking stall (88" wide - narrows at head of stall) | Repaint stalls to be 8' wide each | 2015 ABAAS Section: 502.2 2012 TAS Section: 502.2 2010 ADAS Section: 502.2 | | |

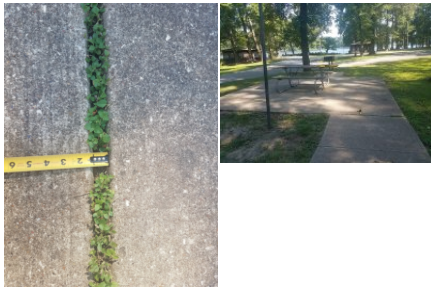
| Finding Number | Area Description | Lat/Long | Finding | As Built | Recommendation | Citation | Photos | Figure |
|---|---|---|---|--|---|--|---|--|
| 571 | Shelter Sites: Shelter Campsites | [30.61765, -95.5369807] | The surface of the outdoor recreation access route, passing spaces, and/or resting intervals are not firm and stable. The surface of outdoor recreation access route, passing spaces, and resting intervals shall be firm and stable, having a width of 36", max gaps of .5" and tread obstacles of .5" or less. | Site 26 - Gap of 1" near picnic table | Correct surface of ORAR to be firm and stable, a min 36" wide and having gaps and changes in level of max .5" | 2015 ABAAS Section: 1016.2 | | |

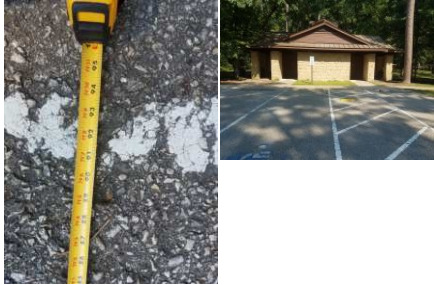
| Finding Number | Area Description | Lat/Long | Finding | As Built | Recommendation | Citation | Photos | Figure |
|---|---|---|---|--|--|---|---|---|
| 577 | Prairie Branch Camping Area: Parking - Prairie Branch Restrooms | [30.6198913 , -95.534857 8] | There are no van accessible parking stalls. 1 in every 6, minimum of one, required accessible stalls must be a van accessible stall. There are a total of 3 parking stalls in the parking lot that could be reasonably associated with this facility. There should be a minimum of 1 accessible stalls with a minimum of 1 being designed as van accessible. | Lacks total required width (189") of stall (96") and access aisle (93") for a van accessible parking space | Add van parking sign to 1 accessible stall and repaint stall and access aisle to 11' and 5' or 8' and 8' per the table | 2015 ABAAS Section: F208.2, F208.2.4 2012 TAS Section: 208.2, 208.2.4 2010 ADAS Section: 208.2, 208.2.4 | | |

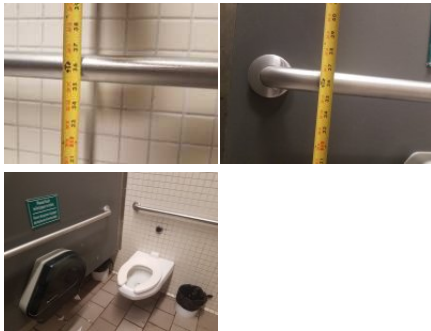
| Finding Number | Area Description | Lat/Long | Finding | As Built | Recommendation | Citation | Photos | Figure |
|---|---|---|---|---|--|--|--|---|
| 584 | Prairie Branch Camping Area: Prairie Branch Restrooms | [30.6197898 , -95.5346579] | The grab bar height and/or spacing fails. Grab bars must be mounted between 33" and 36" to the top of the gripping surface. There must be 1.5" of clearance between the grab bar and the wall. There must be a minimum of 1.5" of clearance below and minimum 12" above the grab bar to any dispenser or other obstruction. | Women's restroom - Side and rear grab bars are 36.75" aff | Remount grab bars in accessible stall to 33" to 36" aff | 2015 ABAAS Section: 609.3, 609.4 2012 TAS Section: 609.4, 609.3 2010 ADAS Section: 609.3, 609.4 | | |

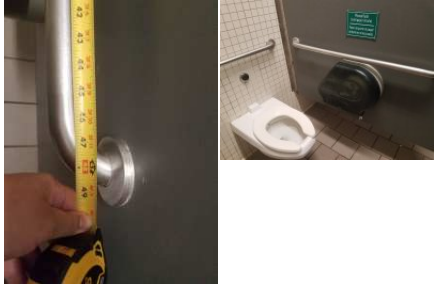
| Finding Number | Area Description | Lat/Long | Finding | As Built | Recommendation | Citation | Photos | Figure |
|---|--|---|---|--|---|--|--|---|
| 595 | Prairie Branch Camping Area: Prairie Branch Restrooms | [30.6197898 , -95.534655 2] | The side grab bars are not in the correct location. Grab bars on the side wall must be installed so that the end closest to the rear wall is maximum 12" from the rear wall. The end furthest from the rear wall must be mounted minimum 54" from the rear wall. | Men's restroom - Side grab bar ends 48.5" from rear wall | Remount side grab bar to max 12" from the rear wall at the close end and min 54" on the far end, and 33" to 36" aff | 2015 ABAAS Section: 604.5.1 2012 TAS Section: 604.5.1 2010 ADAS Section: 604.5.1 | | |

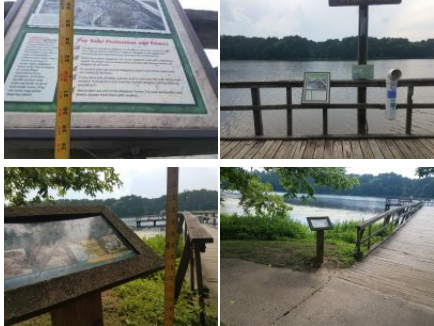
| Finding Number | Area Description | Lat/Long | Finding | As Built | Recommendation | Citation | Photos | Figure |
|---|--|--|--|--|--|---|---|---|
| 615 | Prairie Branch Camping Area: Prairie Branch Loop Fishing | [30.619143, -95.536368 4], [30.6192481, -95.536692 9] | Visual characters shall be 40 inches (1015 mm) minimum above the finish floor or ground. EXCEPTION: Visual characters indicating elevator car controls shall not be required to comply with 703.5.6. | Visual characters of alligator informational signs lack 40" minimum above the finish floor or ground | Remount signage to min 40" aff. | 2015 ABAAS Section: 703.5.6, 703.5.6 EXCEPTION 2012 TAS Section: 703.5.6, 703.5.6 Exception 2010 ADAS Section: 703.5.6, 703.5.6 Exception | | |

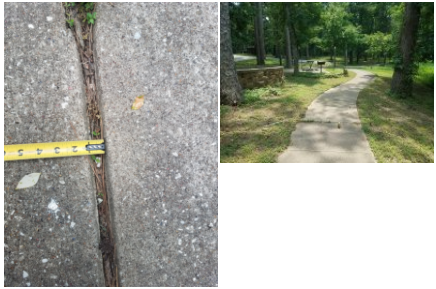
| Finding Number | Area Description | Lat/Long | Finding | As Built | Recommendation | Citation | Photos | Figure |
|---|--|--|--|--|---|--|--|--|
| 618 | Prairie Branch Camping Area: Prairie Branch Loop Fishing | [30.6189296 , -95.5363787] | There is a gap spaced greater than a 1/2 inch. Openings in floor or ground surfaces shall not allow passage of a sphere more than 1/2 inch diameter. Elongated openings shall be placed so that the long dimension is perpendicular to the dominant direction of travel. | Gap of 1" | Correct or fill gaps to be max .5" | 2015 ABAAS Section: 302.3 2012 TAS Section: 302.3 2010 ADAS Section: 302.3 | | |

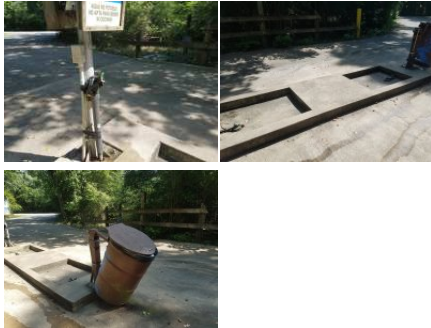
| Finding Number | Area Description | Lat/Long | Finding | As Built | Recommendation | Citation | Photos | Figure |
|---|---|---|---|---|---|--|---|---|
| 625 | Prairie Branch Camping Area: Prairie Branch Camping | [30.6174246 , -95.534866 8] | The dump site amenities are not accessible because they require tight grasping, pinching or twisting of the wrist. | Dump site amenities difficult to operate without tight pinch or grasp, foot operated dump station | Replace spigot with an operable part usable without a tight pinch or grasp Replace the drain cover with an operable part within reach range of 15" to 48" aff | 2015 ABAAS Section: 309.4 2012 TAS Section: 309.4 2010 ADAS Section: 309.4 | | |

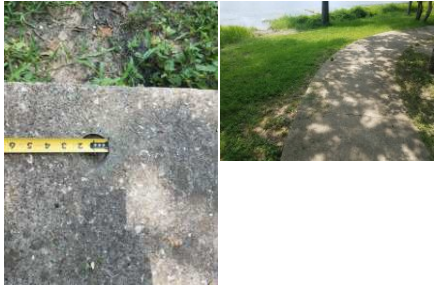
| Finding Number | Area Description | Lat/Long | Finding | As Built | Recommendation | Citation | Photos | Figure |
|---|--|---|--|--|---|--|---|---|
| 658 | Prairie Branch Camping Area: Prairie Branch Camping | [30.6193292 , -95.5362178] | There is a gap spaced greater than a 1/2 inch. Openings in floor or ground surfaces shall not allow passage of a sphere more than 1/2 inch diameter. Elongated openings shall be placed so that the long dimension is perpendicular to the dominant direction of travel. | Gaps/holes of 2" where railing was removed | Correct or fill gaps to be max .5" | 2015 ABAAS Section: 302.3 2012 TAS Section: 302.3 2010 ADAS Section: 302.3 | | |

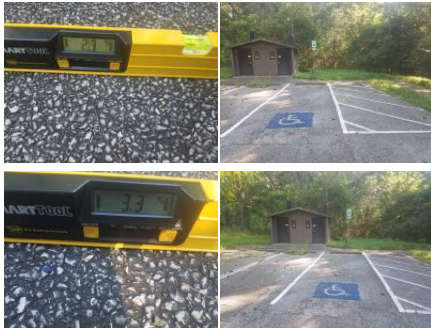
| Finding Number | Area Description | Lat/Long | Finding | As Built | Recommendation | Citation | Photos | Figure |
|---|---|---|---|---|---|--|--|--|
| 691 | Equestrian Area (Closed): Equestrian Area (Closed) | [30.6252982 , -95.526387 3] | The cross slopes (narrow dimension) and/or running slopes (long dimension) of the access aisle exceeds 2%. The running slope and the cross slope in an accessible parking stall and the access aisle must not exceed 2%. | Slopes of 2.9% in access aisle and 3.3% in stall | Repair or correct slope of parking space and access aisle to max 2.08% in any direction | 2015 ABAAS Section: 502.4 2012 TAS Section: 502.4 2010 ADAS Section: 502.4 | | |
